SINCERE
APPRAISAL SERVICES PTE LTD

VEHICLE DAMAGE INSPECTION REPORT

Our Ref: 592/TP/2018

Reg No:	GBF7912S	Make &	Nissan
Reg date:	16/3/2017	Model	NV200
Colour:	Silver	Engine No:	HR16074351D
Type:	Motor Car	Chassis No:	VM20100365
Type of Claims:	Third Party	Odometer No:	23728km
		Engine Cap:	1597cc

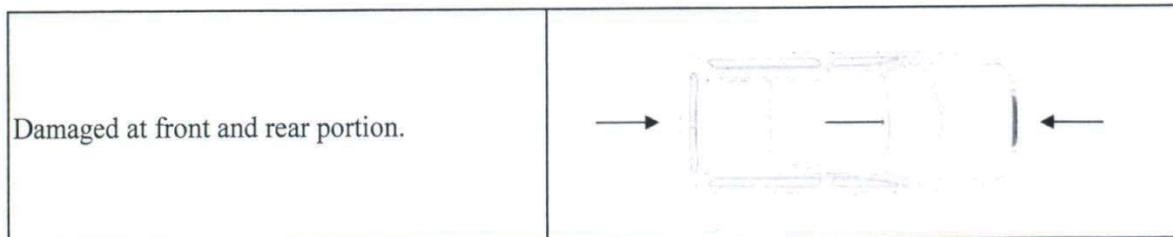
POINT OF IMPACT

Our visual inspection of the vehicle revealed that the damages noted are at the front and rear portion.
