## LKK Auto Consultants Pte Ltd

Vehicle No. GBF 4764Y  
Insured Veh. GBC 4426P  
Claim No. SNM20D203935/C02  
Policy No. DMCVSN3084771900  
Accident Date 28/09/2020  
Inspection Date 15/10/2020

## ADJUSTMENT ON REPAIR COST FOR VEHICLE NO. GBF 4764Y

PHOTOGRAPHS FOR VEHICLE NO. GBF 4764Y

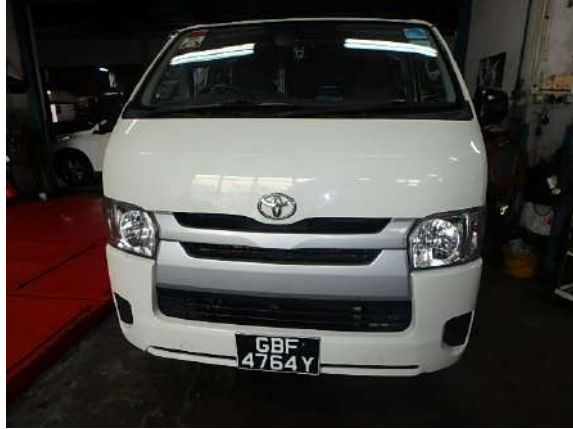
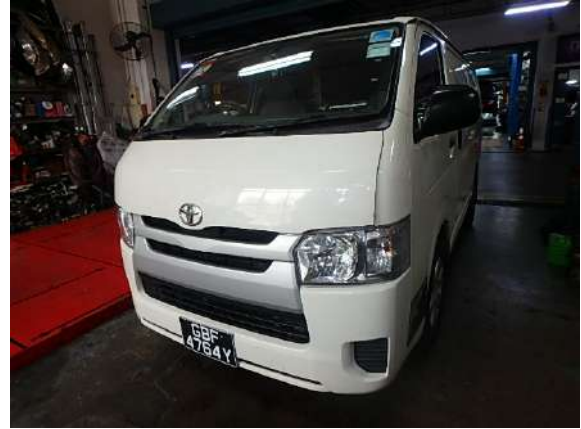
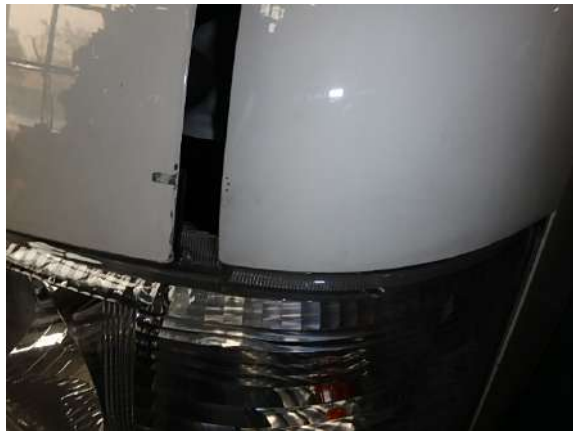
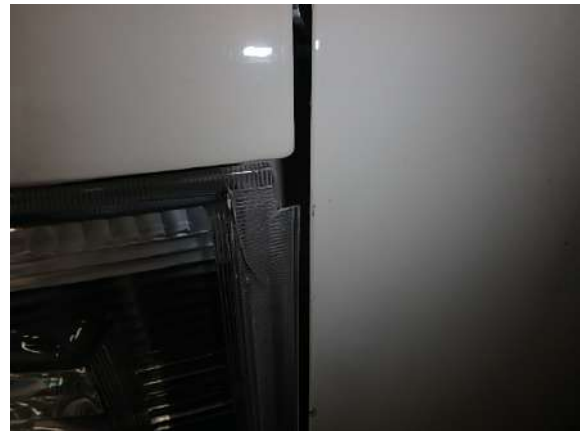
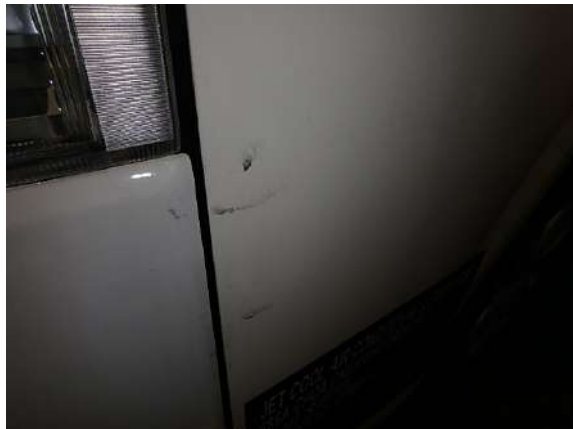
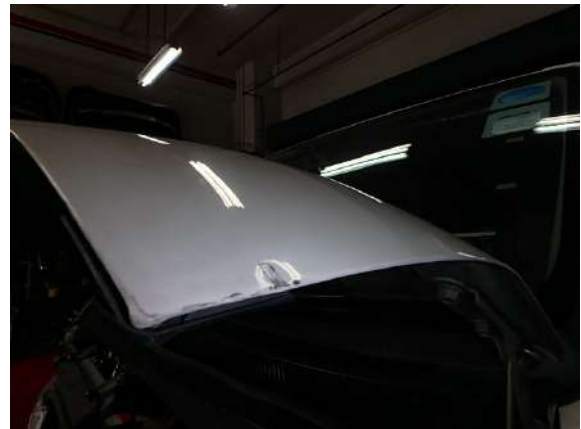
<b>R/H Front Tyre</b>	195 R15X8	BEARWAY	9 mm
	<b>L/H Front Tyre</b>	195 R15X8	BEARWAY	9 mm
	<b>R/H Rear Tyre</b>	195 R15X8	BEARWAY	9 mm
	<b>L/H Rear Tyre</b>	195 R15X8	BEARWAY	9 mm
<b>4. Description of Damages</b>				
	THE VEHICLE SUSTAINED DAMAGES AT THE N/S FRONT PORTION.  DAMAGES SEE DETAILS.			
<b>5. General Information</b>				
	<b>Accident Date</b>	28/09/2020	<b>Inspection Date</b>	15/10/2020
	<b>Survey held at</b>	GUAN MOTOR WORKS 176 SIN MING DRIVE #02-03 SIN MING AUTOCARE SINGAPORE 575721		
<b>5a. Remarks</b>				
	A)THE INSPECTION WAS CONDUCTED ON A"WITHOUT PREJUDICE" BASIS. B)IN ACCORDANCE TO YOUR INSTRUCTIONS, WE HAVE NOT AUTHORISED REPAIRS.			
<b>5b. Estimate Days of Repair</b>				
	ESTIMATED NORMAL PERIOD FOR REPAIR:		<b>3 Working Days</b>
