Affiliated to Federation Internationale Des Experts En Automobile				
QBE	BE INSURANCE (SINGAPORE) PTE LTD Ref : CC6/QBE20011385/Ada3q2				
1 RAFFLES QUAY #29-10 SOUTH TOWERSINGAPORE 048583		Date: 26-11-2020 Code: QBE

ADJUSTMENT ON REPAIR COST FOR VEHICLE NO. SLK 5521E

PHOTOGRAPHS FOR VEHICLE NO. SLK 5521E

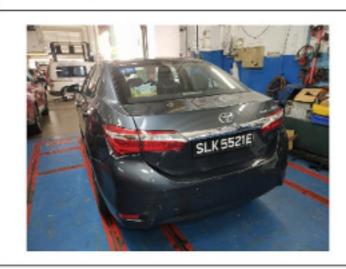
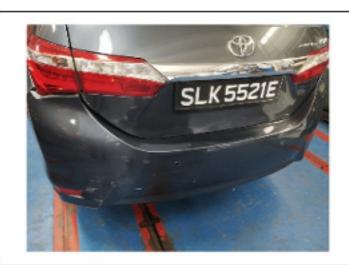
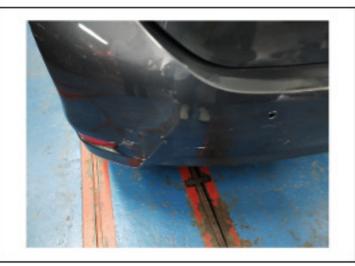
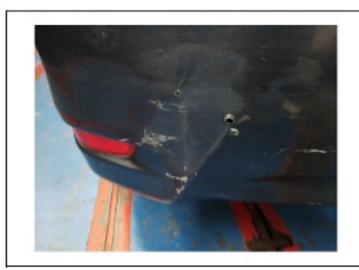
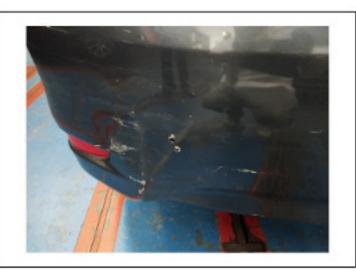
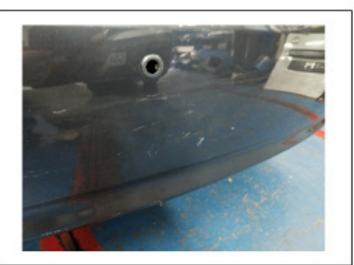
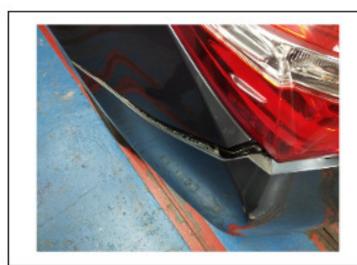
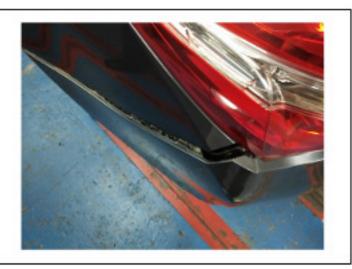
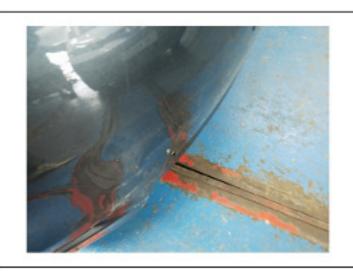
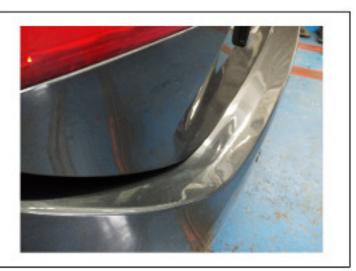
4.	r	•	on of Damages		
	THE VEHICLE SU	STAINED DAMAGES AT THE REA	AR PORTION.		
	DAMAGES SEE D				
5.		General	Information		
	Accident Date	17/10/2020	Inspection Date	19/10/2020	
	Survey held at CN MOTORS PTE LTD				
	1 KAKI BUKIT AVENUE 6 BLK C #01-41 AUTOBAY @ KAKI BUKIT SINGAPORE 417883				
5a.			emarks		
	A)THE INSPECTION WAS CONDUCTED ON A"WITHOUT PREJUDICE" BASIS. B)IN ACCORDANCE TO YOUR INSTRUCTIONS, WE HAVE NOT AUTHORISED REPAIRS.				
5b.	1=/	<u> </u>	Days of Repair		
	ESTIMATED NORMAL PERIOD FOR REPAIR: 6 Working Days				
	<u> </u>
