Your Ref: TP/IP/39835/2020
Our Ref : CI/TPD20011392/P

23rd November 2020

MECHANICAL INSPECTION REPORT OF MOTOR CAR SLD 8602Y

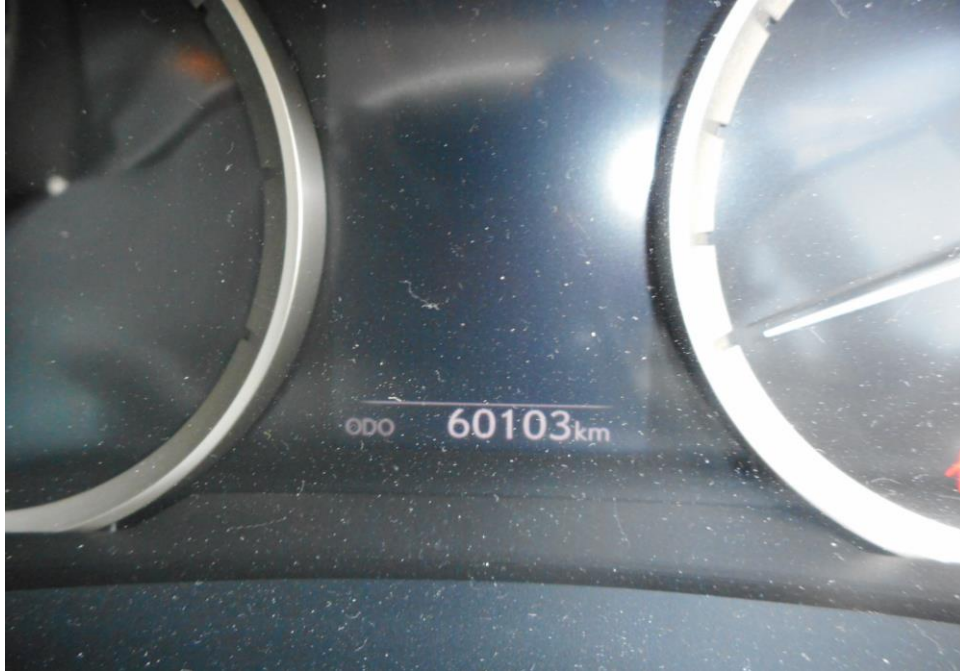
4. The mileage of the Motor car at the time of my inspection was 60,103km.
5. The Motor car was observed to have sustained damage at its front and left portion. Its front windscreen, front bumper, front left fender and front left headlamp were amongst the body parts that were damaged as a result of the accident. The Supplemental Restraint System (SRS) was also activated as a result of the accident.

Photo 1 shows the mileage of the Motor Car at the time of my inspection. The mileage observed was 60,103km.

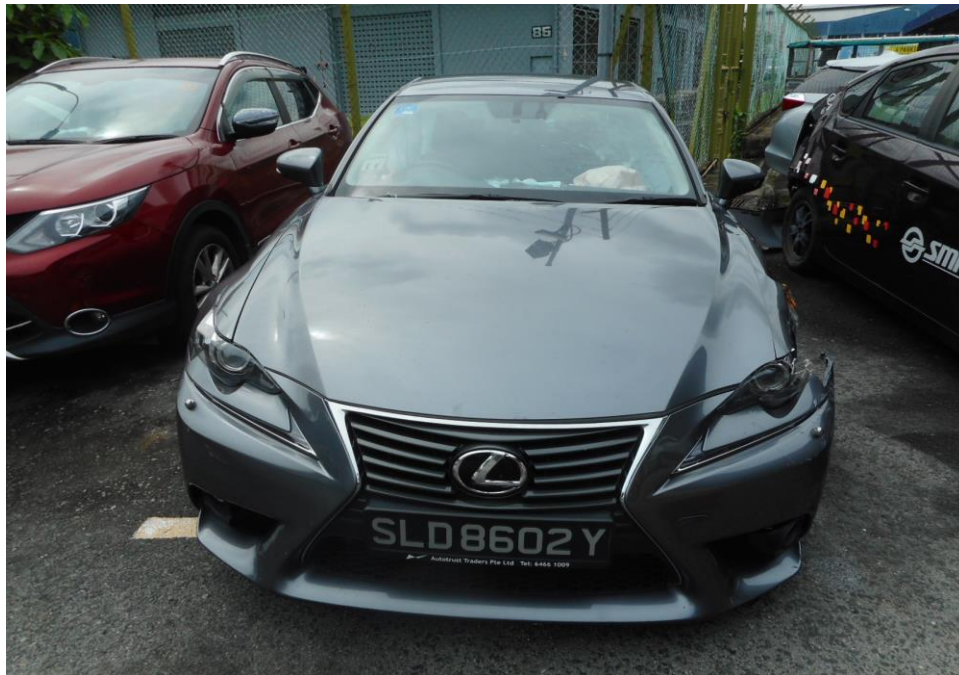
Photo 2 shows a general view of the Motor Car's front body at the time of my inspection. The Motor car was observed to have sustained damage at its front and left portion. Its front windscreen, front bumper, front left fender and front left headlamp were amongst the body parts that were damaged as a result of the accident.

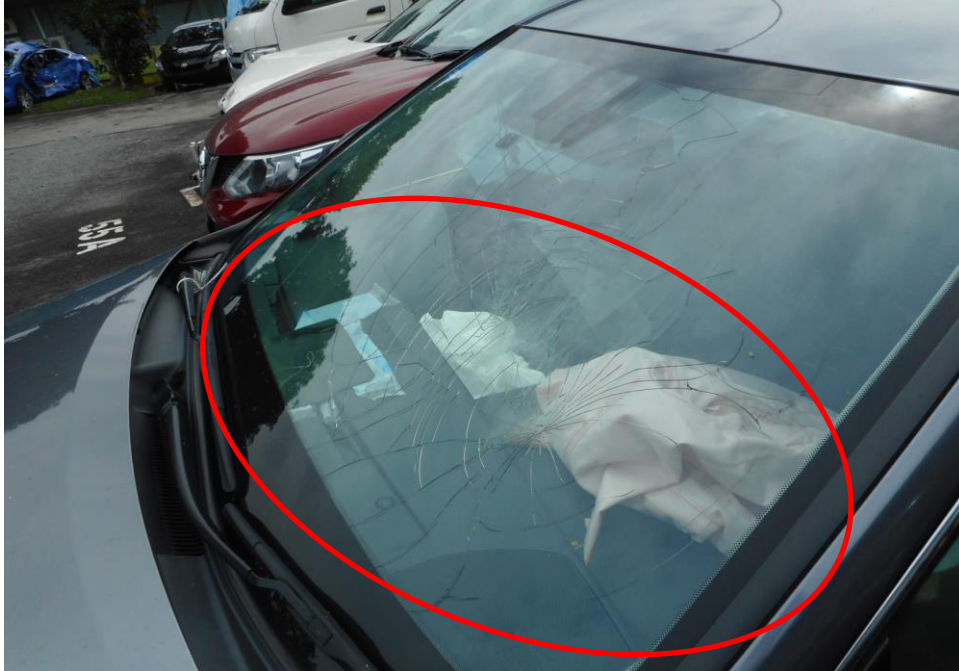
Photo 3 shows the close up view of the Motor Car's front body at the time of my inspection. The Motor car was observed to have sustained damage at its front portion. Its front windscreen (circled) were amongst the body parts that were damaged as a result of the accident.

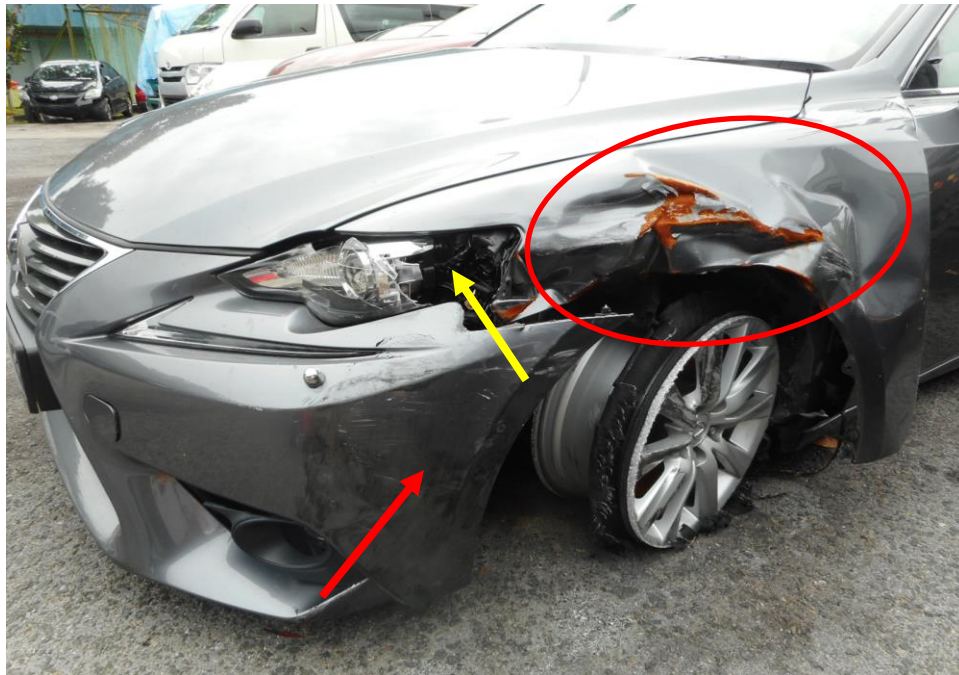
Photo 4 shows a close up view of the Motor Car's front portion at the time of my inspection. The Motor car was observed to have sustained damage at its front portion. Its front bumper (red arrow), front left headlamp (yellow arrow) and front left fender (circled) were amongst the body parts that were damaged as a result of the accident.

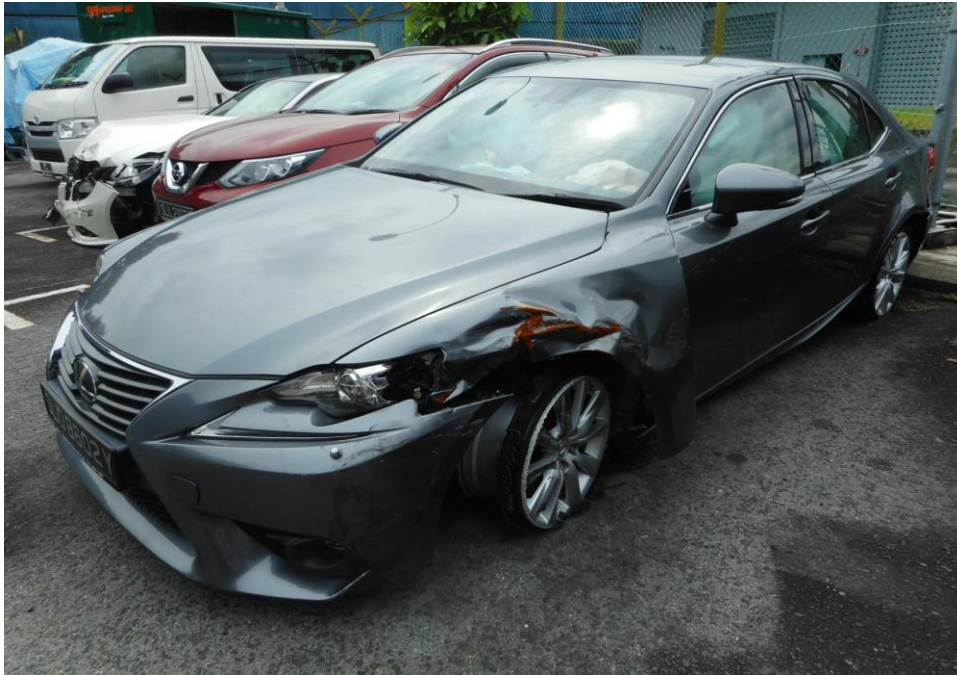
Photo 5 shows a general view of the Motor Car's left body at the time of my inspection. The left rear portion of the Motor Car was observed to have been undamaged by the accident.

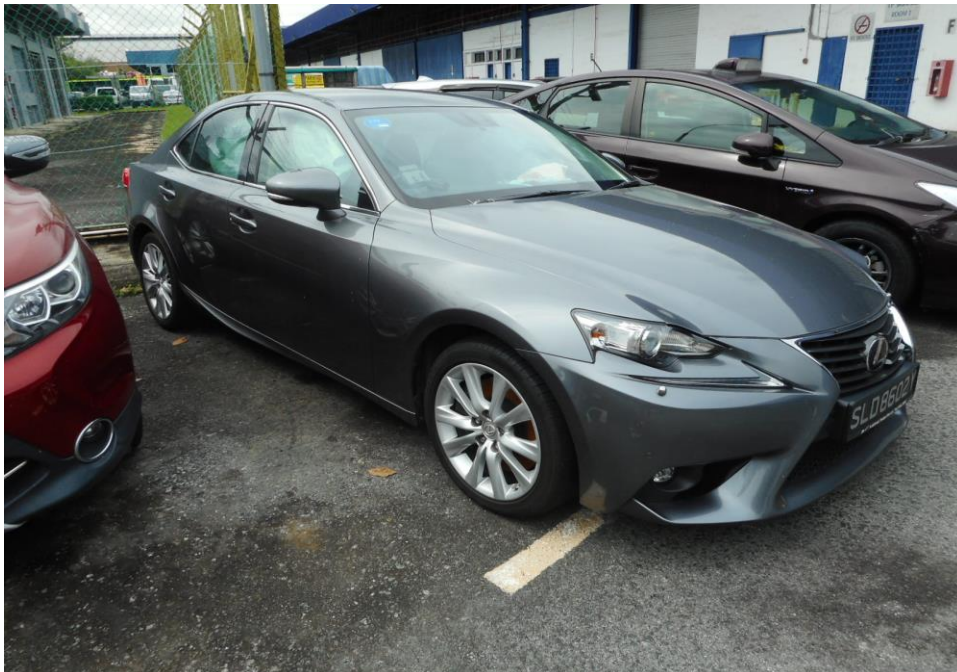
Photo 6 shows a general view of the Motor Car's right body at the time of my inspection. The right portion of the Motor Car was observed to have been undamaged by the accident.

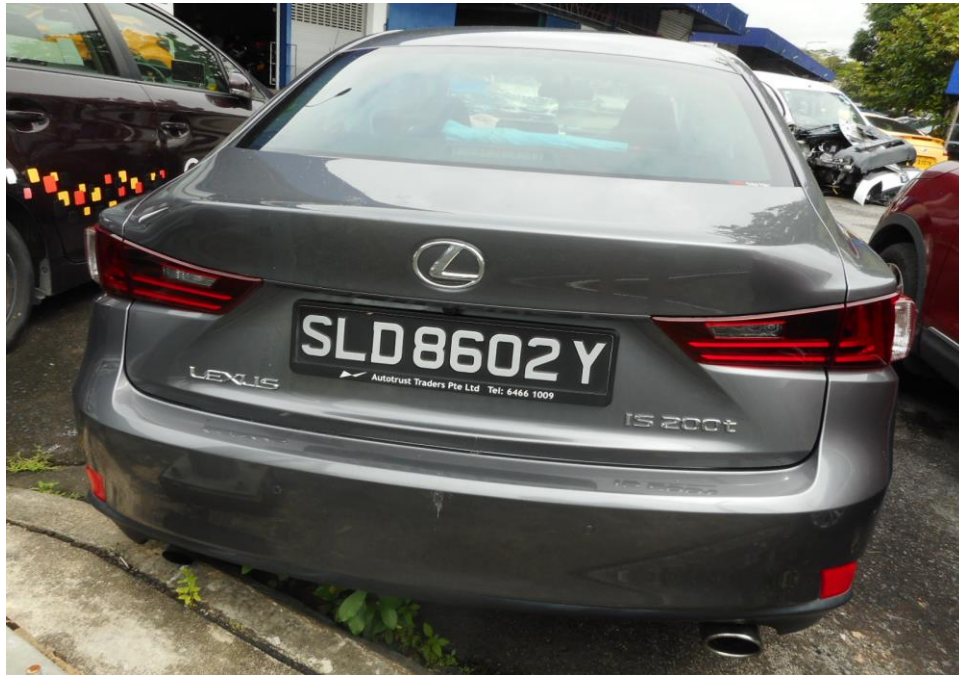
Photo 7 shows a general view of the Motor Car's rear body at the time of my inspection. The rear portion of the Motor Car was observed to have been undamaged by the accident.

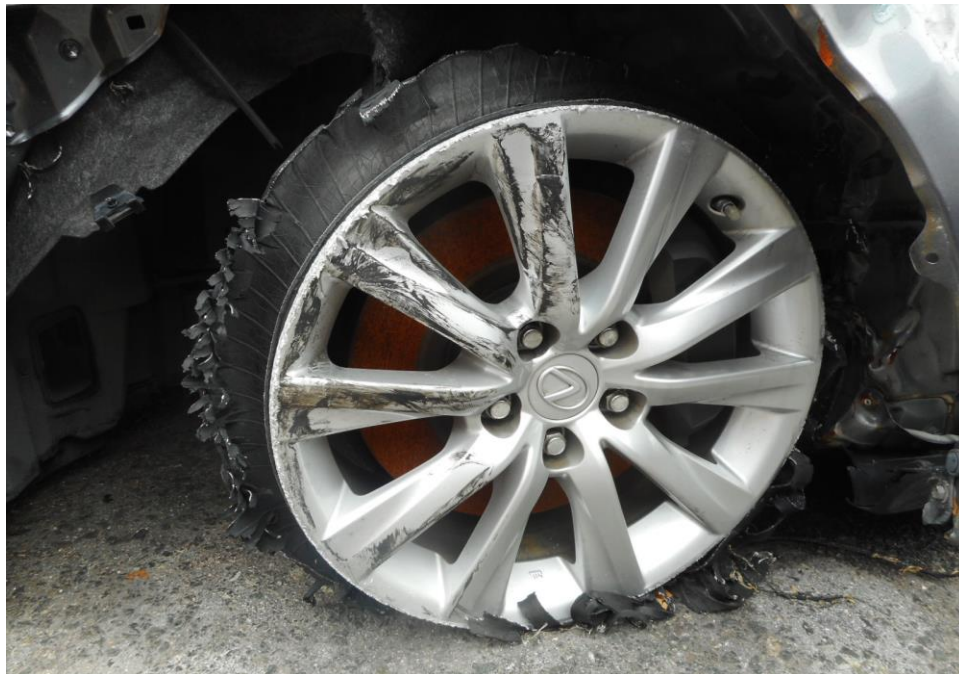
7. The 4 tyres were observed to be wrapped around standard alloy wheel rims, however the front left and rear left wheel rims were found to be damaged. See photo 1 – 12 below.

Photo 8 shows the condition of the front left tyre of the Motor Car, which was observed to be in unserviceable condition. The tyre and alloy wheel rim was observed to be damaged as a result of the accident.

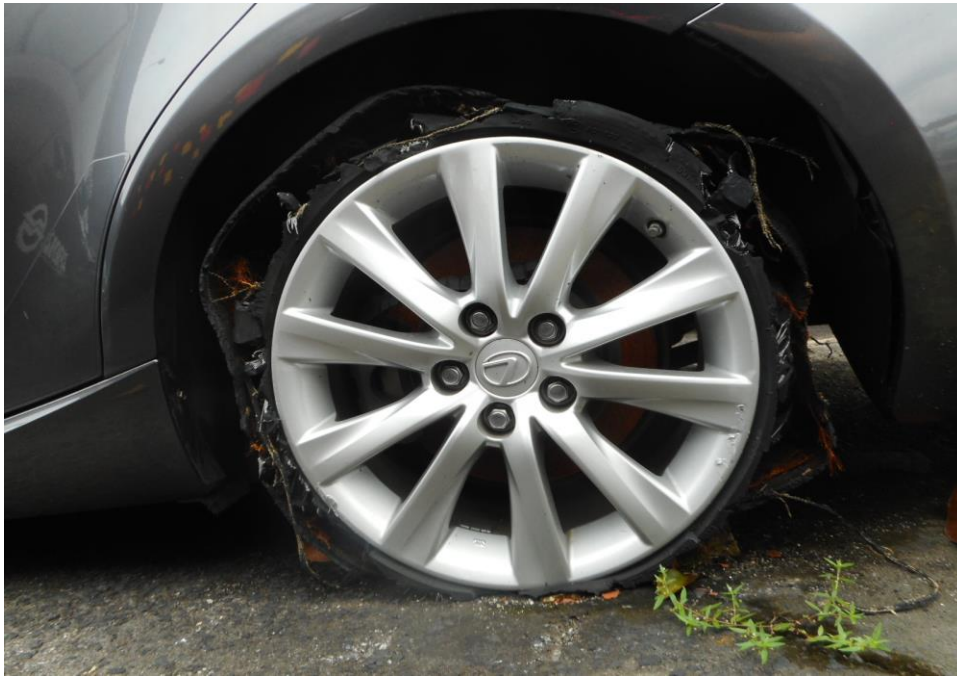
Photo 9 shows the condition of the rear left tyre of the Motor Car, which was observed to be in unserviceable condition. The tyre and alloy wheel rim was observed to be damaged as a result of the accident.

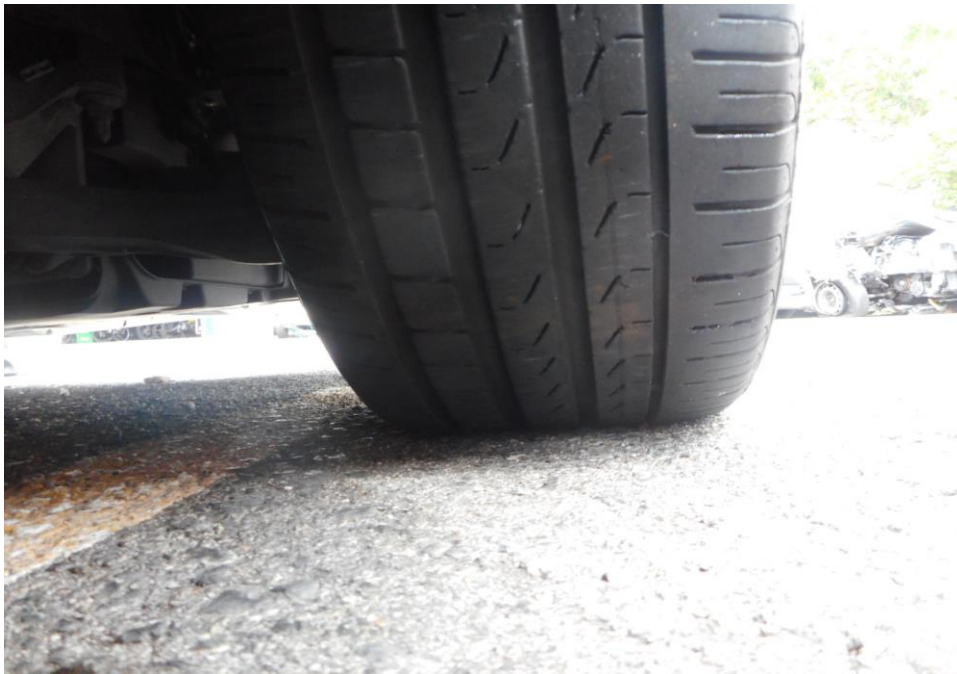
Photo 10 shows the condition of the front right tyre of the Motor Car, which was observed to be in serviceable condition with remaining tread depth of approximately 4.4mm. The tyre was also observed to be sufficiently inflated for vehicular operation with no tear, cut or burst mark(s).

19. Both the right front and rear tyres of the Motor Car were found to be in serviceable condition. I did not find any tear, cut or burst mark(s) on the outer and the inner sidewalls as well as across the tread of the 2 tyres. The 2 tyres were also observed to be sufficiently inflated for vehicular operation with remaining tread depth of approximately 4.4mm and 4.8mm.

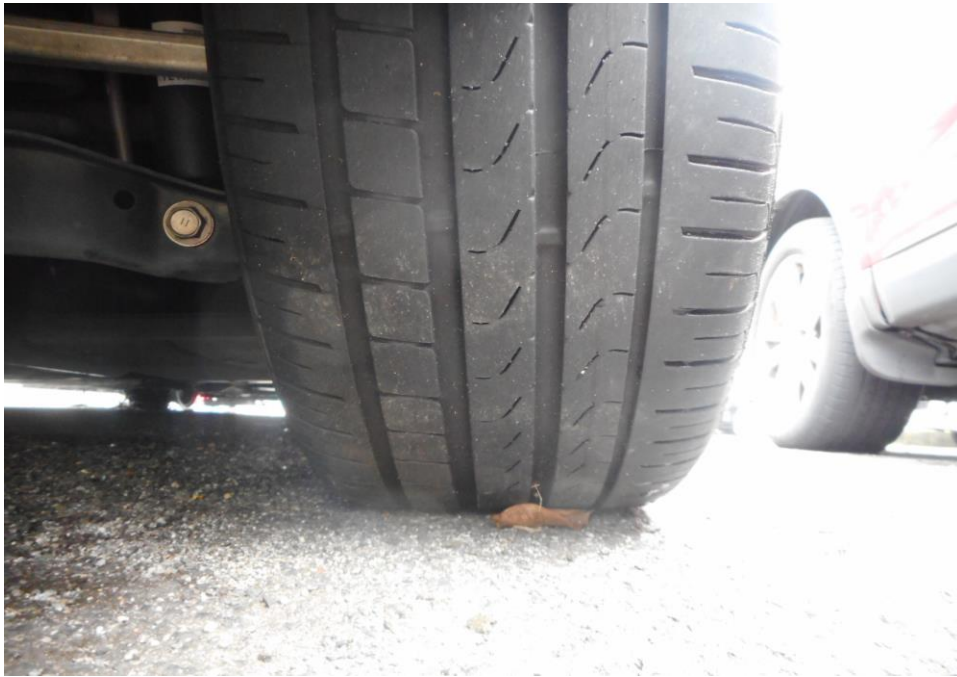
Photo 11 shows the condition of the rear right tyre of the Motor Car, which was observed to be in serviceable condition with remaining tread depth of approximately 4.8mm. The tyre was also observed to be sufficiently inflated for vehicular operation with no tear, cut or burst mark(s).

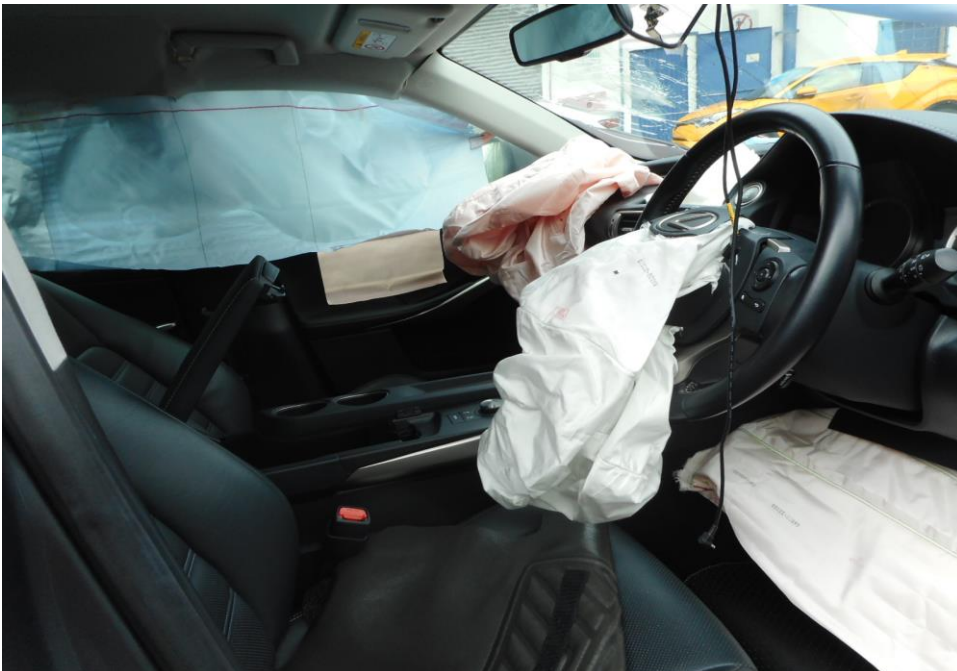
Photo 12 shows the deployment of the Supplemental Restraint System (SRS) airbag in the Motor Car as a result of the accident.

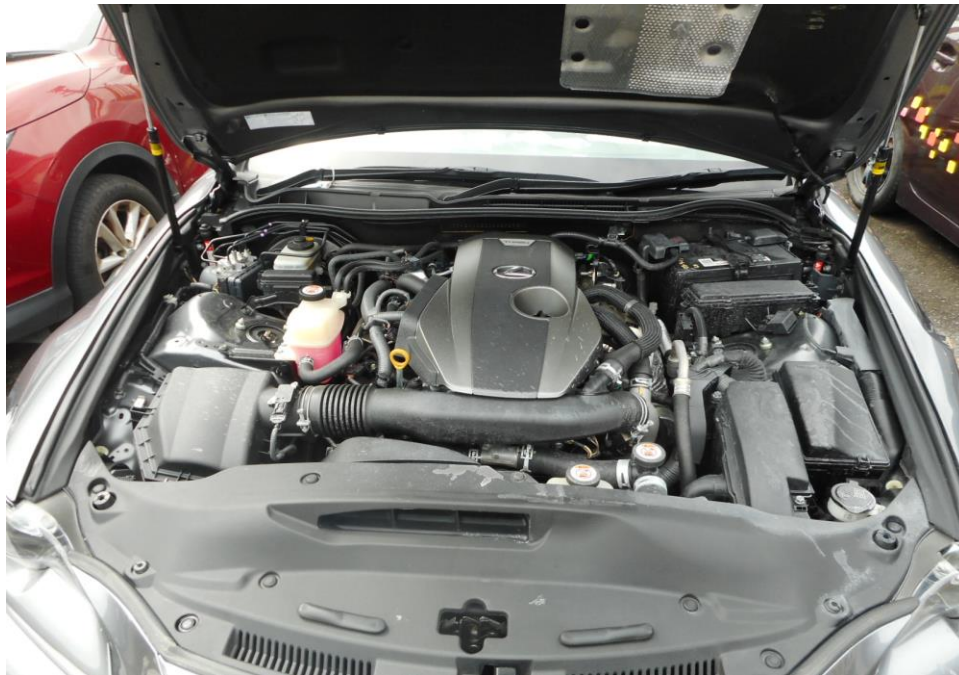
Photo 13 shows a general view of the Motor Car's engine compartment. The various parts and components inside the engine compartment were unaffected by the accident. There was also no sign(s) or indication(s) of fluid leakage and/or fluid stain within the engine compartment.

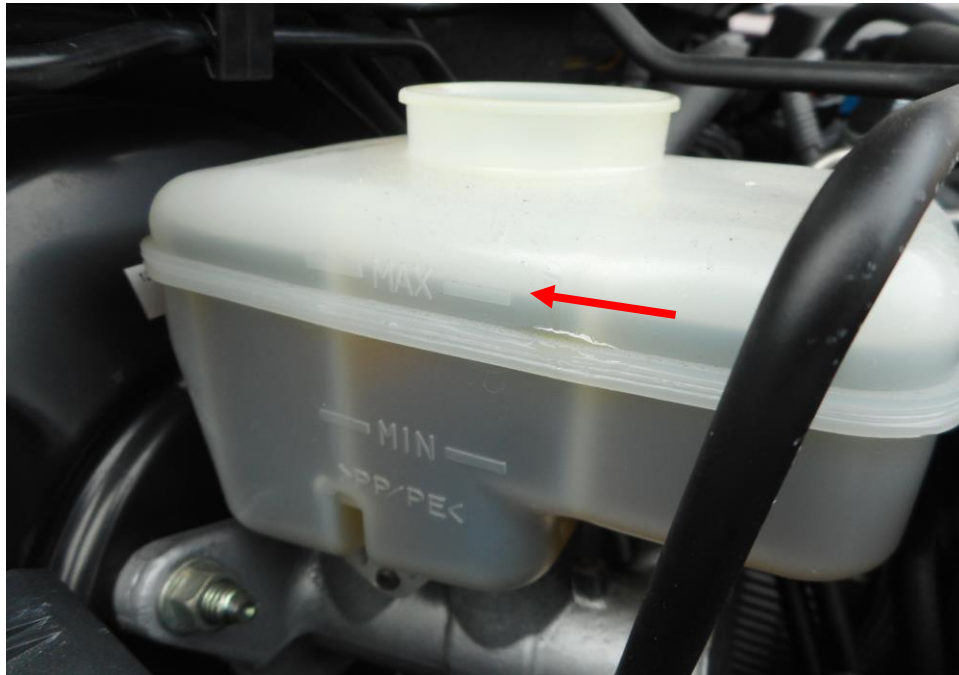
Photo 14 shows the brake fluid reservoir of the Motor Car at the time of my inspection. The brake fluid was observed to be of sufficient level (arrowed) and without any visible contamination.

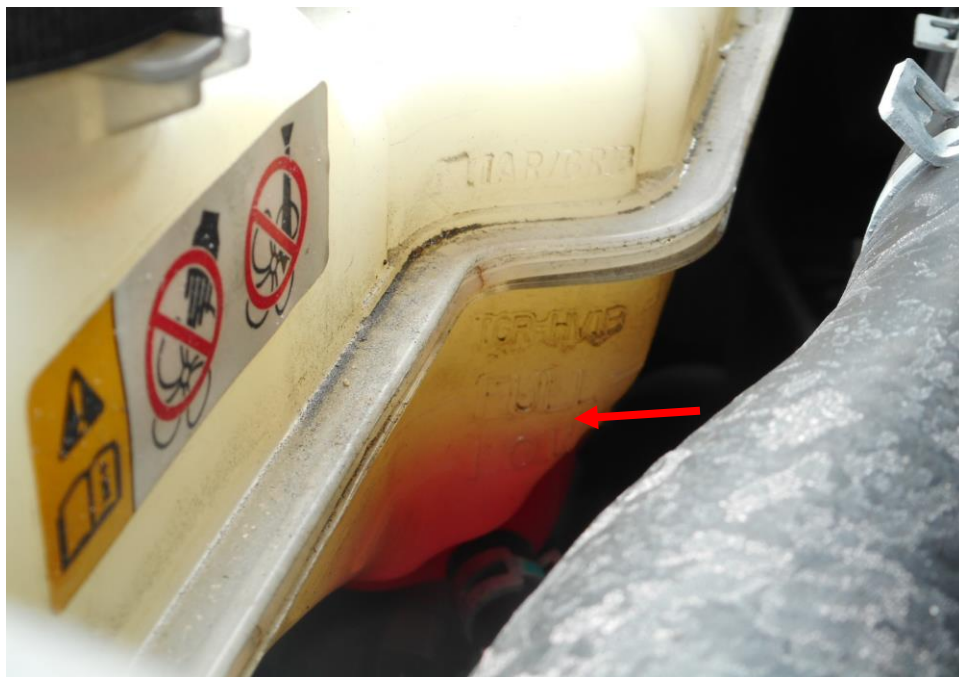
Photo 15 shows checks being carried out to the engine coolant of the Motor Car at the time of my inspection. The engine coolant was observed to be of sufficient level (arrowed) and without any visible contamination.

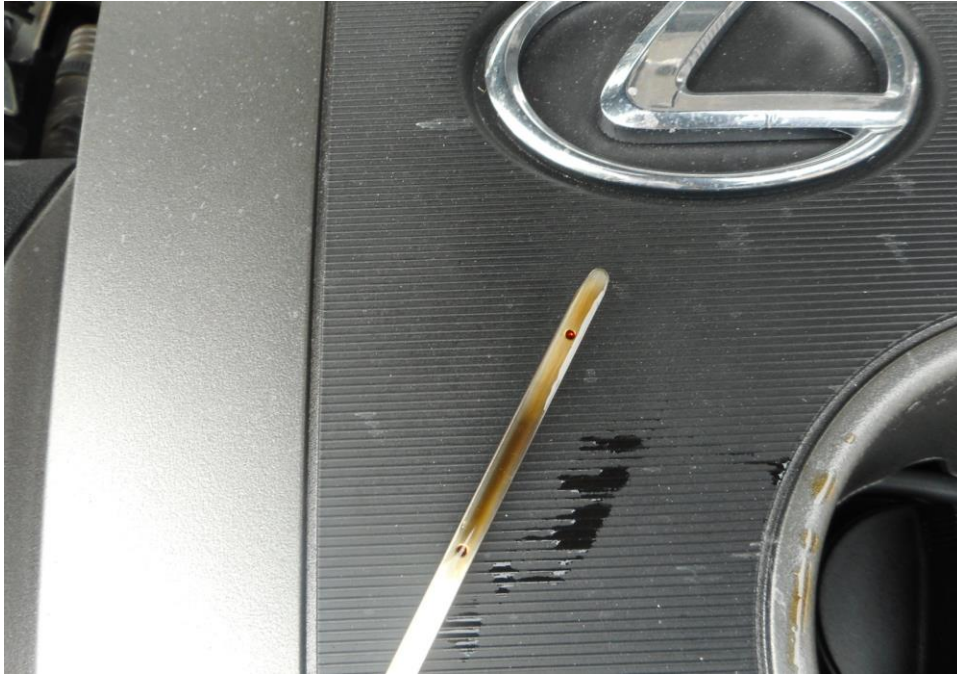
Photo 16 shows the engine oil dip stick of the Motor Car at the time of my inspection. The engine oil was observed to be of sufficient level and without any visible contamination.

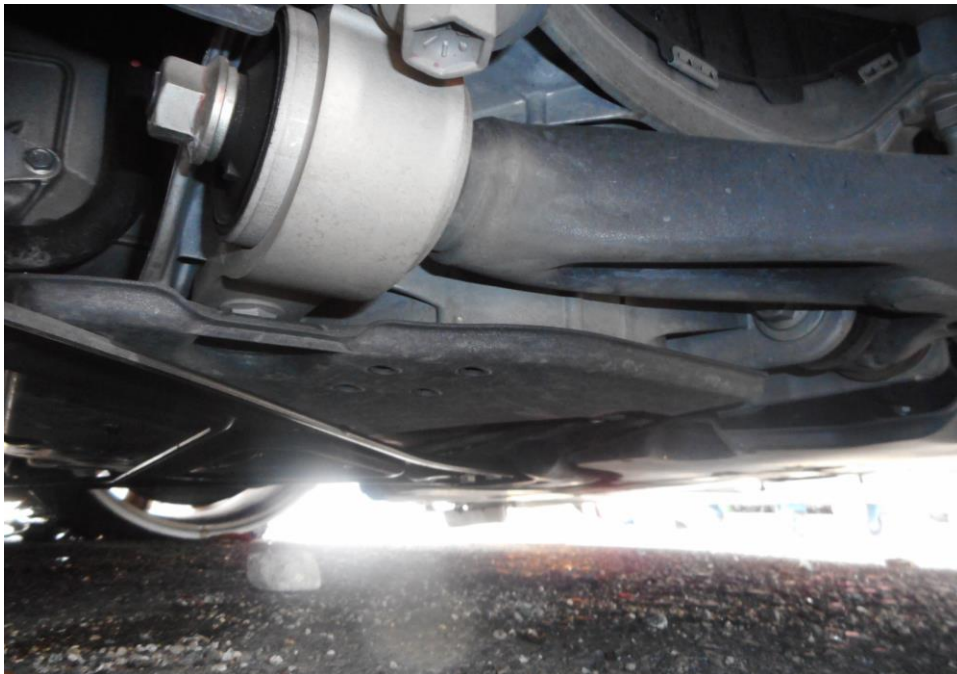
Photo 17 shows the undercarriage of the Motor Car, at the area where the engine housing and transmission housing are located. I did not find any sign(s) or indication(s) of fluid leak and/or fluid stain(s) on the underside of the Motor Car.

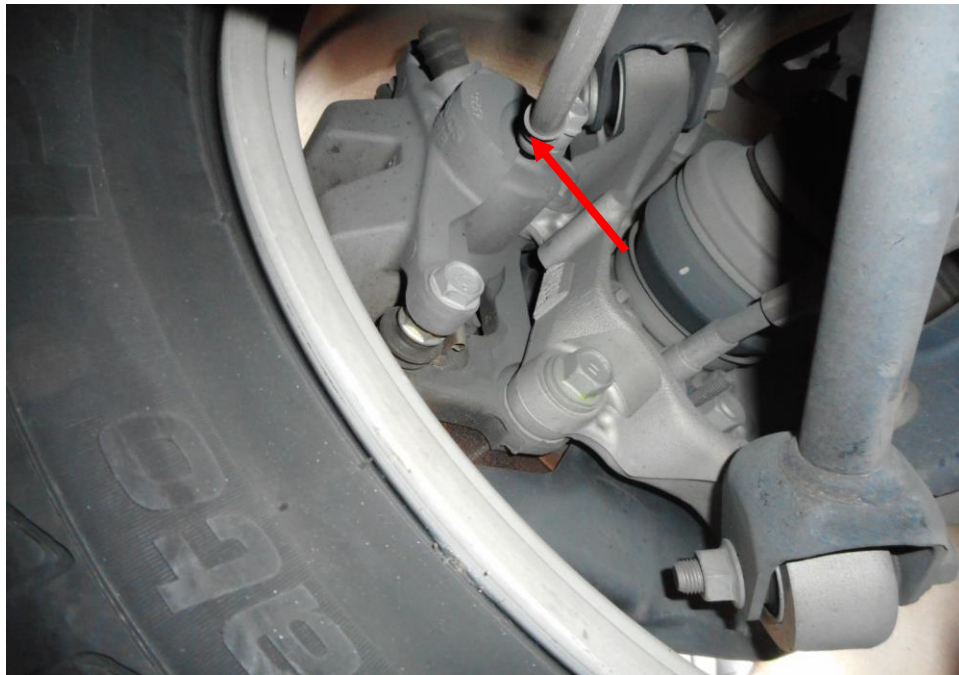
Photo 18 shows the brake hose/pipe (arrowed) at the rear right wheel of the Motor Car. No leakage of brake fluid was observed. Visual examination of the various components of the braking system like the drum brake, brake booster, brake pedal etc. had revealed all to be intact and without visible damage.

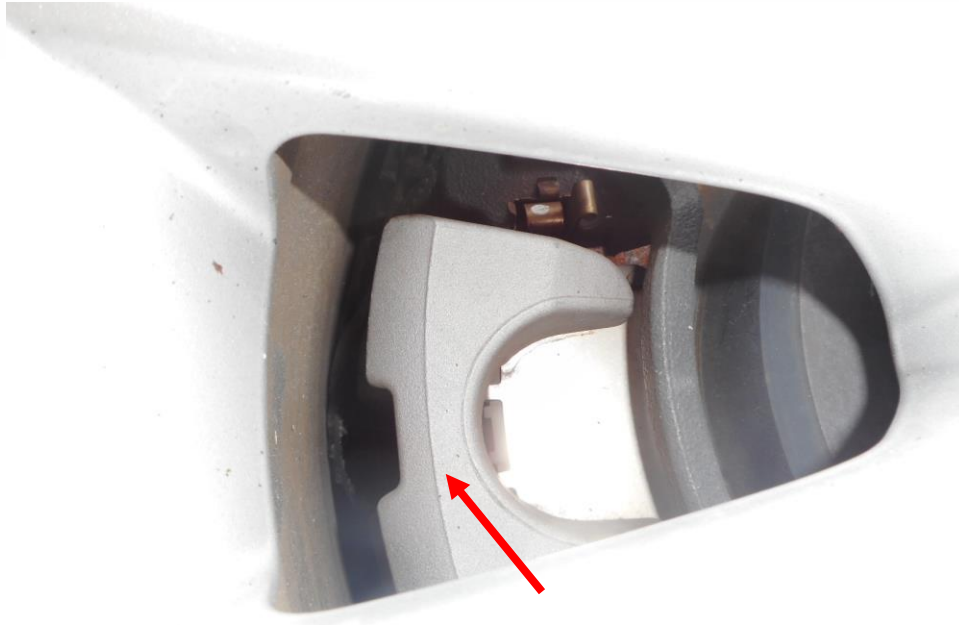
Photo 19 shows the brake caplier (arrowed) at the rear left wheel of the Motor Car. No leakage of brake fluid was observed on the surface. Visual examination of the various components of the braking system like the drum brake, brake booster, brake pedal etc. had revealed all to be intact and without visible damage.

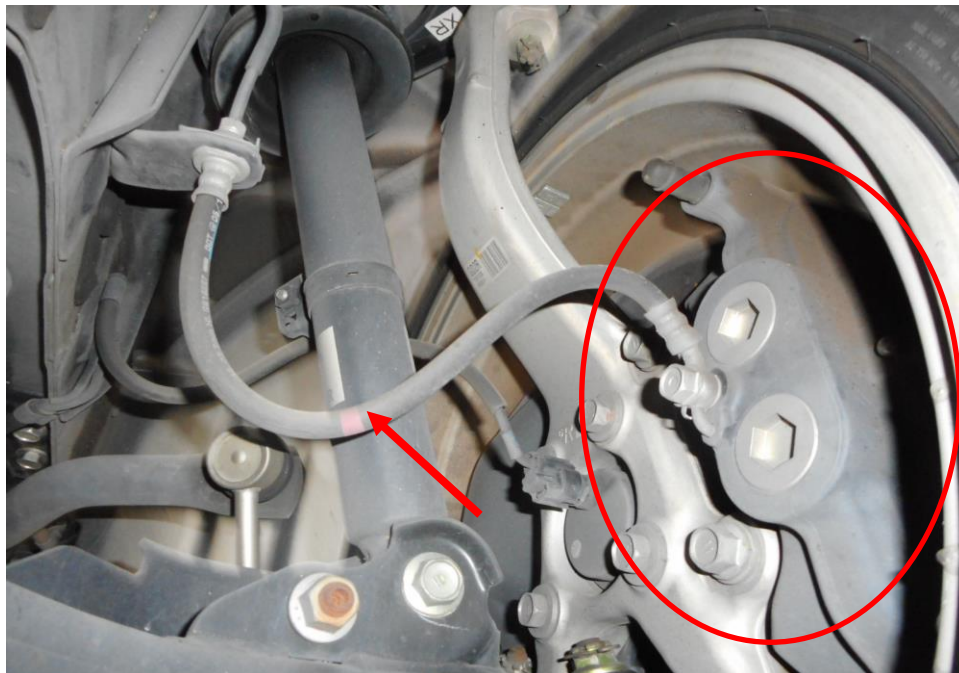
Photo 20 shows the brake hose/pipe (arrowed) at the front right wheel of the Motor Car. No leakage of brake fluid system was observed. Visual examination of the various components of the braking system like the brake caliper (circled), brake booster, brake pedal etc had revealed all to be intact and without visible damage at the time of accident. There was also no sign of fluid stain(s) observed on the various undercarriage components.

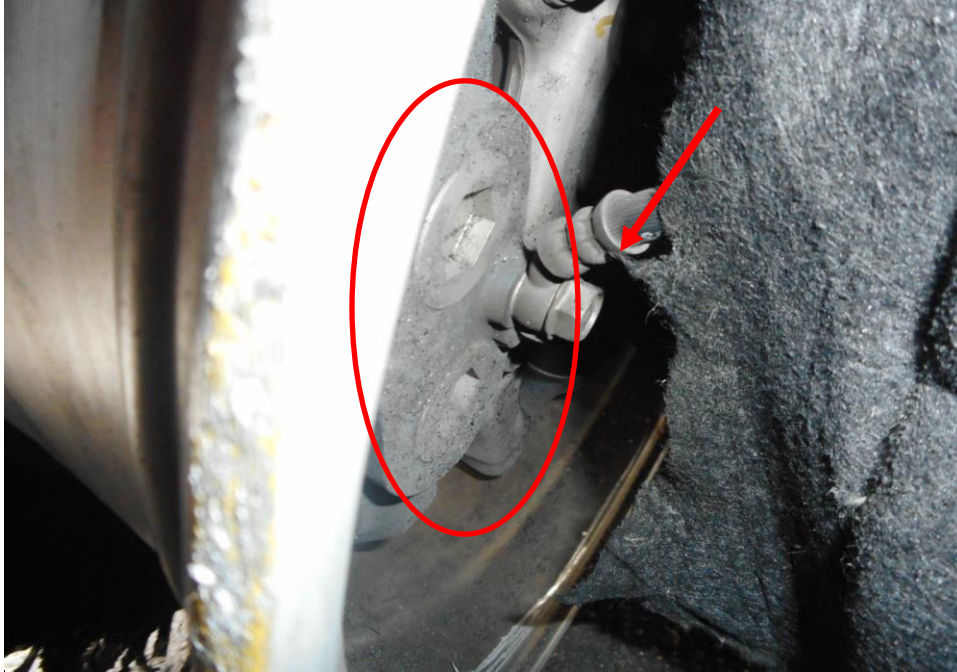
Photo 21 shows the brake hose/pipe (arrowed) at the front left wheel of the Motor Car. No leakage of brake fluid was observed. Visual examination of the various components of the braking system like the brake caliper (circled), brake booster, brake pedal etc had revealed all to be intact and without visible damage at the time of accident. There was also no sign of fluid stain(s) observed on the various undercarriage components.

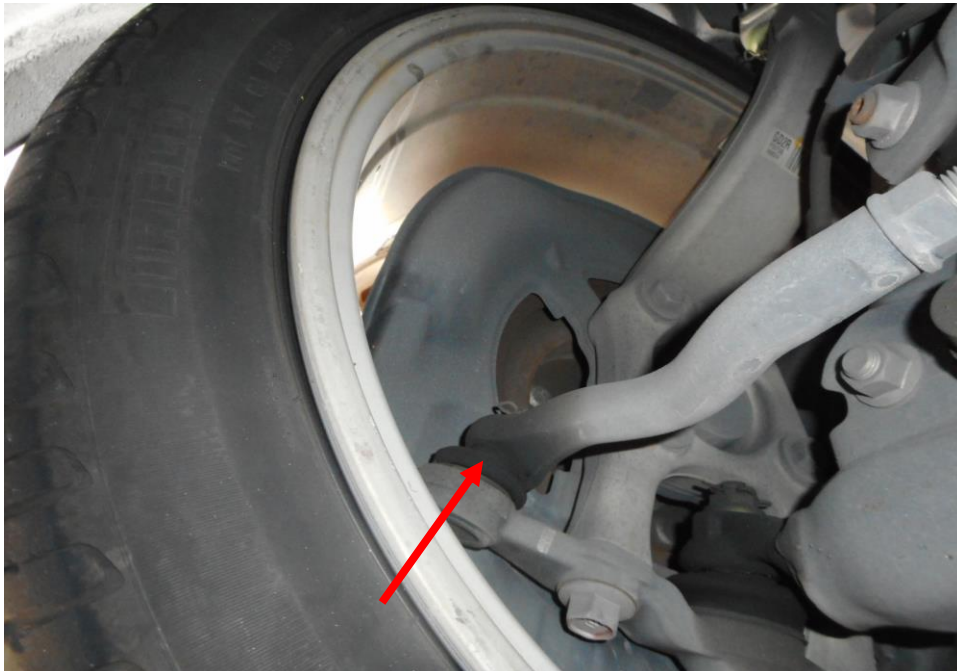
Photo 22 shows the various undercarriage components at the front right wheel of the Motor Car, in particular the steering tie rod, tie rod end and ball joints (arrowed) was observed to be intact and not damaged by the accident. However, old stain was observed on the surface of the tie rod end and ball joint.

18. In our opinion, the old stain was observed on the surface of the front left and right tie rods and ball joints of the Motor Car does not contribute to the accident as the overall component was still observed to be intact without damage.

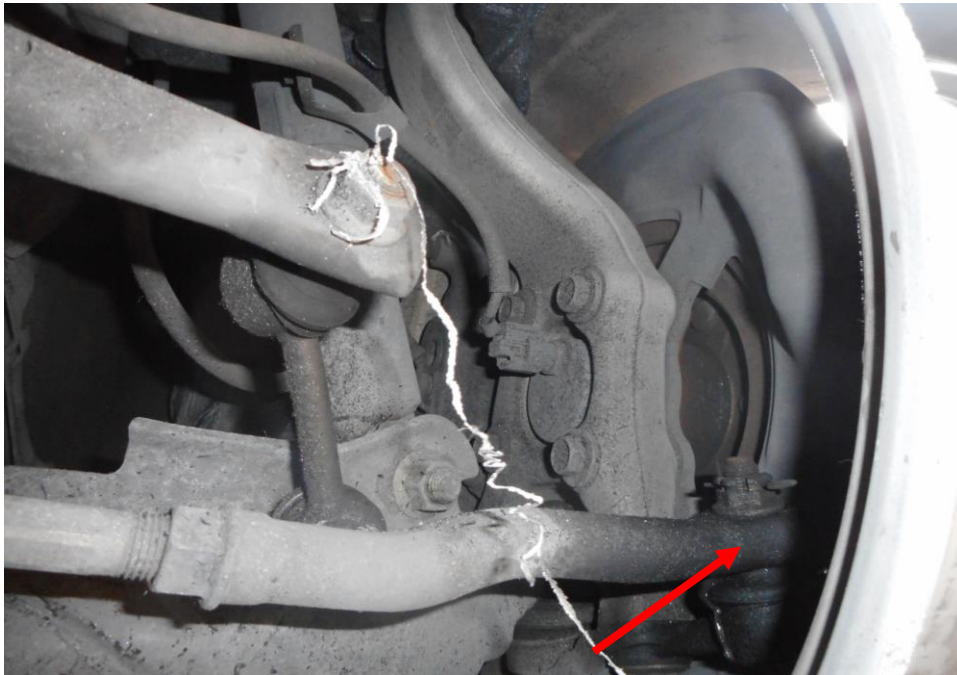
Photo 23 shows the various undercarriage components at the front left wheel of the Motor Car, in particular the steering tie rod, tie rod end and ball joints (arrowed) was observed to be intact and not damaged by the accident. However, old stain was observed on the surface of the tie rod end and ball joint.

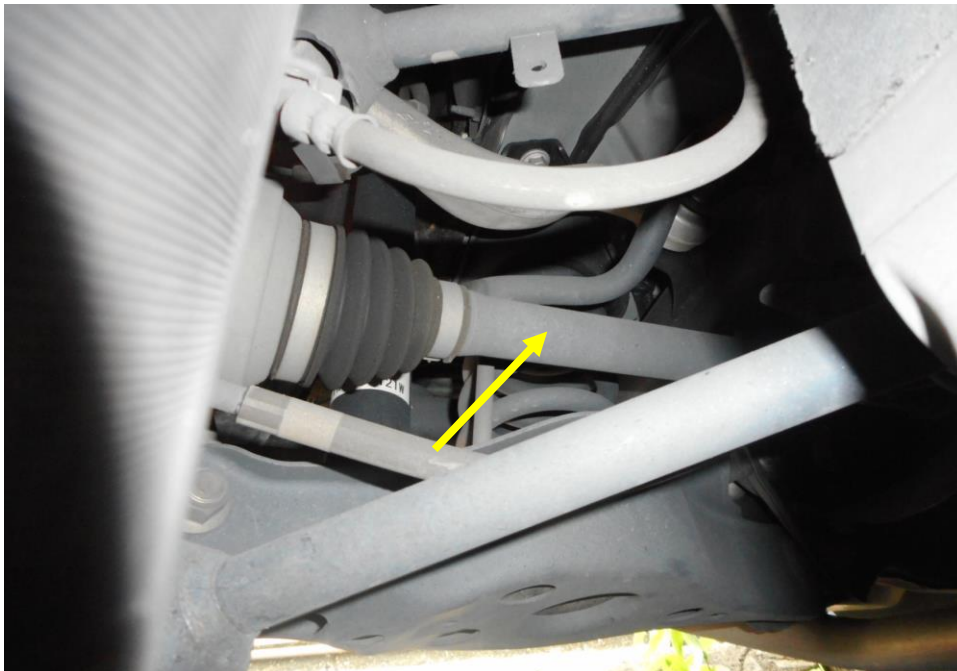
Photo 24 shows the various undercarriage components at the rear left wheel of the Motor Car, in particular the drive shaft (yellow arrow). The various undercarriage components of the Motor Car were all found to be intact without any visible damage. There was also no sign of fluid stain(s) observed on the various undercarriage components.

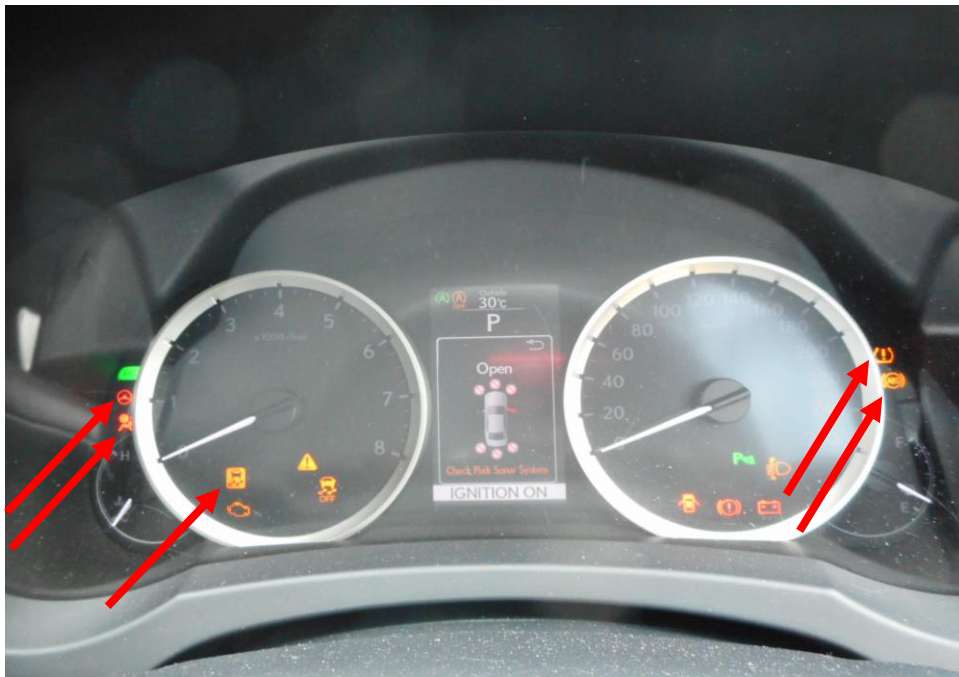
Photo 25 shows the warning light for Anti-Lock Brake System (ABS) and Power Steering System (EPS), Supplemental Restraint System (SRS), Traction Control (TC) and Tyre Pressure Monitoring System (TPMS) (arrowed) appearing on the instrument panel of the Motor Car during the self-test of its various electronic operating systems when its engine was cranked.

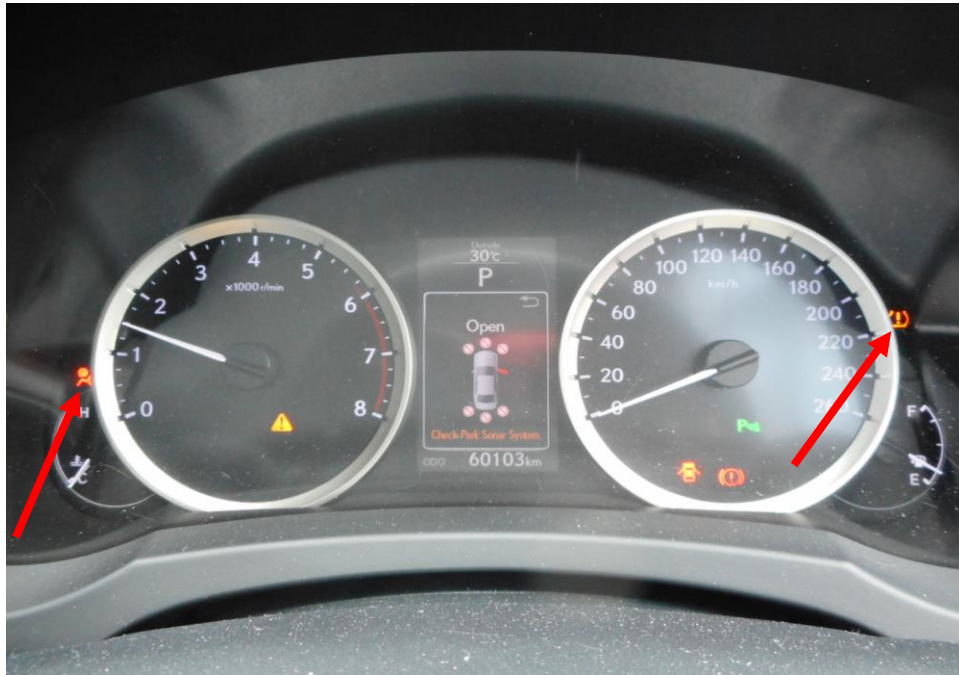
Photo 26 shows the Supplemental Restraint System (SRS) and the Tyre Pressure Monitoring System (TPMS) lights remained illuminated on as the result of the deployment of the airbag and due to the damaged tyres. However, there was no warning lights illuminated on the instrument panel of the Motor Car after the engine was cranked. This would suggest that there was no abnormality to the electronic operating system of the Motor Car, like the ABS, EPS, and TC etc.

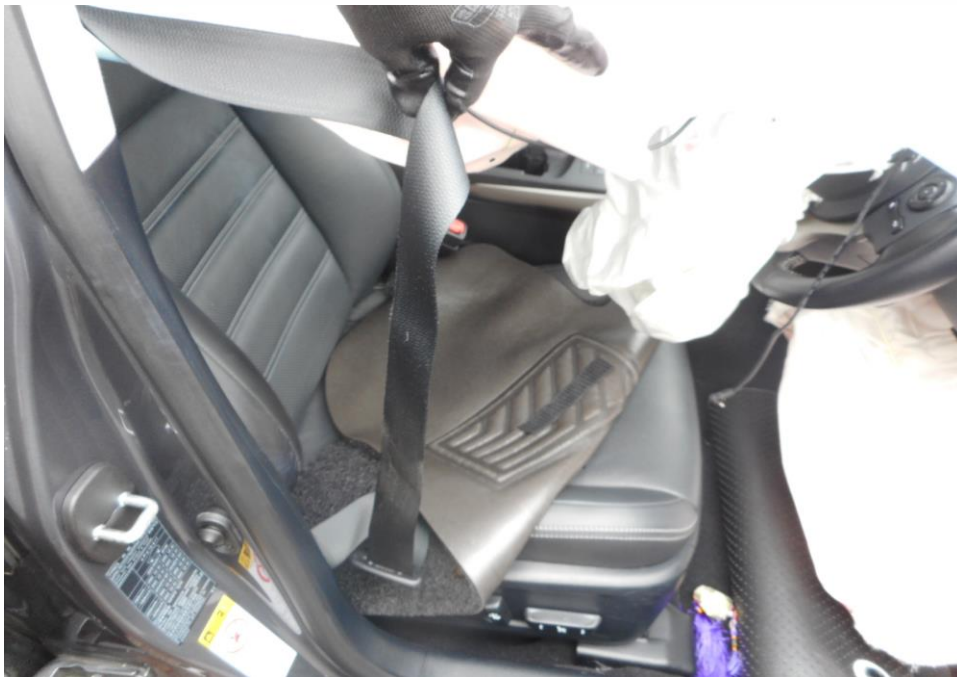
14. The front right seat belt of the “Motor Car” were worn at the material time of accident as the respective pre-tensioners that were fitted at the side of each seat was activated upon the material time. See photo 27 below

Photo 27 shows that the seat belt on the right seat was worn at the material time of accident as the safety pre-tensioners was activated at the moment of impact and caused the seat belt to be locked into the last position.
