Your Ref: TP/IP/37105/2020  
Our Ref : CI/TPD20011394/P

30<sup>th</sup> October 2020

**MECHANICAL INSPECTION REPORT OF MOTOR CAR SGQ 2882K**

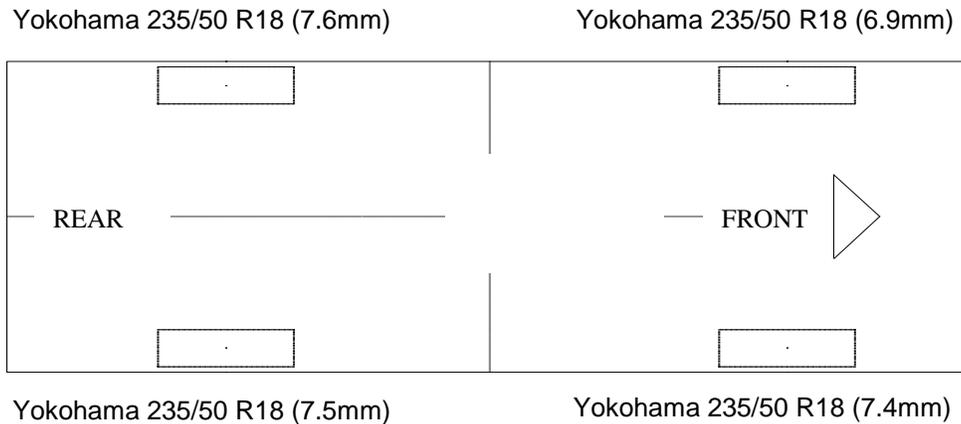
6. The condition of the Motor Car's 4 tyres was observed to be in serviceable condition. I did not find any tear, cut or burst mark(s) on the outer and the inner sidewalls as well as across the tread of the 4 tyres. The 4 tyres were also observed to be sufficiently inflated for vehicular operation. The tyre brand, tyre size and remaining tread depth of the 4 tyres were recorded as follows:-

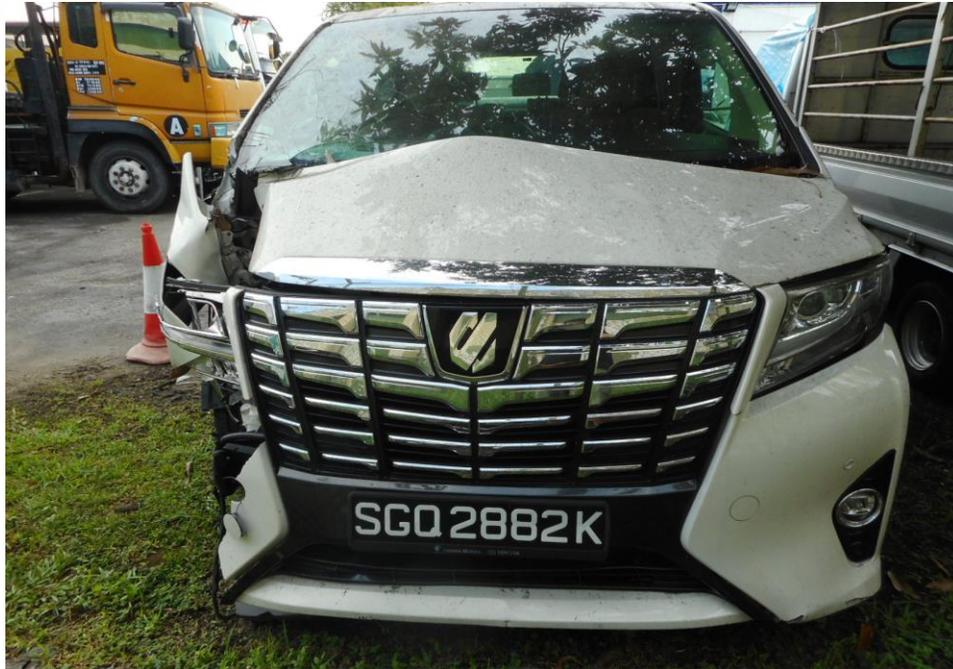
**Photo 1** shows a general view of the Motor Car's front body at the time of my inspection. The Motor car was observed to have sustained damage at its front and left portion. Its front windscreen, front bonnet, front bumper, front right headlamp, front right fender, its left rear mirror and left door panel were amongst the body parts that were damaged as a result of the accident.

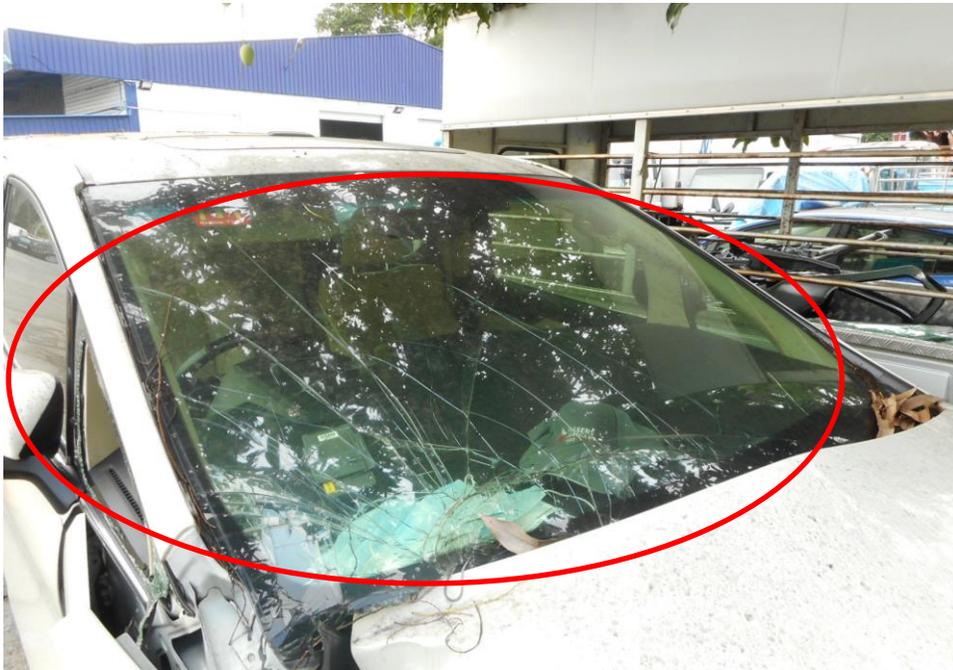
**Photo 2** shows the close up view of the Motor Car's front body at the time of my inspection. The Motor car was observed to have sustained damage at its front portion. Its front windscreen (circled) were amongst the body parts that were damaged as a result of the accident.

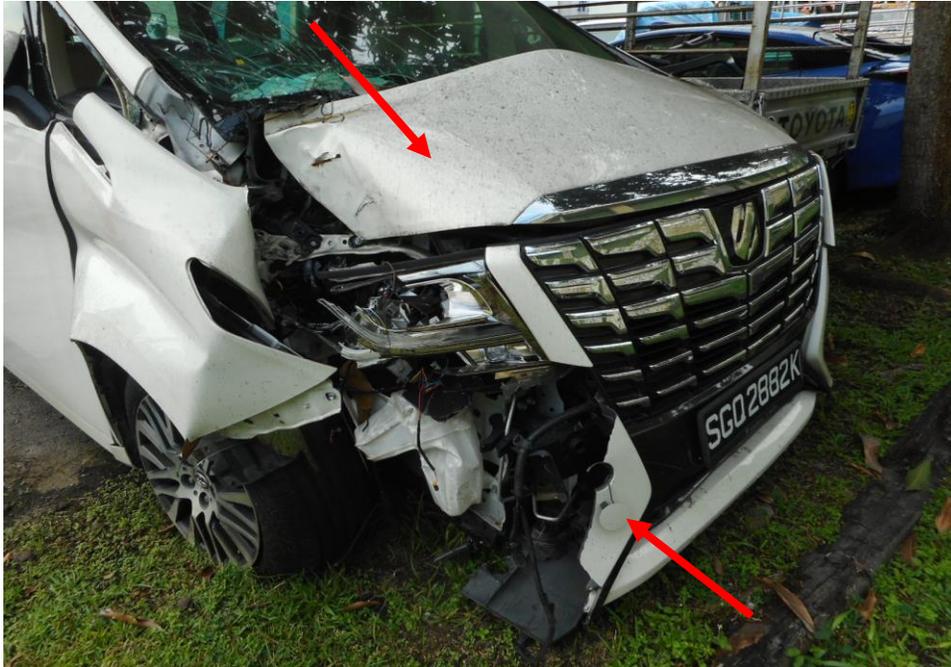
**Photo 3** shows a close up view of the Motor Car's engine compartment at the time of my inspection. The Motor car was observed to have sustained damage at its front portion. Its front bonnet and front bumper (arrowed) were amongst the body parts that were damaged as a result of the accident.

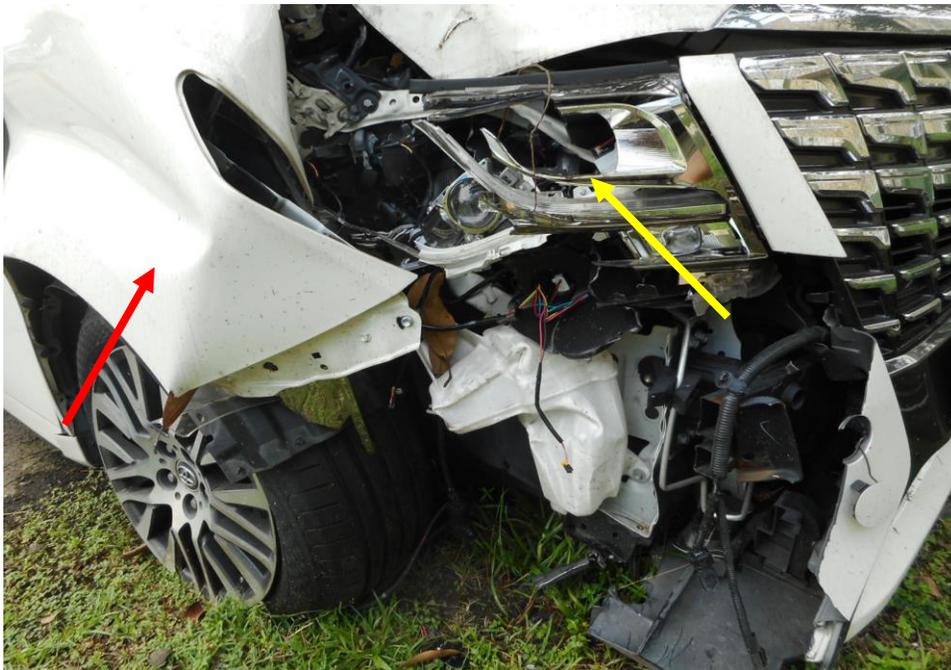
**Photo 4** shows a close up view of the Motor Car's front body at the time of my inspection. The Motor car was observed to have sustained damage at its front portion. Its front right headlamp (red arrow) and front right fender (yellow arrow) were amongst the body parts that were damaged as a result of the accident.

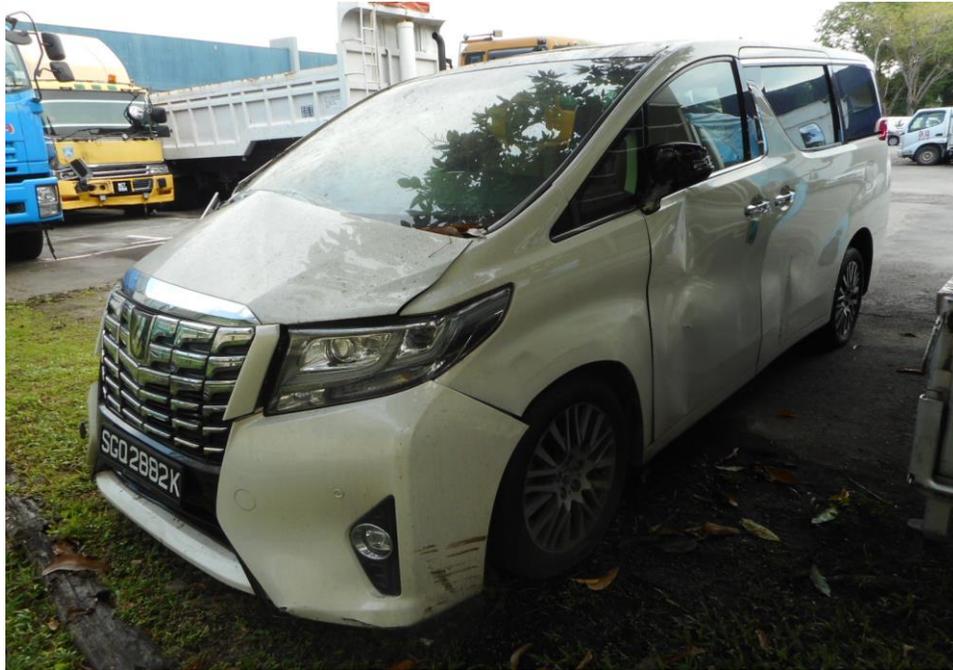
**Photo 5** shows a general view of the Motor Car's left body at the time of my inspection. The left portion of the Motor Car was observed to have sustained damage to its left rear mirror and left door panel were amongst the body parts that were damaged as a result of the accident.

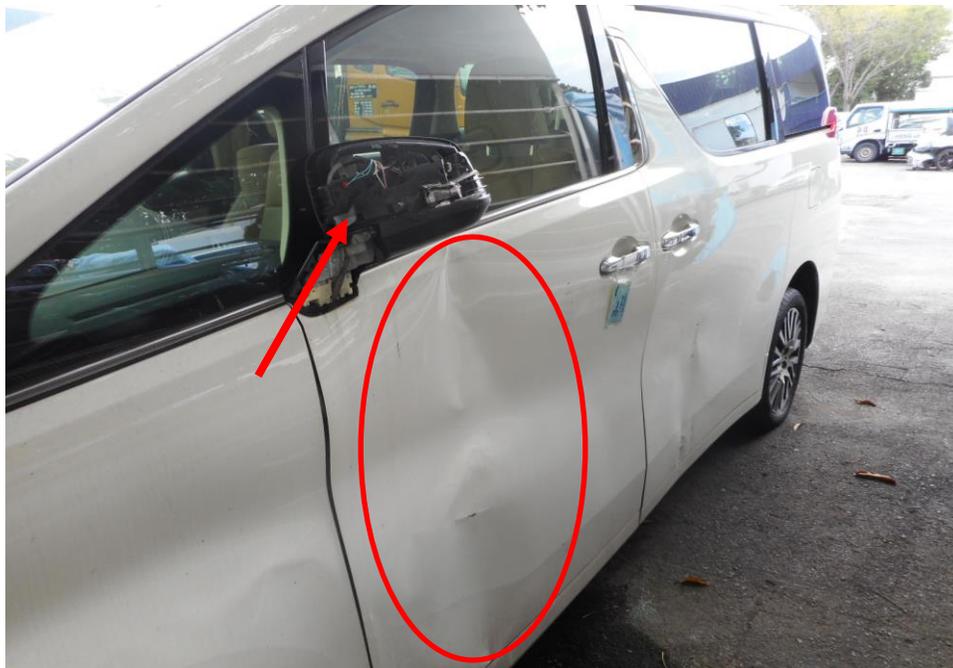
**Photo 6** shows a close up view of the Motor Car's left body at the time of my inspection. The left portion of the Motor Car was observed to have sustained damage to its left rear mirror (arrowed) and left door panel (circled) were amongst the body parts that were damaged as a result of the accident.

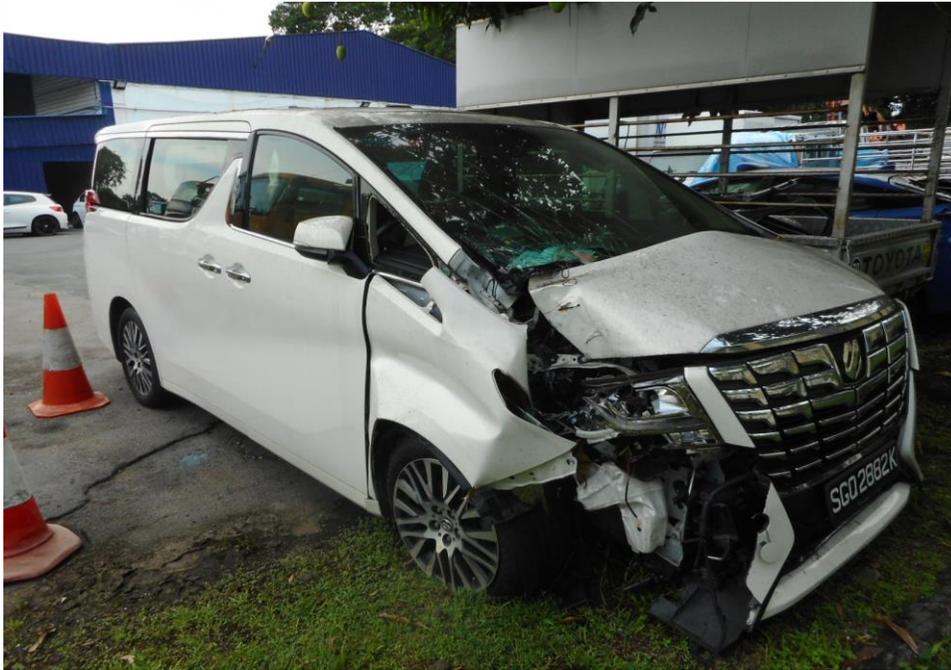
**Photo 7** shows a general view of the Motor Car's right body at the time of my inspection. The right portion of the Motor Car was observed to have been undamaged by the accident.

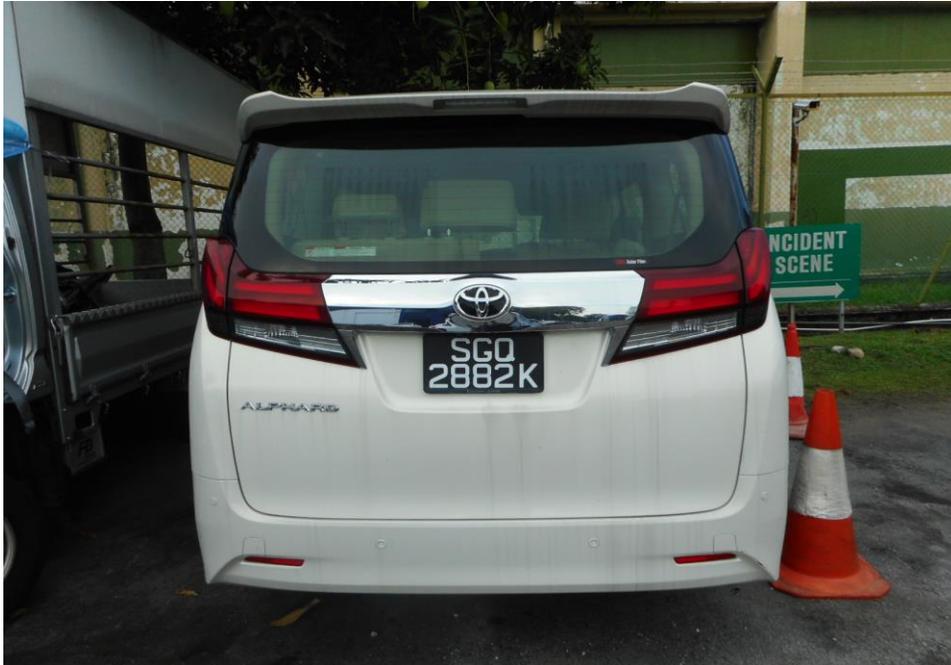
**Photo 8** shows a general view of the Motor Car's rear body at the time of my inspection. The rear portion of the Motor Car was observed to have been undamaged by the accident.

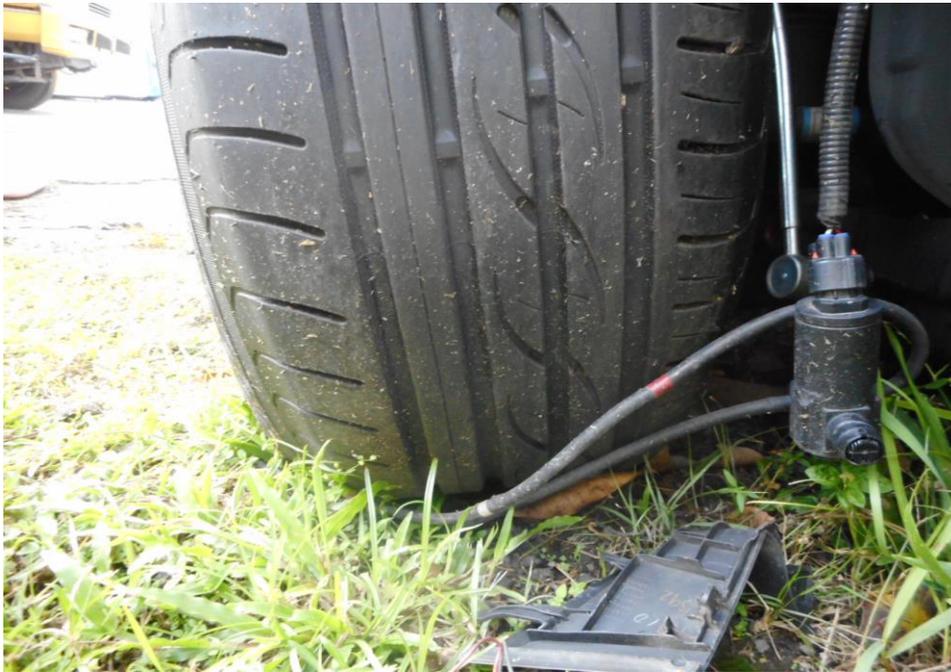
**Photo 9** shows the condition of the front right tyre of the Motor Car, which was observed to be in serviceable condition with remaining tread depth of approximately 7.4mm. The tyre, which was wrapped around alloy wheel rim, was also observed to be sufficiently inflated for vehicular operation.

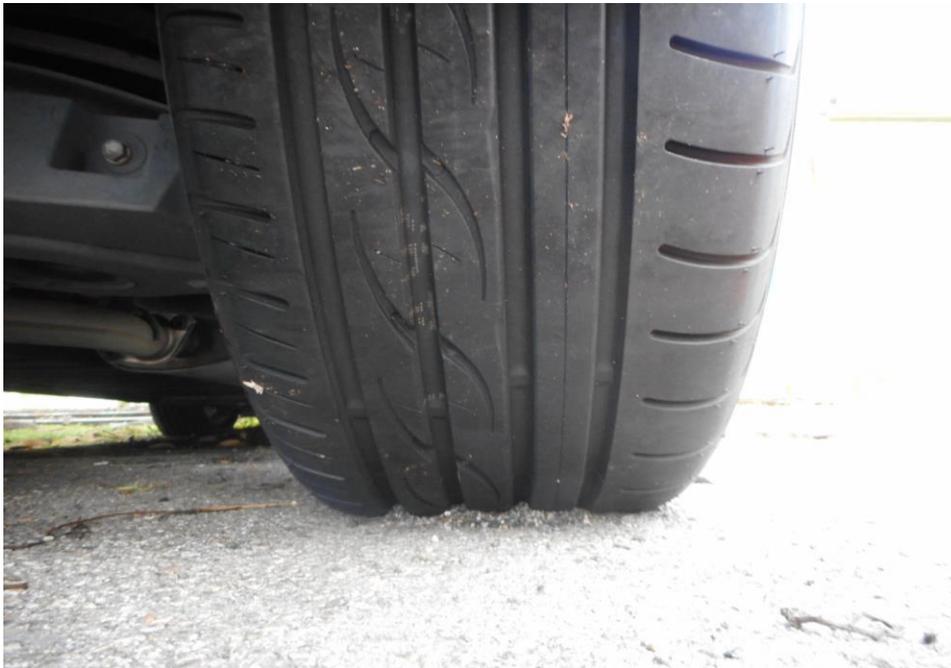
**Photo 10** shows the condition of the rear right tyre of the Motor Car, which was observed to be in serviceable condition with remaining tread depth of approximately 7.5mm. The tyre was also observed to be sufficiently inflated for vehicular operation with no tear, cut or burst mark(s).

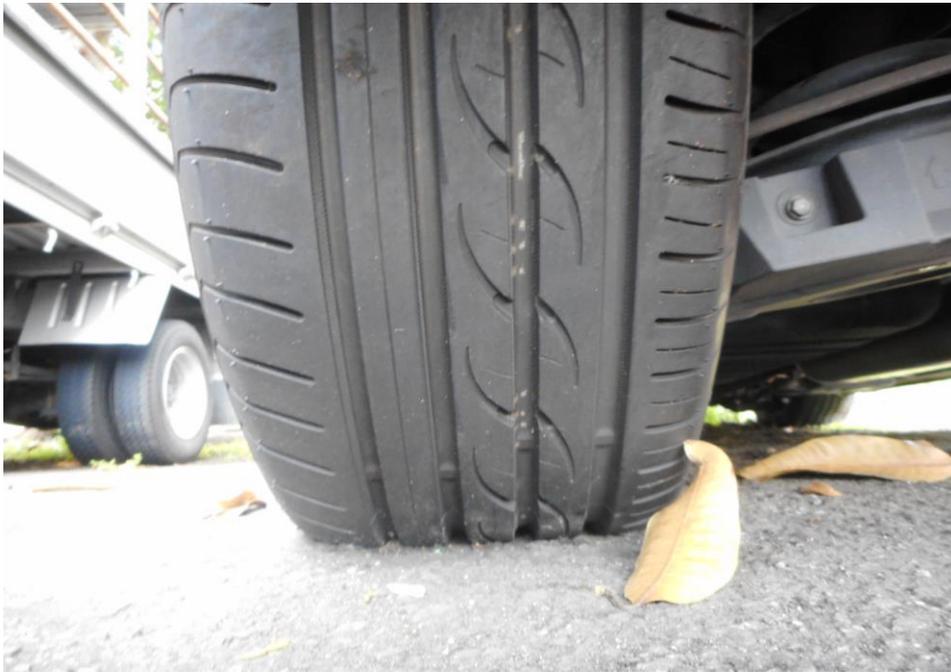
**Photo 11** shows the condition of the rear left tyre of the Motor Car, which was observed to be in serviceable condition with remaining tread depth of approximately 7.6mm. The tyre was also observed to be sufficiently inflated for vehicular operation with no tear, cut or burst mark(s).

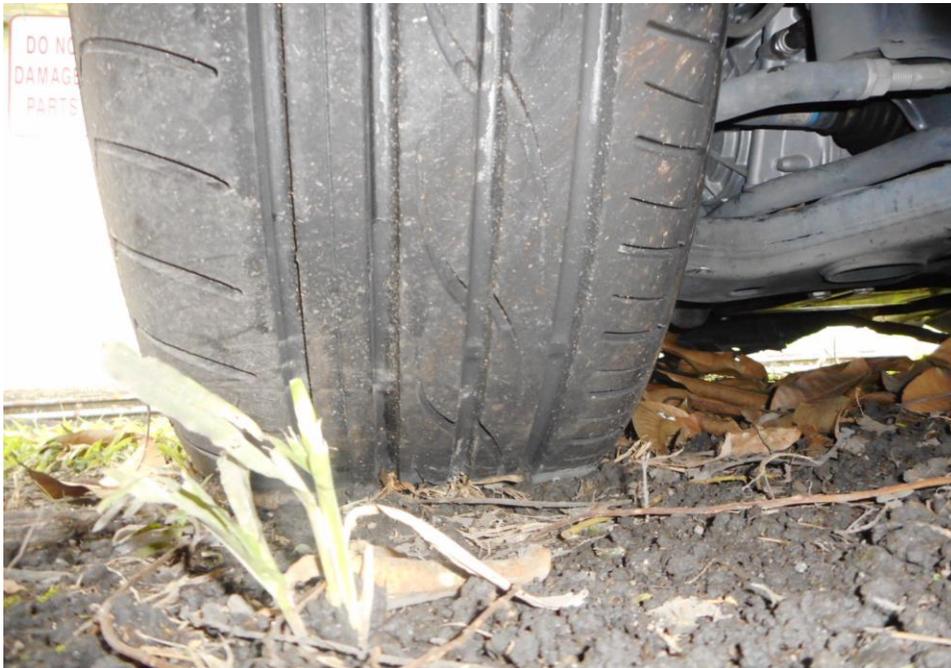
**Photo 12** shows the condition of the front left tyre of the Motor Car, which was observed to be in serviceable condition with remaining tread depth of approximately 6.9mm. The tyre was also observed to be sufficiently inflated for vehicular operation with no tear, cut or burst mark(s).

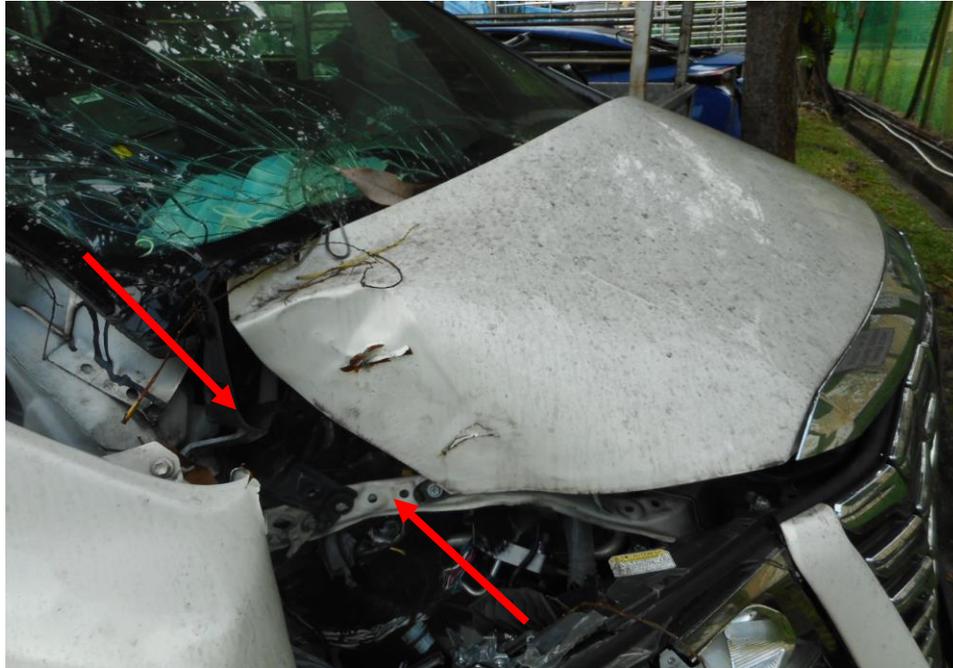
8. We were unable to raise the front bonnet of the Motor car to conduct the examination of the Motor Car's engine compartment because the damage caused by the accident had resulted in the damages to the bonnet and the structure of the engine compartment. (unable to open) See photo 13 below.

**Photo 13** shows a close up view of the damaged front bonnet and the bonnet hinge of the Motor Car at the time of my inspection resulting it unable to open as a result of the accident. (arrowed) (Unable to open)

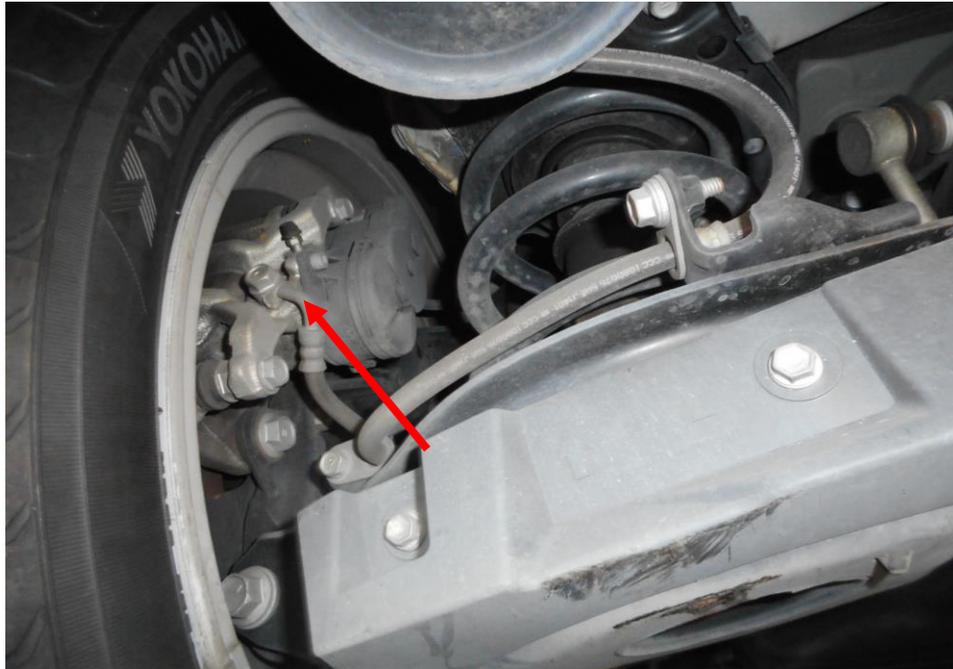
**Photo 15** shows the brake hose/pipe (arrowed) at the rear left wheel of the Motor Car. No leakage of brake fluid was observed. Visual examination of the various components of the braking system like the drum brake, brake booster, brake pedal etc. had revealed all to be intact and without visible damage.

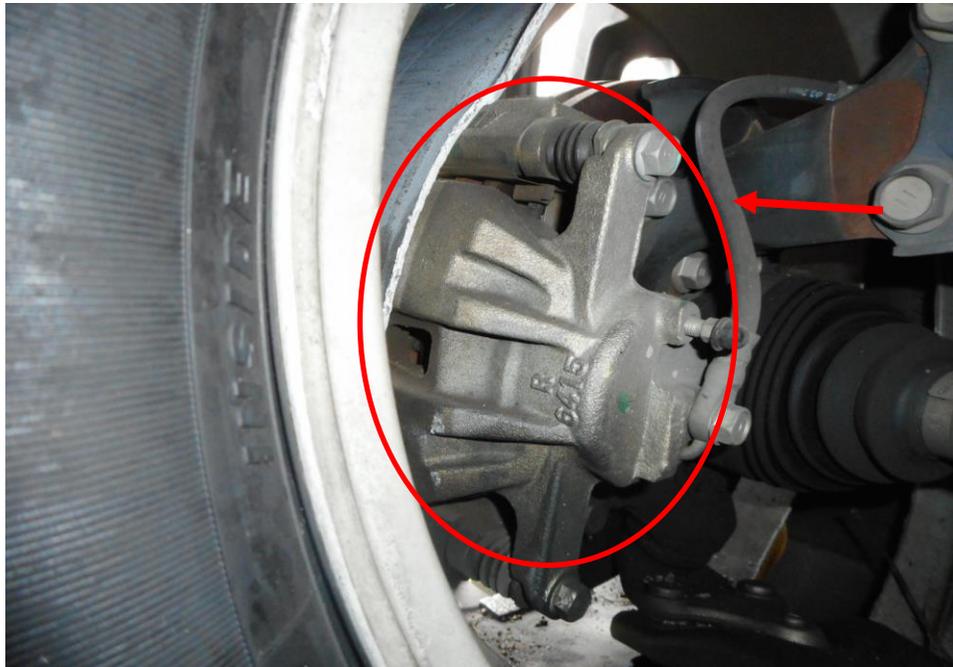
**Photo 16** shows the brake hose/pipe (arrowed) at the front right wheel of the Motor Car. No leakage of brake fluid was observed. Visual examination of the various components of the braking system like the brake caliper (circled), brake booster, brake pedal etc had revealed all to be intact and without visible damage at the time of accident. There was also no sign of fluid stain(s) observed on the various undercarriage components.

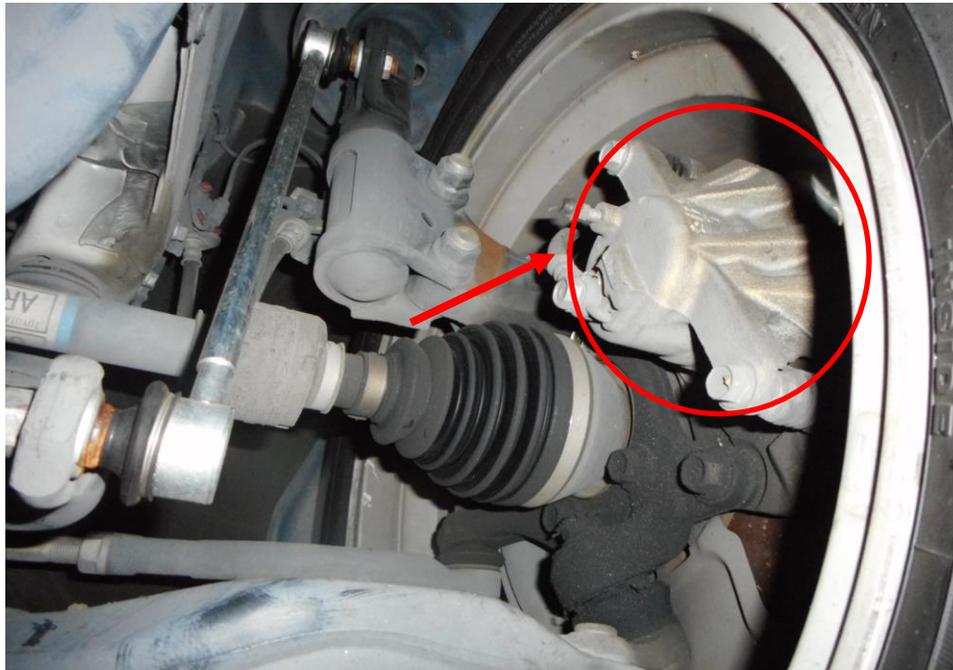
**Photo 17** shows the brake hose/pipe (arrowed) at the front left wheel of the Motor Car. No leakage of brake fluid was observed. Visual examination of the various components of the braking system like the brake caliper (circled), brake booster, brake pedal etc had revealed all to be intact and without visible damage at the time of accident. There was also no sign of fluid stain(s) observed on the various undercarriage components.

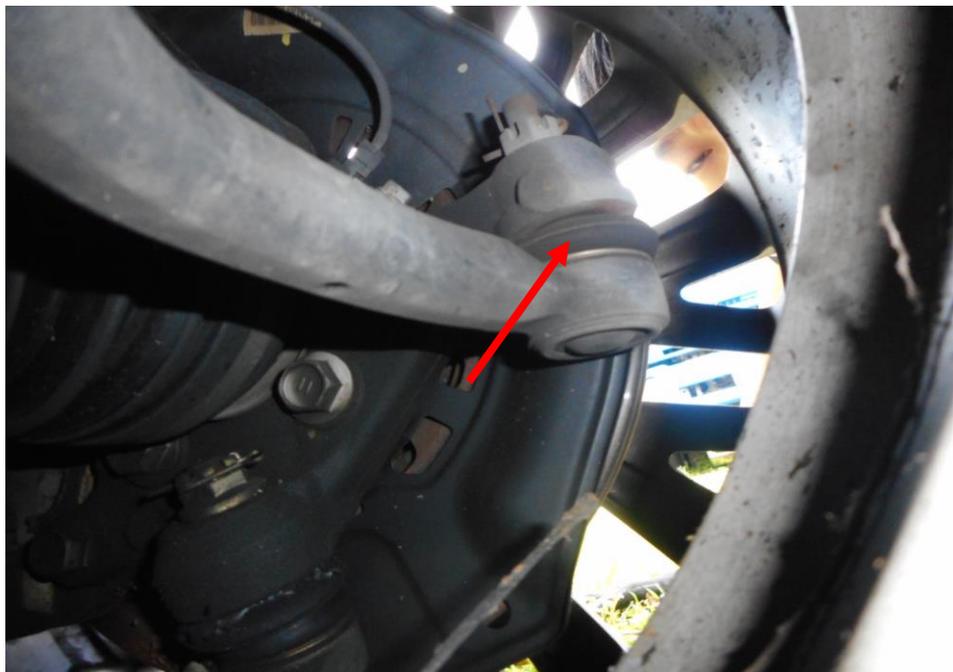
**Photo 18** shows the various undercarriage components at the front right wheel of the Motor Car, in particular the steering tie rod end (arrowed). The various steering components were all found to be intact, suggesting that the steering system of the Motor Car was likely to be in serviceable condition at the material time of accident. There was also no sign of fluid stain(s) observed on the various undercarriage components.

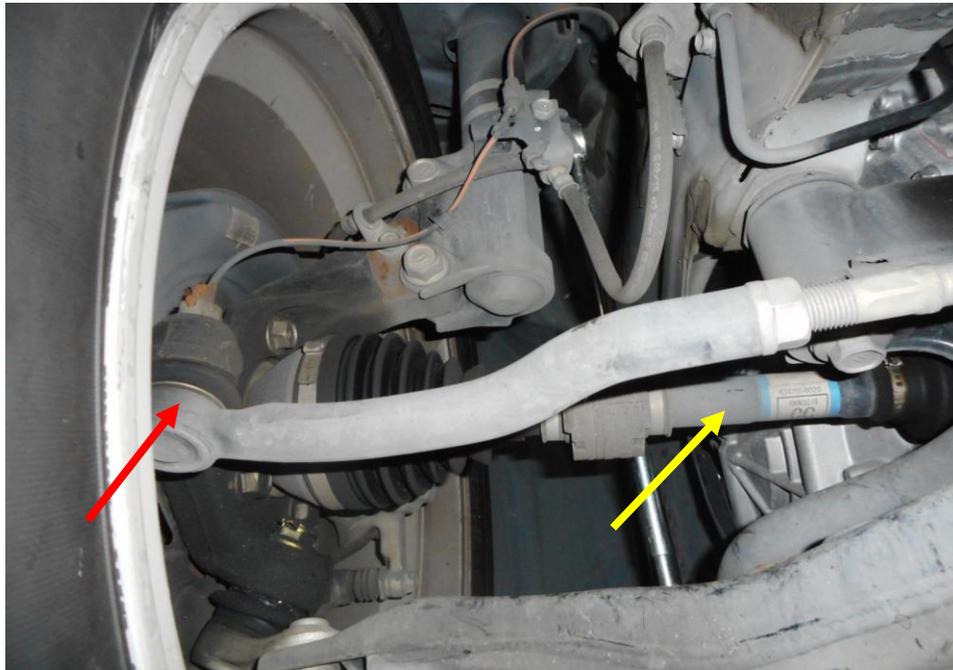
**Photo 19** shows the various undercarriage components at the front left wheel of the Motor Car, in particular the steering tie rod end (arrowed) and drive shaft (yellow arrow). The various undercarriage components of the Motor Car were all found to be intact without any visible damage. There was also no sign of fluid stain(s) observed on the various undercarriage components.
