LKK Auto Consultants Pte Ltd

Vehicle No. SHD 660D
Insured Veh. YP 9617G
Claim No. 20/20/20/VC00/023785
Policy No. Z/20/VC00/108763
Accident Date 15/10/2020
Inspection Date 19/10/2020

ADJUSTMENT ON REPAIR COST FOR VEHICLE NO. SHD 660D

PHOTOGRAPHS FOR VEHICLE NO. SHD 660D

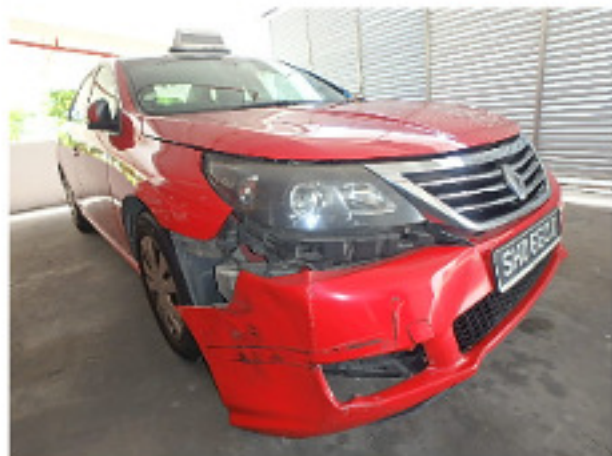
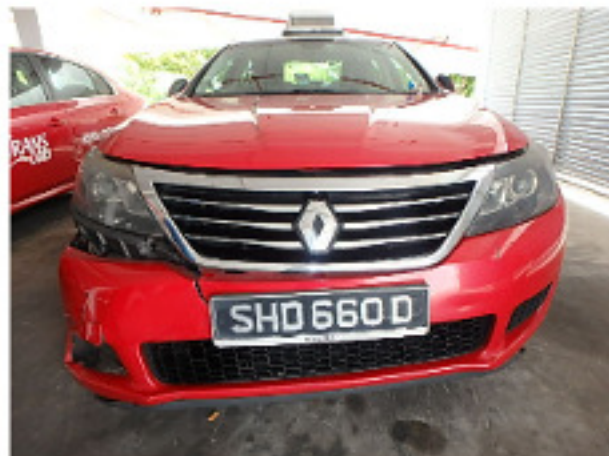
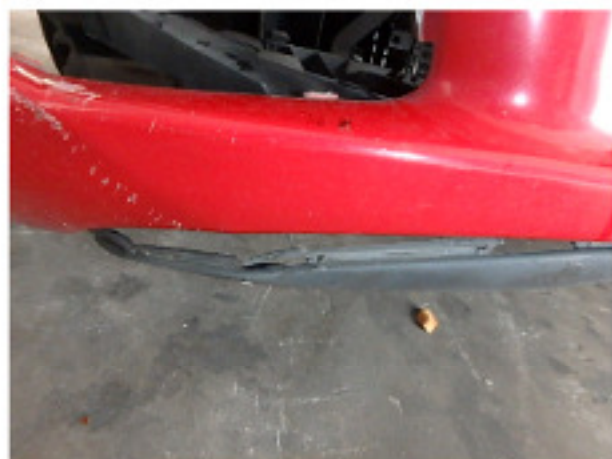
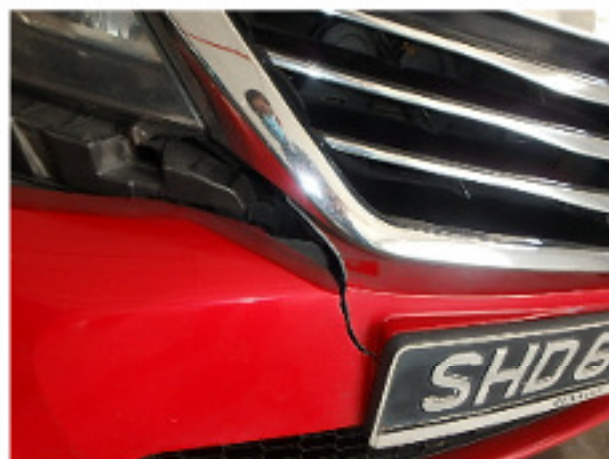
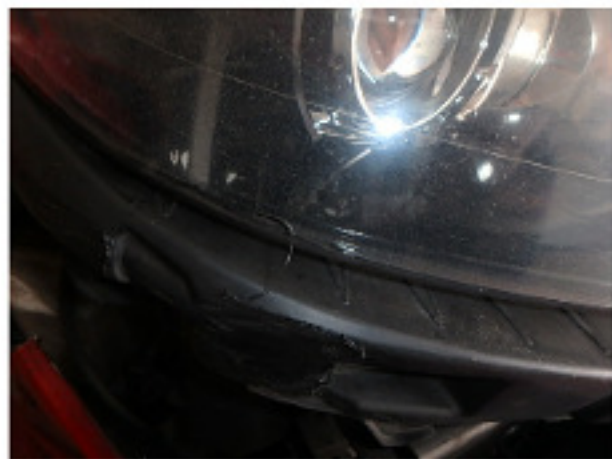
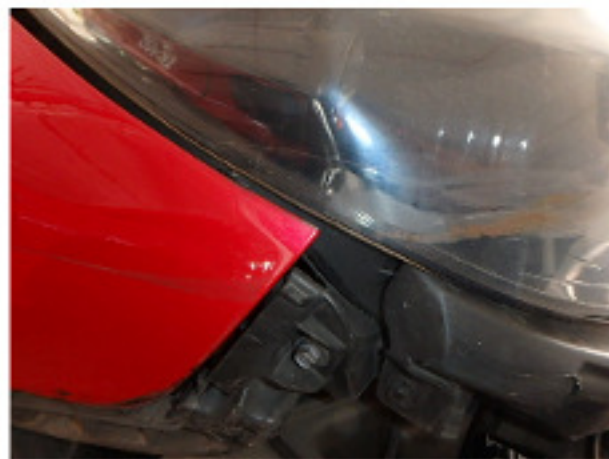
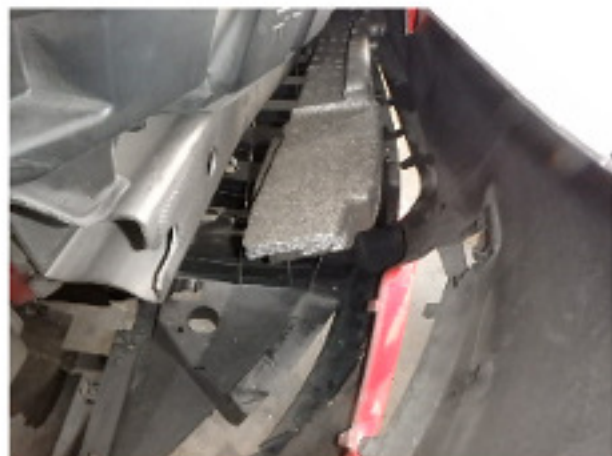
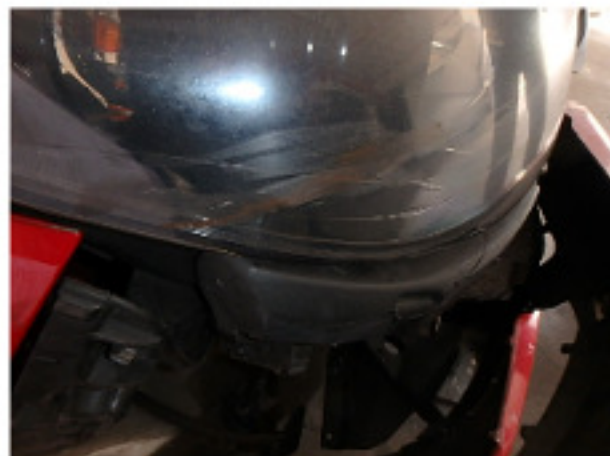
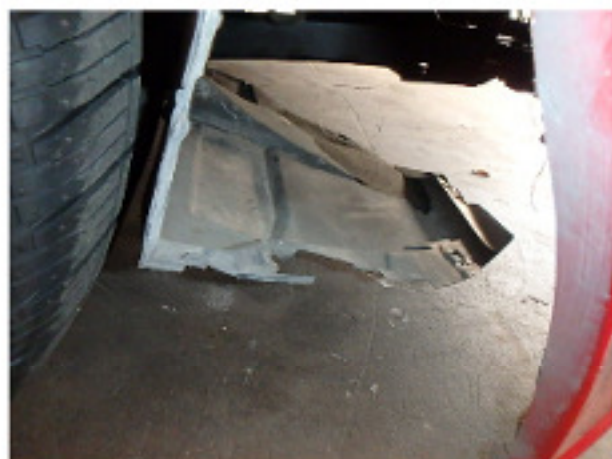
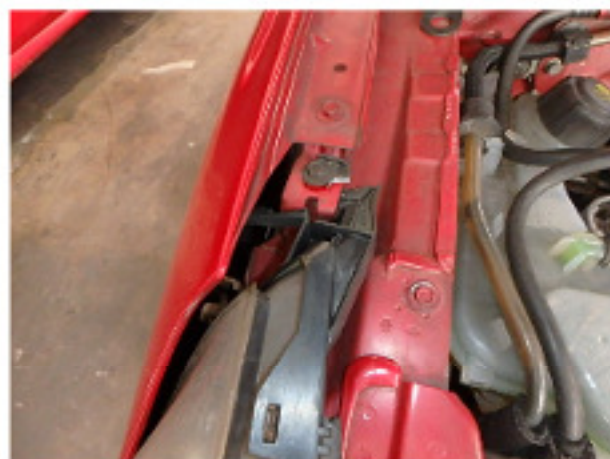
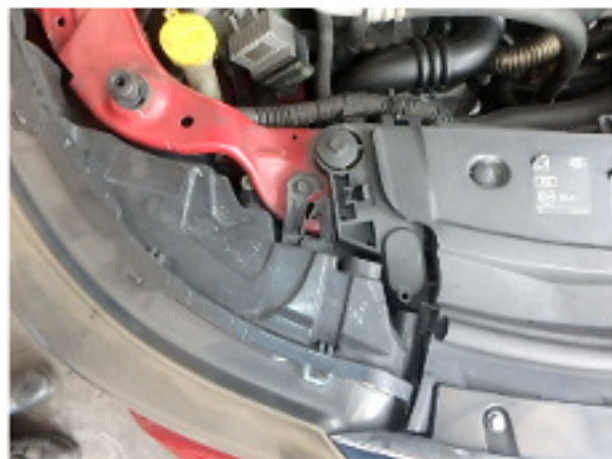
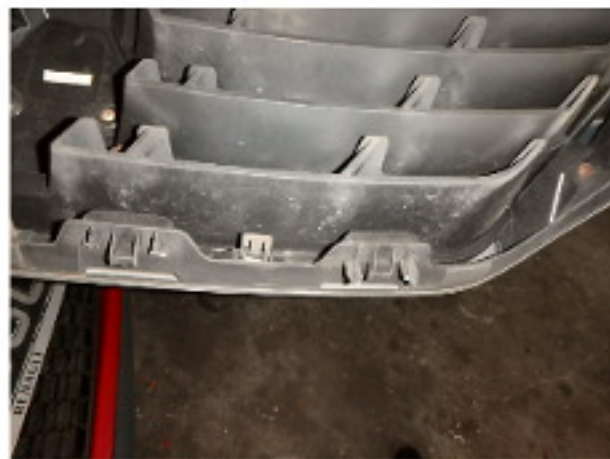
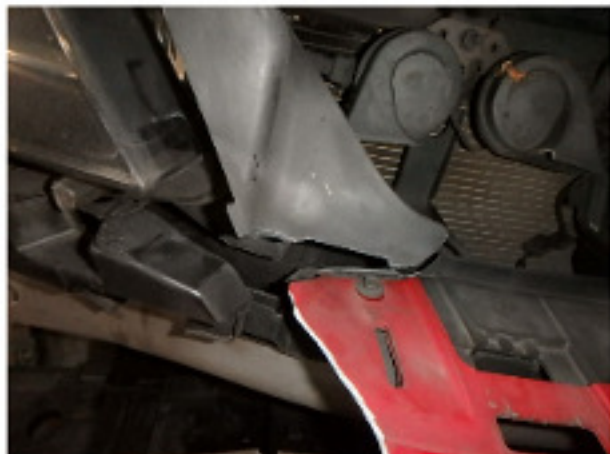
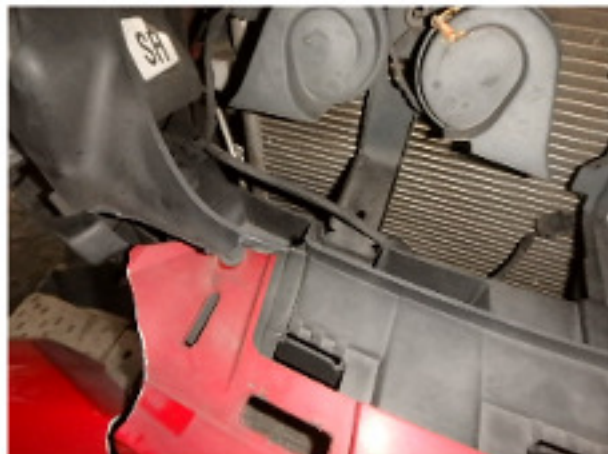
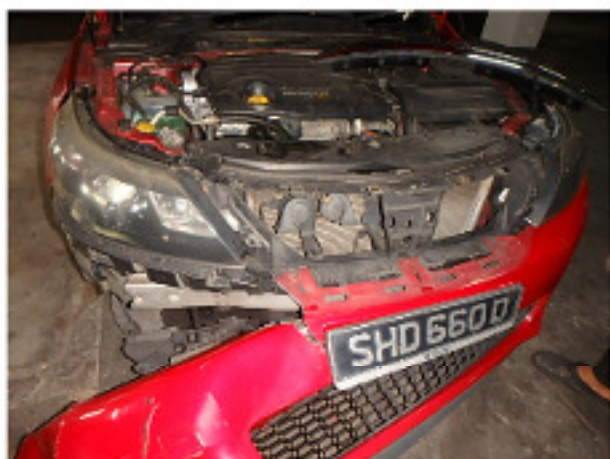
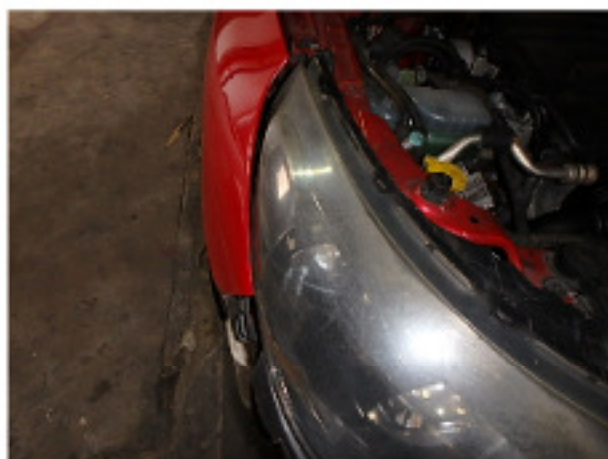
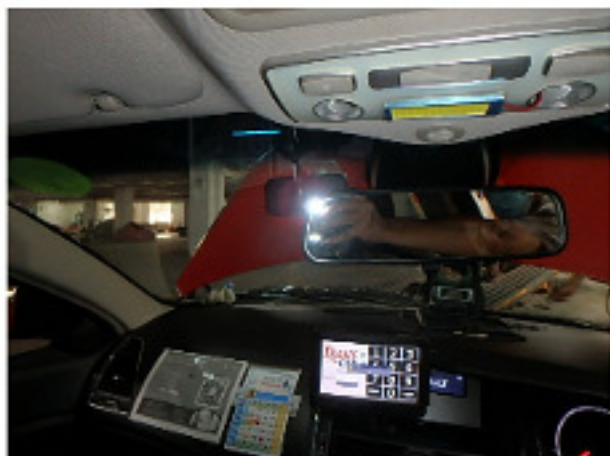
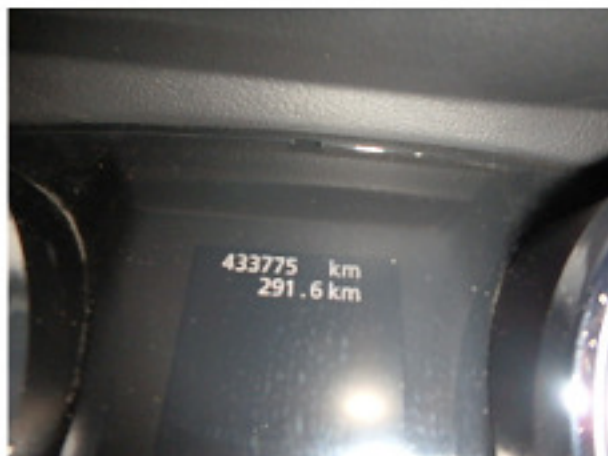
INSPECTION

| THE VEHICLE SUSTAINED DAMAGES AT THE O/S FRONT PORTION. DAMAGES SEE DETAILS. |
