Your Ref: OD/1202000021292
Our Ref : CS4/FWD20011424/N

27 October 2020

**TECHNICAL INVESTIGATION REPORT OF FIRE INCIDENT INVOLVING THE
INSURED VEHICLE SGZ 7677G ON 15 OCTOBER 2020**

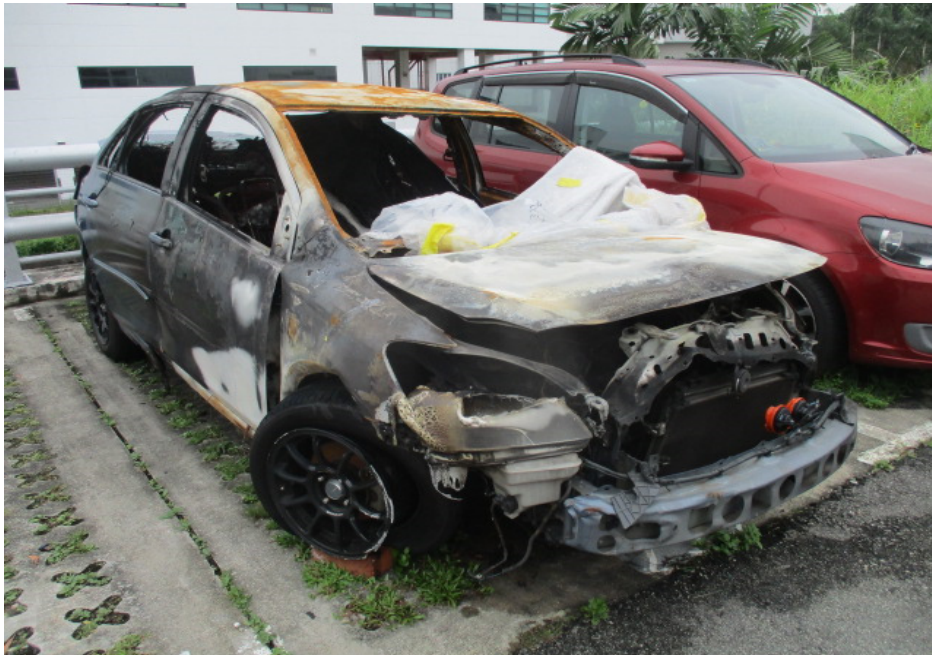
Photo 1 shows the general view of the right body of the Insured Vehicle at the time of our inspection. The Insured Vehicle was observed to have sustained extensive fire damage all around. Its engine compartment and interior compartment were completely burnt. Rust had accumulated all over the Insured Vehicle as a result of exposure to environmental condition for a period of time.

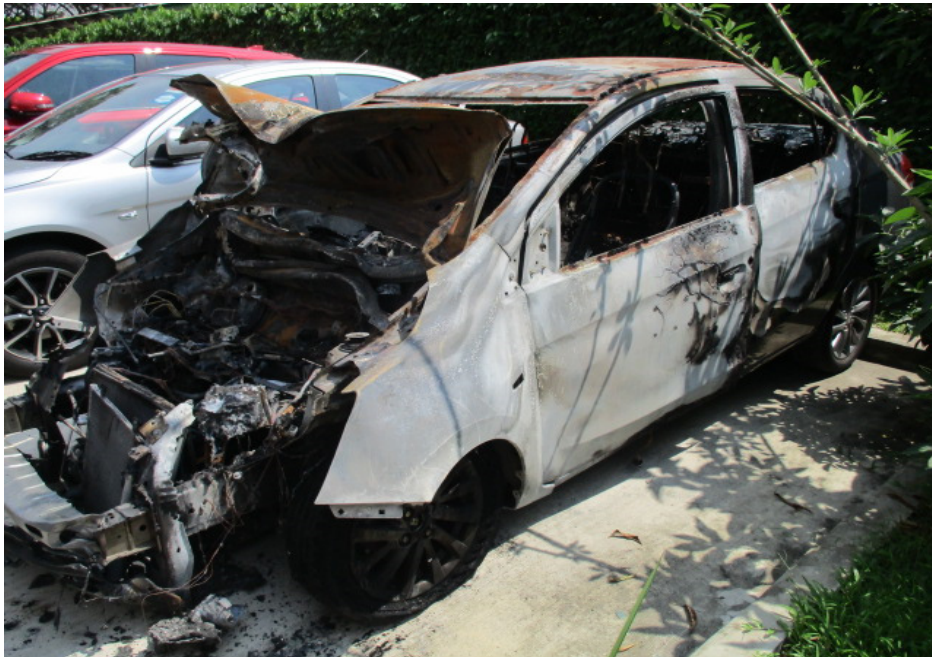
Photo 2 shows the general view of the left body of the Insured Vehicle at the time of our inspection. The Insured Vehicle was observed to have sustained extensive fire damage all around. Rust had accumulated all over the Insured Vehicle as a result of exposure to environmental condition for a period of time.

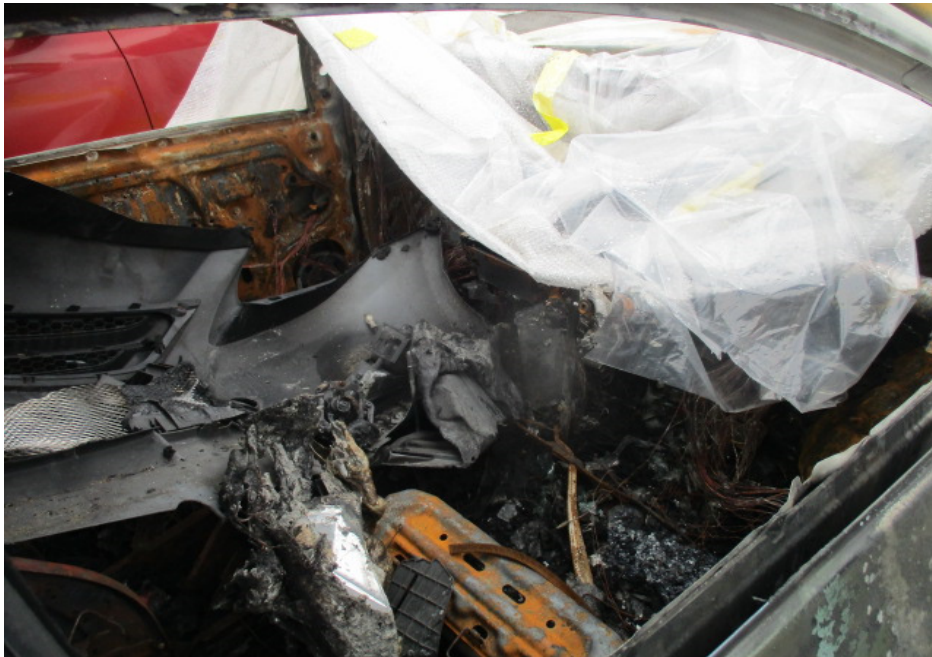
Photo 3 shows the interior compartment of the Insured Vehicle, which was significantly affected by the fire.

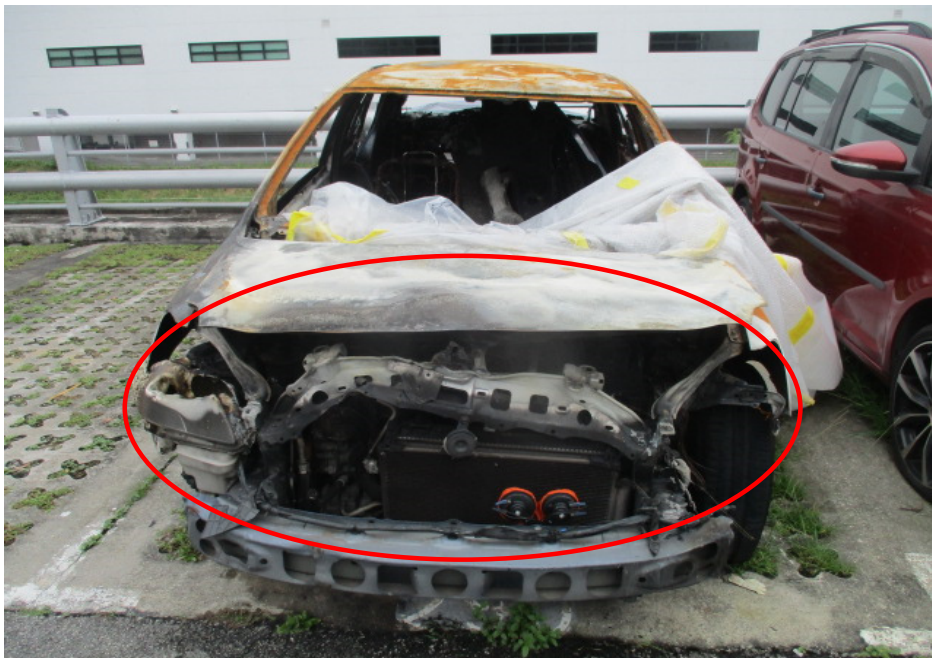
Photo 4 shows the front portion of the Insured Vehicle. Impact damage was observed at its front side (circled). Its front wheels, front support panel, front bumper and front bumper reinforcement were amongst the body parts that were bent/ buckled as a result of the impact force.

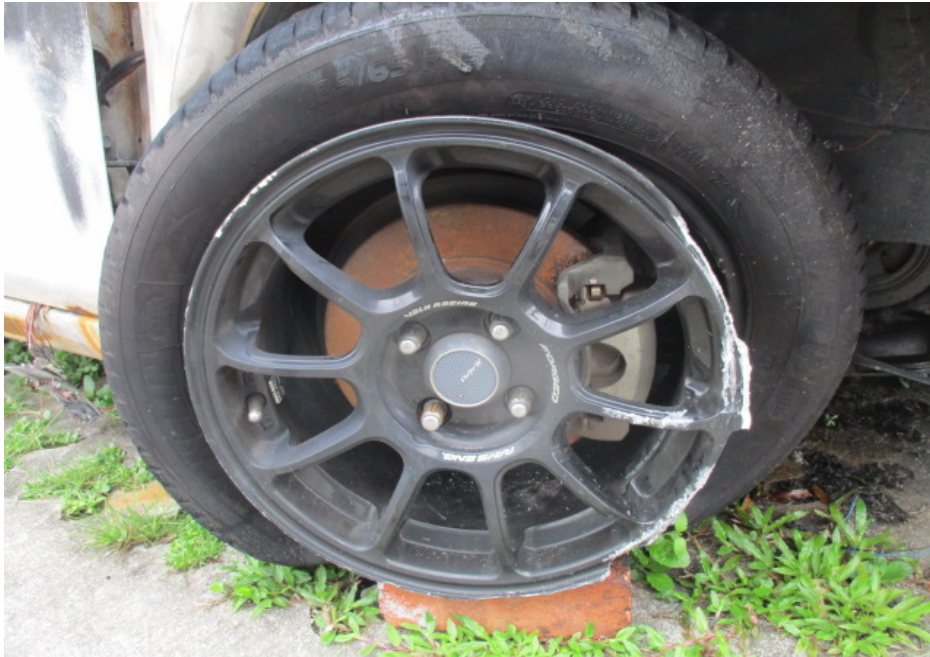
7. At the time of physical inspection of the Insured Vehicle, we had found it to be fitted with aftermarket 15- inch alloy rims. All these fitted components were not the standard type for the Insured Vehicle. See photo 5 below.

Photo 5 shows the non-standard rim found to be fitted on the Insured Vehicle at the time of our inspection. The 15- inch alloy rims fitted on the Insured Vehicle were not the standard type for the Insured Vehicle.

16. We asked Ms Shalene regarding the aftermarket 15- inch alloy rims that were fitted onto the Insured Vehicle. She had replaced the original rims with aftermarket 15- inch alloy rims after purchasing the Insured Vehicle.

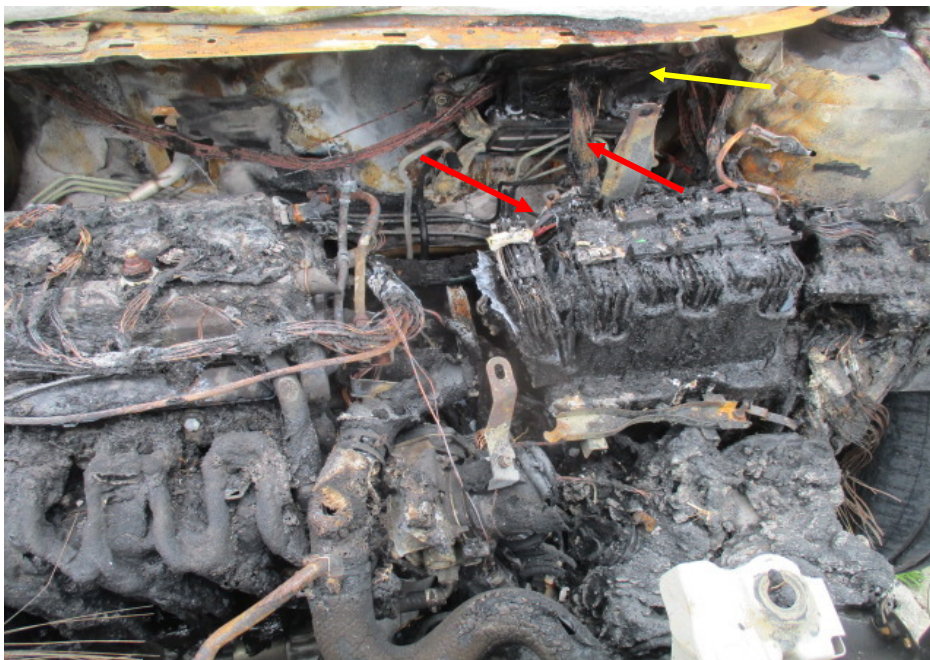
19. Upon closer examination of the rear left portion of the engine compartment, we had found several stretches of wirings burnt internally to its bare copper state. The wirings were original factory fitted wirings leading towards the Engine Control Module (ECM) of the Insured Vehicle. The bright reddish colour of the copper wires suggests that the wirings were exposed to high heat. Such condition normally indicates internal heating of copper wires which is a sign of an electrical short circuit occurring. In addition, we also found greenish residue on some of the wirings. The presence of greenish residue further indicates internal heating of copper wires, another sign of an electrical short circuit occurring. The greenish residue is normally left behind from oxidation as a result of chemical reaction involving the copper wires. These physical evidences would then appear to suggest that the cause of fire to the Insured Vehicle could have possibly been due to electrical in nature. See photos 6 - 8 below.

Photo 6 shows the wirings around the rear left portion of the engine compartment. Several stretches of wirings leading towards the Engine Control Module (ECM) (yellow arrow) were found burnt internally to its bare copper state (red arrows). The bright reddish colour of the copper wires suggests that the wirings were exposed to high heat. Such condition normally indicates internal heating of copper wires which is a sign of an electrical short circuit occurring.

22. Having investigated and technically analysed the damages of burnt nature to the Insured Vehicle, we are of the view that the cause of fire to the Insured Vehicle was of electrical in nature. For this particular case, the fire had originated along the wirings inside the engine compartment, somewhere around the rear left portion of the engine compartment. The wirings were original factory wirings leading to the Engine Control Module (ECM) of the Insured Vehicle.

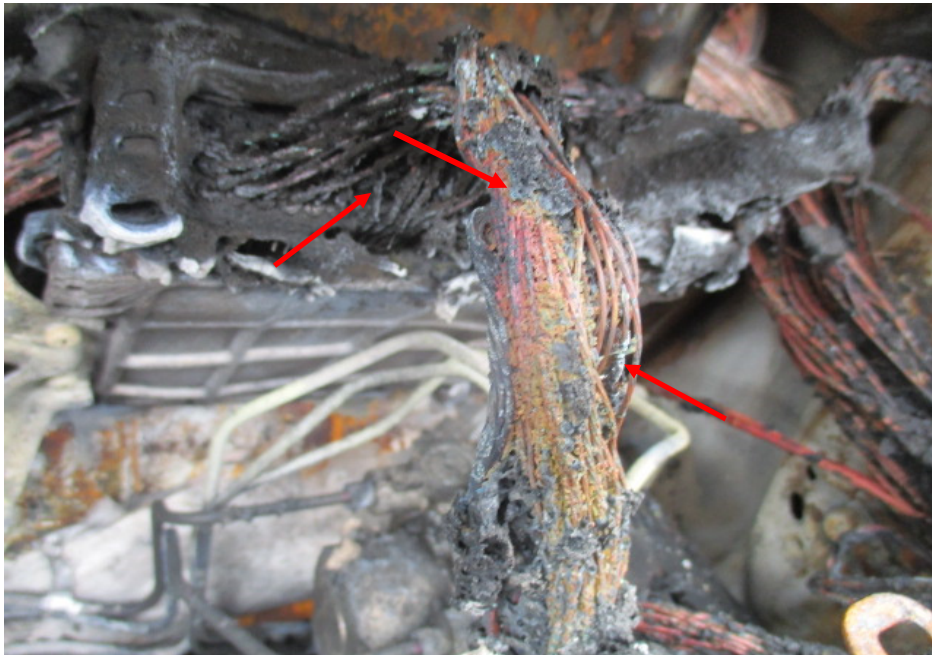
Photo 7 shows a closer view of some of the wirings with greenish residue (red arrows). The presence of such greenish residue suggest occurrence of an electrical short circuit.

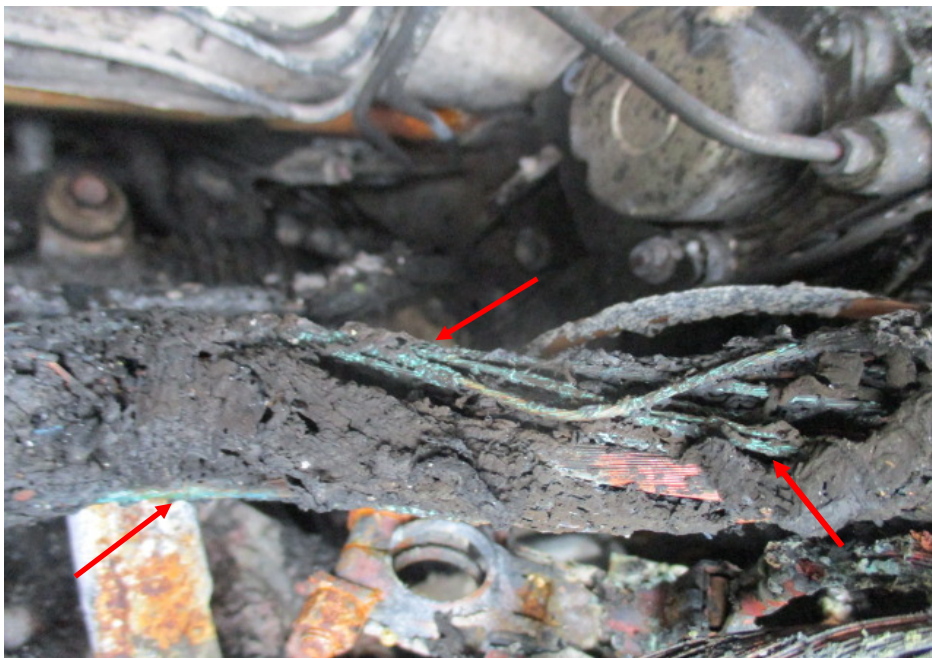
Photo 8 shows a close up view of some of the wirings with greenish residue (arrowed). The presence of such greenish residue suggest occurrence of an electrical short circuit.

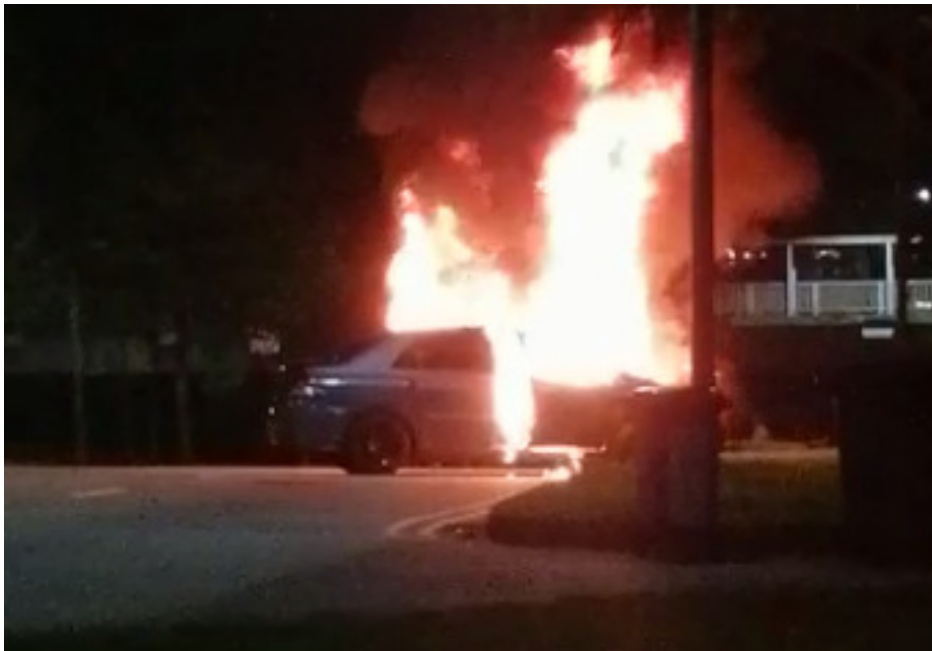
Photo 9 shows the Insured Vehicle on fire after colliding into a centre divider and mounting a kerb, before the arrival of the SCDF. In general, the information that could be gathered from this photograph had corresponded to the events that were related to us by Ms Shalene, which is the fire started from the front bonnet almost immediately after the collision.

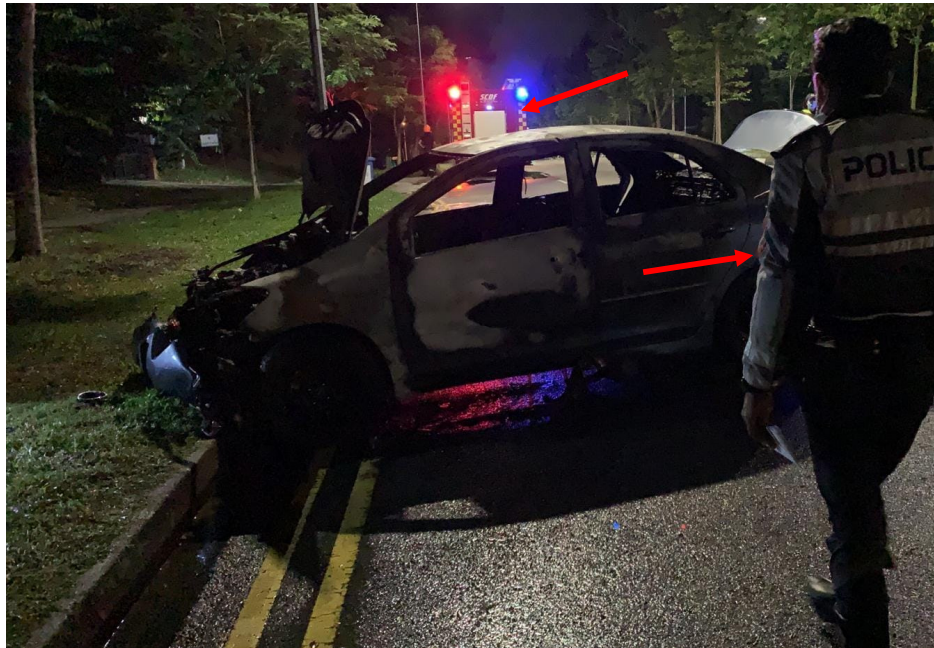
Photo 10 shows the Insured Vehicle at the incident scene after the fire was extinguished. In general, the information that could be gathered from this photograph had corresponded to the events that were related to us by Ms Shalene, which was both the SCDF and police had attended to the incident (arrowed).

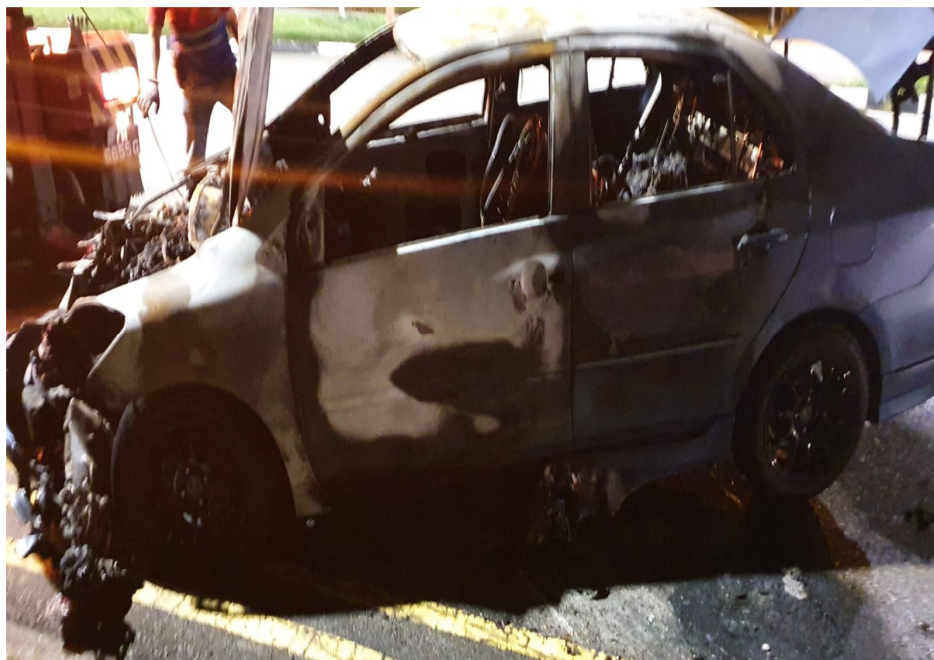
Photo 11 shows the Insured Vehicle being prepped to be towed to Ah Lim.
