Your Ref: TP/IP/43931/2020
Our Ref : CI/TPD20011427/P

30th October 2020

MECHANICAL INSPECTION REPORT OF MOTOR CAR SMQ 5162P

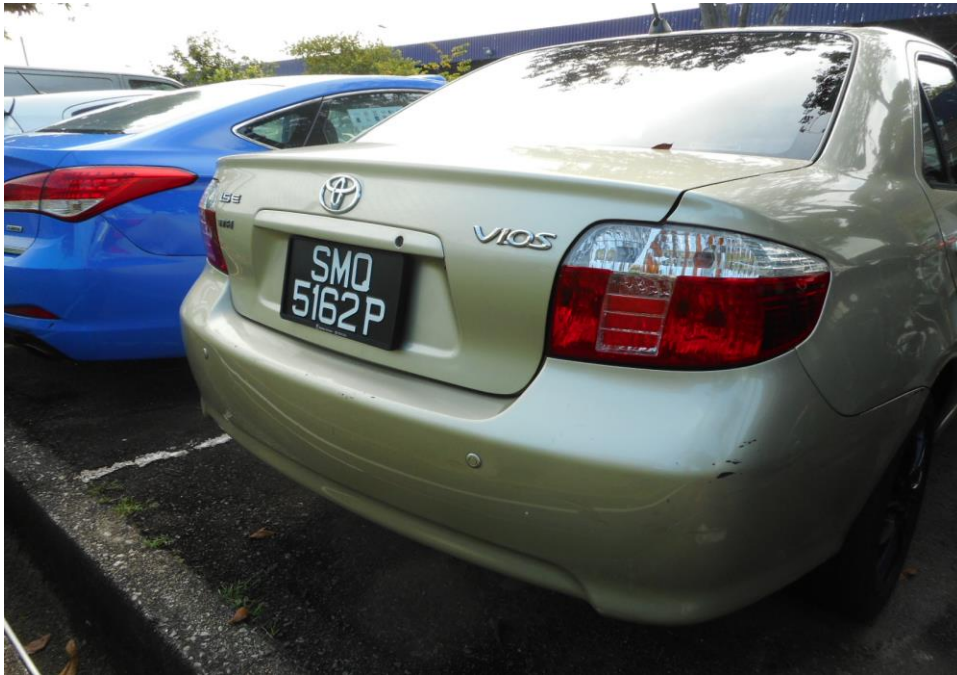
Photo 1 shows the general view of the Motor Car's rear body at the time of my inspection. The Motor Car rear was observed to be unaffected by the accident.

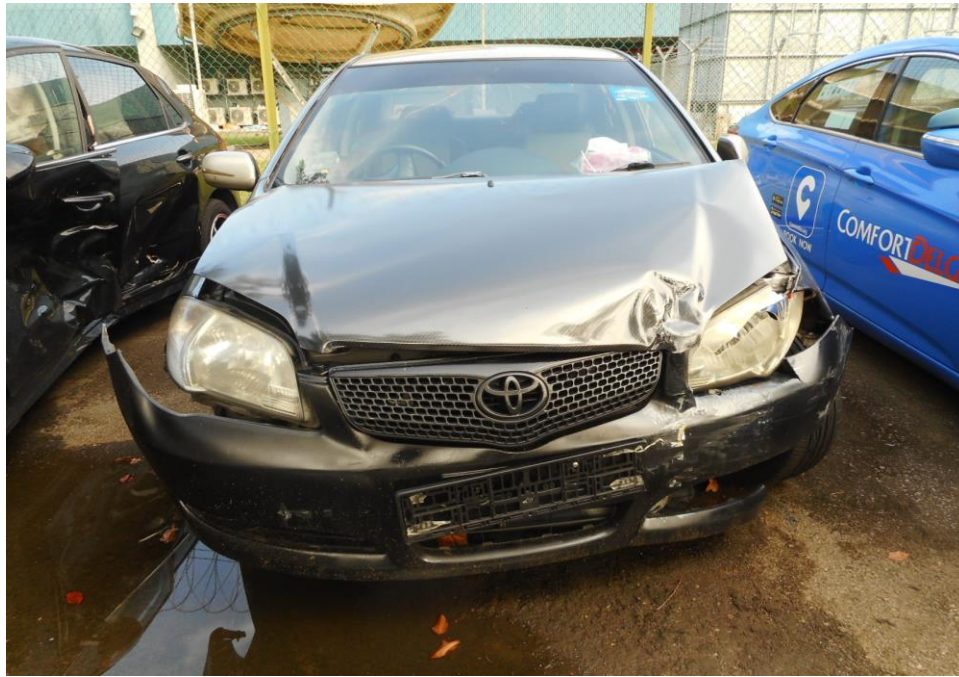
4. The mileage of the Motor Car at the time of my inspection was not recorded as the Motor Car was not able to be started despite multiple attempts in jumpstarting the engine. .
5. The Motor Car was observed to have sustained damage at its front portion. Its front bonnet, front bumper, front left fender, front left headlamp and engine components were amongst the body parts that were damaged as a result of the accident.

Photo 2 shows a general view of the Motor Car's front body at the time of my inspection. The Motor Car was observed to have sustained damage at its front portion. Its front bonnet, front bumper, front left fender, front left headlamp and engine components were amongst the body parts that were damaged as a result of the accident.

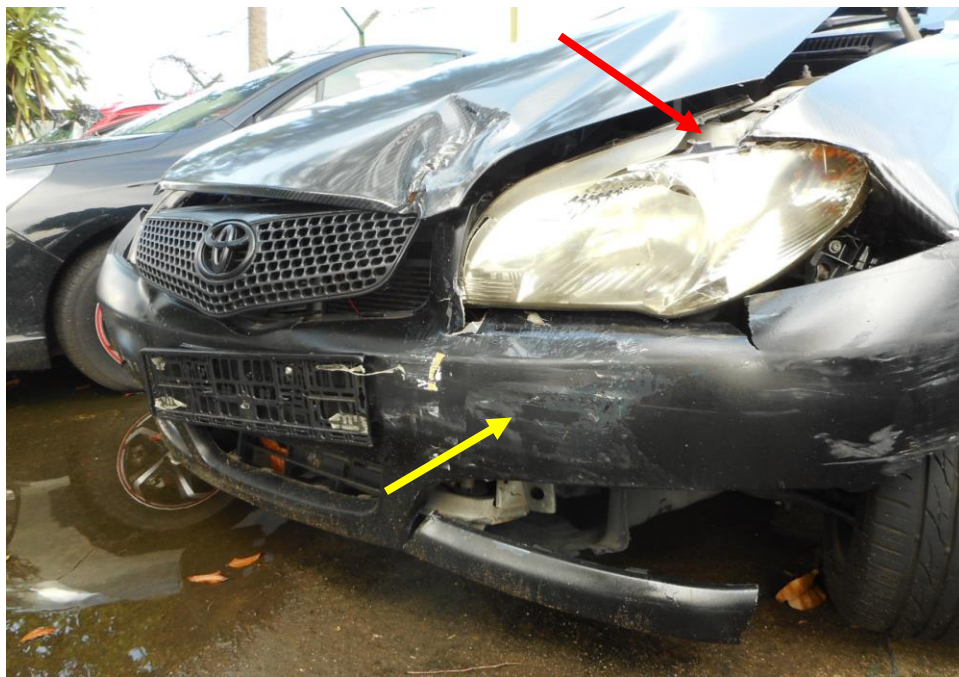
Photo 3 shows the close up view of the Motor Car's front portion at the time of my inspection. The Motor Car was observed to have sustained damage at its front portion. Its front bumper (red arrow) and front left fender (yellow arrow) were amongst the body parts that were damaged as a result of the accident.

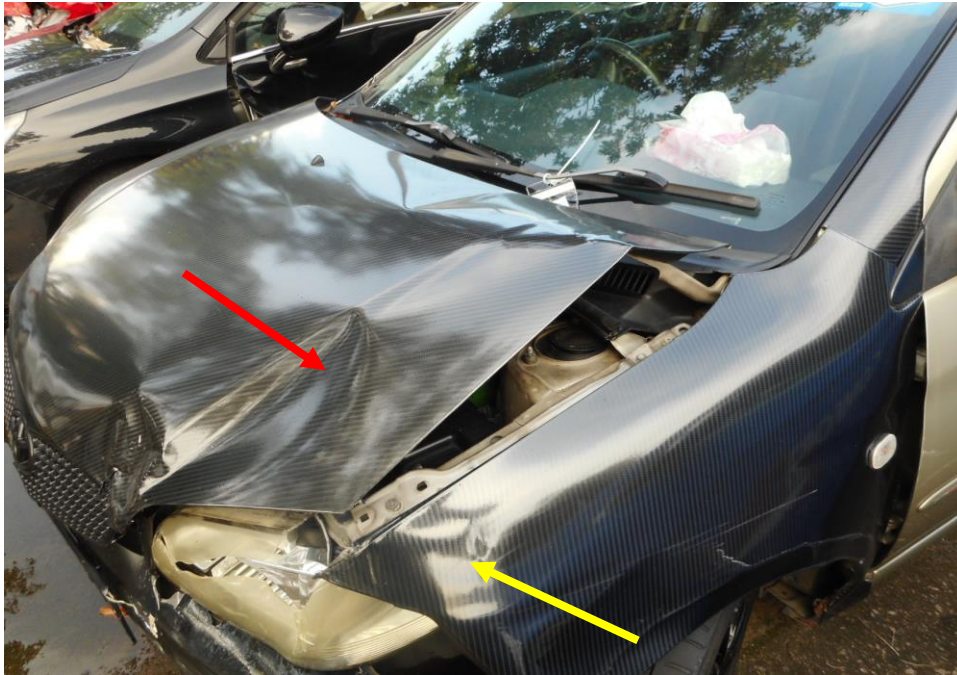
Photo 4 shows the close up view of the Motor Car's front portion at the time of my inspection. Its front bonnet (red arrow) and front left fender (yellow arrow) were amongst the body parts that were damaged as a result of the accident.

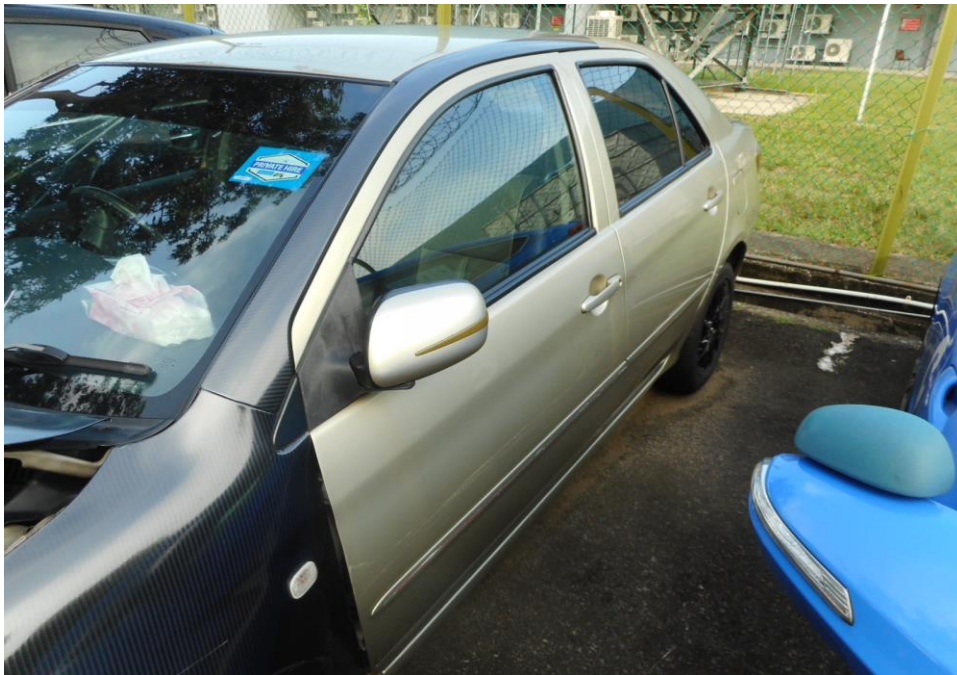
Photo 5 shows a general view of the Motor Car's left body at the time of my inspection. The left portion of the Motor Car was observed to have been unaffected by the accident.

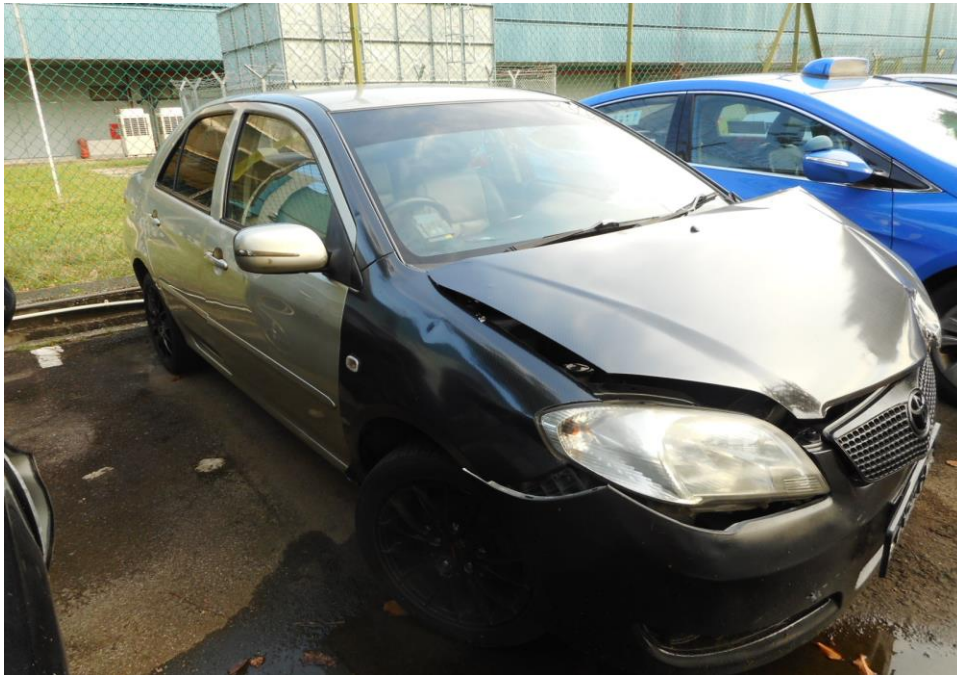
Photo 6 shows a general view of the Motor Car's right body at the time of my inspection. The right portion of the Motor Car was observed to have been unaffected by the accident.

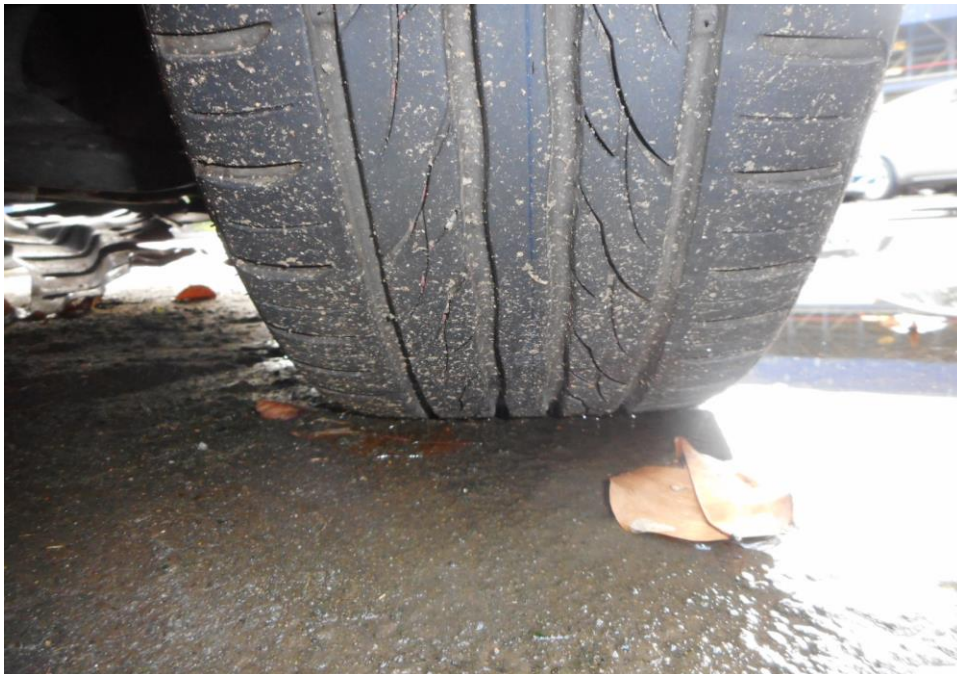
Photo 7 shows the condition of the front right tyre of the Motor Car, which was observed to be in serviceable condition with remaining tread depth of approximately 5.7mm. The tyre was sufficiently inflated for vehicular operation with no tear, cut or burst mark(s) on the outer and the inner sidewalls as well as across the tread. The 4 tyres of the Motor Car were wrapped around standard steel wheel rims without any damage.

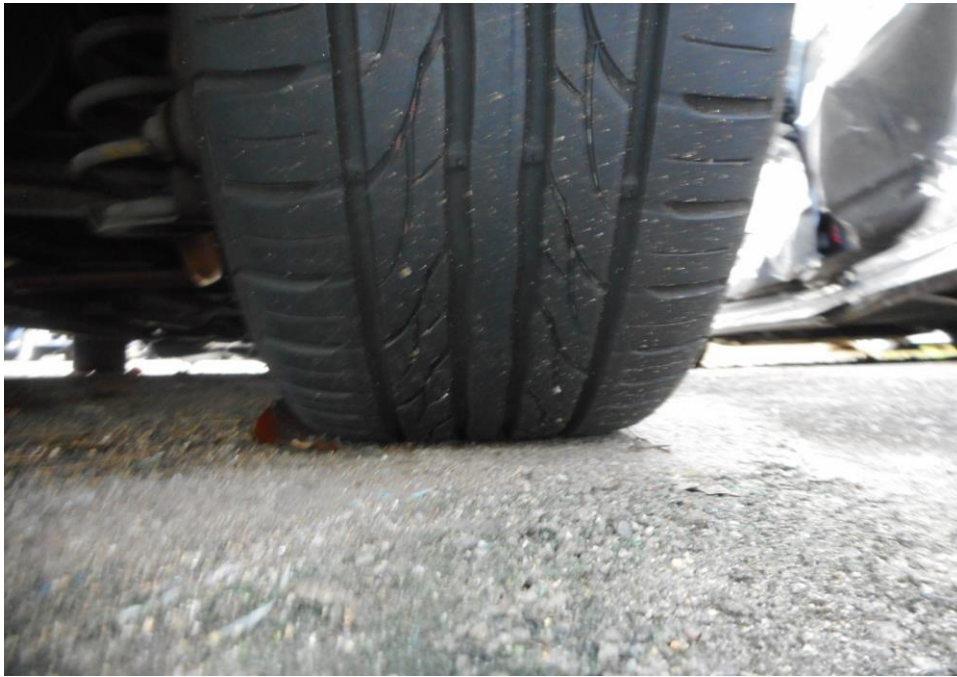
Photo 8 shows the condition of the rear right tyre of the Motor Car, which was observed to be in serviceable condition with remaining tread depth of approximately 6.2mm. The tyre was also observed to be sufficiently inflated for vehicular operation with no tear, cut or burst mark(s).

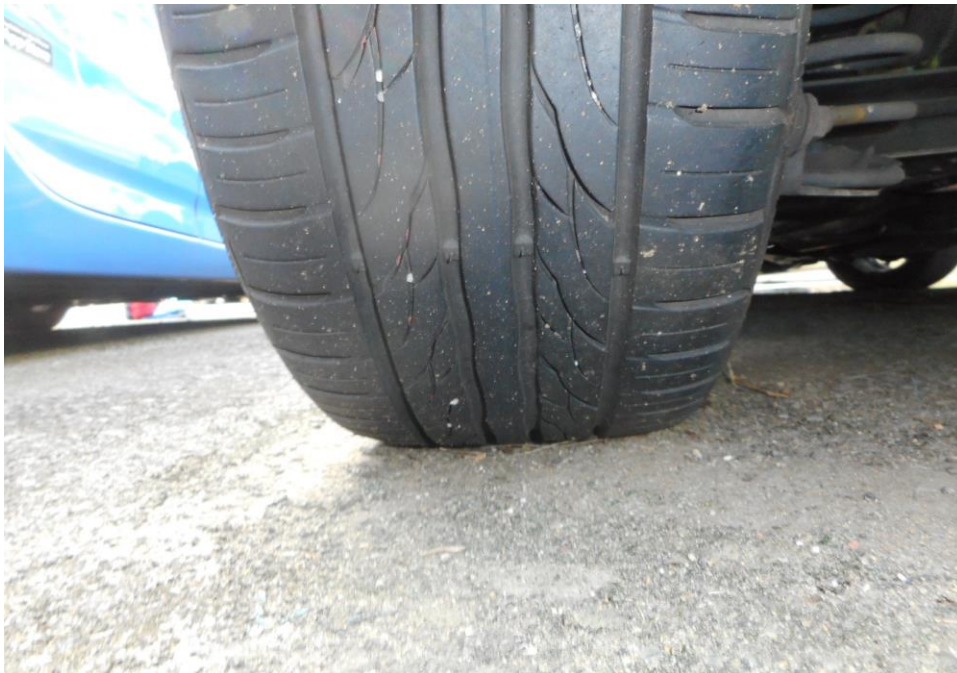
Photo 9 shows the condition of the rear left tyre of the Motor Car, which was observed to be in serviceable condition with remaining tread depth of approximately 6.4mm. The tyre, which was wrapped around steel wheel rim, was also observed to be sufficiently inflated for vehicular operation. The 4 tyres of the Motor Car were wrapped around standard steel wheel rims.

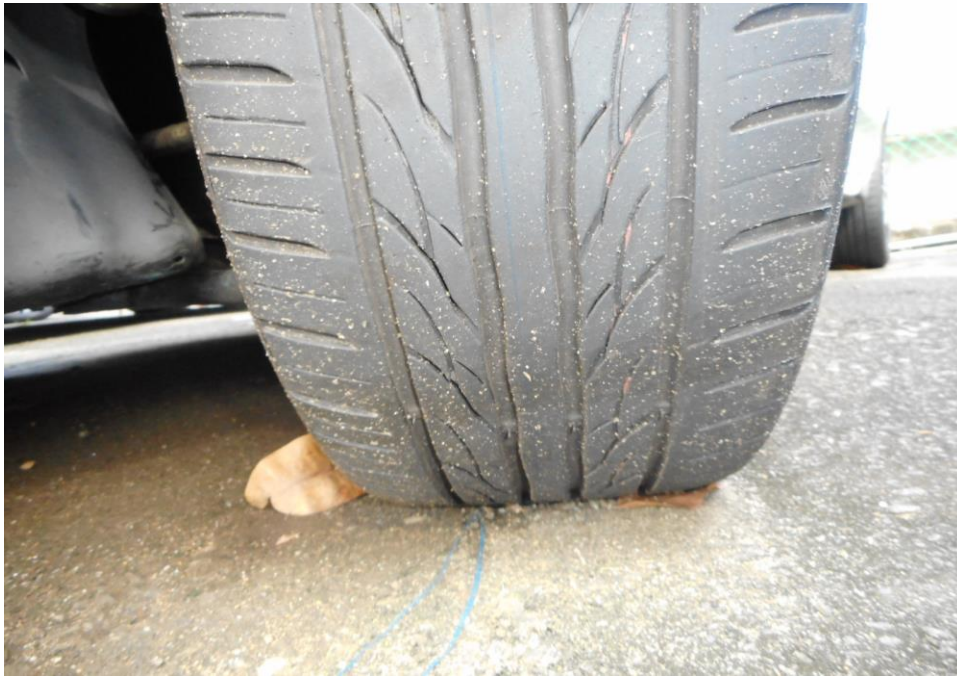
Photo 10 shows the condition of the front left tyre of the Motor Car, which was observed to be in serviceable condition with remaining tread depth of approximately 5.4mm. There was also no tear, cut or burst mark(s) on the outer and the inner sidewalls as well as across the tread of the Motor Car's 4 tyres.

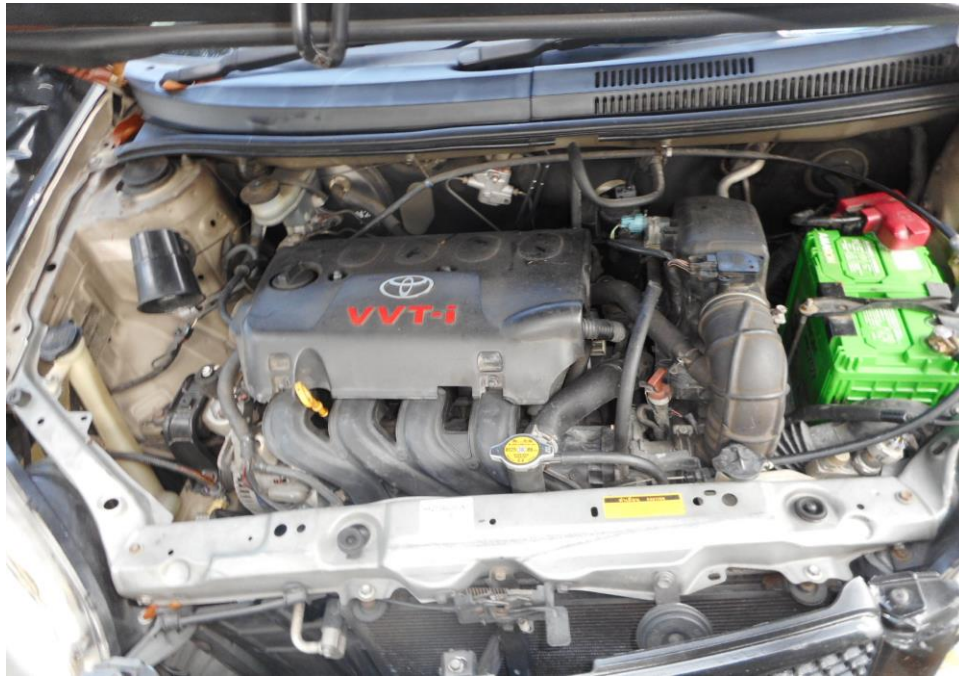
8. Upon examination of the engine compartment of the Motor Car, I had observed that the front panel of the engine compartment was damaged as a result of the accident. However, all the parts and components inside the engine compartment to be intact and unaffected by the accident.

Photo 11 shows a general view of the Motor Car's engine compartment. The front panel of the engine compartment was observed to be damaged as a result of the accident. However, the various parts and components inside the engine compartment were unaffected by the accident. There was also no sign(s) or indication(s) of fluid leakage and/or fluid stain within the engine compartment.

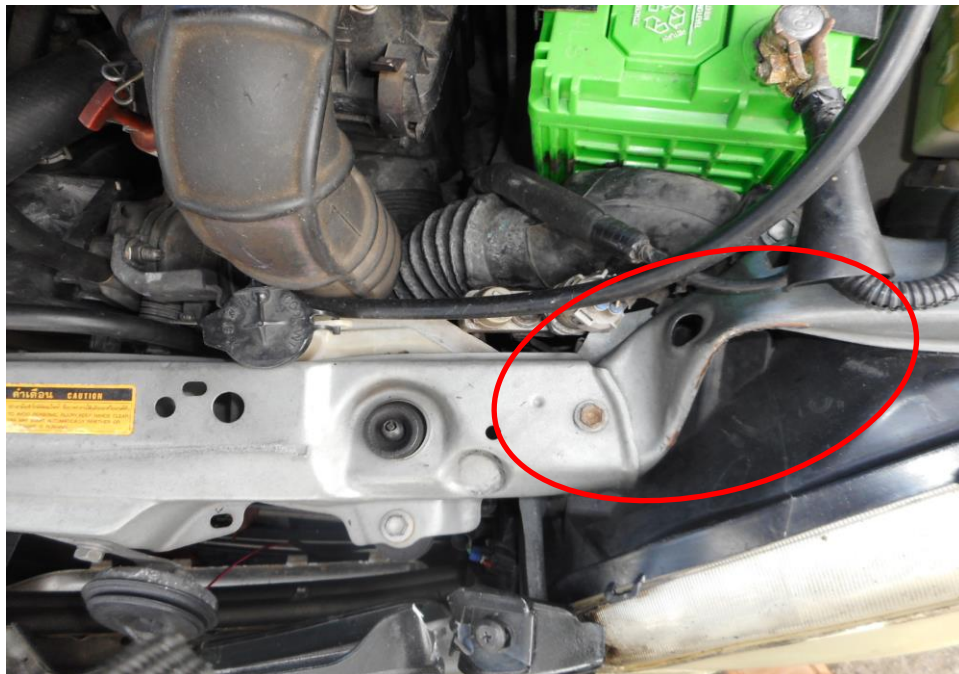
Photo 12 shows a close up view of the Motor Car's engine compartment. The front panel of the engine compartment (circled) was observed to be damaged as a result of the accident.

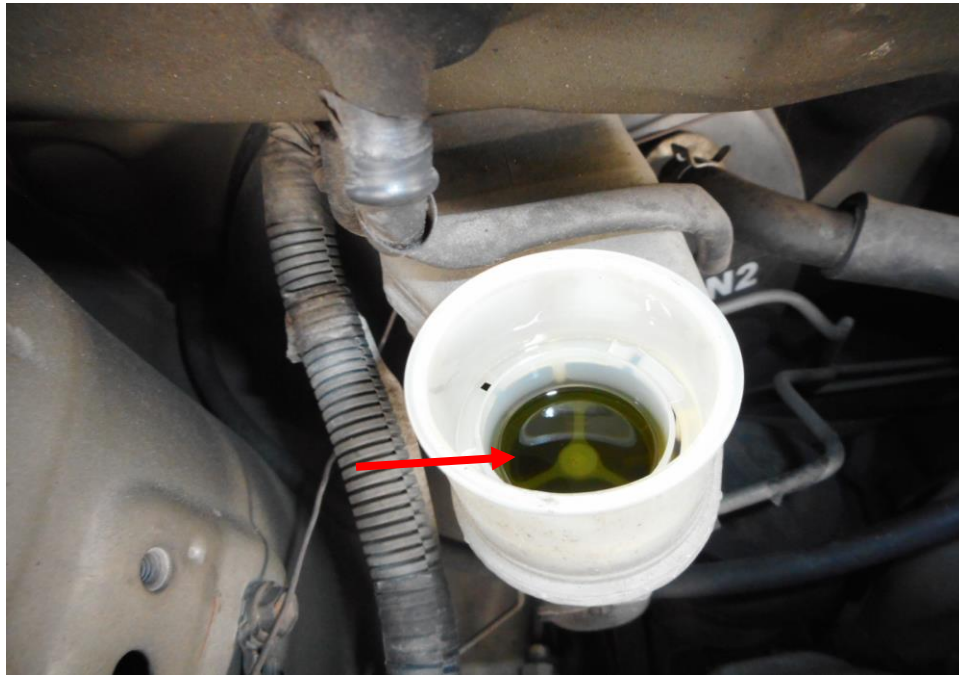
Photo 13 shows the brake fluid reservoir of the Motor Car at the time of my inspection. The brake fluid was observed to be of sufficient level (arrowed) and without any visible contamination.

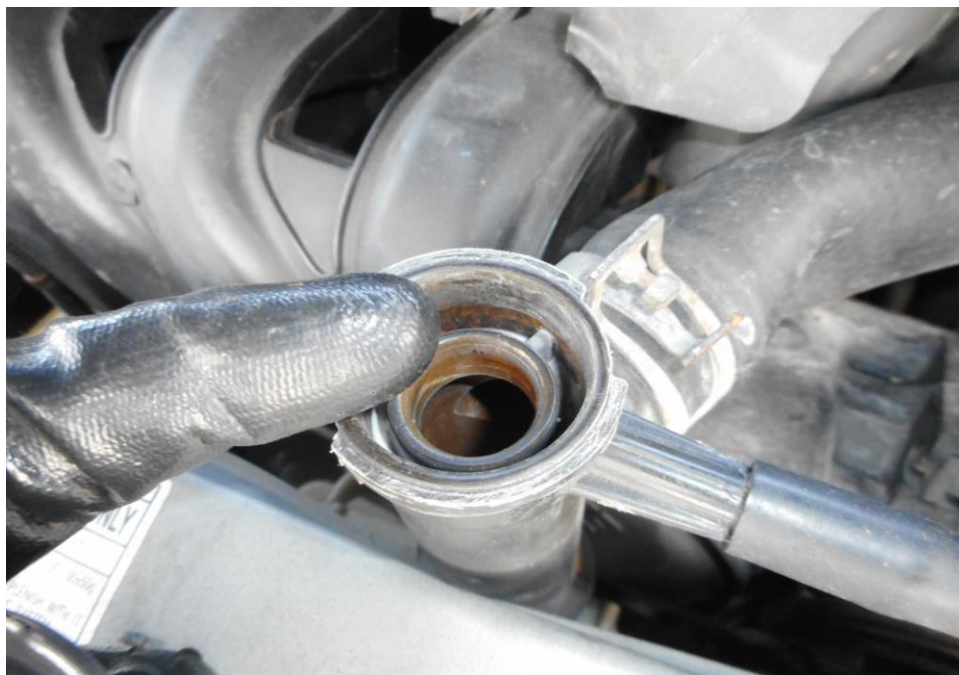
9. The engine coolant was observed to be of insufficient level. However the brake fluid and engine oil were all found to be of sufficient level for operating purposes. Visually, there was also no contamination found to these fluids.

Photo 14 shows checks being carried out to the engine coolant of the Motor Car at the time of my inspection. The engine coolant was observed to be of insufficient level.

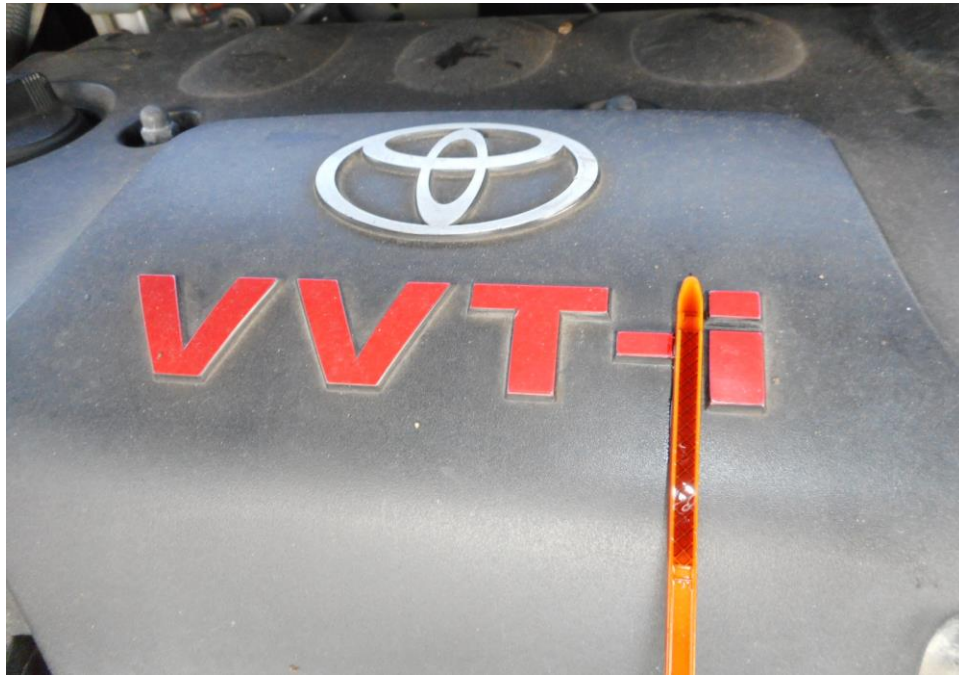
Photo 15 shows the engine oil dip stick of the Motor Car at the time of my inspection. The engine oil was observed to be of sufficient level and without any visible contamination.

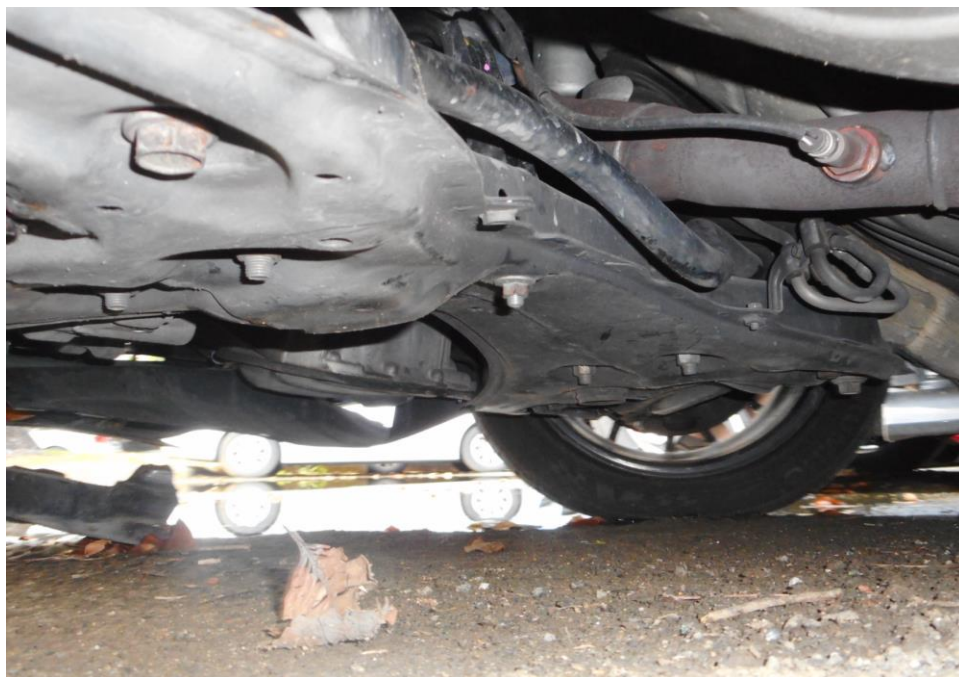
11. My subsequent checks on the underside of the Motor Car also revealed no sign(s) or indication(s) of fluid leak and/or fluid stain(s). Visually, the various undercarriage components of the Motor Car were all observed to be intact and without any visible damage. See photo 11 – 17 below.

Photo 16 shows the undercarriage of the Motor Car, at the area where the engine housing and transmission housing are located. I did not find any sign(s) or indication(s) of fluid leak and/or fluid stain(s) on the underside of the Motor Car.

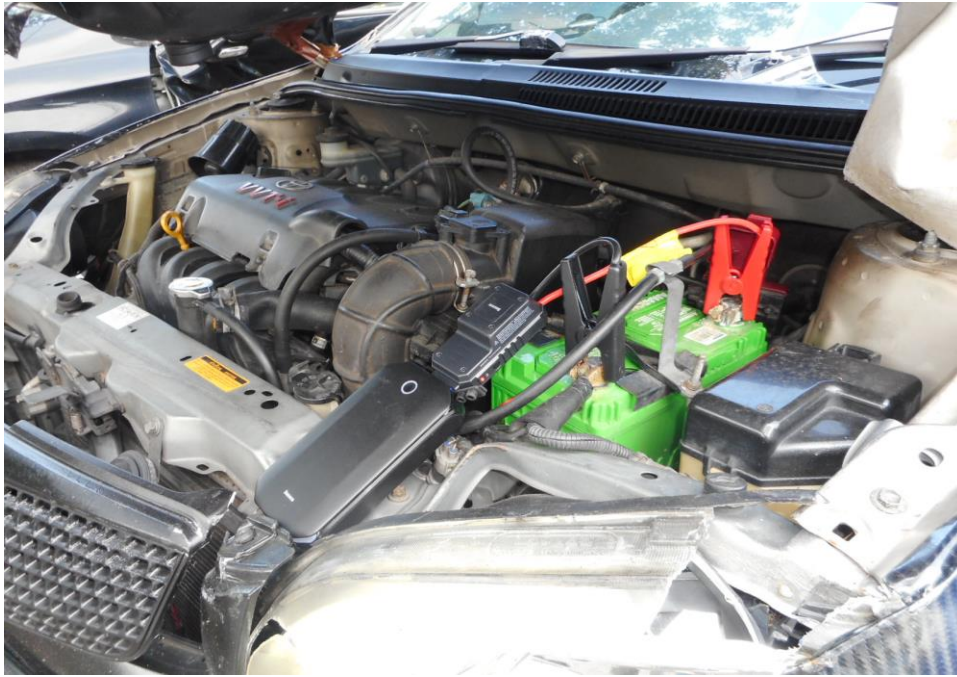
Photo 17 shows the engine of the Motor Car, the engine was not able to be started up despite multiple attempts on jumpstarting it.

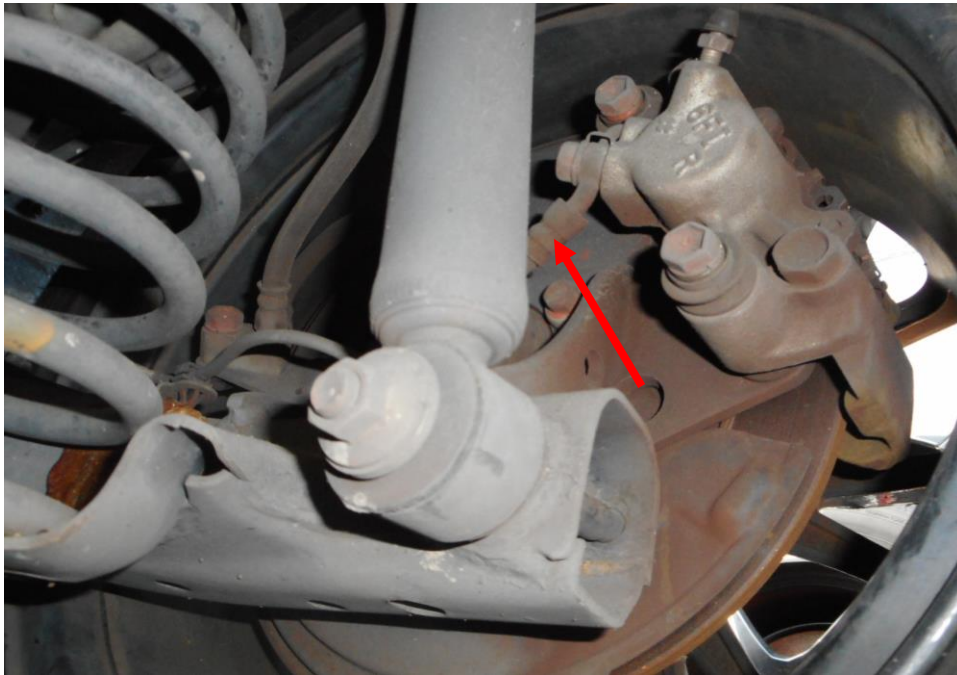
Photo 18 shows the brake hose/pipe (arrowed) at the rear right wheel of the Motor Car. No leakage of brake fluid was observed. Visual examination of the various components of the braking system like the drum brake, brake booster, brake pedal etc. had revealed all to be intact and without visible damage.

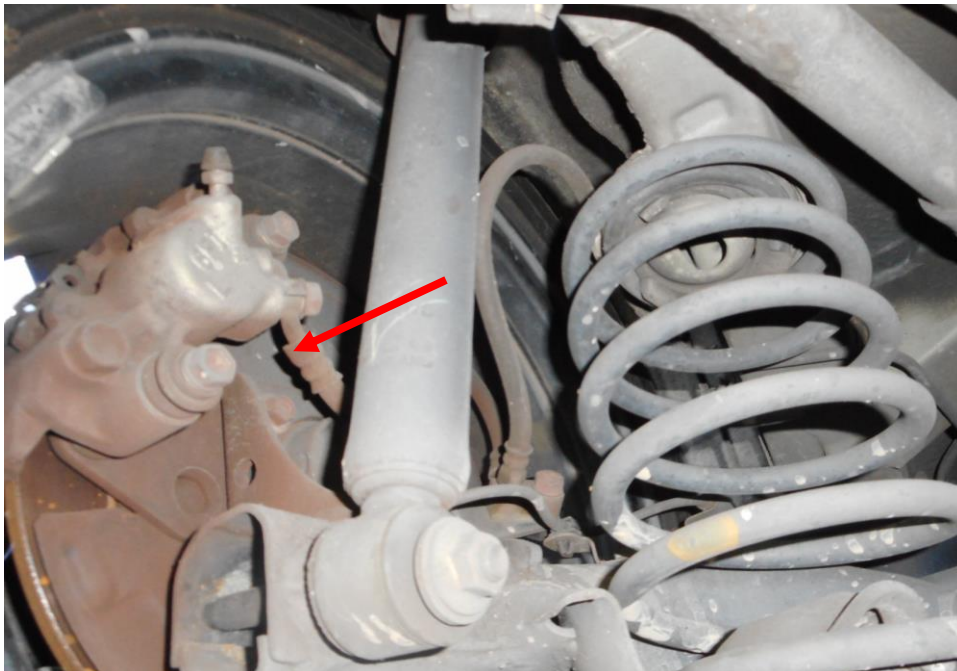
Photo 19 shows the brake hose/pipe (arrowed) at the rear left wheel of the Motor Car. I did not observe any leakage of brake fluid at the time of my inspection of the Motor Car. Static tests of the Motor Car's braking system had indicated that there was no internal leakage of pressure/vacuum. The undercarriage components of the Motor Car were also all found to be intact and without any visible damage.

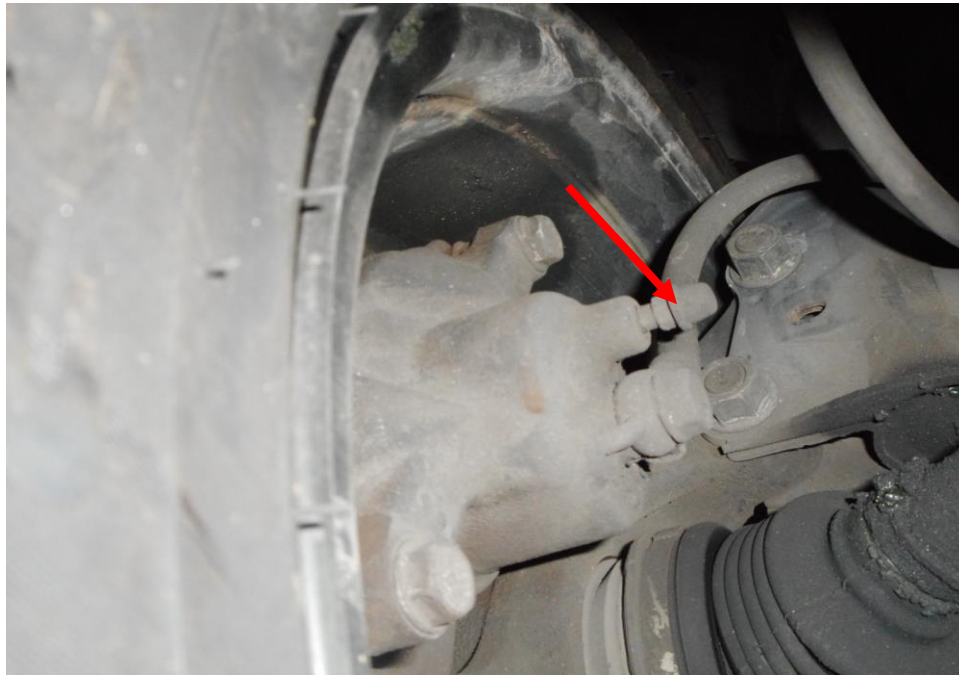
Photo 20 shows the brake hose/pipe (arrowed) at the front right wheel of the Motor Car. I did not observe any leakage of brake fluid at the time of my inspection of the Motor Car. Static tests of the Motor Car's braking system had indicated that there was no internal leakage of pressure/vacuum. The undercarriage components of the Motor Car were also all found to be intact and without any visible damage.

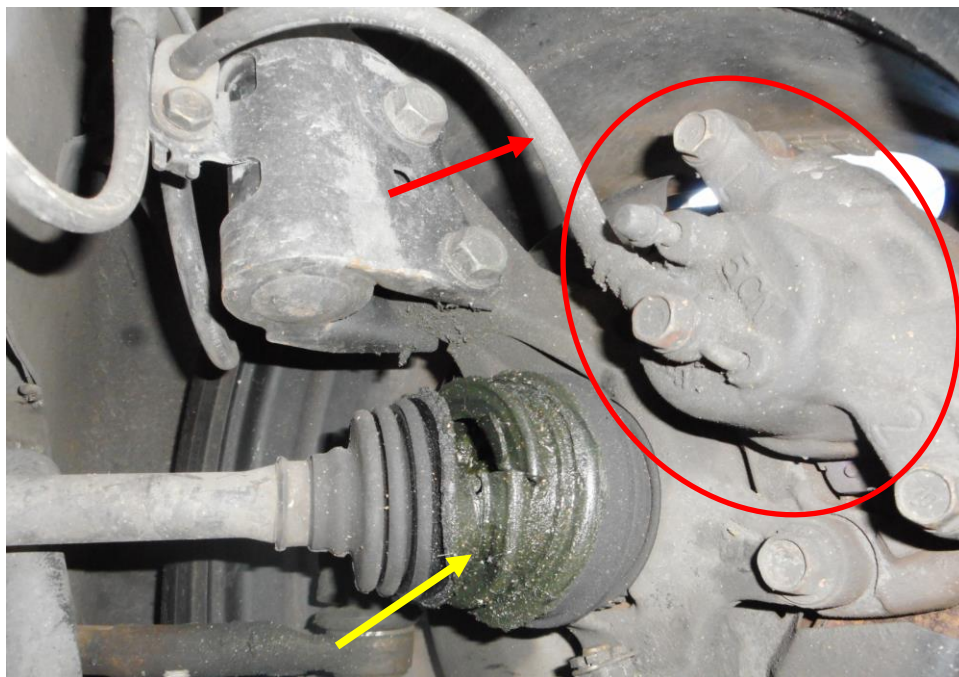
Photo 21 shows the brake hose/pipe (arrowed) at the front left wheel of the Motor Car. No leakage of brake fluid was observed. Visual examination of the various components of the braking system like the brake caliper (circled), brake booster, brake pedal etc had revealed all to be intact and without visible damage. However the driveshaft boot (yellow arrow) was observed to be damaged.

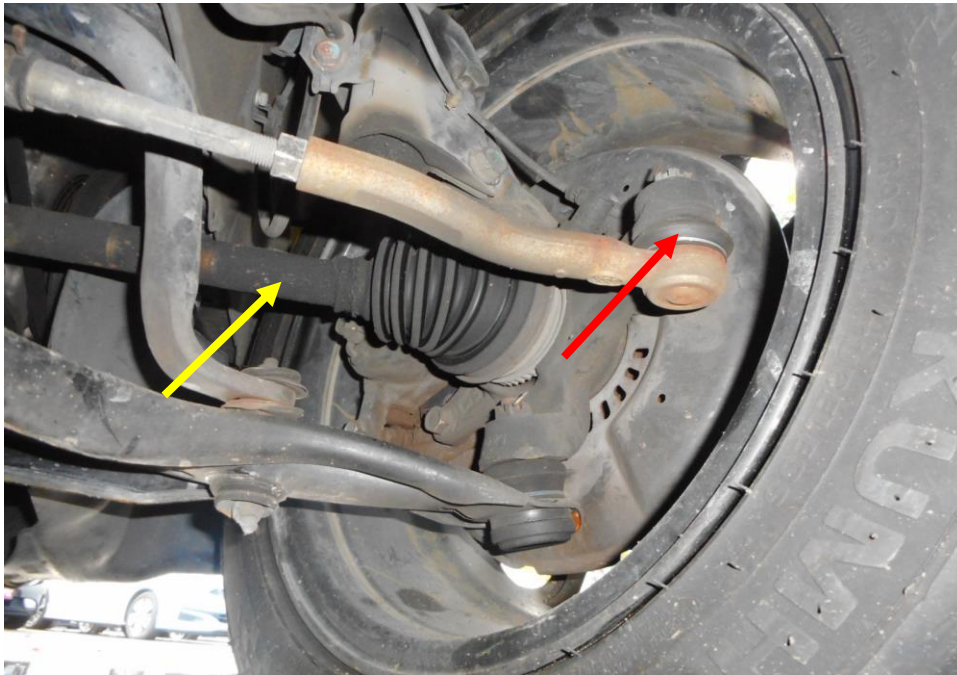
Photo 22 shows the various undercarriage components at the front right wheel of the Motor Car, in particular the steering tie rod (red arrow) and drive shaft (yellow arrow). The various steering components were all found to be intact, suggesting that the steering system of the Motor Car was likely to be in serviceable condition at the material time of accident. There was also no sign of fluid stain observed on the various undercarriage components at the front right wheel of the Motor Car.

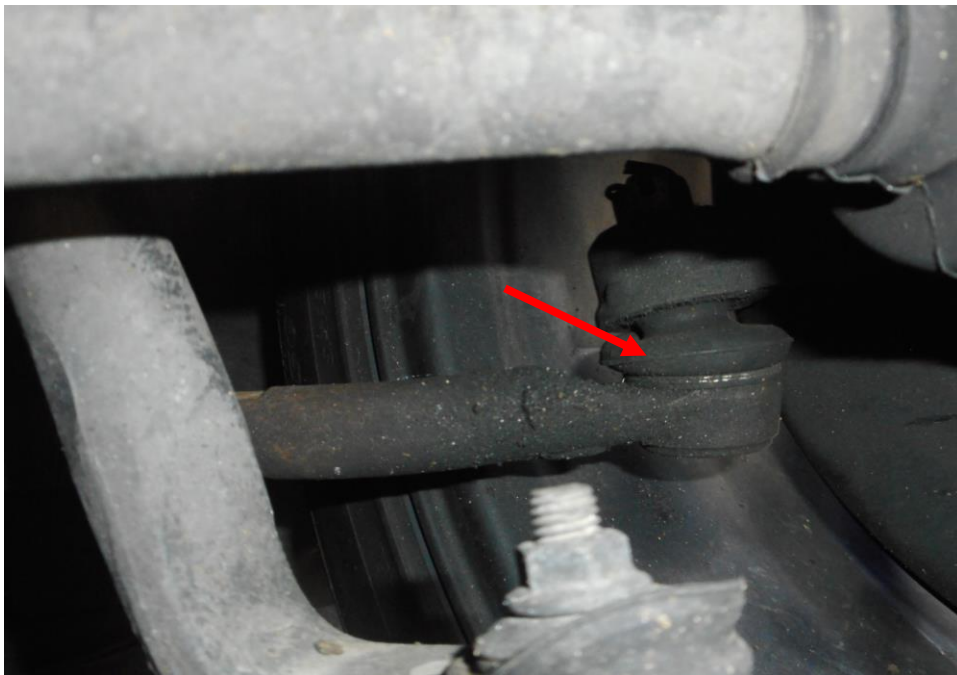
Photo 23 shows the various undercarriage components at the front left wheel of the Motor Car, in particular the steering tie rod (arrowed). The various steering components were all found to be intact, suggesting that the steering system of the Motor Car was likely to be in serviceable condition at the material time of accident. There was also no sign of fluid stain observed on the various undercarriage components at the front left wheel of the Motor Car.
