Your Ref: TP/IP/35277/2020  
Our Ref : CI/TPD20011428/P

**General Investigation Team**

**MECHANICAL INSPECTION REPORT OF MOTOR CAR SKC 994K**

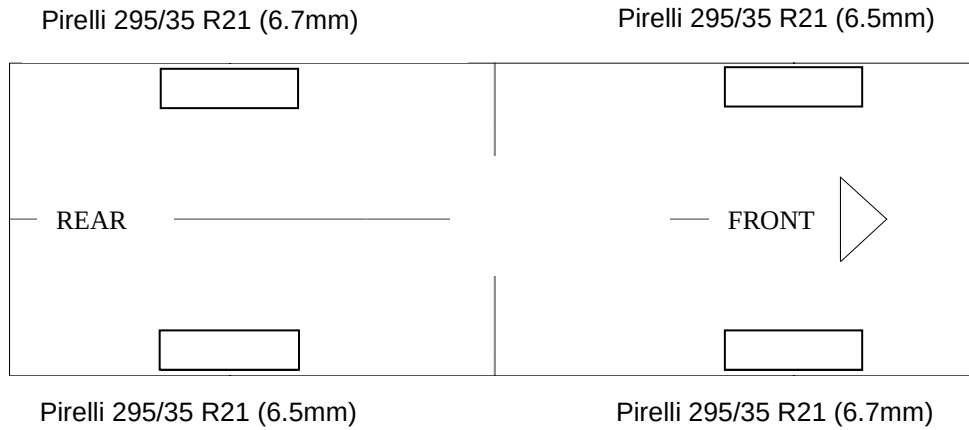
6. The 4 tyres of the Motor Car were observed to be in serviceable condition and sufficiently inflated for vehicular operation. I did not find any tear, cut or burst mark(s) on the outer and the inner sidewalls as well as across the tread of the 4 tyres. The tyre brand, tyre size and remaining tread depth of the 4 tyres of the Motor Car were recorded as follows:-

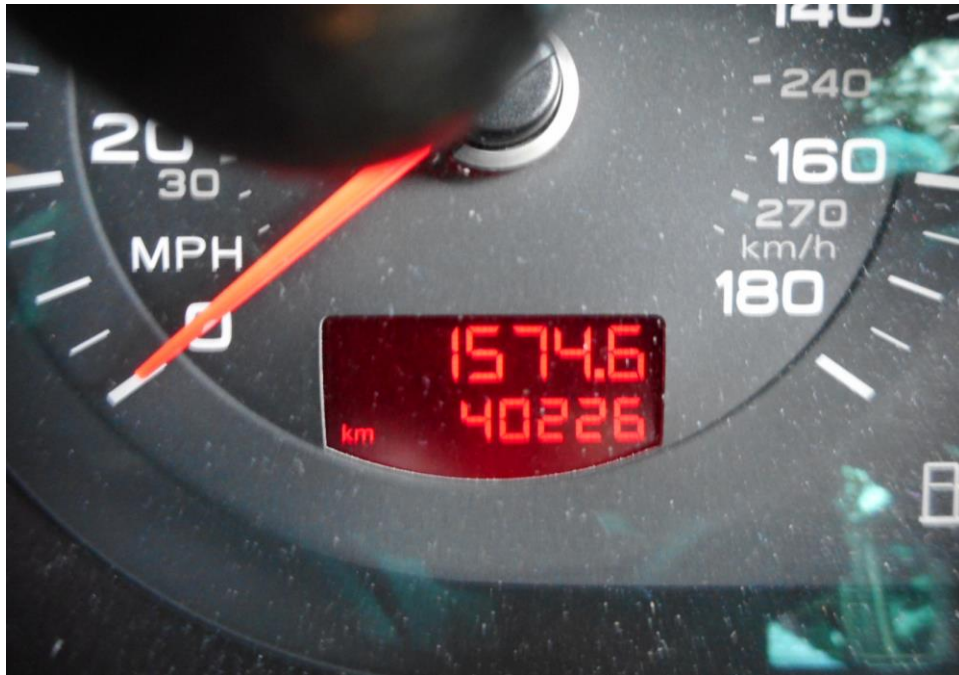
**Photo 1** shows a general view of the instrument cluster of the Motor Car at the time of my inspection. The mileage of the Motor Car was 40,226km

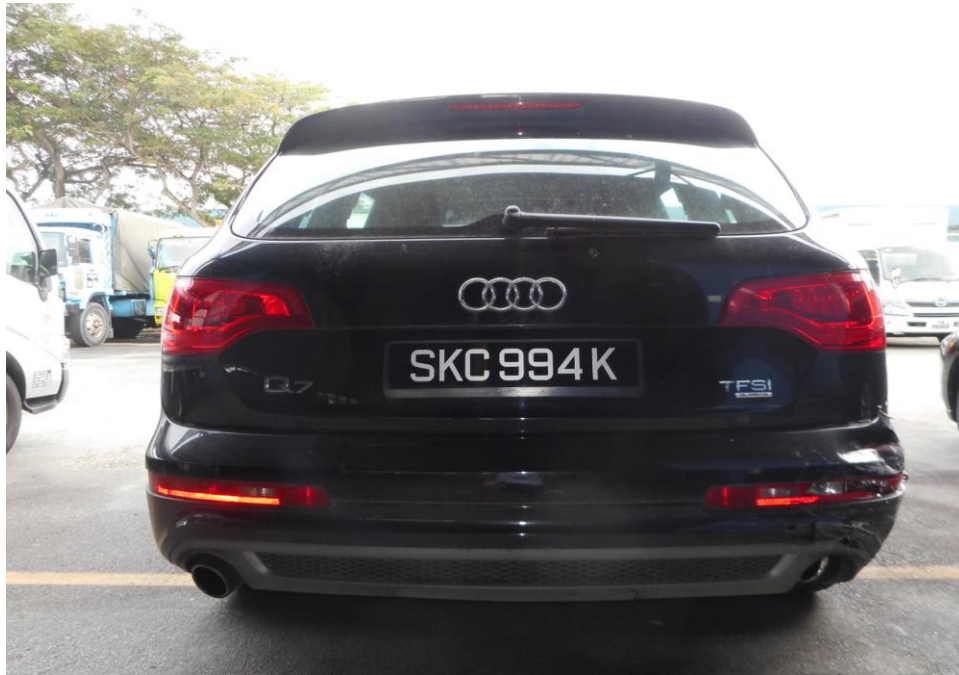
**Photo 2** shows a general view of the Motor Car rear portion at the time of my inspection. The Motor Car was observed to visually sustain damage at its rear bumper at the time of inspection.

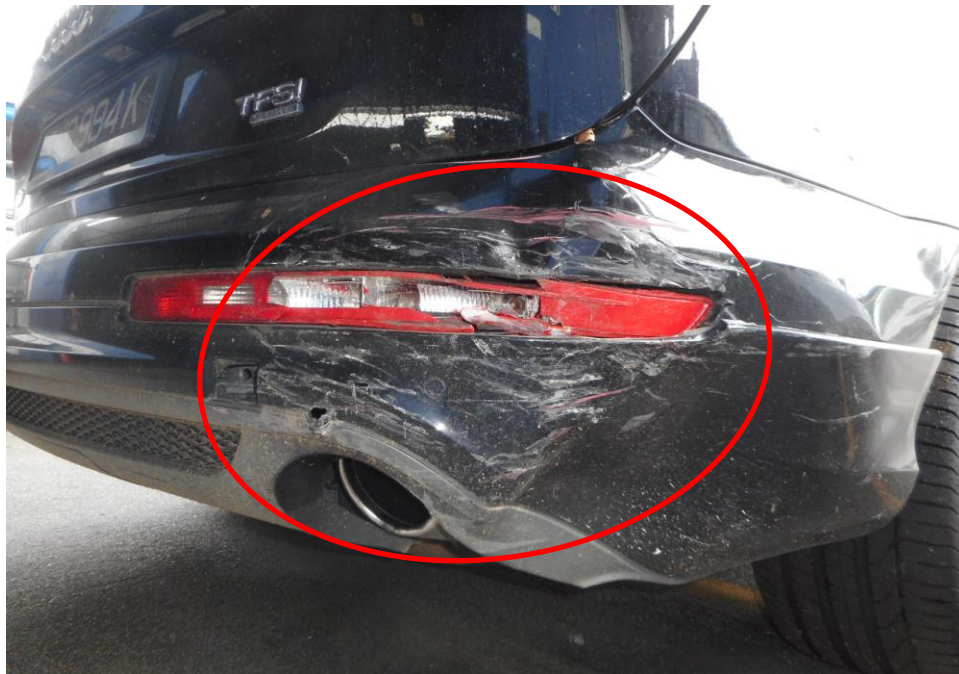
**Photo 3** shows a close up view of the rear body of the Motor Car at the time of my inspection. The Motor Car was observed to visually sustain damage at its rear bumper (circled) at the time of inspection.

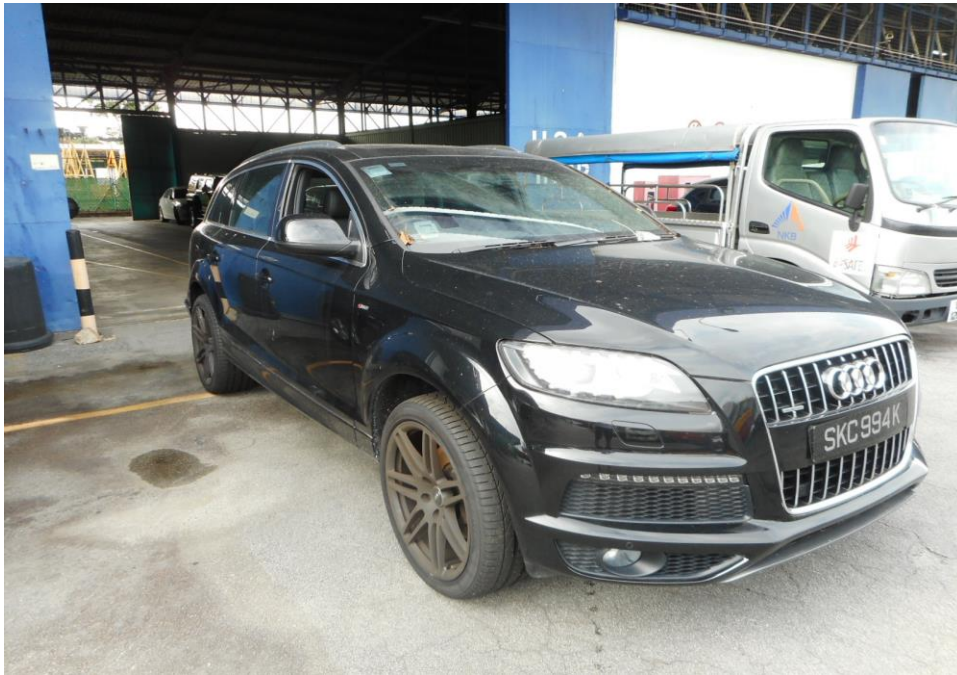
**Photo 4** shows a general view of the right body of the Motor Car at the time of my inspection. The Motor Car was observed to be intact and unaffected by the accident.

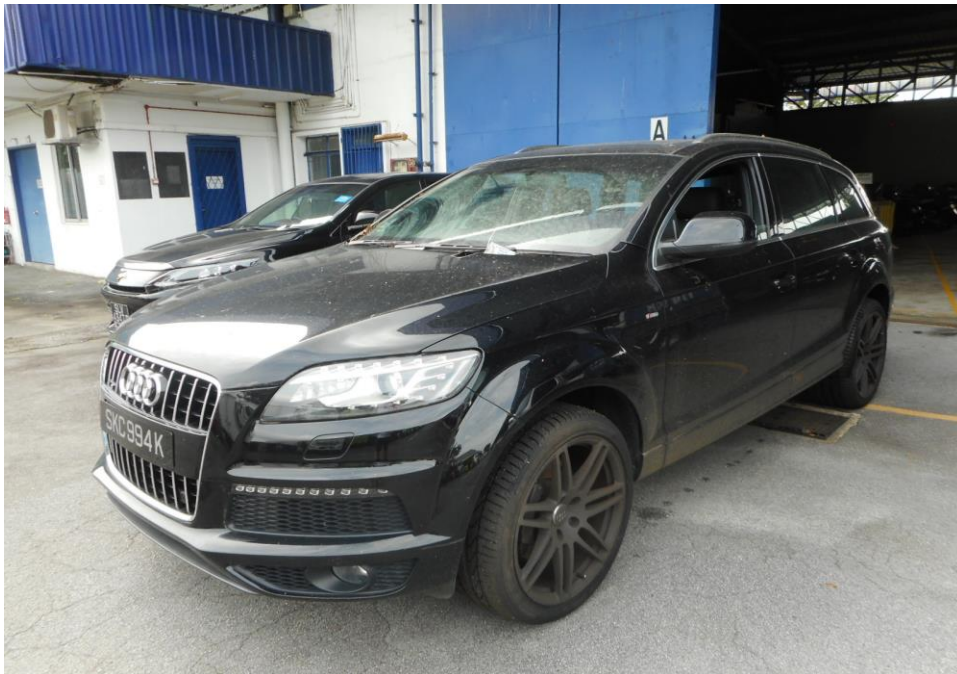
**Photo 5** shows a general view of the left body of the Motor Car at the time of my inspection. The Motor Car was observed to be intact and unaffected by the accident.

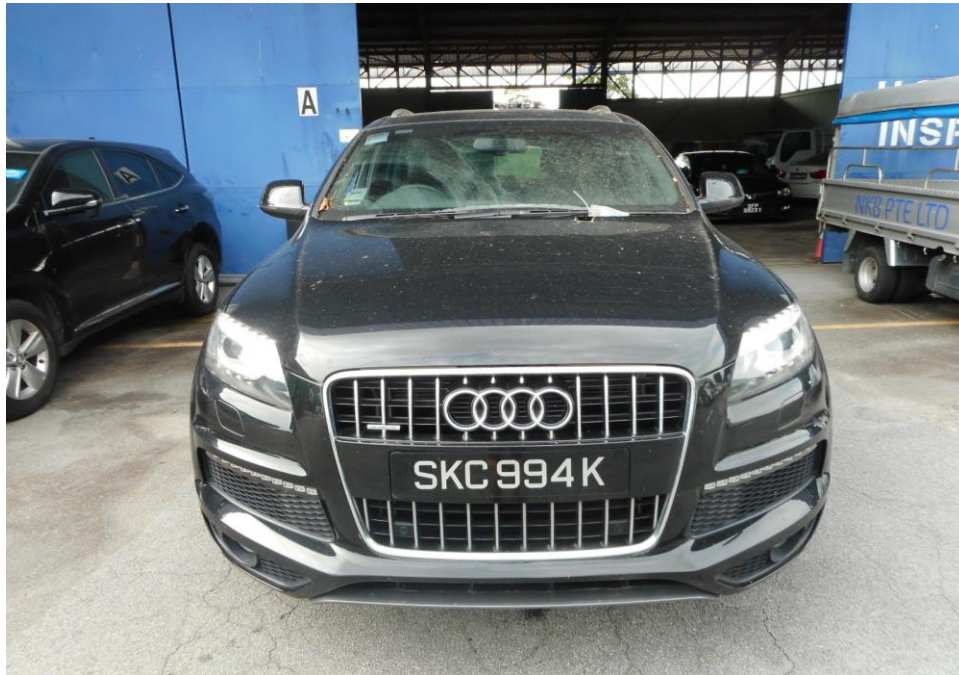
**Photo 6** shows a general view of the front body of the Motor Car at the time of my inspection. The Motor Car was observed to be intact and unaffected by the accident.

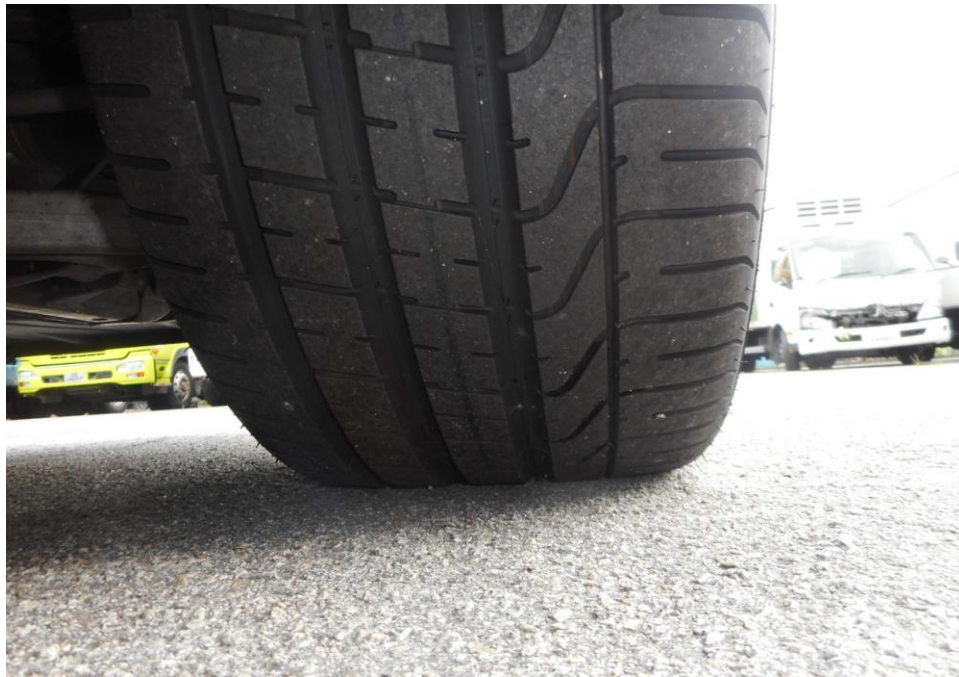
**Photo 7** shows the condition of the front right tyre of the Motor Car, which was observed to be in serviceable condition with remaining tread depth of approximately 6.7mm. The tyre, which was wrapped around standard alloy wheel rim, was also observed to be sufficiently inflated for vehicular operation. There was no tear, cut or burst mark(s) on the outer and the inner sidewalls as well as across the tread of the 4 tyres that were fitted on the Motor Car.

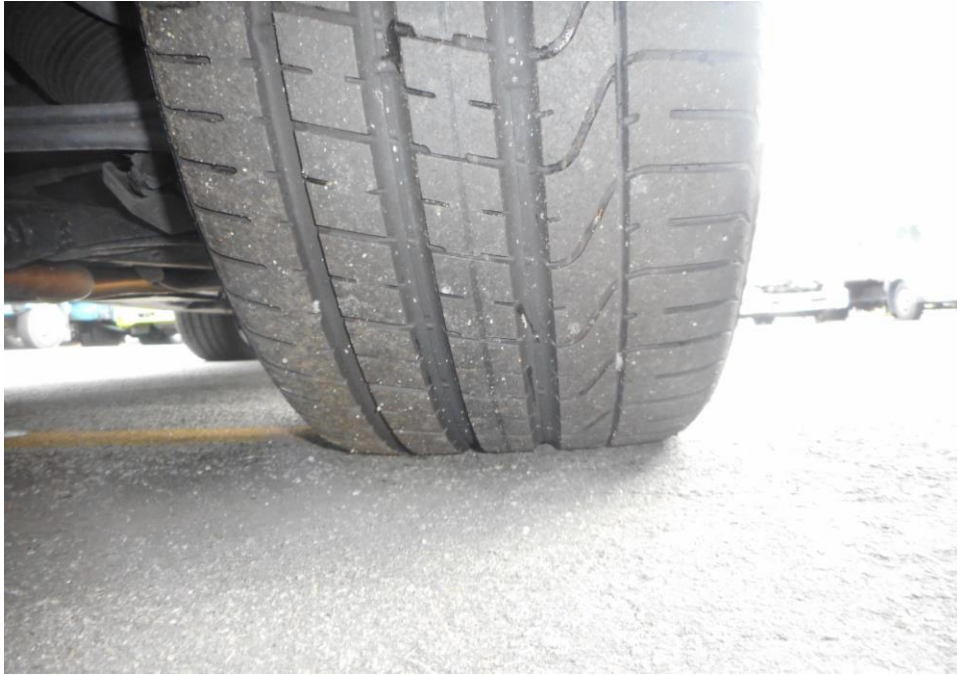
**Photo 8** shows the condition of the rear right tyre of the Motor Car, which was observed to be in serviceable condition with remaining tread depth of approximately 6.5mm. The tyre, which was wrapped around standard alloy wheel rim, was also observed to be sufficiently inflated for vehicular operation.

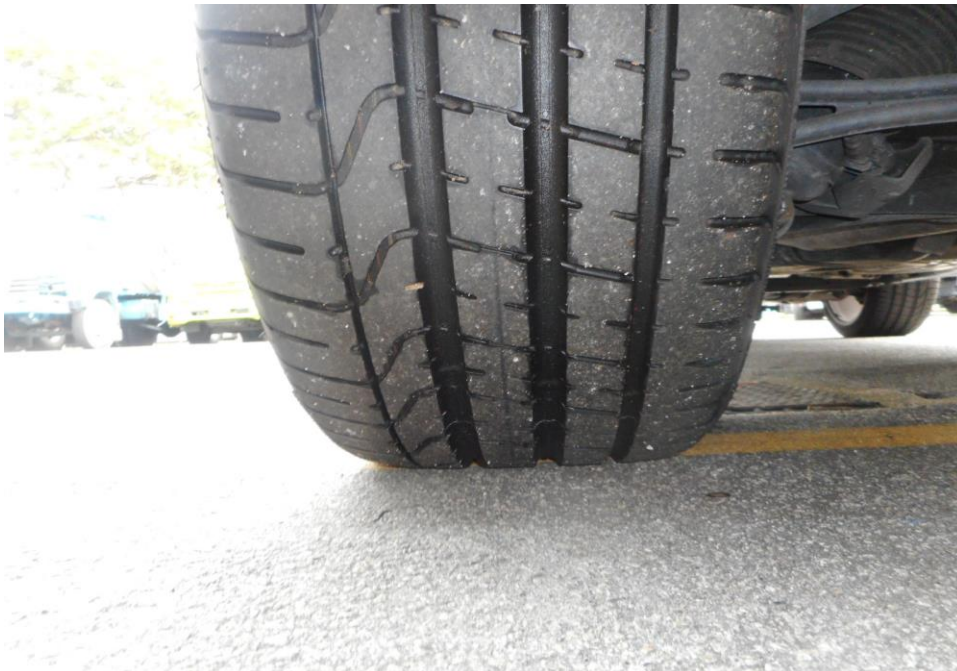
**Photo 9** shows the condition of the rear left tyres of the Motor Car, which was observed to be in serviceable condition with remaining tread depth of approximately 6.7mm. The tyres, which were wrapped around standard alloy wheel rim, were also observed to be sufficiently inflated for vehicular operation. There was also no damage found on all 4 alloy wheel rims of the Motor Car.

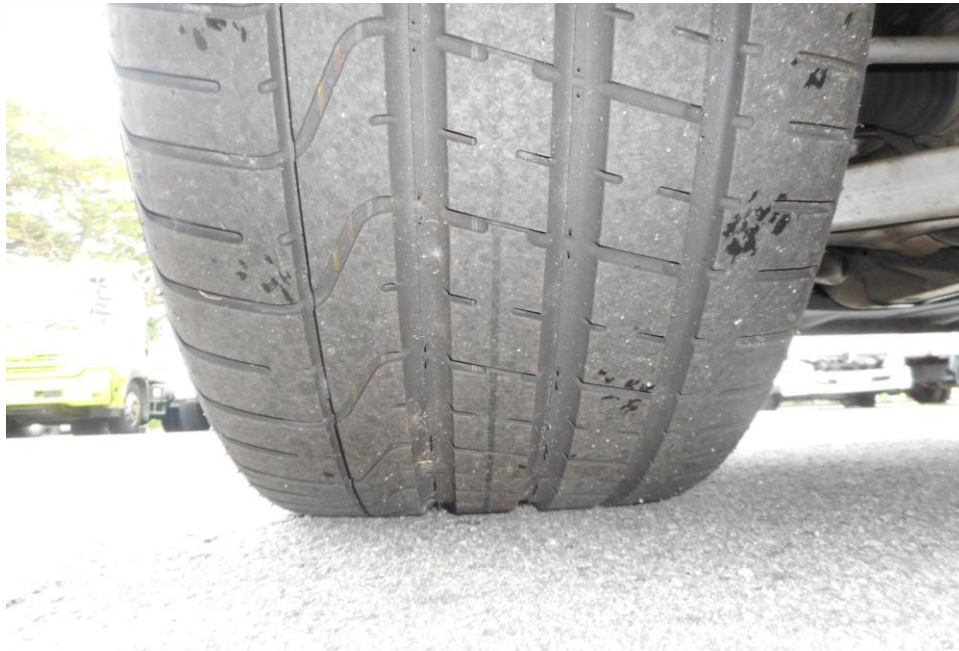
**Photo 10** shows the condition of the rear right tyres of the Motor Car, which were observed to be in serviceable condition with remaining, tread depth of approximately 6.5mm. There was also no tear, cut or burst mark(s) on the outer and the inner sidewalls as well as across the tread of the 4 tyres that were fitted on the Motor Car.

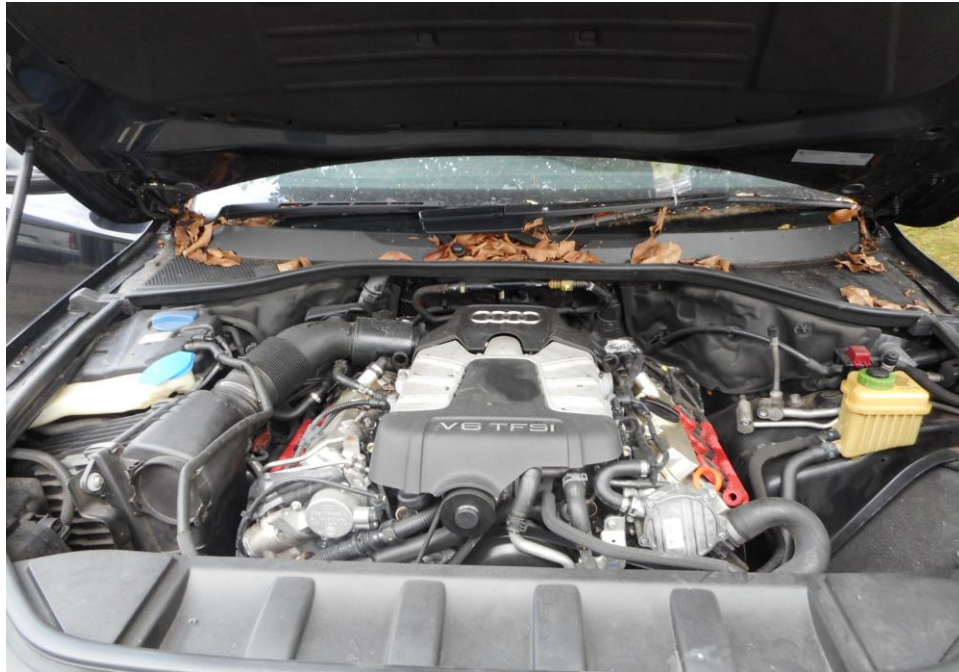
**Photo 11** shows a general view of the Motor Car's engine compartment, which was accessed by lifting the front cabin of the Motor Car. The various parts and components inside the engine compartment were unaffected by the accident. There was also no sign(s) or indication(s) of fresh fluid leakage and/or fluid stain within the engine compartment

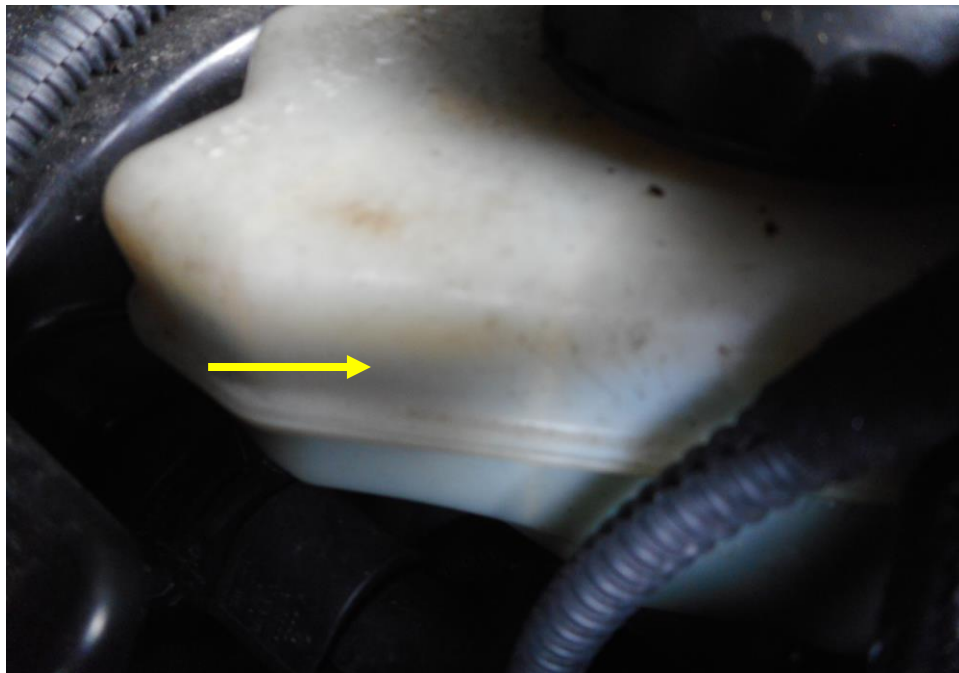
**Photo 12** shows the brake fluid reservoir of the Motor Car at the time of my inspection. The brake fluid was observed to be of sufficient level (arrowed) and without any visible contamination.

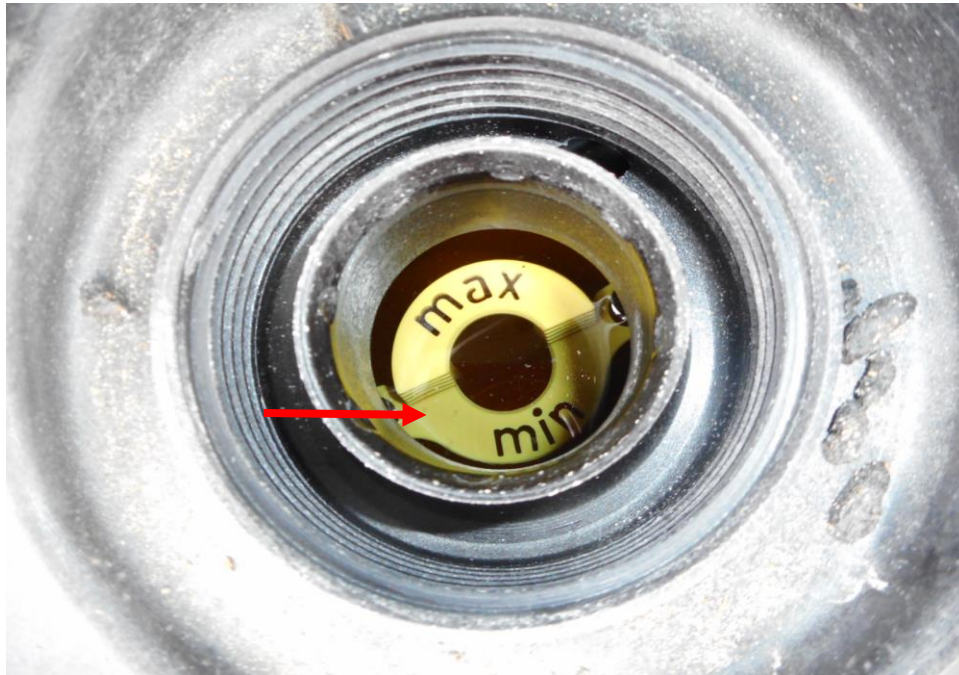
**Photo 13** shows the engine coolant reservoir of the Motor Car at the time of my inspection. The engine coolant was observed to be of sufficient level (arrowed) and without any visible contamination.

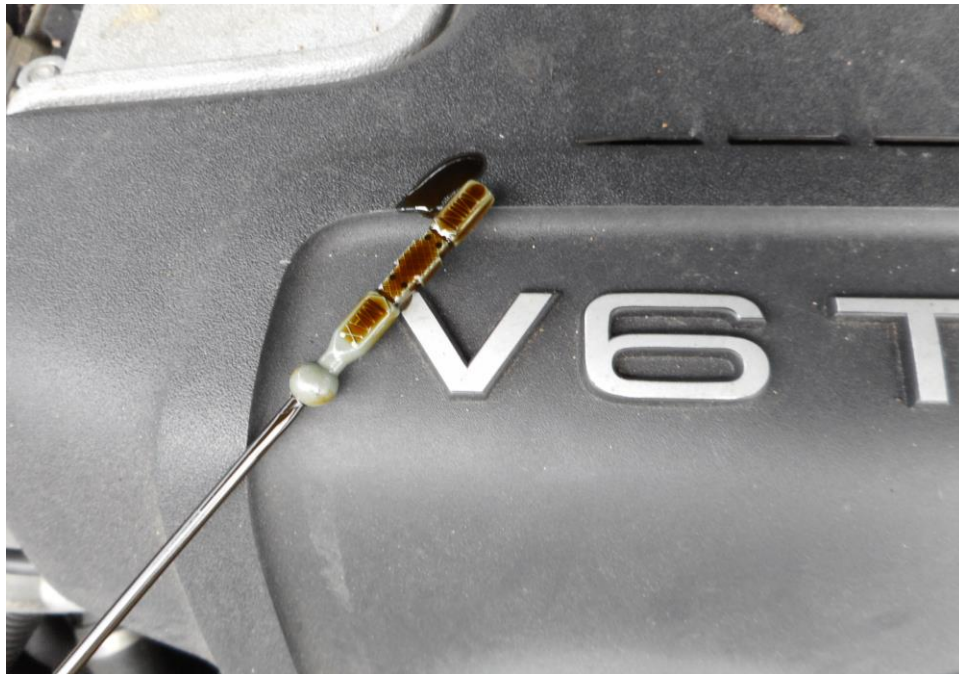
**Photo 14** shows the engine oil dip stick of the Motor Car at the time of my inspection. The engine oil was observed to be of sufficient level and without any visible contamination.

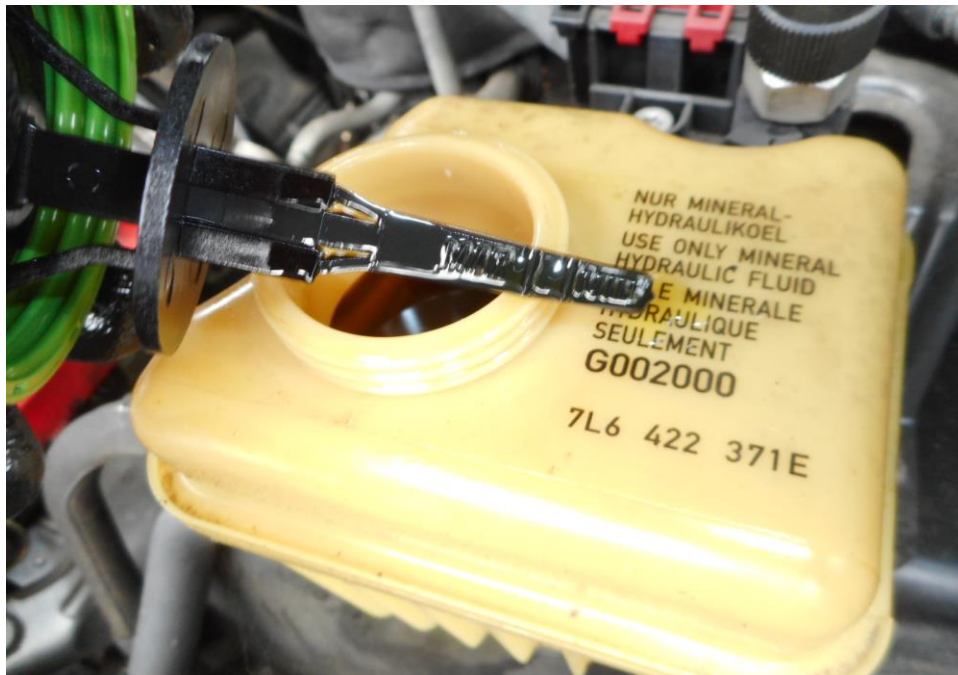
**Photo 15** shows the power steering oil dip stick of the Motor Car at the time of my inspection. The power steering oil was observed to be of sufficient level and without any visible contamination.

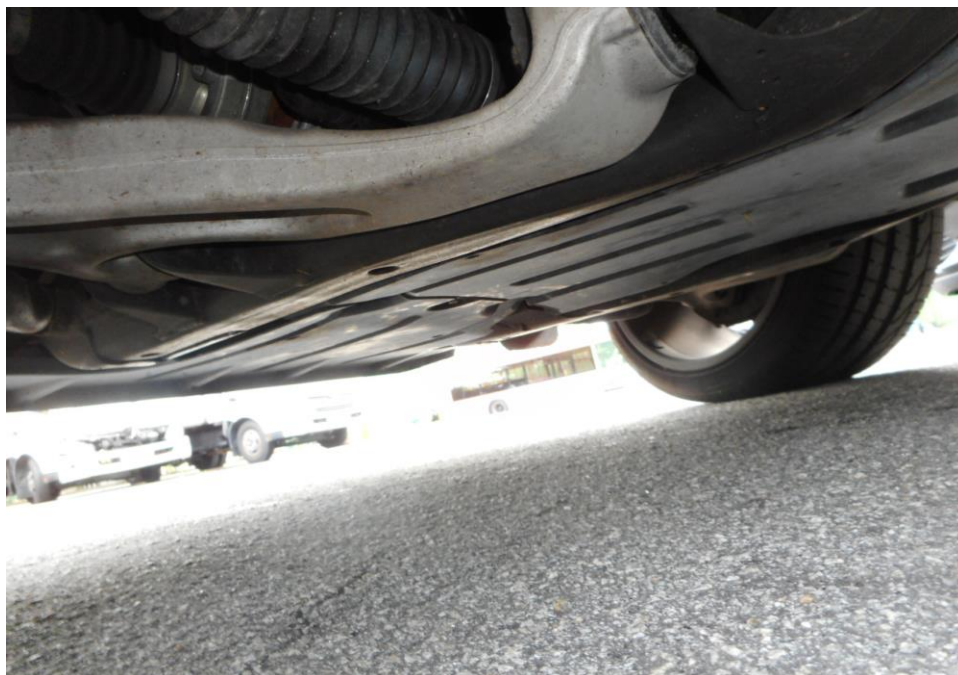
**Photo 16** shows the undercarriage of the Motor Car, at the area where the engine housing and transmission housing are located. . I did not find any sign(s) or indication(s) of fluid leak and/or fluid stain(s) on the underside of the Motor Car.

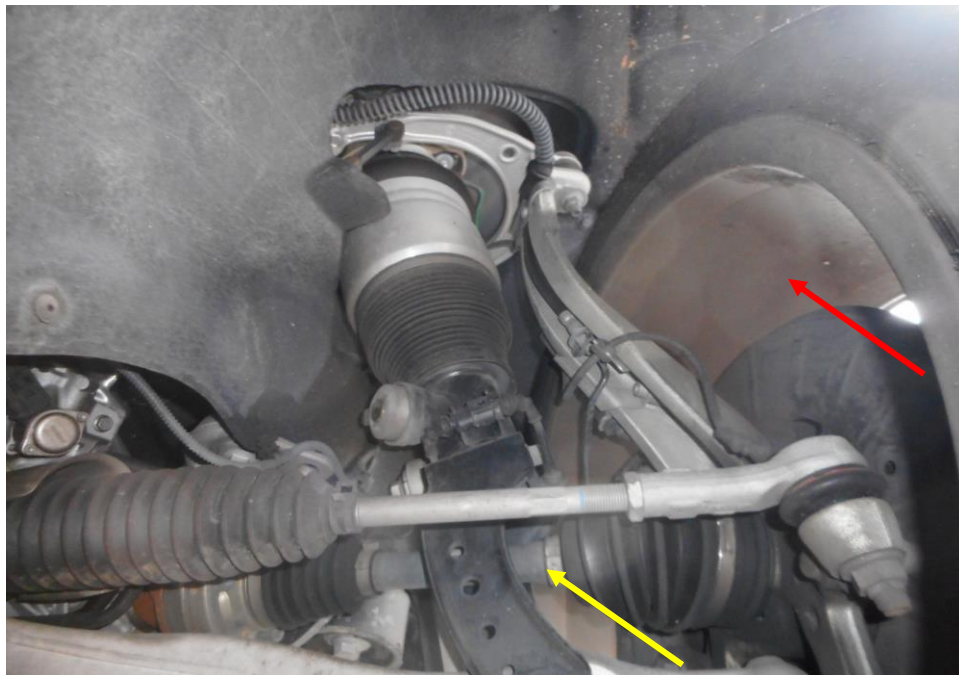
**Photo 17** shows the various undercarriage components at the front right wheel of the Motor Car, in particular the steering tie rod end (arrowed) and drive shaft (yellow arrow). The various steering components were all found to be intact, suggesting that the steering system of the Motor Car was likely to be in serviceable condition at the material time of accident. There was also no sign of fluid stain(s) observed on the various undercarriage components.

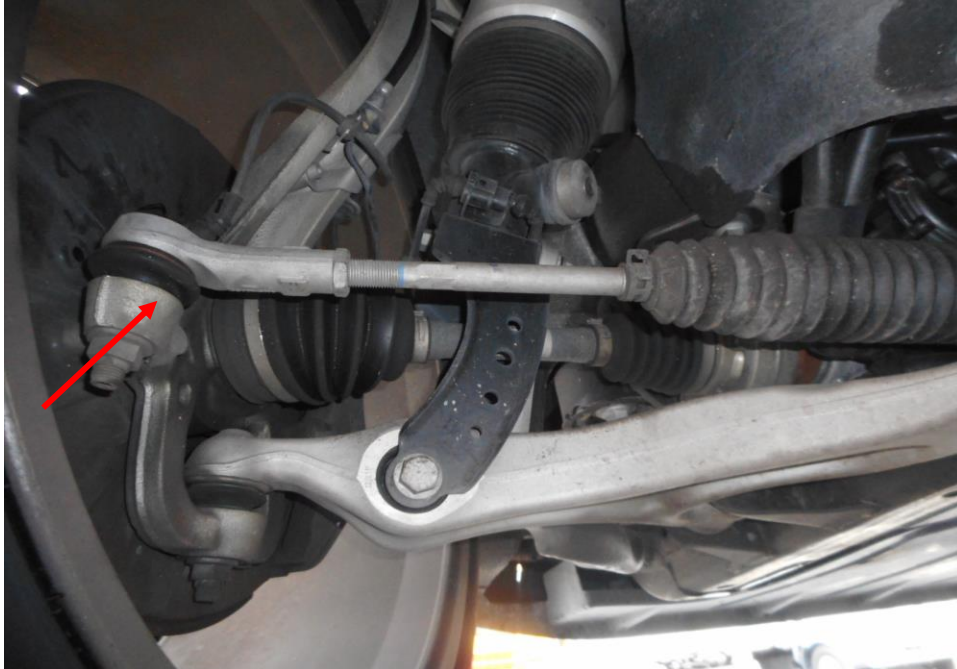
**Photo 18** shows the various undercarriage components at the front left wheel of the Motor Car, in particular the steering tie rod end (arrowed). The various Undercarriage components of the Motor Car were all found to be intact without any visible damage. There was also no sign of fluid stain(s) observed on the various undercarriage components.

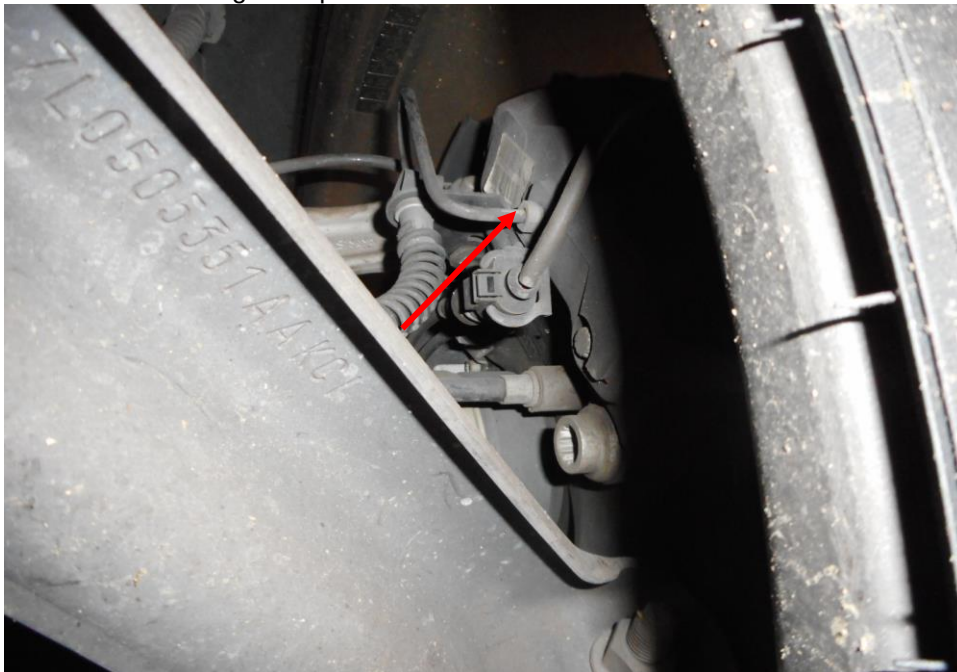
**Photo 19** shows the brake pipe (arrowed) at the rear right wheel of the Motor Car. I did not observe any leakage of brake fluid at the time of my inspection of the Motor Car. My static tests of the Motor Car's braking system, along with my visual examination of the various mechanical components in the braking system, had indicated that there was no internal leakage of pressure/vacuum. Hence the braking system of the Motor Car was likely to be in serviceable condition at the material time of accident.

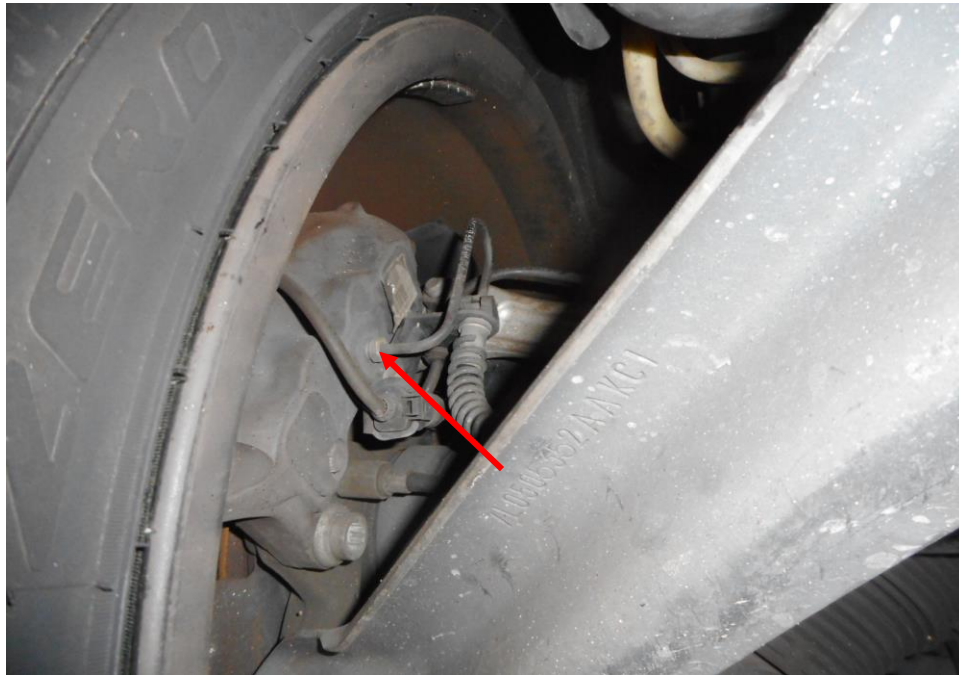
**Photo 20** shows the brake pipe (arrowed) at the rear left wheel of the Motor Car. I did not observe any leakage of brake fluid at the time of my inspection of the Motor Car. My static tests of the Motor Car's braking system, along with my visual examination of the various mechanical components in the braking system had indicated that there was no internal leakage of pressure/vacuum. Hence the braking system of the Motor Car was likely to be in serviceable condition at the material time of accident.

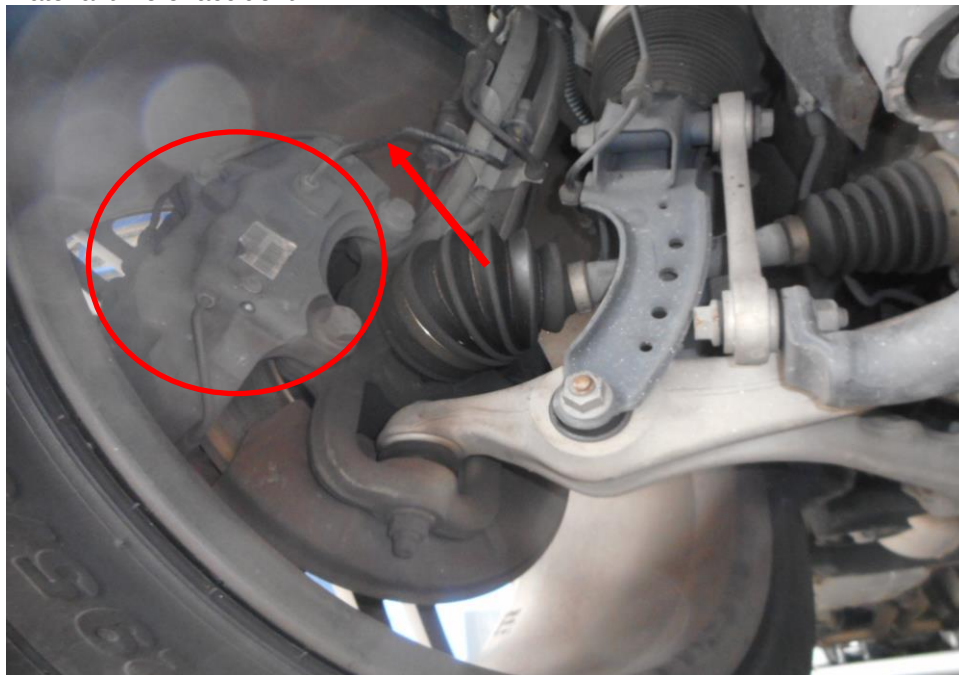
**Photo 21** shows the brake hose/pipe (arrowed) at the front right wheel of the Motor Car. No leakage of brake fluid was observed. Visual examination of the various components of the braking system like the brake caliper (circled), brake booster, brake pedal etc had revealed all to be intact and without visible damage at the time of accident. There was also no sign of fluid stain(s) observed on the various undercarriage components.

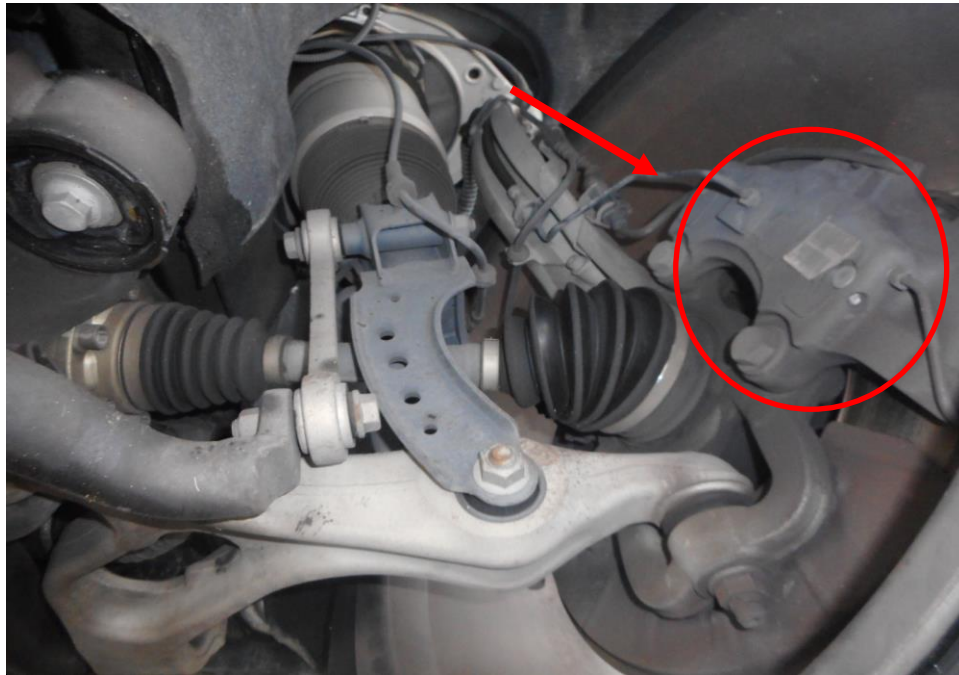
**Photo 22** shows the brake hose/pipe (arrowed) at the front left wheel of the Motor Car. No leakage of brake fluid was observed. Visual examination of the various components of the braking system like the brake caliper (circled), brake booster, brake pedal etc had revealed all to be intact and without visible damage at the time of accident. There was also no sign of fluid stain(s) observed on the various undercarriage components.

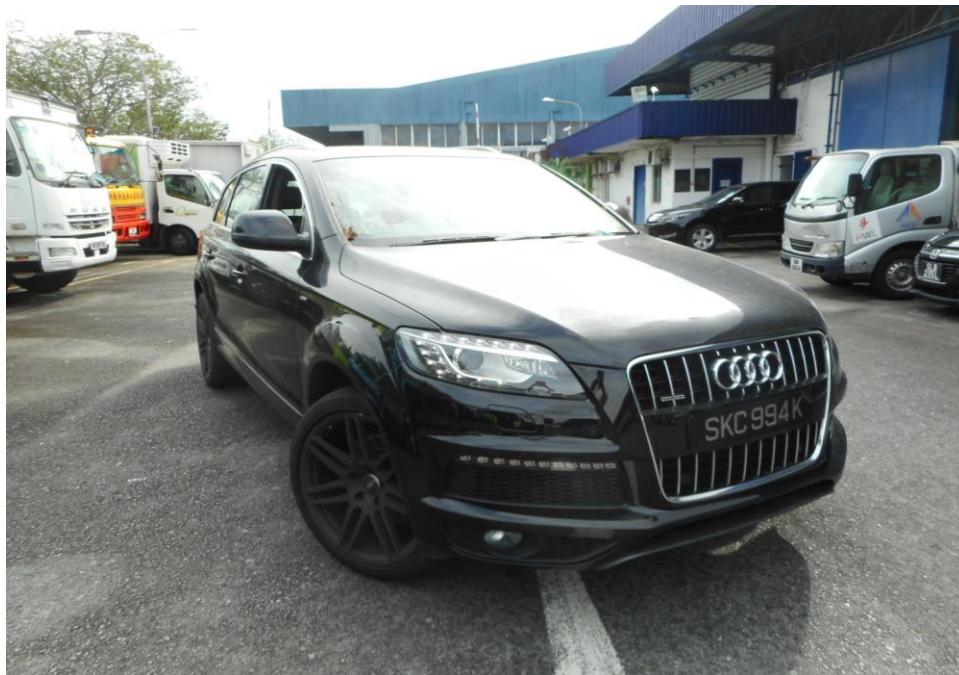
**Photo 23** shows the front right wheel of the Motor Car turned to its full left. During my steering system test, I did not experience any abnormal free play and/or resistance when I had turned the steering wheel towards full left and full right. This would suggest that the steering system of the Motor Car was likely to be in serviceable condition at the material time of accident.

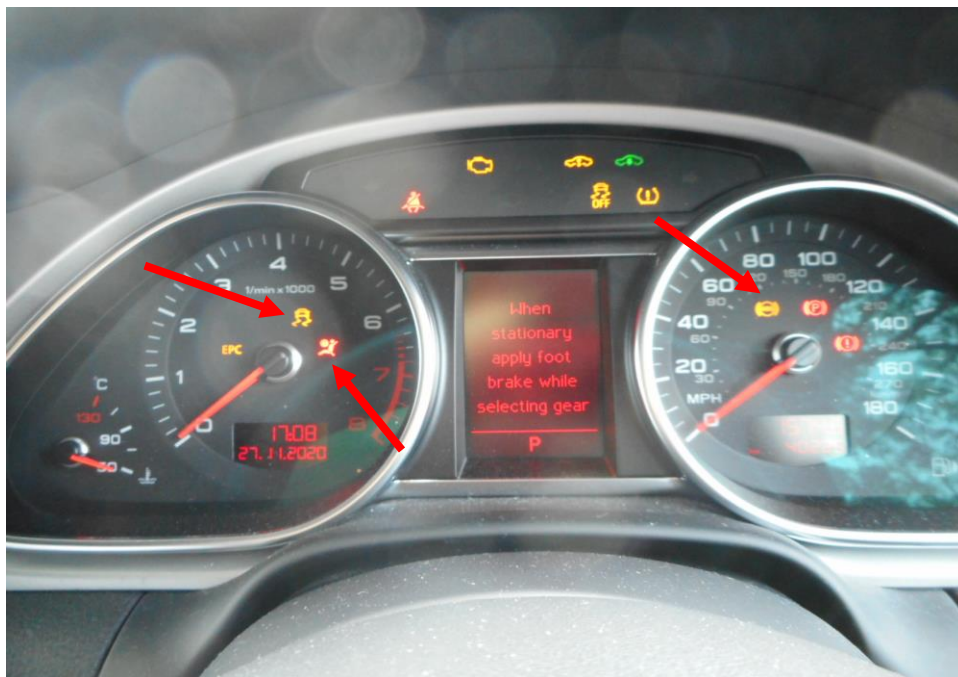
**Photo 24** shows the warning light for Anti-Lock Brake System (ABS), Supplemental Restraint System (SRS) and Traction Control System (TC) appearing on the instrument panel of the Motor Car during the self-test of its various electronic operating systems when its engine was cranked.

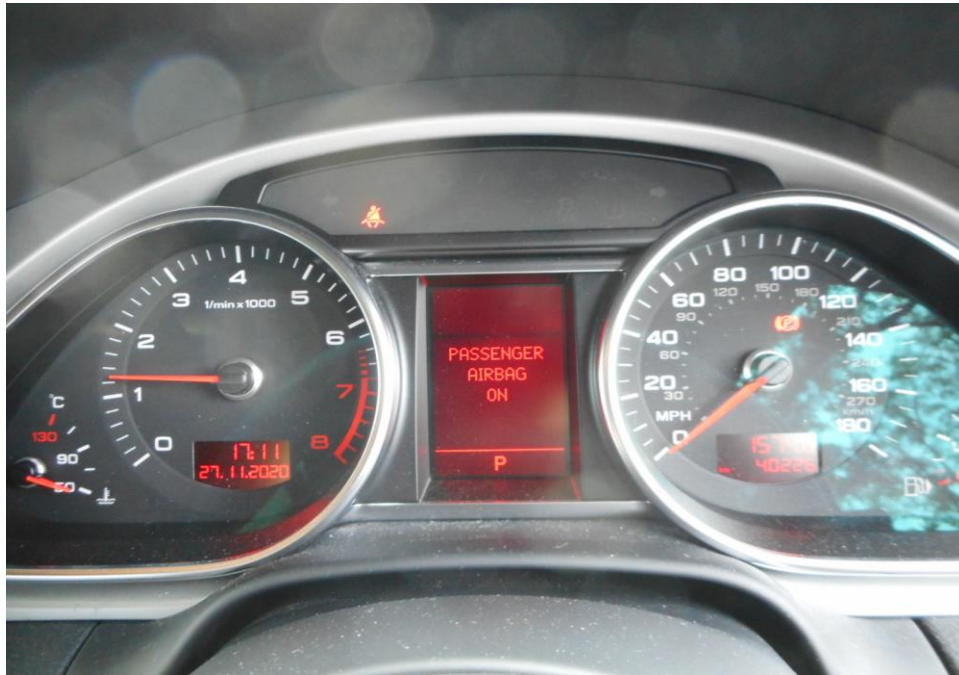
**Photo 25** shows no warning lights illuminated on the instrument panel of the Motor Car after the engine was cranked. This would suggest that there was no abnormality to the various electronic operating systems of the Motor Car, like the ABS, SRS and TC.
