Your Ref: TP/IP/43633/2020
Our Ref: CI/TPD20011429/P

3rd November 2020

MECHANICAL INSPECTION REPORT OF MOTOR LORRY GBJ 5550U

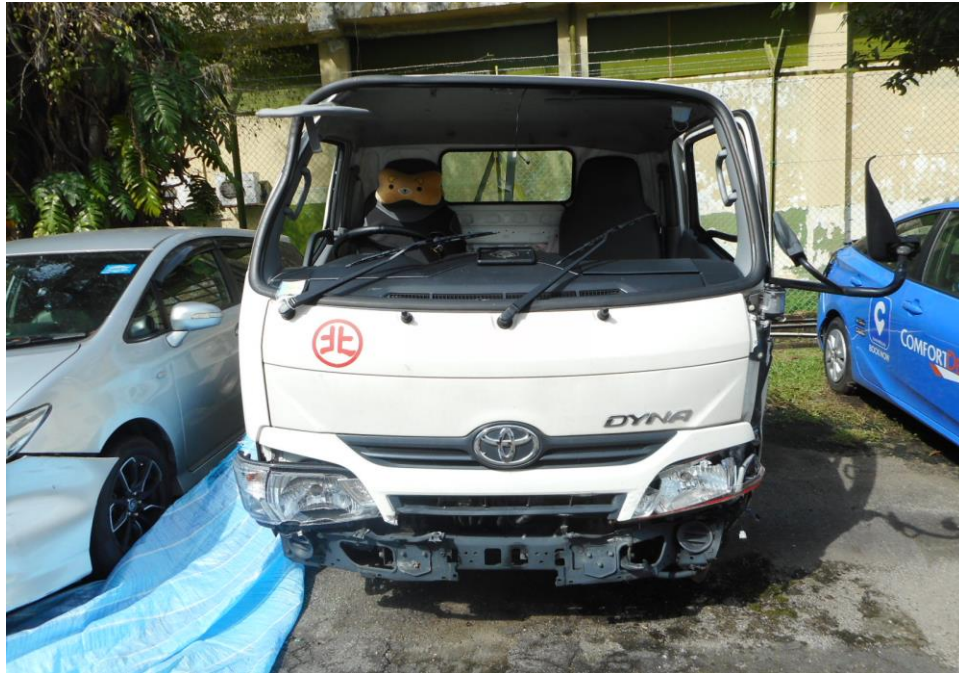
4. The mileage of the Motor Lorry at the time of my inspection was not recorded.
5. The Motor Lorry was observed to have sustained damage at its front cabin, front windscreen, front bumper, both front headlamps, left and right doors as well as its left rear body panel were damaged as a result of the accident.

Photo 1 shows a general view of the front windscreen and body panel of the Motor Lorry at the time of our inspection. The Motor Lorry was observed to have sustained damage at its front cabin, front windscreen, front bumper, both front headlamps, left and right doors as well as its rear left body panel were damaged as a result of the accident.

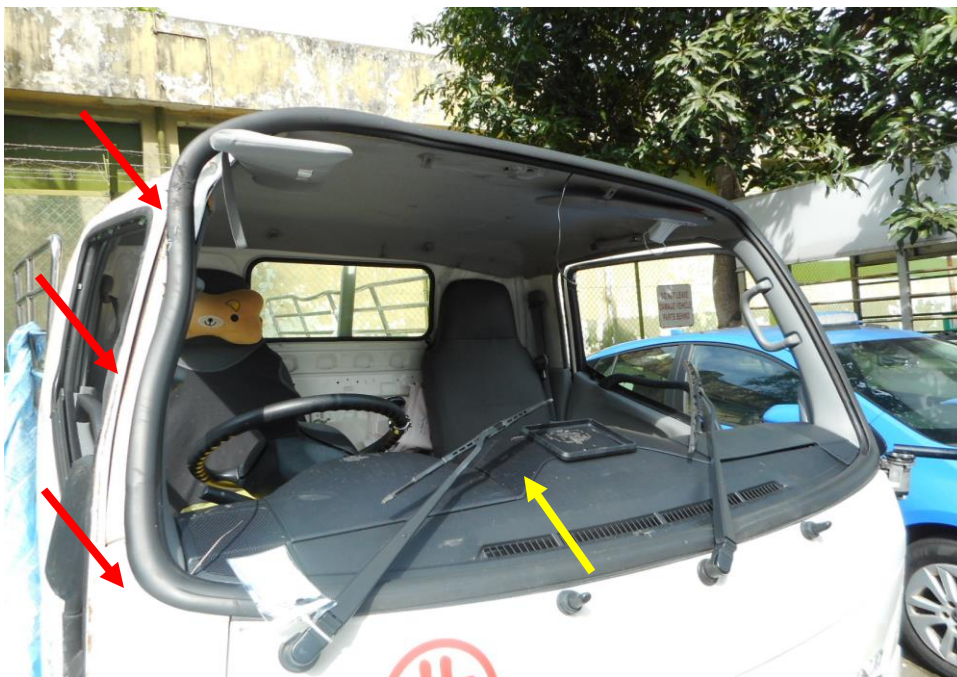
Photo 2 shows the close up view of the front portion of the Motor Lorry at the time of our inspection. The Motor Lorry was observed to have sustained damages to its front cabin (red arrow) and its front windscreen (yellow arrow) due to the accident's impact.

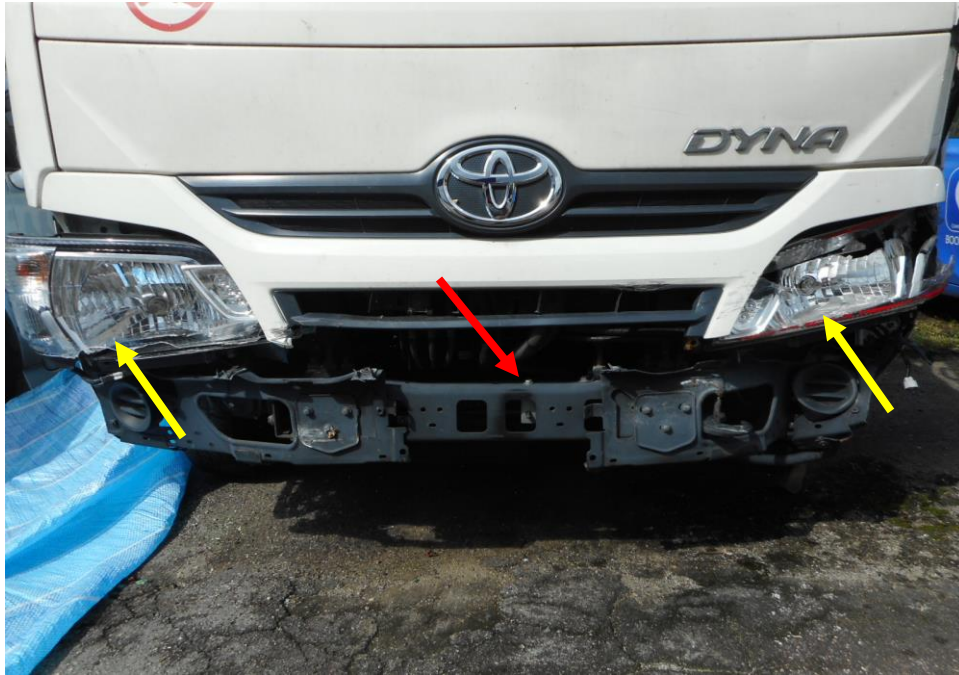
Photo 3 shows the close up view of the front portion of the Motor Lorry at the time of our inspection. The Motor Lorry was observed to have sustained damages to front bumper (red arrow) and its front left and right headlamps (yellow arrow) due to the accident's impact.

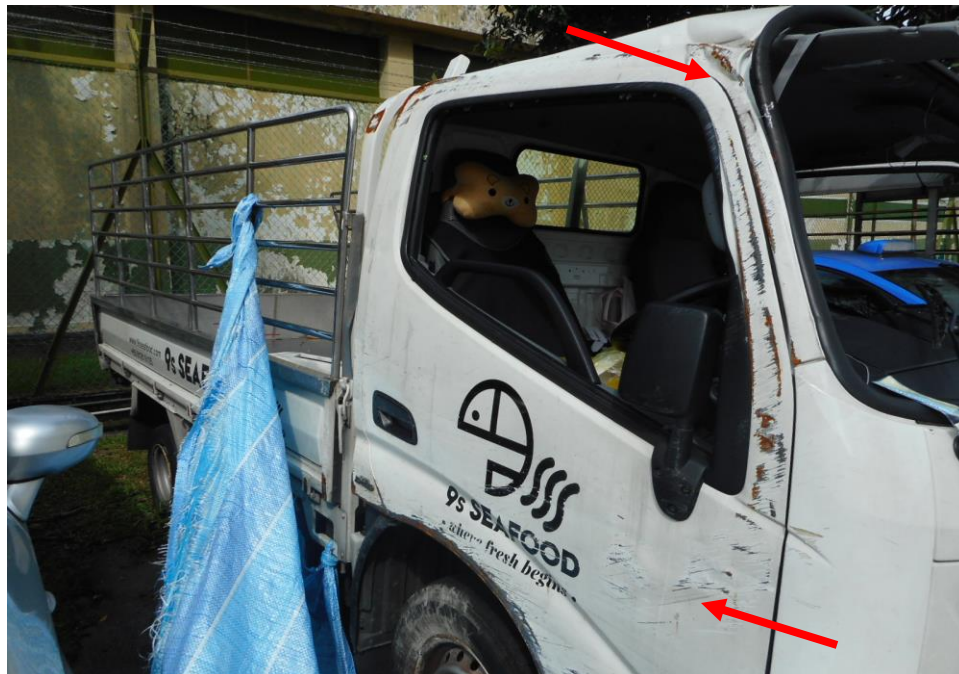
Photo 4 shows the close up view of the right door of the Motor Lorry at the time of our inspection. The Motor Lorry right door (arrowed) was observed to have sustained damages due to the accident.

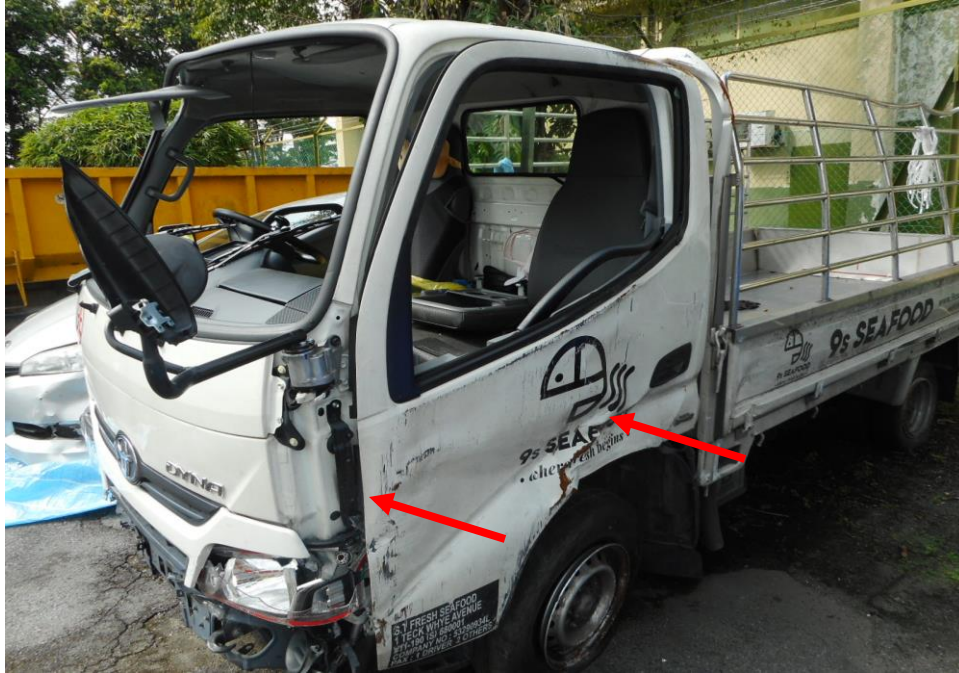
Photo 5 shows the close up view of the left door of the Motor Lorry at the time of our inspection. The Motor Lorry was observed to have sustained damages to its left door (arrowed) as result of the accident.

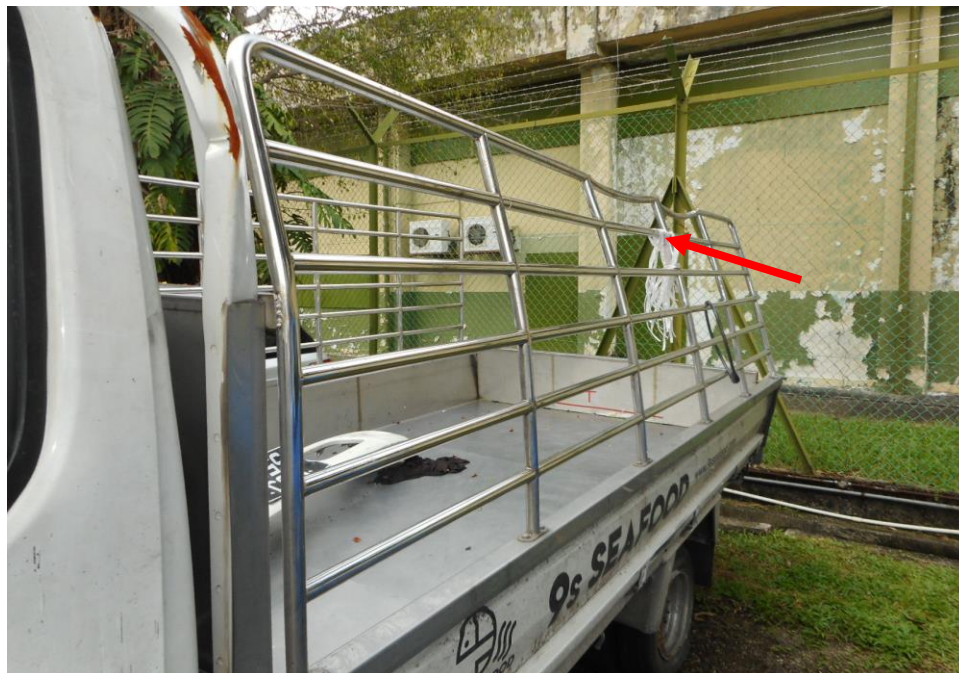
Photo 6 shows a close up view of the Motor Lorry's rear left body at the time of my inspection. The left rear body panel (arrowed) of the Motor Lorry was observed to have been damaged as a result of the accident.

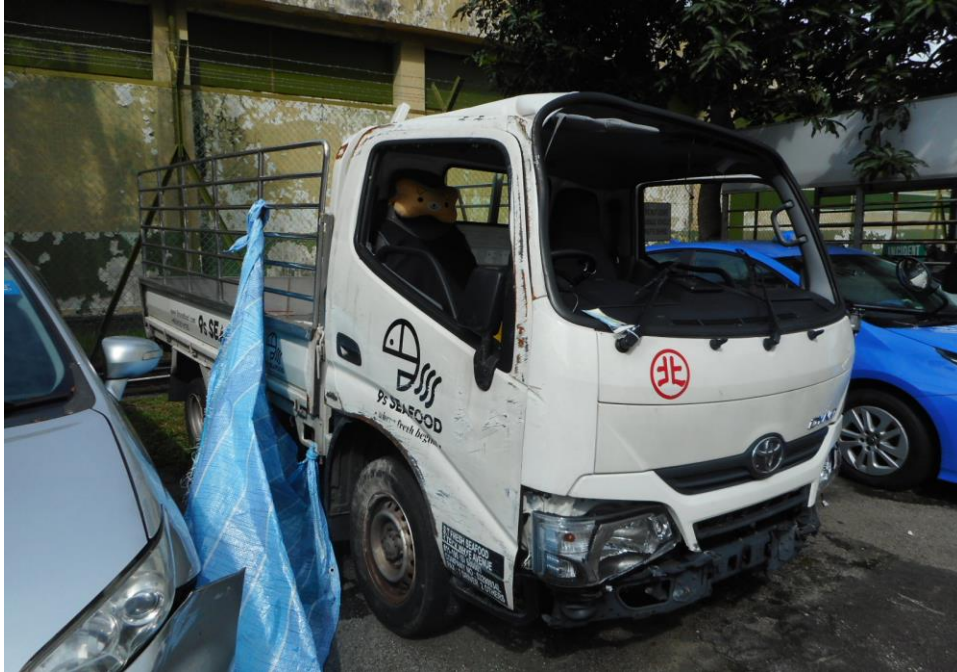
Photo 7 shows a general view of the Motor Lorry's right body at the time of my inspection. The right portion of the Motor Lorry was observed to have been unaffected by the accident.

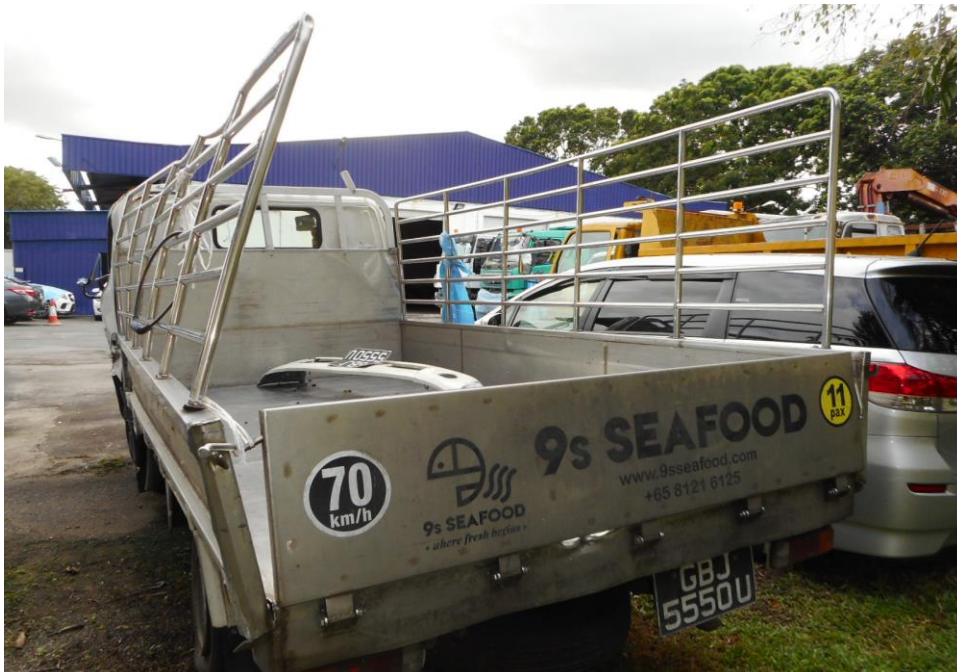
Photo 8 shows the general view of the Motor Lorry's rear body at the time of my inspection. The Motor Lorry rear was observed to be unaffected by the accident.

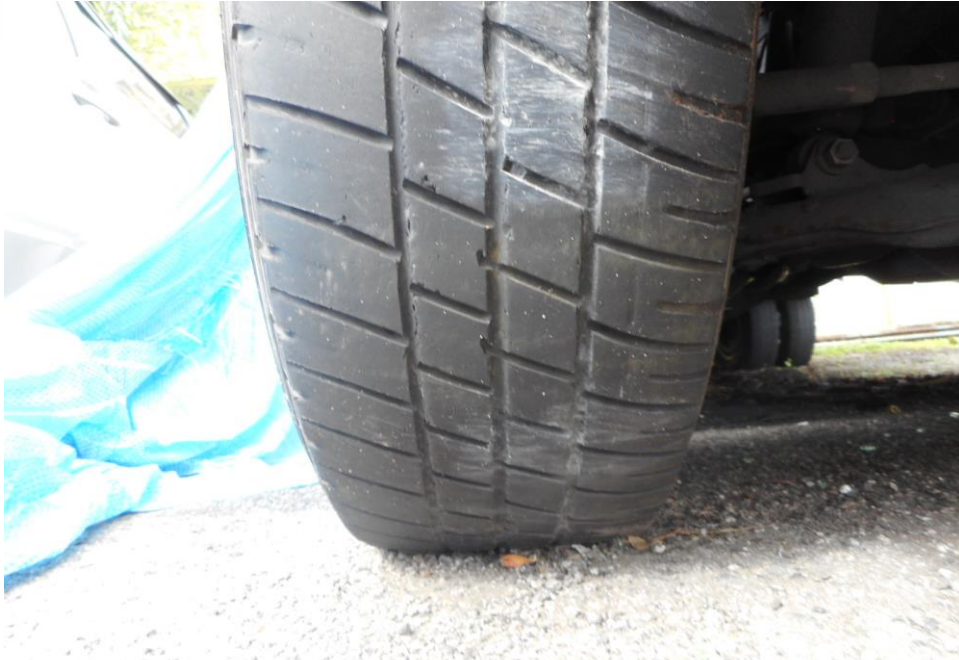
Photo 9 shows the condition of the front right tyre of the Motor Lorry, which was observed to be in serviceable condition with remaining tread depth of approximately 2.3mm. The tyre, which was wrapped around standard steel wheel rim, was also observed to be sufficiently inflated for vehicular operation.

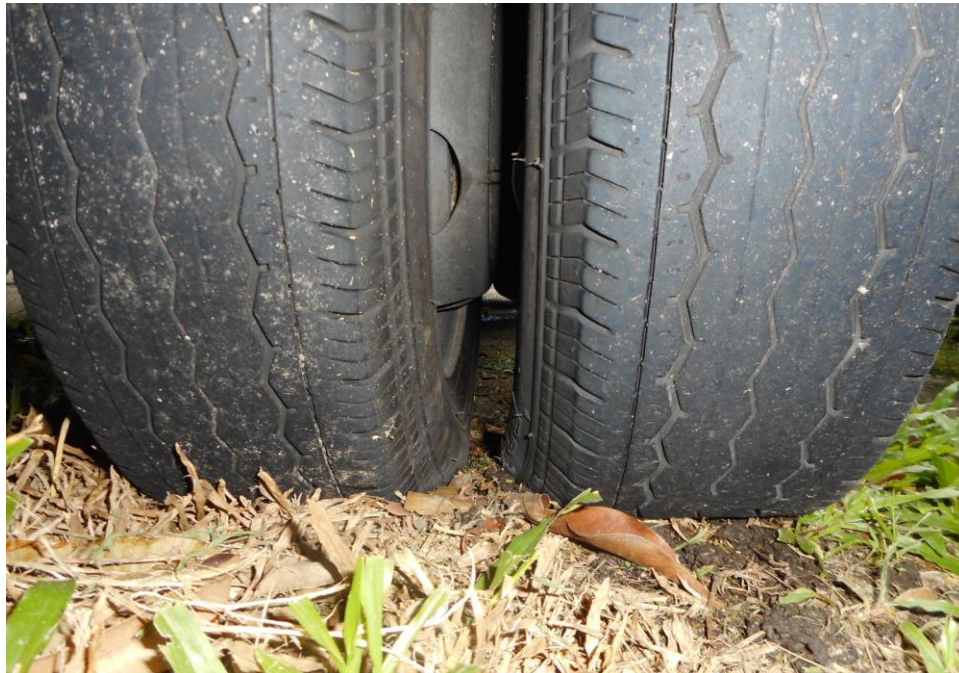
Photo 10 shows the condition of the rear right tyres of the Motor Lorry, which observed to be in serviceable condition with remaining tread depth of approximately 2mm. The tyres, which were wrapped around standard steel wheel rim, were also observed to be sufficiently inflated for vehicular operation.

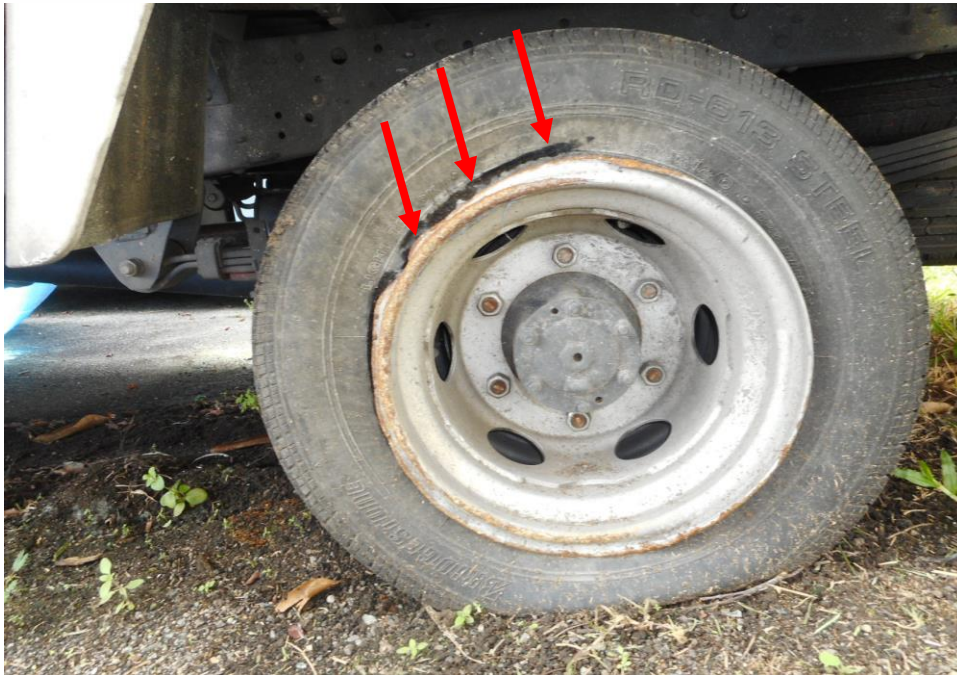
Photo 11 shows the condition of the rear left tyres of the Motor Lorry, which were observed to cut by its rims (arrowed) and deflated as a result of the accident, tread depth of approximately 2.2mm.

19. For this particular case, we observed that the front left was deflated and its rear left tyres were observed to be cut by its rims and deflated as a result of the accident.

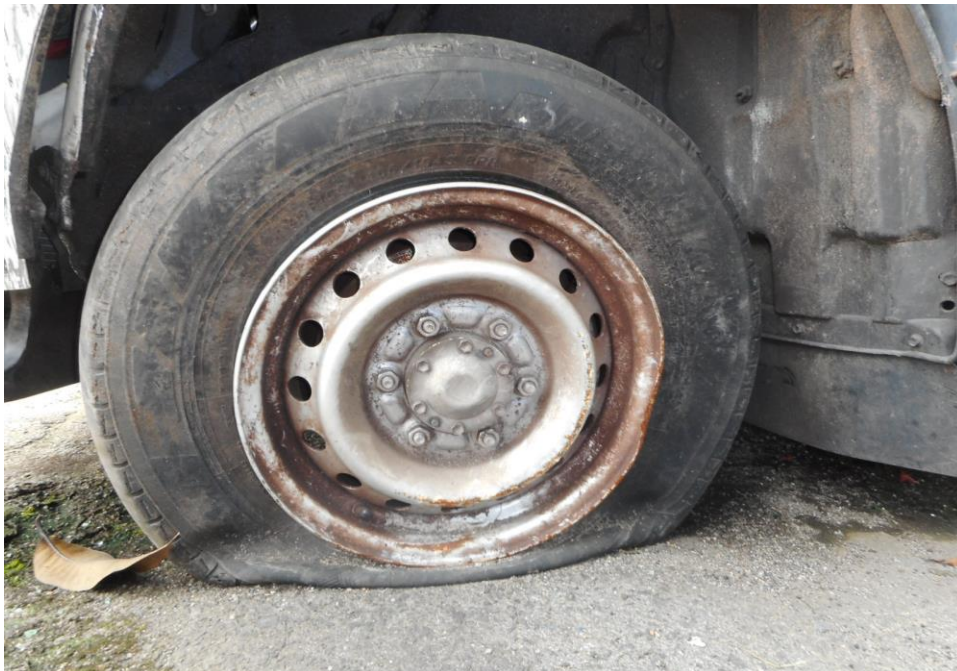
Photo 12 shows the condition of the front right tyre of the Motor Lorry, the tyre were observed to have slipped off the rim and deflated as a result of the accident, tread depth of approximately 2.1mm.

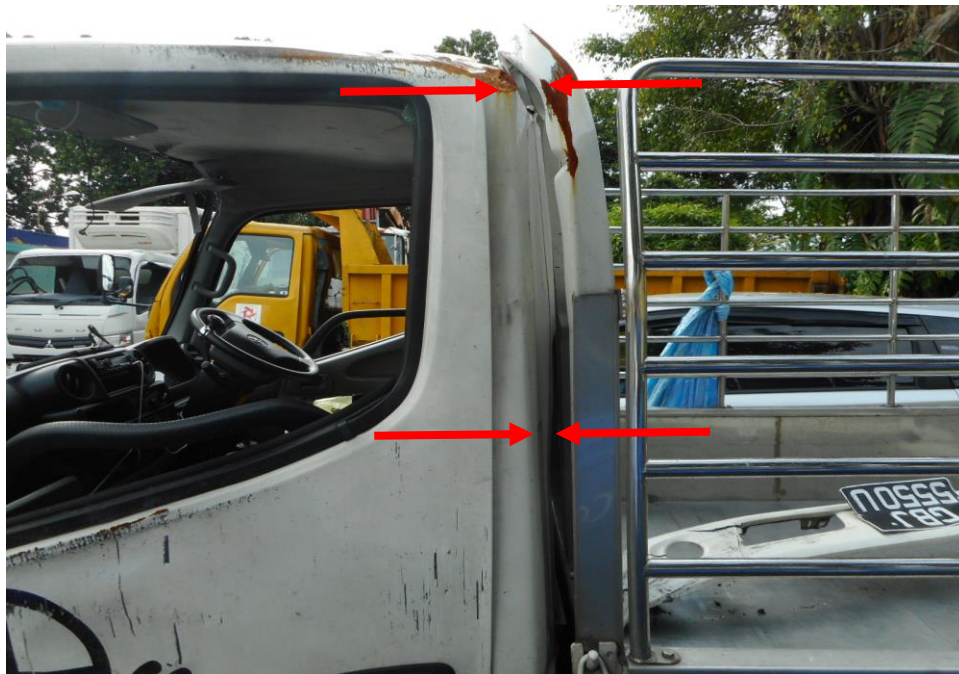
9. Upon examination of the Motor Lorry's engine compartment, we had observed that all the parts, components and fluids could not be inspection as due to the damage induced has crushed and deformed the cabin of the Motor Lorry which immobilized its opening and viewing, however we are able to observed the brake fluid and engine coolant reservoir of the Motor Lorry and was observed to be sufficient level without any visible contamination.
10. Our subsequent checks on the underside of the Motor Lorry also revealed sign of old fluid stain. Visually, the various undercarriage components of the Motor Lorry were all observed to be intact and without any visible damage. See photo 13 – 16 below.

Photo 13 shows the induced damage to the cabin (arrowed) of the Motor Lorry's which immobilised the opening and viewing of the various parts and components inside the engine compartment, a result of the accident.

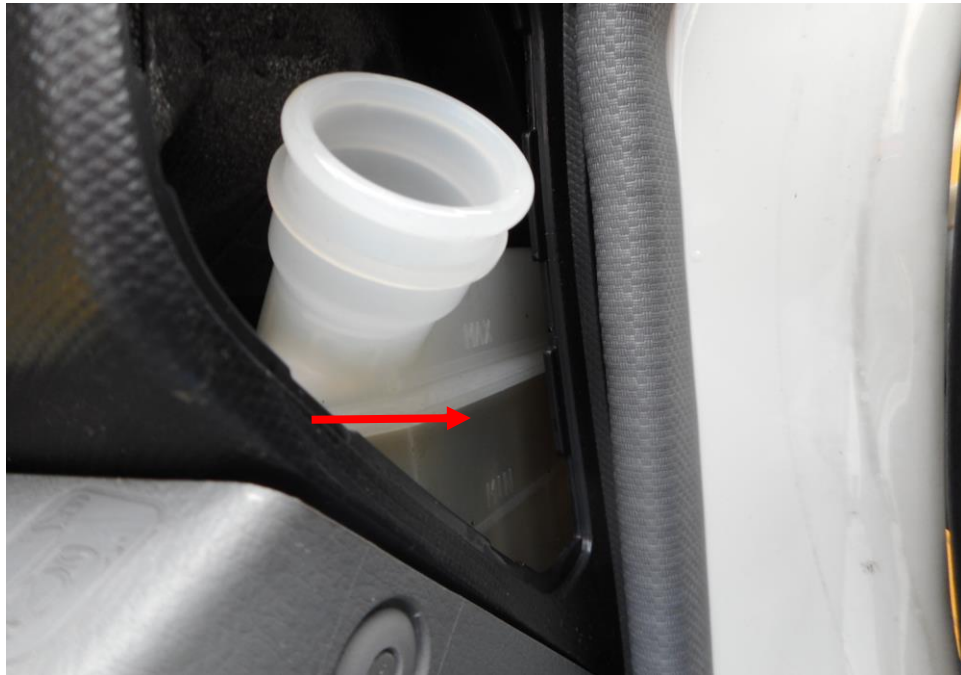
Photo 14 shows the brake fluid reservoir of the Motor Lorry at the time of our inspection. The brake fluid was observed to be of sufficient level and without any visible contamination (arrowed).

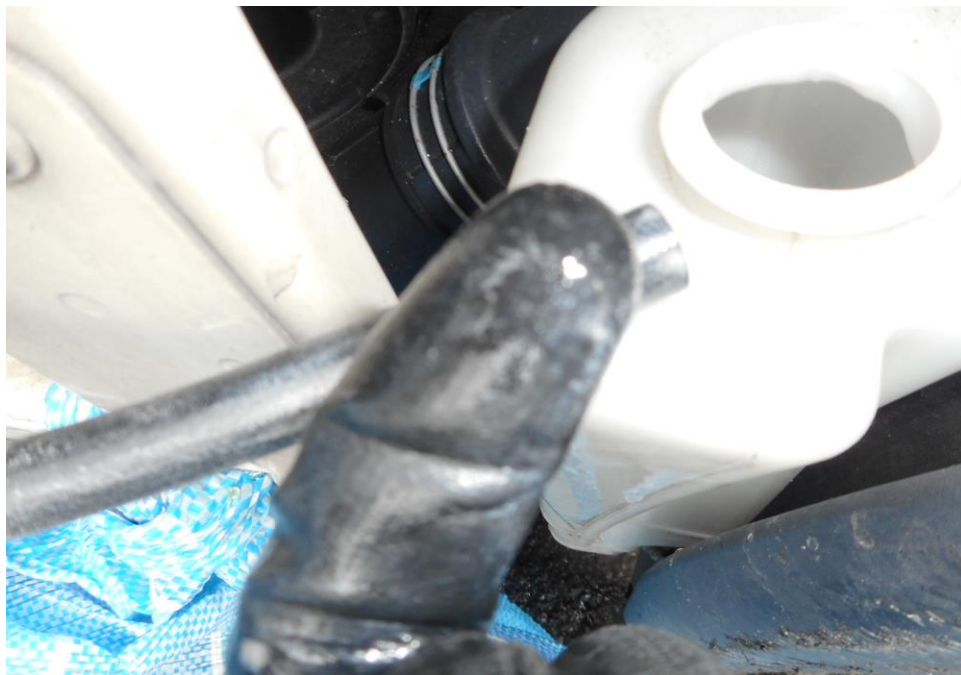
Photo 15 shows the engine coolant reservoir of the Motor Lorry at the time of our inspection. The coolant fluid was observed to be of sufficient level and without any visible contamination.

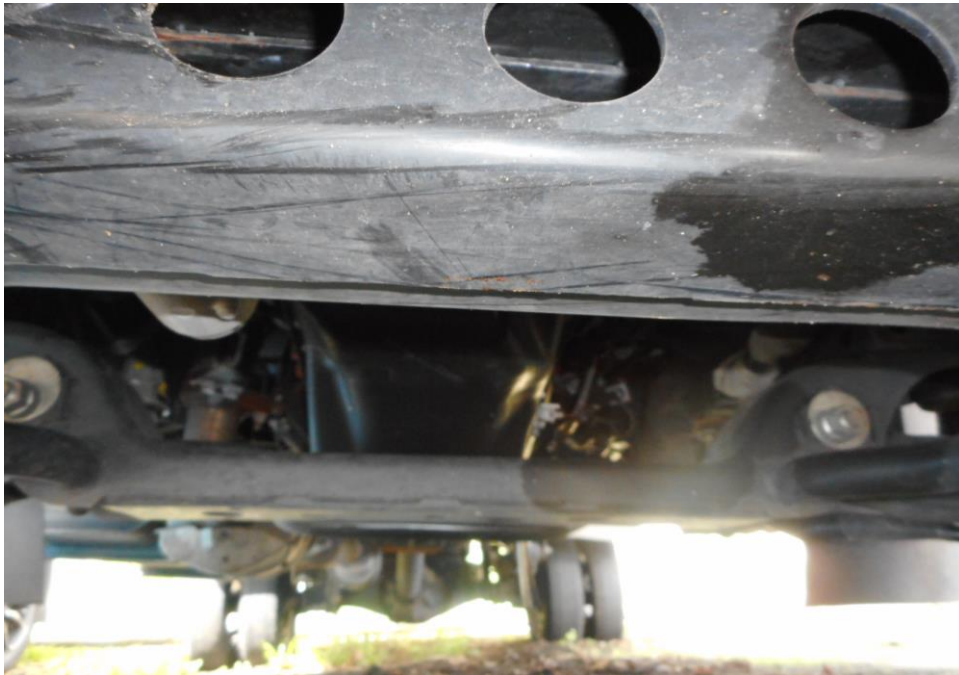
Photo 16 shows the undercarriage of the engine of the Motor Lorry at the time of our inspection. There was no sign(s) and indication(s) of fluid stain within the engine undercarriage area.

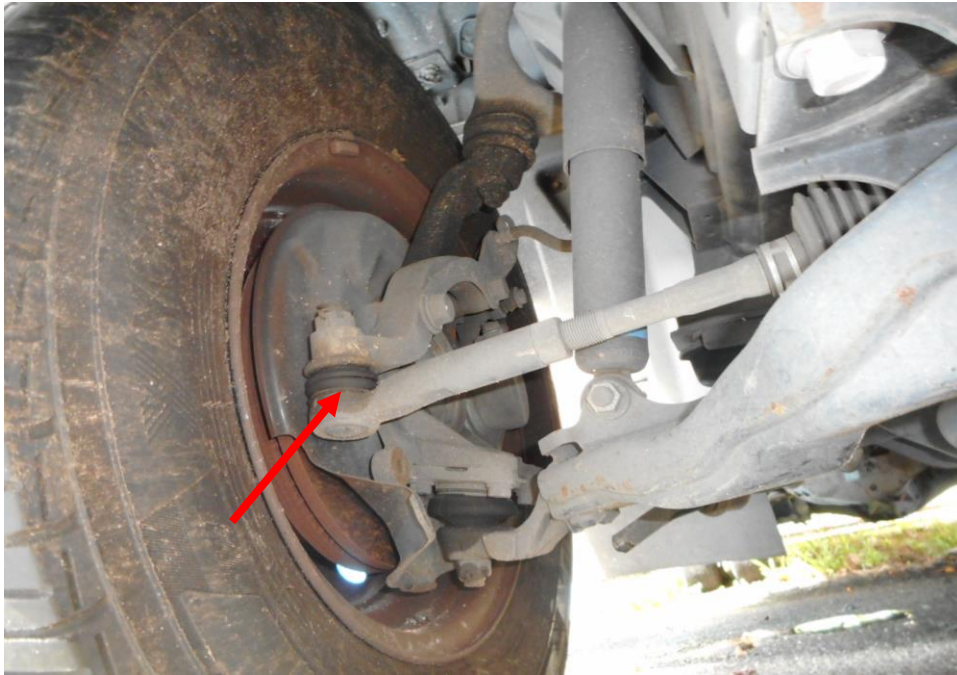
Photo 17 shows the various undercarriage components at the front right wheel of the Motor Lorry, in particular the steering tie rod end and ball joints (arrowed). The various undercarriage components of the Motor Lorry were all found to be intact without any visible damage. There was also no sign of fluid stain(s) observed on the various undercarriage components.

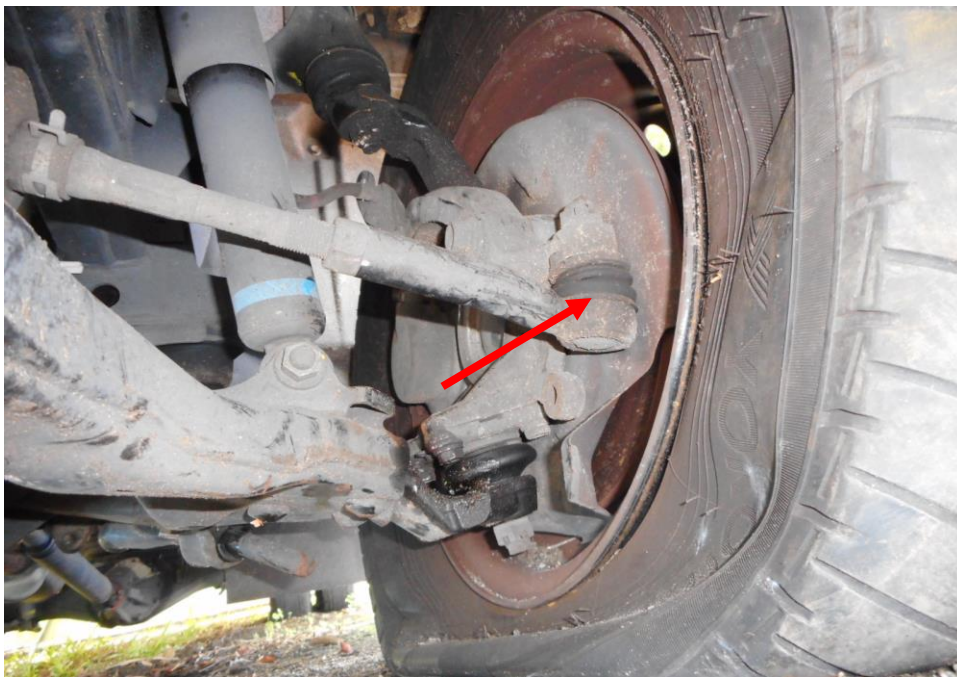
Photo 18 shows the various undercarriage components at the front left wheel of the Motor Lorry, in particular the steering tie rod end and ball joints (arrowed) were observed to be damaged.

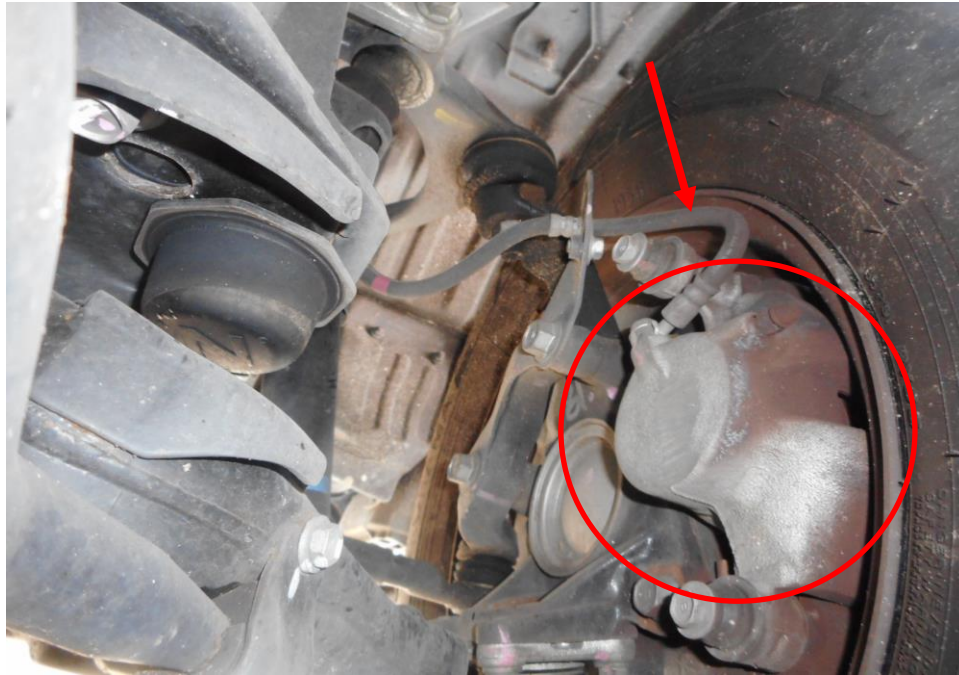
Photo 19 shows the various undercarriage components at the front right wheel of the Motor Lorry, in particular the brake hose (arrowed) and callipers (circled). The various undercarriage components of the Motor Lorry were all found to be intact without any visible damage. There was also no sign of fluid stain(s) observed on the various undercarriage components.

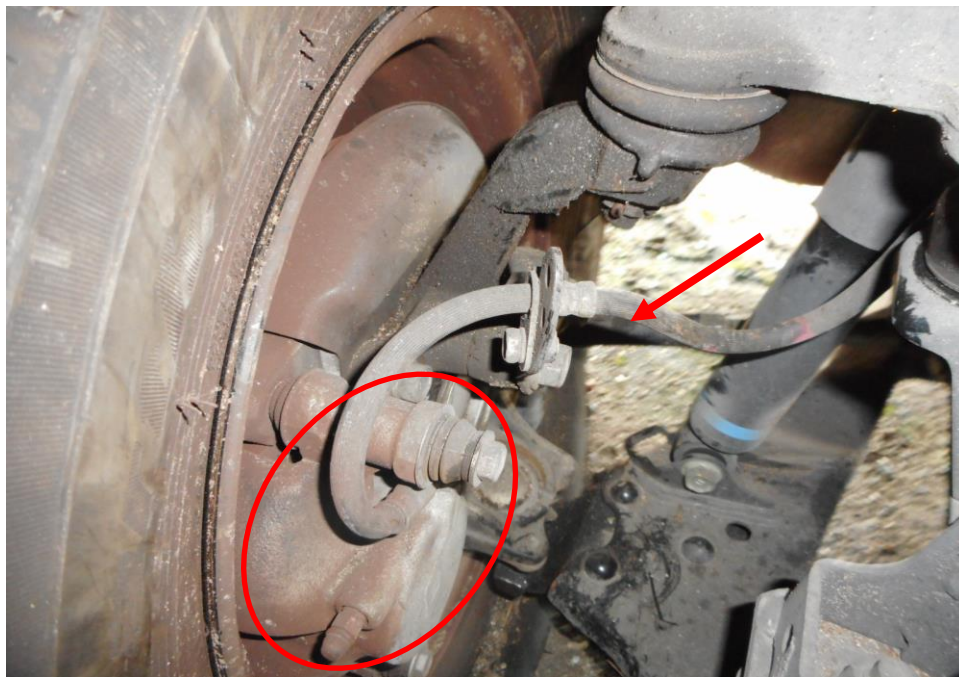
Photo 20 shows the various undercarriage components at the front left wheel of the Motor Lorry, in particular the brake hose (arrowed) and callipers (circled). The various undercarriage components of the Motor Lorry were all found to be intact without any visible damage. There was also no sign of fluid stain(s) observed on the various undercarriage components.

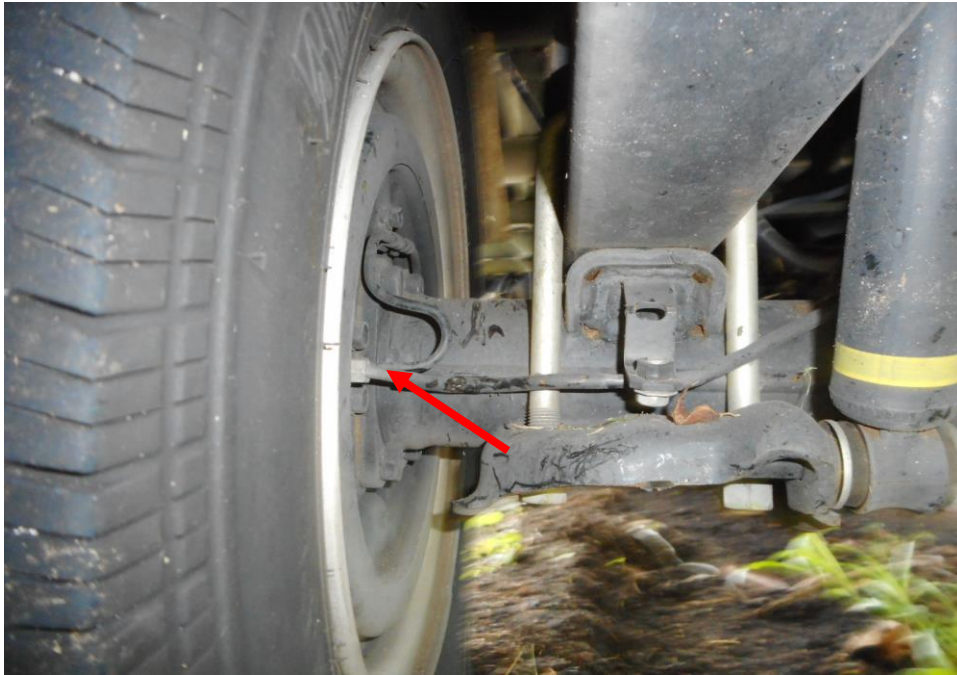
Photo 21 shows the various undercarriage components at the rear left wheel of the Motor Lorry, in particular the brake hose and drum brake (arrowed). The various undercarriage components of the Motor Lorry were all found to be intact without any visible damage. There was also no sign of fluid stain(s) observed on the various undercarriage components.

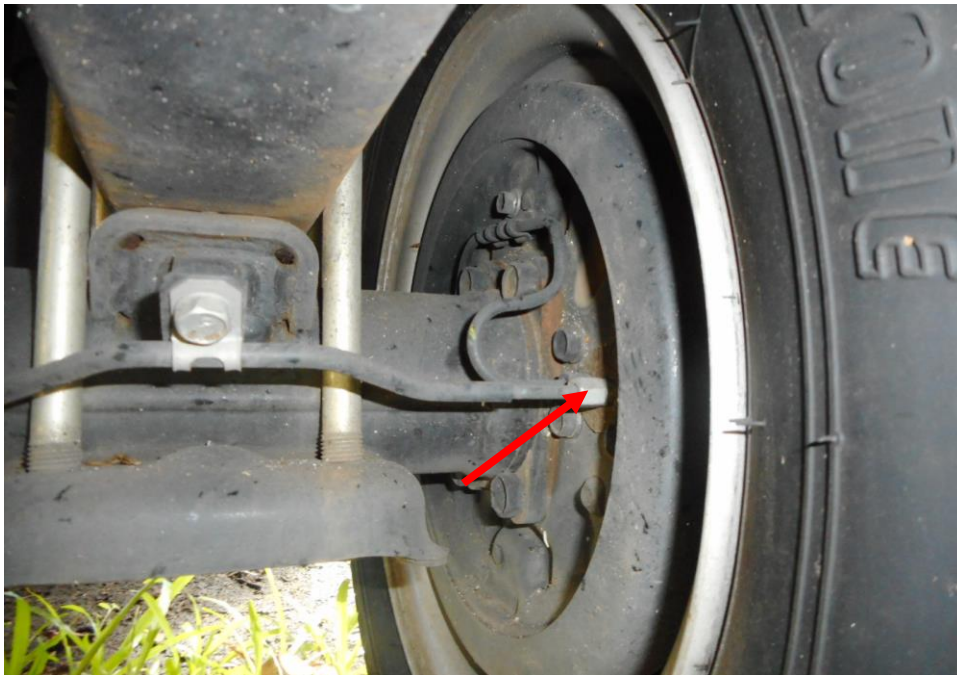
Photo 22 shows the various undercarriage components at the rear right wheel of the Motor Lorry, in particular the brake hose and drum brake (arrowed). The various undercarriage components of the Motor Lorry were all found to be intact without any visible damage. There was also no sign of fluid stain(s) observed on the various undercarriage components.
