Your Ref: TP/IP/39769/2020  
Our Ref : CI/TPD20011431/P

15<sup>th</sup> January 2021

**MECHANICAL INSPECTION REPORT OF MOTOR CAR SJN 3366H**

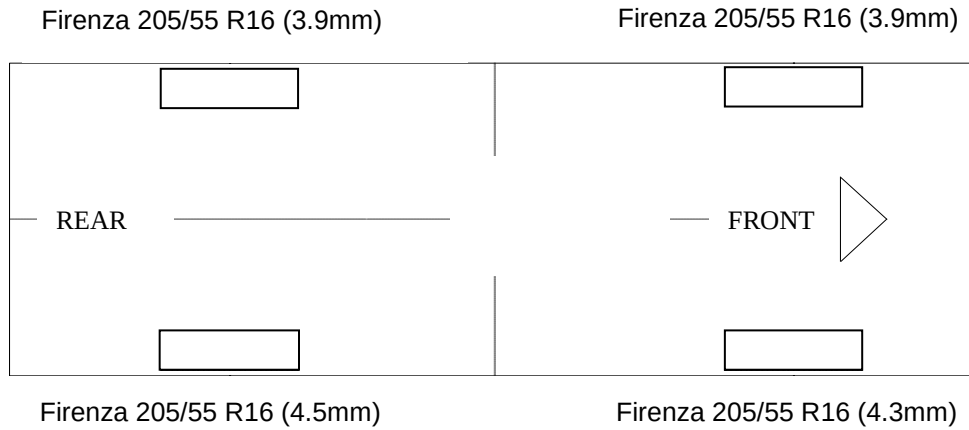
6. The 4 tyres of the Motor Car were observed to be in serviceable condition and sufficiently inflated for vehicular operation. I did not find any tear, cut or burst mark(s) on the outer and the inner sidewalls as well as across the tread of the 4 tyres. The tyre brand, tyre size and remaining tread depth of the 4 tyres of the Motor Car were recorded as follows:-

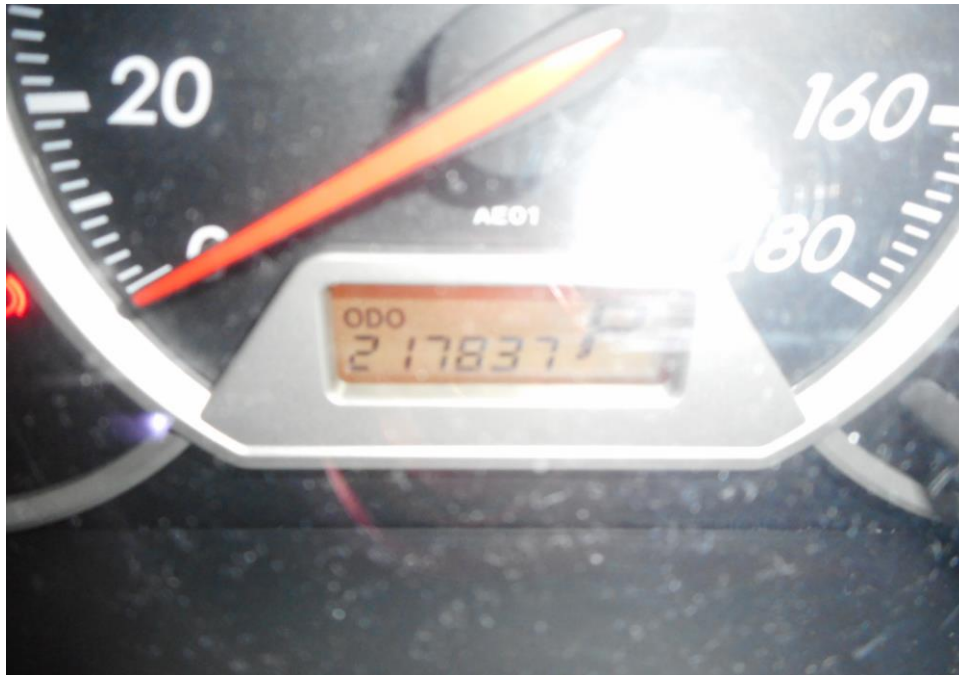
**Photo 1** shows a general view of the instrument cluster of the Motor Car at the time of my inspection. The mileage of the Motor Car was 217,837km

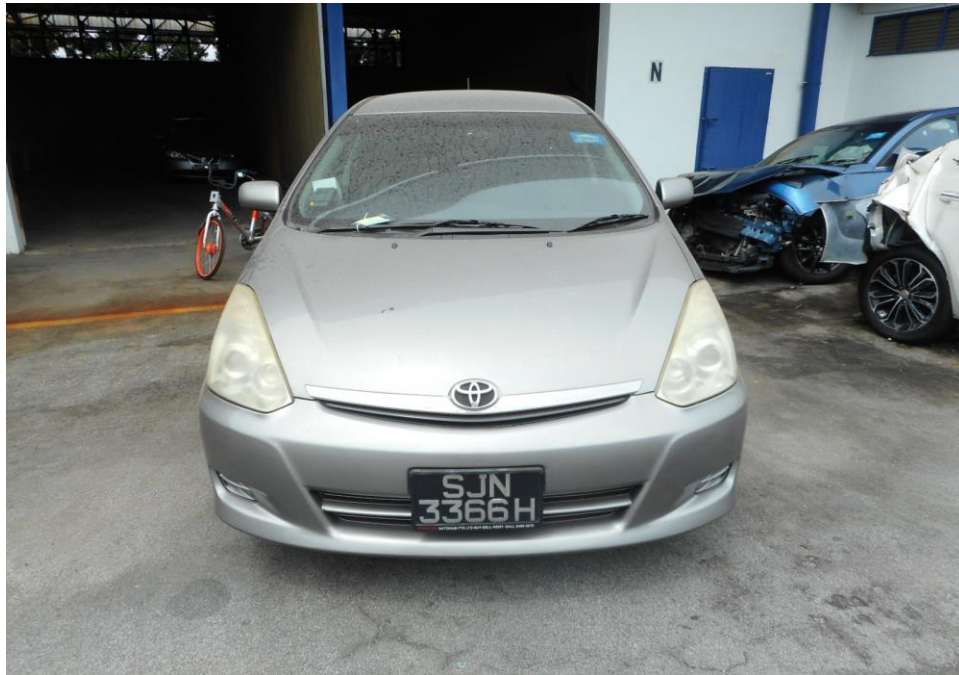
**Photo 2** shows a general view of the Motor Car at the time of my inspection. The Motor Car was observed to be intact and unaffected by the accident.

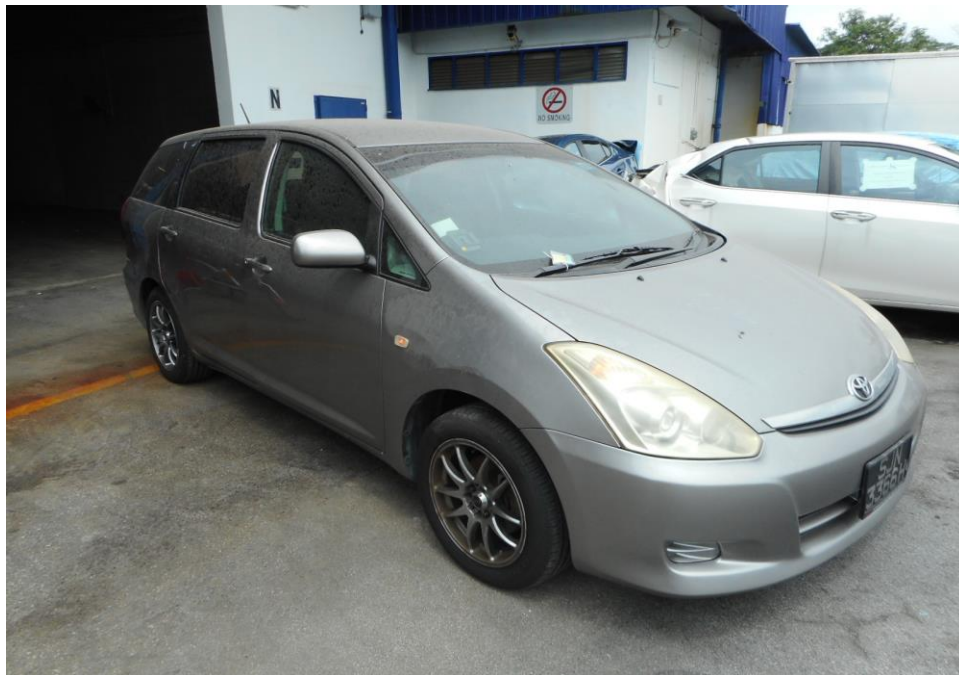
**Photo 3** shows a general view of the right body of the Motor Car at the time of my inspection. The Motor Car was observed to be intact and unaffected by the accident.

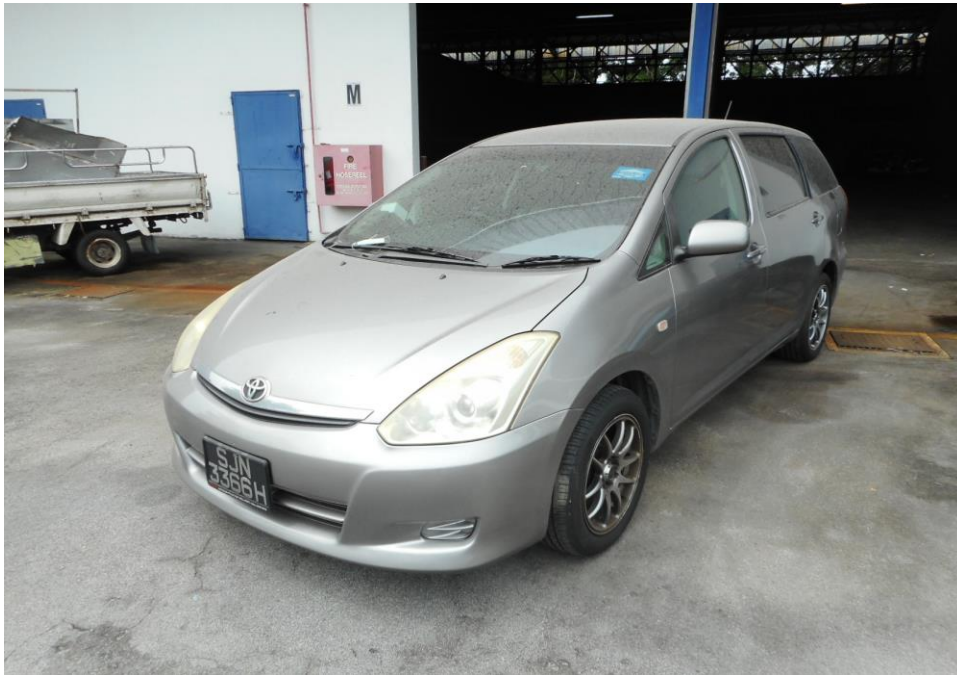
**Photo 4** shows a general view of the left body of the Motor Car at the time of my inspection. The Motor Car was observed to be intact and unaffected by the accident.

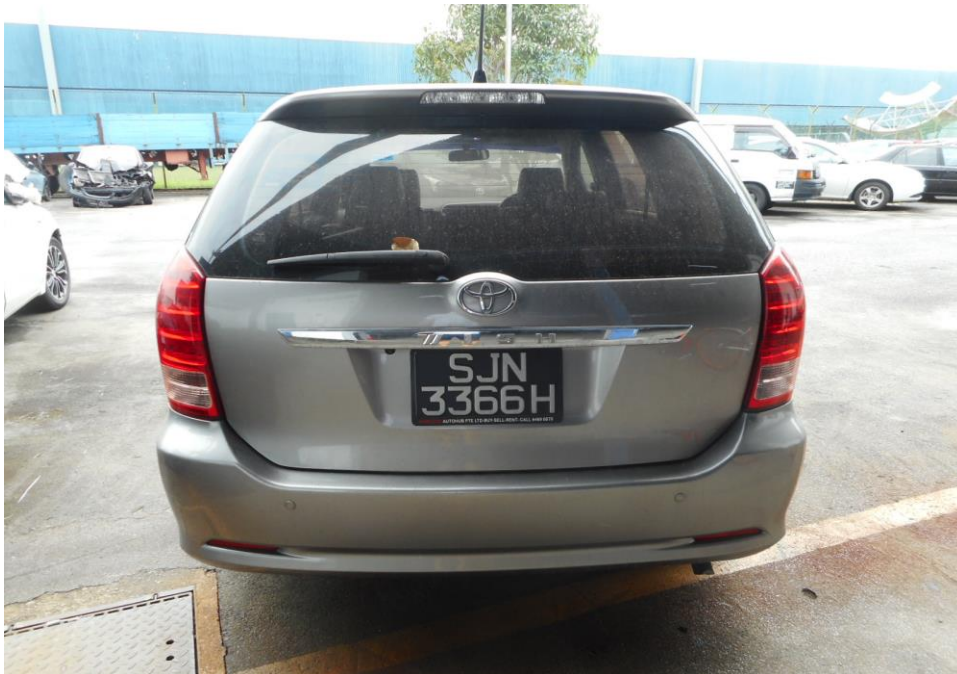
**Photo 5** shows a general view of the rear body of the Motor Car at the time of my inspection. The Motor Car was observed to be intact and unaffected by the accident.

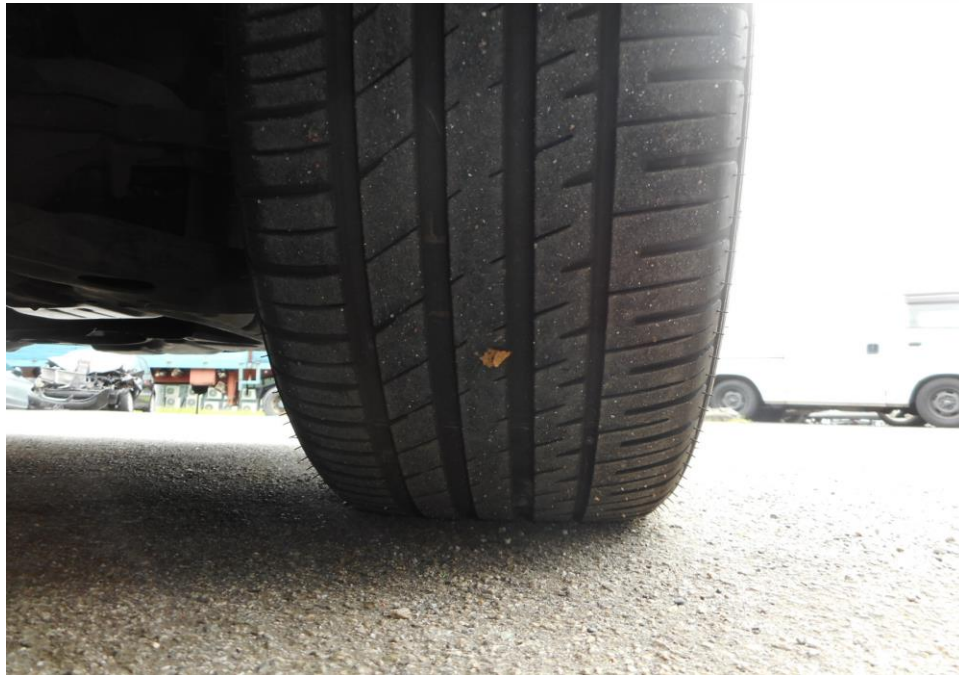
**Photo 6** shows the condition of the front right tyre of the Motor Car, which was observed to be in serviceable condition with remaining tread depth of approximately 4.3mm. The tyre, which was wrapped around standard alloy wheel rim, was also observed to be sufficiently inflated for vehicular operation. There was no tear, cut or burst mark(s) on the outer and the inner sidewalls as well as across the tread of the 4 tyres that were fitted on the Motor Car.

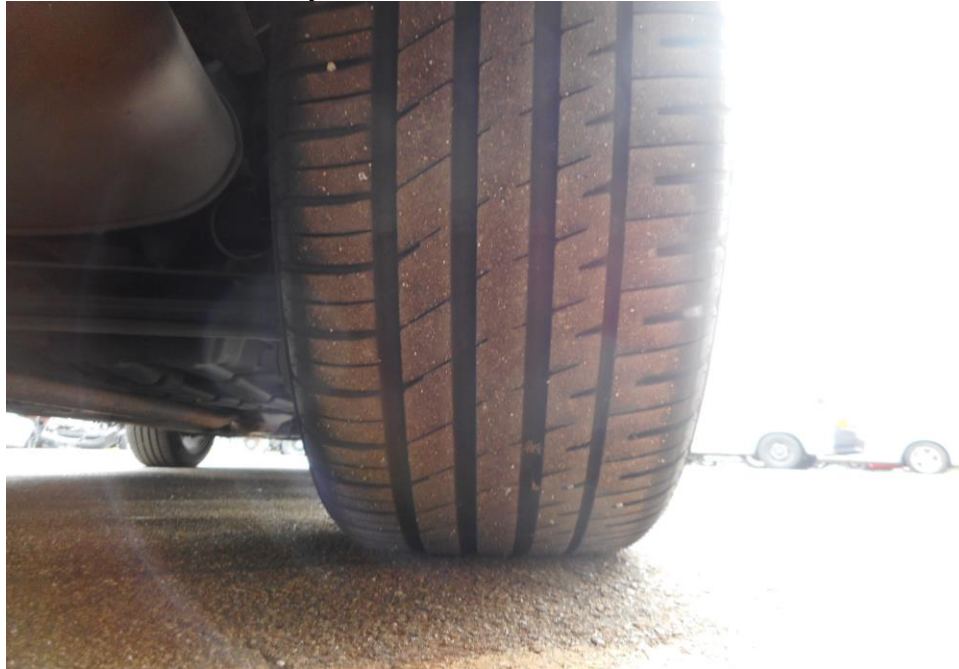
**Photo 7** shows the condition of the rear right tyre of the Motor Car, which was observed to be in serviceable condition with remaining tread depth of approximately 4.5mm. The tyre, which was wrapped around standard alloy wheel rim, was also observed to be sufficiently inflated for vehicular operation.

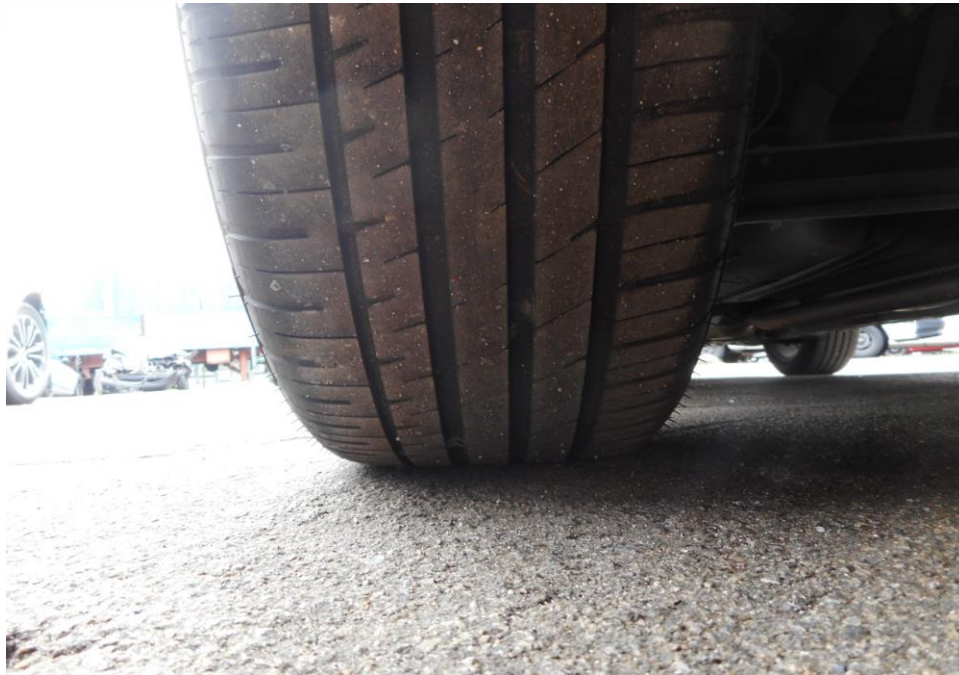
**Photo 8** shows the condition of the rear left tyres of the Motor Car, which was observed to be in serviceable condition with remaining tread depth of approximately 3.9mm. The tyres, which were wrapped around standard alloy wheel rim, were also observed to be sufficiently inflated for vehicular operation. There was also no damage found on all 4 alloy wheel rims of the Motor Car.

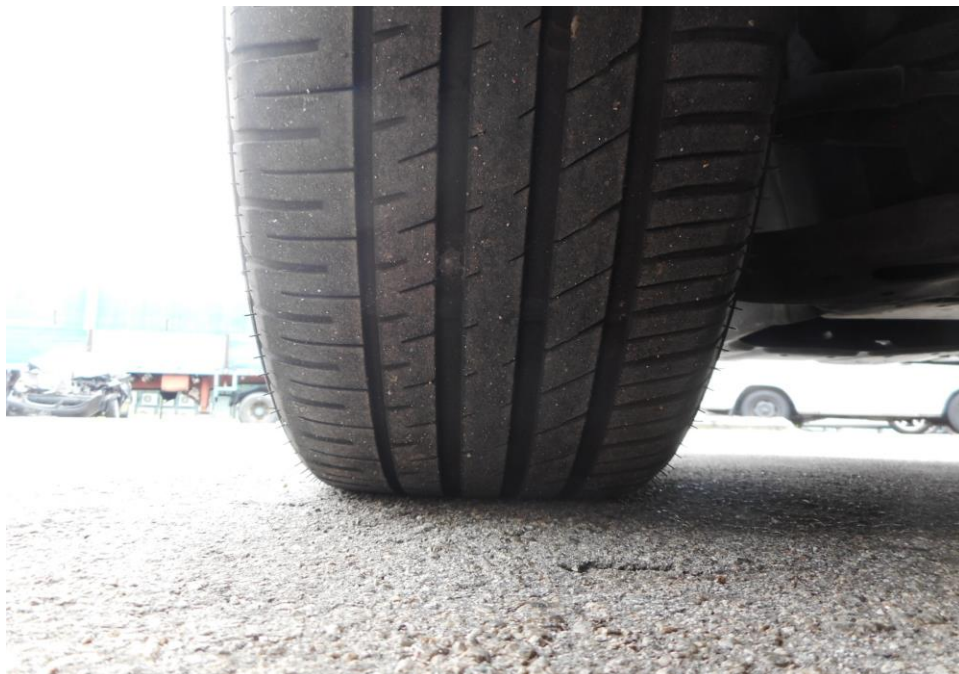
**Photo 9** shows the condition of the rear right tyres of the Motor Car, which were observed to be in serviceable condition with remaining, tread depth of approximately 3.9mm. There was also no tear, cut or burst mark(s) on the outer and the inner sidewalls as well as across the tread of the 4 tyres that were fitted on the Motor Car.

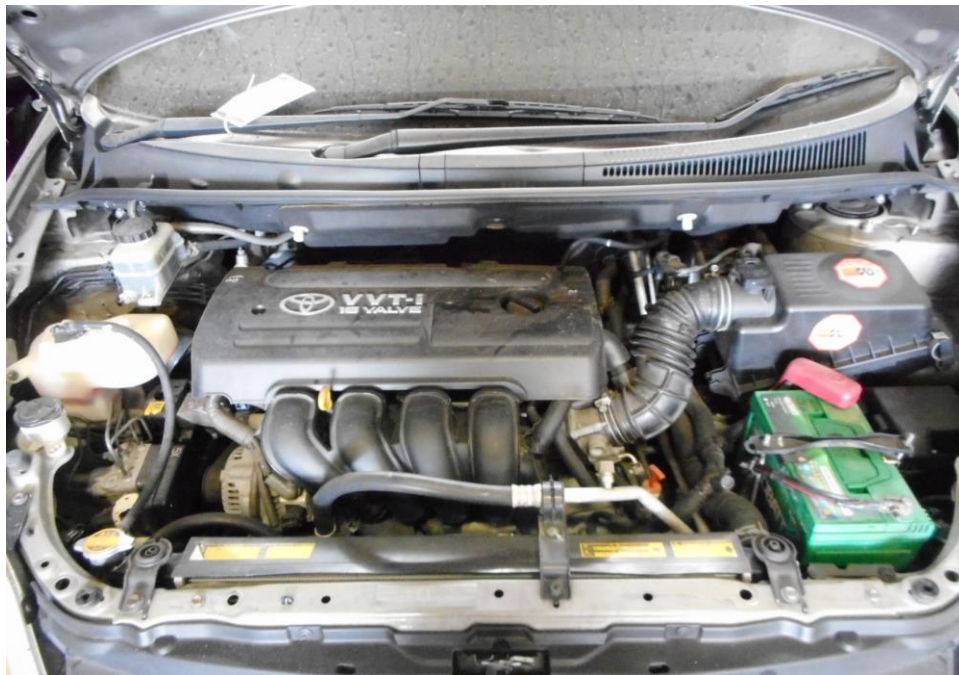
**Photo 10** shows a general view of the Motor Car's engine compartment, which was accessed by lifting the front cabin of the Motor Car. The various parts and components inside the engine compartment were unaffected by the accident. There was also no sign(s) or indication(s) of fresh fluid leakage and/or fluid stain within the engine compartment

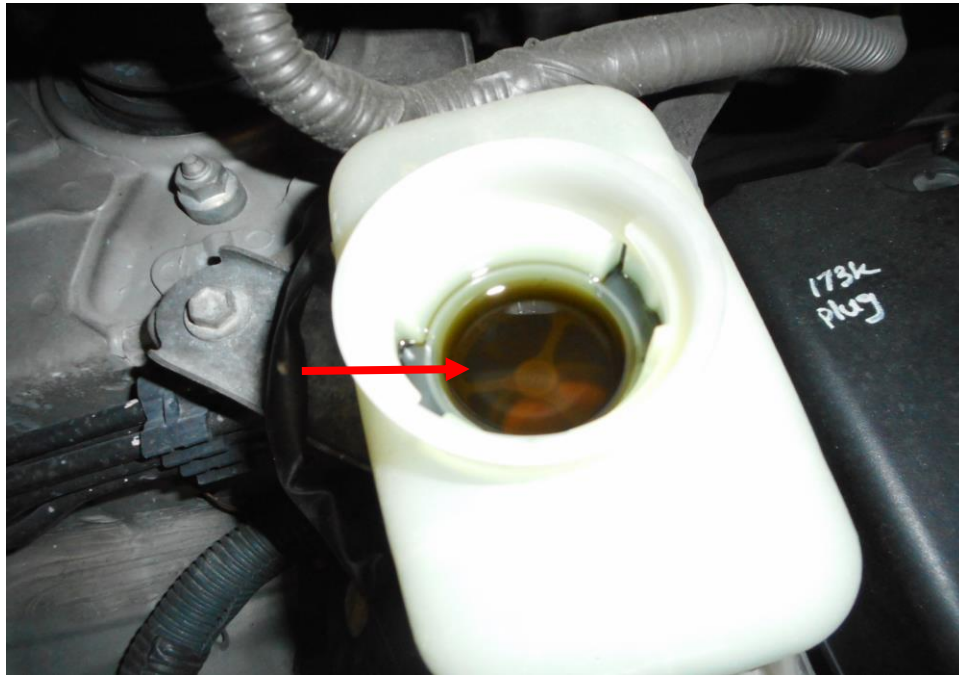
**Photo 11** shows the brake fluid reservoir of the Motor Car at the time of my inspection. The brake fluid was observed to be of sufficient level (arrowed) and without any visible contamination.

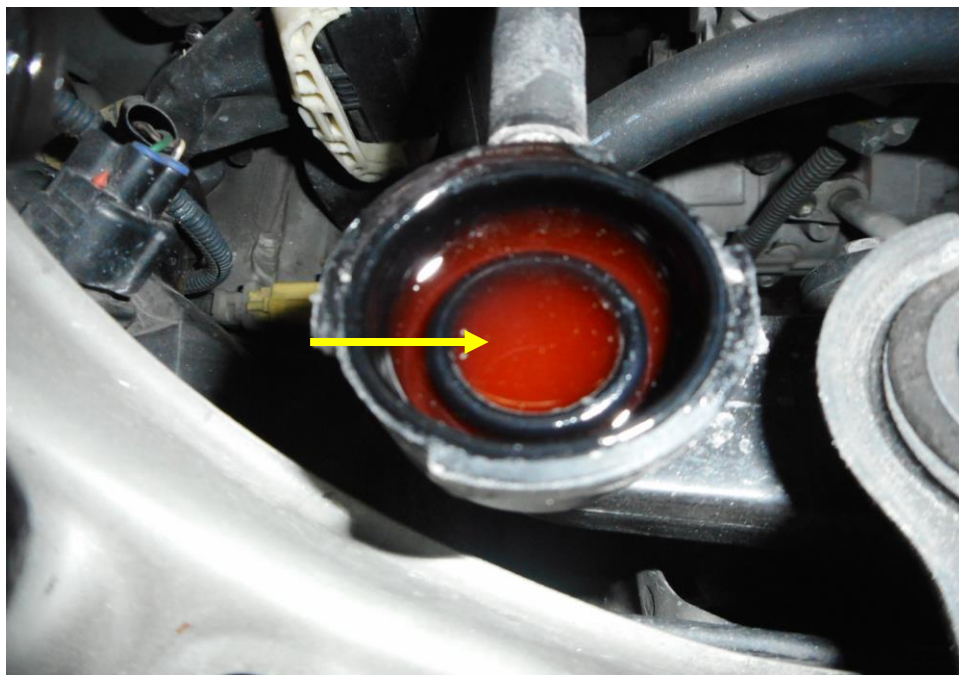
**Photo 12** shows the engine coolant reservoir of the Motor Car at the time of my inspection. The engine coolant was observed to be of sufficient level (arrowed) and without any visible contamination.

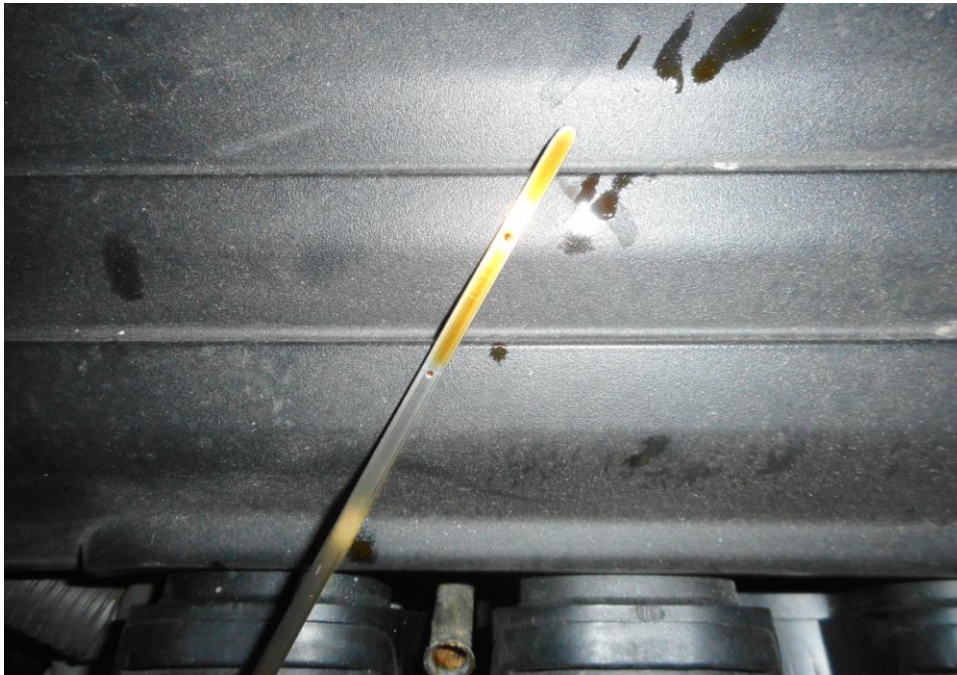
**Photo 13** shows the engine oil dip stick of the Motor Car at the time of my inspection. The engine oil was observed to be of sufficient level and without any visible contamination.

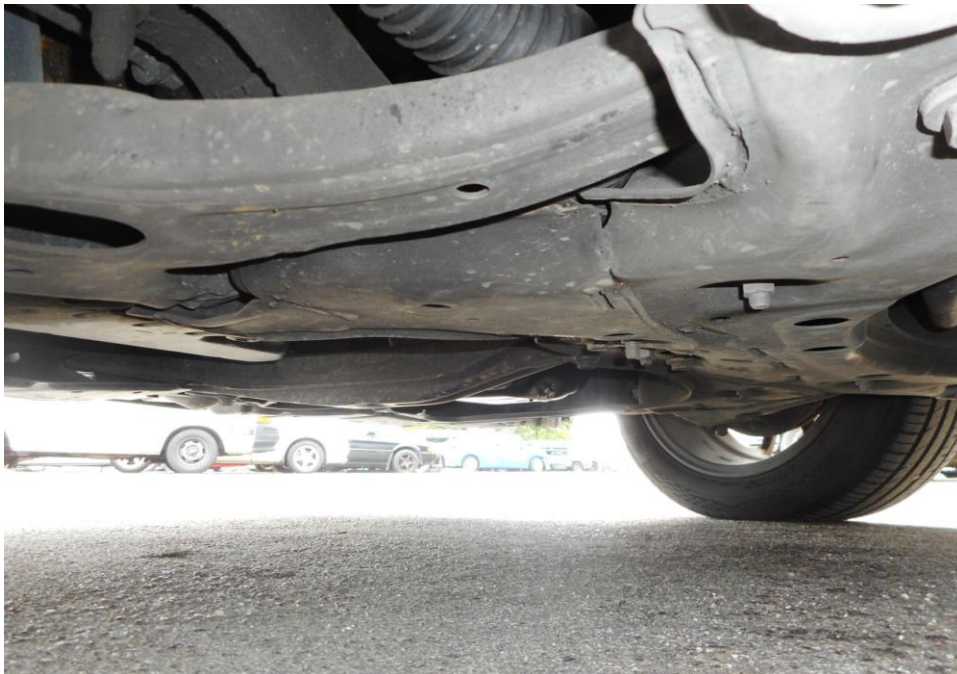
**Photo 14** shows the undercarriage of the Motor Car, at the area where the engine housing and transmission housing are located. . I did not find any sign(s) or indication(s) of fluid leak and/or fluid stain(s) on the underside of the Motor Car.

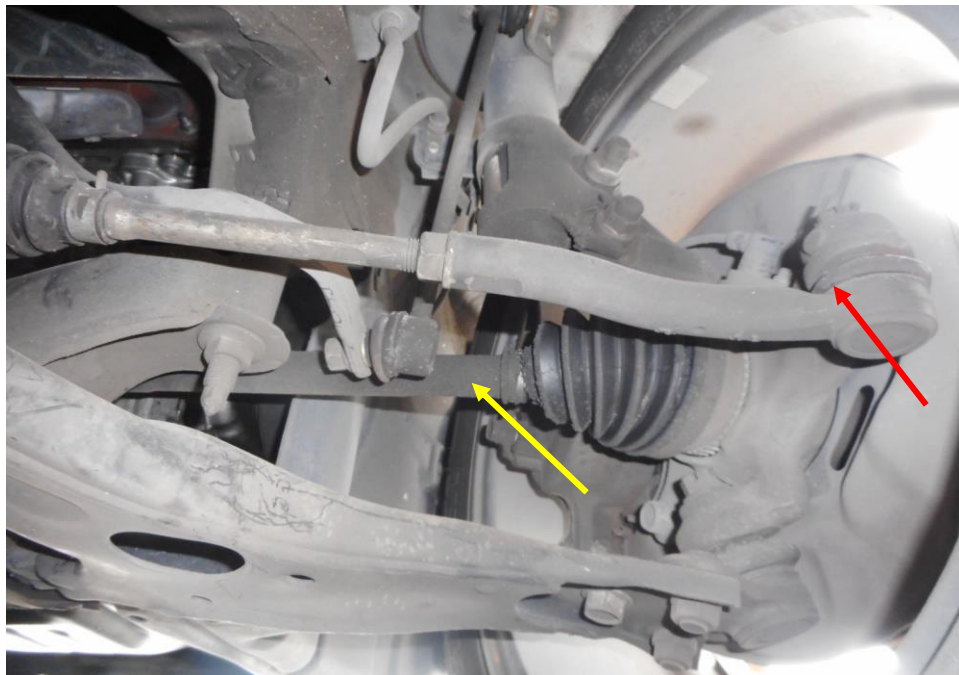
**Photo 15** shows the various undercarriage components at the front right wheel of the Motor Car, in particular the steering tie rod end (red arrowed) and drive shaft (yellow arrow). The various steering components were all found to be intact, suggesting that the steering system of the Motor Car was likely to be in serviceable condition at the material time of accident. There was also no sign of fluid stain(s) observed on the various undercarriage components.

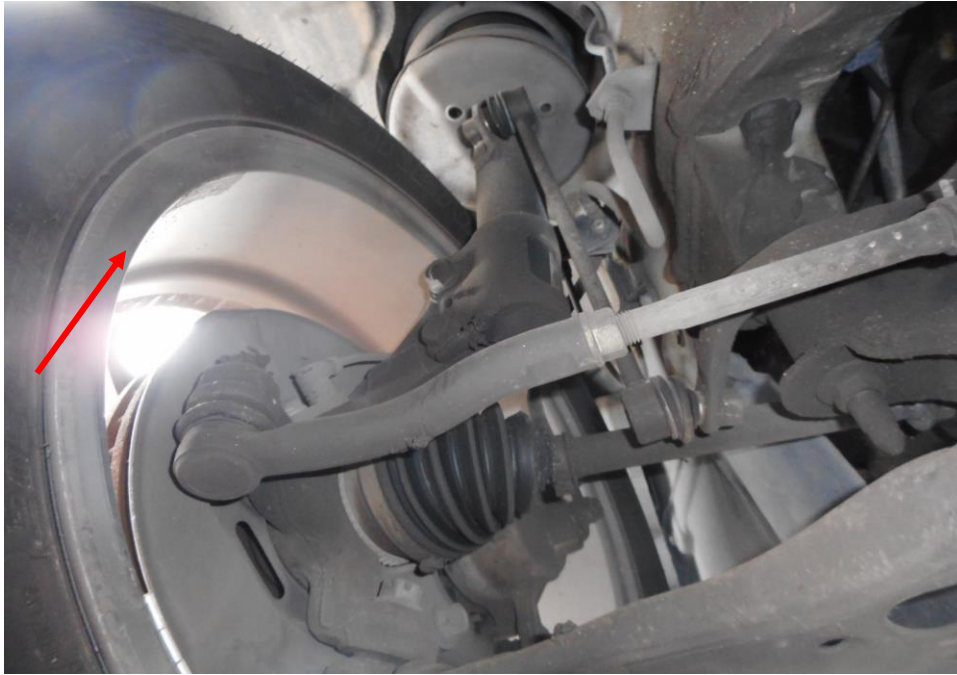
**Photo 16** shows the various undercarriage components at the front left wheel of the Motor Car, in particular the steering tie rod end (arrowed). The various Undercarriage components of the Motor Car were all found to be intact without any visible damage. There was also no sign of fluid stain(s) observed on the various undercarriage components.

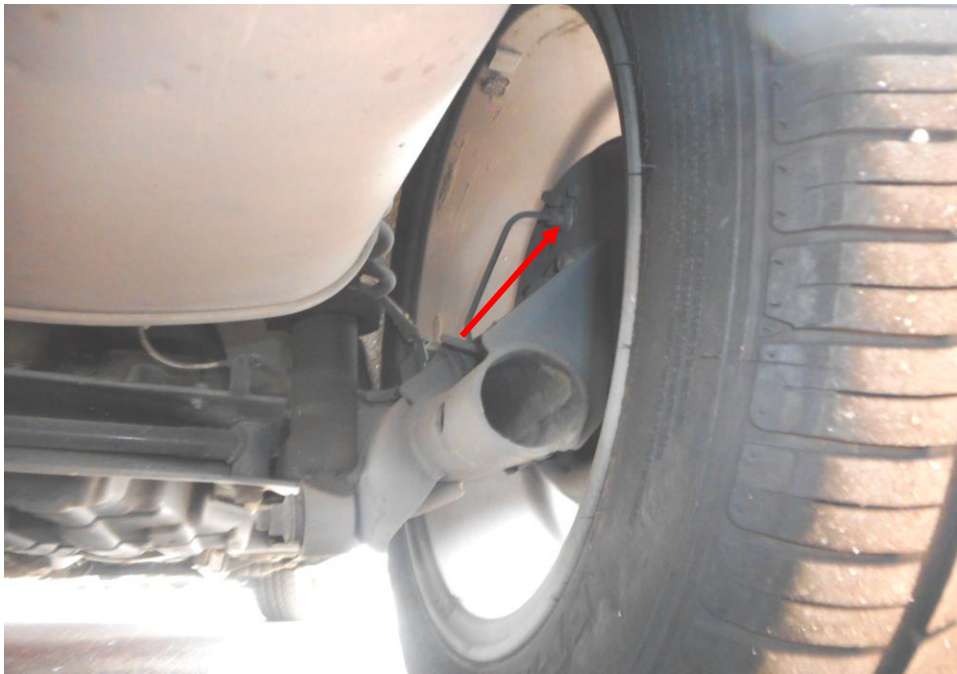
**Photo 17** shows the brake pipe (arrowed) at the rear right wheel of the Motor Car. I did not observe any leakage of brake fluid at the time of my inspection of the Motor Car. My static tests of the Motor Car's braking system, along with my visual examination of the various mechanical components in the braking system, had indicated that there was no internal leakage of pressure/vacuum. Hence the braking system of the Motor Car was likely to be in serviceable condition at the material time of accident.

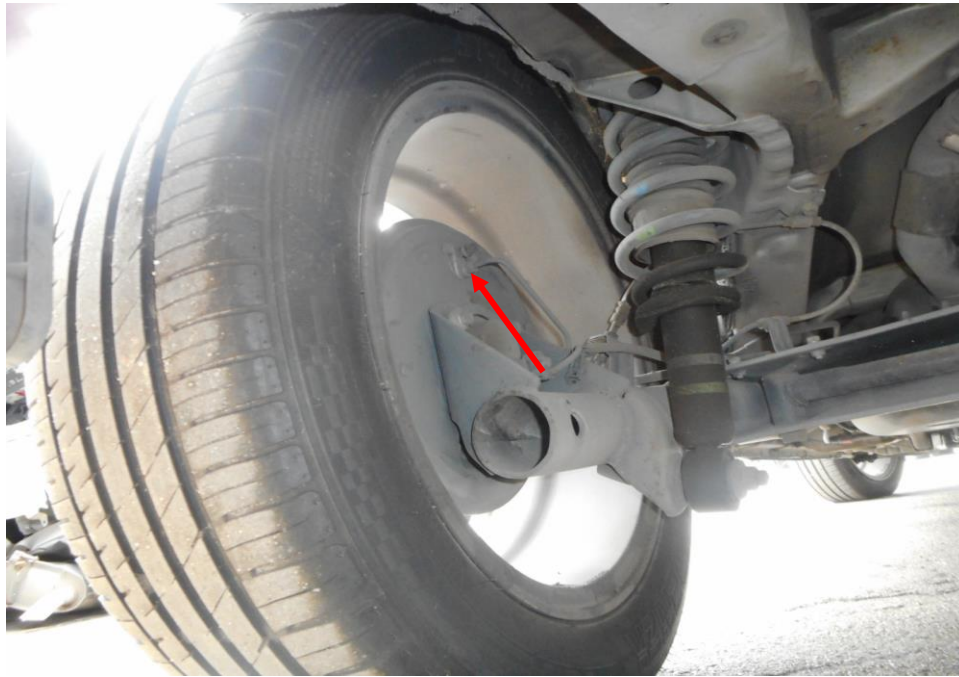
**Photo 18** shows the brake pipe (arrowed) at the rear left wheel of the Motor Car. I did not observe any leakage of brake fluid at the time of my inspection of the Motor Car. My static tests of the Motor Car's braking system, along with my visual examination of the various mechanical components in the braking system had indicated that there was no internal leakage of pressure/vacuum. Hence the braking system of the Motor Car was likely to be in serviceable condition at the material time of accident.

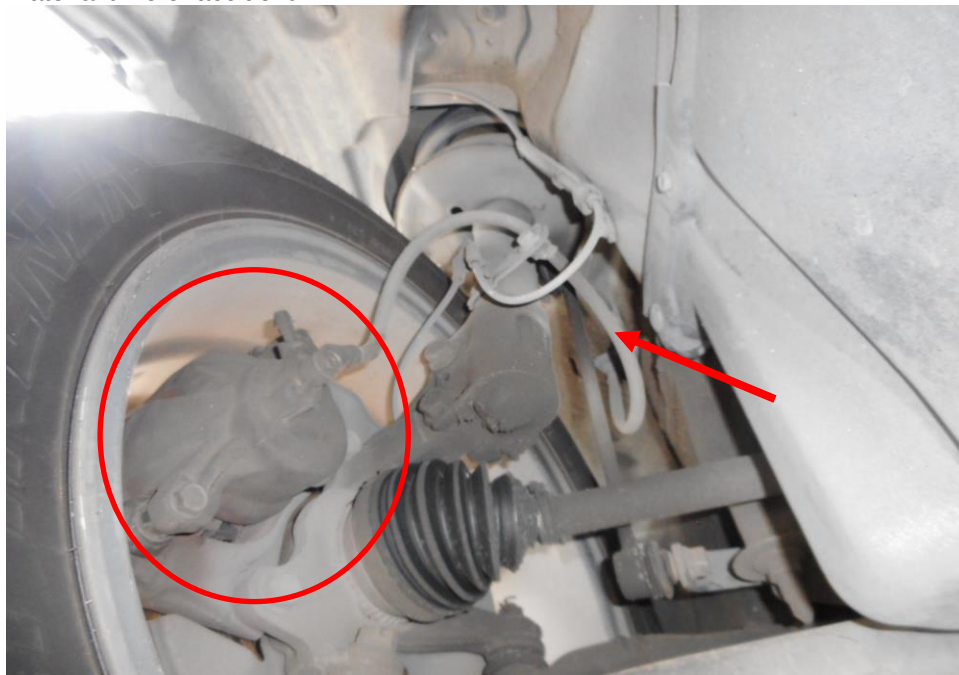
**Photo 19** shows the brake hose/pipe (arrowed) at the front right wheel of the Motor Car. No leakage of brake fluid was observed. Visual examination of the various components of the braking system like the brake caliper (circled), brake booster, brake pedal etc had revealed all to be intact and without visible damage at the time of accident. There was also no sign of fluid stain(s) observed on the various undercarriage components.

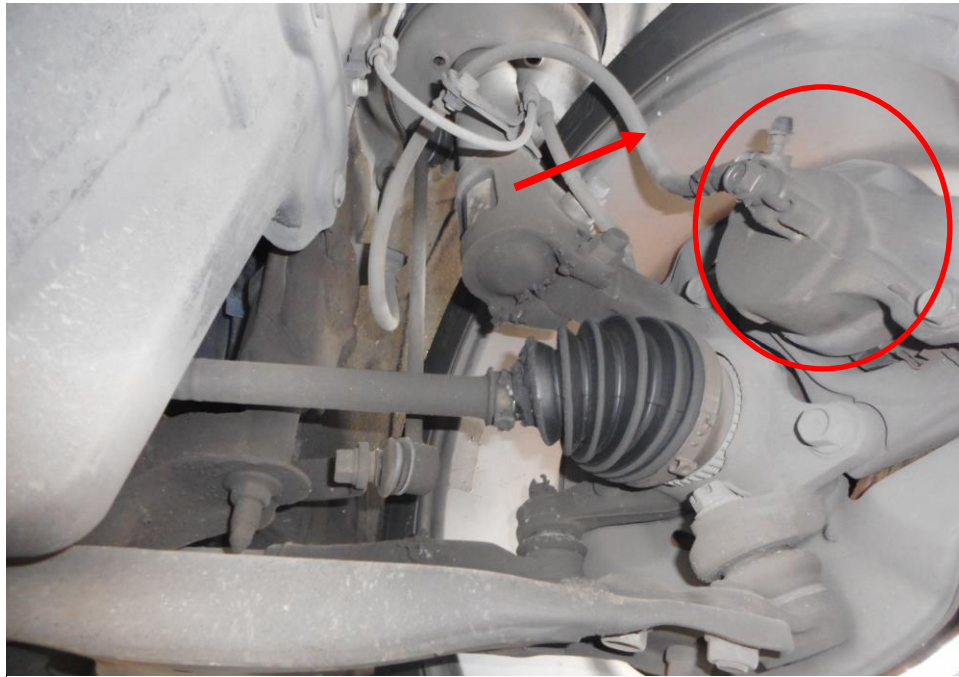
**Photo 20** shows the brake hose/pipe (arrowed) at the front left wheel of the Motor Car. No leakage of brake fluid was observed. Visual examination of the various components of the braking system like the brake caliper (circled), brake booster, brake pedal etc had revealed all to be intact and without visible damage at the time of accident. There was also no sign of fluid stain(s) observed on the various undercarriage components.

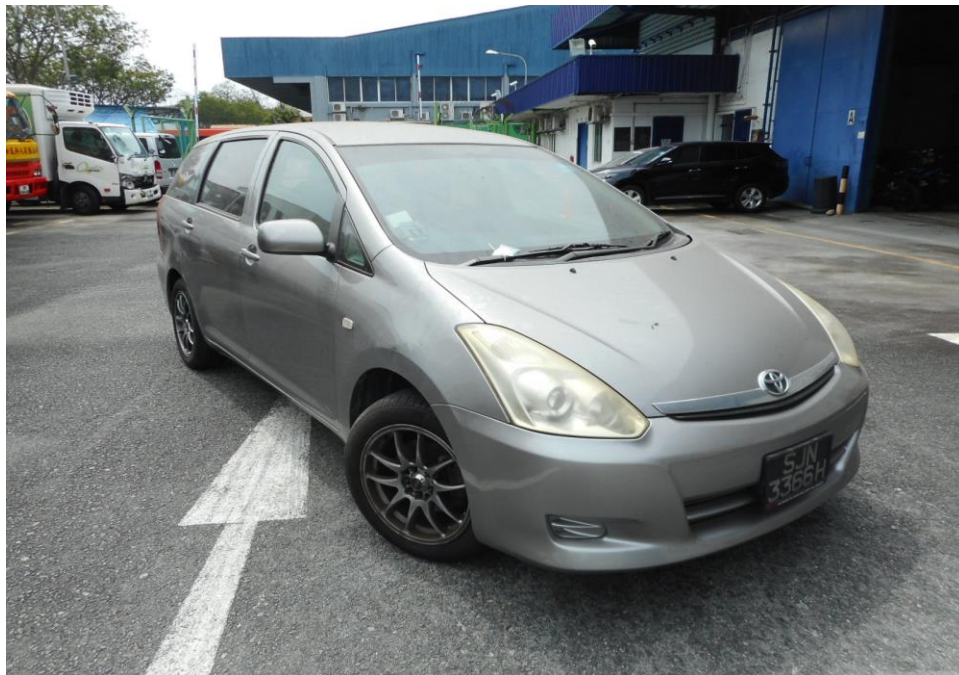
**Photo 21** shows the front right wheel of the Motor Car turned to its full left. During my steering system test, I did not experience any abnormal free play and/or resistance when I had turned the steering wheel towards full left and full right. This would suggest that the steering system of the Motor Car was likely to be in serviceable condition at the material time of accident.

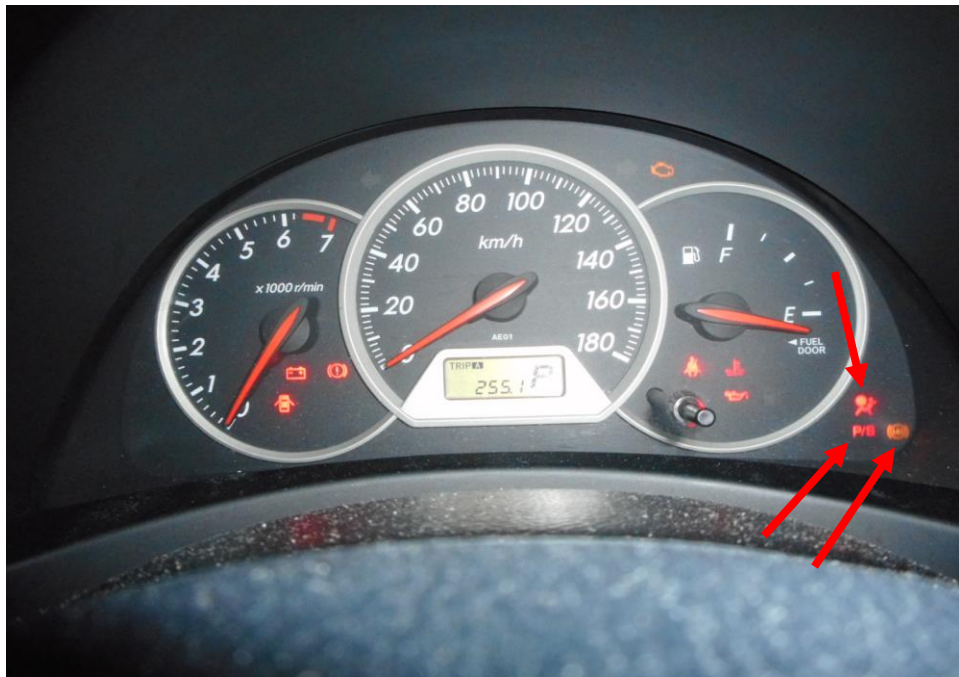
**Photo 22** shows the warning light for Anti-Lock Brake System (ABS), Supplemental Restraint System (SRS) and Electric Power Steering System (EPS) appearing on the instrument panel of the Motor Car during the self-test of its various electronic operating systems when its engine was cranked.

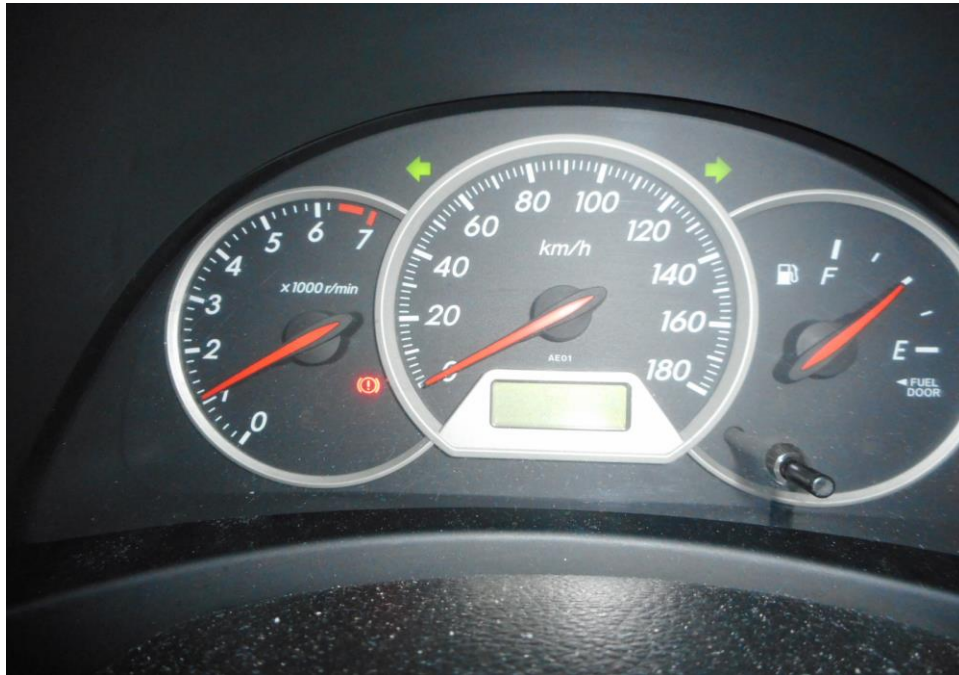
**Photo 23** shows no warning lights illuminated on the instrument panel of the Motor Car after the engine was cranked. This would suggest that there was no abnormality to the various electronic operating systems of the Motor Car, like the ABS, SRS and EPS.
