Vehicle No. GBE 9189E  
Insured Veh. GBG 7015B  
Claim No. SNM20D203971  
Policy No. DMCVSNA00088882003  
Accident Date 19/10/2020  
Inspection Date 20/10/2020

# LKK Auto Consultants Pte Ltd

## ADJUSTMENT ON REPAIR COST FOR VEHICLE NO. GBE 9189E

### PHOTOGRAPHS FOR VEHICLE NO. GBE 9189E

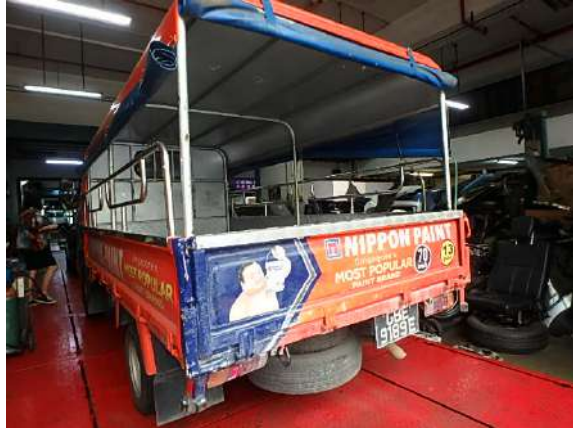
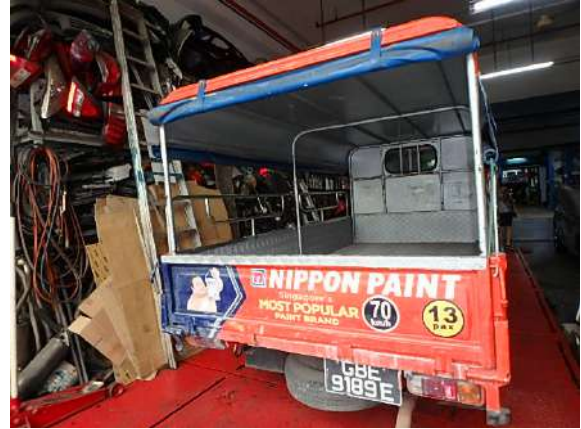
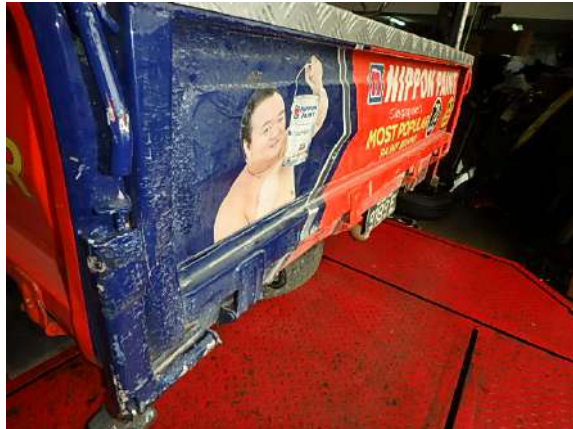
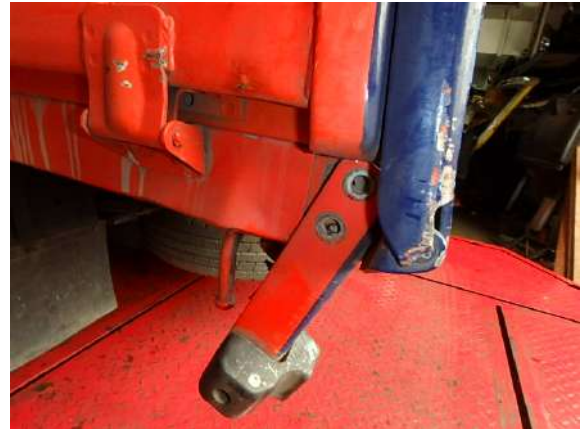
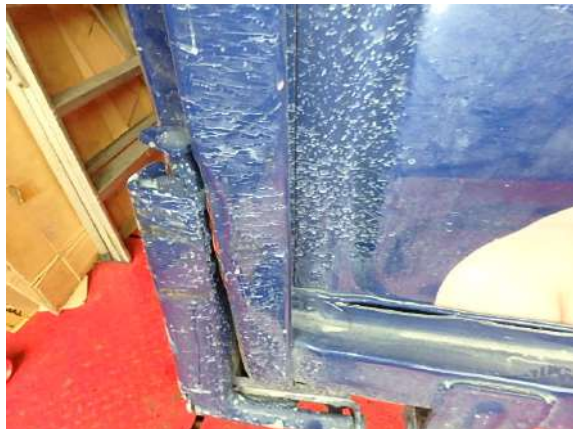
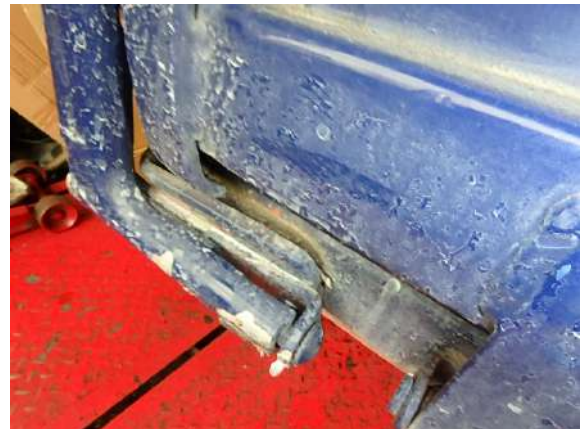
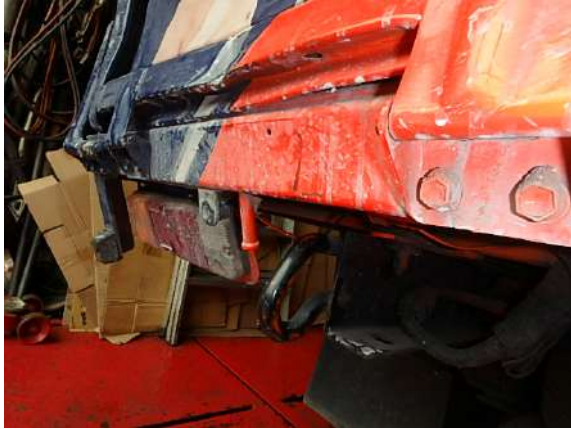
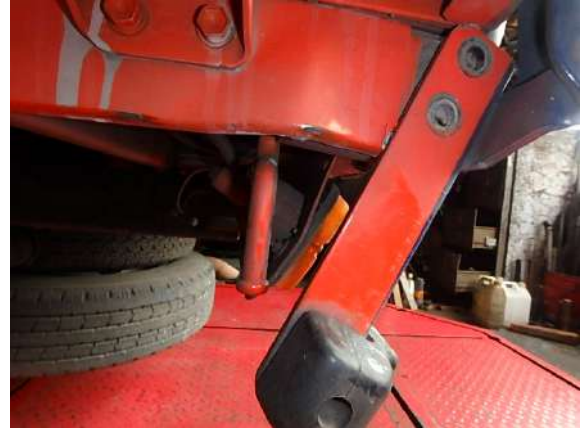
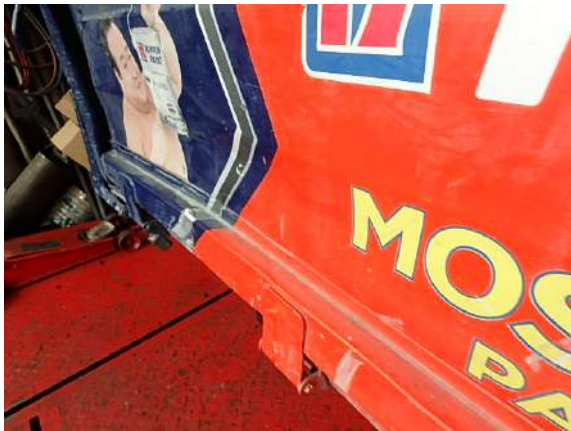
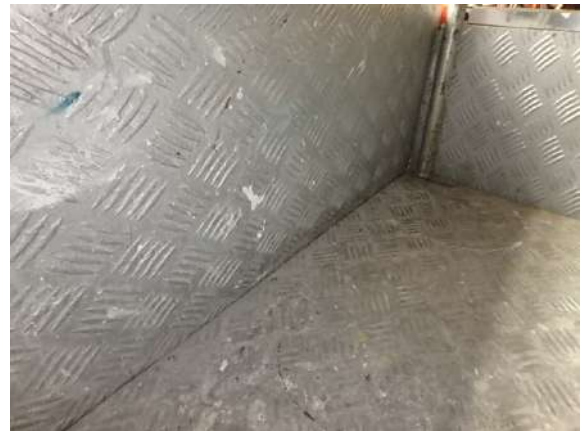
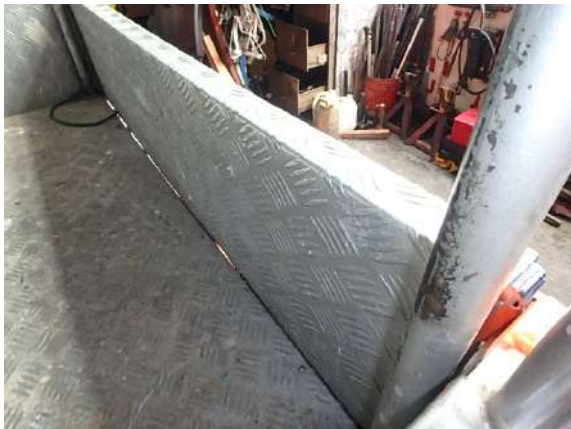
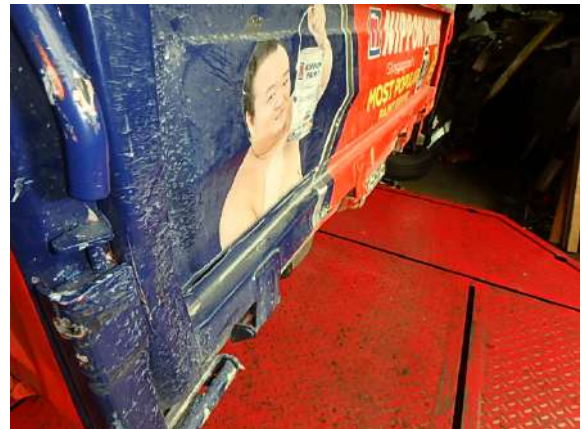
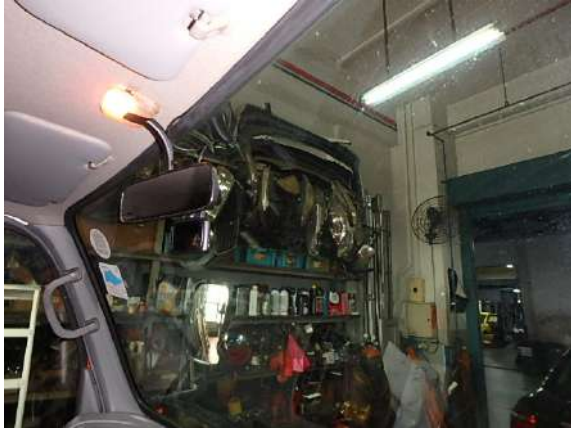
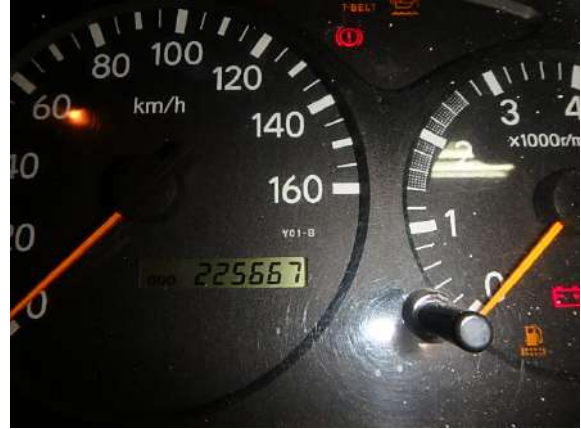
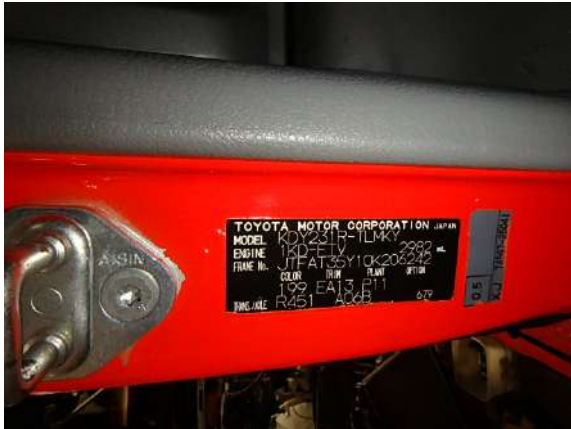
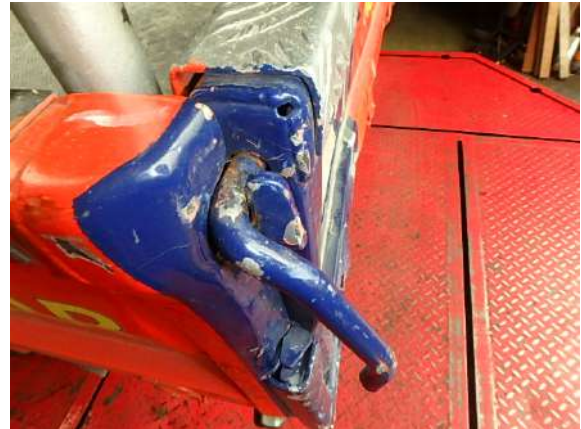
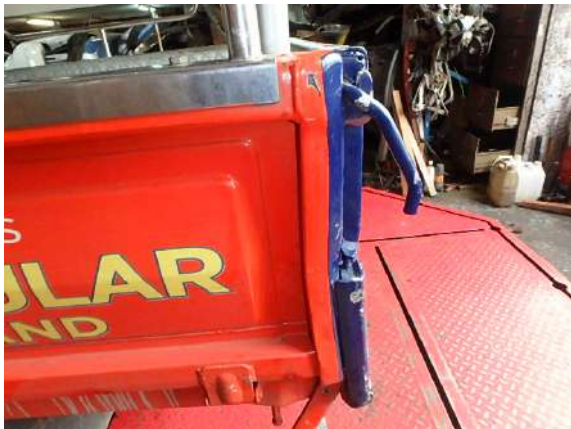
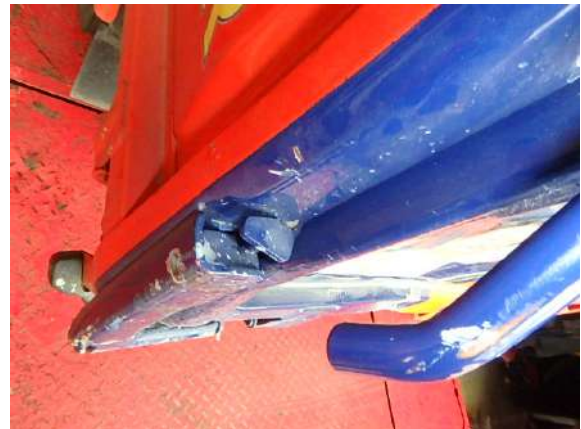
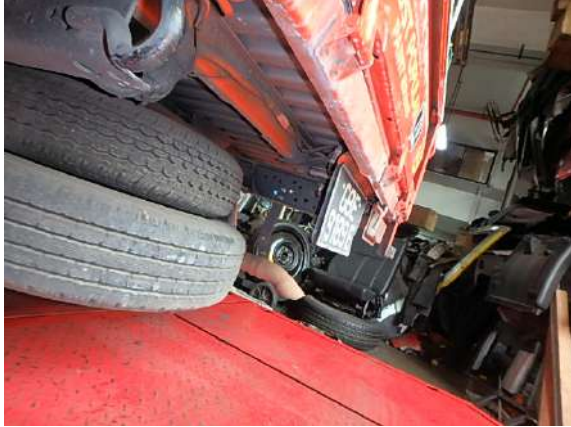
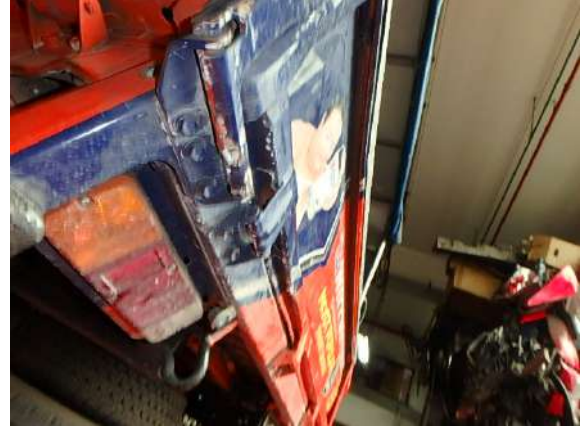
### INSPECTION

| Affiliated to Federation Internationale Des Experts En Automobile | | | | |
|---|---|---|---|--|
| THE VEHICLE SUSTAINED DAMAGES AT THE REAR N/S PORTION.<br><br>DAMAGES SEE DETAILS. | | | | |
