LKK Auto Consultants Pte Ltd

1. Policy Particulars :- THIRD PARTY CLAIM				
Insured Veh.	SHA 9484C	Veh. Inspected	SJL 600L	
Policy No.	D-20094921MFSH	Coverage (\$)	0.00	
Claim No.	D20004257MFSH	Excess (\$)	0.00	
Assign From	MERINA CHIA	Assign Date	23/10/2020

ADJUSTMENT ON REPAIR COST FOR VEHICLE NO. SJL 600L

PHOTOGRAPHS FOR VEHICLE NO. SJL 600L

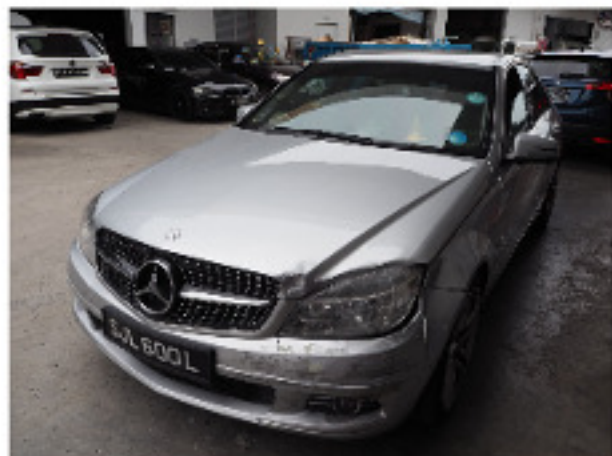
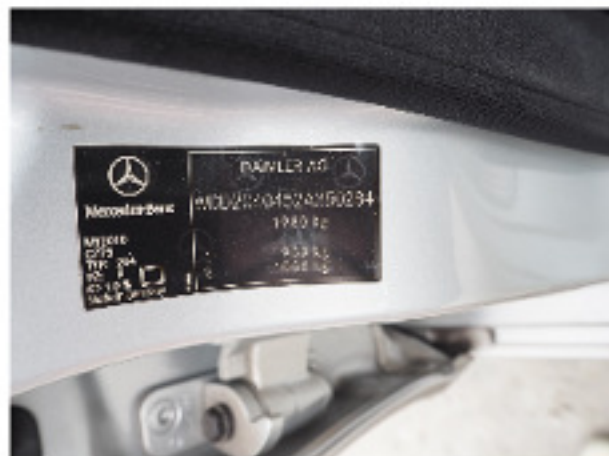
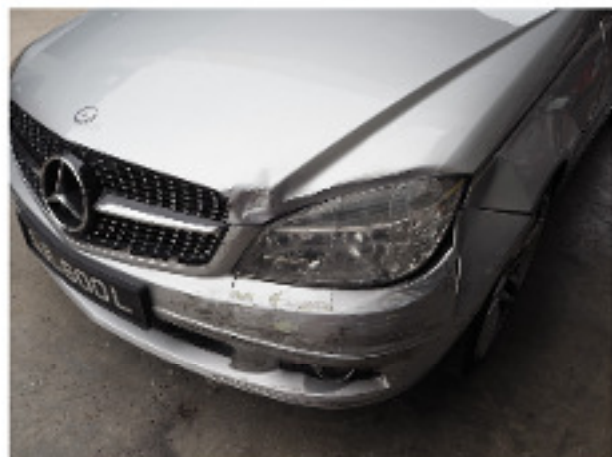
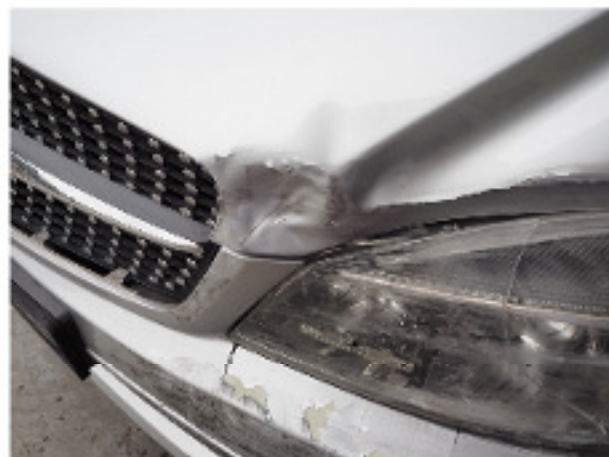
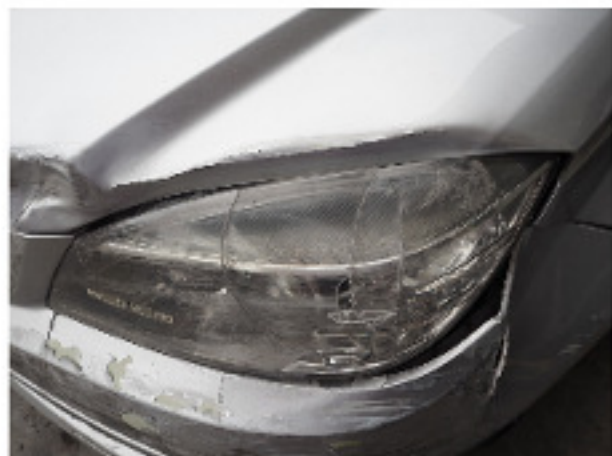
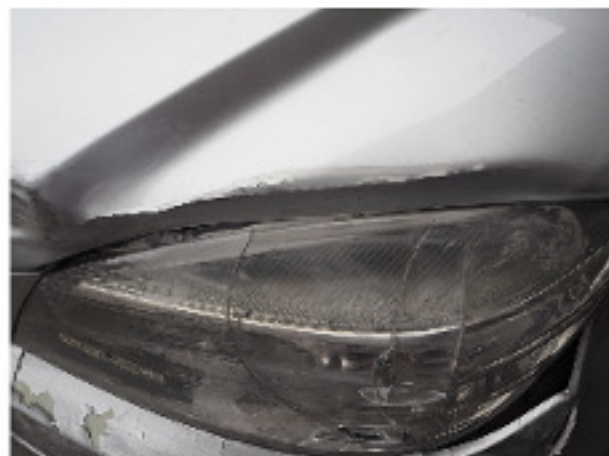
4. Description of Damages				
THE VEHICLE SUSTAINED DAMAGES AT THE FRONT N/S PORTION. DAMAGES SEE DETAILS.				
5. General Information				
Accident Date	23/10/2020	Inspection Date	23/10/2020	
Survey held at	KIANG MOTOR BLK 25 KAKI BUKIT ROAD 4 #08-26 SYNERGY @ KB SINGAPORE 417800			
5a. Remarks				
A)THE INSPECTION WAS CONDUCTED ON A"WITHOUT PREJUDICE" BASIS. B)IN ACCORDANCE TO YOUR INSTRUCTIONS, WE HAVE NOT AUTHORISED REPAIRS.				
5b. Estimate Days of Repair				
ESTIMATED NORMAL PERIOD FOR REPAIR:			6 Working Days
