Your Ref: Maserati Ghibli  
(chassis number ZAMXS57C001303235)  
Our Ref : CI/TP20011512/D

22 October 2020

**INSPECTION REPORT OF AN UNREGISTERD MASERATI GHIBLI MOTOR CAR WITH CHASSIS NUMBER ZAMXS57C001303235**

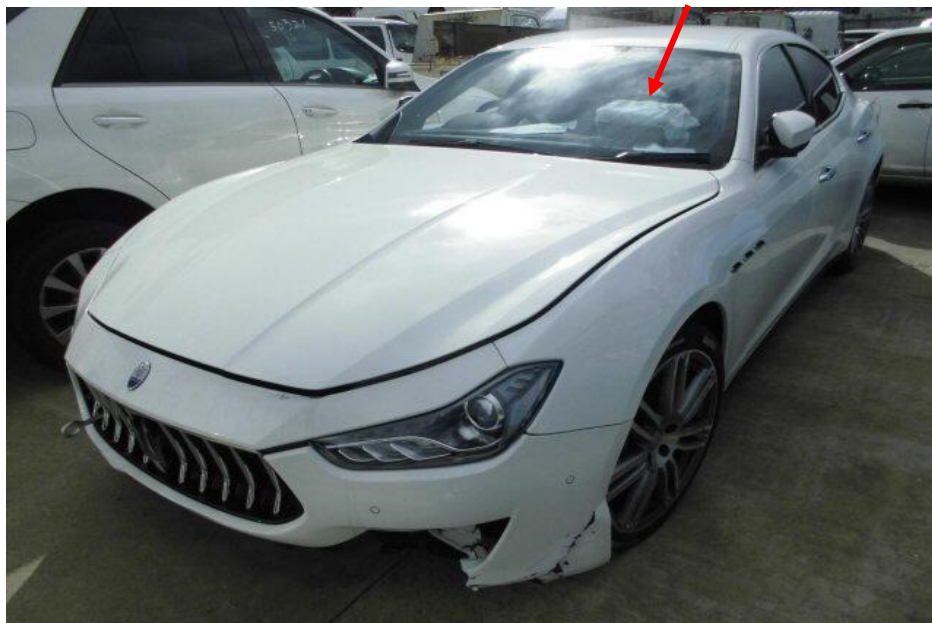
**Photo 1** shows the front left body of the Motor Car prior to any repairs being carried out (photograph provided to me). The Motor Car was observed to have sustained damages at its front left portion. The body parts observed to be damaged include the front bumper, front bumper left lower grille and front left wheel rim. The front left passenger airbag was also observed to be deployed (arrowed).

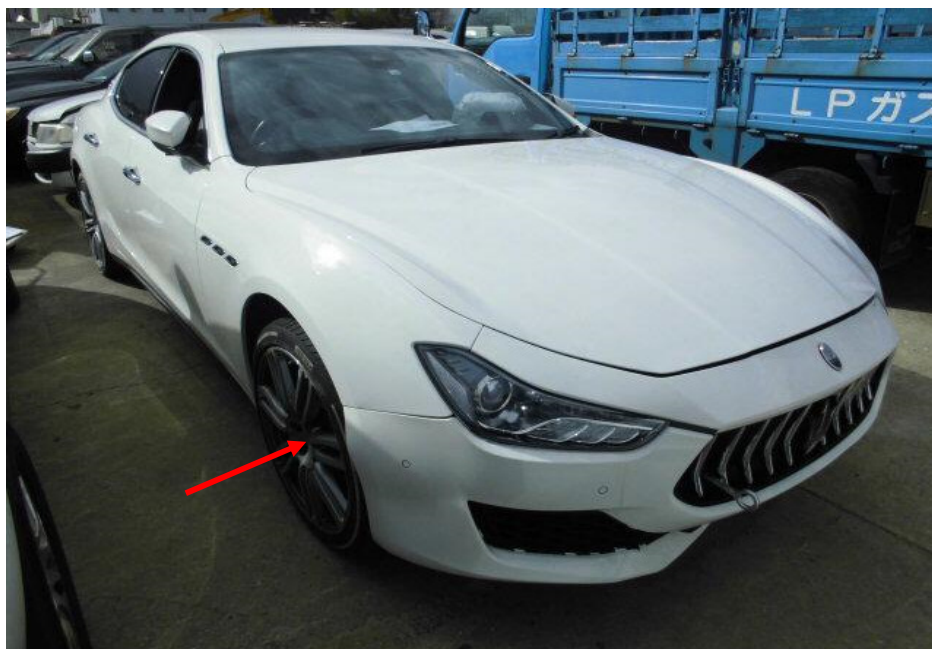
**Photo 2** shows the front right body of the Motor Car prior to any repairs being carried out (photograph provided to me). The front right wheel (arrowed) and front left wheel were both oriented inwards of the Motor Car (refer to photograph 1 above). This would indicate damage to the front undercarriage parts of the Motor Car, likely to be the front left undercarriage parts since the front left wheel rim was damaged.

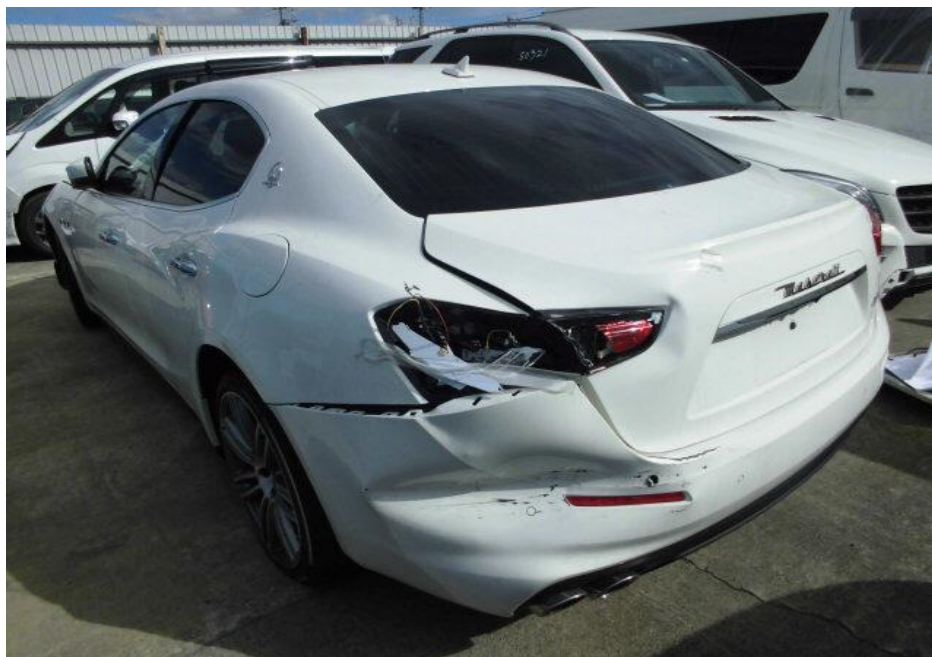
**Photo 3** shows the rear left body of the Motor Car prior to any repairs being carried out (photograph provided to me). Apart for the front left portion, the Motor Car had also sustained damage to its rear left portion. Body parts damage include the rear bumper, rear left fender, rear left taillamp, rear bootlid and rear left bootlid lamp amongst others.

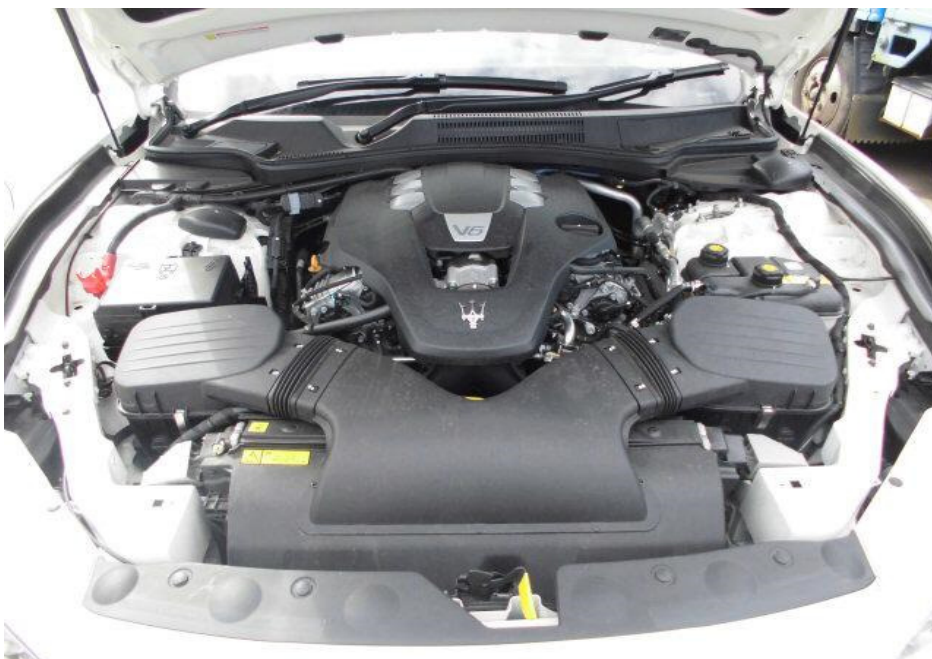
**Photo 4** shows the engine compartment of the Motor Car prior to any repairs being carried out (photograph provided to me). Parts and components within the engine compartment were observed to be intact and unaffected.

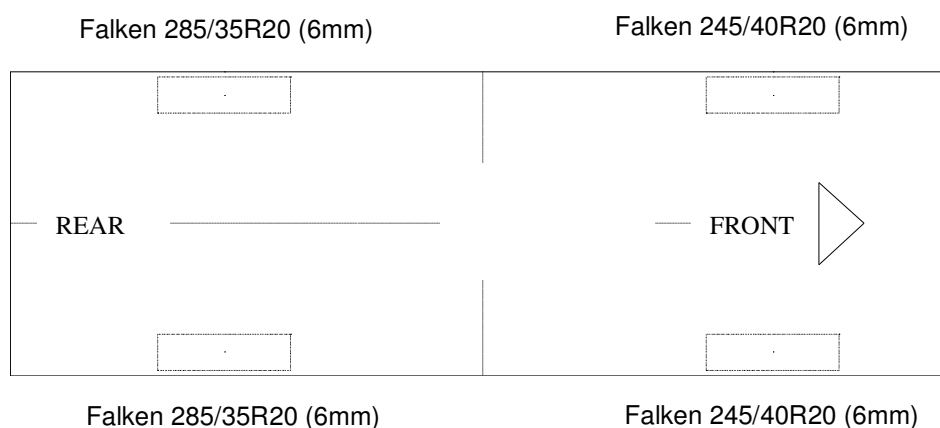
8. It was fitted with 20inch sport wheel rims that were wrapped with tyres that were observed to be of serviceable condition. The tyres were also sufficiently inflated for vehicular operation. The tyre brand, tyre size and approximate remaining tread depth of the 4 tyres of the Motor Car were recorded as follows: -

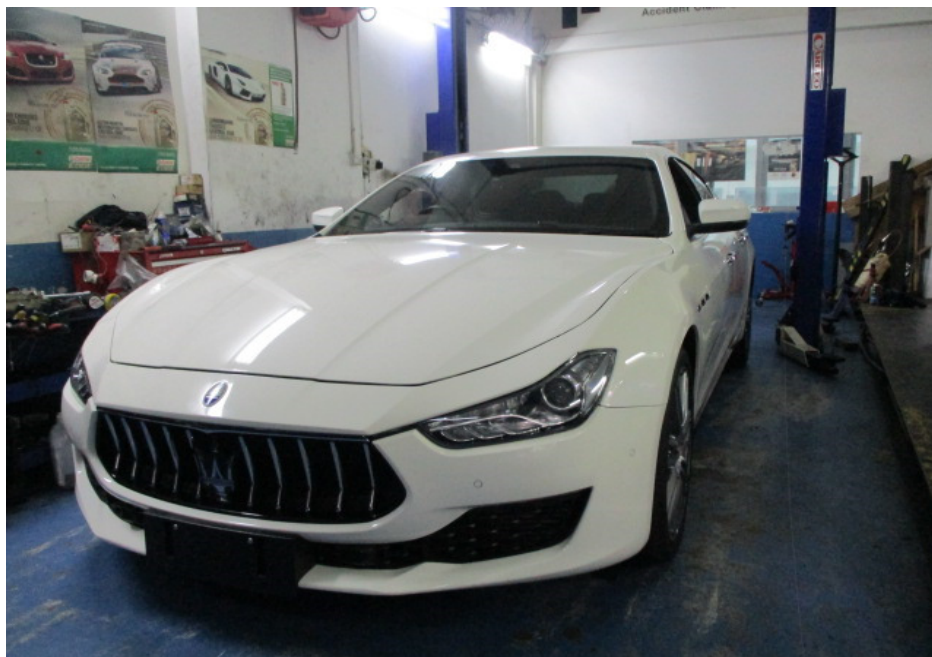
**Photo 5** shows a general view of the front left body of the Motor Car at the time of my inspection. The Motor Car was observed to be in a relatively good general condition with no loose exterior fittings observed. The body parts at the front left portion of the Motor Car were visually examined and it was observed that the repair/restoration works carried out to the damaged area of the Motor Car (refer photograph 1 above) were reasonably adequate and in order.

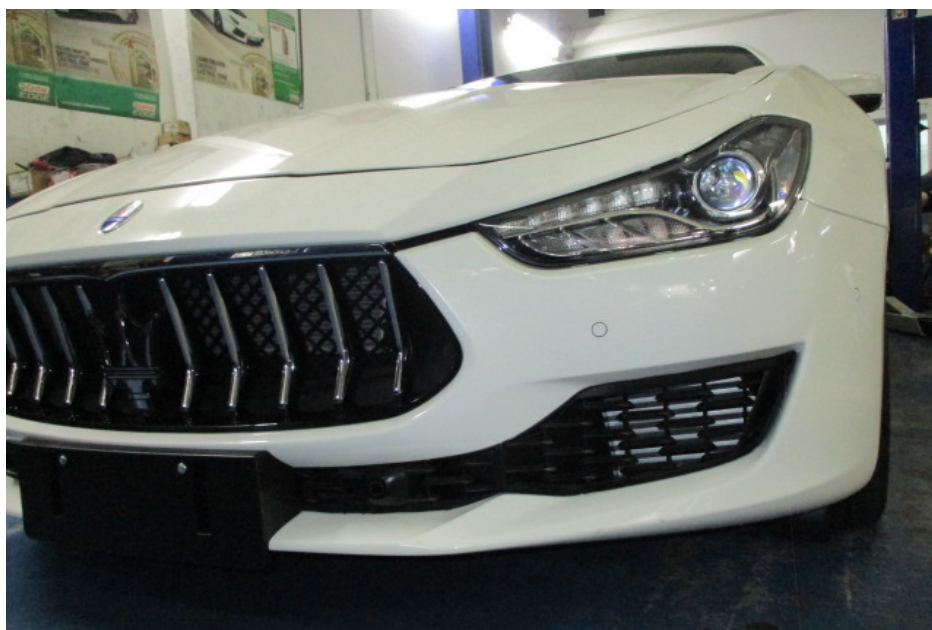
**Photo 6** shows a closer view of the front bumper and front bumper left lower grille of the Motor Car. The body parts at the front left portion of the Motor Car were visually examined and it was observed that the repair/restoration works carried out to the damaged area of the Motor Car (refer photograph 1 above) were reasonably adequate and in order.

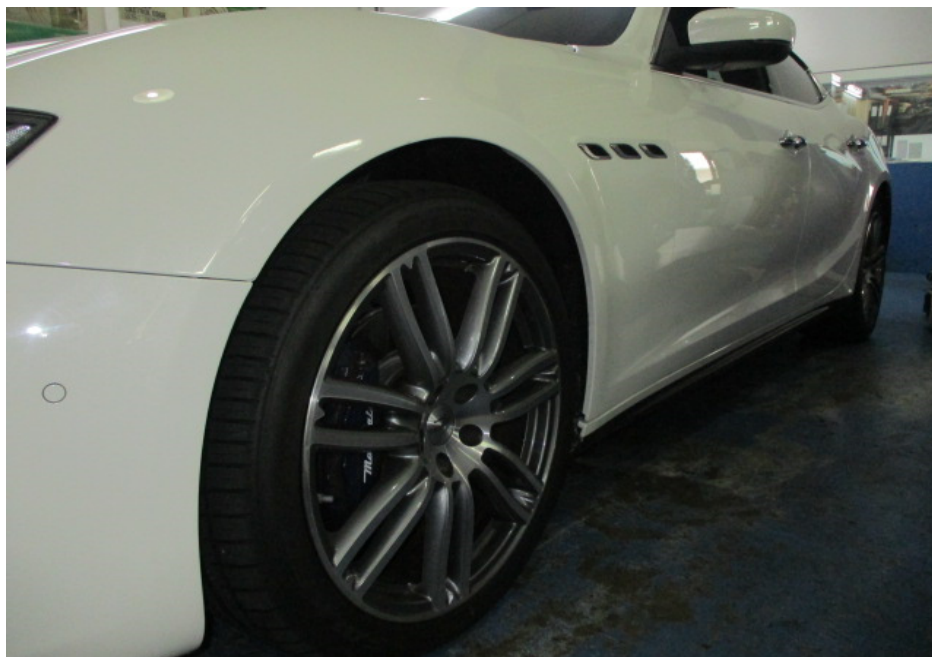
**Photo 7** shows a closer view of the front left wheel rim of the Motor Car. The body parts at the front left portion of the Motor Car were visually examined and it was observed that the repair/restoration works carried out to the damaged area of the Motor Car (refer photograph 1 above) were reasonably adequate and in order.

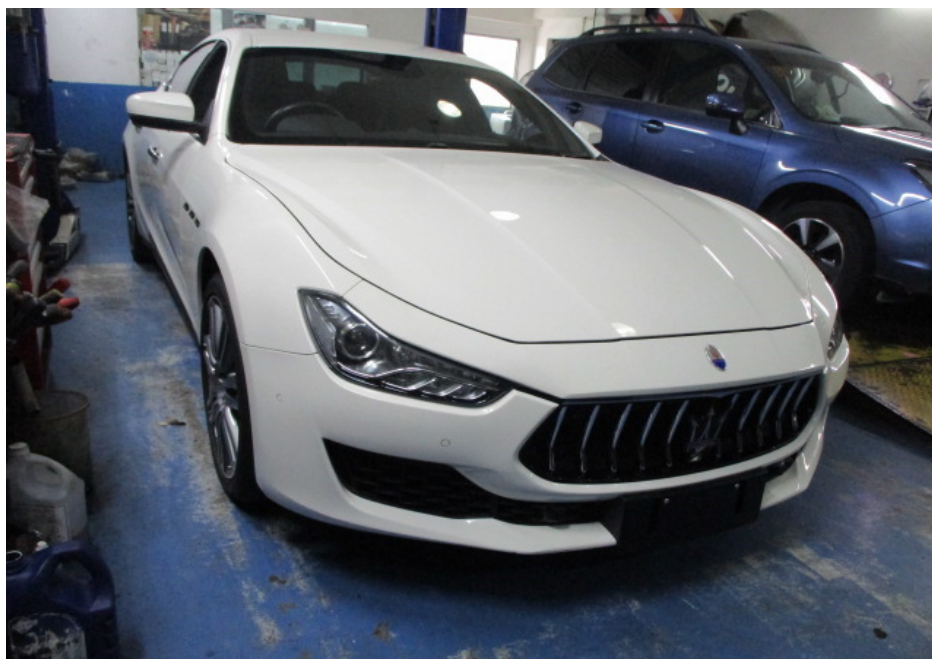
**Photo 8** shows a general view of the front right body of the Motor Car at the time of my inspection. The Motor Car was observed to be in relatively good general condition with no loose exterior fittings observed. The mileage of the Motor Car recorded at the time of my inspection was 4,028km.

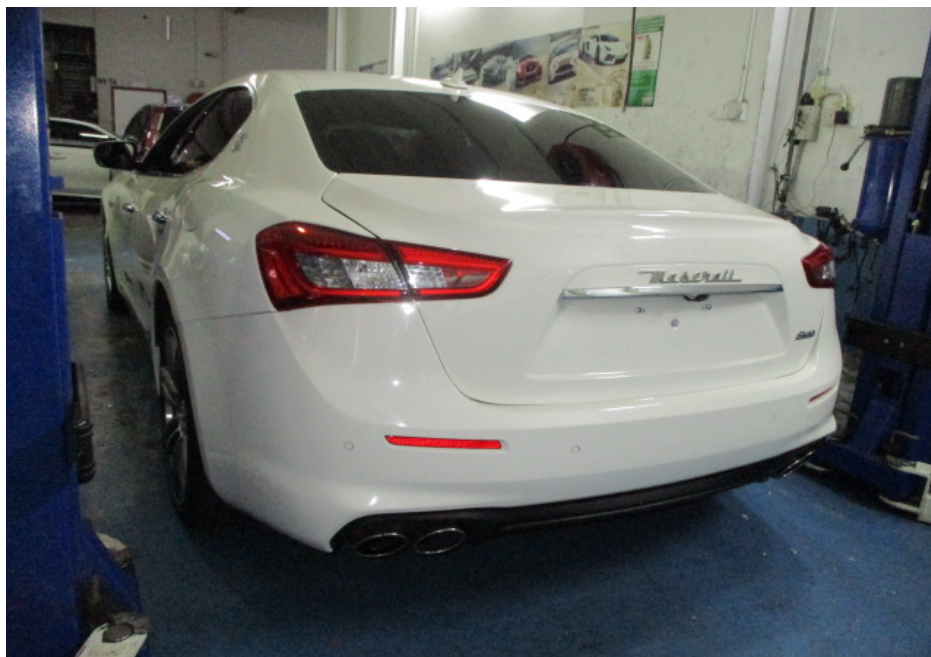
**Photo 9** shows a general view of the rear left body of the Motor Car at the time of my inspection. The body parts at the rear left portion of the Motor Car were visually examined and it was observed that the repair/restoration works carried out to the damaged area of the Motor Car (refer photograph 3 above) were reasonably adequate and in order.

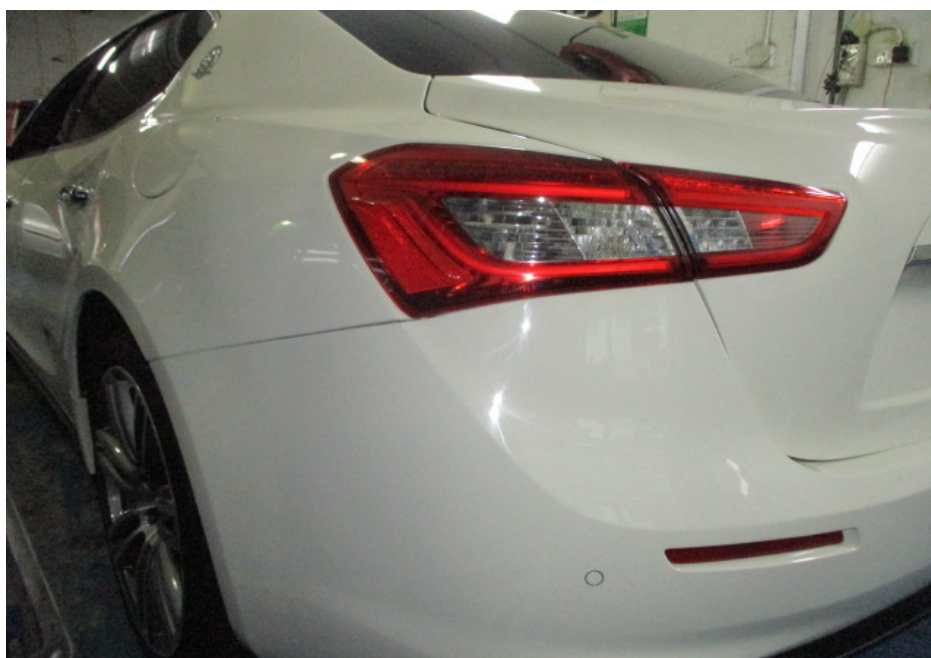
**Photo 10** shows a closer view of the rear bumper, rear left fender and rear left taillamp of the Motor Car. The body parts at the rear left portion of the Motor Car were visually examined and it was observed that the repair/restoration works carried out to the damaged area of the Motor Car (refer photograph 3 above) were reasonably adequate and in order.

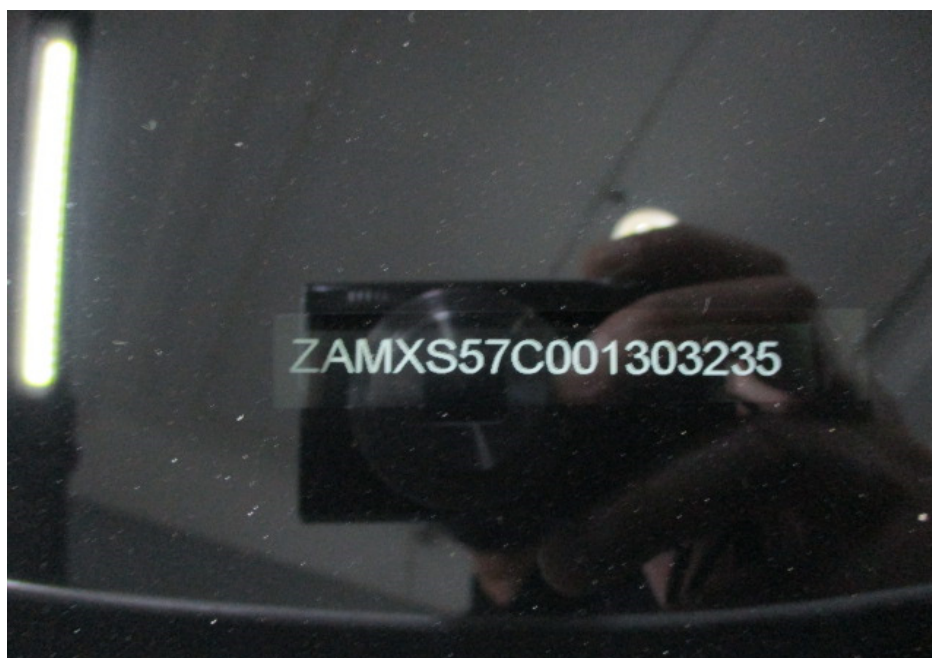
**Photo 11** shows the chassis number of the Motor Car. The chassis number recorded was ZAMXS57C001303235.

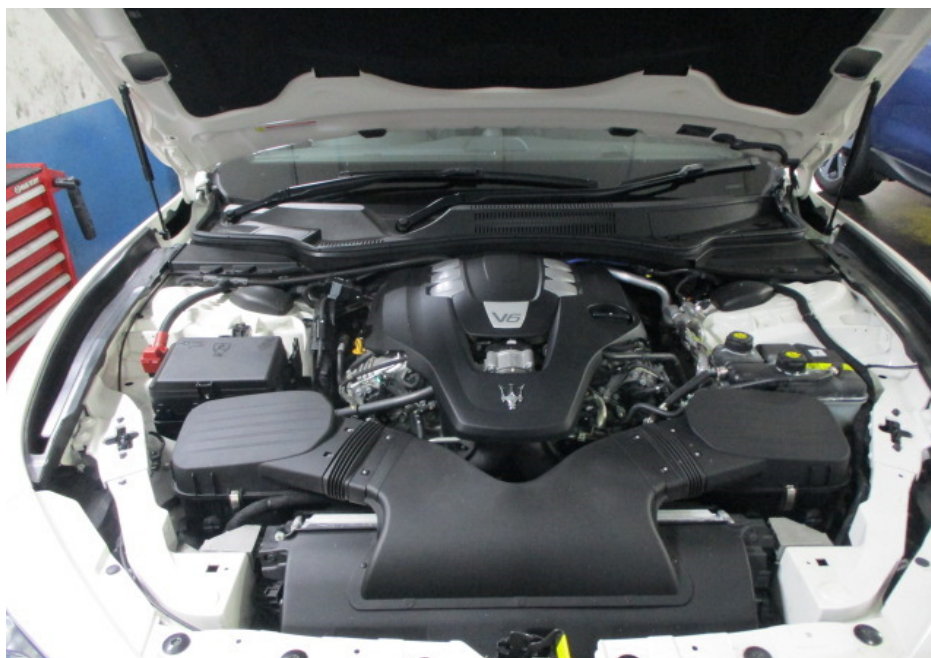
**Photo 12** shows a general view of the engine compartment of the Motor Car at the time of my inspection. The various parts and components inside the engine compartment were all observed to be intact and properly fitted. There was also no sign(s) or indication(s) of fluid leak and/or fluid stain found inside the engine compartment.

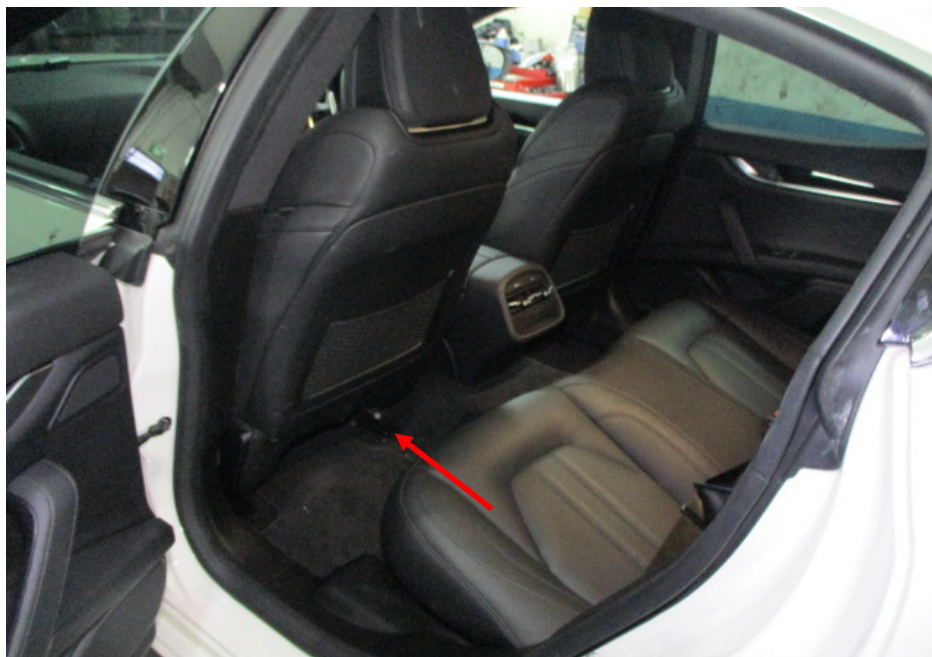
**Photo 13** shows the seats of the Motor Car, which were secured via seat rails (arrowed) to the floorboard. All the seats of the Motor Car were fitted with a retractable seat belt reel and pre-tensioner. The seat belts were tested and able to be fastened into the respective pre-tension that were fitted on the side of each individual seat.

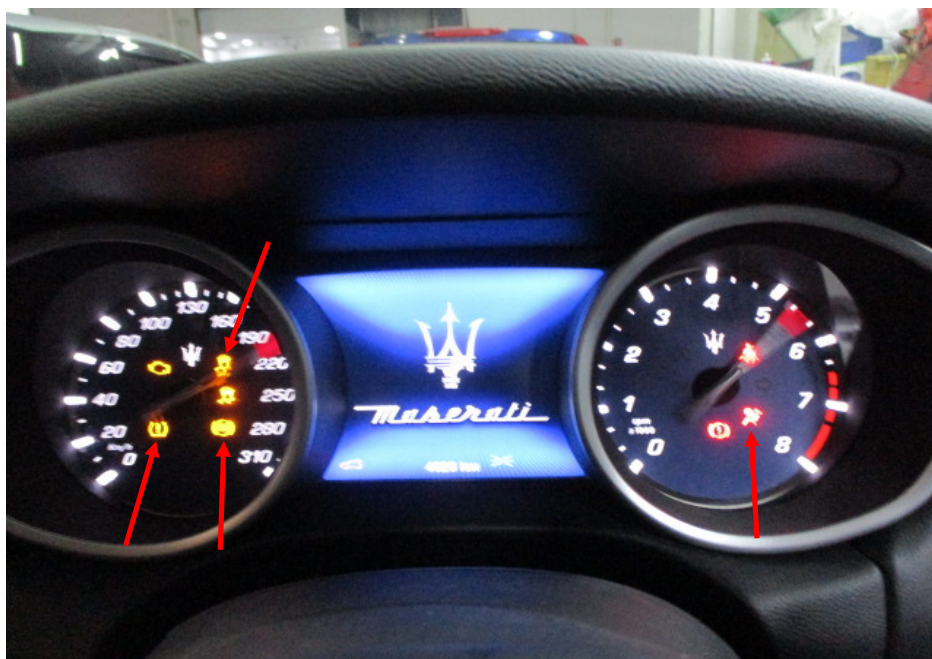
**Photo 14** shows the warning lights for the various electronic safety features appearing on the instrument panel of the Motor Car during its self-test when the engine is cranked, in particular the ABS, SRS, TPM and TCS lights (arrowed).

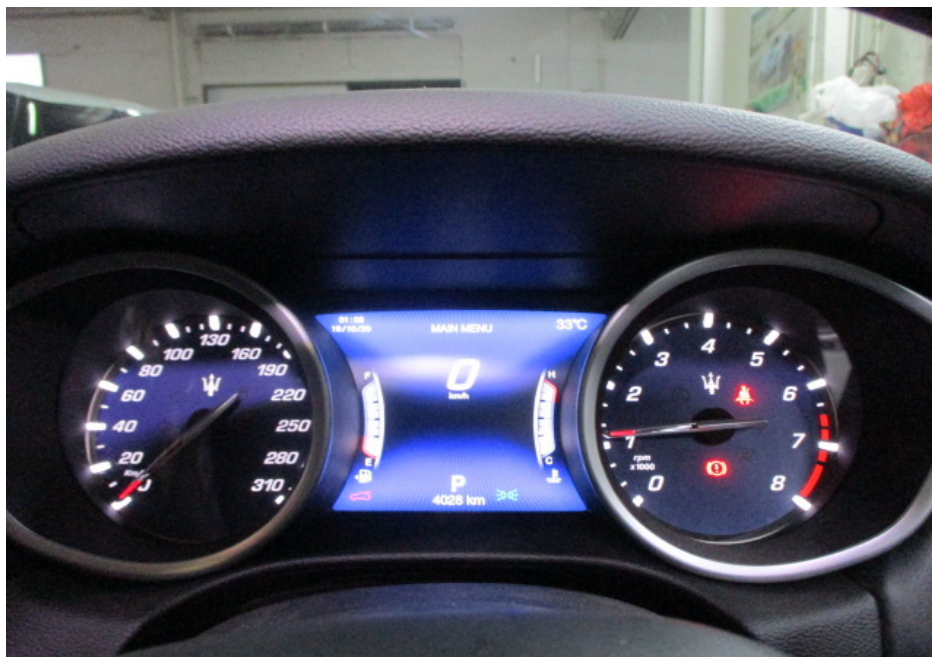
**Photo 15** shows the respective warning lights no longer illuminated after the engine was started, indicating that there was no fault detected to the ABS, SRS, TPM and TCS systems of the Motor Car during the self-test. These electronic systems were hence in working condition at the time of my inspection.

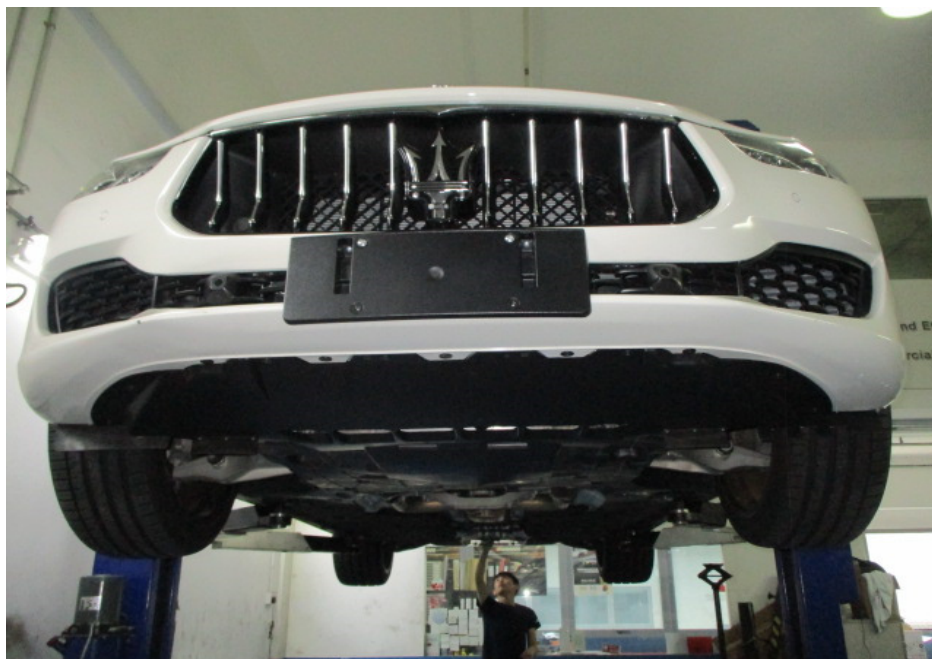
**Photo 16** shows the Motor Car hoisted up for checks on its undercarriage. There was no sign(s) or indication(s) of fluid leakage and/or fluid stain(s) on the underside of the Motor Car. The undercarriage components of the Motor Car were also all observed to be intact and secured in an appropriate manner.

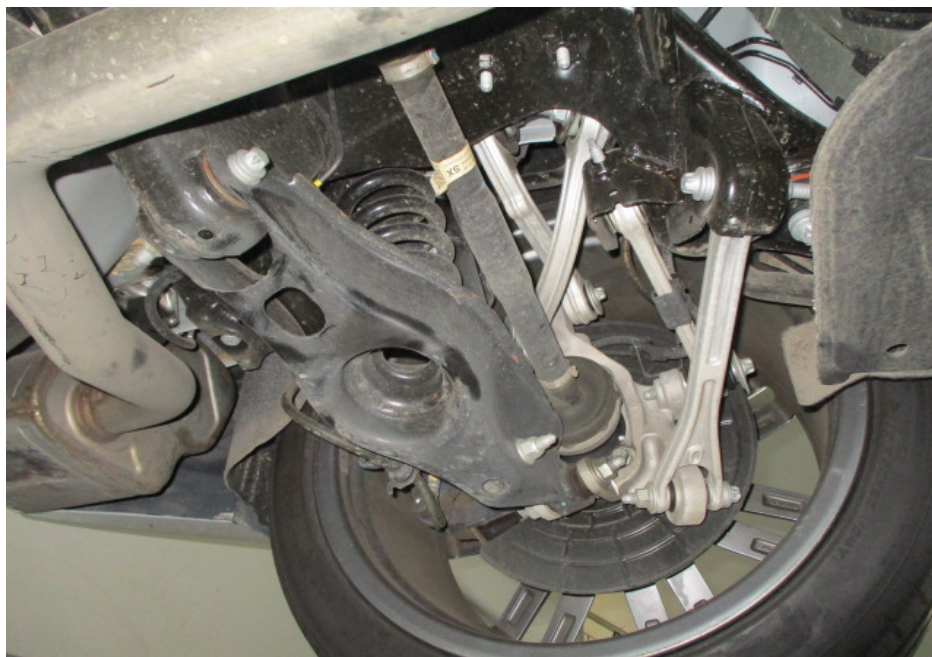
**Photo 17** shows a general view of the control arms and linkages at the rear left wheel of the Motor Car. I did not observe any fluid leak and/or fluid stain on the underside of the Motor Car. All of the Motor Car's undercarriage components were observed to be intact and secured in an appropriate manner.

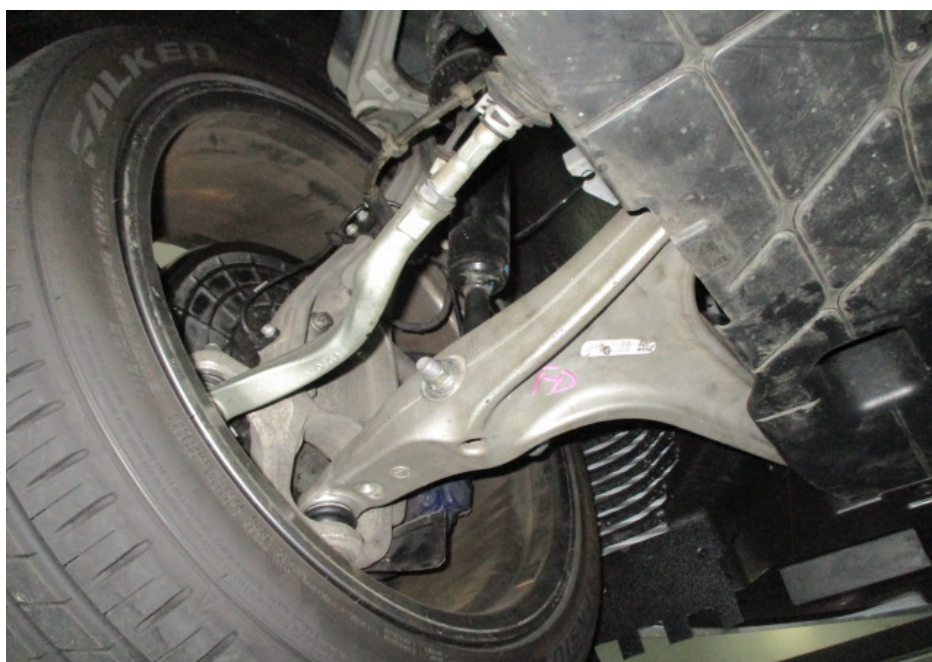
**Photo 18** shows the various undercarriage components at the front left wheel of the Motor Car. The mechanical components, control arms and linkages were all found to be intact and secured in an appropriate manner.

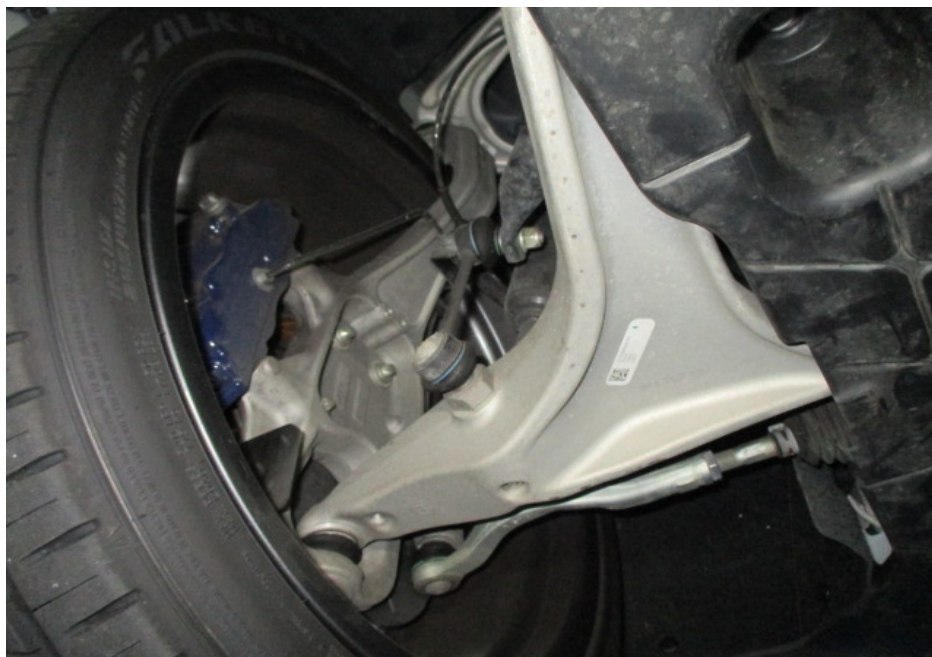
**Photo 19** shows the various undercarriage components at the front right wheel of the Motor Car. The mechanical components, control arms and linkages were all found to be intact and secured in an appropriate manner.

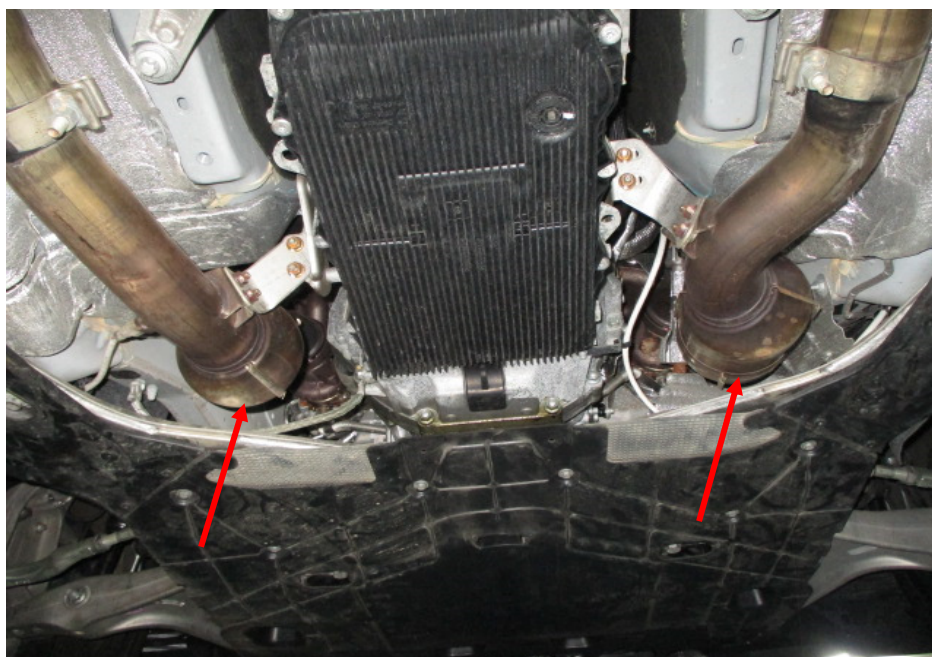
**Photo 20** shows the Motor Car's catalytic converters (arrowed). My examination of the Motor Car's exhaust system revealed no sign(s) or indication(s) of any cut or weld marks along its exhaust pipes and on its rear mufflers.

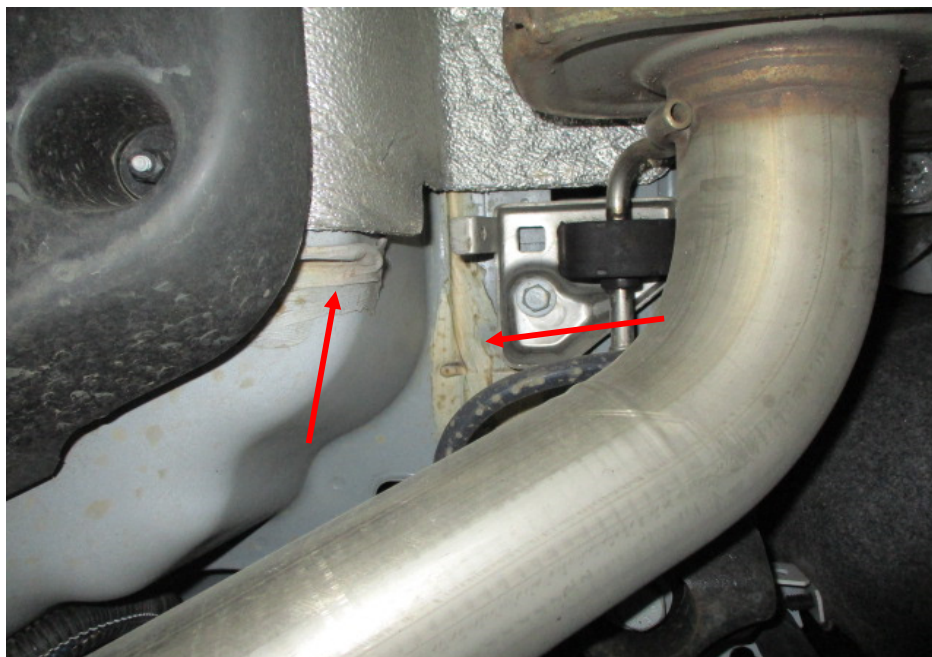
**Photo 21** shows the chassis/structural body at the underside rear right of the Motor Car. I did not find any weld marks other than original spot weld marks on the chassis/structural body of the Motor Car. The original factory sealant (arrowed) at the joints along the chassis/structural body was also untouched, indicating no work was done on the chassis/structural body of the Motor Car and that the chassis/structural body was originally fitted.

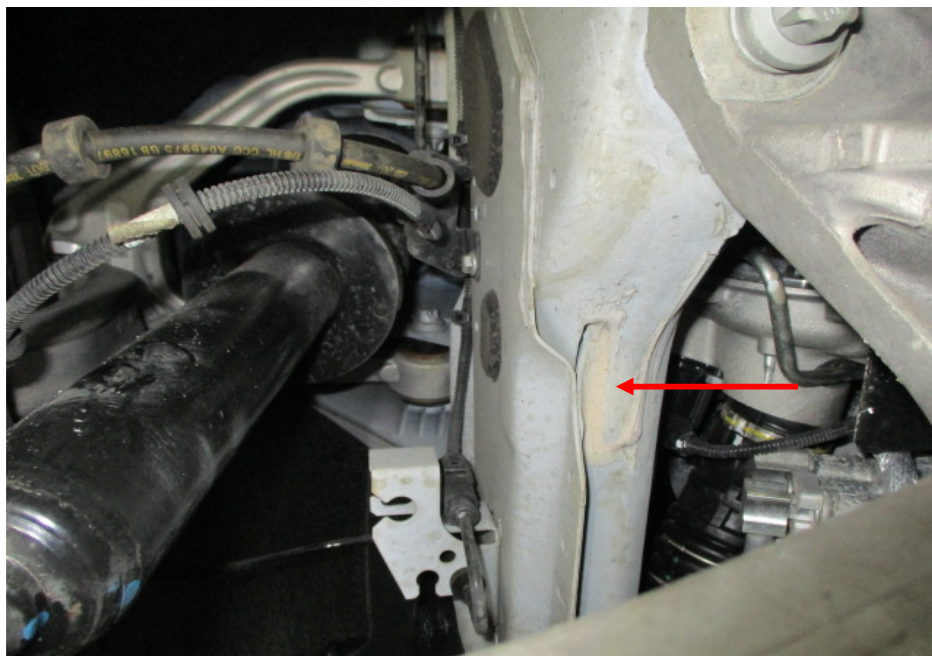
**Photo 22** shows the chassis/structural body at the underside front left of the Motor Car. The original factory sealant (arrowed) at the joints along the chassis/structural body was also untouched, indicating no work was done on the chassis/structural body of the Motor Car and that the chassis/structural body was originally fitted.

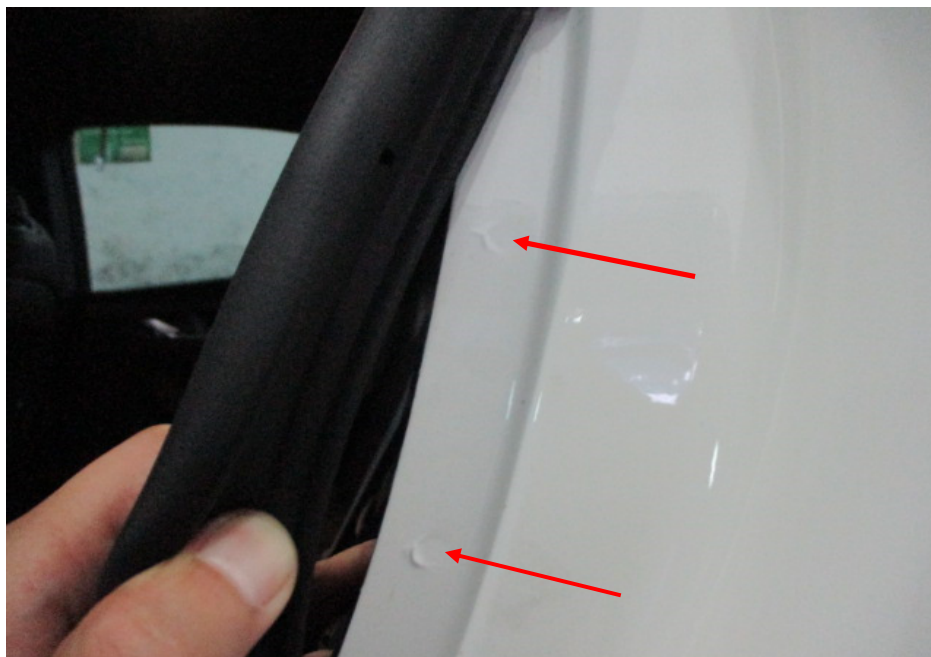
**Photo 23** shows the rear left "C" pillar of the Motor Car. I did not find any weld marks other than original spot weld marks (arrowed) on the rear left "C" pillar of the Motor Car. In general, I had found the non-detachable body panels of the Motor Car to be originally fitted at the time of my inspection.
