Your Ref: Mercedes Benz GLC 63s AMG
(chassis number WDC2539892F530018)

22 October 2020

Our Ref : CI/TP20011514/D

**INSPECTION REPORT OF AN UNREGISTERD MERCEDES BENZ GLC 63s
AMG MOTOR CAR WITH CHASSIS NUMBER WDC2539892F530018**

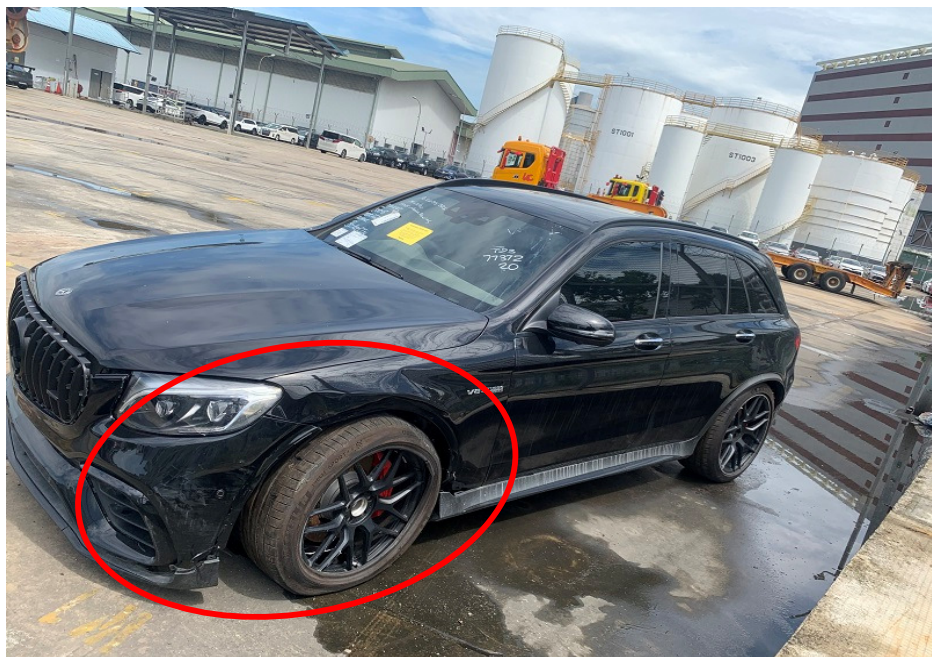
3. From the photographs provided to me, it was observed that the Motor Car had sustained damages at its front left portion. Body parts observed to have been damaged include the front bumper, front left headlamp, front left fender, front left fender garnish, front left wheel rim and left side rocker panel garnish amongst others. The front left undercarriage parts of the Motor Car were likely to be also damaged as the photographs provided had showed the front left wheel of the Motor Car shifted backwards.
4. Apart for the front left portion, I did not observe damage to other areas of the Motor Car. Parts and components within the engine compartment were also observed to be intact and unaffected. The airbag(s) was not deployed as seen from the photographs that were provided to me. See photo 1 – 4 below.

Photo 1 shows the front left body of the Motor Car prior to any repairs being carried out (photograph provided to me). The Motor Car was observed to have sustained damages at its front left portion (circled). The body parts observed to be damaged include the front bumper, front left fender, front left headlamp and front left wheel rim amongst others.

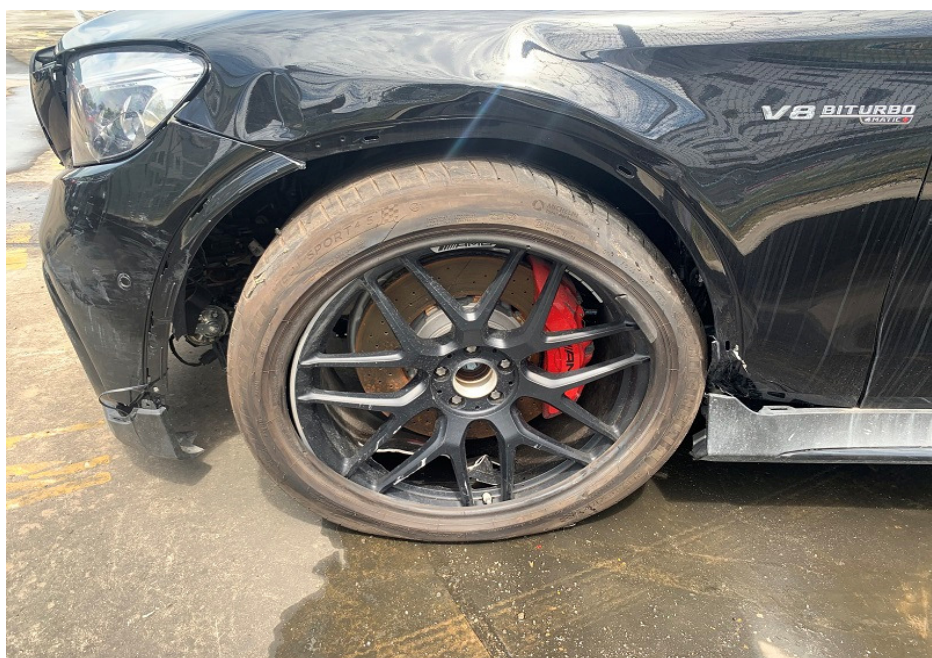
Photo 2 shows a closer view of the damaged front left portion of the Motor Car prior to any repairs being carried out (photograph provided to me). The front bumper, front left fender and left side rocker panel garnish were observed to be damaged. The front left wheel was observed to be shifted backwards, an indication that the front left undercarriage parts of the Motor Car were damaged.

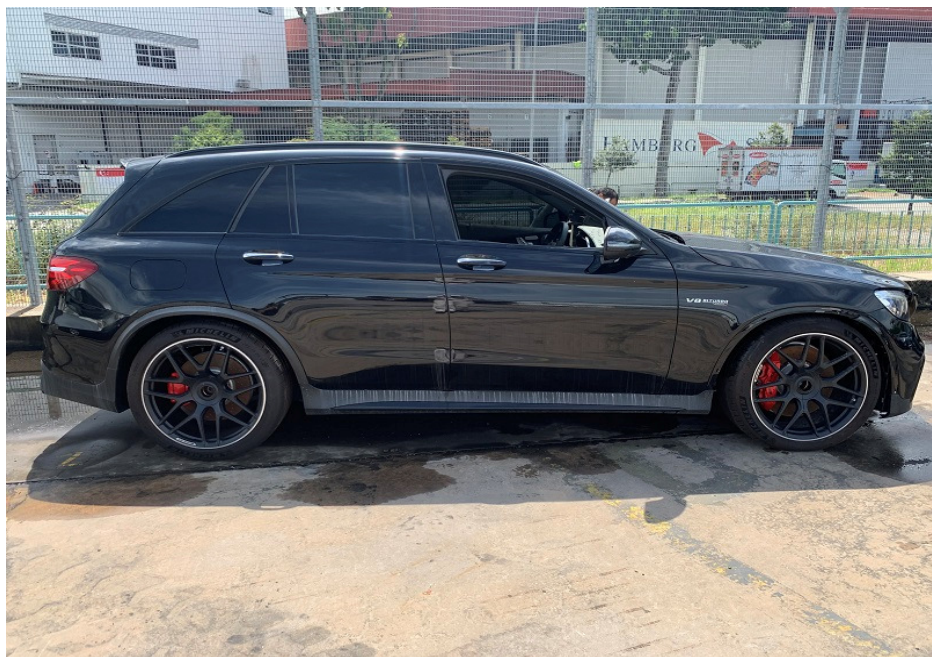
Photo 3 shows the right body of the Motor Car prior to any repairs being carried out (photograph provided to me). Apart for the front left portion, there was no damage observed to other areas of the Motor Car.

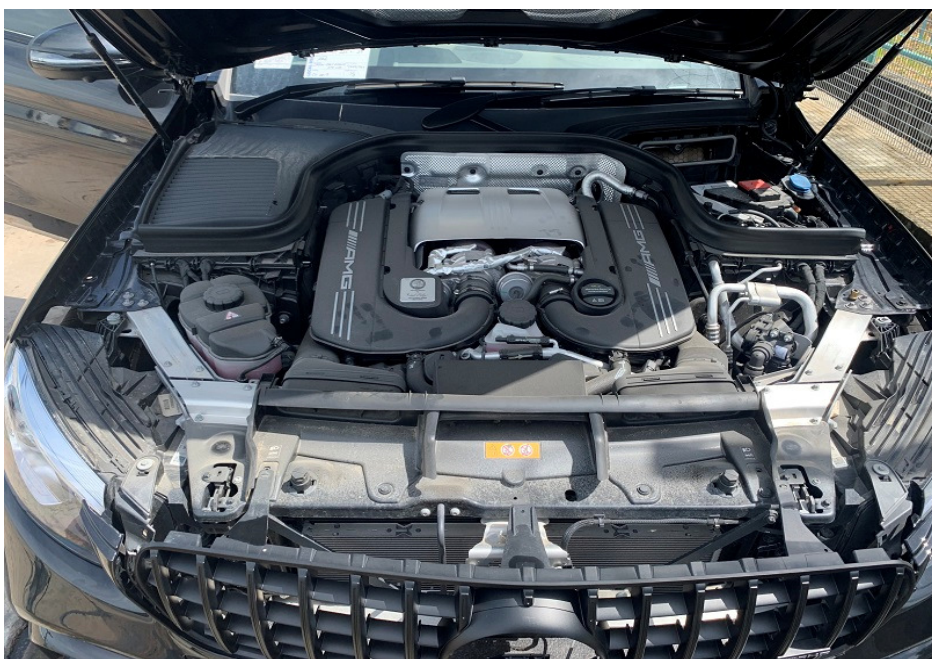
Photo 4 shows the engine compartment of the Motor Car prior to any repairs being carried out (photograph provided to me). Parts and components within the engine compartment were observed to be intact and unaffected.

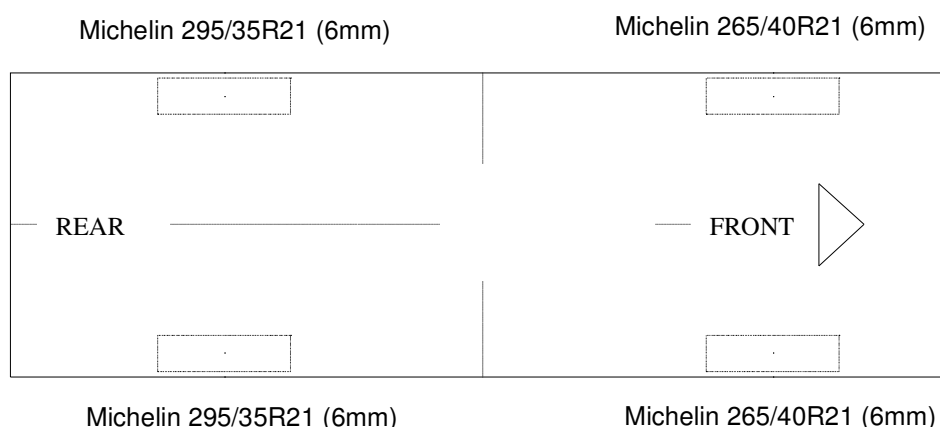
8. It was fitted with 21inch sport wheel rims that were wrapped with tyres that were observed to be of serviceable condition. The tyres were also sufficiently inflated for vehicular operation. The tyre brand, tyre size and approximate remaining tread depth of the 4 tyres of the Motor Car were recorded as follows: -

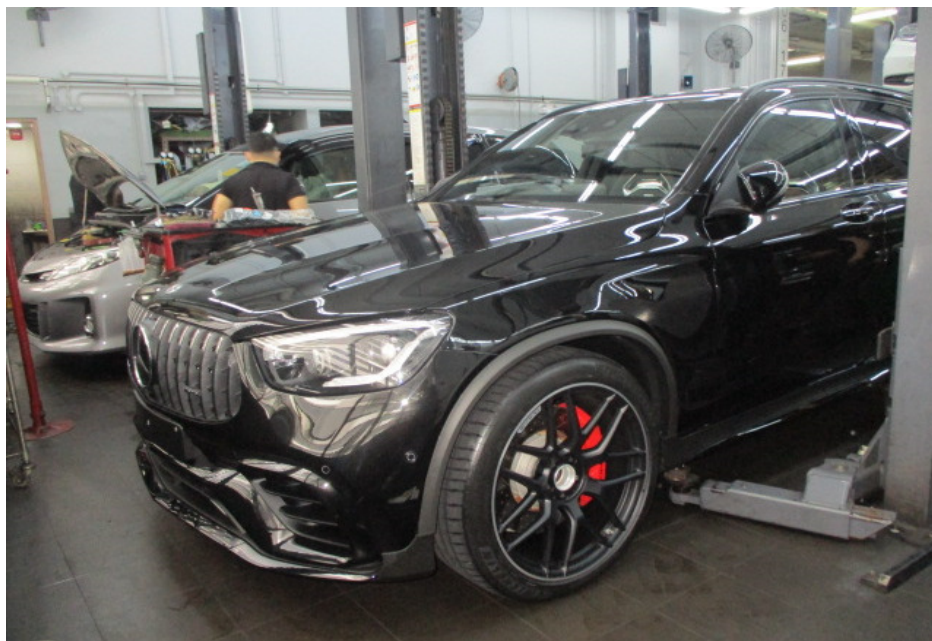
22. The body parts at the front left portion and the undercarriage parts at the front left of the Motor Car were visually examined and it was noted that the repair/restoration works carried out to the damaged area of the Motor Car (refer photograph 1 & 2 above) were adequate and in order.

Photo 5 shows a general view of the front left body of the Motor Car at the time of my inspection. The Motor Car was observed to be in a relatively good general condition with no loose exterior fittings observed. The body parts at the front left portion of the Motor Car were visually examined and it was observed that the repair/restoration works carried out to the damaged area of the Motor Car (refer photograph 1 & 2 above) were reasonably adequate and in order.

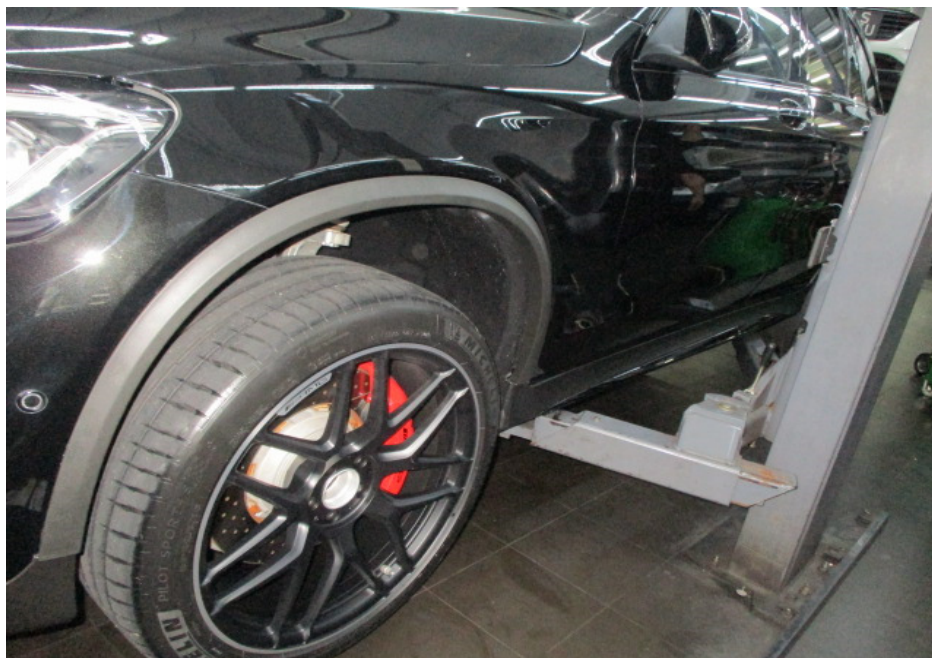
Photo 6 shows a closer view of the front bumper, front left fender and front left wheel of the Motor Car. The body parts at the front left portion of the Motor Car were visually examined and it was observed that the repair/restoration works carried out to the damaged area of the Motor Car (refer photograph 1 & 2 above) were reasonably adequate and in order.

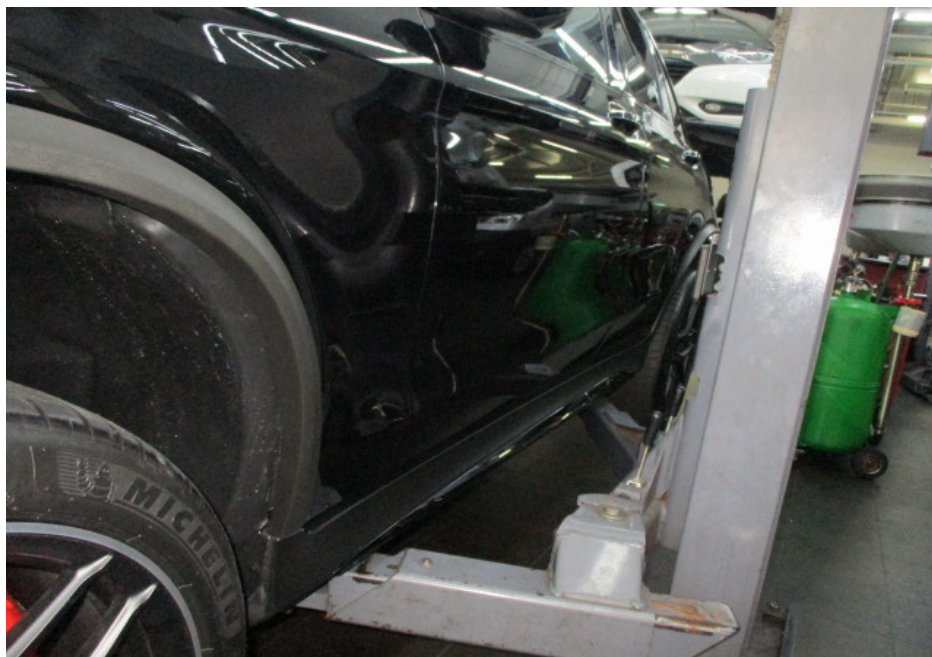
Photo 7 shows a closer view of the front left fender garnish and left side rocker panel garnish of the Motor Car. The body parts at the front left portion of the Motor Car were visually examined and it was observed that the repair/restoration works carried out to the damaged area of the Motor Car (refer photograph 1 & 2 above) were reasonably adequate and in order.

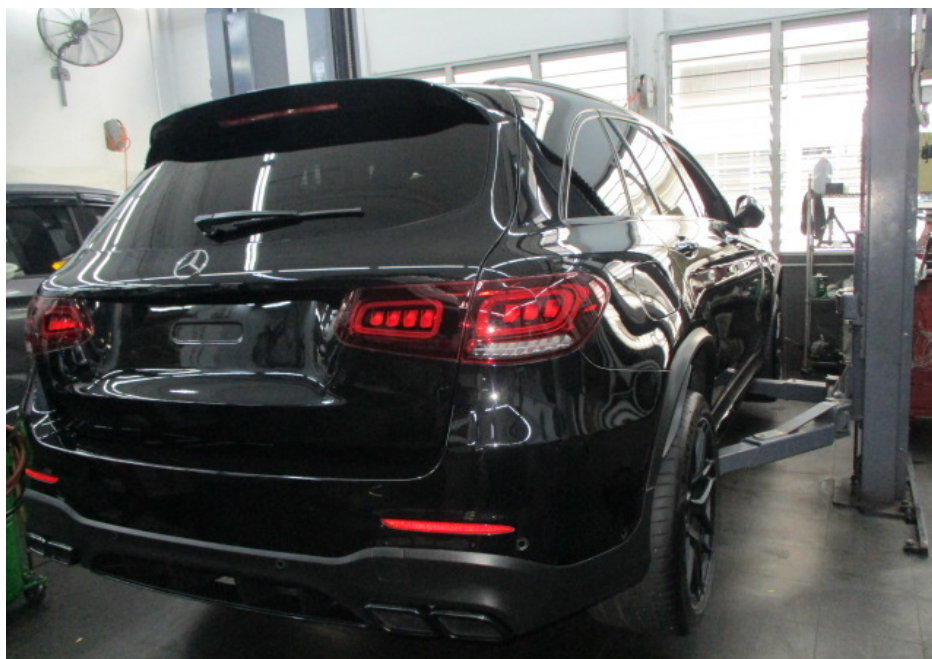
Photo 8 shows a general view of the rear right body of the Motor Car at the time of my inspection. The Motor Car was observed to be in relatively good general condition with no loose exterior fittings observed. The mileage of the Motor Car recorded at the time of my inspection was 3,042km

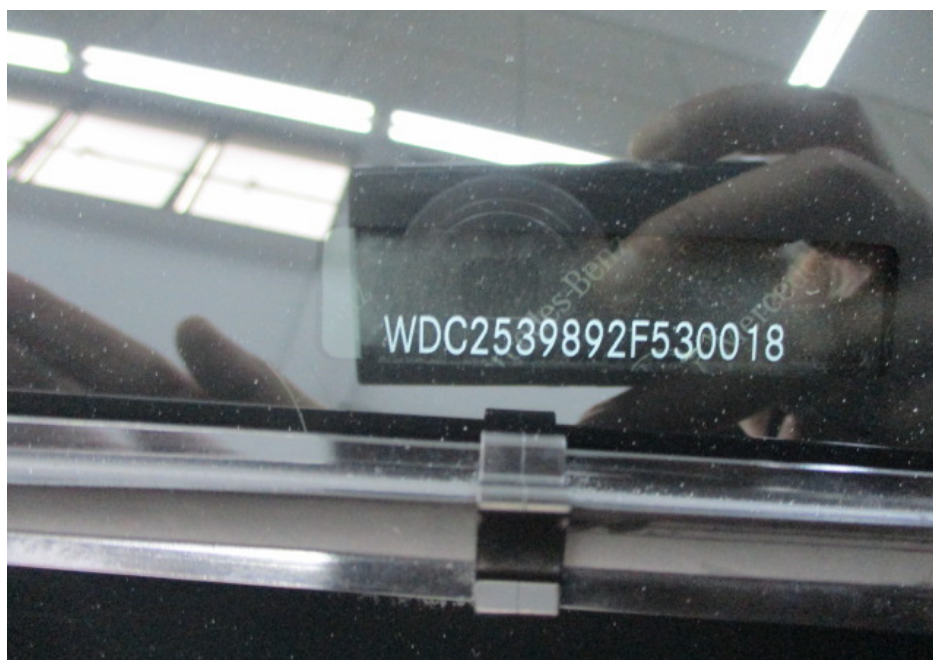
Photo 9 shows the chassis number of the Motor Car. The chassis number recorded was WDC2539892F530018.

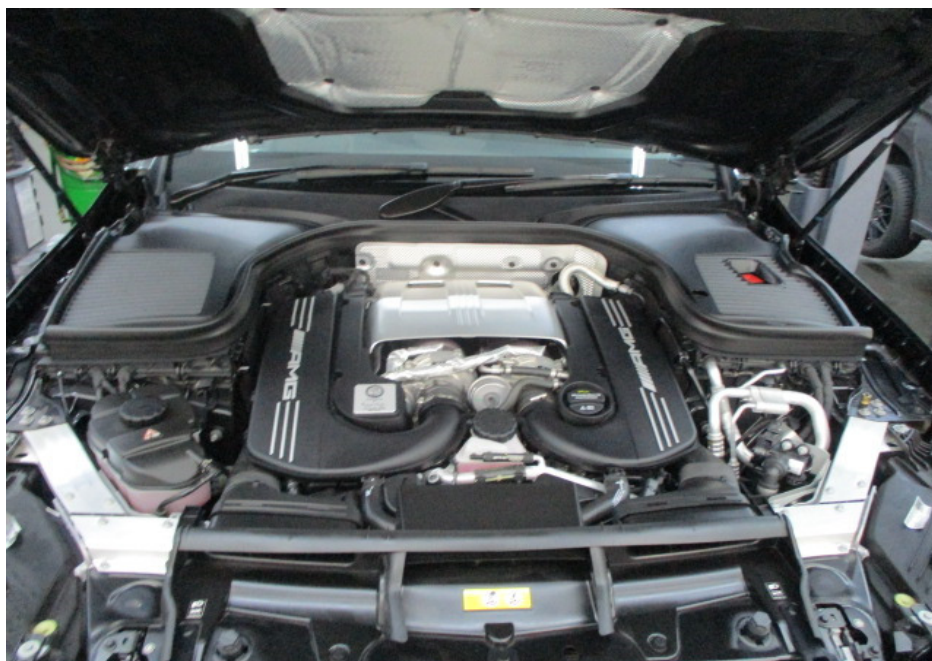
14. My examination of the engine compartment of the Motor Car revealed that the various parts and components inside the engine compartment were all intact and properly fitted. The engine oil, brake fluid and engine coolant were all found to be of sufficient level for operating purposes. Visually, there was also no contamination found to these fluids.
15. My checks on the underside of the Motor Car revealed no sign(s) or indication(s) of fluid leakage and/or fluid stain(s). The engine block and automatic transmission assembly were both secured properly. All undercarriage components of the Motor Car were also observed to be intact and secured in an appropriate manner.

Photo 10 shows a general view of the engine compartment of the Motor Car at the time of my inspection. The various parts and components inside the engine compartment were all observed to be intact and properly fitted. There was also no sign(s) or indication(s) of fluid leak and/or fluid stain found inside the engine compartment.

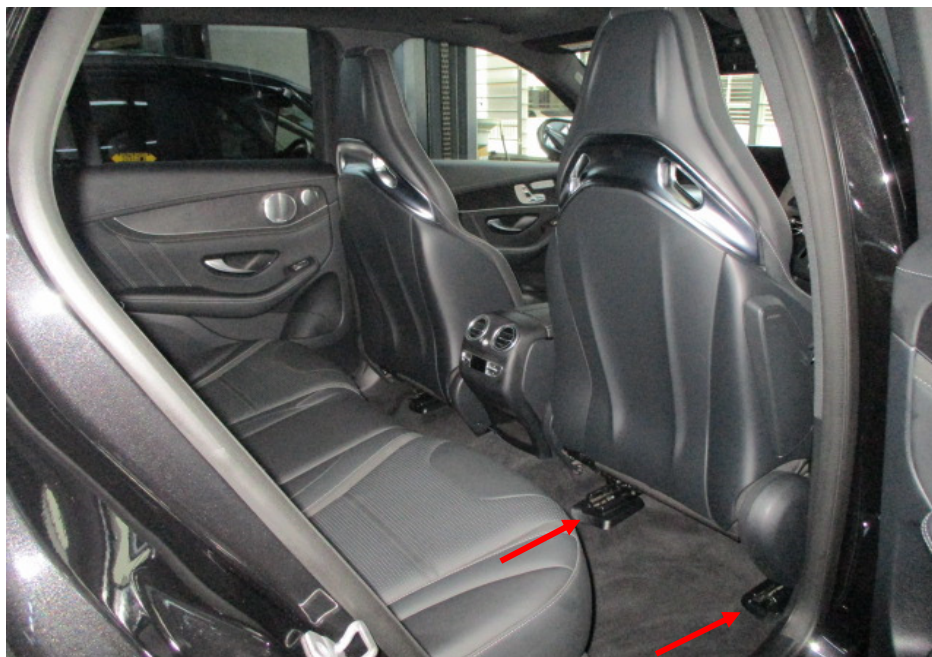
12. The seats of the Motor Car were found to be secured to the floorboard of the Motor Car via seat rails bolted onto the floorboard. Retractable seat belt reels and pre-tensioners were fitted on all seats of the Motor Car. The seat belts were tested and were able to be fastened securely into the respective pre-tensioner that were fixed to the side of all the seats.

Photo 11 shows the seats of the Motor Car, which were secured via seat rails (arrowed) to the floorboard. All the seats of the Motor Car were fitted with a retractable seat belt reel and pre-tensioner. The seat belts were tested and able to be fastened into the respective pre-tension that were fitted on the side of each individual seat.

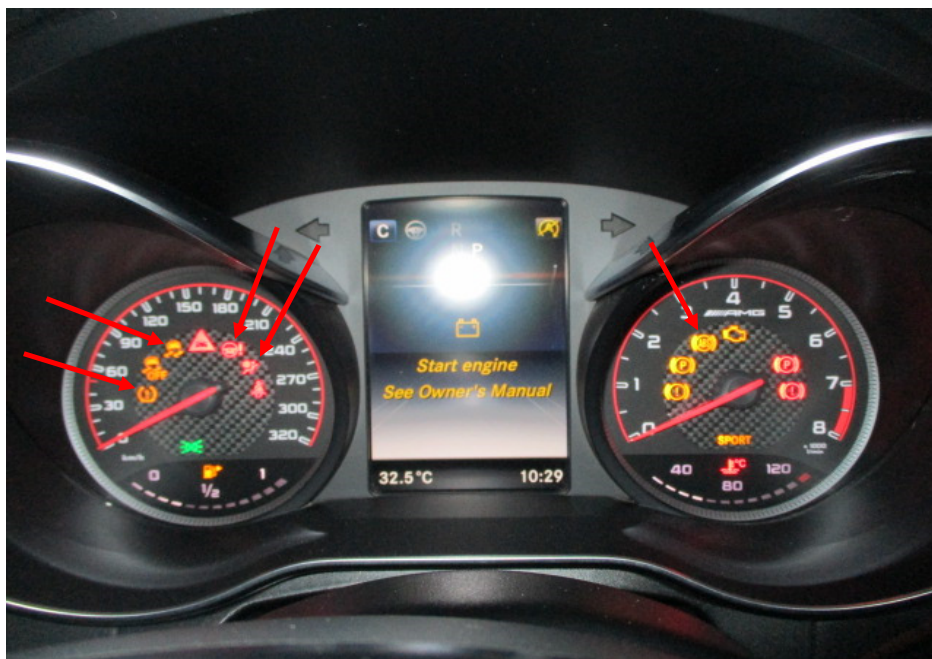
Photo 12 shows the warning lights for the various electronic safety features appearing on the instrument panel of the Motor Car during its self-test when the engine is cranked, in particular the ABS, SRS, EPS, TPM and ESP lights (arrowed).

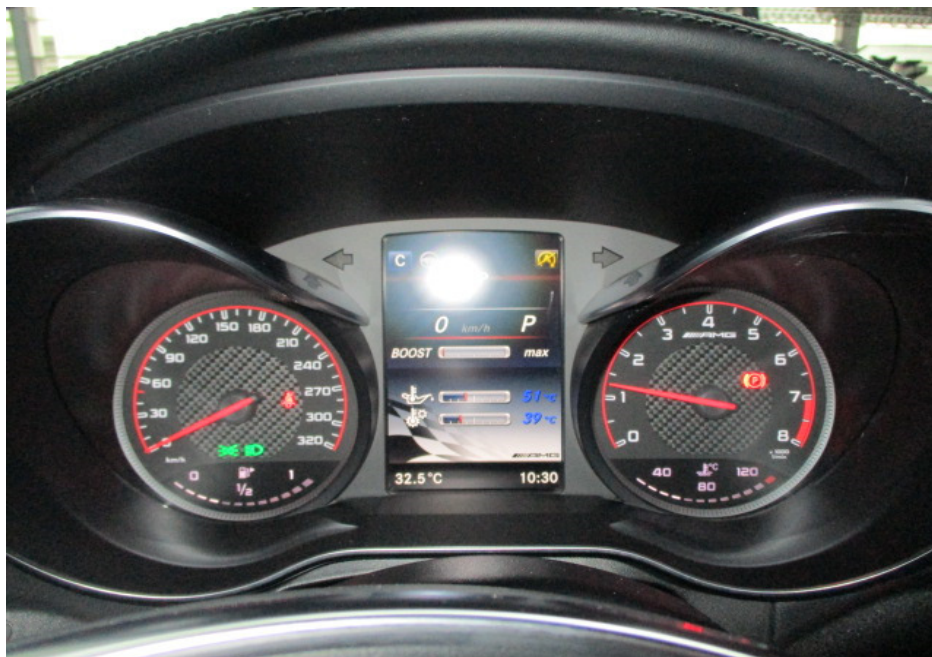
13. The Motor Car's automatic self-test of the functionality of its various electronic safety features like the Anti-Lock Brake System (ABS), Supplemental Restraint System (SRS), Electric Power Steering (EPS), Tyre Pressure Monitor (TPM) and Electronic Stability Program (ESP) during cranking of the engine had indicated that these electronic systems were in working condition. This was determined from the respective warning lights disappearing from the instrument panel after the self-test.

Photo 13 shows the respective warning lights no longer illuminated after the engine was started, indicating that there was no fault detected to the ABS, SRS, EPS, TPM and ESP systems of the Motor Car during the self-test. These electronic systems were hence in working condition at the time of my inspection.

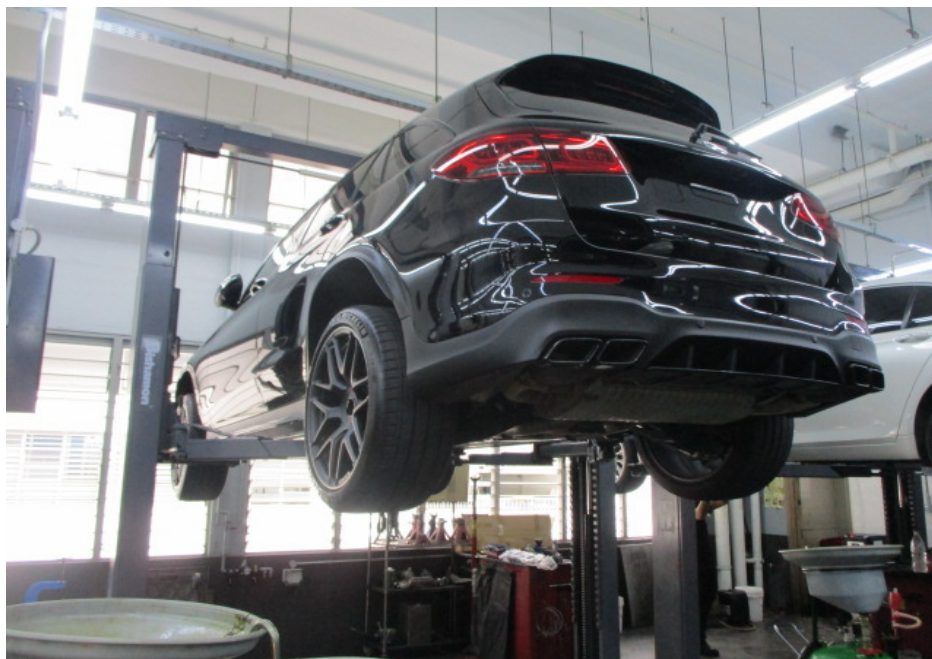
Photo 14 shows the Motor Car hoisted up for checks on its undercarriage. There was no sign(s) or indication(s) of fluid leakage and/or fluid stain(s) on the underside of the Motor Car. The undercarriage components of the Motor Car were also all observed to be intact and secured in an appropriate manner.

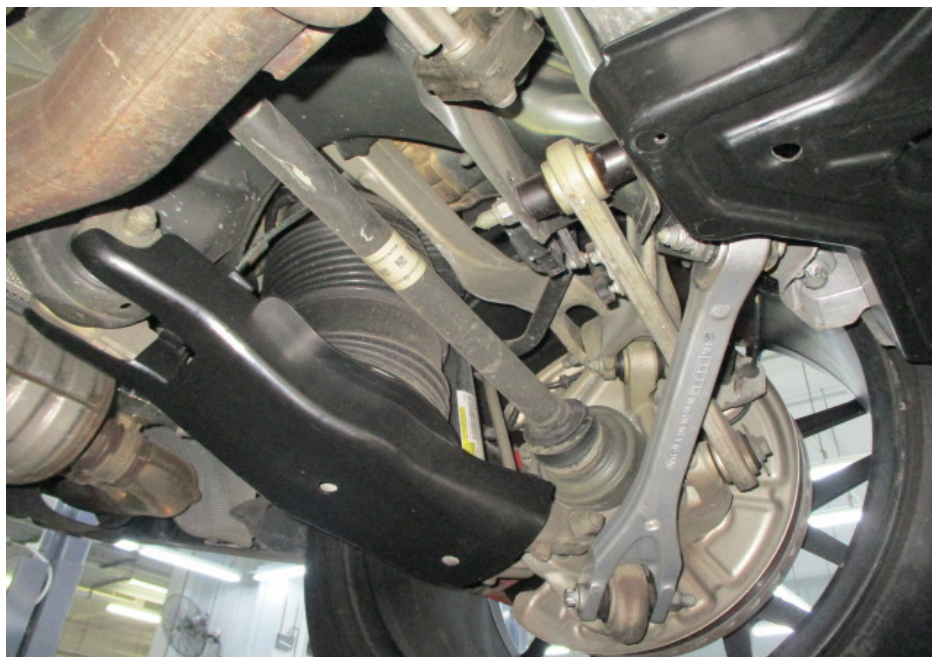
Photo 15 shows a general view of the control arms and linkages at the rear left wheel of the Motor Car. I did not observe any fluid leak and/or fluid stain on the underside of the Motor Car. All of the Motor Car's undercarriage components were observed to be intact and secured in an appropriate manner.

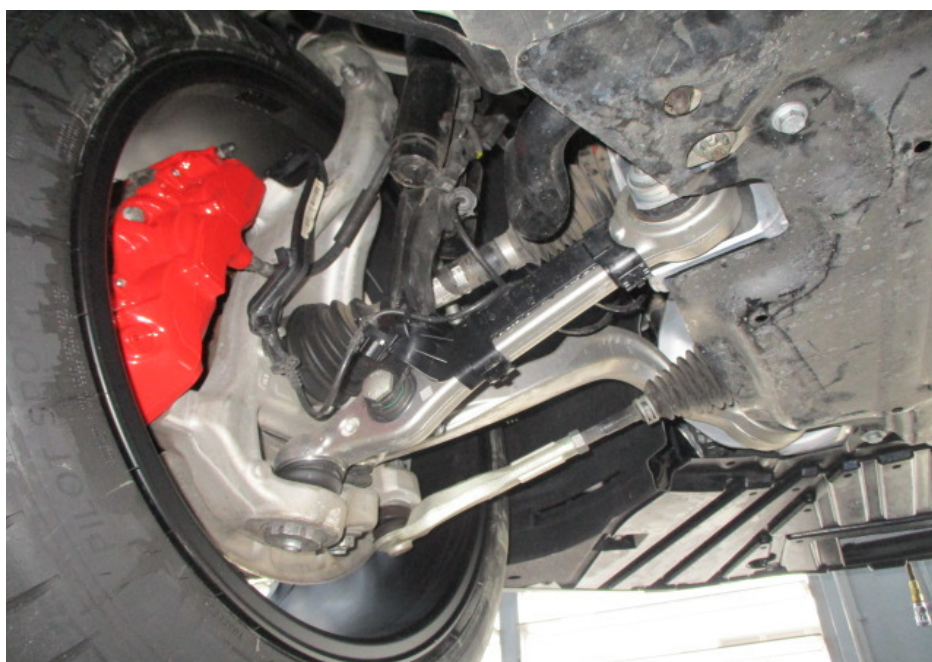
Photo 16 shows the various undercarriage components at the front left wheel of the Motor Car. The mechanical components, control arms and linkages were all found to be intact and secured in an appropriate manner.

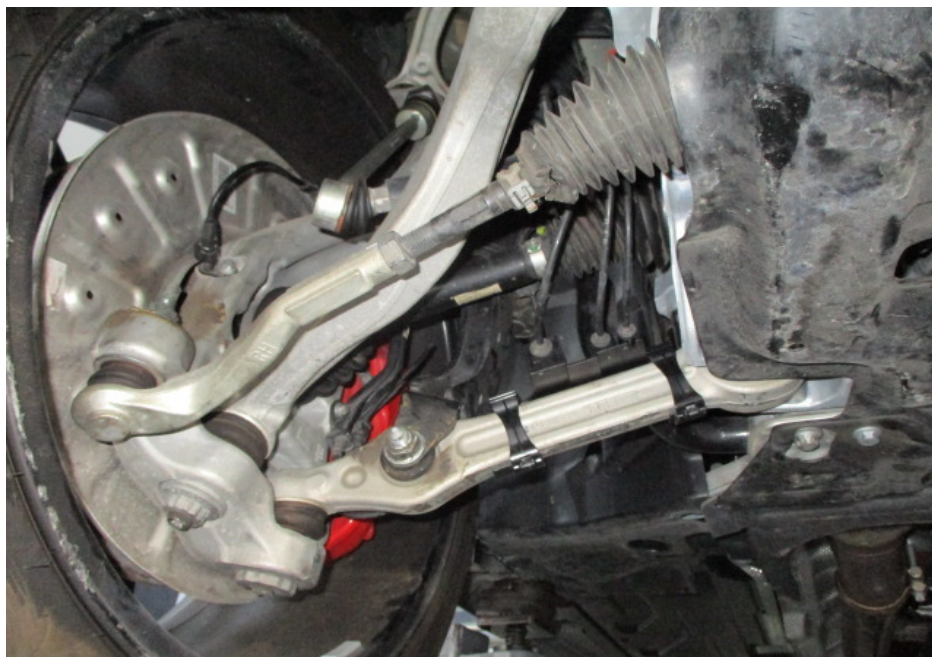
Photo 17 shows the various undercarriage components at the front right wheel of the Motor Car. The mechanical components, control arms and linkages were all found to be intact and secured in an appropriate manner.

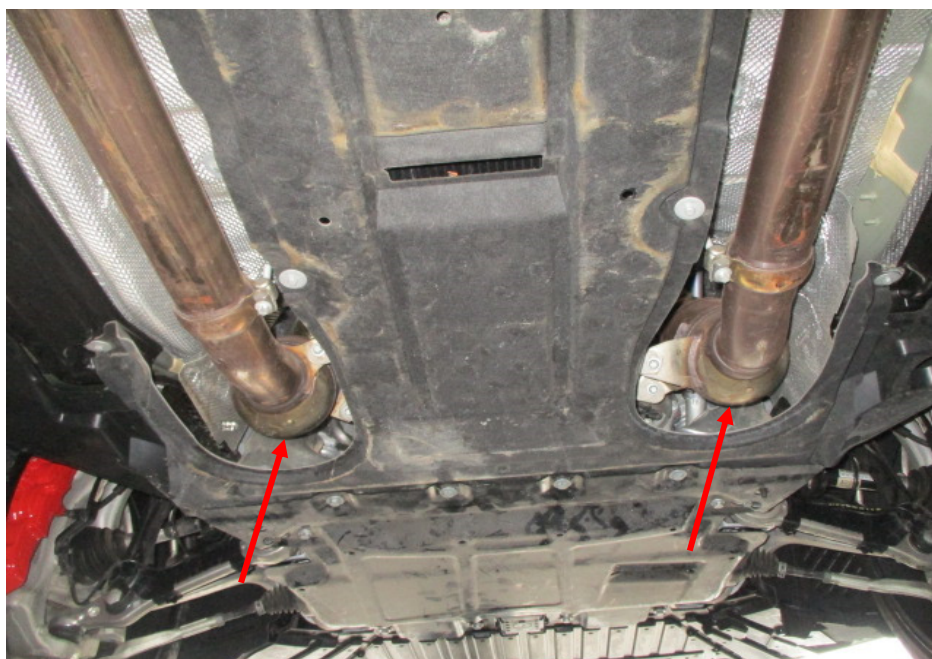
Photo 18 shows the Motor Car's catalytic converters (arrowed). My examination of the Motor Car's exhaust system revealed no sign(s) or indication(s) of any cut or weld marks along its exhaust pipes and on its rear mufflers.

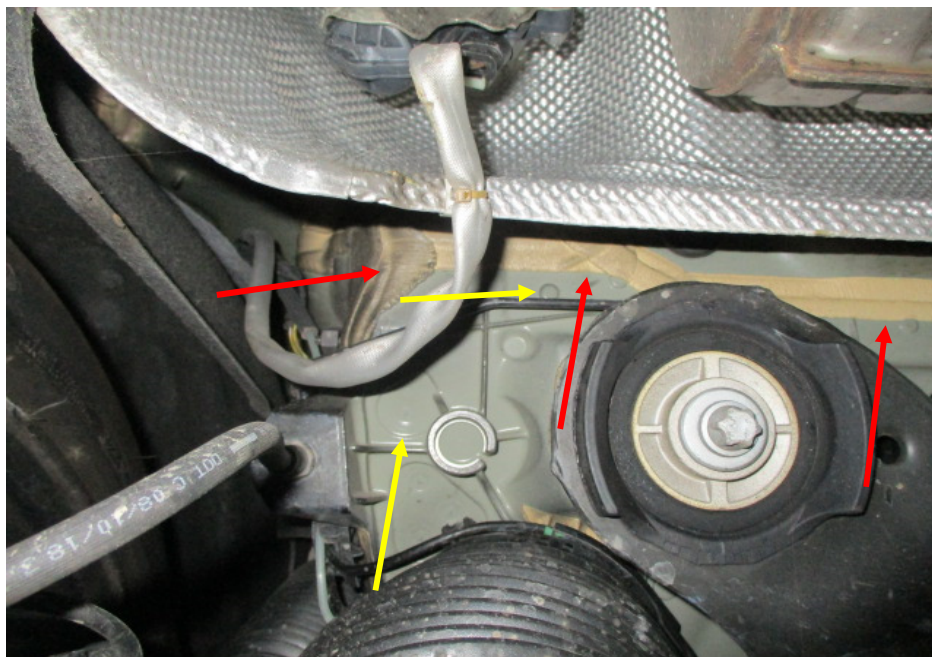
11. Visually, I did not find any weld marks, other than the original spot weld marks, on the chassis/structural body of the Motor Car. The original factory sealant at the joints along the chassis/structural body was also untouched, again indicating that no replacement of the chassis/structural body was carried out; and that the chassis/structural body was originally fitted.

Photo 19 shows the chassis/structural body at the underside rear left of the Motor Car. I did not find any weld marks other than original spot weld marks (yellow arrow) on the chassis/structural body of the Motor Car. The original factory sealant (red arrow) at the joints along the chassis/structural body was also untouched, indicating no work was done on the chassis/structural body of the Motor Car and that the chassis/structural body was originally fitted.

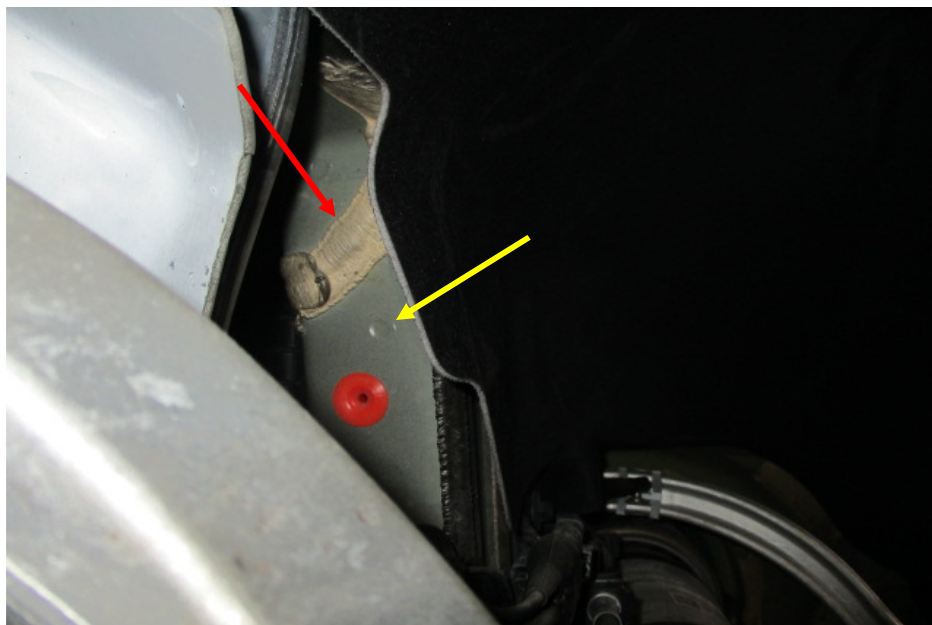
Photo 20 shows the chassis/structural body at the underside front left of the Motor Car. I did not find any weld marks other than original spot weld marks (yellow arrow) on the chassis/structural body of the Motor Car. The original factory sealant (red arrow) at the joints along the chassis/structural body was untouched, indicating no work was done on the chassis/structural body of the Motor Car and that the chassis/structural body was originally fitted.

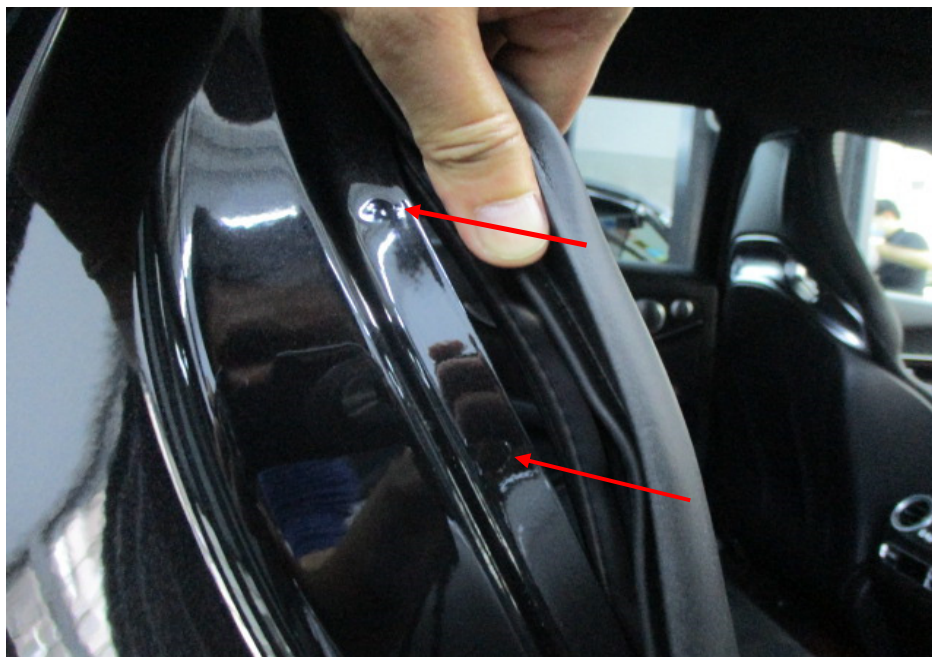
Photo 21 shows the rear right "C" pillar of the Motor Car. I did not find any weld marks other than original spot weld marks (arrowed) on the rear left "C" pillar of the Motor Car. In general, I had found the non-detachable body panels of the Motor Car to be originally fitted at the time of my inspection.
