Your Ref: D20004337MVQC
Our Ref : CS4/FCI20011575/D

12 November 2020

TECHNICAL INVESTIGATION REPORT OF FIRE INCIDENT INVOLVING THE INSURED VEHICLE QX 84E ON 24 OCTOBER 2020

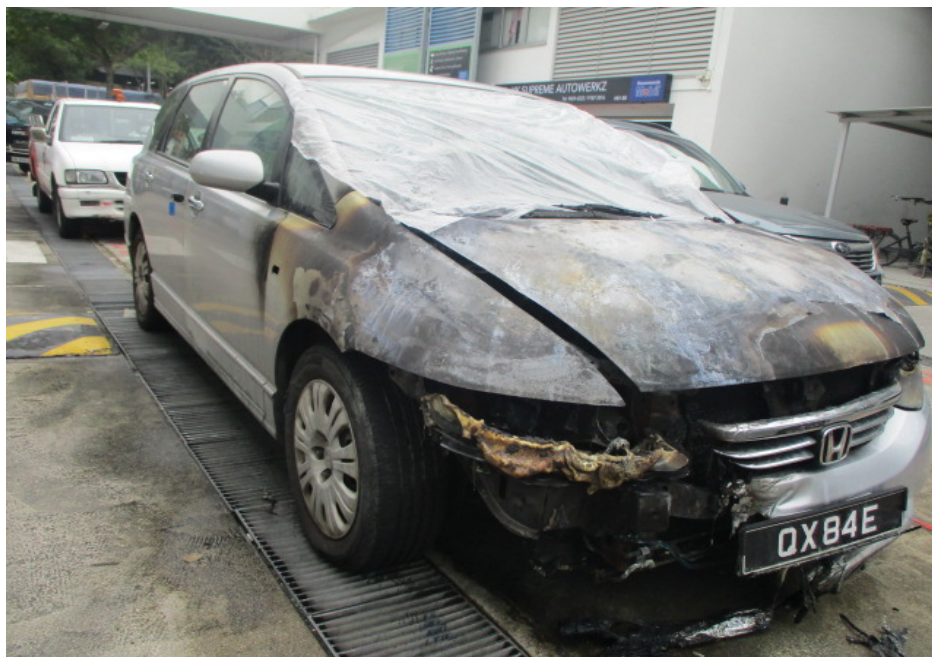
Photo 1 shows a general view of the front right body of the Insured Vehicle at the time of my inspection. The fire damage to the Insured Vehicle was confined to its frontal portion. Its front bumper, front bonnet, front right headlamp, front grille, front right door and front right fender were amongst the exterior body parts that were found to have been affected as a result of the fire.

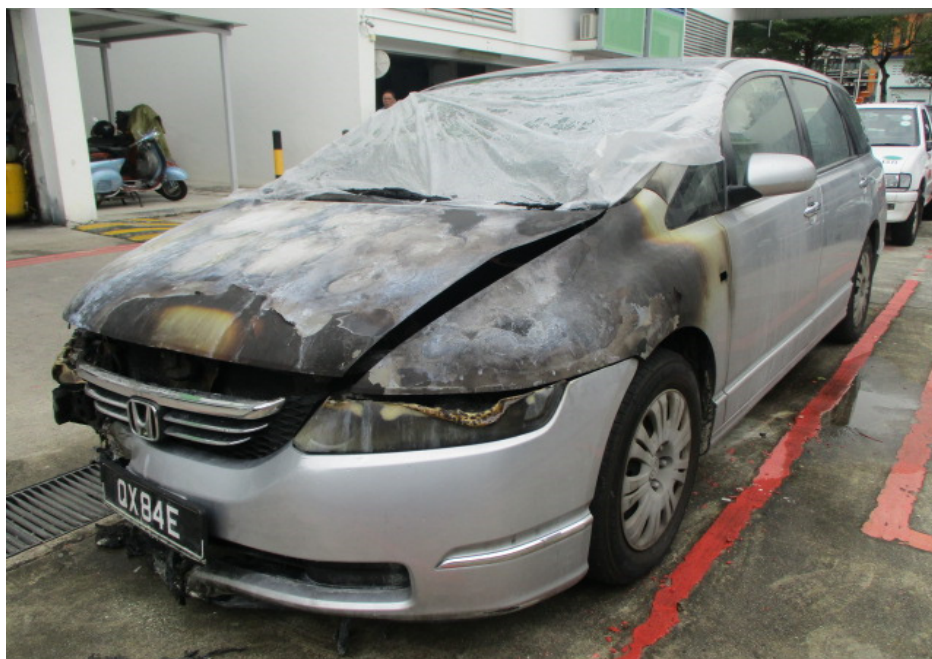
Photo 2 shows a general view of the front left body of the Insured Vehicle at the time of my inspection. The front left fender, front bonnet, front grille, front left headlamp and front windscreen were amongst the exterior body parts that were found to have been affected as a result of the fire.

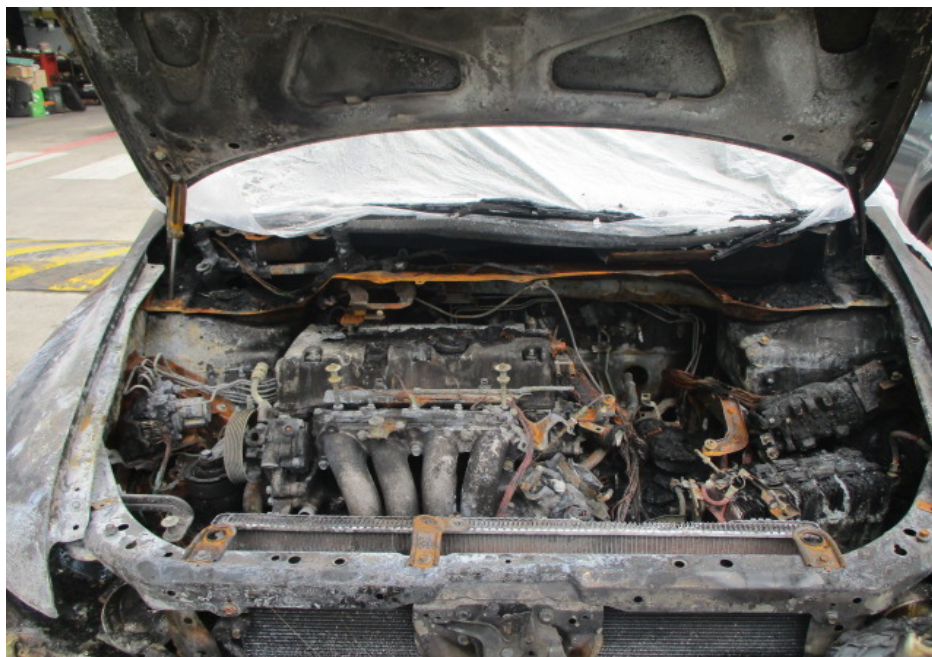
Photo 3 shows the engine compartment of the Insured Vehicle at the time of my inspection. Almost all the parts inside the engine compartment were observed to have been burnt and/or melted. The parts include the air intake manifold, exhaust manifold, engine top cover, battery, wirings, fuse box, various hoses and pipes amongst others.

16. As commented earlier in paragraph 10 above, the fire to the Insured Vehicle had originated from the engine compartment and as seen in photograph 3 above, the engine compartment was severely burnt with almost all the parts within the engine compartment burnt and/or melted. The engine compartment of the Insured Vehicle was therefore exposed to high heat intensity.

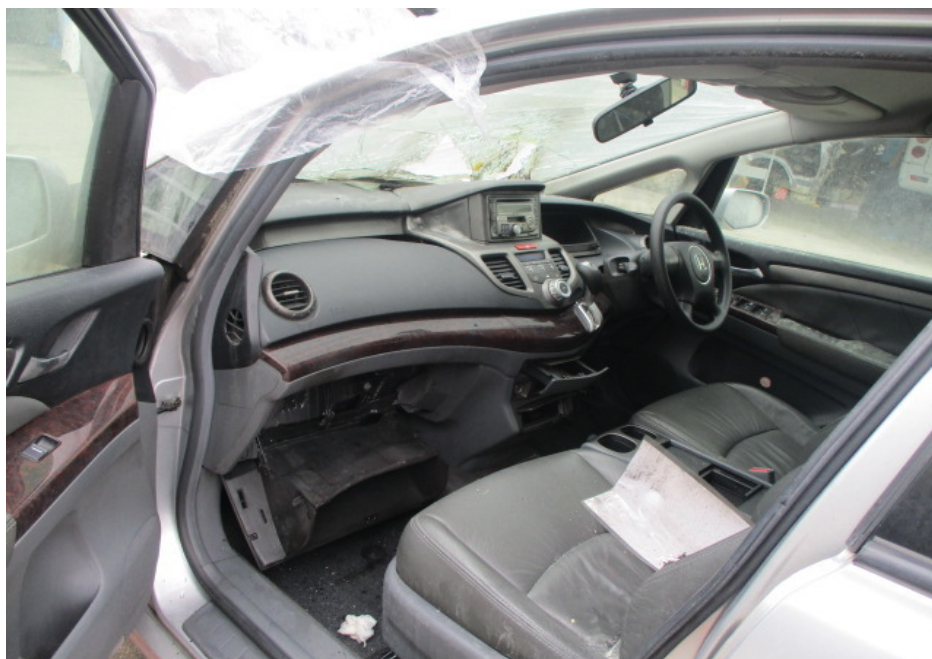
Photo 4 shows the interior compartment of the Insured Vehicle, which was slightly affected at the front area by the fire incident. The front windscreen, instrument panel and front area of the dashboard were amongst the parts within the interior compartment that were affected.

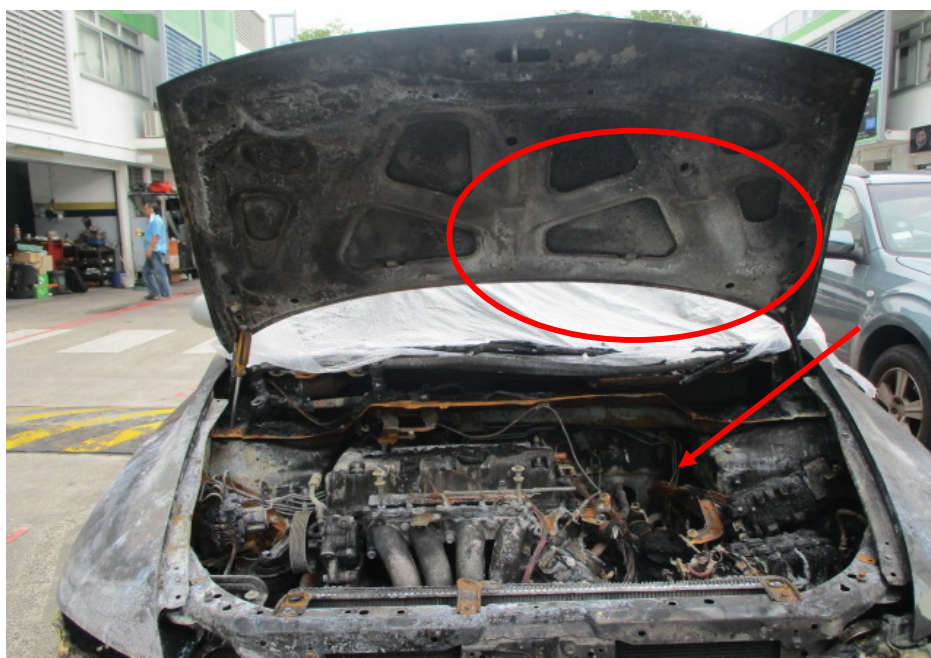
10. Since high heat intensity burned marks were formed on the underside of the front bonnet, and if following the characteristic of heat rising upwards, the origin of fire can then be determined to be around the rear left area of the Insured Vehicle's engine compartment. This is directly below the area where the high heat intensity burned marks were formed on the underside of the front bonnet. See photo 5 below.

Photo 8 shows the high heat intensity burn marks (circled) that were found on the rear left area of the Insured Vehicle's front bonnet. Such whitish burn marks are a result of exposure to prolonged heat intensity. Following the characteristic of heat rising upwards, the fire to the Insured Vehicle can then be determined to have originated around the rear left area (arrowed) of the Insured Vehicle's engine compartment.

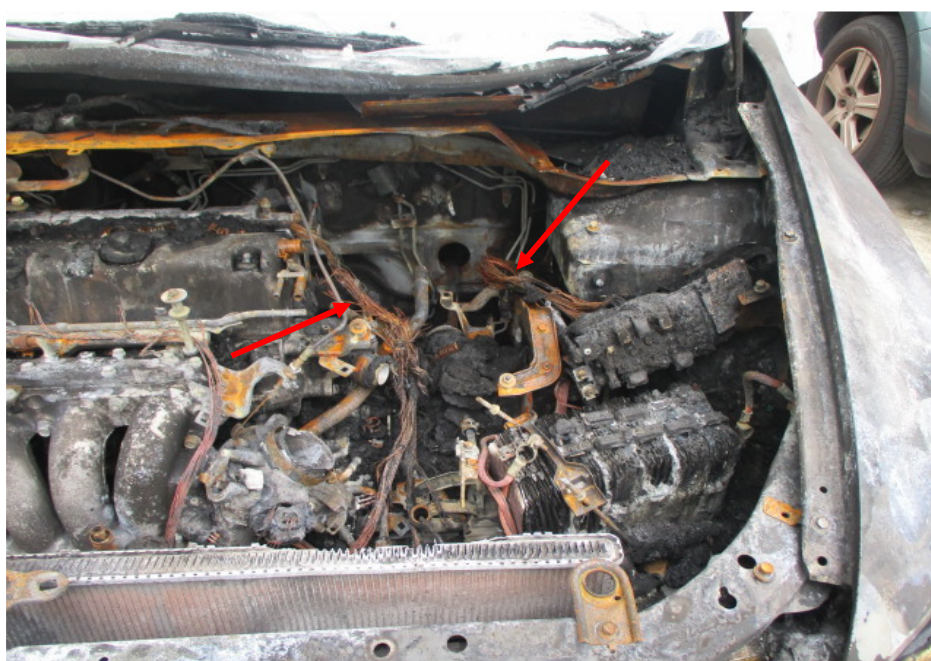
14. It was observed that several stretches of original wire harnesses were completely burned to its bare copper state and in bright reddish colour. This is an indication that the wires were exposed to high heat. Such condition normally indicates internal heating of copper wires, which is a sign of an electrical short circuit occurring. Hence, the condition of the wirings seen at the area where the fire had originated supports the cause of fire to the Insured Vehicle being due to electrical in nature. See photo 9 - 11 below.

Photo 9 shows the wirings around the rear left area of the Insured Vehicle's engine compartment, which was where the fire to the Insured Vehicle had originated. I had observed several stretches of original wire harnesses (arrowed) around this area to be burnt to its bare copper state, and in bright reddish colour. This indicates internal heating of copper wires, which is a sign of an electrical short circuit.

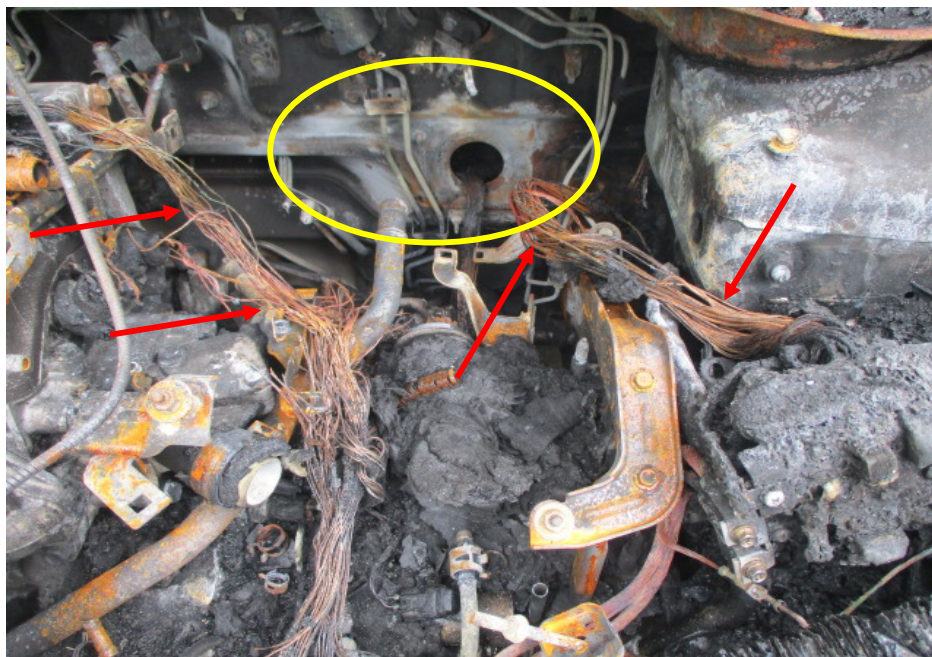
Photo 10 shows a closer view of the wirings (arrowed) at the rear left area of the engine compartment that was burnt to its bare copper state, and in bright reddish colour. This indicates internal heating of copper wires, which is a sign of an electrical short circuit. High heat intensity burned marks, same type of burned mark as seen on the underside of the front bonnet, was also seen on the firewall panel (yellow circle) at the rear left area of the engine compartment. This further supports my findings that the rear left area of the engine compartment was exposed to high heat intensity and was the area where the fire to the Insured Vehicle had originated.

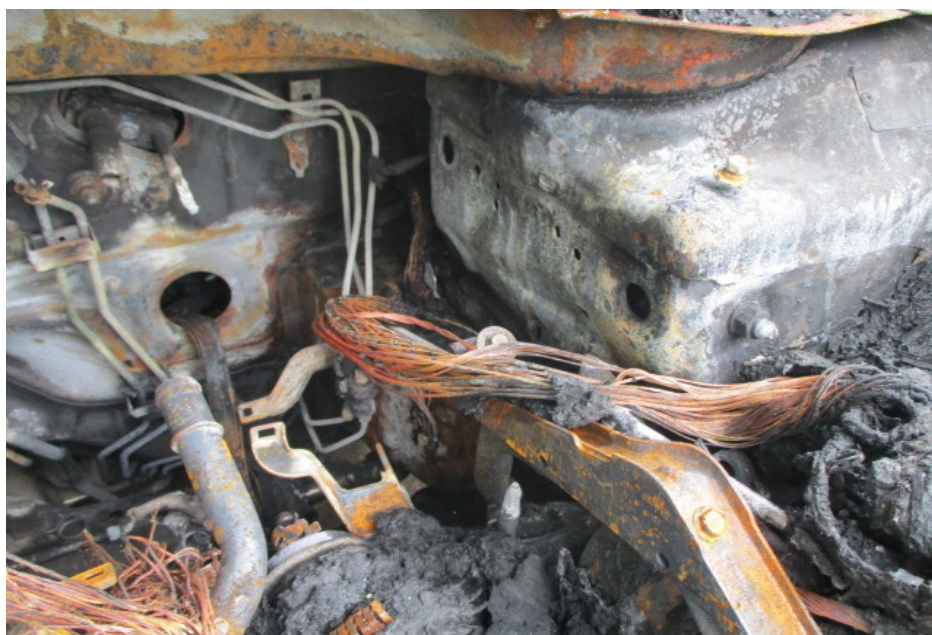
Photo 11 shows a closer view of the wirings at the rear left area of the engine compartment that was burnt to its bare copper state, and in bright reddish colour.

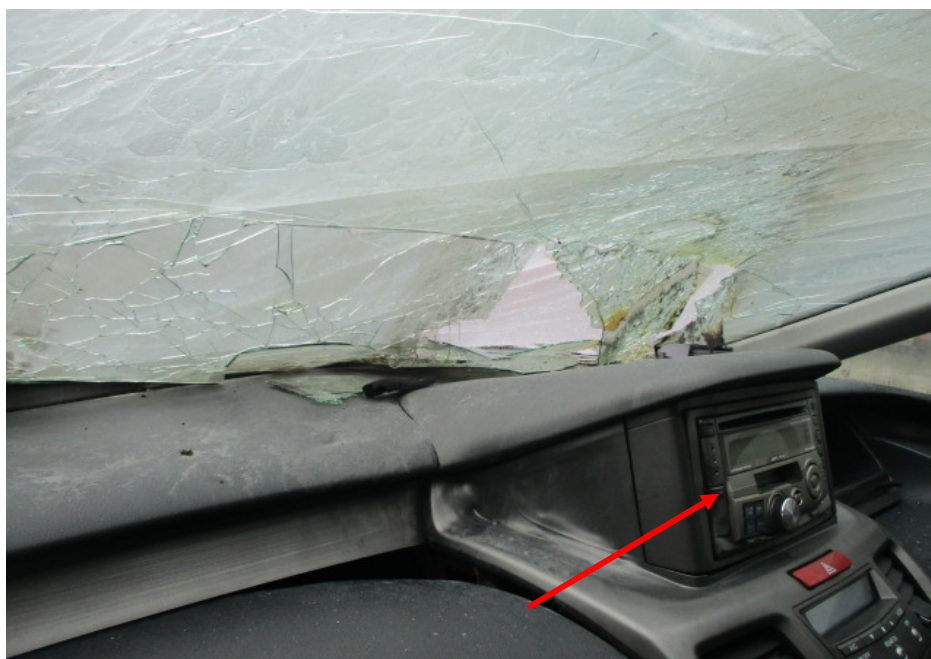
18. At the time of my inspection of the Insured Vehicle, I had found the Insured Vehicle fitted with the original standard in-car entertainment unit. Due to the fire, affecting the front dashboard of the Insured Vehicle, the in-car entertainment unit was also consequently affected. See photo 12 below.

Photo 12 shows the in-car entertainment unit (arrowed) of the Insured Vehicle. Due to the fire, affecting the front dashboard of the Insured Vehicle, the in-car entertainment unit was also affected.

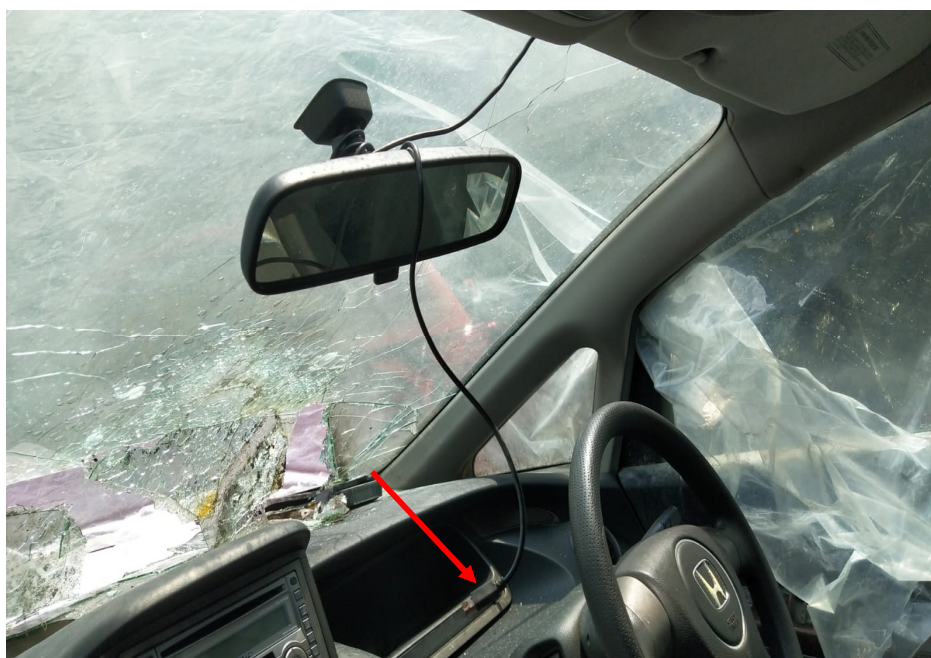
19. The Insured Vehicle was likely to be fitted with a video camera at its front windscreen. This was determined given that I had found an additional connecting wire dangling around the rear-view mirror of the Insured Vehicle. However, there was no video camera device connected to this wire at the time of my inspection. See photo 13 below.

Photo 13 shows an additional wire dangling around the rear-view mirror of the Insured Vehicle, likely for a video camera device. However, there was no video camera device connected to this wire at the time of my inspection. The connecting socket of the wire (arrowed) was seen not connected to any device.
