Your Ref: Mercedes Benz E400  
(chassis number WDD2384662F048814)  
Our Ref : CI/TP20011895/D

**INSPECTION REPORT OF AN UNREGISTERD MERCEDES BENZ E400  
MOTOR CAR WITH CHASSIS NUMBER WDD2384662F048814**

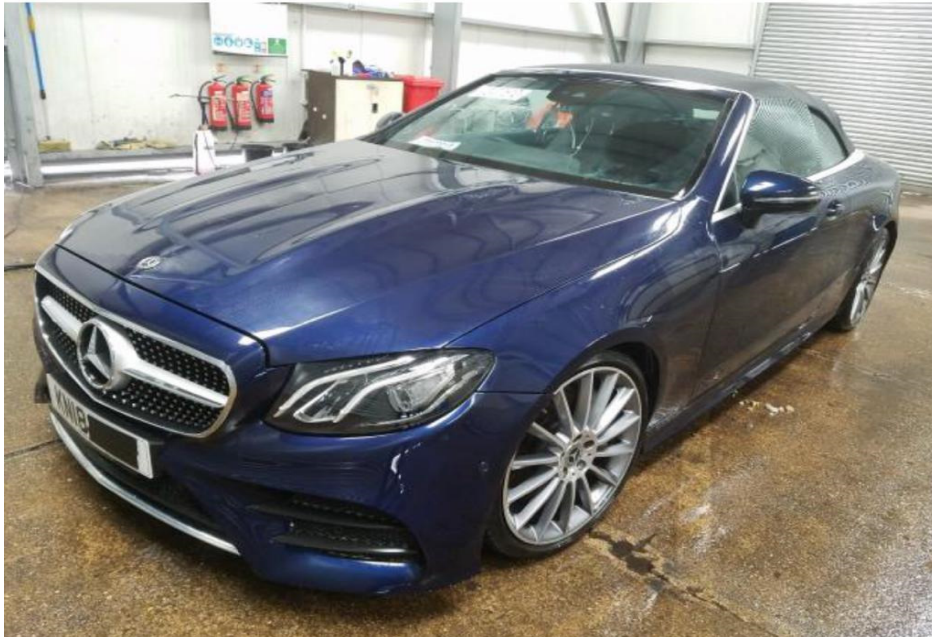
**Photo 1** shows the front left body of the Motor Car (photograph provided to me). There was no physical damage seen to the Motor Car from the photographs that were provided to me.

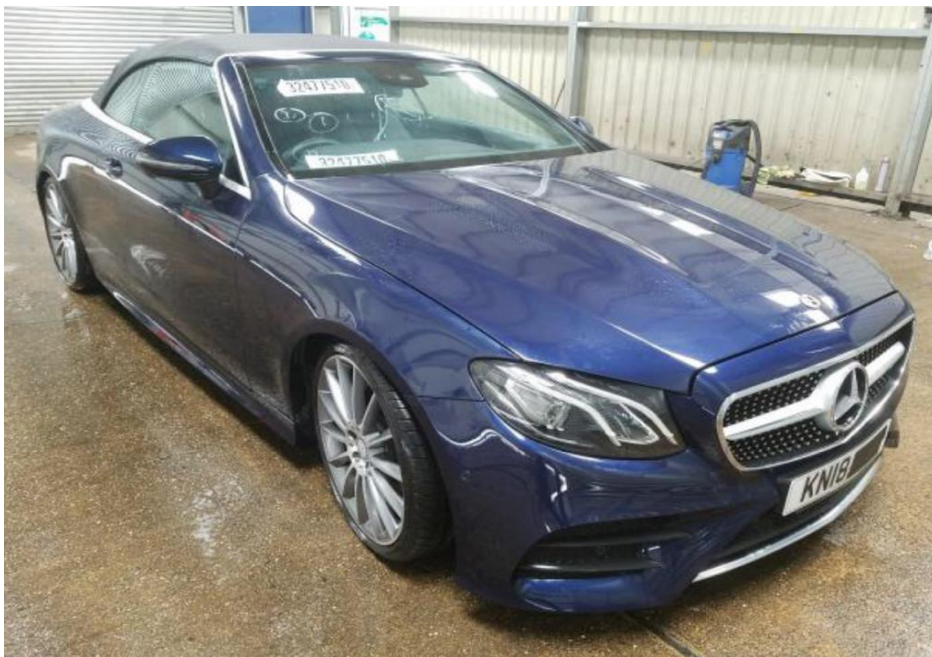
**Photo 2** shows the front right body of the Motor Car (photograph provided to me). There was no physical damage seen to the Motor Car from the photographs that were provided to me.

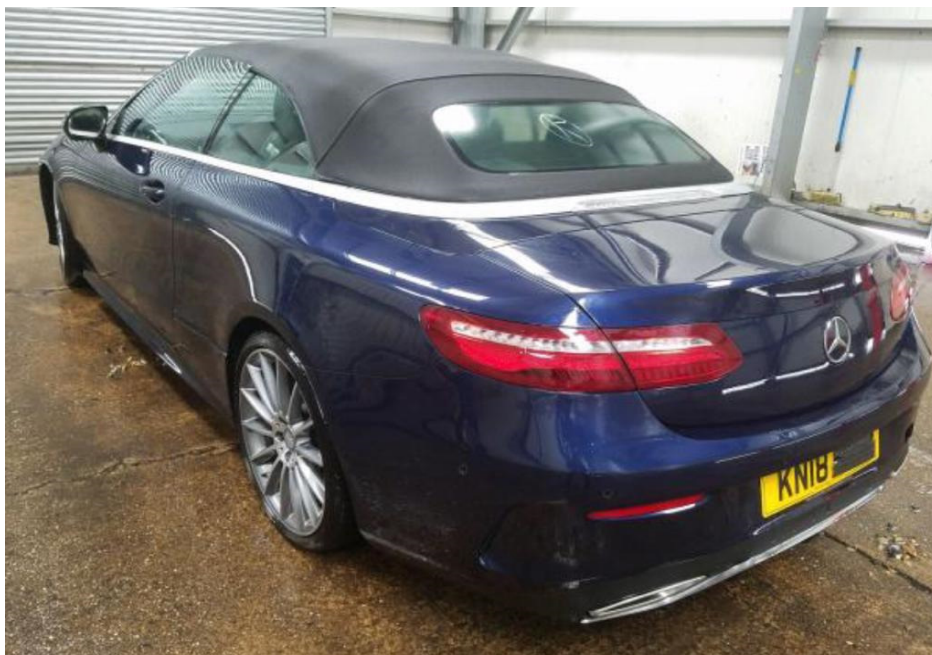
**Photo 3** shows the rear left body of the Motor Car (photograph provided to me). There was no physical damage seen to the Motor Car from the photographs that were provided to me.

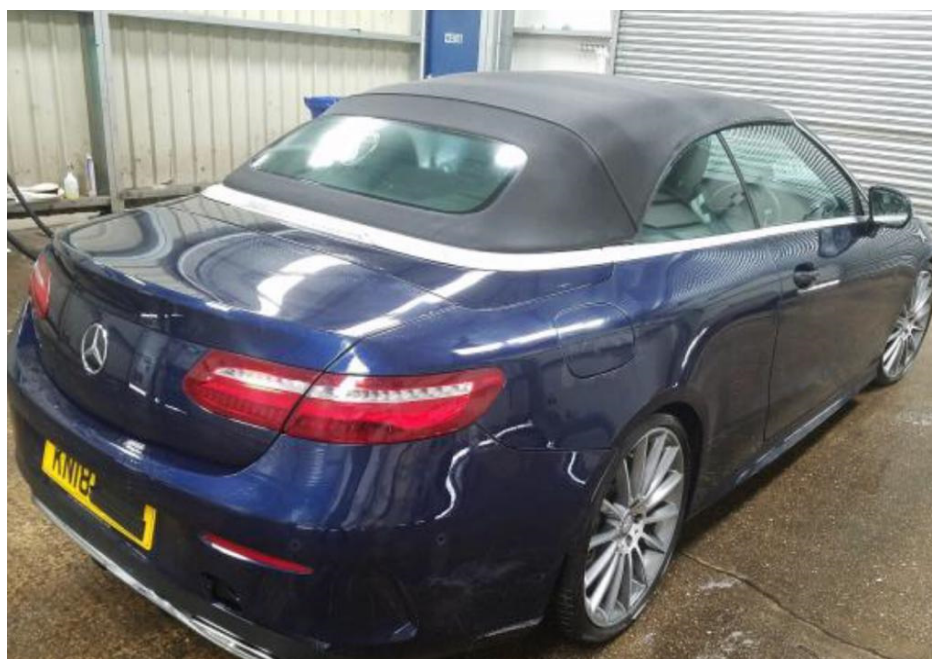
**Photo 4** shows the rear right body of the Motor Car (photograph provided to me). There was no physical damage seen to the Motor Car from the photographs that were provided to me.

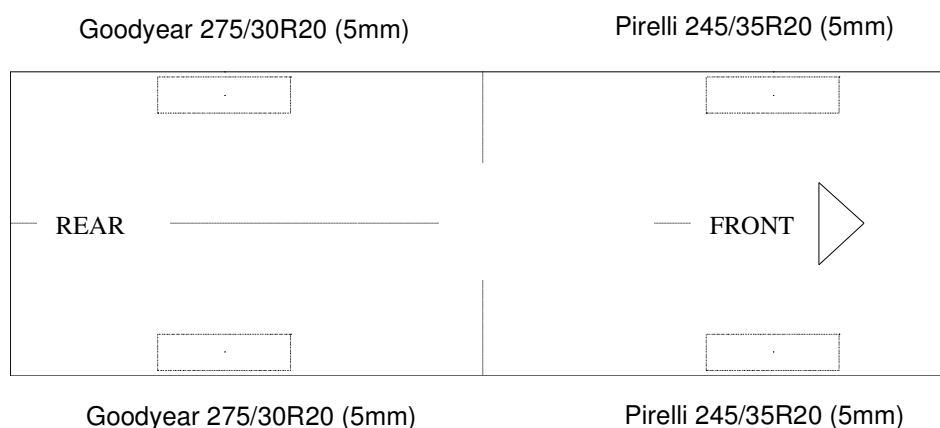
7. It was fitted with 20inch sport wheel rims that were wrapped with tyres that were observed to be of serviceable condition. The tyres were also sufficiently inflated for vehicular operation. The tyre brand, tyre size and approximate remaining tread depth of the 4 tyres of the Motor Car were recorded as follows: -

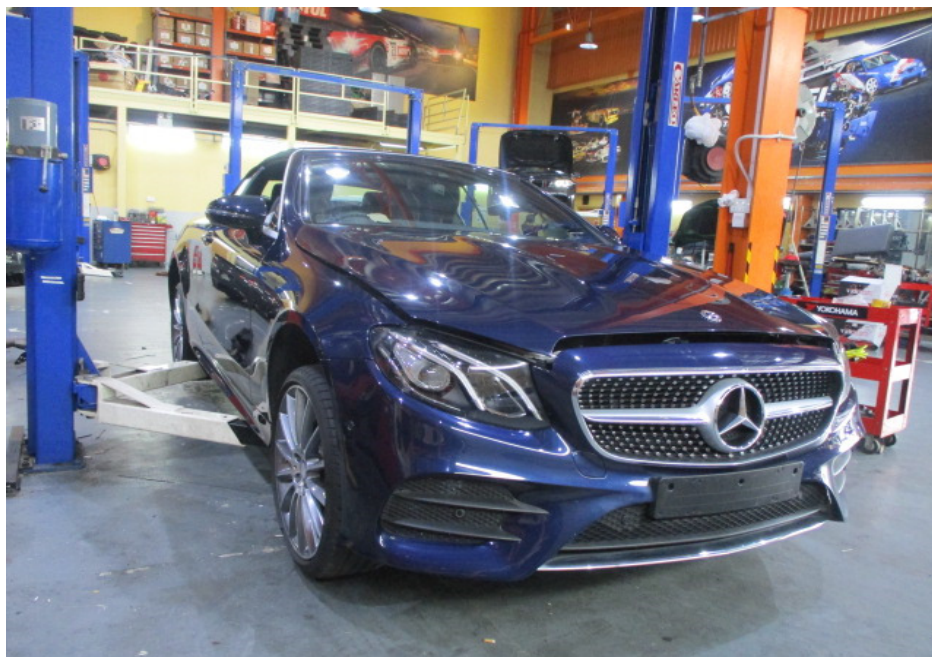
**Photo 5** shows a general view of the front right body of the Motor Car at the time of my inspection. The Motor Car was observed to be in a relatively good general condition with no loose exterior fittings observed.

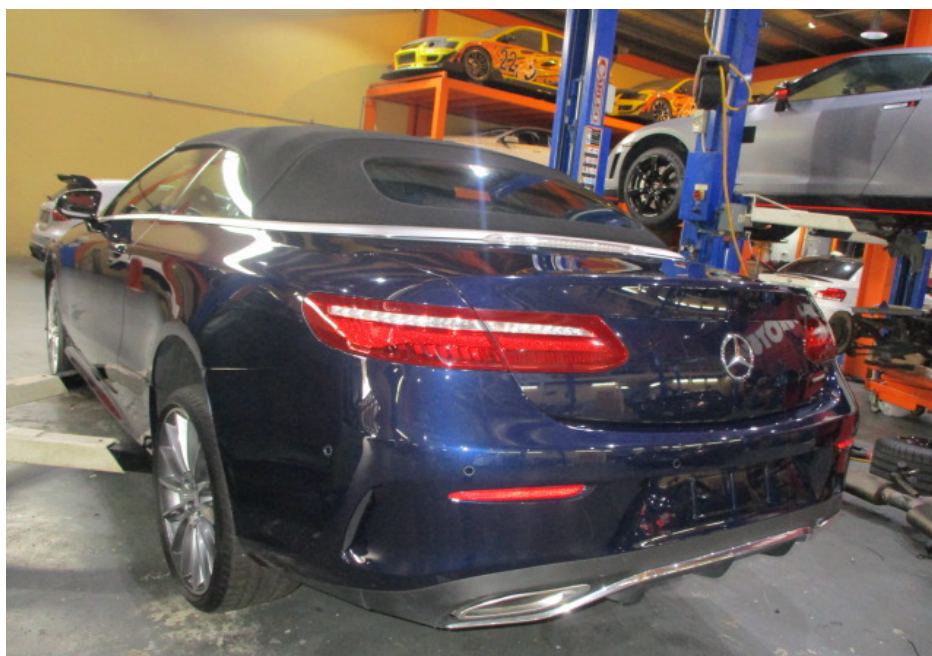
**Photo 6** shows a general view of the rear left body of the Motor Car at the time of my inspection. The Motor Car was observed to be in a relatively good general condition with no loose exterior fittings observed. The mileage of the Motor Car recorded at the time of my inspection was 14,052km.

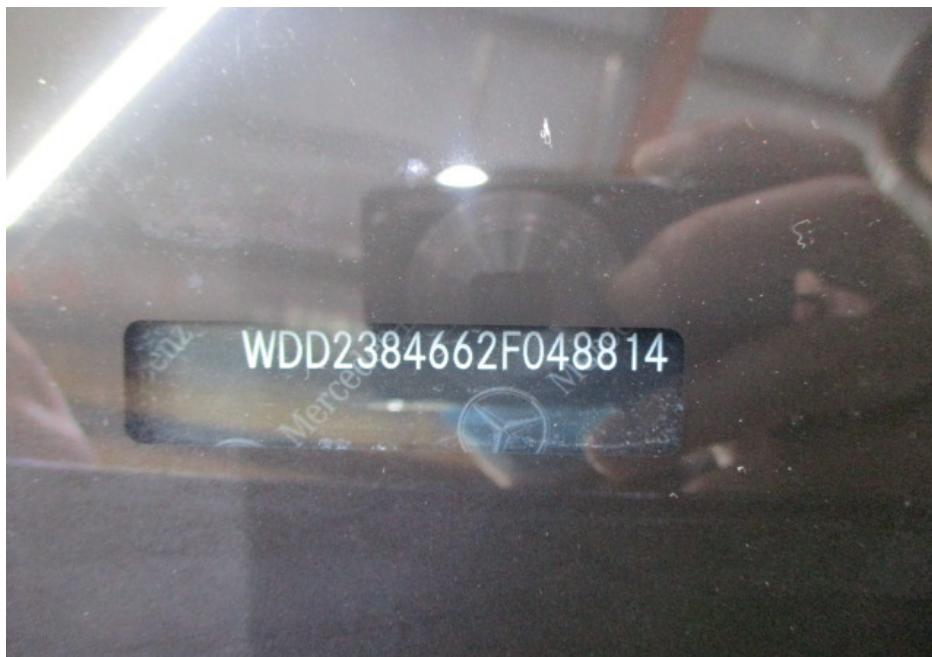
**Photo 7** shows the chassis number of the Motor Car. The chassis number recorded was WDD2384662F048814

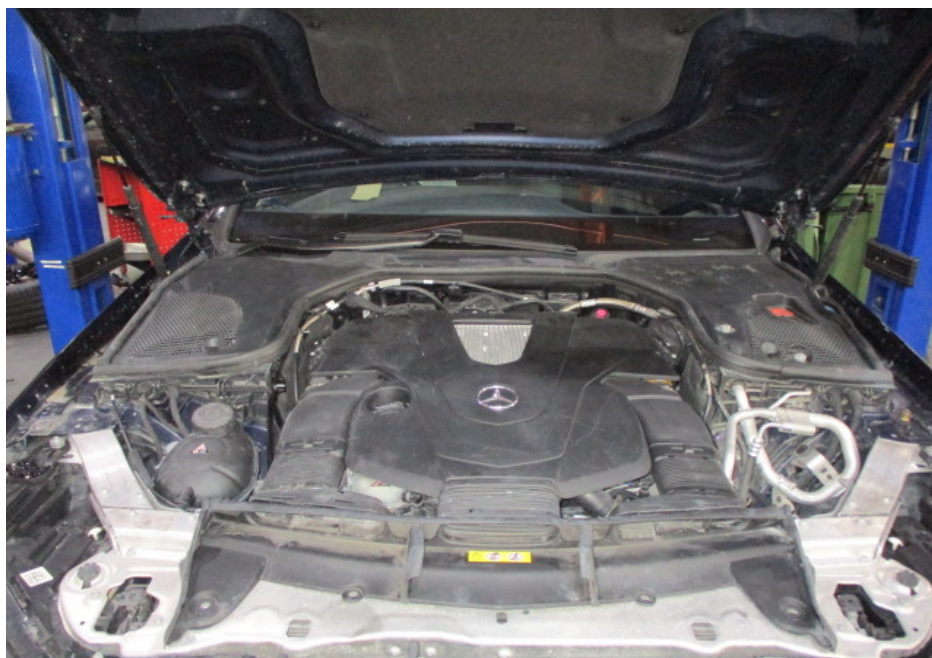
13. My examination of the engine compartment of the Motor Car revealed that the various parts and components inside the engine compartment were all intact and properly fitted. The engine oil, brake fluid and engine coolant were all found to be of sufficient level for operating purposes. Visually, there was also no contamination found to these fluids.
14. My checks on the underside of the Motor Car revealed no sign(s) or indication(s) of fluid leakage and/or fluid stain(s). The engine block and automatic transmission assembly were both secured properly. All undercarriage components of the Motor Car were also observed to be intact and secured in an appropriate manner.

**Photo 8** shows a general view of the engine compartment of the Motor Car at the time of my inspection. The various parts and components inside the engine compartment were all observed to be intact and properly fitted. There was also no sign(s) or indication(s) of fluid leak and/or fluid stain found inside the engine compartment.

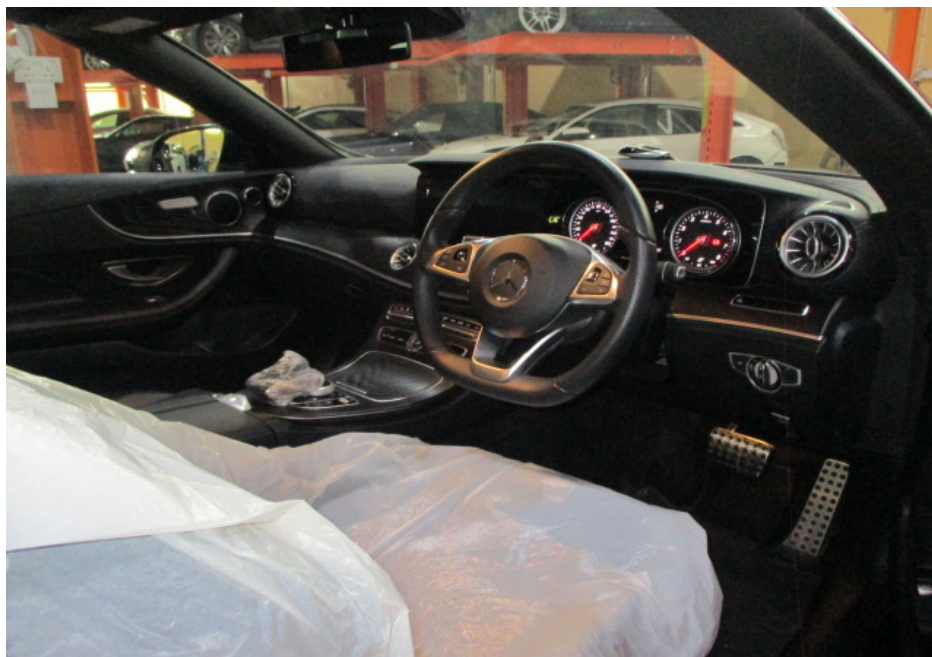
11. The seats of the Motor Car were found to be secured to the floorboard of the Motor Car via seat rails bolted onto the floorboard. Retractable seat belt reels and pre-tensioners were fitted on all seats of the Motor Car. The seat belt reels were tested and were able to be fastened securely into the respective pre-tensioners that were fixed to the side of all the seats.

**Photo 9** shows the interior compartment of the Motor Car. All the seats of the Motor Car were secured via seat rails to the floorboard and were also all fitted with a retractable seat belt reel and pre-tensioner. The seat belts were tested and able to be fastened into the respective pre-tensions that were fitted on the side of each individual seat.

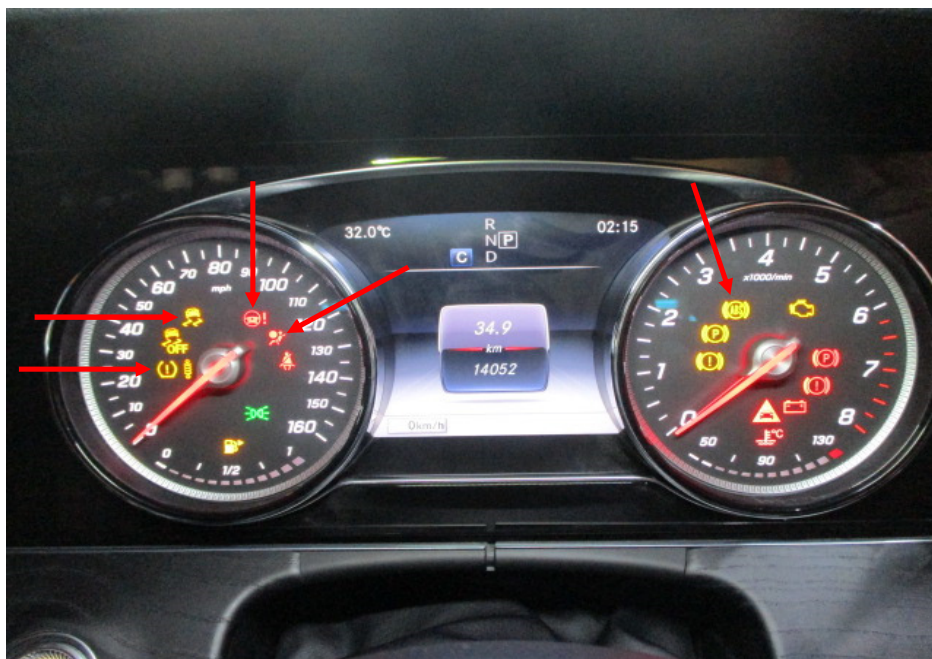
**Photo 10** shows the warning lights for the various electronic safety features appearing on the instrument panel of the Motor Car during its self-test when the engine is cranked, in particular the ABS, SRS, EPS, TPM and TCS lights (arrowed).

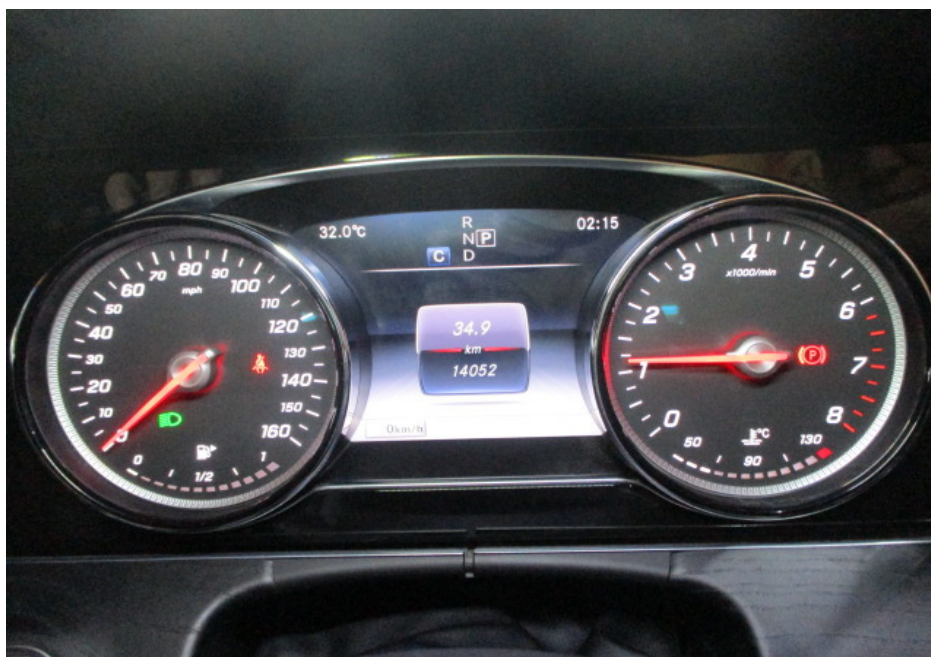
12. The Motor Car's automatic self-test of the functionality of its various electronic safety features like the Anti-Brake Lock System (ABS), Supplemental Restraint System (SRS), Electric Power Steering (EPS), Tyre Pressure Monitor (TPM) and Traction Control System (TCS) during cranking of the engine had indicated that these electronic systems were in working condition. This was determined from the respective warning lights disappearing from the instrument panel after the self-test.

**Photo 11** shows the respective warning lights no longer illuminated, indicating that there is no fault detected to the ABS, SRS, EPS, TPM and TCS systems of the Motor Car during the self-test. These electronic systems were hence in working condition at the time of my inspection.

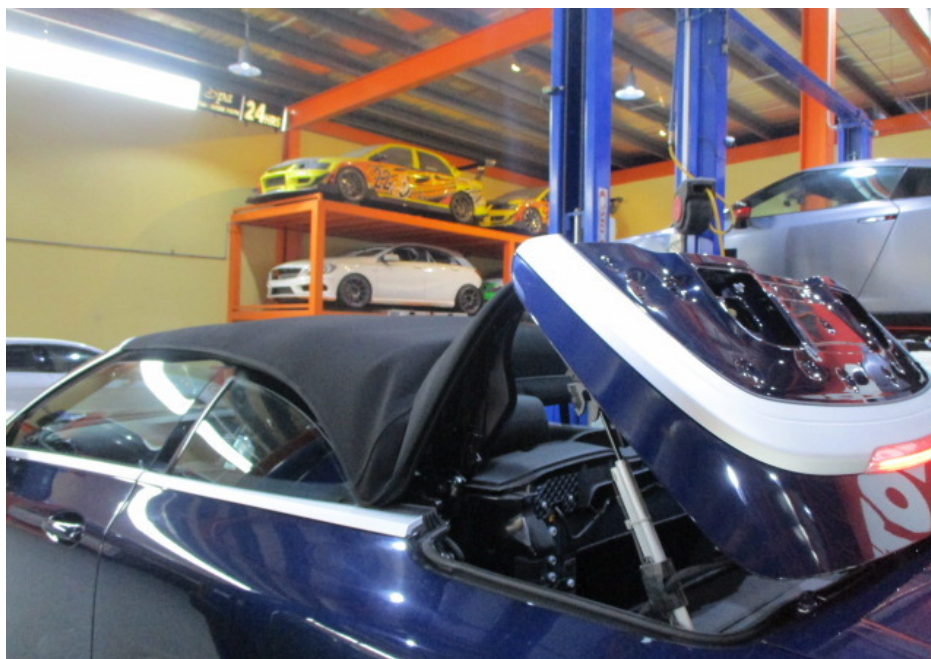
**Photo 12** shows the Motor Car's soft top (convertible) being tested. It was observed that as a safety feature, the soft top could only open and close when the Motor Car was in a stationary position. When opened, the soft top is completely folded into the rear boot compartment with no parts protruding out of the Motor Car's body. The soft top was also found adequately secured to the "A" pillar after closing.

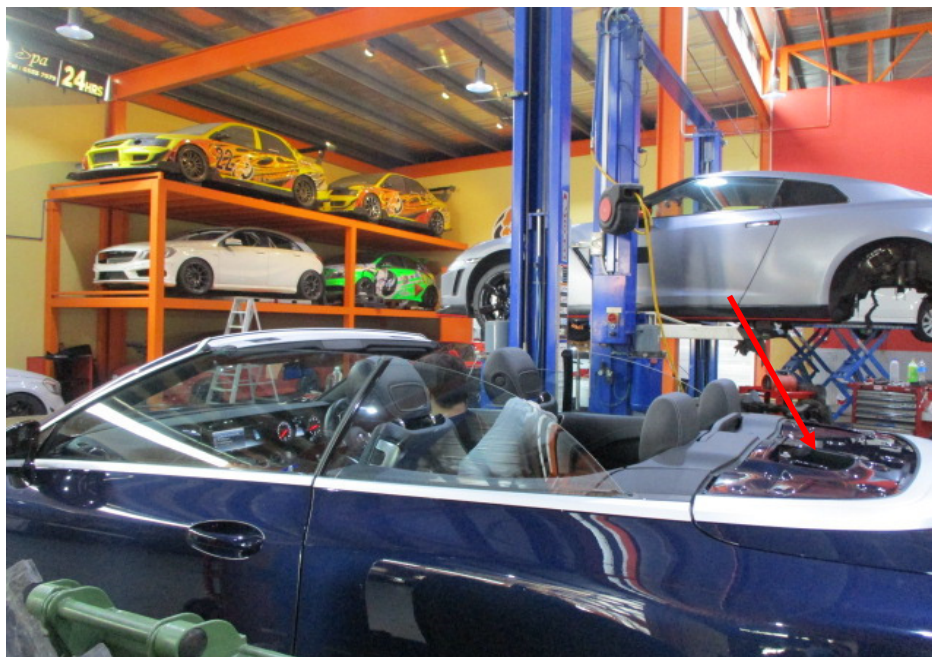
17. The Motor Car's soft top (convertible) was also tested and it was observed that, as a safety feature, the soft top could only open and close when the Motor Car was in a stationary position. When opened, the soft top is completely folded into the rear boot compartment with no parts protruding out of the Motor Car's body. The soft top was also found adequately secured to the "A" Pillar after closing.

**Photo 13** shows the Motor Car's soft top (convertible) completely opened during my testing. It was observed that as a safety feature, the soft top could only open and close when the Motor Car was in a stationary position. When opened, the soft top is completely folded into the rear boot compartment (arrowed) with no parts protruding out of the Motor Car's body. The soft top was also found adequately secured to the "A" pillar after closing.

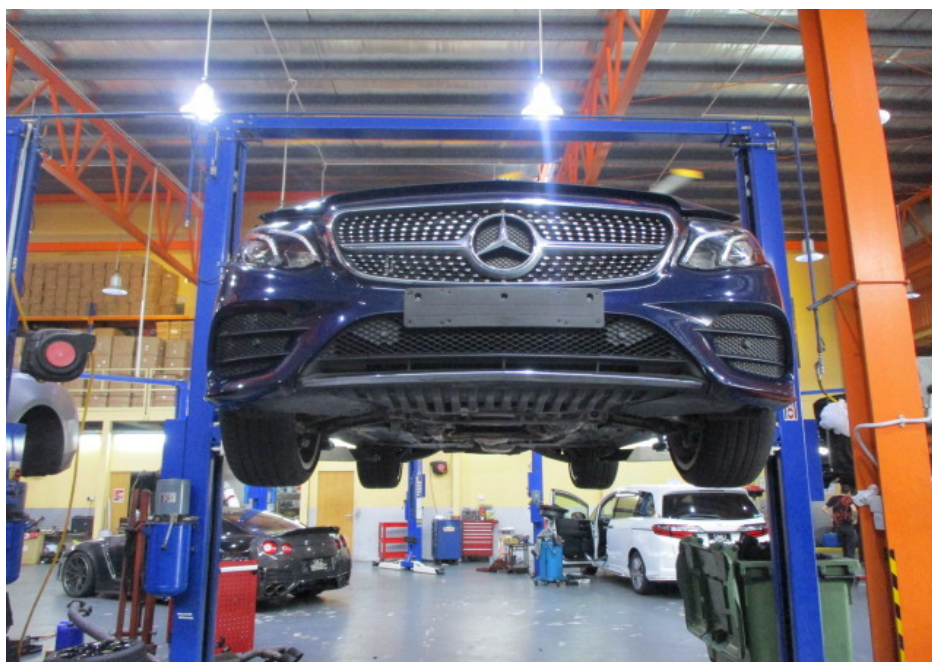
**Photo 14** shows the Motor Car hoisted up for checks on its undercarriage. There was no sign(s) or indication(s) of fluid leakage and/or fluid stain(s) on the underside of the Motor Car. The undercarriage components of the Motor Car were also all observed to be intact and secured in an appropriate manner.

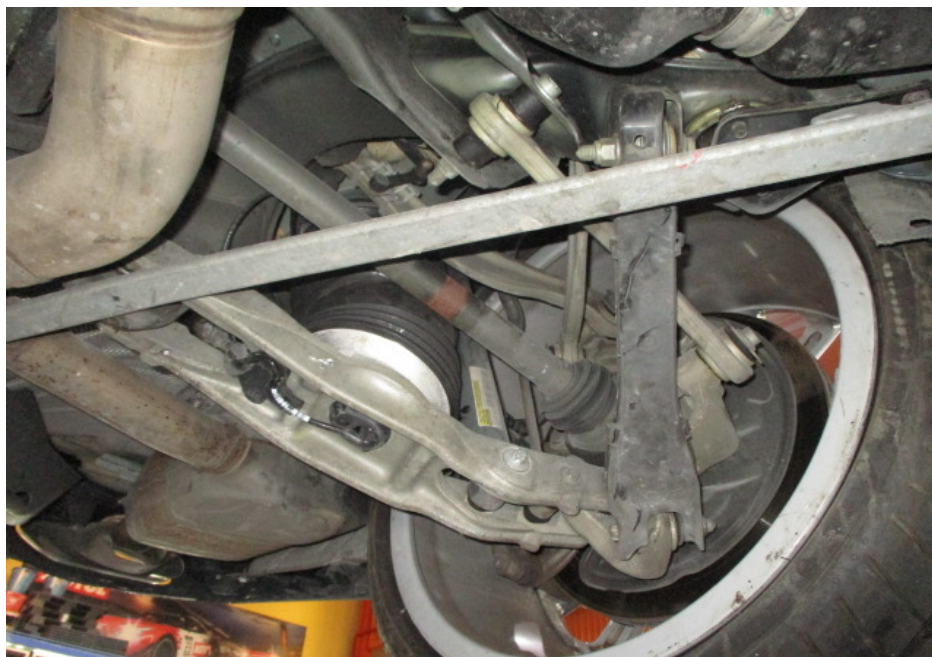
**Photo 15** shows a general view of the control arms and linkages at the rear left wheel of the Motor Car. I did not observe any fluid leak and/or fluid stain on the underside of the Motor Car. All of the Motor Car's undercarriage components were observed to be intact and secured in an appropriate manner.

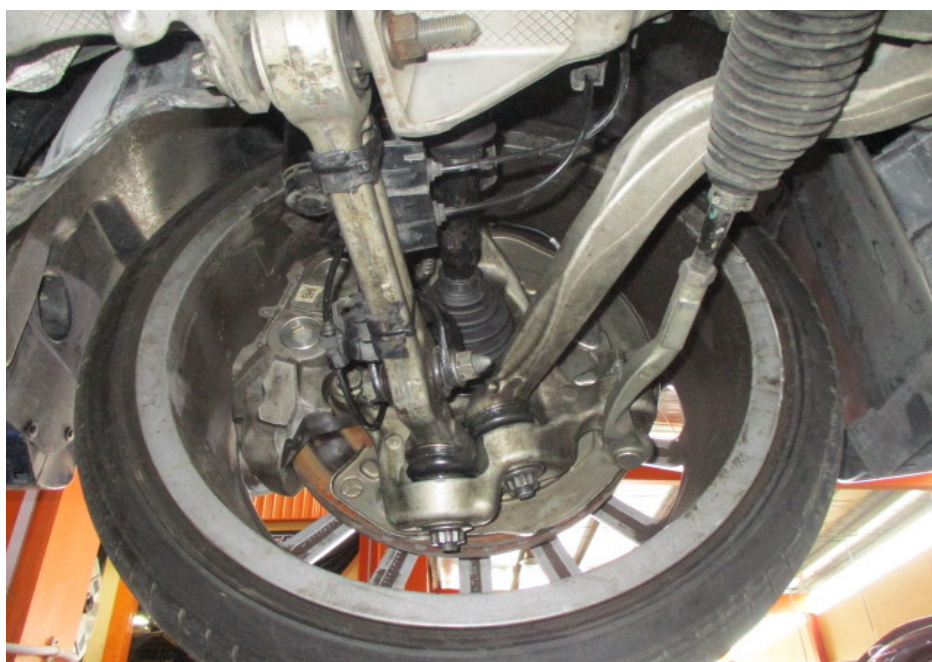
**Photo 16** shows the various undercarriage components at the front left wheel of the Motor Car. The mechanical components, control arms and linkages were all found to be intact and secured in an appropriate manner.

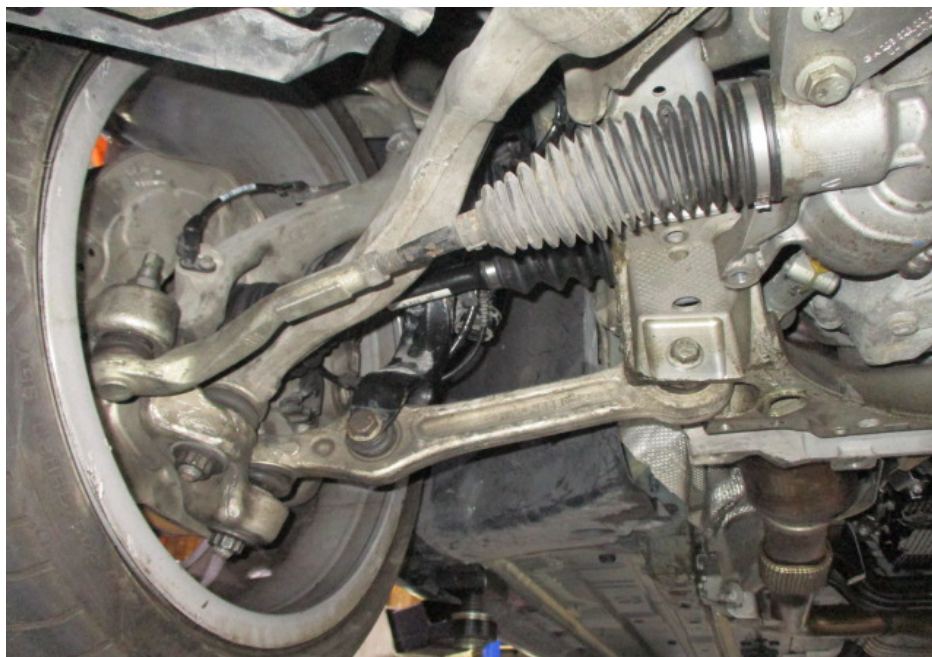
**Photo 17** shows the various undercarriage components at the front right wheel of the Motor Car. The mechanical components, control arms and linkages were all found to be intact and secured in an appropriate manner. I also did not observe any fluid leak and/or fluid stain on the underside of the Motor Car.

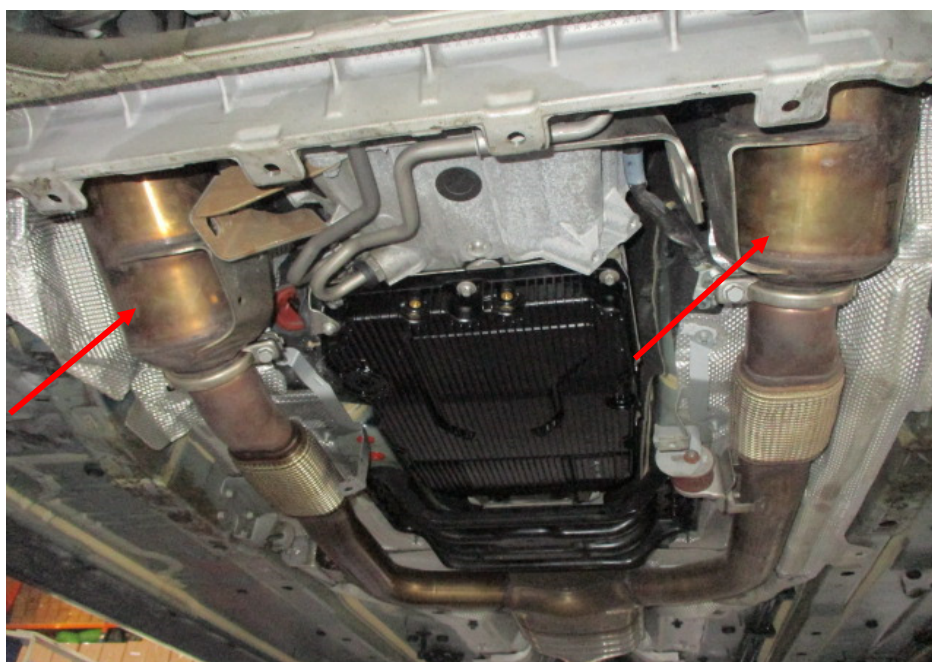
**Photo 18** shows the Motor Car's catalytic converters (arrowed). My examination of the Motor Car's exhaust system revealed no sign(s) or indication(s) of any cut or weld marks along its exhaust pipes and on its rear mufflers.

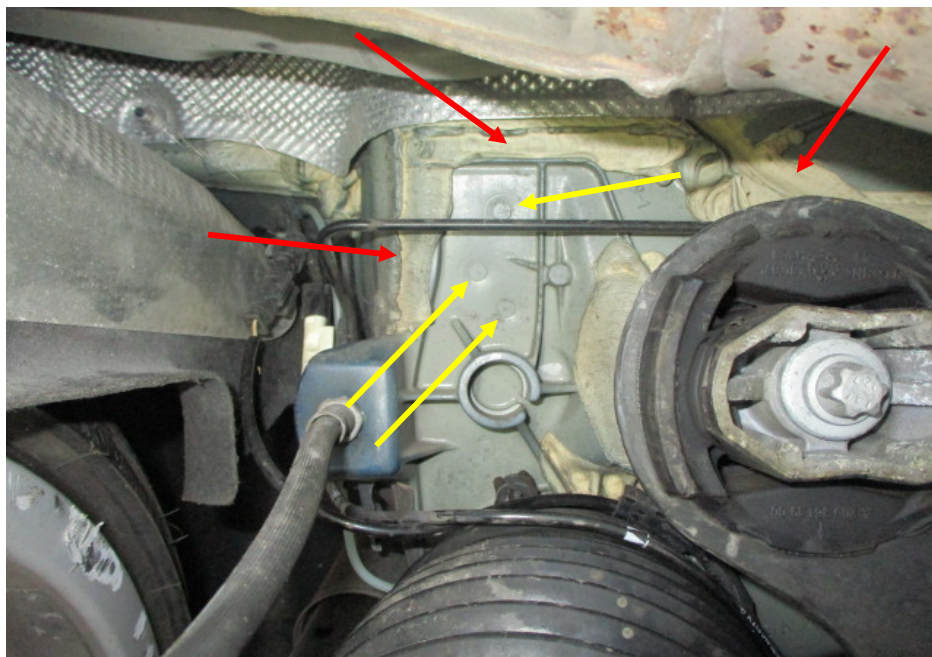
10. Visually, I did not find any weld marks, other than the original spot weld marks, on the chassis/structural body of the Motor Car. The original factory sealant at the joints along the chassis/structural body was also untouched, again indicating that no replacement of the chassis/structural body was carried out; and that the chassis/structural body was originally fitted.

**Photo 19** shows the chassis/structural body at the underside rear left of the Motor Car. I did not find any weld marks other than original spot weld marks (yellow arrow) on the chassis/structural body of the Motor Car. The original factory sealant (red arrow) at the joints along the chassis/structural body was untouched, indicating no work was done on the chassis/structural body of the Motor Car and that the chassis/structural body was originally fitted.

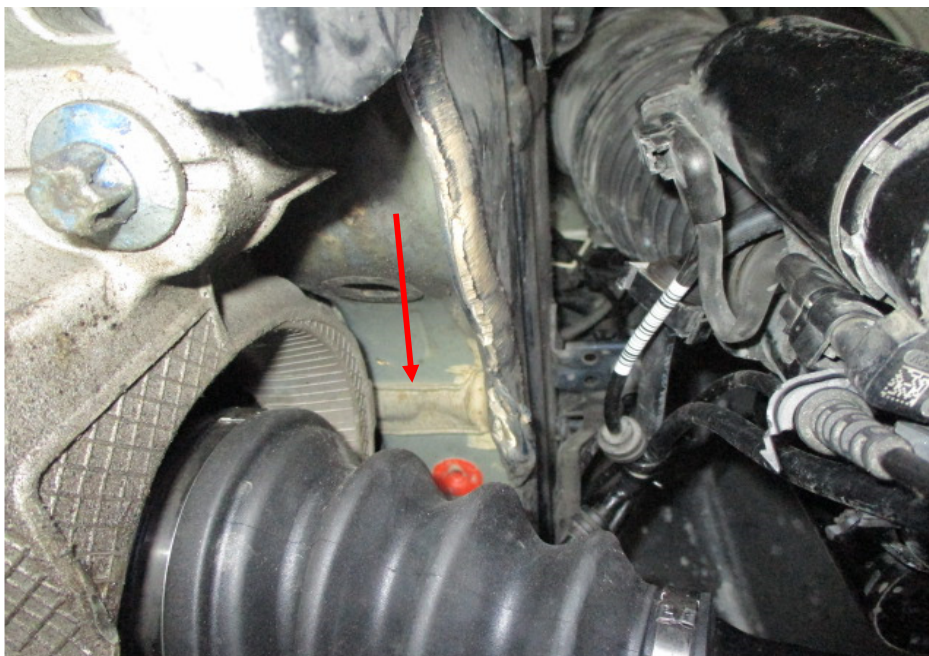
**Photo 20** shows the chassis/structural body at the underside front right of the Motor Car. The original factory sealant (arrowed) at the joints along the chassis/structural body was also untouched, indicating no work was done on the chassis/structural body of the Motor Car and that the chassis/structural body was originally fitted.

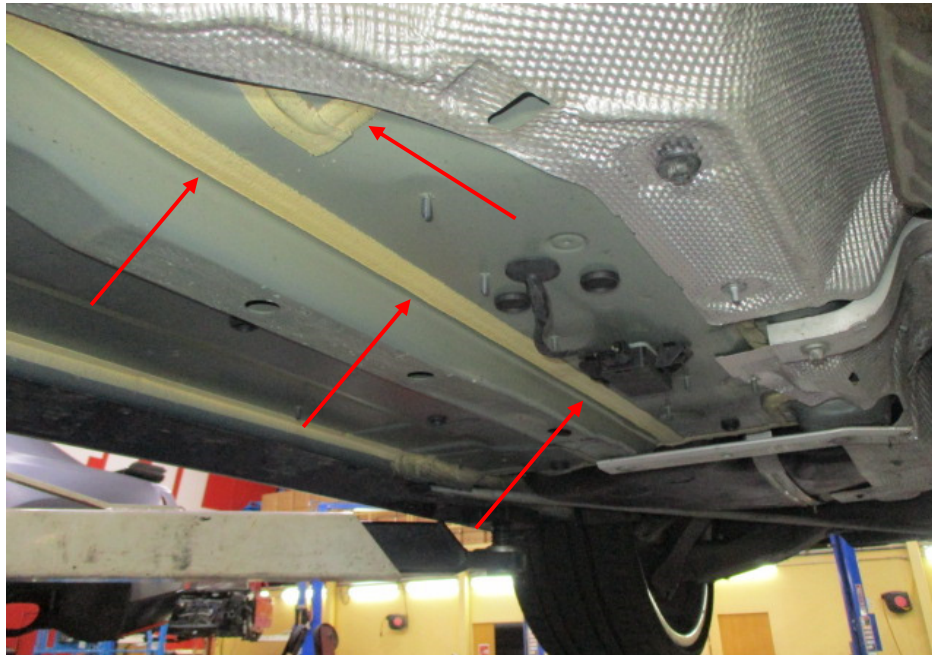
8. The detachable body panels of the Motor Car like the front fenders, front bumper, rear bumper, doors, bonnet and rear bootlid amongst others were all found to be fitted securely.
9. Checks on the non-detachable body panels like the rear fenders, floorboard, roof panel, pillars and rocker panels amongst others, revealed that these body panels were spot welded onto the chassis/structural body of the Motor Car. The original factory sealant at the joints of the non-detachable body panels was all untouched indicating no replacement of the non-detachable body panels was carried out; and that these body panels were all originally fitted.

**Photo 21** shows the floorboard at the right underside of the Motor Car. The original factory sealant (arrowed) at the joints along the non-detachable body panels were untouched, indicating no work was done on the non-detachable body panels of the Motor Car; and that these body panels were originally fitted. In general, I had found all the non-detachable body panels of the Motor Car to be originally fitted at the time of my inspection.
