Your Ref: Mercedes Benz E400
(chassis number WDD2384662F048814)
Our Ref : CI/TP20011895/D

01 November 2020

**INSPECTION REPORT OF AN UNREGISTERD MERCEDES BENZ E400
MOTOR CAR WITH CHASSIS NUMBER WDD2384662F048814**

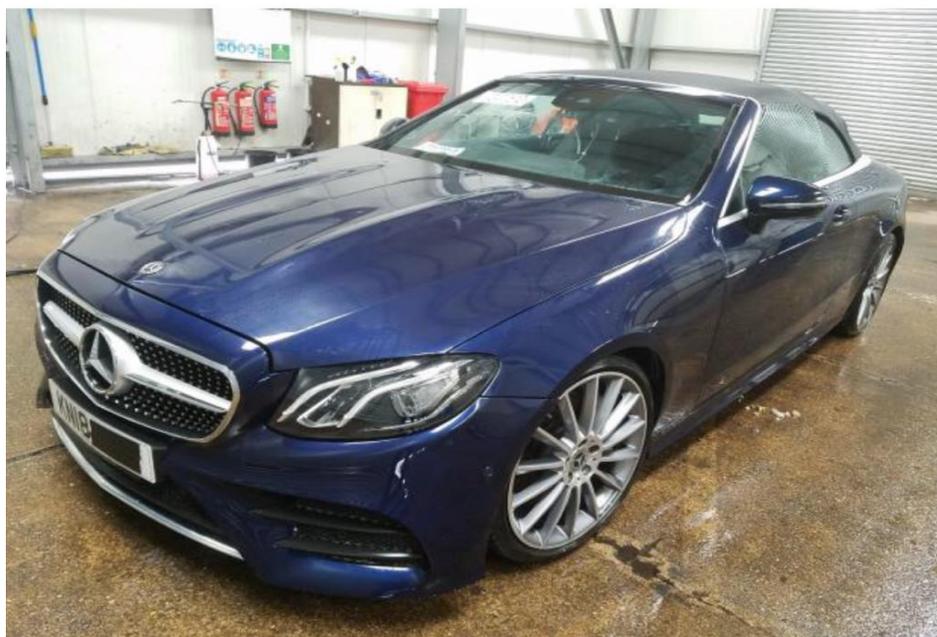
Photo 1 shows the front left body of the Motor Car (photograph provided to me). There was no physical damage seen to the Motor Car from the photographs that were provided to me.

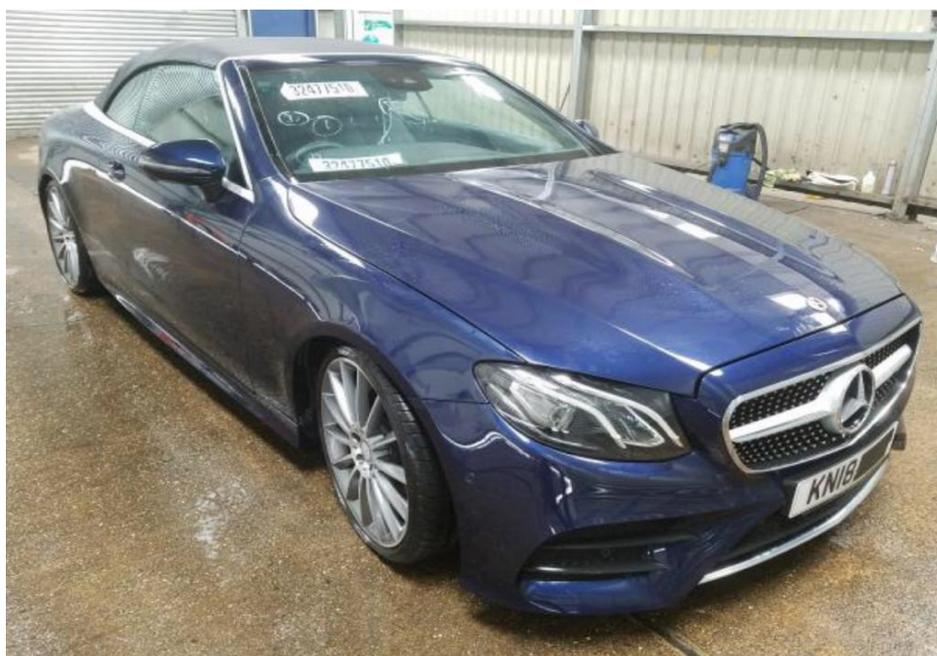
Photo 2 shows the front right body of the Motor Car (photograph provided to me). There was no physical damage seen to the Motor Car from the photographs that were provided to me.

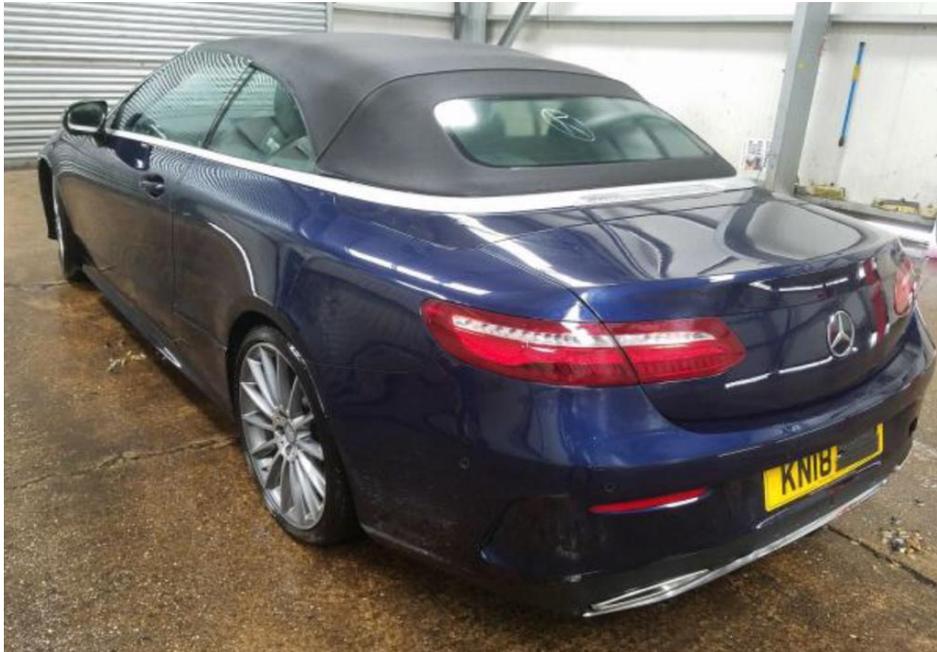
Photo 3 shows the rear left body of the Motor Car (photograph provided to me). There was no physical damage seen to the Motor Car from the photographs that were provided to me.

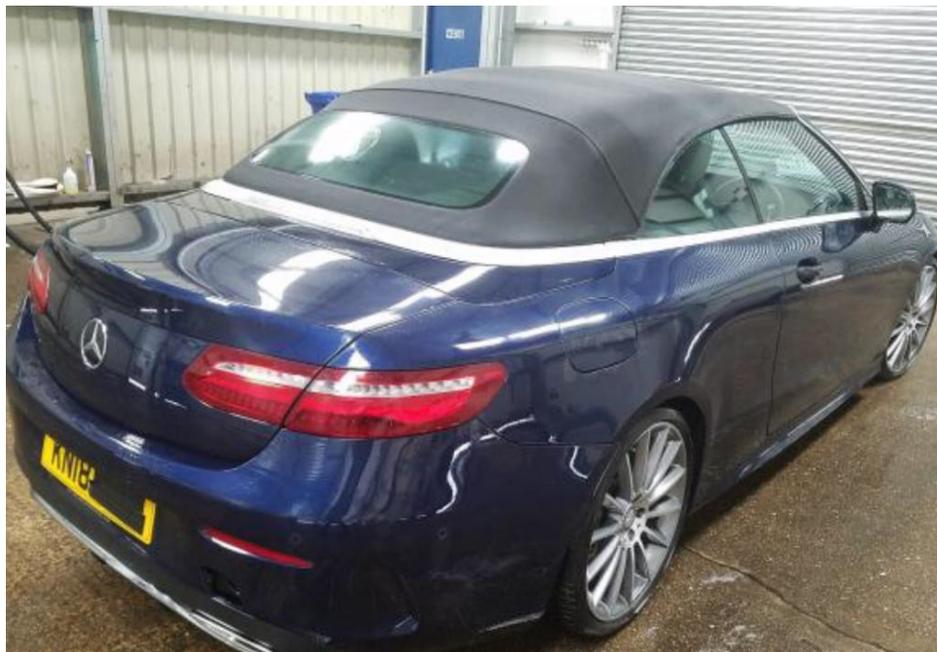
Photo 4 shows the rear right body of the Motor Car (photograph provided to me). There was no physical damage seen to the Motor Car from the photographs that were provided to me.

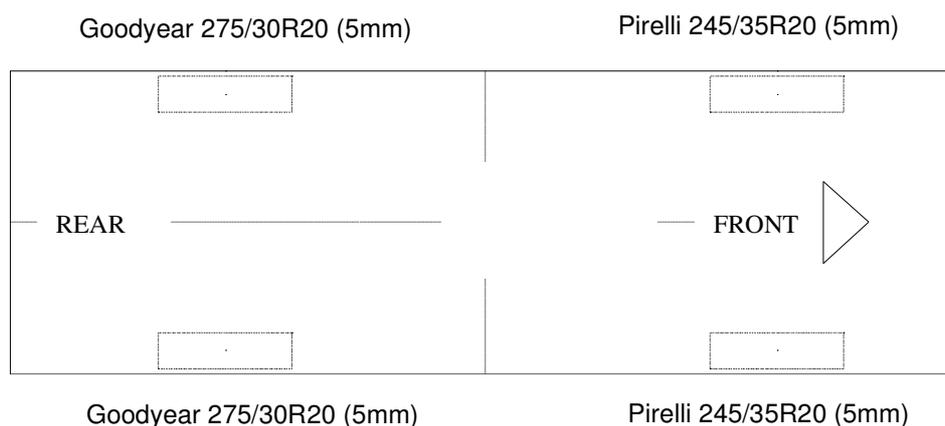
- It was fitted with 20inch sport wheel rims that were wrapped with tyres that were observed to be of serviceable condition. The tyres were also sufficiently inflated for vehicular operation. The tyre brand, tyre size and approximate remaining tread depth of the 4 tyres of the Motor Car were recorded as follows: -

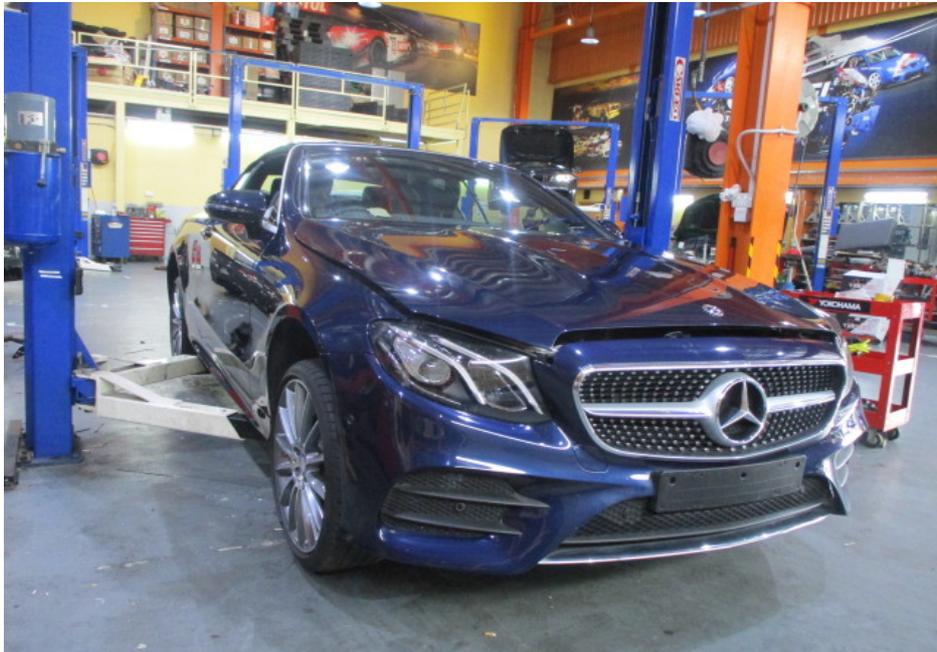
Photo 5 shows a general view of the front right body of the Motor Car at the time of my inspection. The Motor Car was observed to be in a relatively good general condition with no loose exterior fittings observed.

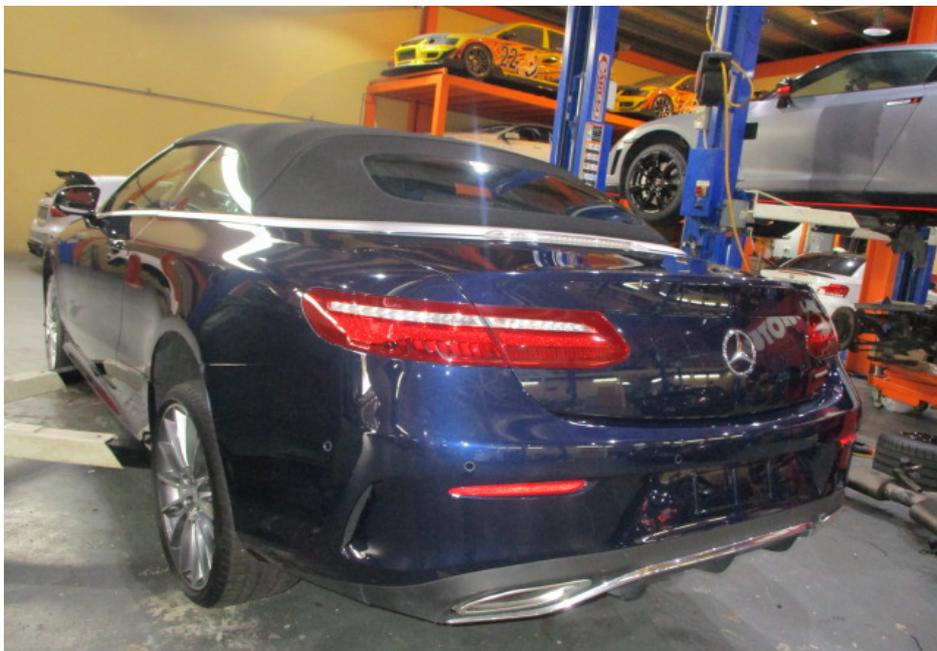
Photo 6 shows a general view of the rear left body of the Motor Car at the time of my inspection. The Motor Car was observed to be in a relatively good general condition with no loose exterior fittings observed. The mileage of the Motor Car recorded at the time of my inspection was 14,052km.

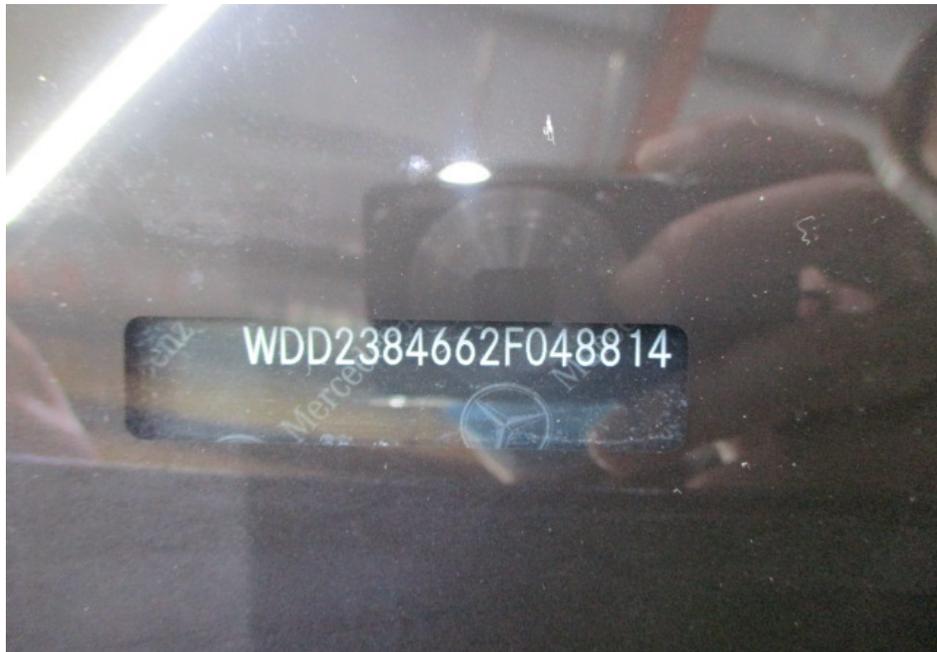
Photo 7 shows the chassis number of the Motor Car. The chassis number recorded was WDD2384662F048814

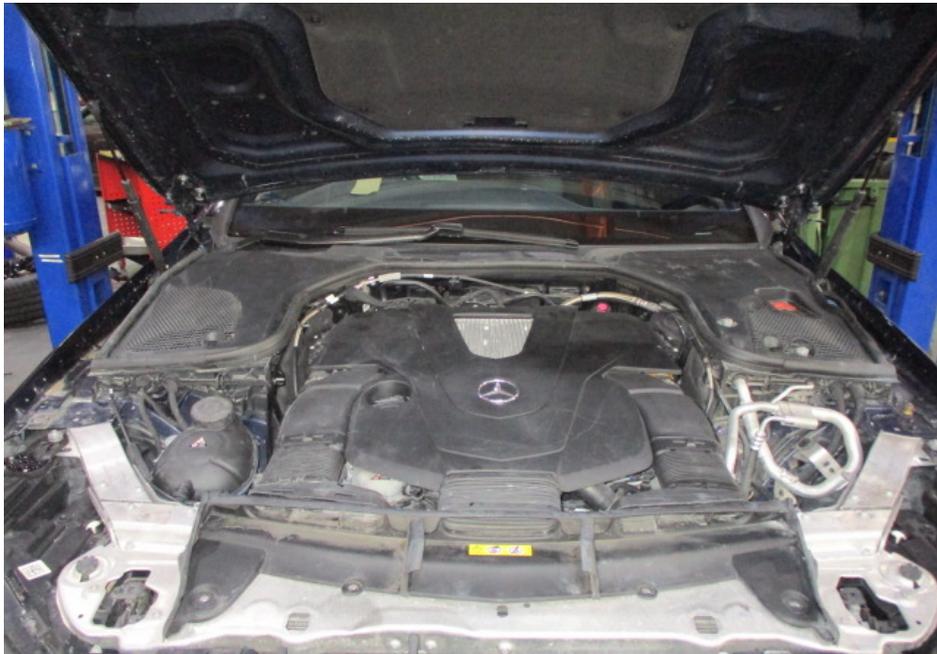
13. My examination of the engine compartment of the Motor Car revealed that the various parts and components inside the engine compartment were all intact and properly fitted. The engine oil, brake fluid and engine coolant were all found to be of sufficient level for operating purposes. Visually, there was also no contamination found to these fluids.
14. My checks on the underside of the Motor Car revealed no sign(s) or indication(s) of fluid leakage and/or fluid stain(s). The engine block and automatic transmission assembly were both secured properly. All undercarriage components of the Motor Car were also observed to be intact and secured in an appropriate manner.

Photo 8 shows a general view of the engine compartment of the Motor Car at the time of my inspection. The various parts and components inside the engine compartment were all observed to be intact and properly fitted. There was also no sign(s) or indication(s) of fluid leak and/or fluid stain found inside the engine compartment.

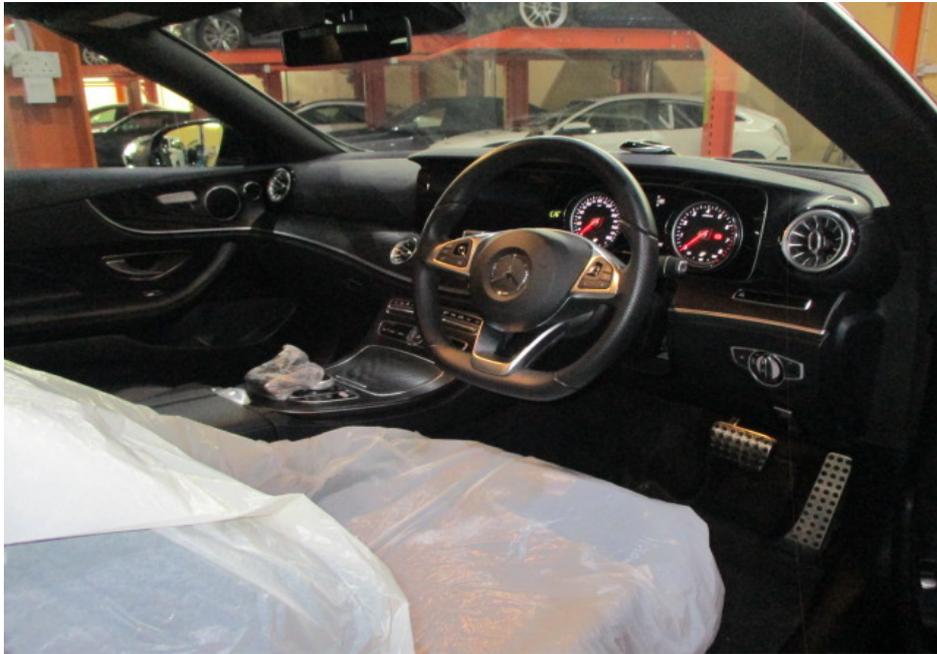
11. The seats of the Motor Car were found to be secured to the floorboard of the Motor Car via seat rails bolted onto the floorboard. Retractable seat belt reels and pre-tensioners were fitted on all seats of the Motor Car. The seat belt reels were tested and were able to be fastened securely into the respective pre-tensioners that were fixed to the side of all the seats.

Photo 9 shows the interior compartment of the Motor Car. All the seats of the Motor Car were secured via seat rails to the floorboard and were also all fitted with a retractable seat belt reel and pre-tensioner. The seat belts were tested and able to be fastened into the respective pre-tensions that were fitted on the side of each individual seat.

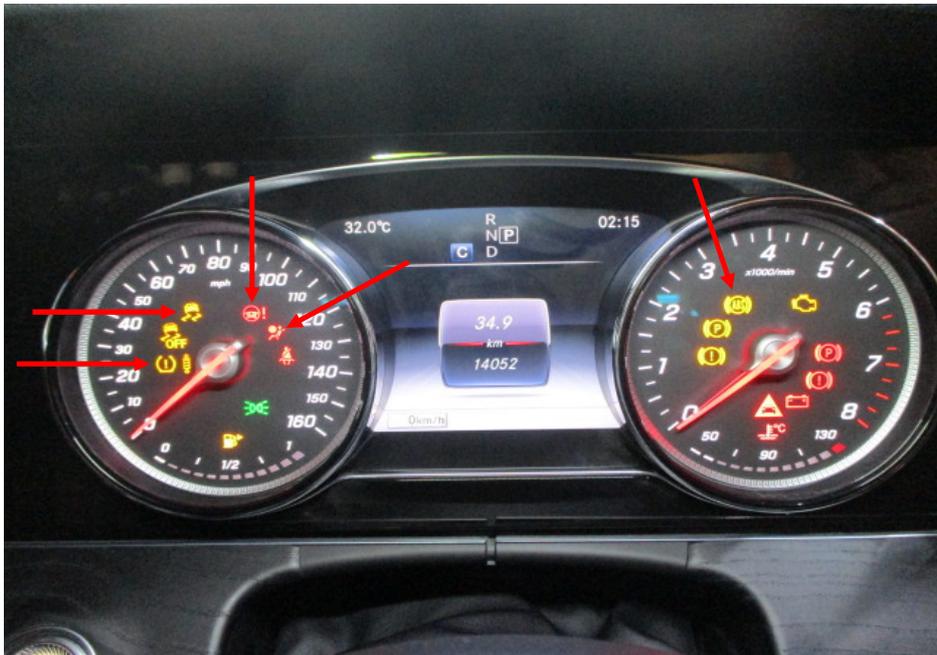
Photo 10 shows the warning lights for the various electronic safety features appearing on the instrument panel of the Motor Car during its self-test when the engine is cranked, in particular the ABS, SRS, EPS, TPM and TCS lights (arrowed).

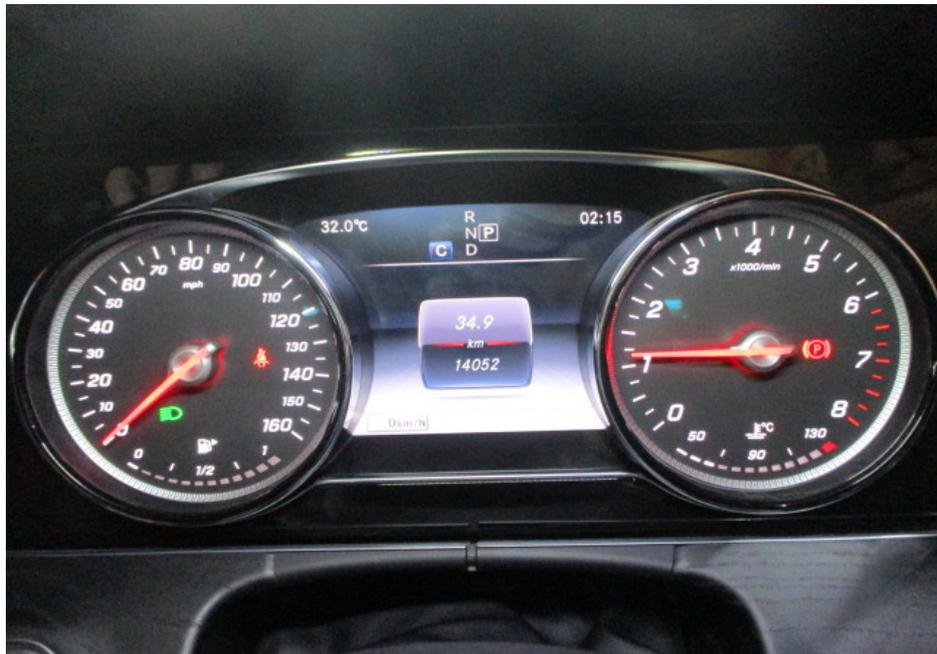
12. The Motor Car's automatic self-test of the functionality of its various electronic safety features like the Anti-Brake Lock System (ABS), Supplemental Restraint System (SRS), Electric Power Steering (EPS), Tyre Pressure Monitor (TPM) and Traction Control System (TCS) during cranking of the engine had indicated that these electronic systems were in working condition. This was determined from the respective warning lights disappearing from the instrument panel after the self-test.

Photo 11 shows the respective warning lights no longer illuminated, indicating that there is no fault detected to the ABS, SRS, EPS, TPM and TCS systems of the Motor Car during the self-test. These electronic systems were hence in working condition at the time of my inspection.

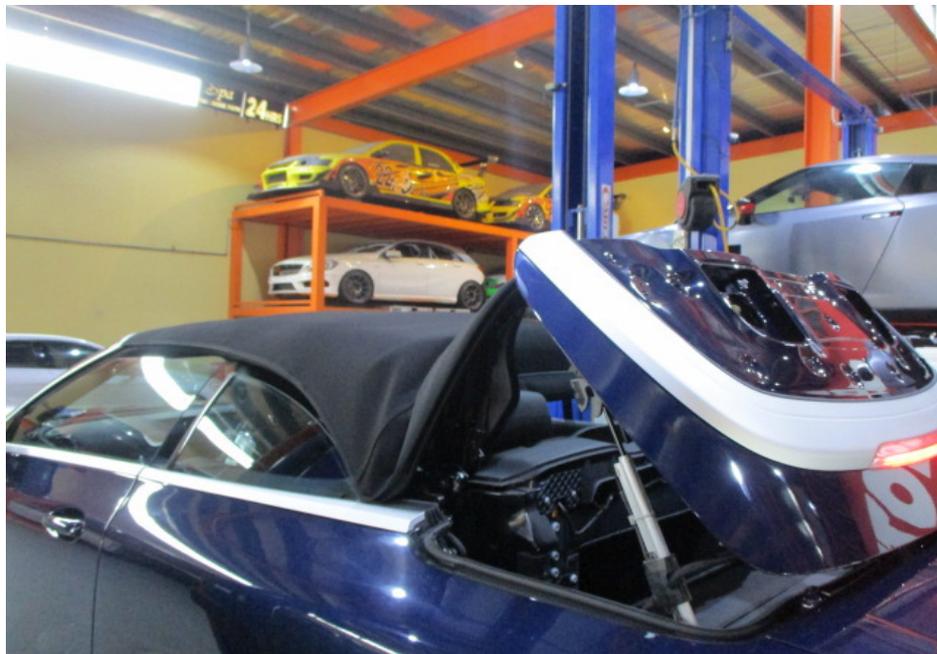
17. The Motor Car's soft top (convertible) was also tested and it was observed that, as a safety feature, the soft top could only open and close when the Motor Car was in a stationary position. When opened, the soft top is completely folded into the rear boot compartment with no parts protruding out of the Motor Car's body. The soft top was also found adequately secured to the "A" Pillar after closing.

Photo 12 shows the Motor Car's soft top (convertible) being tested. It was observed that as a safety feature, the soft top could only open and close when the Motor Car was in a stationary position. When opened, the soft top is completely folded into the rear boot compartment with no parts protruding out of the Motor Car's body. The soft top was also found adequately secured to the "A" pillar after closing.

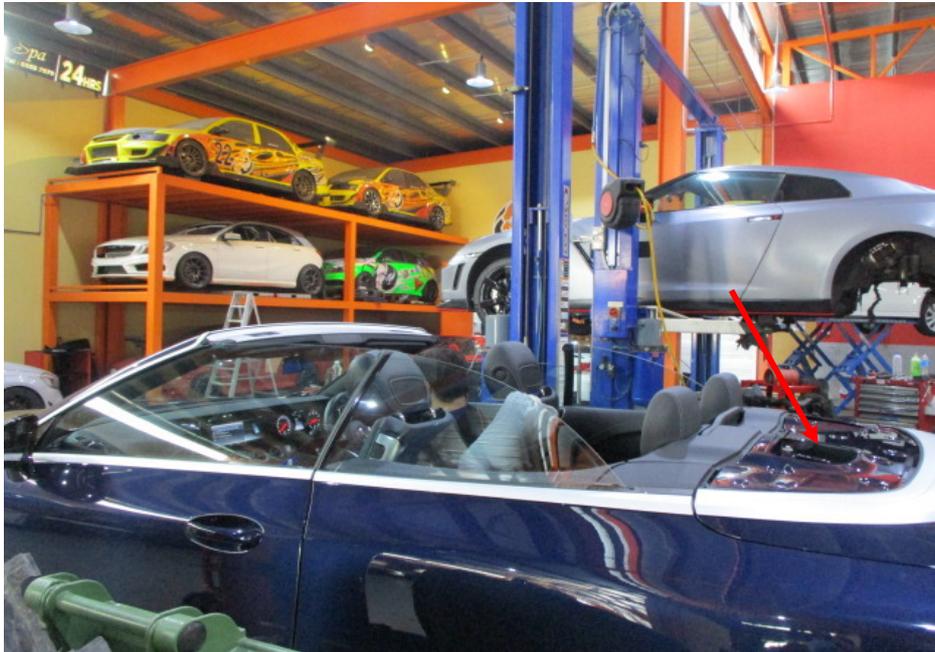
Photo 13 shows the Motor Car's soft top (convertible) completely opened during my testing. It was observed that as a safety feature, the soft top could only open and close when the Motor Car was in a stationary position. When opened, the soft top is completely folded into the rear boot compartment (arrowed) with no parts protruding out of the Motor Car's body. The soft top was also found adequately secured to the "A" pillar after closing.

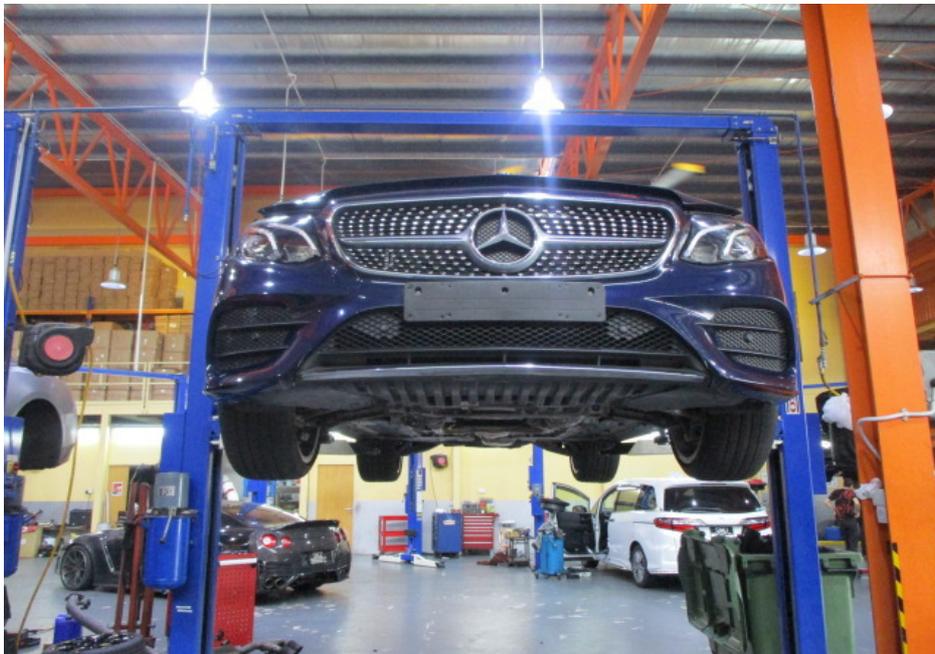
Photo 14 shows the Motor Car hoisted up for checks on its undercarriage. There was no sign(s) or indication(s) of fluid leakage and/or fluid stain(s) on the underside of the Motor Car. The undercarriage components of the Motor Car were also all observed to be intact and secured in an appropriate manner.

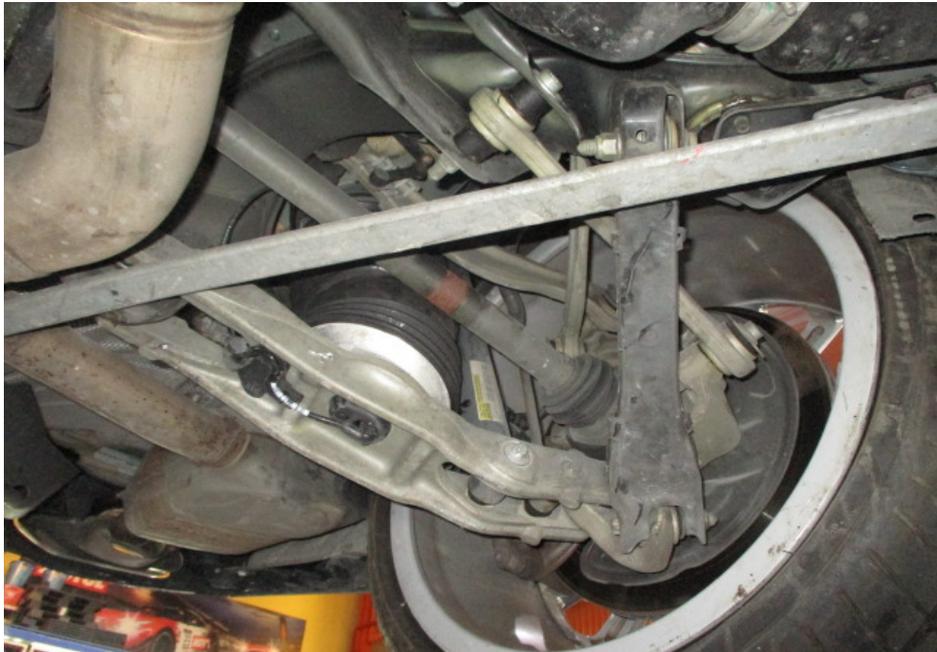
Photo 15 shows a general view of the control arms and linkages at the rear left wheel of the Motor Car. I did not observe any fluid leak and/or fluid stain on the underside of the Motor Car. All of the Motor Car's undercarriage components were observed to be intact and secured in an appropriate manner.

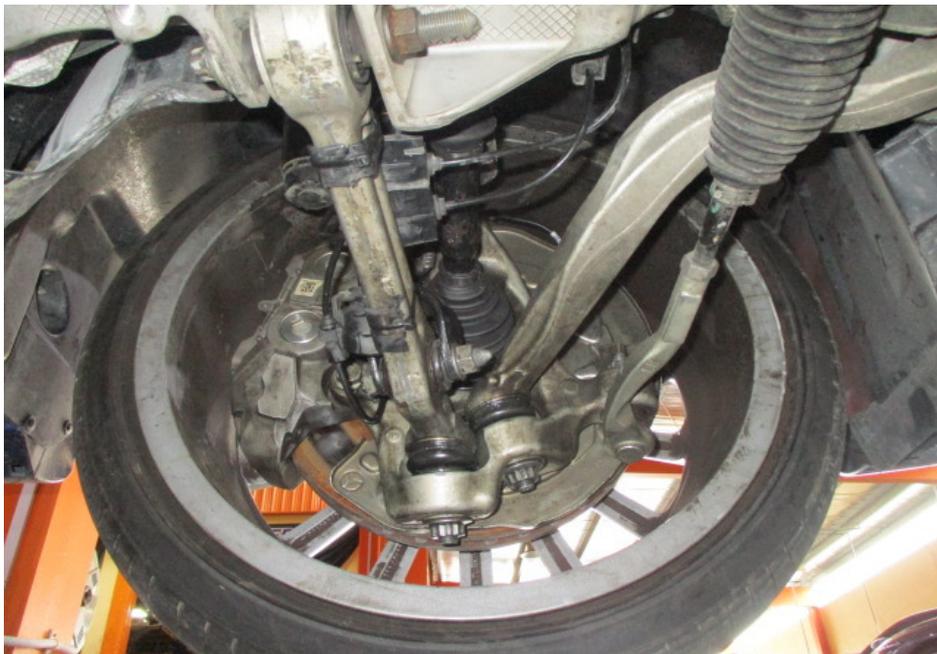
Photo 16 shows the various undercarriage components at the front left wheel of the Motor Car. The mechanical components, control arms and linkages were all found to be intact and secured in an appropriate manner.

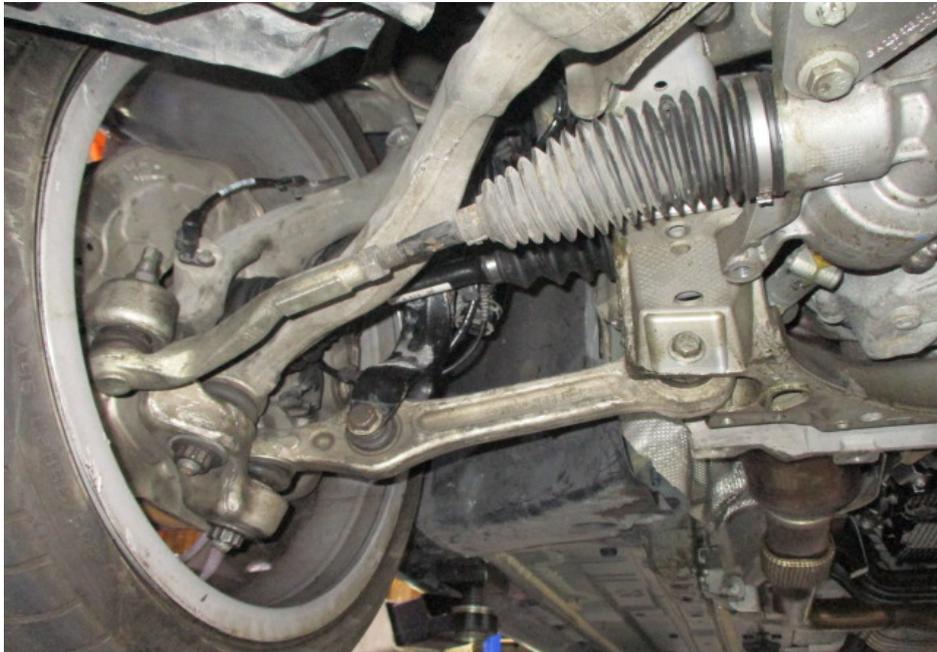
Photo 17 shows the various undercarriage components at the front right wheel of the Motor Car. The mechanical components, control arms and linkages were all found to be intact and secured in an appropriate manner. I also did not observe any fluid leak and/or fluid stain on the underside of the Motor Car.

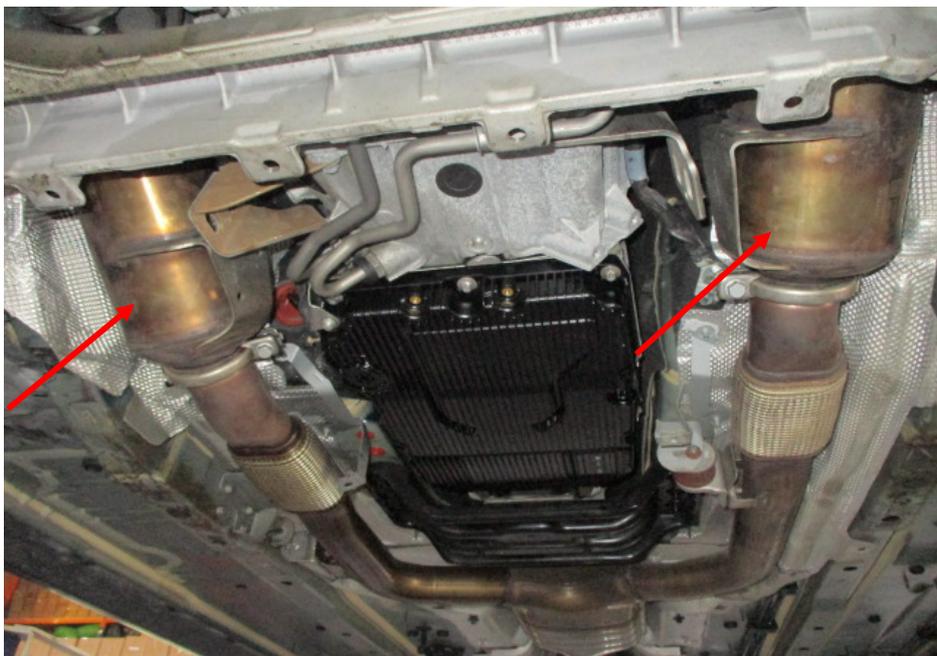
Photo 18 shows the Motor Car's catalytic converters (arrowed). My examination of the Motor Car's exhaust system revealed no sign(s) or indication(s) of any cut or weld marks along its exhaust pipes and on its rear mufflers.

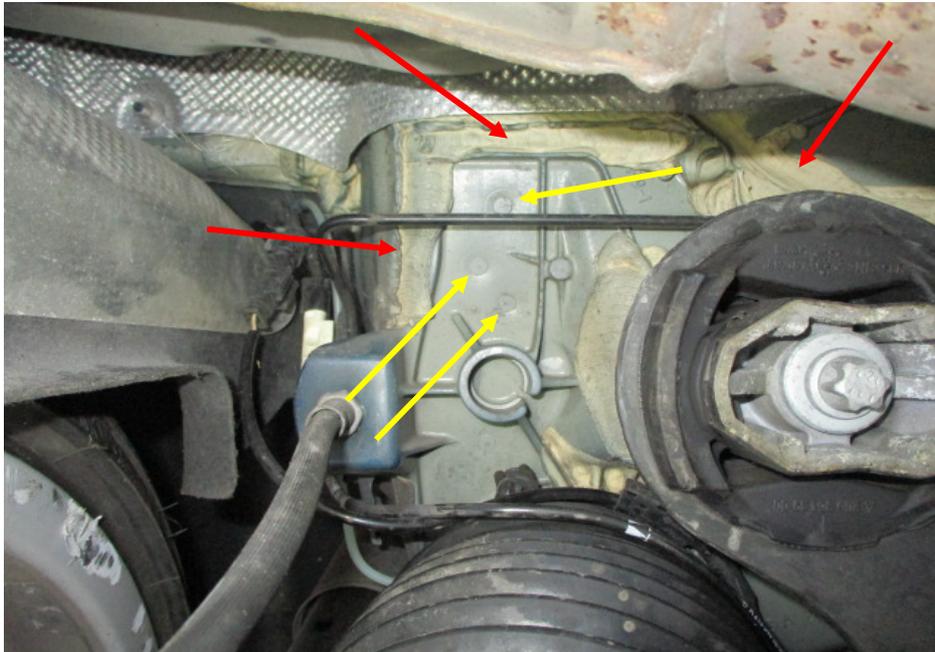
10. Visually, I did not find any weld marks, other than the original spot weld marks, on the chassis/structural body of the Motor Car. The original factory sealant at the joints along the chassis/structural body was also untouched, again indicating that no replacement of the chassis/structural body was carried out; and that the chassis/structural body was originally fitted.

Photo 19 shows the chassis/structural body at the underside rear left of the Motor Car. I did not find any weld marks other than original spot weld marks (yellow arrow) on the chassis/structural body of the Motor Car. The original factory sealant (red arrow) at the joints along the chassis/structural body was untouched, indicating no work was done on the chassis/structural body of the Motor Car and that the chassis/structural body was originally fitted.

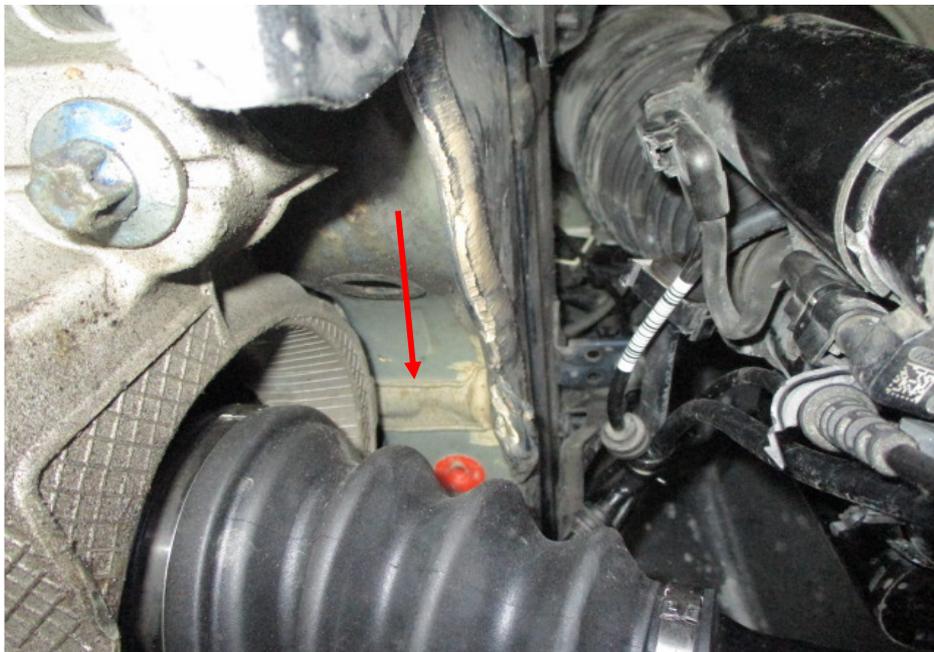
Photo 20 shows the chassis/structural body at the underside front right of the Motor Car. The original factory sealant (arrowed) at the joints along the chassis/structural body was also untouched, indicating no work was done on the chassis/structural body of the Motor Car and that the chassis/structural body was originally fitted.

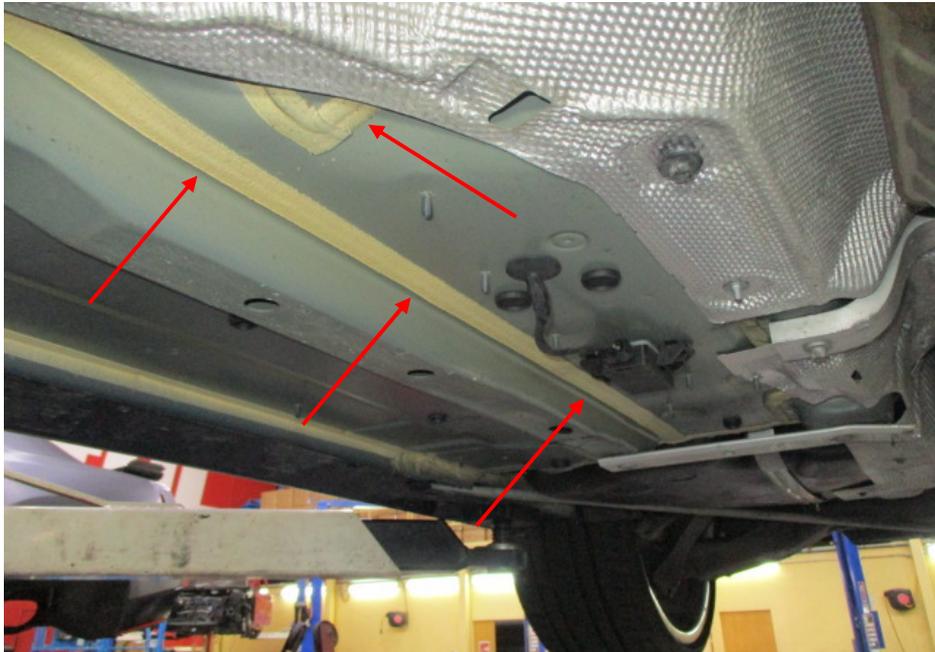
8. The detachable body panels of the Motor Car like the front fenders, front bumper, rear bumper, doors, bonnet and rear bootlid amongst others were all found to be fitted securely.
9. Checks on the non-detachable body panels like the rear fenders, floorboard, roof panel, pillars and rocker panels amongst others, revealed that these body panels were spot welded onto the chassis/structural body of the Motor Car. The original factory sealant at the joints of the non-detachable body panels was all untouched indicating no replacement of the non-detachable body panels was carried out; and that these body panels were all originally fitted.

Photo 21 shows the floorboard at the right underside of the Motor Car. The original factory sealant (arrowed) at the joints along the non-detachable body panels were untouched, indicating no work was done on the non-detachable body panels of the Motor Car; and that these body panels were originally fitted. In general, I had found all the non-detachable body panels of the Motor Car to be originally fitted at the time of my inspection.
