Your Ref: BMW 330i
(chassis number WBA5R12030FH17424)
Our Ref : CI/TP20011896/D

01 November 2020

INSPECTION REPORT OF AN UNREGISTERD BMW 330i MOTOR CAR WITH CHASSIS NUMBER WBA5R12030FH17424

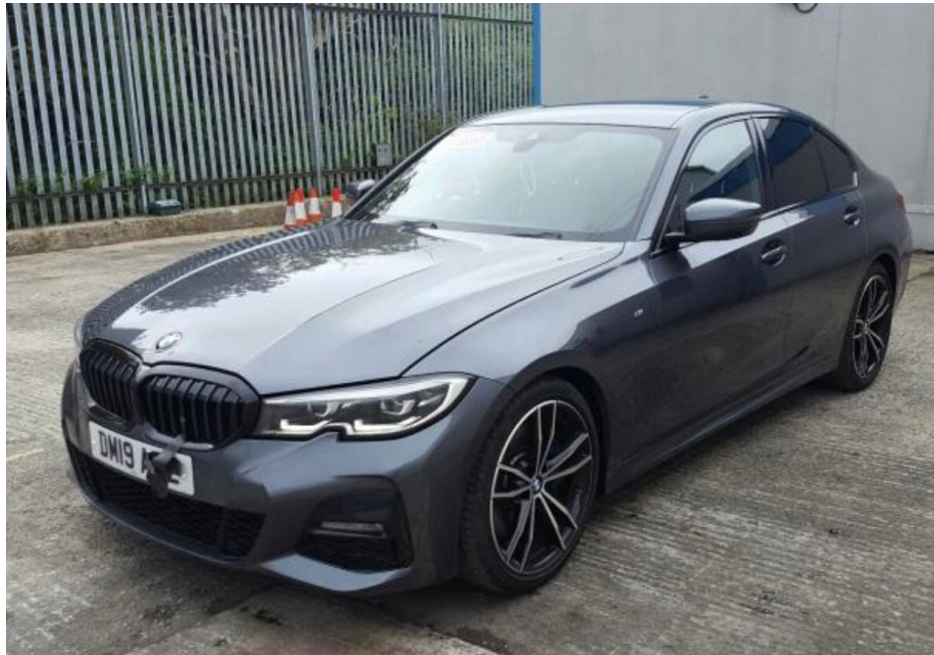
Photo 1 shows the front left body of the Motor Car (photograph provided to me). There was no physical damage seen to the Motor Car from the photographs that were provided to me.

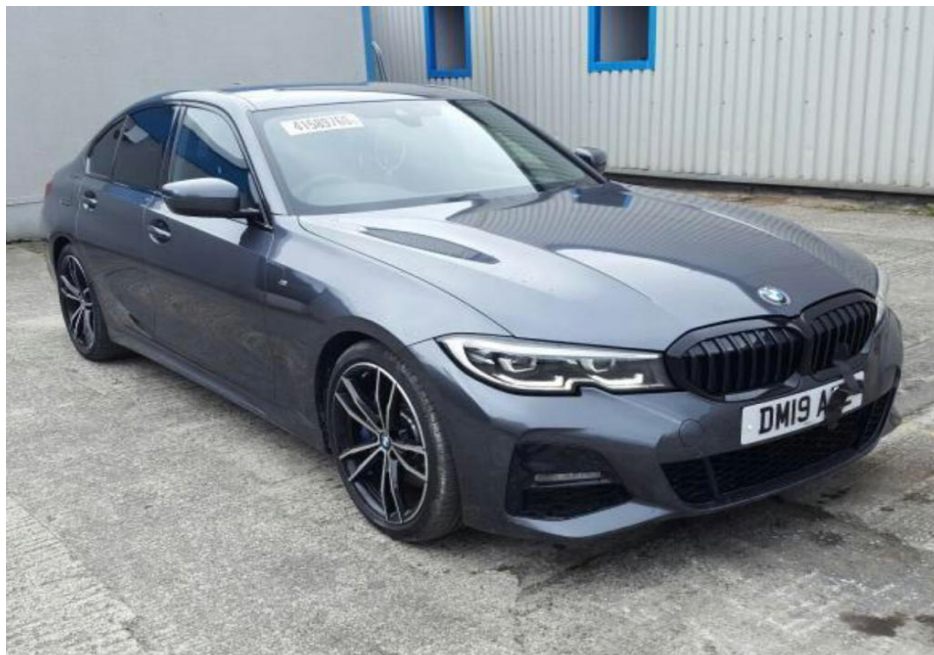
Photo 2 shows the front right body of the Motor Car (photograph provided to me). There was no physical damage seen to the Motor Car from the photographs that were provided to me.

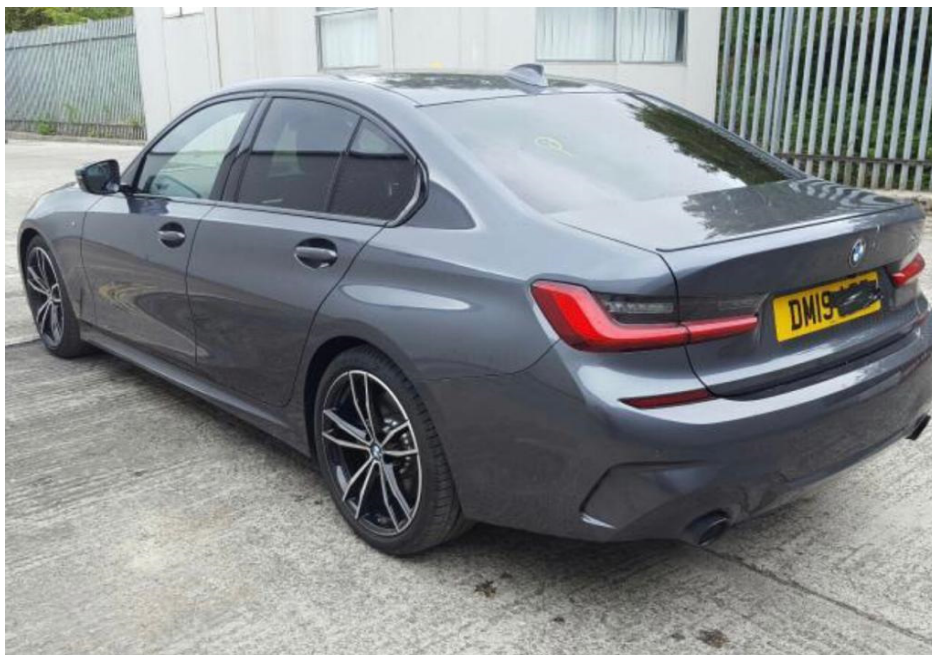
Photo 3 shows the rear left body of the Motor Car (photograph provided to me). There was no physical damage seen to the Motor Car from the photographs that were provided to me.

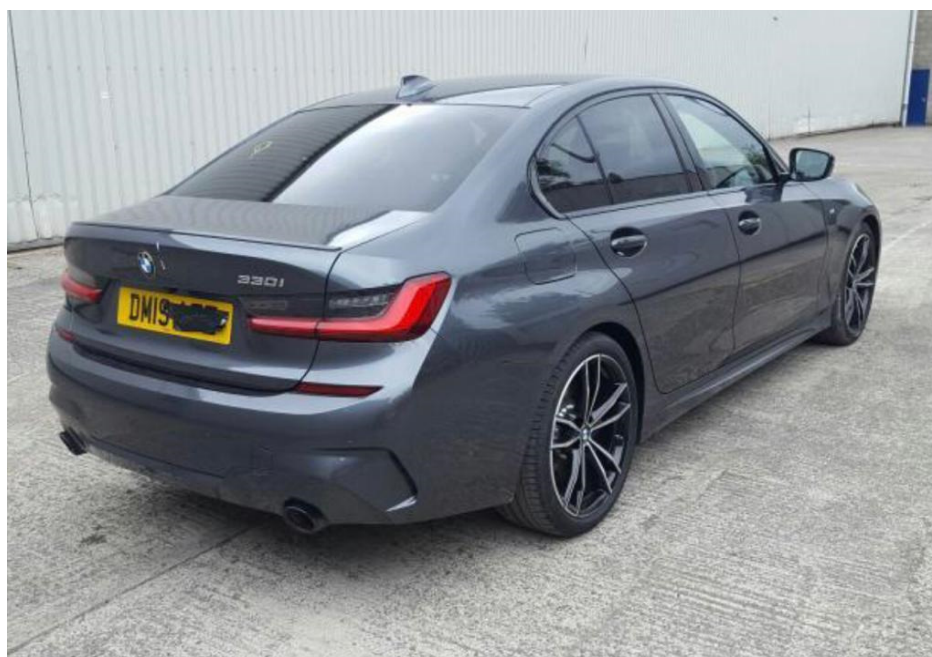
Photo 4 shows the rear right body of the Motor Car (photograph provided to me). There was no physical damage seen to the Motor Car from the photographs that were provided to me.

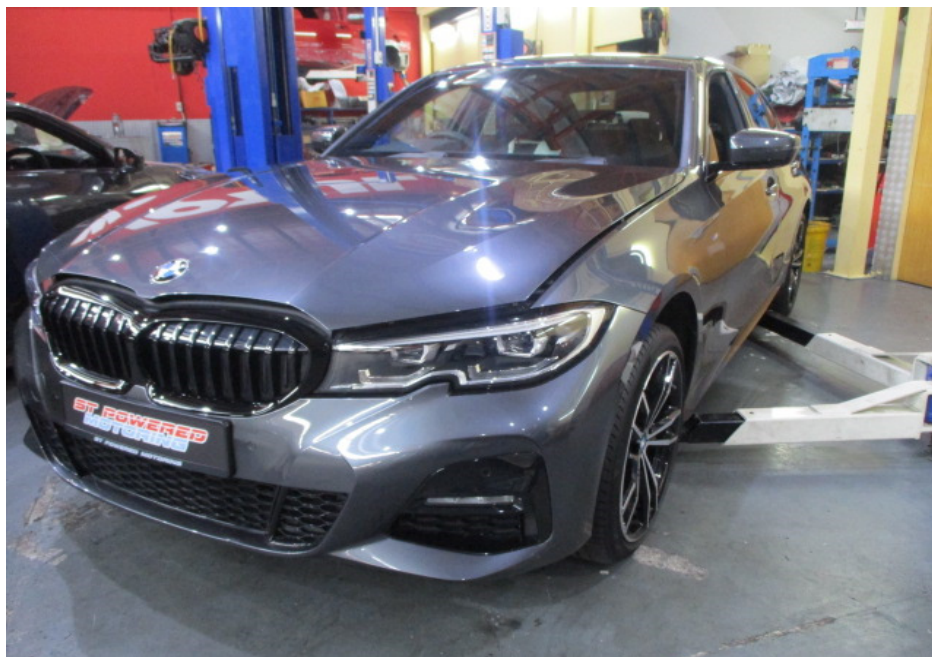
Photo 5 shows a general view of the front left body of the Motor Car at the time of my inspection. The Motor Car was observed to be in a relatively good general condition with no loose exterior fittings observed.

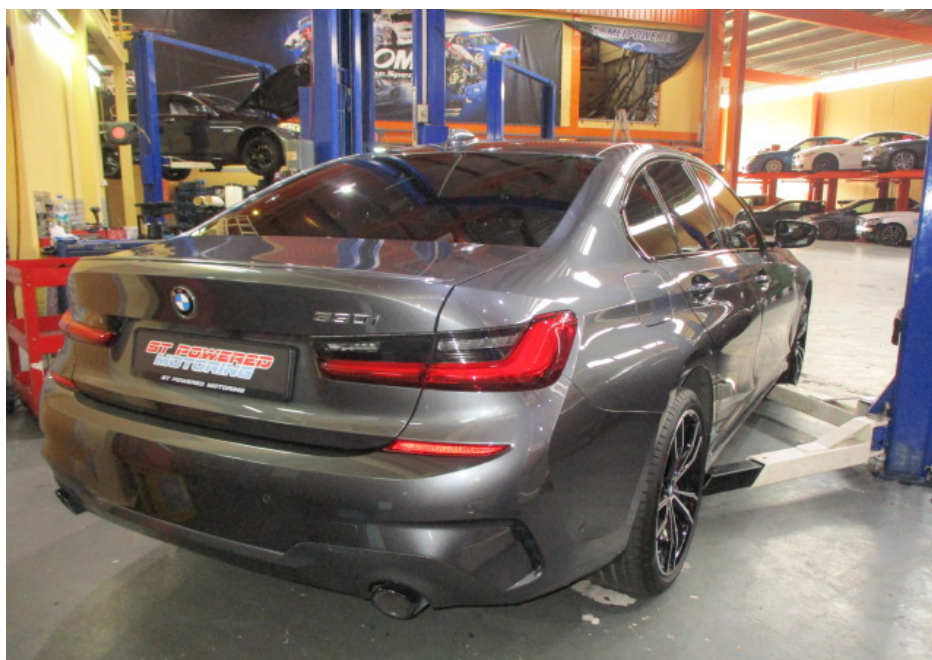
Photo 6 shows a general view of the rear right body of the Motor Car at the time of my inspection. The Motor Car was observed to be in a relatively good general condition with no loose exterior fittings observed. The mileage of the Motor Car recorded at the time of my inspection was 9,107km.

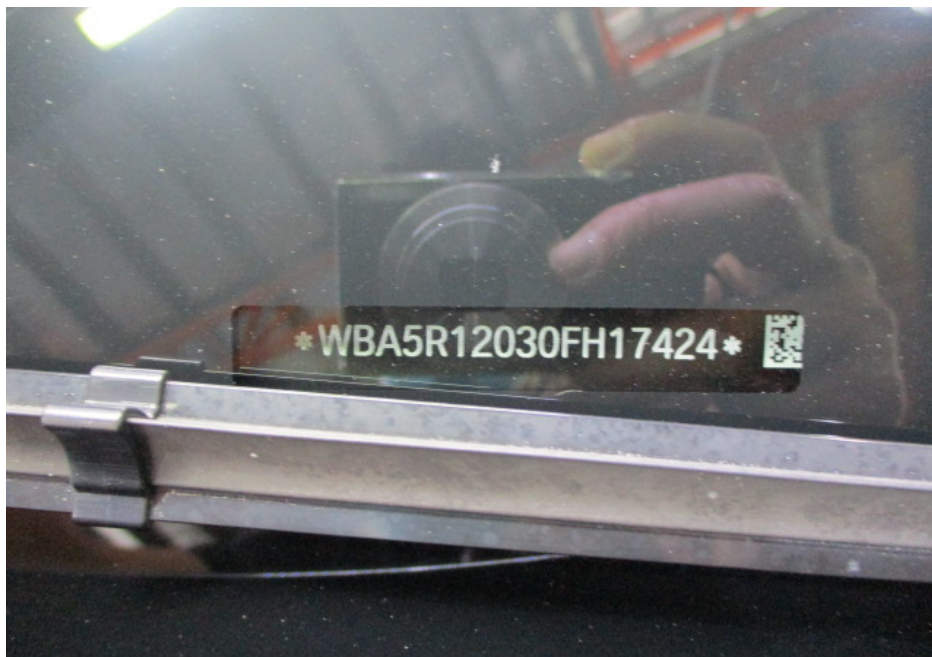
Photo 7 shows the chassis number of the Motor Car. The chassis number recorded was WBA5R12030FH17424.

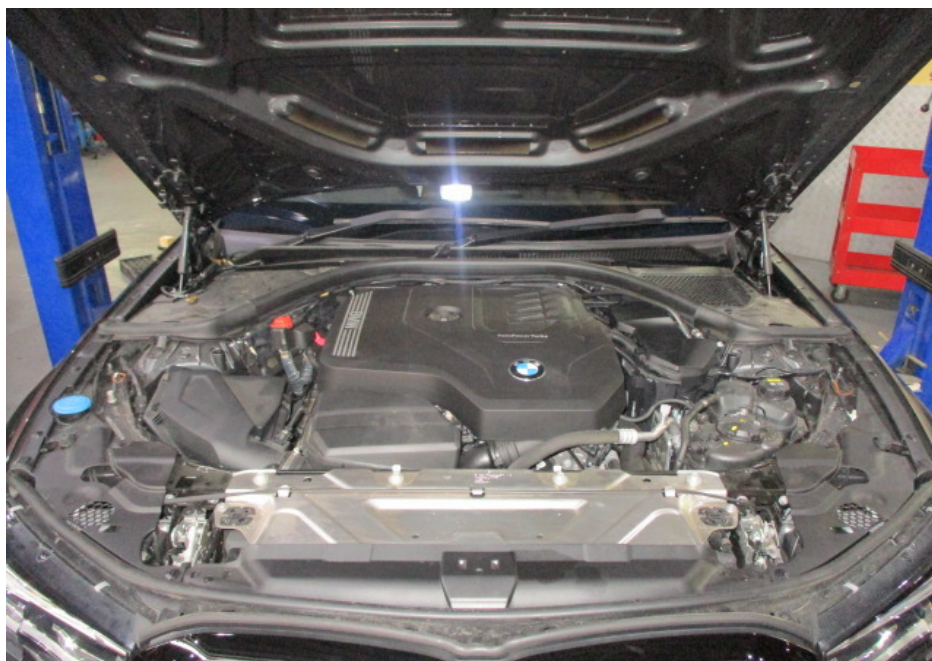
13. My examination of the engine compartment of the Motor Car revealed that the various parts and components inside the engine compartment were all intact and properly fitted. The engine oil, brake fluid and engine coolant were all found to be of sufficient level for operating purposes. Visually, there was also no contamination found to these fluids.
14. My checks on the underside of the Motor Car revealed no sign(s) or indication(s) of fluid leakage and/or fluid stain(s). The engine block and automatic transmission assembly were both secured properly. All undercarriage components of the Motor Car were also observed to be intact and secured in an appropriate manner.

Photo 8 shows a general view of the engine compartment of the Motor Car at the time of my inspection. The various parts and components inside the engine compartment were all observed to be intact and properly fitted. There was also no sign(s) or indication(s) of fluid leak and/or fluid stain found inside the engine compartment.

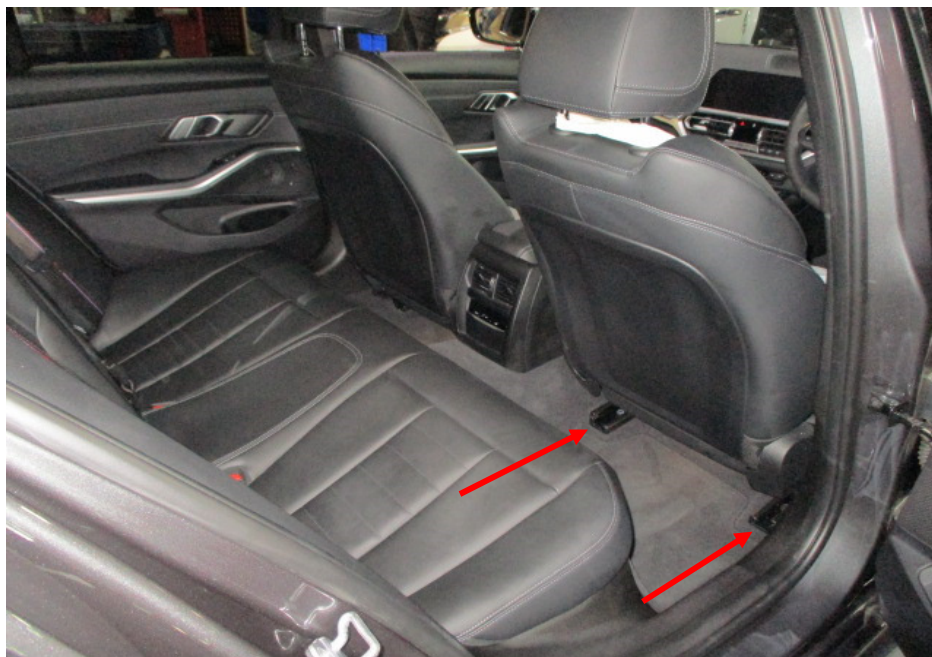
11. The seats of the Motor Car were found to be secured to the floorboard of the Motor Car via seat rails bolted onto the floorboard. Retractable seat belt reels and pre-tensioners were fitted on all seats of the Motor Car. The seat belt reels were tested and were able to be fastened securely into the respective pre-tensioners that were fixed to the side of all the seats.

Photo 9 shows the seats of the Motor Car, which were secured via seat rails (arrowed) to the floorboard. All the seats of the Motor Car were fitted with a retractable seat belt reel and pre-tensioner. The seat belts were tested and able to be fastened into the respective pre-tensions that were fitted on the side of each individual seat.

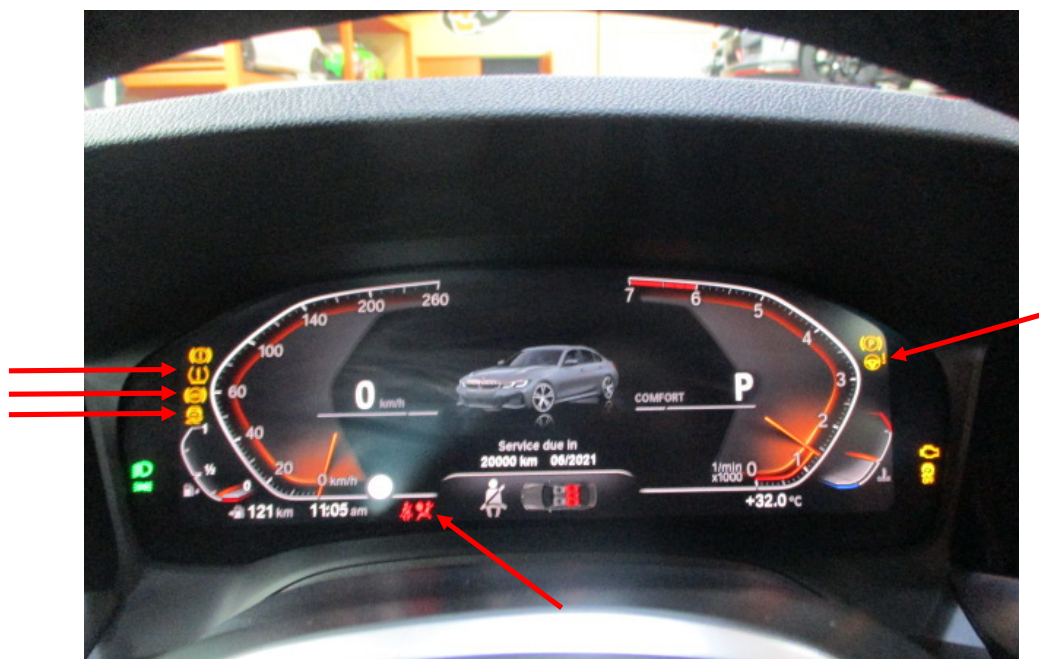
Photo 10 shows the warning lights for the various electronic safety features appearing on the instrument panel of the Motor Car during its self-test when the engine is cranked, in particular the ABS, SRS, IAS, TPM and DSC lights (arrowed).

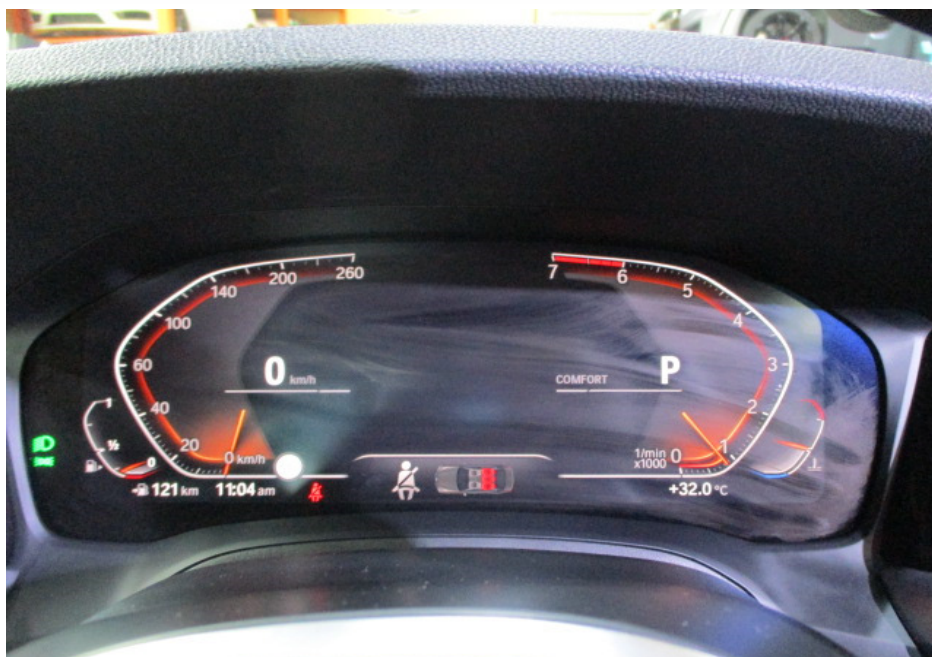
12. The Motor Car's automatic self-test of the functionality of its various electronic safety features like the Anti-Lock Brake System (ABS), Supplemental Restraint System (SRS), Integral Active Steering (IAS), Tyre Pressure Monitor (TPM) and Dynamic Stability Control (DSC) during cranking of the engine had indicated that these electronic systems were in working condition. This was determined from the respective warning lights disappearing from the instrument panel after the self-test.

Photo 11 shows the respective warning lights no longer illuminated, indicating that there is no fault detected to the ABS, SRS, IAS, TPM and DSC systems of the Motor Car during the self-test. These electronic systems were hence in working condition at the time of my inspection.

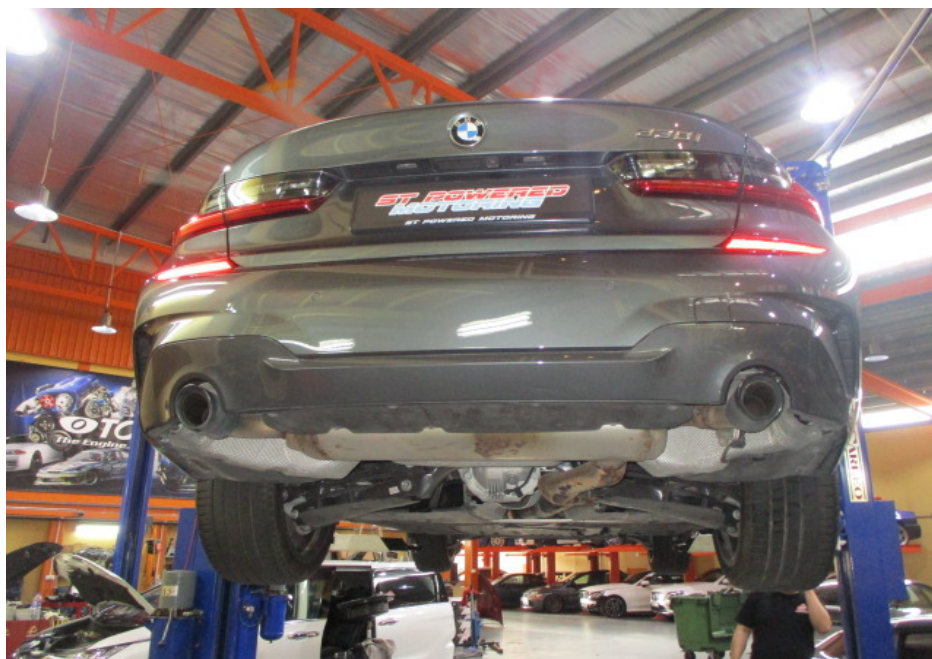
Photo 12 shows the Motor Car hoisted up for checks on its undercarriage. There was no sign(s) or indication(s) of fluid leakage and/or fluid stain(s) on the underside of the Motor Car. The undercarriage components of the Motor Car were also all observed to be intact and secured in an appropriate manner.

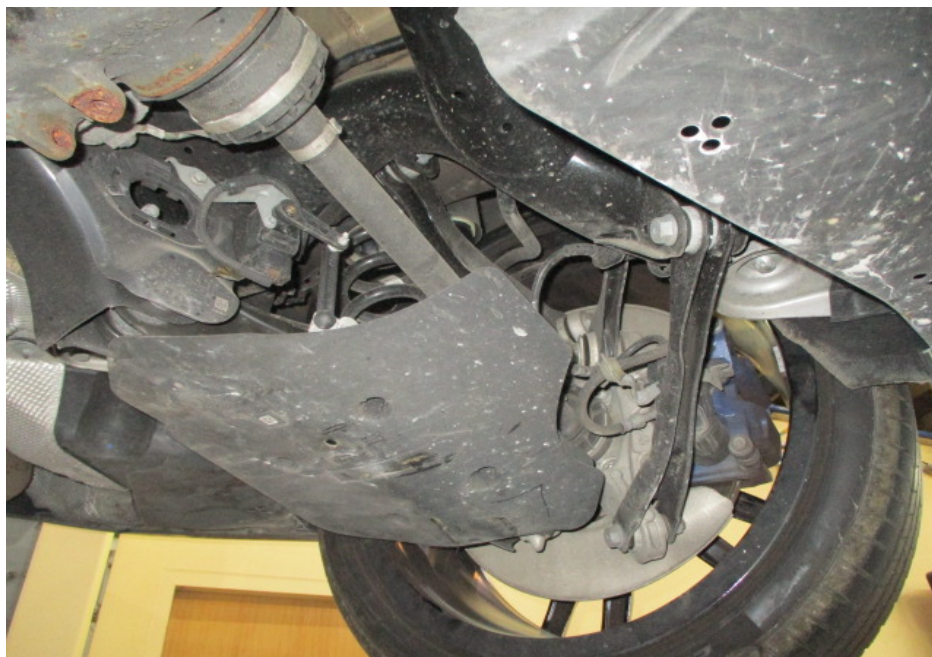
Photo 13 shows a general view of the control arms and linkages at the rear left wheel of the Motor Car. I did not observe any fluid leak and/or fluid stain on the underside of the Motor Car. All of the Motor Car's undercarriage components were observed to be intact and secured in an appropriate manner.

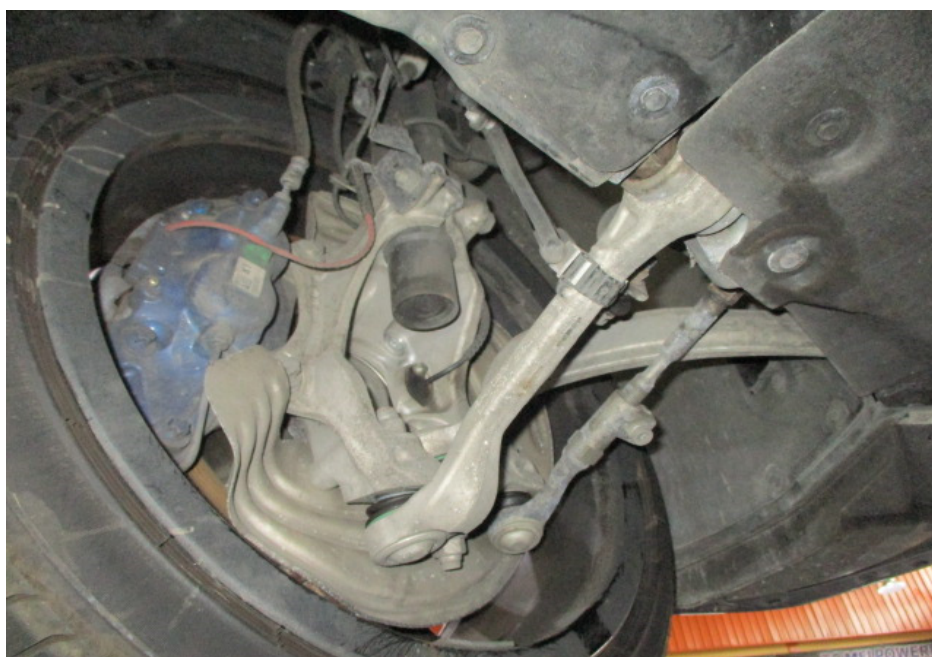
Photo 14 shows the various undercarriage components at the front left wheel of the Motor Car. The mechanical components, control arms and linkages were all found to be intact and secured in an appropriate manner.

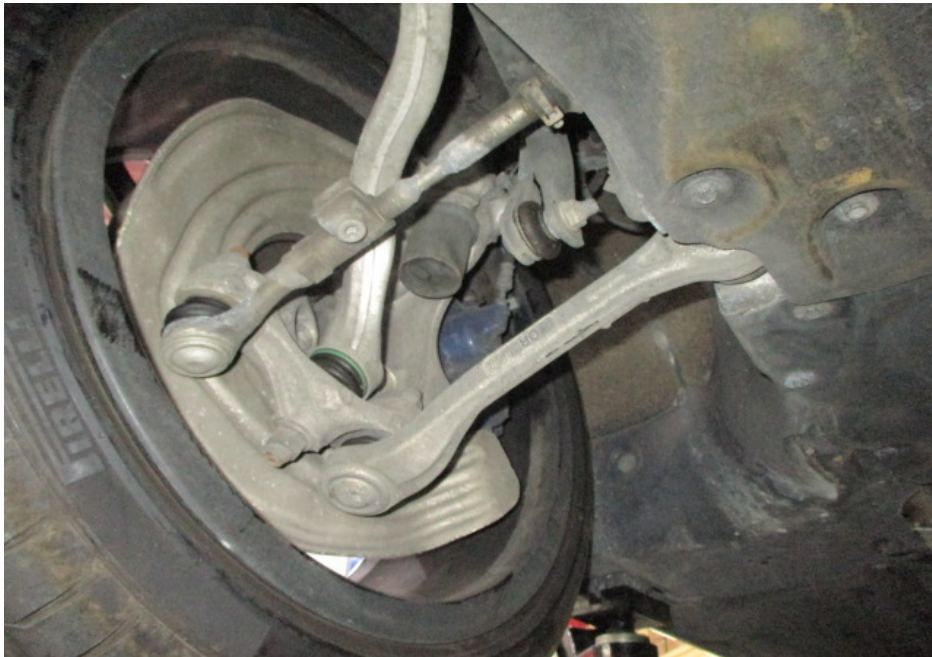
Photo 15 shows the various undercarriage components at the front right wheel of the Motor Car. The mechanical components, control arms and linkages were all found to be intact and secured in an appropriate manner. I also did not observe any fluid leak and/or fluid stain on the underside of the Motor Car.

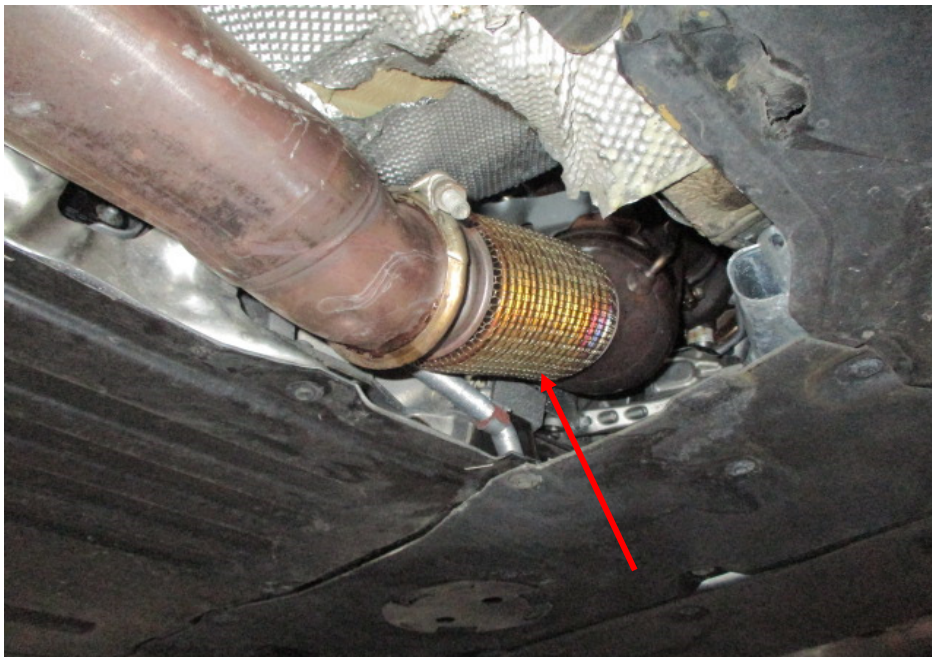
Photo 16 shows the Motor Car's catalytic converter (arrowed). My examination of the Motor Car's exhaust system revealed no sign(s) or indication(s) of any cut or weld marks along its exhaust pipes and on its rear muffler.

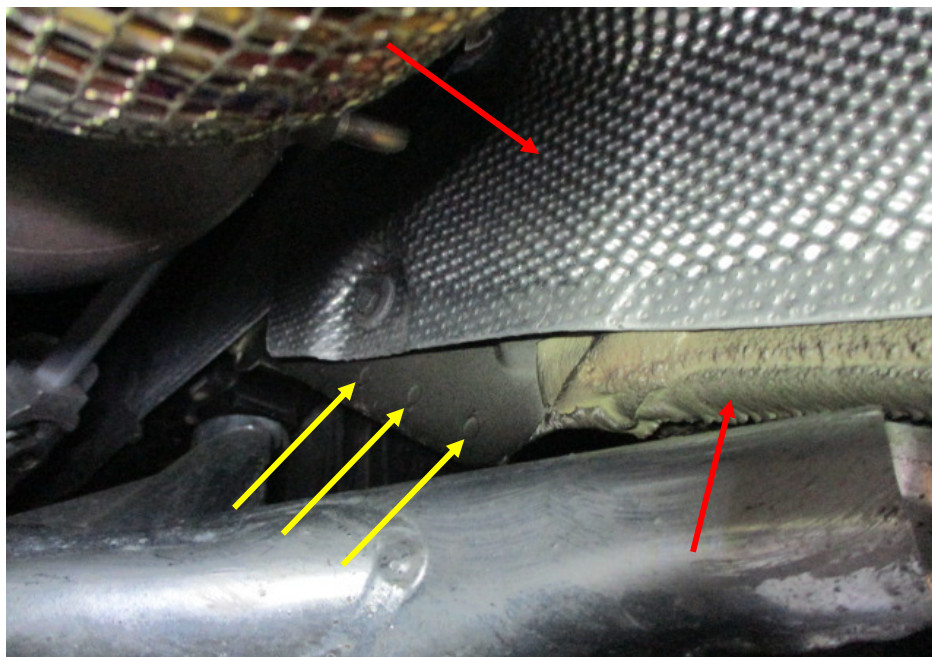
10. Visually, I did not find any weld marks, other than the original spot weld marks, on the chassis/structural body of the Motor Car. The original factory sealant at the joints along the chassis/structural body was also untouched, again indicating that no replacement of the chassis/structural body was carried out; and that the chassis/structural body was originally fitted.

Photo 17 shows the chassis/structural body at the underside front left of the Motor Car. I did not find any weld marks other than original spot weld marks (yellow arrow) on the chassis/structural body of the Motor Car. The original factory sealant (red arrow) at the joints along the chassis/structural body was untouched, indicating no work was done on the chassis/structural body of the Motor Car and that the chassis/structural body was originally fitted.

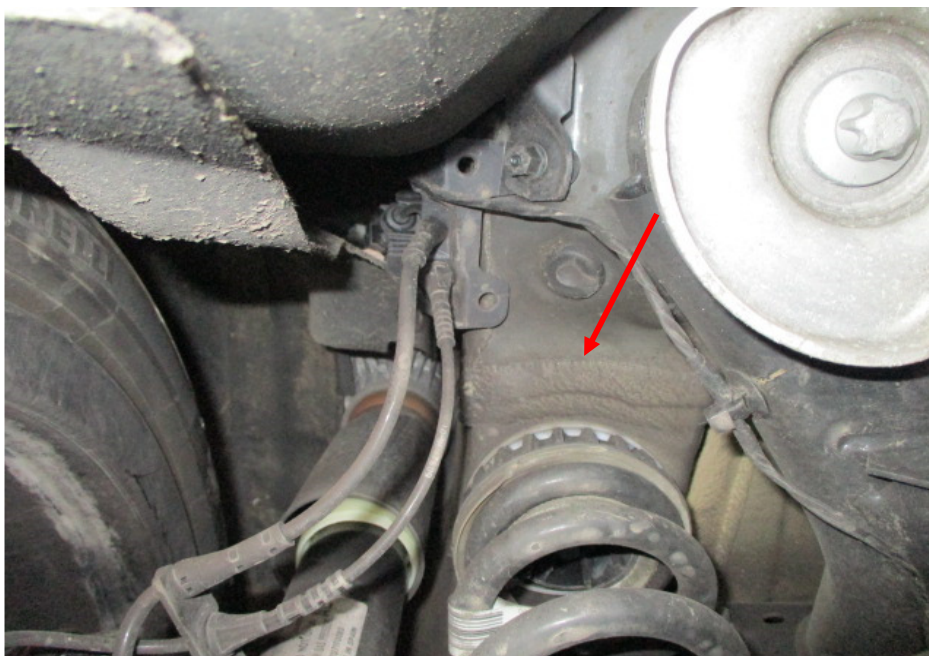
Photo 18 shows the chassis/structural body at the underside rear left of the Motor Car. The original factory sealant (arrowed) at the joints along the chassis/structural body was also untouched, indicating no work was done on the chassis/structural body of the Motor Car and that the chassis/structural body was originally fitted.

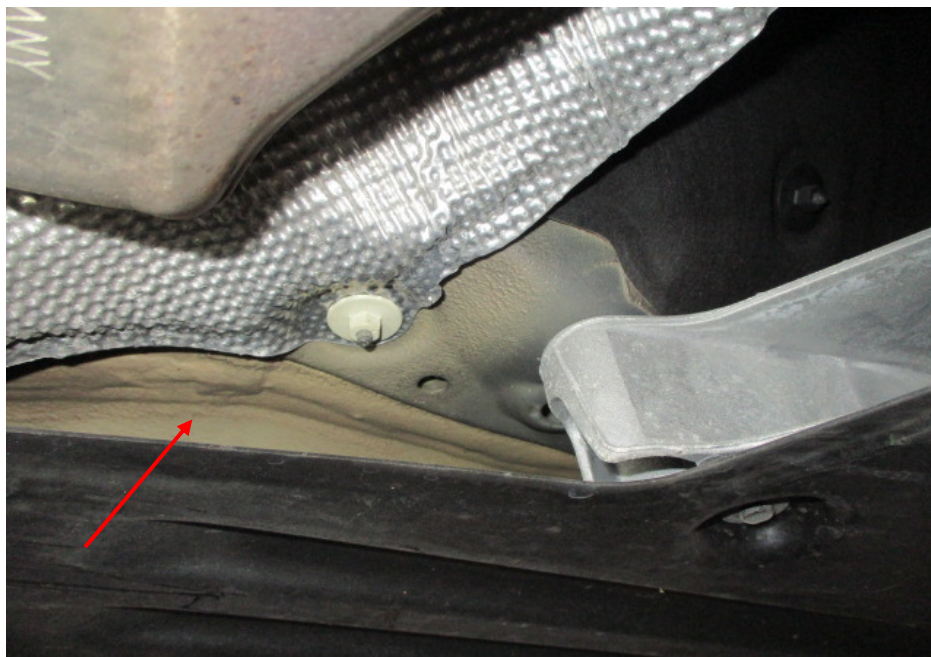
Photo 19 shows the floorboard at the underside centre left of the Motor Car. The original factory sealant (arrowed) at the joints along the non-detachable body panels were untouched, indicating no work was done on the non-detachable body panels of the Motor Car; and that these body panels were originally fitted. In general, I had found all the non-detachable body panels of the Motor Car to be originally fitted at the time of my inspection.
