Our Ref : TP / TJCC SGS8228A/ 10.03/20

## **DAMAGED VEHICLE (SGS 8228 A) INSPECTION REPORT (WITHOUT PREJUDICE)**

Registration No	: SGS 8228 A	Mileage	: 48672 Km
Make & Model	: MERCEDES BENZ S400	Engine No	: 27696030683360
Date of Registration	: 2 <sup>nd</sup> Oct 2014	Chassis No.	: WDD2221572A081823
Colour	: Silver	Engine Capacity	: 3,498 cc

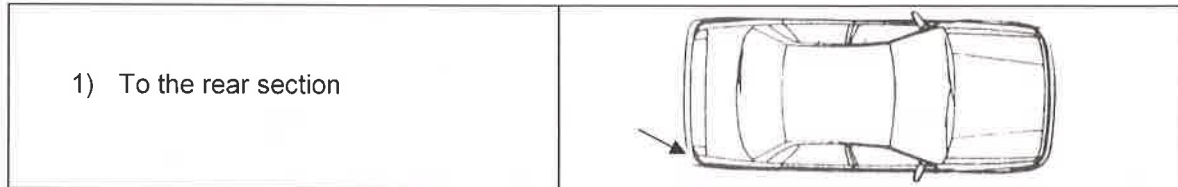
**(E) Point of Impact**

The impact of the collision has damaged/affected the rear bumper, rear bumper sensor, tail pipe cover and etc.

Our adjusted cost of lump sum repair is **\$3,750.00** and an estimated **3** days is required to repair the vehicle. Please refer to the Annex for a detailed account of the cost estimates.
