LKK Auto Consultants Pte Ltd

Vehicle No. GBD 5769M

ADJUSTMENT ON REPAIR COST FOR VEHICLE NO. GBD 5769M

PHOTOGRAPHS FOR VEHICLE NO. GBD 5769M

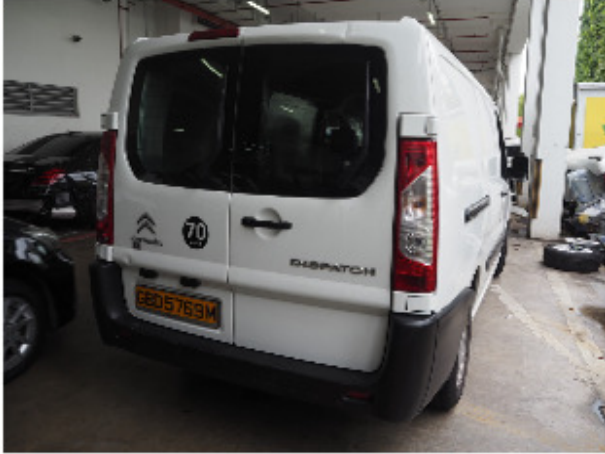
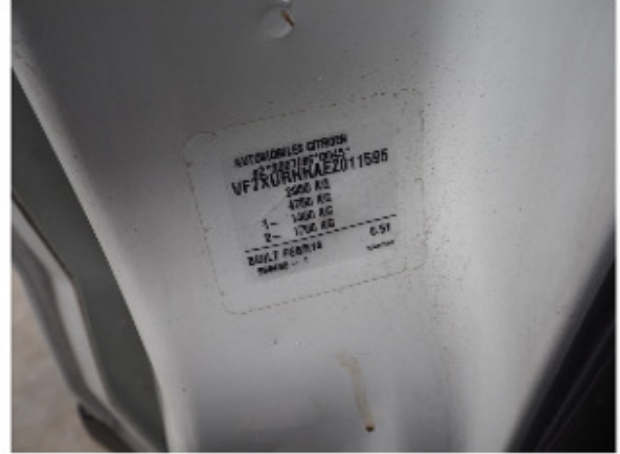
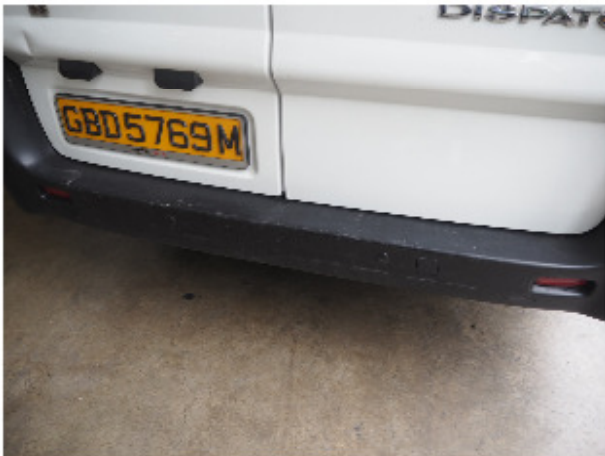
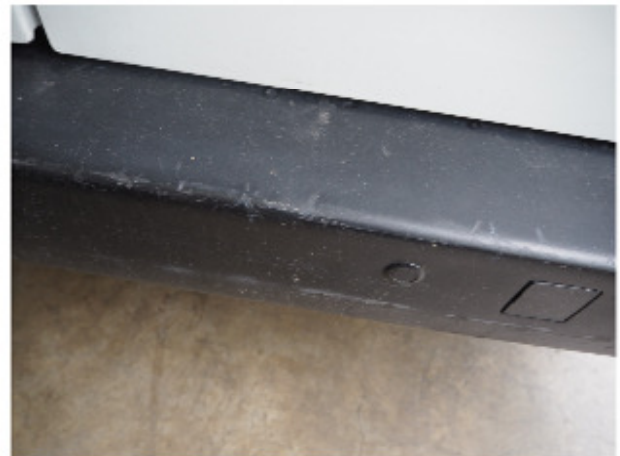
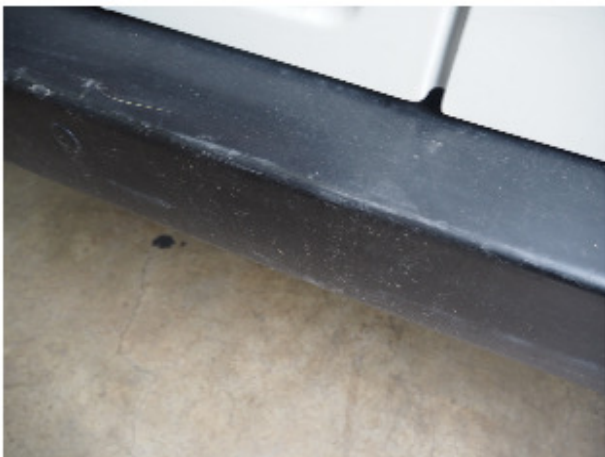
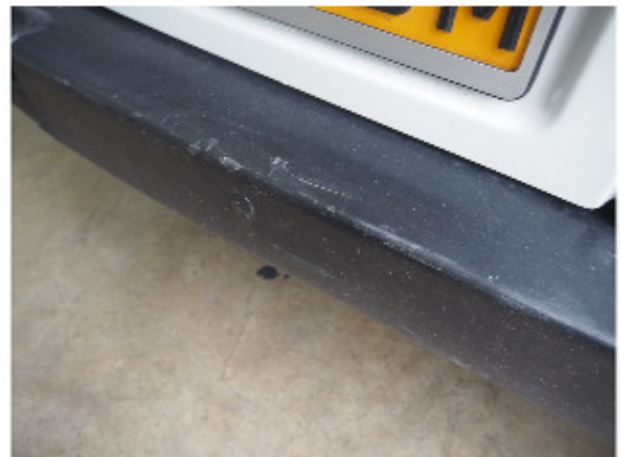
INSPECTION

THE VEHICLE SUSTAINED DAMAGES AT THE REAR PORTION. DAMAGES SEE DETAILS.
--
