### VEHICLE DAMAGE INSPECTION REPORT

Our Ref: 677/TP/2019

Date of loss: 5/12/2019  
Claimant: Rigging and Marine Services Pte Ltd

| Reg No: | YN2935U | Make & | Mitsubishi |

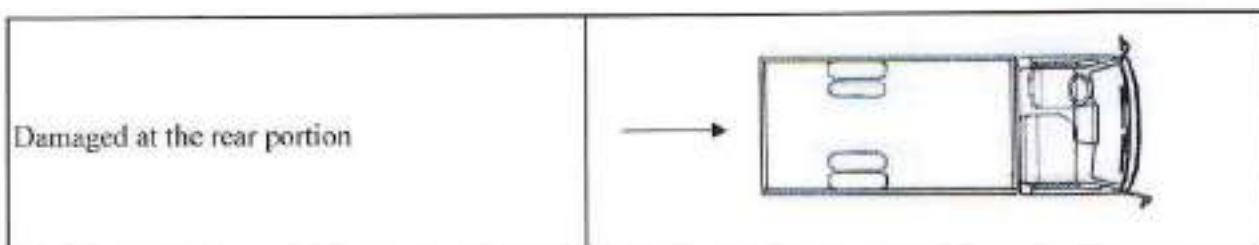
### POINT OF IMPACT

The Insured's vehicle collided onto the Third Party's vehicle along Tuas Road.

Our visual inspection of the vehicle revealed that the damages noted are at the rear portion.
