Your Ref: Honda Engine  
(number K20A5801775)  
Our Ref : CI/TP20012166/D

09 November 2020

**INSPECTION REPORT OF A HONDA ENGINE WITH NUMBER K20A5801775**

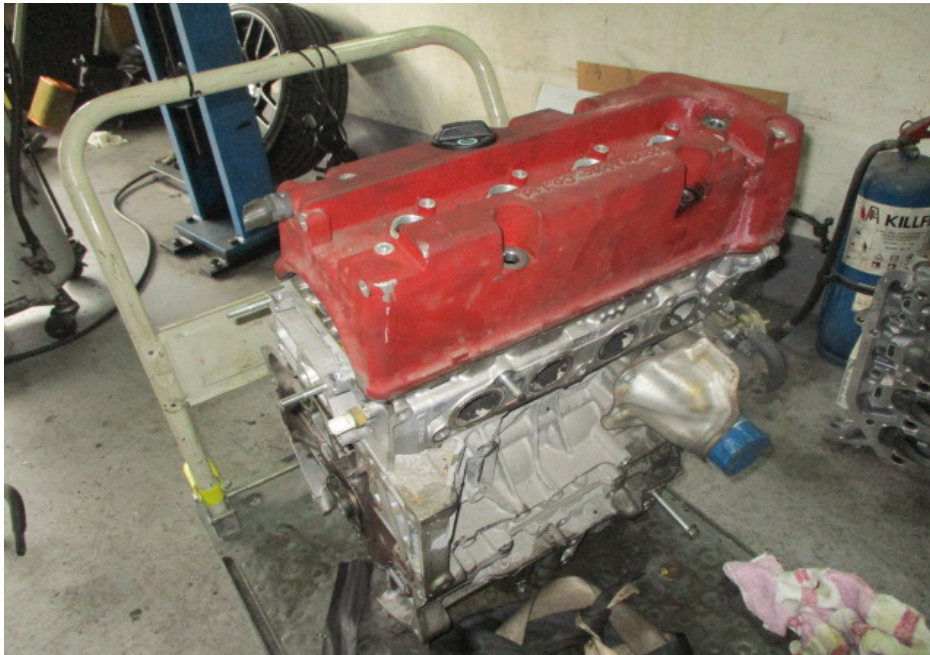
**Photo 1** shows a general view of the Honda engine that I had inspected. The Honda engine was observed to be a used engine and was not fitted on any motor car. It was also observed to be a complete assembly with all mechanical parts still intact, within the engine housing.

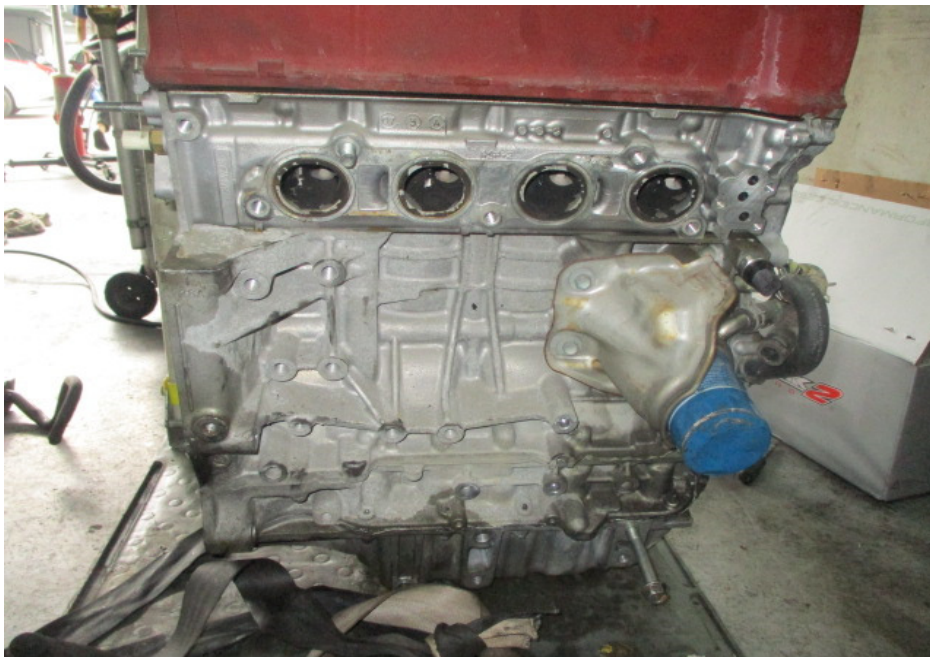
**Photo 2** shows a general view of the Honda engine that I had inspected. My visual examination of the engine housing revealed the housing to be of serviceable/satisfactory condition. There was no crack and/or hole observed on the engine housing.

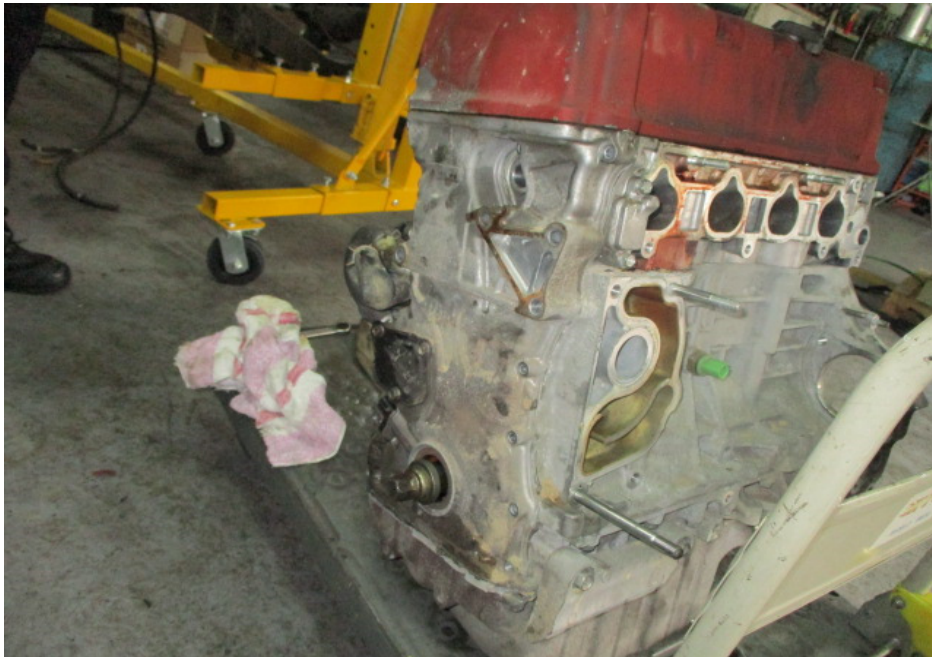
**Photo 3** shows a general view of the Honda engine that I had inspected. My visual examination of the engine housing revealed the housing to be of serviceable/satisfactory condition. There was no crack and/or hole observed on the engine housing.

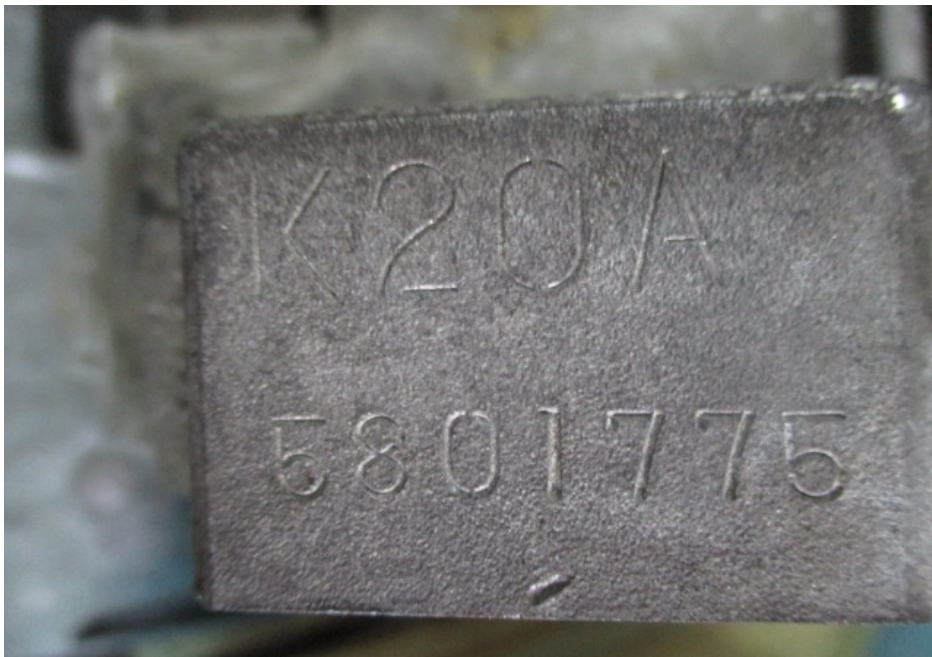
**Photo 4** shows the engine number engraved on the housing of the Honda engine that I had inspected. The engine number was K20A5801775.

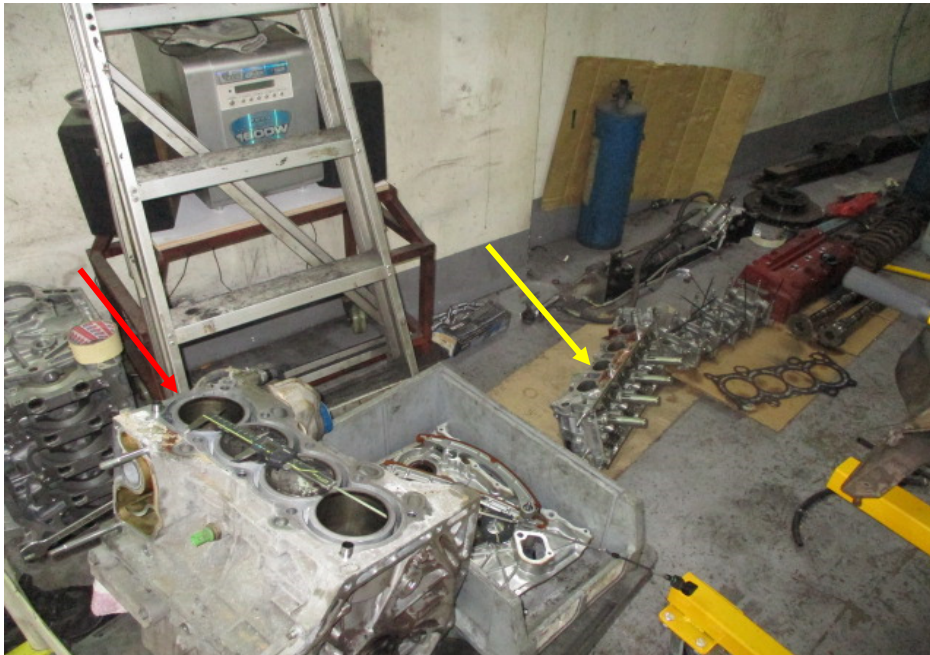
**Photo 5** shows the top block (red arrow) of the Honda engine separated from its bottom block (yellow arrow). This was to enable me to carry out measurements of its cylinders, in particular the bore and stroke measurements of each cylinder, which typically can be used to determine the engine displacement or more commonly referred to as engine cc.

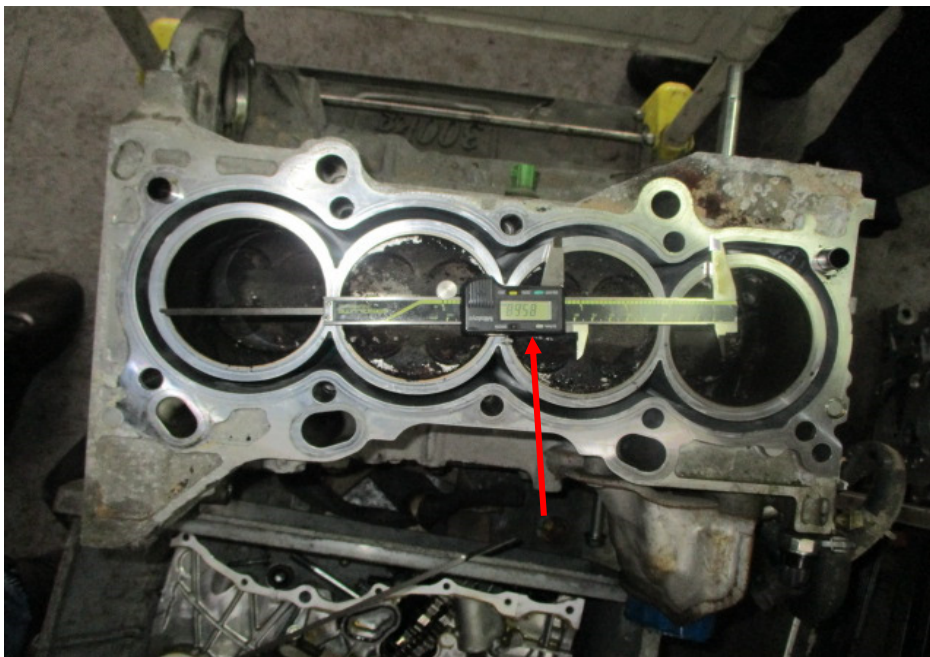
**Photo 6** shows the bottom block of the Honda engine and the digital Vernier Caliper (arrowed) that was used to measure the bore and stroke measurements of each cylinder, which typically can be used to determine the engine displacement or more commonly referred to as engine cc. The digital Vernier Caliper was calibrated before the start of the measurements.

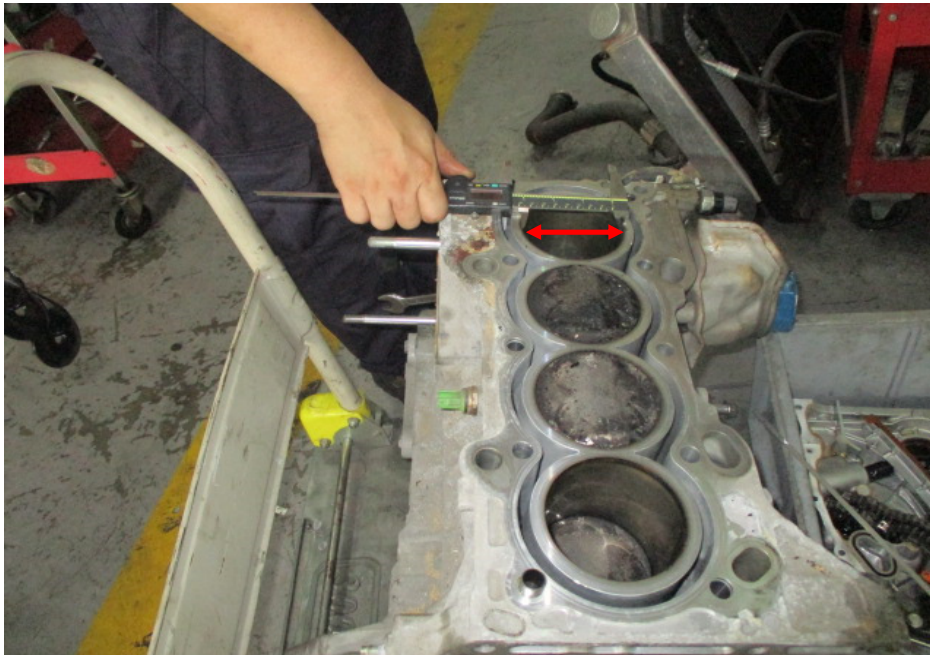
**Photo 7** shows measurement being carried out to the bore (arrowed) of cylinder 1 of the Honda engine. The measurements were carried out using a digital Vernier Caliper that was calibrated before the start of the measurements.

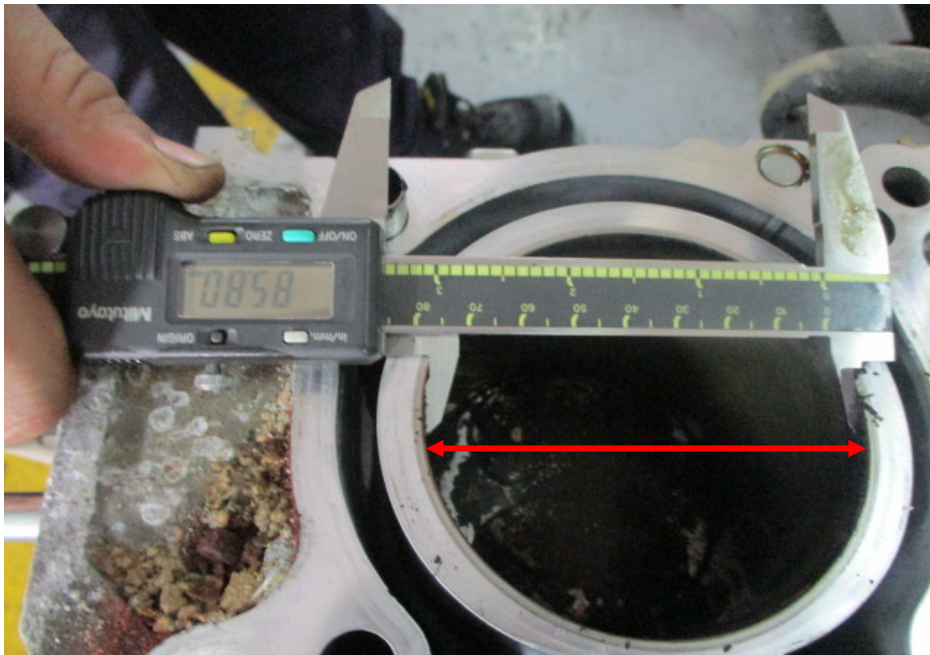
**Photo 8** shows the bore measurement of cylinder 1, which was recorded to be 85.80mm.

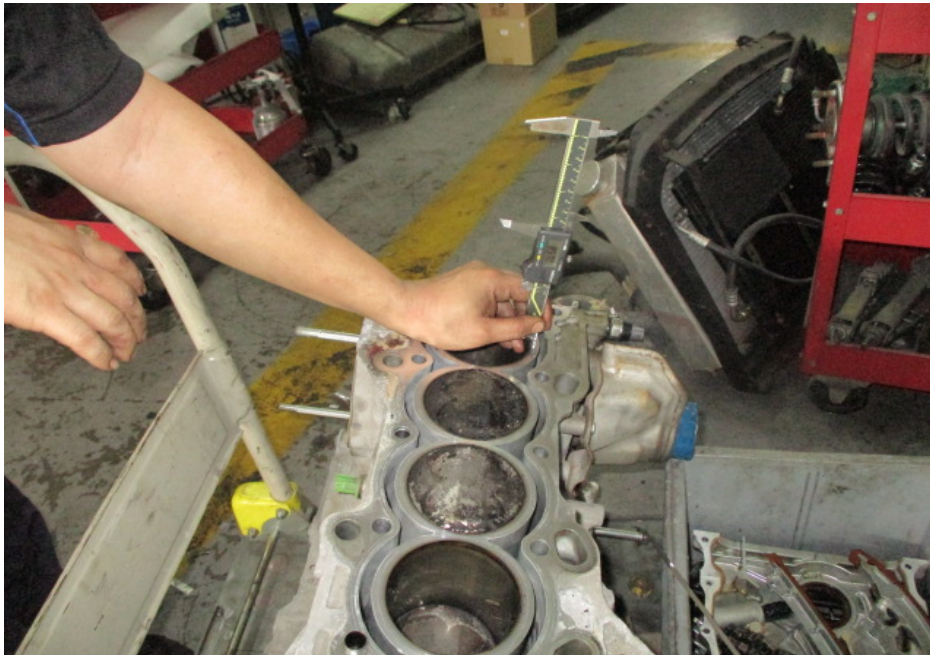
**Photo 9** shows measurement being carried out to the stroke of cylinder 1 of the Honda engine. The bore and stroke measurements of the Honda engine were carried out using a digital Vernier Caliper.

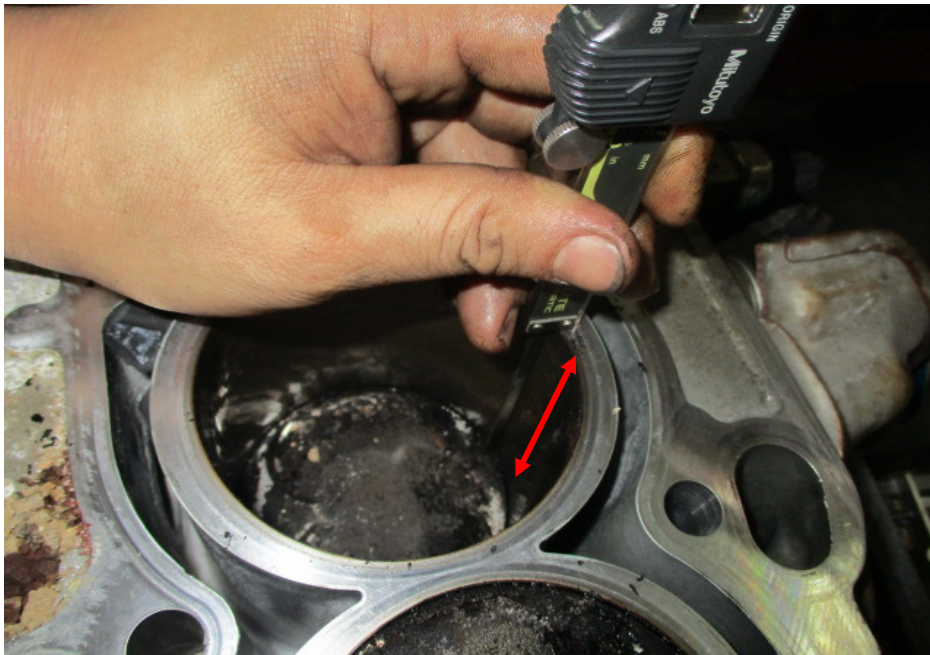
**Photo 10** shows measurement being carried out to the stroke (arrowed) of cylinder 1 of the Honda engine. The bore and stroke measurements of the Honda engine were carried out using a digital Vernier Caliper that was calibrated before the start of the measurements,

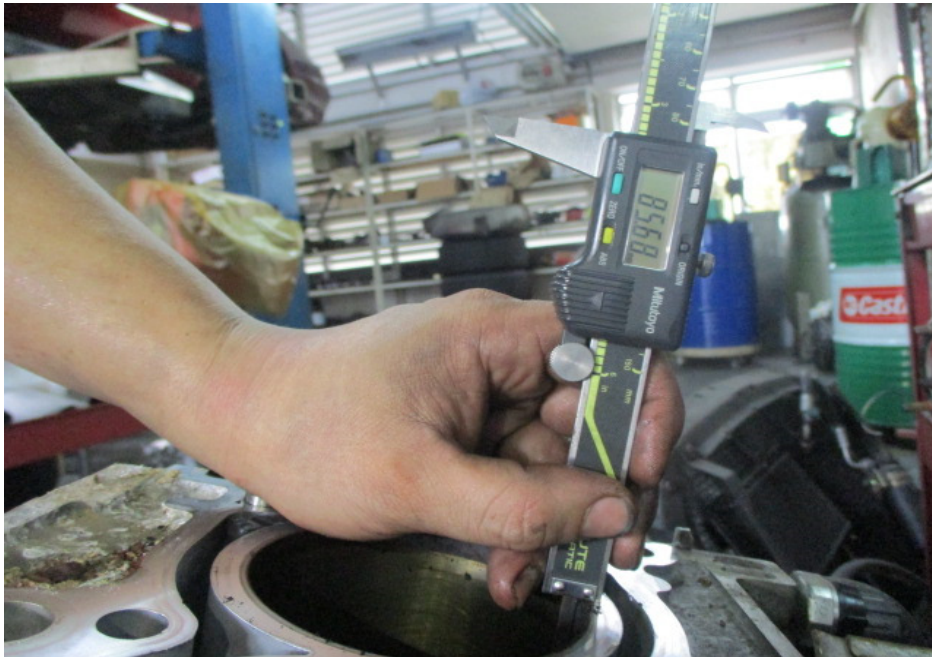
**Photo 11** shows the stroke measurement of cylinder 1, which was recorded to be 85.68mm.

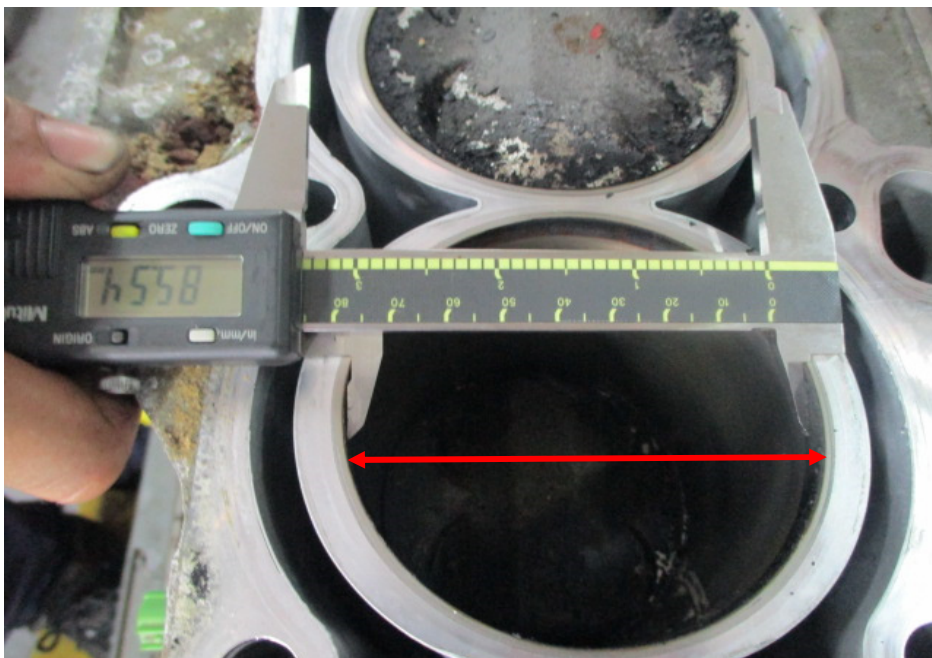
**Photo 12** shows measurement being carried out to the bore (arrowed) of cylinder 2 of the Honda engine. The bore measurement of cylinder 2 was recorded to be 85.54mm.

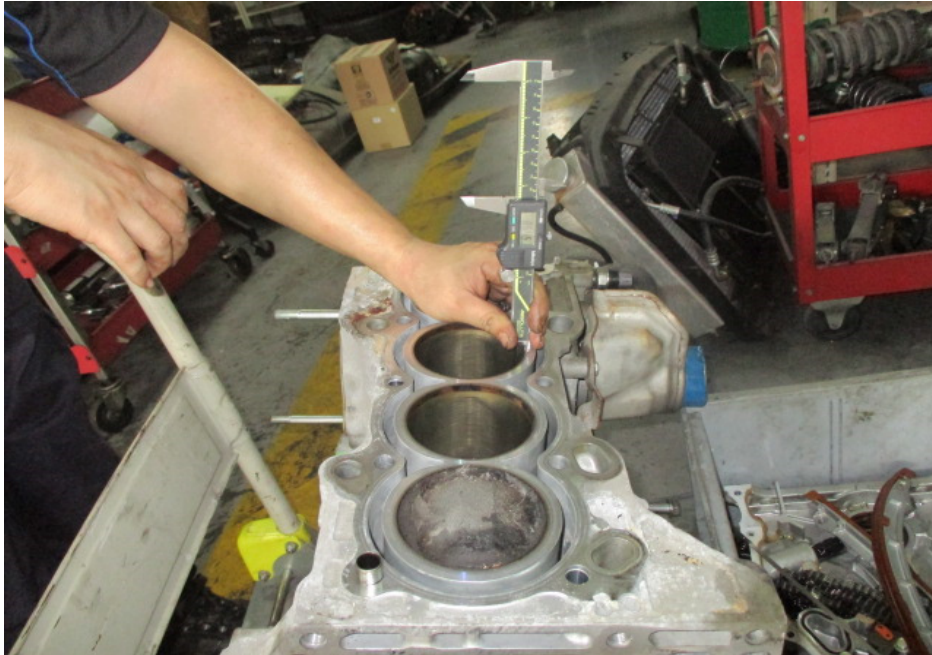
**Photo 13** shows measurement of the stroke for cylinder 2 of the Honda engine that I had inspected.

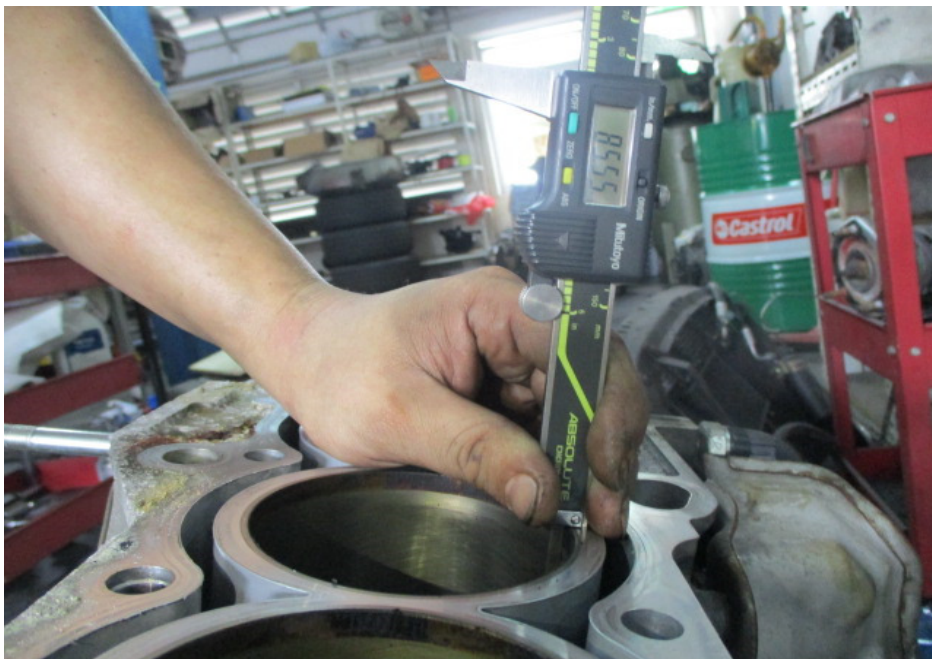
**Photo 14** shows the stroke measurement of cylinder 2, which was recorded to be 85.55mm.

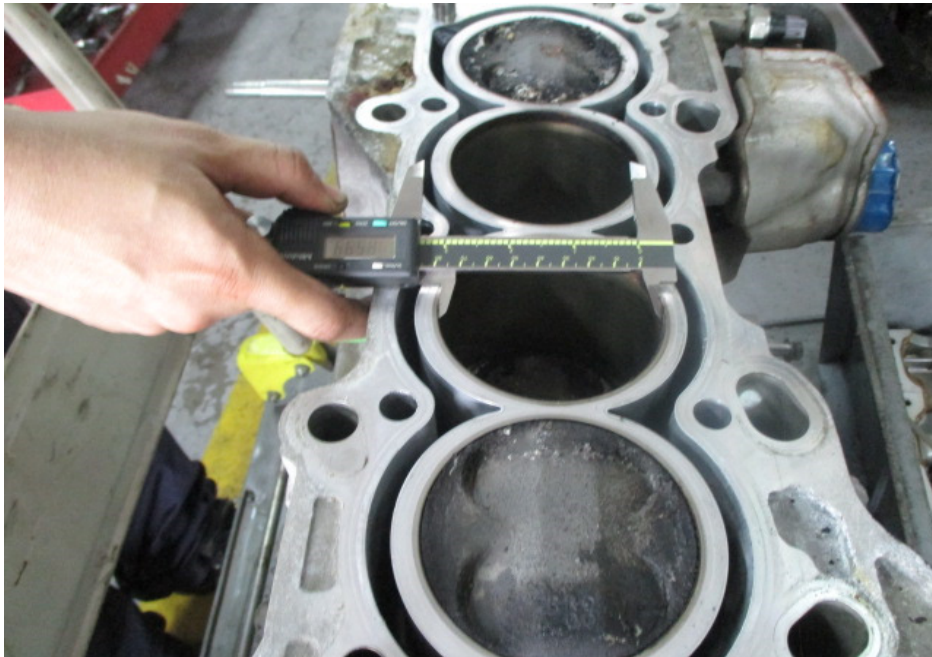
**Photo 15** shows measurement being carried out to the bore of cylinder 3 of the Honda engine. The bore and stroke measurements of the Honda engine were carried out using a digital Vernier Caliper.

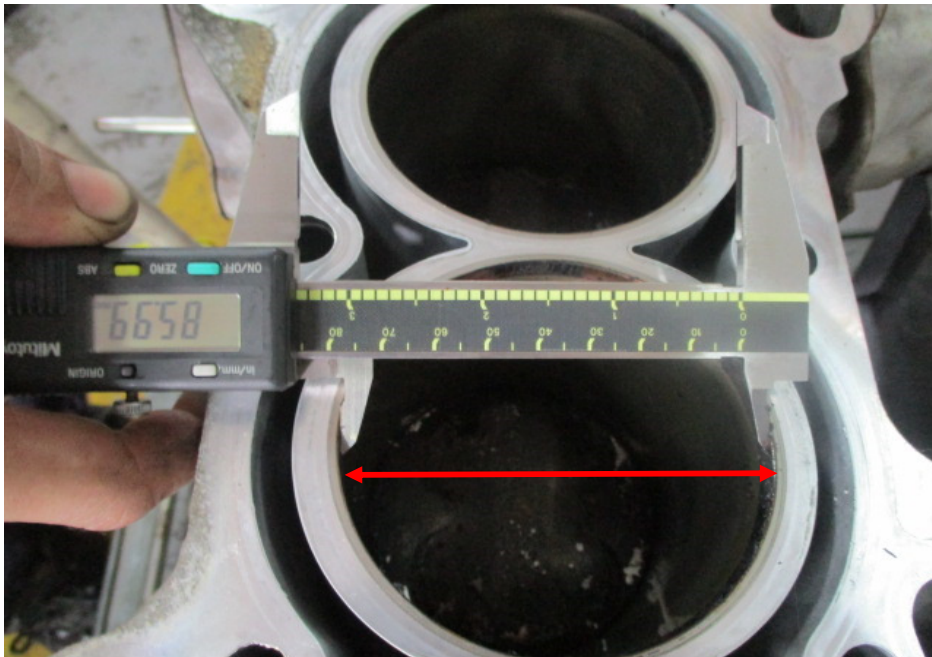
**Photo 16** shows measurement being carried out to the bore (arrowed) of cylinder 3 of the Honda engine. The bore measurement of cylinder 3 was recorded to be 85.99mm.

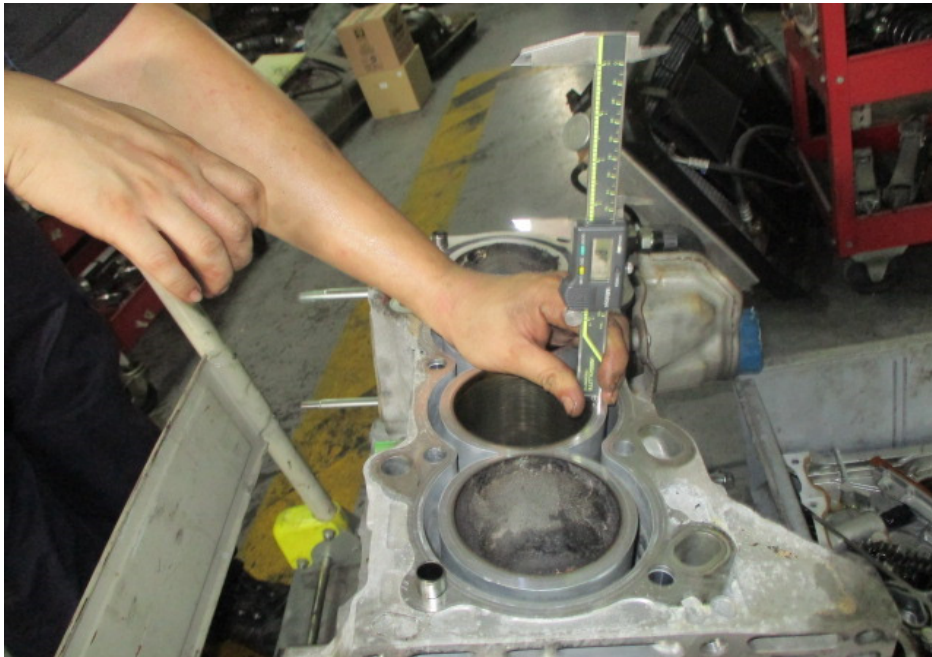
**Photo 17** shows measurement of the stroke for cylinder 3 of the Honda engine that I had inspected. The bore and stroke measurements of the Honda engine were carried out using a digital Vernier Caliper that was calibrated before the start of measurements.

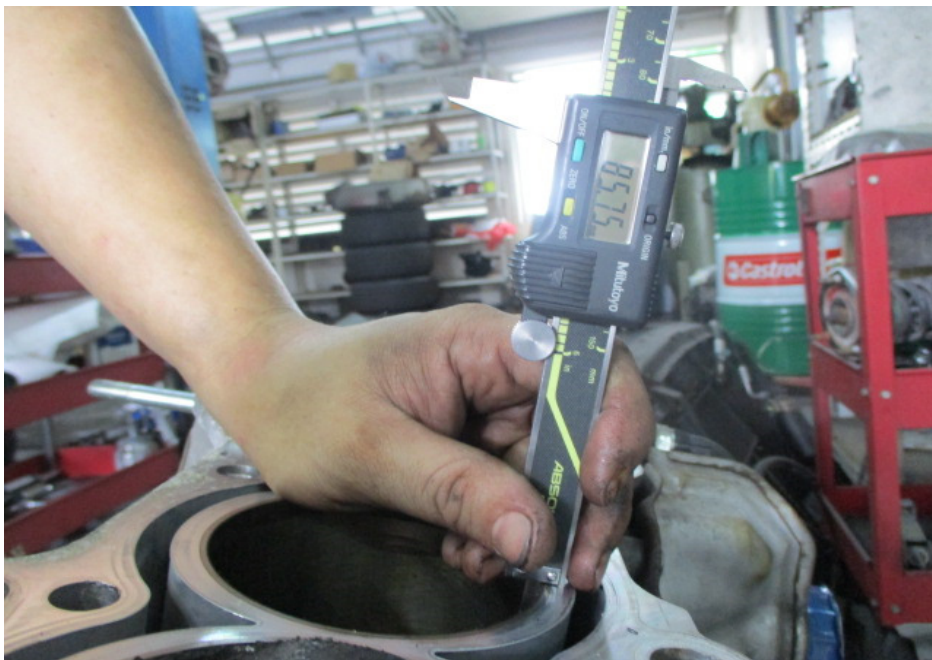
**Photo 18** shows the stroke measurement of cylinder 3, which was recorded to be 85.75mm.

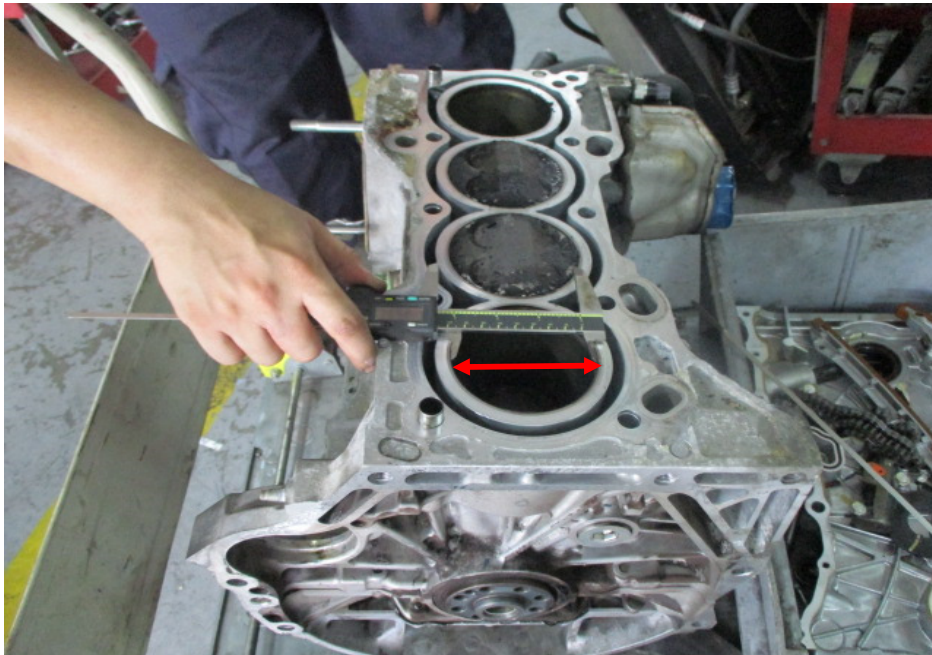
**Photo 19** shows measurement being carried out to the bore (arrowed) of cylinder 4 of the Honda engine. The bore and stroke measurements of the Honda engine were carried out using a digital Vernier Caliper.

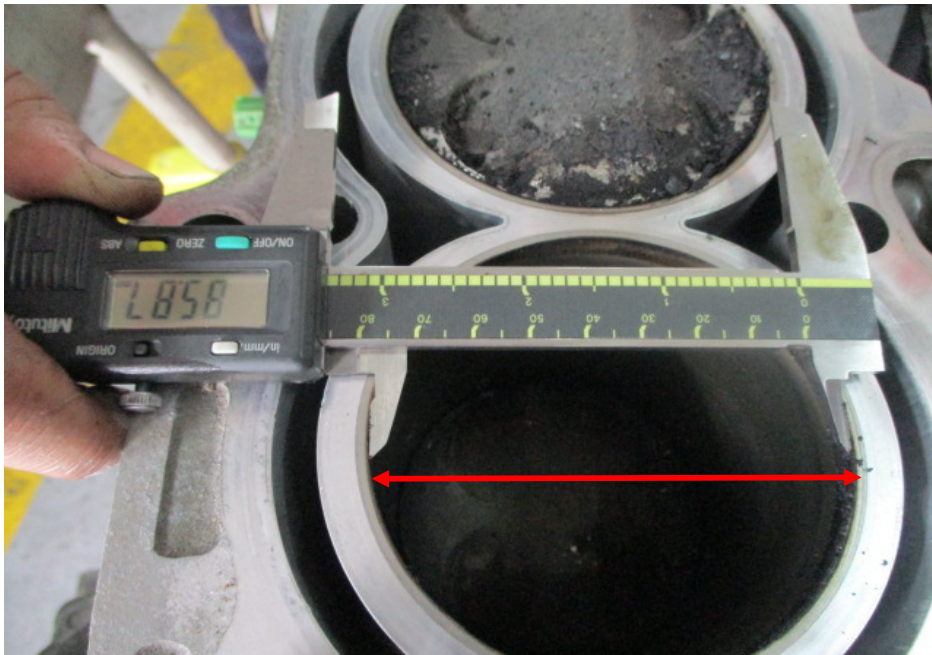
**Photo 20** shows the bore measurement of cylinder 4, which was recorded to be 85.87mm.

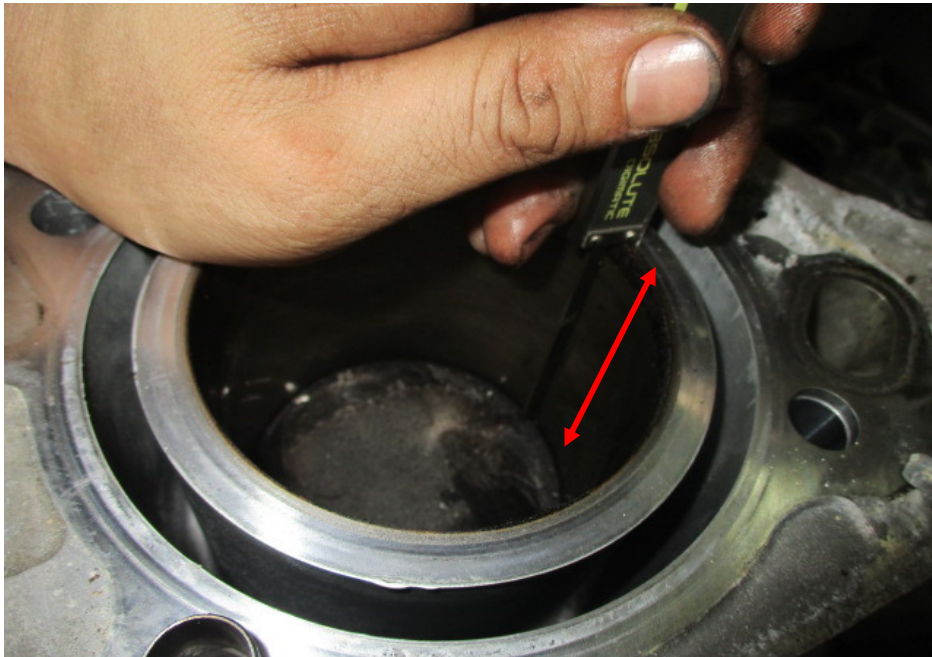
**Photo 21** shows measurement being carried out to the stroke (arrowed) of cylinder 4 of the Honda engine. The bore and stroke measurements of the Honda engine were carried out using a digital Vernier Caliper that was calibrated prior to the start of measurements.

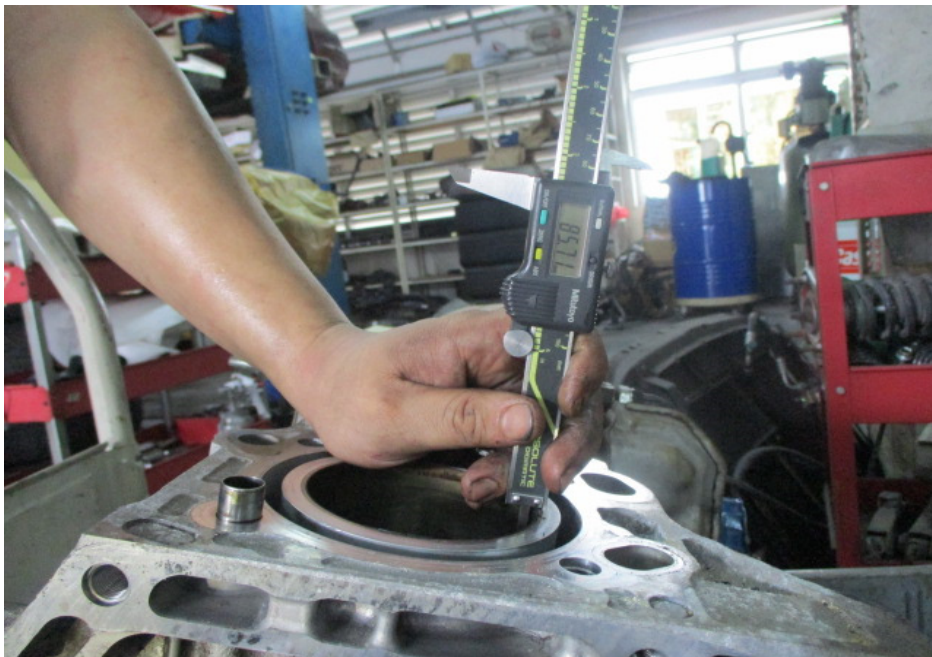
**Photo 22** shows the stroke measurement of cylinder 4, which was recorded to be 85.71mm.
