Your Ref: Mercedes Benz A180  
(chassis number WDD1770842N089571)  
Our Ref : CI/TP20012167/D

**INSPECTION REPORT OF AN UNREGISTERD MERCEDES BENZ A180  
MOTOR CAR WITH CHASSIS NUMBER WDD1770842N089571**

1. I refer to your request on 29 October 2020 to conduct a physical inspection of an unregistered Mercedes Benz A180 motor car bearing chassis number WDD1770842N089571 (herein referred to as "**Motor Car**").
2. The purpose of this inspection is to primarily determine: -
  - a) the general road worthiness of the Motor Car, whether there is any possible mechanical problem(s) and/or operational issue(s) to the various operating systems of the Motor Car;
  - b) whether there was any work (repair) done to the chassis/structural body of the Motor Car, and if yes, whether all major components, welding and critical points of the Motor Car has been properly restored.

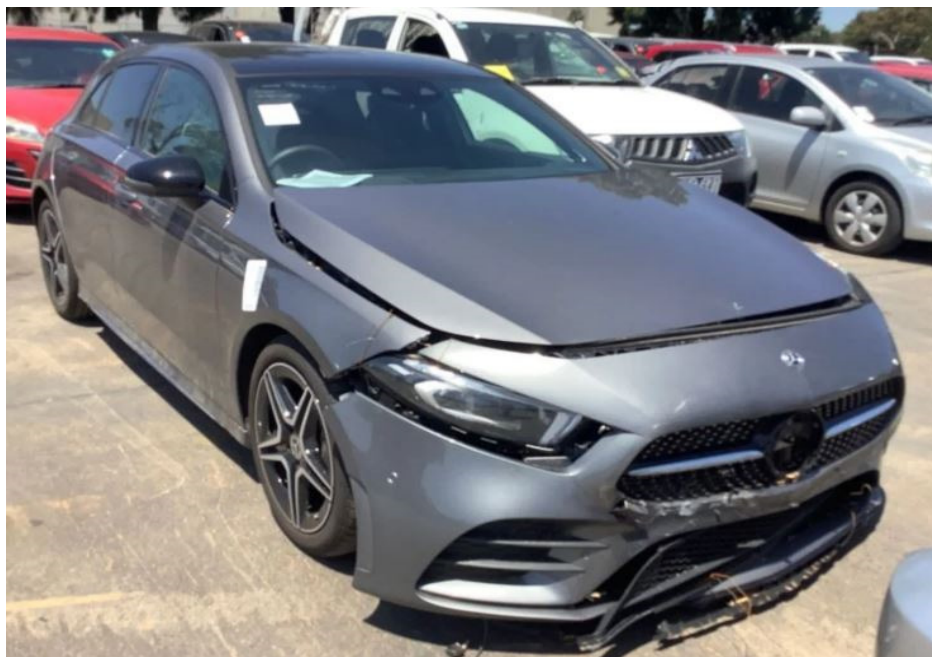
3. From the photographs provided to me, it was observed that the Motor Car had sustained damages at its frontal portion. Body parts observed to have been damaged include its front bumper, front bumper lower grille, front bumper lower skirt, radiator grille, front logo, front bonnet and front left fender amongst others.
4. Parts and components within the engine compartment were unaffected as seen from the photographs that were provided to me. The airbags of the Motor Car were also not deployed. See photo 1 – 3 below.

**Photo 1** shows the front right body of the Motor Car prior to any repairs being carried out (photograph provided to me). The Motor Car was observed to have sustained damages at its frontal portion. The body parts observed to be damaged had included its front bumper, front bumper lower grille, front bumper lower skirt, radiator grille and front logo amongst others.

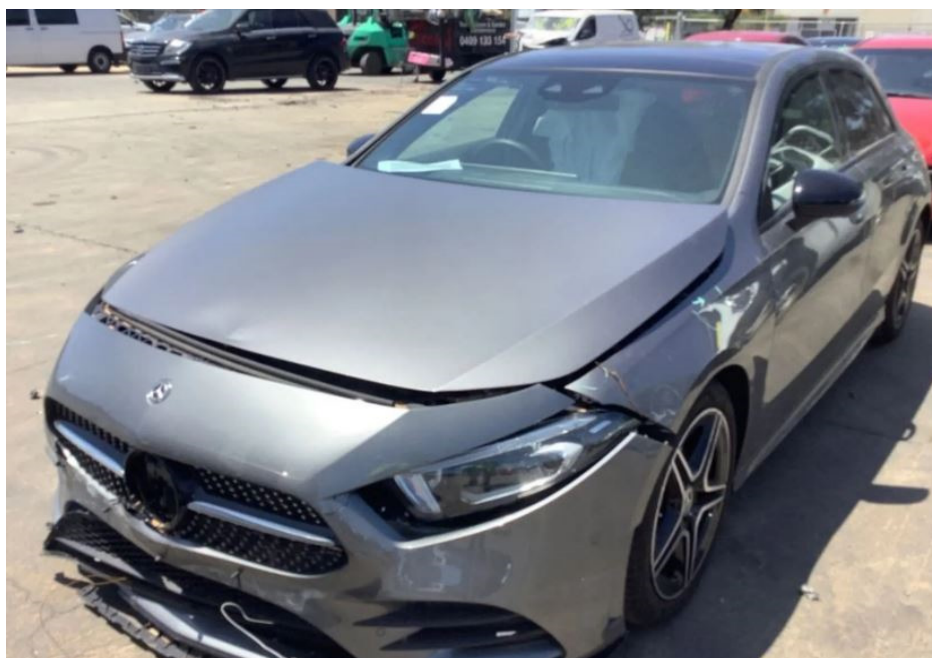
**Photo 2** shows the front left body of the Motor Car prior to any repairs being carried out (photograph provided to me). The Motor Car was observed to have sustained damages at its frontal portion. The body parts observed to be damaged had included its front bumper, front bumper lower grille, front bonnet, front left fender, radiator grille and front logo amongst others.

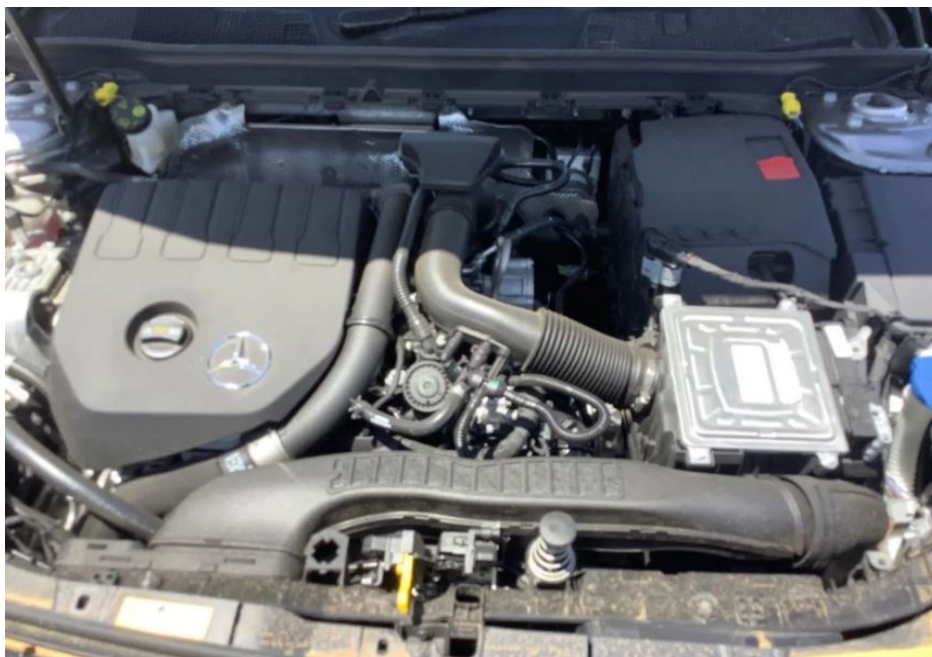
**Photo 3** shows the engine compartment of the Motor Car prior to any repairs being carried out (photograph provided to me). Parts and components within the engine compartment were unaffected.

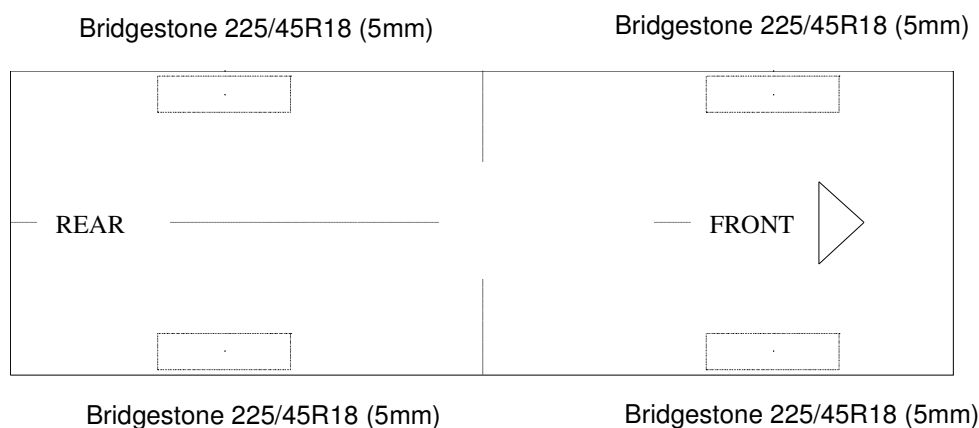
8. It was fitted with 18inch sport wheel rims that were wrapped with tyres that were observed to be of serviceable condition. The tyres were also sufficiently inflated for vehicular operation. The tyre brand, tyre size and approximate remaining tread depth of the 4 tyres of the Motor Car were recorded as follows: -

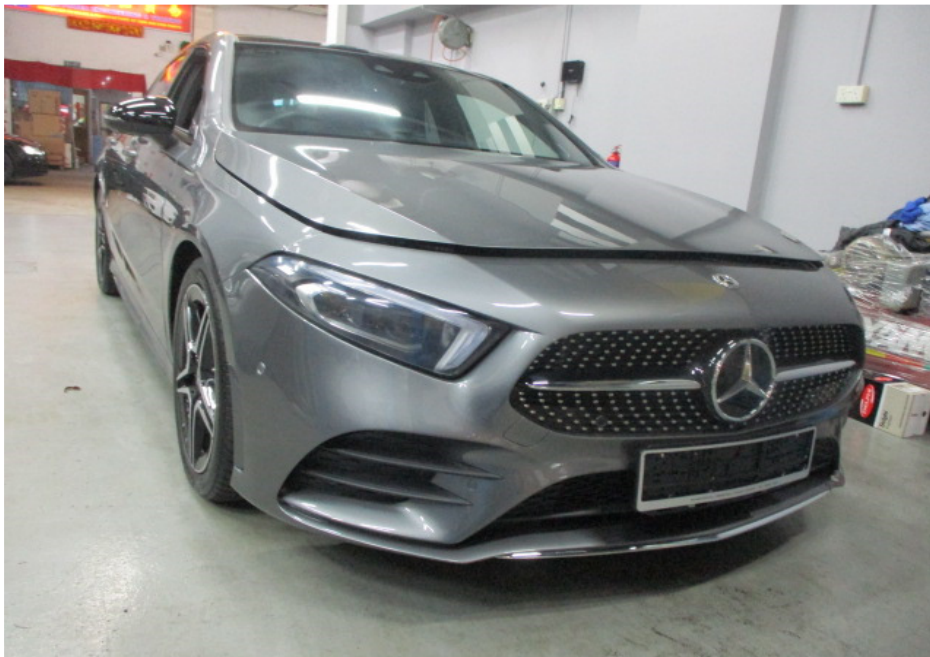
**Photo 4** shows a general view of the front right body of the Motor Car at the time of my inspection. The Motor Car was observed to be in a relatively good general condition with no loose exterior fittings observed. The body parts at the frontal portion of the Motor Car were visually examined and it was observed that the repair/restoration works carried out to the damaged area of the Motor Car (refer photograph 1 & 2 above) were reasonably adequate and in order.

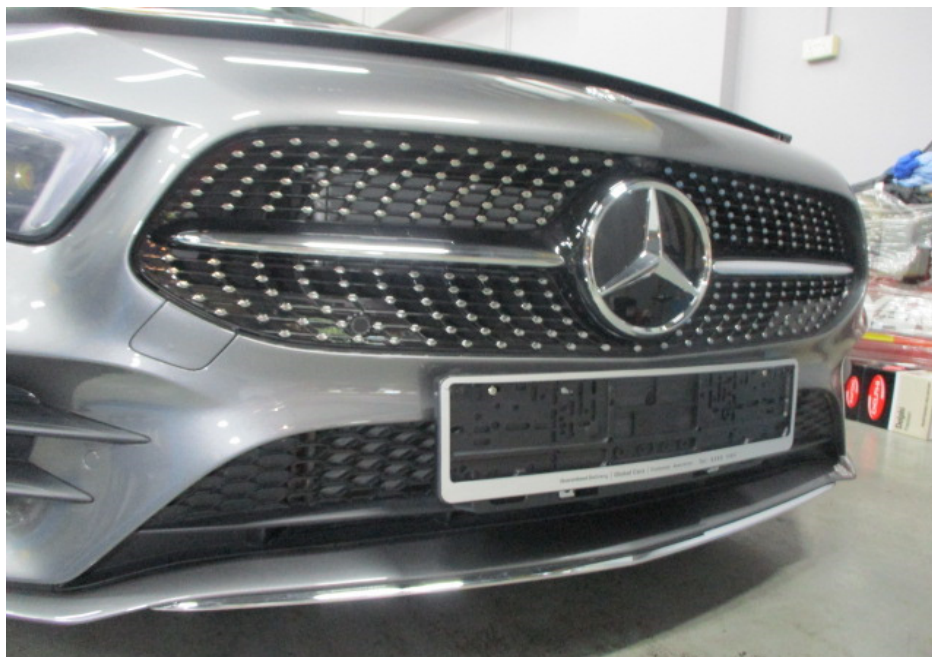
**Photo 5** shows a closer view of the front bumper lower grille, front bumper lower skirt, radiator grille and logo of the Motor Car. The body parts at the frontal portion of the Motor Car were visually examined and it was observed that the repair/restoration works carried out to the damaged area of the Motor Car (refer photograph 1 & 2 above) were reasonably adequate and in order.

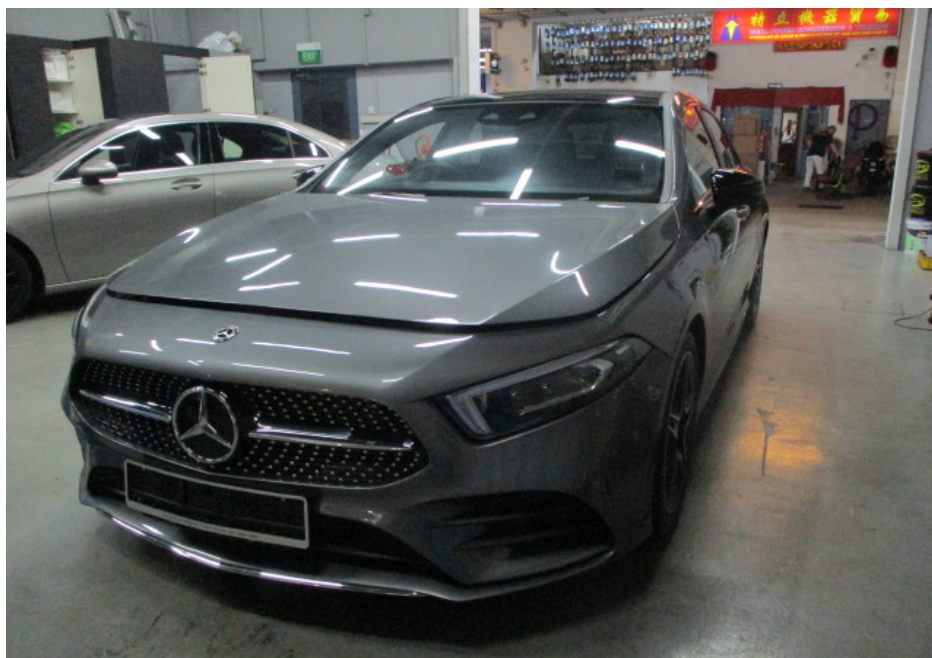
**Photo 6** shows a general view of the front left body of the Motor Car at the time of my inspection. The Motor Car was observed to be in a relatively good general condition with no loose exterior fittings observed. The body parts at the frontal portion of the Motor Car were visually examined and it was observed that the repair/restoration works carried out to the damaged area of the Motor Car (refer photograph 1 & 2 above) were reasonably adequate and in order.

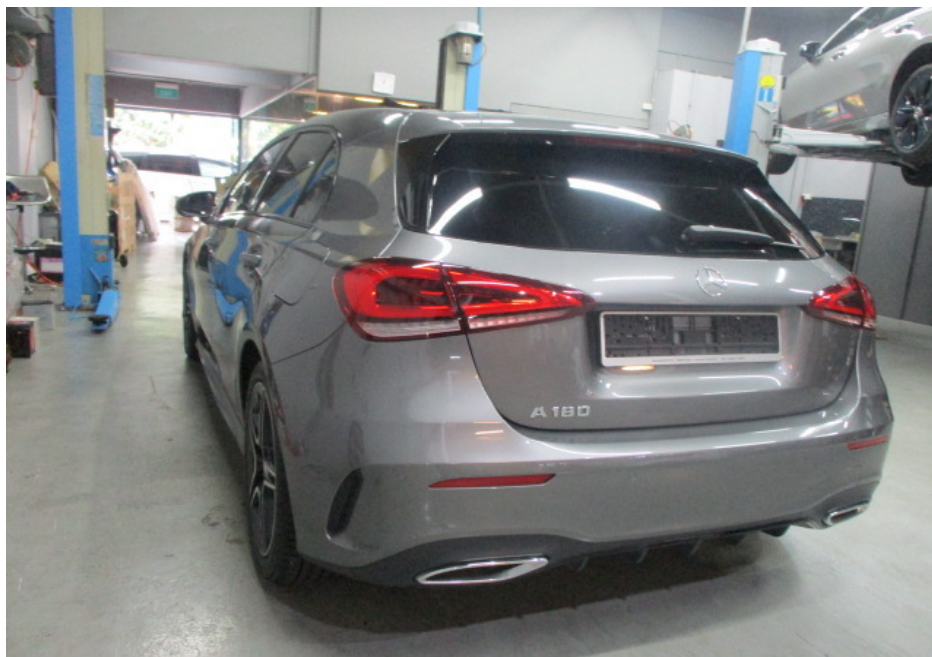
**Photo 7** shows a general view of the rear left body of the Motor Car at the time of my inspection. The Motor Car was observed to be in a relatively good general condition with no loose exterior fittings observed. The mileage of the Motor Car recorded at the time of my inspection was 3,567km.

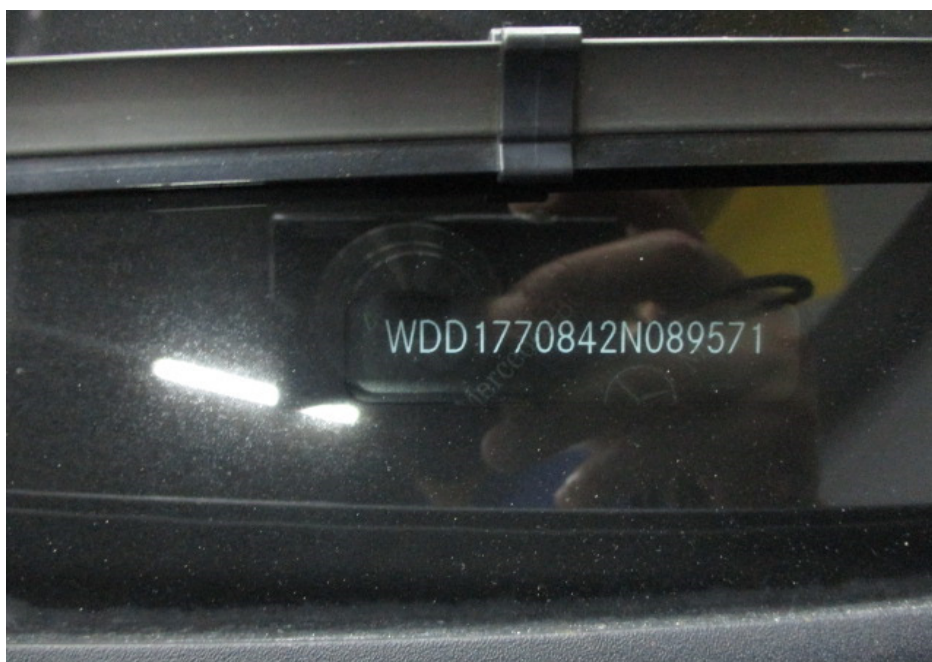
**Photo 8** shows the chassis number of the Motor Car. The chassis number recorded was WDD1770842N089571.

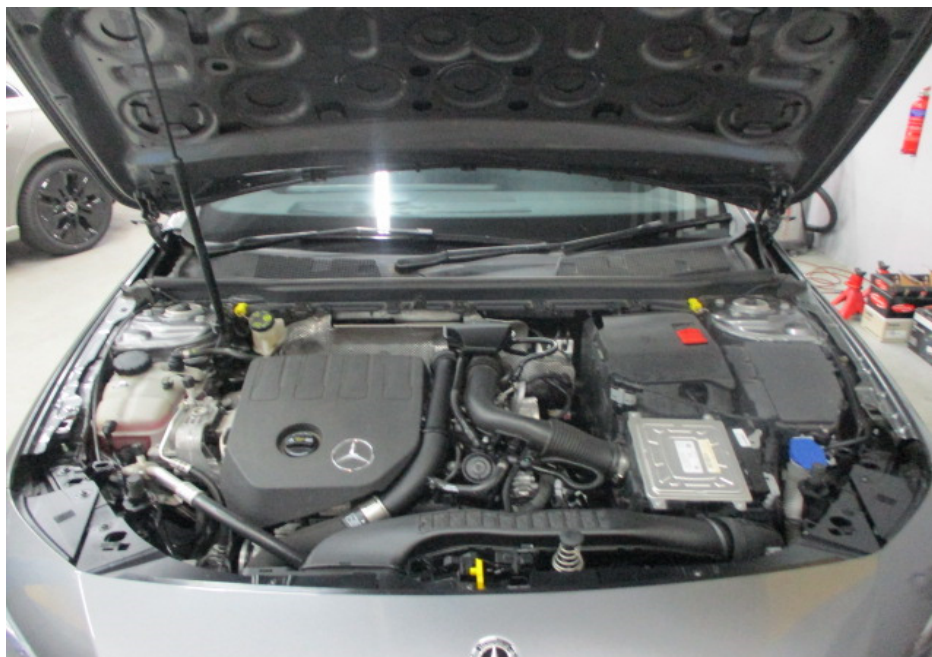
14. My examination of the engine compartment of the Motor Car revealed that the various parts and components inside the engine compartment were all intact and properly fitted. The engine oil, brake fluid and engine coolant were all found to be of sufficient level for operating purposes. Visually, there was also no contamination found to these fluids.
15. My checks on the underside of the Motor Car revealed no sign(s) or indication(s) of fluid leakage and/or fluid stain(s). The engine block and automatic transmission assembly were both secured properly. All undercarriage components of the Motor Car were also observed to be intact and secured in an appropriate manner.

**Photo 9** shows a general view of the engine compartment of the Motor Car at the time of my inspection. The various parts and components inside the engine compartment were all observed to be intact and properly fitted. There was also no sign(s) or indication(s) of fluid leak and/or fluid stain found inside the engine compartment.

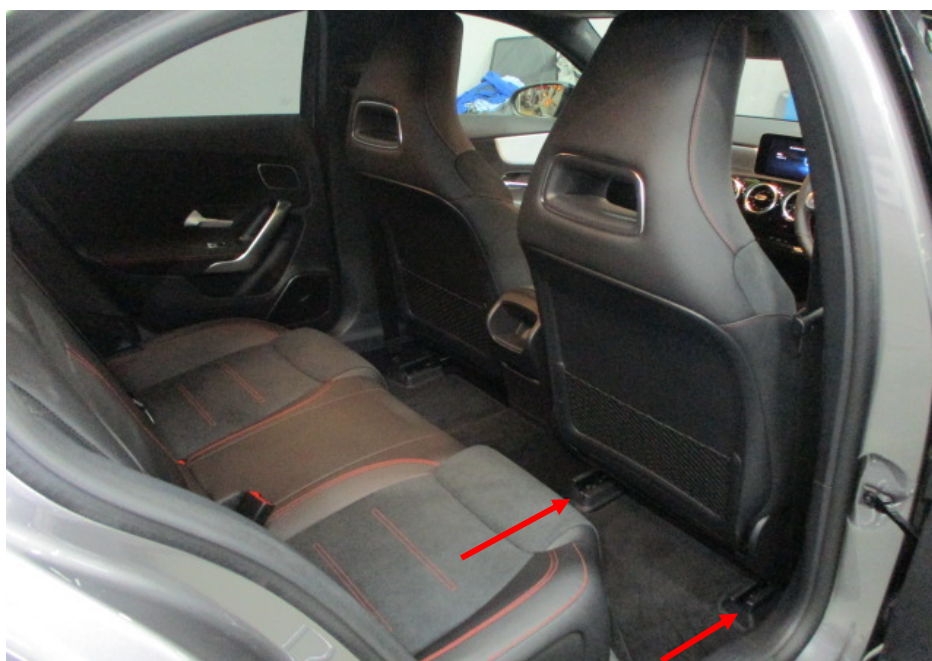
12. The seats of the Motor Car were found to be secured to the floorboard of the Motor Car via seat rails bolted onto the floorboard. Retractable seat belt reels and pre-tensioners were fitted on all seats of the Motor Car. The seat belts were tested and were able to be fastened securely into the respective pre-tensioners that were fixed to the side of all the seats.

**Photo 10** shows the interior compartment of the Motor Car. The seats of the Motor Car were secured via seat rails (arrowed) to the floorboard. All the seats of the Motor Car were fitted with a retractable seat belt reel and a pre-tensioner. The seat belts were tested and able to be fastened into the respective pre-tensions that were fitted on the side of each individual seat.

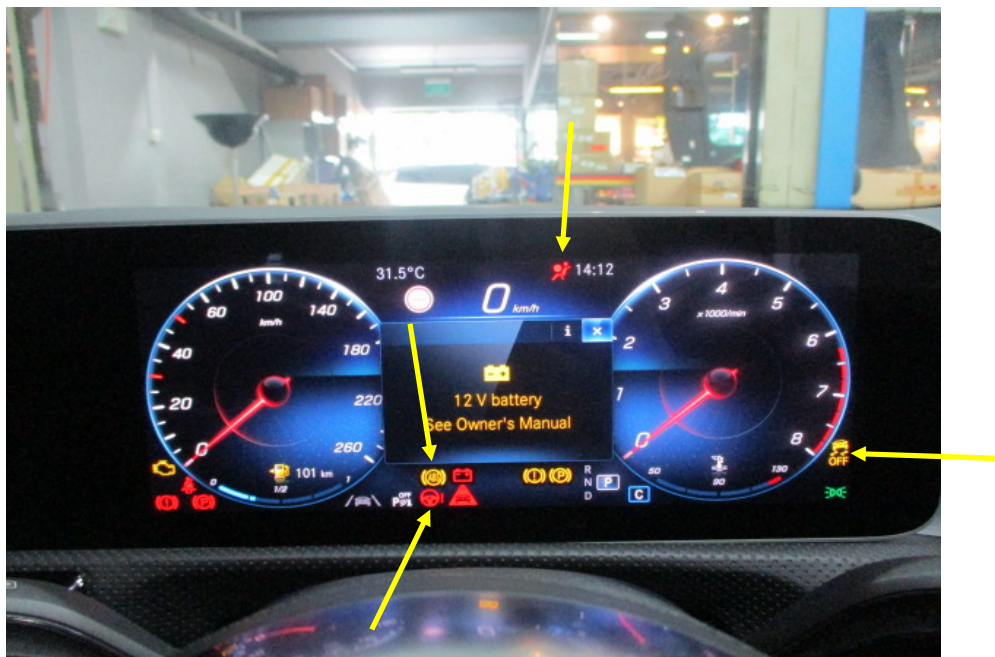
**Photo 11** shows the warning lights for the various electronic safety features appearing on the instrument panel of the Motor Car during its self-test when the engine is cranked, in particular the ABS, SRS, EPS and ESP lights (arrowed).

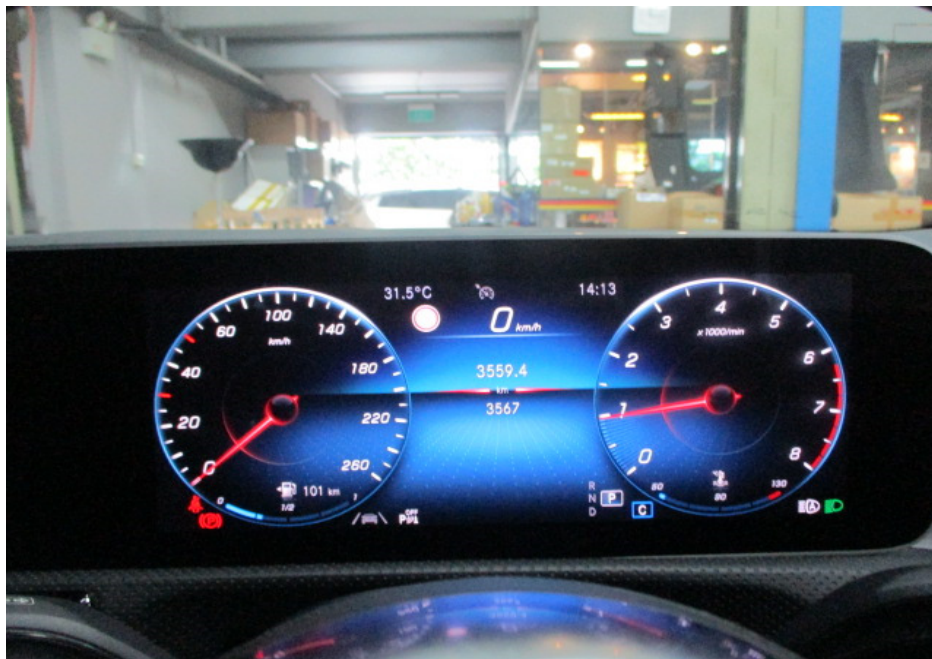
13. The Motor Car's automatic self-test of the functionality of its various electronic safety features like the Anti-Lock Brake System (ABS), Supplemental Restraint System (SRS), Electric Power Steering (EPS) and Electronic Stability Program (ESP) during cranking of the engine had indicated that these electronic systems were in working condition. This was determined from the respective warning lights disappearing from the instrument panel after the self-test.

**Photo 12** shows the respective warning lights no longer illuminated, indicating that there is no fault detected to the ABS, SRS, EPS and ESP systems of the Motor Car during the self-test. These electronic systems were hence in working condition at the time of my inspection.

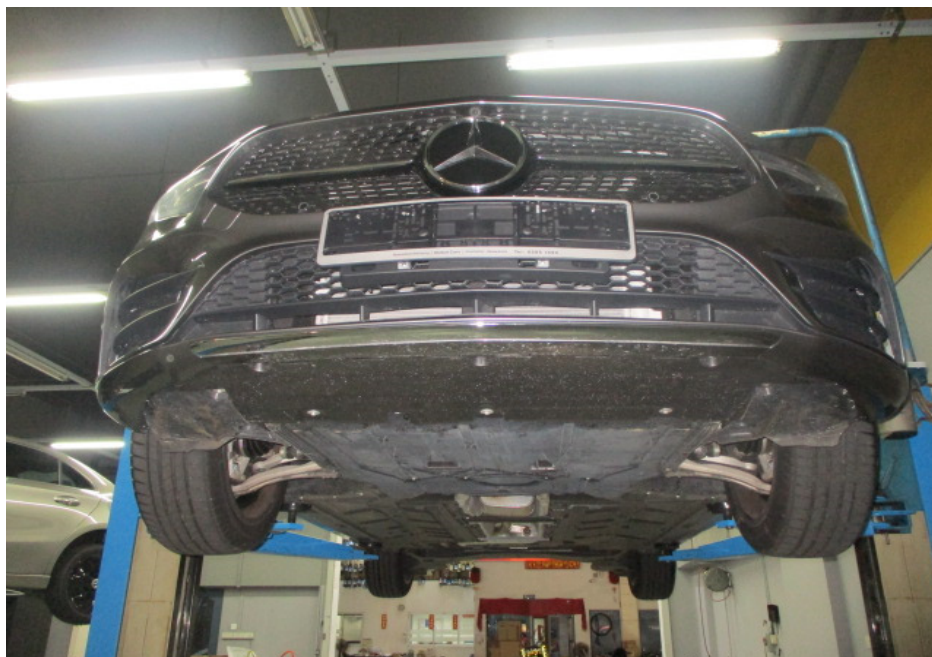
**Photo 13** shows the Motor Car hoisted up for checks on its undercarriage. There was no sign(s) or indication(s) of fluid leakage and/or fluid stain(s) on the underside of the Motor Car. The undercarriage components of the Motor Car were also all observed to be intact and secured in an appropriate manner.

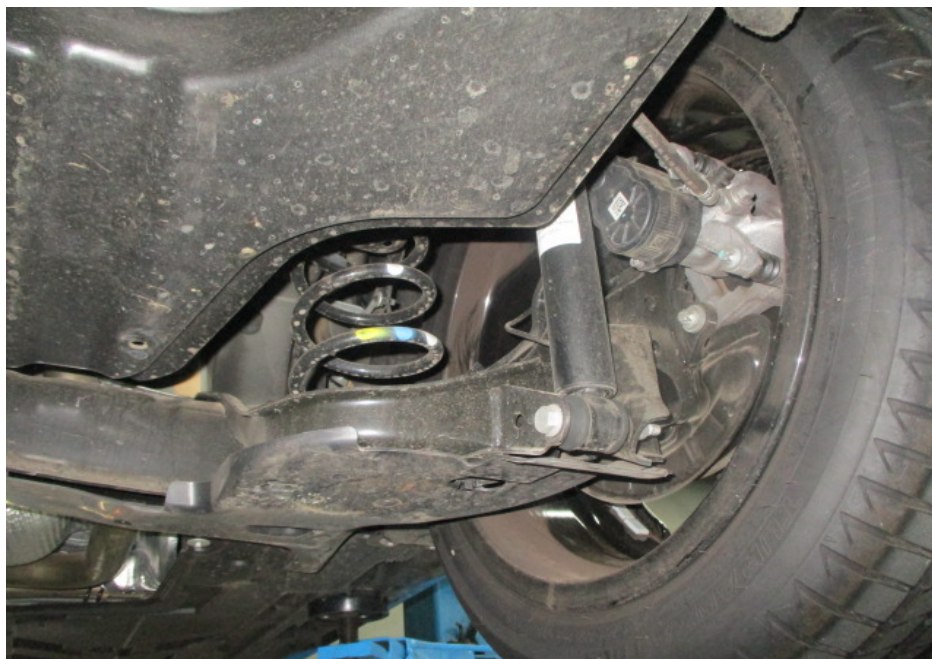
**Photo 14** shows a general view of the control arms and linkages at the rear right wheel of the Motor Car. I did not observe any fluid leak and/or fluid stain on the underside of the Motor Car. All of the Motor Car's undercarriage components were observed to be intact and secured in an appropriate manner.

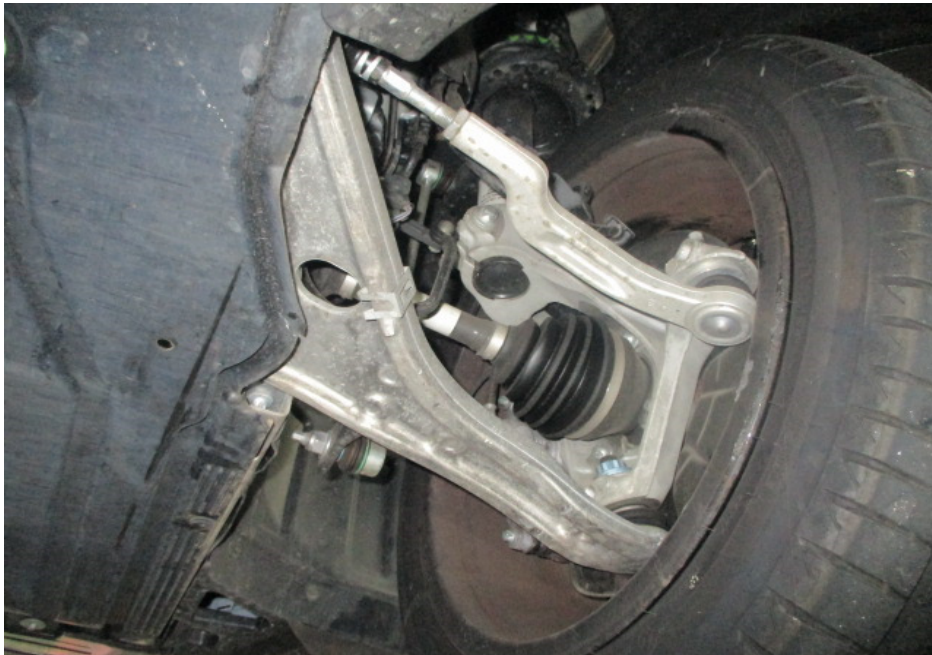
**Photo 15** shows the various undercarriage components at the front right wheel of the Motor Car. The mechanical components, control arms and linkages were all found to be intact and secured in an appropriate manner.

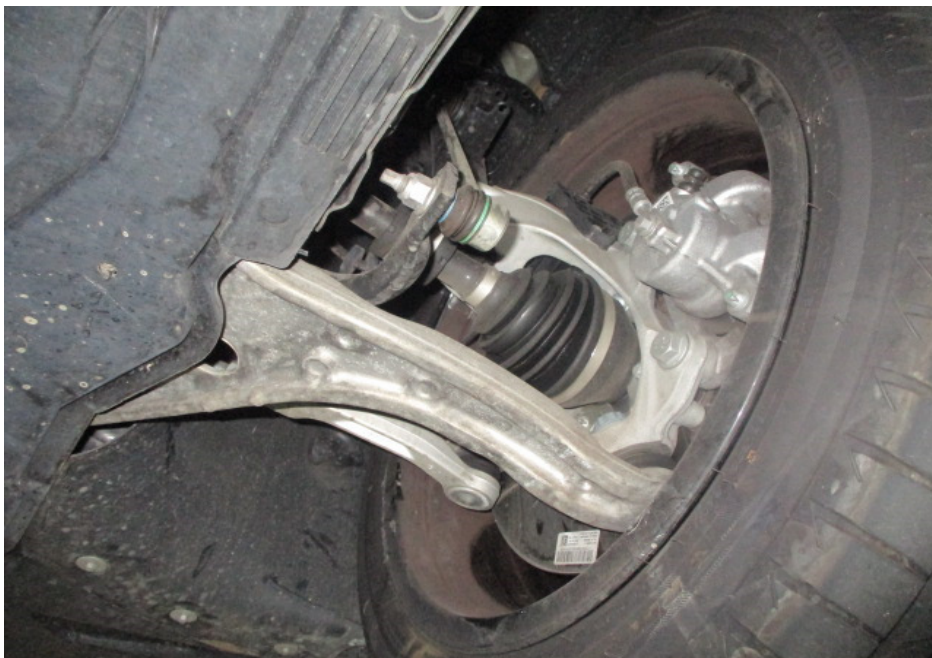
**Photo 16** shows the various undercarriage components at the front left wheel of the Motor Car. The mechanical components, control arms and linkages were all found to be intact and secured in an appropriate manner. I also did not observe any fluid leak and/or fluid stain on the underside of the Motor Car.

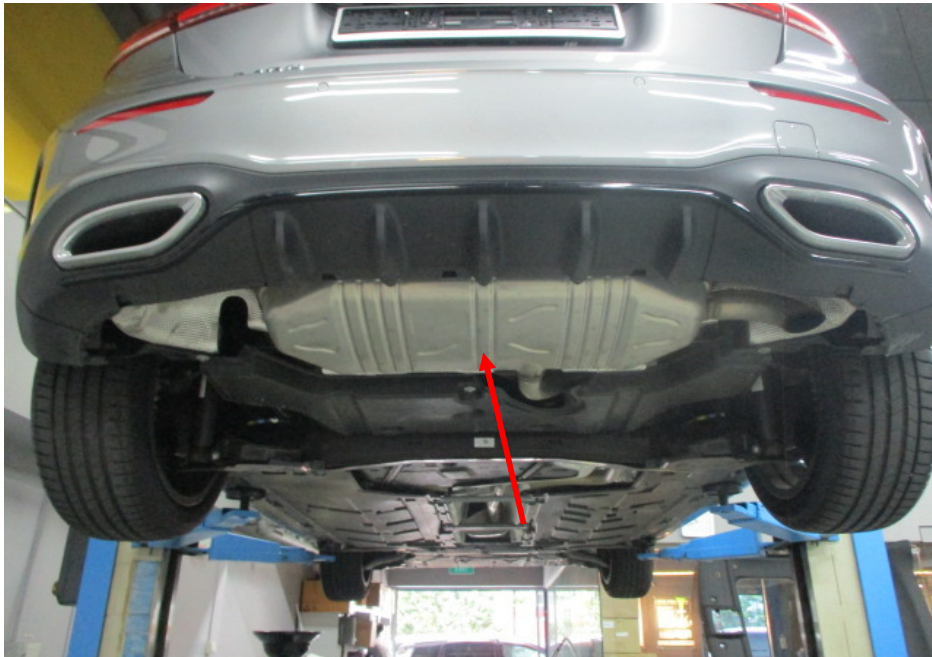
**Photo 17** shows the Motor Car's rear muffler (arrowed). My examination of the Motor Car's exhaust system revealed no sign(s) or indication(s) of any cut or weld marks along its exhaust pipes and on its catalytic converter.

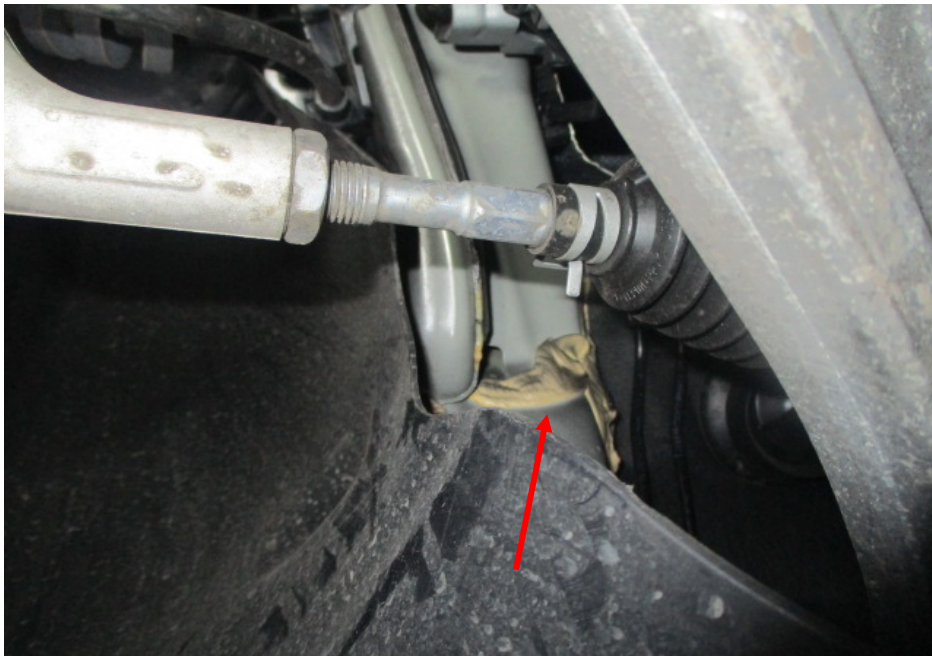
11. Visually, I did not find any weld marks, other than the original spot weld marks, on the chassis/structural body of the Motor Car. The original factory sealant at the joints along the chassis/structural body was also untouched, again indicating that no replacement of the chassis/structural body was carried out; and that the chassis/structural body was originally fitted.

**Photo 18** shows the chassis/structural body at the underside front right of the Motor Car. Visually, I did not find any weld marks other than original spot weld marks on the chassis/structural body of the Motor Car. The original factory sealant (arrowed) at the joints along the chassis/structural body was also untouched, indicating no work was done on the chassis/structural body of the Motor Car and that the chassis/structural body was originally fitted.

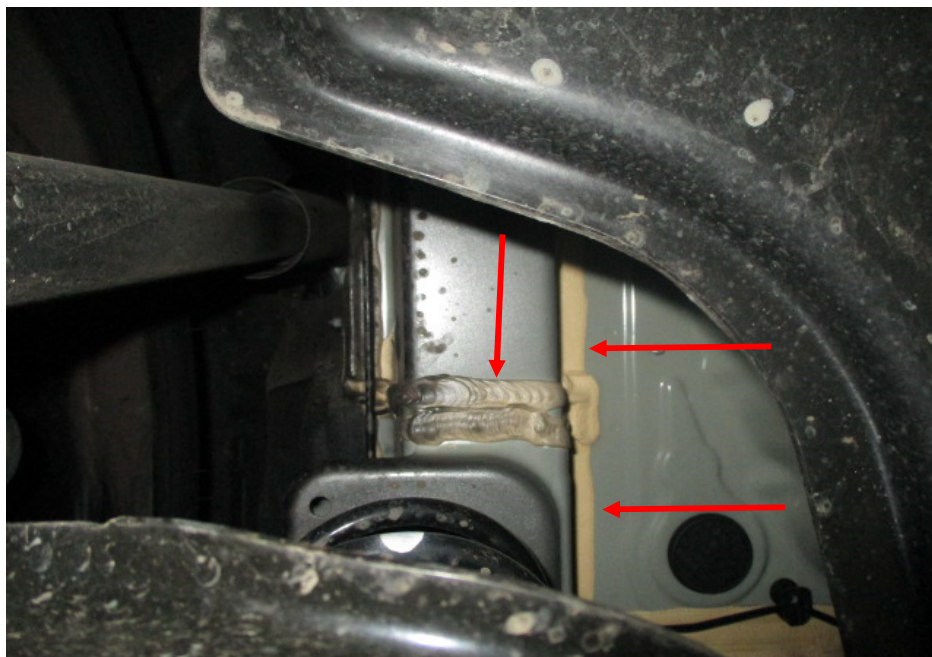
**Photo 19** shows the chassis/structural body at the underside rear left of the Motor Car. Visually, the original factory sealant (arrowed) at the joints along the chassis/structural body was untouched, indicating no work was done on the chassis/structural body of the Motor Car and that the chassis/structural body was originally fitted.

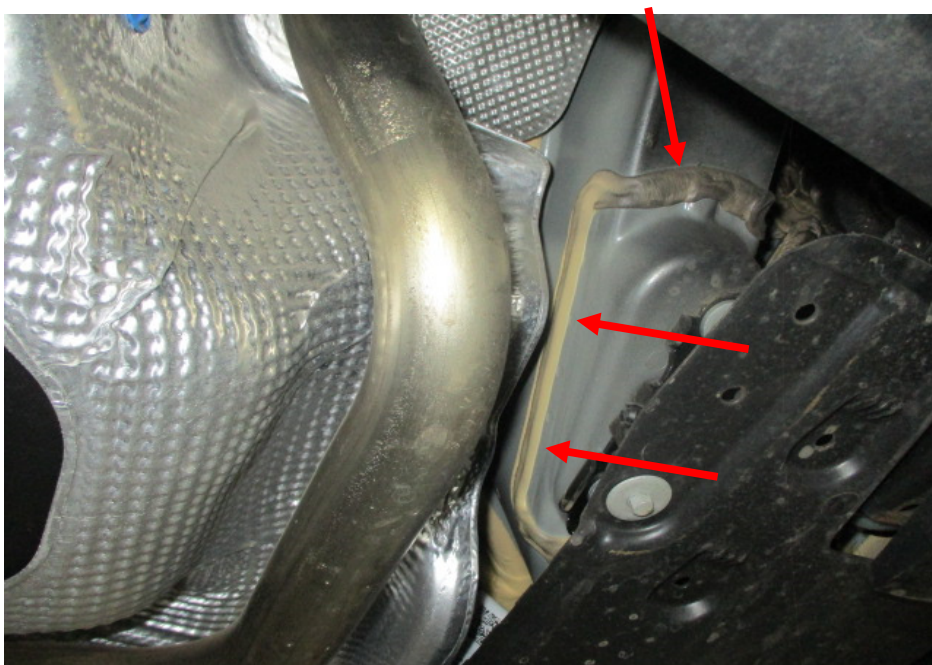
**Photo 20** shows the floorboard at the right underside of the Motor Car. The original factory sealant (arrowed) at the joints along the floorboard were untouched, indicating that the floorboard of the Motor Car was originally fitted. In general, I had found all the non-detachable body panels of the Motor Car to be originally fitted at the time of my inspection.

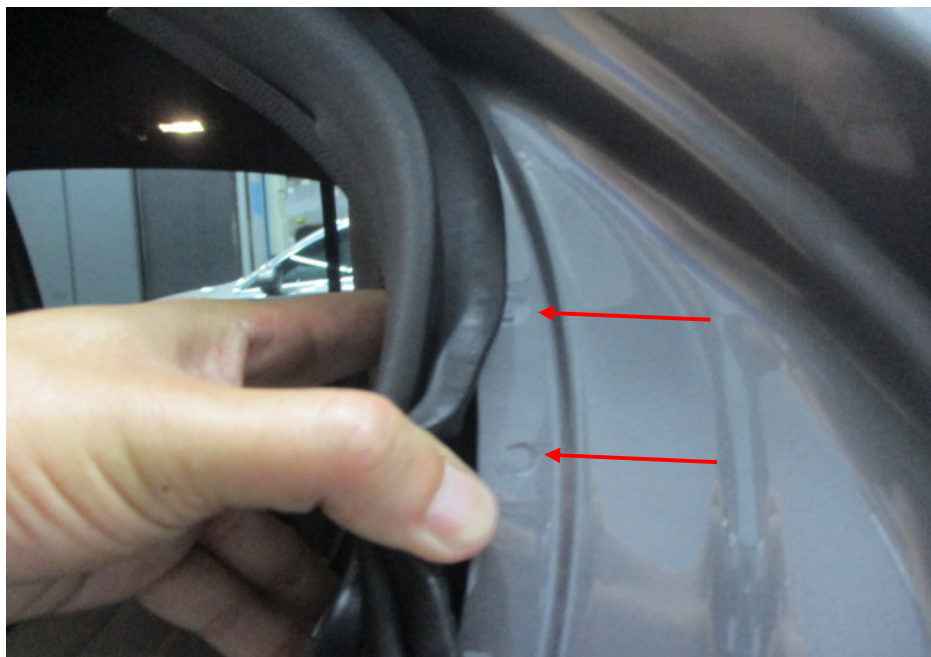
**Photo 21** shows the left "C" pillar of the Motor Car. I did not find any weld marks other than original spot weld marks (arrowed) on the left "C" pillar of the Motor Car. In general, I had found all the non-detachable body panels of the Motor Car to be originally fitted at the time of my inspection.
