Your Ref: Mercedes Benz A200
(chassis number WDD1771872W031753)
Our Ref : CI/TP20012168/D

09 November 2020

**INSPECTION REPORT OF AN UNREGISTERED MERCEDES BENZ A200
MOTOR CAR WITH CHASSIS NUMBER WDD1771872W031753**

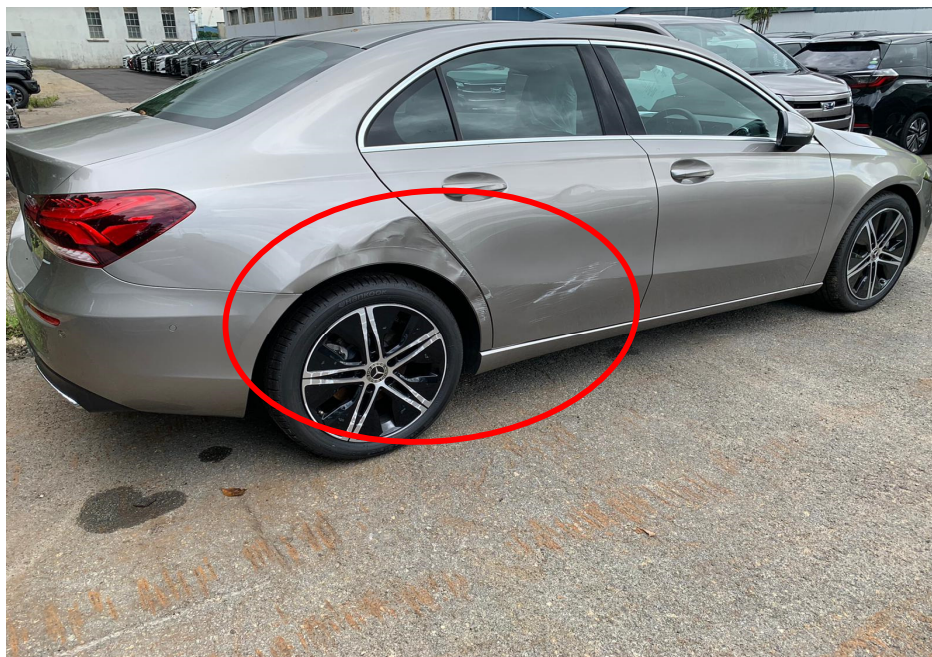
3. From the photographs provided to me, it was observed that the Motor Car had sustained damages at its right side rear portion. Body parts observed to have been damaged include its rear bumper, rear right fender, rear right door and rear right wheel rim amongst others.
4. Apart for the right side rear portion, there was no visible damage observed to other areas of the Motor Car. The airbags were also not deployed, as seen from the photographs that were provided to me. See photo 1 – 3 below.

Photo 1 shows the right body of the Motor Car prior to any repairs being carried out (photograph provided to me). The Motor Car was observed to have sustained damages at its right side rear portion (circled). The body parts observed to be damaged had included its rear bumper, rear right fender, rear right door and rear right wheel rim amongst others.

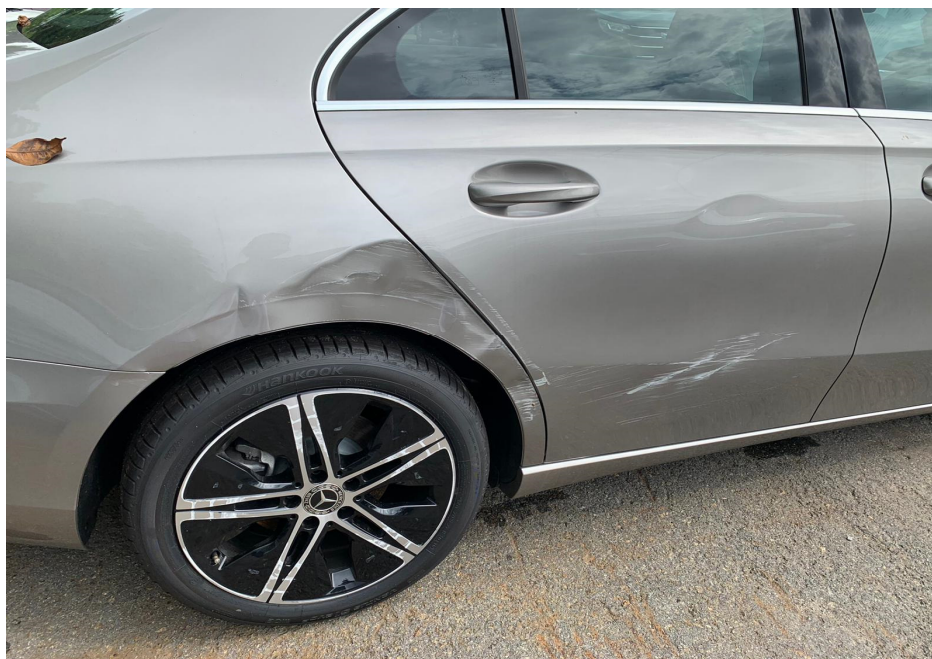
Photo 2 shows a closer view of the damaged right side rear portion of the Motor Car prior to any repairs being carried out (photograph provided to me). The rear bumper, rear right fender, rear right door and rear right wheel rim were observed to be damaged.

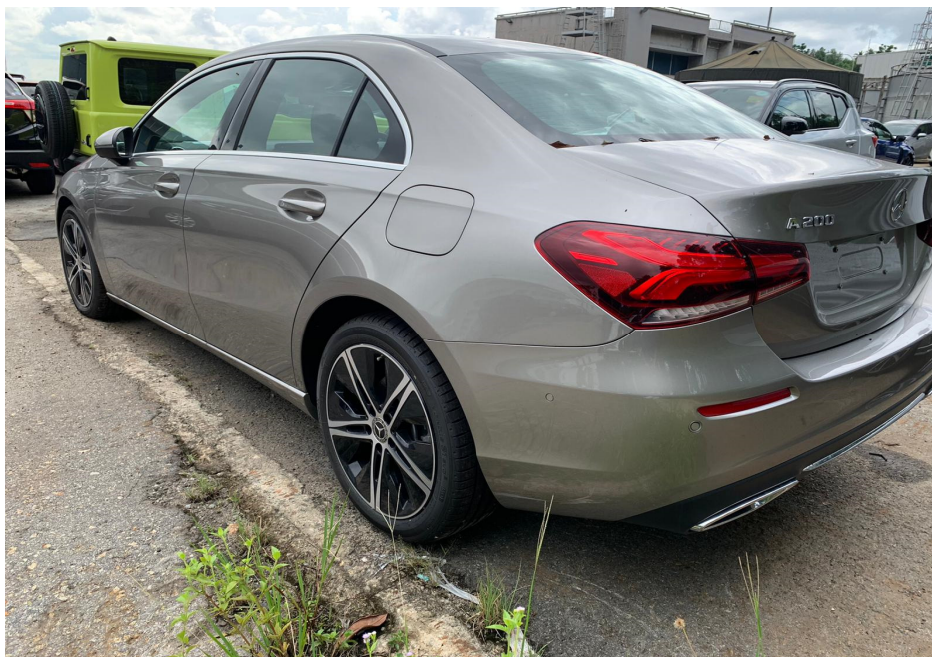
Photo 3 shows the left body of the Motor Car prior to any repairs being carried out (photograph provided to me). No visible damage was observed to other areas of the Motor Car. The airbags were also not deployed.

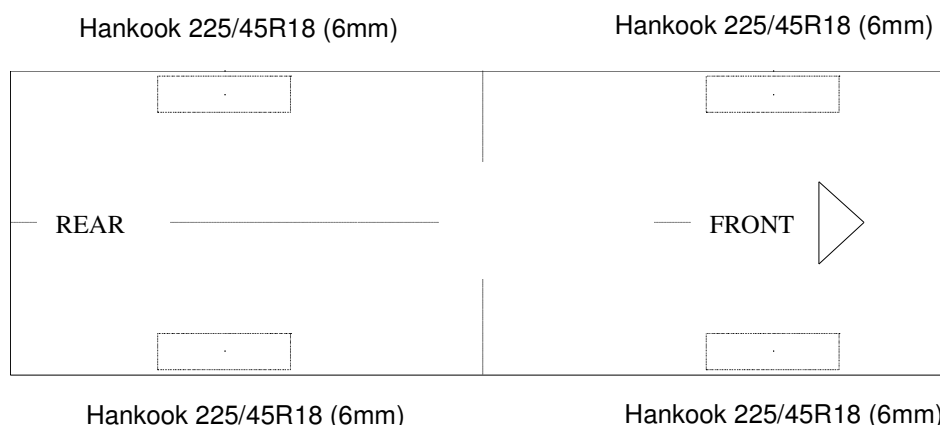
8. It was fitted with 18inch sport wheel rims that were wrapped with tyres that were observed to be of serviceable condition. The tyres were also sufficiently inflated for vehicular operation. The tyre brand, tyre size and approximate remaining tread depth of the 4 tyres of the Motor Car were recorded as follows: -

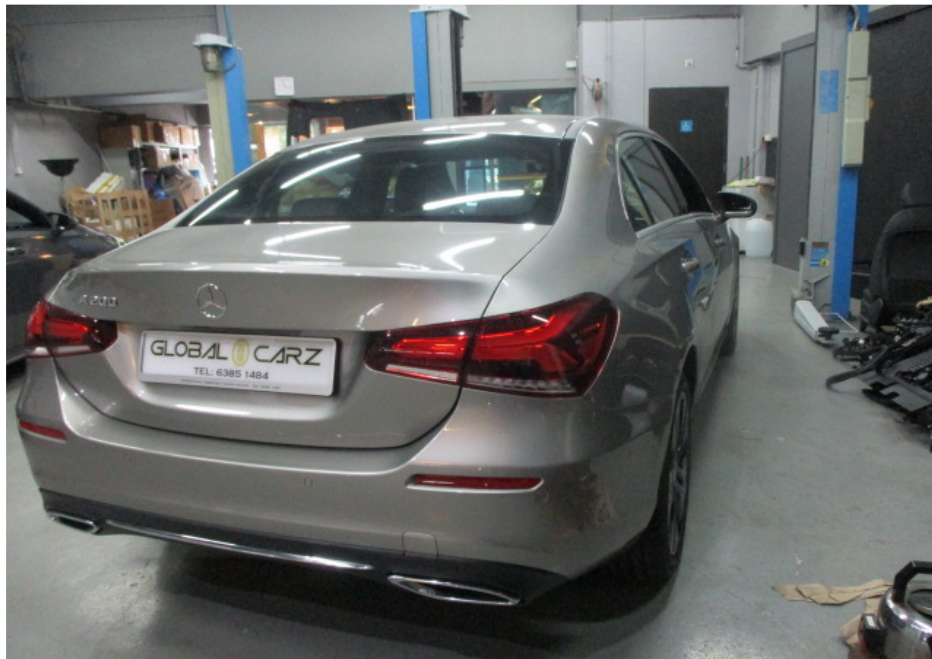
Photo 4 shows a general view of the rear right body of the Motor Car at the time of my inspection. The Motor Car was observed to be in a relatively good general condition with no loose exterior fittings observed. The body parts at the right side rear portion of the Motor Car were visually examined and it was observed that the repair/restoration works carried out to the damaged area of the Motor Car (refer photograph 1 & 2 above) were reasonably adequate and in order.

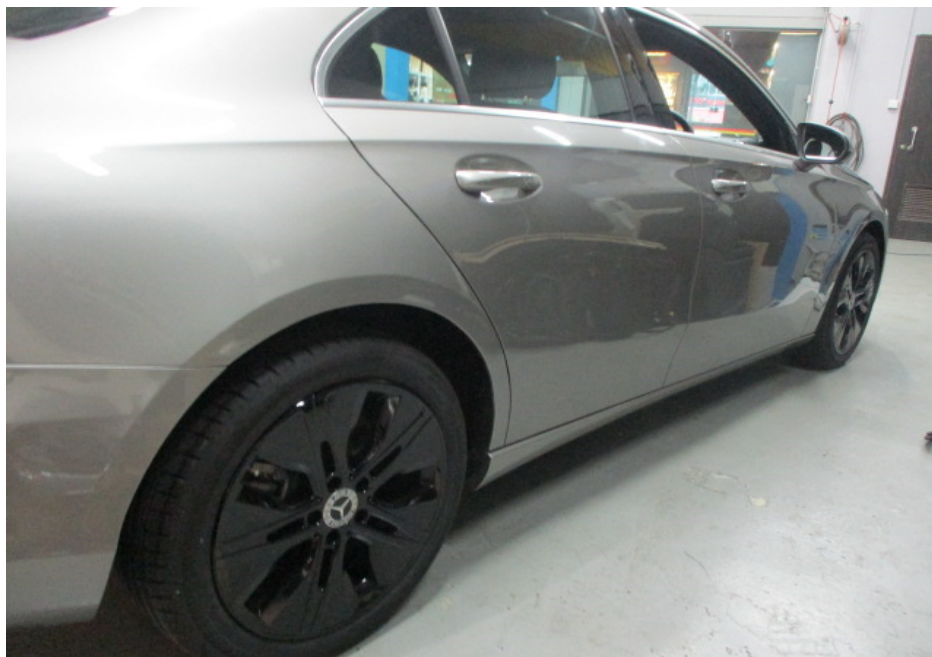
Photo 5 shows a closer view of the right side rear portion of the Motor Car at the time of my inspection. The Motor Car was observed to be in a relatively good general condition with no loose exterior fittings observed. The body parts at the right side rear portion of the Motor Car were visually examined and it was observed that the repair/restoration works carried out to the damaged area of the Motor Car (refer photograph 1 & 2 above) were reasonably adequate and in order.

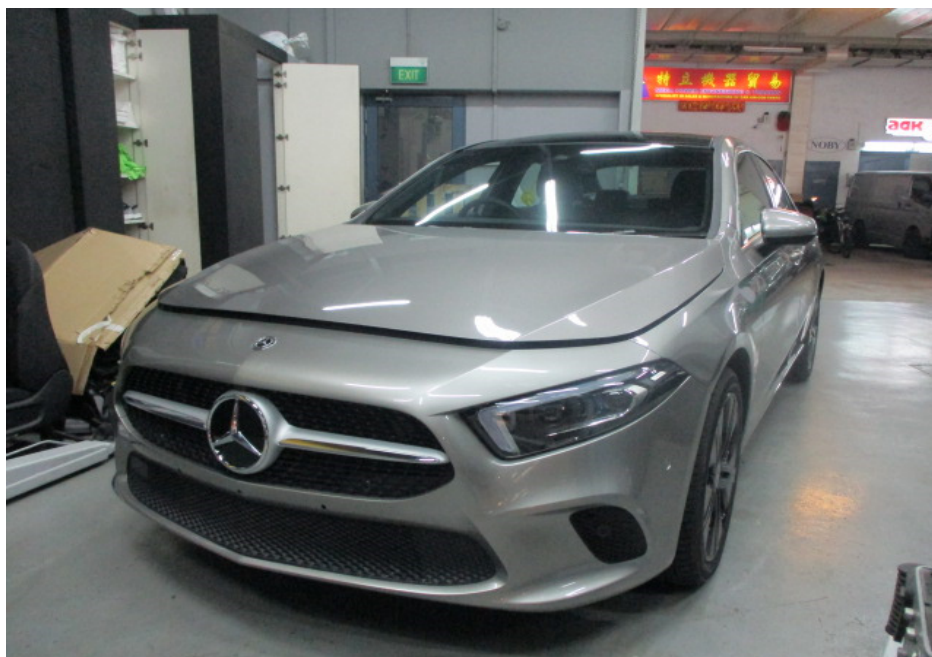
Photo 6 shows a general view of the front left body of the Motor Car at the time of my inspection. The Motor Car was observed to be in a relatively good general condition with no loose exterior fittings observed. The mileage of the Motor Car recorded at the time of my inspection was 152km.

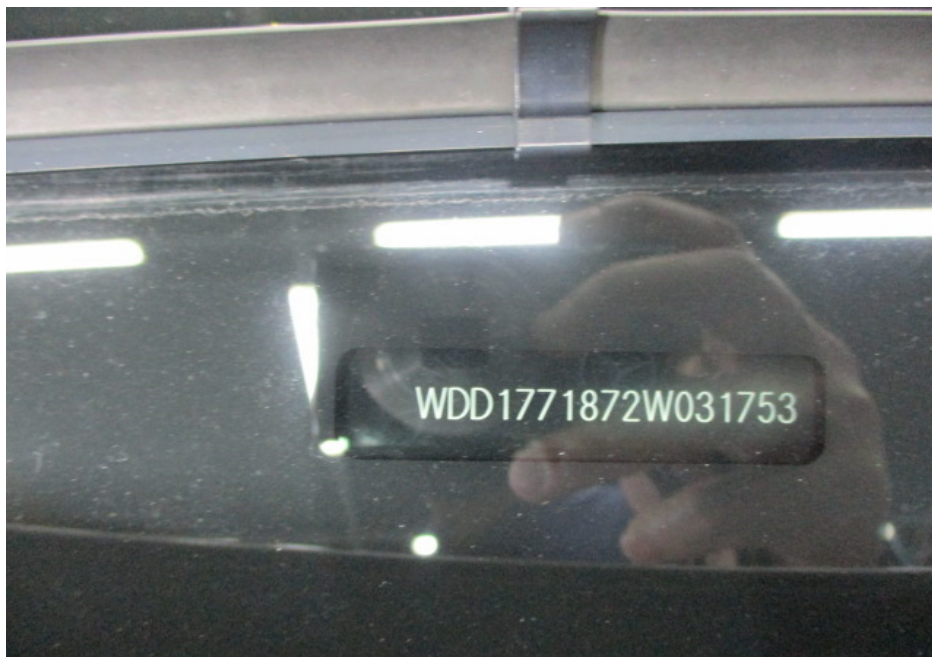
Photo 7 shows the chassis number of the Motor Car. The chassis number recorded was WDD1771872W031753.

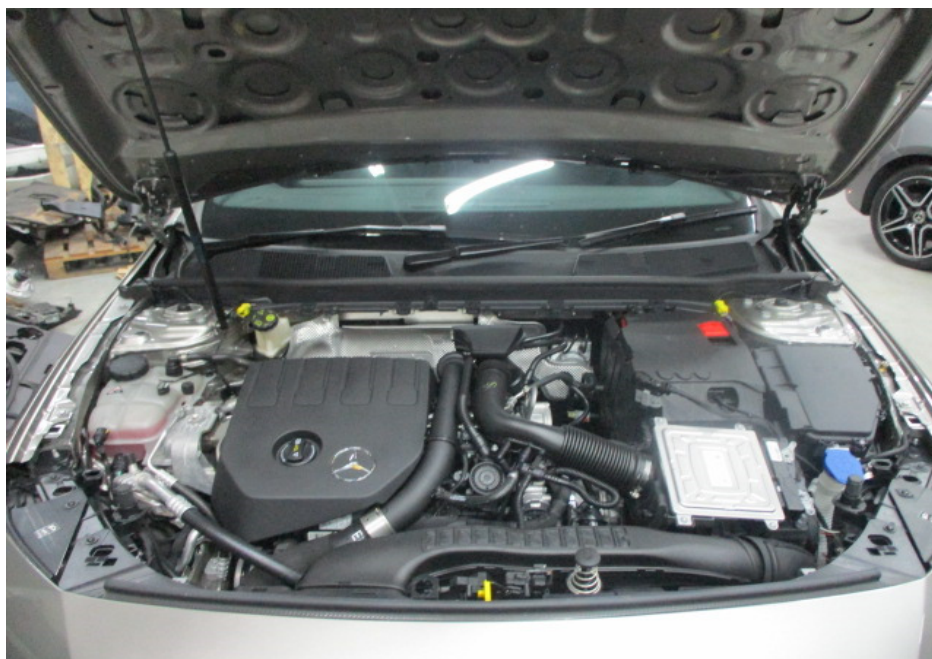
Photo 8 shows a general view of the engine compartment of the Motor Car at the time of my inspection. The various parts and components inside the engine compartment were all observed to be intact and properly fitted. There was also no sign(s) or indication(s) of fluid leak and/or fluid stain found inside the engine compartment.

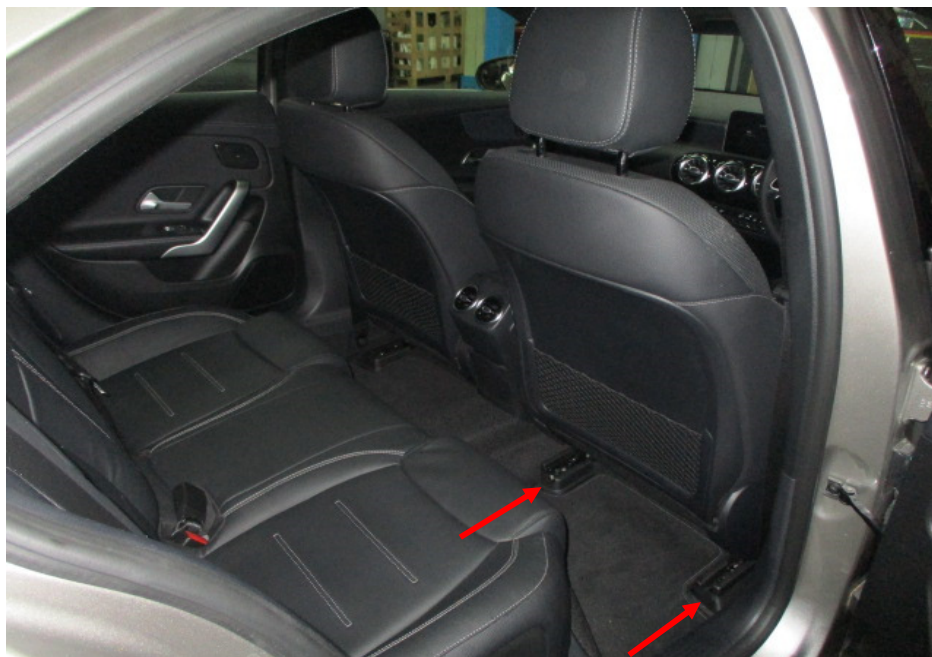
Photo 9 shows the interior compartment of the Motor Car. The seats of the Motor Car were secured via seat rails (arrowed) to the floorboard. All the seats of the Motor Car were fitted with a retractable seat belt reel and a pre-tensioner. The seat belts were tested and able to be fastened into the respective pre-tensions that were fitted on the side of each individual seat.

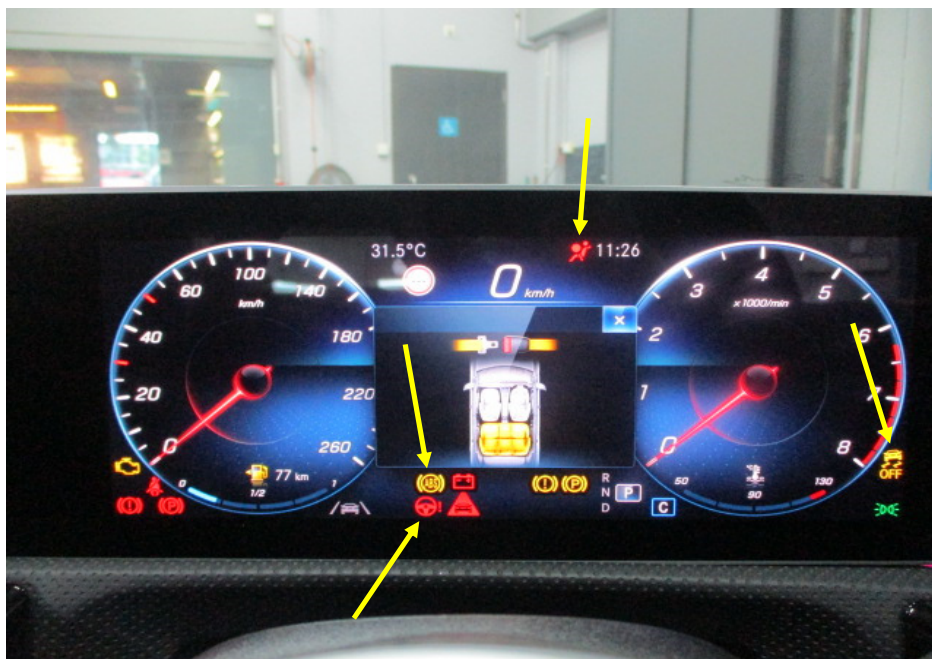
Photo 10 shows the warning lights for the various electronic safety features appearing on the instrument panel of the Motor Car during its self-test when the engine is cranked, in particular the ABS, SRS, EPS and ESP lights (arrowed).

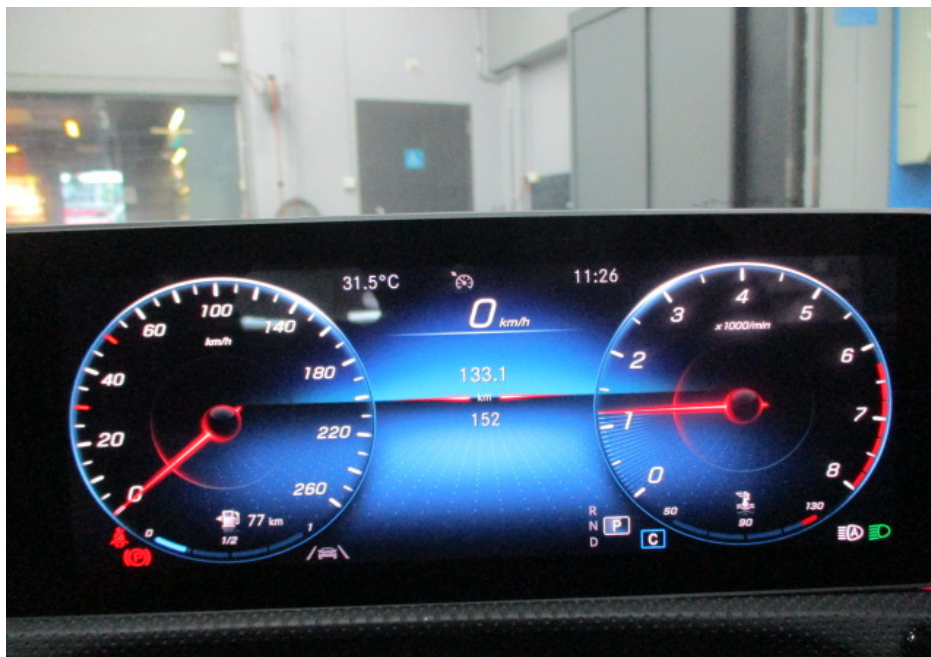
Photo 11 shows the respective warning lights no longer illuminated, indicating that there is no fault detected to the ABS, SRS, EPS and ESP systems of the Motor Car during the self-test. These electronic systems were hence in working condition at the time of my inspection.

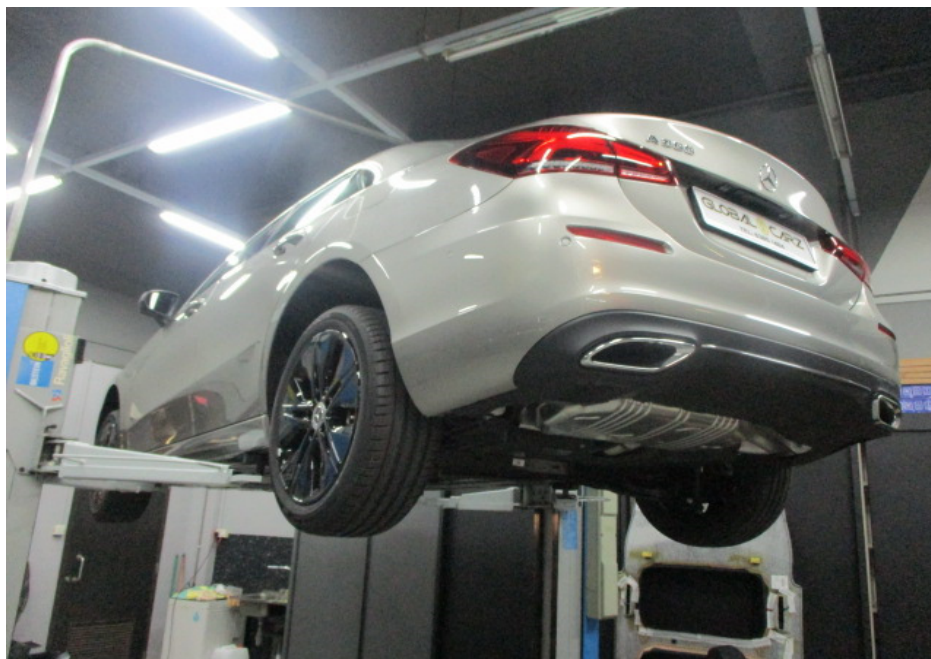
Photo 12 shows the Motor Car hoisted up for checks on its undercarriage. There was no sign(s) or indication(s) of fluid leakage and/or fluid stain(s) on the underside of the Motor Car. The undercarriage components of the Motor Car were also all observed to be intact and secured in an appropriate manner.

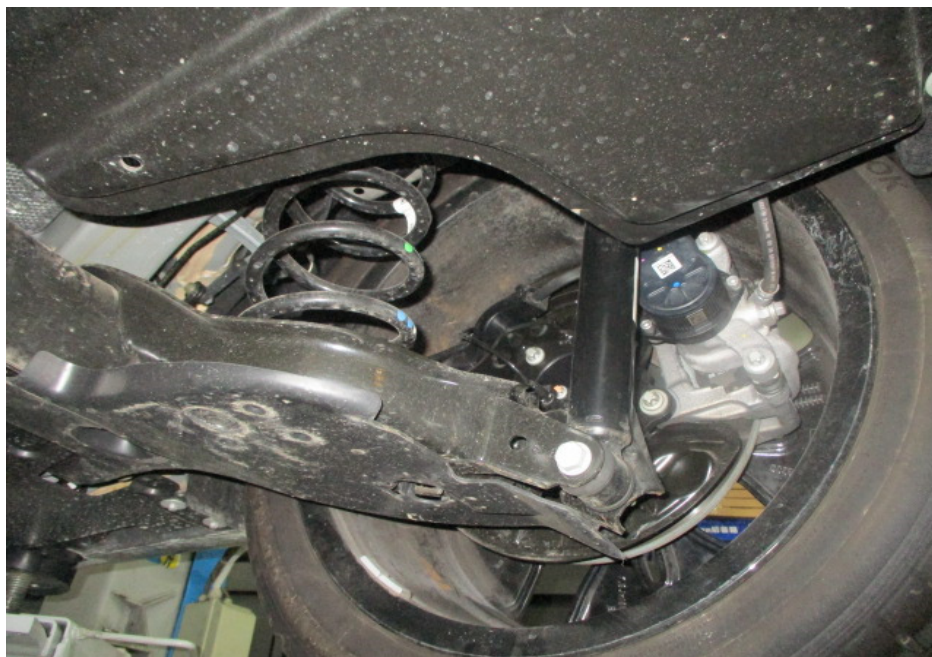
Photo 13 shows a general view of the control arms and linkages at the rear right wheel of the Motor Car. I did not observe any fluid leak and/or fluid stain on the underside of the Motor Car. All of the Motor Car's undercarriage components were observed to be intact and secured in an appropriate manner.

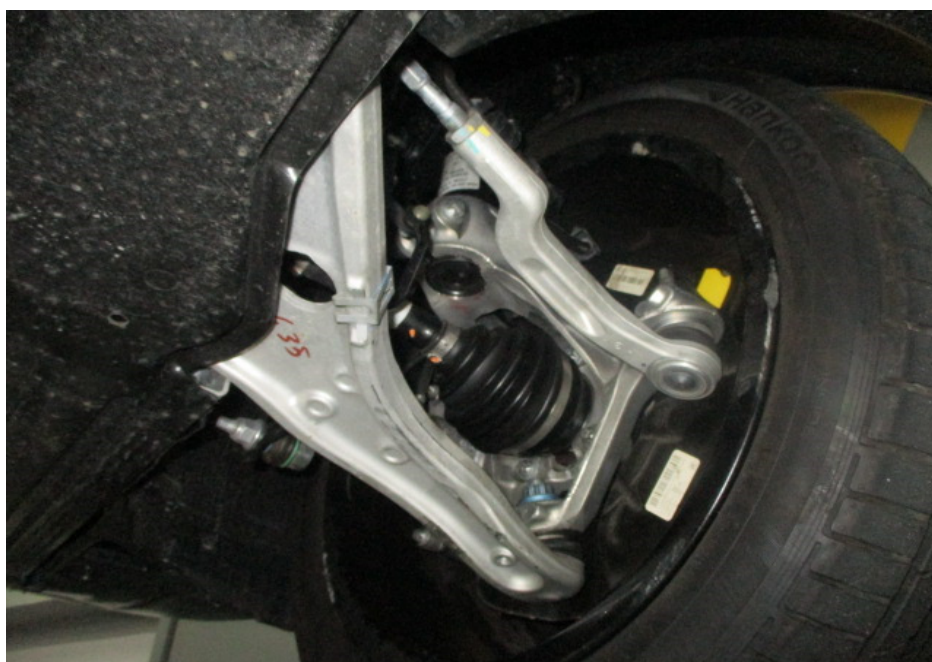
Photo 14 shows the various undercarriage components at the front right wheel of the Motor Car. The mechanical components, control arms and linkages were all found to be intact and secured in an appropriate manner.

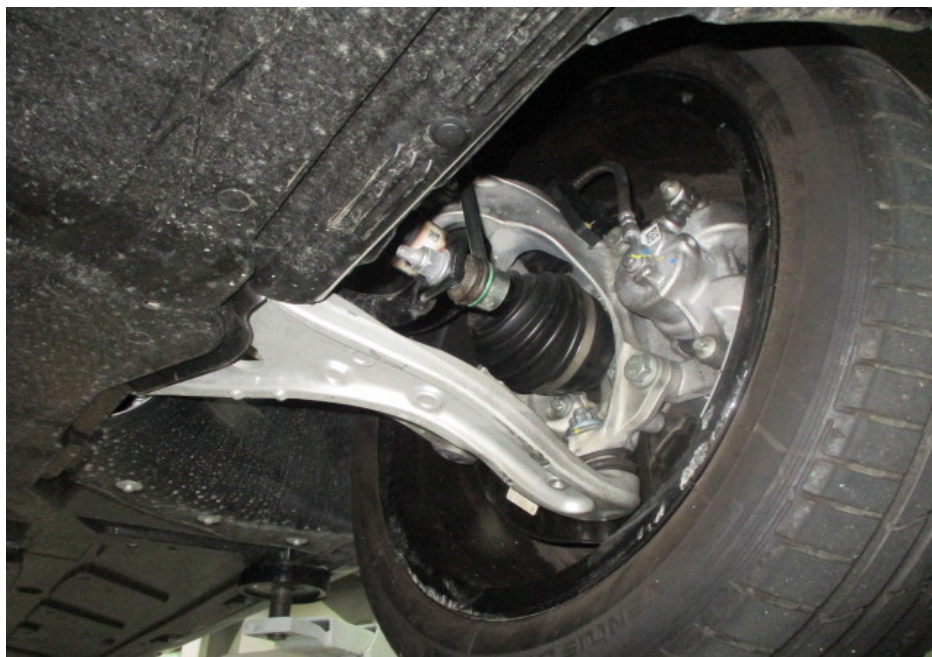
Photo 15 shows the various undercarriage components at the front left wheel of the Motor Car. The mechanical components, control arms and linkages were all found to be intact and secured in an appropriate manner. I also did not observe any fluid leak and/or fluid stain on the underside of the Motor Car.

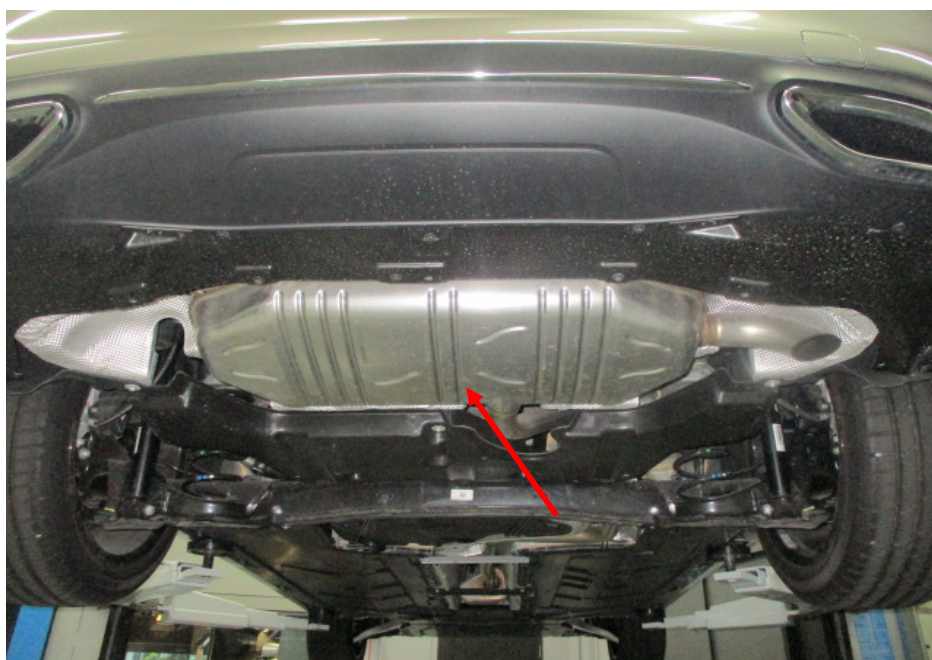
Photo 16 shows the Motor Car's rear muffler (arrowed). My examination of the Motor Car's exhaust system revealed no sign(s) or indication(s) of any cut or weld marks along its exhaust pipes and on its catalytic converter.

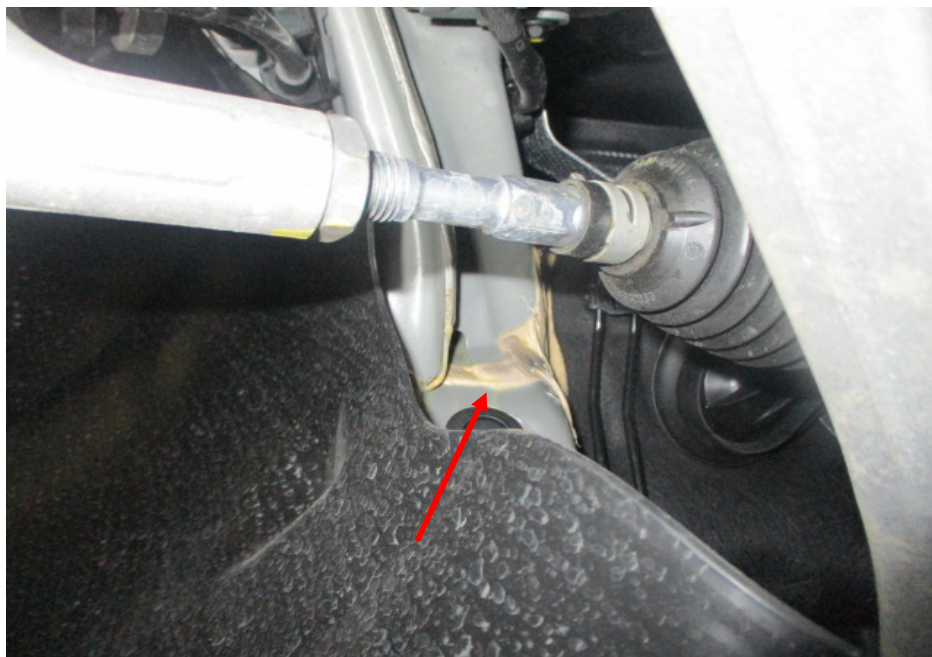
Photo 17 shows the chassis/structural body at the underside front right of the Motor Car. Visually, the original factory sealant (arrowed) at the joints along the chassis/structural body was untouched, indicating no work was done on the chassis/structural body of the Motor Car and that the chassis/structural body was originally fitted.

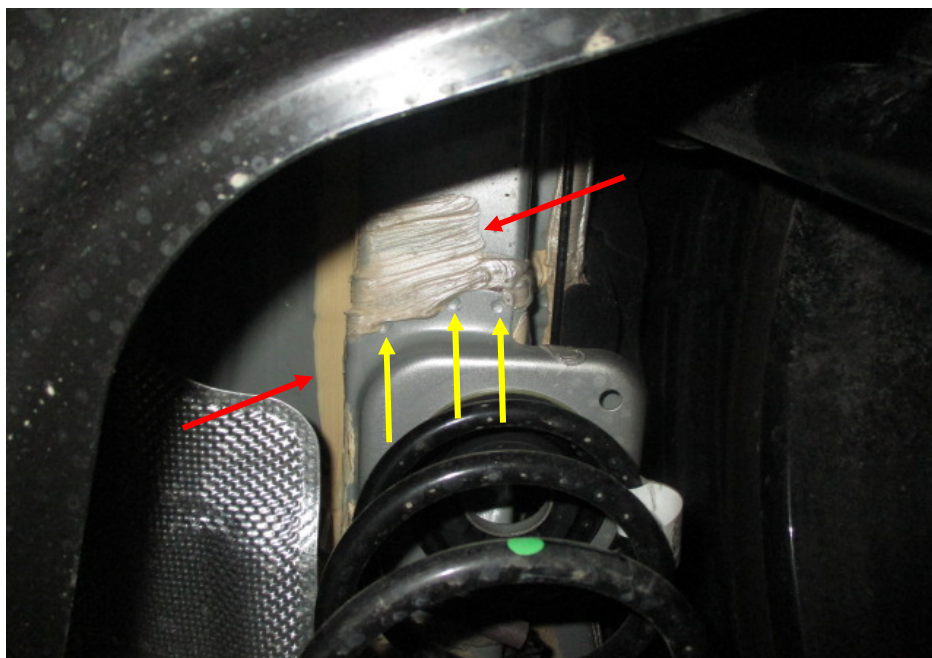
Photo 18 shows the chassis/structural body at the underside rear right of the Motor Car. Visually, I did not find any weld marks other than original spot weld marks (yellow arrow) on the chassis/structural body of the Motor Car. The original factory sealant (red arrow) at the joints along the chassis/structural body was also untouched, indicating no work was done on the chassis/structural body of the Motor Car and that the chassis/structural body was originally fitted.

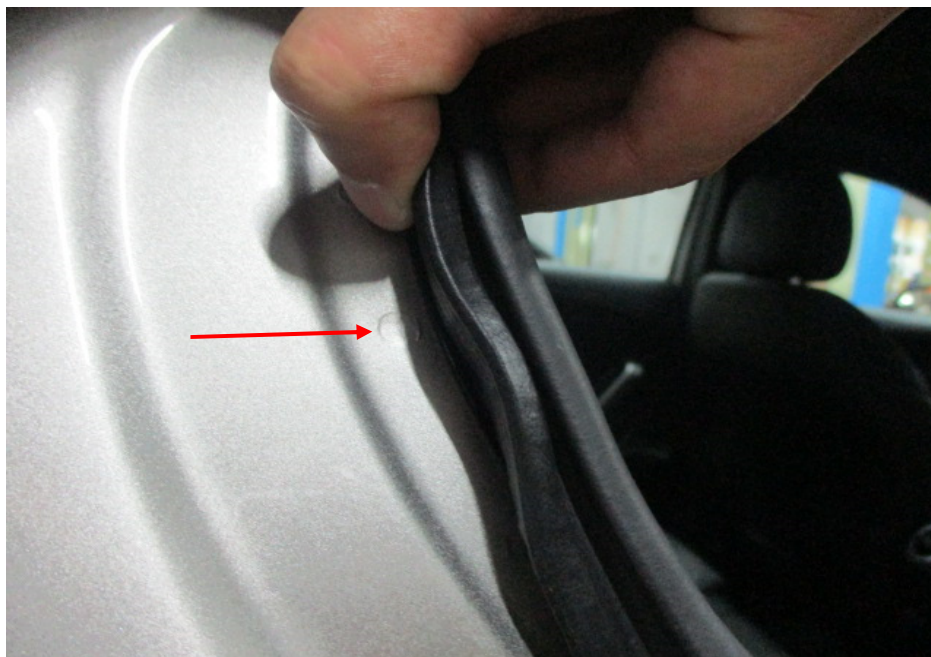
Photo 19 shows the right "C" pillar of the Motor Car. I did not find any weld marks other than original spot weld marks (arrowed) on the right "C" pillar of the Motor Car. In general, I had found all the non-detachable body panels of the Motor Car to be originally fitted at the time of my inspection.
