Your Ref :S0M02UGE  
Our Ref : CS4/ASM20012219/N

13 November 2020

**TECHNICAL INVESTIGATION REPORT OF FIRE INCIDENT INVOLVING THE  
INSURED MOTORCYCLE FBQ 4513Y ON 19 SEPTEMBER 2020**

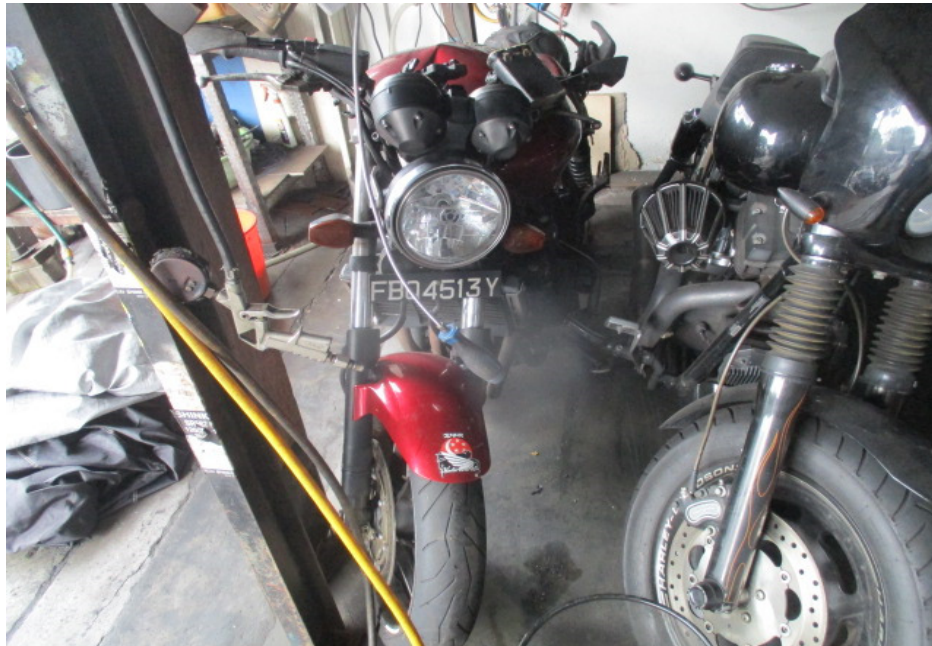
**Photo 1** shows the general view of the front portion of the Insured Motorcycle at the time of our inspection. The Insured Motorcycle was observed to have sustained extensive fire damage all around. Rust had accumulated all over the rear portion of the Insured Motorcycle as a result of exposure to environmental condition for a period of time.

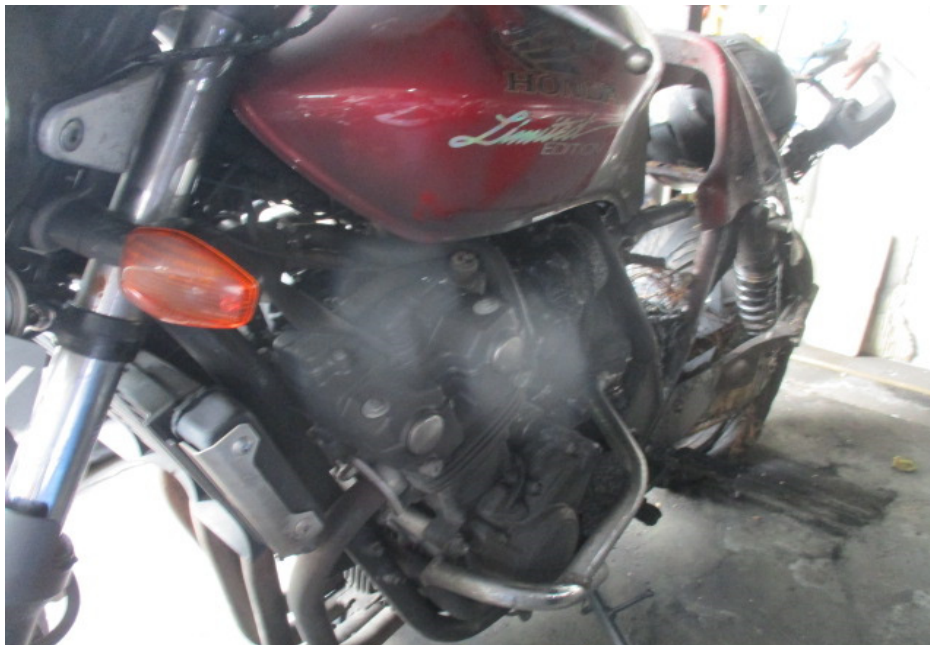
**Photo 2** shows the general view of the left body of the Insured Motorcycle at the time of our inspection. The Insured Motorcycle was observed to have sustained extensive fire damage all around. Rust had accumulated all over the rear portion of the Insured Motorcycle as a result of exposure to environmental condition for a period of time.

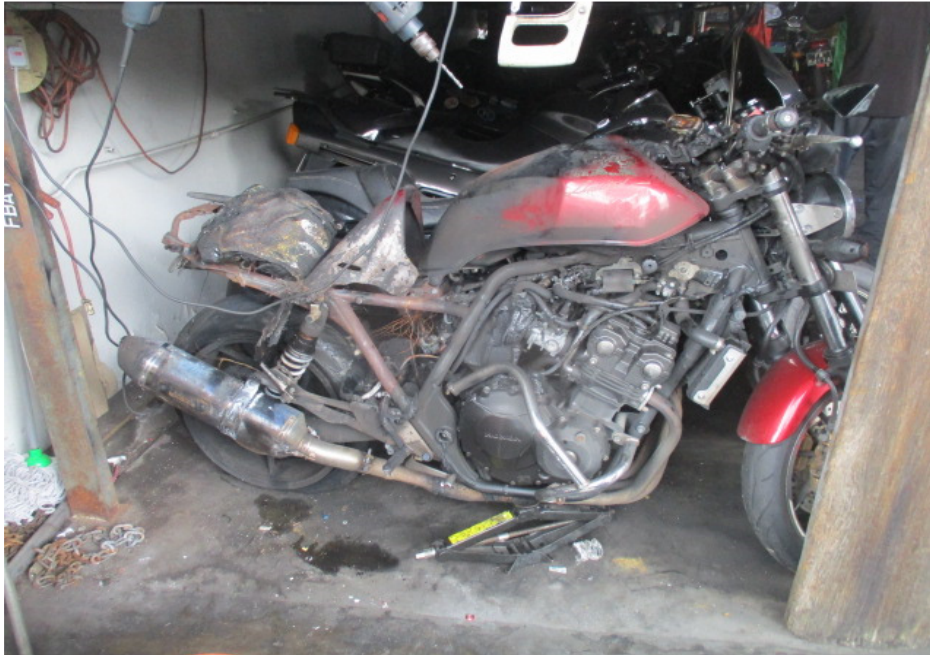
**Photo 3** shows the general view of the right body of the Insured Motorcycle at the time of our inspection. The Insured Motorcycle was observed to have sustained extensive fire damage all around. Rust had accumulated all over the rear portion of the Insured Motorcycle as a result of exposure to environmental condition for a period of time.

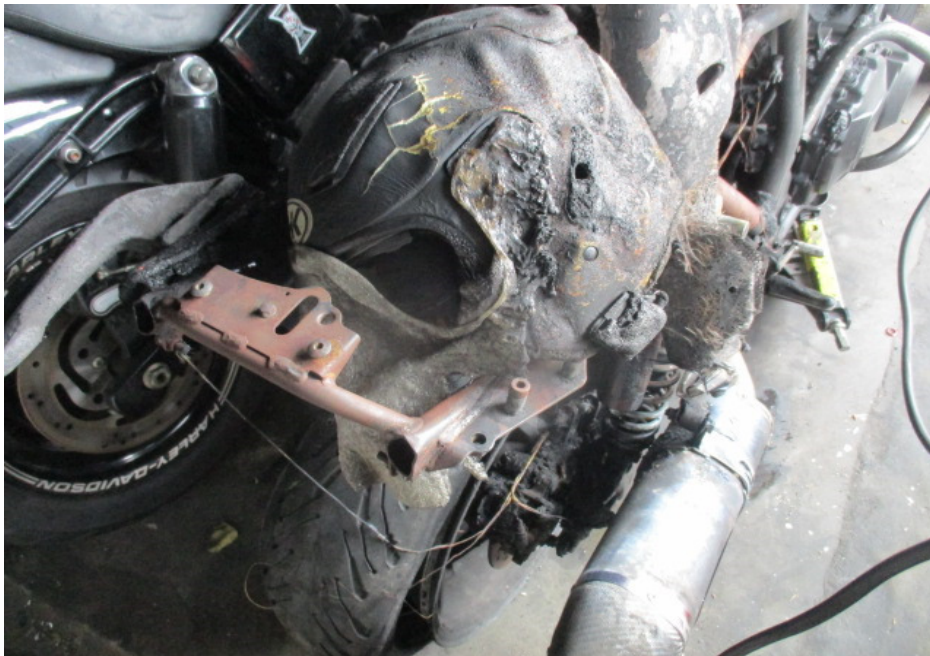
**Photo 4** shows the general view of the rear portion of the Insured Motorcycle at the time of our inspection. The Insured Motorcycle was observed to have sustained extensive fire damage all around. Rust had accumulated all over the rear portion of the Insured Motorcycle as a result of exposure to environmental condition for a period of time.

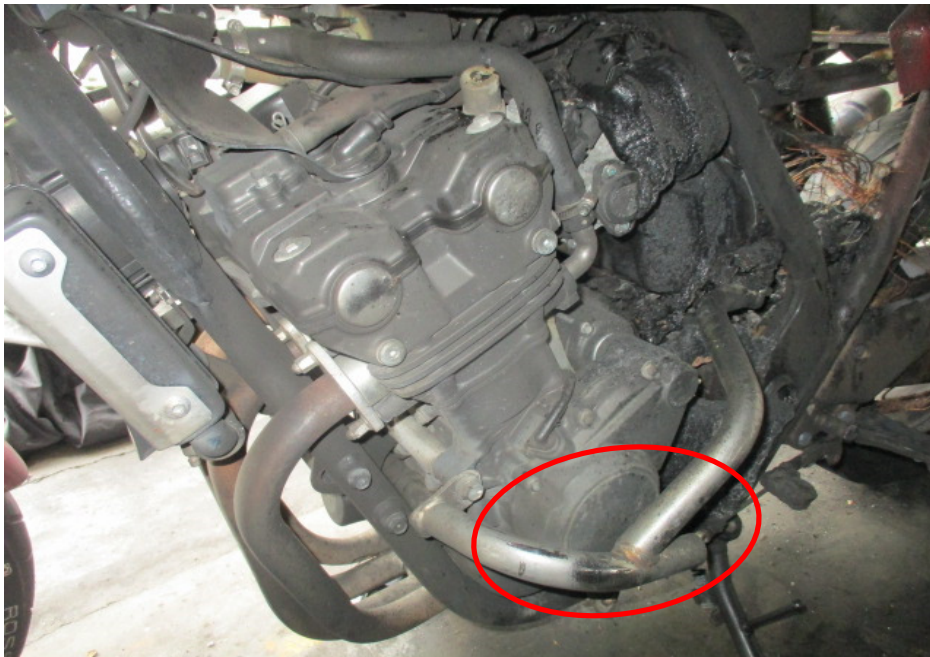
**Photo 5** shows the left engine crash bar fitted on the Insured Motorcycle which had sustained visible fire damage (circled).

25. Although the aftermarket engine crash bars and rear exhaust muffler fitted on the Insured Motorcycle were not the standard type for the Insured Motorcycle, we are of the view that these parts did not cause and/or contribute to the fire incident.

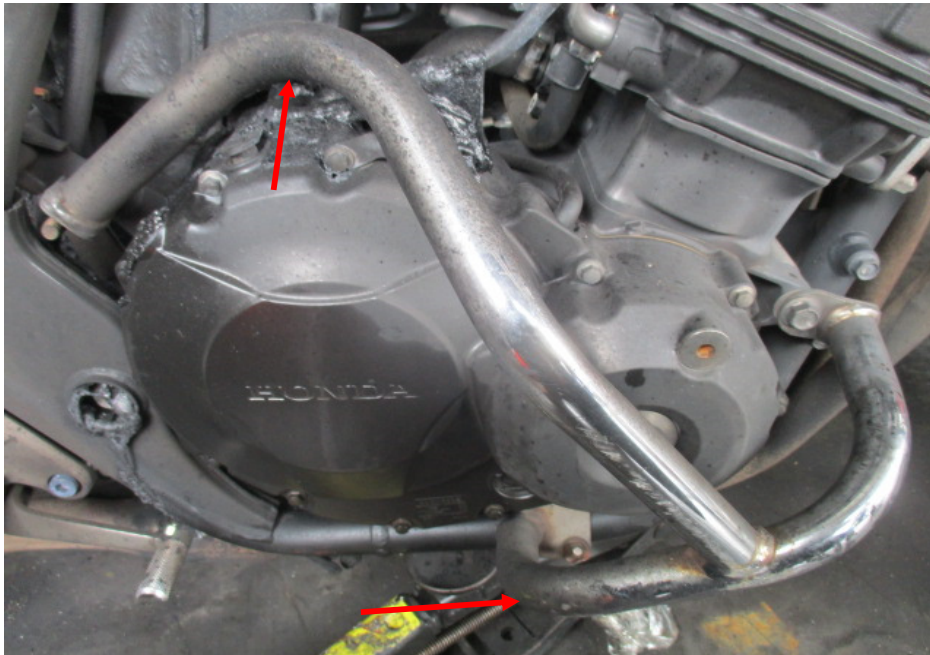
**Photo 6** shows the right engine crash bar fitted on the Insured Motorcycle which had sustained visible fire damage (arrowed).

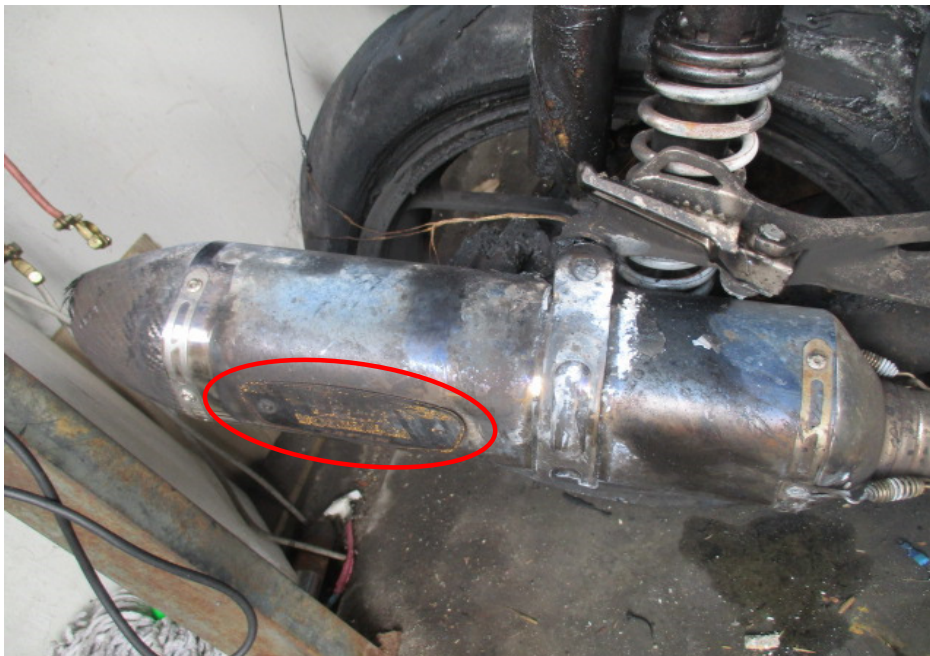
**Photo 7** shows the right view of the non-standard rear exhaust muffler that was found to be fitted on the Insured Motorcycle at the time of our inspection. The brand of the rear exhaust muffler was 'YOSHIMURA' (circled).

24. We found the Insured Motorcycle to be fitted with aftermarket engine crash bars and rear exhaust muffler. The engine crash bars fitted do not require prior approval from LTA however the non-standard rear exhaust muffler would require prior approval from LTA. AT the time of writing this report, Mr Juainizal has not provided the LTA documentation for the non-standard rear exhaust muffler. We will forward a copy of the documents once it is made available to us.

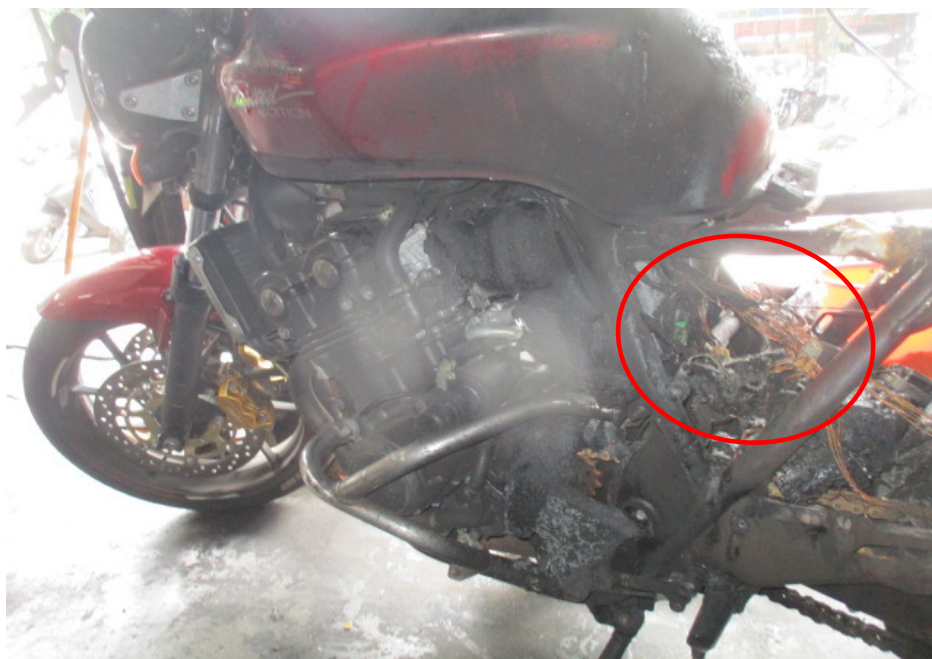
7. For this particular case, based on the nature of fire damage, the fire seemed to have started from the rear portion of the Insured Motorcycle.
8. Upon closer examination of the left rear portion of the Insured Motorcycle where the fire had likely started, we had found several stretches of wirings with greenish residue. These wirings were original factory fitted wirings. The presence of greenish residue indicates internal heating of copper wires, a sign of an electrical short circuit occurring. The greenish residue is normally left behind from oxidation as a result of chemical reaction involving the copper wires. This physical evidence would appear to suggest that the cause of fire to the Insured Motorcycle could have possibly been due to electrical in nature. See photos 8 – 13 below.

**Photo 8** shows a view of the left body of the Insured Motorcycle. Upon closer examination of the left rear portion of the Insured Motorcycle which was where the fire had likely started, we had found several stretches of wirings with greenish residue (circled). These wirings were original factory fitted wirings. The presence of such greenish residue suggests occurrence of an electrical short circuit. The greenish residue is normally left behind from oxidation as a result of chemical reaction involving the copper wires.

23. Having investigated and technically analysed the damages of burnt nature to the Insured Motorcycle, we are of the view that the cause of fire to the Insured Motorcycle was of electrical in nature. For this particular case, the fire had originated along the wirings at the left rear portion of the Insured Motorcycle. The wirings were original factory wirings of the Insured Motorcycle.

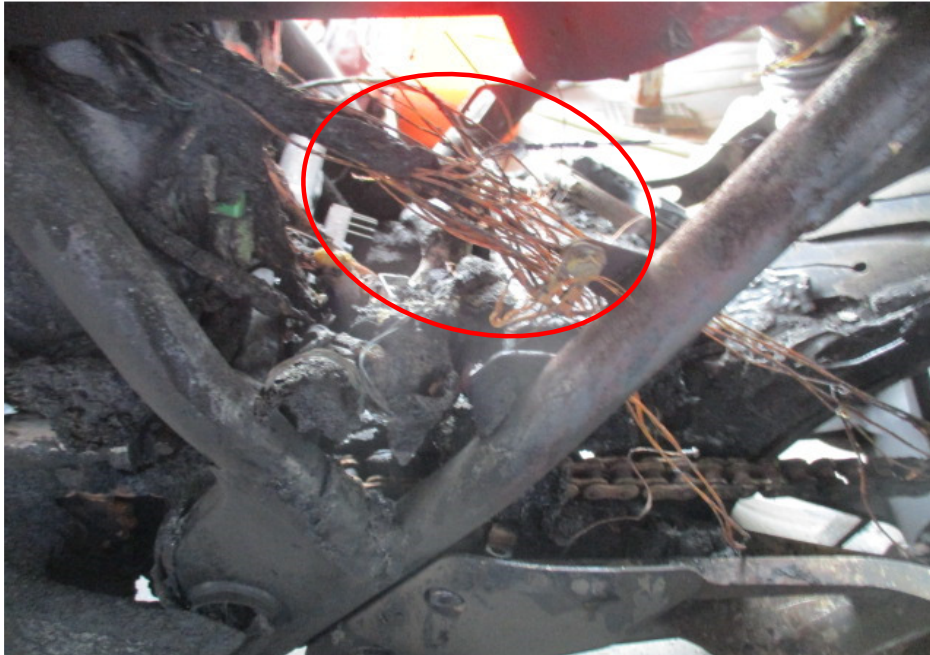
**Photo 9** shows a closer view of the left rear portion of the Insured Motorcycle which was where the fire had likely started. We had found several stretches of wirings with greenish residue (circled). The presence of greenish residue indicates internal heating of copper wires, a sign of an electrical short circuit occurring.

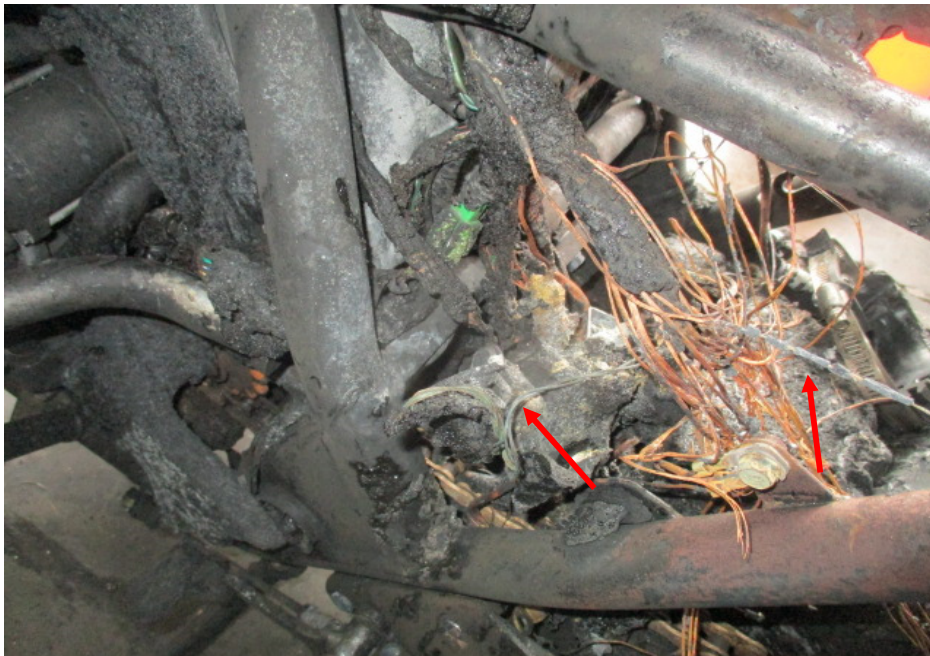
**Photo 10** shows a closer view of the left rear portion of the Insured Motorcycle which was where the fire had likely started. We had found several stretches of wirings with greenish residue (arrowed). The presence of greenish residue indicates internal heating of copper wires, a sign of an electrical short circuit occurring.

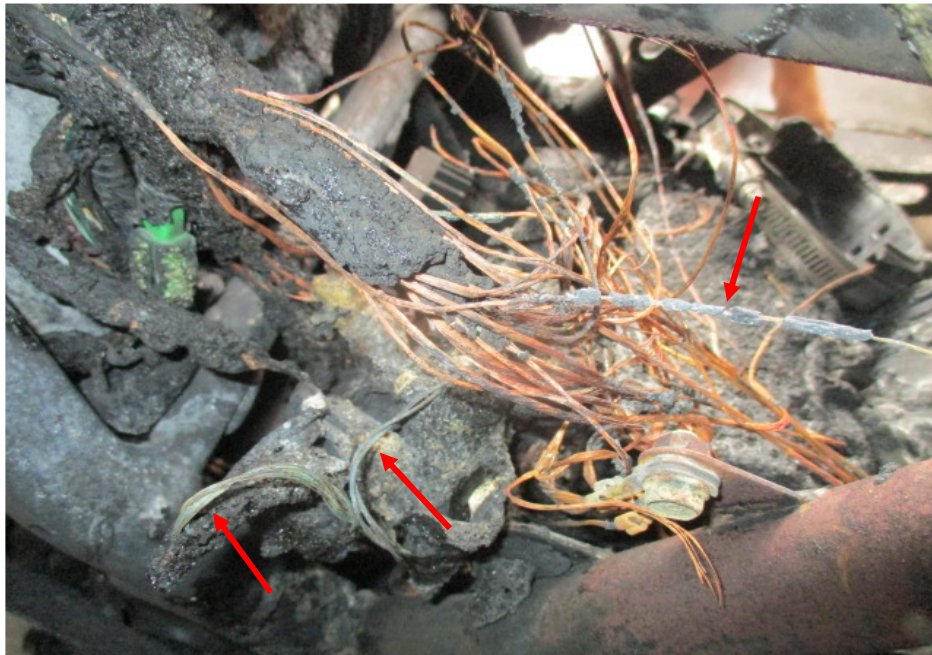
**Photo 11** shows a closer view of the wirings with greenish residue (red arrows). The presence of greenish residue indicates internal heating of copper wires, a sign of an electrical short circuit occurring.

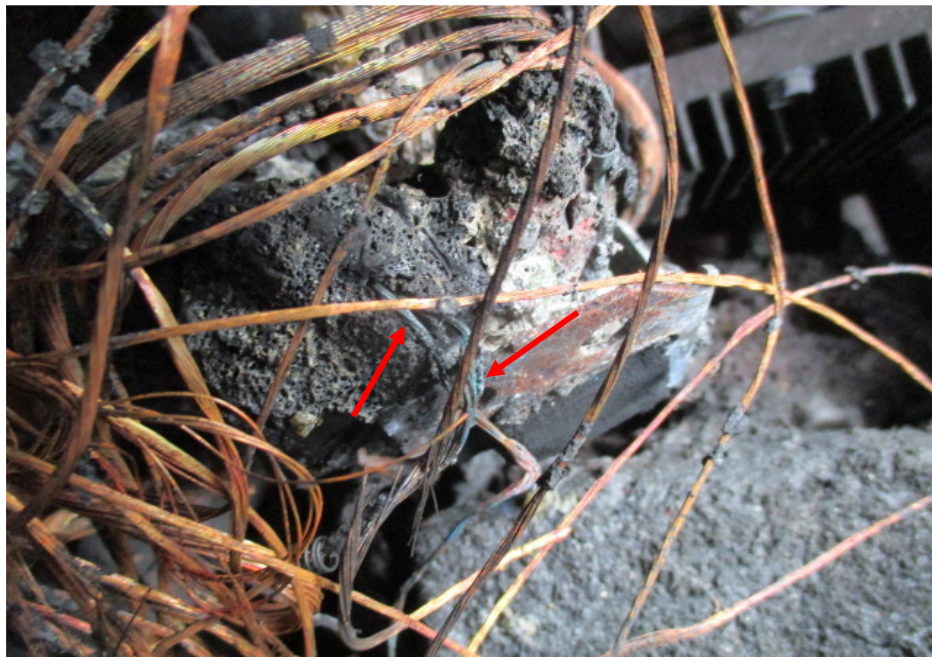
**Photo 12** shows a close up view of the wirings with greenish residue (red arrows). The presence of greenish residue indicates internal heating of copper wires, a sign of an electrical short circuit occurring.

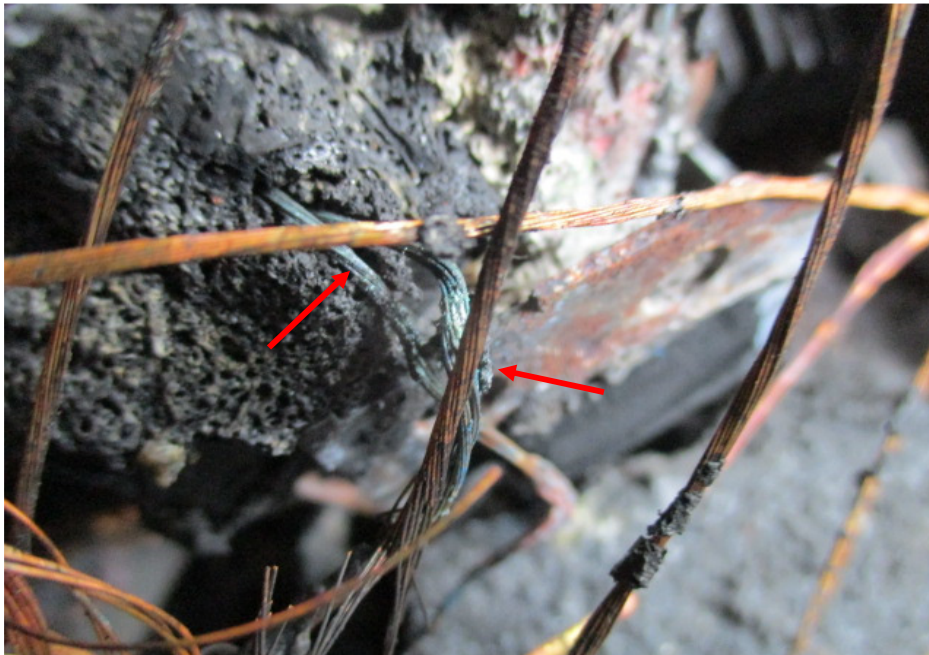
**Photo 13** shows a close up view of the wirings with greenish residue (red arrows). The presence of greenish residue indicates internal heating of copper wires, a sign of an electrical short circuit occurring.

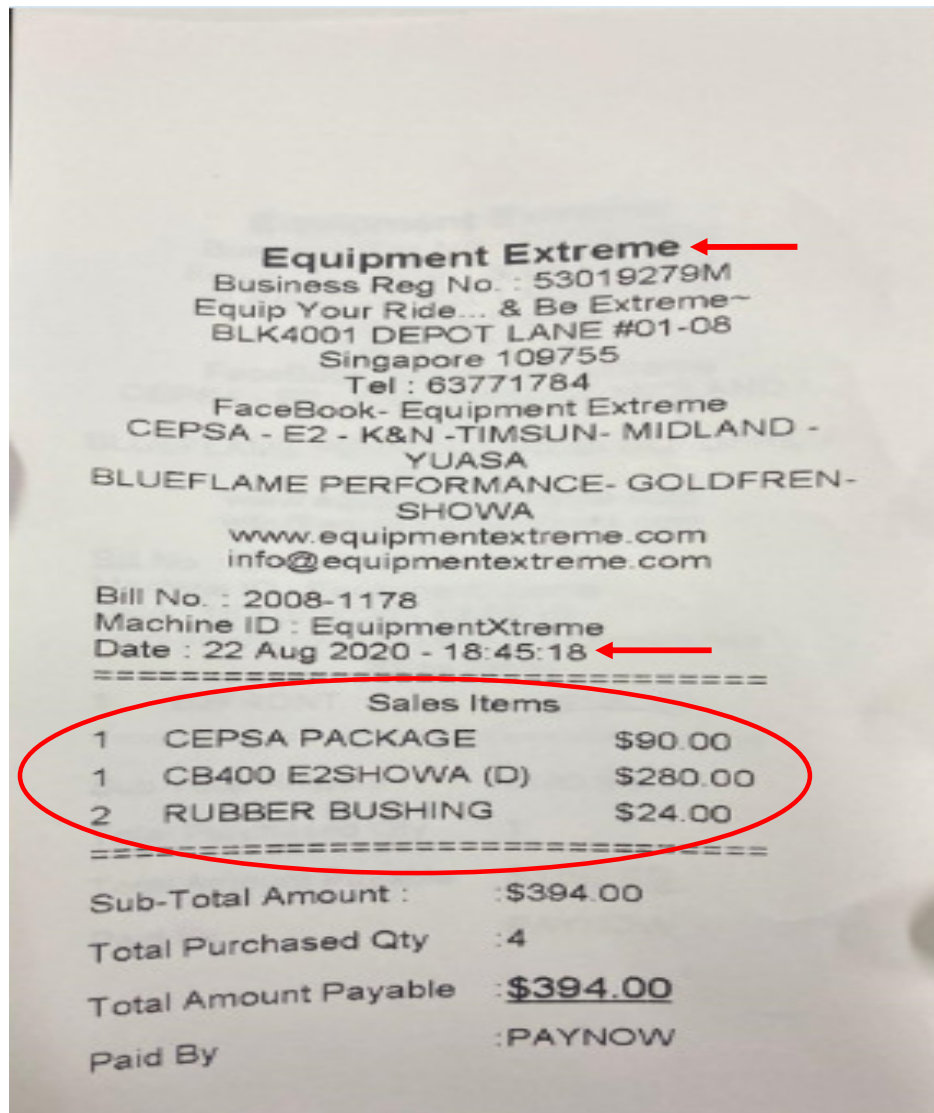
**Invoice 1** shows the last servicing package done on the Insured Motorcycle at Equipment Extreme on 22 August 2020 (red arrows) which had included changing the engine oil and oil filter. The rear shock absorbers and rubber bushings were also changed (circled).

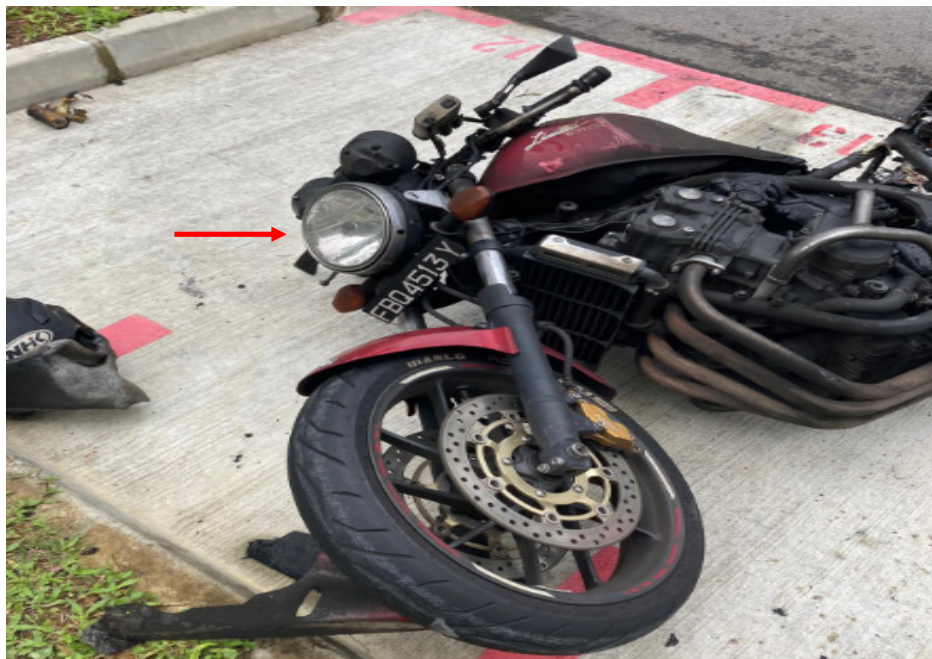
**Photo 14** shows a closer view of the Insured Motorcycle (arrowed) which was found completely burnt by the fire at the parking lot of Block 60 Dakota Crescent.

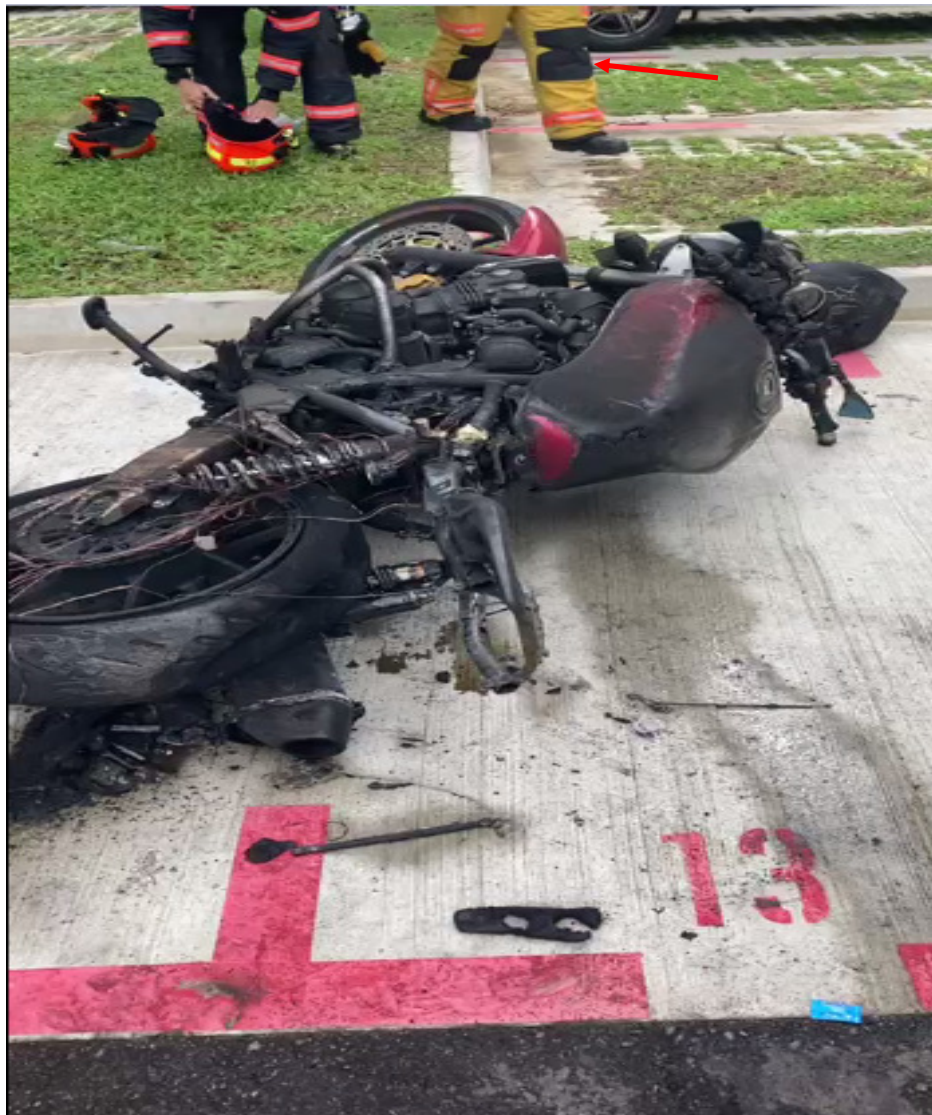
**Photo 15** shows the rear portion of the Insured Motorcycle post- incident. In general, the information that could be gathered from this photograph had corresponded to the events that were related to us by Mr Juainizal, which is the SCDF had responded to the fire (arrowed).

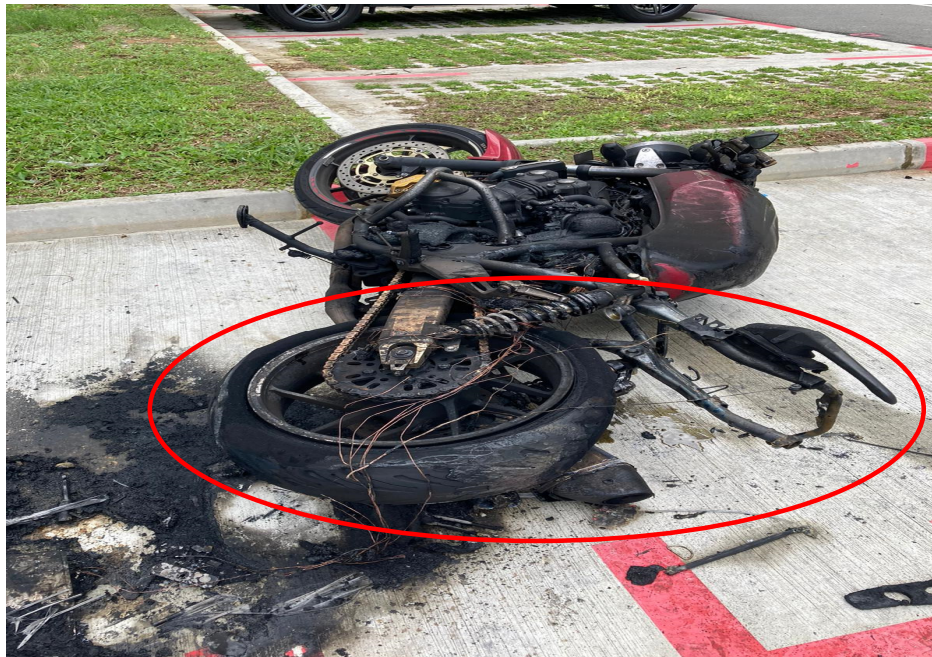
**Photo 16** shows a closer view of the rear portion of the Insured Motorcycle at the incident scene after the fire was extinguished. The extent of fire damage observed indicates that the fire had started from the left rear portion (circled).
