Your Ref: S0M02WT4  
Our Ref : CS4/ASM20012296/P

**TECHNICAL INVESTIGATION REPORT OF FIRE INCIDENT INVOLVING THE  
INSURED VEHICLE SKZ 9085D ON 7<sup>th</sup> November 2020**

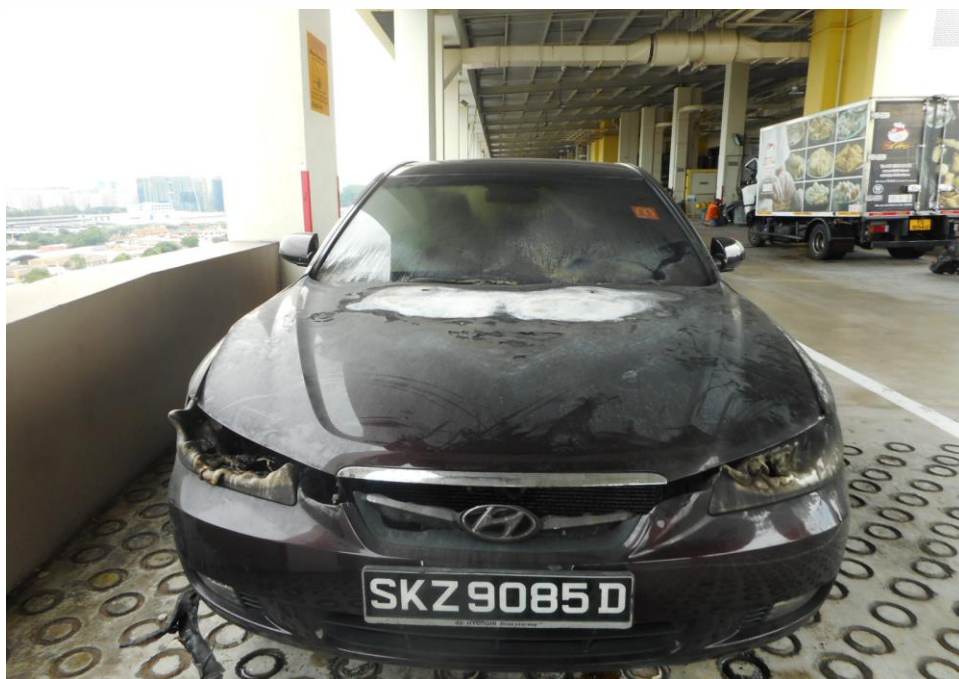
**Photo 1** shows the general view of the front portion of the Insured Vehicle at the time of our inspection. The Insured Vehicle was observed to have sustained extensive fire damage all around. Its engine compartment completely burnt and interior compartment had sustained smoke and heat damage. Rust had accumulated all over the front engine portion of the Insured Vehicle as a result of exposure to environmental condition for a period of time.

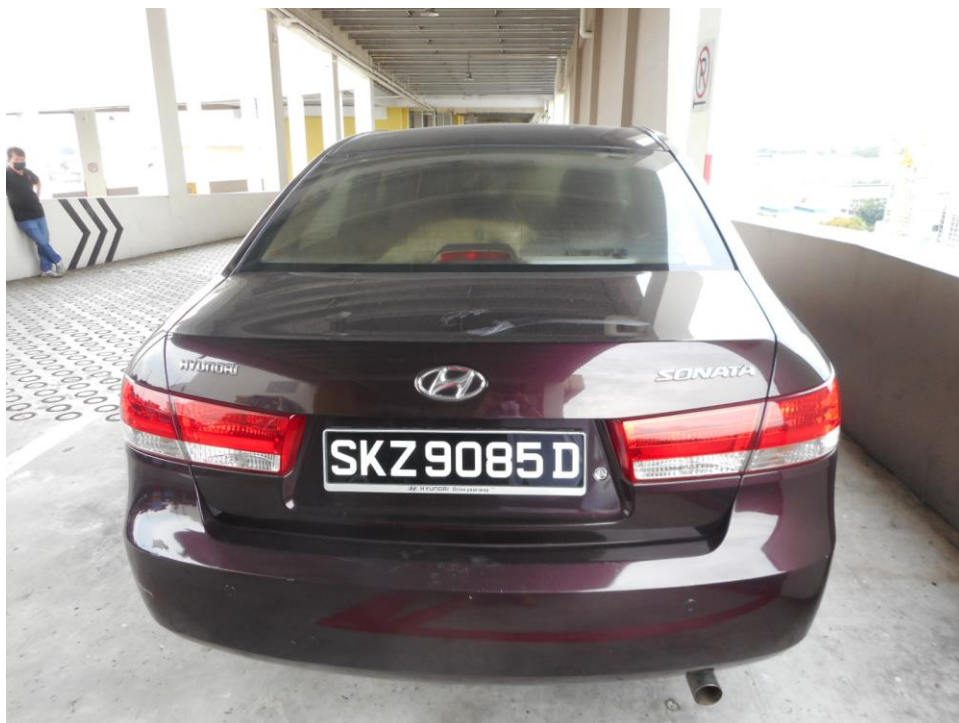
**Photo 2** shows the general view of the rear portion of the Insured Vehicle which was observed to be unaffected by heat smoke damage at the time of our inspection as a result of the fire.

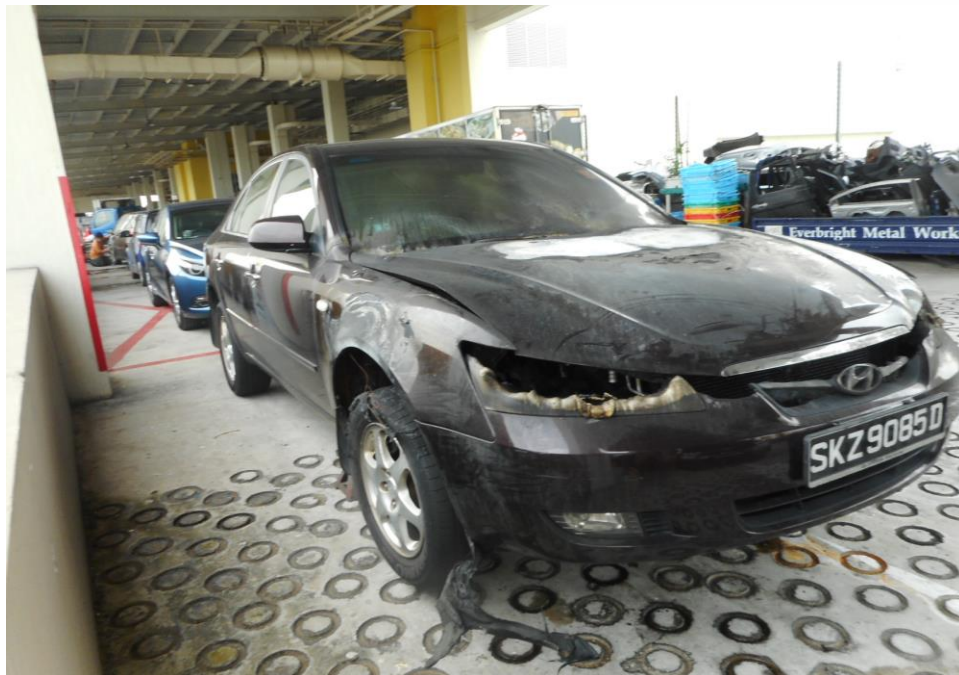
**Photo 3** shows the general view of the right body of the Insured Vehicle at the time of our inspection. The Insured Vehicle was observed to have sustained extensive fire damage all around. Rust had accumulated all over the front and interior compartment of the Insured Vehicle as a result of exposure to environmental condition for a period of time.

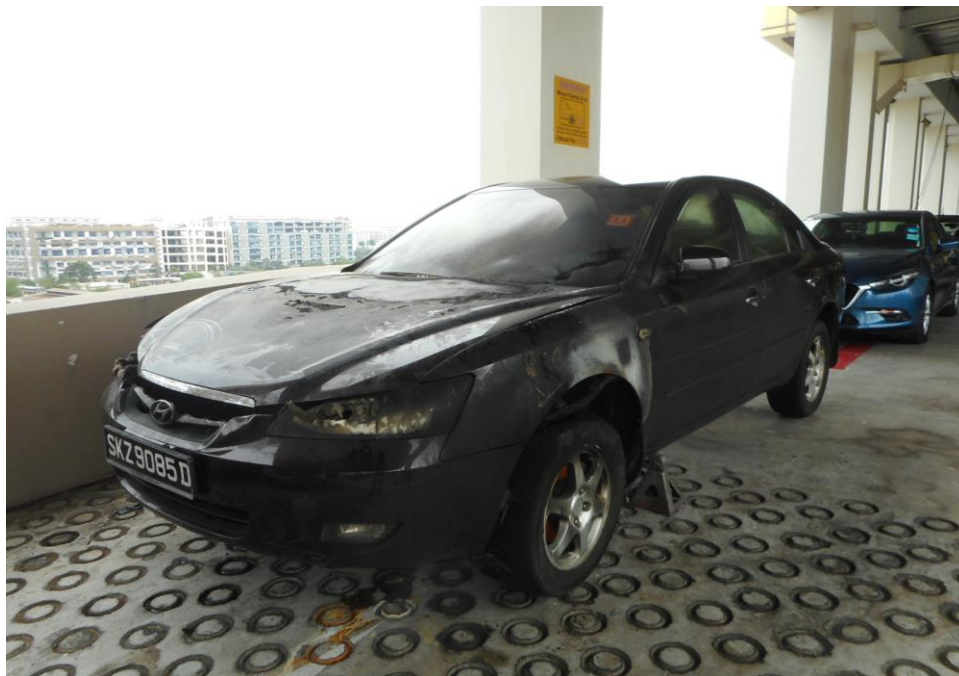
**Photo 4** shows the general view of the left body of the Insured Vehicle at the time of our inspection. The Insured Vehicle was observed to have sustained extensive fire damage all around. Rust had accumulated all over the front and centre portion of the Insured Vehicle as a result of exposure to environmental condition for a period of time.

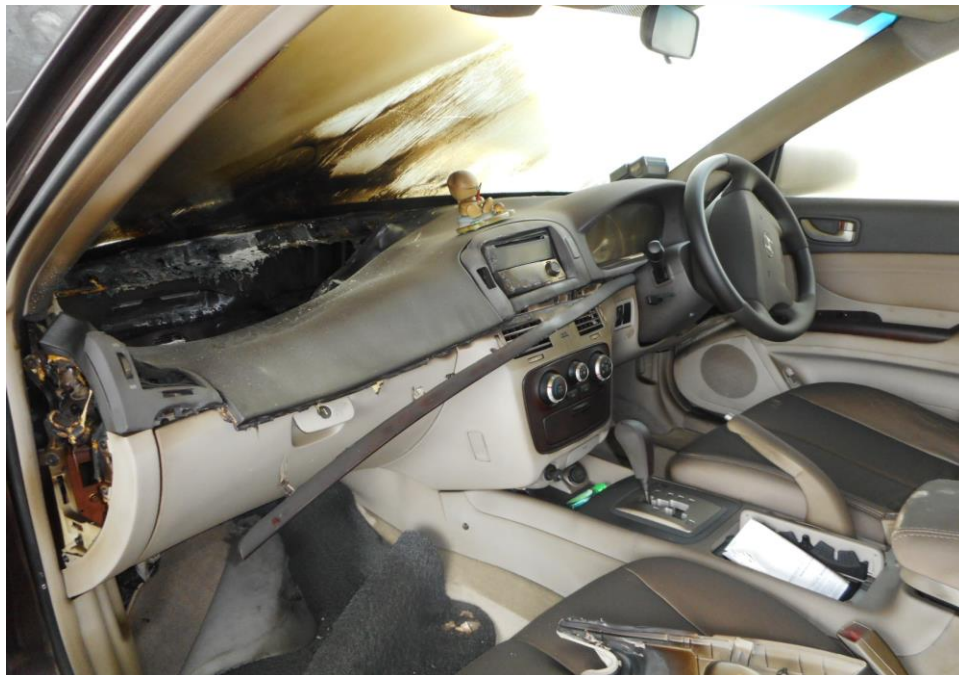
**Photo 5** shows the general view of the interior compartment of the Insured Vehicle at the time of our inspection. Its interior compartment was had sustained heat and smoke damage as a result of the fire.

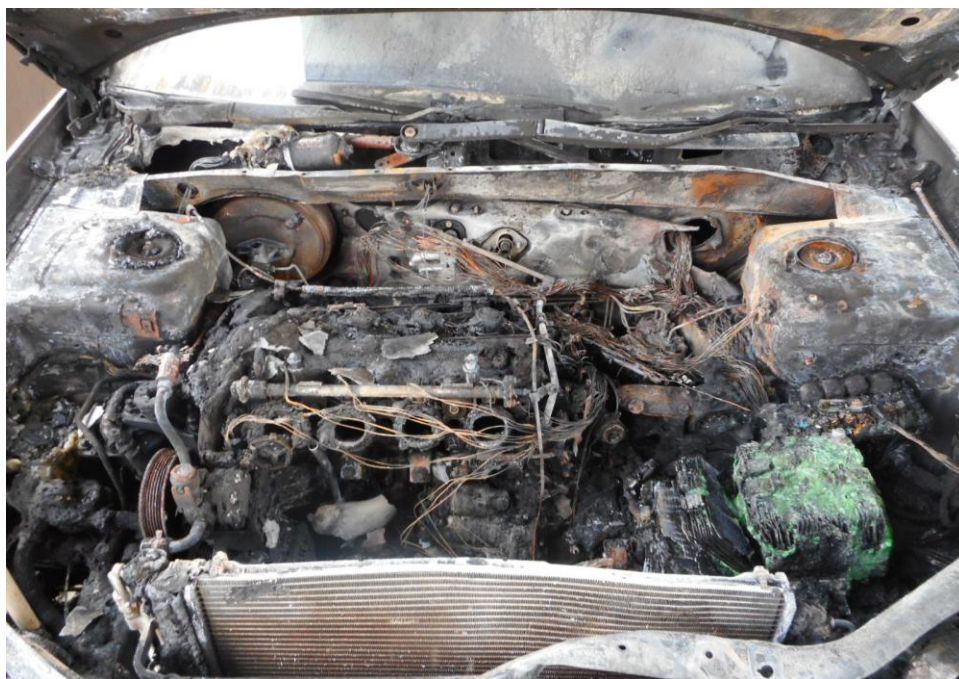
**Photo 6** shows the engine compartment of the Insured Vehicle at the time of our inspection. The entire engine compartment of the Insured Vehicle was observed to be severely burnt. Most of the parts inside the engine compartment were found to be burnt and/or melted as a result of the fire.

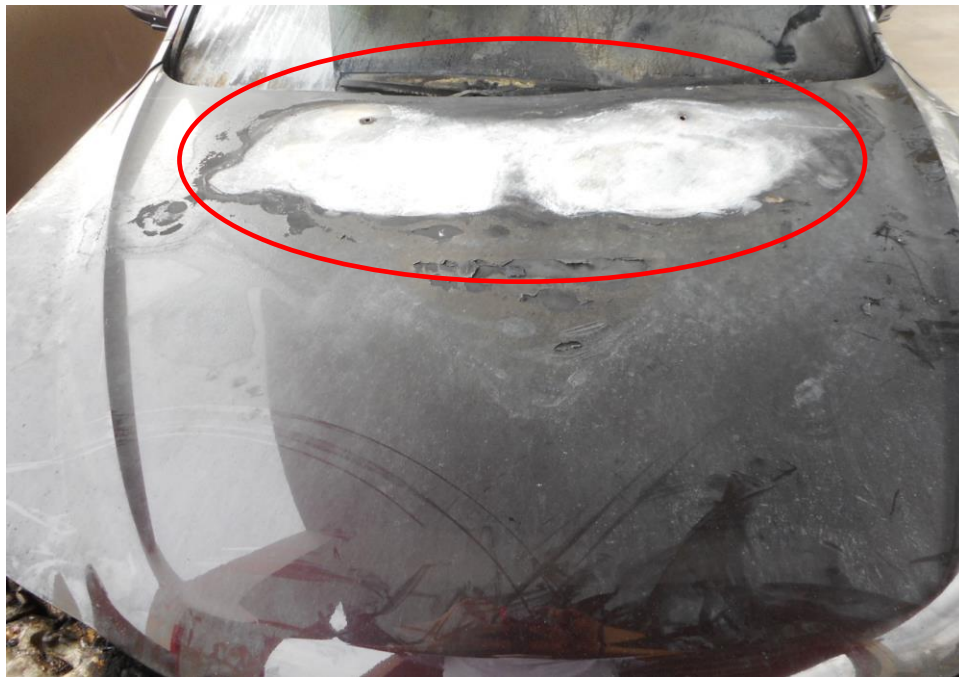
7. Based on the circumstances for this particular case, the fire appears to have originated from the front of the Insured Vehicle, somewhere around the front centre portion. This can be determined basing on the area where the extent of fire damage was most severe, the circumstances of the fires' origin at the material time of incident and also the high heat intensity burn marks (whitish burn marks) that were found on the exterior surface of its front bonnet centre portion.

8. These whitish burn marks are a result of exposure to prolong heat intensity. Rust would normally start to develop around these areas soon after a fire as the prolonged exposure to high heat intensity usually causes the bare steel/metal material of the body parts to be exposed to natural environmental condition. The rust that had developed on the front bonnet and centre portion, in the immediate vicinity of where these whitish burn marks were found, would also support our findings of where the fire had affected the Insured Vehicle. See photo 7- 10 below.

**Photo 7** shows the exterior of the front bonnet of the Insured Vehicle at the time of our inspection. The high heat intensity burn marks (whitish burn marks) (circled) and rust that had development found on the exterior surface of the bonnet indicates that the fire had originated from the front portion of the Insured Vehicle.

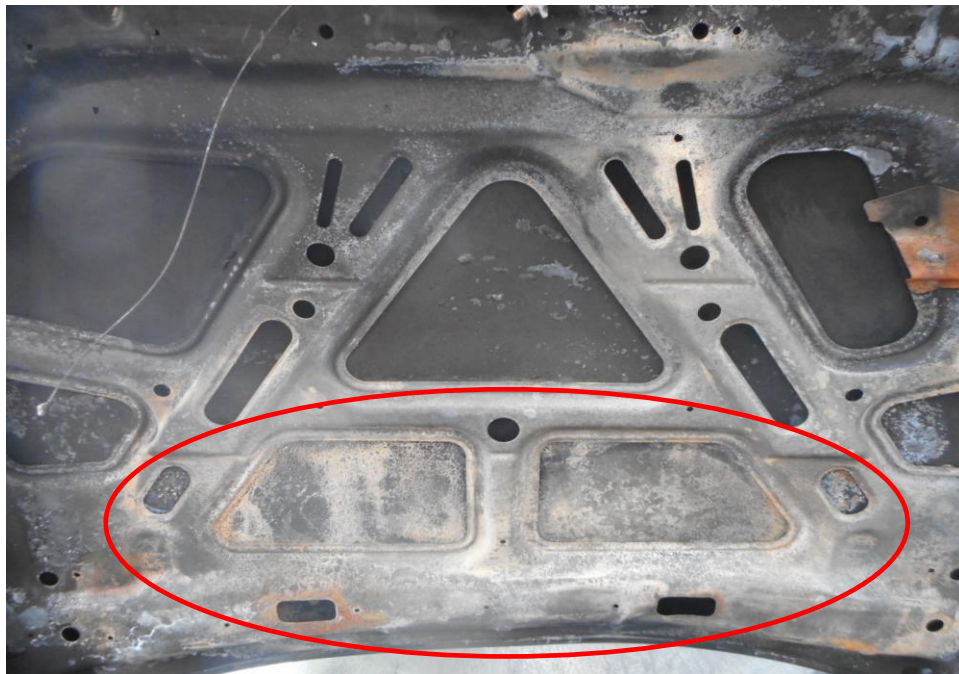
**Photo 8** shows the underside of the front bonnet cover of the Insured Vehicle at the time of our inspection. The High heat intensity burn marks (whitish burn marks) and rust that had development found on the interior surface of the bonnet indicates that the fire had originated from the front portion of the Insured Vehicle.

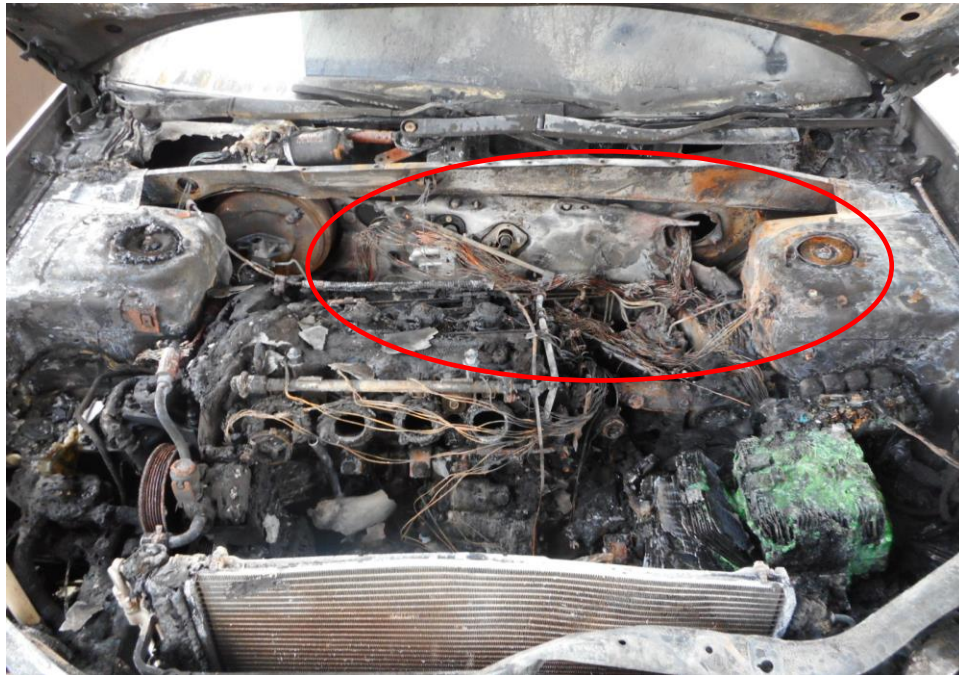
**Photo 9** shows general view of the engine compartment portion of the Insured Vehicle at the time of our inspection. The high heat intensity burn marks (whitish burn marks) and rust (circled) that had development found on the exterior surface indicates that the fire had originated from this area of the Insured Vehicle.

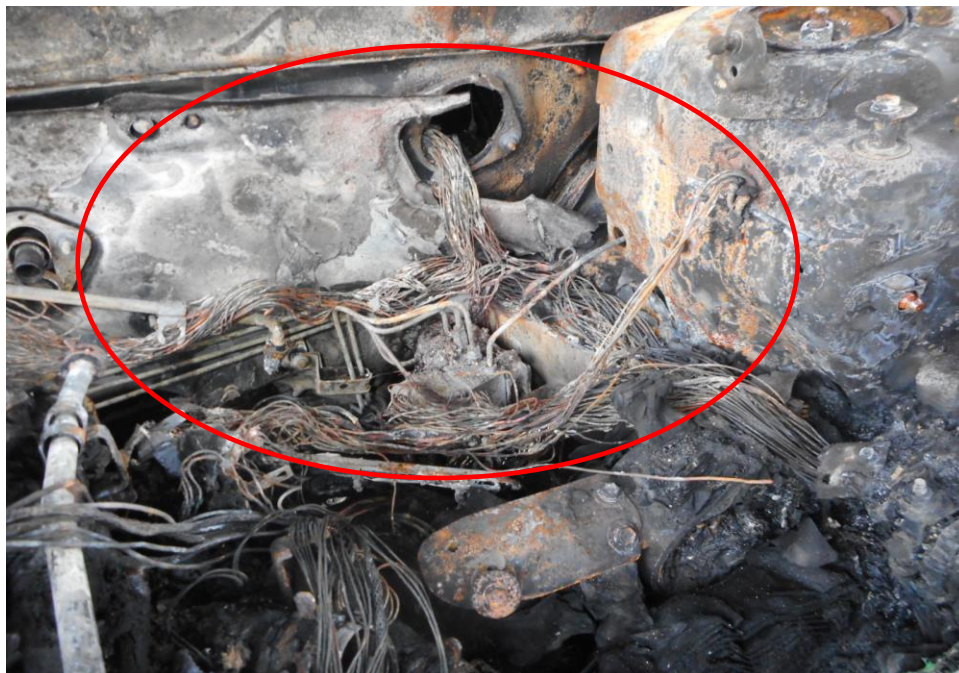
**Photo 10** shows close up view of the engine compartment portion of the Insured Vehicle at the time of our inspection. The high heat intensity burn marks (whitish burn marks) and rust (circled) that had development found on the exterior surface indicates that the fire had originated from this area of the Insured Vehicle.

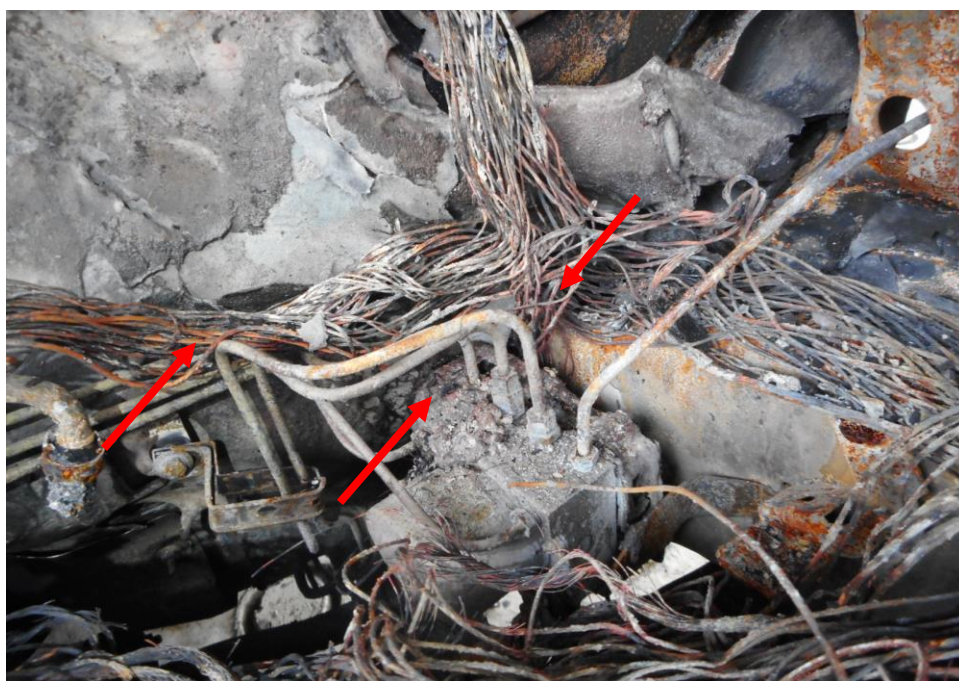
9. Upon closer examination of the engine compartment portion of the Insured Vehicle which was where the fire had likely started, we had found several stretches of wiring from the ABS pump and its connector which was burnt internally to its bare copper state. Such condition normally indicates internal heating of copper wires which is a sign of an electrical short circuit occurring. This would then appear to suggest that the cause of fire to the Insured Vehicle could have possibly been due to electrical in nature. See photos 11 and 12 below.

**Photo 11** shows the wirings from the ABS pump connector, which is in the immediate vicinity where the fire to the Insured Vehicle had likely started. The wirings (red arrows) were found to have been burnt internally to its bare copper state, suggesting occurrence of an electrical short circuit.

22. The possibility of the fire being due to electrical in nature would then seem more likely given that engine overheating and external factors would both seem unlikely. The fire being due to electrical nature is also supported by the condition of the several stretches of wiring from the ABS pump and its connector which was burnt internally to its bare copper state on the Insured Vehicle which was a sign of short circuit that which was earlier discussed in paragraph 9 above.

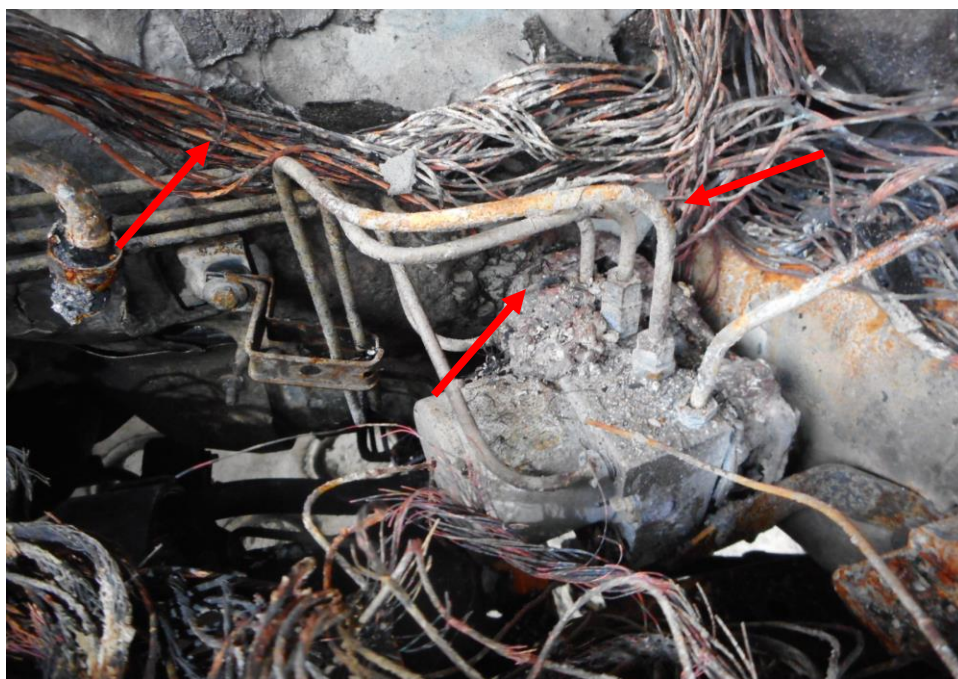
**Photo 12** shows close up view of the wirings from the ABS pump connector, which is in the immediate vicinity where the fire to the Insured Vehicle had likely started. The wirings (red arrows) were found to have been burnt internally to its bare copper state, suggesting occurrence of an electrical short circuit.

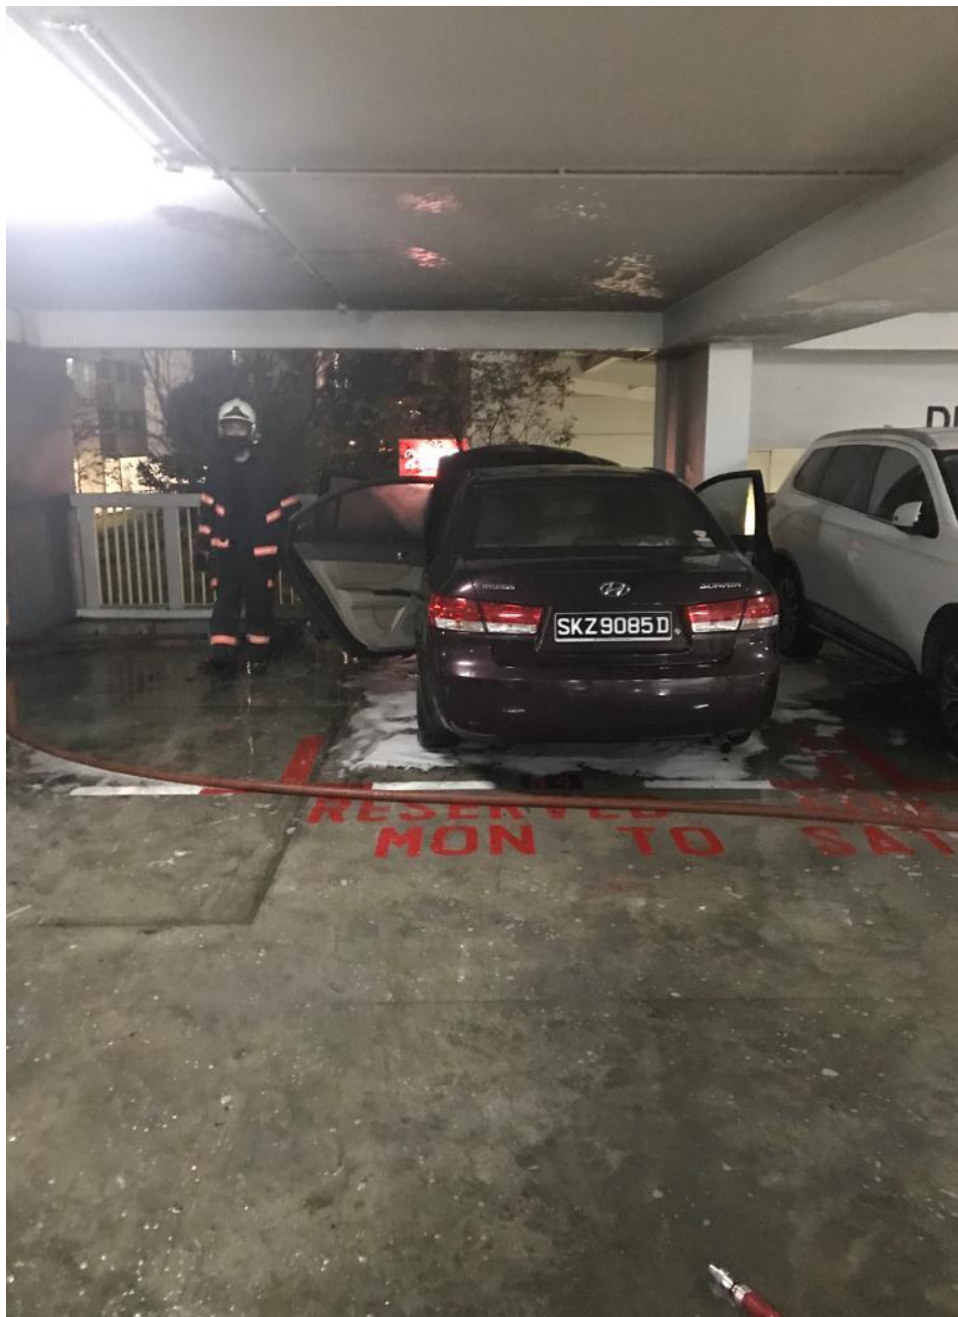
**Photo 13** shows the SCDF officer on scene after the fire was put out on the Insured Vehicle. In general, the information that could be gathered from this photograph had corresponded to the events that were related to us by Mr Tan, location when the fire broke out.

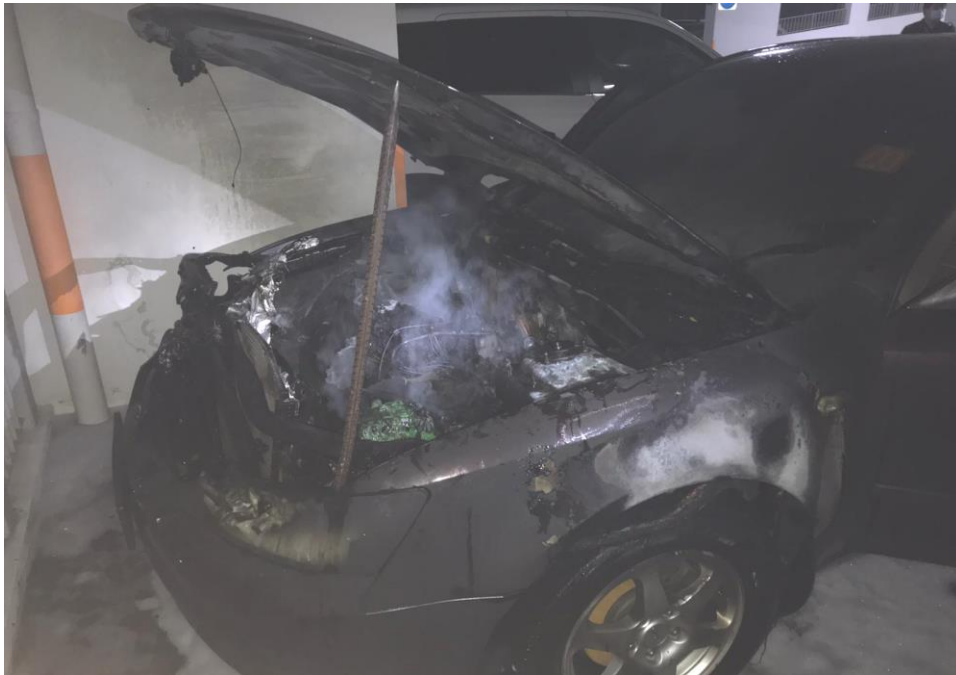
**Photo 14** shows the badly burned Insured Vehicle at the MSCP after the fire was put out by the SCDF. In general, the information that could be gathered from this photograph had corresponded to the events that were related to us by Mr Tan, location when the fire broke out.
