**SURVEY OF VEHICLE NO. SKJ 8921G**

## AUTOMOBILE ASSESSMENT REPORT

**Assessment of Vehicle No** : **SKJ 8921G**  
**Date of Accident** : **24-January-2019**  
**Date of Inspection** : **29-January-2019**  
**Address of Inspection** : **Blk 9 Pioneer Road North #01-56 S'628461**

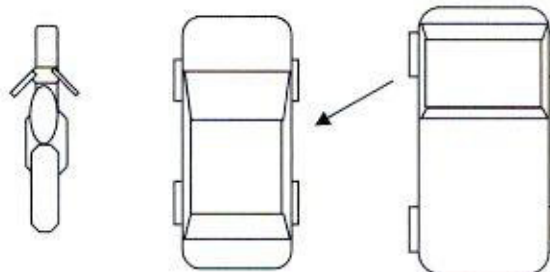
At the time of inspection, this vehicle sustained damages to the **RH Side** portion. Please see attached scheduled for details.
