Our Reference : TP/2010/SLB3133C/DM

## VEHICLE APPRAISAL REPORT

Registration No.	: SLB3133C	First Registration Date	: 24 Mar 2016
Make	: Subaru	COE Expiry	: 23 Mar 2026
Model	: Forester 2.0XT CVT AWD SR	Odometer	: 106897
Color	: Black	Engine No.	: FA20A871544
Manufacturing Year	: 2016	Chassis No.	: JF1SJGK85GG067453

## ASSESSMENT FOR REPAIR : SLB3133C

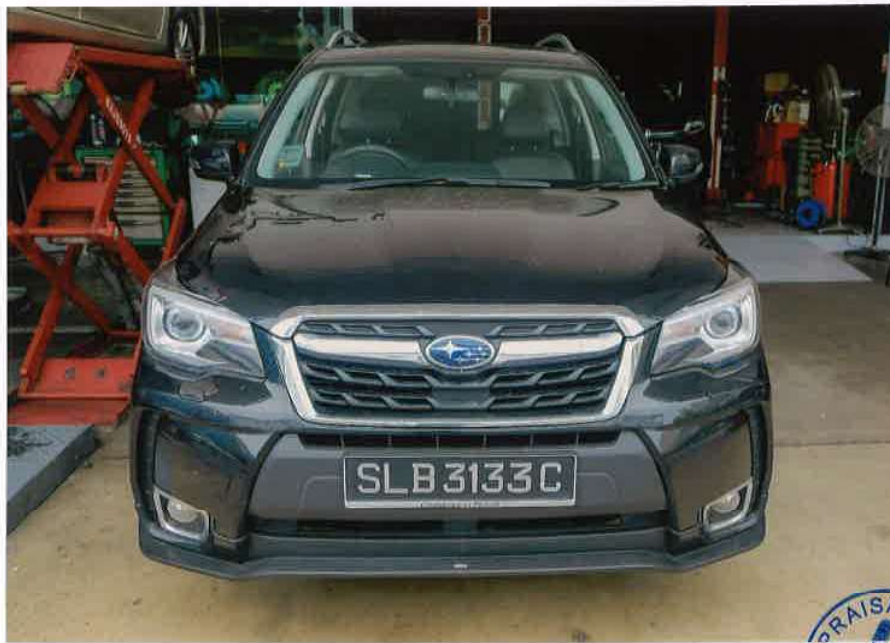
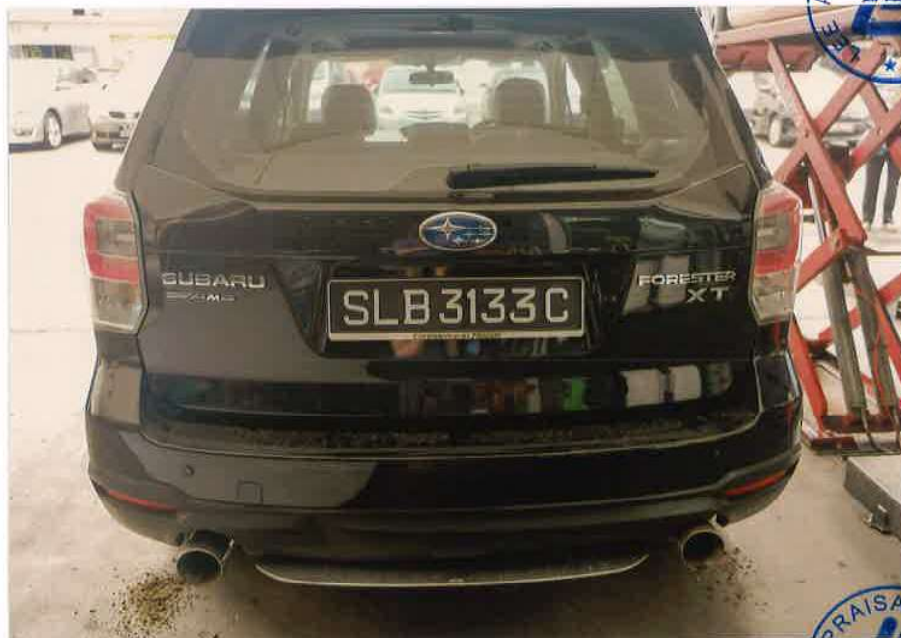
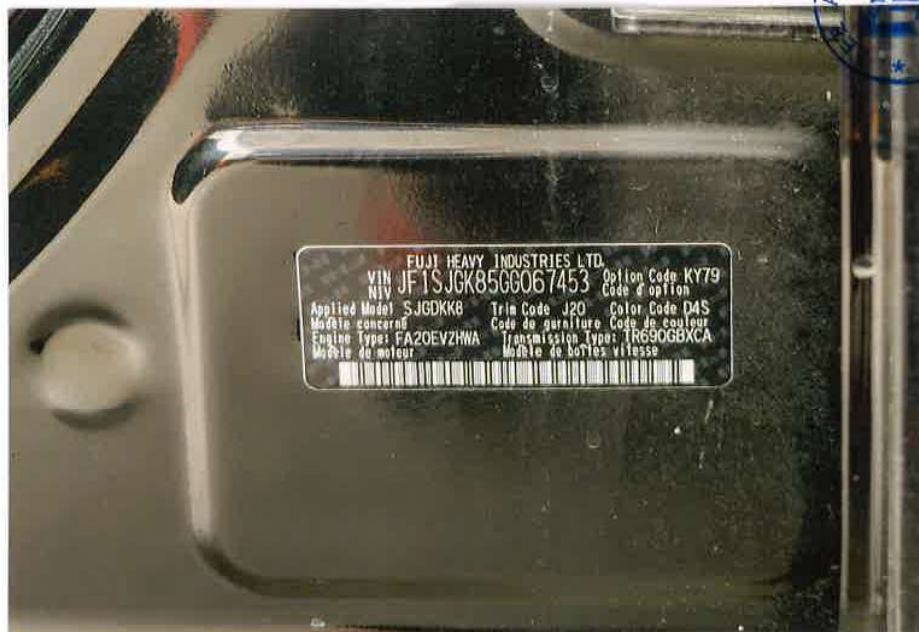
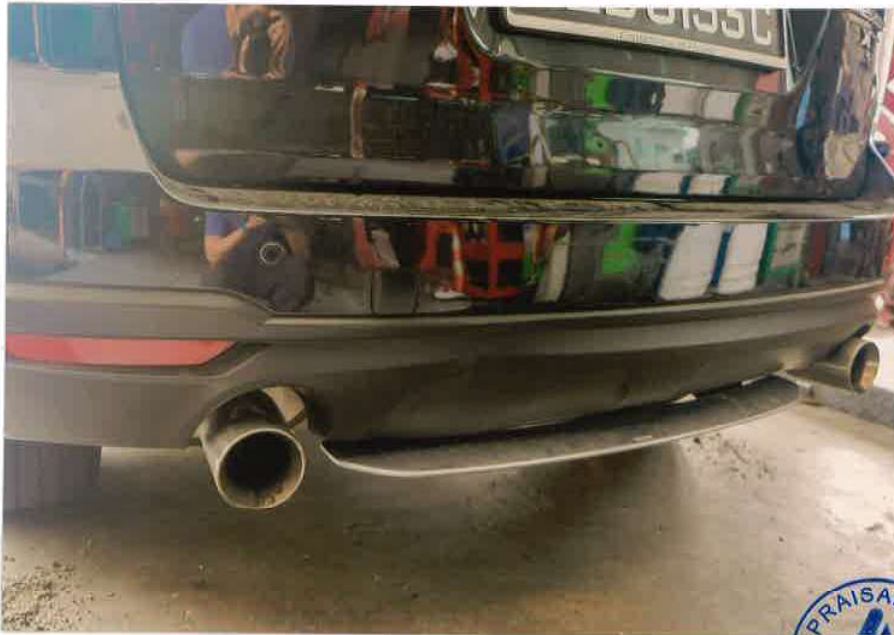
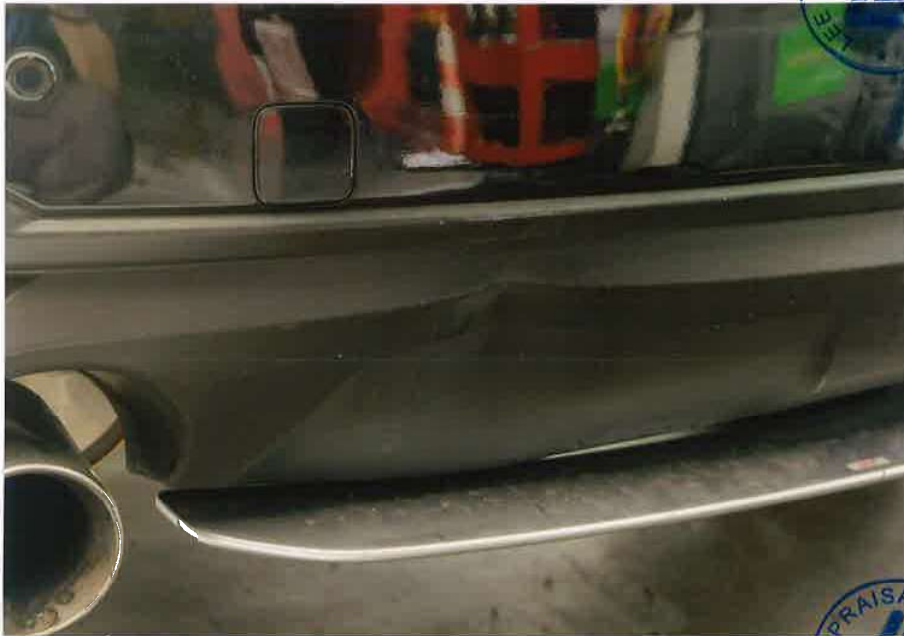
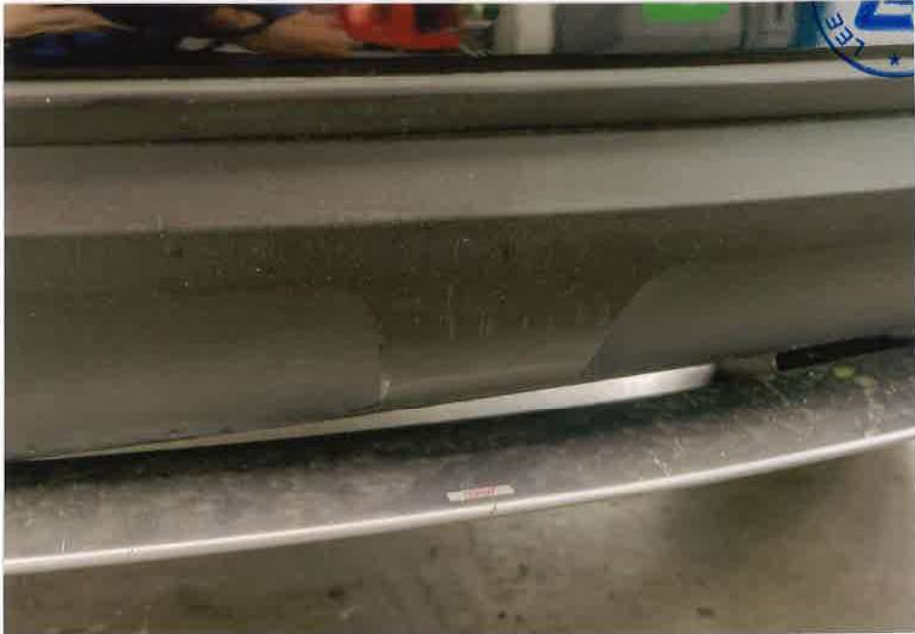
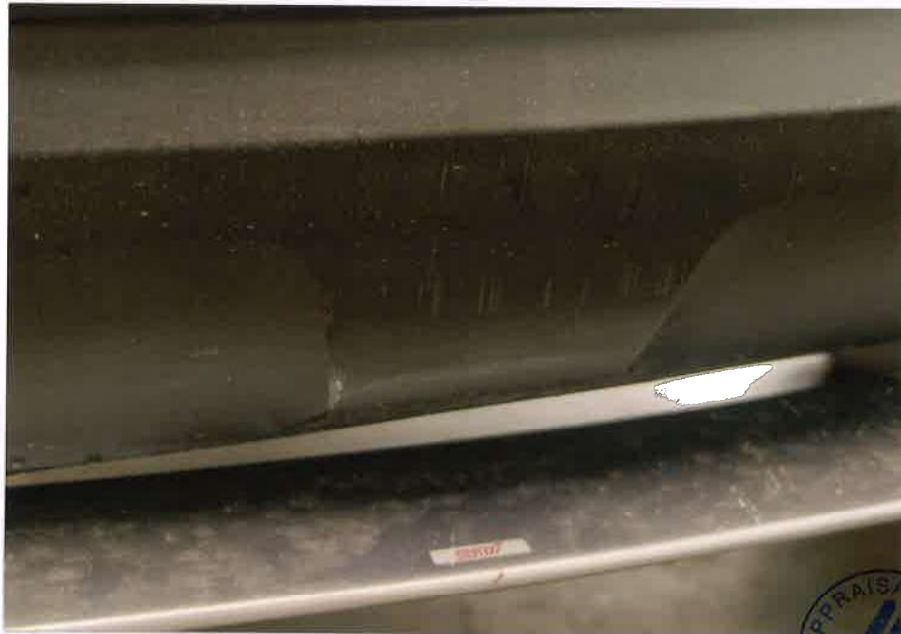
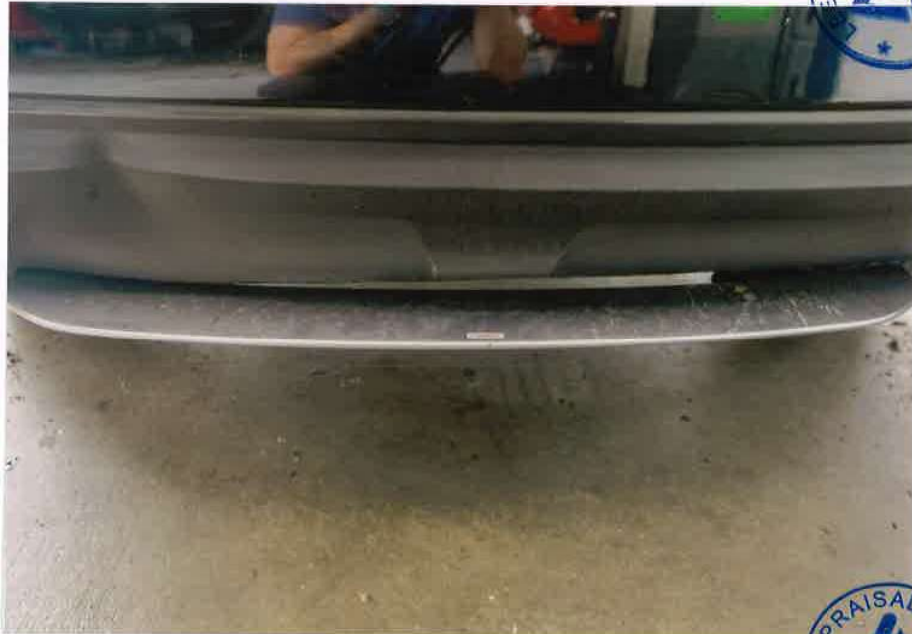
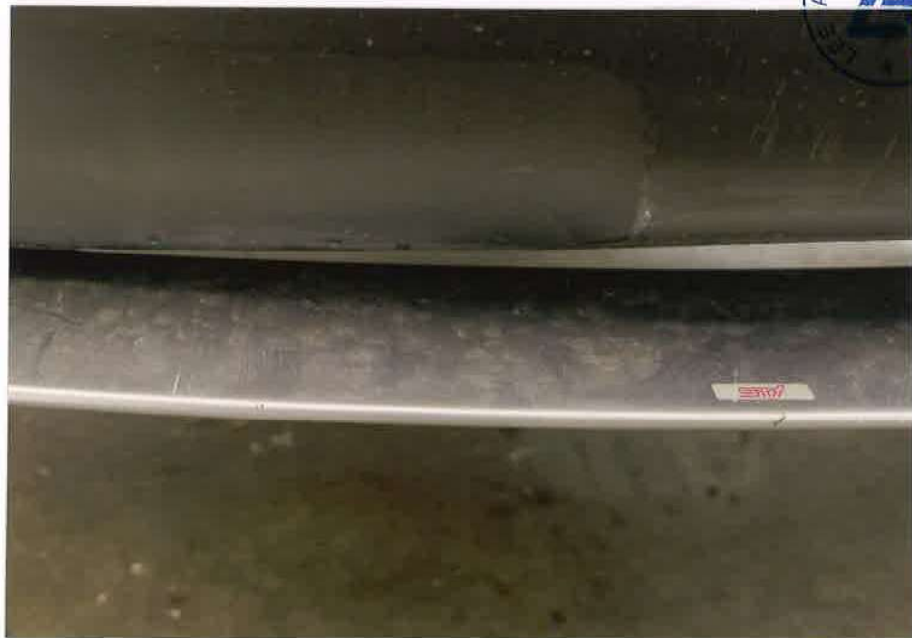
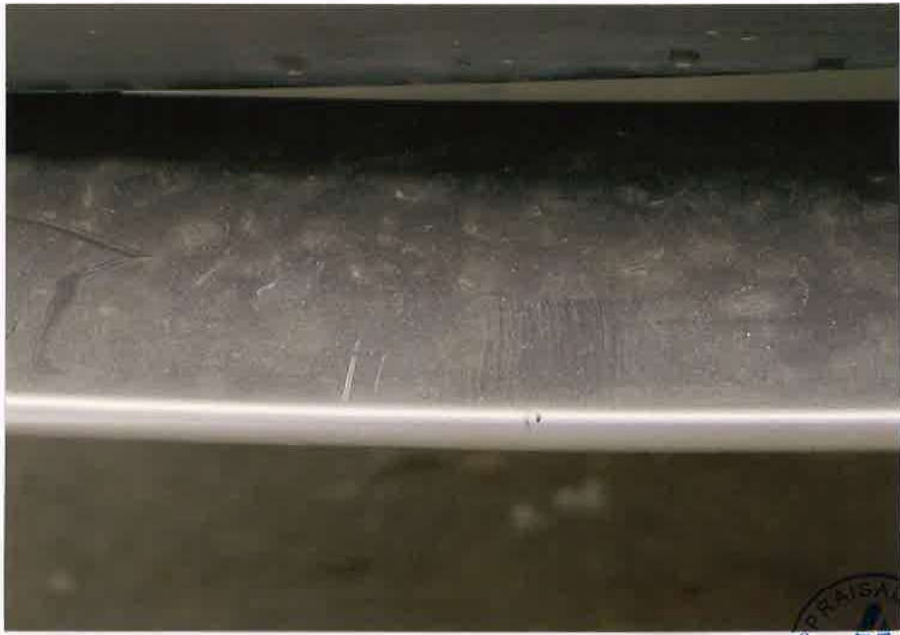
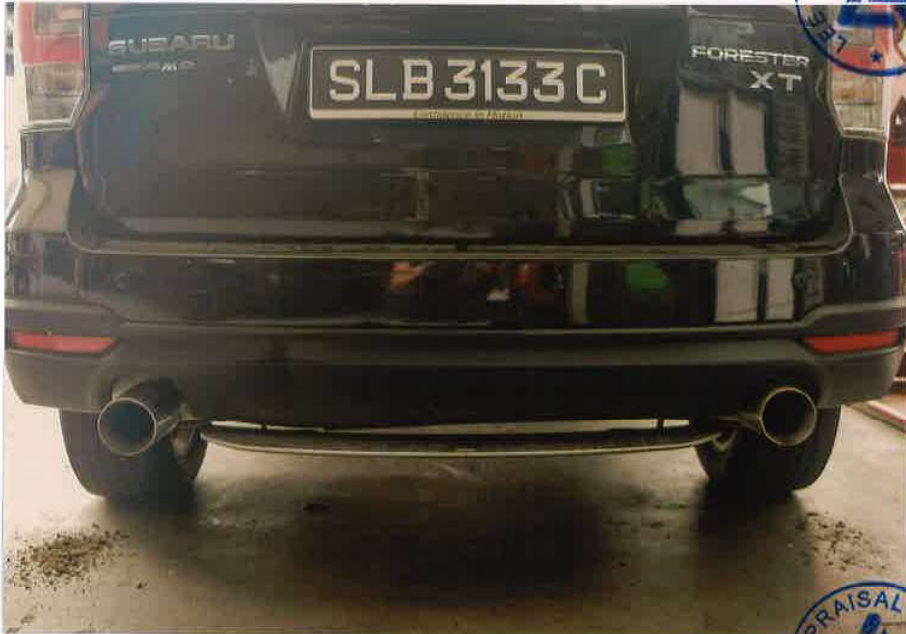
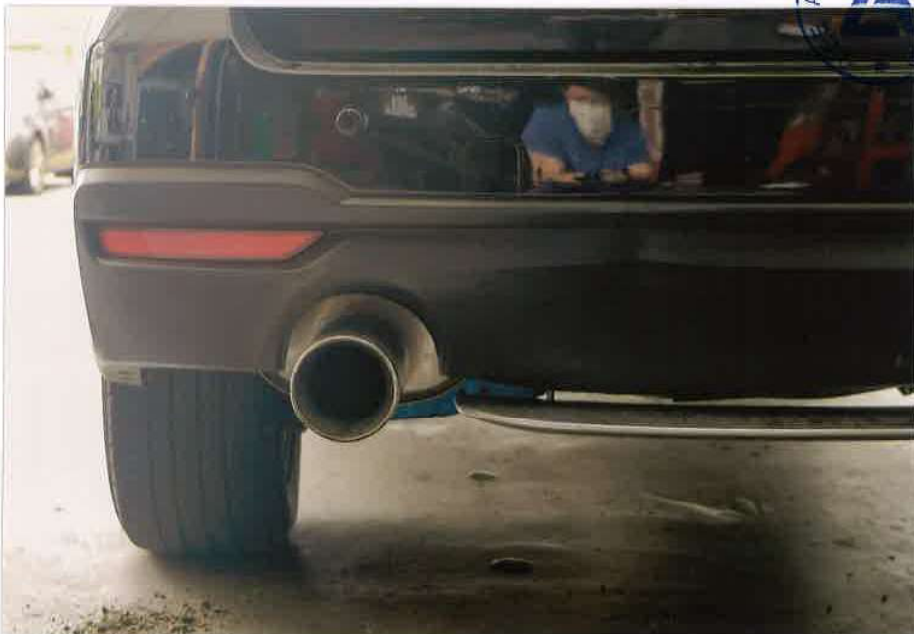
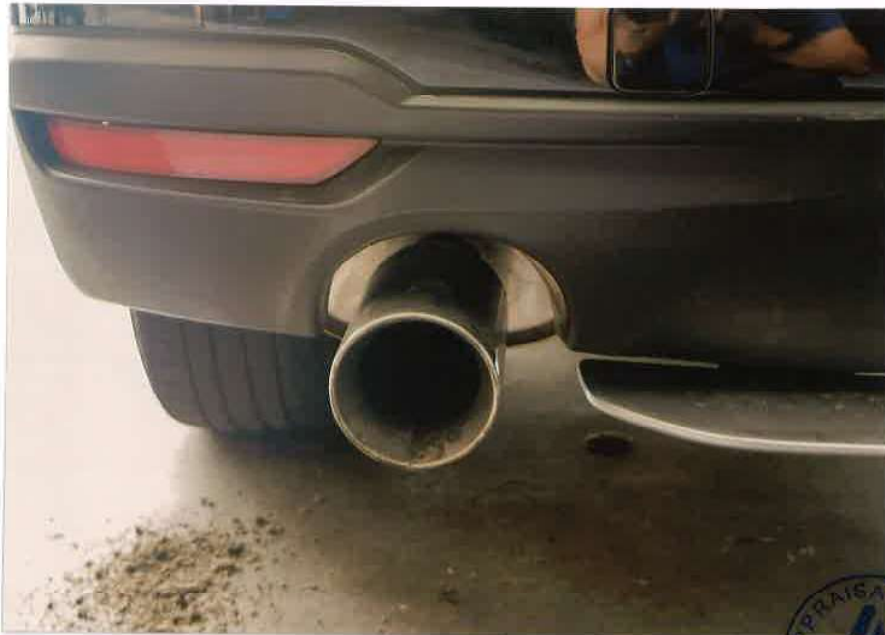
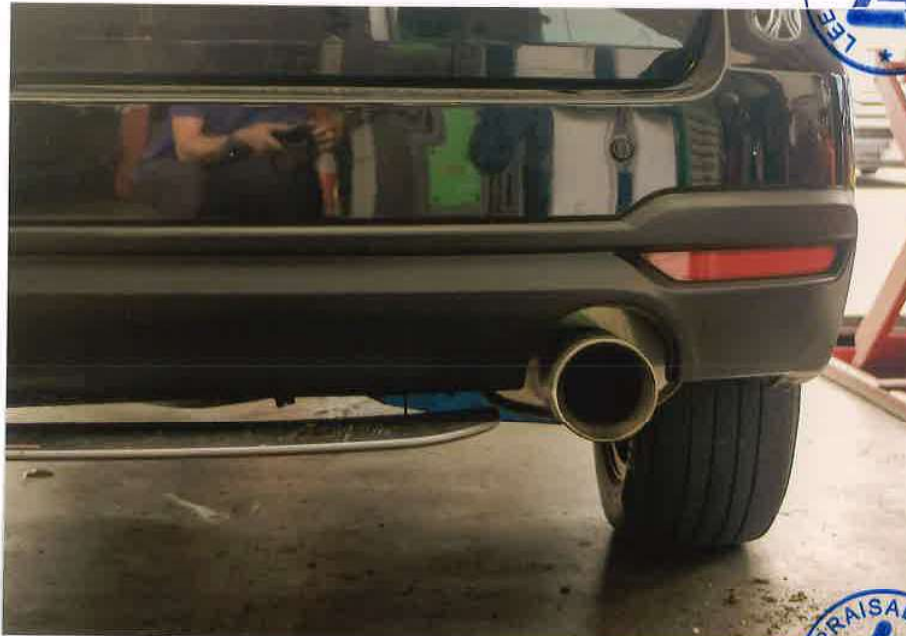
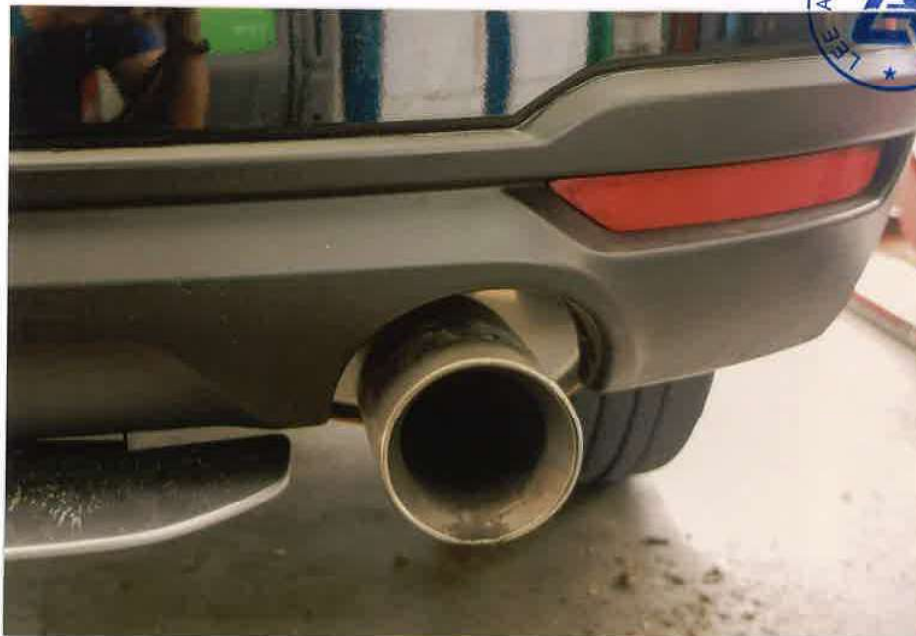
The vehicle sustained damages on rear portion. After market exhaust system was bent.

<u>Qty</u>	<u>Description</u>	<u>Condition</u>	<u>Repairer's Estimate</u>	<u>Our Assessment</u>
1 pc	Rear bumper cover	Dented & Cut	1,741.00	1,741.00
2 pcs	Rear bumper reflector @73.00	Necessary	146.00	146.00
2 pcs	Rear bumper side bracket @64.00	Necessary	128.00	128.00
2 pcs	Rear bumper corner support @76.00	Necessary	152.00	152.00
1 pc	Rear impact bar	Repair	1,509.00	~
			3,676.00	2,167.00
		Less 10%	367.60	216.70
			3,308.40	1,950.30
<u>Special Nett Items</u>				
1 set	HKS exhaust system	LH Bent	3,125.00	3,125.00
1 pc	Rear under spoiler	Cut	765.00	765.00
			3,890.00	3,890.00
	Total Parts		7,198.40	5,840.30
<u>Labour Charges</u>				
1	Spray painting for rear bumper & under spoiler		600.00	500.00
2	Workmanship to repair impact bar; replace bumper & exhaust system & other affected areas		600.00	550.00
			1,200.00	1,050.00
	Total Parts & Labours Concluded		8,398.40	6,890.30
	Lump Sum Repair Adjustment			5,500.00
