Your Ref: SMM 95D  
Our Ref : CI/TP20012392/D

## **AUTOMOBILE INSPECTION REPORT OF MOTOR CAR SMM 95D**

Vehicle Registration No.	: SMM 95D
Make / Model	: Mitsubishi Lancer Evolution Wagon 5A/T
Chassis No	: CT9W0002759
Year of Registration	: 2006 (October)
Mileage	: 122,898km

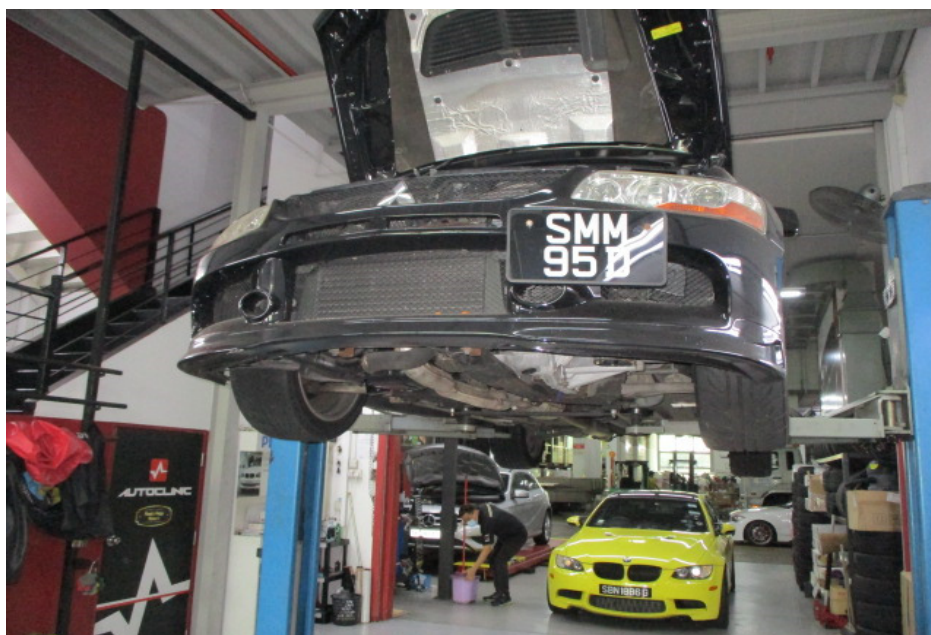
**Photo 1** shows the Motor Car hoisted for checks on its undercarriage, in particular to its transmission assembly.

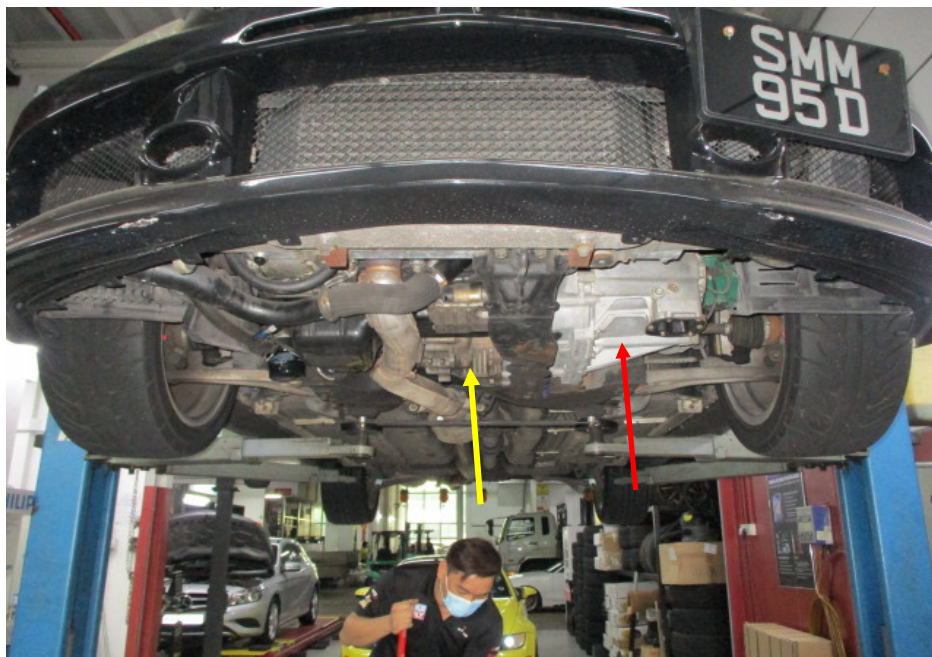
**Photo 2** shows a general view of the transmission assembly (red arrow) that was fitted on the Motor Car. This was the input side of the transmission, which houses the main shaft and various gear sets. It is bolted to the crankshaft side of the engine block. The input side of the transmission connects to the transfer case (yellow arrow), which is the output side of the Motor Car's transmission.

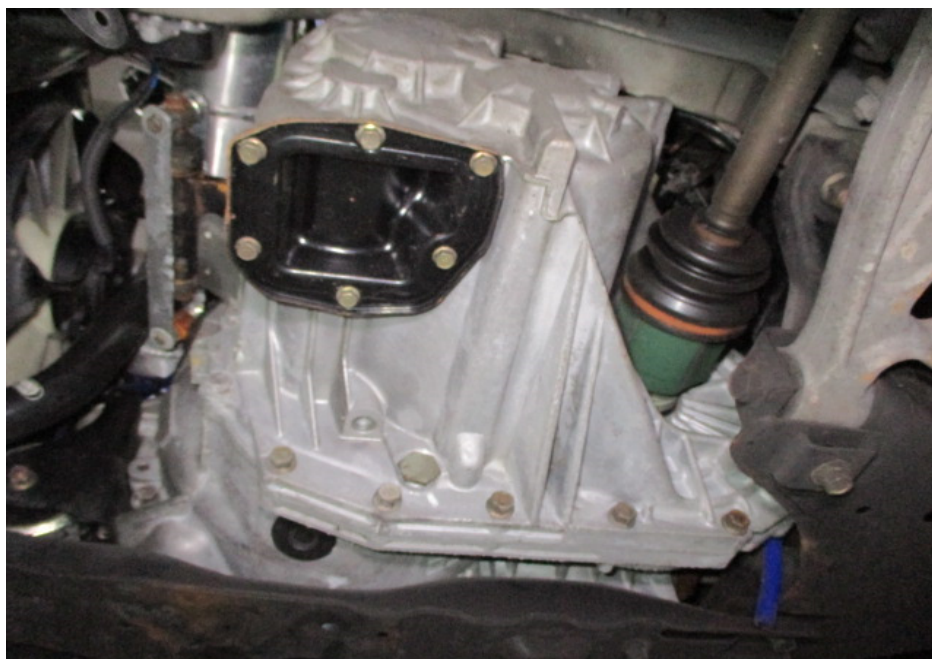
**Photo 3** shows another view of the transmission assembly that was fitted on the Motor Car. This was the input side of the transmission, which houses the main shaft and various gear sets. There was no crack and/or hole observed on the transmission housing.

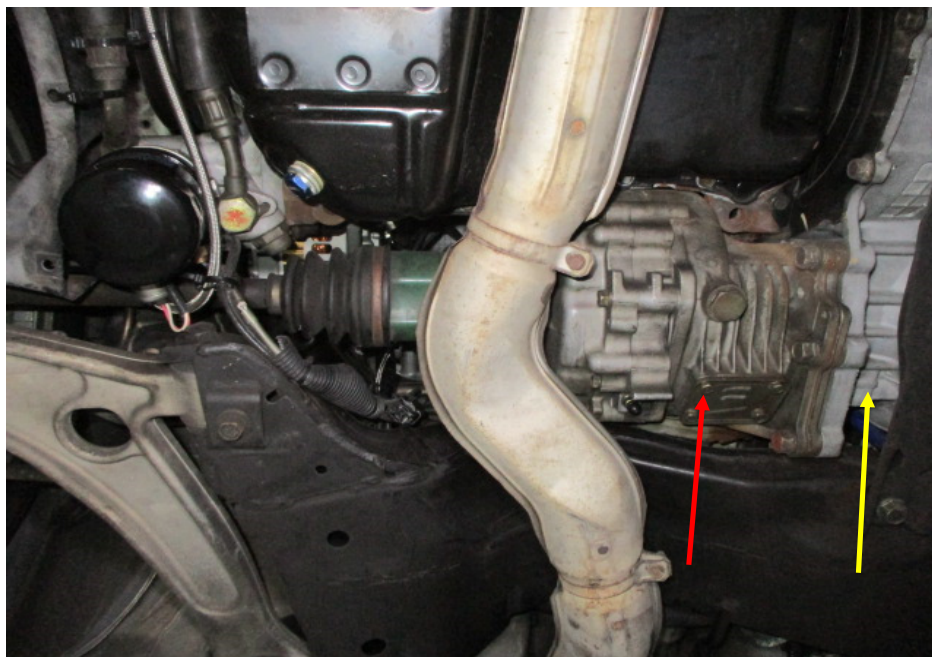
**Photo 4** shows the transfer case (red arrow) of the Motor Car. The transfer case is also the output side of the Motor Car's transmission. The gear set in the input side of the transmission (yellow arrow) connects to the transfer case, which is the second of the 2 main housings of the Motor Car's transmission assembly. Drive to the front wheels of the Motor Car is provided via drive shafts that are extended from this transfer case. The transfer case also connects to the propeller shaft, which leads to the rear differential of the Motor Car.

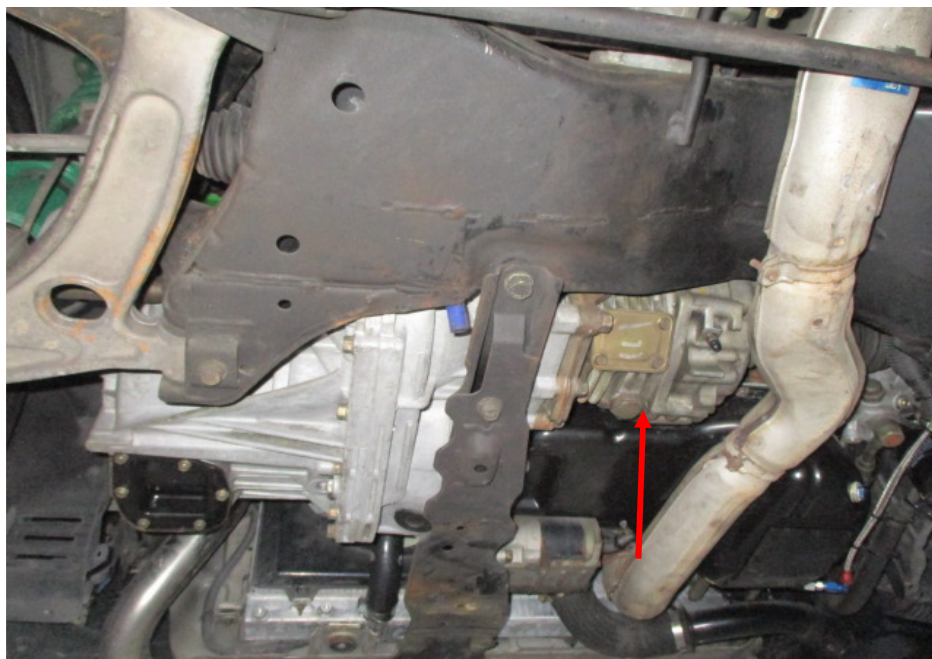
**Photo 5** shows another view of the transfer case (arrowed) that was fitted on the Motor Car. The transfer case is the output side of the transmission. There was no crack and/or hole observed on the housing of the transfer case.

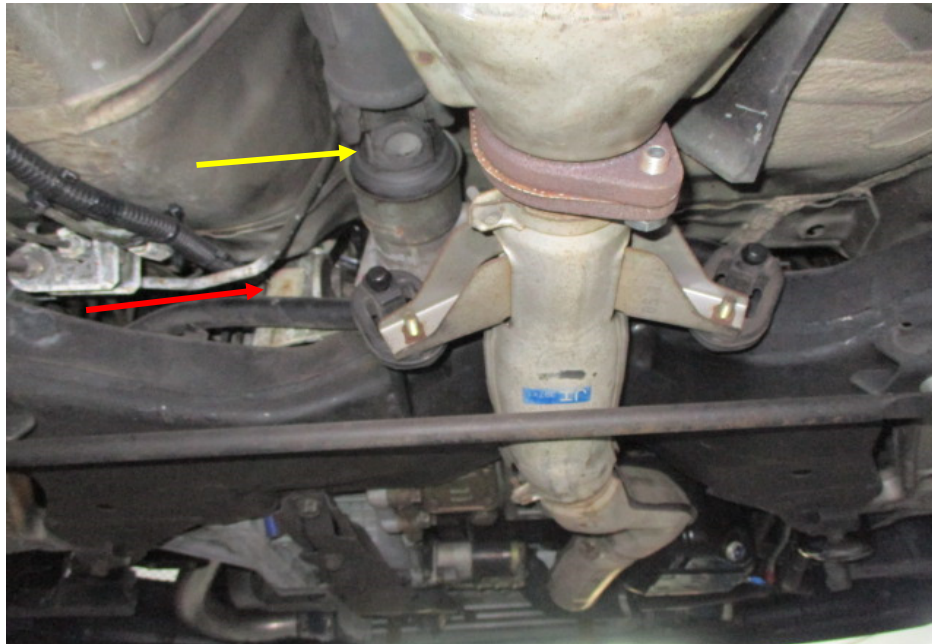
**Photo 6** shows the propeller shaft (yellow arrow), which is connected to the transfer case of the Motor Car. This propeller shaft connects to the rear differential of the Motor Car, providing the drive to its rear wheels. The transmission assembly of the Motor Car is supported by 2 brackets. One at the front and one at the rear (red arrow) of the transmission assembly.

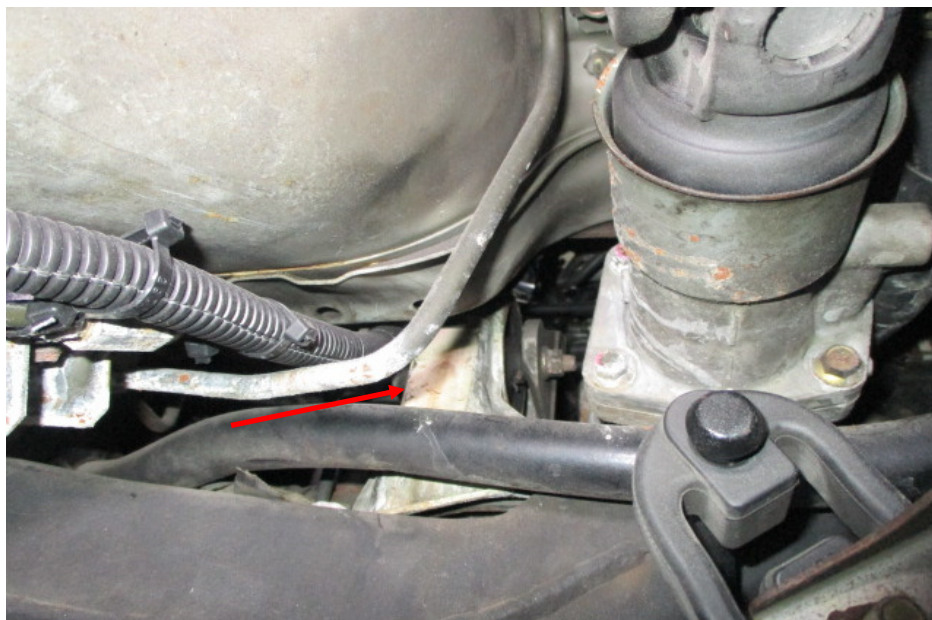
**Photo 7** shows one of the 2 brackets that supports the transmission assembly of the Motor Car. This was the bracket at the rear of the transmission assembly, which was observed to be mounted onto the Motor Car's crossmember. The bracket (arrowed) was with rubber bushings, which absorbs any vibrations arising from the rotation of the transmission gears, minimising any stress to the bracket and correspondingly also minimise any stress to the crossmember that this bracket is mounted onto.

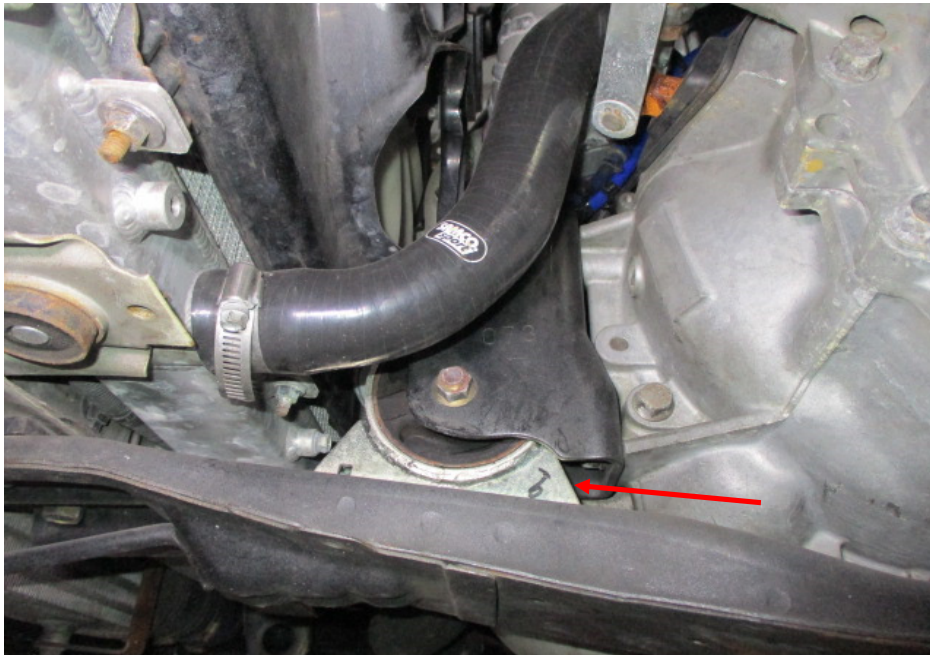
**Photo 8** shows the other bracket that supports the transmission assembly of the Motor Car. This was the bracket at the front of the transmission assembly, which was also observed to be mounted onto the Motor Car's crossmember. Similar to the bracket at the rear, this bracket (arrowed) was also with rubber bushings, which absorbs any vibrations arising from the rotation of the transmission gears, minimising any stress to the bracket and correspondingly also minimise any stress to the crossmember that this bracket is mounted onto.

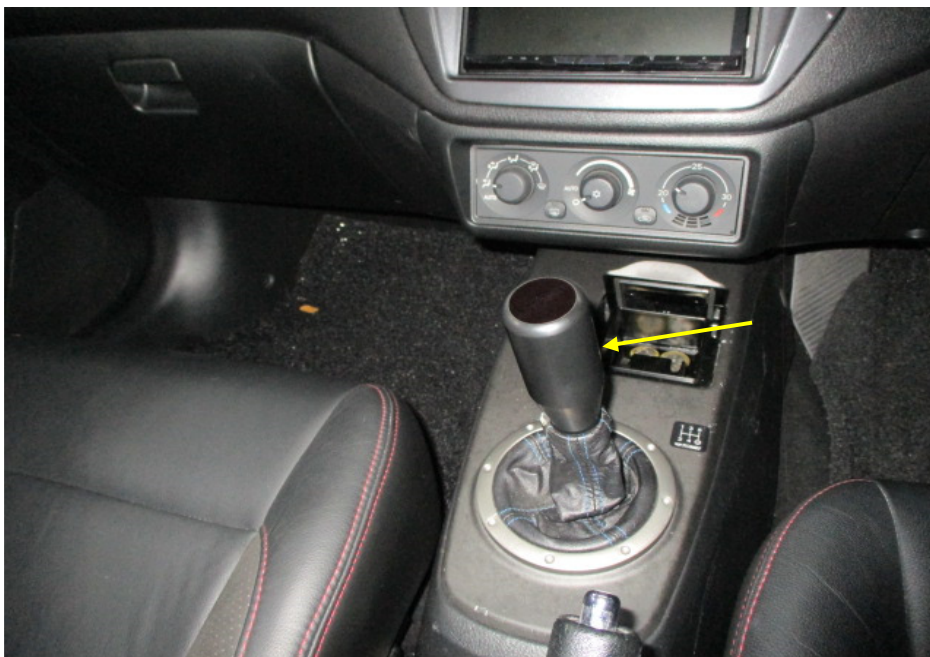
**Photo 9** shows the manual gear shifter (arrowed) that was fitted on the Motor Car, for manually selecting the transmission gear to be engaged.

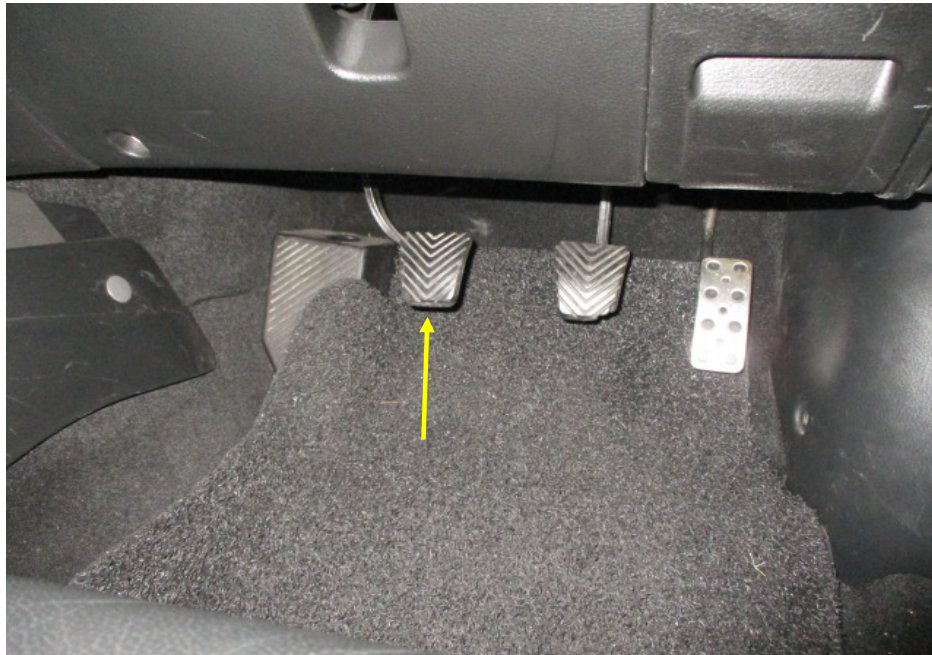
**Photo 10** shows the clutch pedal (arrowed) of the Motor Car, for engaging and disengaging the transmission gears.
