Your Ref: Ford Mustang GT  
(chassis number 1FA6P8NF5L5101811)  
Our Ref : CI/TP20012393/D

13 November 2020

**INSPECTION REPORT OF AN UNREGISTERD FORD MUSTANG GT MOTOR CAR WITH CHASSIS NUMBER 1FA6P8NF5L5101811**

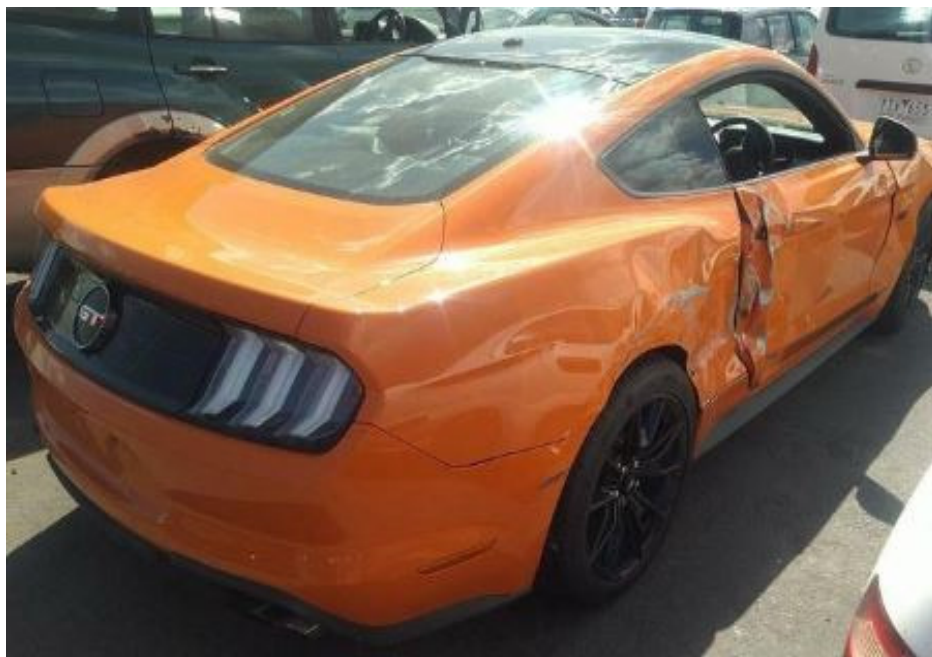
3. From the photographs provided to me, it was observed that the Motor Car had sustained damages at its right centre portion. Body parts observed to have been damaged include its driver's door, driver's door handle and right rear body panel. The driver's door glass window was also observed to be shattered.
4. Parts and components within the engine compartment were unaffected as seen from the photographs that were provided to me. The airbags of the Motor Car were also not deployed. See photo 1 – 3 below.

**Photo 1** shows the rear right body of the Motor Car prior to any repairs being carried out (photograph provided to me). The Motor Car was observed to have sustained damages at its right centre portion. The body parts observed to be damaged had included its driver's door and right rear body panel.

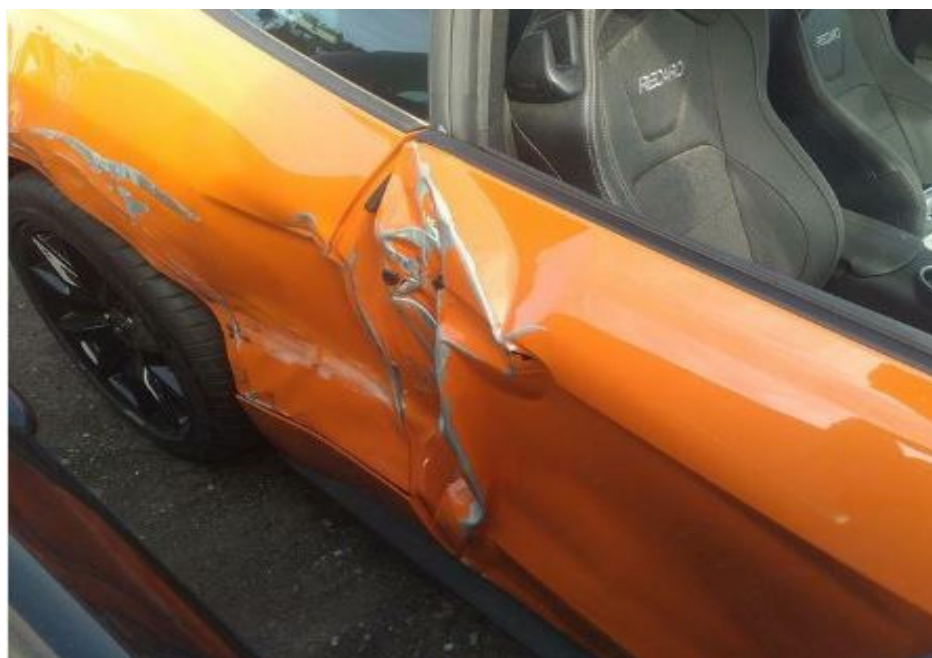
**Photo 2** shows a closer view of the damaged right centre portion of the Motor Car prior to any repairs being carried out (photograph provided to me). The body parts observed to be damaged had included its driver's door, driver's door handle and right rear body panel. The driver's door glass window was also observed to be shattered.

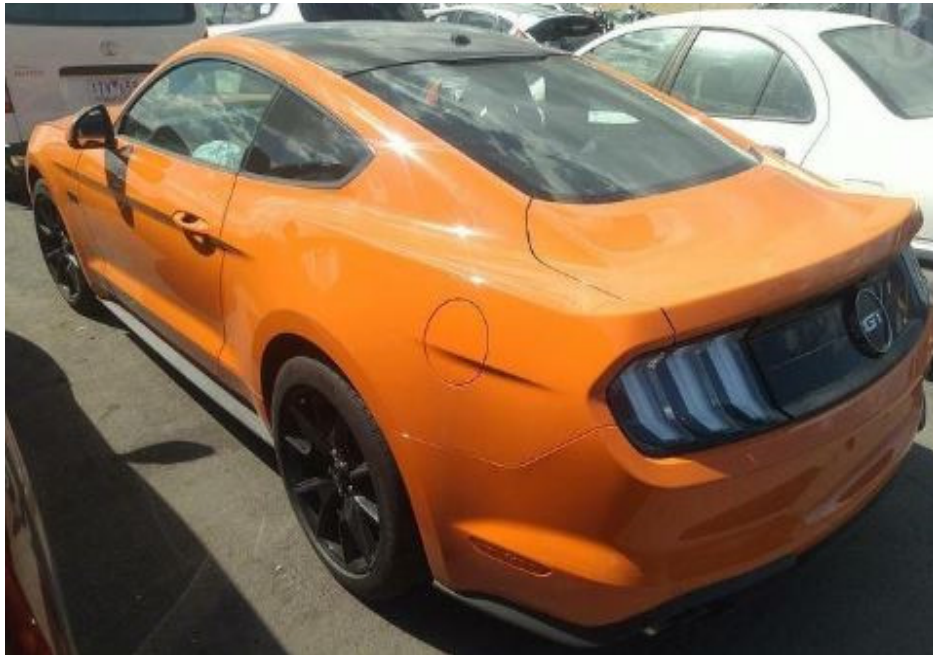
**Photo 3** shows the rear left body of the Motor Car prior to any repairs being carried out (photograph provided to me). Other than the right centre portion, there was no visible damage observed to other areas of the Motor Car. Parts and components within the engine compartment were also unaffected.

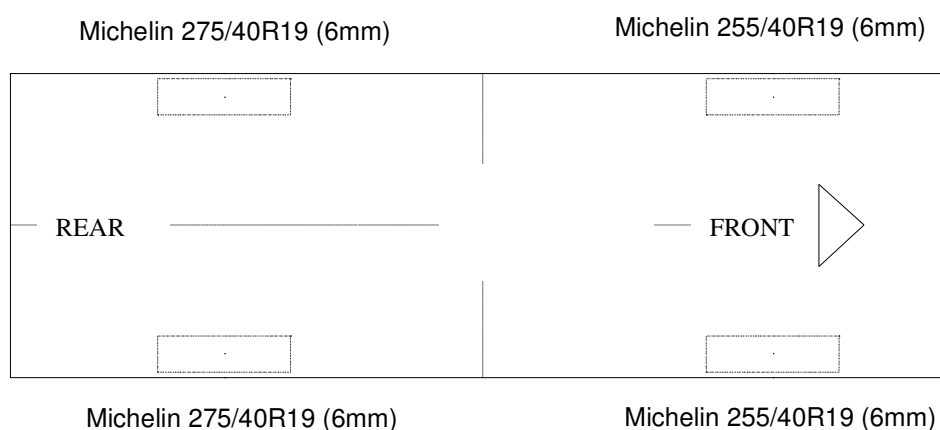
8. It was fitted with 19inch sport wheel rims that were wrapped with tyres that were observed to be of serviceable condition. The tyres were also sufficiently inflated for vehicular operation. The tyre brand, tyre size and approximate remaining tread depth of the 4 tyres of the Motor Car were recorded as follows: -

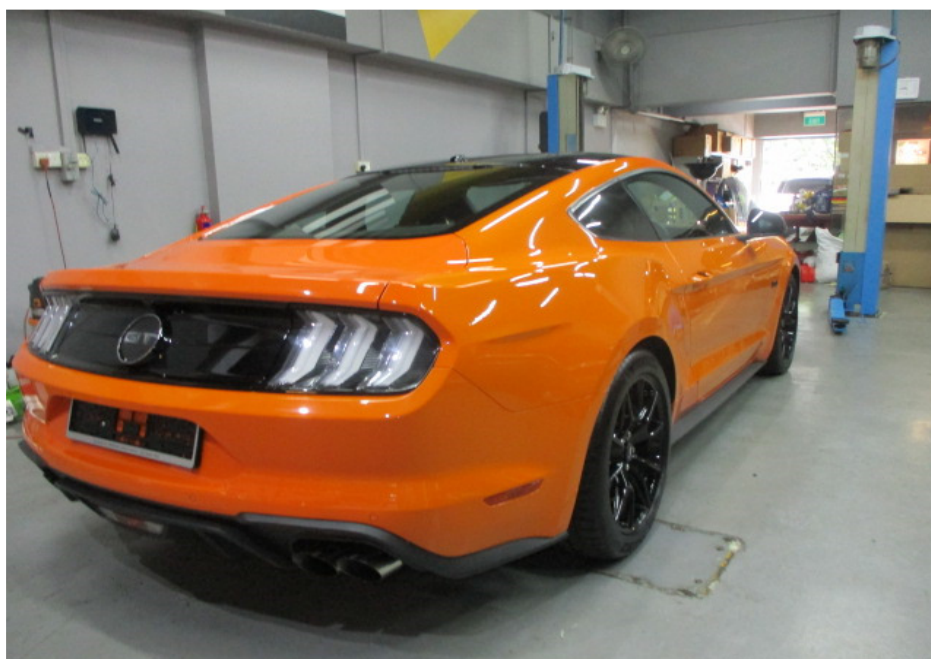
**Photo 4** shows a general view of the rear right body of the Motor Car at the time of my inspection. The Motor Car was observed to be in a relatively good general condition with no loose exterior fittings observed. The body parts at the right centre portion of the Motor Car were visually examined and it was observed that the repair/restoration works carried out to the damaged area of the Motor Car (refer photograph 1 & 2 above) were reasonably adequate and in order.

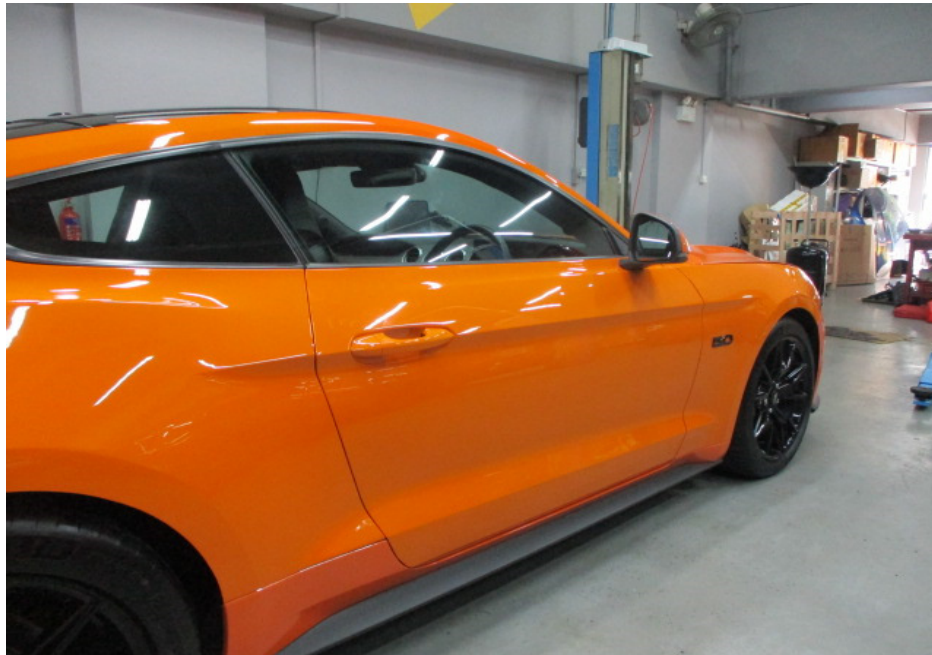
**Photo 5** shows a closer view of the driver's door and right rear body panel of the Motor Car. The body parts at the right centre portion of the Motor Car were visually examined and it was observed that the repair/restoration works carried out to the damaged area of the Motor Car (refer photograph 1 & 2 above) were reasonably adequate and in order.

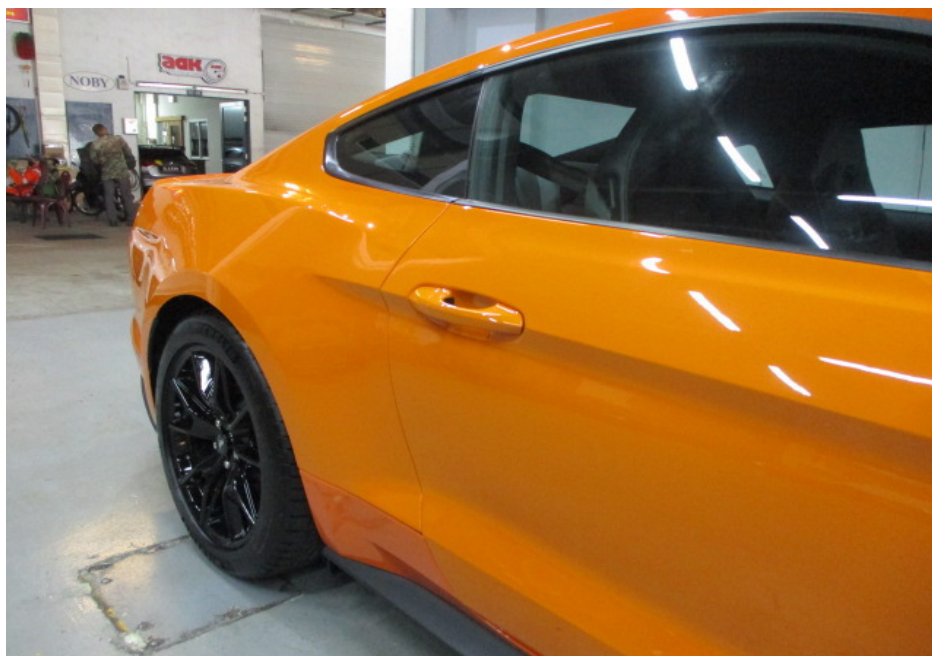
**Photo 6** shows a closer view of the right centre portion of the Motor Car at the time of my inspection. The driver's door, driver's door handle and right rear body panel of the Motor Car were visually examined and it was observed that the repair/restoration works carried out to the damaged area of the Motor Car (refer photograph 1 & 2 above) were reasonably adequate and in order.

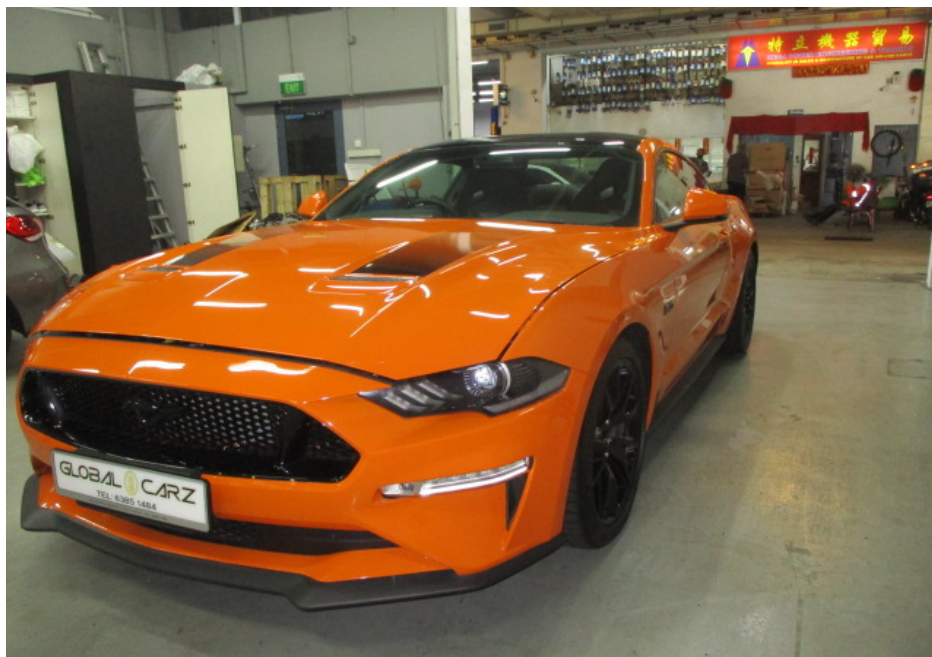
**Photo 7** shows a general view of the front left body of the Motor Car at the time of my inspection. The Motor Car was observed to be in a relatively good general condition with no loose exterior fittings observed. The mileage of the Motor Car recorded at the time of my inspection was 1,424km.

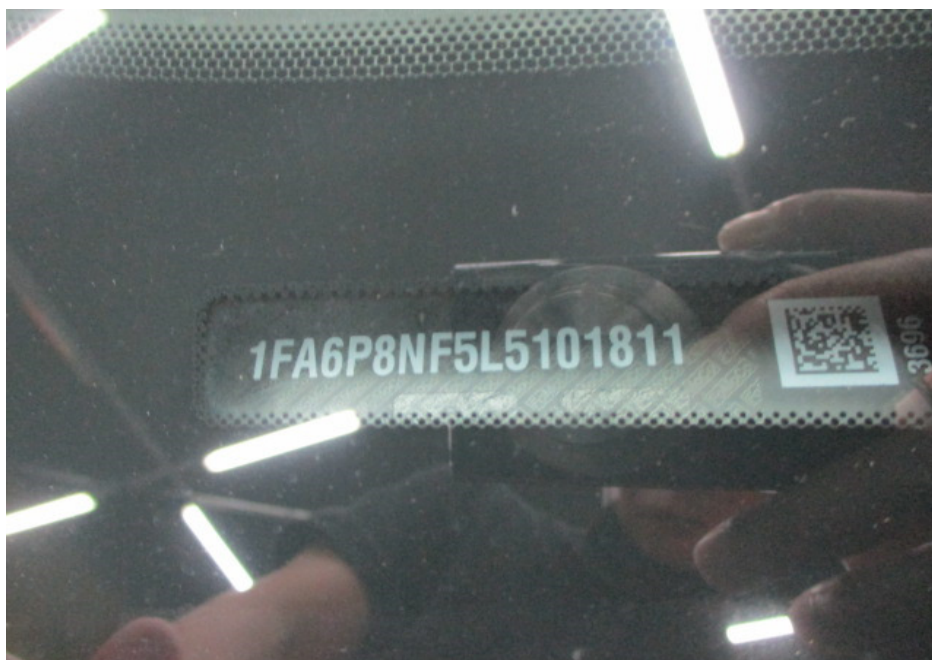
**Photo 8** shows the chassis number of the Motor Car. The chassis number recorded was 1FA6P8NF5L5101811.

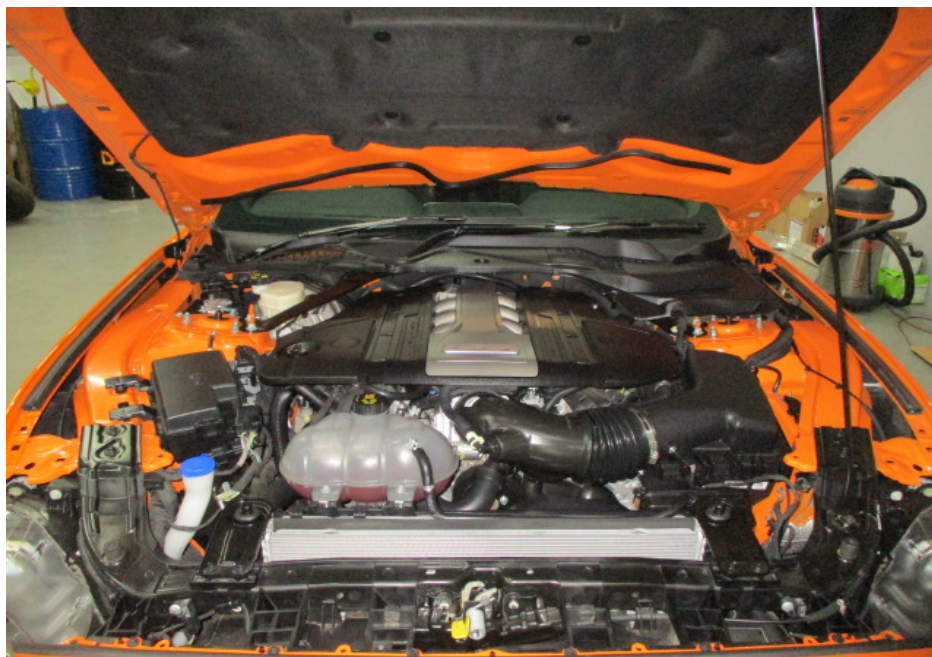
**Photo 9** shows a general view of the engine compartment of the Motor Car at the time of my inspection. The various parts and components inside the engine compartment were all observed to be intact and properly fitted. There was also no sign(s) or indication(s) of fluid leak and/or fluid stain found inside the engine compartment.

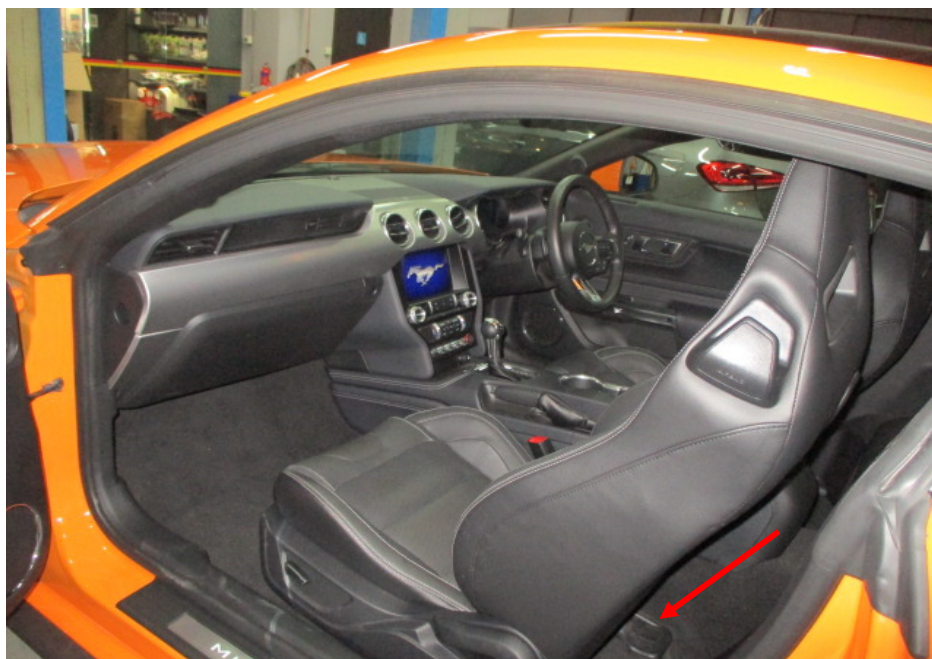
**Photo 10** shows the interior compartment of the Motor Car. The seats of the Motor Car were secured via seat rails (arrowed) to the floorboard. All the seats of the Motor Car were fitted with a retractable seat belt reel and a pre-tensioner. The seat belts were tested and able to be fastened into the respective pre-tensions that were fitted on the side of each individual seat.

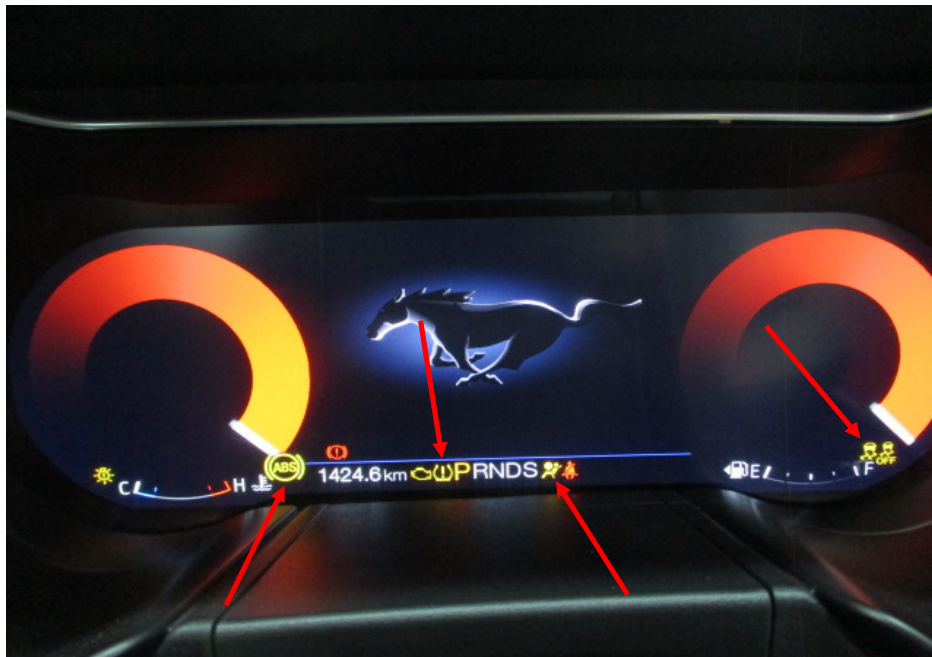
**Photo 11** shows the warning lights for the various electronic safety features appearing on the instrument panel of the Motor Car during its self-test when the engine is cranked, in particular the ABS, SRS, TPM and SCS lights (arrowed).

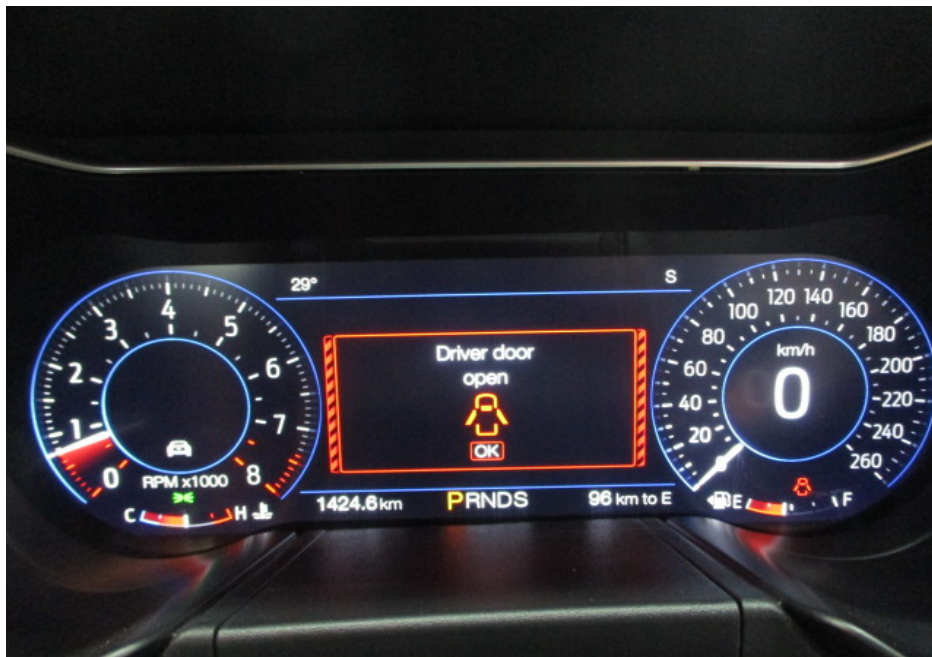
**Photo 12** shows the respective warning lights no longer illuminated, indicating that there is no fault detected to the ABS, SRS, TPM and SCS systems of the Motor Car during the self-test. These electronic systems were hence in working condition at the time of my inspection.

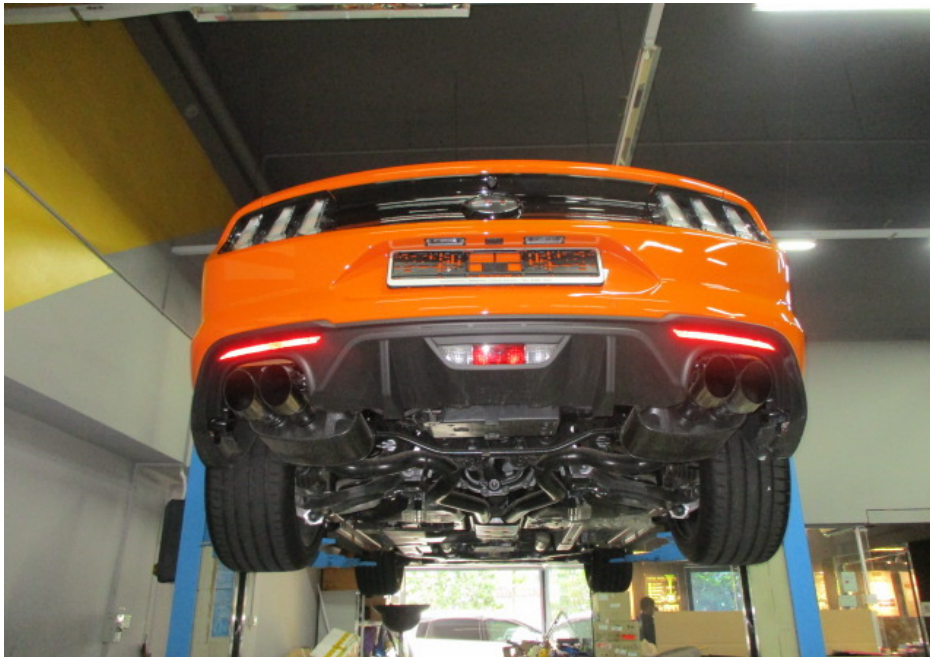
**Photo 13** shows the Motor Car hoisted up for checks on its undercarriage. There was no sign(s) or indication(s) of fluid leakage and/or fluid stain(s) on the underside of the Motor Car. The undercarriage components of the Motor Car were also all observed to be intact and secured in an appropriate manner.

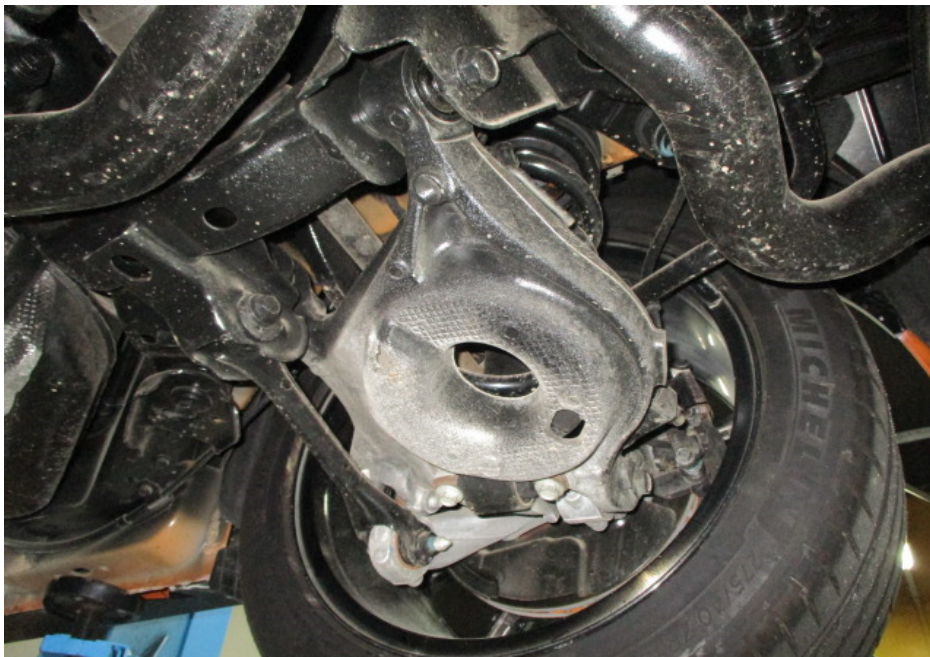
**Photo 14** shows a general view of the control arms and linkages at the rear right wheel of the Motor Car. I did not observe any fluid leak and/or fluid stain on the underside of the Motor Car. All of the Motor Car's undercarriage components were observed to be intact and secured in an appropriate manner.

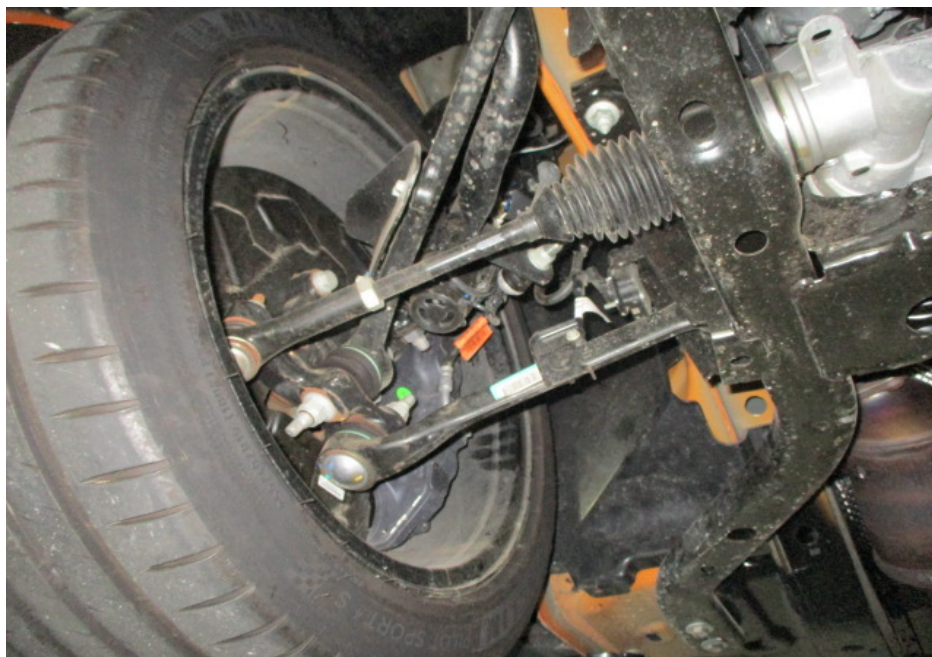
**Photo 15** shows the various undercarriage components at the front right wheel of the Motor Car. The mechanical components, control arms and linkages were all found to be intact and secured in an appropriate manner.

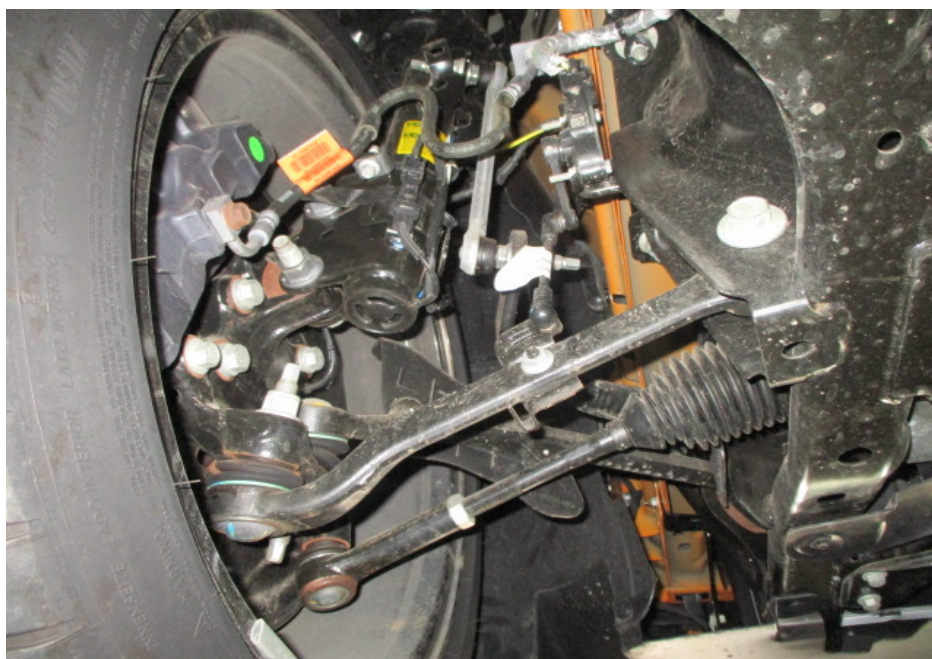
**Photo 16** shows the various undercarriage components at the front left wheel of the Motor Car. The mechanical components, control arms and linkages were all found to be intact and secured in an appropriate manner. I also did not observe any fluid leak and/or fluid stain on the underside of the Motor Car.

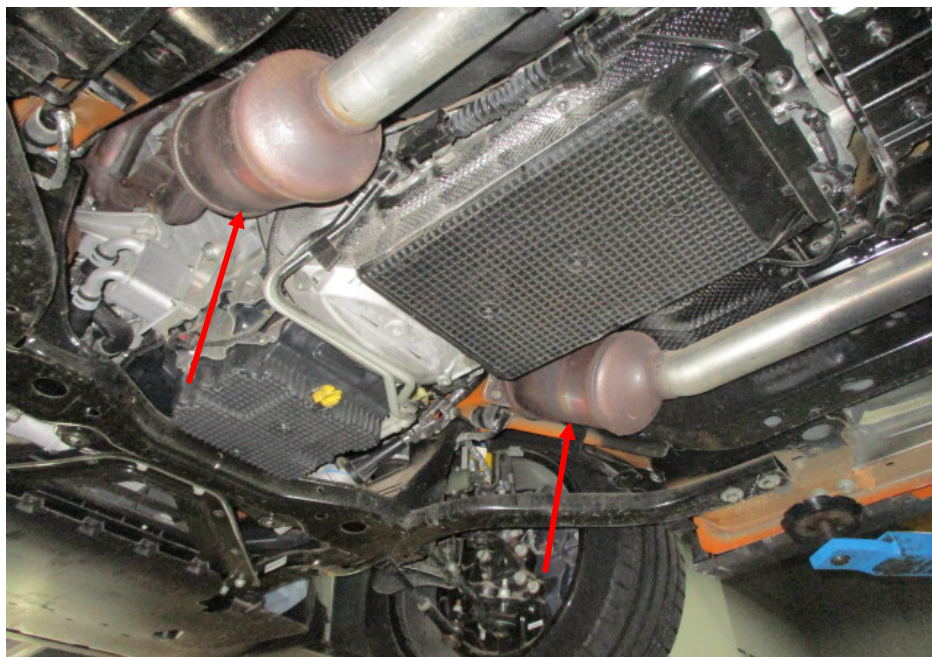
**Photo 17** shows the Motor Car's catalytic converters (arrowed). My examination of the Motor Car's exhaust system revealed no sign(s) or indication(s) of any cut or weld marks along its exhaust pipes and on its rear mufflers.

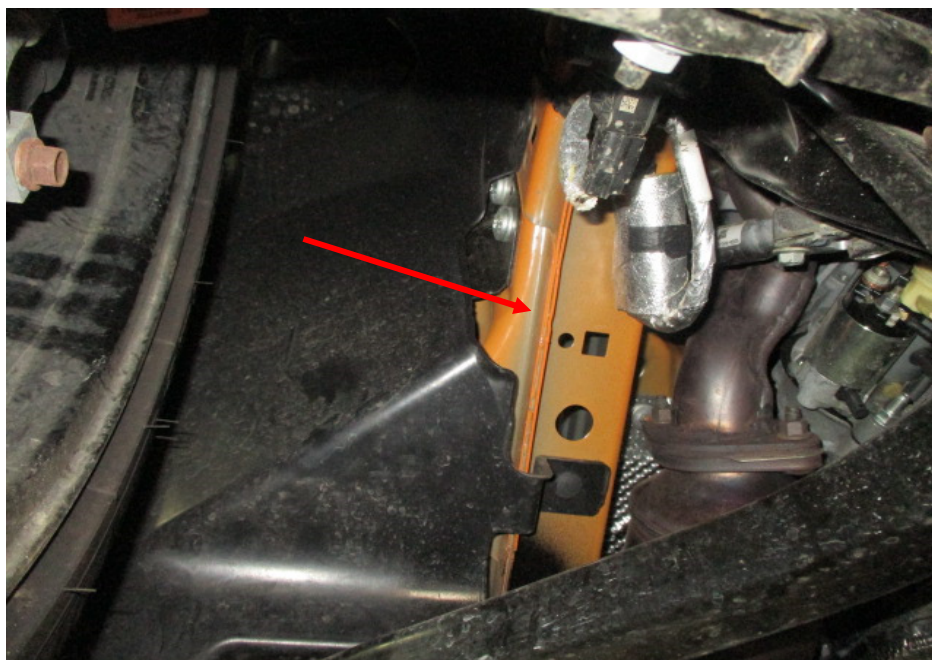
11. Visually, I did not find any weld marks, other than the original spot weld marks, on the chassis/structural body of the Motor Car. The original factory sealant at the joints along the chassis/structural body was also untouched, again indicating that no replacement of the chassis/structural body was carried out; and that the chassis/structural body was originally fitted.

**Photo 18** shows the chassis/structural body (arrowed) at the underside front right of the Motor Car. Visually, I did not find any weld marks other than original spot weld marks on the chassis/structural body of the Motor Car. The original factory sealant at the joints along the chassis/structural body was also untouched, indicating no work was done on the chassis/structural body of the Motor Car and that the chassis/structural body was originally fitted.

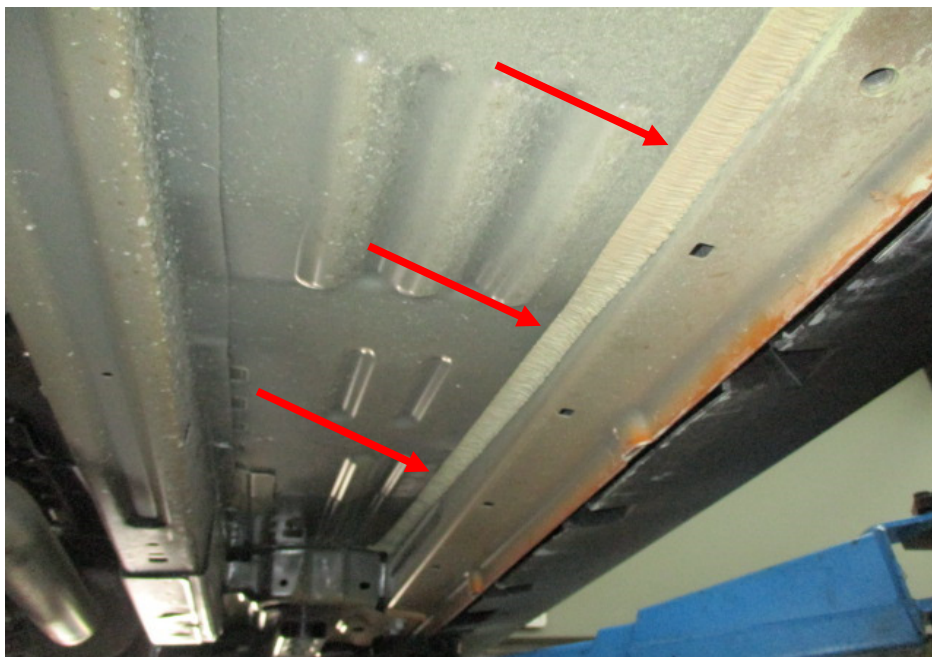
**Photo 19** shows the floorboard at the right centre underside of the Motor Car. The original factory sealant (arrowed) at the joints along the floorboard were untouched, indicating that the floorboard of the Motor Car was originally fitted. In general, except for the right rear body panel, I had found all the non-detachable body panels of the Motor Car to be originally fitted at the time of my inspection.

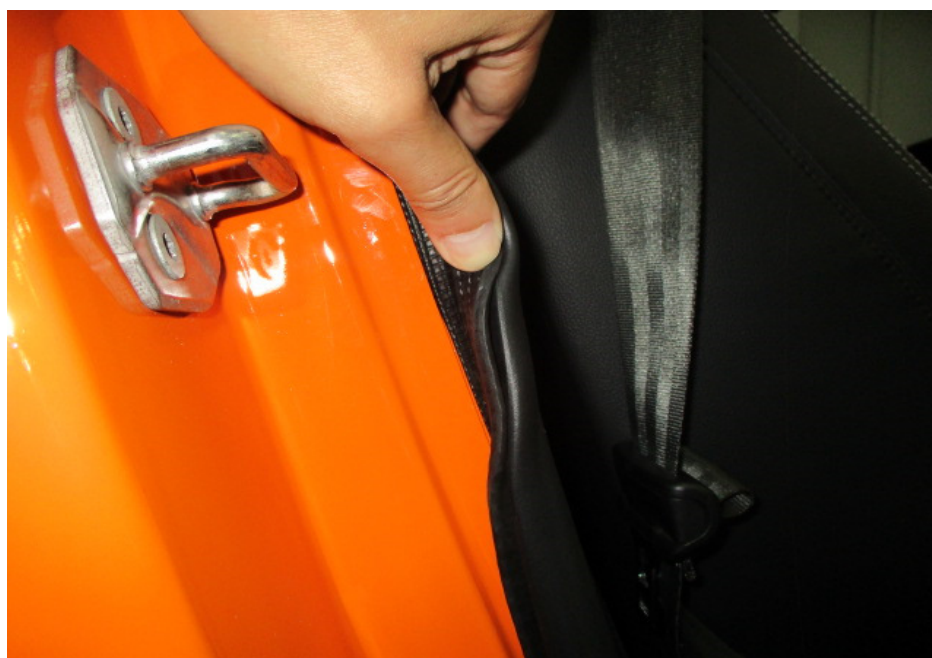
9. The detachable body panels of the Motor Car like the front fenders, front bumper, rear bumper, doors, bonnet and rear bootlid amongst others were all found to be fitted securely.
10. Checks on the non-detachable body panels like the rear fenders, floorboard, roof panel, pillars and rocker panels amongst others, revealed that these body panels were spot welded onto the chassis/structural body of the Motor Car. The original factory sealant at the joints of the non-detachable body panels was all untouched indicating no replacement of the non-detachable body panels was carried out; and that these body panels were all originally fitted except for the right rear body panel, which was found to be replaced (refer to photograph 20 below)

**Photo 20** shows the right rear body panel of the Motor Car. I did not find any weld marks on the right rear body panel of the Motor Car, indicating that the right rear body panel of the Motor Car was replaced. The lack of weld marks seen was due to replacement work when the replaced right rear body panel was re-welded onto the Motor Car and thereafter smoothen for re-spraying work.

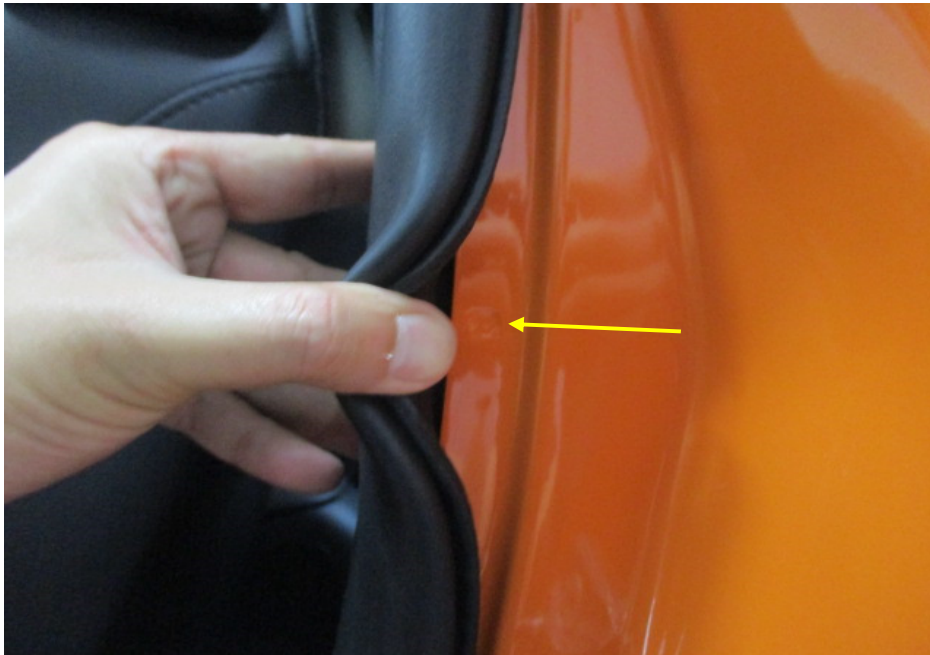
**Photo 21** shows the left rear body panel of the Motor Car. I did not find any weld marks other than original spot weld marks (arrowed) on the left rear body panel of the Motor Car, indicating that there was no re-welding works carried out. In general, apart for the right rear body panel, I had found all the non-detachable body panels of the Motor Car to be originally fitted.
