Your Ref : S0M02WWJ  
Our Ref: CS4/ASM20012443/P

**M/s AXA Insurance Pte Ltd**  
8 Shenton Way #24-01  
AXA Tower  
Singapore 068811  
(Motor Claims Department)

**TECHNICAL INVESTIGATION REPORT OF FIRE INCIDENT INVOLVING THE  
INSURED MOTORCYCLE FBP 67A ON 09<sup>th</sup> November 2020**

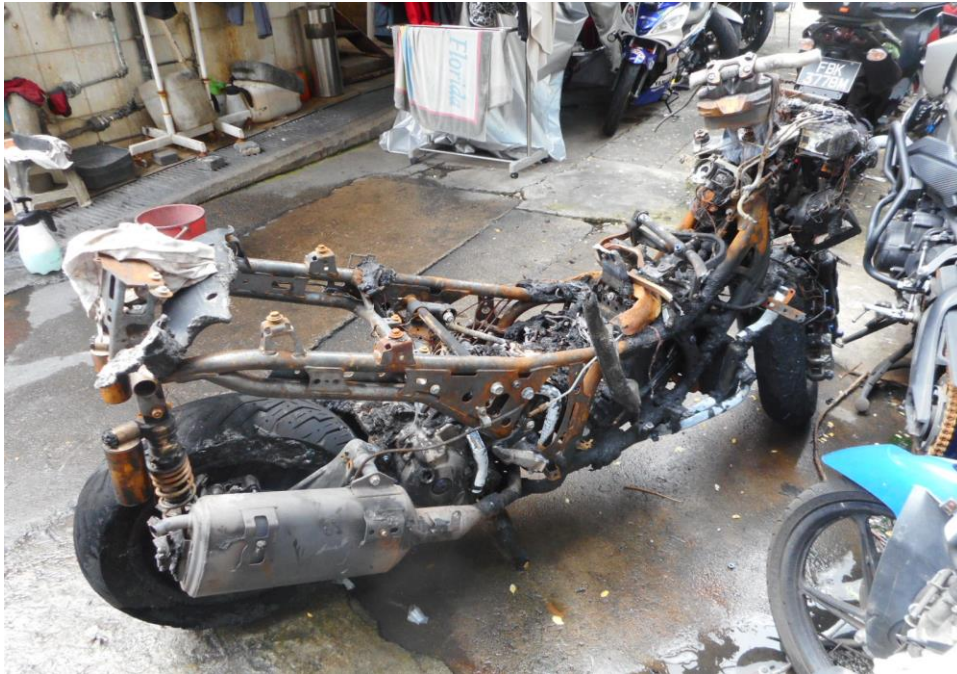
**Photo 1** shows the general view of the right of the Insured Motorcycle at the time of inspection. The Insured Motorcycle was observed to have sustained severe fire damage all around. Its front and rear number plate, front fairings; handle bar assembly, instrument panel, fuel tank, engine and seats amongst others that were found to have been affected as a result of the fire.

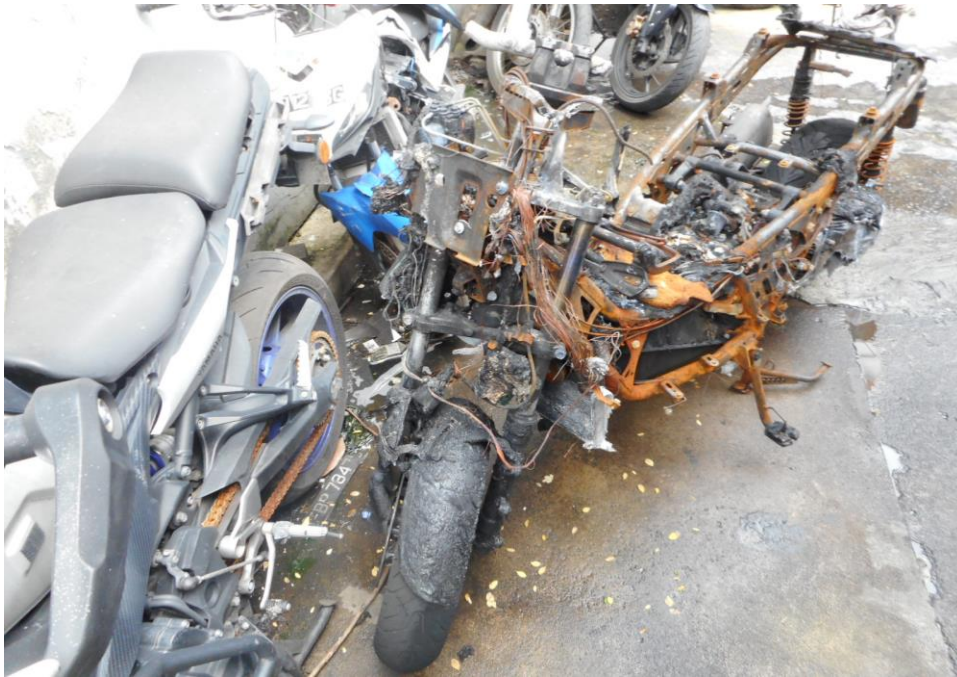
**Photo 2** shows the general view of the front of the Insured Motorcycle at the time of inspection. The Insured Motorcycle was observed to have sustained severe fire damage all around. Its front and rear number plate, front fairings; handle bar assembly, instrument panel, fuel tank, engine and seats amongst others that were found to have been affected as a result of the fire.

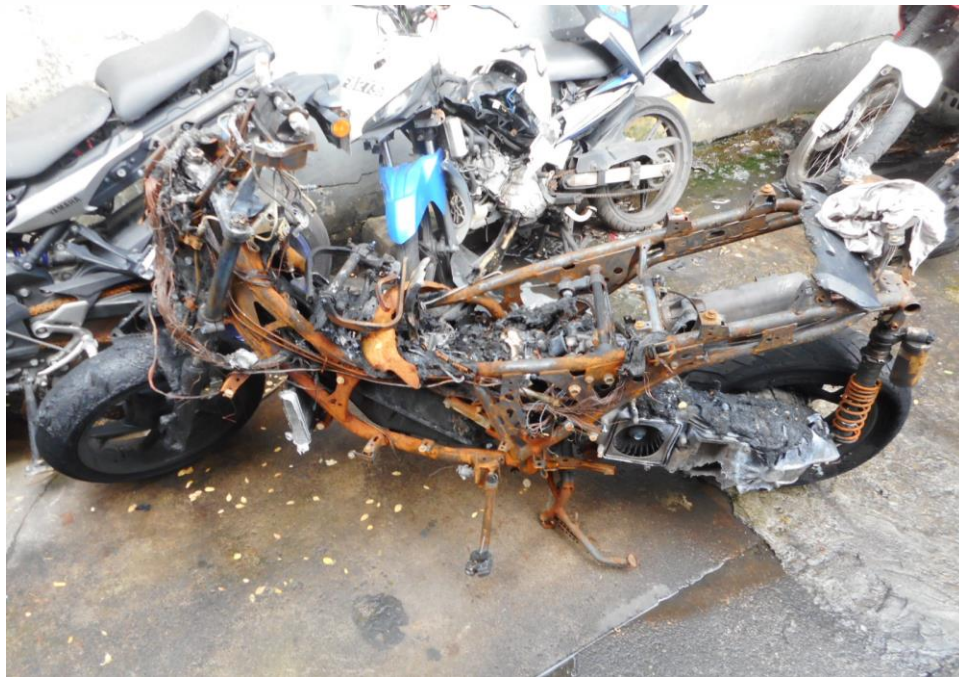
**Photo 3** shows the general view of the left side of the Insured Motorcycle at the time of inspection. The Insured Motorcycle was observed to have sustained severe fire damage all around. Its front and rear number plate, front fairings; handle bar assembly, instrument panel, fuel tank, engine and seats amongst others that were found to have been affected as a result of the fire.

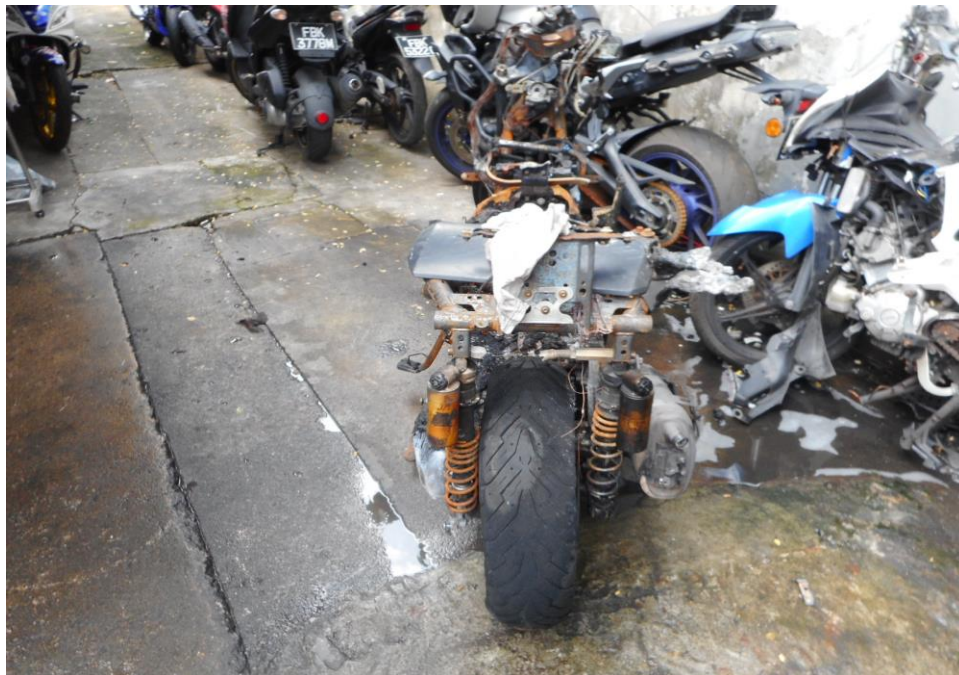
**Photo 4** shows the general view of the rear of the Insured Motorcycle at the time of inspection. The Insured Motorcycle was observed to have sustained severe fire damage all around. Its front and rear number plate, front fairings; handle bar assembly, instrument panel, fuel tank, engine and seats amongst others that were found to have been affected as a result of the fire.

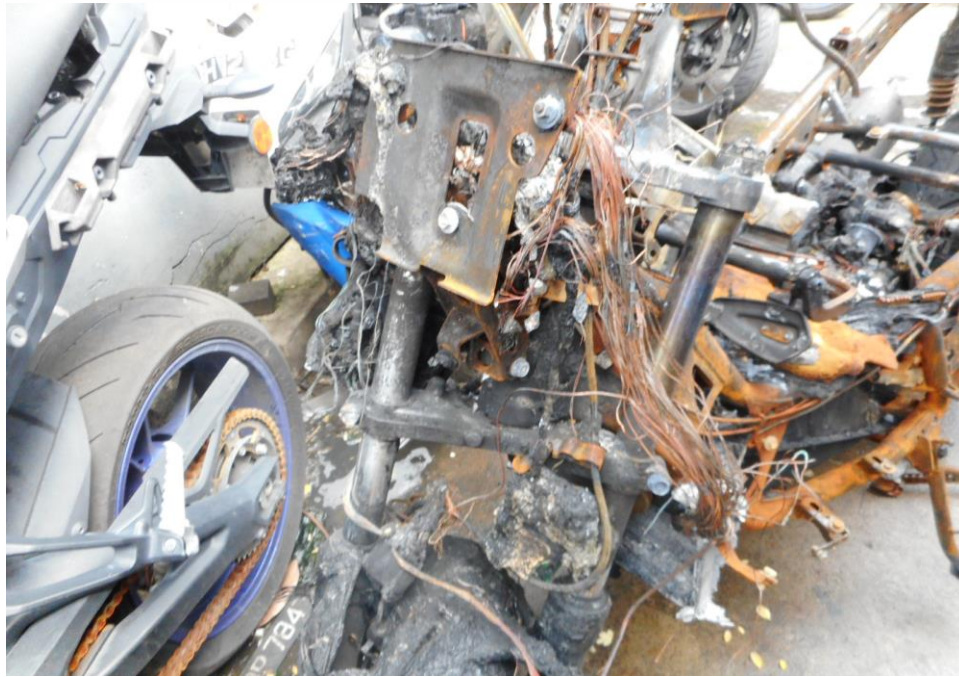
**Photo 5** shows the front number plate and fairings of the Insured Motorcycle had been burnt and/or melted as a result of the fire.

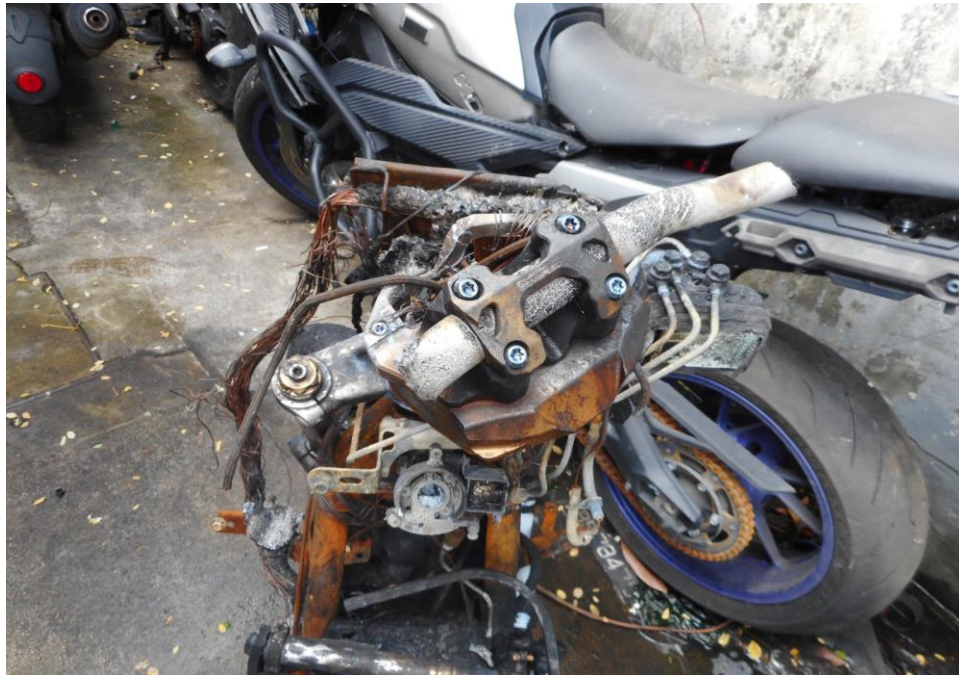
**Photo 6** shows the general view of the handle bar assembly and instrument panel of the Insured Motorcycle had been partially burnt and/or melted as a result of the fire.

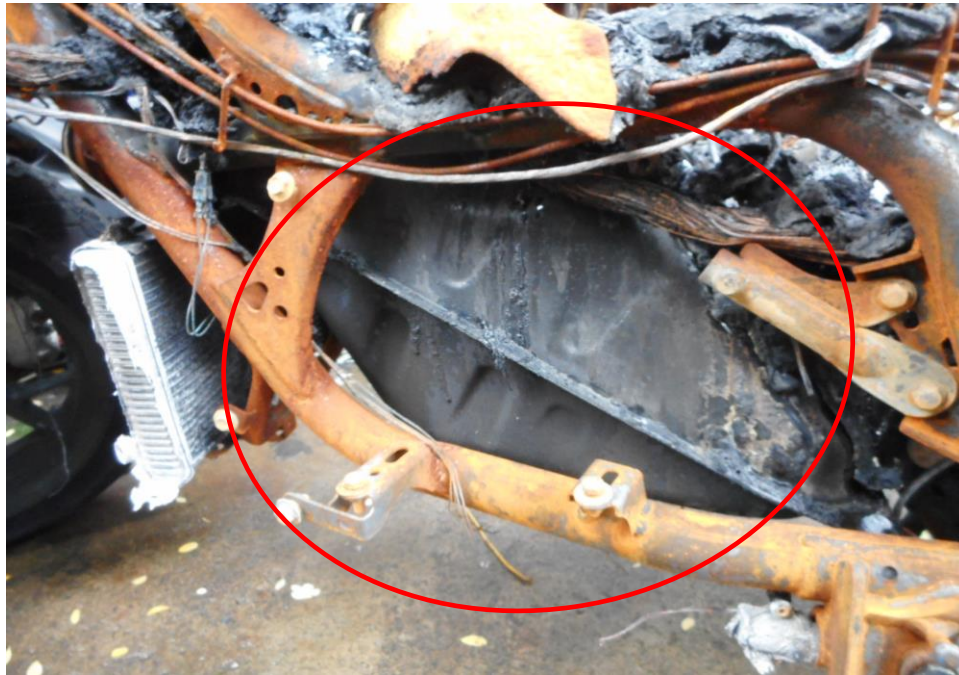
**Photo 7** shows the general view of the fuel tank (circled) of the Insured Motorcycle partially burnt and/or melted as a result of the fire.

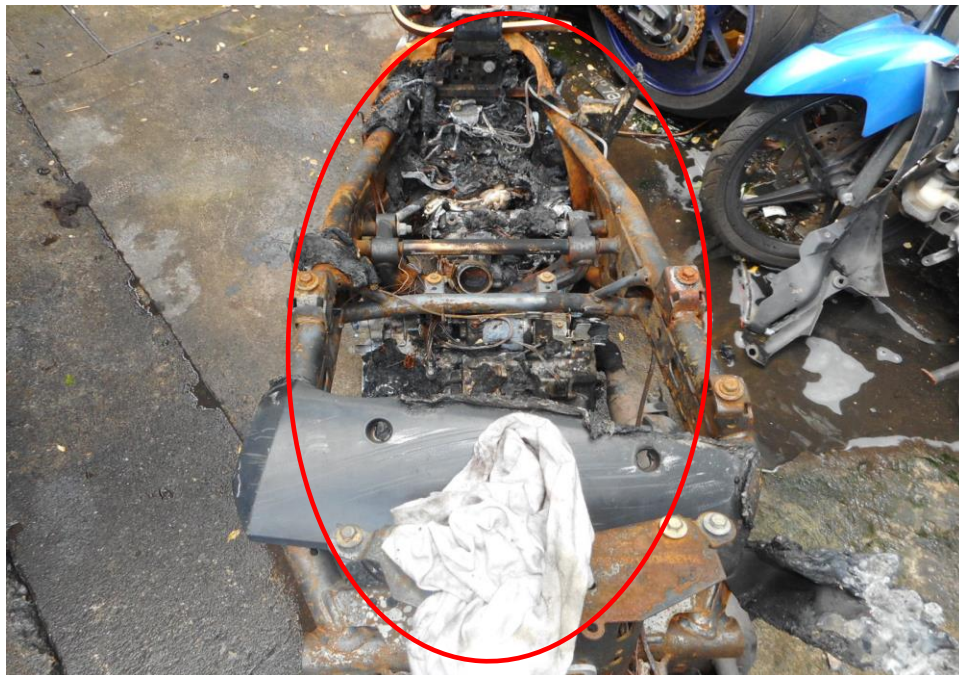
**Photo 8** shows the top view of the seat and the engine of the Insured Motorcycle was totally burnt and/or melted as a result of the fire.

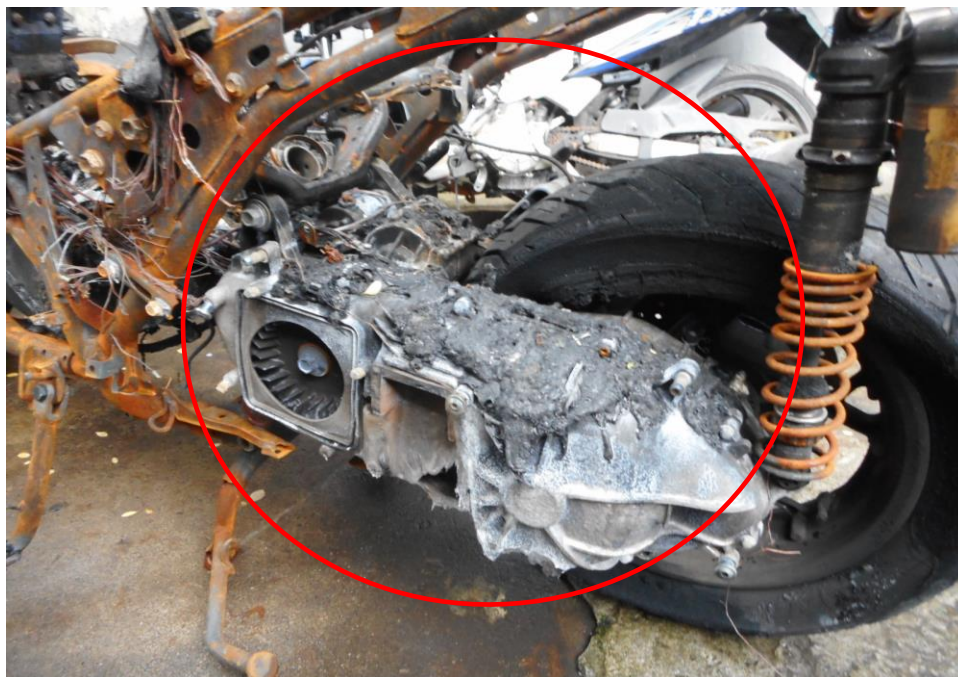
**Photo 9** shows the close up view of the engine of the Insured Motorcycle partially burnt and/or melted as a result of the fire.

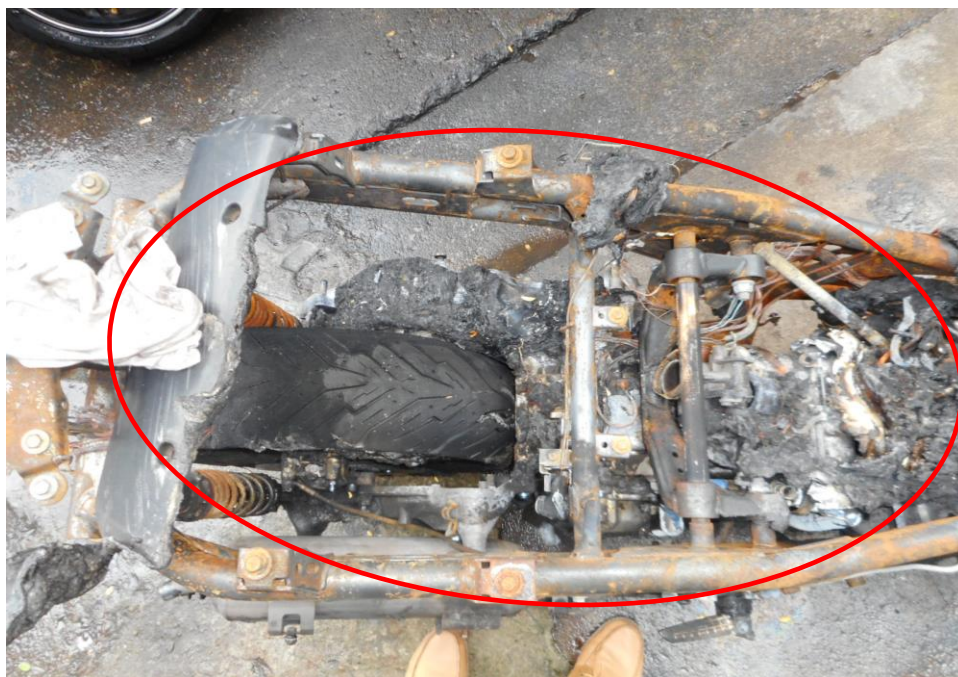
8. Based on the circumstances for this particular case, the fire appears to have originated from the middle of the Insured Motorcycle, somewhere around the centre portion below the seat where the engine and its components is located at. This can be determined basing on the area where the extent of fire damage was most severe, the circumstances of the fires' origin at the material time of incident and also the high heat intensity burn marks (whitish burn marks) that were found on the exterior surface around the engine area below the seat

9. These whitish burn marks are a result of exposure to prolong heat intensity. Rust would normally start to develop around these areas soon after a fire as the prolonged exposure to high heat intensity usually causes the bare steel/metal material of the body parts to be exposed to natural environmental condition. The rust that had developed on the centre portion, in the immediate vicinity of where these whitish burn marks were found, would also support our findings of where the fire had likely started from on the Insured Motorcycle. See photo 10- 12 below.

**Photo 10** shows general view of the engine portion of the Insured Motorcycle at the time of our inspection. The high heat intensity burn marks (whitish burn marks) and rust (circled) that had development found on the exterior surface around the engine area indicates that the fire had originated from this area of the Insured Motorcycle.

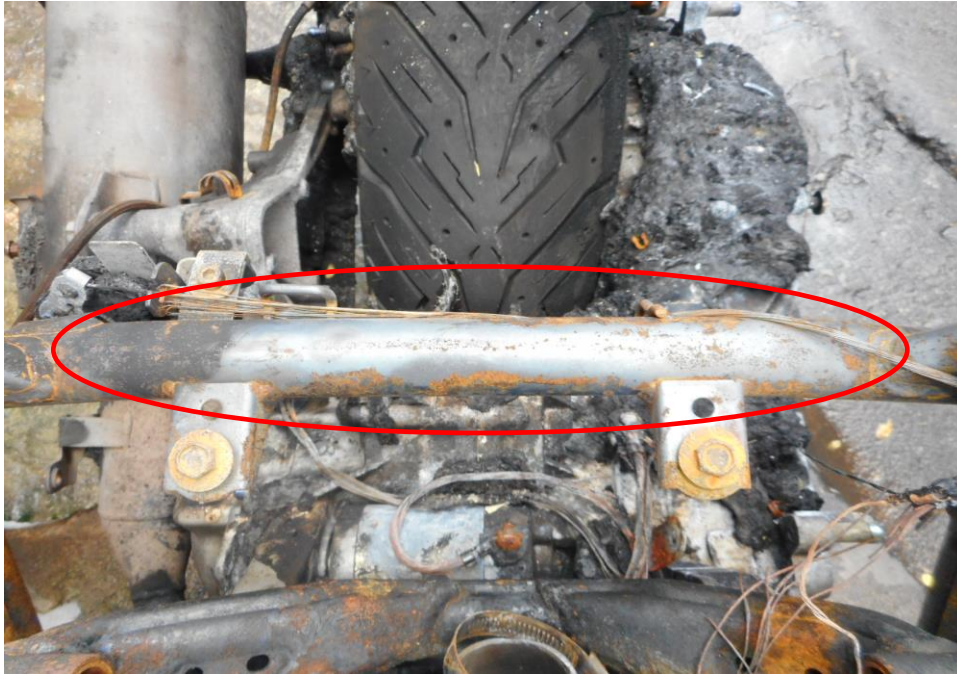
**Photo 11** shows close up view of the engine portion of the Insured Motorcycle at the time of our inspection. The high heat intensity burn marks (whitish burn marks) and rust (circled) that had development found on the exterior surface around the engine area indicates that the fire had originated from this area of the Insured Motorcycle.

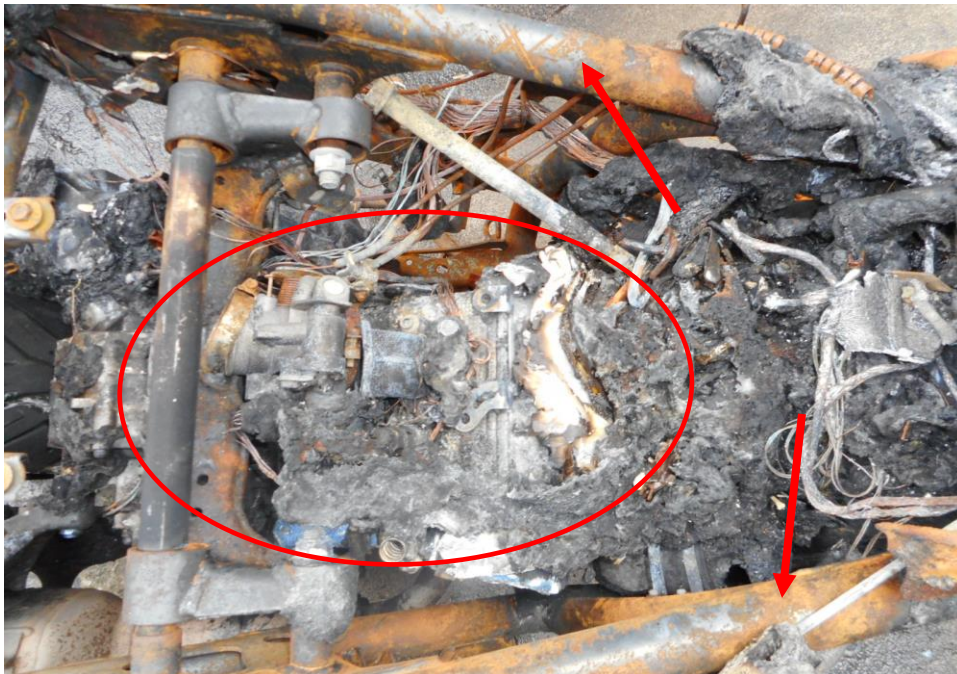
**Photo 12** shows close up view of the engine portion of the Insured Motorcycle at the time of our inspection. We observed engine and its throttle body of the Insured Motorcycle and the components in its vicinity had sustained the high heat intensity burn marks (whitish burn marks) (circled) and rust (arrowed) that had development found on the exterior surface around the engine area indicates that the fire had originated from this area of the Insured Motorcycle.

23. Since engine overheating, electrical in nature and fire to external factors were all unlikely the cause of fire, the most probable cause would then be the leakage of fluid, which was also what we had observed between the throttle body and its engine area where the fuel hose is supplying petrol to the throttle body that maybe leaking petrol to the area of the engine and cause a fire to be ignited on Insured Motorcycle. The leaked fluid comes into contact with hot surfaces; such the heated engine surfaces would possibly have been at a sufficient temperature that could result in leaked fluid to self-ignite and started burning the seat of the Insured Motorcycle and spread onto the whole Insured Motorcycle. This is further supported by Mr Shafiq statement that he had smell petrol while he was in the midst of riding the Insured Motorcycle.

25. Having investigated and technically analysed the damages of burnt nature to the Insured Motorcycle, we are of the view that the cause of fire to the Insured Motorcycle was of leakage of fluid which contacted on to hot surface that caused the self-ignition of fire. For this particular case, the fire had originated from between the throttle body and the heated engine surfaces, somewhere around the from the engine area below the seat portion of the insured Motorcycle.

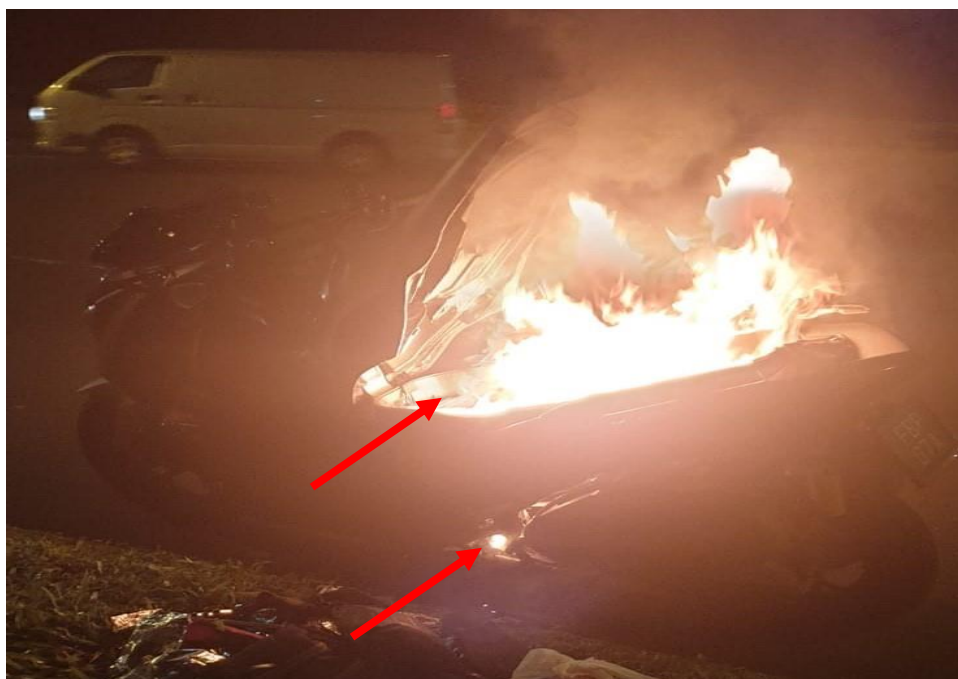
**Photo 13** shows the flames started engulfing the centre part of the Insured Motorcycle at the incident scene. The fire could be seen burning from the seat and the engine below (arrowed) of the Insured Motorcycle

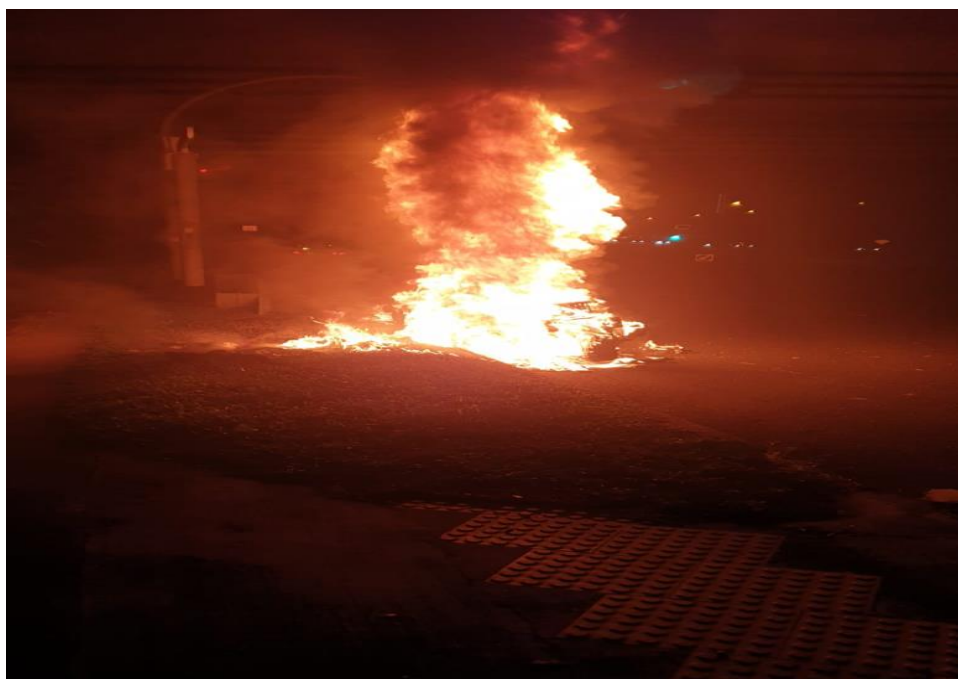
**Photo 14** shows the flames started engulfing the whole of the Insured Motorcycle at the incident scene. The fire could be seen burning the whole of the Insured Motorcycle

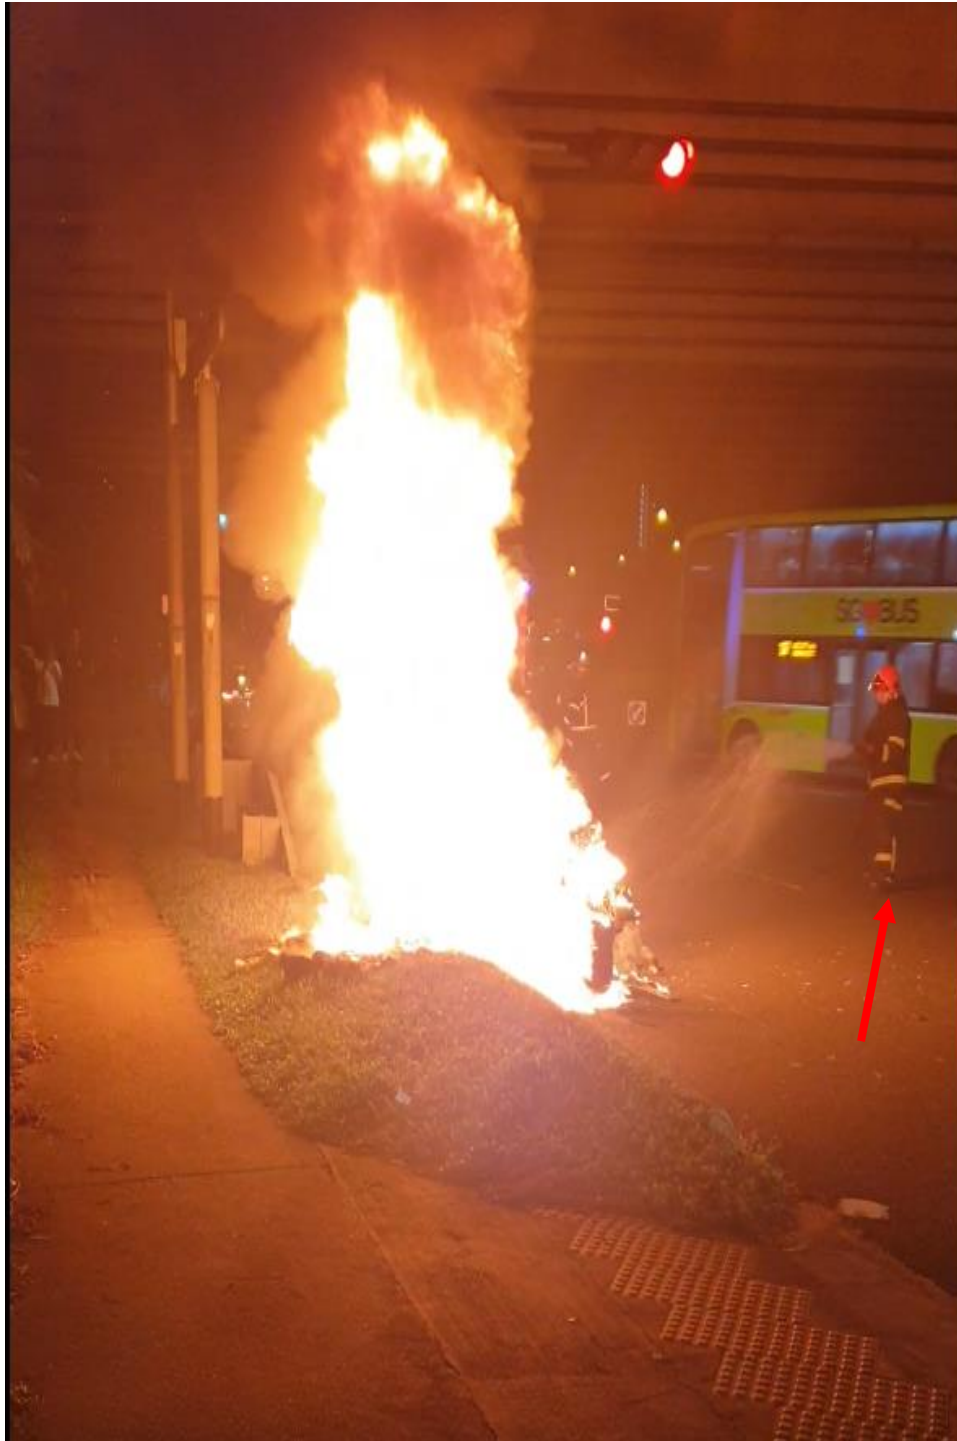
**Photo 15** shows the SCDF officer (arrowed) in attempting to put out the fire on the Insured Motorcycle at the incident scene. In general, the information that could be gathered from these photographs had corresponded to the events that were related to us by Mr Shafiq.

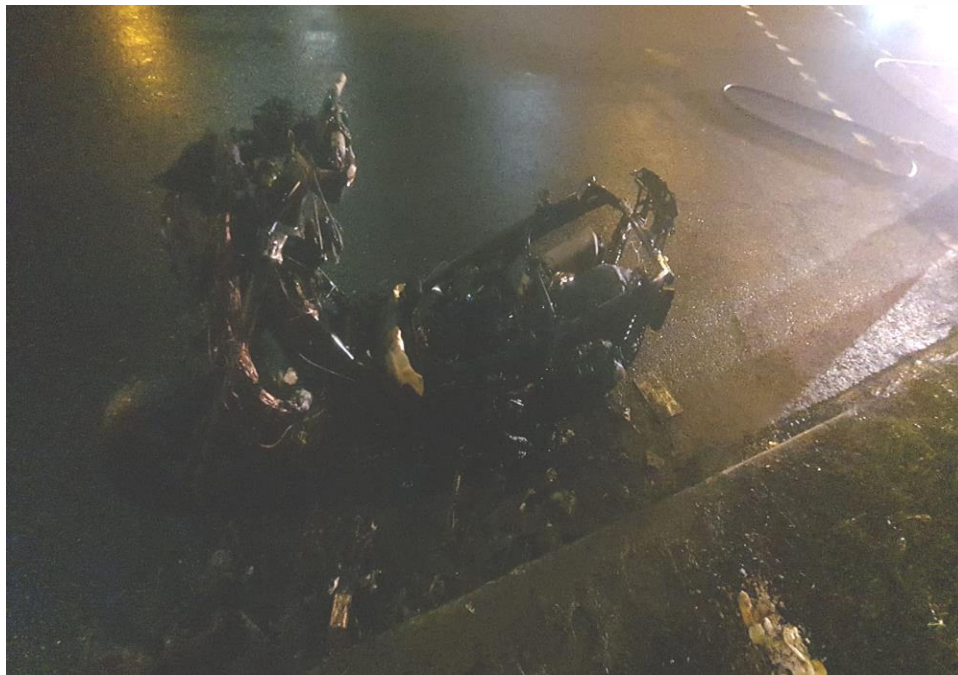
**Photo 16** shows the Insured Motorcycle at the incident location after the fire was extinguished. In general, the information that could be gathered from this photograph had corresponded to the events that were related to us by Mr Shafiq, location when the fire broke out.
