Your Ref : S0M02WWJ
Our Ref: CS4/ASM20012443/P

18th November 2020

**TECHNICAL INVESTIGATION REPORT OF FIRE INCIDENT INVOLVING THE
INSURED MOTORCYCLE FBP 67A ON 09th November 2020**

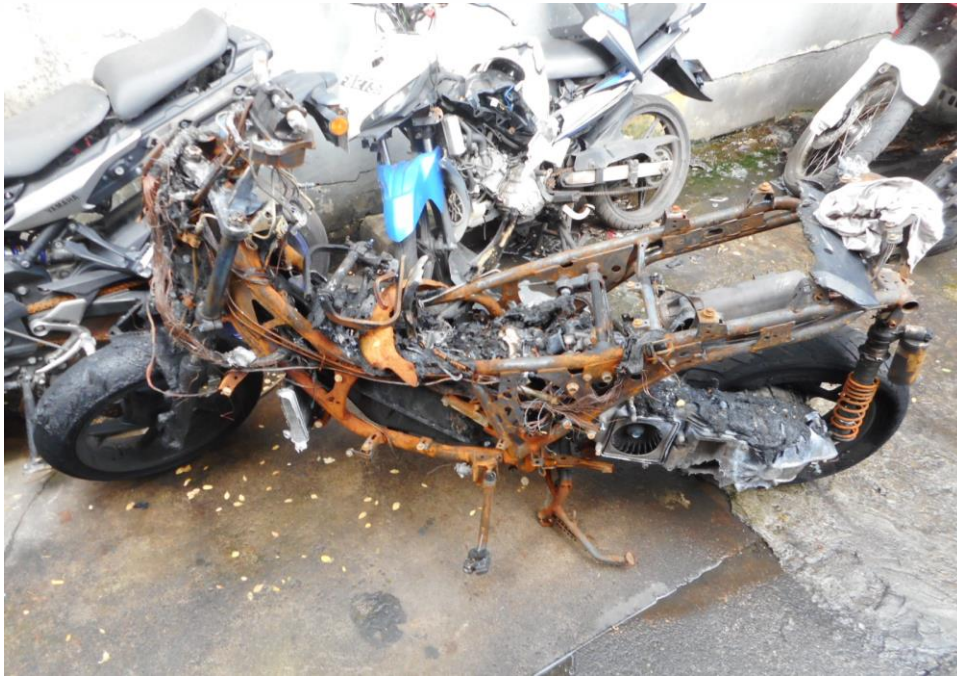
Photo 3 shows the general view of the left side of the Insured Motorcycle at the time of inspection. The Insured Motorcycle was observed to have sustained severe fire damage all around. Its front and rear number plate, front fairings; handle bar assembly, instrument panel, fuel tank, engine and seats amongst others that were found to have been affected as a result of the fire.

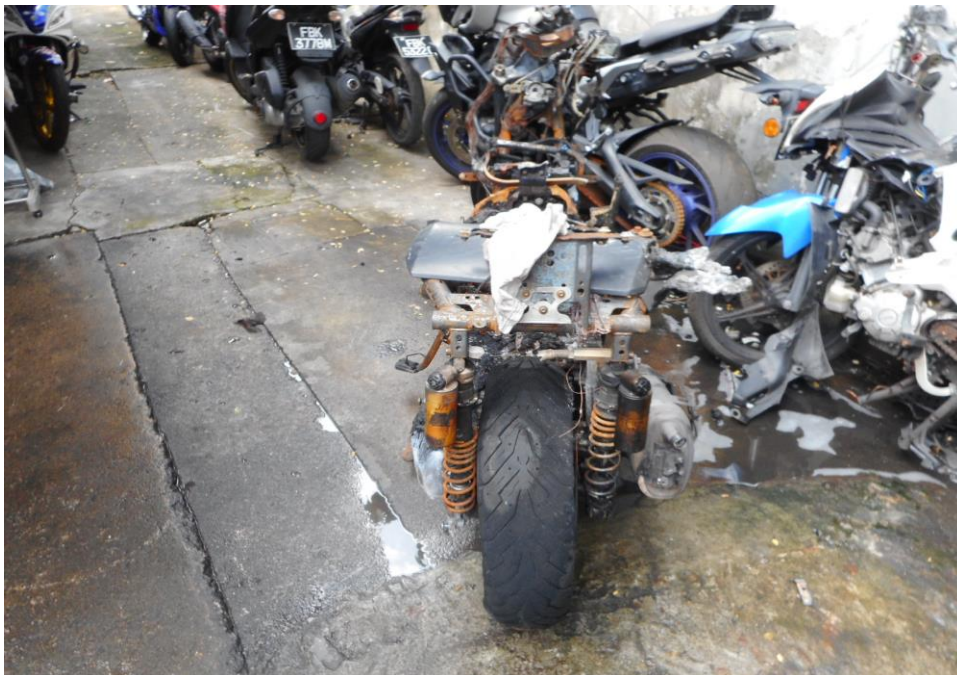
Photo 4 shows the general view of the rear of the Insured Motorcycle at the time of inspection. The Insured Motorcycle was observed to have sustained severe fire damage all around. Its front and rear number plate, front fairings; handle bar assembly, instrument panel, fuel tank, engine and seats amongst others that were found to have been affected as a result of the fire.

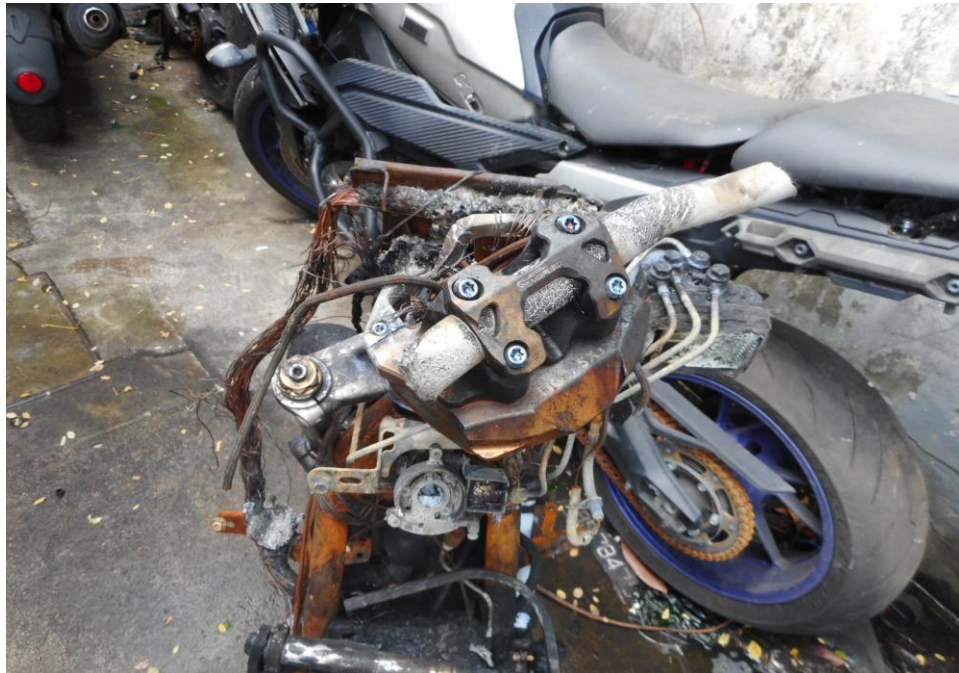
Photo 6 shows the general view of the handle bar assembly and instrument panel of the Insured Motorcycle had been partially burnt and/or melted as a result of the fire.

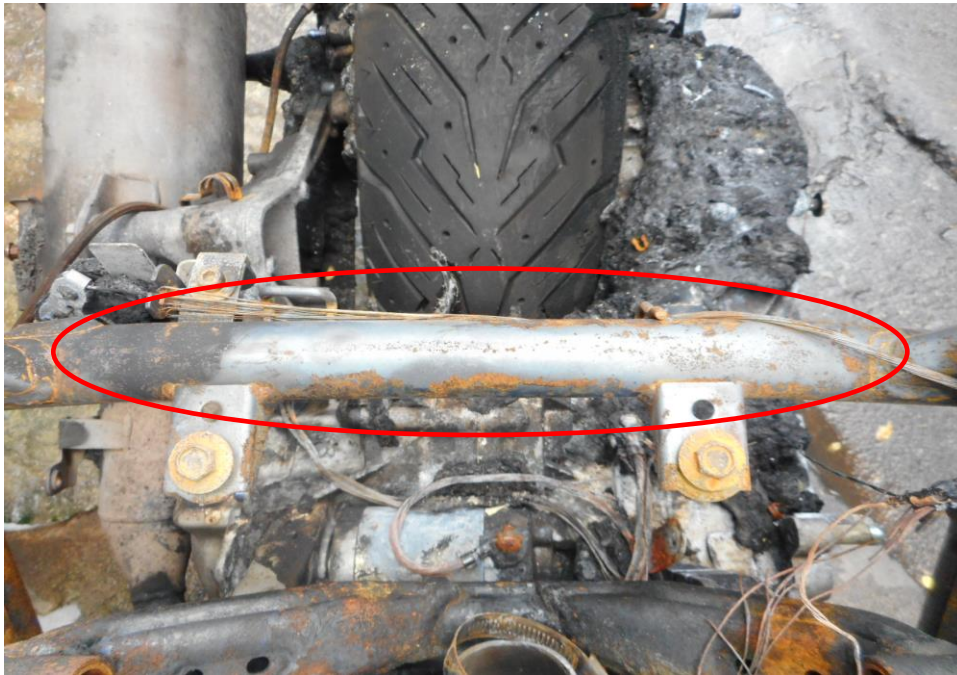
8. Based on the circumstances for this particular case, the fire appears to have originated from the middle of the Insured Motorcycle, somewhere around the centre portion below the seat where the engine and its components is located at. This can be determined basing on the area where the extent of fire damage was most severe, the circumstances of the fires' origin at the material time of incident and also the high heat intensity burn marks (whitish burn marks) that were found on the exterior surface around the engine area below the seat

9. These whitish burn marks are a result of exposure to prolong heat intensity. Rust would normally start to develop around these areas soon after a fire as the prolonged exposure to high heat intensity usually causes the bare steel/metal material of the body parts to be exposed to natural environmental condition. The rust that had developed on the centre portion, in the immediate vicinity of where these whitish burn marks were found, would also support our findings of where the fire had likely started from on the Insured Motorcycle. See photo 10- 12 below.

Photo 11 shows close up view of the engine portion of the Insured Motorcycle at the time of our inspection. The high heat intensity burn marks (whitish burn marks) and rust (circled) that had development found on the exterior surface around the engine area indicates that the fire had originated from this area of the Insured Motorcycle.

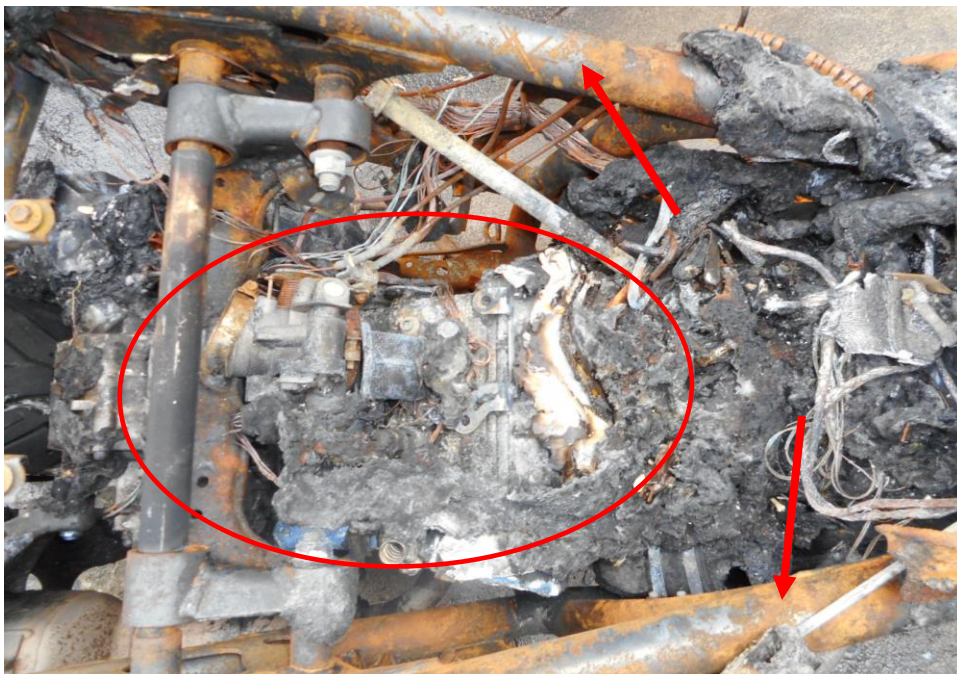
Photo 12 shows close up view of the engine portion of the Insured Motorcycle at the time of our inspection. We observed engine and its throttle body of the Insured Motorcycle and the components in its vicinity had sustained the high heat intensity burn marks (whitish burn marks) (circled) and rust (arrowed) that had development found on the exterior surface around the engine area indicates that the fire had originated from this area of the Insured Motorcycle.

23. Since engine overheating, electrical in nature and fire to external factors were all unlikely the cause of fire, the most probable cause would then be the leakage of fluid, which was also what we had observed between the throttle body and its engine area where the fuel hose is supplying petrol to the throttle body that maybe leaking petrol to the area of the engine and cause a fire to be ignited on Insured Motorcycle. The leaked fluid comes into contact with hot surfaces; such the heated engine surfaces would possibly have been at a sufficient temperature that could result in leaked fluid to self-ignite and started burning the seat of the Insured Motorcycle and spread onto the whole Insured Motorcycle. This is further supported by Mr Shafiq statement that he had smell petrol while he was in the midst of riding the Insured Motorcycle.

25. Having investigated and technically analysed the damages of burnt nature to the Insured Motorcycle, we are of the view that the cause of fire to the Insured Motorcycle was of leakage of fluid which contacted on to hot surface that caused the self-ignition of fire. For this particular case, the fire had originated from between the throttle body and the heated engine surfaces, somewhere around the from the engine area below the seat portion of the insured Motorcycle.

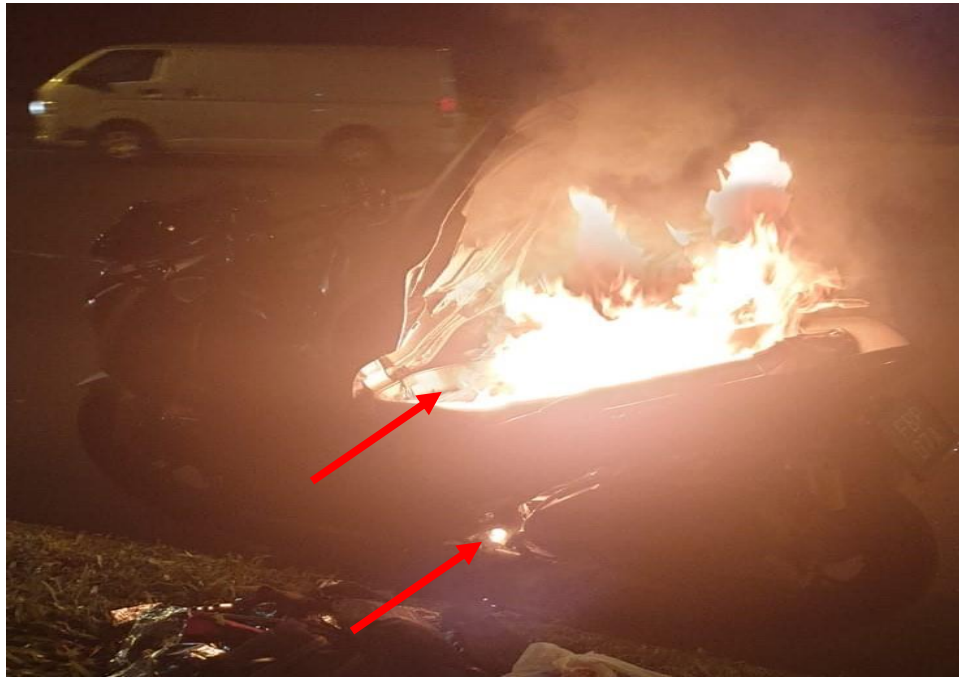
Photo 13 shows the flames started engulfing the centre part of the Insured Motorcycle at the incident scene. The fire could be seen burning from the seat and the engine below (arrowed) of the Insured Motorcycle

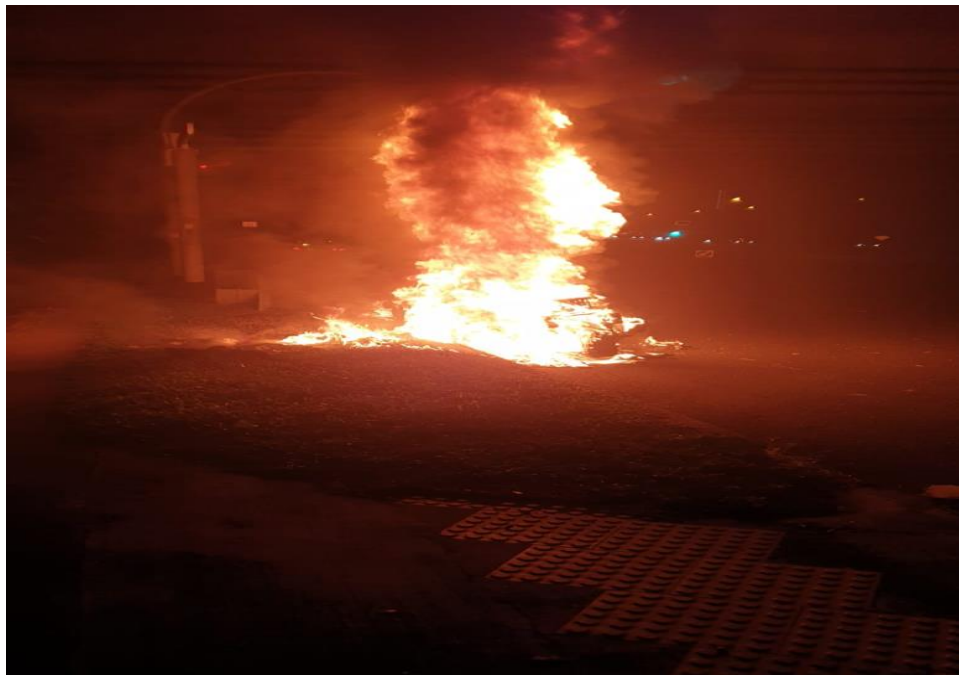
Photo 14 shows the flames started engulfing the whole of the Insured Motorcycle at the incident scene. The fire could be seen burning the whole of the Insured Motorcycle
