You're Ref: TP/IP/47771/2020  
Our Ref: CI/TPD20012445/P

**Fatal Accident Investigation Team**

**MECHANICAL INSPECTION REPORT OF MOTOR CAR SDV 8850Y**

1. I refer to your request on 11<sup>th</sup> November 2020 to conduct a physical inspection of a Motor Car bearing registration number SDV 8850Y (herein referred to as "**Motor Car**"), which was involved in a fatal road traffic accident on 1<sup>st</sup> November 2020.
2. The objective of the inspection is to determine if there was any possible mechanical failure to the Motor Car that may have contributed to the accident.
3. Following the request, I had carried out a physical inspection of the Motor Car on 24<sup>th</sup> November 2020 at the premises of Traffic Police vehicle pound, 517 Airport Road Singapore 539942. I now set out below my observations and comments with respect to this inspection.

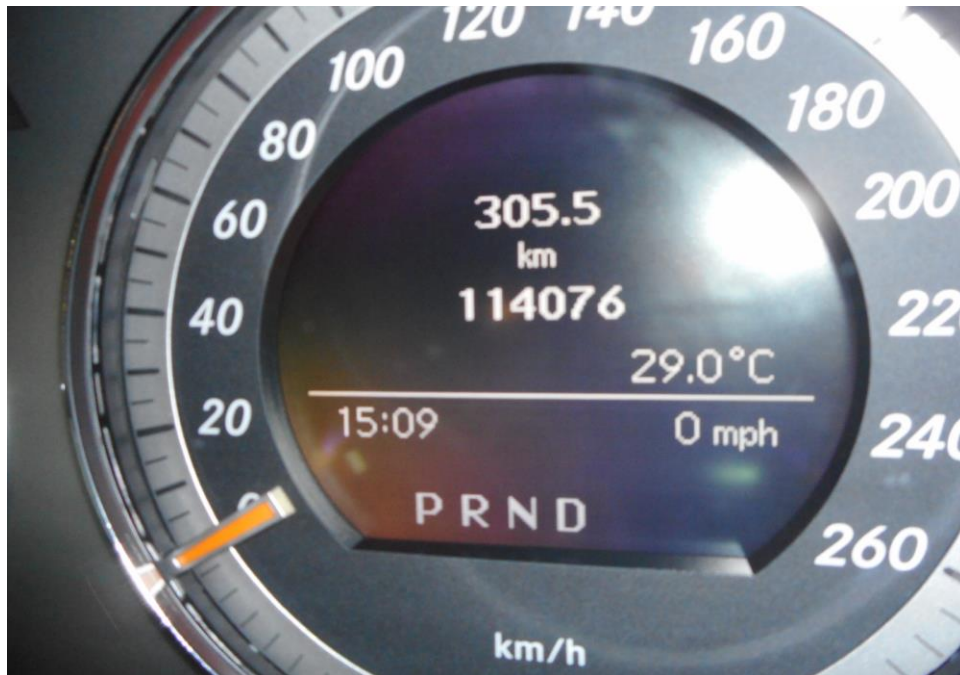
4. The mileage of the Motor Car at the time of my inspection was 114,076km.
5. The Motor Car was observed to have sustained damage at its front portion. Its front bumper was the body part that were damaged as a result of the accident.

**Photo 1** shows the mileage of the Motor Car at the time of my inspection. The mileage observed was 114,076km.

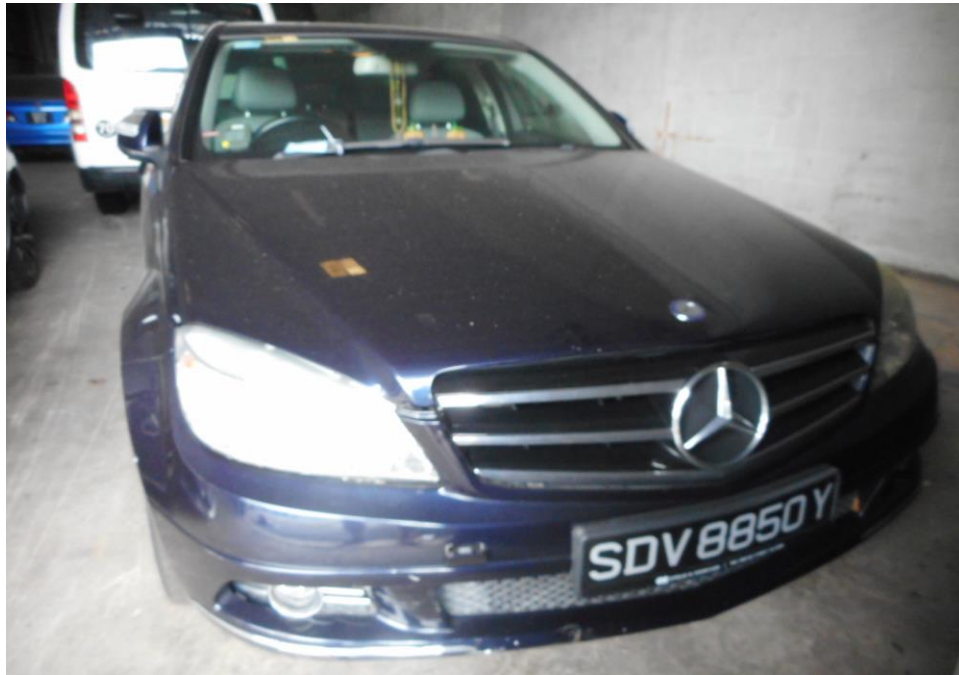
**Photo 2** shows a general view of the Motor Car's front body at the time of my inspection. The front portion of the Motor Car was observed to have sustained damage. Its front bumper was the body part that were damaged as a result of the accident.

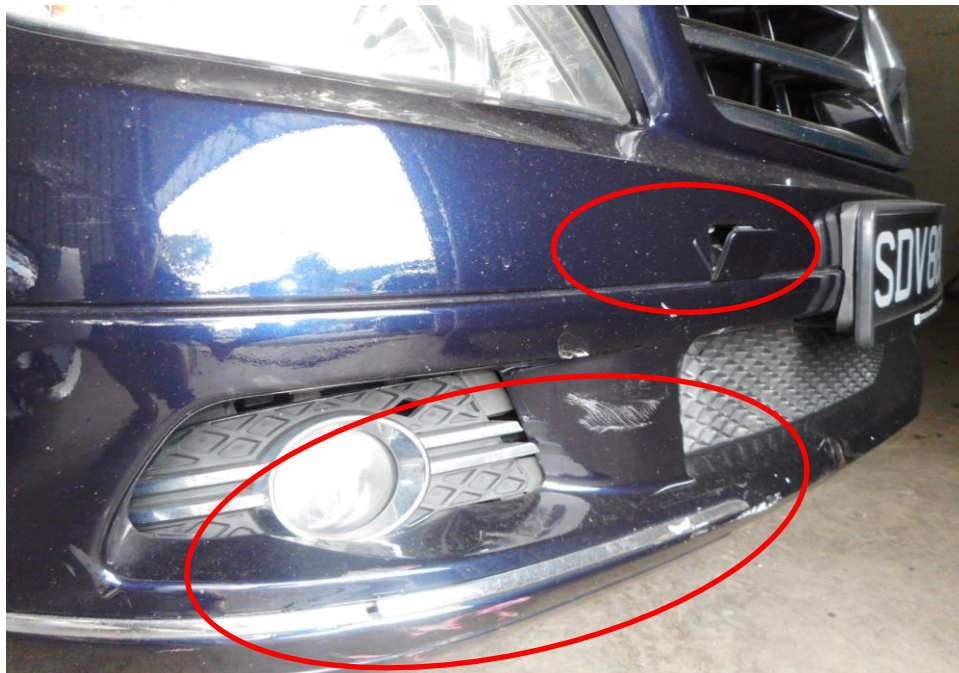
**Photo 3** shows the close up view of the Motor Car's front body at the time of my inspection. The Motor Car was observed to have sustained damage at its front bumper (circled), as a result of the accident.

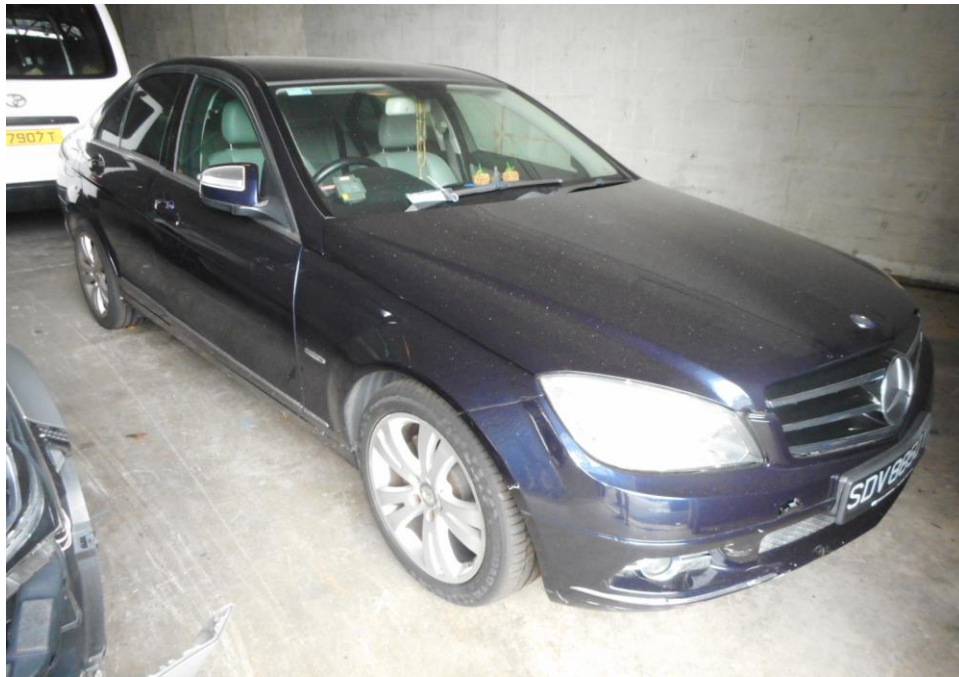
**Photo 4** shows a general view of the Motor Car's right body at the time of my inspection. The right portion of the Motor Car was observed to have been unaffected by the accident.

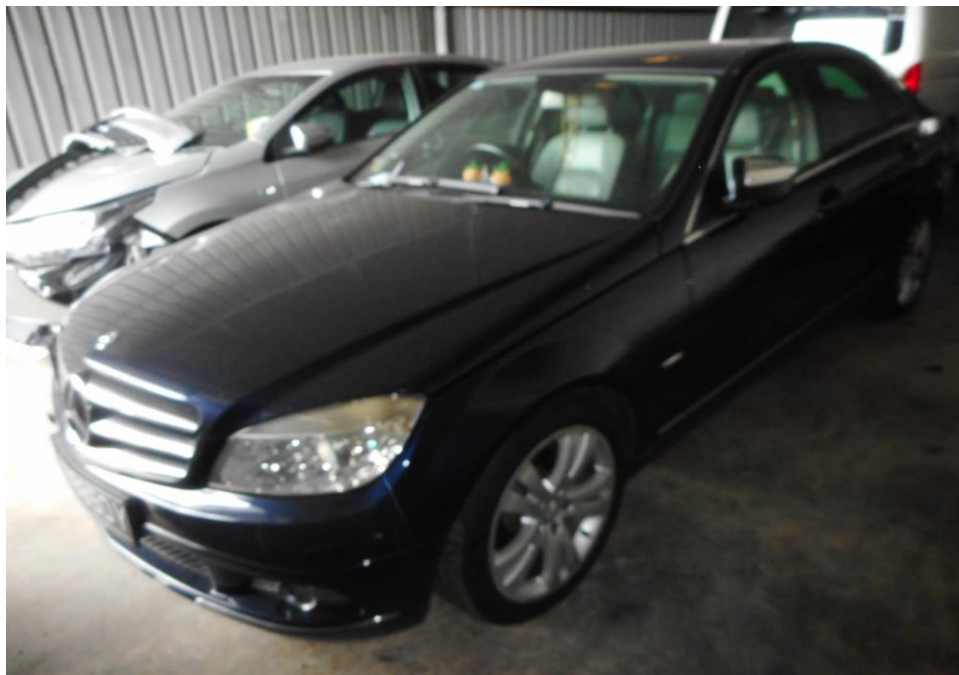
**Photo 5** shows a general view of the Motor Car's left body at the time of my inspection. The left portion of the Motor Car was observed to have been unaffected by the accident.

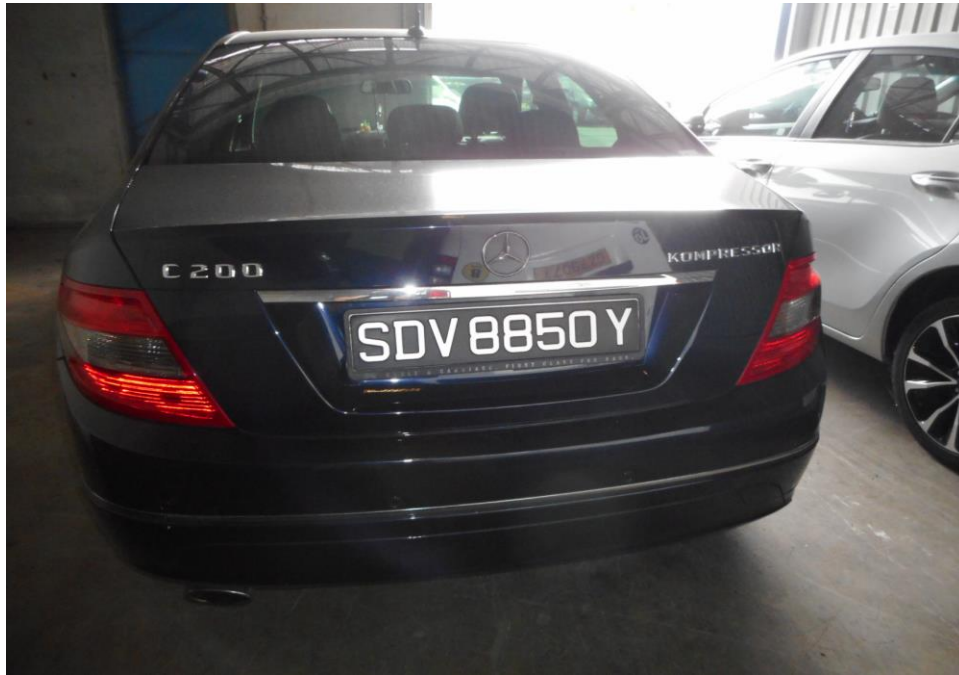
**Photo 6** shows the general view of the Motor Car's rear body at the time of my inspection. The Motor Car rear was observed to be unaffected by the accident.

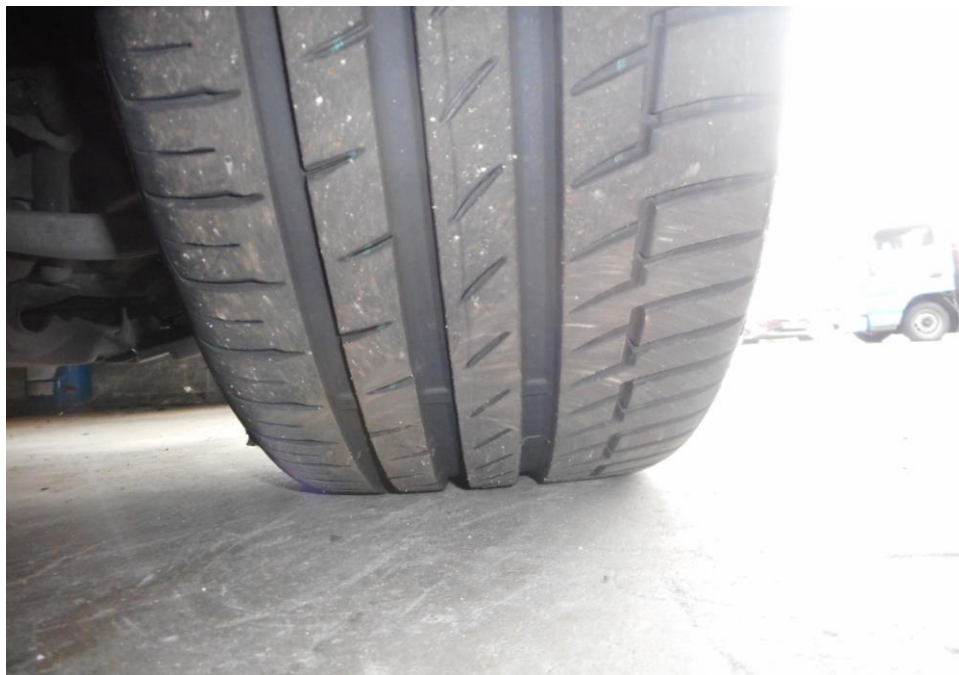
**Photo 7** shows the condition of the front right tyre of the Motor Car, which was observed to be in serviceable condition with remaining tread depth of approximately 6.7mm. The tyre was sufficiently inflated for vehicular operation with no tear, cut or burst mark(s) on the outer and the inner sidewalls as well as across the tread. The 4 tyres of the Motor Car were wrapped around standard steel wheel rims without any damage.

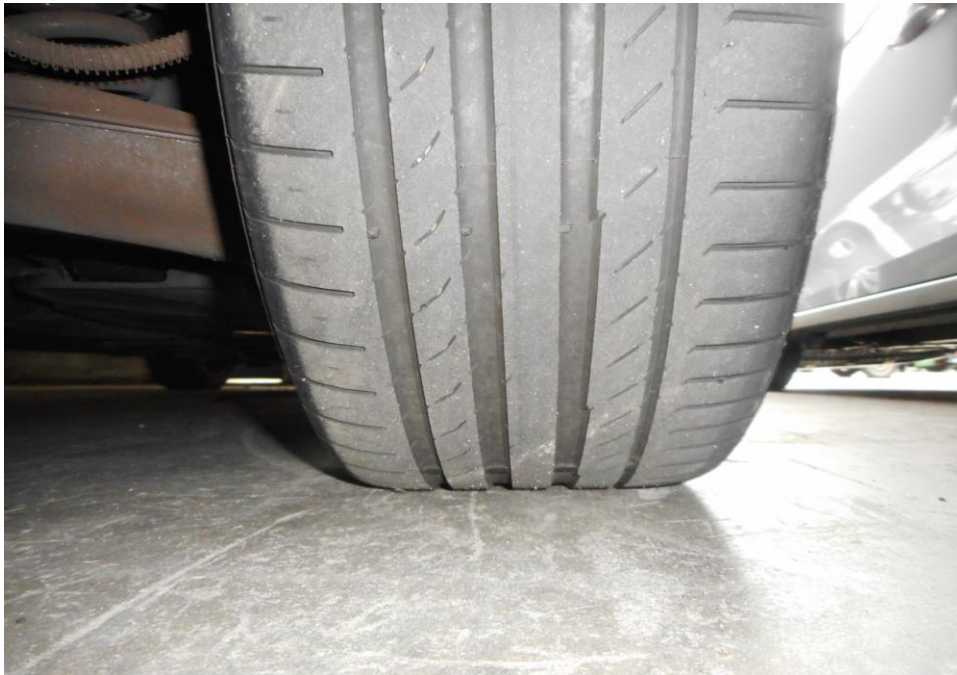
**Photo 8** shows the condition of the rear right tyre of the Motor Car, which was observed to be in serviceable condition with remaining tread depth of approximately 2.5mm. The tyre was also observed to be sufficiently inflated for vehicular operation with no tear, cut or burst mark(s).

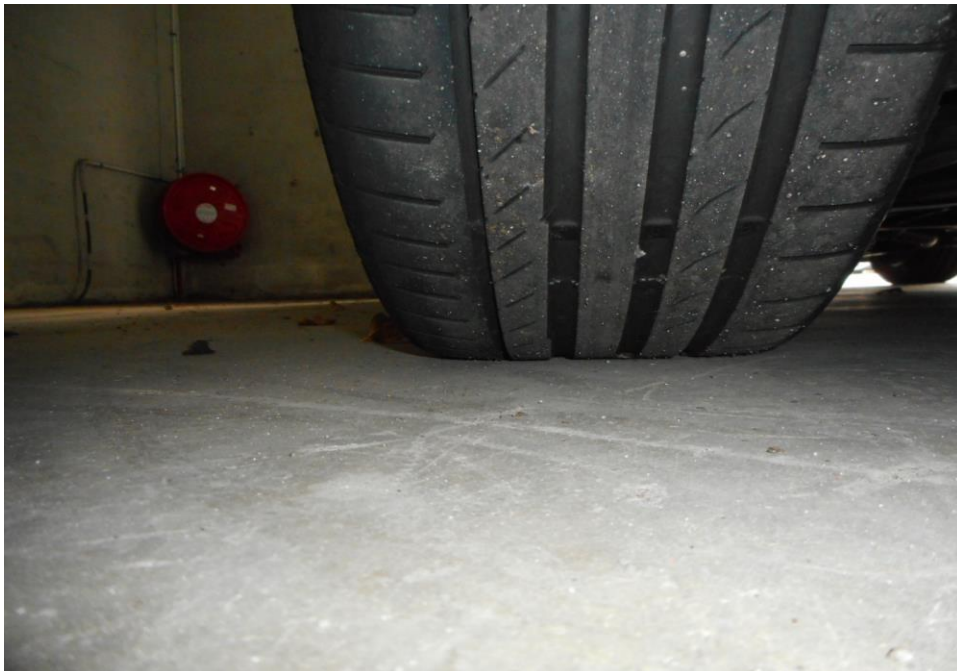
**Photo 9** shows the condition of the rear left tyre of the Motor Car, which was observed to be in serviceable condition with remaining tread depth of approximately 2.5mm. The tyre, which was wrapped around steel wheel rim, was also observed to be sufficiently inflated for vehicular operation. The 4 tyres of the Motor Car were wrapped around standard steel wheel rims.

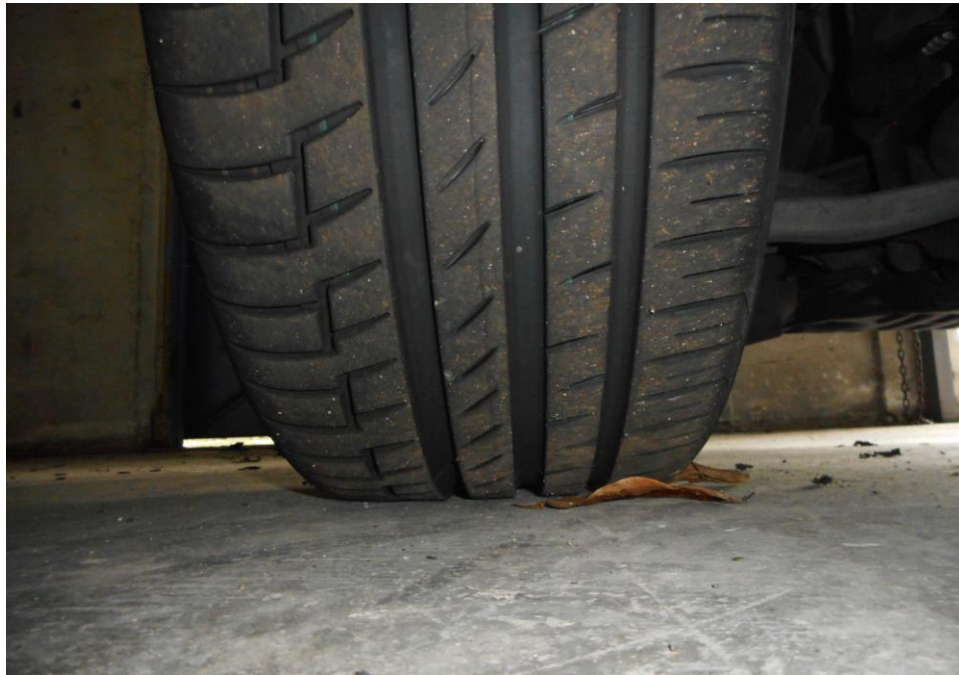
**Photo 10** shows the condition of the front left tyre of the Motor Car, which was observed to be in serviceable condition with remaining tread depth of approximately 6.1mm. There was also no tear, cut or burst mark(s) on the outer and the inner sidewalls as well as across the tread of the Motor Car's 4 tyres.

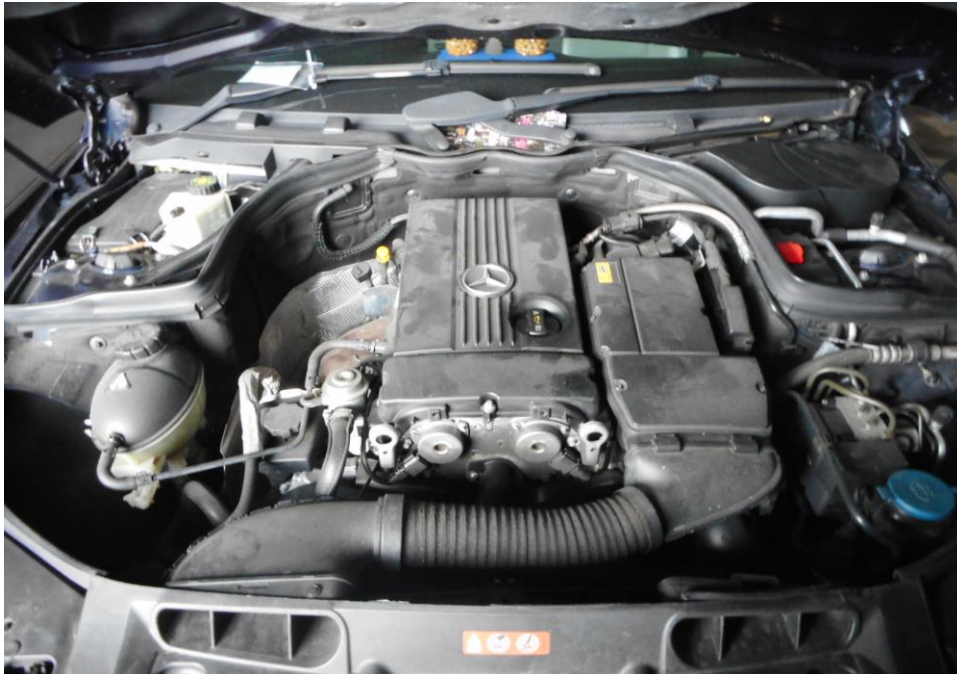
**Photo 11** shows a general view of the Motor Car's engine compartment. The various parts and components inside the engine compartment were unaffected by the accident. There was also no sign(s) or indication(s) of fluid leakage and/or fluid stain within the engine compartment.

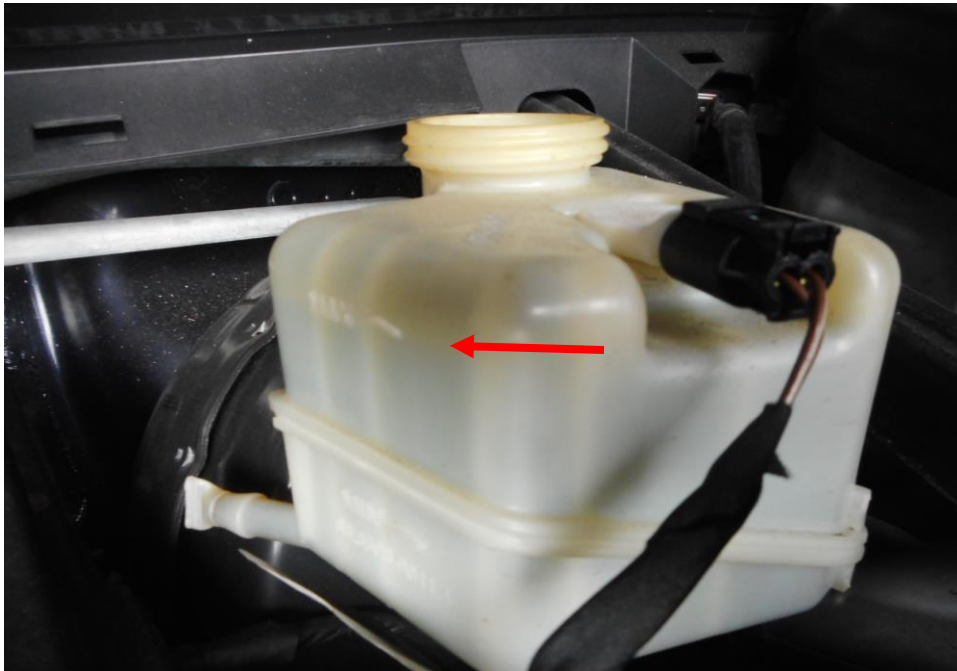
**Photo 12** shows the brake fluid reservoir of the Motor Car at the time of my inspection. The brake fluid was observed to be of sufficient level (arrowed) and without any visible contamination.

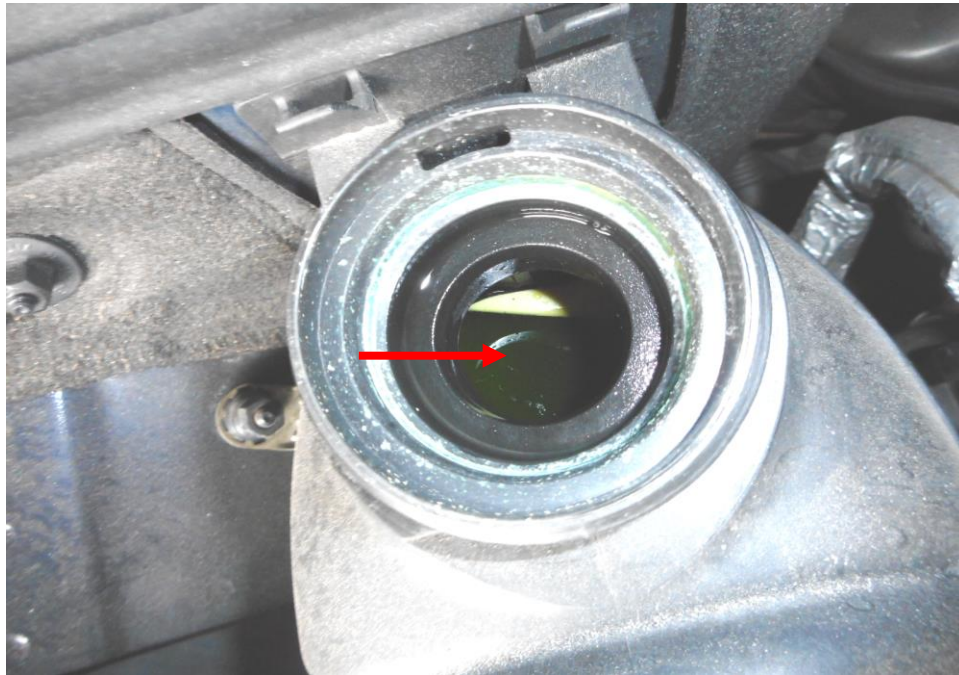
**Photo 13** shows checks being carried out to the engine coolant of the Motor Car at the time of my inspection. The engine coolant was observed to be of sufficient level (arrowed) and without any visible contamination.

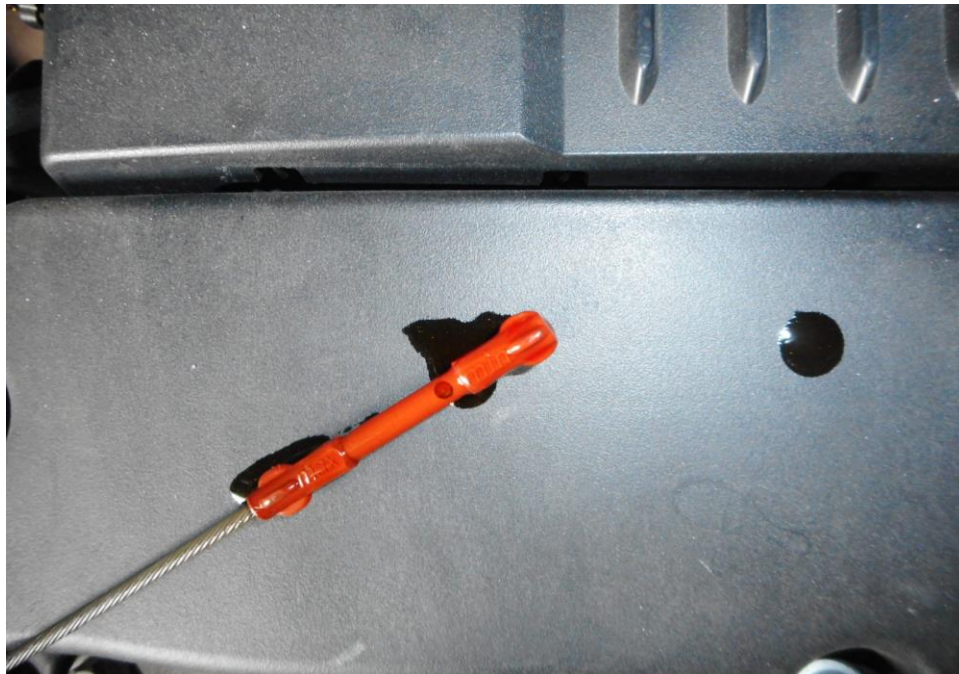
**Photo 14** shows the engine oil dip stick of the Motor Car at the time of my inspection. The engine oil was observed to be of sufficient level and without any visible contamination.

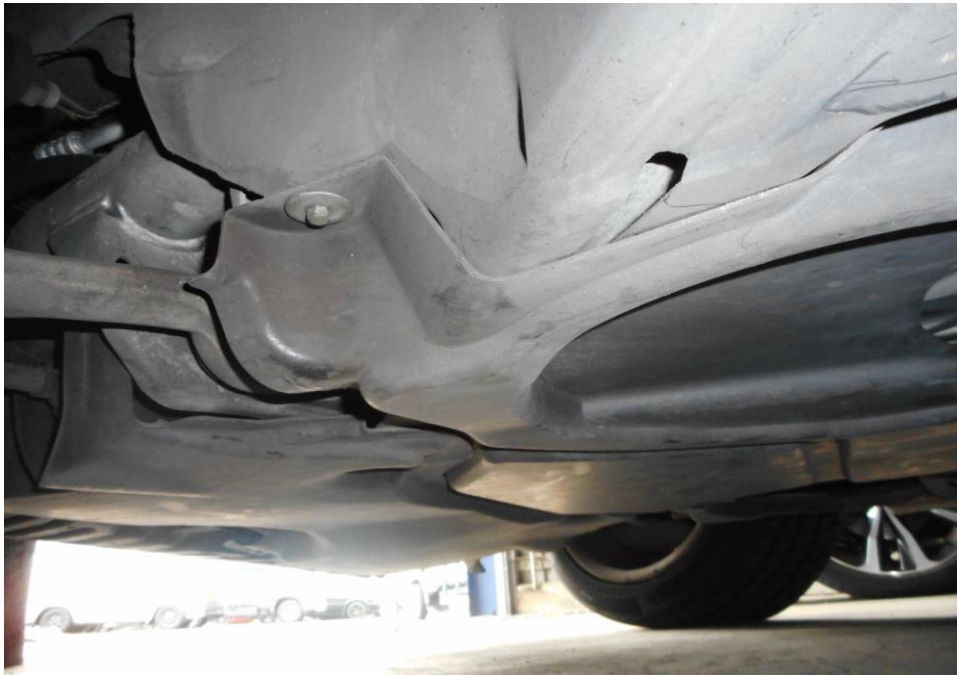
**Photo 15** shows the undercarriage of the Motor Car, at the area where the engine housing and transmission housing are located. I did not find any sign(s) or indication(s) of fluid leak and/or fluid stain(s) on the underside of the Motor Car.

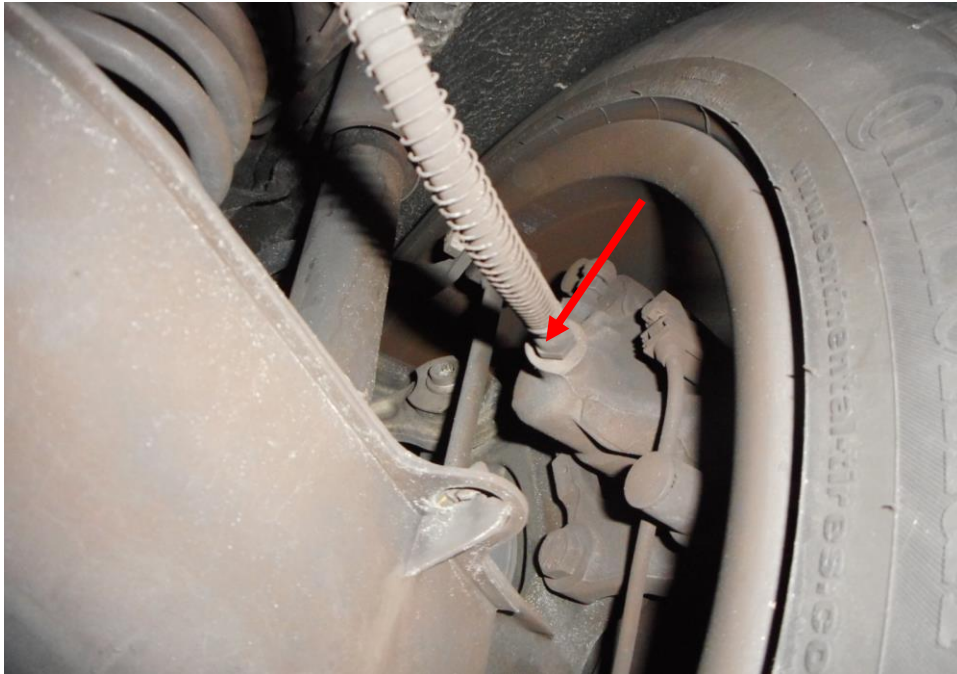
**Photo 16** shows the brake hose/pipe (arrowed) at the rear right wheel of the Motor Car. No leakage of brake fluid was observed. Visual examination of the various components of the braking system like the drum brake, brake booster, brake pedal etc. had revealed all to be intact and without visible damage.

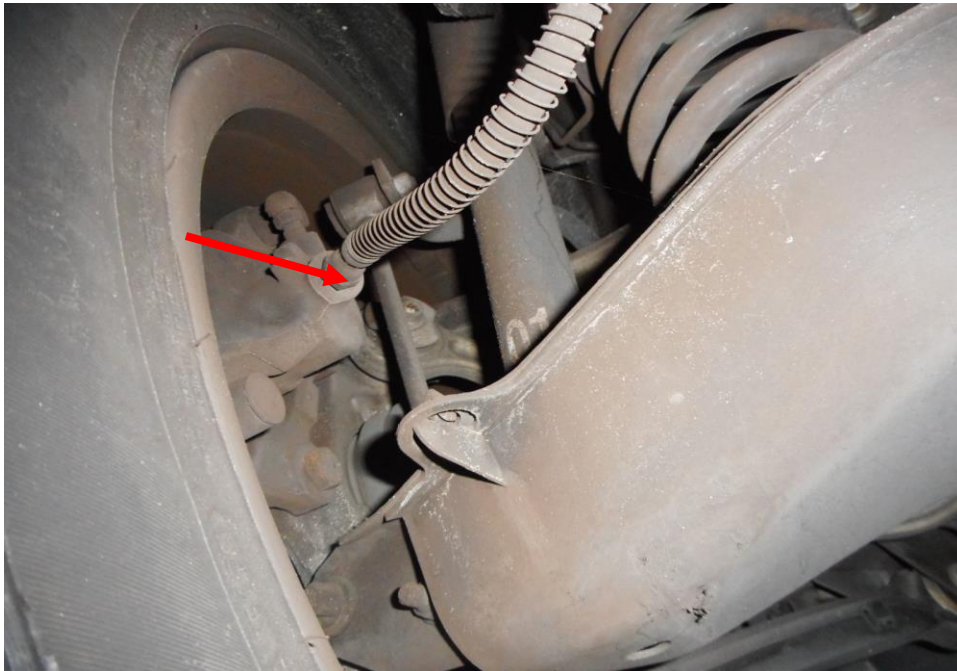
**Photo 17** shows the brake hose/pipe (arrowed) at the rear left wheel of the Motor Car. I did not observe any leakage of brake fluid at the time of my inspection of the Motor Car. Static tests of the Motor Car's braking system had indicated that there was no internal leakage of pressure/vacuum. The undercarriage components of the Motor Car were also all found to be intact and without any visible damage.

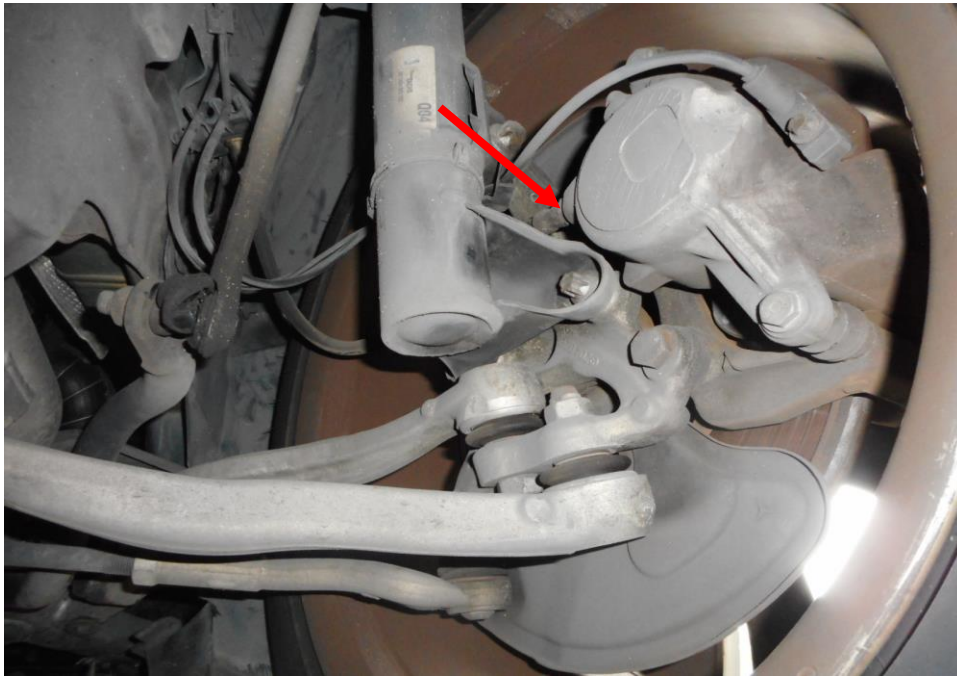
**Photo 18** shows the brake hose/pipe (arrowed) at the front right wheel of the Motor Car. I did not observe any leakage of brake fluid at the time of my inspection of the Motor Car. Static tests of the Motor Car's braking system had indicated that there was no internal leakage of pressure/vacuum. The undercarriage components of the Motor Car were also all found to be intact and without any visible damage.

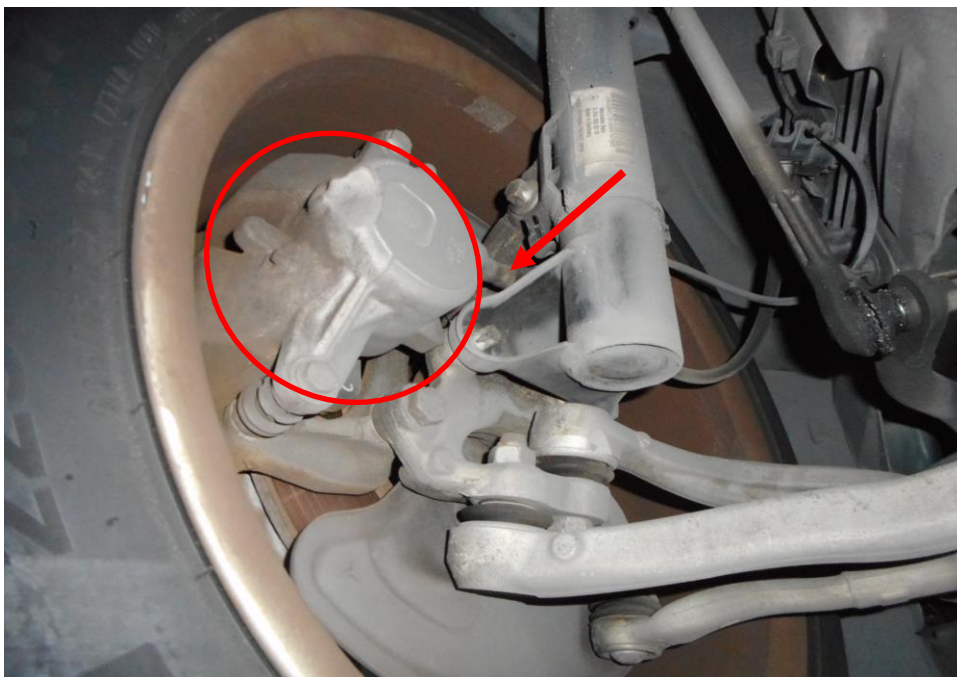
**Photo 19** shows the brake hose/pipe (arrowed) at the front left wheel of the Motor Car. No leakage of brake fluid was observed. Visual examination of the various components of the braking system like the brake caliper (circled), brake booster, brake pedal etc had revealed all to be intact and without visible damage.

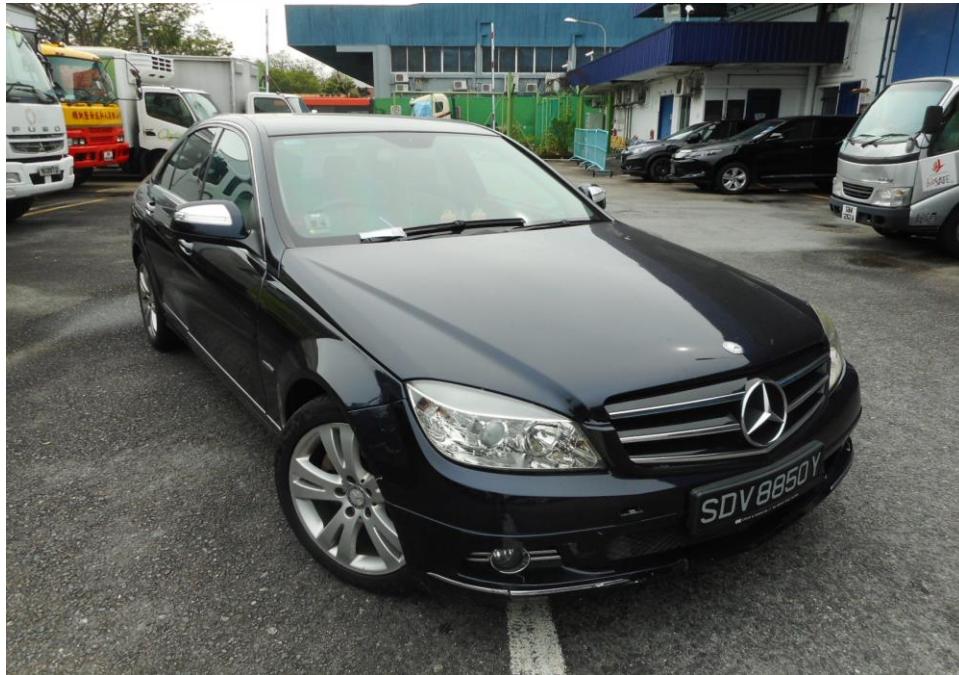
**Photo 20** shows the front right wheel of the Motor Car turned to its full left. During my steering system test, I did not experience any abnormal free play and/or resistance when I had turned the steering wheel towards the left and right. This would suggest that the steering system of the Motor Car was likely to be in serviceable condition at the material time of accident.

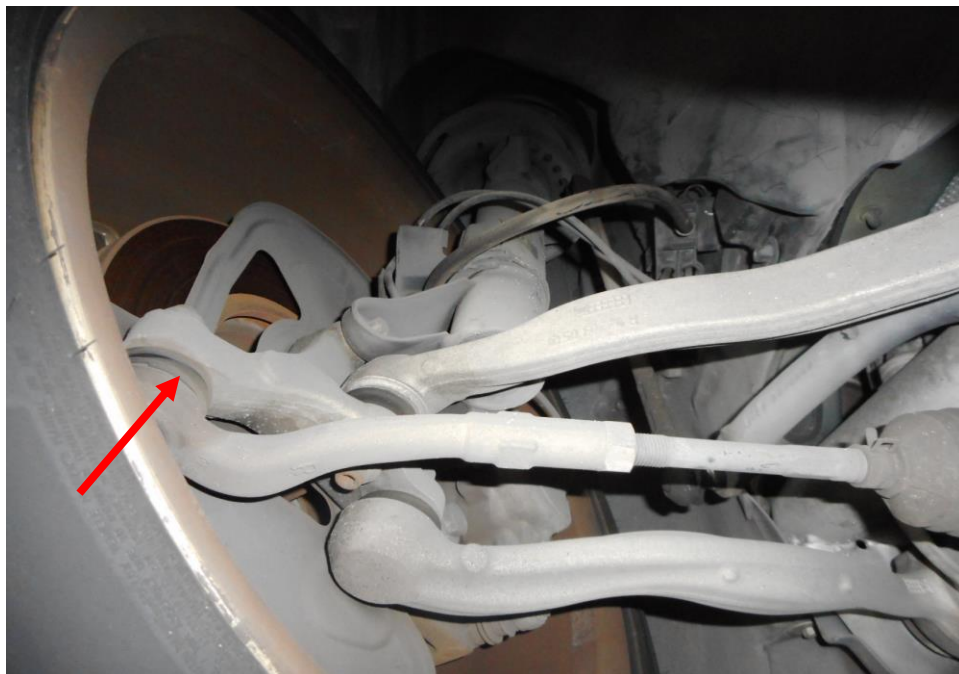
**Photo 21** shows the various undercarriage components at the front right wheel of the Motor Car, in particular the steering tie rod (red arrow). The various steering components were all found to be intact, suggesting that the steering system of the Motor Car was likely to be in serviceable condition at the material time of accident. There was also no sign of fluid stain observed on the various undercarriage components at the front right wheel of the Motor Car.

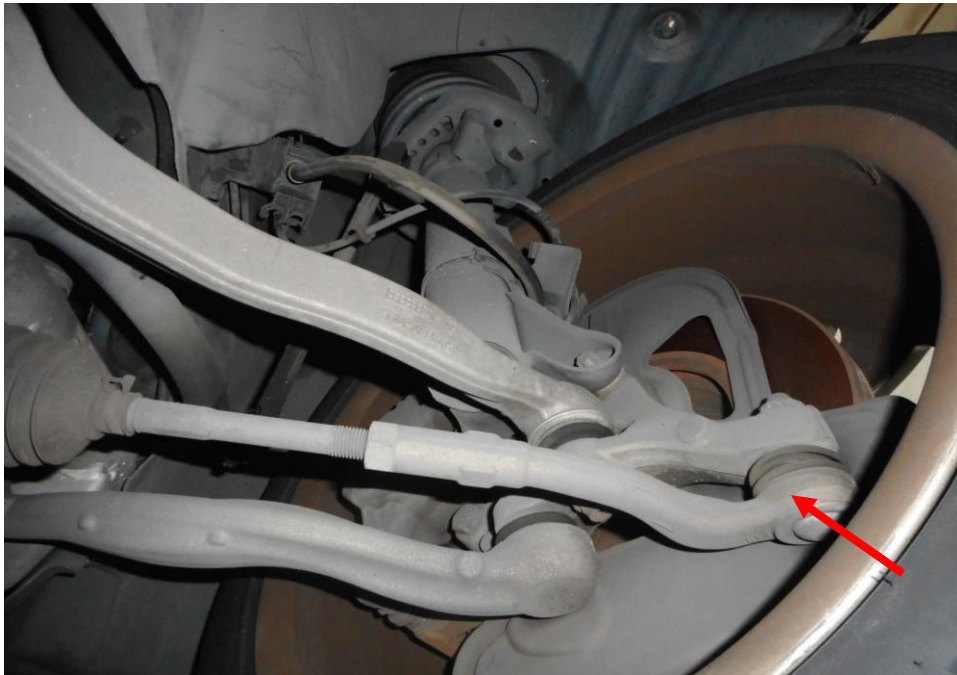
**Photo 22** shows the various undercarriage components at the front left wheel of the Motor Car, which had included the steering tie rod (red arrow). The various undercarriage components of the Motor Car were all found to be intact without any visible damage.

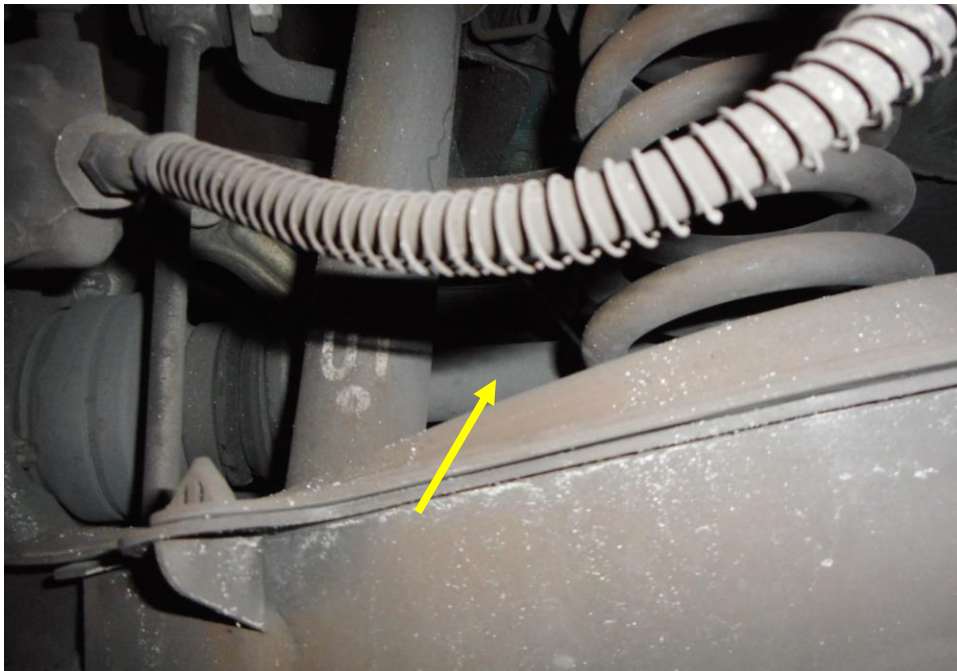
**Photo 23** shows the various undercarriage components at the rear left wheel of the Motor Car, which had included the drive shaft (yellow arrow). The various undercarriage components of the Motor Car were all found to be intact without any visible damage.

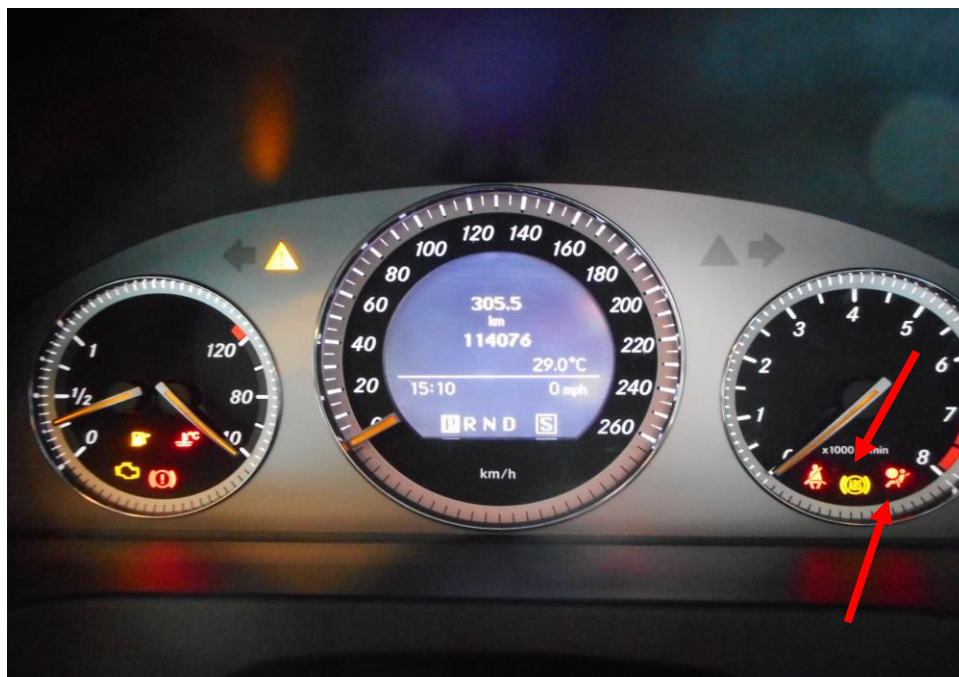
**Photo 24** shows the warning light for Anti-Lock Brake System (ABS) Supplemental Restraint System (SRS) (arrowed) appearing on the instrument panel of the Motor Car during the self-test of its various electronic operating systems when its engine was cranked.

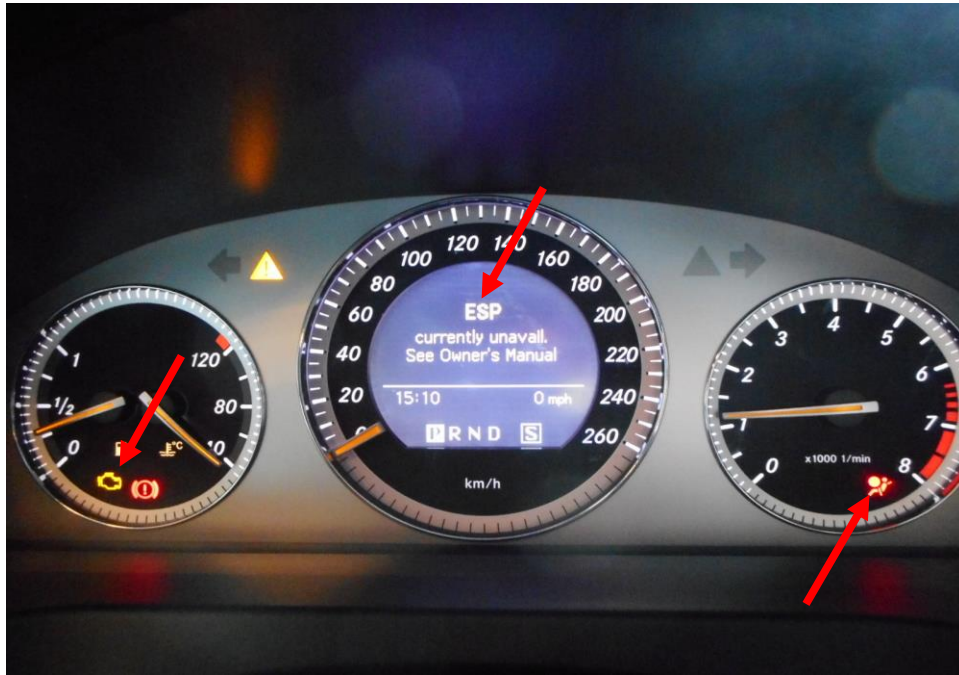
13. The Motor Car's automatic self-test of the functionality of its electronic operating systems like the Anti-Lock Brake System (ABS), during cranking of the engine had indicated that the system were in working condition and without abnormality. This can be established from the warning lights disappearing from the instrument panel after the self-test. However, the Supplemental Restraint System (SRS), Electronic Stability System (ESP) and Engine warning light remaining illuminated up, this is likely due to a result of the accident. See photo 24 & 25 below.

**Photo 25** shows the Supplemental Restraint System (SRS), Electronic Stability System (ESP) and Engine warning light remained illuminated up on the instrument panel of the Motor Car after the engine was cranked. This is likely due to the result of the accident.
