You're Ref: TP/IP/47771/2020
Our Ref: CI/TPD20012446/P

Fatal Accident Investigation Team

MECHANICAL INSPECTION REPORT OF MOTOR CAR SLZ 7003S

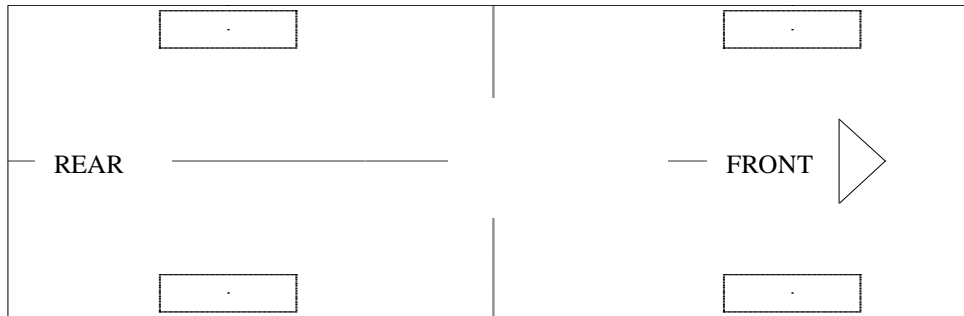
6. The condition of the Motor Car's 4 tyres was observed to be in serviceable condition. I did not find any tear, cut or burst mark(s) on the outer and the inner sidewalls as well as across the tread of the 4 tyres. The 4 tyres were also observed to be sufficiently inflated for vehicular operation. The tyre brand, tyre size and remaining tread depth of the 4 tyres were recorded as follows:-

Michelin 215/45 R17 (5.2mm)

Michelin 215/45 R17 (3.8mm)

Michelin 215/45 R17 (5.5mm)

Michelin 215/45 R17 (3.2mm)

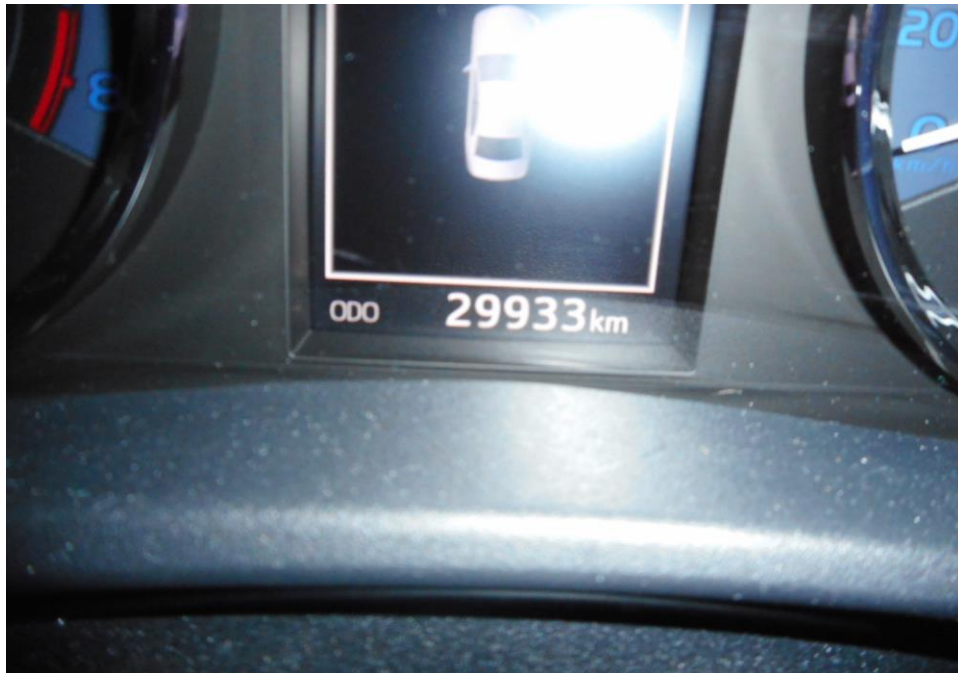
Photo 1 shows the mileage of the Motor Car at the time of my inspection. The mileage observed was 29,933km.

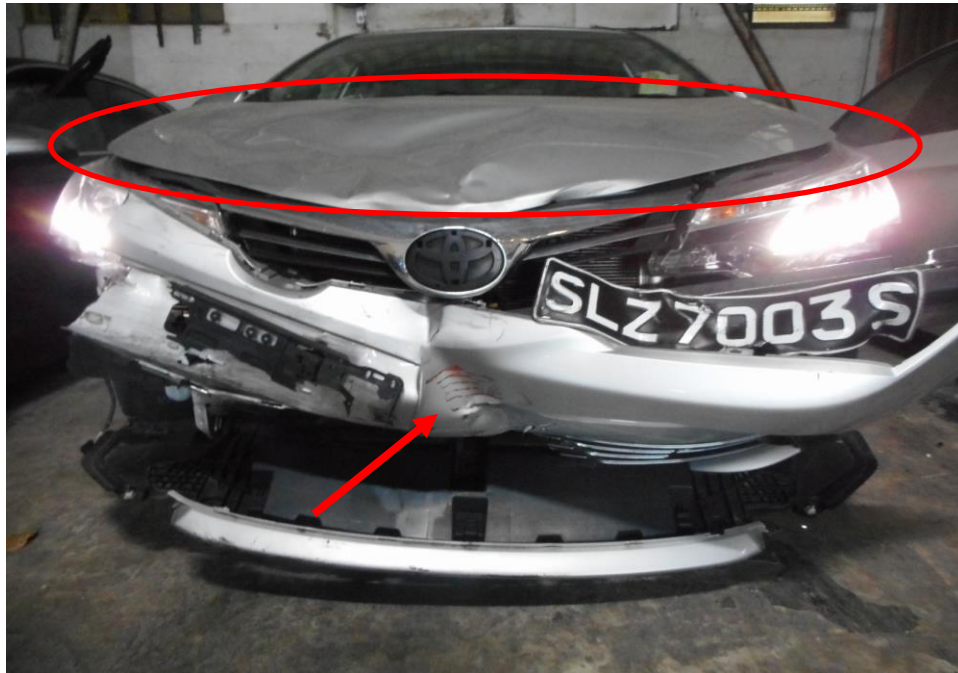
4. The mileage of the Motor Car at the time of my inspection was 29,933km.
5. The Motor Car was observed to have sustained damage at its front portion. Its front bonnet and front bumper are the body parts that were damaged as a result of the accident.

Photo 2 shows a general view of the Motor Car's front body at the time of my inspection. Its front bonnet (circled) and front bumper (arrowed) were the body parts that were damaged as a result of the accident.

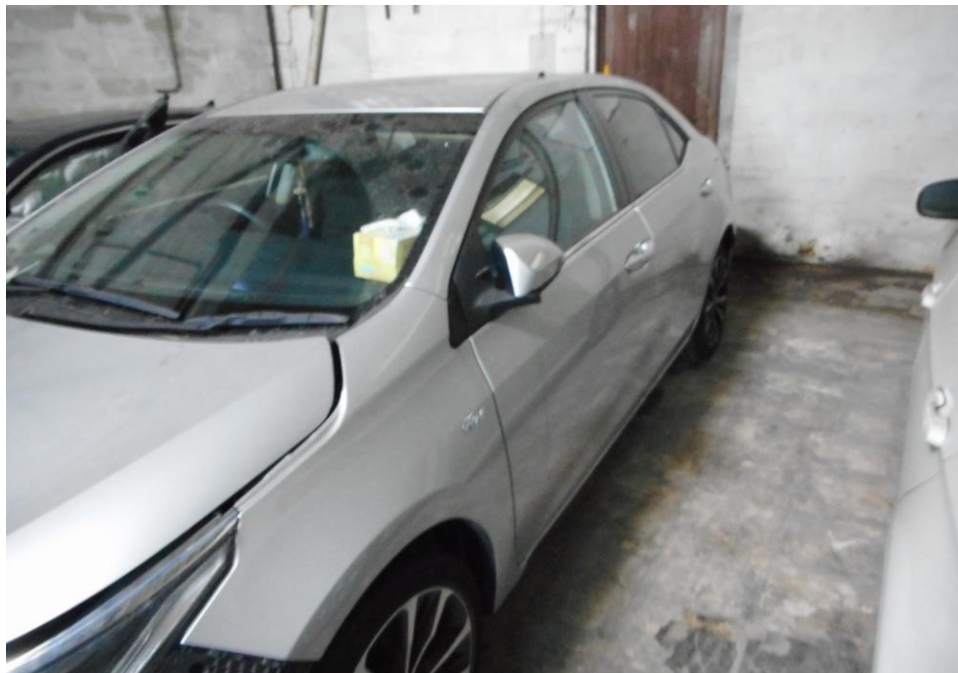
Photo 3 shows a general view of the Motor Car's right body at the time of my inspection. The right portion of the Motor Car was observed to have been unaffected by the accident.

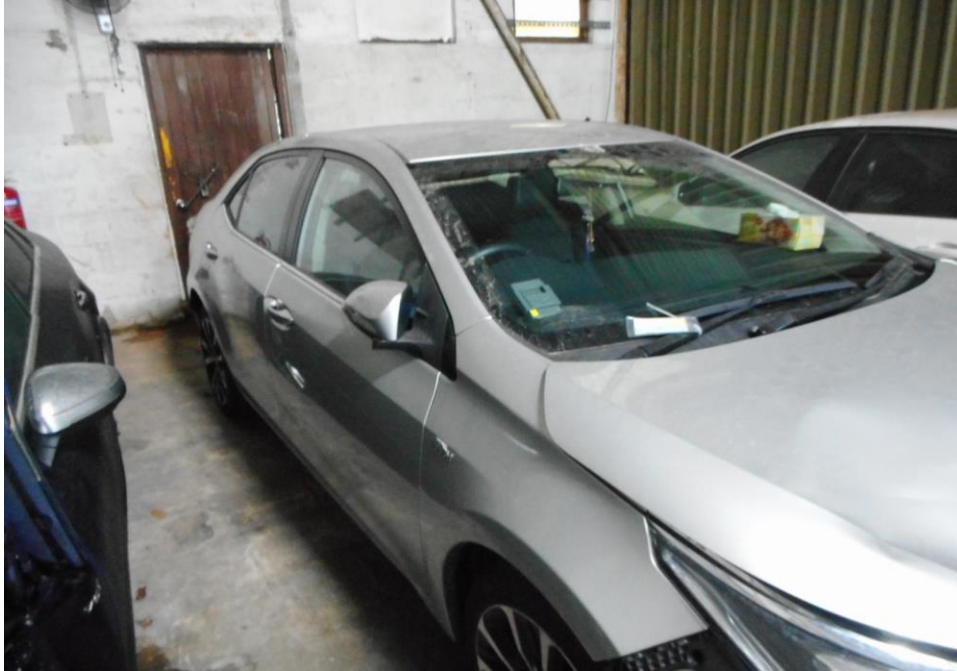
Photo 4 shows a general view of the Motor Car's left body at the time of my inspection. The left portion of the Motor Car was observed to have been unaffected by the accident.

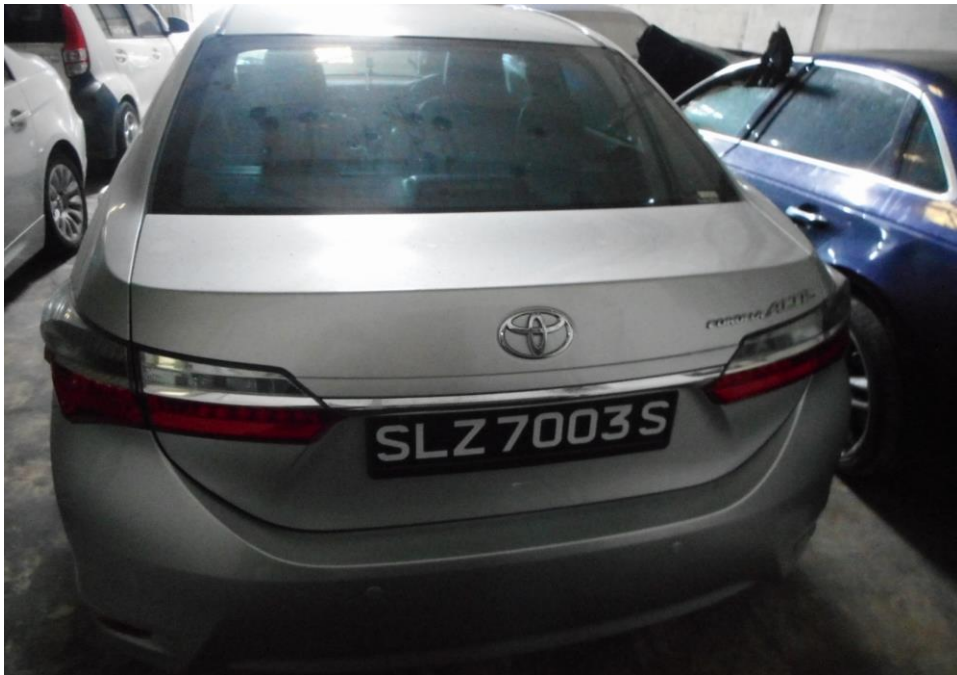
Photo 5 shows the general view of the Motor Car's rear body at the time of my inspection. The Motor Car rear was observed to be unaffected by the accident.

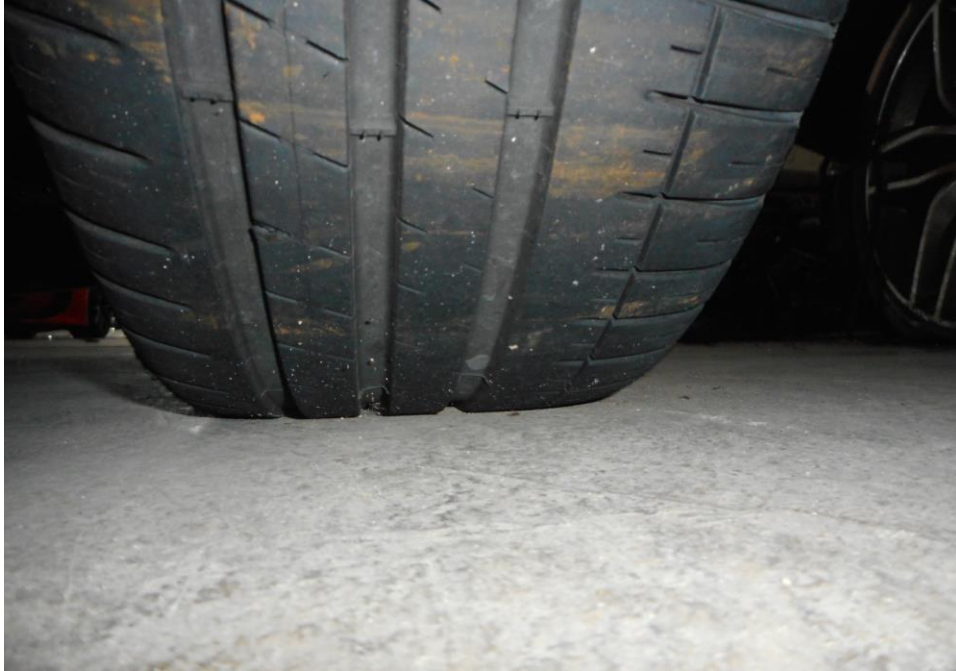
Photo 6 shows the condition of the front right tyre of the Motor Car, which was observed to be in serviceable condition with remaining tread depth of approximately 3.2mm. The tyre was sufficiently inflated for vehicular operation with no tear, cut or burst mark(s) on the outer and the inner sidewalls as well as across the tread. The 4 tyres of the Motor Car were wrapped around standard steel wheel rims without any damage.

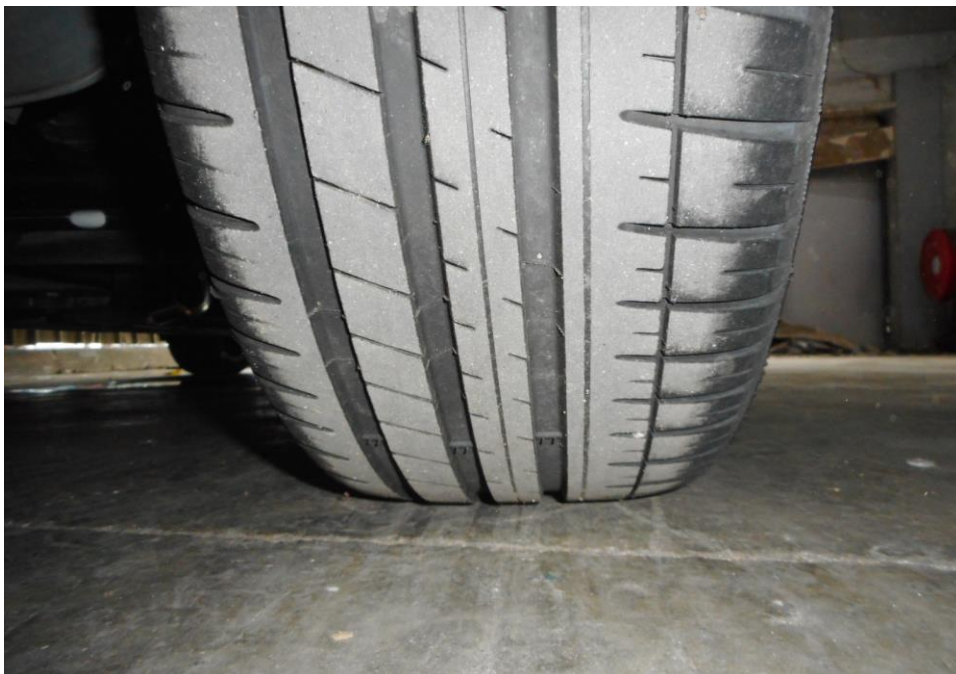
Photo 7 shows the condition of the rear right tyre of the Motor Car, which was observed to be in serviceable condition with remaining tread depth of approximately 5.5mm. The tyre was also observed to be sufficiently inflated for vehicular operation with no tear, cut or burst mark(s).

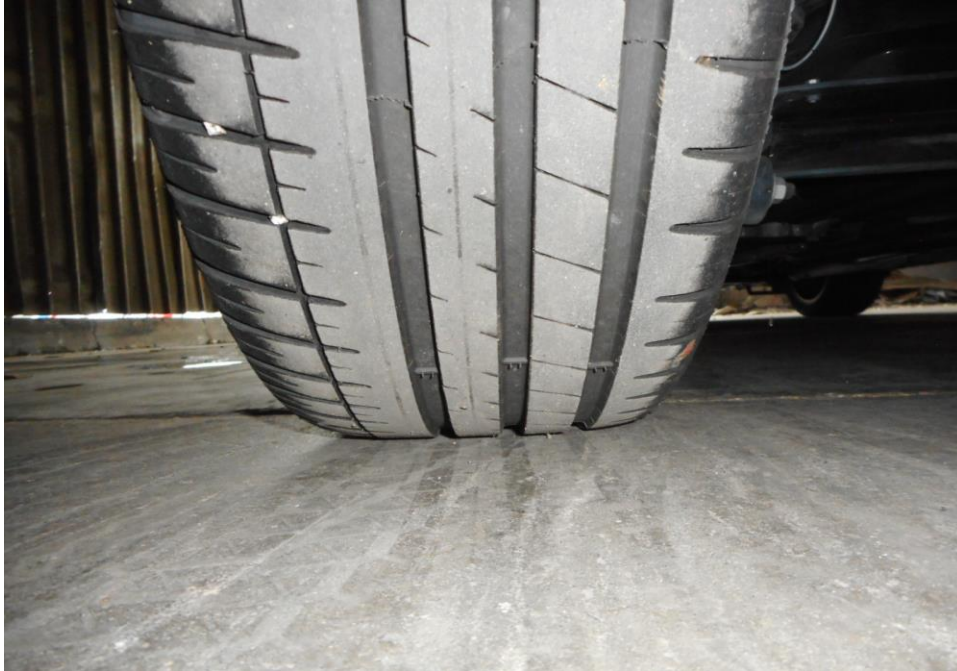
Photo 8 shows the condition of the rear left tyre of the Motor Car, which was observed to be in serviceable condition with remaining tread depth of approximately 5.2mm. The tyre, which was wrapped around alloy wheel rim, was also observed to be sufficiently inflated for vehicular operation. The 4 tyres of the Motor Car were wrapped around standard steel wheel rims.

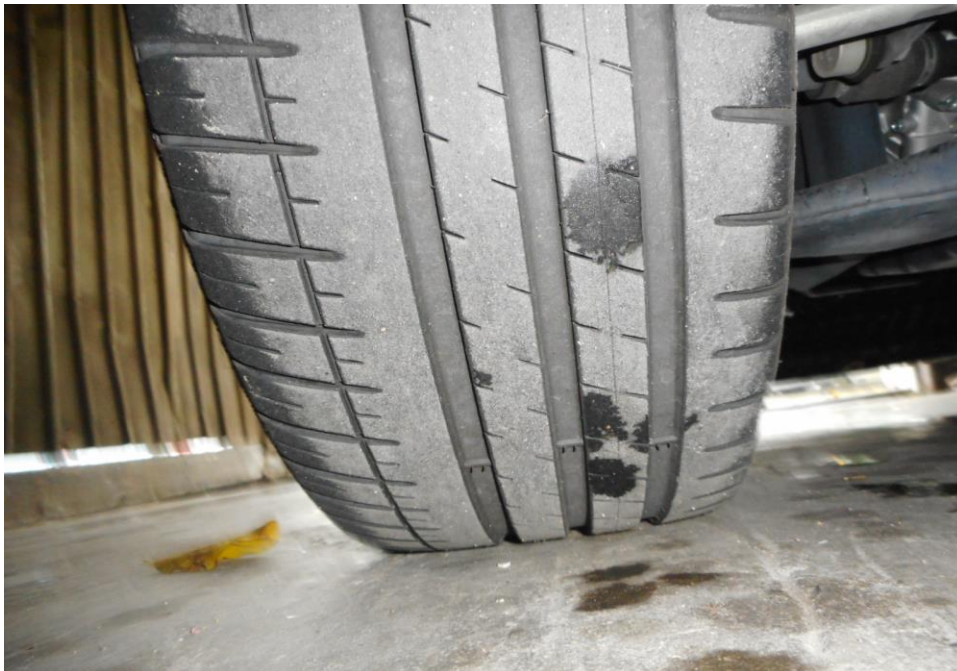
Photo 9 shows the condition of the front left tyre of the Motor Car, which was observed to be in serviceable condition with remaining tread depth of approximately 3.8mm. The tyre was sufficiently inflated for vehicular operation with no tear, cut or burst mark(s) on the outer and the inner sidewalls as well as across the tread. The 4 tyres of the Motor Car were wrapped around standard alloy wheel rims without any damage.

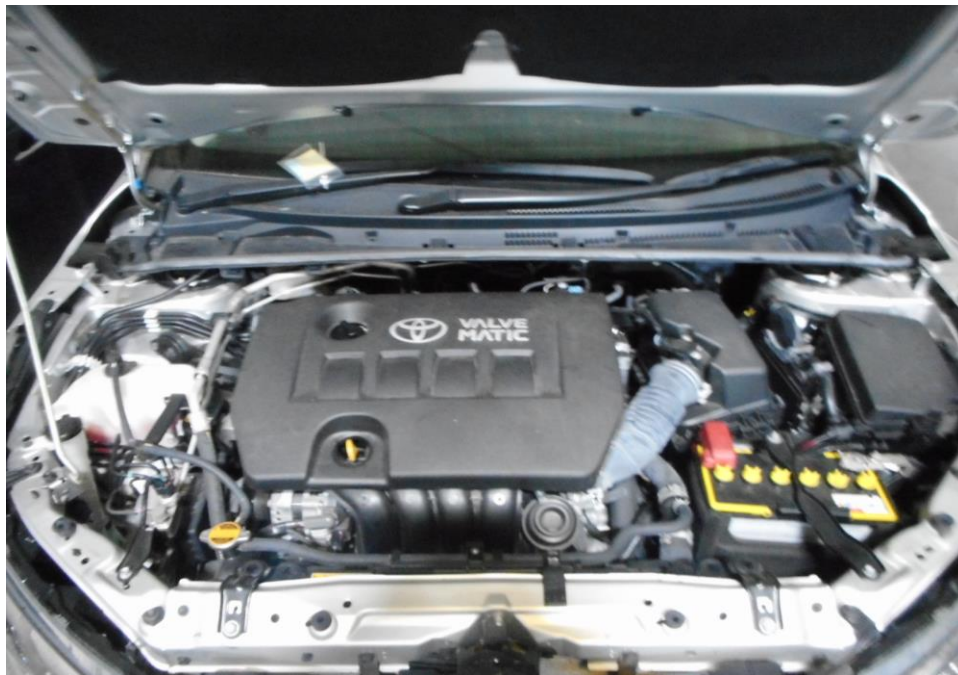
Photo 10 shows a general view of the Motor Car's engine compartment. The various parts and components inside the engine compartment were unaffected by the accident. There was also no sign(s) or indication(s) of fluid leakage and/or fluid stain within the engine compartment.

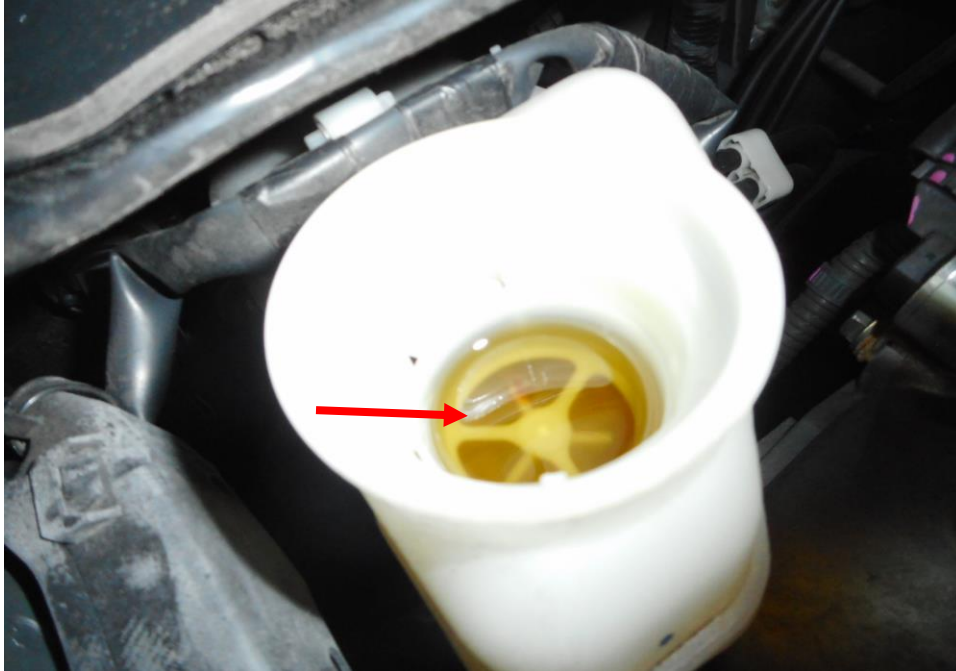
Photo 11 shows the brake fluid reservoir of the Motor Car at the time of my inspection. The brake fluid was observed to be of sufficient level (arrowed) and without any visible contamination.

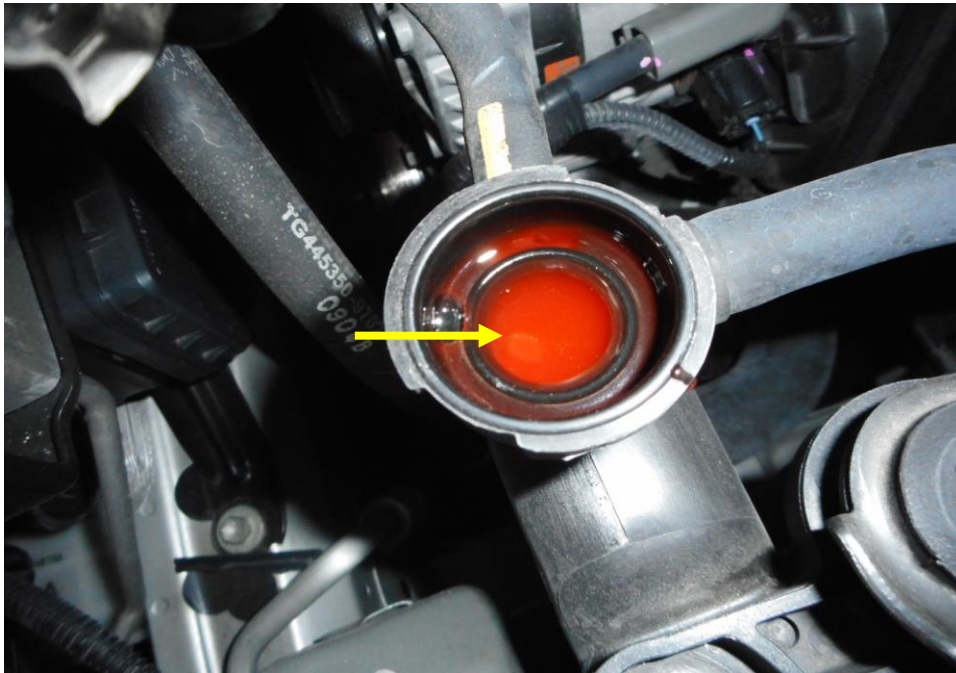
Photo 12 shows checks being carried out to the engine coolant of the Motor Car at the time of my inspection. The engine coolant was observed to be of sufficient level (arrowed) and without any visible contamination.

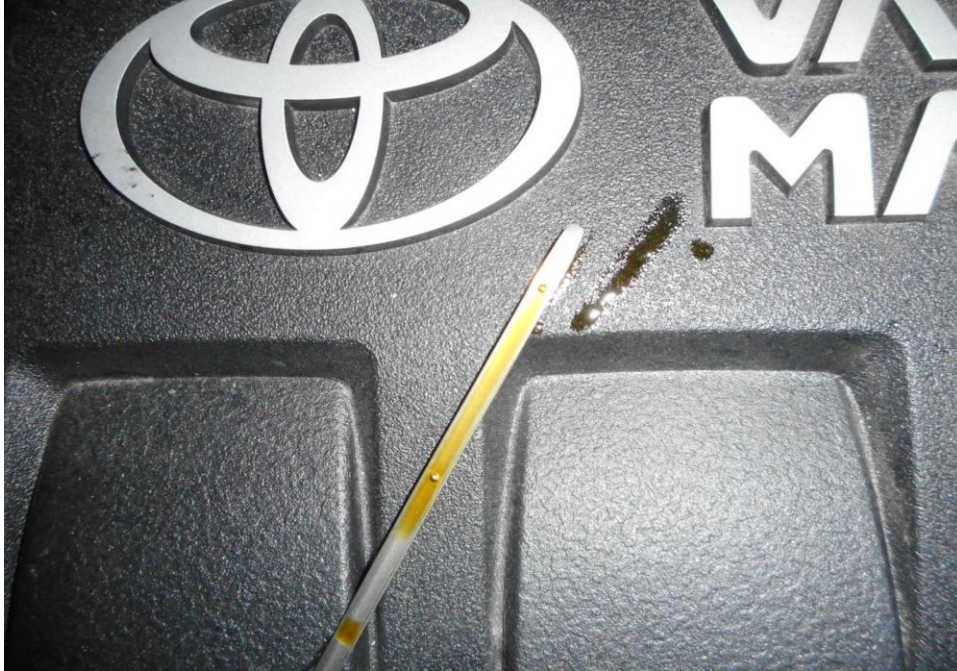
Photo 13 shows the engine oil dip stick of the Motor Car at the time of my inspection. The engine oil was observed to be of sufficient level and without any visible contamination.

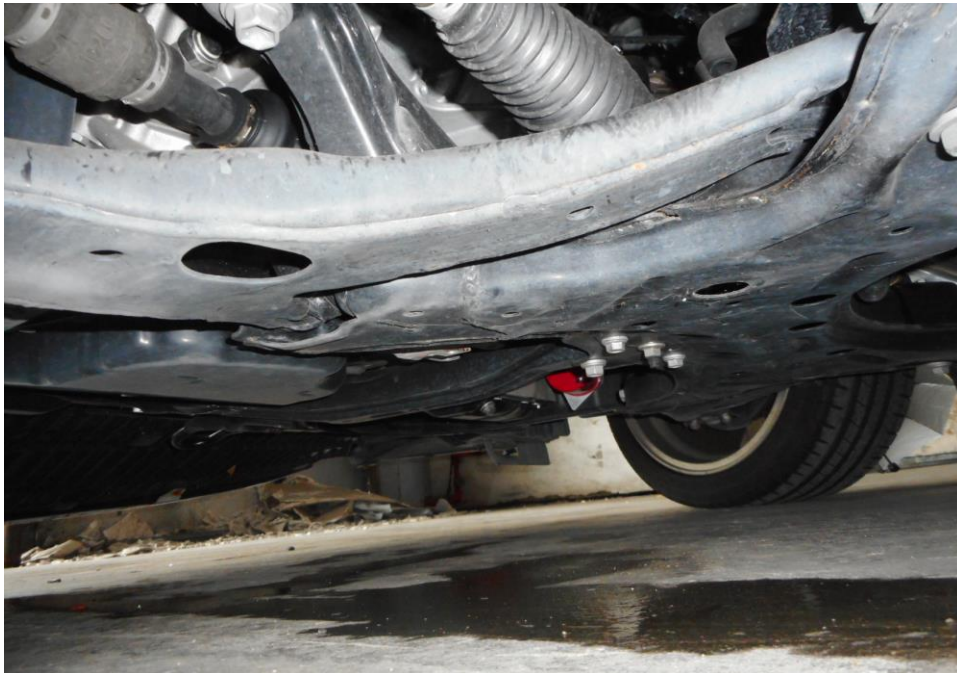
Photo 14 shows the undercarriage of the Motor Car, at the area where the engine housing and transmission housing are located. I did not find any sign(s) or indication(s) of fluid leak and/or fluid stain(s) on the underside of the Motor Car.

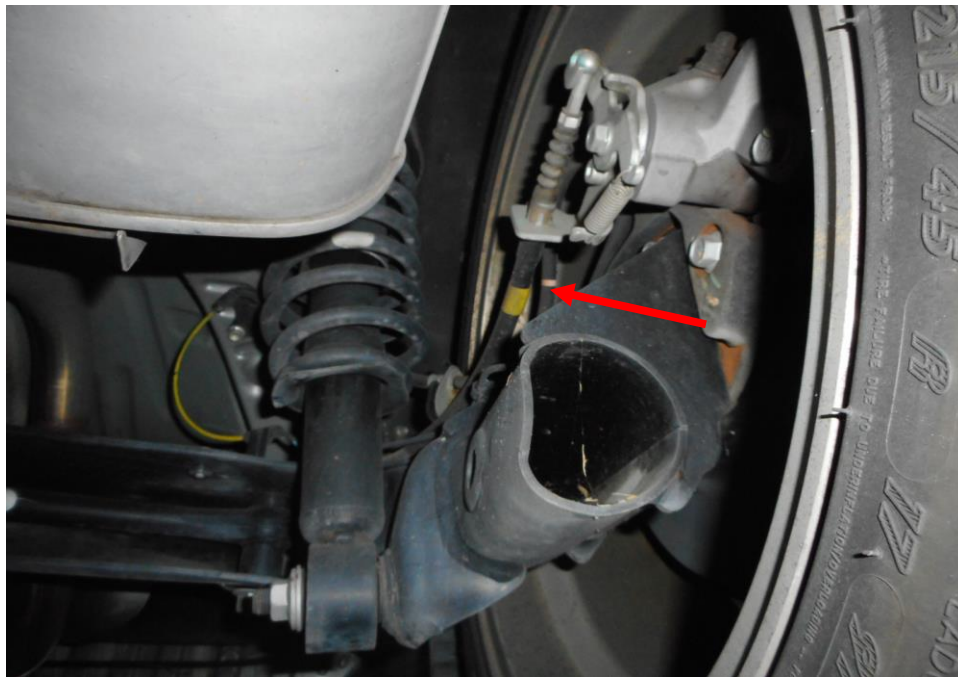
Photo 15 shows the brake hose/pipe (arrowed) at the rear right wheel of the Motor Car. No leakage of brake fluid was observed. Visual examination of the various components of the braking system like the brake caplier, brake booster, brake pedal etc. had revealed all to be intact and without visible damage.

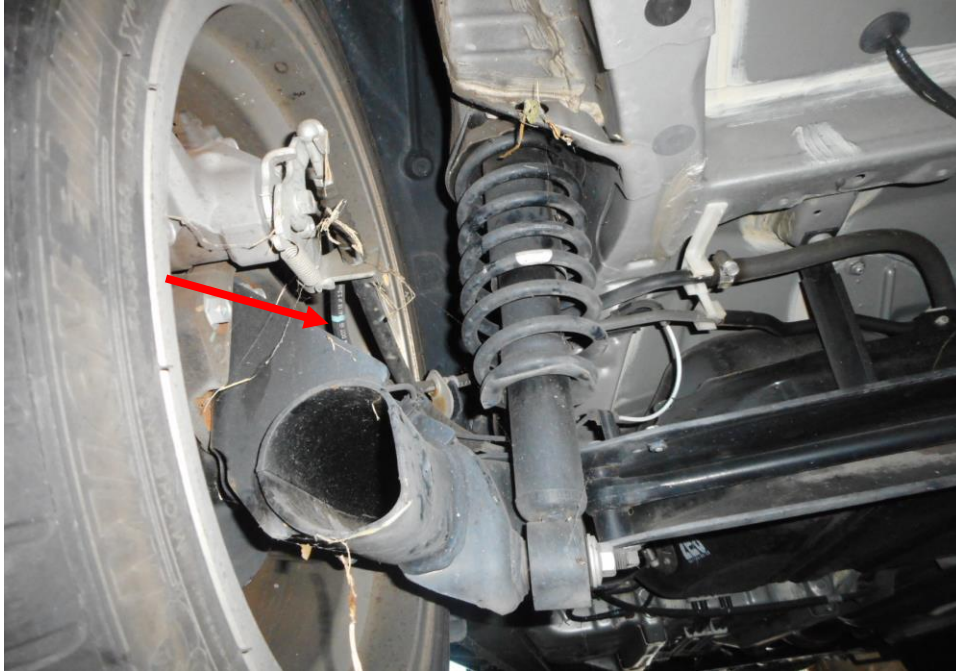
Photo 16 shows the brake hose/pipe (arrowed) at the rear left wheel of the Motor Car. I did not observe any leakage of brake fluid at the time of my inspection of the Motor Car. Static tests of the Motor Car's braking system had indicated that there was no internal leakage of pressure/vacuum. The undercarriage components of the Motor Car were also all found to be intact and without any visible damage.

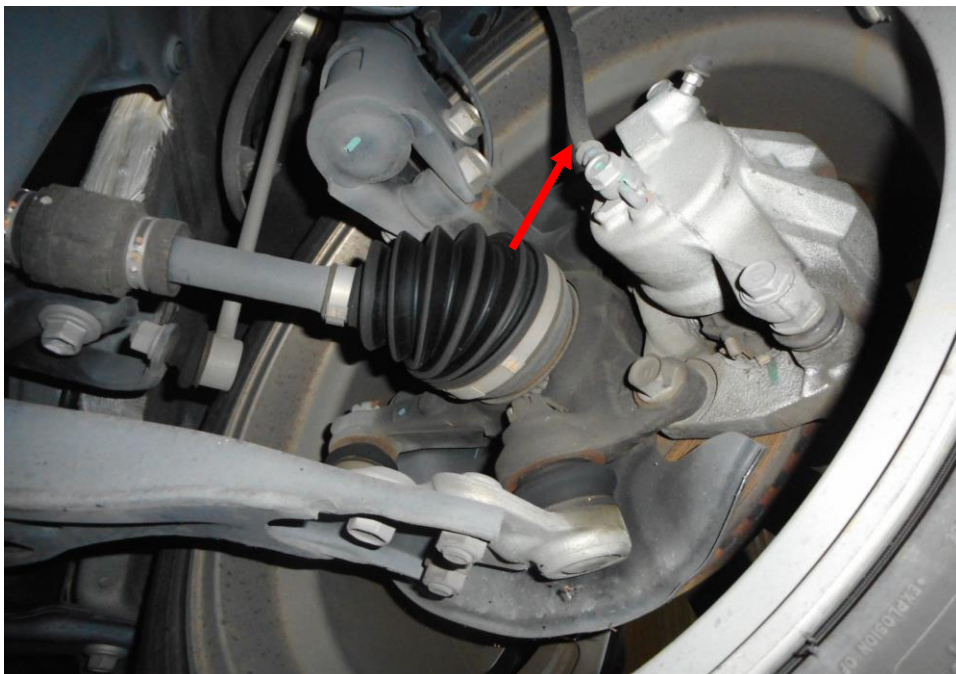
Photo 17 shows the brake hose/pipe (arrowed) at the front right wheel of the Motor Car. I did not observe any leakage of brake fluid at the time of my inspection of the Motor Car. Static tests of the Motor Car's braking system had indicated that there was no internal leakage of pressure/vacuum. The undercarriage components of the Motor Car were also all found to be intact and without any visible damage.

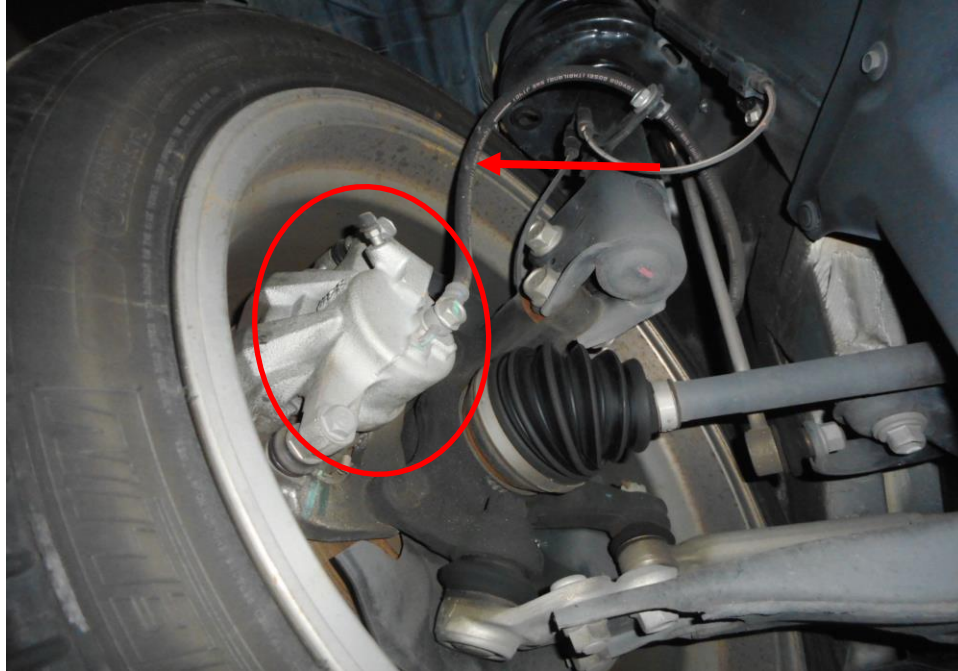
Photo 18 shows the brake hose/pipe (arrowed) at the front left wheel of the Motor Car. No leakage of brake fluid was observed. Visual examination of the various components of the braking system like the brake caliper (circled), brake booster, brake pedal etc had revealed all to be intact and without visible damage.

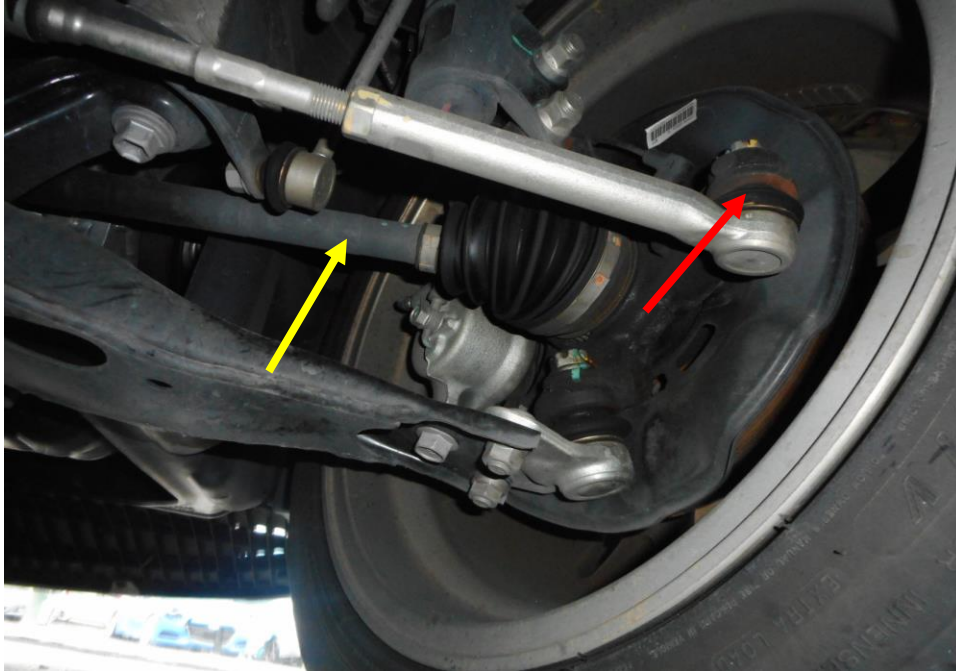
Photo 20 shows the various undercarriage components at the front right wheel of the Motor Car, in particular the steering tie rod (red arrow) and drive shaft (yellow arrow). The various steering components were all found to be intact, suggesting that the steering system of the Motor Car was likely to be in serviceable condition at the material time of accident. There was also no sign of fluid stain observed on the various undercarriage components at the front right wheel of the Motor Car.

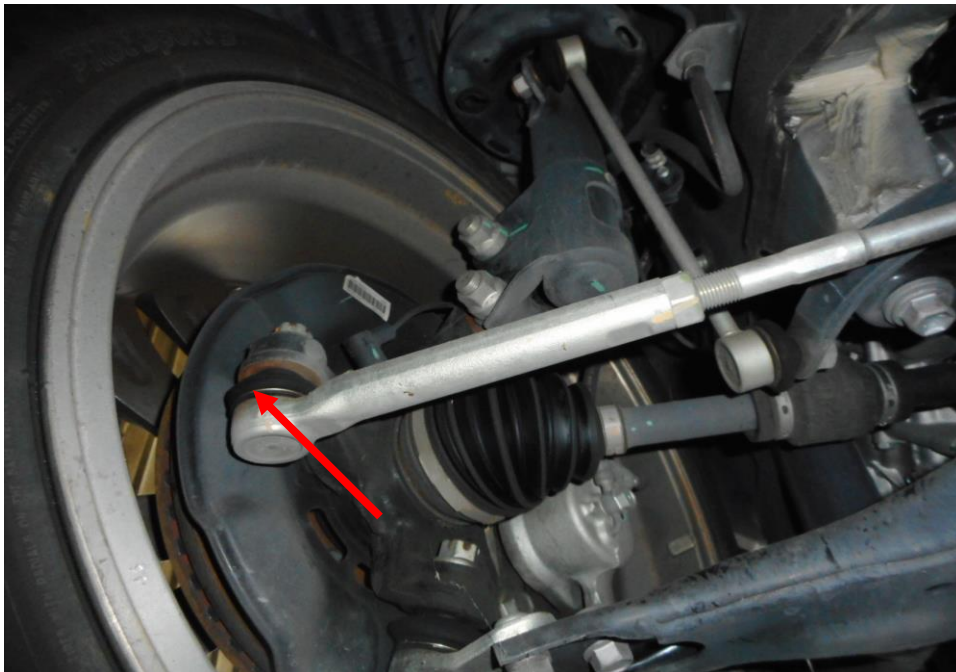
Photo 21 shows the various undercarriage components at the front left wheel of the Motor Car, which had included the steering tie rod (red arrow). The various undercarriage components of the Motor Car were all found to be intact without any visible damage.

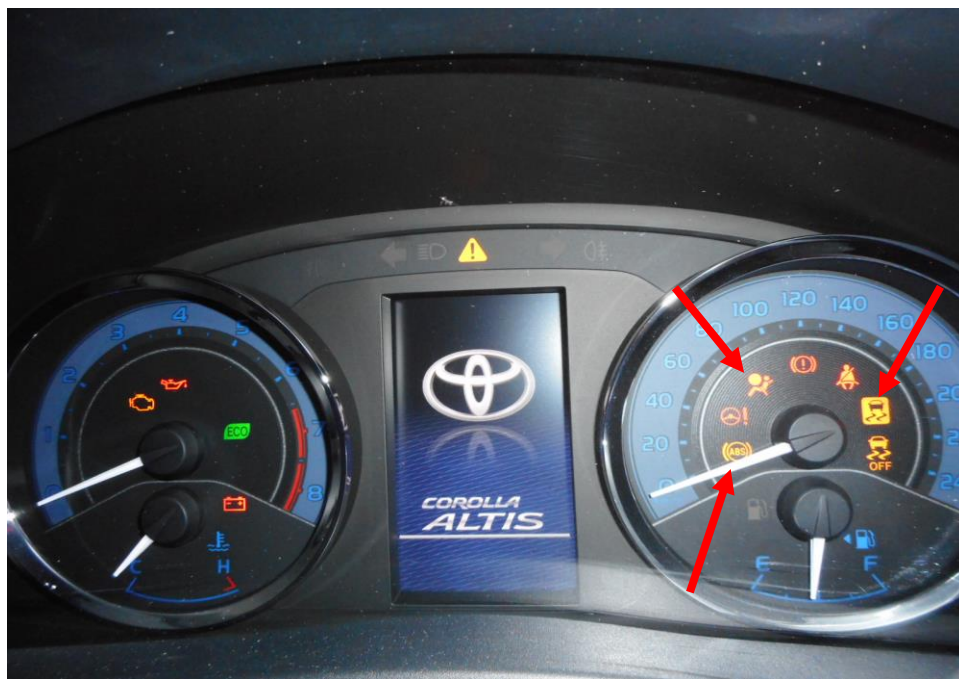
Photo 22 shows the warning light for Anti-Lock Brake System (ABS), Traction Control System (TCS) and Supplemental Restraint System (SRS) (arrowed) appearing on the instrument panel of the Motor Car during the self-test of its various electronic operating systems when its engine was cranked.

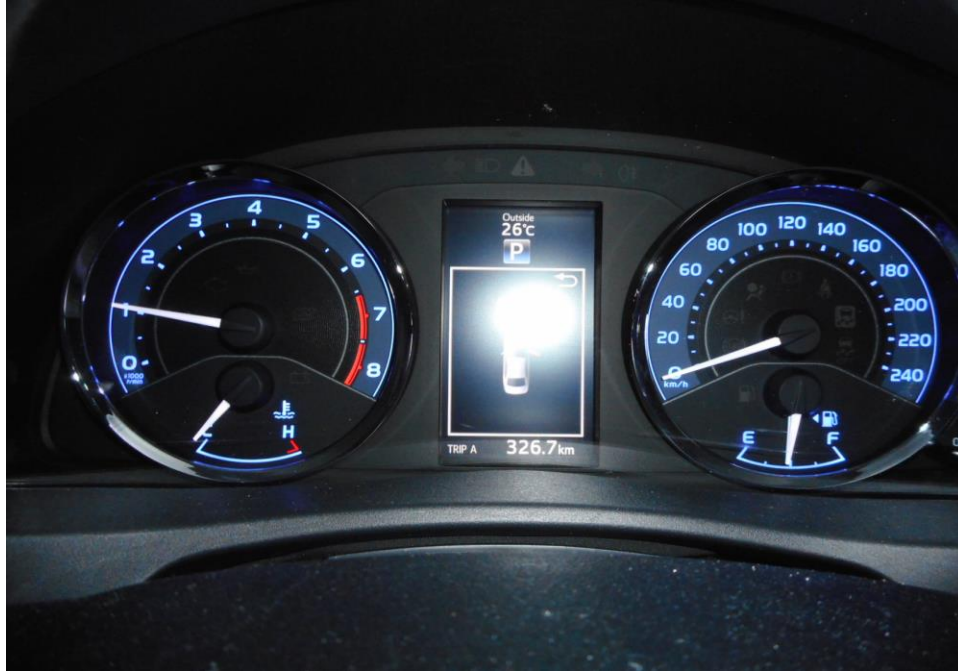
Photo 23 shows no warning lights illuminated on the instrument panel of the Motor Car after the engine was cranked. This would suggest that there was no abnormality to the various electronic operating systems of the Motor Car, like the ABS, SRS and TCS.
