Your Ref: TP/IP/41847/2020  
Our Ref : CI/TPD20012448/P

**General Investigation Team**

**MECHANICAL INSPECTION REPORT OF MOTOR TRAILER MCL 8869 and  
REAR TRAILER T/JJ2214 (CHASSIS)**

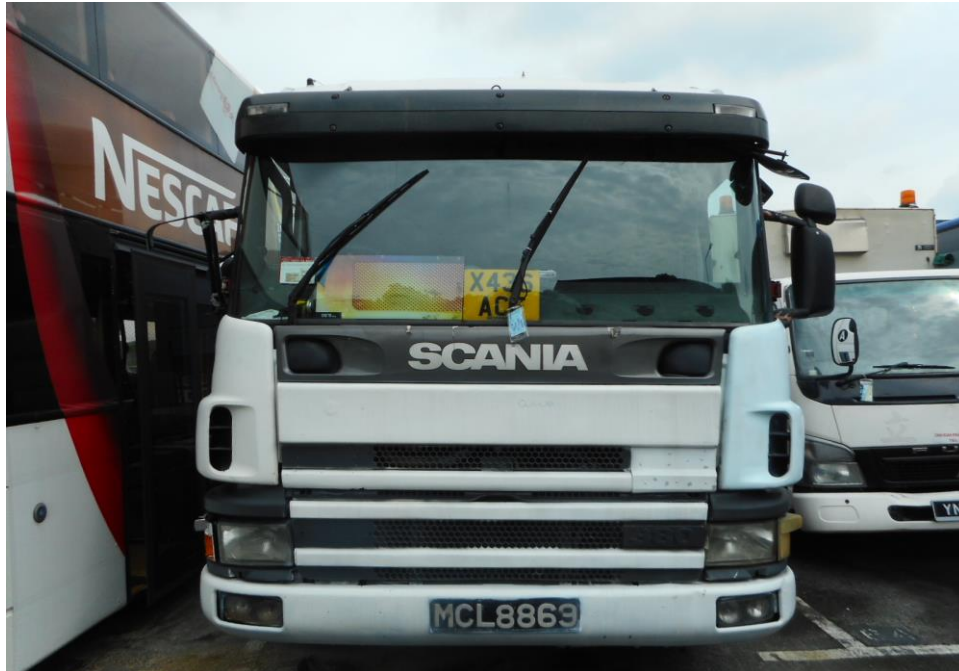
**Photo 1** shows a general view of the front body of the Motor Trailer at the time of my inspection. The Motor Trailer was observed to sustain damage at its right and middle portion. The Motor Trailer's right door, middle chassis, fifth wheel unit and its rear trailer right body panel was damaged as a result of the accident.

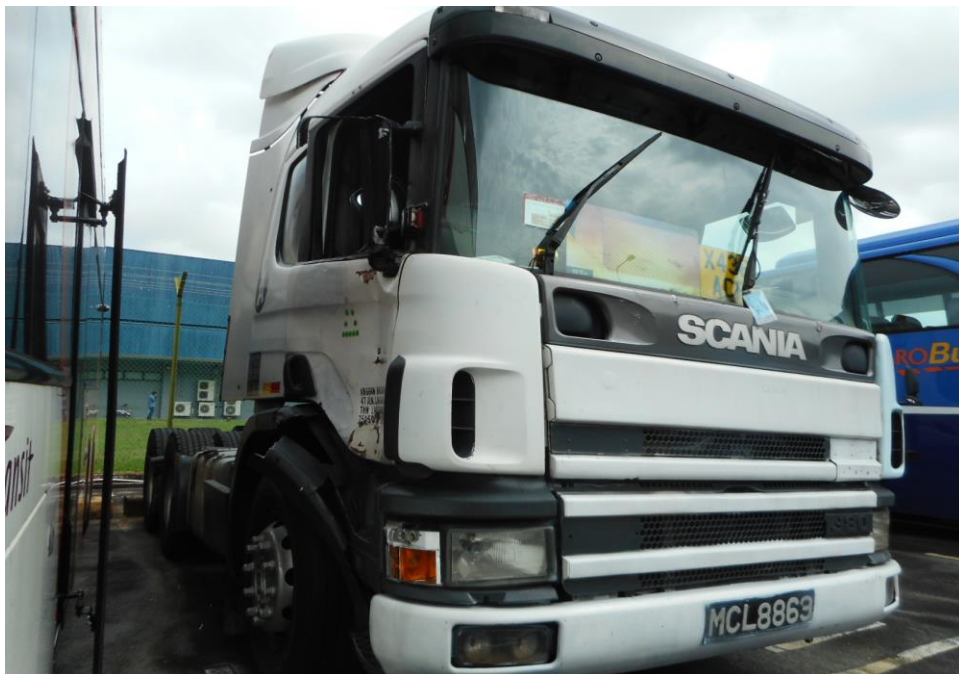
**Photo 2** shows a general view of the right body of the Motor Trailer at the time of my inspection. The Motor Trailer was observed to sustain damage at its right door as a result of the accident.

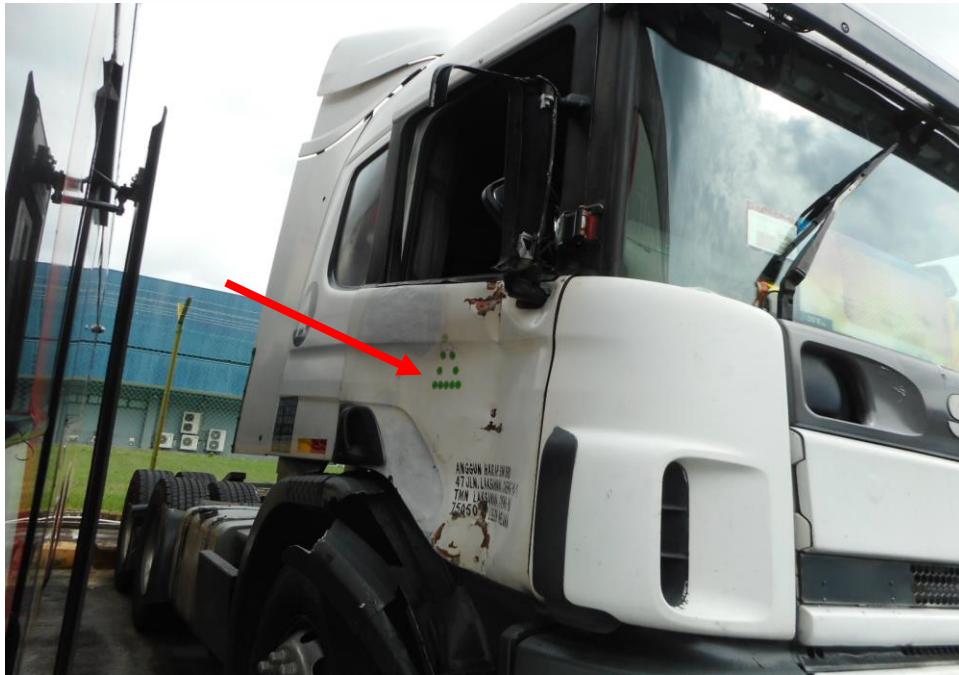
**Photo 3** shows a close up view of the right body of the Motor Trailer at the time of my inspection. The Motor Trailer was observed to sustain damage at its right door (arrowed) as a result of the accident.

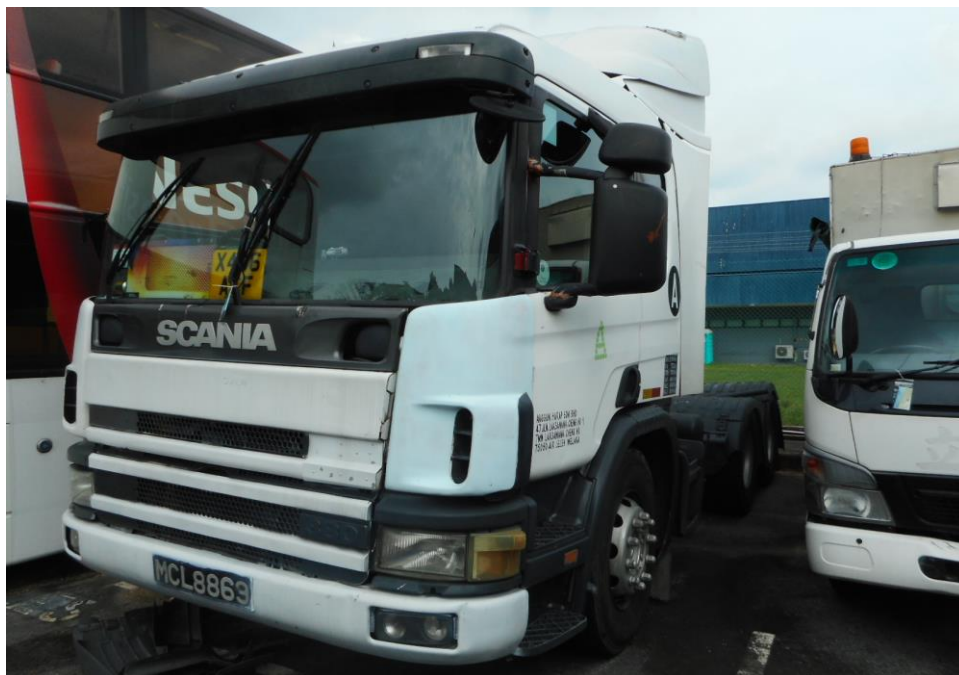
**Photo 4** shows a general view of the left body of the Motor Trailer at the time of my inspection. The Motor Trailer left body was observed to be intact and unaffected by the accident.

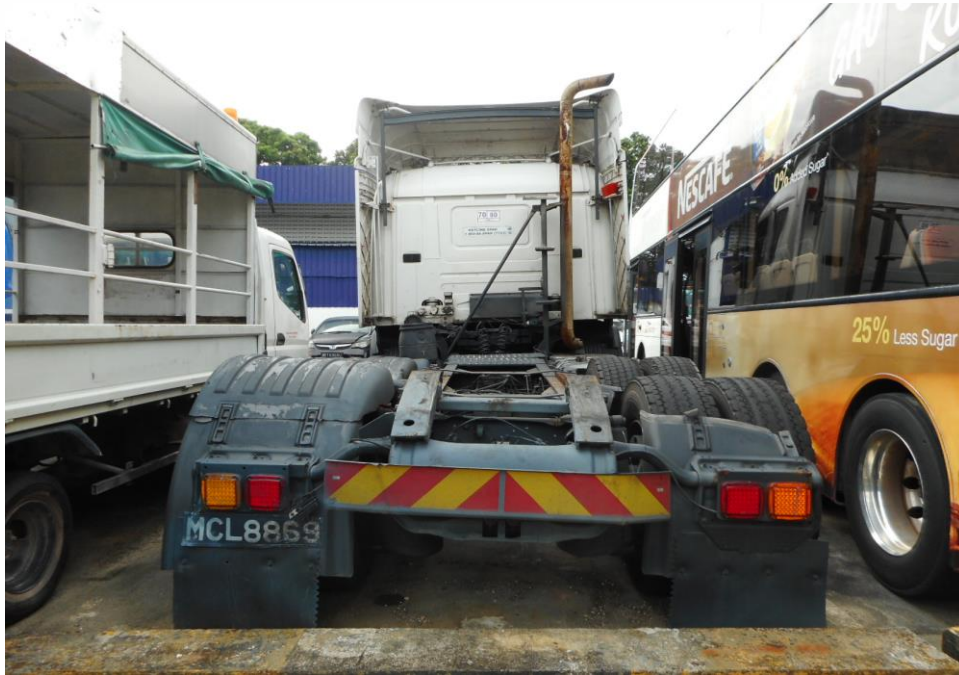
**Photo 5** shows a general view of the Motor Trailer's middle chassis portion at the time of my inspection. The Motor Trailer middle chassis was bent and had slanted to the right side and its middle fifth wheel unit was observed to be missing from the middle chassis as a result of the accident.

22. We are in view that the likely cause of the accident was due to the weight transfer of the loaded rear chassis towards right side of the Motor Trailer when it is negotiating a left bend. The weight transfer had caused the middle chassis of the Motor Trailer to bend and give way, resulting in the detachment of the base mounting plate, its fifth wheel unit and the rear Trailer causing it to topple over to the right side.

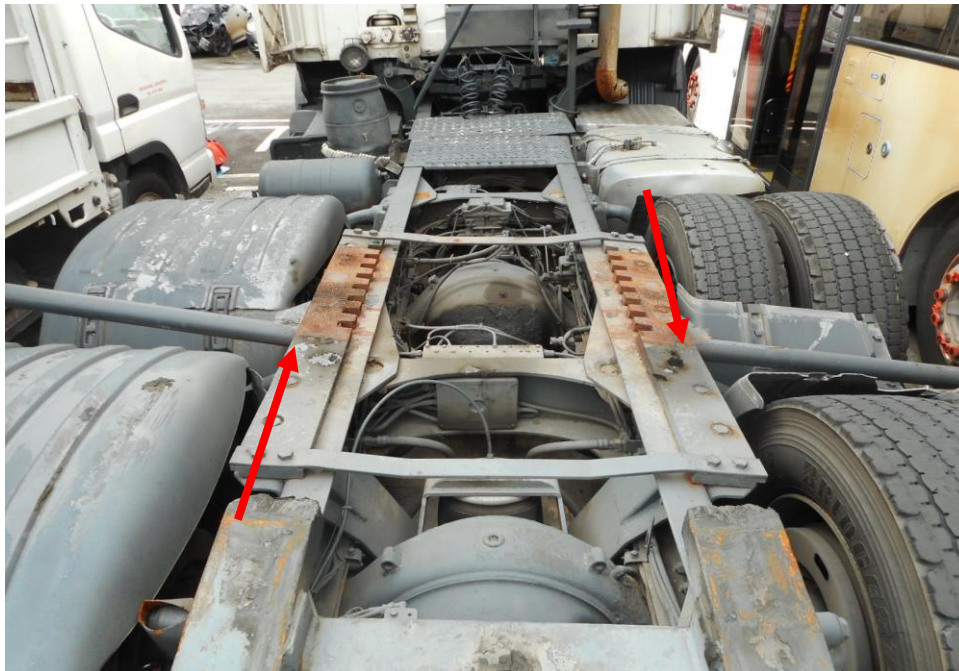
**Photo 6** shows a close up view of the Motor Trailer's middle portion at the time of my inspection. The Motor Trailer middle chassis was bent and had slanted to the right side (arrowed); its fifth wheel unit was also observed to be missing as a result of the accident.

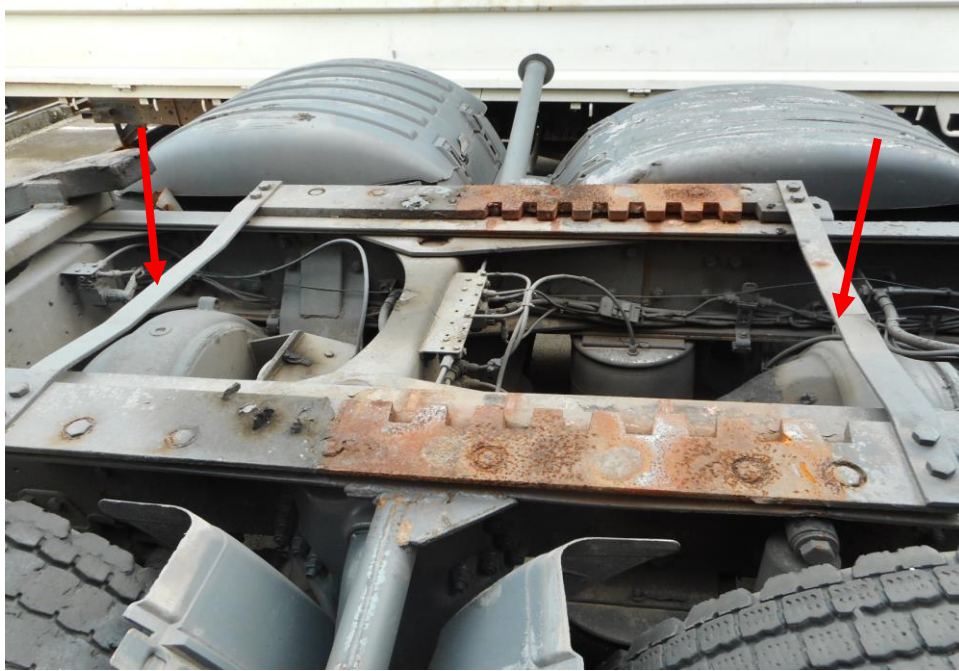
**Photo 7** shows a close up view of the Motor Trailer's middle portion at the time of my inspection. The support bars for mounting plate for the middle fifth wheel unit was observed to be bent as a result of the accident.

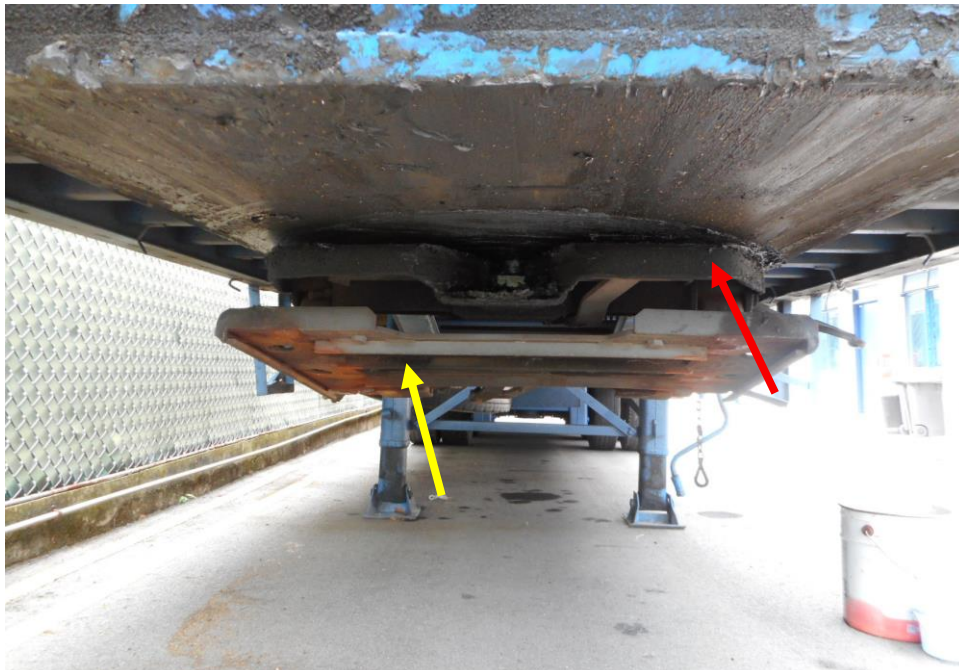
**Photo 8** shows a general view of the rear Trailer undercarriage at the time of my inspection. We observed that the fifth wheel unit (red arrow) and the base plate (yellow arrow) that was supposedly mounted on the Motor Trailer had detached and stayed on the rear Trailer after the accident.

20. From our visual inspection of the Motor Trailer, we did not observe any broken marks on the fifth wheel unit as well as on its base mounting plate and its middle chassis.

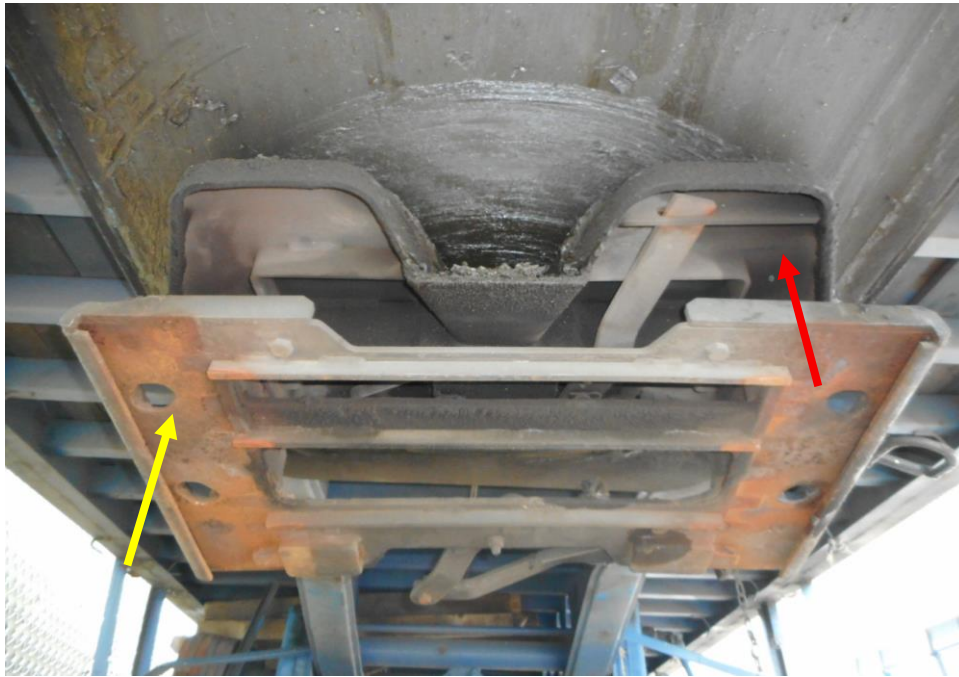
**Photo 9** shows a general view of the rear Trailer undercarriage at the time of my inspection. We observed that the fifth wheel unit (red arrow) and the base plate (yellow arrow) that was supposedly mounted on the Motor Trailer had detached and stayed on the rear Trailer after the accident.

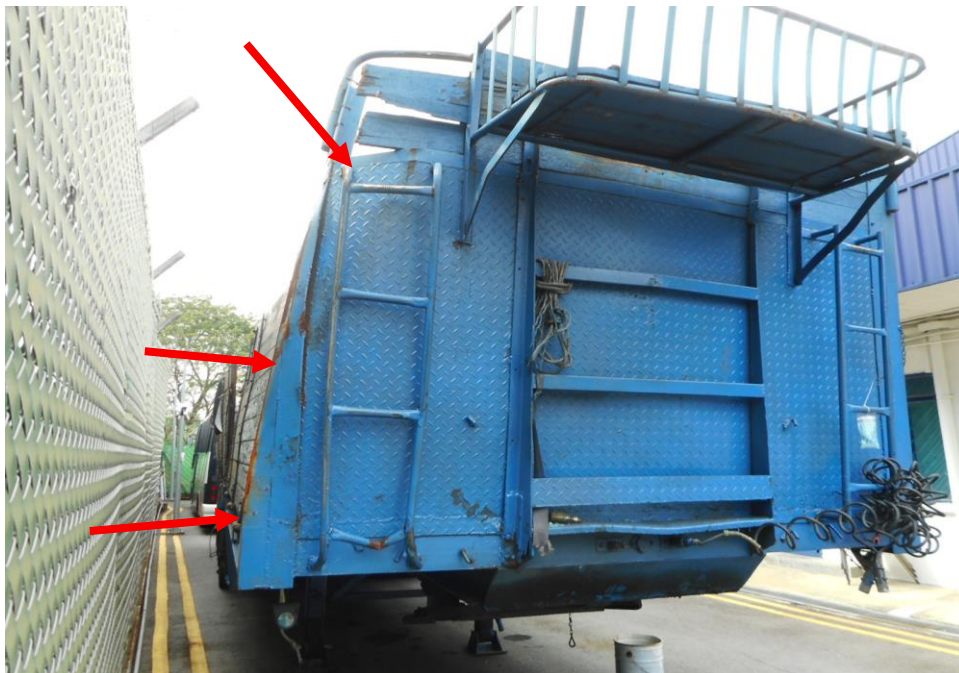
**Photo 10** shows a general view of the rear trailer's right body at the time of my inspection. The Motor Trailer's right body panel was observed to sustained damage as a result of the accident.

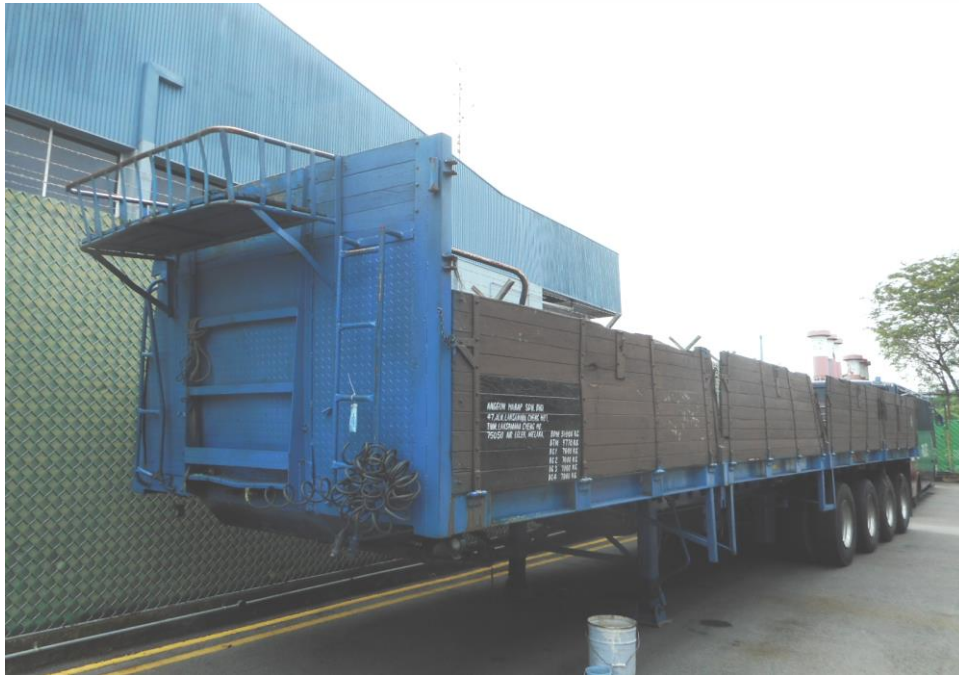
**Photo 11** shows a general view of the trailer's left body at the time of my inspection. The Motor Trailer's left body was observed to be intact and unaffected by the accident.

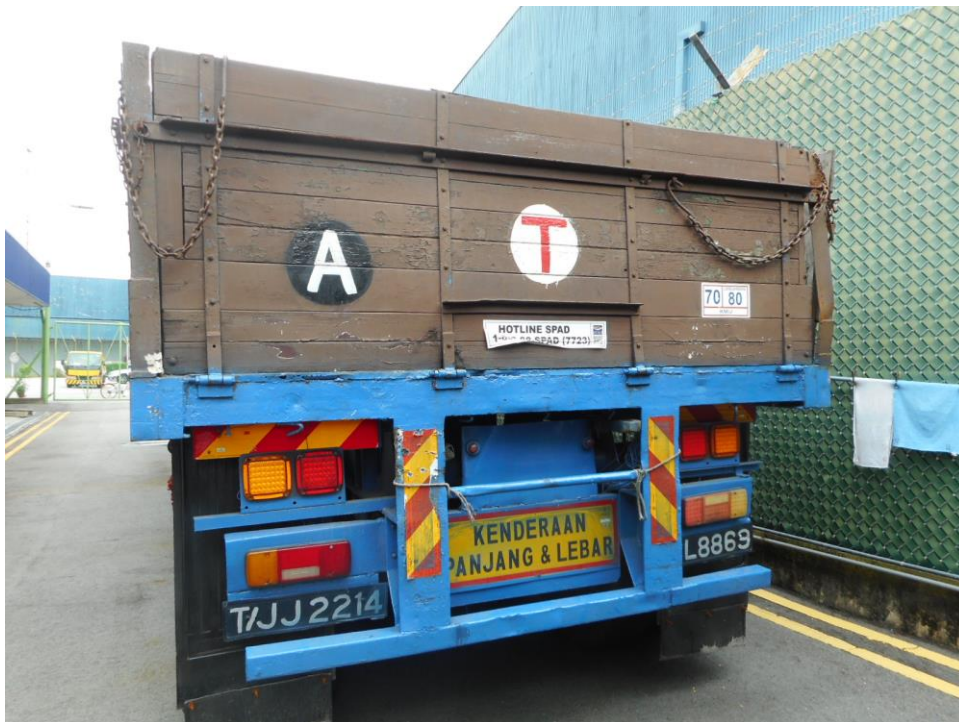
**Photo 12** shows a general view of the rear body of the trailer at the time of my inspection. The Motor Trailer's rear body was observed to be intact and unaffected by the accident.

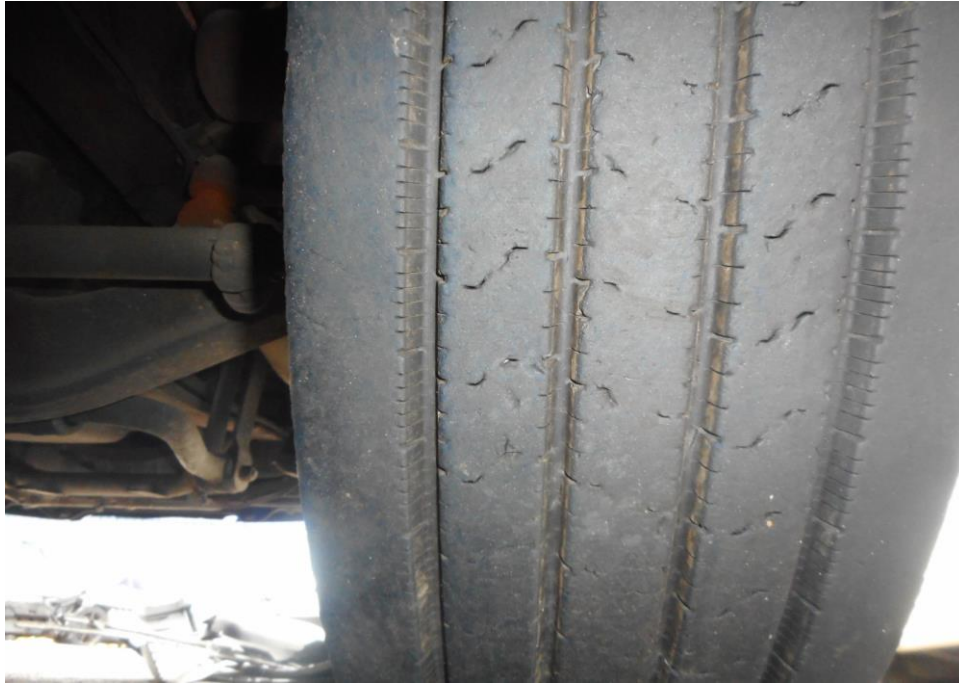
**Photo 13** shows the condition of the front right tyre of the Motor Trailer, which was observed to be in serviceable condition with remaining tread depth of approximately 8.9 mm. The tyre, which was wrapped around standard steel wheel rim, was also observed to be sufficiently inflated for vehicular operation. There was no tear, cut or burst mark(s) on the outer and the inner sidewalls as well as across the tread of the 10 tyres that were fitted on the Motor Trailer.

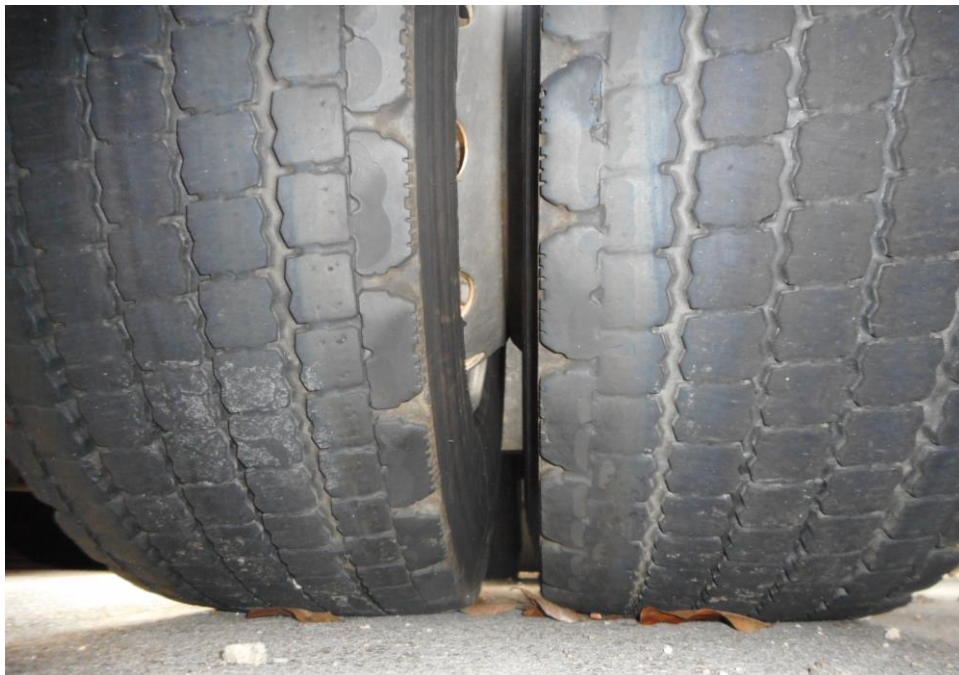
**Photo 14** shows the condition of the rear right tyre of the Motor Trailer, which was observed to be in serviceable condition with remaining tread depth of approximately 7.4mm. The tyre, which was wrapped around standard steel wheel rim, was also observed to be sufficiently inflated for vehicular operation.

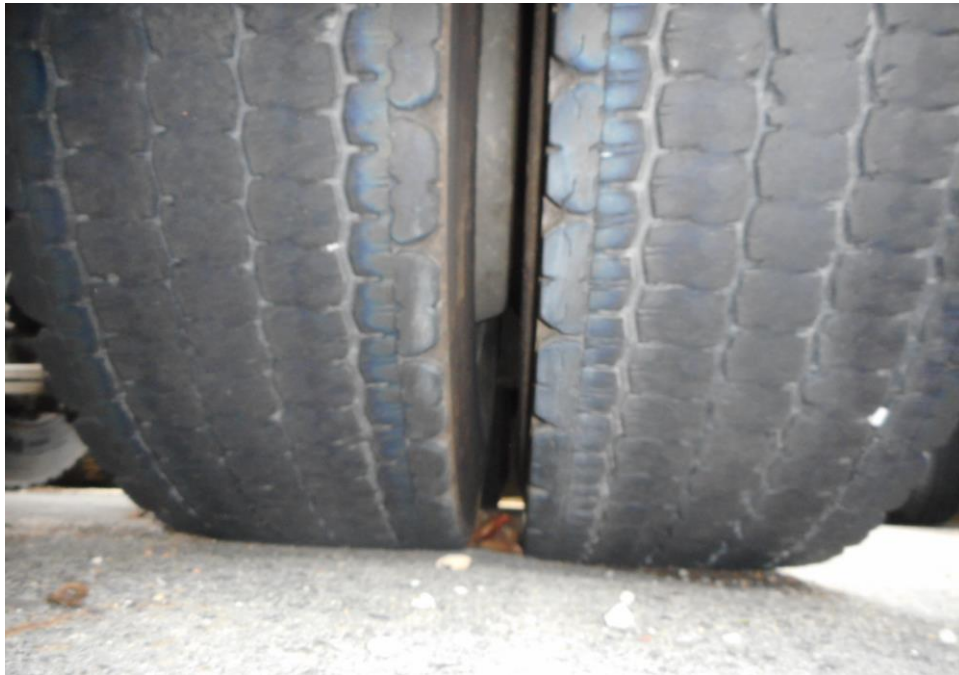
**Photo 15** shows the condition of the rear left tyres of the Motor Trailer, which was observed to be in serviceable condition with remaining tread depth of approximately 4.8mm. The tyres, which were wrapped around standard steel wheel rim, were also observed to be sufficiently inflated for vehicular operation. There was also no damage found on all 10 steel wheel rims of the Motor Trailer.

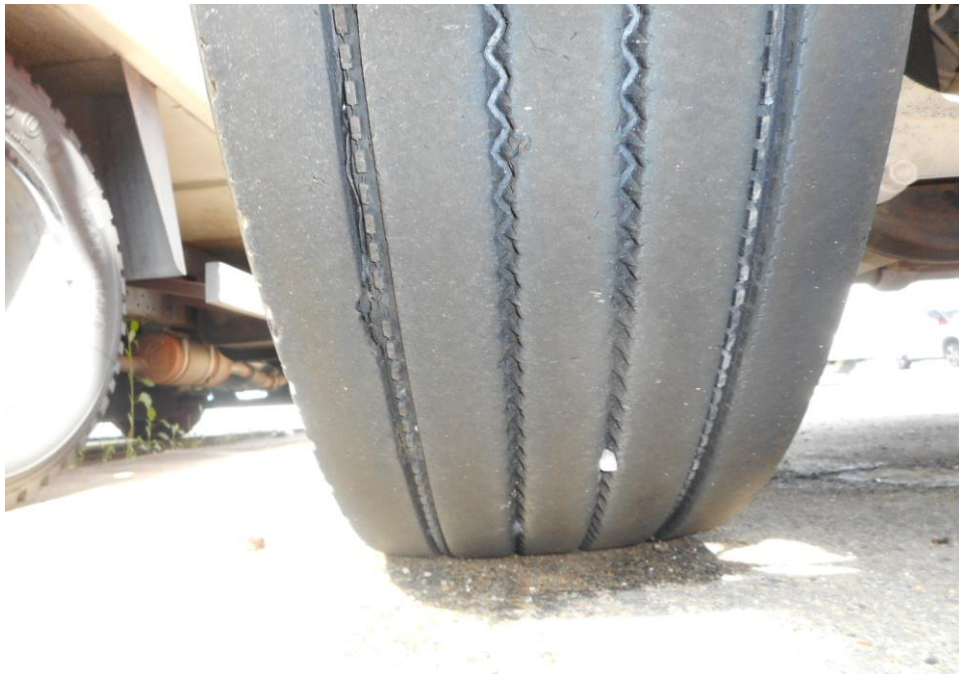
**Photo 16** shows the condition of the front left tyres of the Motor Trailer, which were observed to be in serviceable condition with remaining tread depth of approximately 8.5mm. There was also no tear, cut or burst mark(s) on the outer and the inner sidewalls as well as across the tread of the 10 tyres that were fitted on the Motor Trailer.

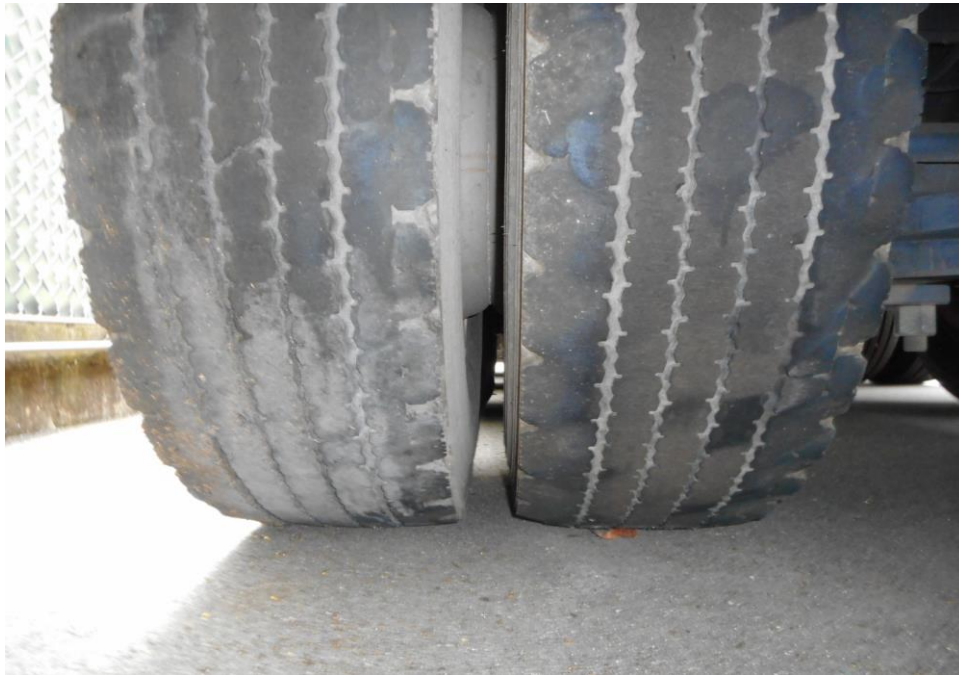
**Photo 17** shows the condition of the right tyres of the rear trailer, which was observed to be in serviceable condition with remaining tread depth of approximately 5mm. The tyre, which was wrapped around standard steel wheel rim, was also observed to be sufficiently inflated for vehicular operation.

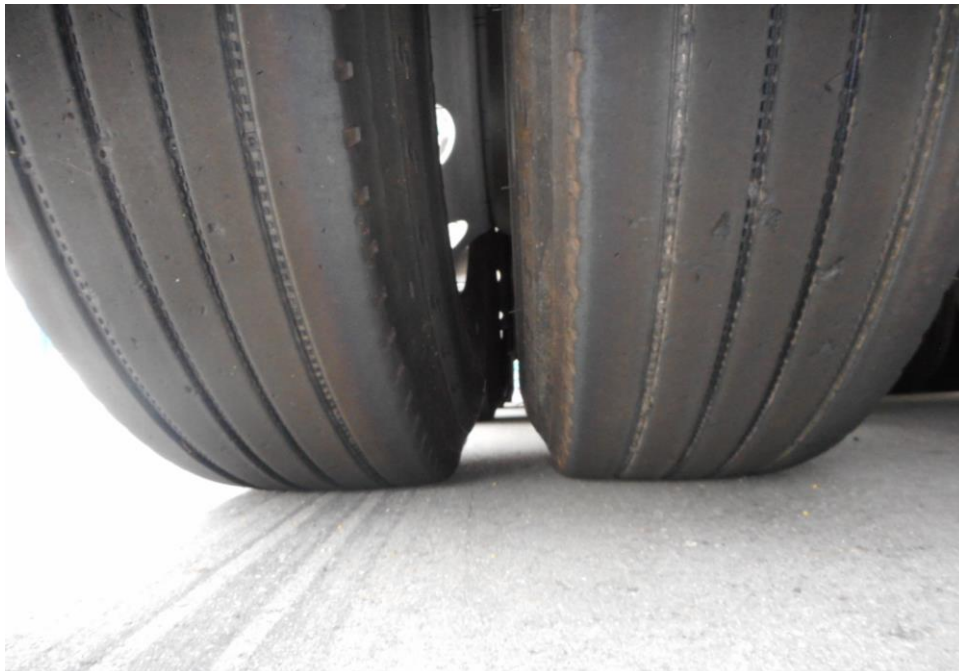
**Photo 18** shows the condition of the left tyres of the rear trailer, which was observed to be in serviceable condition with remaining tread depth of approximately 4.2mm. The tyres, which were wrapped around standard steel wheel rim, were also observed to be sufficiently inflated for vehicular operation. There was also no damage found on all 12 steel wheel rims of the Rear Trailer.

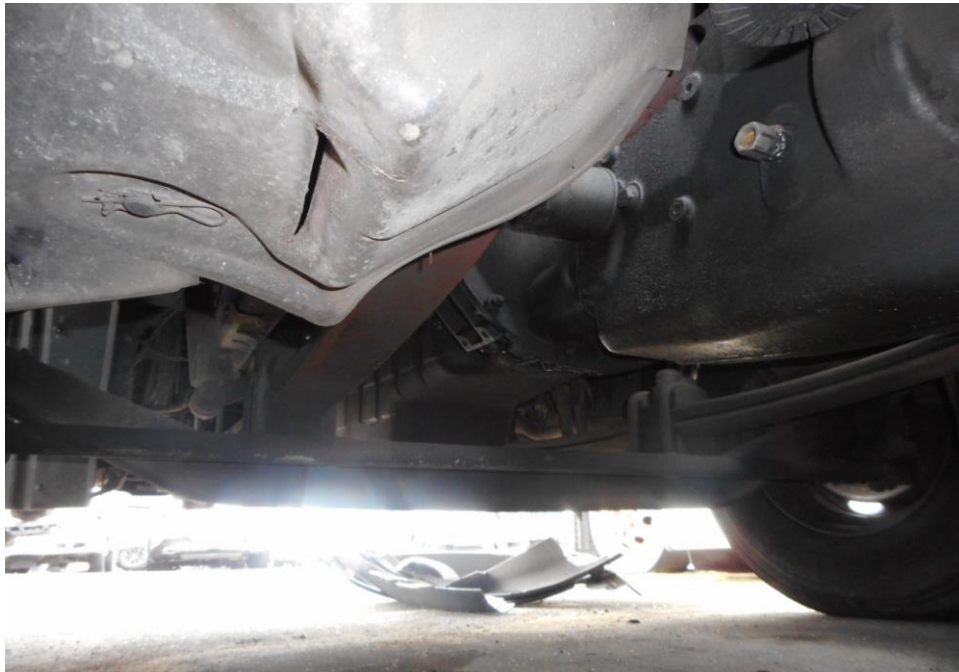
**Photo 19** shows the undercarriage of the Motor Trailer, at the area where the engine housing located. I did not find any sign(s) or indication(s) of fluid leak or fluid stain(s) on the underside of the Motor Trailer.

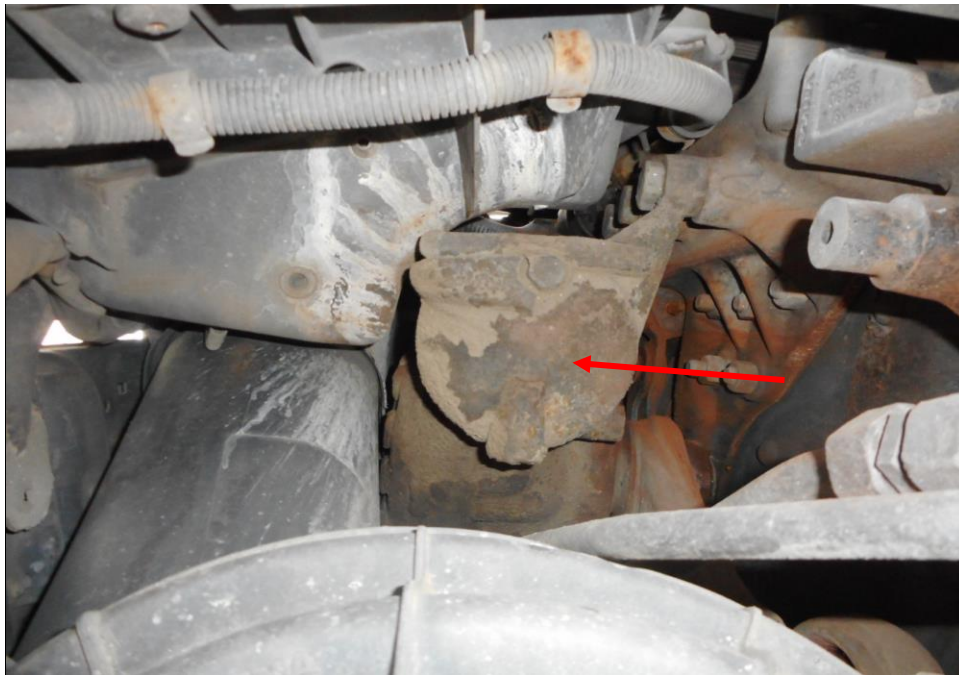
**Photo 20** shows the front underside of the Motor Trailer. I was not able to conduct any test(s) on the steering system of the Motor Trailer as the engine of the Motor Trailer could not be started. However, my visual checks on the various mechanical components of the steering system like the steering box, steering shaft and steering linkages (arrowed) amongst others revealed all to be intact

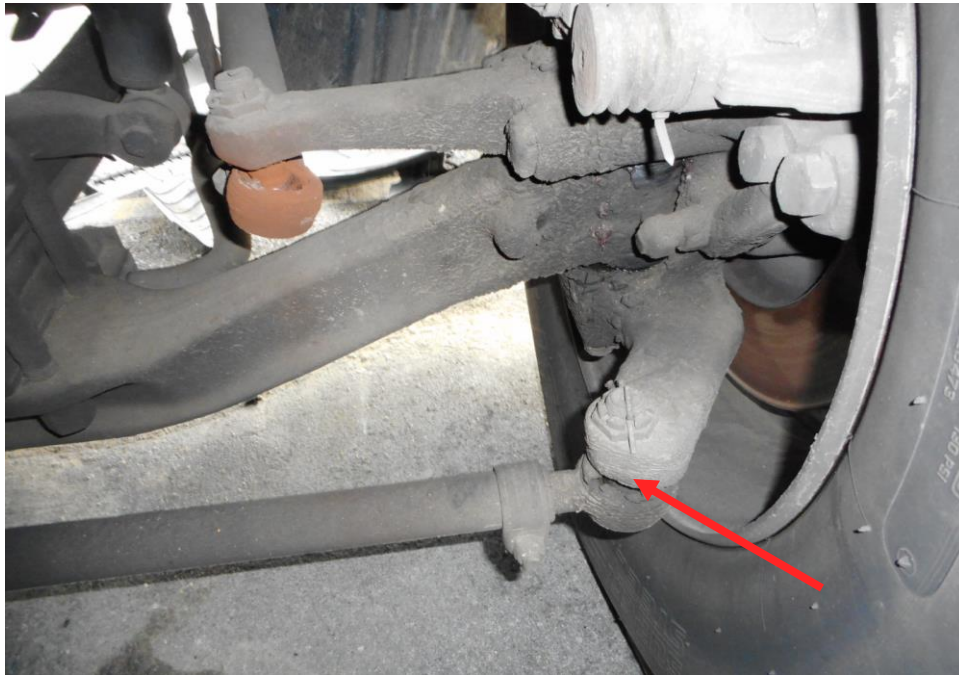
**Photo 21** shows the various undercarriage components at the front right wheel of the Motor Trailer, in particular the steering tie rod end (arrowed). The various undercarriage components of the Motor Trailer were all found to be intact without any visible damage. There was also no sign of fluid stain(s) observed on the various undercarriage components to indicate that the Motor Trailer's steering system was in serviceable condition.

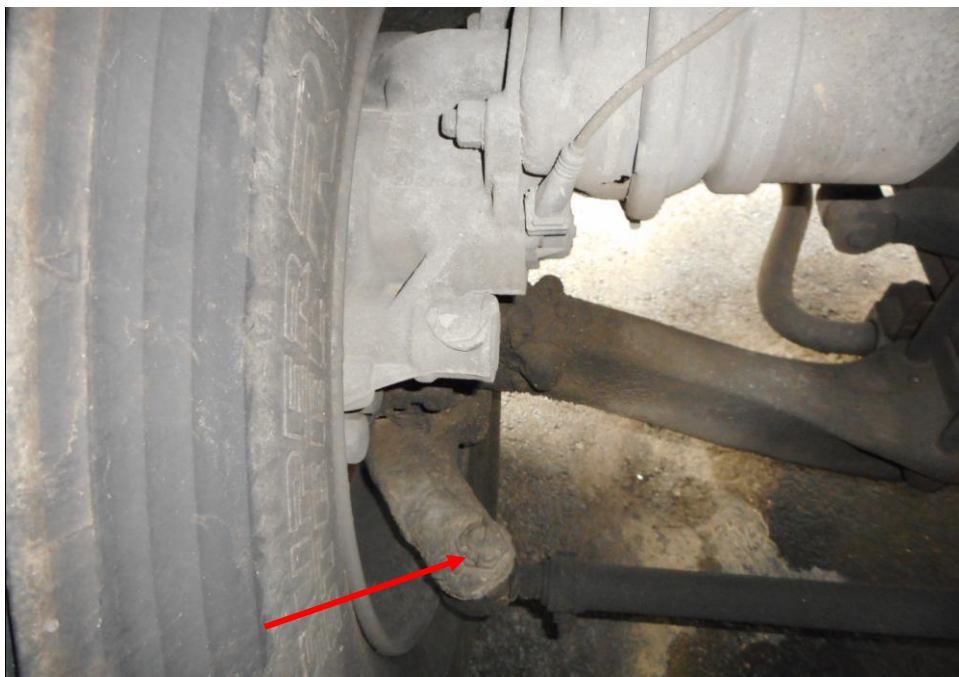
**Photo 22** shows the various undercarriage components at the front left wheel of the Motor Trailer, in particular the steering tie rod end (arrowed). The various undercarriage components of the Motor Trailer were all found to be intact without any visible damage. There was also no sign of fluid stain(s) observed on the various undercarriage components to indicate that the Motor Trailer's steering system was in serviceable condition.

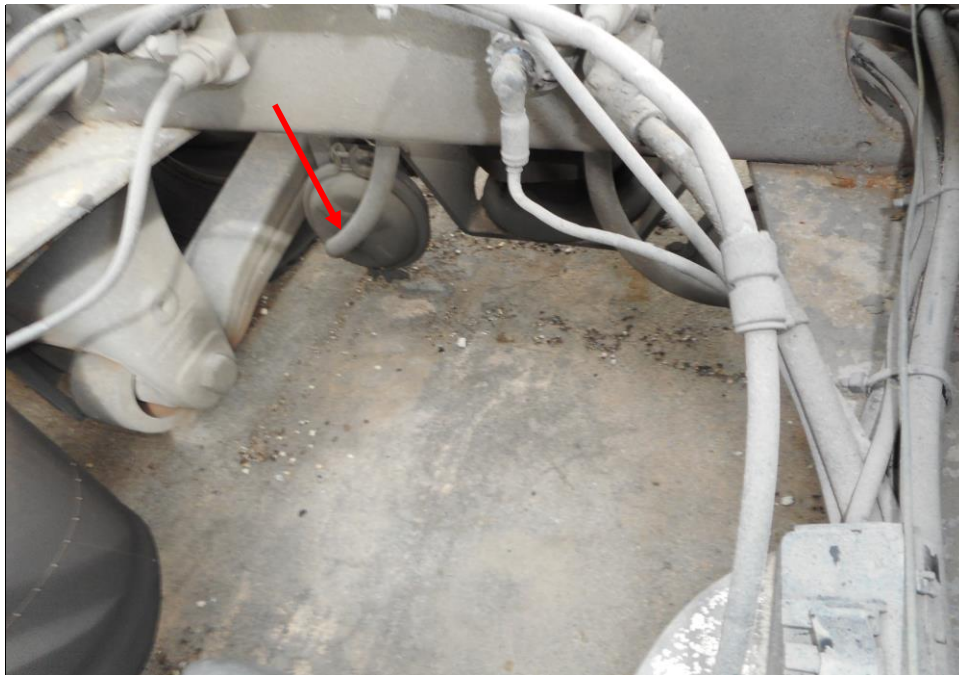
**Photo 23** shows the brake pipe (arrowed) at the rear left wheel of the Motor Trailer. I did not observe any leakage of brake fluid at the time of my inspection of the Motor Trailer. My visual examination of the various mechanical components in the braking system, had indicated that there was no internal leakage of pressure/vacuum and were generally intact to suggest that its braking system was in serviceable condition at the material time of accident.

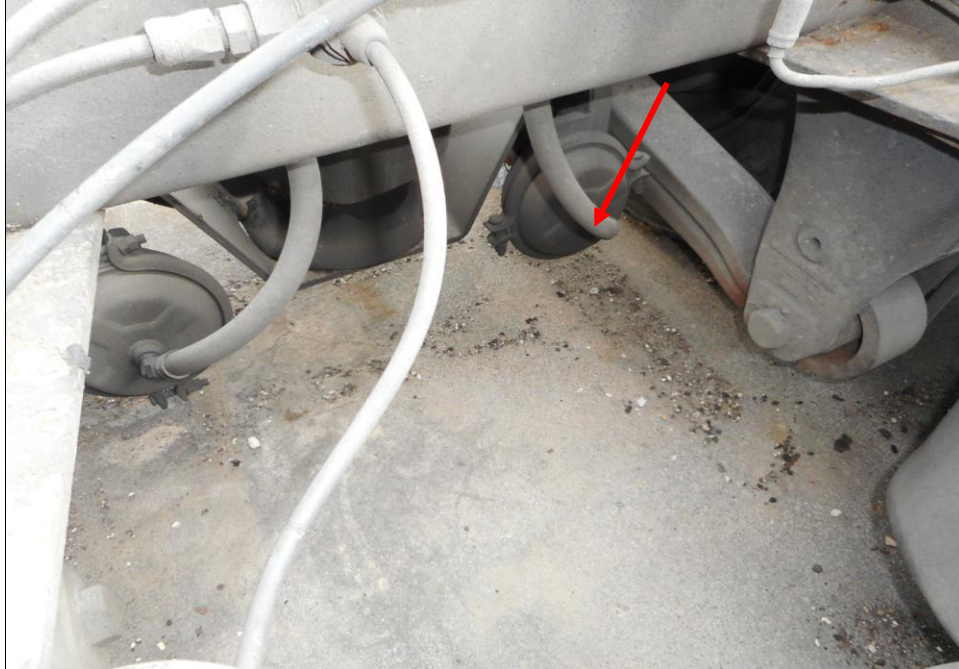
**Photo 24** shows the brake pipe (arrowed) at the rear right wheel of the Motor Trailer. I did not observe any leakage of brake fluid at the time of my inspection of the Motor Trailer. My visual examination of the various mechanical components in the braking system, had indicated that there was no internal leakage of pressure/vacuum and were generally intact to suggest that its braking system was in serviceable condition at the material time of accident.

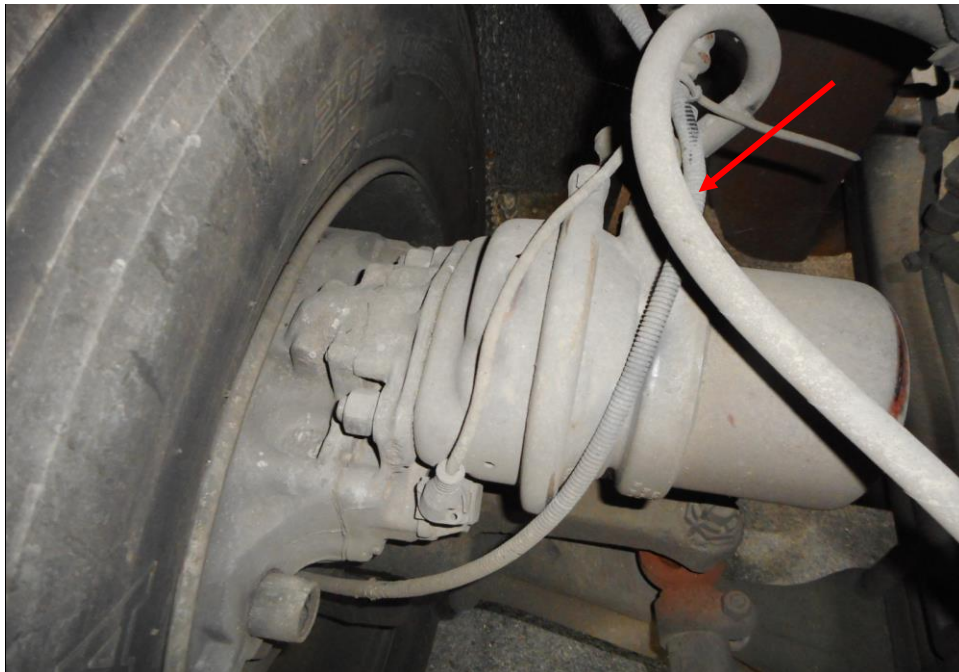
**Photo 25** shows the brake pipe (arrowed) at the front right wheel of the Motor Trailer. I did not observe any leakage of brake fluid at the time of my inspection of the Motor Trailer. My visual examination of the various mechanical components in the braking system, had indicated that there was no internal leakage of pressure/vacuum and were generally intact to suggest that its braking system was in serviceable condition at the material time of accident.

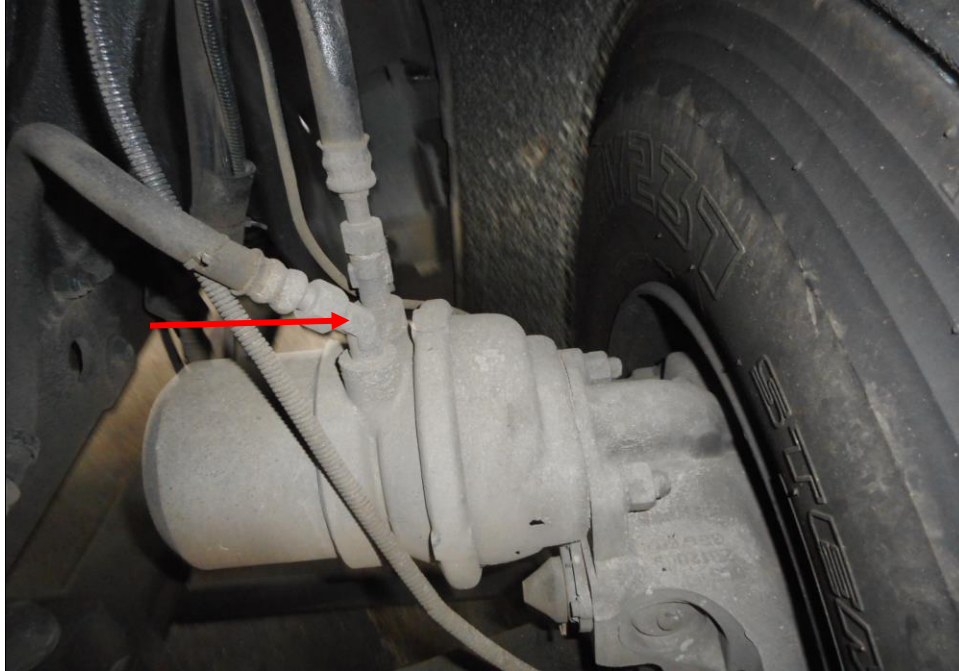
**Photo 26** shows the brake pipe (arrowed) at the front left wheel of the Motor Trailer. I did not observe any leakage of brake fluid at the time of my inspection of the Motor Trailer. My visual examination of the various mechanical components in the braking system, had indicated that there was no internal leakage of pressure/vacuum and were generally intact to suggest that its braking system was in serviceable condition at the material time of accident.

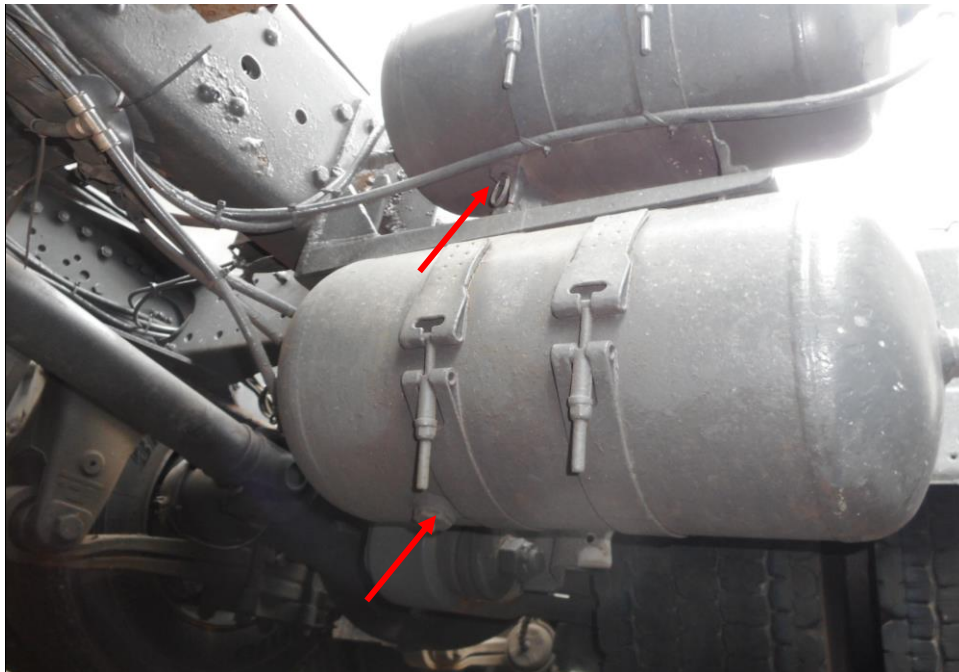
**Photo 27** shows the air brake cylinders (arrowed) at the undercarriage of the Motor Trailer. I did not observe any leakage of air brake fluid at the time of my inspection of the Motor Trailer. My visual examination of the various mechanical components in the braking system, had indicated that there was no internal leakage of pressure/vacuum and were generally intact
