You're Ref: TP/IP/39011/2020  
Our Ref: CI/TPD20012449/P

16<sup>th</sup> December 2020

**MECHANICAL INSPECTION REPORT OF MOTOR CAR SML 5693A**

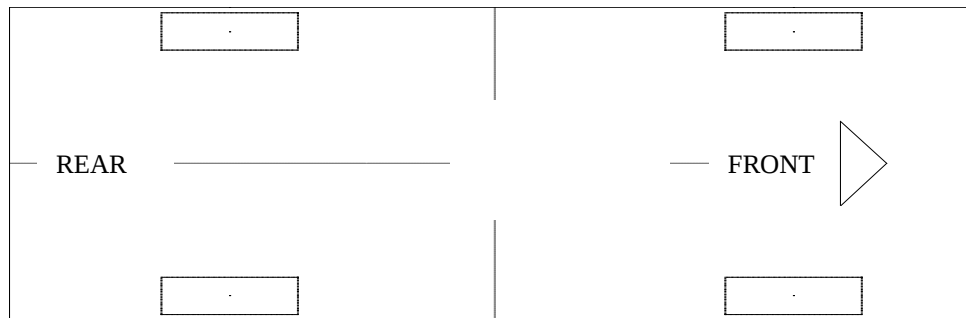
6. The condition of the Motor Car's 4 tyres was observed to be in serviceable condition. I did not find any tear, cut or burst mark(s) on the outer and the inner sidewalls as well as across the tread of the 4 tyres. The 4 tyres were also observed to be sufficiently inflated for vehicular operation. The tyre brand, tyre size and remaining tread depth of the 4 tyres were recorded as follows:-

Yokohama 185/60R15 (4.2mm)

Michelin 185/60R15 (3mm)

Yokohama 185/60R15 (4.8mm)

Arivo 185/60R15 (5.5mm)

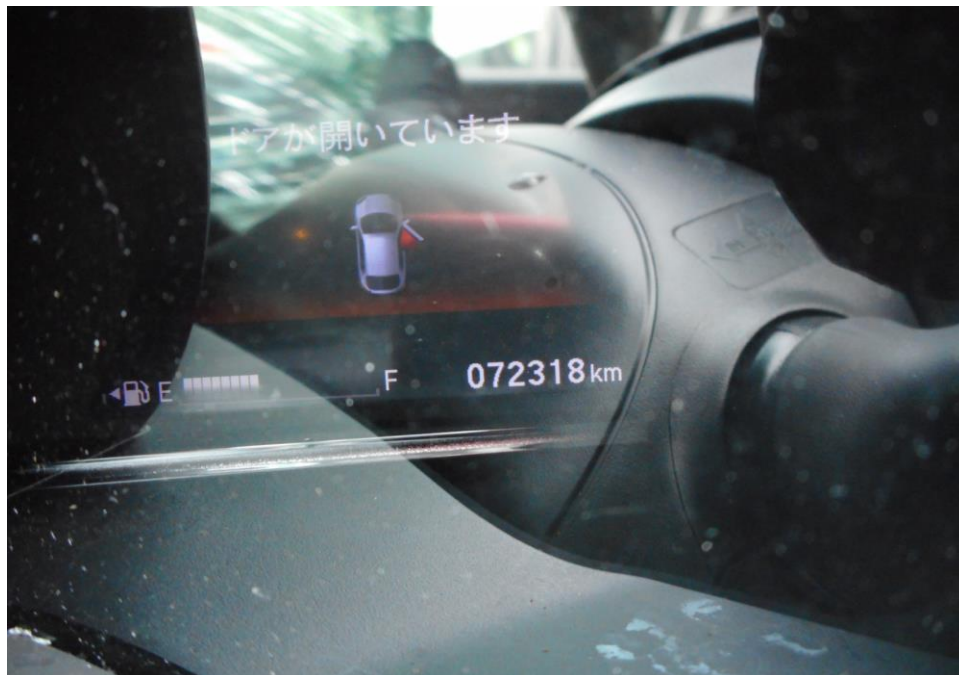
**Photo 1** shows the mileage of the Motor Car at the time of my inspection. The mileage observed was 72,318km.

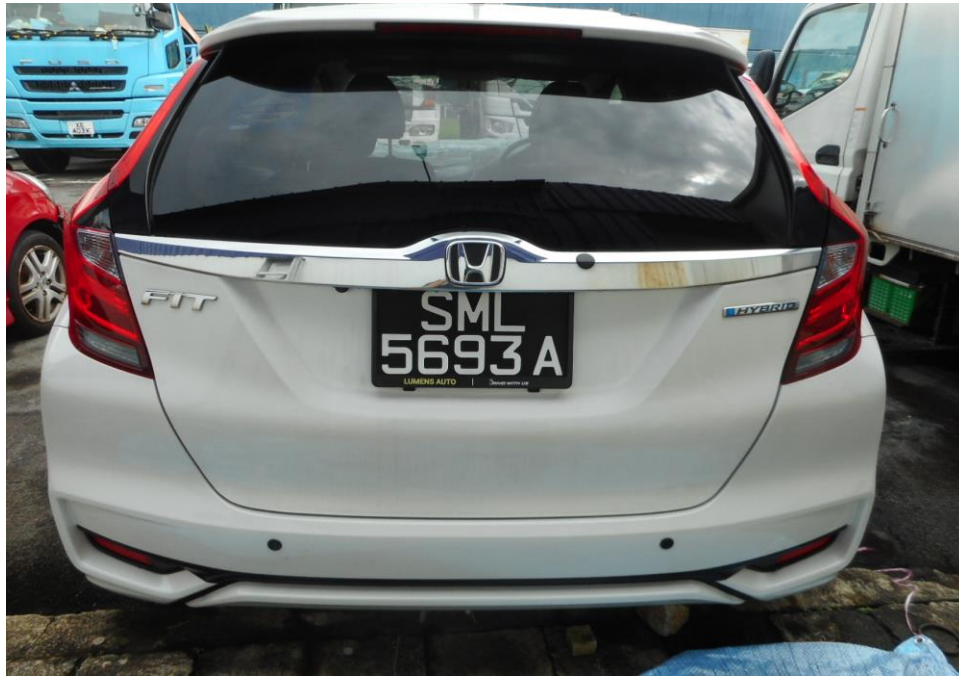
**Photo 2** shows the general view of the Motor Car's rear body at the time of my inspection. The Motor Car rear was observed to be unaffected by the accident.

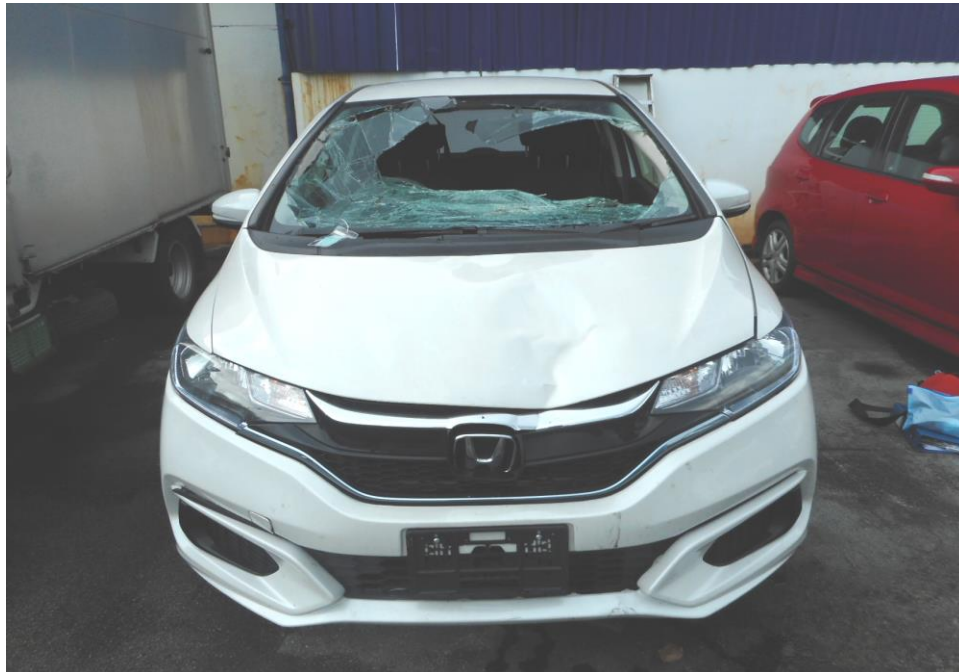
4. The mileage of the Motor Car at the time of my inspection was 72,318km.
5. The Motor Car was observed to have sustained damage at its front portion. Its front windscreen, front bonnet, front grille, front number plate and front bumper was amongst the body parts that were damaged as a result of the accident.

**Photo 3** shows a general view of the Motor Car's front body at the time of my inspection. Its front windscreen, front bonnet, front grille, front number plate and front bumper was amongst the body parts that were damaged as a result of the accident.

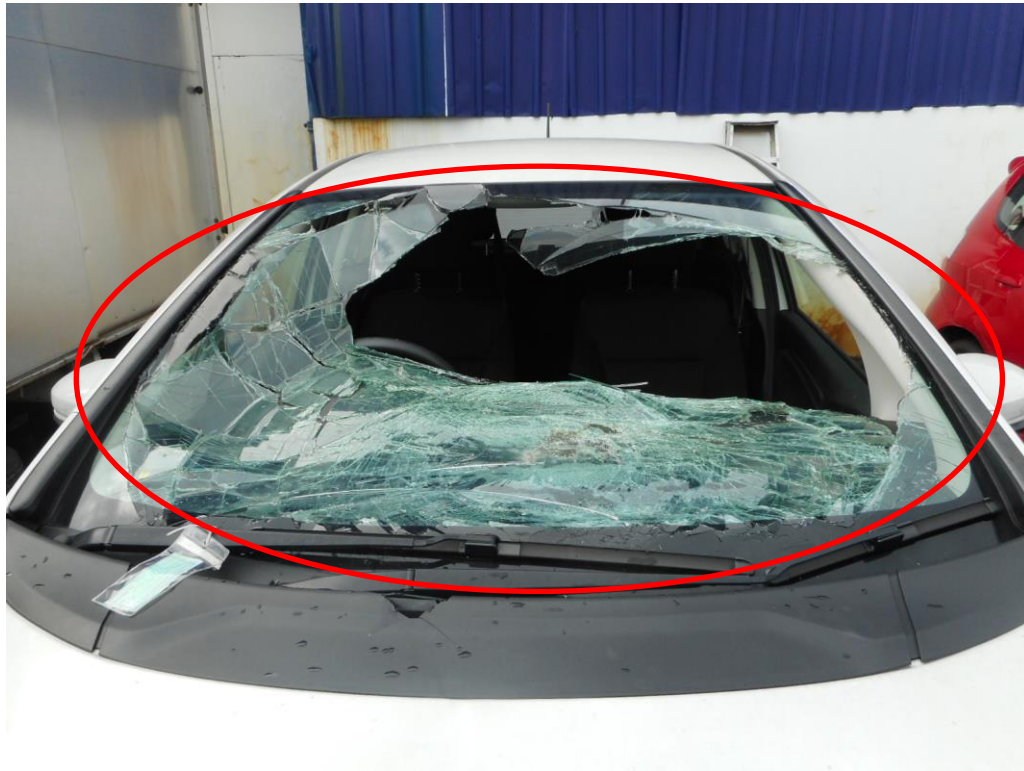
**Photo 4** shows the close up view of the Motor Car's front body at the time of my inspection. The Motor Car was observed to have sustained damage at its front windscreen (circled), as a result of the accident.

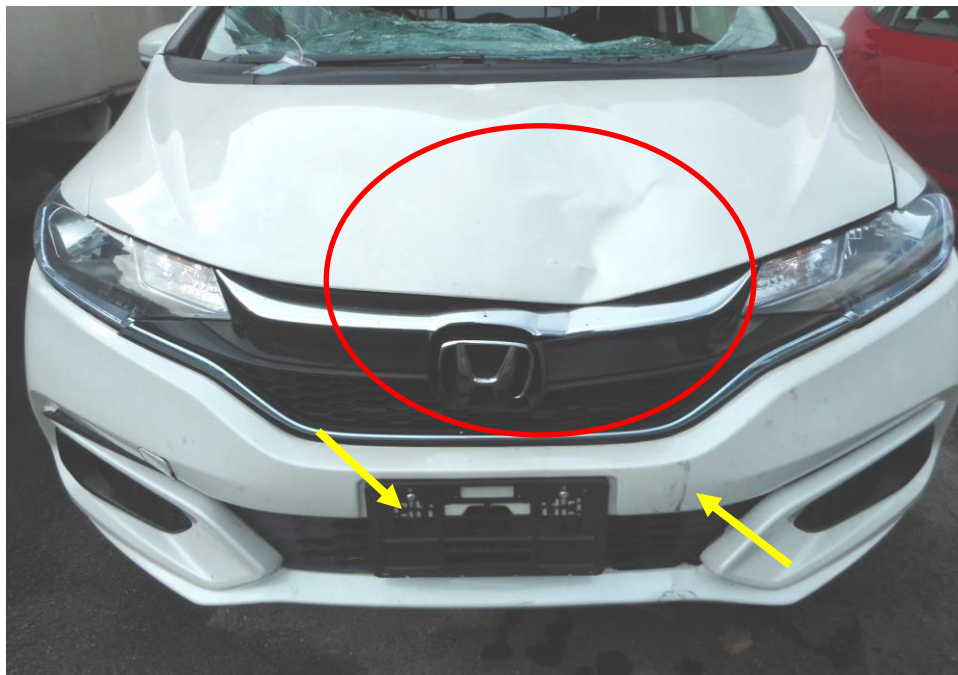
**Photo 5** shows the close up view of the Motor Car's front body at the time of my inspection. The Motor Car was observed to have sustained damage at its front bonnet, front grille (circled), front number plate and front bumper (arrowed) was amongst the body parts that were damaged as a result of the accident.

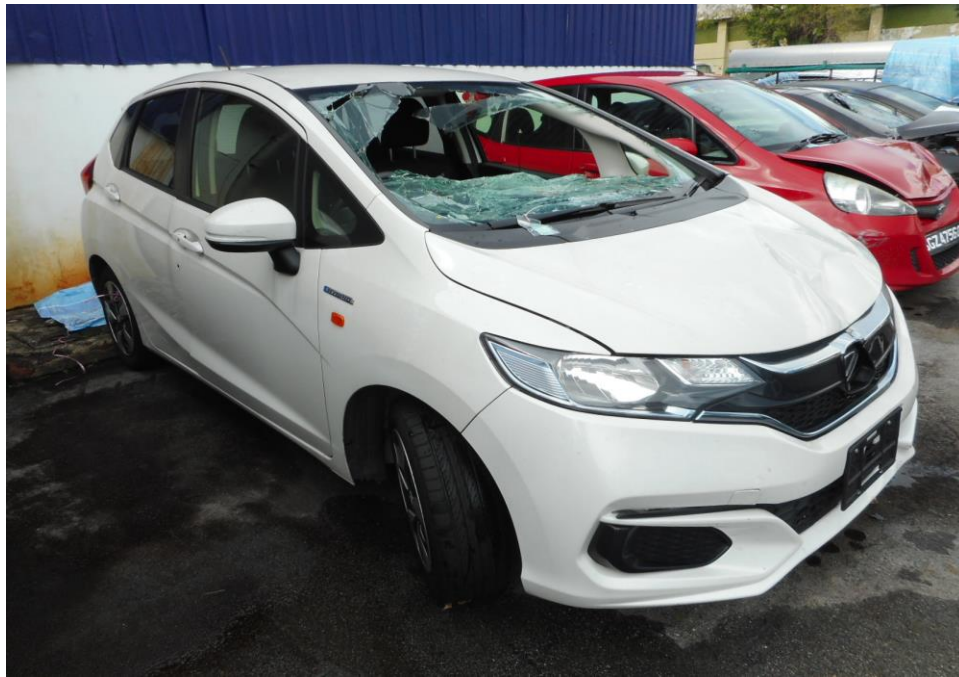
**Photo 6** shows a general view of the Motor Car's right body at the time of my inspection. The right portion of the Motor Car was observed to have been unaffected by the accident.

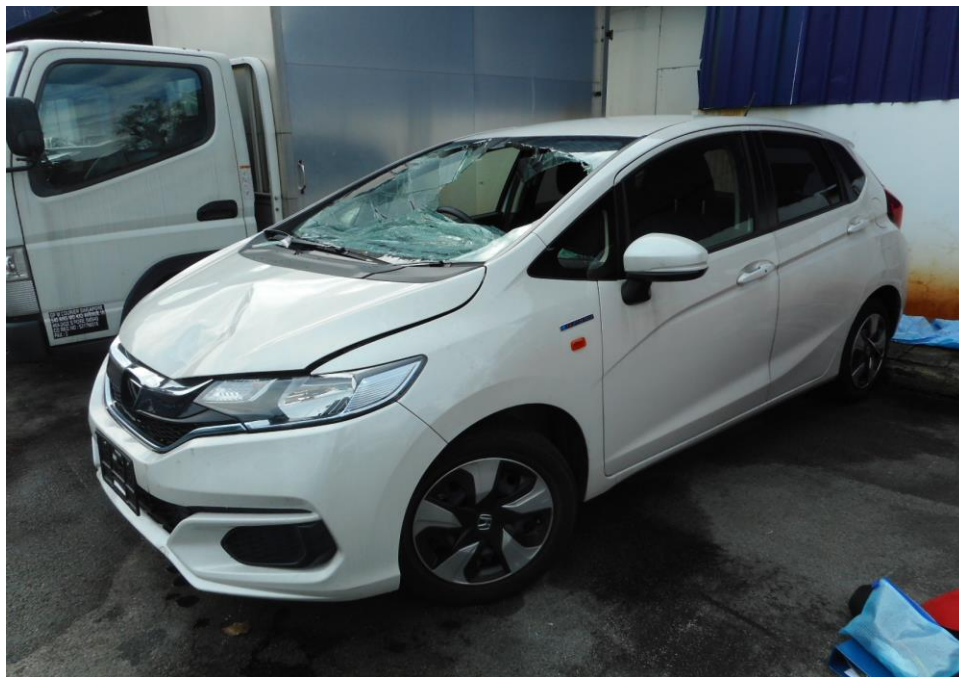
**Photo 7** shows a general view of the Motor Car's left body at the time of my inspection. The left portion of the Motor Car was observed to have been unaffected by the accident.

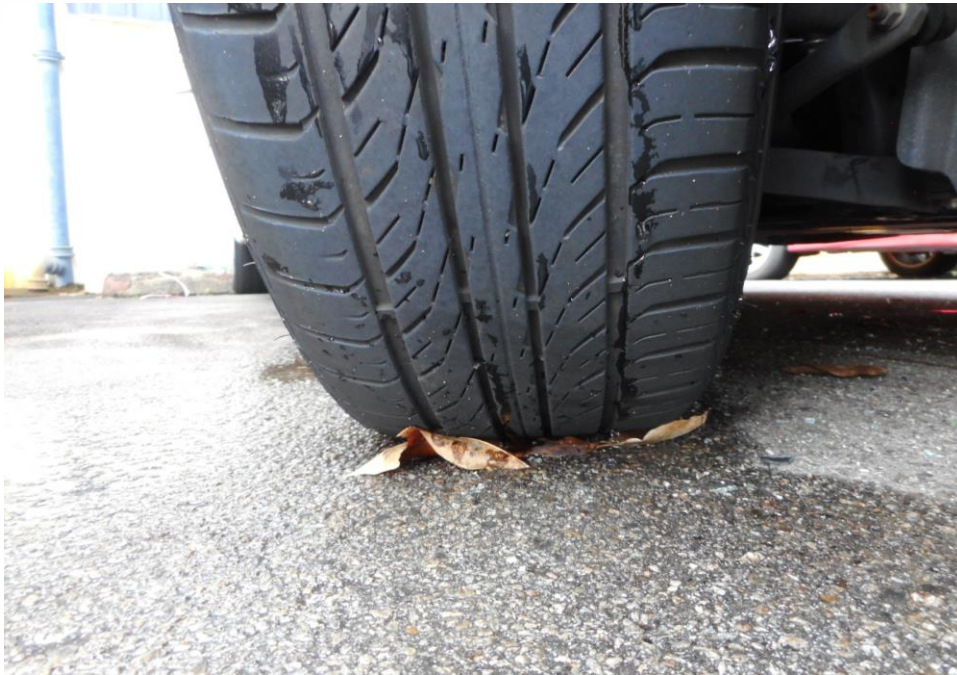
**Photo 8** shows the condition of the front right tyre of the Motor Car, which was observed to be in serviceable condition with remaining tread depth of approximately 4.5mm. The tyre was sufficiently inflated for vehicular operation with no tear, cut or burst mark(s) on the outer and the inner sidewalls as well as across the tread. The 4 tyres of the Motor Car were wrapped around standard steel wheel rims without any damage.

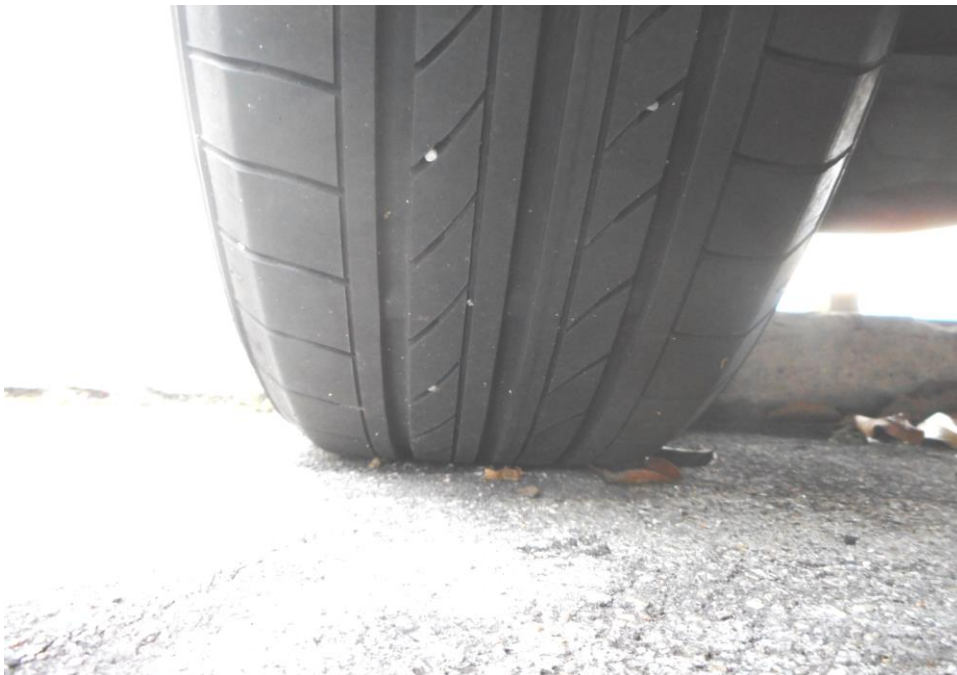
**Photo 9** shows the condition of the rear right tyre of the Motor Car, which was observed to be in serviceable condition with remaining tread depth of approximately 4.8mm. The tyre was also observed to be sufficiently inflated for vehicular operation with no tear, cut or burst mark(s).

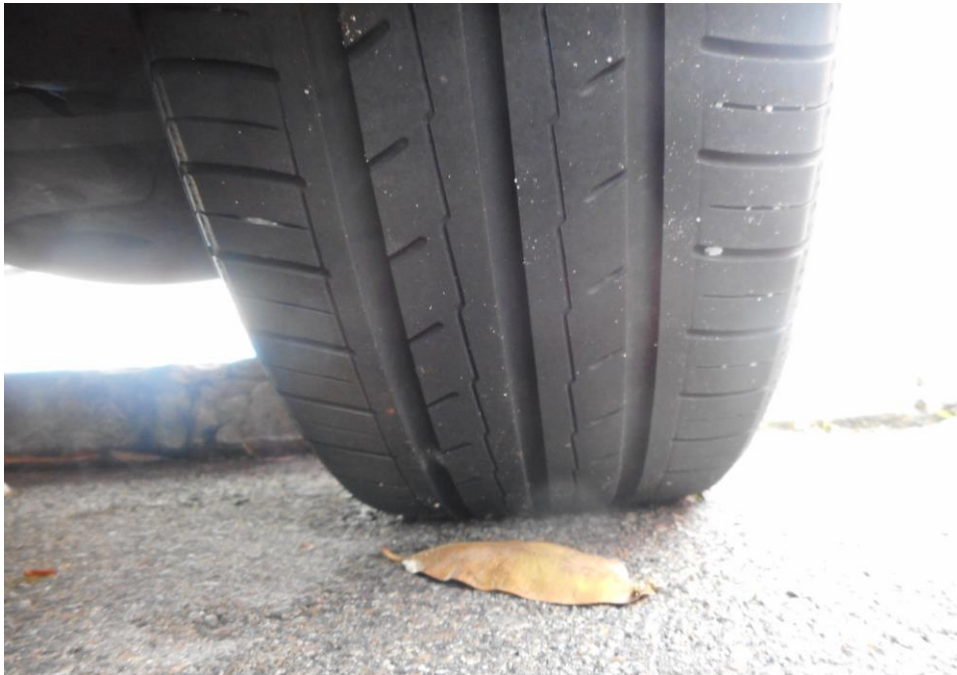
**Photo 10** shows the condition of the rear left tyre of the Motor Car, which was observed to be in serviceable condition with remaining tread depth of approximately 4.2mm. The tyre, which was wrapped around steel wheel rim, was also observed to be sufficiently inflated for vehicular operation. The 4 tyres of the Motor Car were wrapped around standard steel wheel rims.

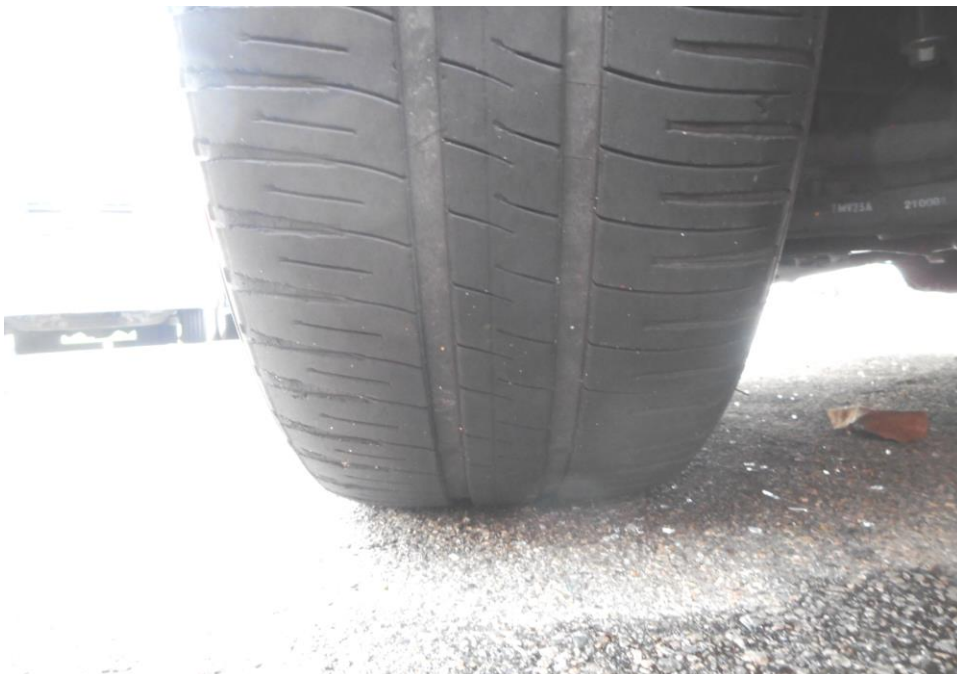
**Photo 11** shows the condition of the front left tyre of the Motor Car, which was observed to be in serviceable condition with remaining tread depth of approximately 3mm. There was also no tear, cut or burst mark(s) on the outer and the inner sidewalls as well as across the tread of the Motor Car's 4 tyres.

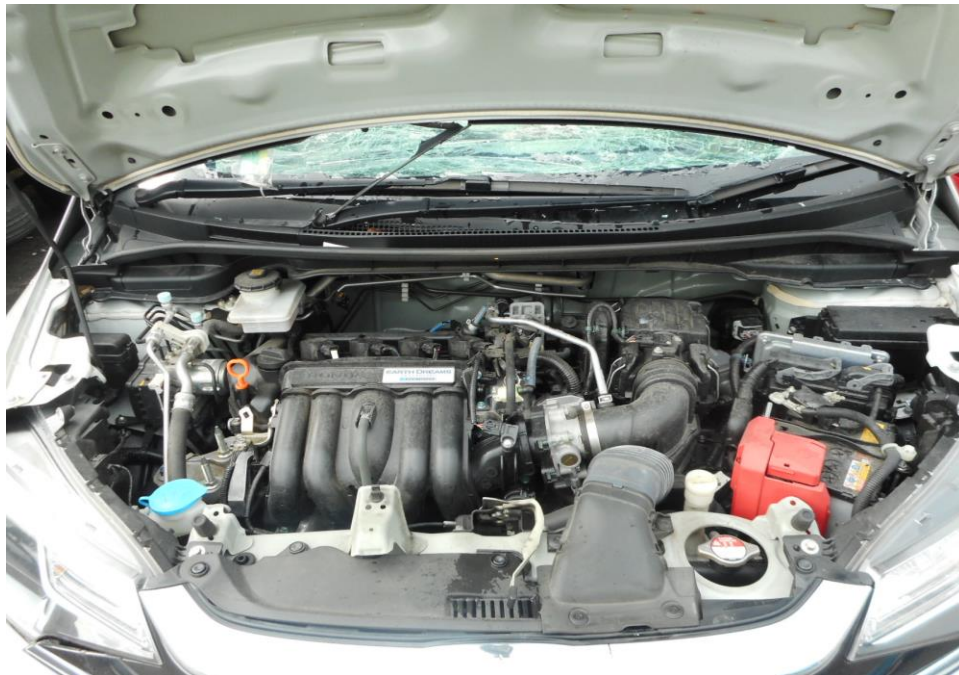
**Photo 12** shows a general view of the Motor Car's engine compartment. The various parts and components inside the engine compartment were unaffected by the accident. There was also no sign(s) or indication(s) of fluid leakage and/or fluid stain within the engine compartment.

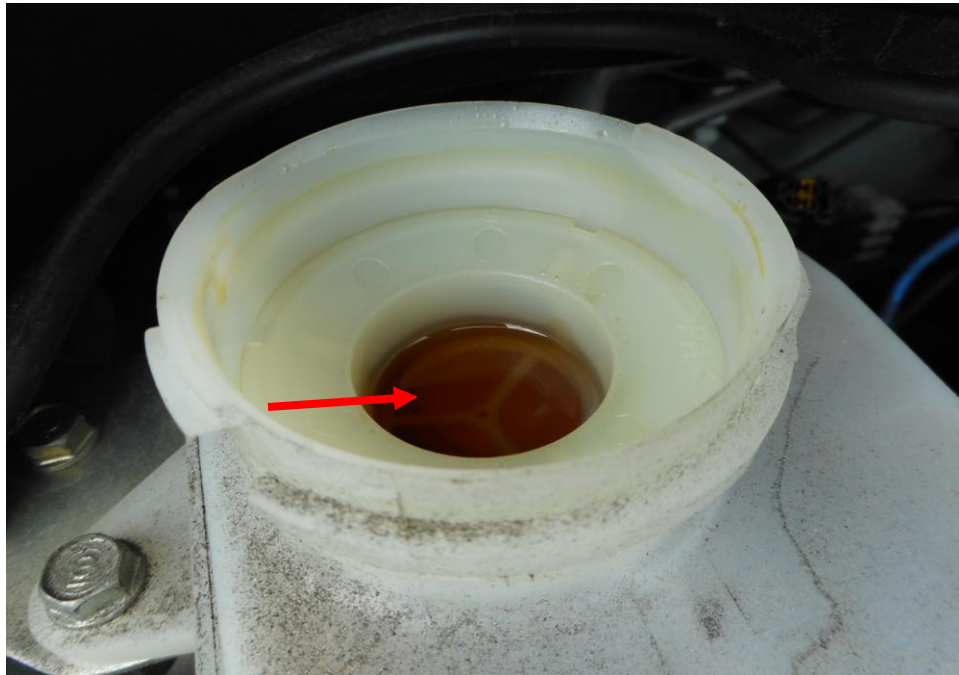
**Photo 13** shows the brake fluid reservoir of the Motor Car at the time of my inspection. The brake fluid was observed to be of sufficient level (arrowed) and without any visible contamination.

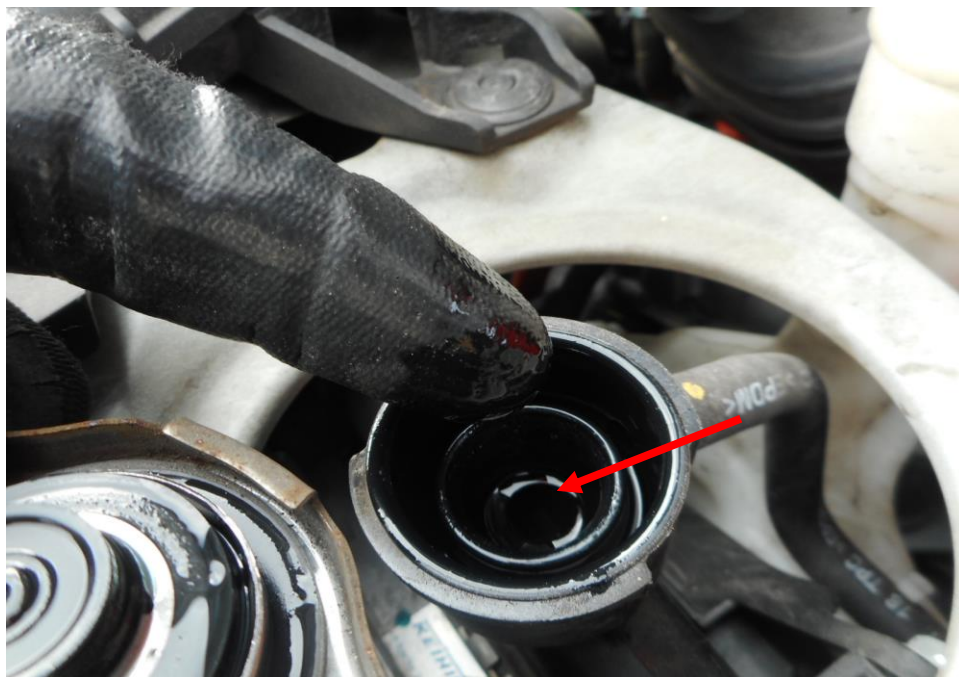
**Photo 14** shows checks being carried out to the engine coolant of the Motor Car at the time of my inspection. The engine coolant was observed to be of sufficient level (arrowed) and without any visible contamination.

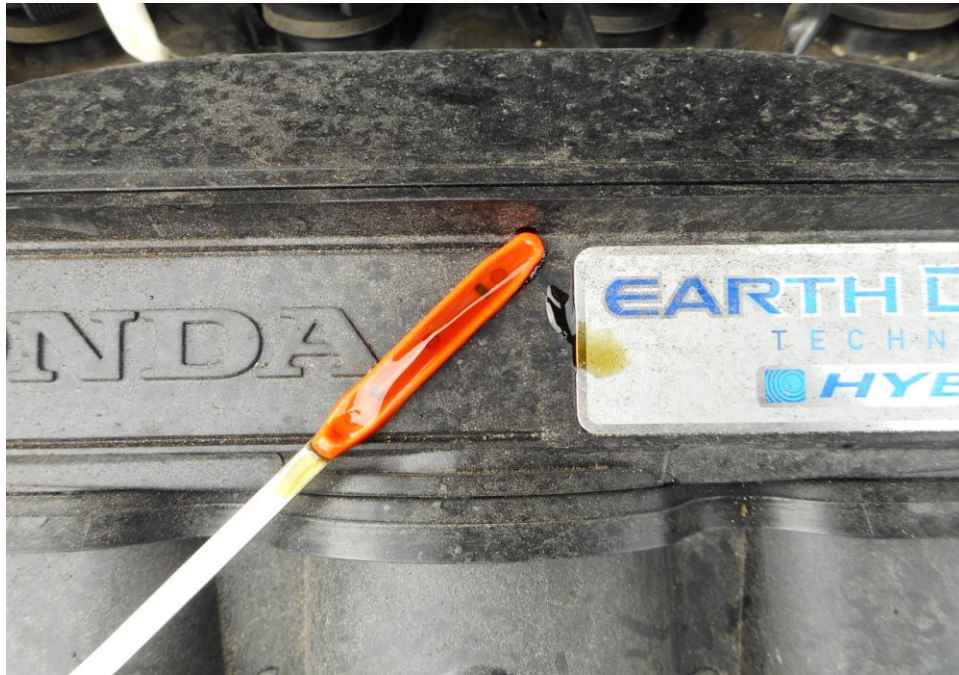
**Photo 15** shows the engine oil dip stick of the Motor Car at the time of my inspection. The engine oil was observed to be of sufficient level and without any visible contamination.

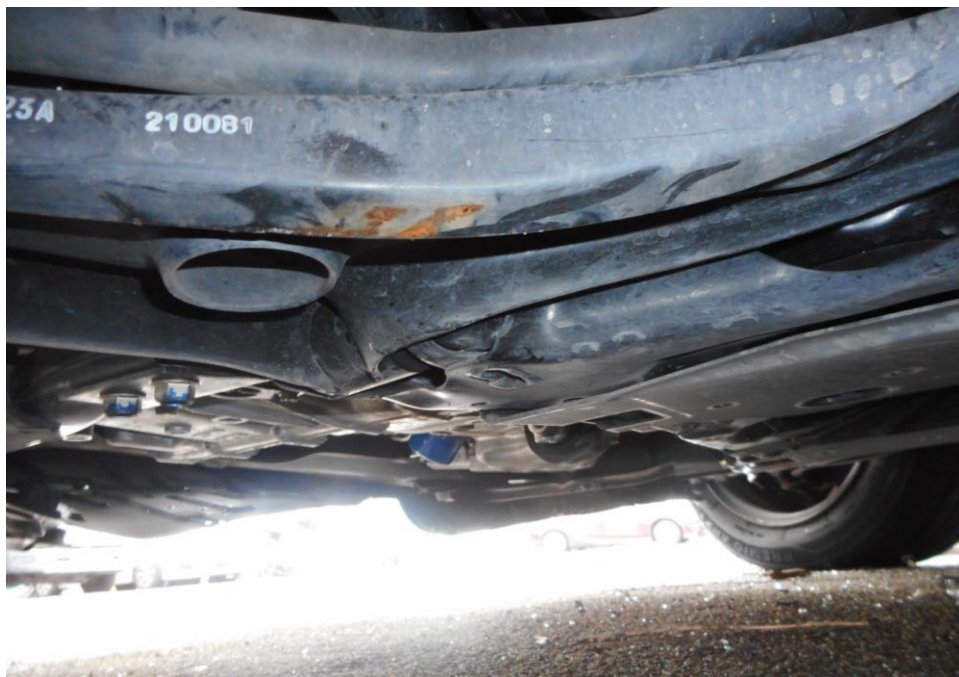
**Photo 16** shows the undercarriage of the Motor Car, at the area where the engine housing and transmission housing are located. I did not find any sign(s) or indication(s) of fluid leak and/or fluid stain(s) on the underside of the Motor Car.

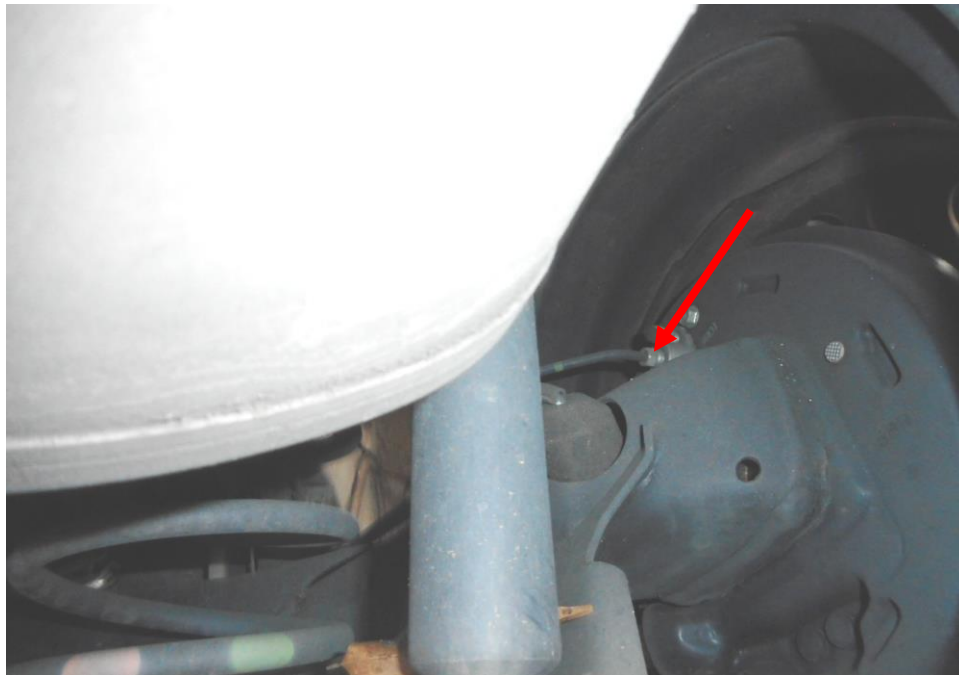
**Photo 17** shows the brake hose/pipe (arrowed) at the rear right wheel of the Motor Car. No leakage of brake fluid was observed. Visual examination of the various components of the braking system like the drum brake, brake booster, brake pedal etc. had revealed all to be intact and without visible damage.

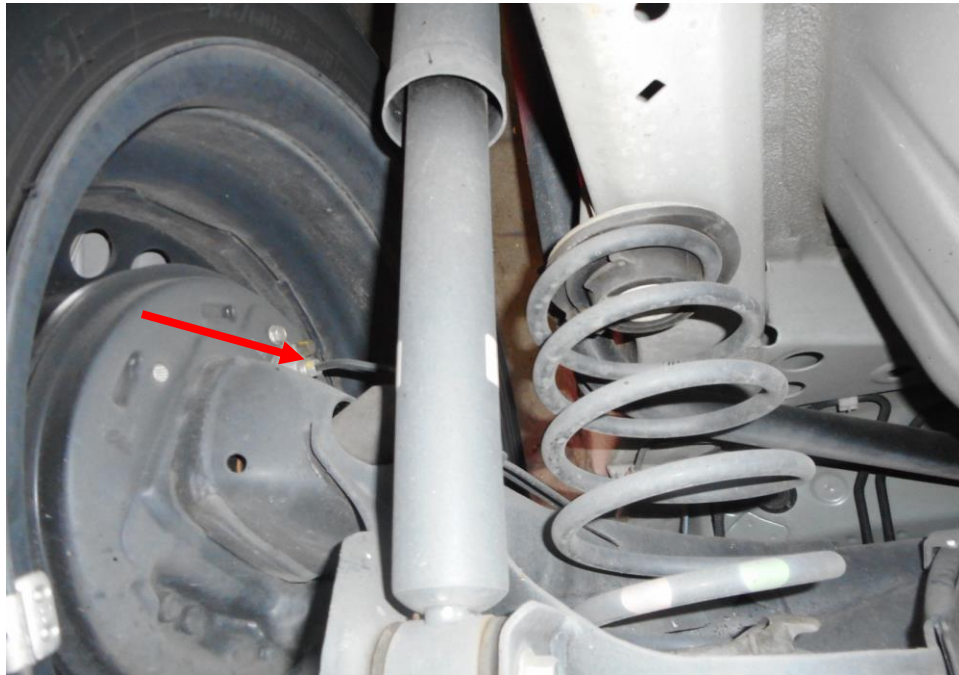
**Photo 18** shows the brake hose/pipe (arrowed) at the rear left wheel of the Motor Car. I did not observe any leakage of brake fluid at the time of my inspection of the Motor Car. Static tests of the Motor Car's braking system had indicated that there was no internal leakage of pressure/vacuum. The undercarriage components of the Motor Car were also all found to be intact and without any visible damage.

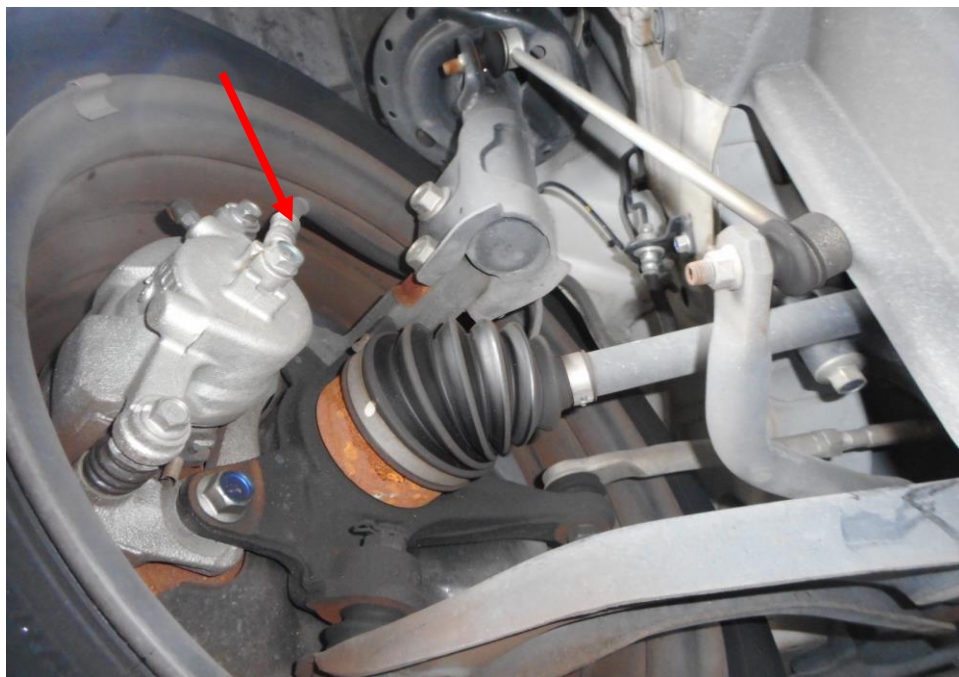
**Photo 19** shows the brake hose/pipe (arrowed) at the front right wheel of the Motor Car. I did not observe any leakage of brake fluid at the time of my inspection of the Motor Car. Static tests of the Motor Car's braking system had indicated that there was no internal leakage of pressure/vacuum. The undercarriage components of the Motor Car were also all found to be intact and without any visible damage.

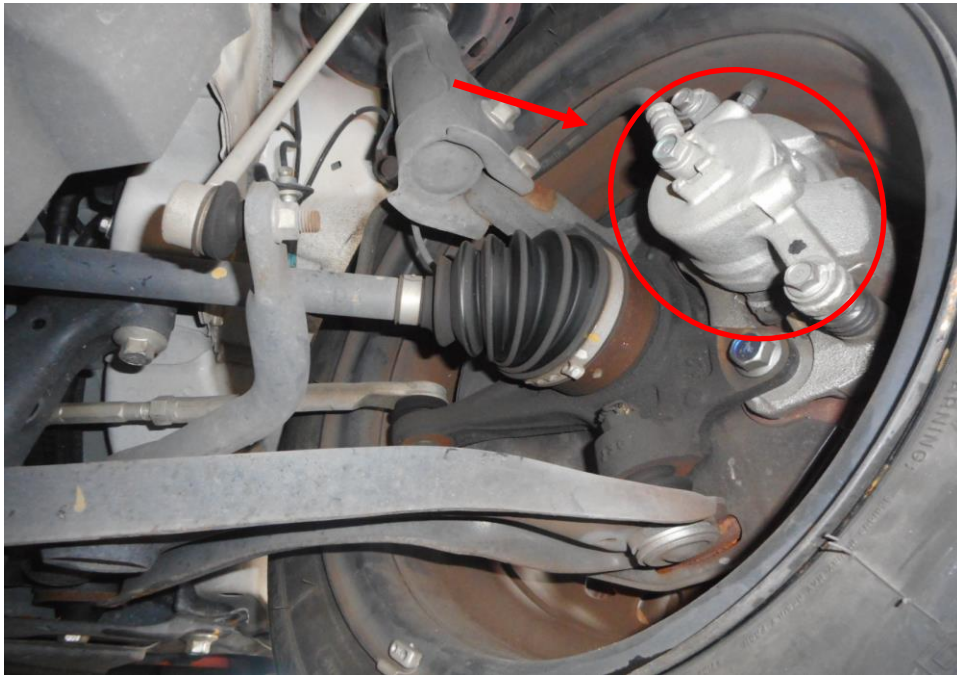
**Photo 20** shows the brake hose/pipe (arrowed) at the front left wheel of the Motor Car. No leakage of brake fluid was observed. Visual examination of the various components of the braking system like the brake caliper (circled), brake booster, brake pedal etc had revealed all to be intact and without visible damage.

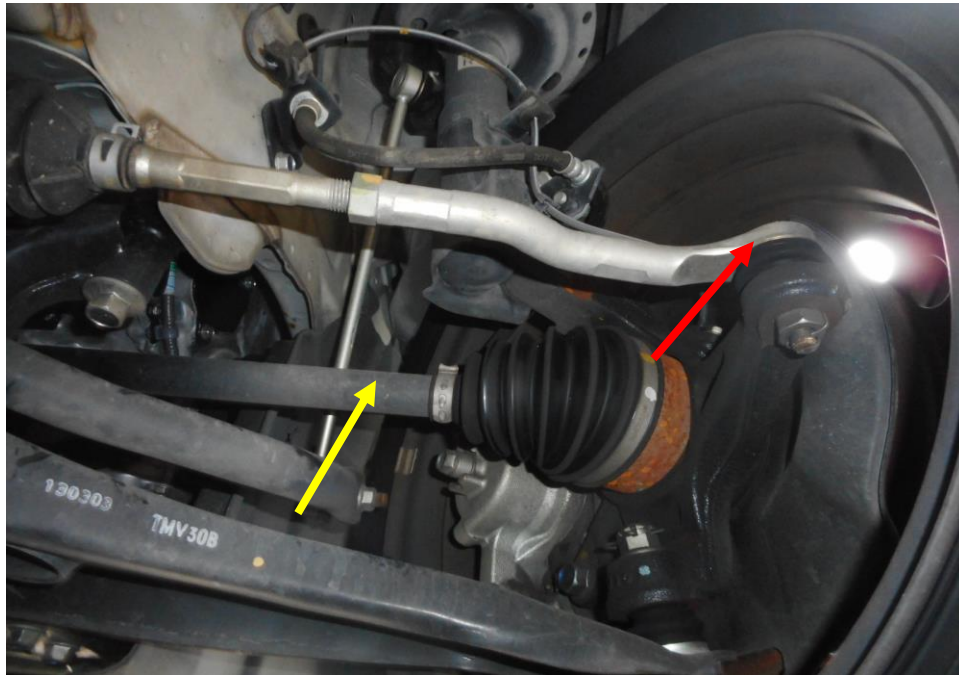
**Photo 22** shows the various undercarriage components at the front right wheel of the Motor Car, in particular the steering tie rod (red arrow) and drive shaft (yellow arrow). The various steering components were all found to be intact, suggesting that the steering system of the Motor Car was likely to be in serviceable condition at the material time of accident. There was also no sign of fluid stain observed on the various undercarriage components at the front right wheel of the Motor Car.

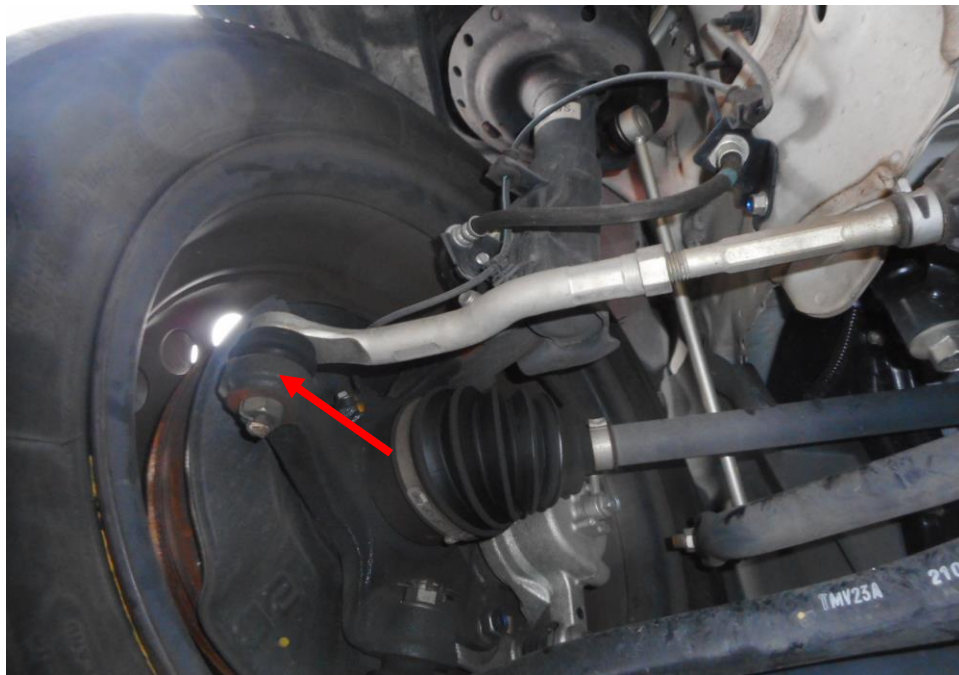
**Photo 23** shows the various undercarriage components at the front left wheel of the Motor Car, which had included the steering tie rod (red arrow). The various undercarriage components of the Motor Car were all found to be intact without any visible damage.

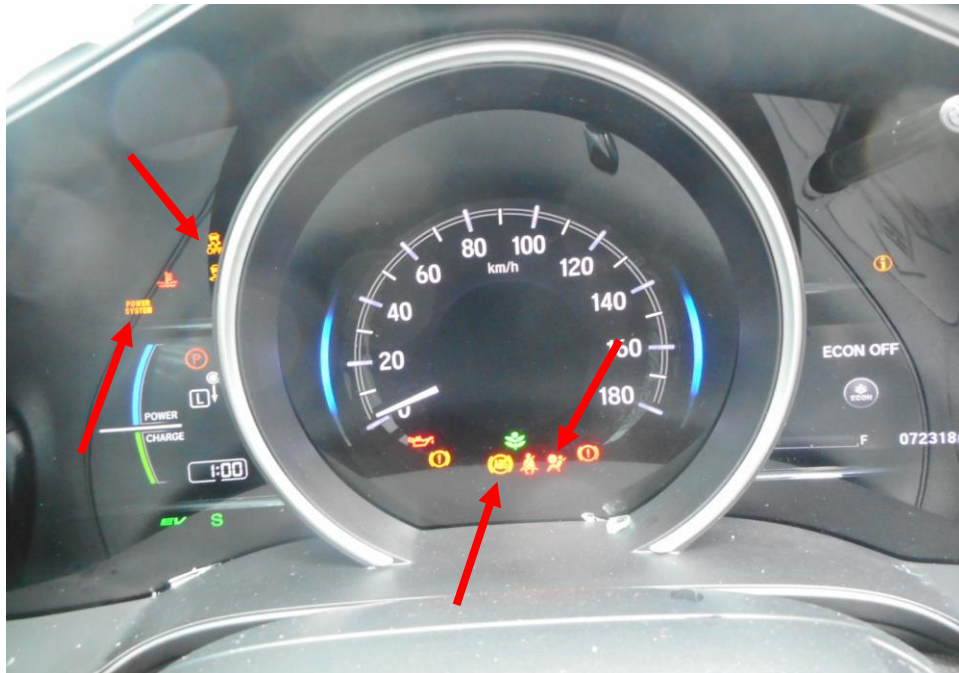
**Photo 24** shows the warning light for Anti-Lock Brake System (ABS) and Power Steering System (EPS), Supplemental Restraint System (SRS) and Traction Control (TC) (arrowed) appearing on the instrument panel of the Motor Car during the self-test of its various electronic operating systems when its engine was cranked.

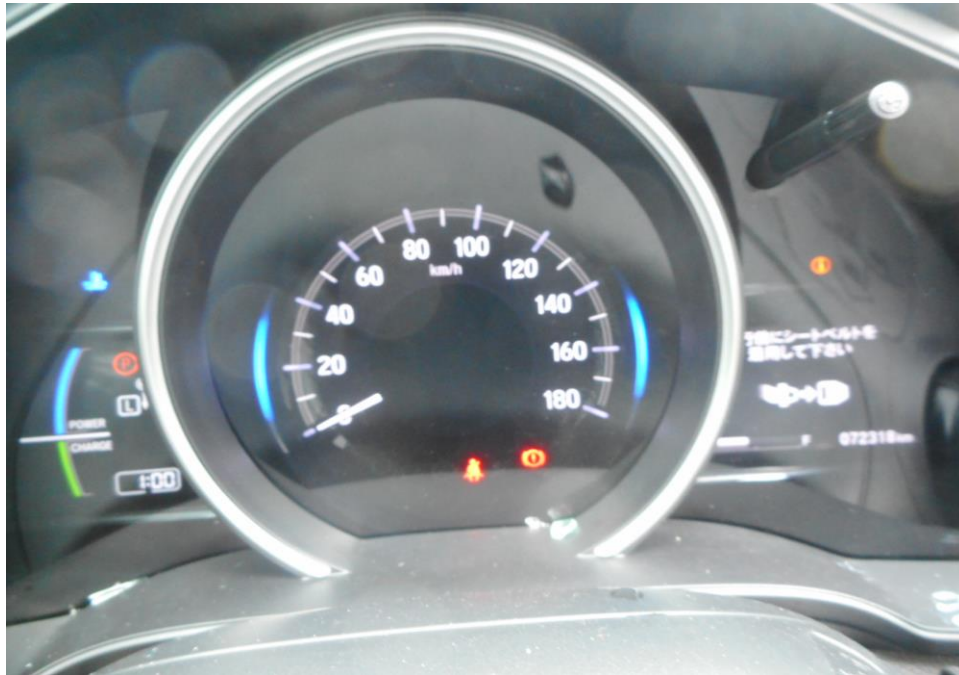
**Photo 25** shows no warning lights illuminated on the instrument panel of the Motor Car after the engine was cranked. This would suggest that there was no abnormality to the electronic operating system of the Motor Car, like the ABS, EPS, SRS, and TC etc.
