Your Ref: TP/IP/32267/2020
Our Ref : CI/TPD20012451/P

Fatal Accident Investigation Team

MECHANICAL INSPECTION REPORT OF MOTOR TAXI SHA 1458G

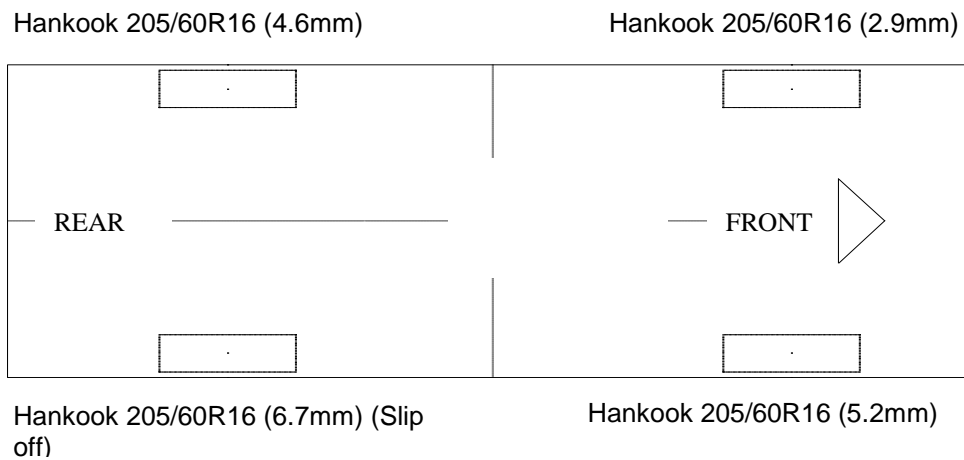
6. The condition of the Motor Taxi's 4 tyres was observed to be in serviceable condition. I did not find any tear, cut or burst mark(s) on the outer and the inner sidewalls as well as across the tread of the 4 tyres. The right rear tyre was observed to slip out of the rim as a result of the accident. However the other 3 tyre were observed to be sufficiently inflated for vehicular operation. The tyre brand, tyre size and remaining tread depth of the 4 tyres were recorded as follows:-

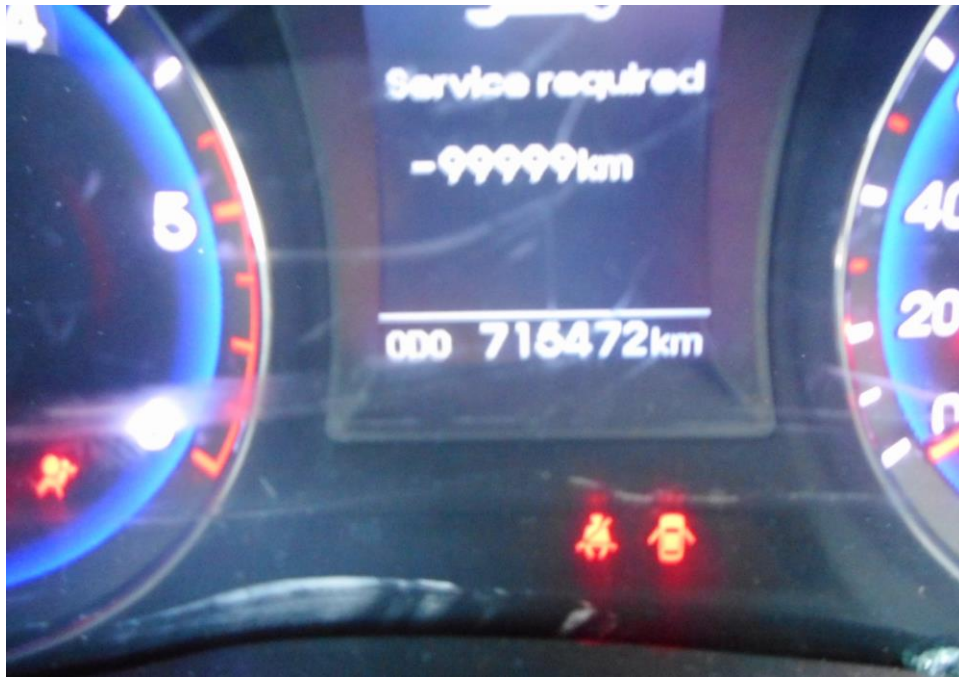
Photo 1 shows a general view of the instrument cluster of the Motor Taxi at the time of my inspection. The mileage of the Motor Taxi was 715,472km

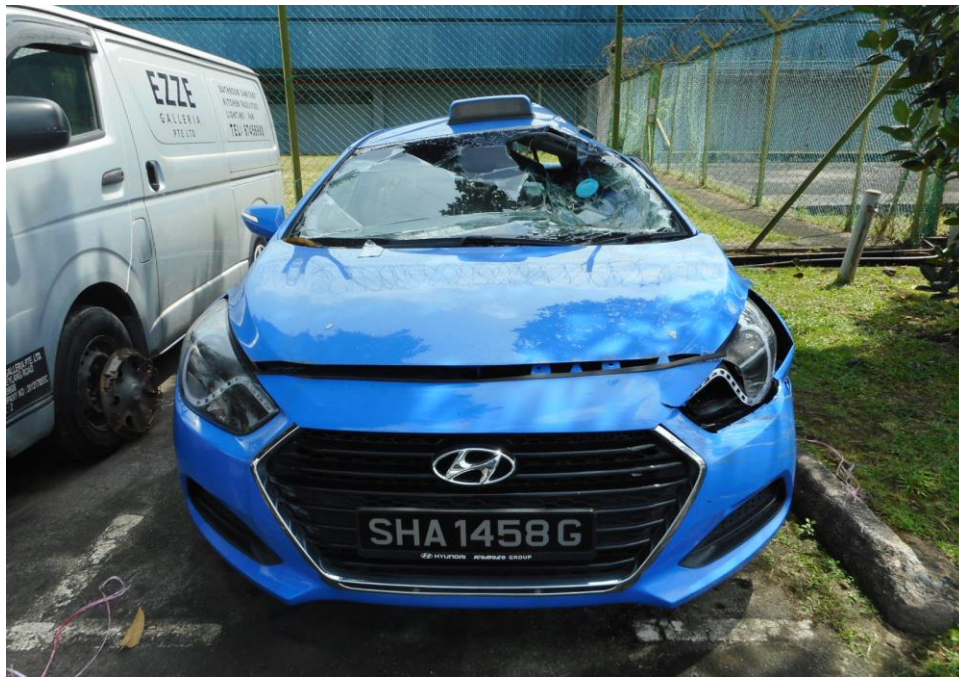
4. The mileage of the Motor Taxi at the time of my inspection was 715,472km.
5. The Motor Taxi was observed to have sustained damage at its front, left, rear and roof portion. Its front windscreen, bumper, bonnet, front left fender, front left headlamp, its left body panels, rear windscreen, rear boot and roof were amongst the body parts that were damaged as a result of the accident.

Photo 2 shows a general view of the Motor Taxi's front body at the time of my inspection. The Motor Taxi was observed to sustained damage at its front, left, rear and roof portion. Its front windscreen, bumper, bonnet, front left fender, front left headlamp, its left body panels, rear windscreen, rear boot and roof were amongst the body parts that were damaged as a result of the accident.

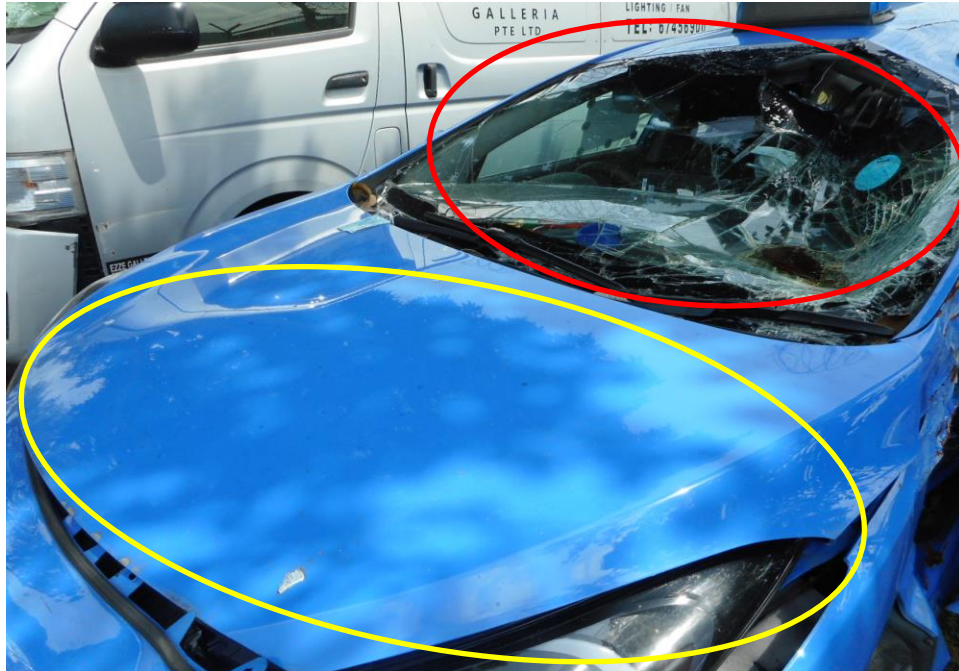
Photo 3 shows the close up view of the Motor Taxi's front body at the time of my inspection. The Motor Taxi was observed to have sustained damage at its front portion. Its front windscreen (red circle) and front bonnet (yellow circle) were amongst the body parts that were damaged as a result of the accident.

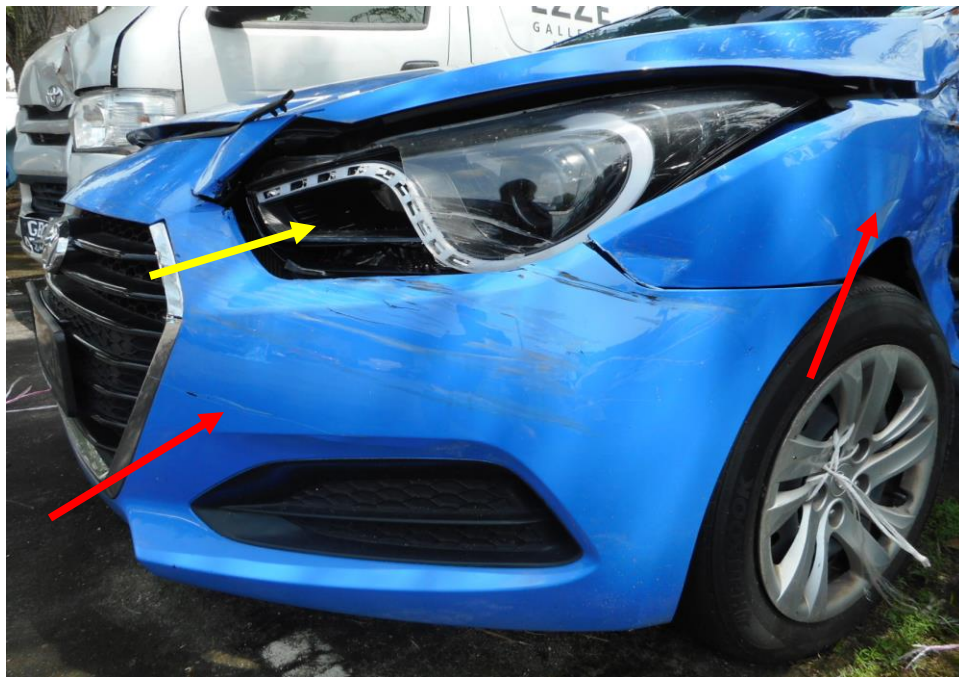
Photo 4 shows the close up view of the Motor Taxi's front body at the time of my inspection. The Motor Taxi was observed to have sustained damage at its front portion. Its front bumper, front left fender (red arrows), front left headlamp (yellow arrow) were amongst the body parts that were damaged as a result of the accident.

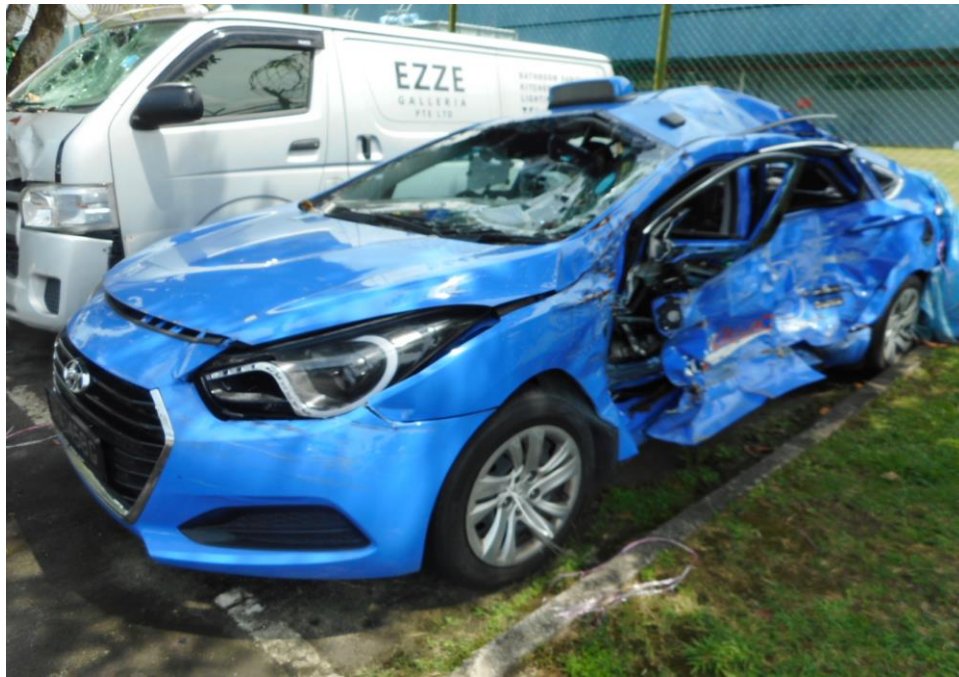
Photo 5 shows a general view of the Motor Taxi's left body at the time of my inspection. The Motor Taxi was observed to sustained damage at its left portion. Its left body panels were amongst the body parts that were damaged as a result of the accident.

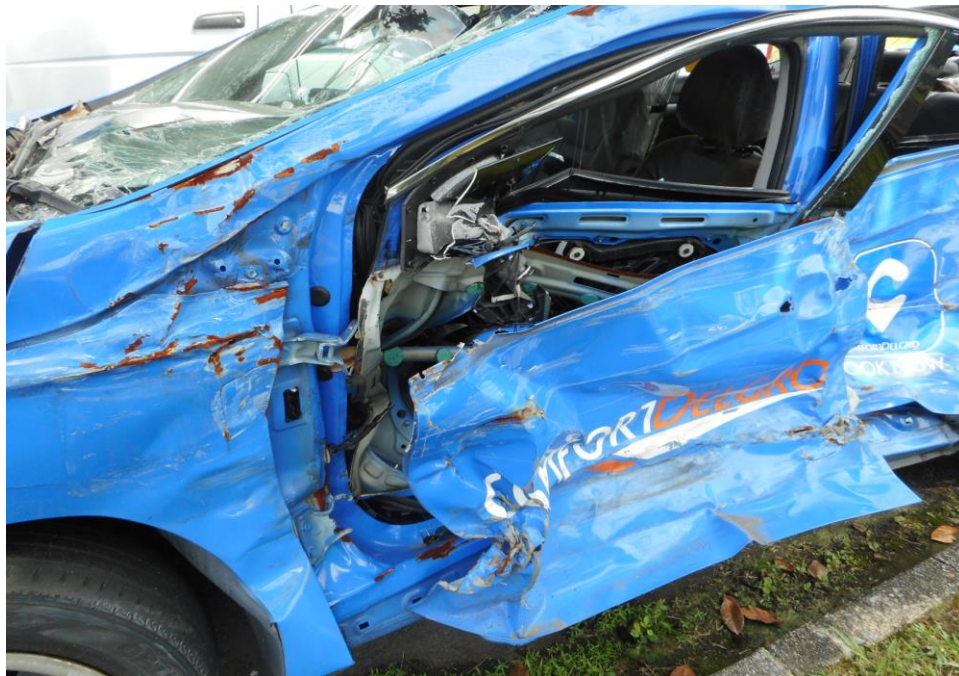
Photo 6 shows a close up view of the Motor Taxi's left body at the time of my inspection. The Motor Taxi was observed to sustained damage at its left portion. Its left front door body panel were amongst the body parts that were damaged as a result of the accident.

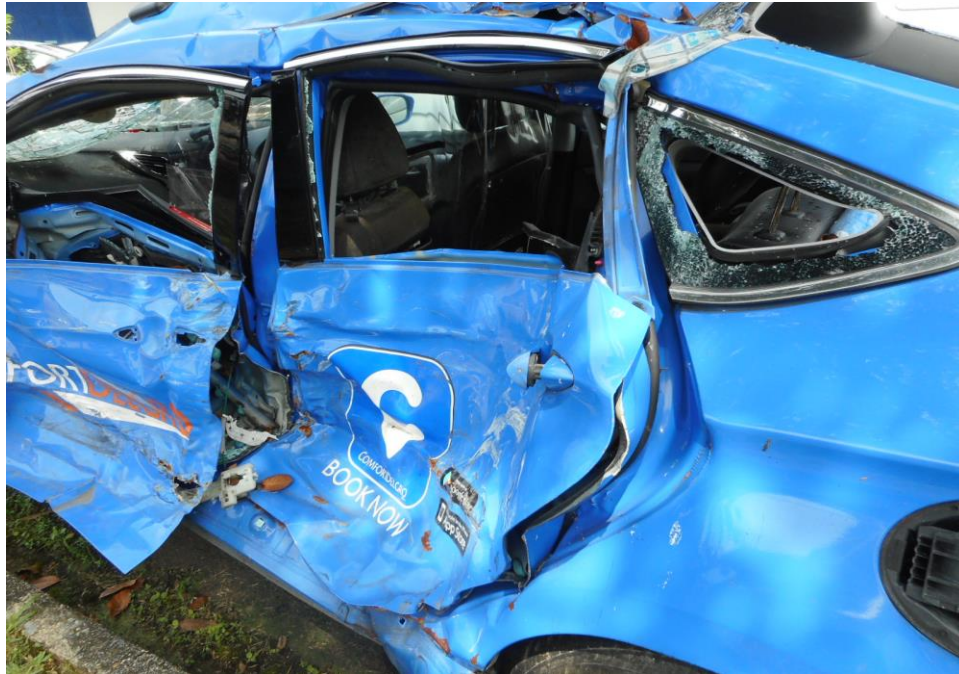
Photo 7 shows a close up view of the Motor Taxi's left body at the time of my inspection. The Motor Taxi was observed to sustained damage at its left portion. Its left rear door body panel were amongst the body parts that were damaged as a result of the accident.

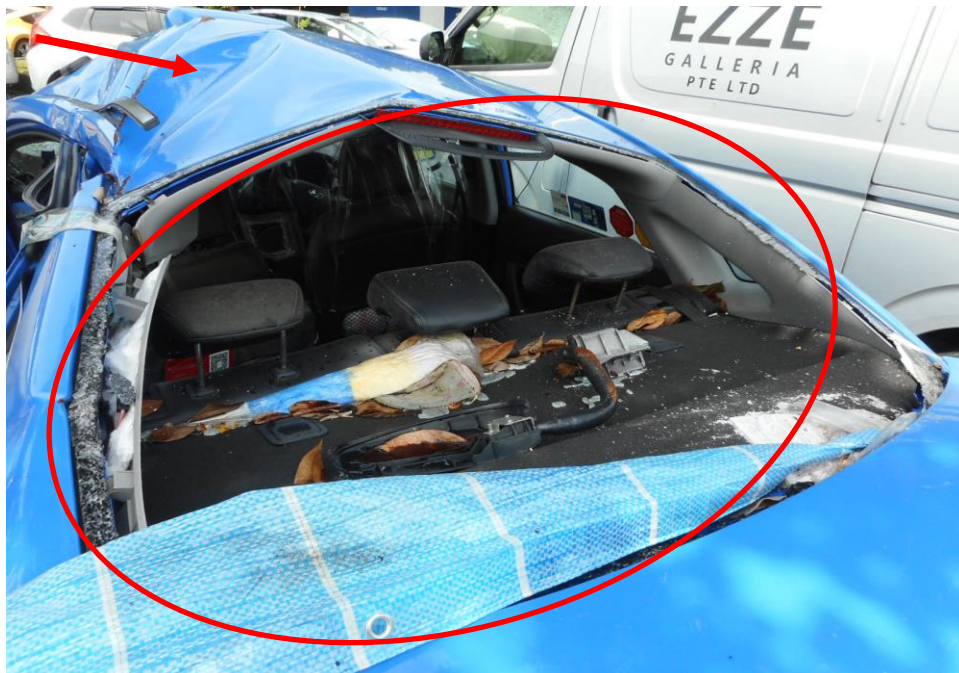
Photo 8 shows the close up view of the Motor Taxi's top and rear portion at the time of my inspection. The Motor Taxi was observed to sustained damage at its rear and roof portion. Its roof (arrowed) and rear windscreen (circled), were amongst the body parts that were damaged as a result of the accident.

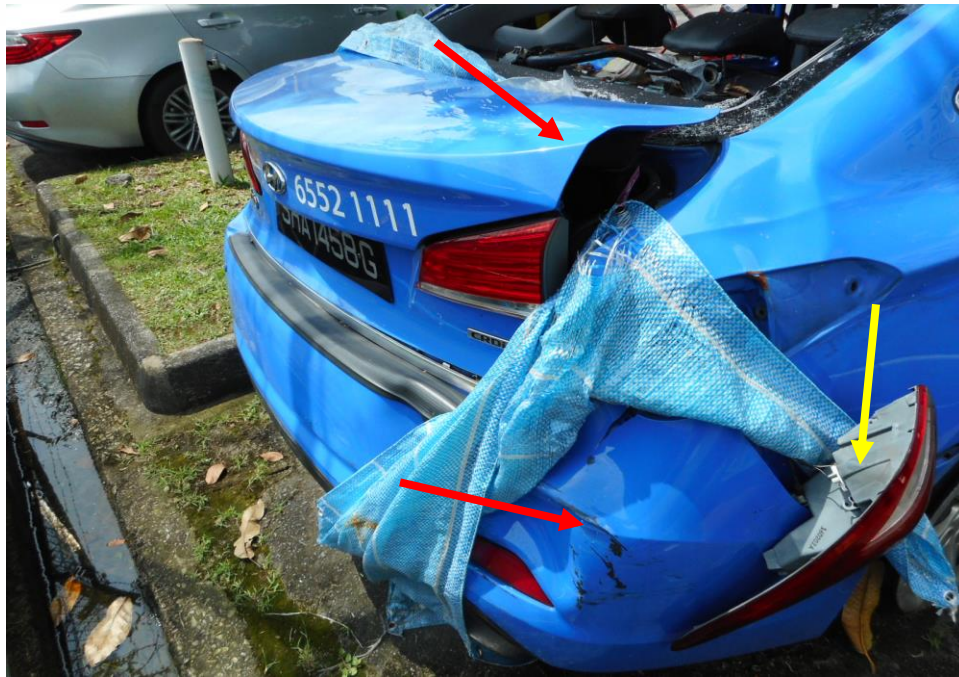
Photo 9 shows the close up view of the Motor Taxi's rear body at the time of my inspection. The Motor Taxi rear was observed to sustained damage at its rear portion. Its rear boot, rear bumper (red arrows) and rear right headlamp (yellow arrow) were amongst the body parts that were damaged as a result of the accident.

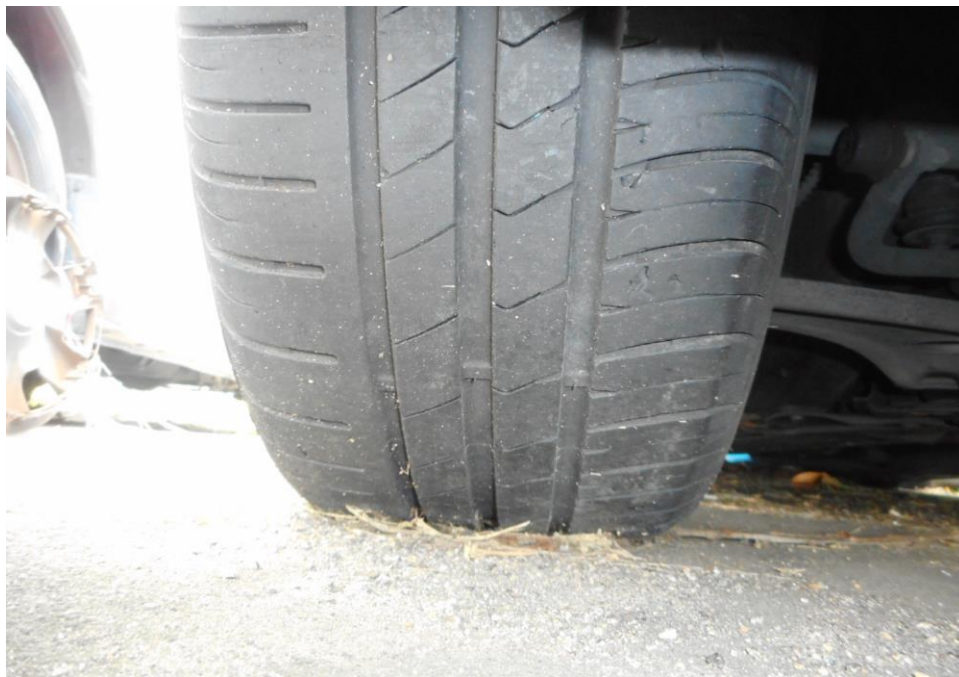
Photo 10 shows the condition of the front right tyre of the Motor Taxi, which was observed to be in serviceable condition with remaining tread depth of approximately 5.2mm. The tyre was sufficiently inflated for vehicular operation with no tear, cut or burst mark(s) on the outer and the inner sidewalls as well as across the tread.

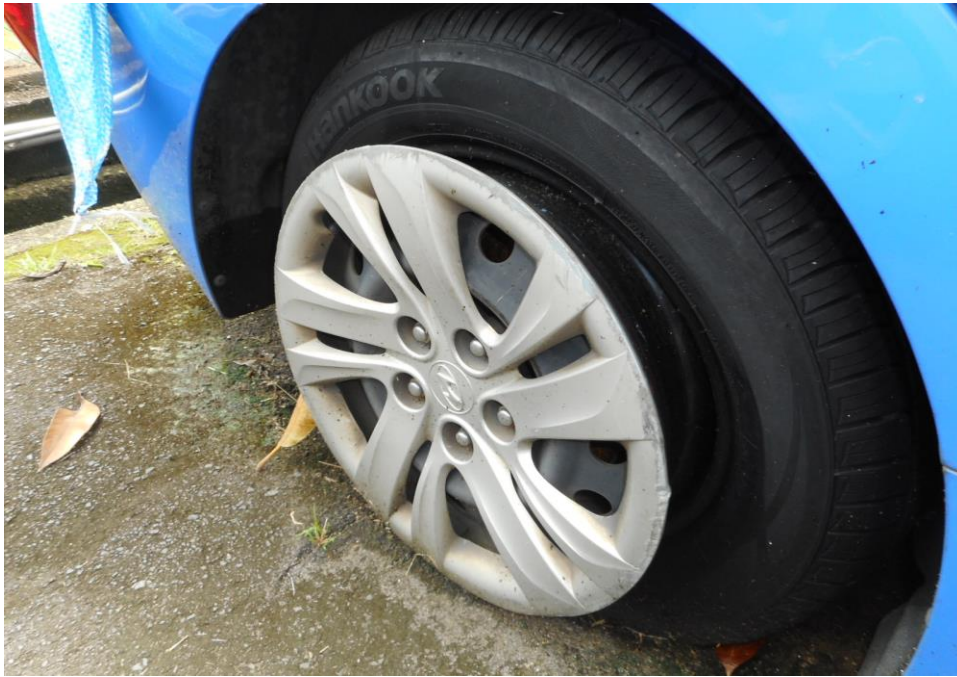
7. The right rear tyre was observed to slip out of the rim as a result of the accident. However the other 3 tyre were observed to be wrapped around standard steel wheel rims that were found to be without any damage. See photo 1 – 13 below.

Photo 11 shows the condition of the rear right tyre of the Motor Taxi, which was observed to slip off the rim as a result of the accident. The remaining tread depth of approximately 6.7mm. The tyre was observed to be deflated with no tear, cut or burst mark(s).

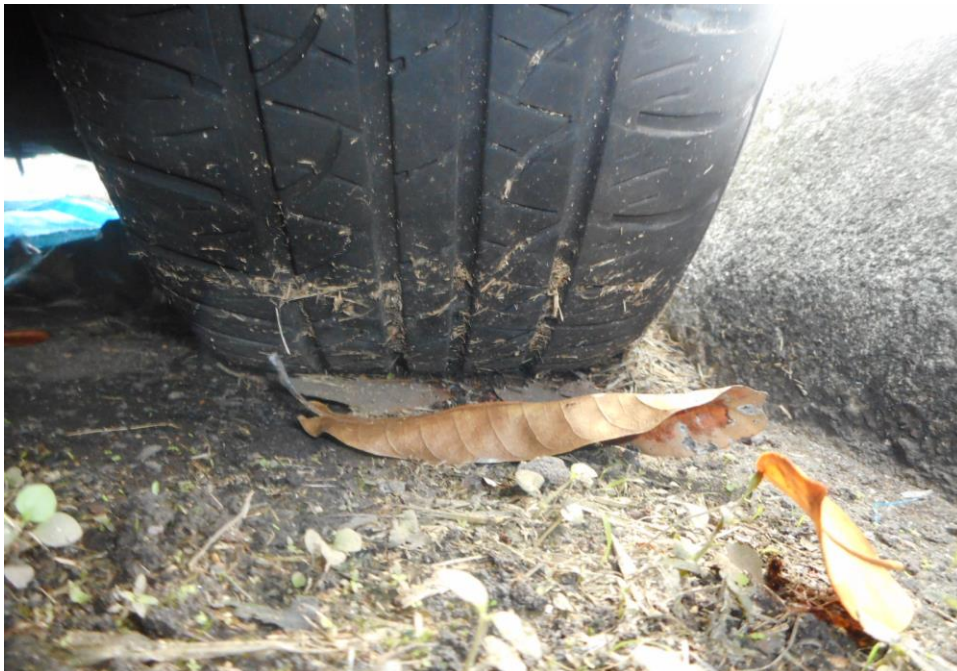
Photo 12 shows the condition of the rear left tyre of the Motor Taxi, which was observed to be in serviceable condition with remaining tread depth of approximately 4.6mm. The tyre, which was wrapped around steel wheel rim, was also observed to be sufficiently inflated for vehicular operation.

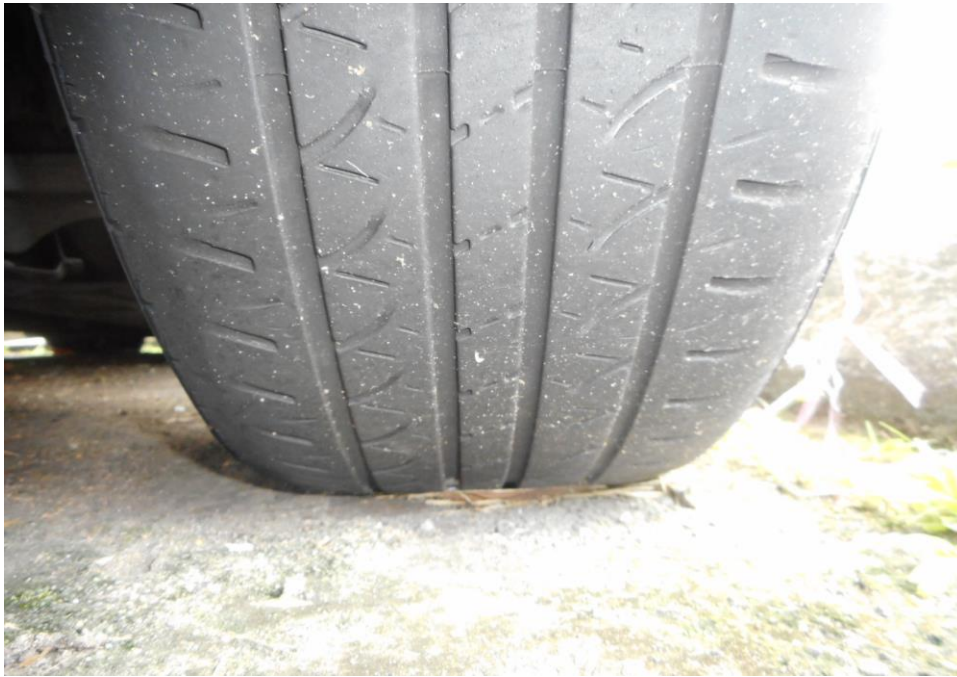
Photo 13 shows the condition of the front left tyre of the Motor Taxi, which was observed to be in serviceable condition with remaining tread depth of approximately 2.9mm. There was also no tear, cut or burst mark(s) on the outer and the inner sidewalls as well as across the tread of the Motor Taxi's 4 tyres.

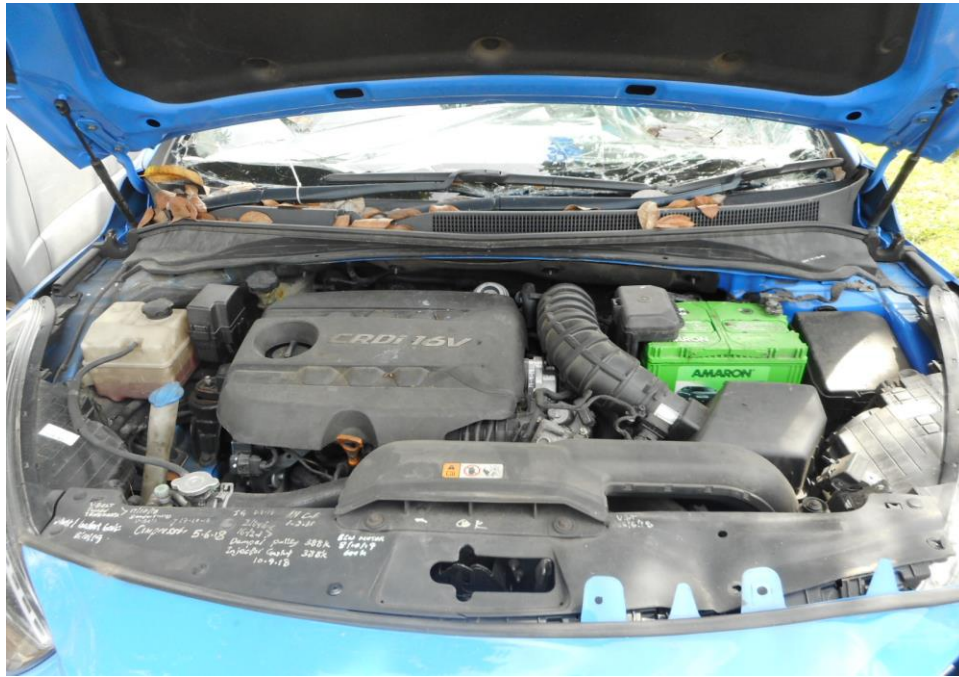
Photo 14 shows a general view of the Motor Taxi's engine compartment. The various parts and components inside the engine compartment were unaffected by the accident. There was also no sign(s) or indication(s) of fluid leakage and/or fluid stain within the engine compartment.

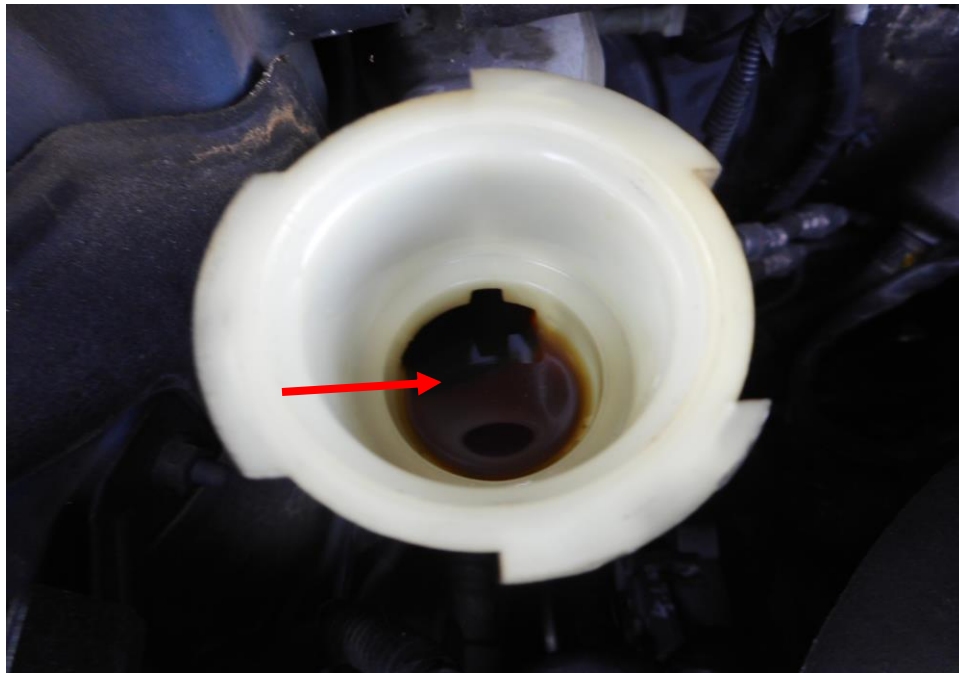
Photo 15 shows the brake fluid reservoir of the Motor Taxi at the time of my inspection. The brake fluid was observed to be of sufficient level (arrowed) and without any visible contamination.

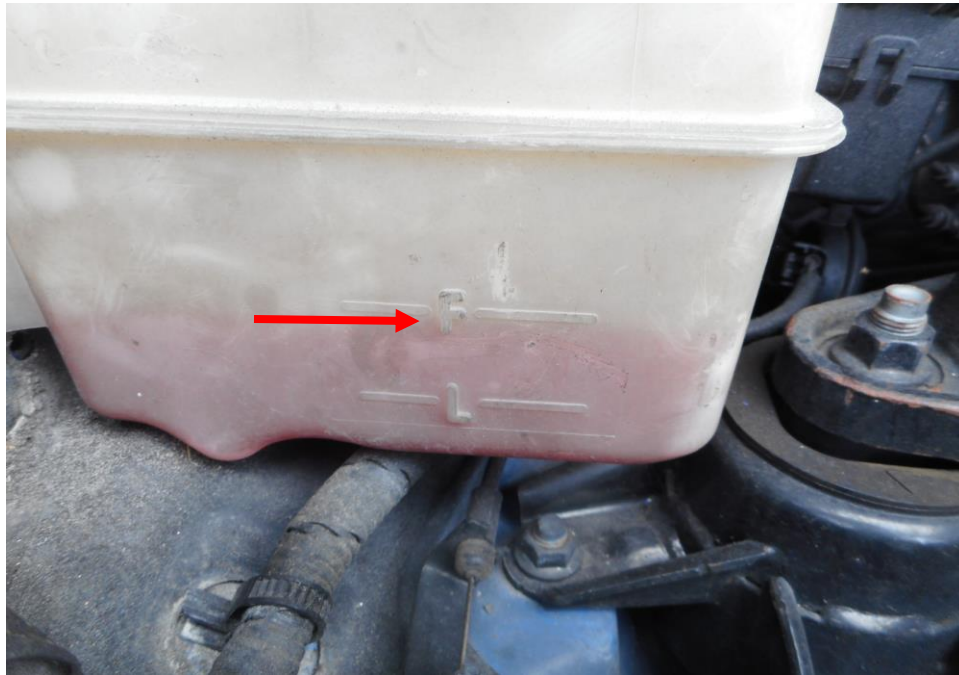
Photo 16 shows checks being carried out to the engine coolant of the Motor Taxi at the time of my inspection. The engine coolant was observed to be of sufficient level (arrowed) and without any visible contamination.

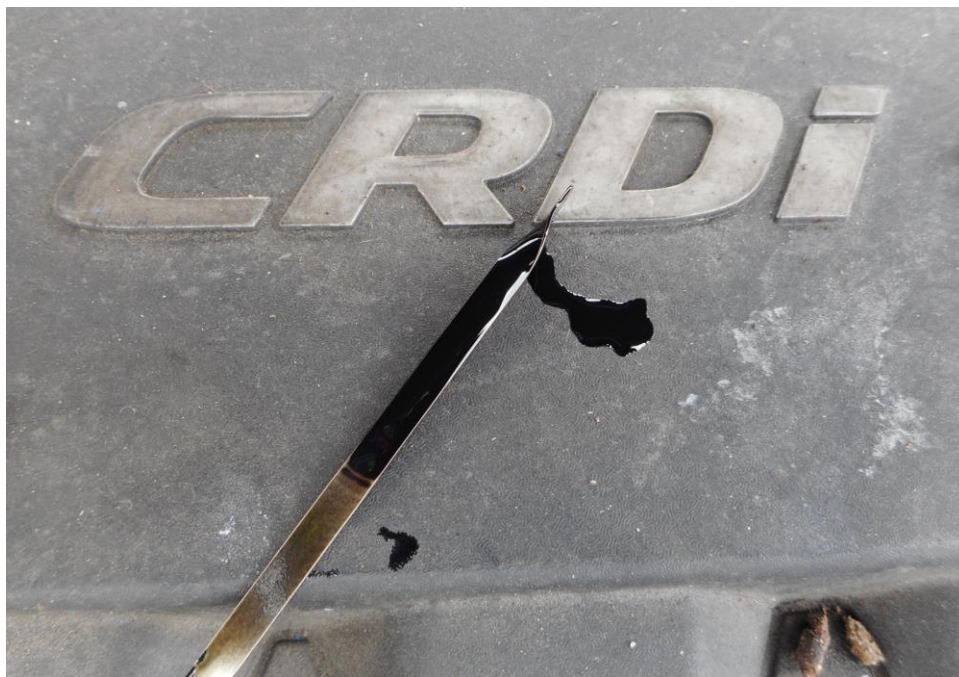
Photo 17 shows the engine oil dip stick of the Motor Taxi at the time of my inspection. The engine oil was observed to be of sufficient level and without any visible contamination.

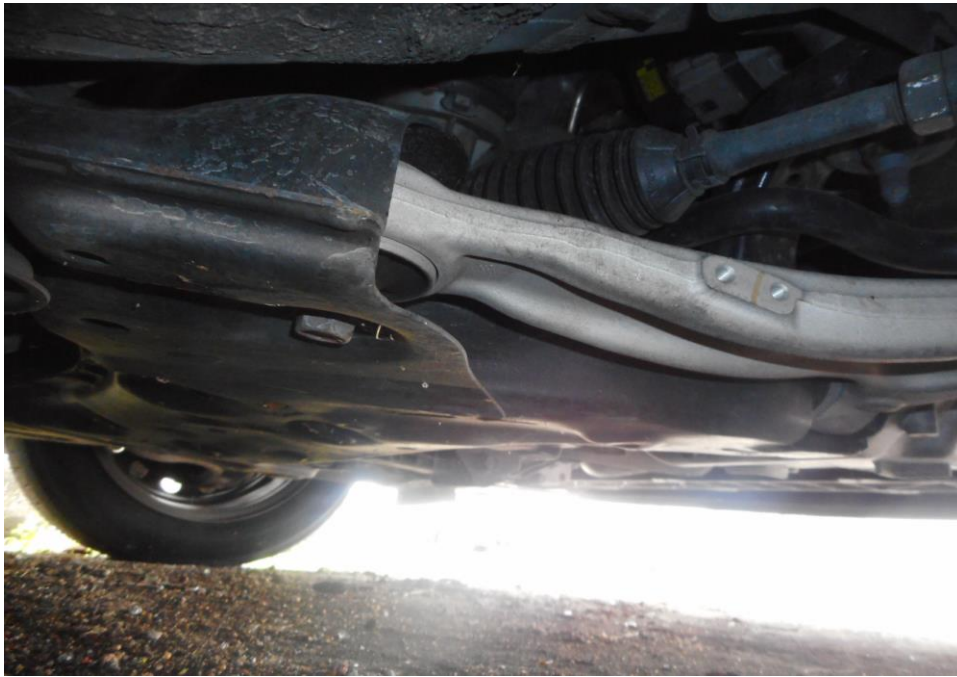
Photo 18 shows the undercarriage of the Motor Taxi, at the area where the engine housing and transmission housing are located. . I did not find any sign(s) or indication(s) of fluid leak and/or fluid stain(s) on the underside of the Motor Taxi.

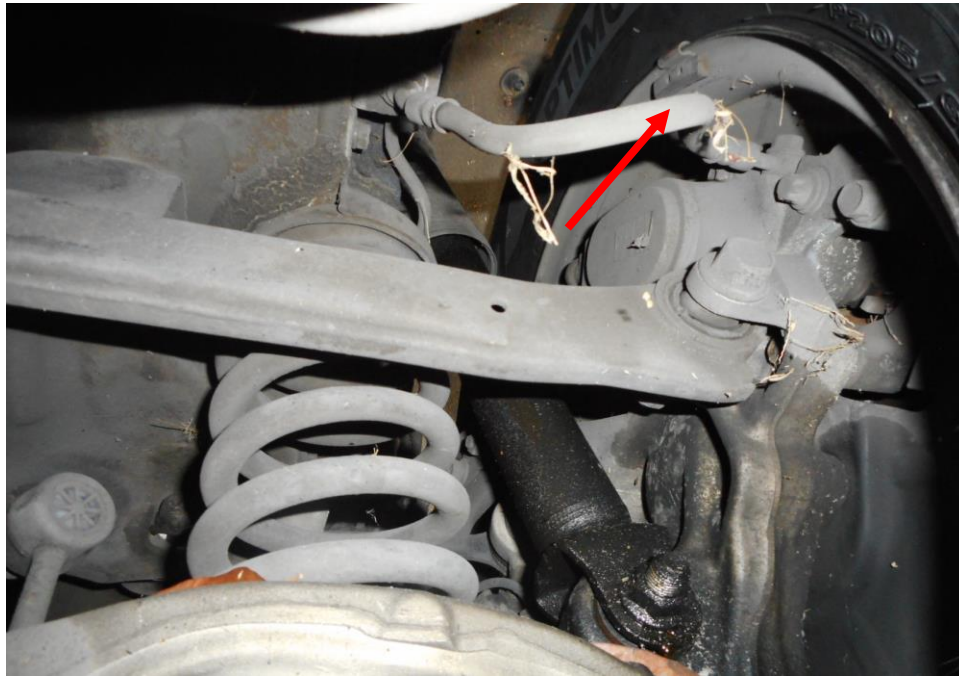
Photo 19 shows the brake hose/pipe (arrowed) at the rear right wheel of the Motor Taxi. No leakage of brake fluid was observed. Visual examination of the various components of the braking system like the drum brake, brake booster, brake pedal etc. had revealed all to be intact and without visible damage.

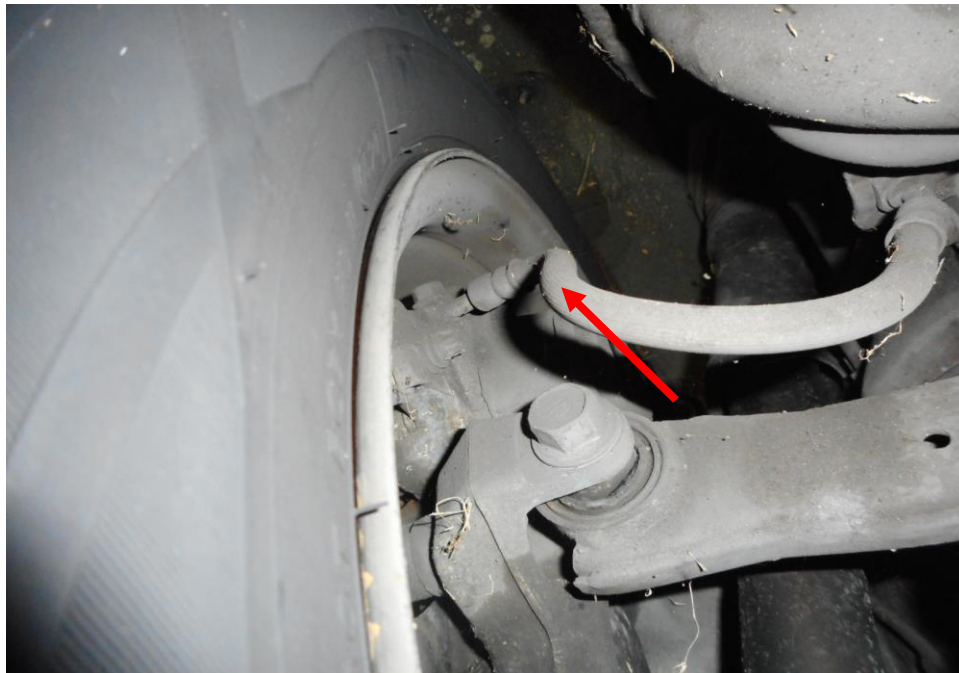
Photo 20 shows the brake hose/pipe (arrowed) at the rear left wheel of the Motor Taxi. I did not observe any leakage of brake fluid at the time of my inspection of the Motor Taxi. Static tests of the Motor Taxi's braking system had indicated that there was no internal leakage of pressure/vacuum. The undercarriage components of the Motor Taxi were also all found to be intact and without any visible damage.

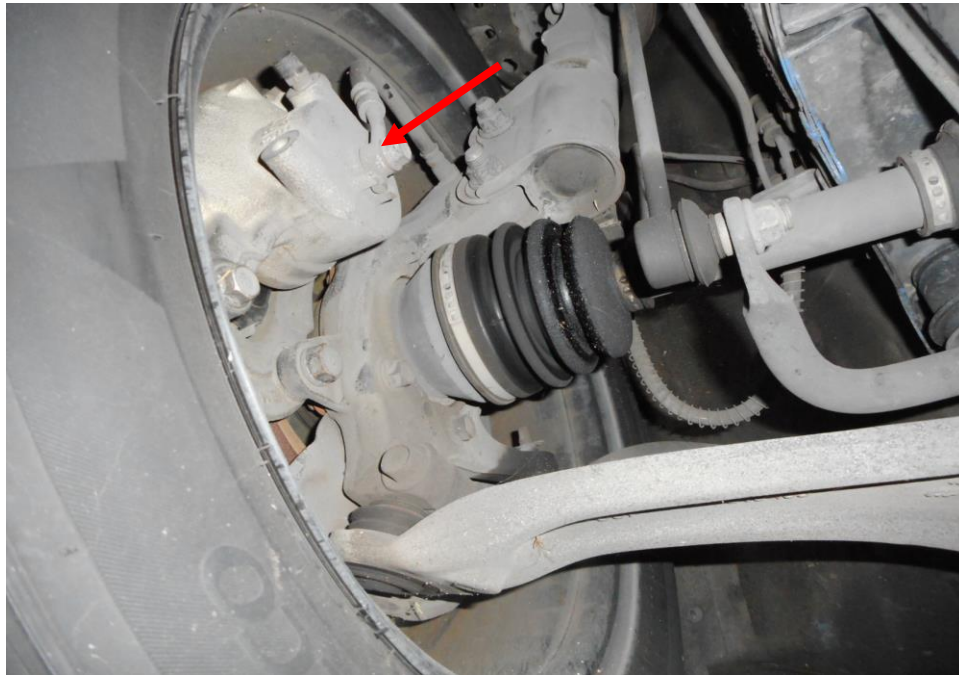
Photo 21 shows the brake hose/pipe (arrowed) at the front right wheel of the Motor Taxi. I did not observe any leakage of brake fluid at the time of my inspection of the Motor Taxi. Static tests of the Motor Taxi's braking system had indicated that there was no internal leakage of pressure/vacuum. The undercarriage components of the Motor Taxi were also all found to be intact and without any visible damage.

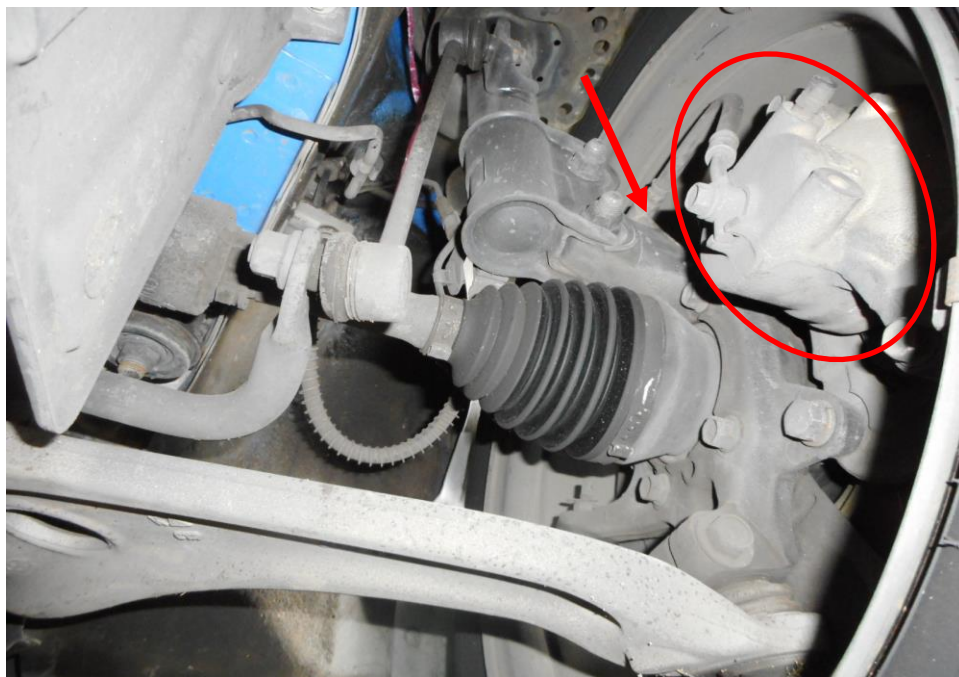
Photo 22 shows the brake hose/pipe (arrowed) at the front left wheel of the Motor Taxi. No leakage of brake fluid was observed. Visual examination of the various components of the braking system like the brake caliper (circled), brake booster, brake pedal etc had revealed all to be intact and without visible damage.

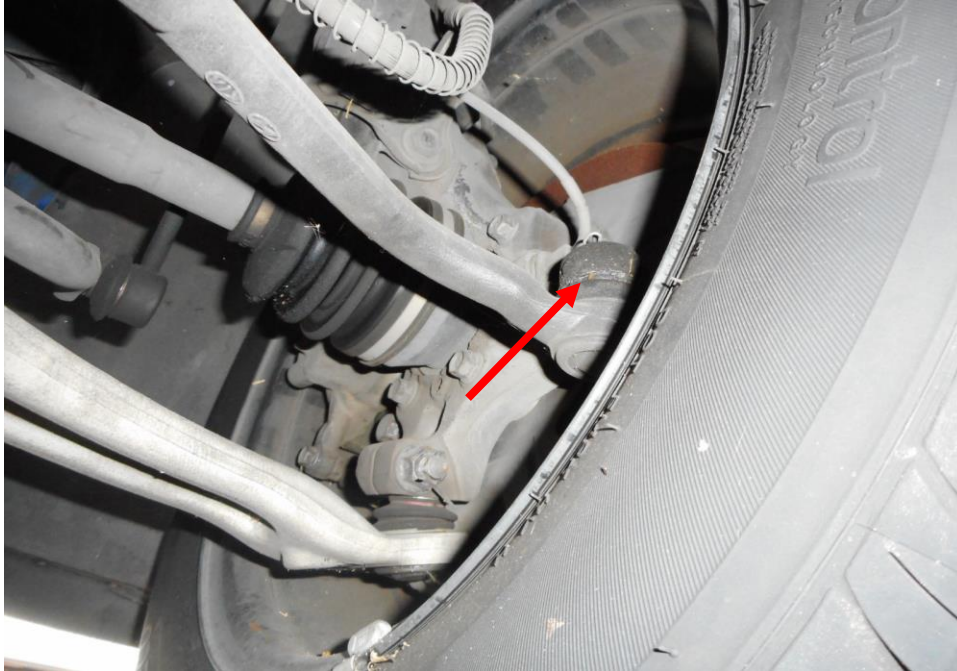
Photo 23 shows the various undercarriage components at the front right wheel of the Motor Taxi, in particular the steering tie rod (red arrow). The various steering components were all found to be intact, suggesting that the steering system of the Motor Taxi was likely to be in serviceable condition at the material time of accident. There was also no sign of fluid stain observed on the various undercarriage components at the front right wheel of the Motor Taxi.

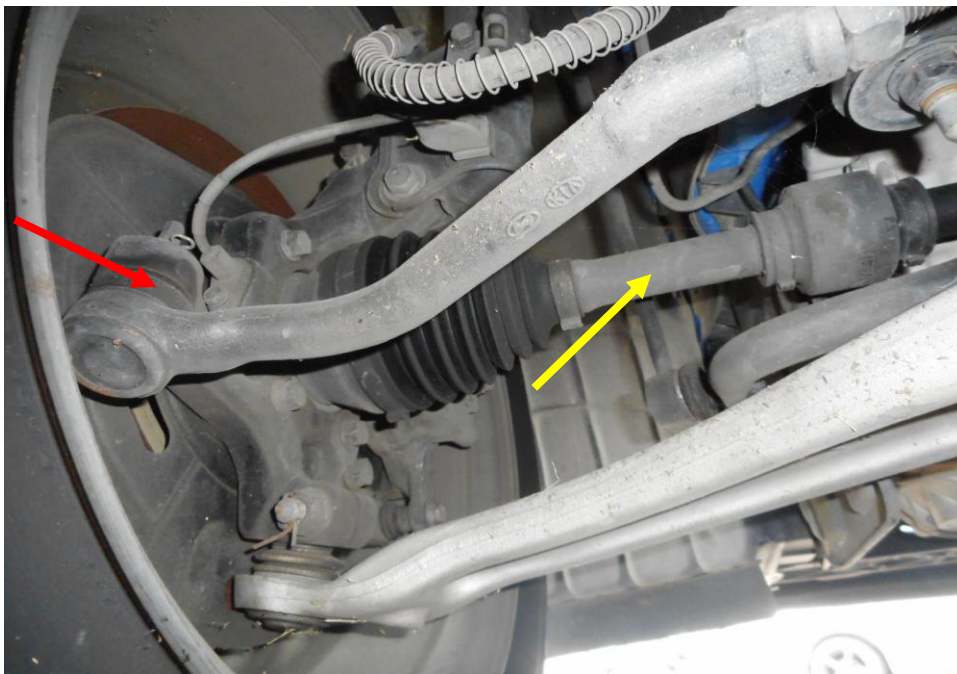
Photo 24 shows the various undercarriage components at the front left wheel of the Motor Taxi, in particular the steering tie rod (red arrow) and drive shaft (yellow arrow). The various steering components were all found to be intact, suggesting that the steering system of the Motor Taxi was likely to be in serviceable condition at the material time of accident. There was also no sign of fluid stain observed on the various undercarriage components at the front left wheel of the Motor Taxi.

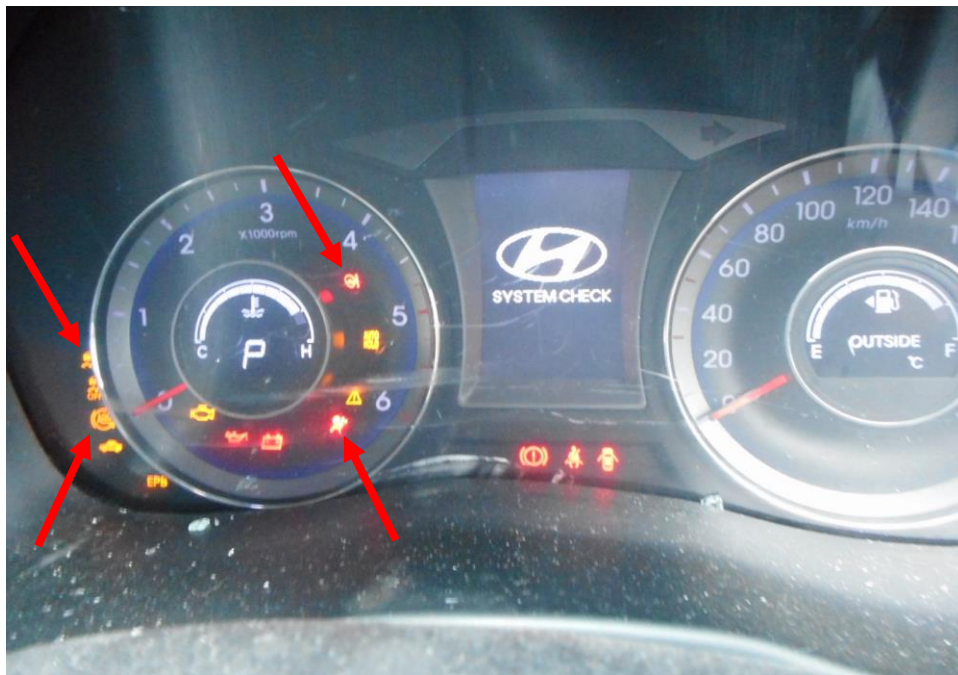
Photo 25 shows the warning light for Anti-Lock Brake System (ABS), Supplemental Restraint System (SRS), Electric Power Steering System (EPS) and Traction Control System (TC) appearing on the instrument panel of the Motor Taxi during the self-test of its various electronic operating systems when its engine was cranked.

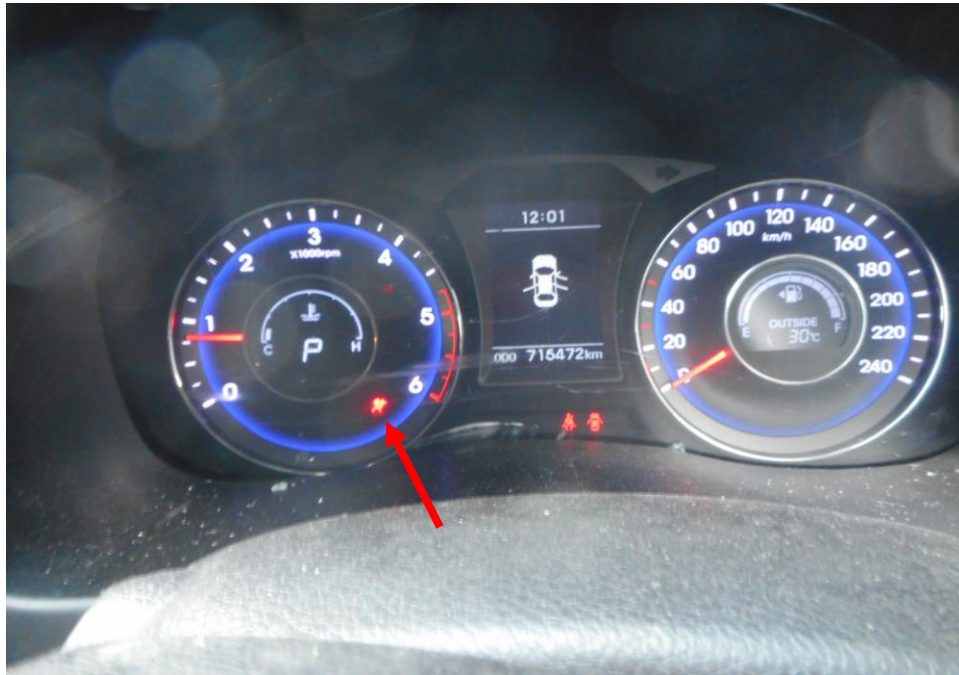
13. The Motor Taxi's automatic self-test of the functionality of its various electronic operating systems like the Anti-Lock Brake System (ABS), Supplemental Restraint System (SRS) and Electric Power Steering System (EPS) during cranking of the engine had indicated that these systems were in working condition and without abnormality. This can be established from the warning lights disappearing from the instrument panel after the self-test.
14. After cranking the engine, only the Supplemental Restraint System (SRS) (arrowed) remained illuminated on as this is likely due by the result of the accident to the Motor Taxi. See photo 25 & 26 below.

Photo 26 shows only the Supplemental Restraint System (SRS) (arrowed) remained illuminated on as this is likely caused by the result of the accident to the Motor Taxi. However, there was no other warning lights illuminated on the instrument panel of the Motor Taxi after the engine was cranked. This would suggest that there was no abnormality to the various electronic operating systems of the Motor Taxi, like the ABS, TC and EPS.
