Your Ref: TP/IP/32267/2020  
Our Ref: CI/TPD20012452/P

13<sup>th</sup> January 2021

**Fatal Accident Investigation Team**

**MECHANICAL INSPECTION REPORT OF MOTOR LORRY YN 4215B**

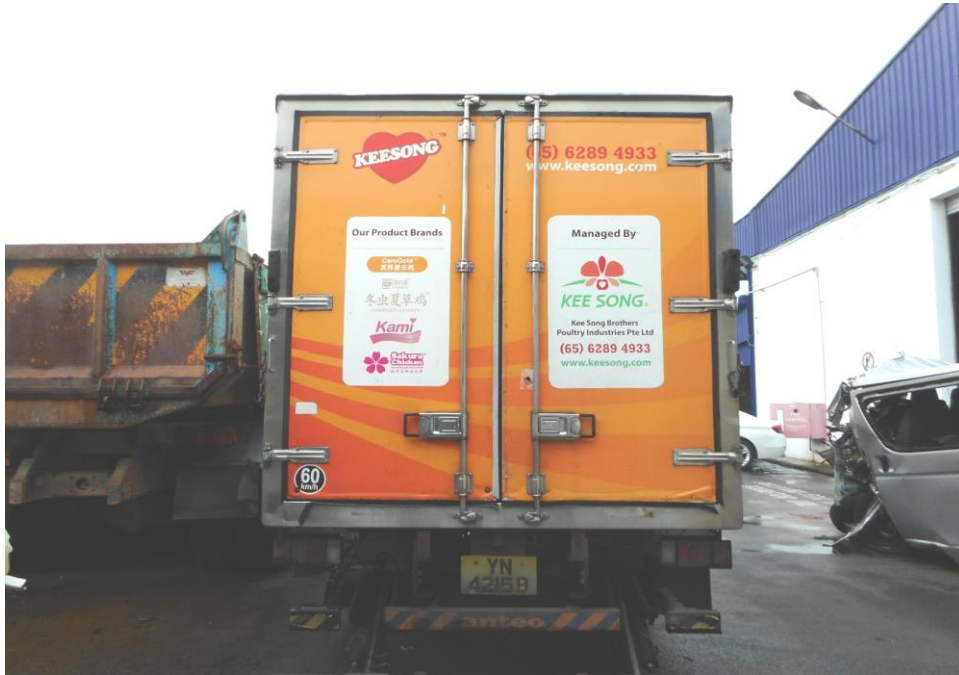
**Photo 1** shows the general view of the rear portion of the Motor Lorry at the time of our inspection. The Motor Lorry was observed to be unaffected by the accident.

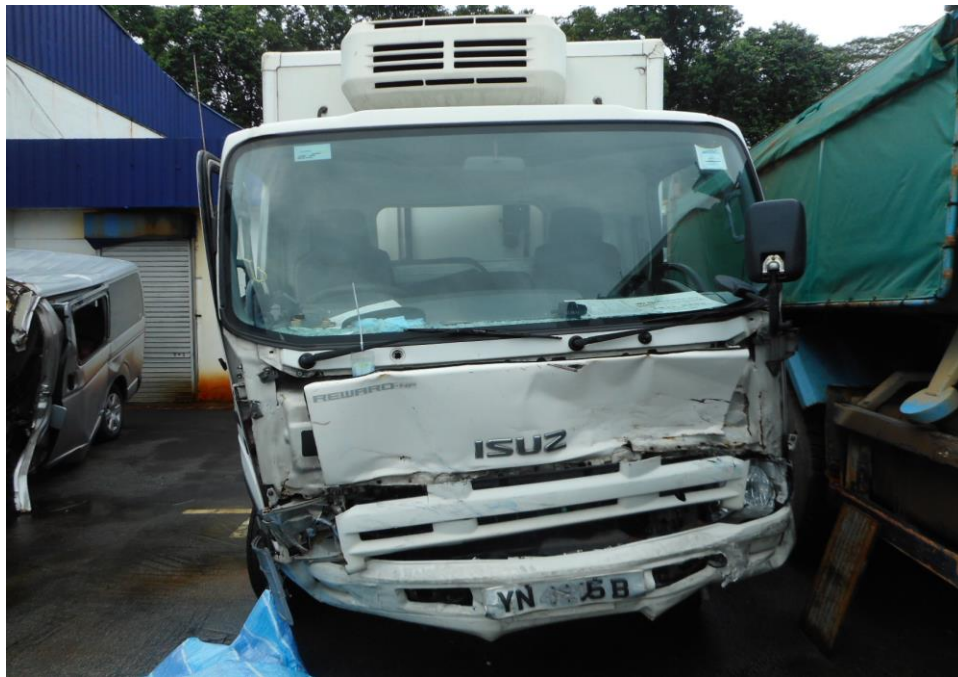
**Photo 2** shows a general view of its front cabin structure portion. Its front windscreen, front body panel, front bumper, right and left doors as well as both front headlamps was damaged as a result of the accident.

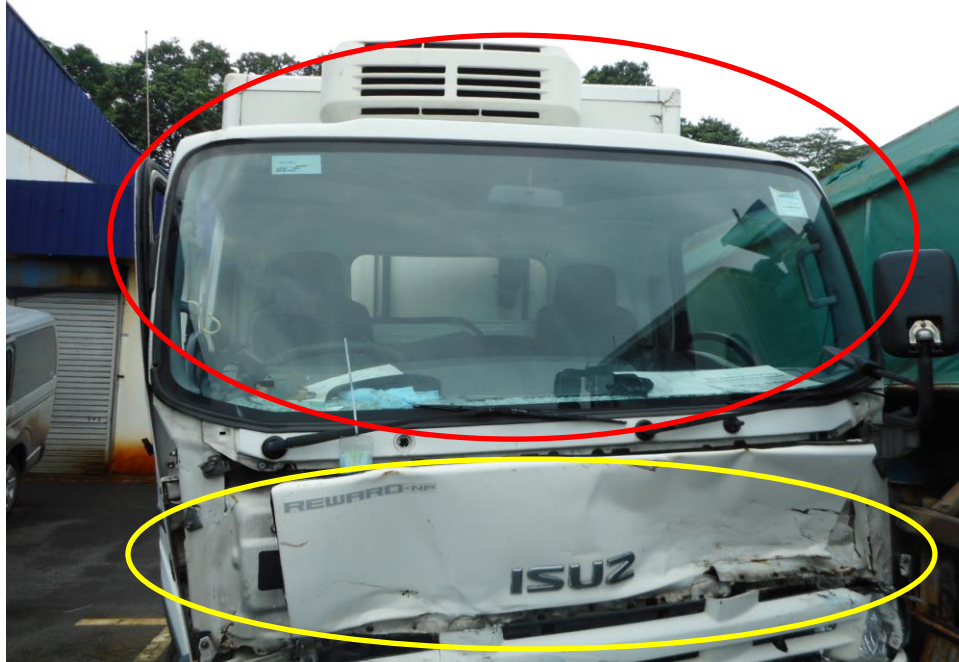
**Photo 3** shows a close up view of the front body of the Motor Lorry at the time of our inspection. The Motor Lorry was observed to have sustained damages to its front cabin body structure, front windscreen (red circle) and front cabin body panel (yellow circle) as a result of the accident.

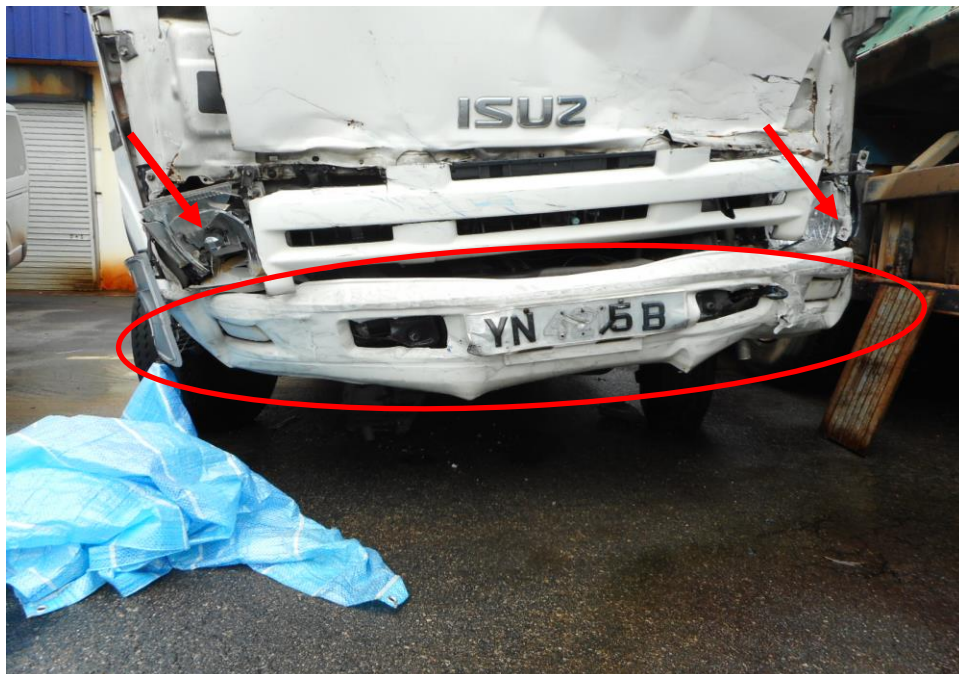
**Photo 4** shows a close up view of the front body of the Motor Lorry at the time of our inspection. The Motor Lorry was observed to have sustained damages to its front bumper (circled) and both its front headlamps (arrowed) as a result of the accident.

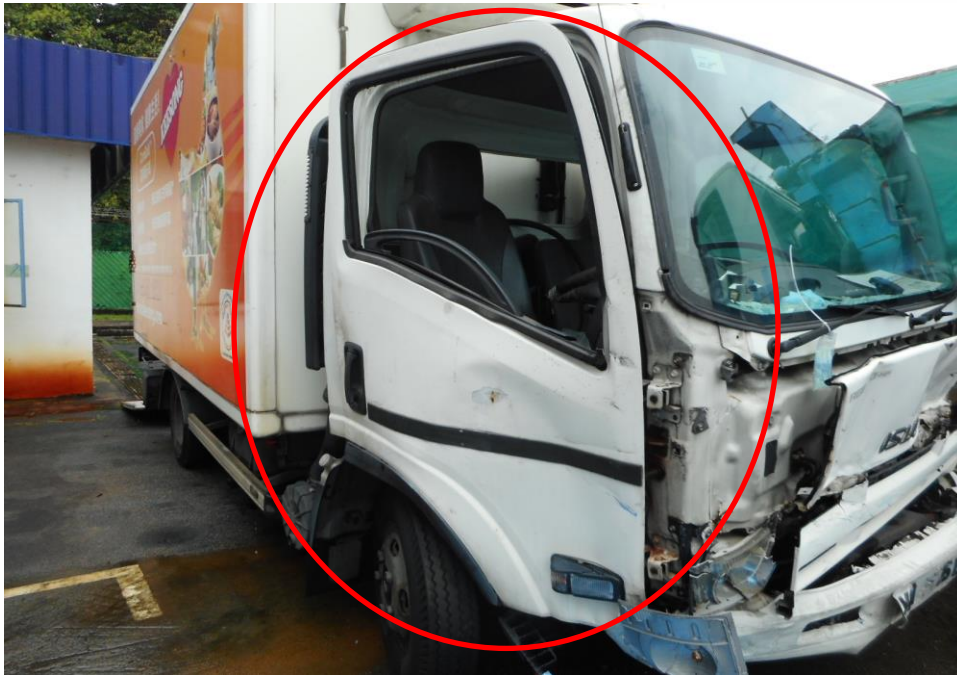
**Photo 5** shows a close up view of the right body of the Motor Lorry at the time of our inspection. The Motor Lorry was observed to have sustained damages to its right door (circled) as a result of the accident.

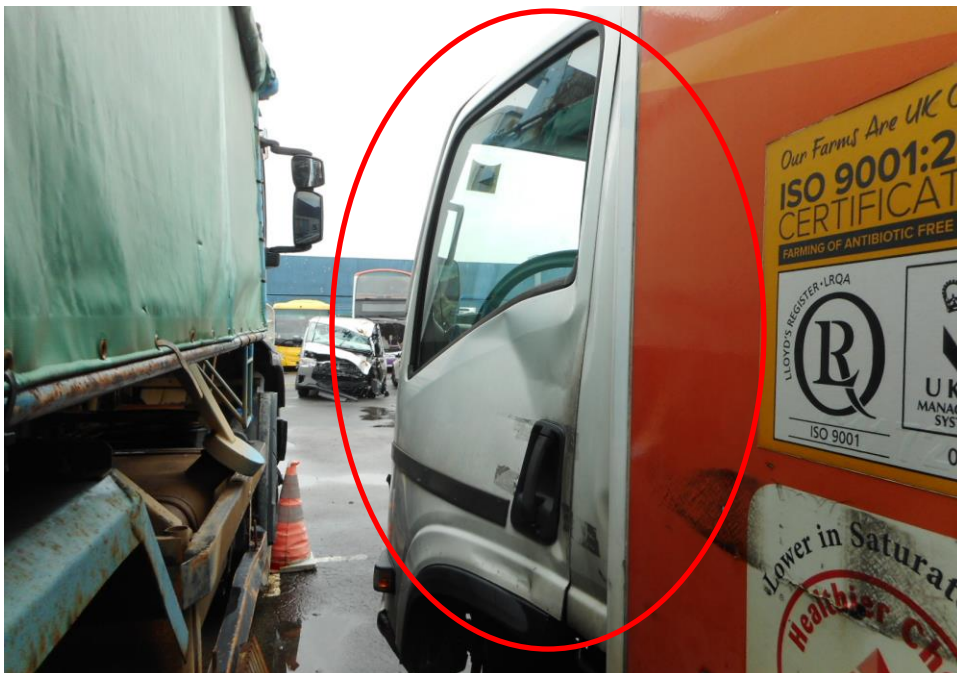
**Photo 6** shows a close up view of the left body of the Motor Lorry at the time of our inspection. The Motor Lorry was observed to have sustained damages to its left door (circled) as a result of the accident.

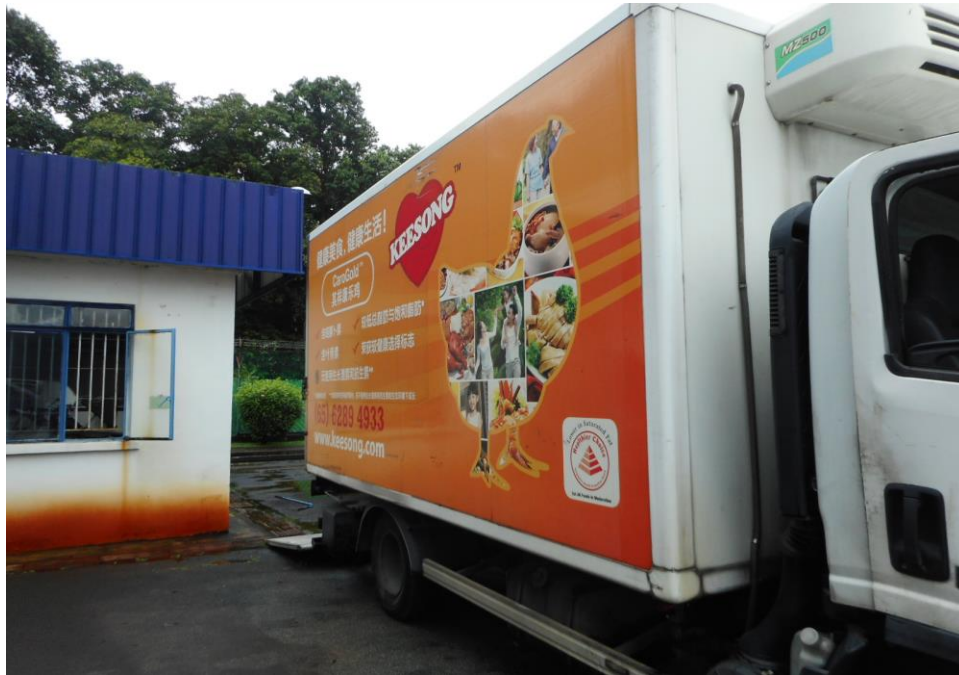
**Photo 7** shows a general view of the right portion of the Motor Lorry at the time of our inspection. The Motor Lorry right portion was observed to be unaffected by the accident.

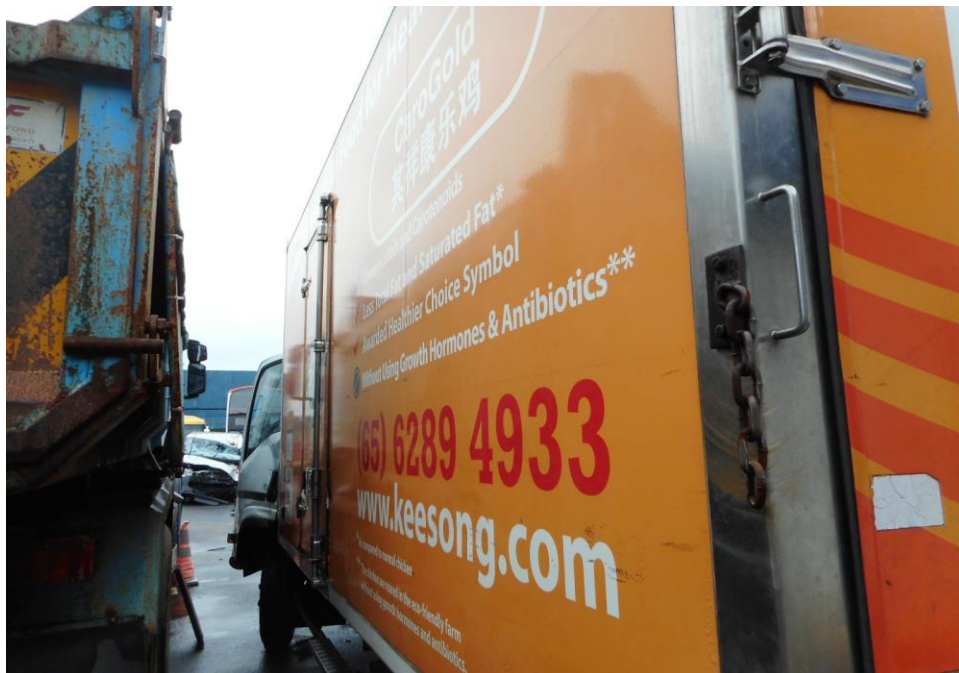
**Photo 8** shows a general view of the left portion of the Motor Lorry at the time of our inspection. The Motor Lorry left portion was observed to be unaffected by the accident.

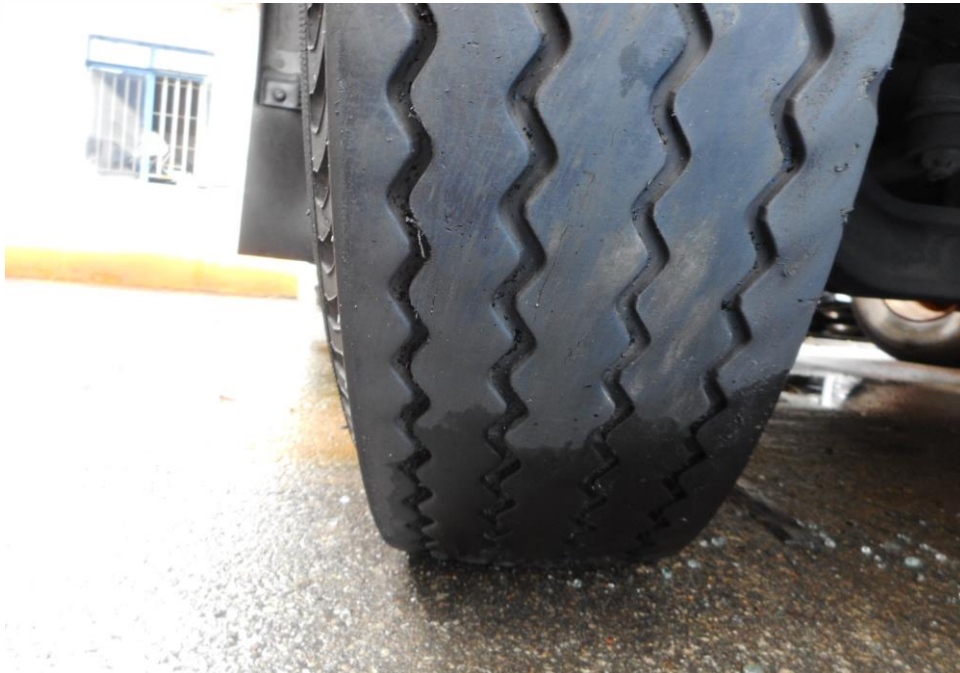
**Photo 9** shows the condition of the front right tyre of the Motor Lorry, which was observed to be in serviceable condition with remaining tread depth of approximately 5.4mm. The tyre, which was wrapped around standard steel wheel rim, was also observed to be sufficiently inflated for vehicular operation.

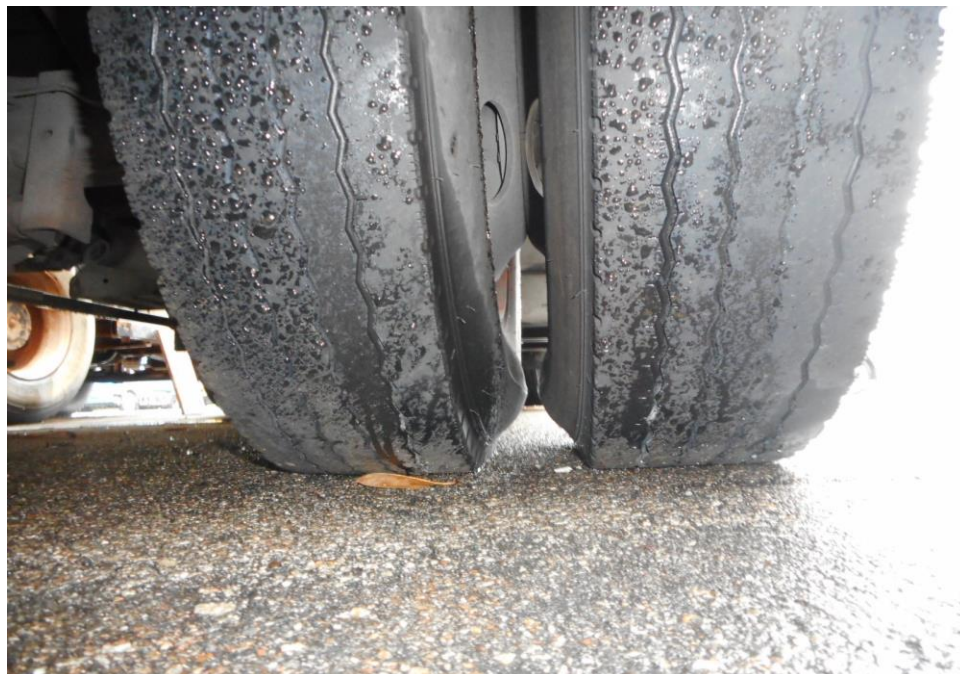
**Photo 10** shows the condition of the rear right tyres of the Motor Lorry, which was observed to be in serviceable condition with remaining tread depth of approximately 0.4mm. The tyre, which was wrapped around standard steel wheel rim, was also observed to be sufficiently inflated for vehicular operation.

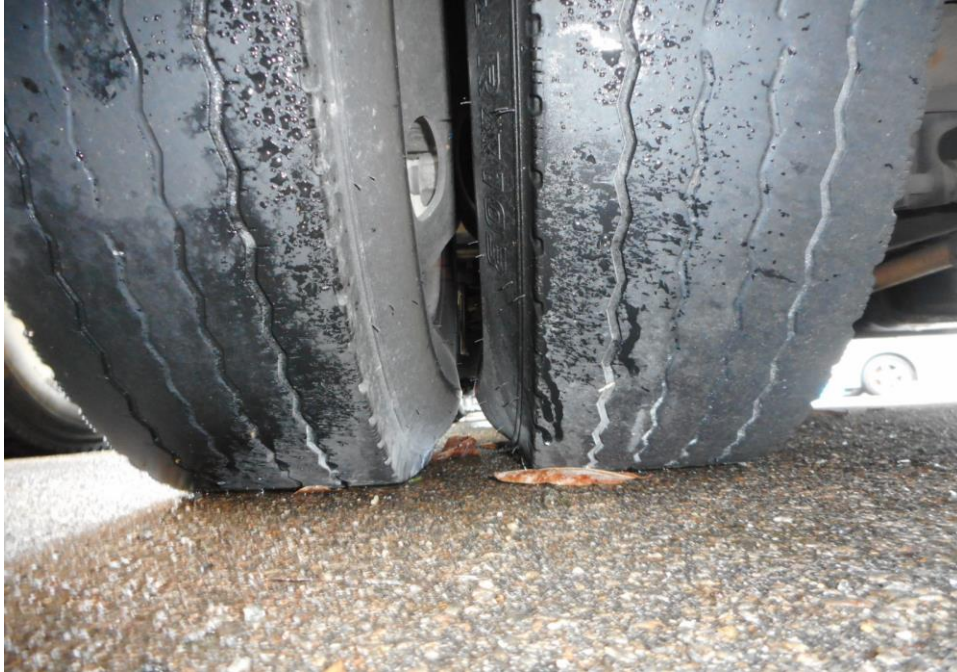
**Photo 11** shows the condition of the rear left tyre of the Motor Lorry, which was observed to be in serviceable condition with remaining tread depth of approximately 1.8mm. The tyre, which was wrapped around standard steel wheel rim, was also observed to be sufficiently inflated for vehicular operation.

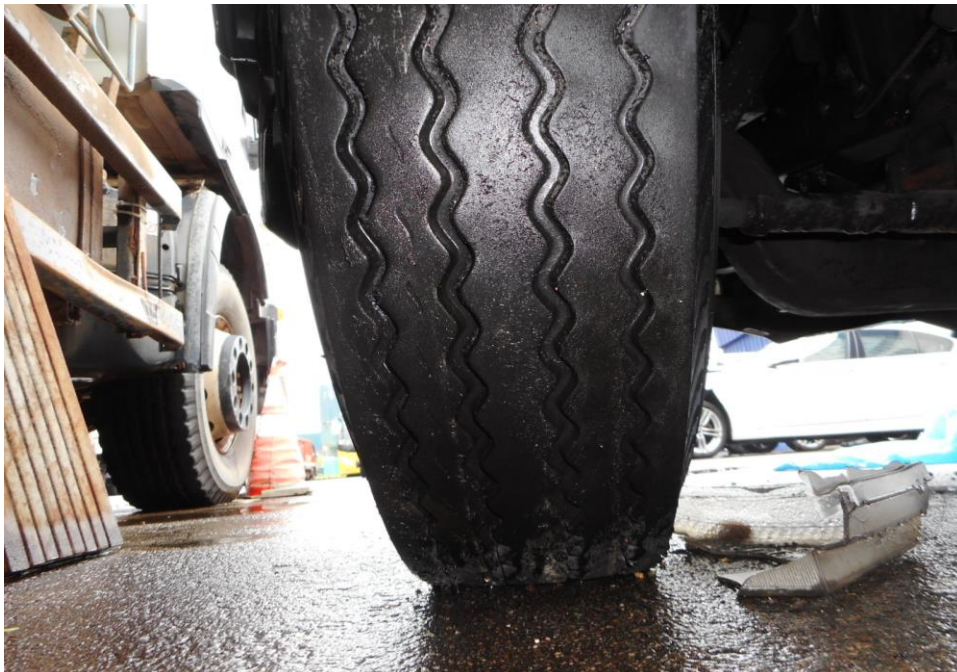
**Photo 12** shows the condition of the front left tyres of the Motor Lorry, which observed to be in serviceable condition with remaining tread depth of approximately 7.8mm. The tyres, which were wrapped around standard steel wheel rim, were also observed to be sufficiently inflated for vehicular operation.

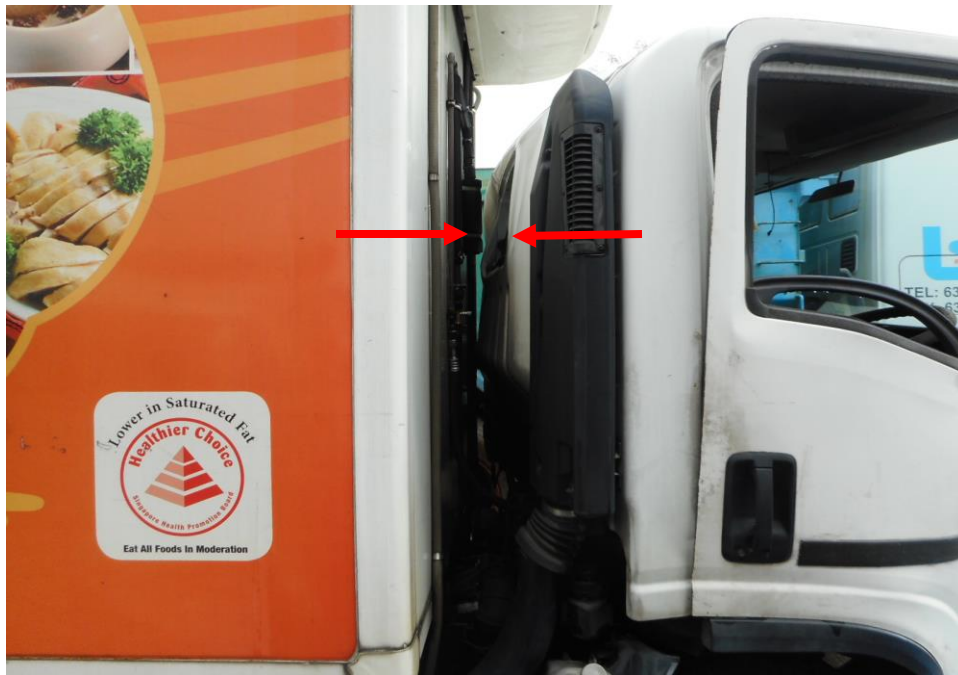
8. Upon examination of the Motor Lorry's engine compartment, we had observed that all the parts, components and fluids could not be inspected as due to the damage induced has crushed and deformed the cabin of the Motor Lorry which immobilized its opening and viewing, however we are able to observe the brake fluid reservoir, engine coolant reservoir and the power steering fluid of the Motor Lorry and it was observed to be sufficient level without any visible contamination.
9. Our subsequent checks on the underside of the Motor Lorry also revealed no sign(s) or indication(s) of fluid leak and/or fluid stain(s). Visually, the various undercarriage components of the Motor Lorry were all observed to be intact and without any visible damage. See photo 13 – 17 below.

**Photo 13** shows the induced damage to the cabin of the Motor Lorry's which immobilised the opening and viewing (arrowed) of the various parts and components inside the engine compartment, a result of the accident.

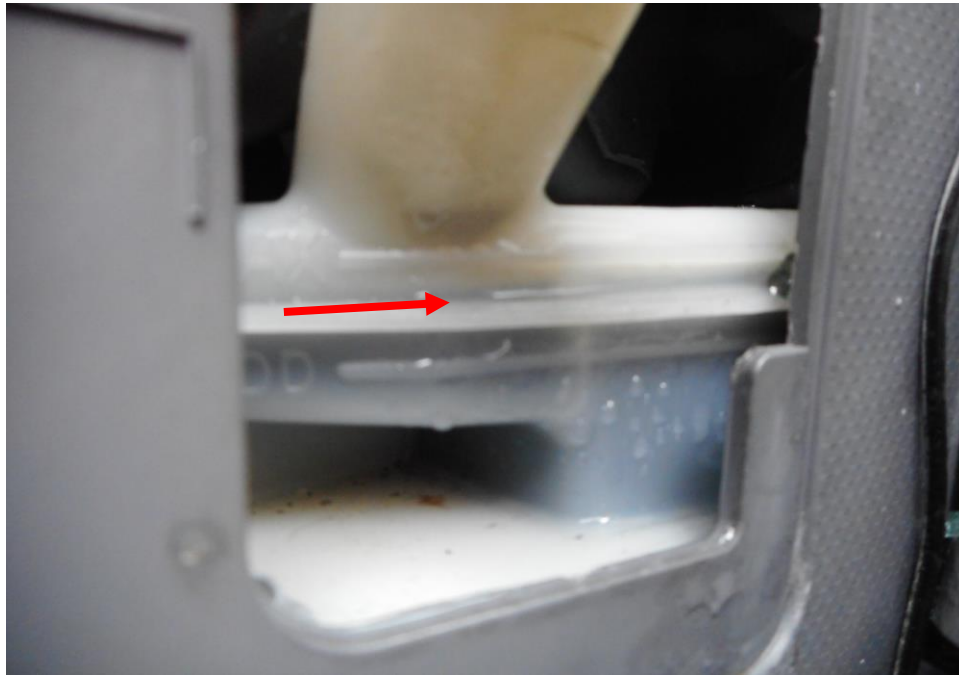
**Photo 14** shows the brake fluid reservoir of the Motor Lorry at the time of my inspection. The brake fluid was observed to be of sufficient level (arrowed) and without any visible contamination.

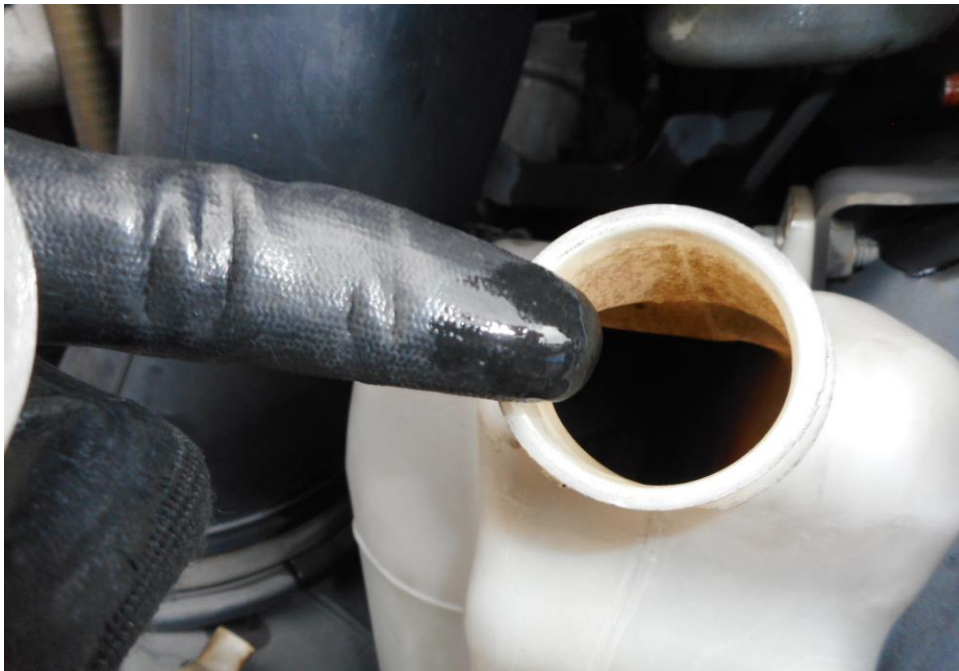
**Photo 15** shows the engine coolant reservoir of the Motor Lorry at the time of my inspection. The engine coolant was observed to be of sufficient level and without any visible contamination.

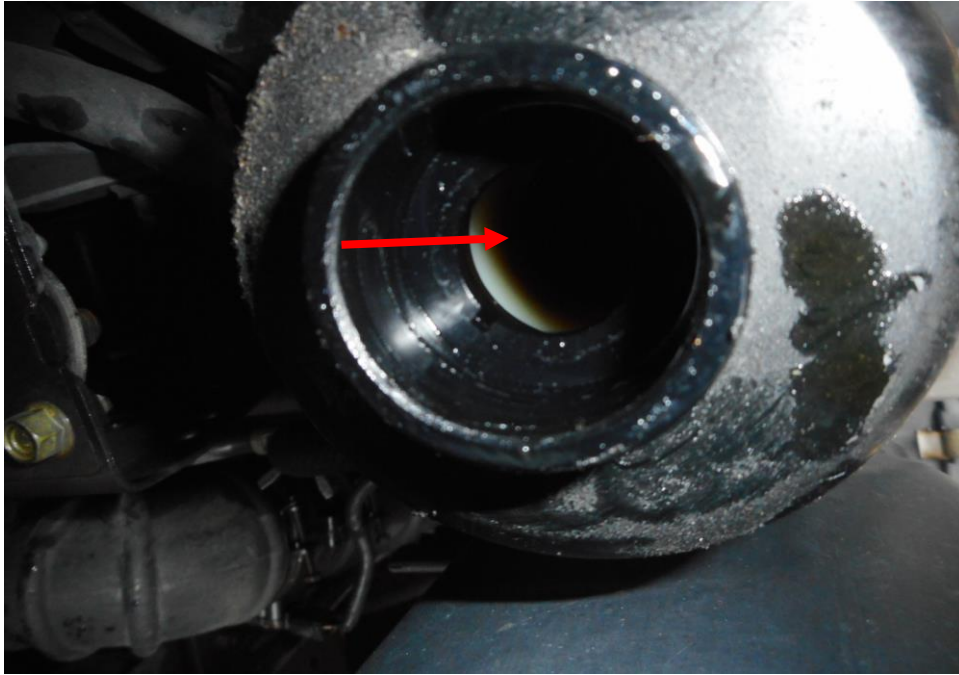
**Photo 16** shows the power steering fluid dip stick of the Motor Lorry at the time of my inspection. The steering fluid oil was observed to be of sufficient level (arrowed) and without any visible contamination.

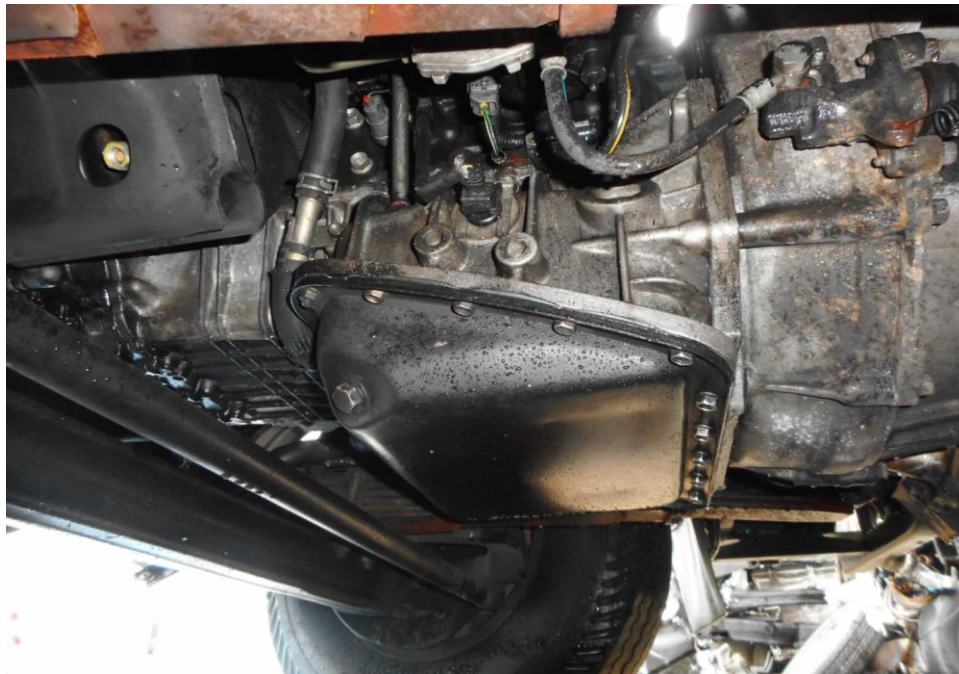
**Photo 17** shows the undercarriage of the Motor Lorry, at the area where the engine housing and transmission housing are located. . I did not find any sign(s) or indication(s) of fluid leak and/or fluid stain(s) on the underside of the Motor Lorry.

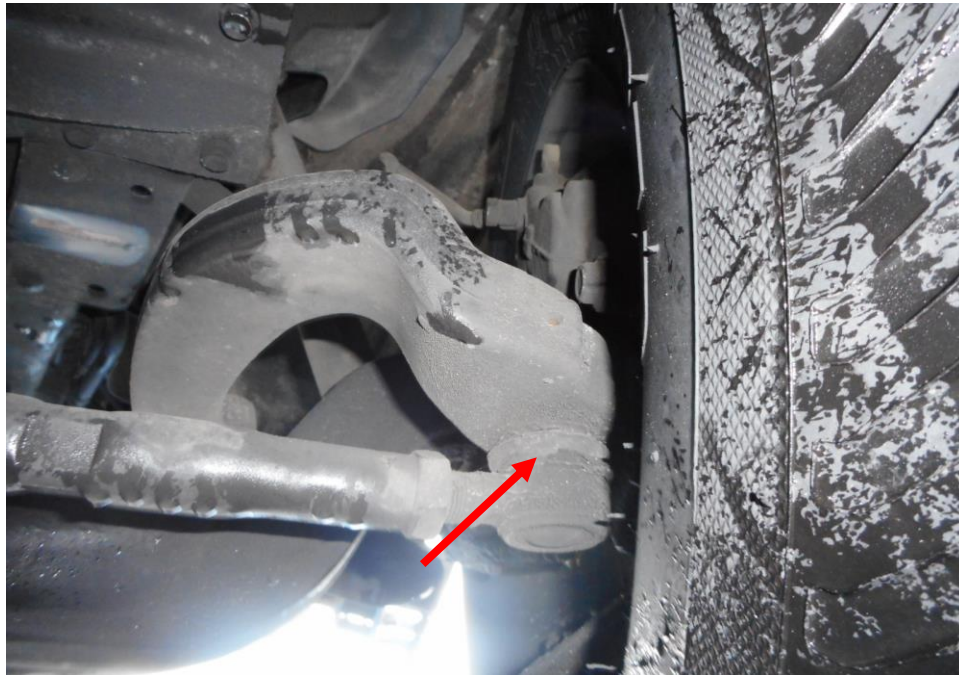
**Photo 18** shows the various undercarriage components at the front right wheel of the Motor Lorry, in particular the steering tie rod end (arrowed). The various steering components were all found to be intact, suggesting that the steering system of the Motor Lorry was likely to be in serviceable condition at the material time of accident. There was also no sign of fluid stain(s) observed on the various undercarriage components.

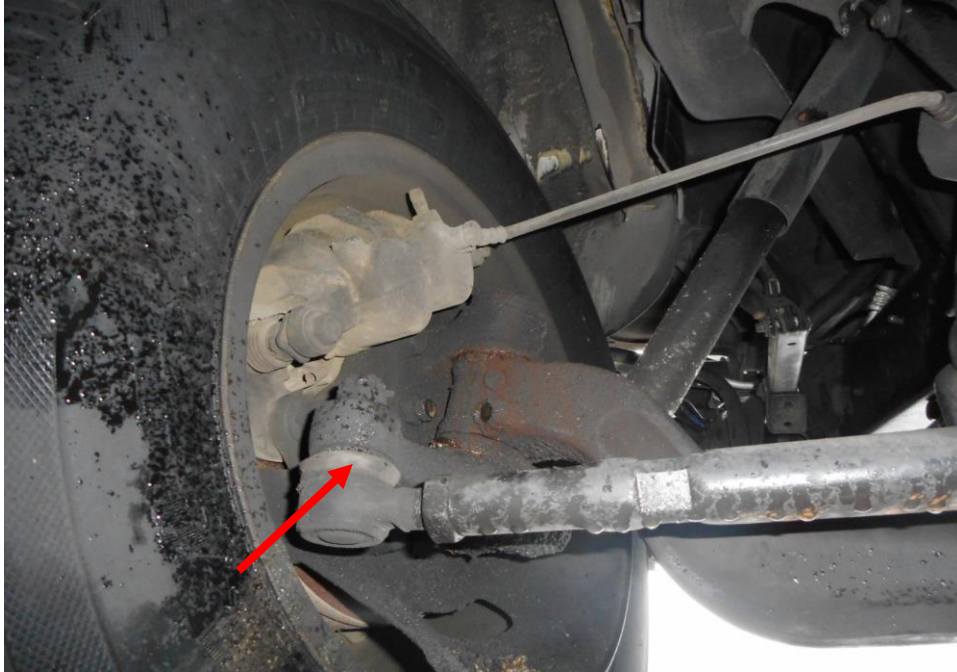
**Photo 19** shows the various undercarriage components at the front left wheel of the Motor Lorry, in particular the steering tie rod end (arrowed). The various undercarriage components of the Motor Lorry were all found to be intact without any visible damage. There was also no sign of fluid stain(s) observed on the various undercarriage components.

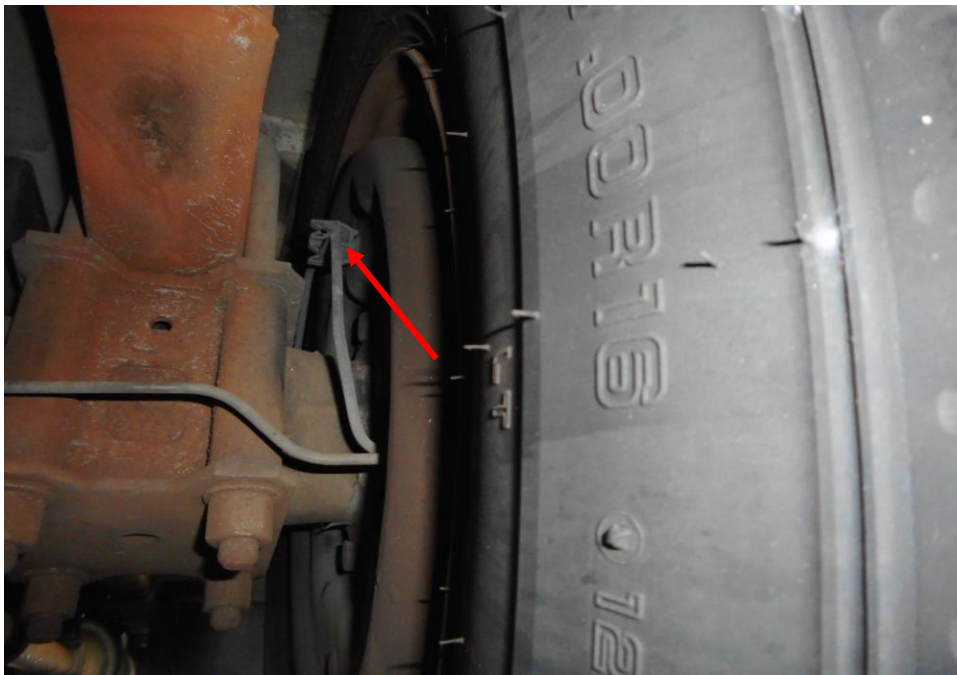
**Photo 20** shows the brake pipe (arrowed) at the rear right wheel of the Motor Lorry. I did not observe any leakage of brake fluid at the time of my inspection of the Motor Lorry. My static tests of the Motor Lorry's braking system, along with my visual examination of the various mechanical components in the braking system, had indicated that there was no internal leakage of pressure/vacuum.

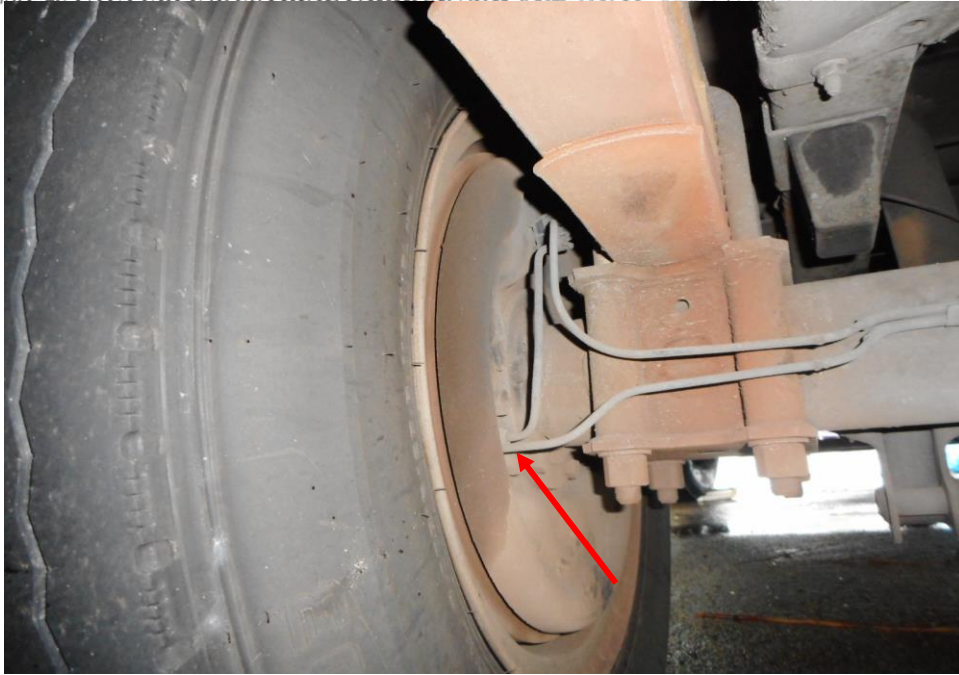
**Photo 21** shows the brake pipe (arrowed) at the rear left wheel of the Motor Lorry. I did not observe any leakage of brake fluid at the time of my inspection of the Motor Lorry. My static tests of the Motor Lorry's braking system, along with my visual examination of the various mechanical components in the braking System had indicated that there was no internal leakage of pressure/vacuum. Hence the braking system of the Motor Lorry was likely to be in serviceable condition at the material time of accident.

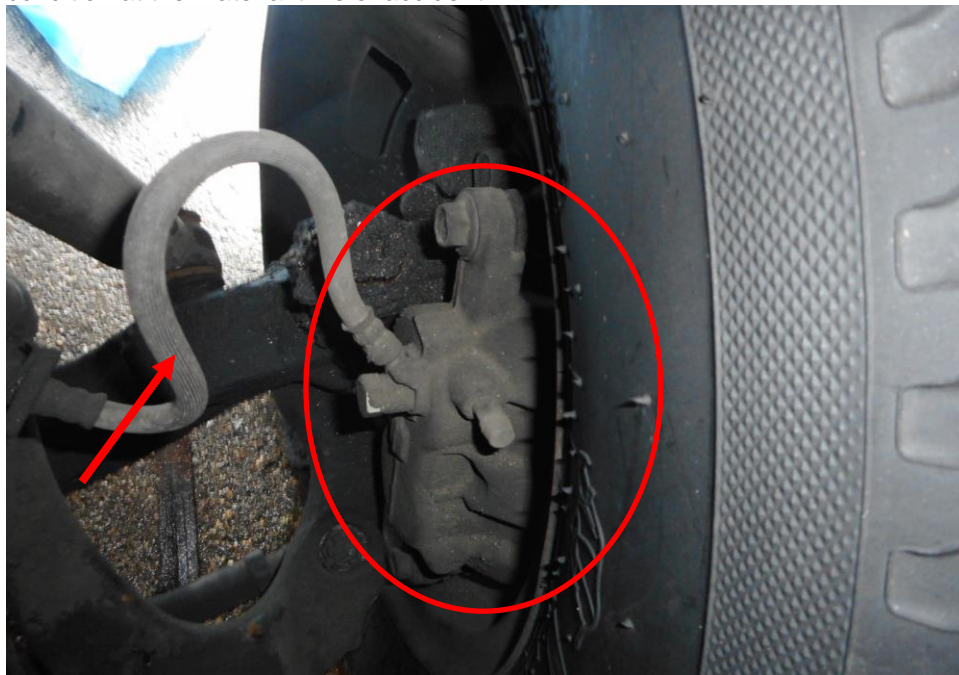
**Photo 22** shows the brake hose/pipe (arrowed) at the front right wheel of the Motor Lorry. No leakage of brake fluid was observed. Visual examination of the various components of the braking system like the brake caliper (circled), brake booster, brake pedal etc had revealed all to be intact and without visible damage at the time of accident. There was also no sign of fluid stain(s) observed on the various undercarriage components.

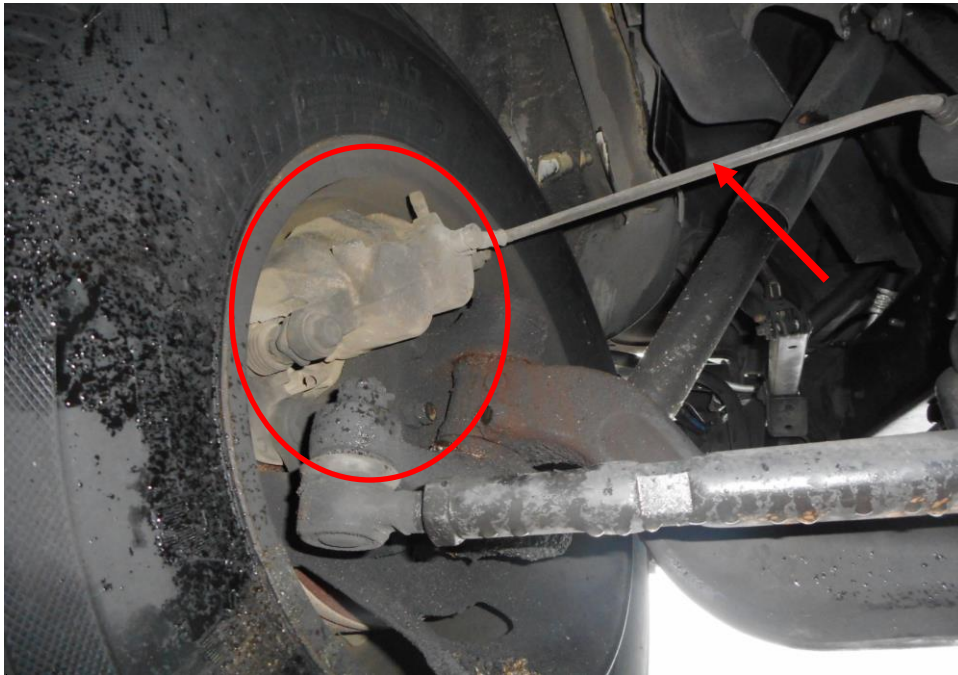
**Photo 23** shows the brake hose/pipe (arrowed) at the front left wheel of the Motor Lorry. No leakage of brake fluid was observed. Visual examination of the various components of the braking system like the brake caliper (circled), brake booster, brake pedal etc had revealed all to be intact and without visible damage at the time of accident. There was also no sign of fluid stain(s) observed on the various undercarriage components.
