You're Ref: TP/IP/35857/2020  
Our Ref: CI/TPD20012453/P

**Fatal Accident Investigation Team**

**MECHANICAL INSPECTION REPORT OF MOTOR CAR SKF 2148H**

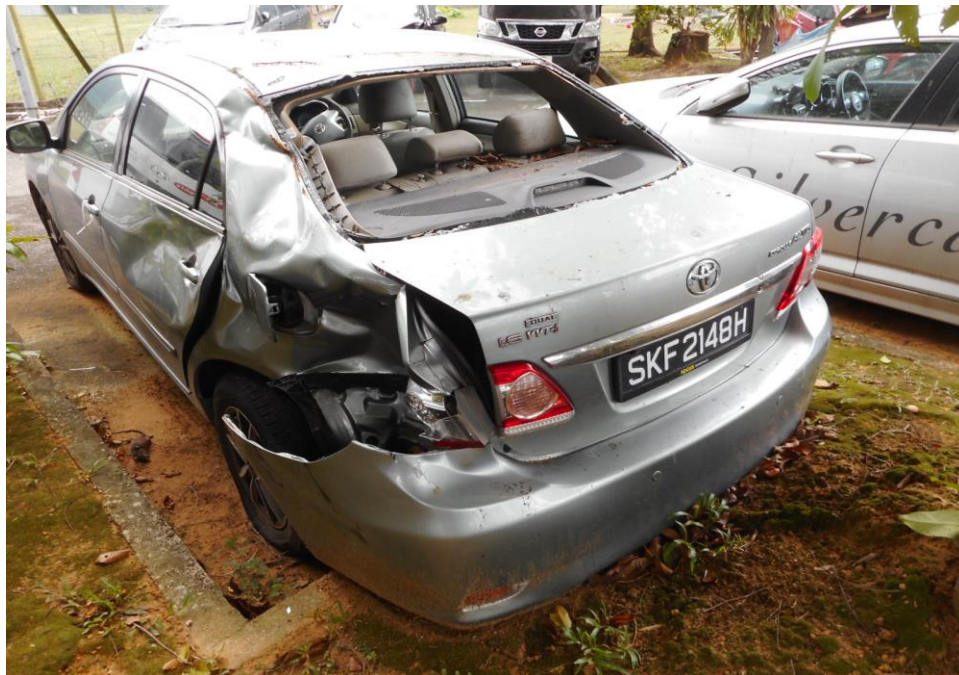
4. The mileage of the Motor Car mileage was not recorded as the engine was not able to be started up despite multiple attempts in jumpstarting it.
5. The Motor Car was observed to have sustained damage at its rear and left portion. Its rear windscreen, rear bumper, left body panel, left door, rear left brake lamp were damaged as a result of the accident.

**Photo 1** shows a general view of the Motor Car's rear body at the time of my inspection. The rear and left portion of the Motor Car was observed to have been damaged by the accident. Its rear windscreen, rear bumper, left body panel, left door, rear left brake lamp were damaged as a result of the accident.

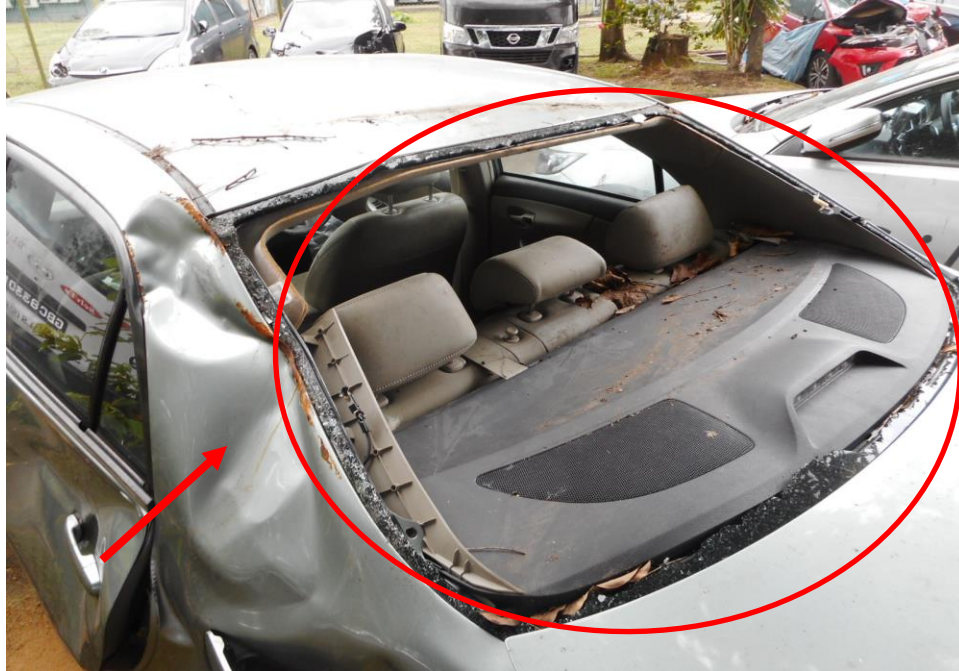
**Photo 2** shows the close up view of the Motor Car's rear body at the time of my inspection. The rear windscreen (circled) and the rear body panel (arrowed) was observed to have been damaged by the accident.

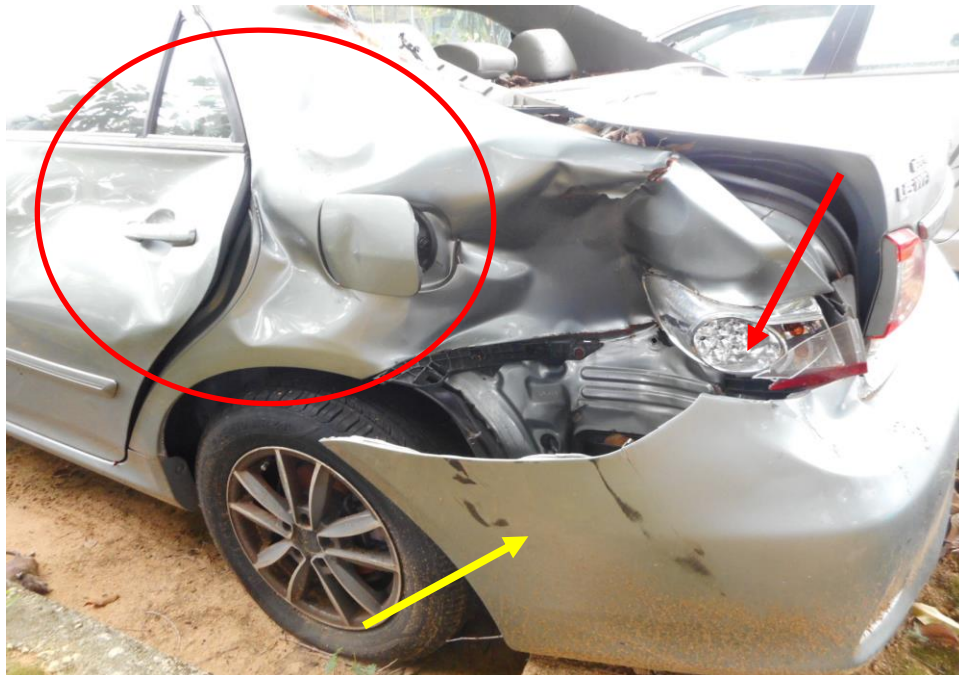
**Photo 3** shows the close up view of the Motor Car's left body at the time of my inspection. The rear bumper (yellow arrow), rear left brake lamp (red arrow) and the left door and body panels (circled) of the Motor Car was observed to have been damaged by the accident.

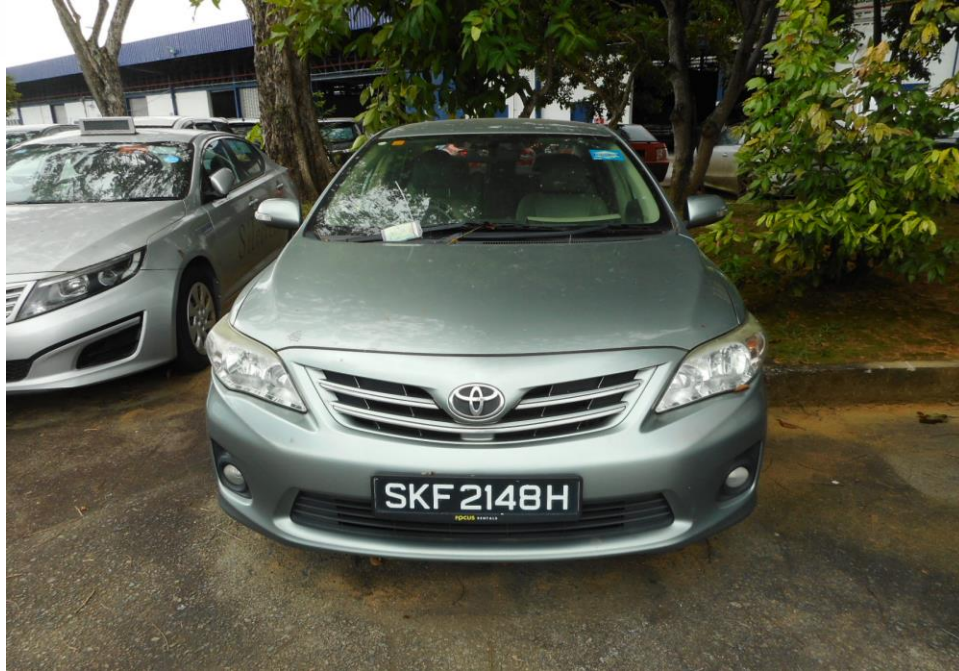
**Photo 4** shows a general view of the Motor Car's front body at the time of my inspection. The front portion of the Motor Car was observed to be unaffected by the accident.

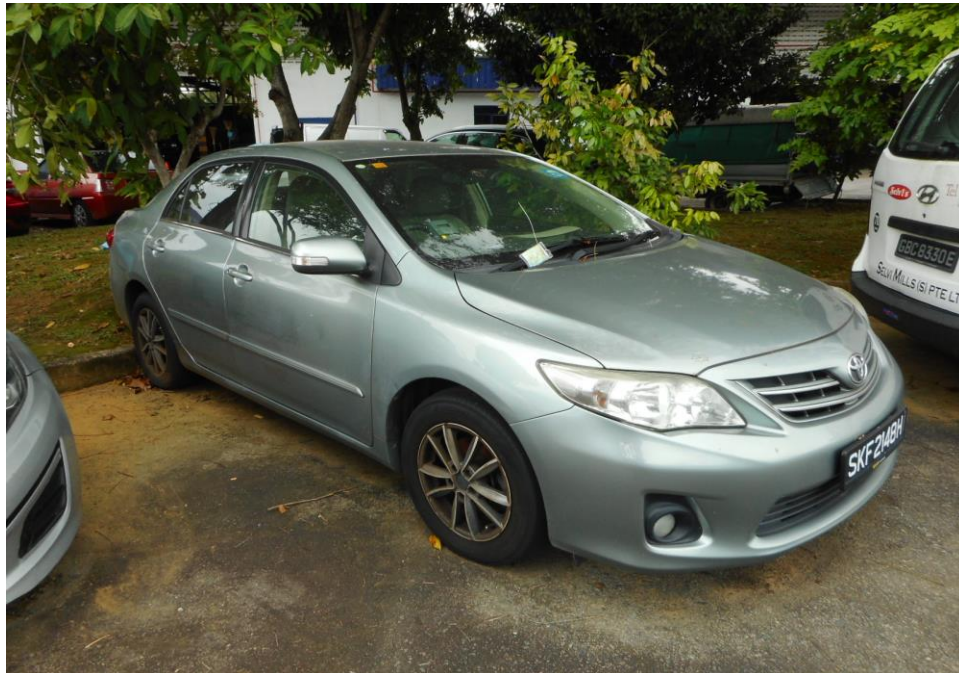
**Photo 5** shows a general view of the Motor Car's right body at the time of my inspection. The right portion of the Motor Car was observed to have be unaffected by the accident.

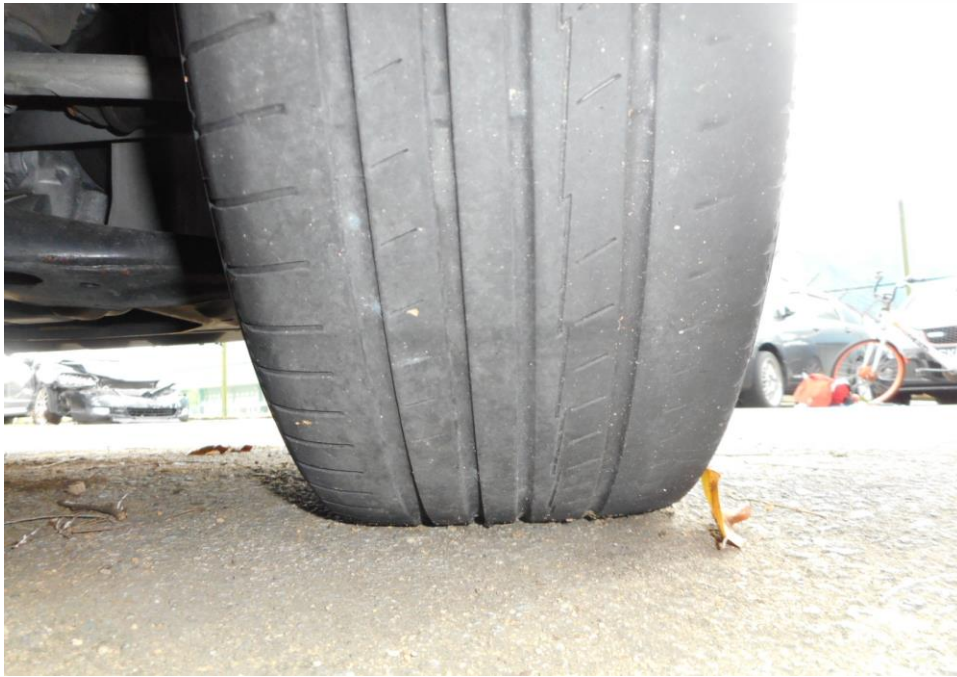
**Photo 6** shows the condition of the front right tyre of the Motor Car, which was observed to be in serviceable condition with remaining tread depth of approximately 3.4mm. The tyre was sufficiently inflated for vehicular operation with no tear, cut or burst mark(s) on the outer and the inner sidewalls as well as across the tread. The 4 tyres of the Motor Car were wrapped around standard alloy wheel rims without any damage.

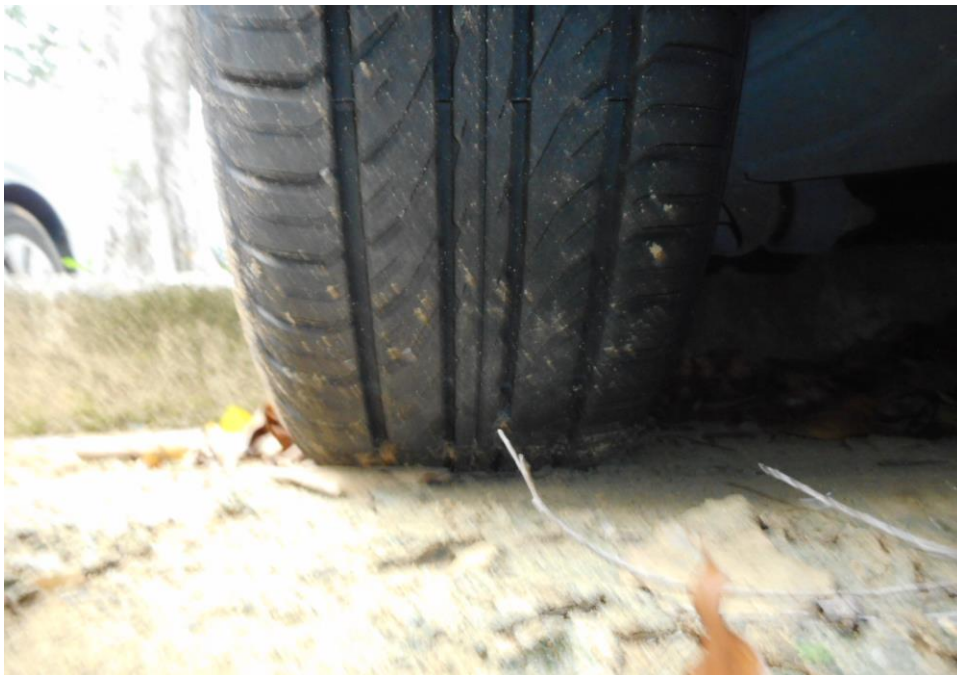
**Photo 7** shows the condition of the rear right tyre of the Motor Car, which was observed to be in serviceable condition with remaining tread depth of approximately 6.2mm. The tyre was also observed to be sufficiently inflated for vehicular operation with no tear, cut or burst mark(s).

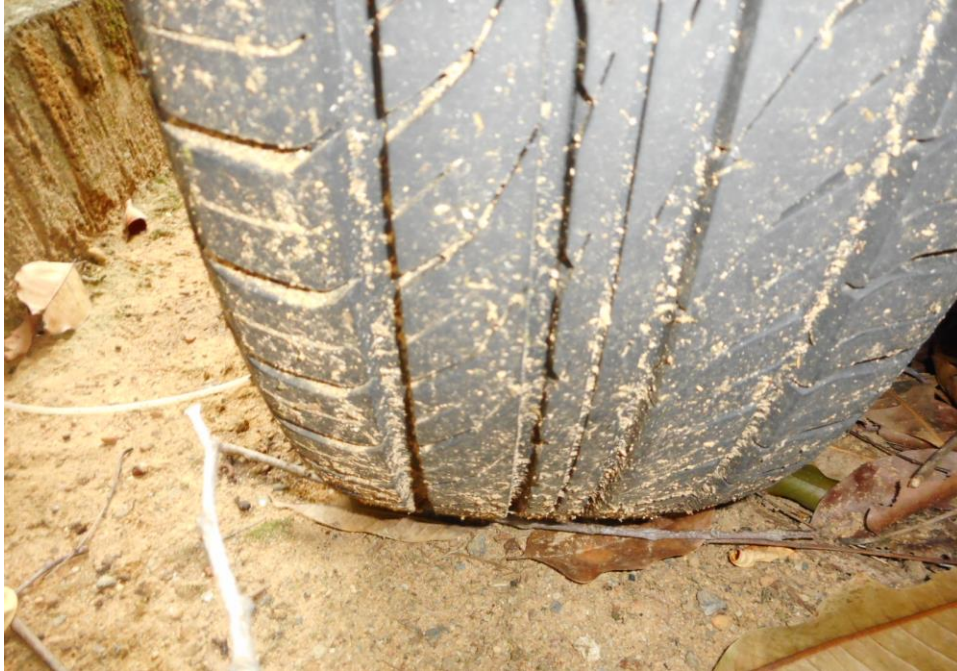
**Photo 8** shows the condition of the rear left tyre of the Motor Car, which was observed to be in serviceable condition with remaining tread depth of approximately 6mm. The tyre was also observed to be sufficiently inflated for vehicular operation with no tear, cut or burst mark(s).

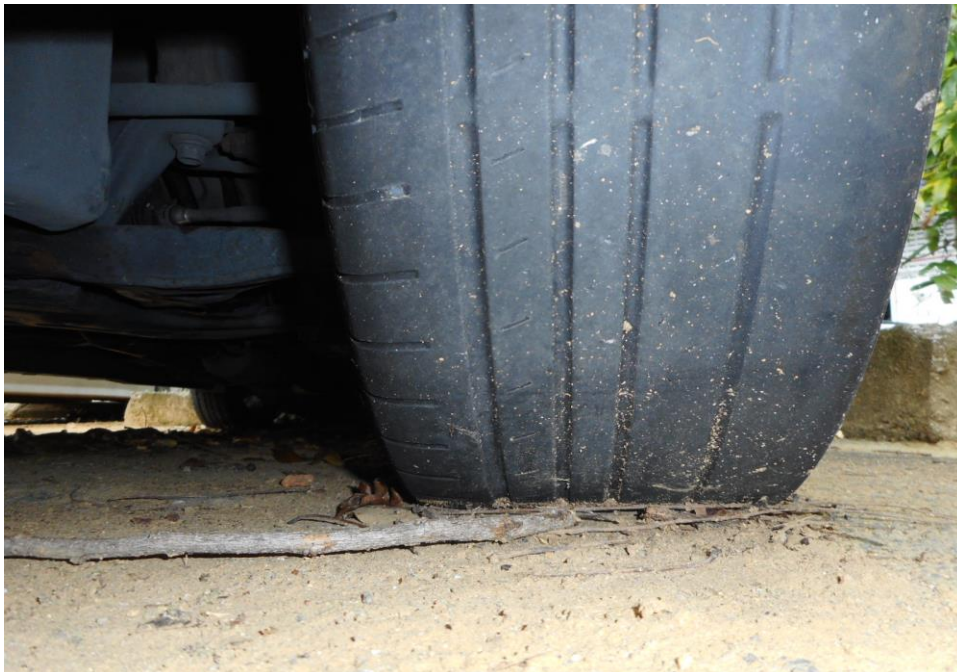
**Photo 9** shows the condition of the front left tyre of the Motor Car, which was observed to be in serviceable condition with remaining tread depth of approximately 1.8 mm. There was also no tear, cut or burst mark(s) on the outer and the inner sidewalls as well as across the tread of the Motor Car's 4 tyres.

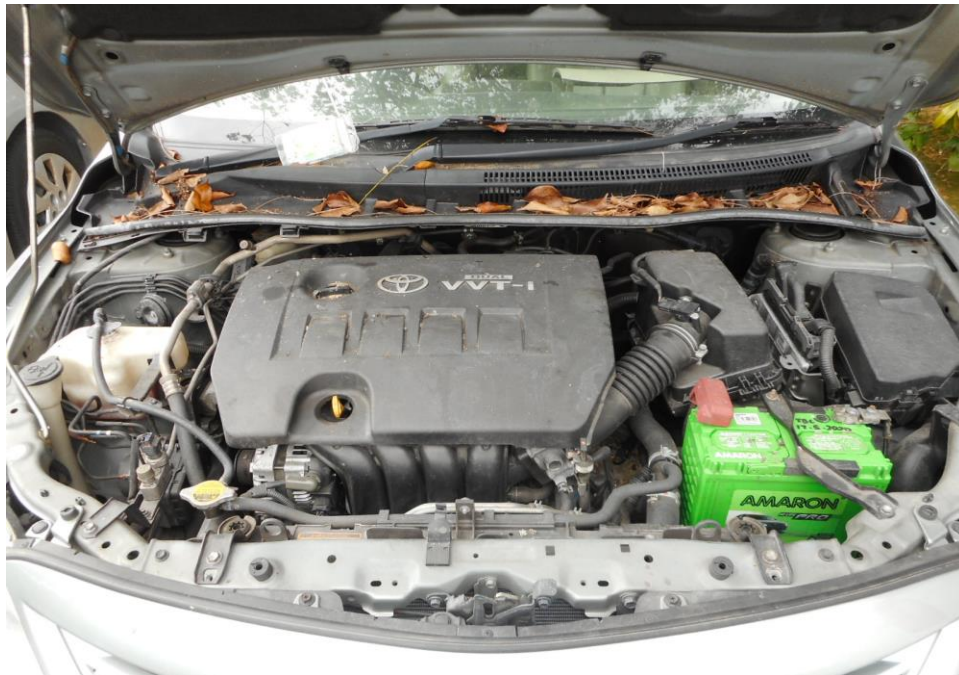
**Photo 10** shows a general view of the Motor Car's engine compartment. The various parts and components inside the engine compartment were unaffected by the accident. There was also no sign(s) or indication(s) of fluid leakage and/or fluid stain within the engine compartment.

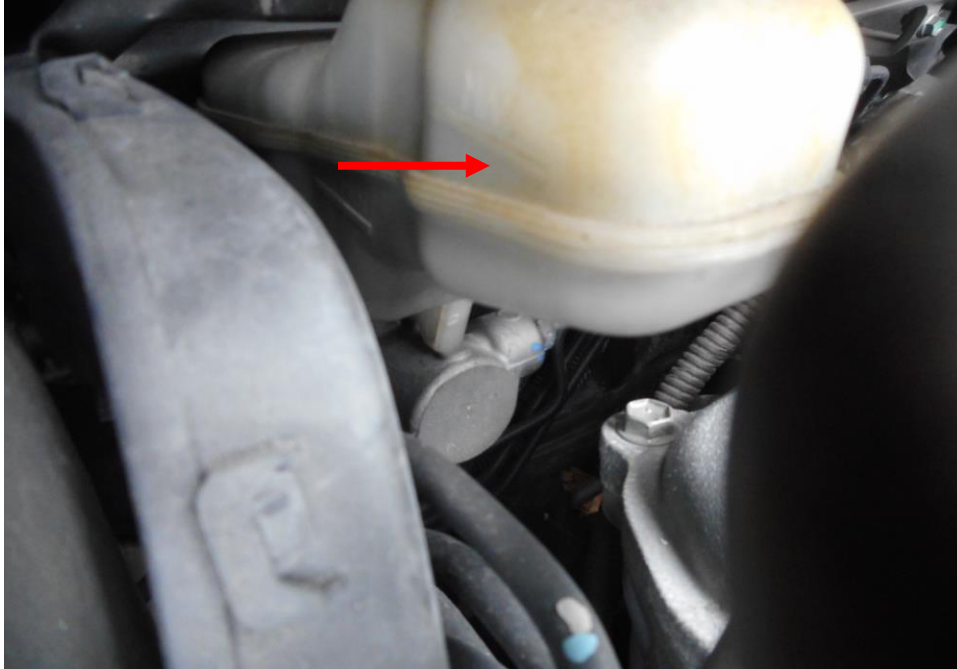
**Photo 11** shows the brake fluid reservoir of the Motor Car at the time of my inspection. The brake fluid was observed to be of sufficient level (arrowed) and without any visible contamination.

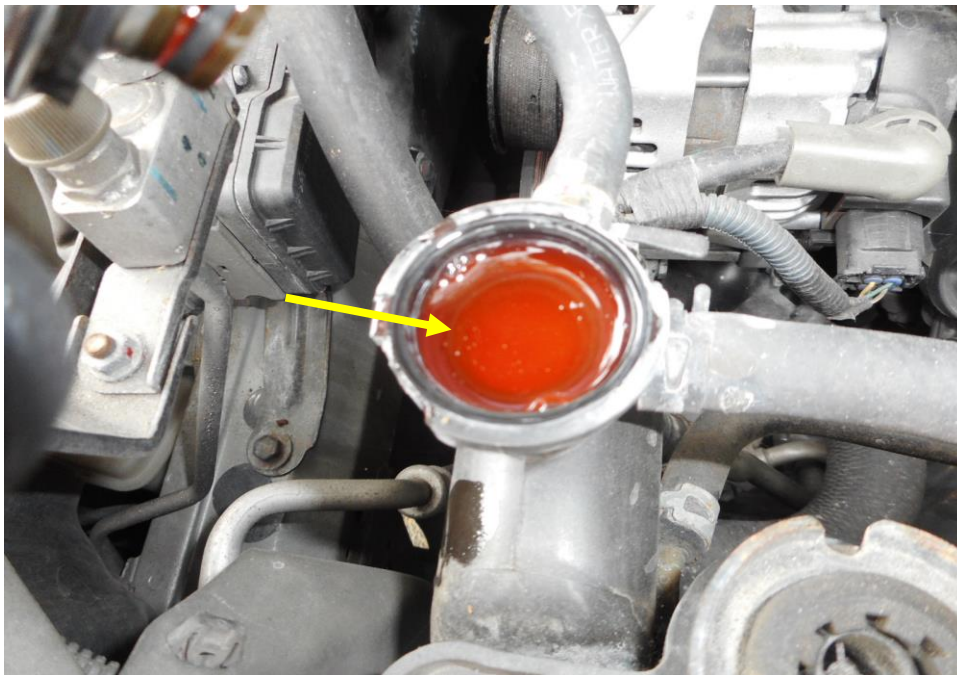
**Photo 12** shows checks being carried out to the engine coolant of the Motor Car at the time of my inspection. The engine coolant was observed to be of sufficient level (arrowed) and without any visible contamination.

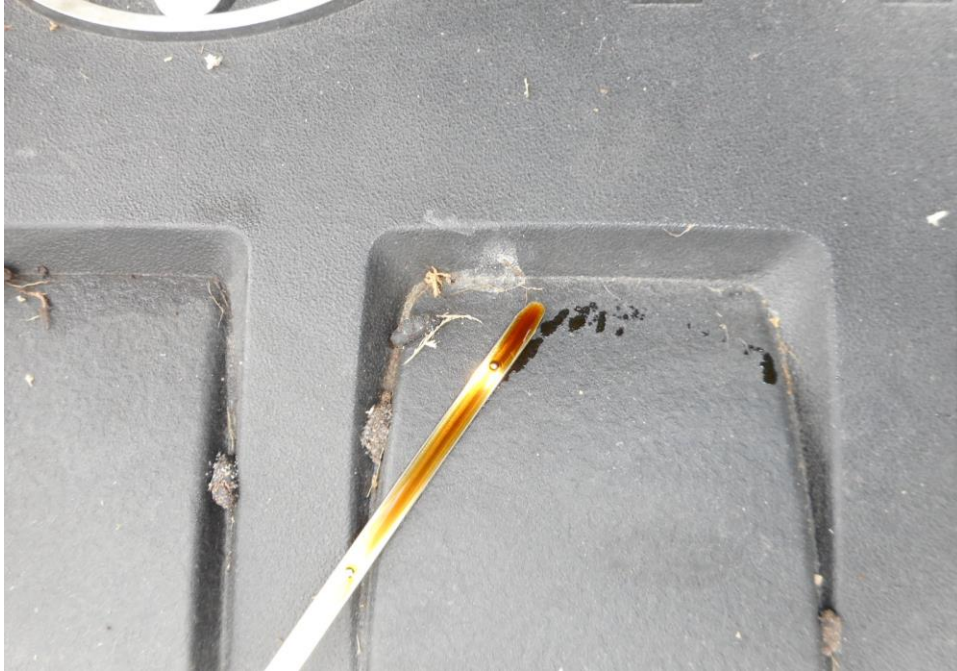
**Photo 13** shows the engine oil dip stick of the Motor Car at the time of my inspection. The engine oil was observed to be of sufficient level and without any visible contamination.

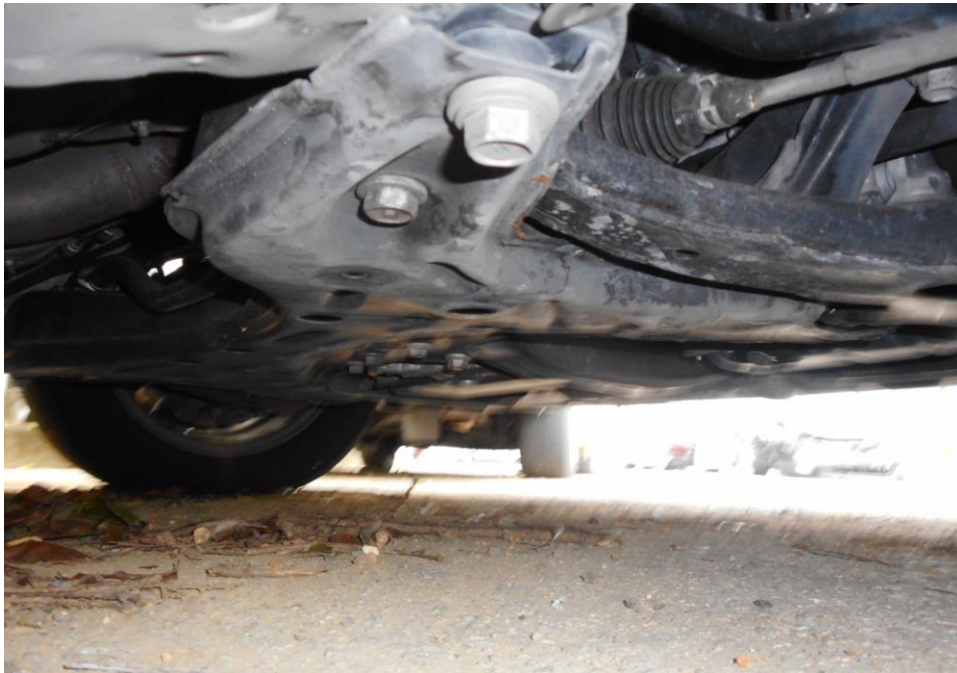
**Photo 14** shows the undercarriage of the Motor Car, at the area where the engine housing and transmission housing are located. I did not find any sign(s) or indication(s) of fluid leak and/or fluid stain(s) on the underside of the Motor Car.

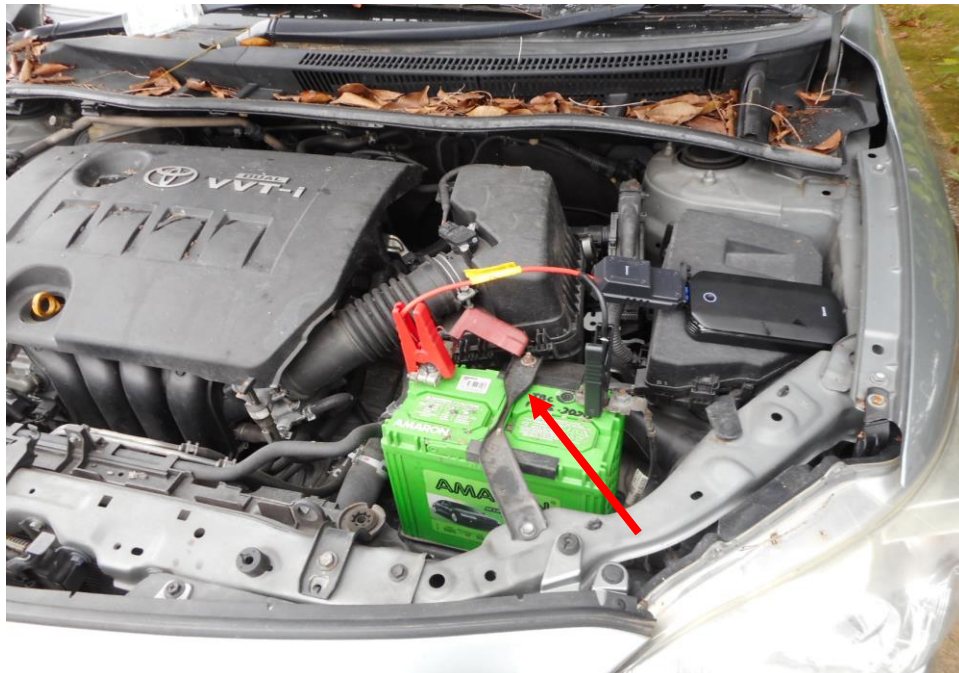
**Photo 15** shows the jumpstarting process of the Motor Car's engine. The engine of the Motor Car was unable to be jumpstarted up despite multiple attempts in starting it.

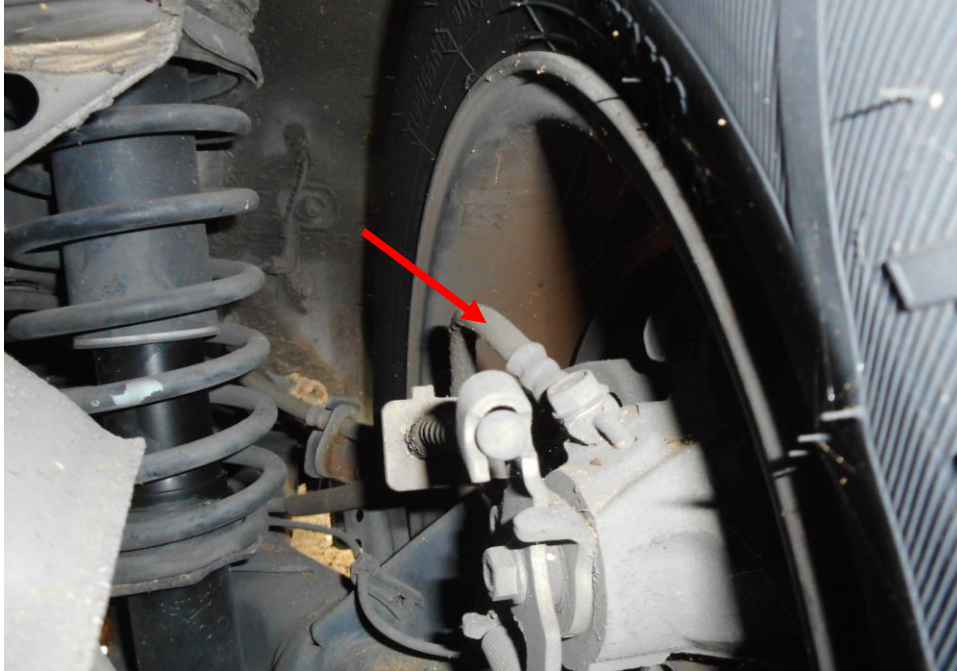
**Photo 16** shows the brake hose/pipe (arrowed) at the rear right wheel of the Motor Car. No leakage of brake fluid was observed. Visual examination of the various components of the braking system like the drum brake, brake booster, brake pedal etc. had revealed all to be intact and without visible damage.

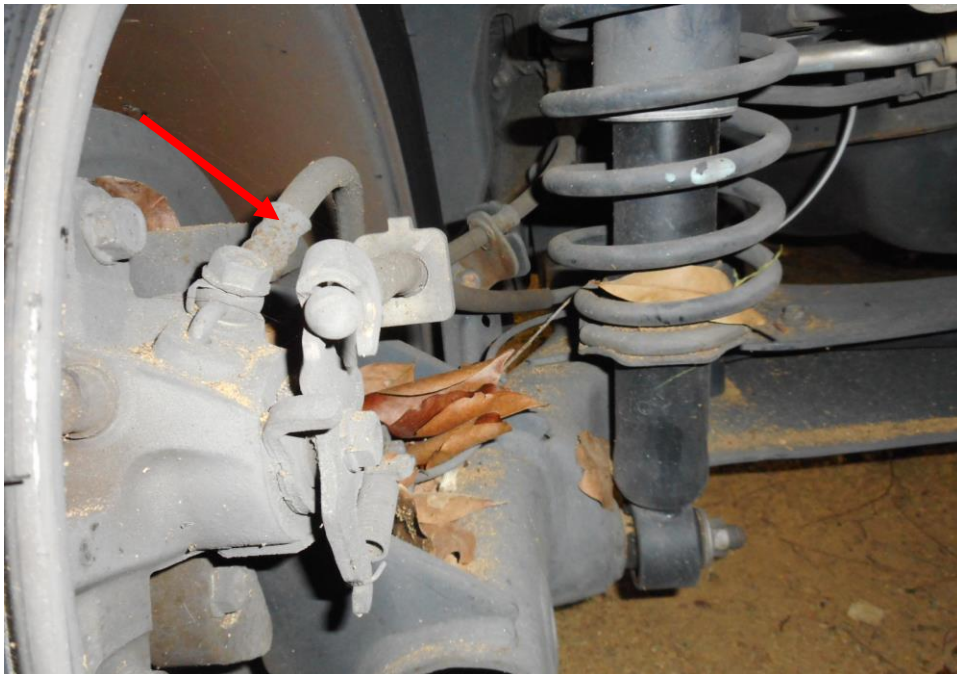
**Photo 17** shows the brake hose/pipe (arrowed) at the rear left wheel of the Motor Car. I did not observe any leakage of brake fluid at the time of my inspection of the Motor Car. Static tests of the Motor Car's braking system had indicated that there was no internal leakage of pressure/vacuum. The undercarriage components of the Motor Car were also all found to be intact and without any visible damage.

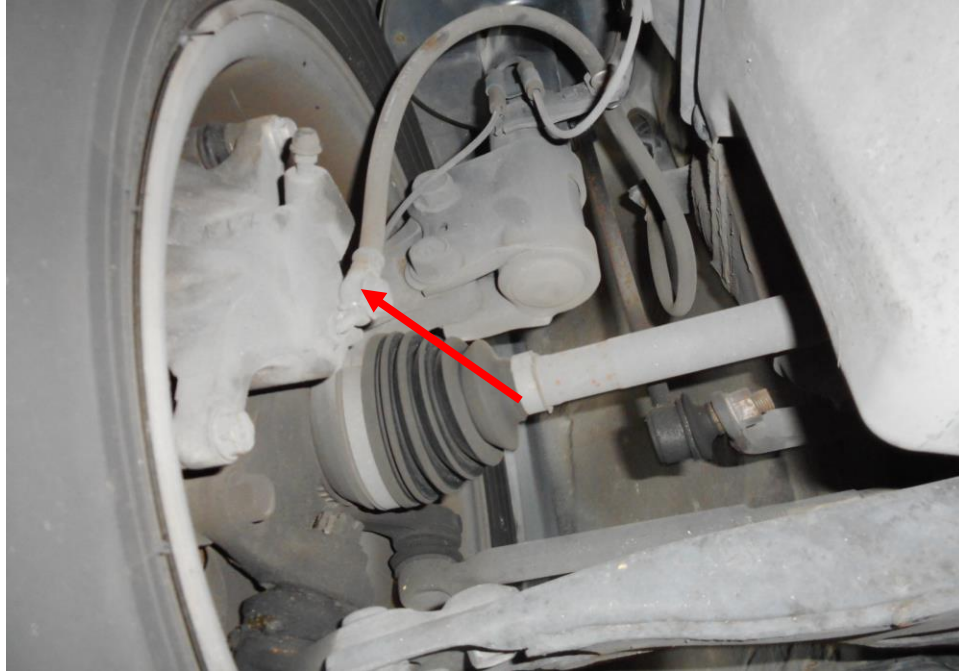
**Photo 18** shows the brake hose/pipe (arrowed) at the front right wheel of the Motor Car. I did not observe any leakage of brake fluid at the time of my inspection of the Motor Car. Static tests of the Motor Car's braking system had indicated that there was no internal leakage of pressure/vacuum. The undercarriage components of the Motor Car were also all found to be intact and without any visible damage.

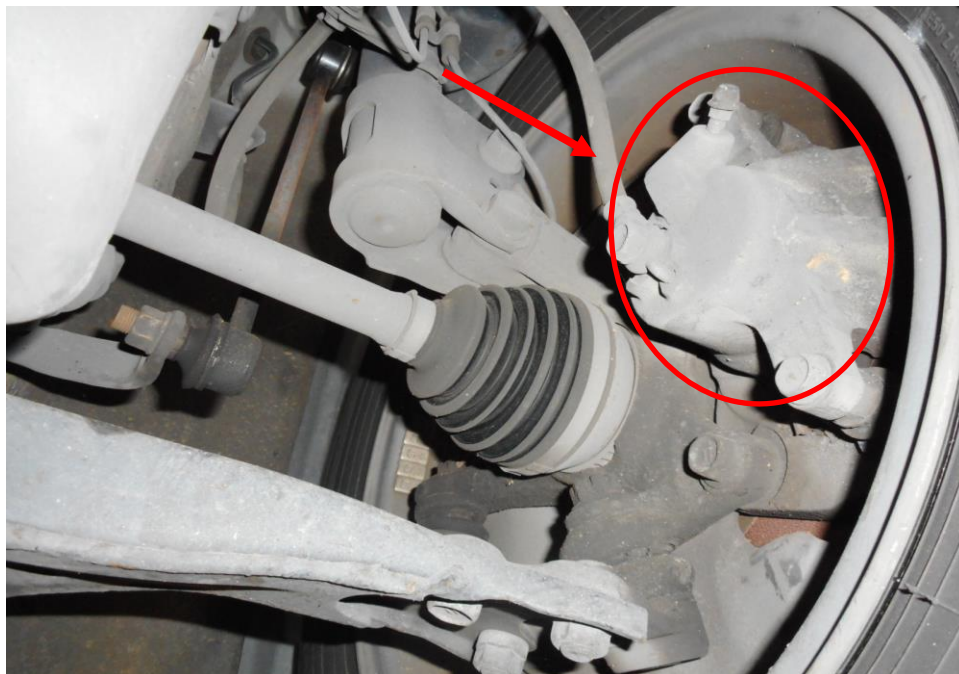
**Photo 19** shows the brake hose/pipe (arrowed) at the front left wheel of the Motor Car. No leakage of brake fluid was observed. Visual examination of the various components of the braking system like the brake caliper (circled), brake booster, brake pedal etc had revealed all to be intact and without visible damage.

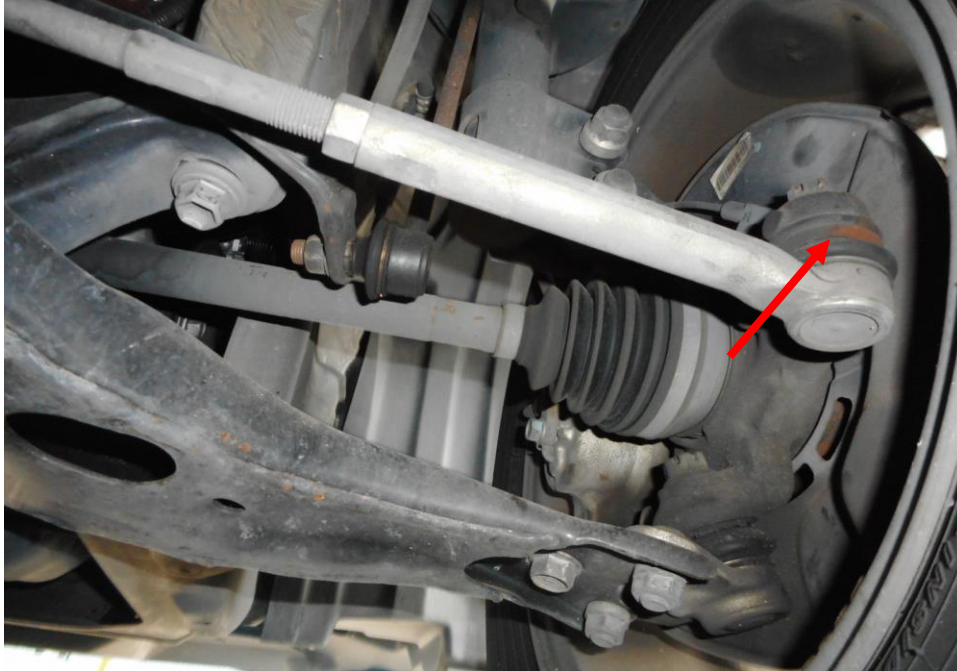
**Photo 20** shows the various undercarriage components at the front right wheel of the Motor Car, in particular the steering tie rod (red arrow). The various steering components were all found to be intact, suggesting that the steering system of the Motor Car was likely to be in serviceable condition at the material time of accident. There was also no sign of fluid stain observed on the various undercarriage components at the front right wheel of the Motor Car.

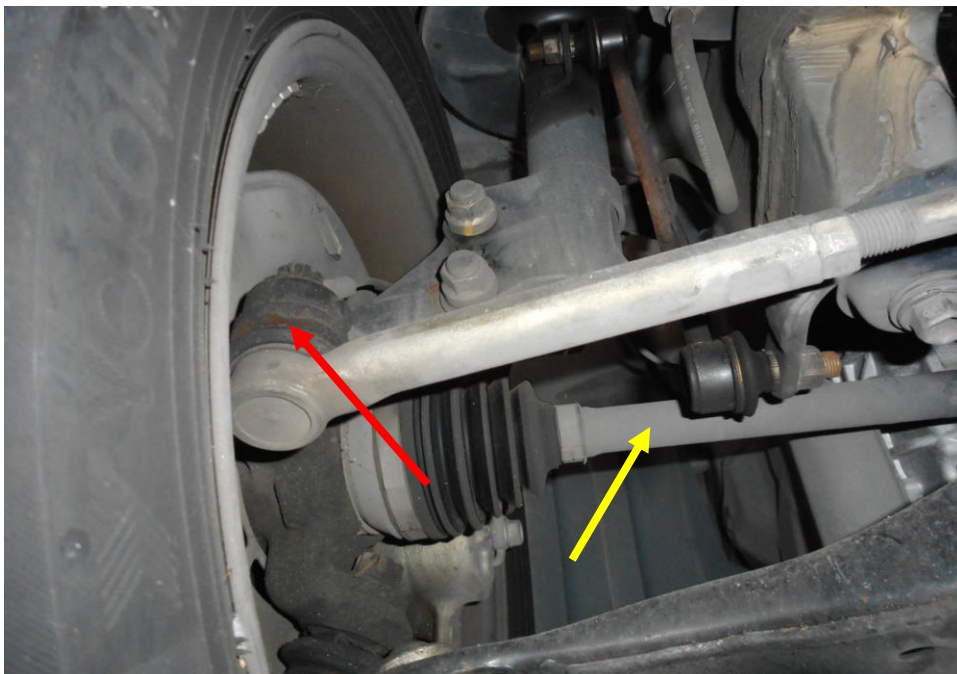
**Photo 21** shows the various undercarriage components at the front left wheel of the Motor Car, which had included the steering tie rod (red arrow) and drive shaft (yellow arrow). The various undercarriage components of the Motor Car were all found to be intact without any visible damage.
