Your Ref: TP/IP/44943/2020
Our Ref : CI/TPD20012456/P

25th January 2021

MECHANICAL INSPECTION REPORT OF MOTOR LORRY YP 3259X

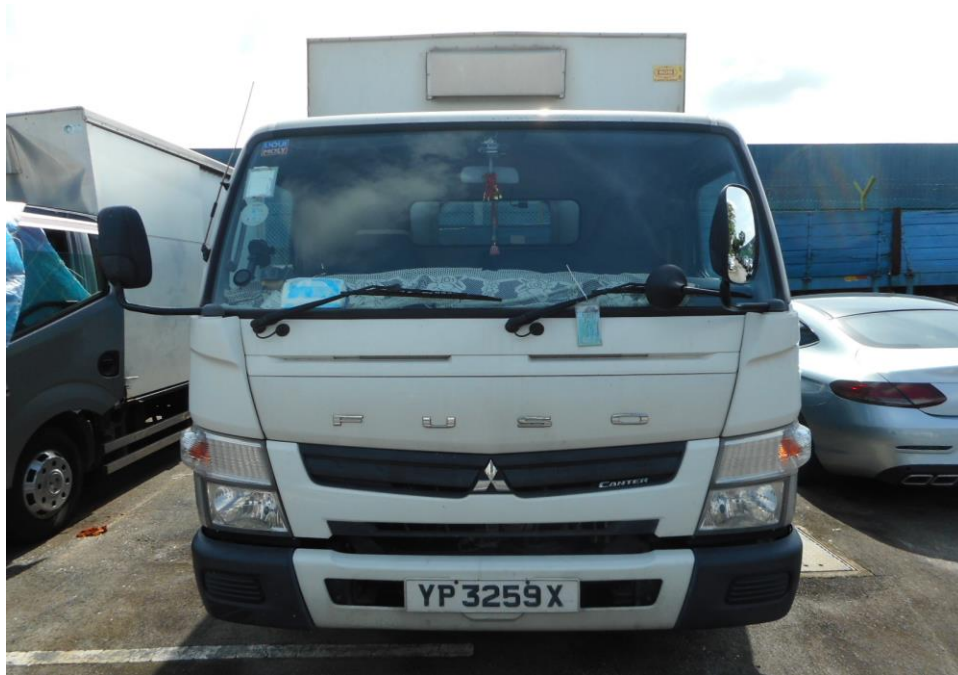
Photo 1 shows a general view of the Motor Lorry at the time of my inspection. The Motor Lorry was observed to be intact and unaffected by the accident.

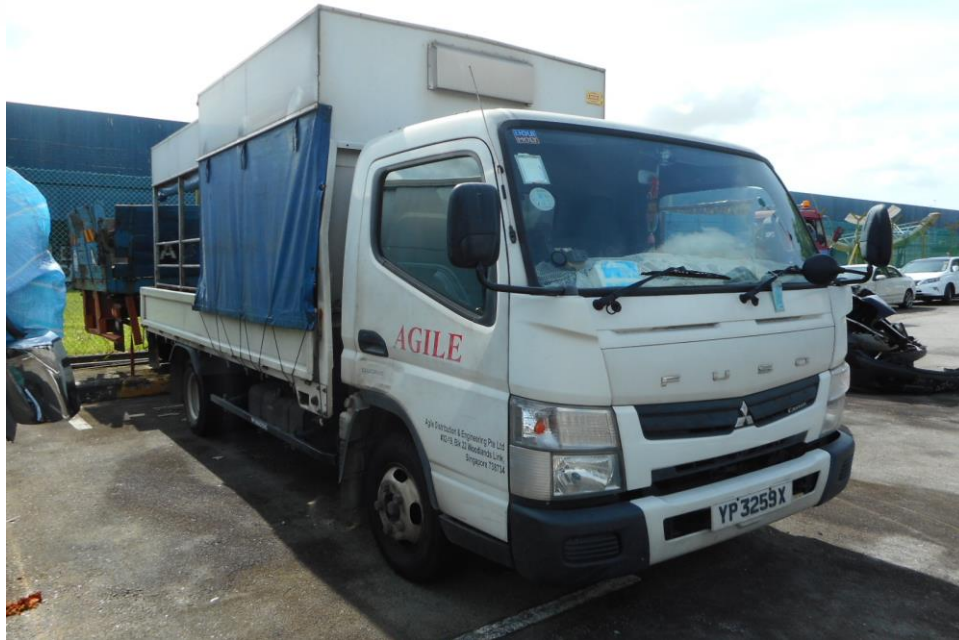
Photo 2 shows a general view of the right body of the Motor Lorry at the time of my inspection. The Motor Lorry was observed to be intact and unaffected by the accident.

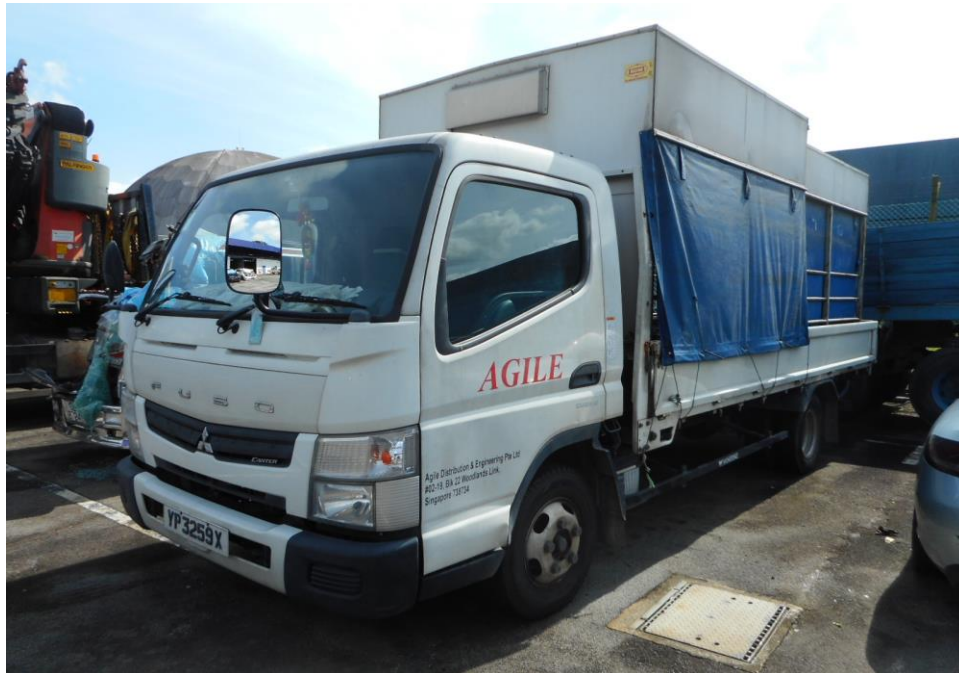
Photo 3 shows a general view of the left body of the Motor Lorry at the time of my inspection. The Motor Lorry was observed to be intact and unaffected by the accident.

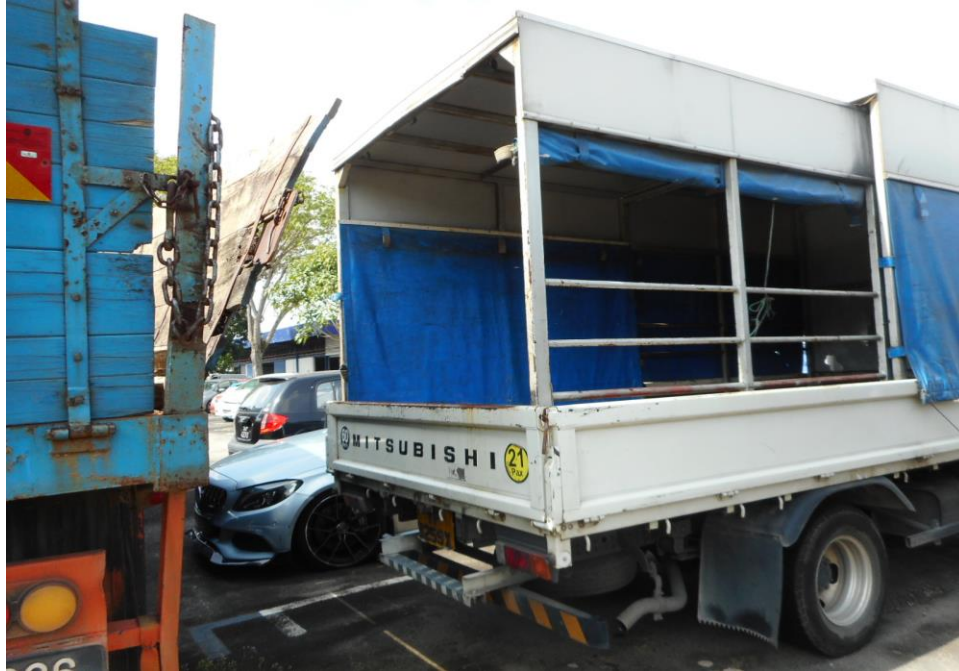
Photo 4 shows a general view of the rear body of the Motor Lorry at the time of my inspection. The Motor Lorry was observed to be intact and unaffected by the accident.

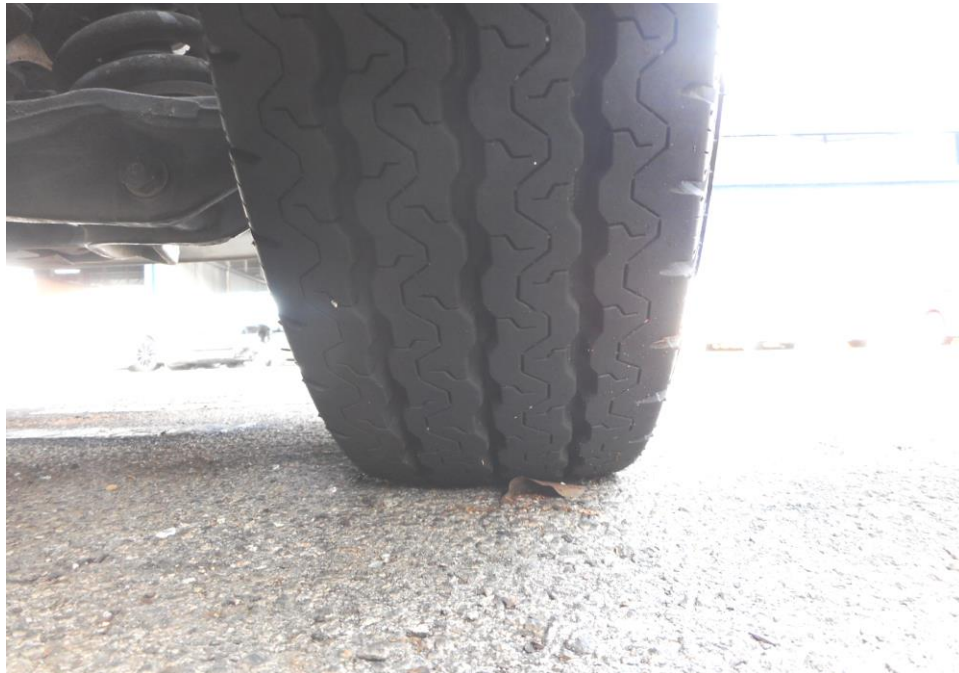
Photo 5 shows the condition of the front right tyre of the Motor Lorry, which was observed to be in serviceable condition with remaining tread depth of approximately 8.8mm. The tyre, which was wrapped around standard steel wheel rim, was also observed to be sufficiently inflated for vehicular operation. There was no tear, cut or burst mark(s) on the outer and the inner sidewalls as well as across the tread of the 6 tyres that were fitted on the Motor Lorry.

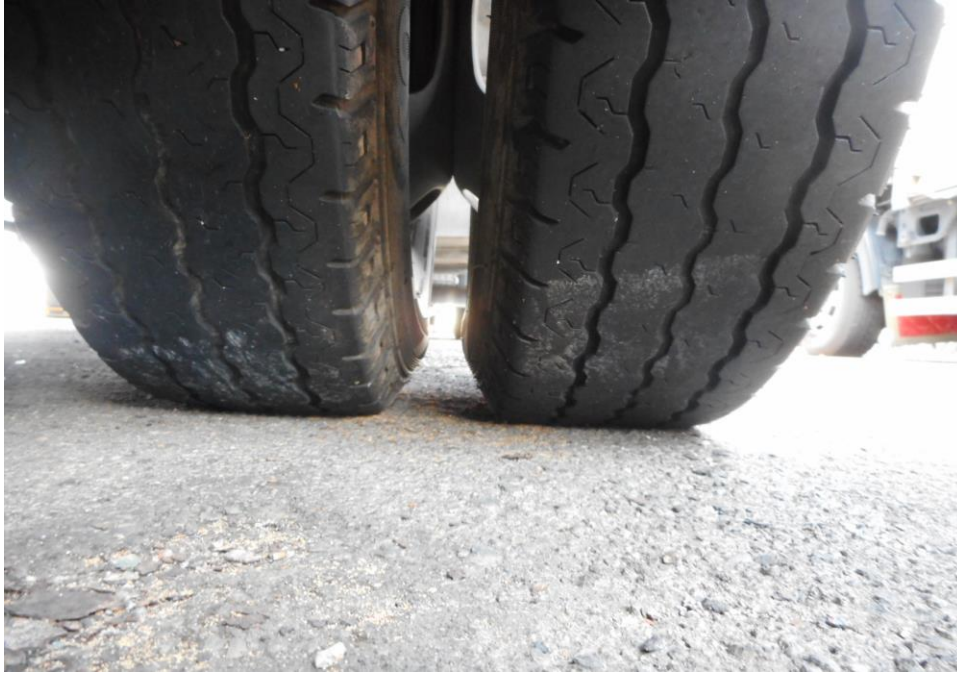
Photo 6 shows the condition of the rear right tyre of the Motor Lorry, which was observed to be in serviceable condition with remaining tread depth of approximately 7.8mm. The tyre, which was wrapped around standard steel wheel rim, was also observed to be sufficiently inflated for vehicular operation.

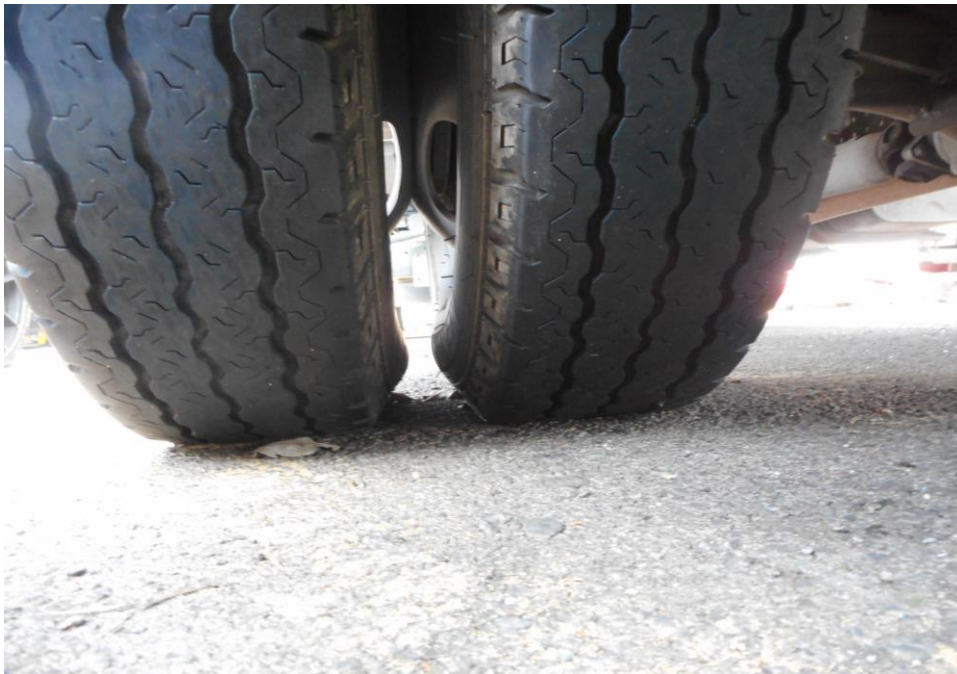
Photo 7 shows the condition of the rear left tyres of the Motor Lorry, which was observed to be in serviceable condition with remaining tread depth of approximately 3.5mm. The tyres, which were wrapped around standard steel wheel rim, were also observed to be sufficiently inflated for vehicular operation. There was also no damage found on all 6 steel wheel rims of the Motor Lorry.

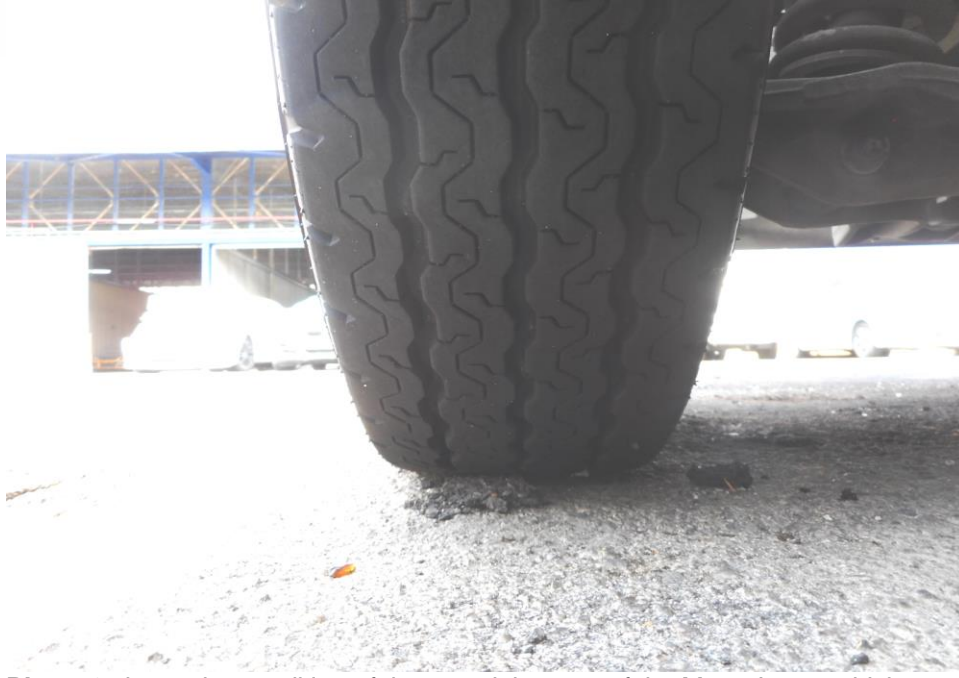
Photo 8 shows the condition of the rear right tyres of the Motor Lorry, which were observed to be in serviceable condition with remaining, tread depth of approximately 8.2mm. There was also no tear, cut or burst mark(s) on the outer and the inner sidewalls as well as across the tread of the 4 tyres that were fitted on the Motor Lorry.

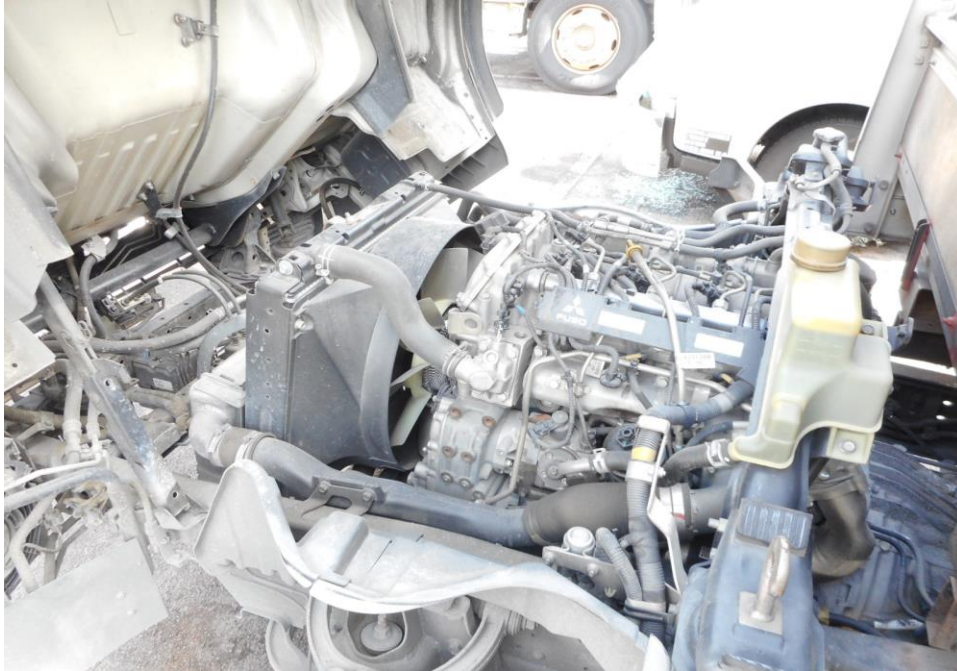
Photo 9 shows a general view of the Motor Lorry's engine compartment, which was accessed by lifting the front cabin of the Motor Lorry. The various parts and components inside the engine compartment were unaffected by the accident. There was also no sign(s) or indication(s) of fresh fluid leakage and/or fluid stain within the engine compartment

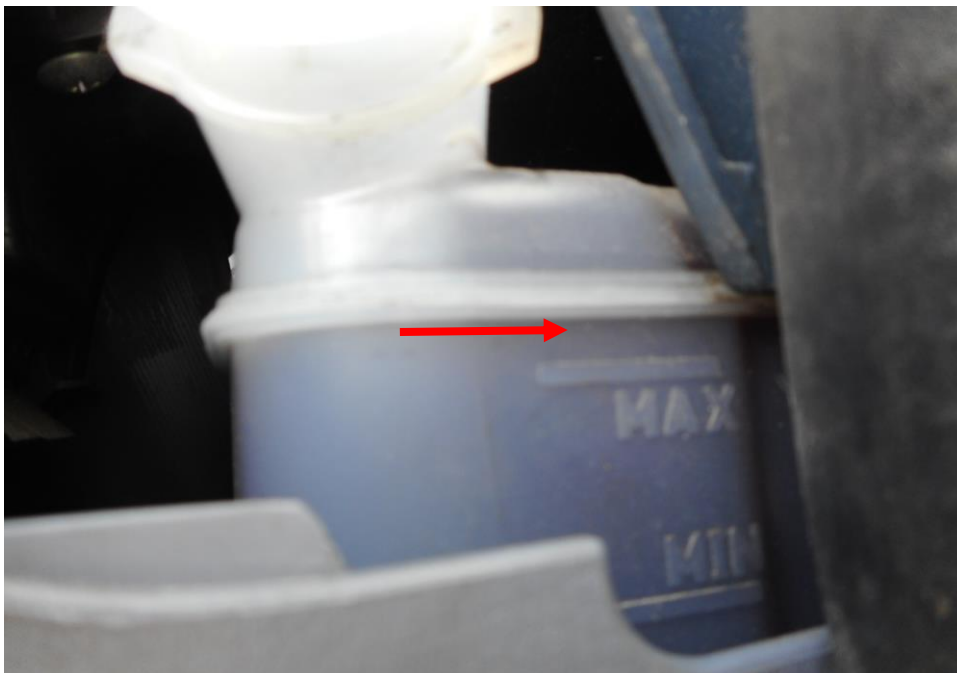
Photo 10 shows the brake fluid reservoir of the Motor Lorry at the time of my inspection. The brake fluid was observed to be of sufficient level (arrowed) and without any visible contamination.

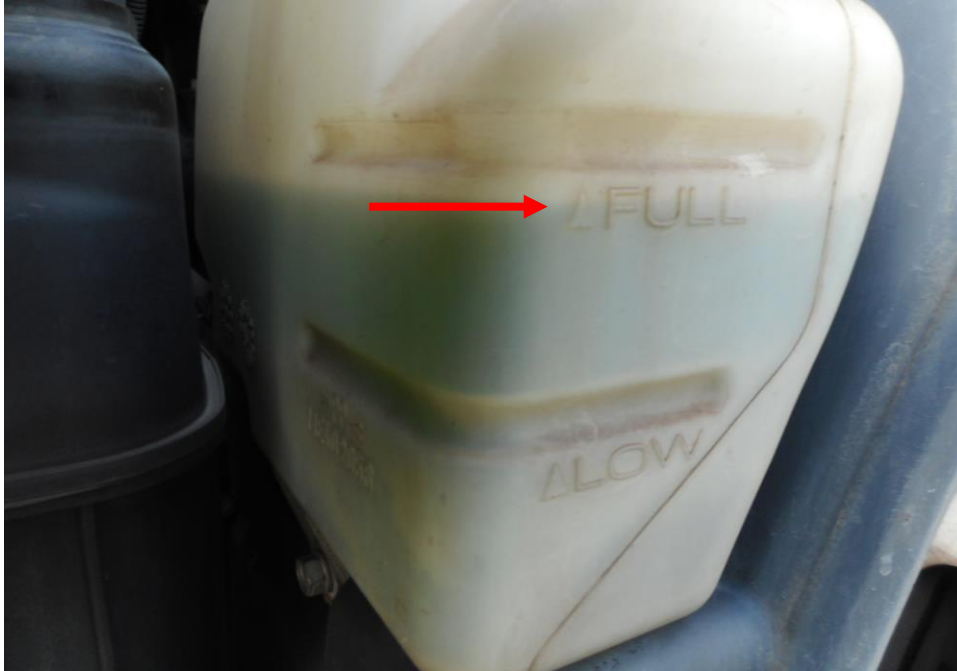
Photo 11 shows the engine coolant reservoir of the Motor Lorry at the time of my inspection. The engine coolant was observed to be of sufficient level (arrowed) and without any visible contamination.

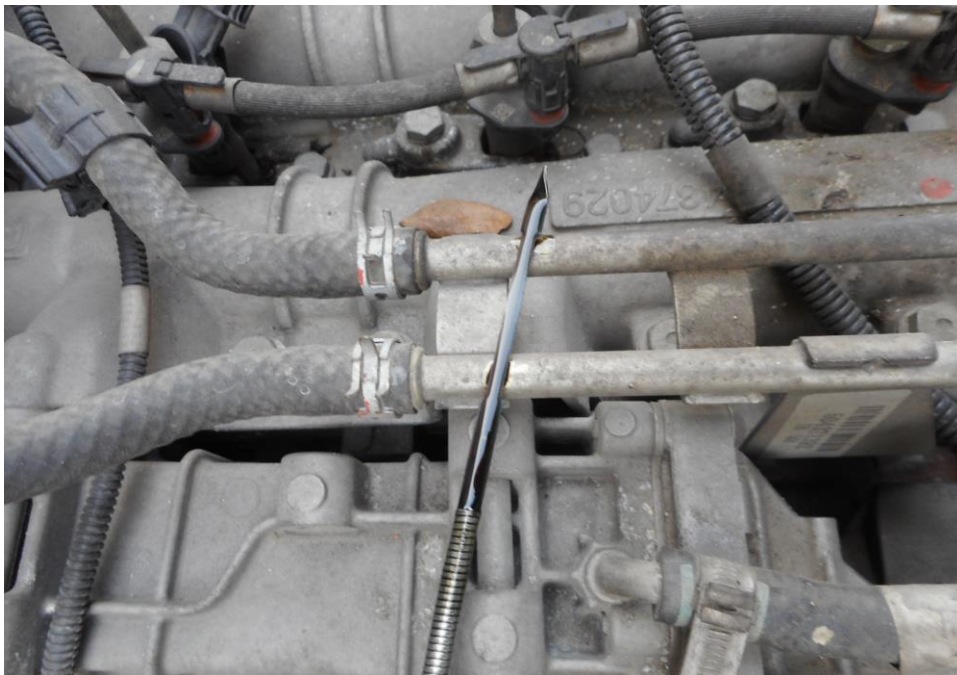
Photo 12 shows the engine oil dip stick of the Motor Lorry at the time of my inspection. The engine oil was observed to be of sufficient level and without any visible contamination.

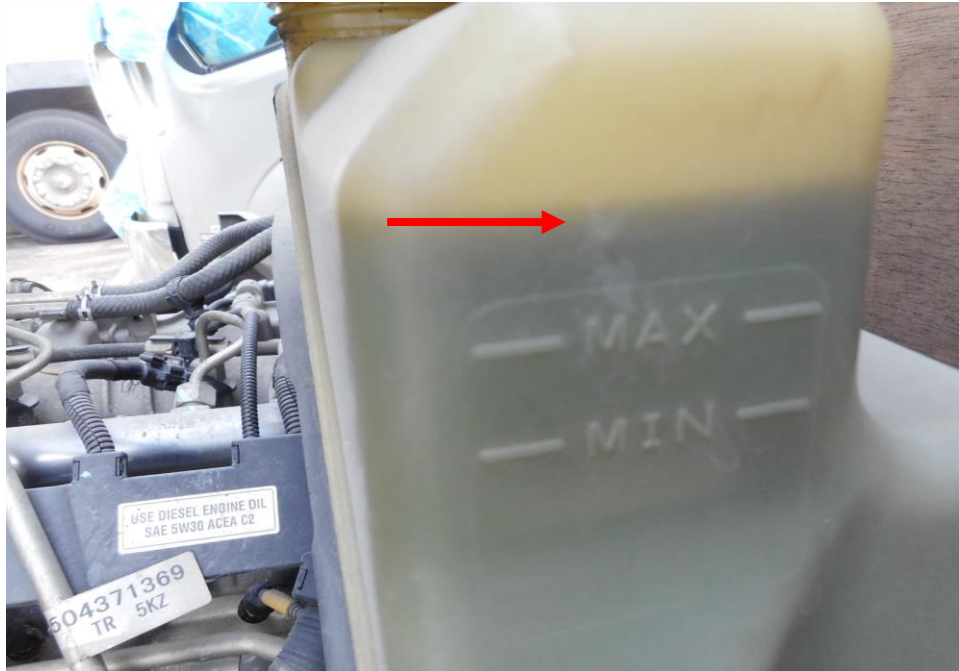
Photo 13 shows the power steer fluid reservoir of the Motor Lorry at the time of my inspection. The power steering fluid was observed to be of sufficient level (arrowed) and without any visible contamination.

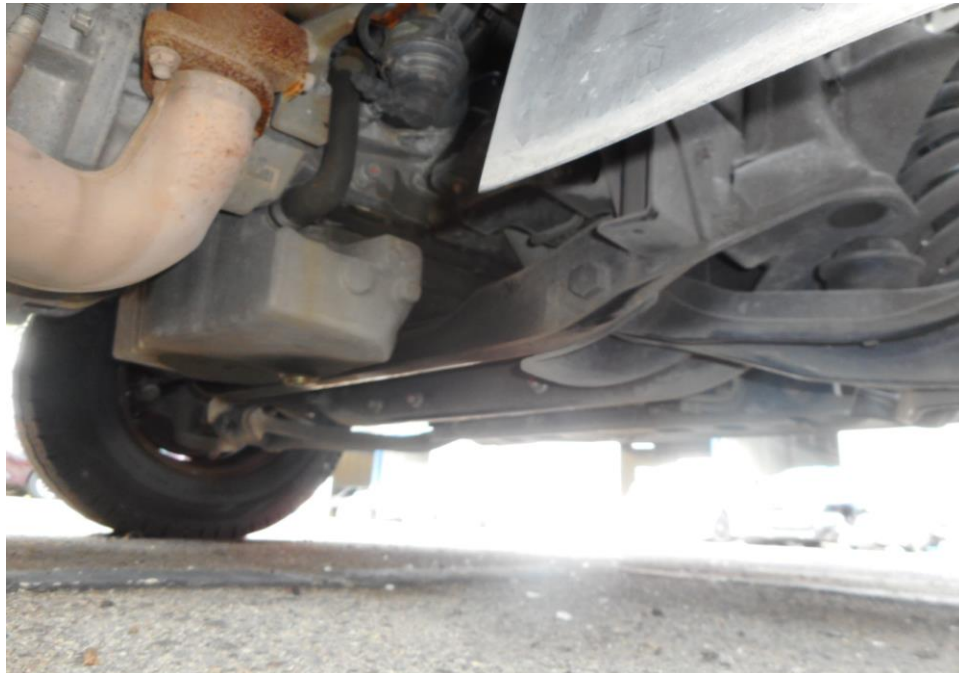
Photo 14 shows the undercarriage of the Motor Lorry, at the area where the engine housing and transmission housing are located. . I did not find any sign(s) or indication(s) of fluid leak and/or fluid stain(s) on the underside of the Motor Lorry.

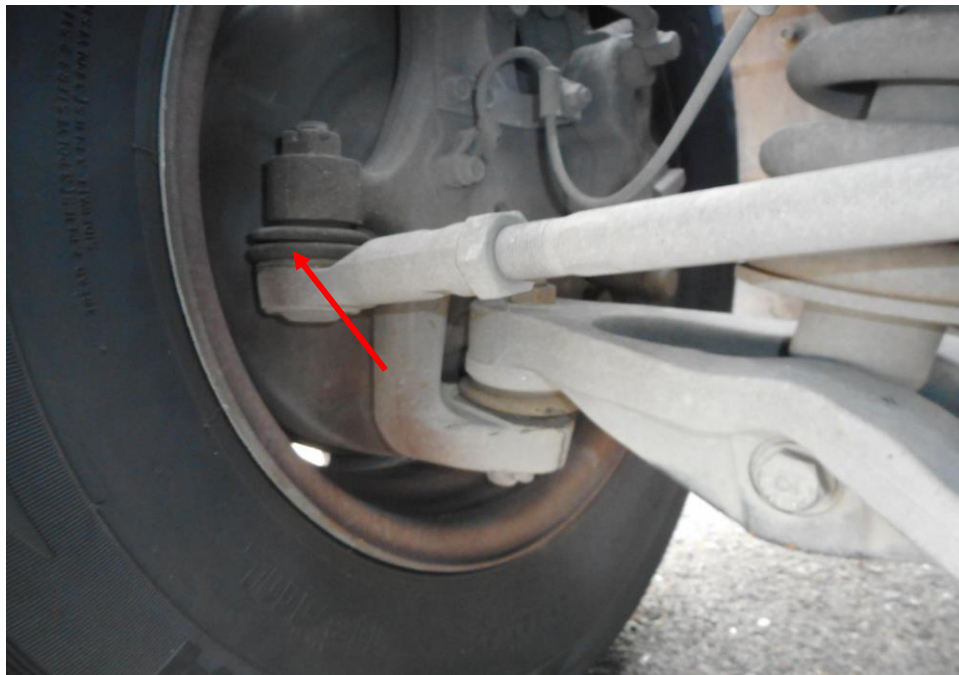
Photo 15 shows the various undercarriage components at the front right wheel of the Motor Lorry, in particular the steering tie rod end (arrowed). The various steering components were all found to be intact, suggesting that the steering system of the Motor Lorry was likely to be in serviceable condition at the material time of accident. There was also no sign of fluid stain(s) observed on the various undercarriage components.

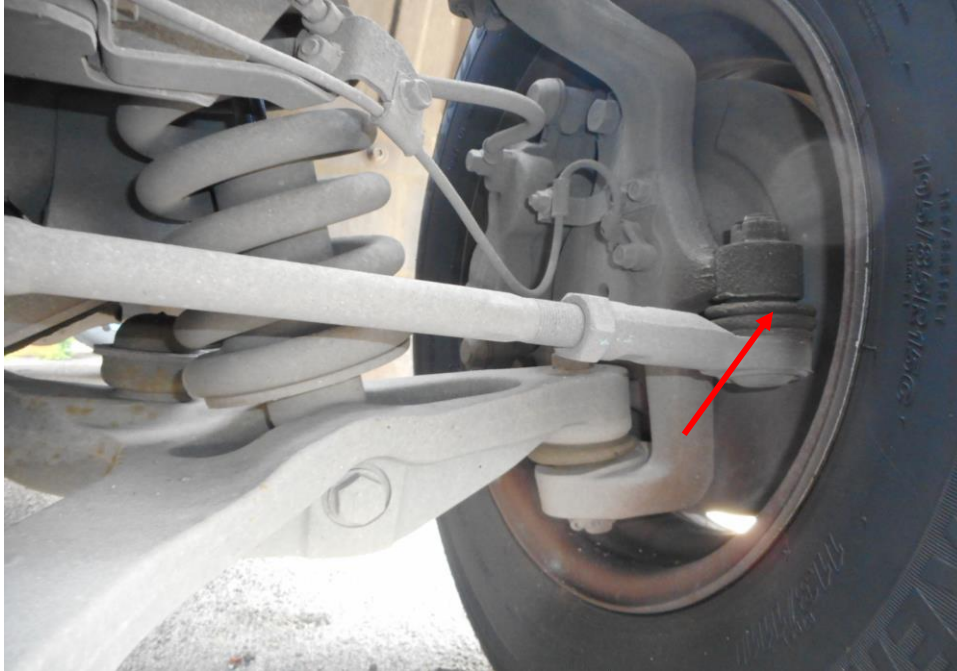
Photo 16 shows the various undercarriage components at the front left wheel of the Motor Lorry, in particular the steering tie rod end (arrowed). The various Undercarriage components of the Motor Lorry were all found to be intact without any visible damage. There was also no sign of fluid stain(s) observed on the various undercarriage components.

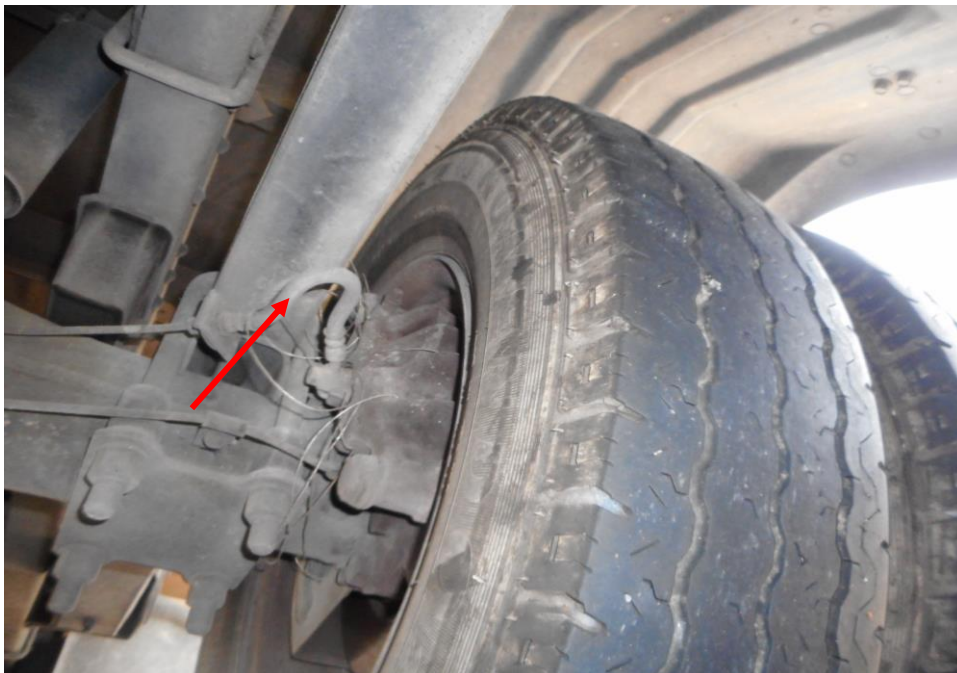
Photo 17 shows the brake pipe (arrowed) at the rear right wheel of the Motor Lorry. I did not observe any leakage of brake fluid at the time of my inspection of the Motor Lorry. My static tests of the Motor Lorry's braking system, along with my visual examination of the various mechanical components in the braking system, had indicated that there was no internal leakage of pressure/vacuum. Hence the braking system of the Motor Lorry was likely to be in serviceable condition at the material time of accident.

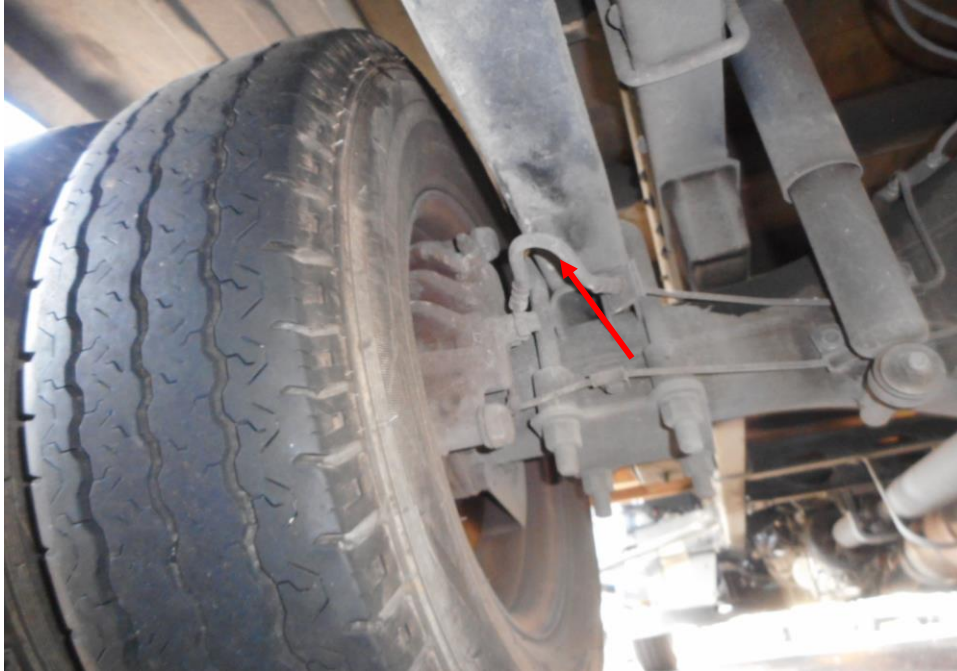
Photo 18 shows the brake pipe (arrowed) at the rear left wheel of the Motor Lorry. I did not observe any leakage of brake fluid at the time of my inspection of the Motor Lorry. My static tests of the Motor Lorry's braking system, along with my visual examination of the various mechanical components in the braking system had indicated that there was no internal leakage of pressure/vacuum. Hence the braking system of the Motor Lorry was likely to be in serviceable condition at the material time of accident.

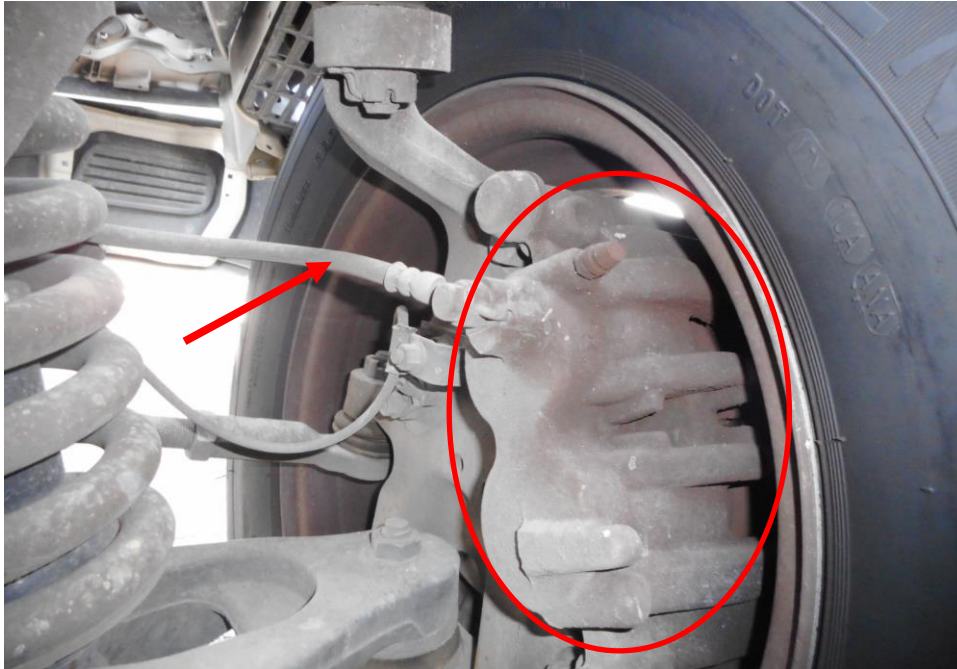
Photo 19 shows the brake hose/pipe (arrowed) at the front right wheel of the Motor Lorry. No leakage of brake fluid was observed. Visual examination of the various components of the braking system like the brake caliper (circled), brake booster, brake pedal etc had revealed all to be intact and without visible damage at the time of accident. There was also no sign of fluid stain(s) observed on the various undercarriage components.

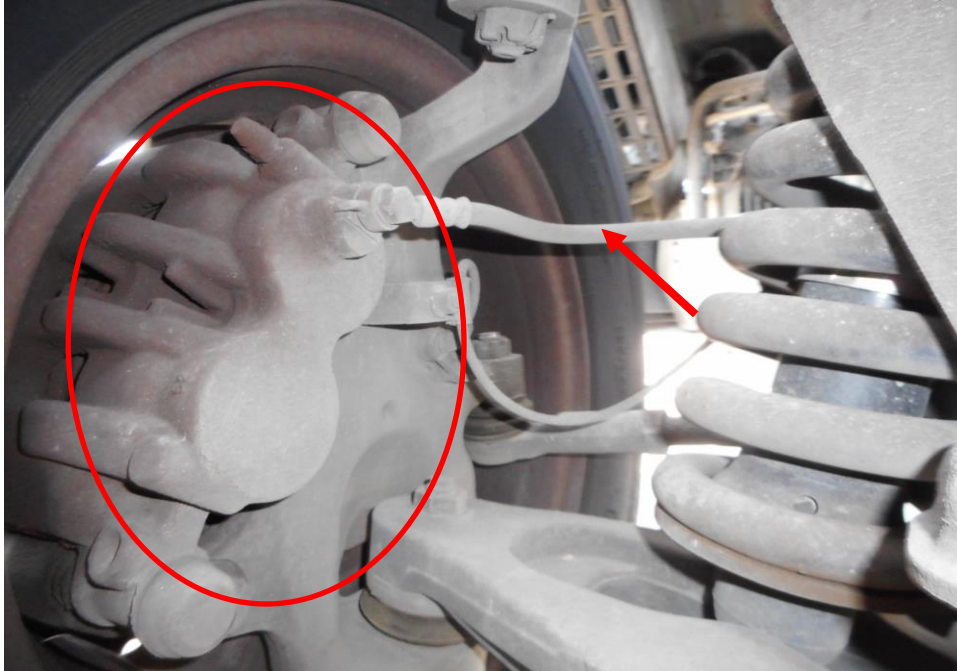
Photo 20 shows the brake hose/pipe (arrowed) at the front left wheel of the Motor Lorry. No leakage of brake fluid was observed. Visual examination of the various components of the braking system like the brake caliper (circled), brake booster, brake pedal etc had revealed all to be intact and without visible damage at the time of accident. There was also no sign of fluid stain(s) observed on the various undercarriage components.

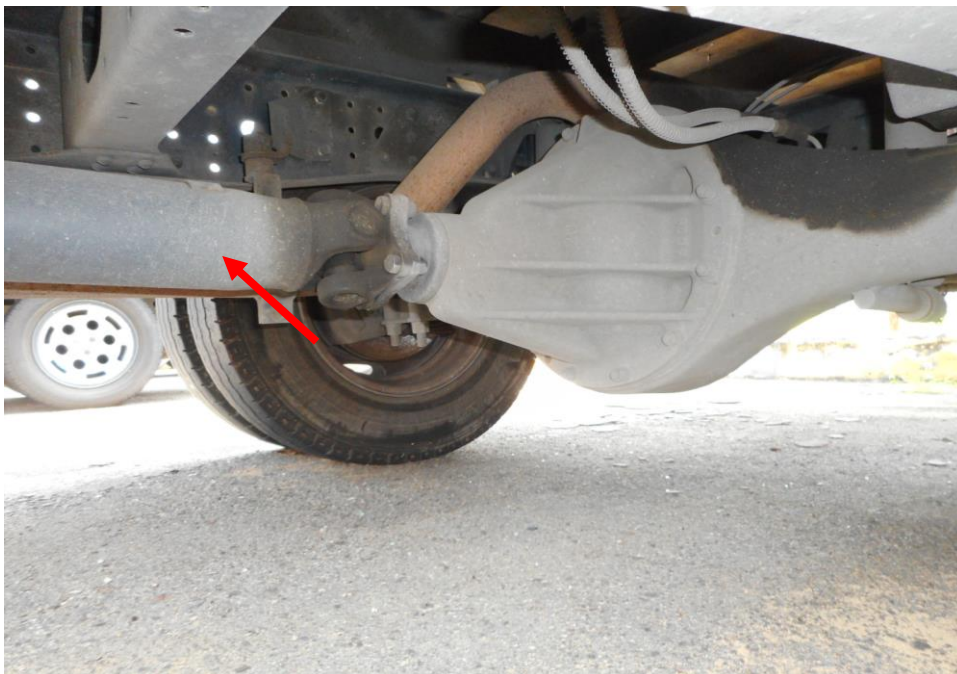
Photo 21 shows the various undercarriage components at the rear right wheel of the Motor Lorry, in particular the drive shaft (arrowed). The various steering components were all found to be intact, suggesting that the steering system of the Motor Lorry was likely to be in serviceable condition at the material time of accident. There was also no sign of fluid stain(s) observed on the various undercarriage components.
