Your Ref: TP/IP/46719/2020
Our Ref : CI/TPD20012457/P

Fatal Accident Investigation Team

MECHANICAL INSPECTION REPORT OF TIPPER TRUCK XD 5749K

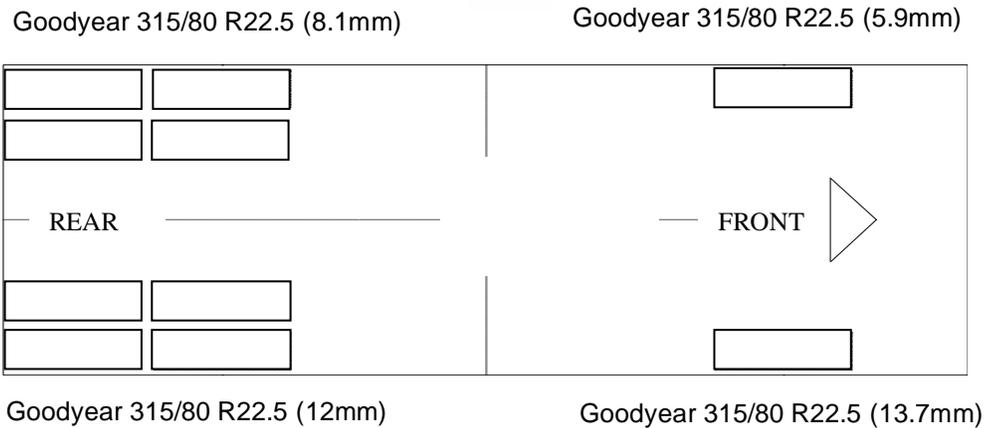
6. The 10 tyres of the Tipper Truck were observed to be in serviceable condition and sufficiently inflated for vehicular operation. I did not find any tear, cut or burst mark(s) on the outer and the inner sidewalls as well as across the tread of the 10 tyres of the Tipper Truck. The tyre brand, tyre size and remaining tread depth of the 10 tyres of the Tipper Truck were recorded as follows:-

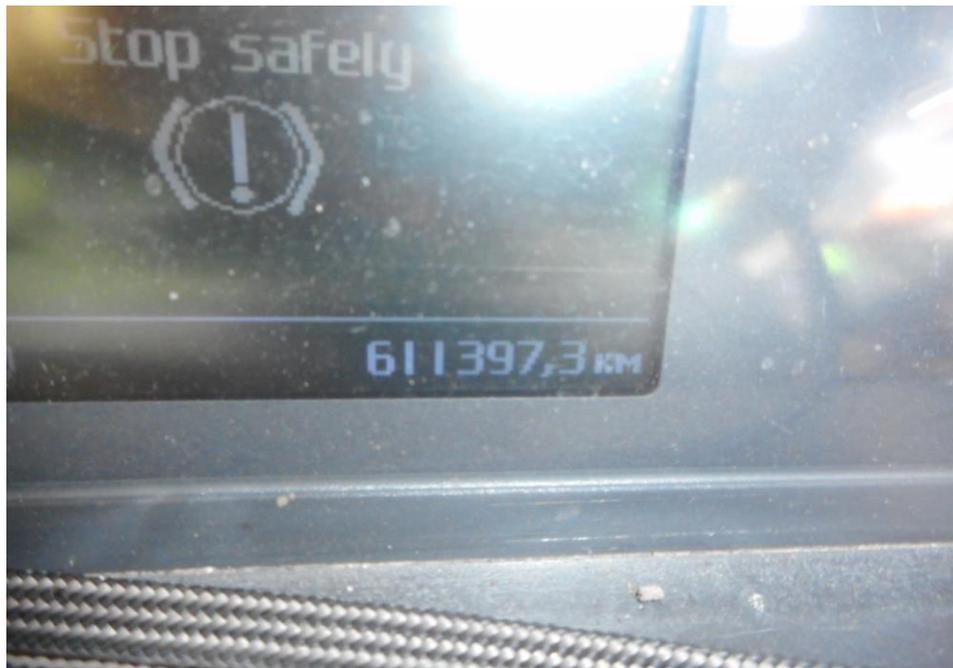
Photo 1 shows a general view of the instrument cluster of the Tipper Truck at the time of my inspection. The mileage of the Tipper Truck was 611,397km

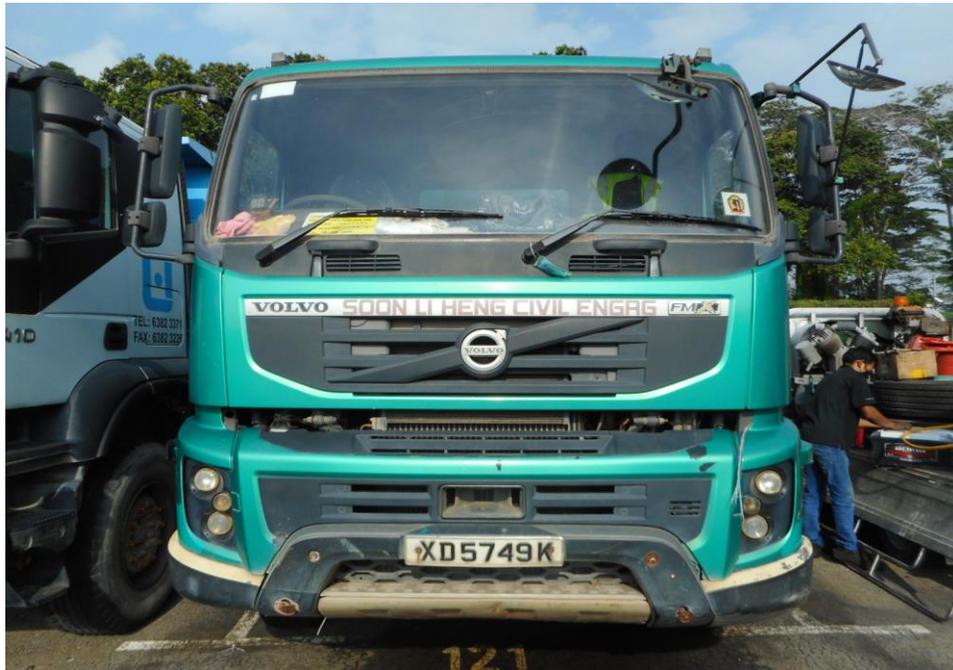
Photo 2 shows a general view of the front body of the Tipper Truck at the time of my inspection. The Tipper Truck was observed to not sustain any damage

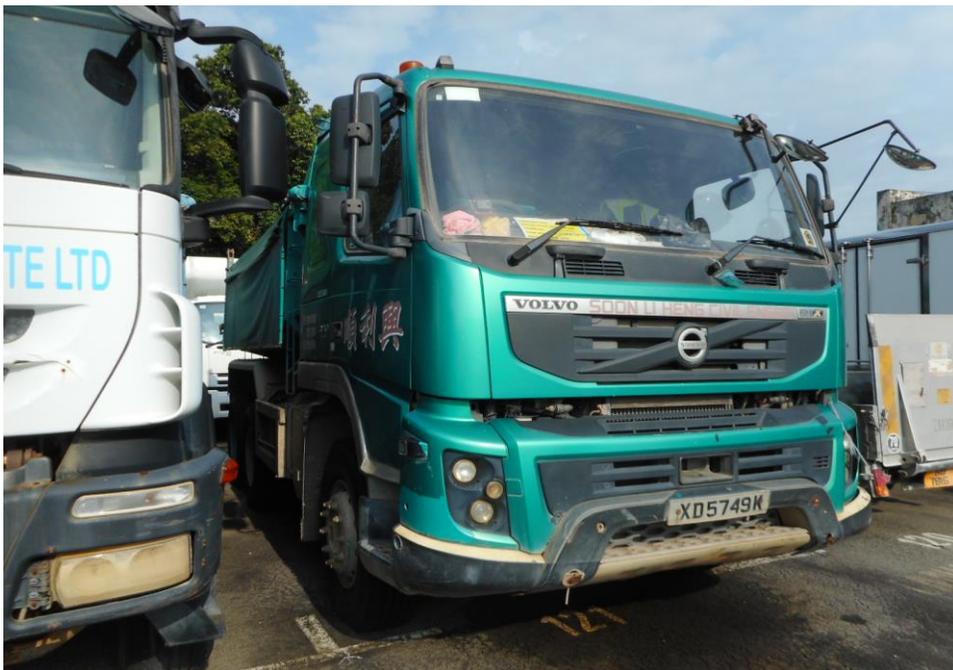
Photo 3 shows a general view of the front right body of the Tipper Truck at the time of my inspection, observed to have been unaffected by the accident.

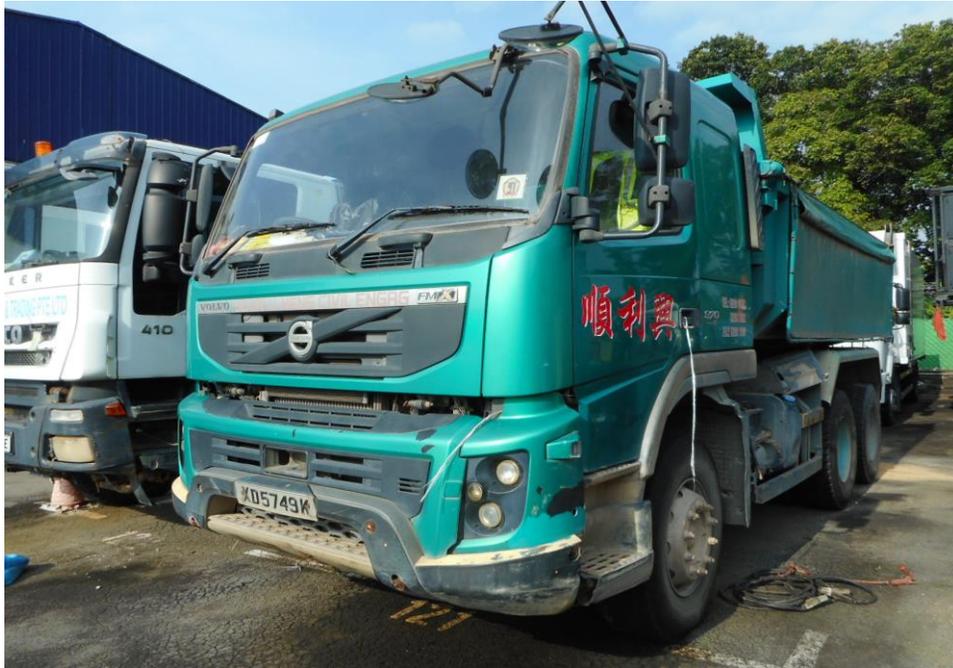
Photo 4 shows a general view of the front right body of the Tipper Truck at the time of my inspection, observed to have been unaffected by the accident.

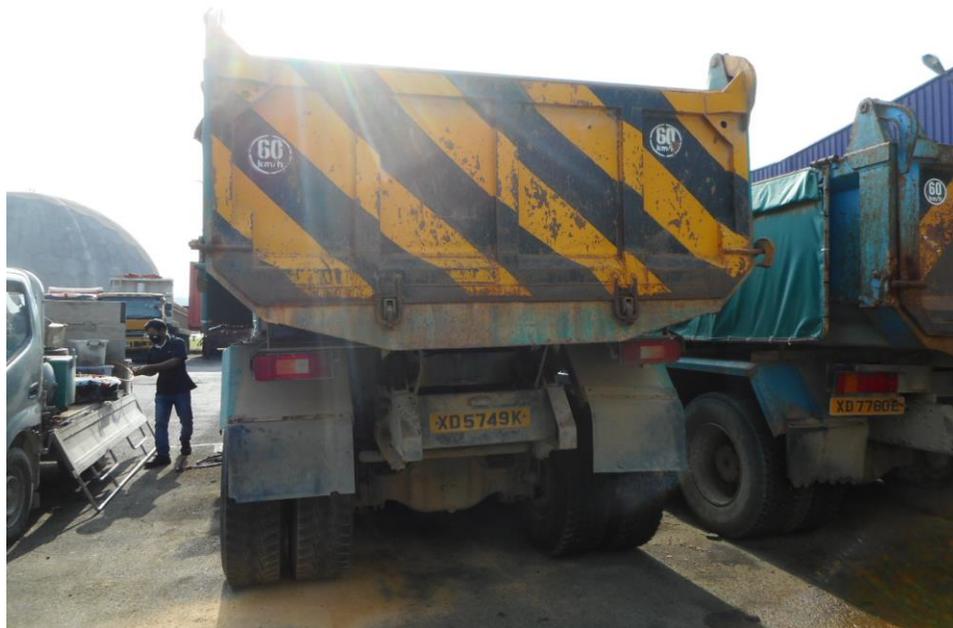
Photo 5 shows a general view of the Tipper Truck's rear body at the time of my inspection. There was no damage found to the rear portion of the Tipper Truck.

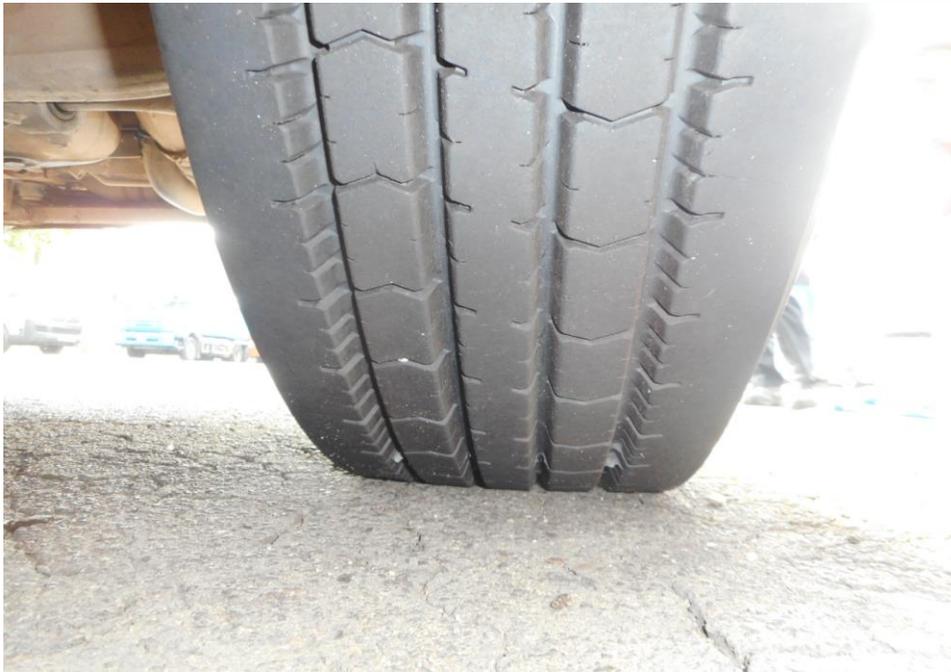
Photo 6 shows the condition of the front right tyre of the Tipper Truck, which was observed to be in serviceable condition with remaining tread depth of approximately 13.7 mm. The tyre, which was wrapped around standard steel wheel rim, was also observed to be sufficiently inflated for vehicular operation. There was no tear, cut or burst mark(s) on the outer and the inner sidewalls as well as across the tread of the 10 tyres that were fitted on the Tipper Truck.

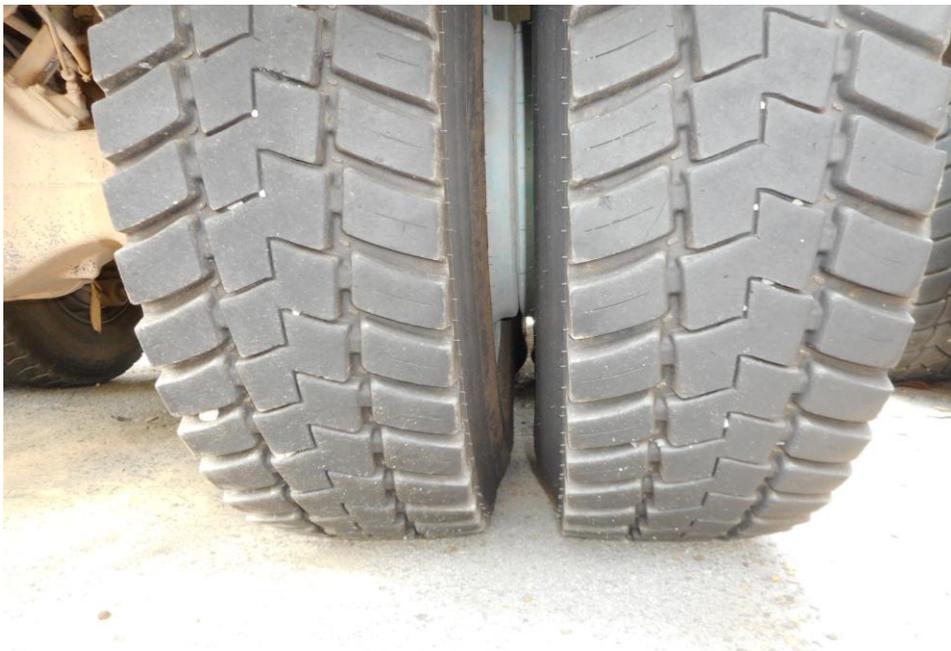
Photo 7 shows the condition of the rear right tyre of the Tipper Truck, which was observed to be in serviceable condition with remaining tread depth of approximately 12mm. The tyre, which was wrapped around standard steel wheel rim, was also observed to be sufficiently inflated for vehicular operation.

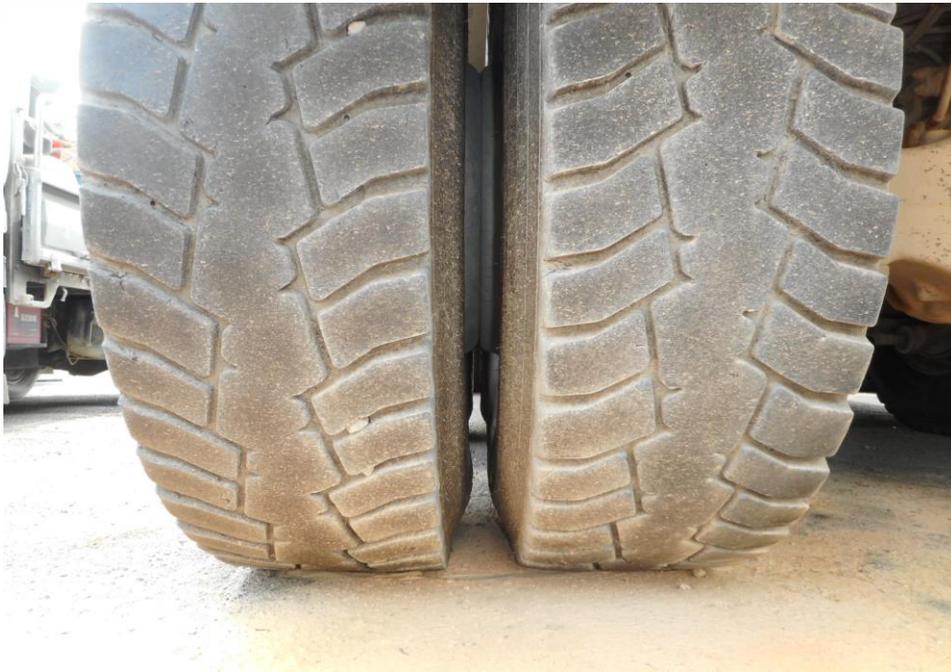
Photo 8 shows the condition of the rear left tyres of the Tipper Truck, which was observed to be in serviceable condition with remaining tread depth of approximately 8.1mm. The tyres, which were wrapped around standard steel wheel rim, were also observed to be sufficiently inflated for vehicular operation. There was also no damage found on all 10 steel wheel rims of the Tipper Truck.

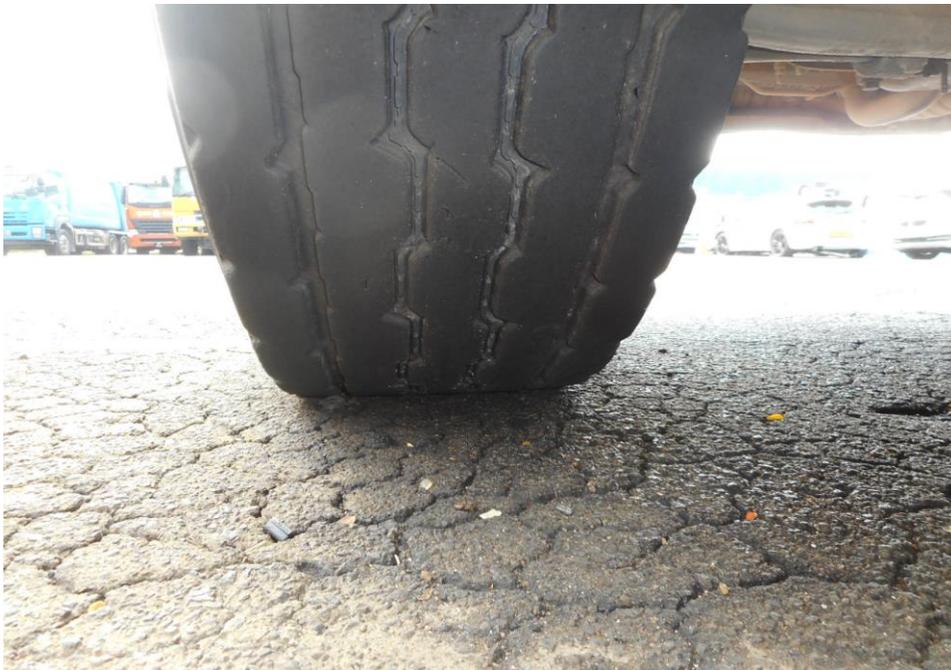
Photo 9 shows the condition of the front left tyres of the Tipper Truck, which were observed to be in serviceable condition with remaining tread depth of approximately 5.9mm. There was also no tear, cut or burst mark(s) on the outer and the inner sidewalls as well as across the tread of the 10 tyres that were fitted on the Tipper Truck.

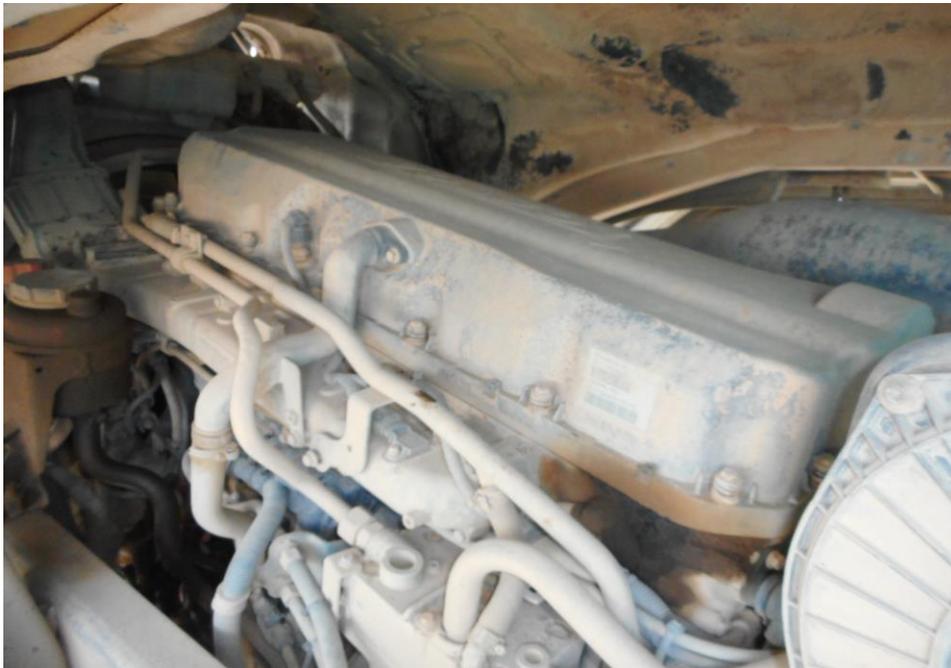
Photo 10 shows a general view of the Tipper Truck's engine compartment, which was accessed by lifting the front cabin of the Tipper Truck. The various parts and components inside the engine compartment were unaffected by the accident. There was also no sign(s) or indication(s) of fresh fluid leakage and/or fluid stain within the engine compartment

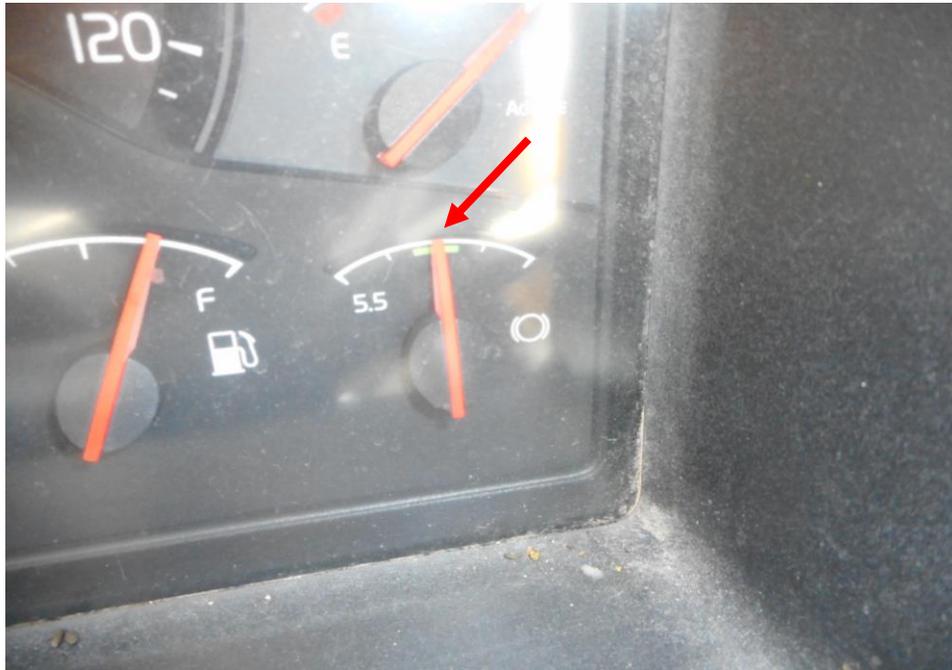
Photo 11 shows the air in the air brake cylinders of the Tipper Truck at the time of my inspection. The air in the cylinder was observed to be of sufficient level & serviceable at the time of the accident.

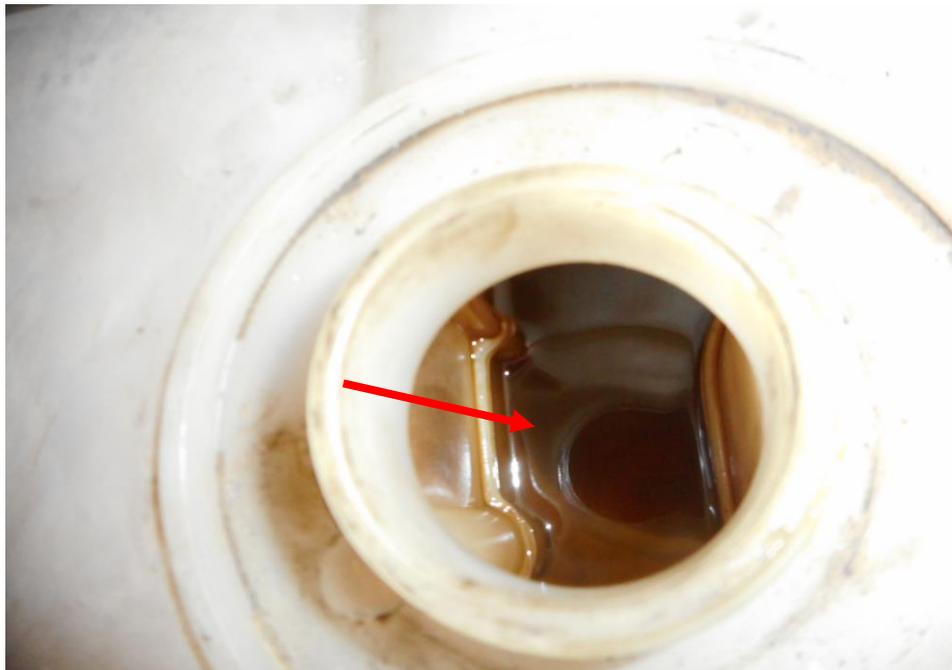
Photo 12 shows the engine coolant reservoir of the Tipper Truck at the time of my inspection. The engine coolant was observed to be of sufficient level (arrowed) and without any visible contamination.

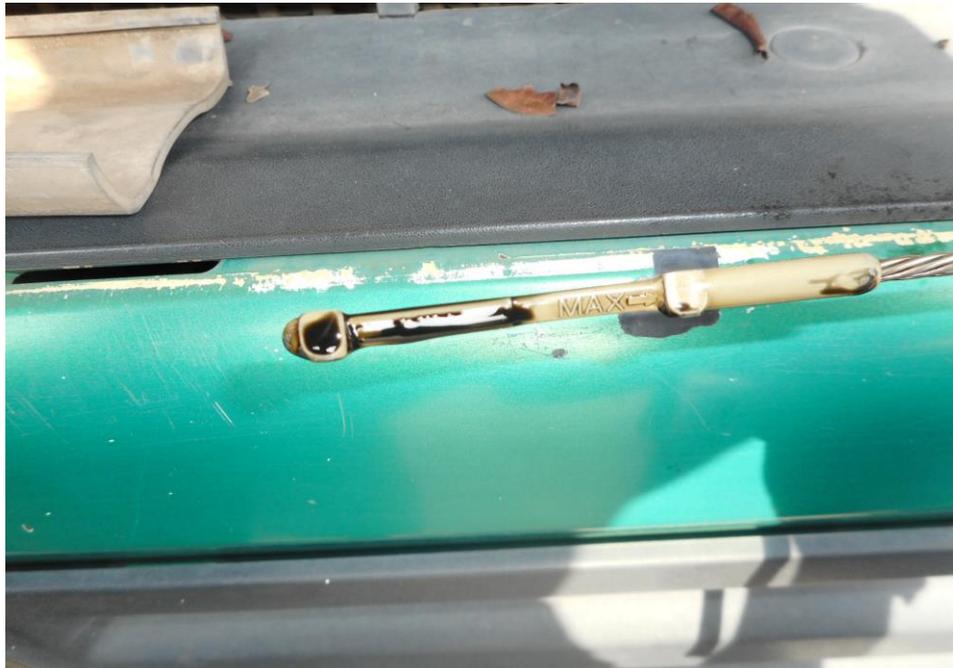
Photo 13 shows the engine oil dipstick of the Tipper Truck at the time of my inspection. The engine oil was observed to be of sufficient level.

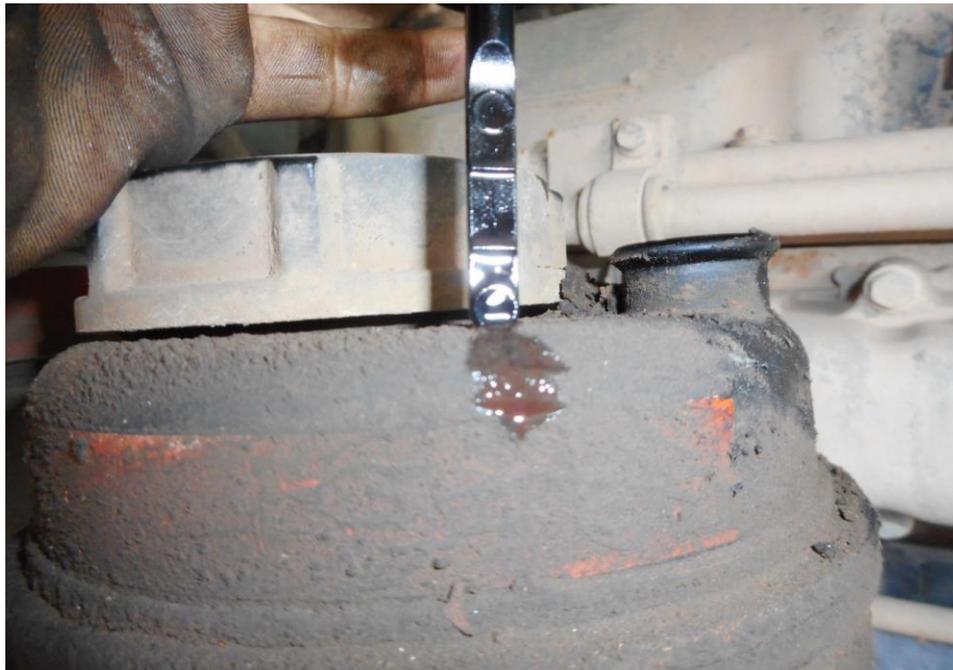
Photo 14 shows the power steering fluid dipstick of the Tipper Truck at the time of my inspection. The power steering fluid was observed to be of sufficient level.

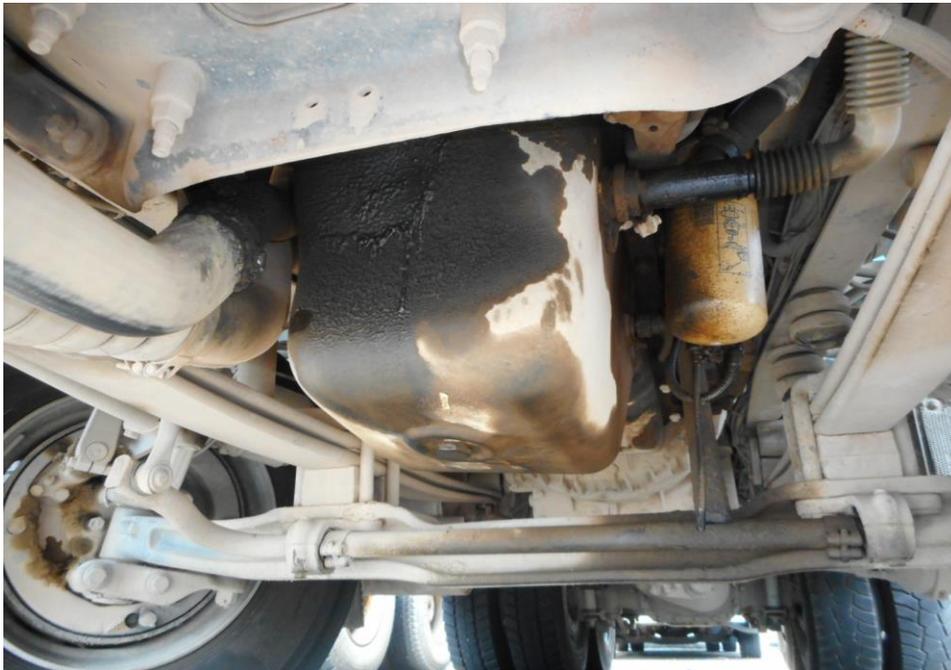
Photo 15 shows the undercarriage of the Tipper Truck, at the area where the engine housing located. I did not find any sign(s) or indication(s) of fluid leak, however old fluid stain(s) was observed on the underside of the Tipper Truck.

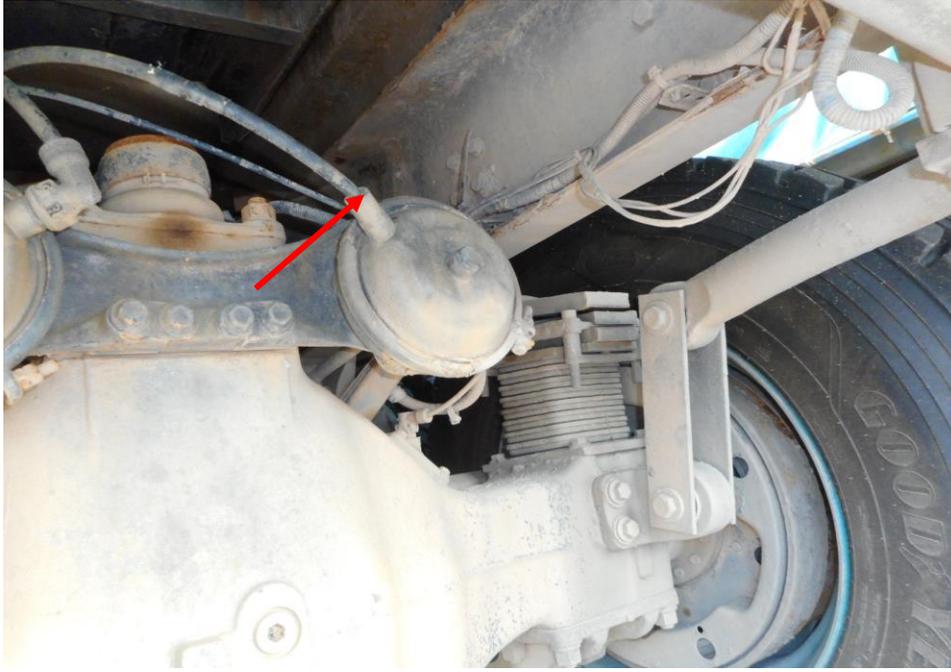
Photo 16 shows the brake pipe (arrowed) at the rear right wheel of the Tipper Truck. I did not observe any leakage of brake fluid at the time of my inspection of the Tipper Truck. My static tests of the Tipper Truck's braking system, along with my visual examination of the various mechanical components in the braking system, had indicated that there was no internal leakage of pressure/vacuum. Hence the braking system of the Tipper Truck was likely to be in serviceable condition at the material time of accident.

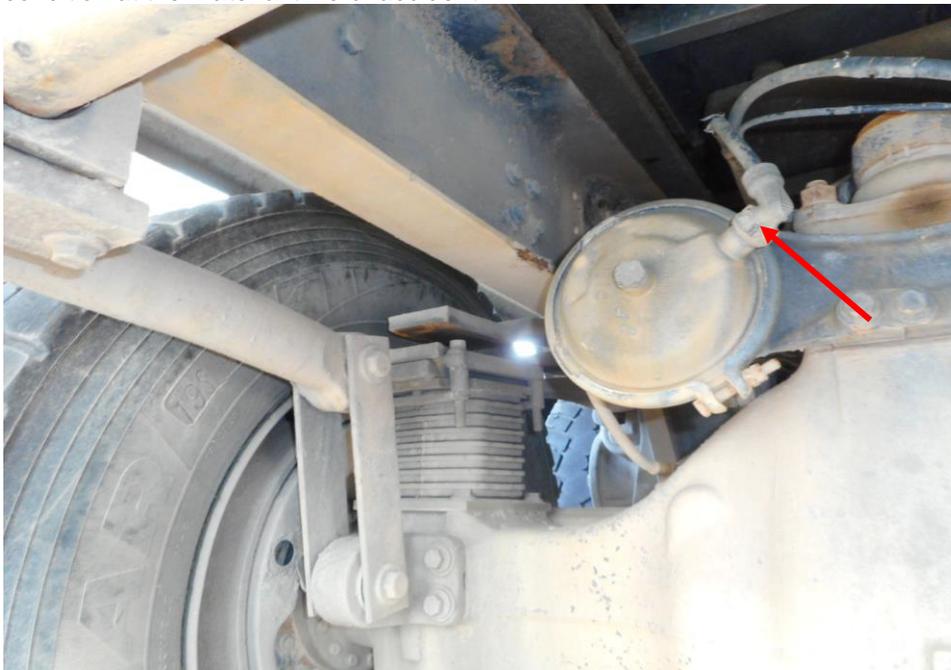
Photo 17 shows the brake pipe (arrowed) at the rear left wheel of the Tipper Truck. I did not observe any leakage of brake fluid at the time of my inspection of the Tipper Truck. My static tests of the Tipper Truck's braking system, along with my visual examination of the various mechanical components in the braking system, had indicated that there was no internal leakage of pressure/vacuum. Hence the braking system of the Tipper Truck was likely to be in serviceable condition at the material time of accident.

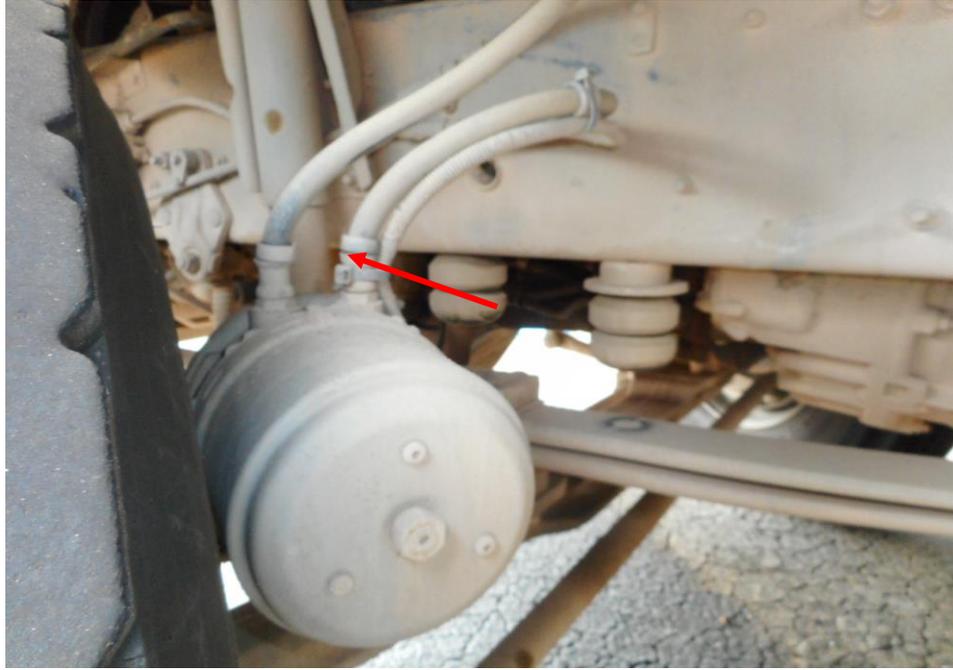
Photo 18 shows the brake pipe (arrowed) at the front left wheel of the Tipper Truck. I did not observe any leakage of brake fluid at the time of my inspection of the Tipper Truck. My static tests of the Tipper Truck's braking system, along with my visual examination of the various mechanical components in the braking system, had indicated that there was no internal leakage of pressure/vacuum. Hence the braking system of the Tipper Truck was likely to be in serviceable condition at the material time of accident.

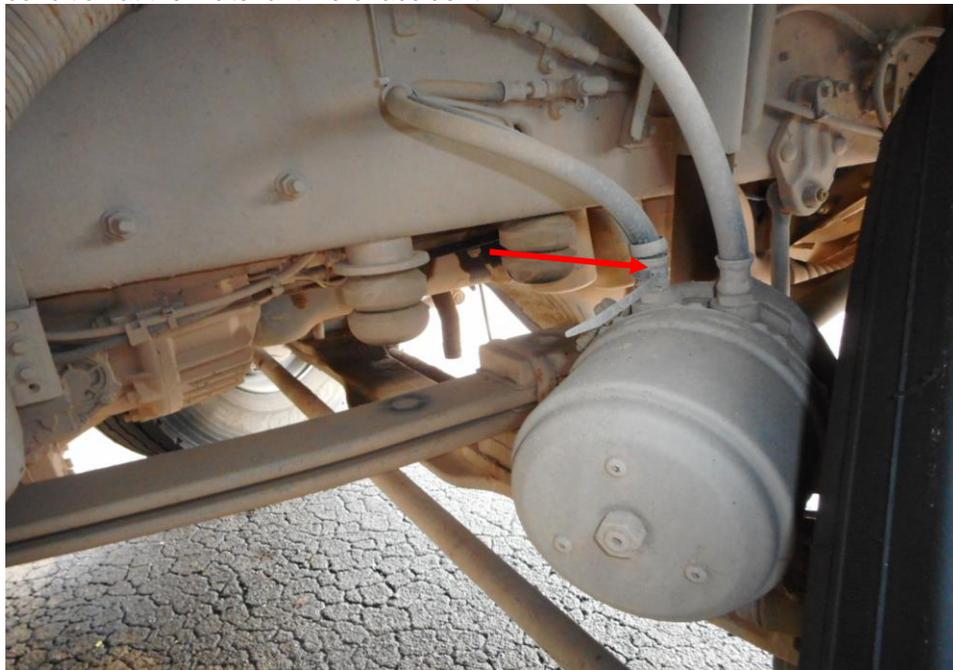
Photo 19 shows the brake pipe (arrowed) at the front right wheel of the Tipper Truck. I did not observe any leakage of brake fluid at the time of my inspection of the Tipper Truck. My static tests of the Tipper Truck's braking system, along with my visual examination of the various mechanical components in the braking system had indicated that there was no internal leakage of pressure/vacuum. Hence the braking system of the Tipper Truck was likely to be in serviceable condition at the material time of accident.

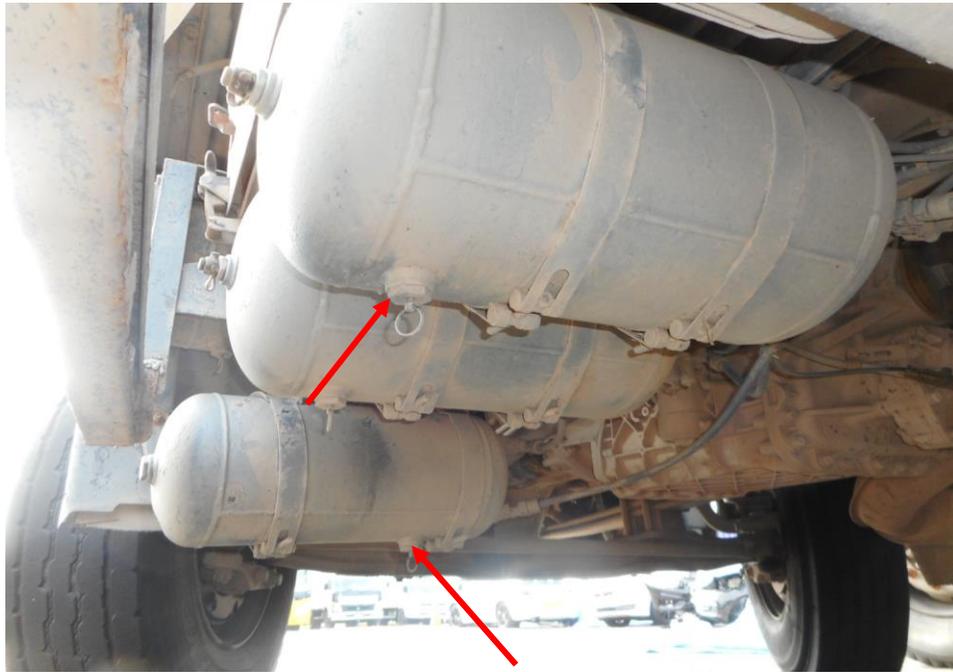
Photo 20 shows the air brake cylinders (arrowed) at the undercarriage of the Tipper Truck. I did not observe any leakage of air brake fluid at the time of my inspection of the Tipper Truck. My static tests of the Tipper Truck's braking system, along with my visual examination of the various mechanical components in the braking system had indicated that there was no internal leakage of pressure/vacuum. Hence the braking system of the Tipper Truck was likely to be in serviceable condition at the material time of accident.

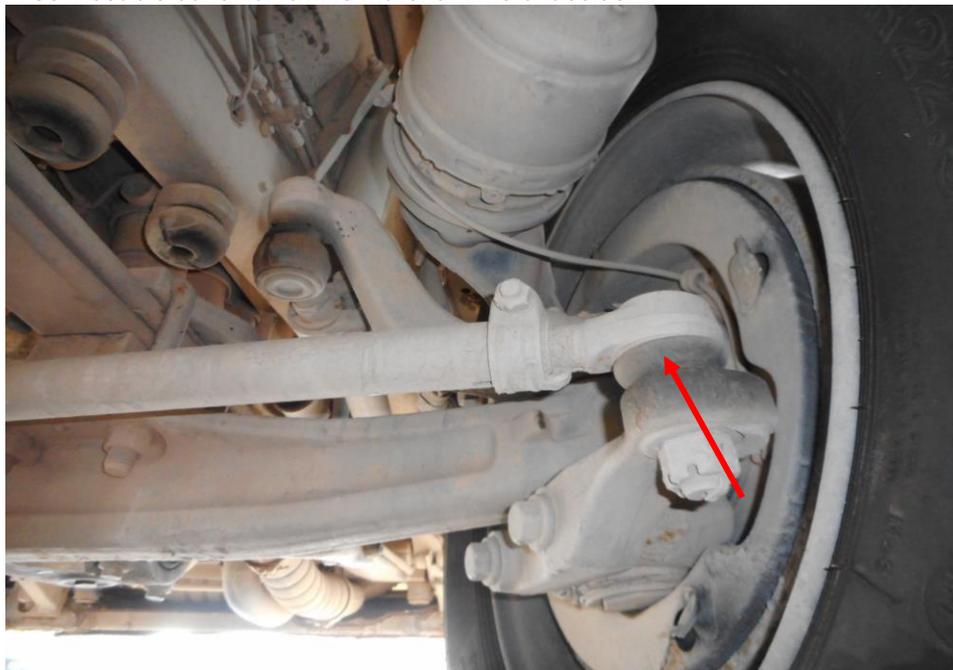
Photo 21 shows the various undercarriage components at the front right wheel of the Tipper Truck, in particular the steering tie rod end (arrowed). The various steering components were all found to be intact, suggesting that the steering system of the Tipper Truck was likely to be in serviceable condition at the material time of accident. There was also no sign of fluid stain(s) observed on the various undercarriage components.

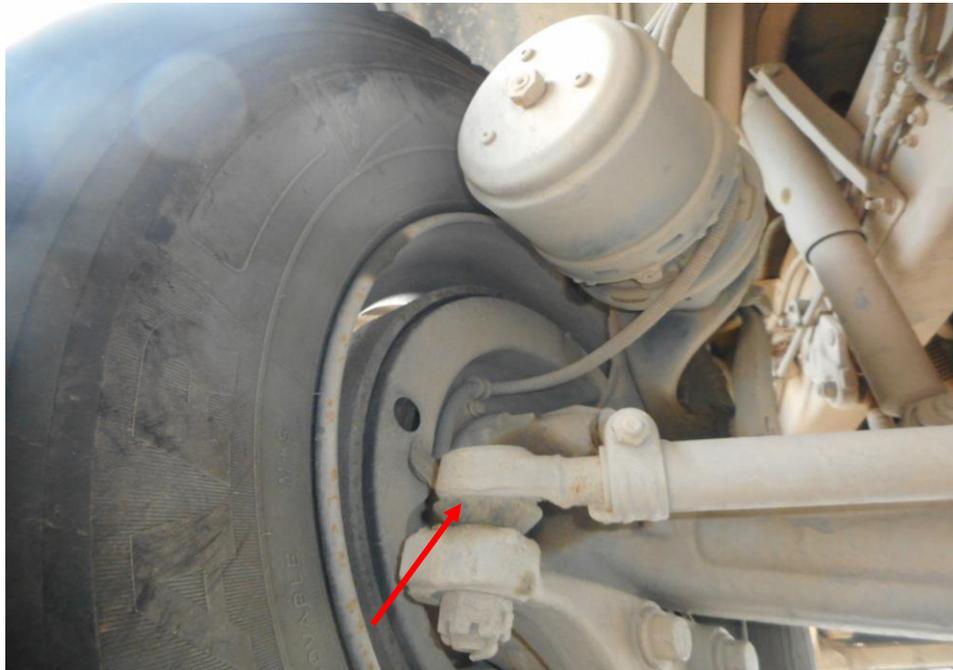
Photo 22 shows the various undercarriage components at the front left wheel of the Tipper Truck, in particular the steering tie rod end (arrowed). The various undercarriage components of the Tipper Truck were all found to be intact without any visible damage. There was also no sign of fluid stain(s) observed on the various undercarriage components.

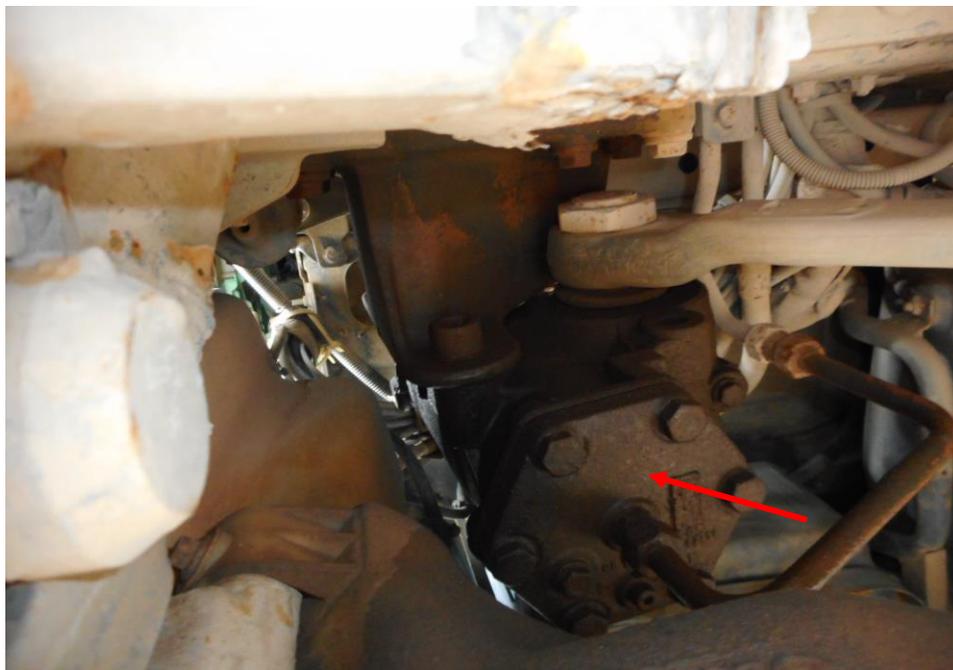
Photo 23 shows the steering box component (arrowed) at the undercarriage of the Tipper Truck was found to be intact without any visible damage. There was also no sign of fluid stain(s) observed on the various undercarriage components.

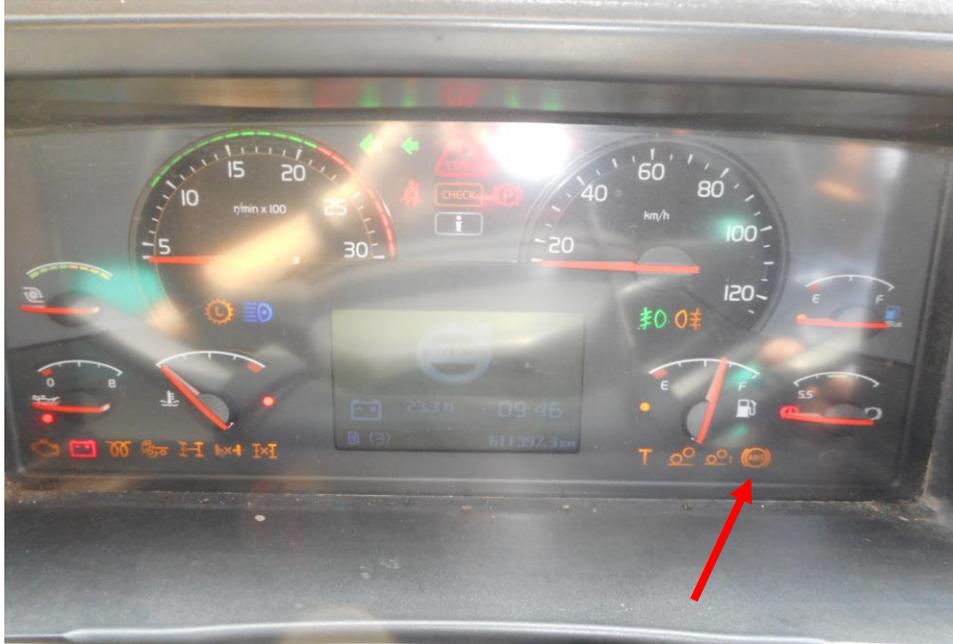
Photo 25 shows the warning light for Anti-Lock Brake System (ABS) (arrowed) appearing on the instrument panel of the Tipper Truck during the self-test of its various electronic operating systems when its engine was cranked.

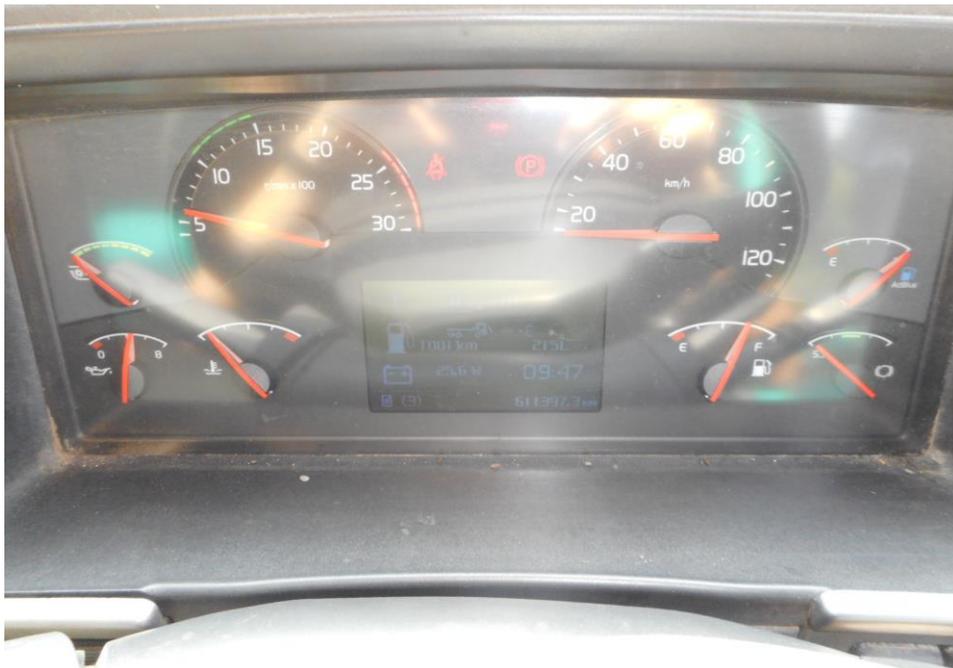
Photo 26 shows no warning lights illuminated on the instrument panel of the Tipper Truck after the engine was cranked. This would suggest that there was no abnormality to the various electronic operating systems of the Tipper Truck, like the ABS.
