You're Ref: TP/IP/47663/2020  
Our Ref: CI/TPD20012461/P

9<sup>th</sup> December 2020

**MECHANICAL INSPECTION REPORT OF MOTOR CAR SJV 8275L**

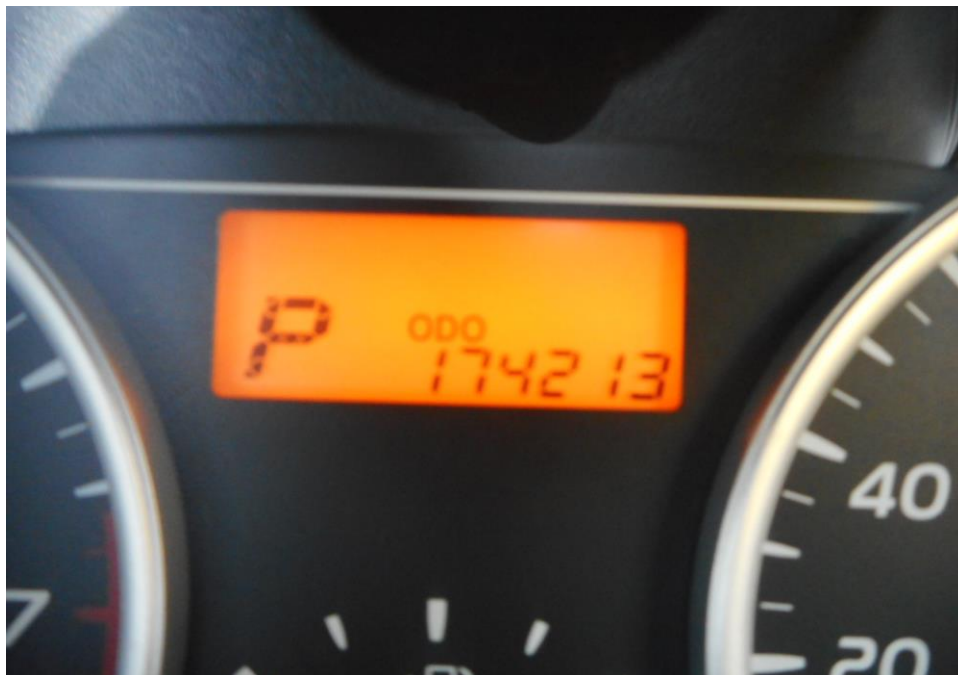
4. The mileage of the Motor Car at the time of my inspection was 174,213km.
5. The Motor Car was observed to have sustained damage at its front portion. Its front bumper was the body part that were damaged as a result of the accident.

**Photo 1** shows the mileage of the Motor Car at the time of my inspection. The mileage observed was 174,213km.

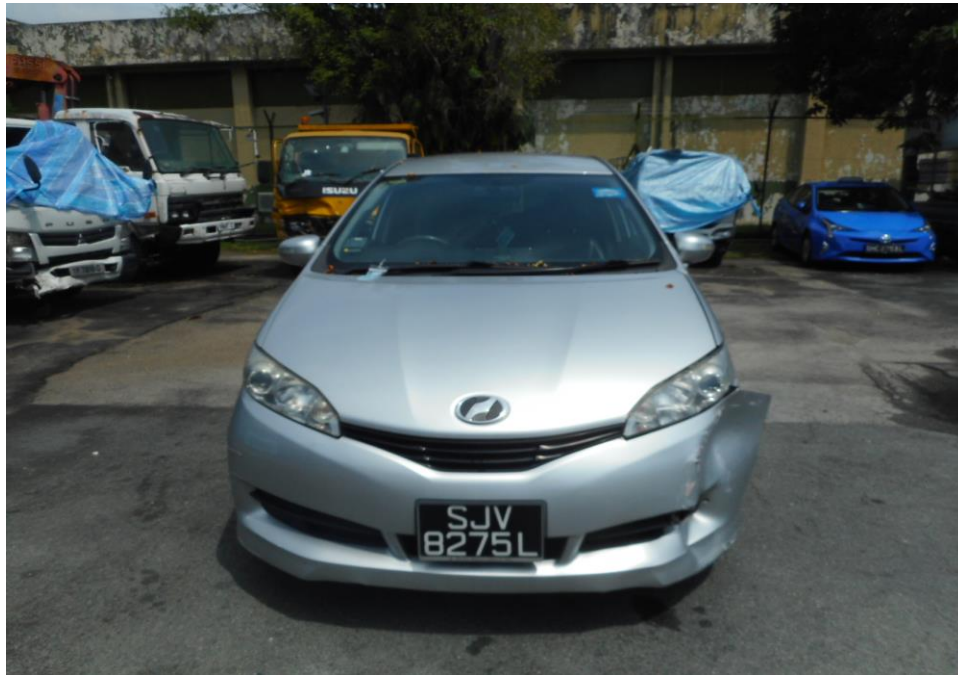
**Photo 2** shows a general view of the Motor Car's front body at the time of my inspection. The front portion of the Motor Car was observed to have sustained damage. Its front bumper was the body part that were damaged as a result of the accident.

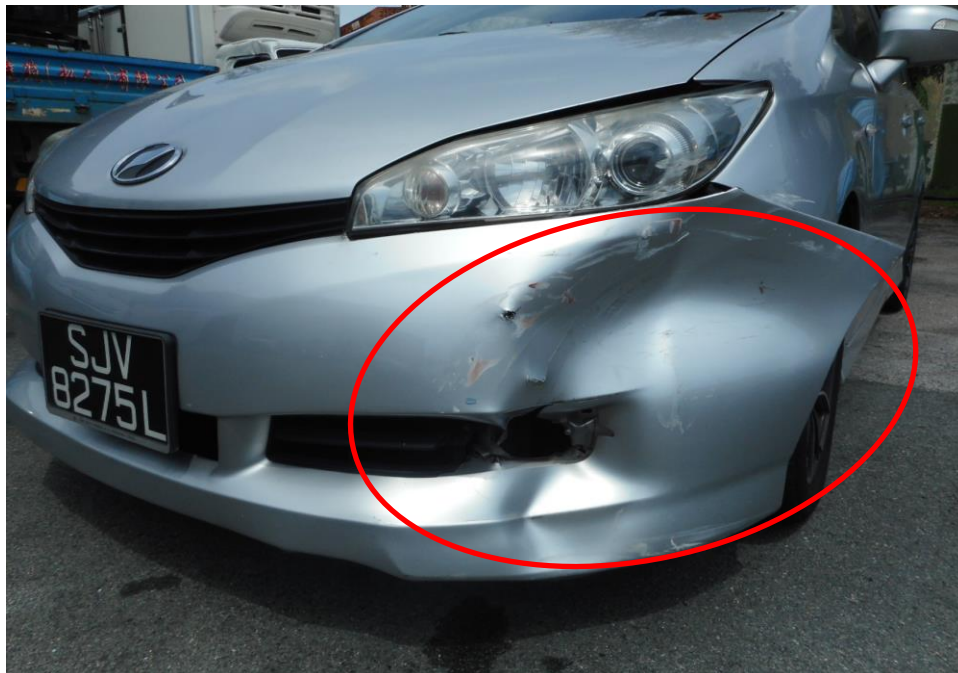
**Photo 3** shows the close up view of the Motor Car's front body at the time of my inspection. The Motor Car was observed to have sustained damage at its front bumper (circled), as a result of the accident.

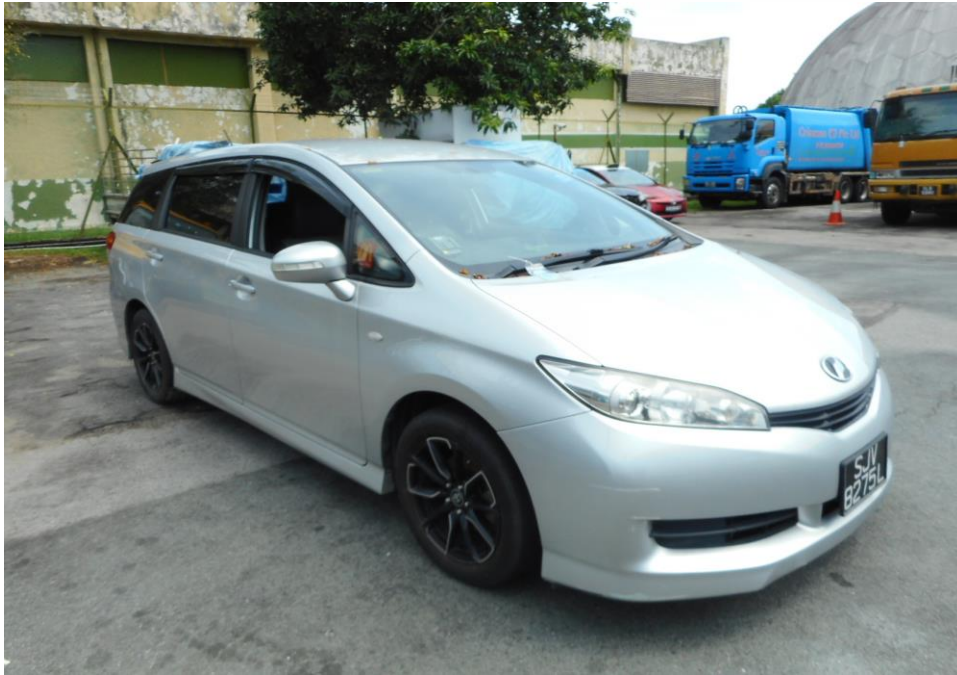
**Photo 4** shows a general view of the Motor Car's right body at the time of my inspection. The right portion of the Motor Car was observed to have been unaffected by the accident.

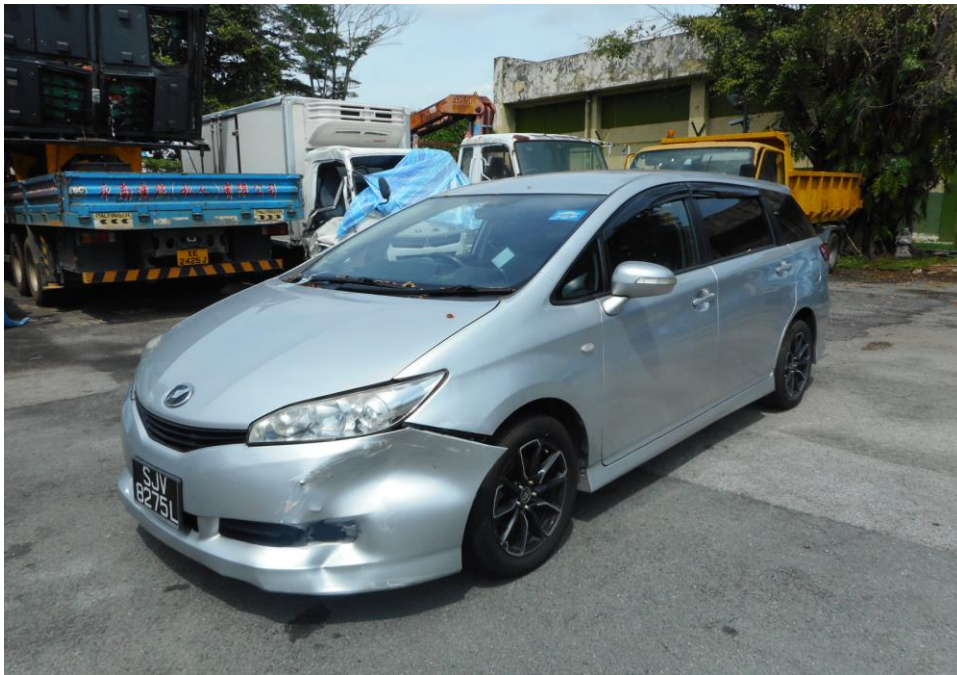
**Photo 5** shows a general view of the Motor Car's left body at the time of my inspection. The left portion of the Motor Car was observed to have been unaffected by the accident.

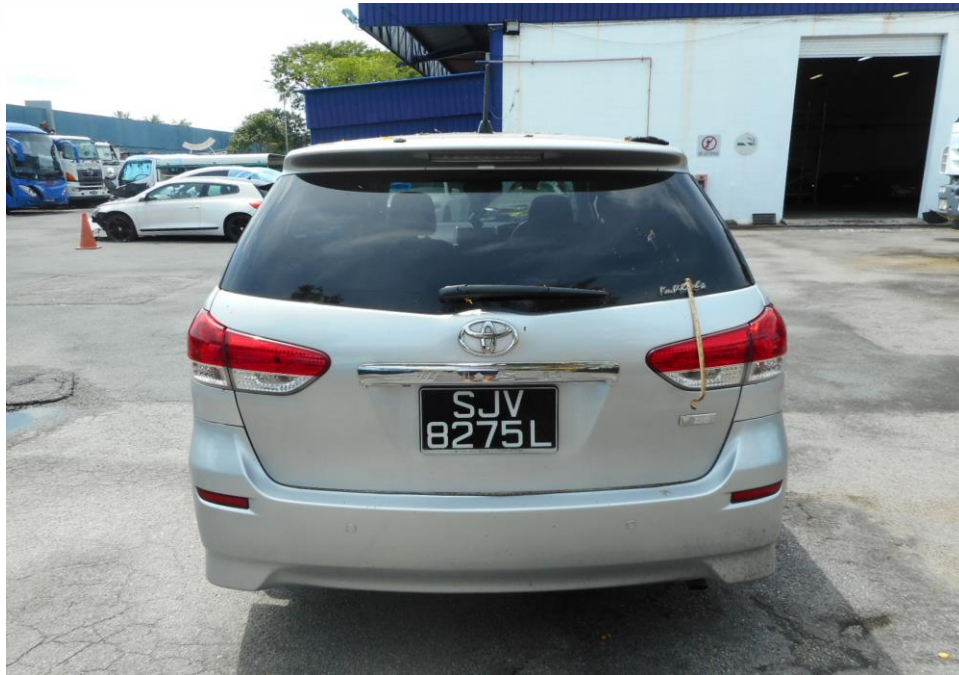
**Photo 6** shows the general view of the Motor Car's rear body at the time of my inspection. The Motor Car rear was observed to be unaffected by the accident.

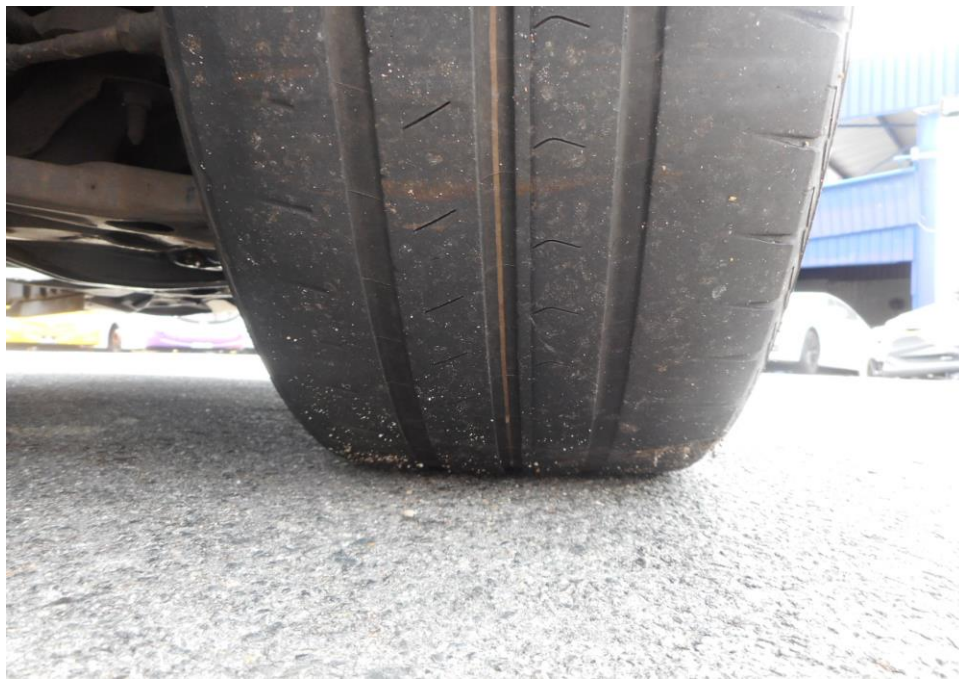
**Photo 7** shows the condition of the front right tyre of the Motor Car, which was observed to be in serviceable condition with remaining tread depth of approximately 2.5mm. The tyre was sufficiently inflated for vehicular operation with no tear, cut or burst mark(s) on the outer and the inner sidewalls as well as across the tread. The 4 tyres of the Motor Car were wrapped around standard steel wheel rims without any damage.

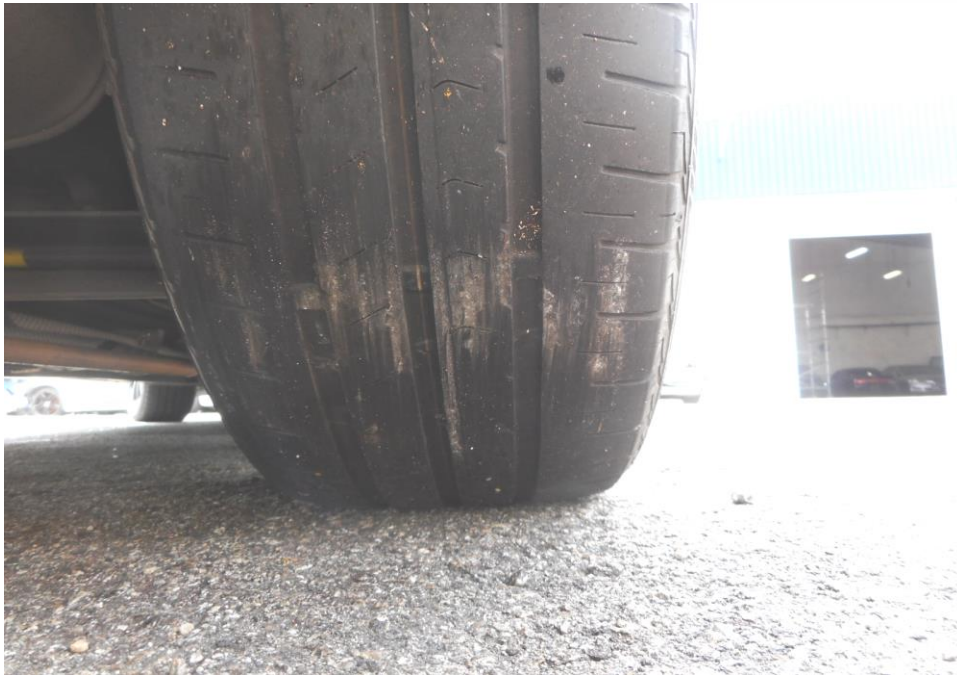
**Photo 8** shows the condition of the rear right tyre of the Motor Car, which was observed to be in serviceable condition with remaining tread depth of approximately 3mm. The tyre was also observed to be sufficiently inflated for vehicular operation with no tear, cut or burst mark(s).

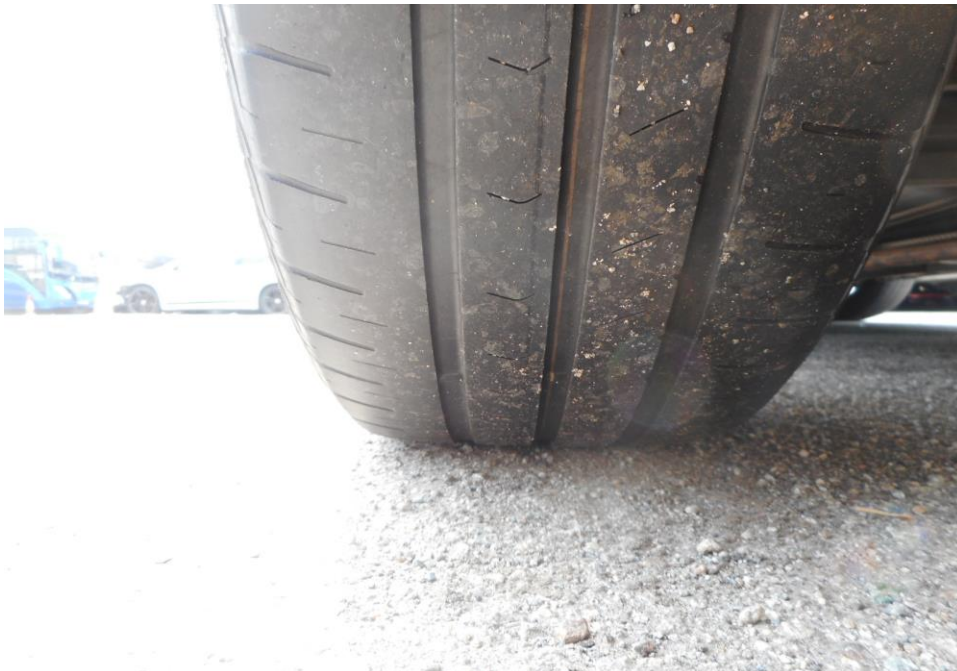
**Photo 9** shows the condition of the rear left tyre of the Motor Car, which was observed to be in serviceable condition with remaining tread depth of approximately 2.8mm. The tyre, which was wrapped around steel wheel rim, was also observed to be sufficiently inflated for vehicular operation. The 4 tyres of the Motor Car were wrapped around standard steel wheel rims.

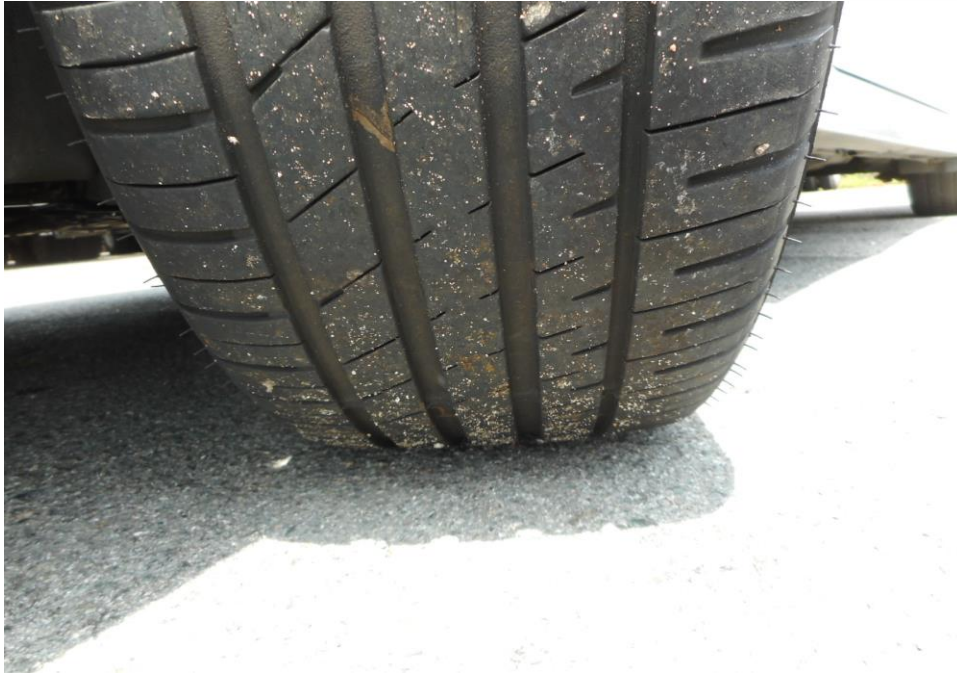
**Photo 10** shows the condition of the front left tyre of the Motor Car, which was observed to be in serviceable condition with remaining tread depth of approximately 4.5mm. There was also no tear, cut or burst mark(s) on the outer and the inner sidewalls as well as across the tread of the Motor Car's 4 tyres.

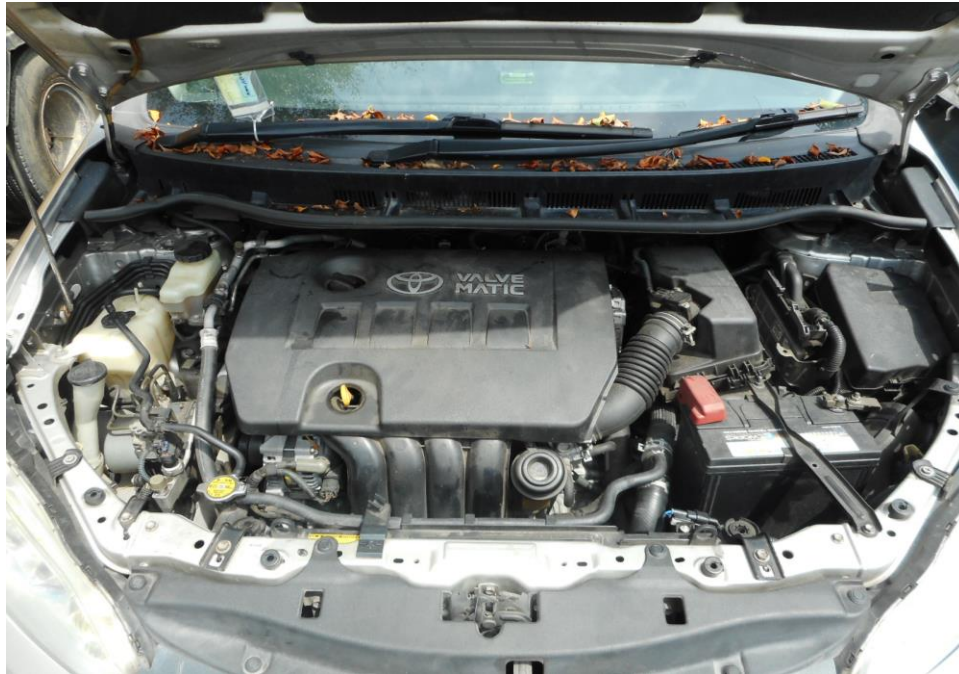
**Photo 11** shows a general view of the Motor Car's engine compartment. The various parts and components inside the engine compartment were unaffected by the accident. There was also no sign(s) or indication(s) of fluid leakage and/or fluid stain within the engine compartment.

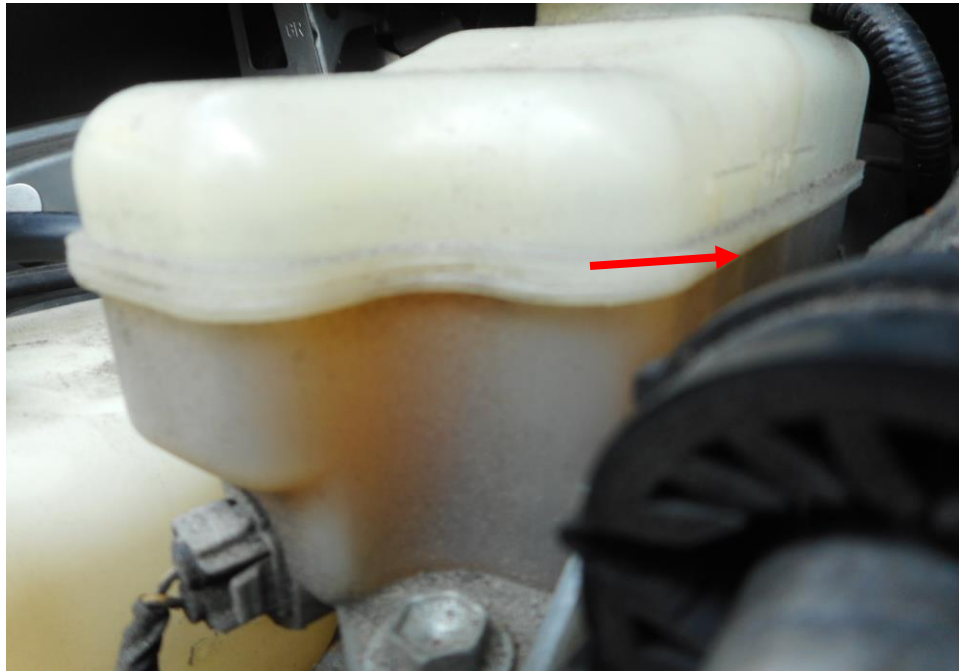
**Photo 12** shows the brake fluid reservoir of the Motor Car at the time of my inspection. The brake fluid was observed to be of sufficient level (arrowed) and without any visible contamination.

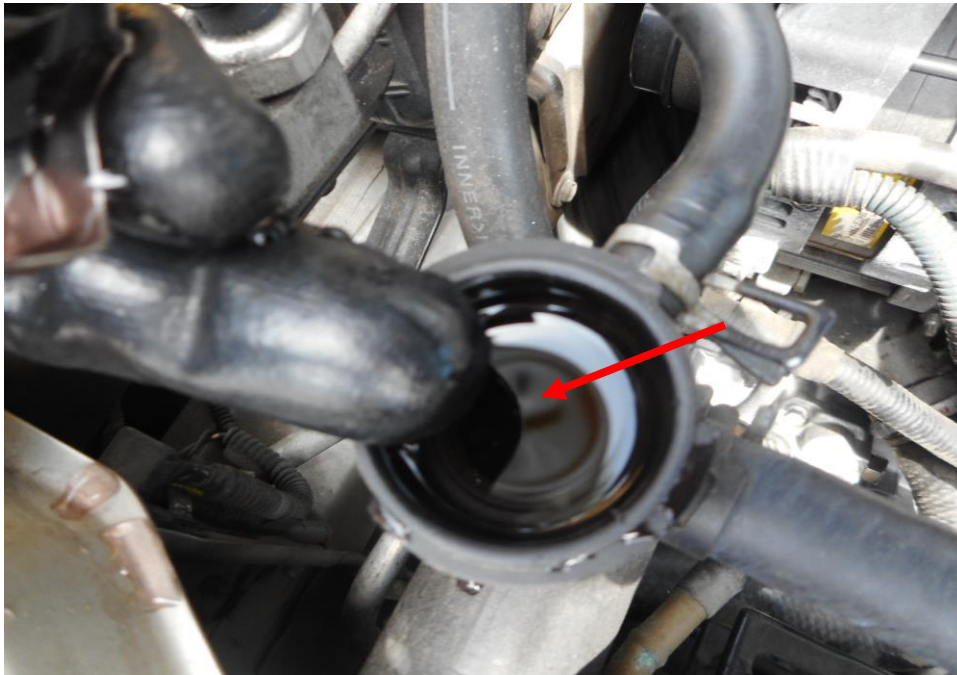
**Photo 13** shows checks being carried out to the engine coolant of the Motor Car at the time of my inspection. The engine coolant was observed to be of sufficient level (arrowed) and without any visible contamination.

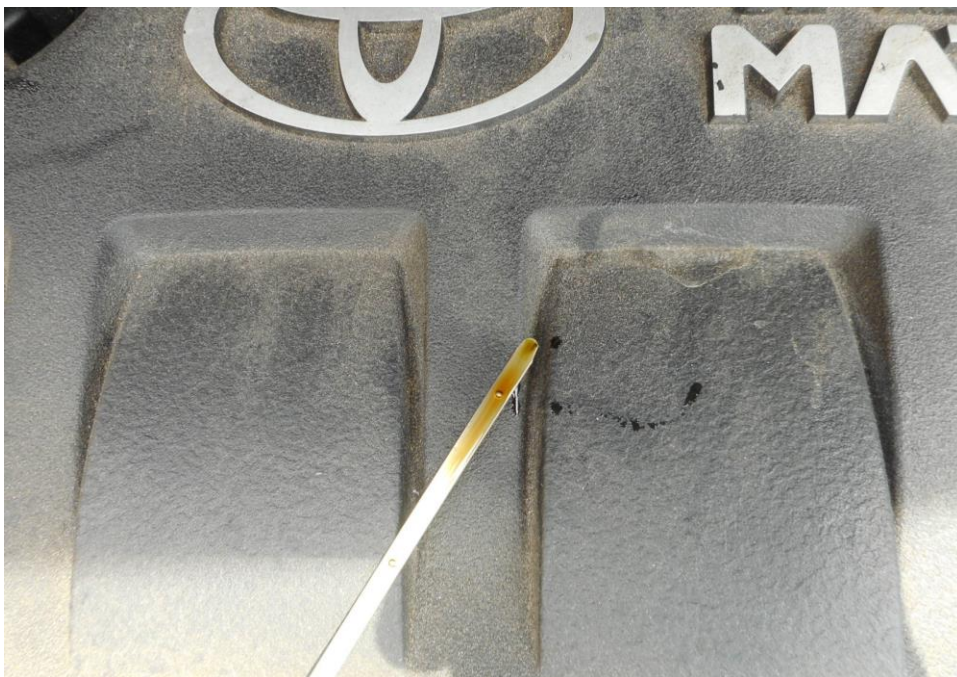
**Photo 14** shows the engine oil dip stick of the Motor Car at the time of my inspection. The engine oil was observed to be of sufficient level and without any visible contamination.

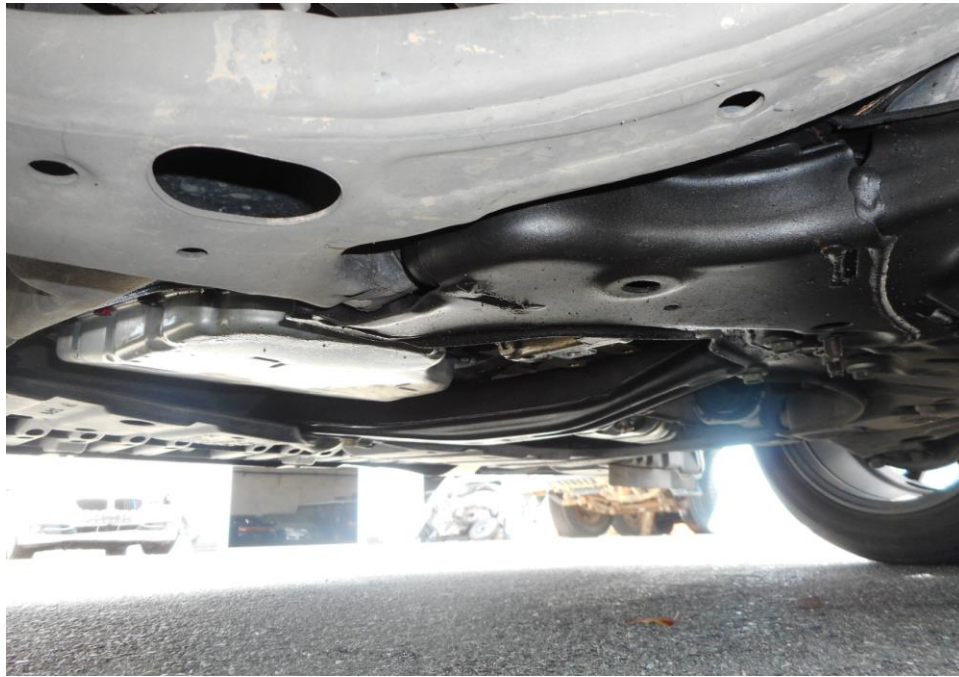
**Photo 15** shows the undercarriage of the Motor Car, at the area where the engine housing and transmission housing are located. I did not find any sign(s) or indication(s) of fluid leak and/or fluid stain(s) on the underside of the Motor Car.

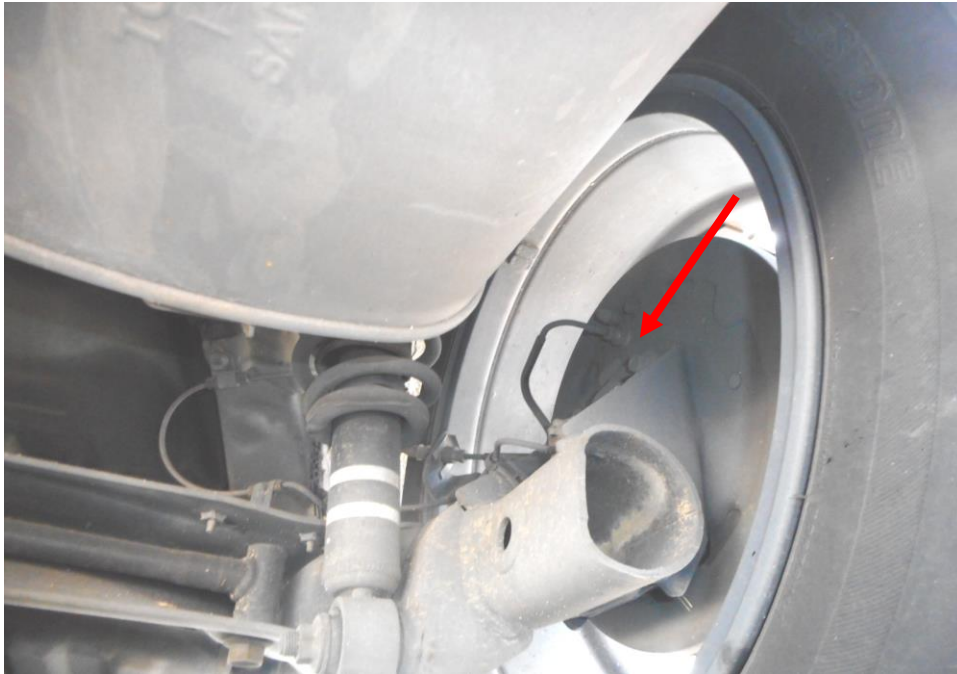
**Photo 16** shows the brake hose/pipe (arrowed) at the rear right wheel of the Motor Car. No leakage of brake fluid was observed. Visual examination of the various components of the braking system like the drum brake, brake booster, brake pedal etc. had revealed all to be intact and without visible damage.

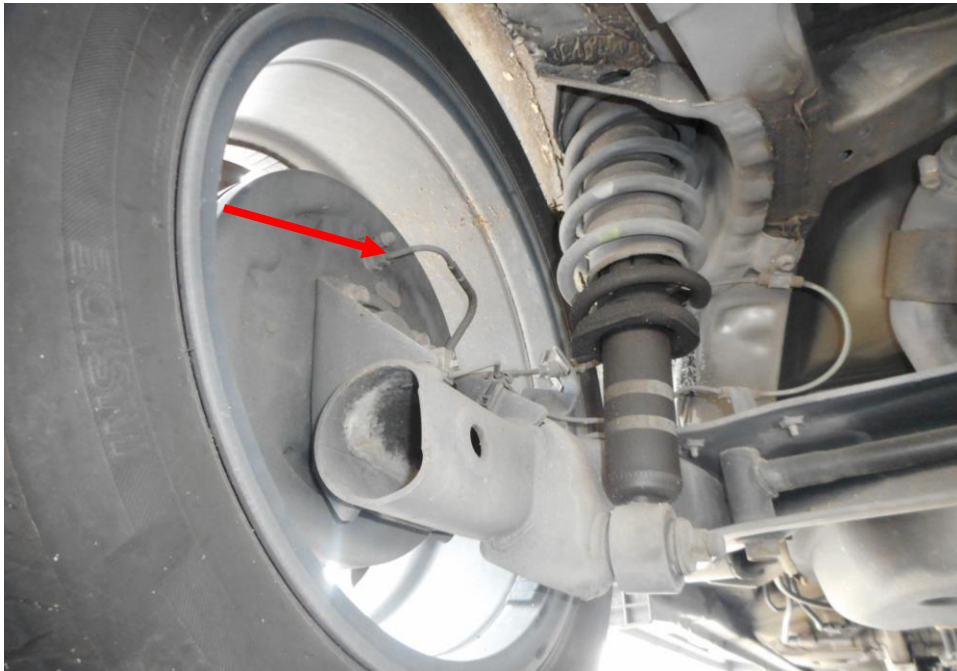
**Photo 17** shows the brake hose/pipe (arrowed) at the rear left wheel of the Motor Car. I did not observe any leakage of brake fluid at the time of my inspection of the Motor Car. Static tests of the Motor Car's braking system had indicated that there was no internal leakage of pressure/vacuum. The undercarriage components of the Motor Car were also all found to be intact and without any visible damage.

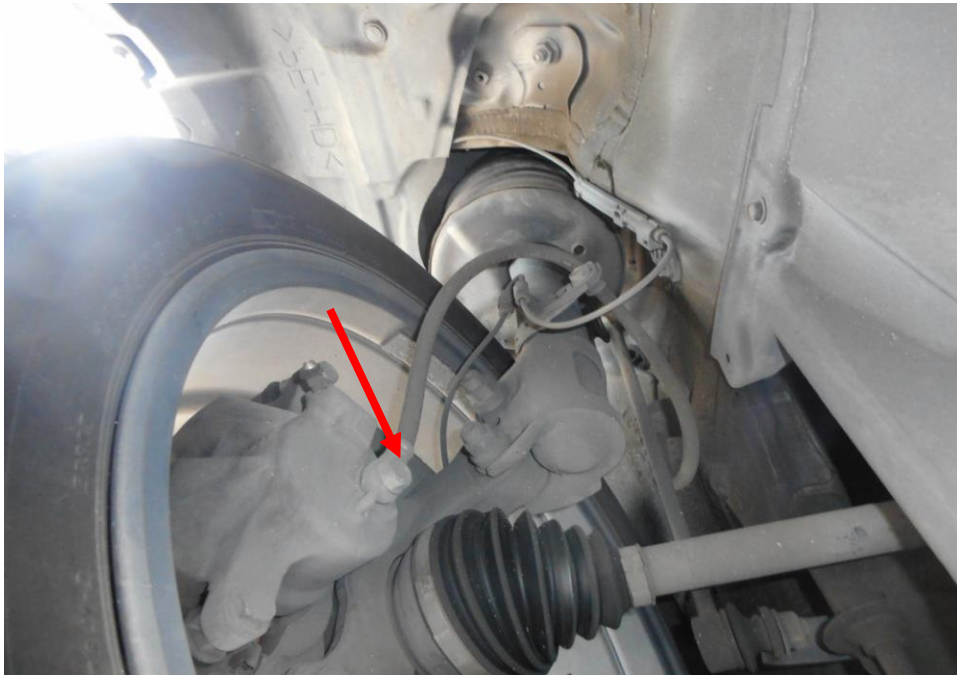
**Photo 18** shows the brake hose/pipe (arrowed) at the front right wheel of the Motor Car. I did not observe any leakage of brake fluid at the time of my inspection of the Motor Car. Static tests of the Motor Car's braking system had indicated that there was no internal leakage of pressure/vacuum. The undercarriage components of the Motor Car were also all found to be intact and without any visible damage.

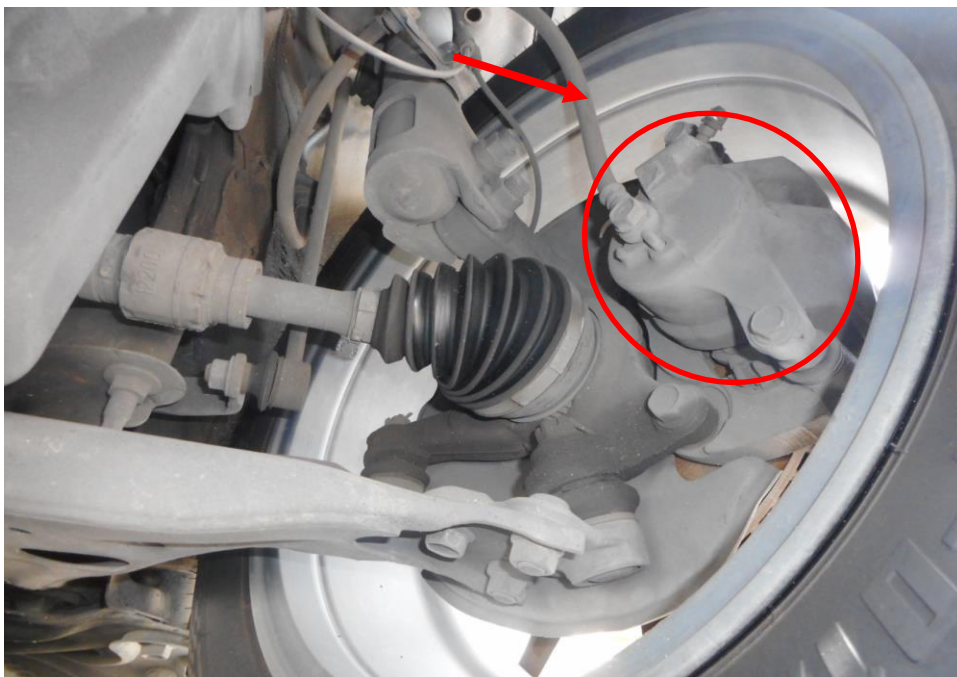
**Photo 19** shows the brake hose/pipe (arrowed) at the front left wheel of the Motor Car. No leakage of brake fluid was observed. Visual examination of the various components of the braking system like the brake caliper (circled), brake booster, brake pedal etc had revealed all to be intact and without visible damage.

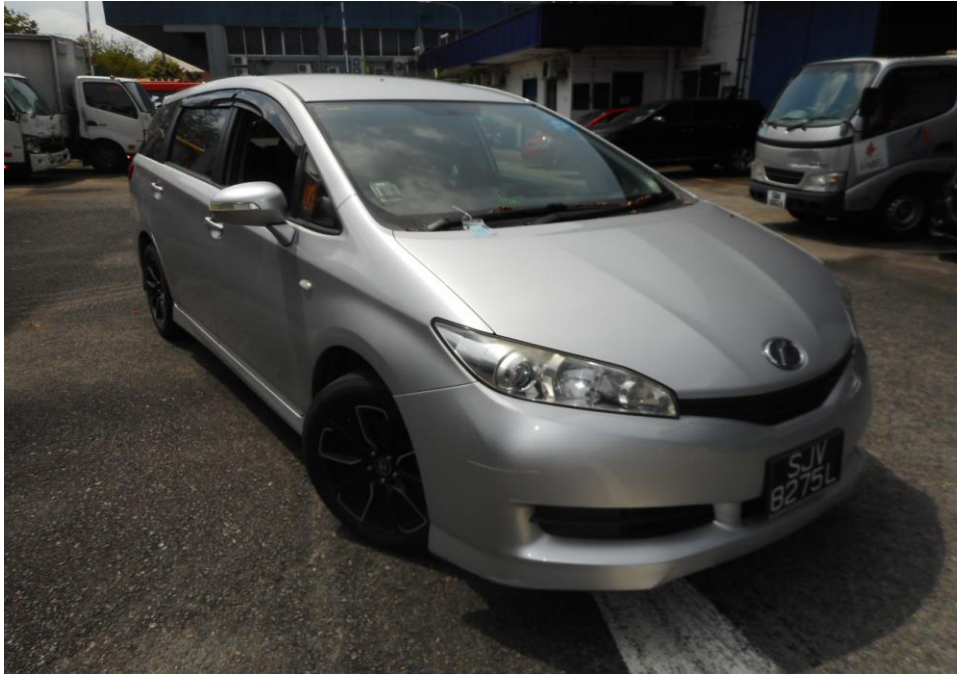
**Photo 20** shows the front right wheel of the Motor Car turned to its full left. During my steering system test, I did not experience any abnormal free play and/or resistance when I had turned the steering wheel towards the left and right. This would suggest that the steering system of the Motor Car was likely to be in serviceable condition at the material time of accident.

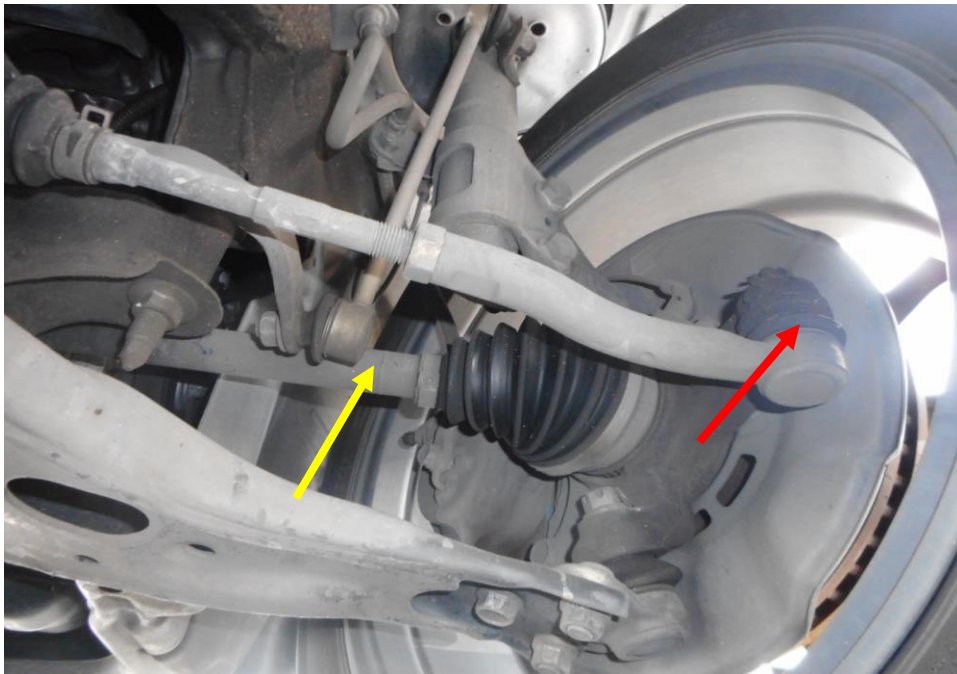
**Photo 21** shows the various undercarriage components at the front right wheel of the Motor Car, in particular the steering tie rod (red arrow) and drive shaft (yellow arrow). The various steering components were all found to be intact, suggesting that the steering system of the Motor Car was likely to be in serviceable condition at the material time of accident. There was also no sign of fluid stain observed on the various undercarriage components at the front right wheel of the Motor Car.

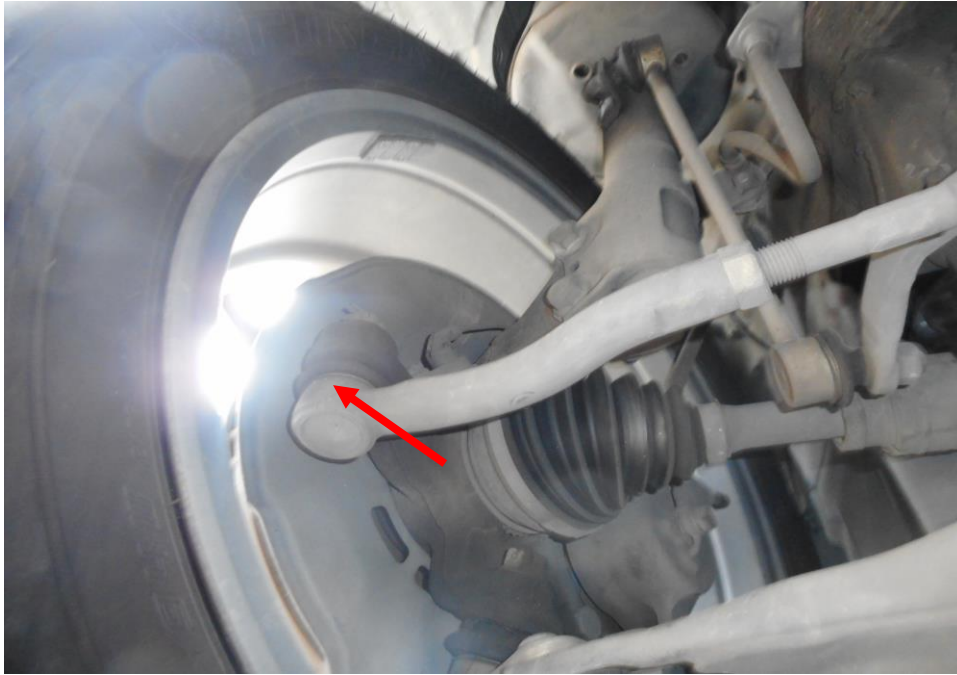
**Photo 22** shows the various undercarriage components at the front left wheel of the Motor Car, which had included the steering tie rod (red arrow). The various undercarriage components of the Motor Car were all found to be intact without any visible damage.

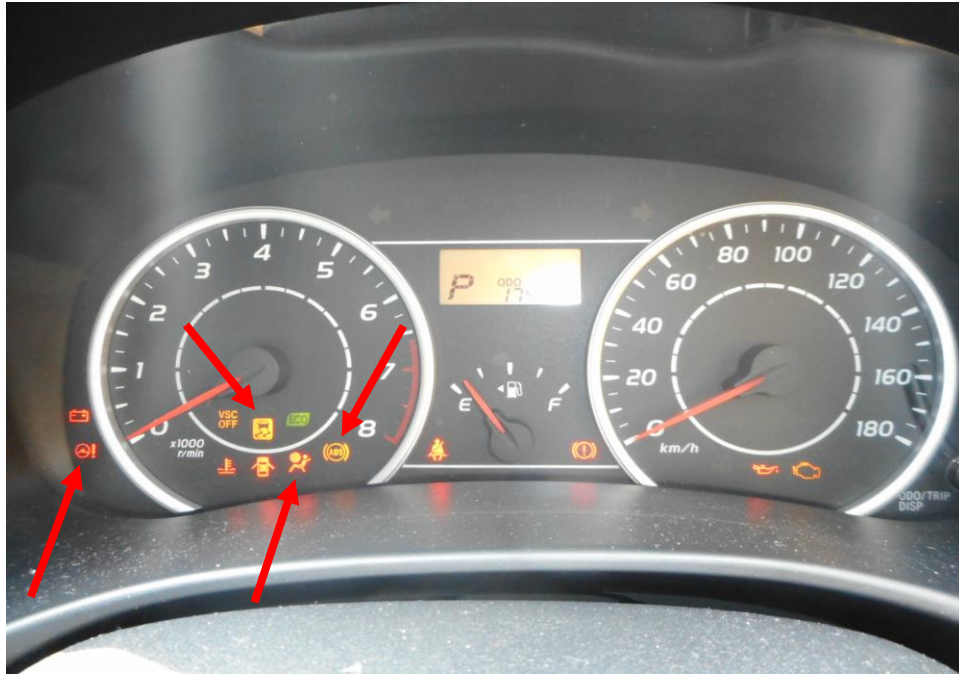
**Photo 23** shows the warning light for Anti-Lock Brake System (ABS) and Power Steering System (EPS), Supplemental Restraint System (SRS) and Traction Control (TC) (arrowed) appearing on the instrument panel of the Motor Car during the self-test of its various electronic operating systems when its engine was cranked.

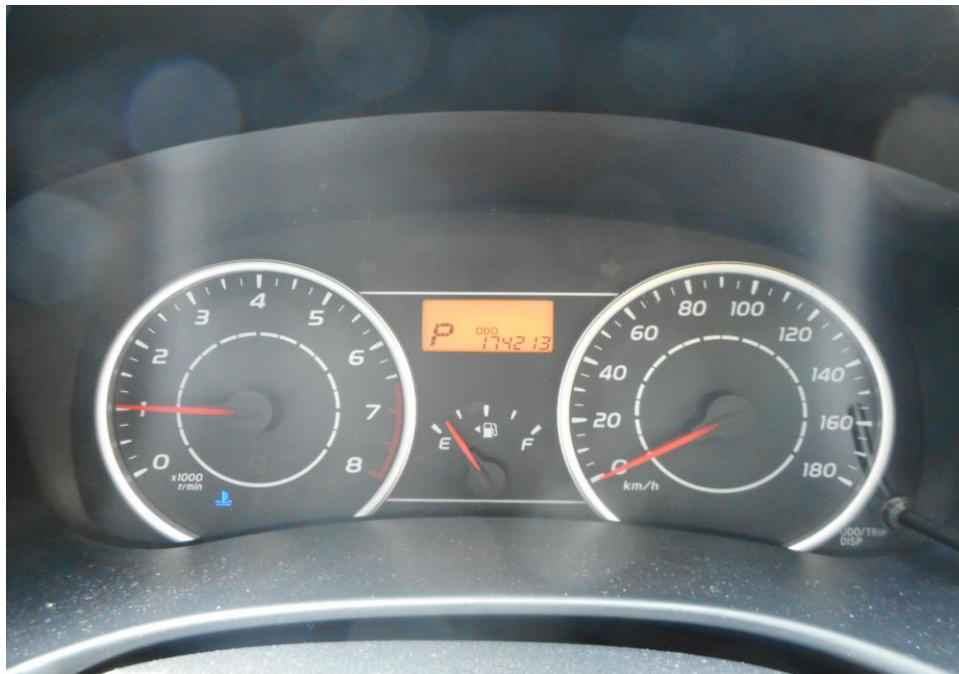
**Photo 24** shows no warning lights illuminated on the instrument panel of the Motor Car after the engine was cranked. This would suggest that there was no abnormality to the electronic operating system of the Motor Car, like the ABS, EPS, SRS, and TC etc.
