Your Ref: TP/IP/77197/2020  
Our Ref : CI/TPD20012462/P

7<sup>th</sup> December 2020

**MECHANICAL INSPECTION REPORT OF MOTOR CAR SLG 6887P**

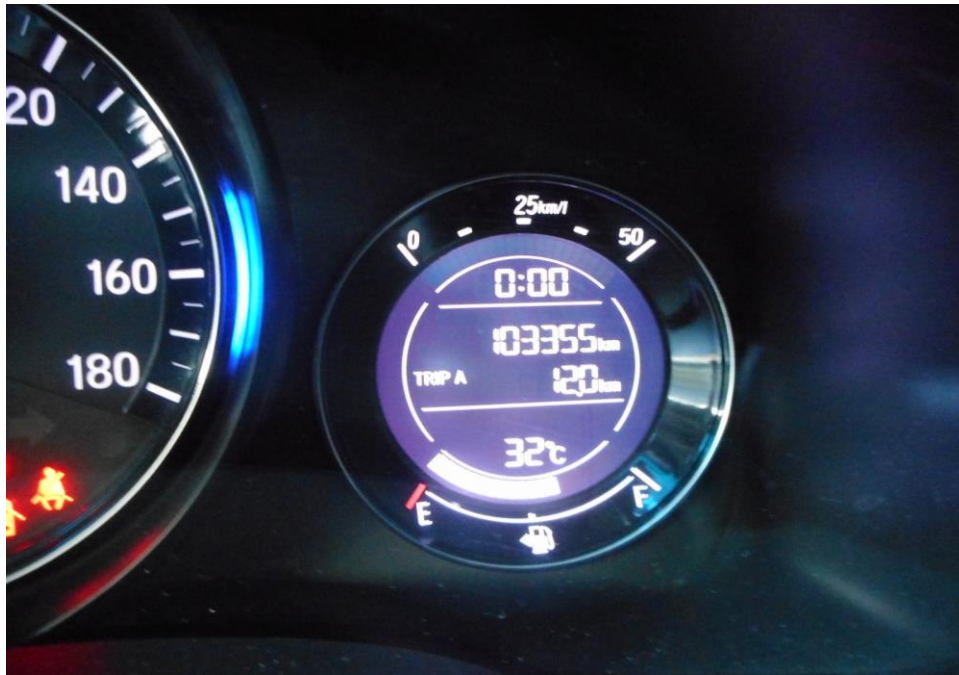
**Photo 1** shows a general view of the instrument cluster of the Motor Car at the time of my inspection. The mileage of the Motor Car was 103,355km

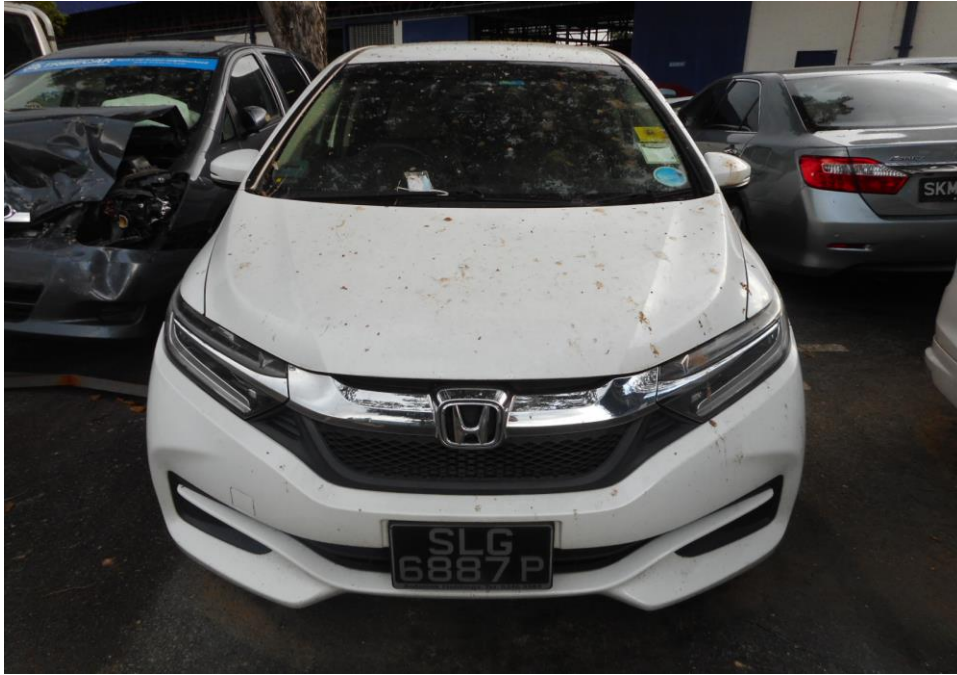
**Photo 2** shows a general view of the Motor Car at the time of my inspection. The Motor Car was observed to be intact and unaffected by the accident.

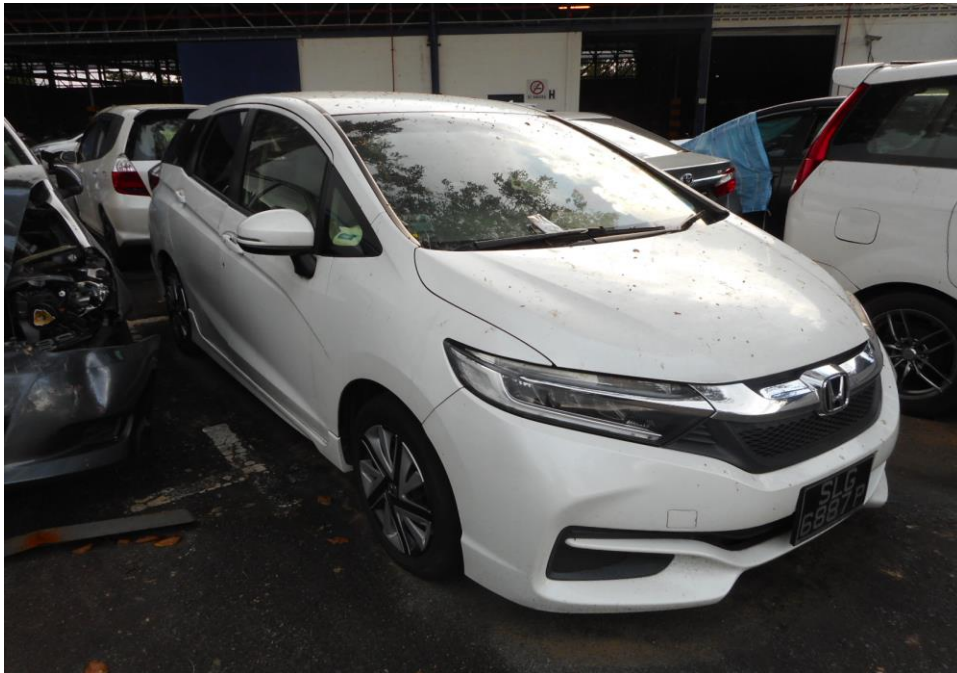
**Photo 3** shows a general view of the right body of the Motor Car at the time of my inspection. The Motor Car was observed to be intact and unaffected by the accident.

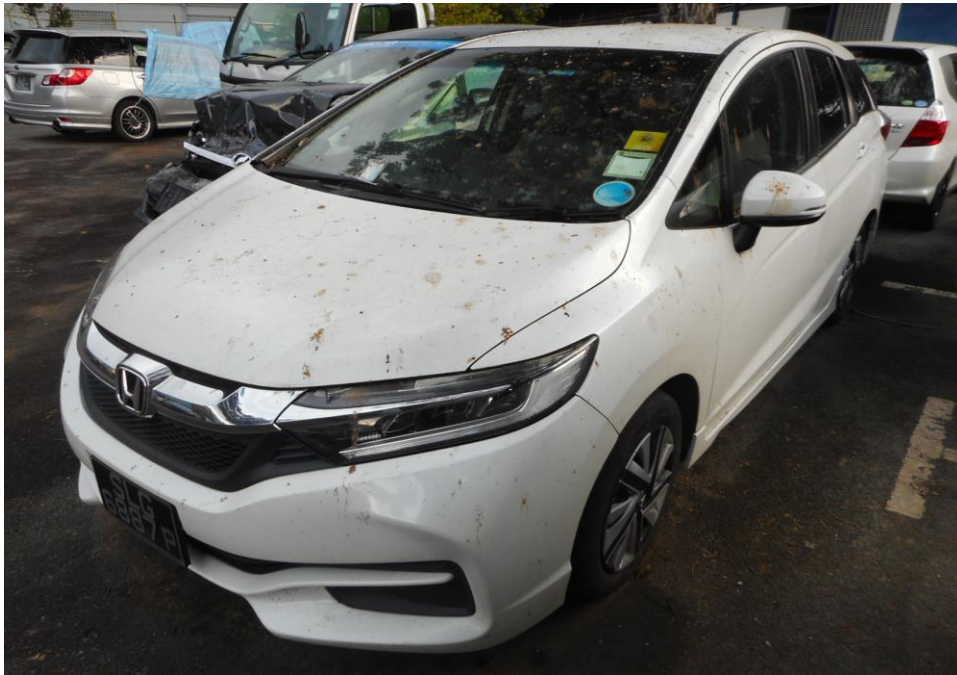
**Photo 4** shows a general view of the left body of the Motor Car at the time of my inspection. The Motor Car was observed to be intact and unaffected by the accident.

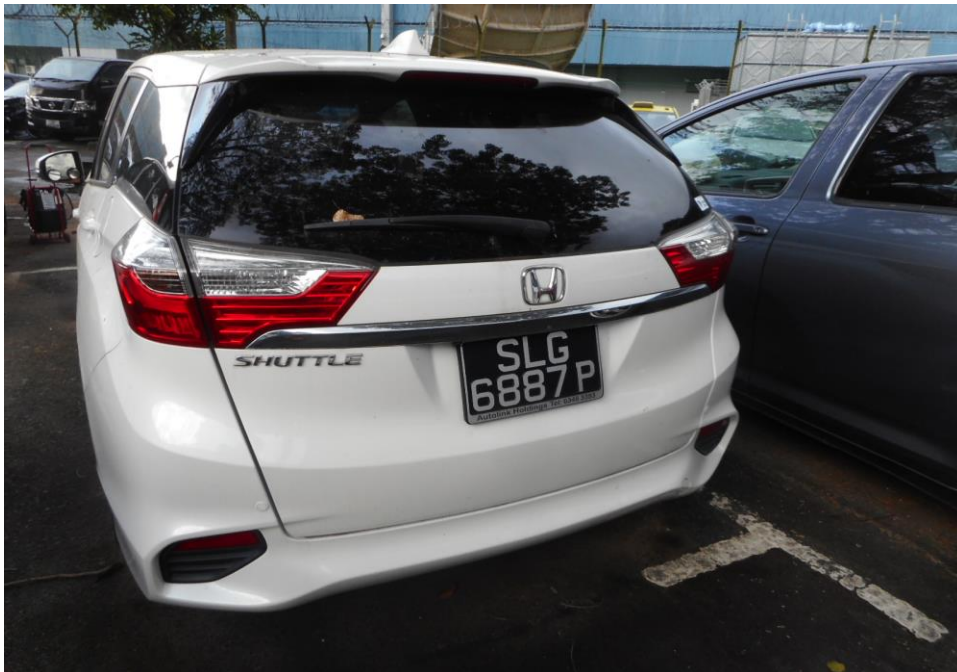
**Photo 5** shows a general view of the rear body of the Motor Car at the time of my inspection. The Motor Car was observed to be intact and unaffected by the accident.

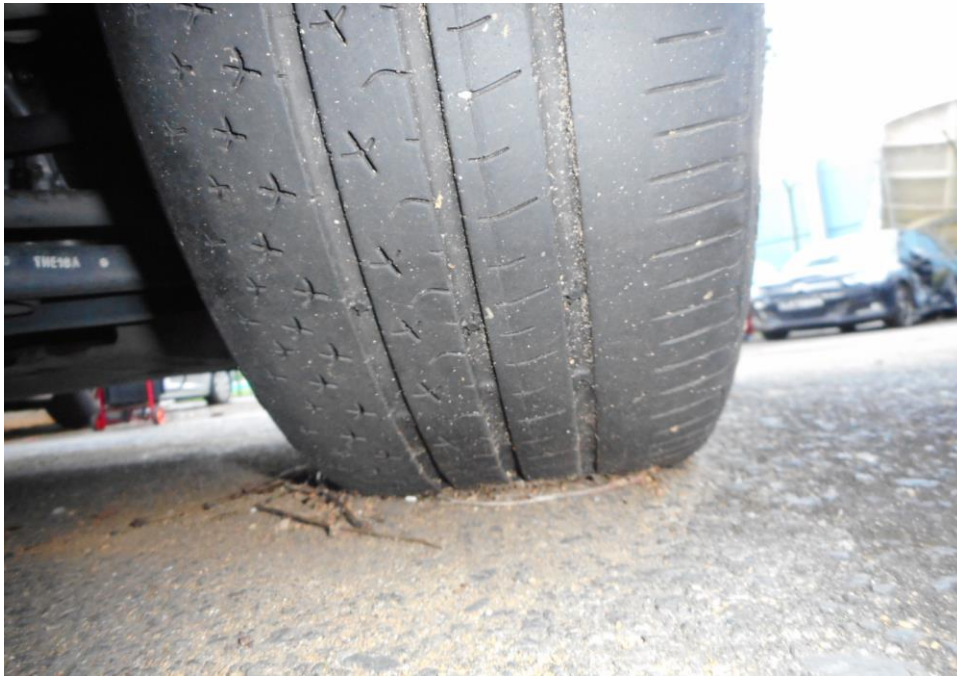
**Photo 6** shows the condition of the front right tyre of the Motor Car, which was observed to be in serviceable condition with remaining tread depth of approximately 3.8mm. The tyre, which was wrapped around standard alloy wheel rim, was also observed to be sufficiently inflated for vehicular operation. There was no tear, cut or burst mark(s) on the outer and the inner sidewalls as well as across the tread of the 4 tyres that were fitted on the Motor Car.

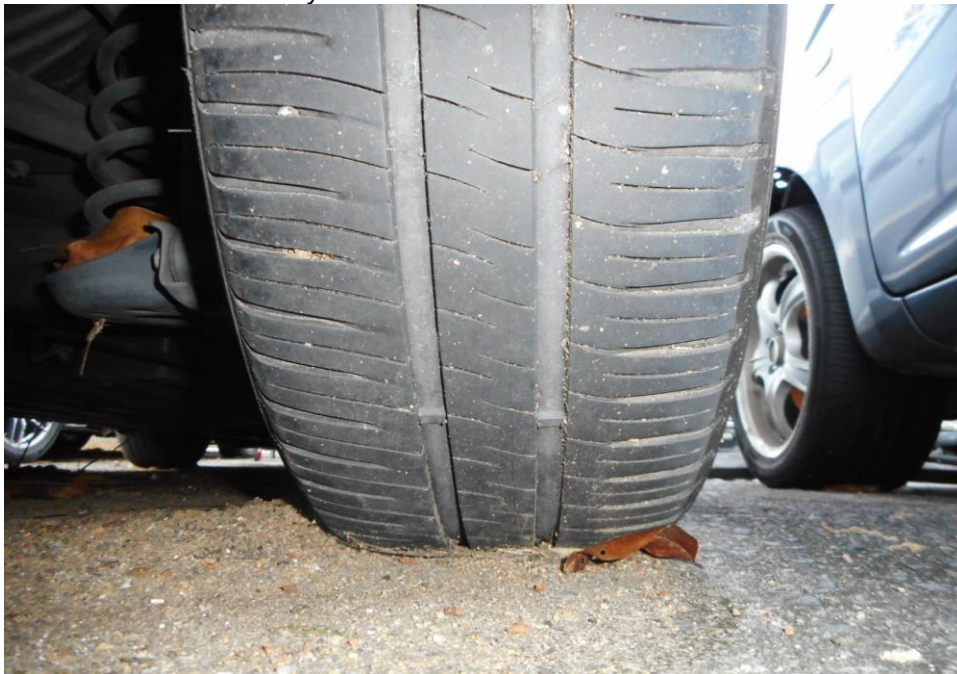
**Photo 7** shows the condition of the rear right tyre of the Motor Car, which was observed to be in serviceable condition with remaining tread depth of approximately 4.1mm. The tyre, which was wrapped around standard alloy wheel rim, was also observed to be sufficiently inflated for vehicular operation.

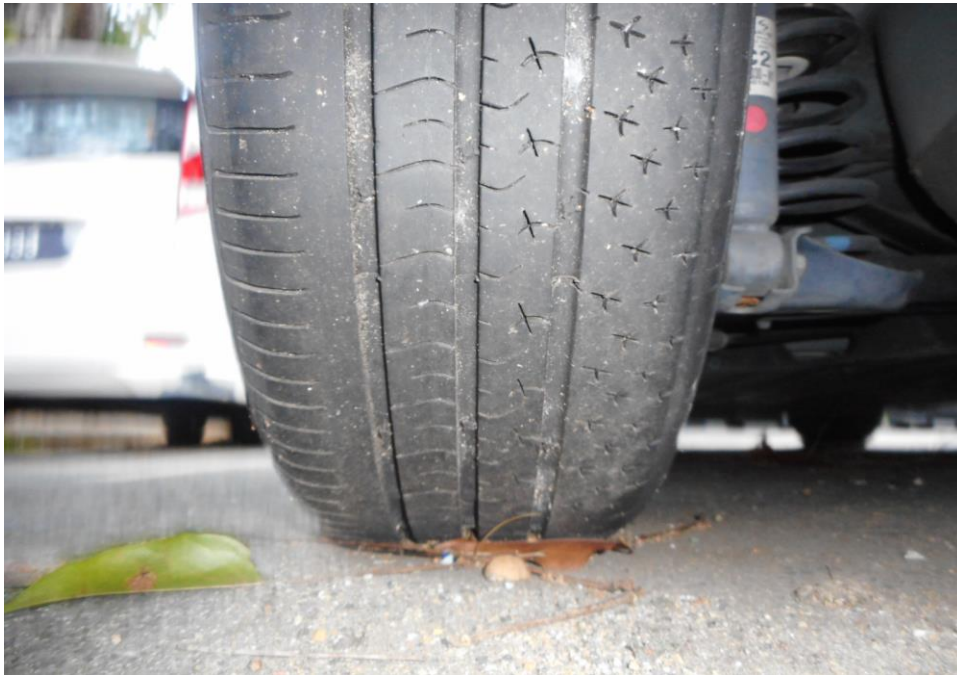
**Photo 8** shows the condition of the rear left tyres of the Motor Car, which was observed to be in serviceable condition with remaining tread depth of approximately 6mm. The tyres, which were wrapped around standard alloy wheel rim, were also observed to be sufficiently inflated for vehicular operation. There was also no damage found on all 4 alloy wheel rims of the Motor Car.

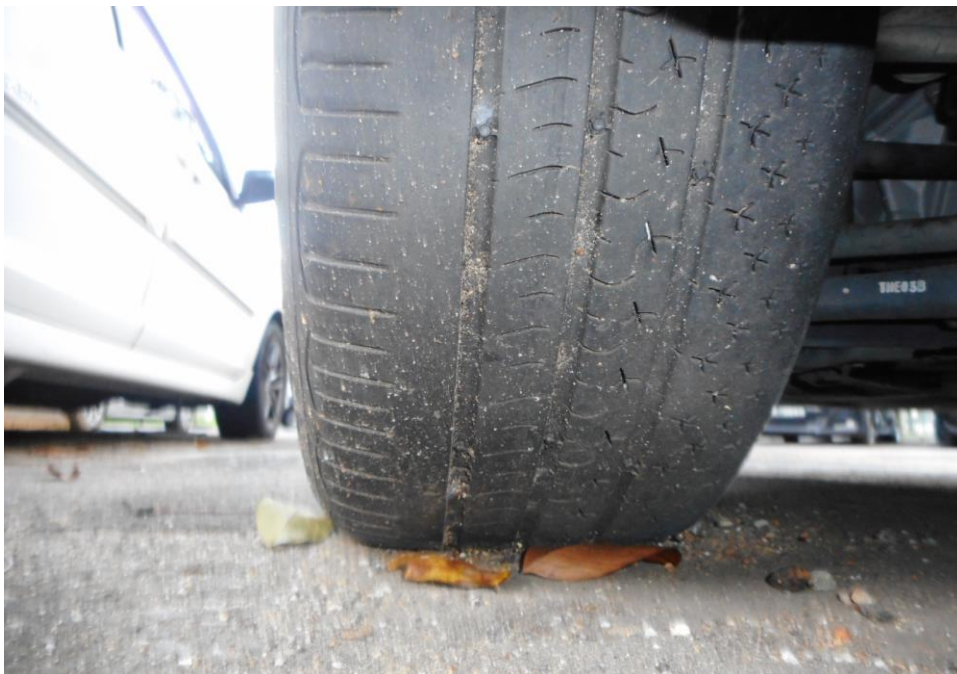
**Photo 9** shows the condition of the rear right tyres of the Motor Car, which were observed to be in serviceable condition with remaining, tread depth of approximately 4mm. There was also no tear, cut or burst mark(s) on the outer and the inner sidewalls as well as across the tread of the 4 tyres that were fitted on the Motor Car.

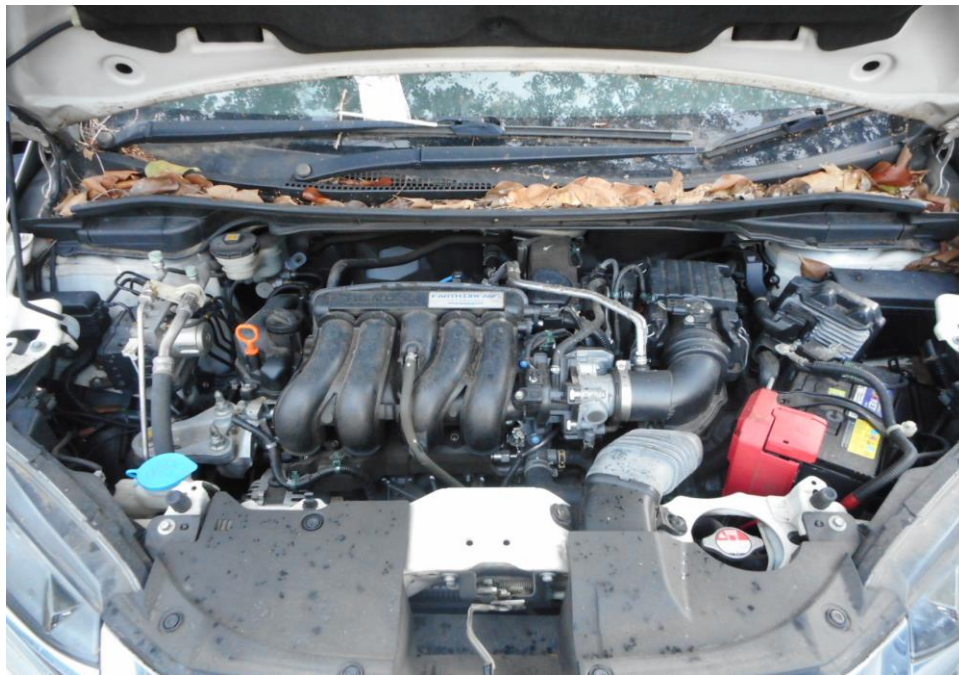
**Photo 10** shows a general view of the Motor Car's engine compartment, which was accessed by lifting the front cabin of the Motor Car. The various parts and components inside the engine compartment were unaffected by the accident. There was also no sign(s) or indication(s) of fresh fluid leakage and/or fluid stain within the engine compartment

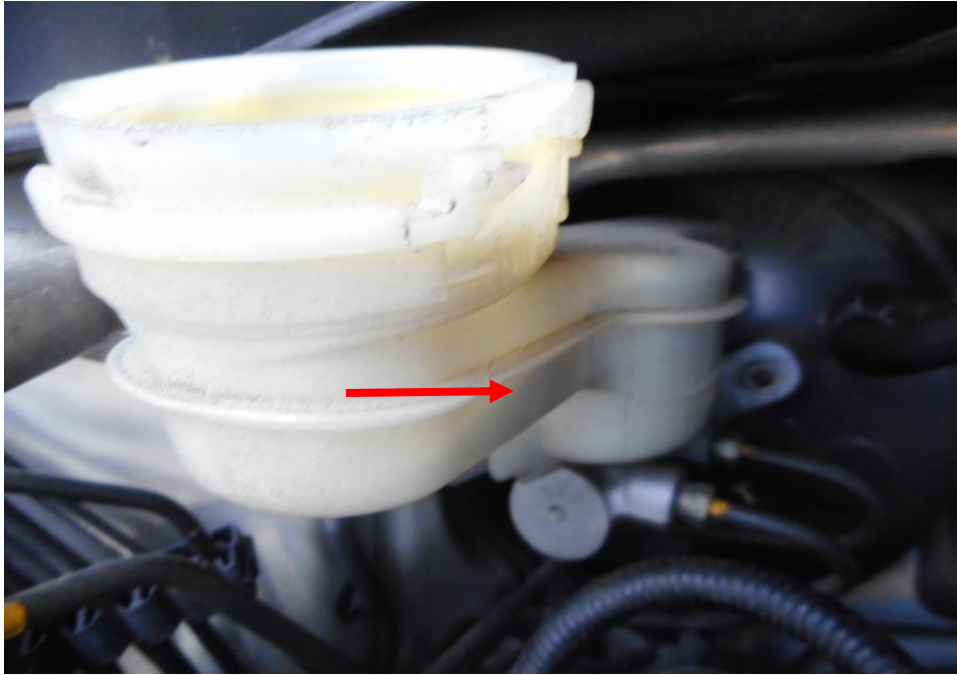
**Photo 11** shows the brake fluid reservoir of the Motor Car at the time of my inspection. The brake fluid was observed to be of sufficient level (arrowed) and without any visible contamination.

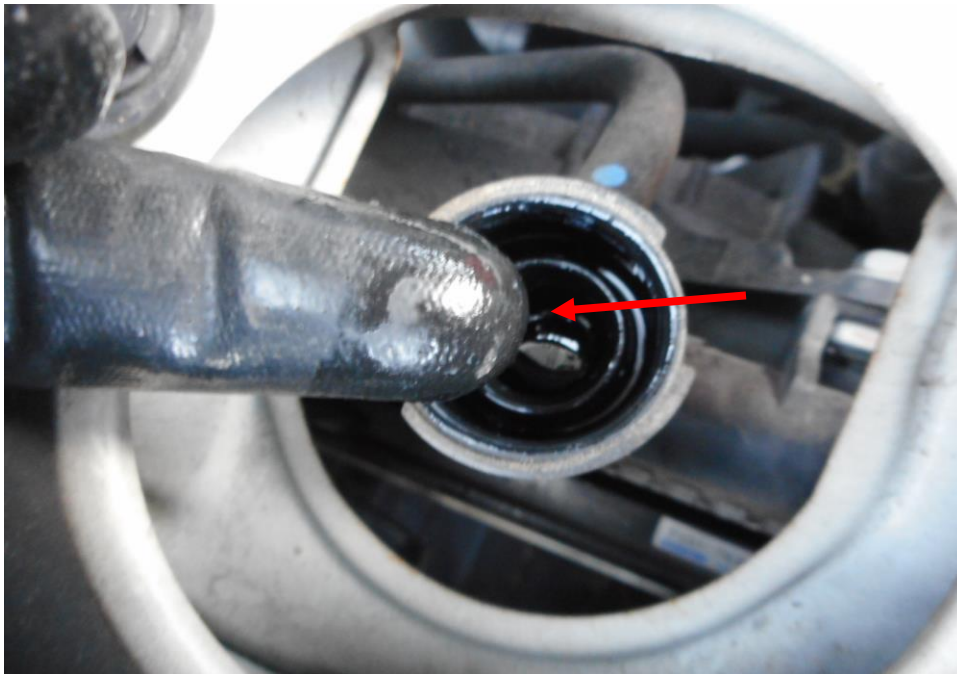
**Photo 12** shows the engine coolant reservoir of the Motor Car at the time of my inspection. The engine coolant was observed to be of sufficient level (arrowed) and without any visible contamination.

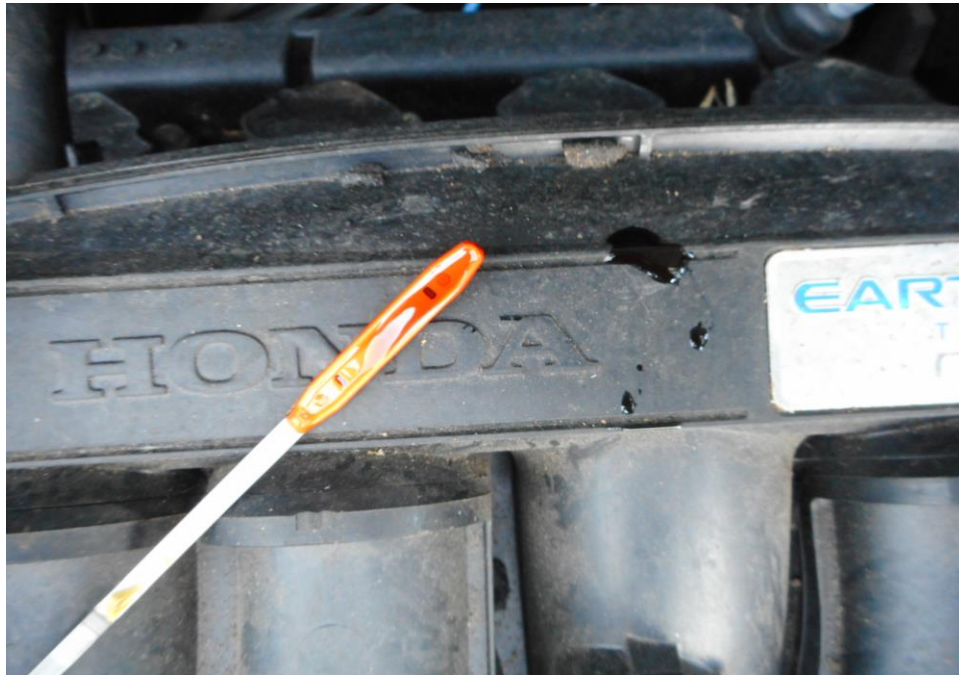
**Photo 13** shows the engine oil dip stick of the Motor Car at the time of my inspection. The engine oil was observed to be of sufficient level and without any visible contamination.

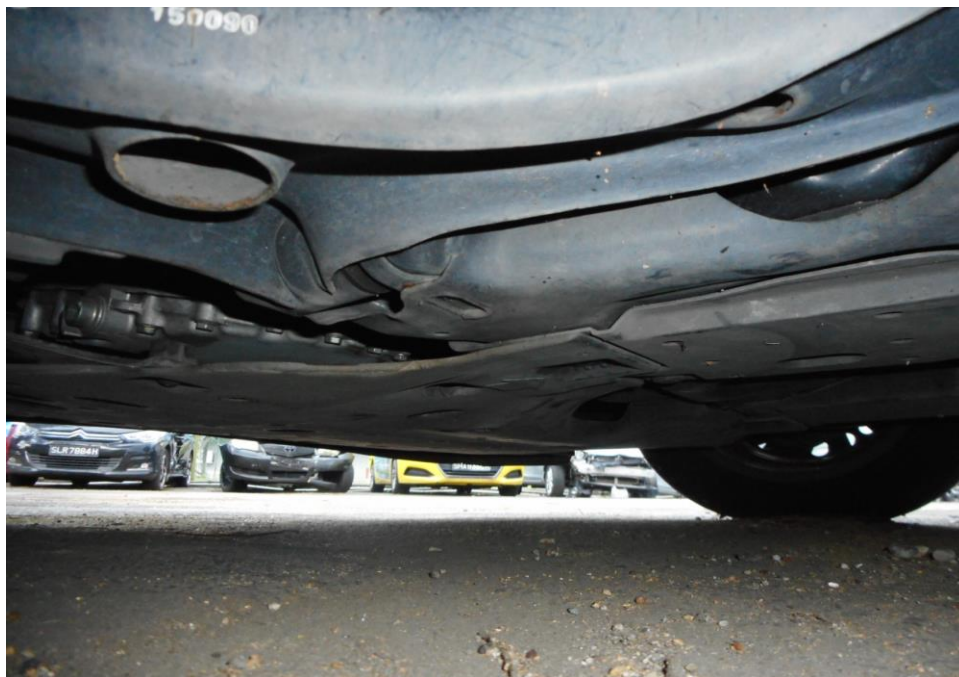
**Photo 14** shows the undercarriage of the Motor Car, at the area where the engine housing and transmission housing are located. . I did not find any sign(s) or indication(s) of fluid leak and/or fluid stain(s) on the underside of the Motor Car.

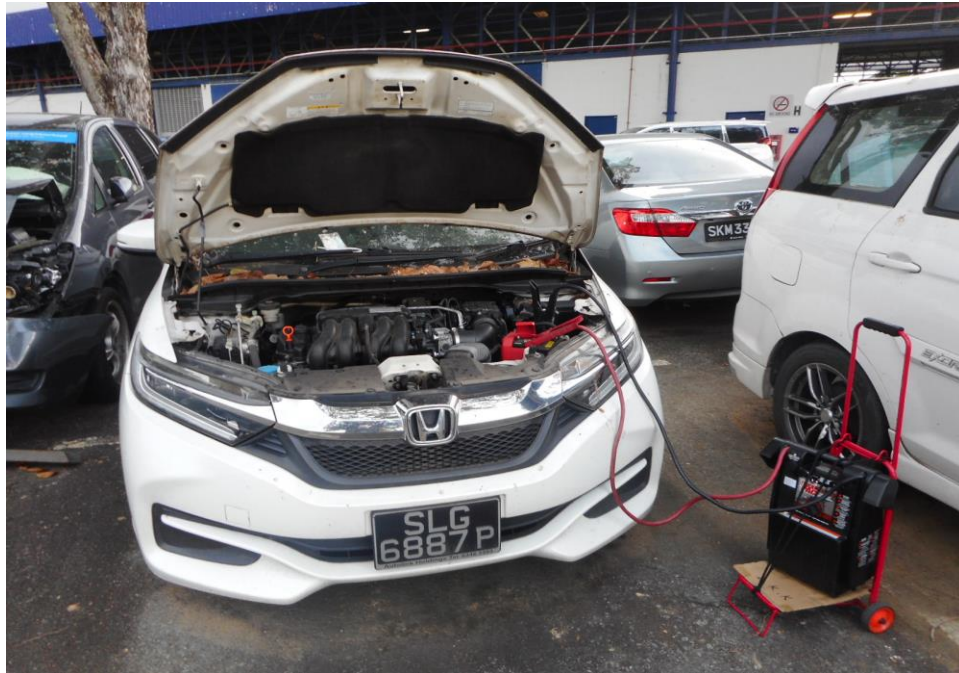
11. However the Motor car's engine was not able to be started up despite multiple attempts of jumpstarting it. See photo 15 below.

**Photo 15** shows the jumpstarting of the Motor Car's engine, it was not able to be started up despite multiple attempts in jump starting the engine.

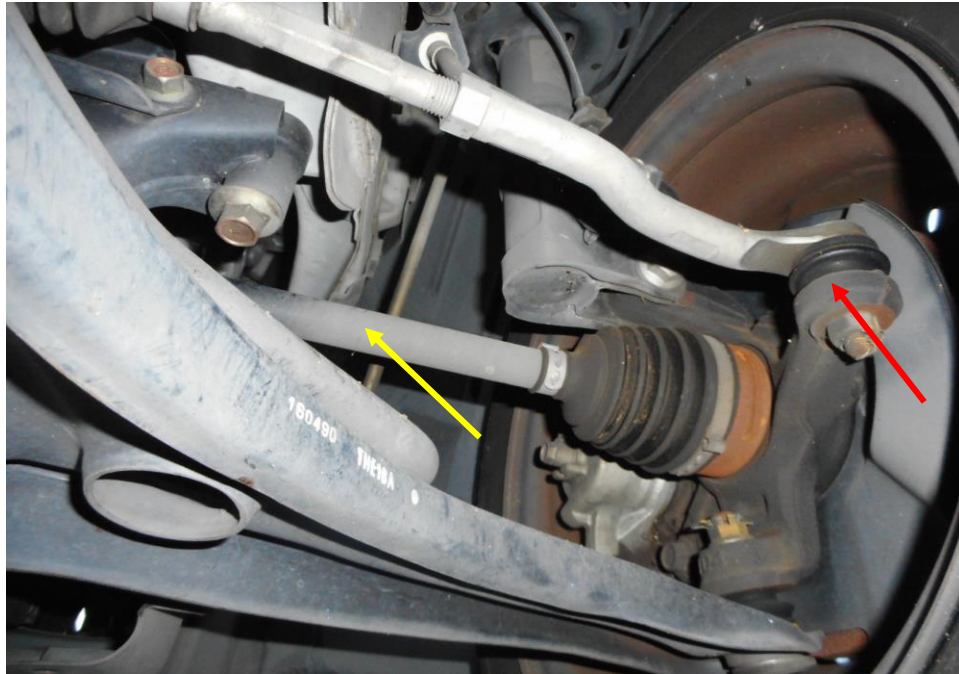
**Photo 16** shows the various undercarriage components at the front right wheel of the Motor Car, in particular the steering tie rod end (red arrow) and drive shaft (yellow arrow). The various steering components were all found to be intact, suggesting that the steering system of the Motor Car was likely to be in serviceable condition at the material time of accident. There was also no sign of fluid stain(s) observed on the various undercarriage components.

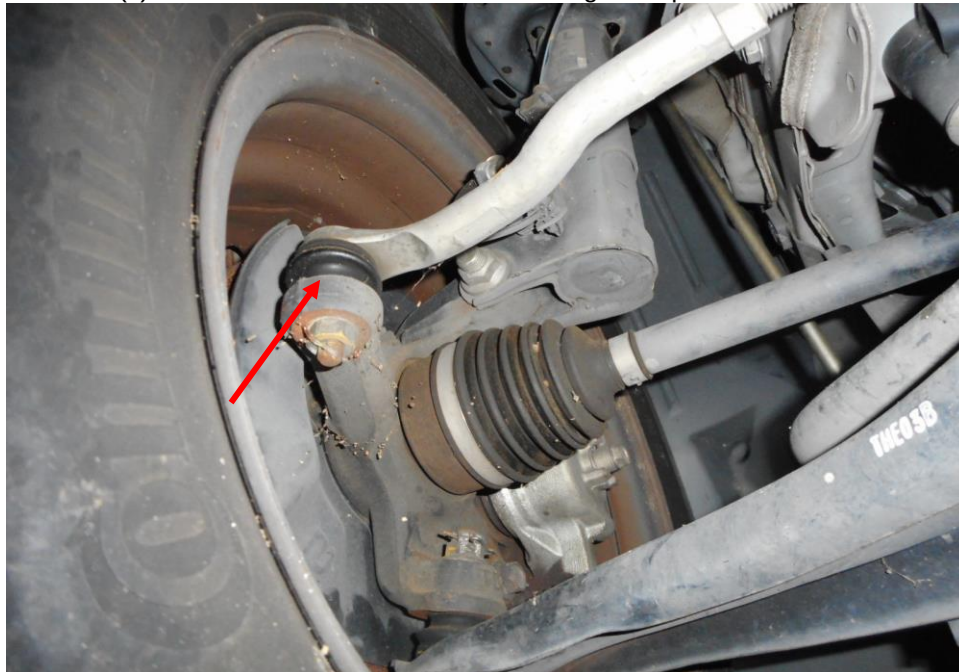
**Photo 17** shows the various undercarriage components at the front left wheel of the Motor Car, in particular the steering tie rod end (arrowed). The various Undercarriage components of the Motor Car were all found to be intact without any visible damage. There was also no sign of fluid stain(s) observed on the various undercarriage components.

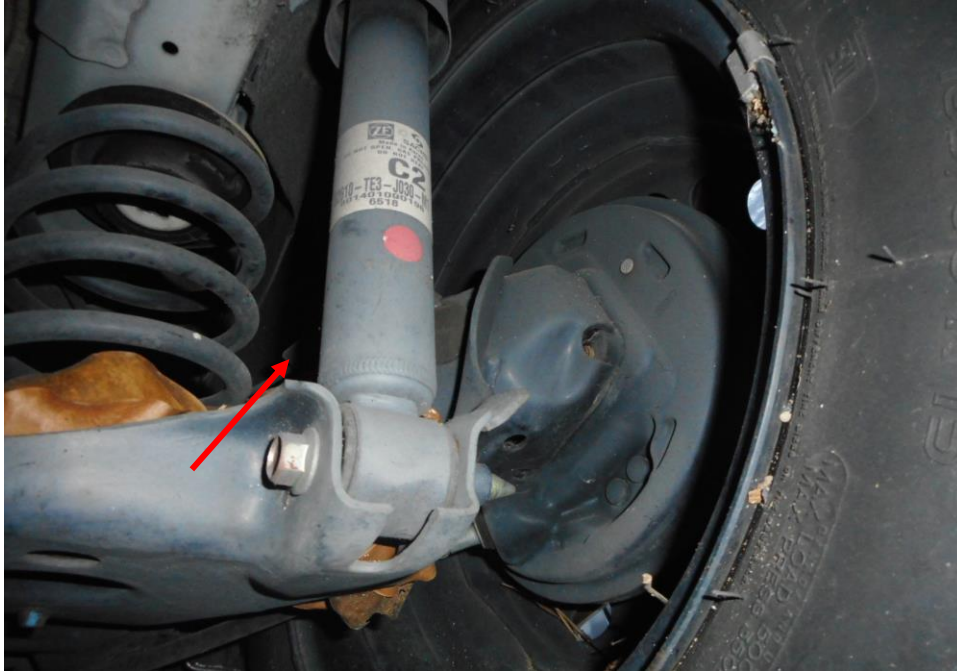
**Photo 18** shows the brake pipe (arrowed) at the rear right wheel of the Motor Car. I did not observe any leakage of brake fluid at the time of my inspection of the Motor Car. My static tests of the Motor Car's braking system, along with my visual examination of the various mechanical components in the braking system, had indicated that there was no internal leakage of pressure/vacuum. Hence the braking system of the Motor Car was likely to be in serviceable condition at the material time of accident.

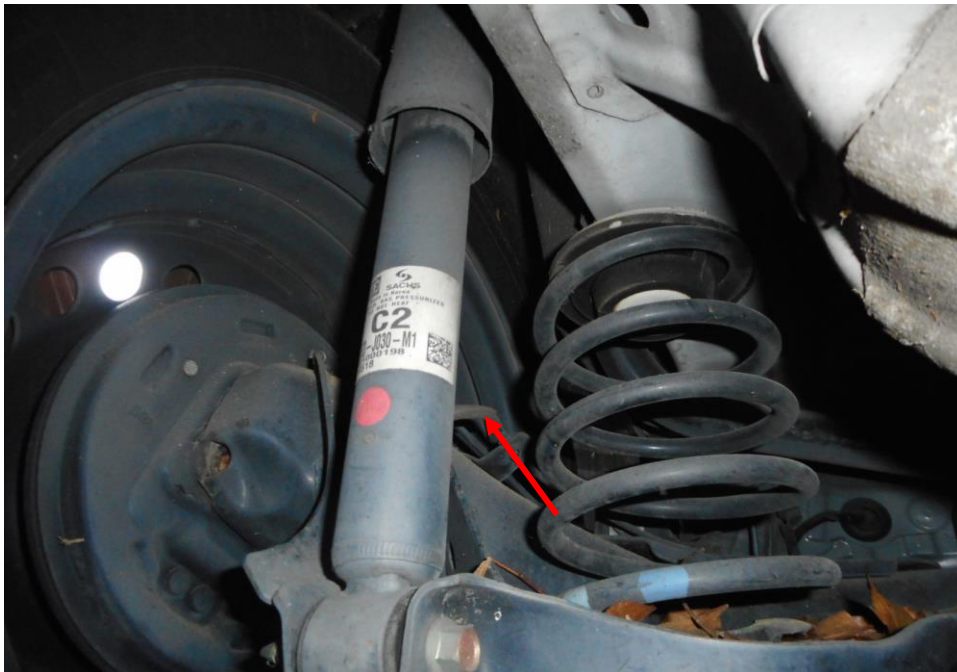
**Photo 19** shows the brake pipe (arrowed) at the rear left wheel of the Motor Car. I did not observe any leakage of brake fluid at the time of my inspection of the Motor Car. My static tests of the Motor Car's braking system, along with my visual examination of the various mechanical components in the braking system had indicated that there was no internal leakage of pressure/vacuum. Hence the braking system of the Motor Car was likely to be in serviceable condition at the material time of accident.

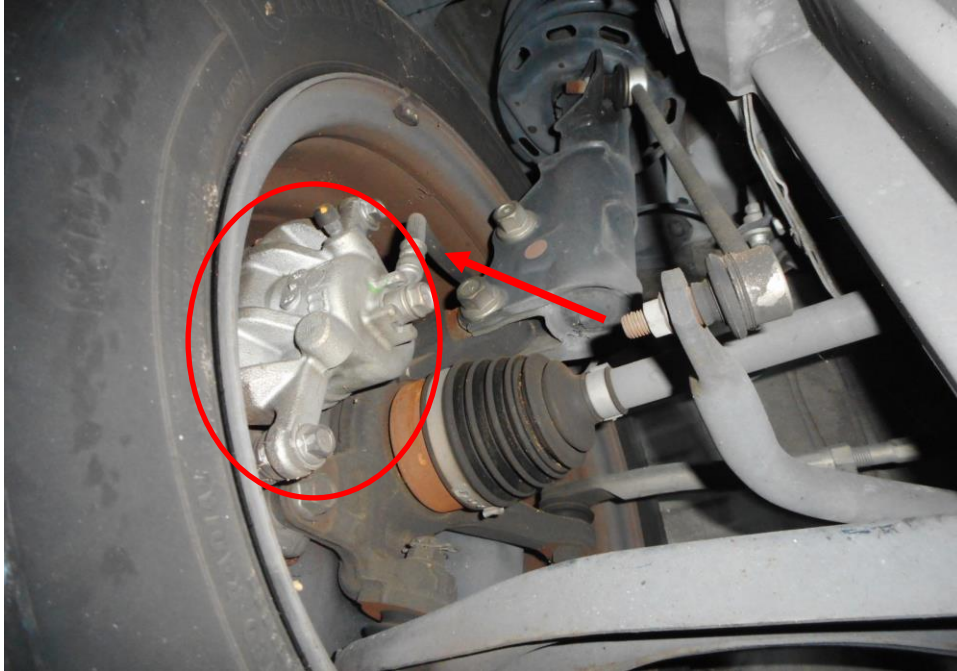
**Photo 20** shows the brake hose/pipe (arrowed) at the front right wheel of the Motor Car. No leakage of brake fluid was observed. Visual examination of the various components of the braking system like the brake caliper (circled), brake booster, brake pedal etc had revealed all to be intact and without visible damage at the time of accident. There was also no sign of fluid stain(s) observed on the various undercarriage components.

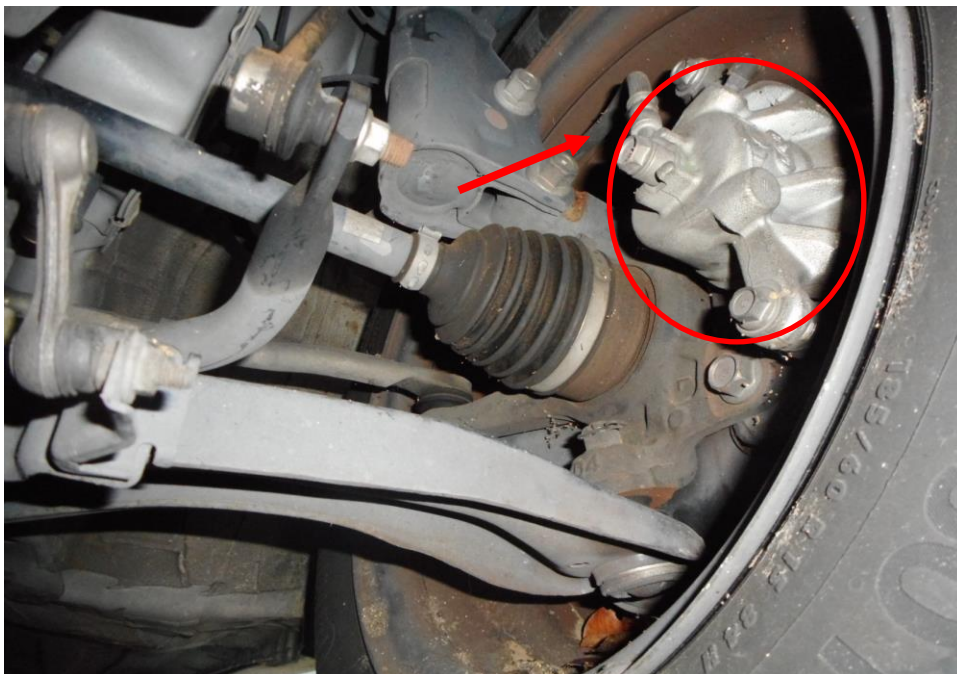
**Photo 21** shows the brake hose/pipe (arrowed) at the front left wheel of the Motor Car. No leakage of brake fluid was observed. Visual examination of the various components of the braking system like the brake caliper (circled), brake booster, brake pedal etc had revealed all to be intact and without visible damage at the time of accident. There was also no sign of fluid stain(s) observed on the various undercarriage components.
