Your Ref: TP/IP/34521/2020  
Our Ref : CI/TPD20012512/N

**Fatal Accident Investigation Team**

**INSPECTION REPORT OF MOTORCYCLE FBP 6477K**

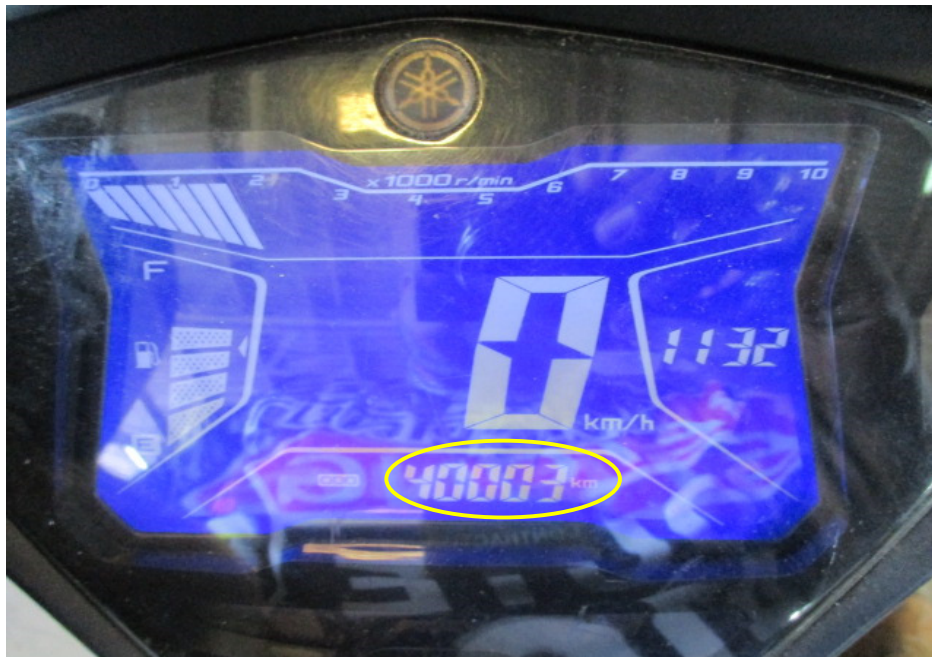
4. The mileage of the Motorcycle recorded at the time of our inspection was 40,003km.
5. The Motorcycle was observed to have sustained damages all around. The body parts that were found to have been damaged include its head cowlings, side mirrors, side cowlings, front mudguard, brake levers, drive train cover, exhaust muffler heat shield, rear mudguard and left pillion foot peg, amongst others as a result of the accident. See photos 1 – 14 below.

**Photo 1** shows the speedometer gauge of the Motorcycle where the mileage recorded at the time of our inspection was 40, 003km (circled).

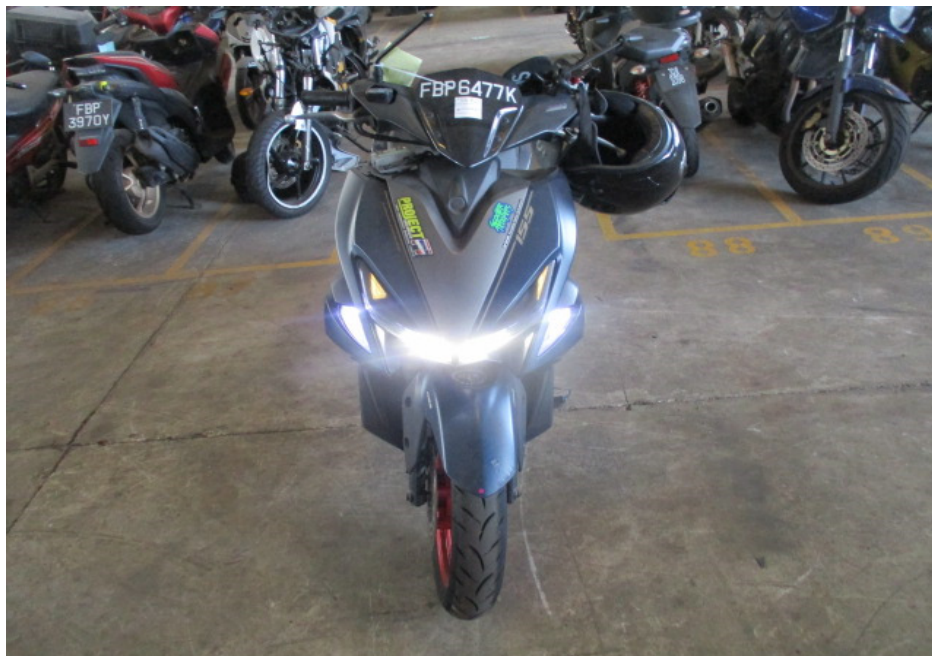
**Photo 2** shows a general view of the frontal portion of the Motorcycle at the time of our inspection. The Motorcycle was observed to have sustained damages all around.

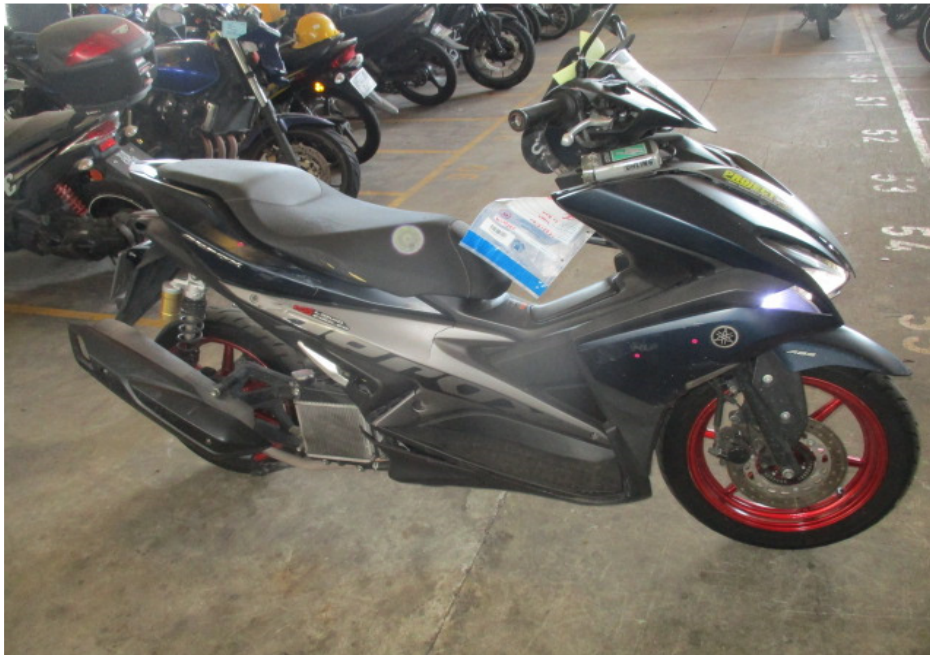
**Photo 3** shows a general view of the right body of the Motorcycle at the time of our inspection. The Motorcycle was observed to have sustained damages all around. The body parts that were found to have been damaged include its head cowlings, side mirrors, side cowlings, front mudguard, brake levers, drive train cover, exhaust muffler heat shield, rear mudguard and left pillion foot peg, amongst others as a result of the accident

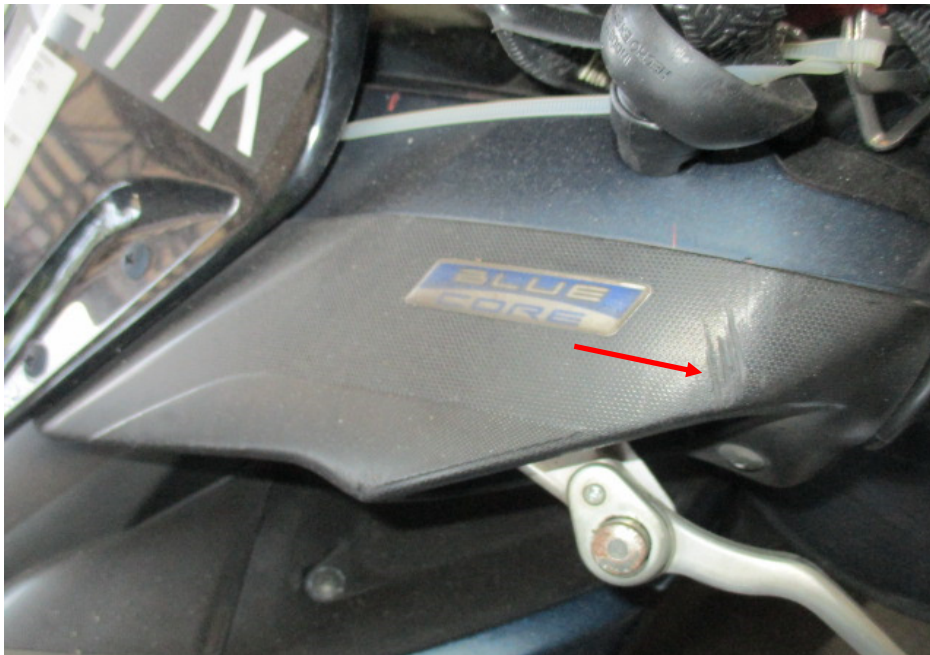
**Photo 4** shows a closer view of the grazed head cowl (arrowed) which was amongst the body parts at the front body of the Motorcycle that had sustained damage as a result of the accident.

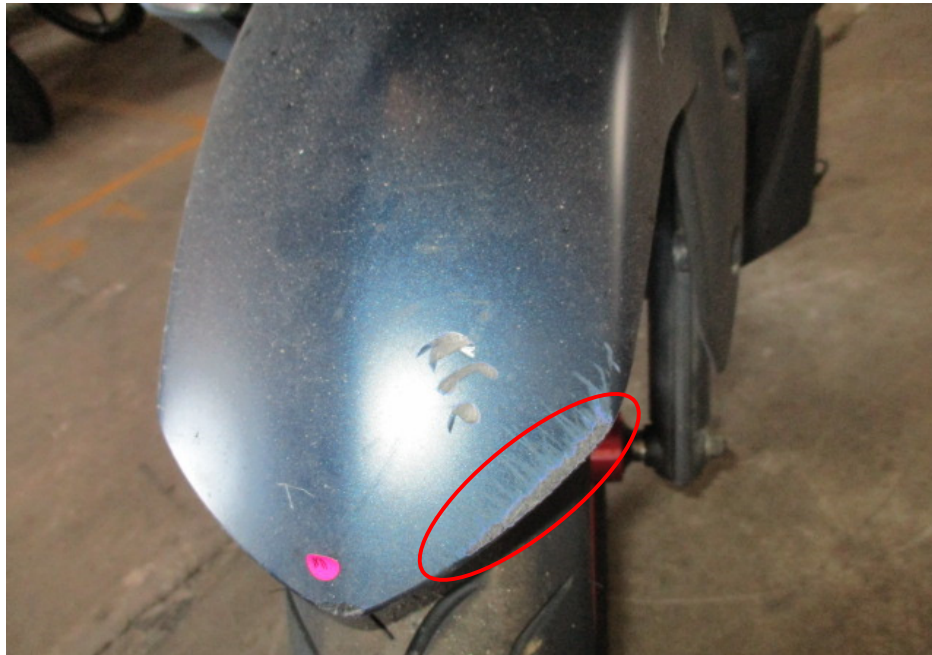
**Photo 5** shows a closer view of the front mudguard (circled) which was amongst the body parts at the front body of the Motorcycle that had sustained damage as a result of the accident.

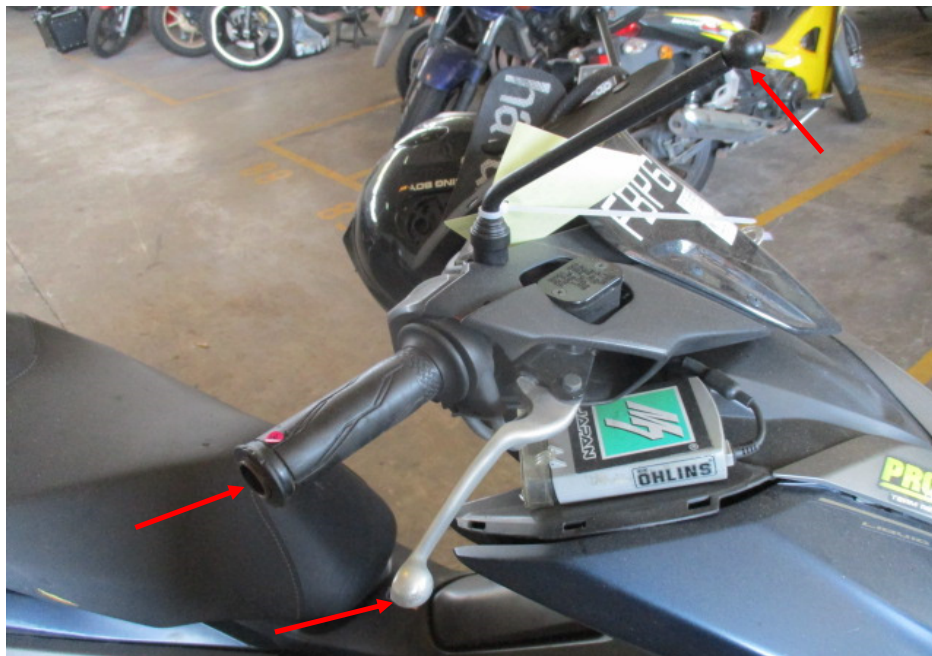
**Photo 6** shows a closer view of the front brake lever, right side mirror and right handlebar end of the Motorcycle which were observed to be damaged due to the accident (arrowed).

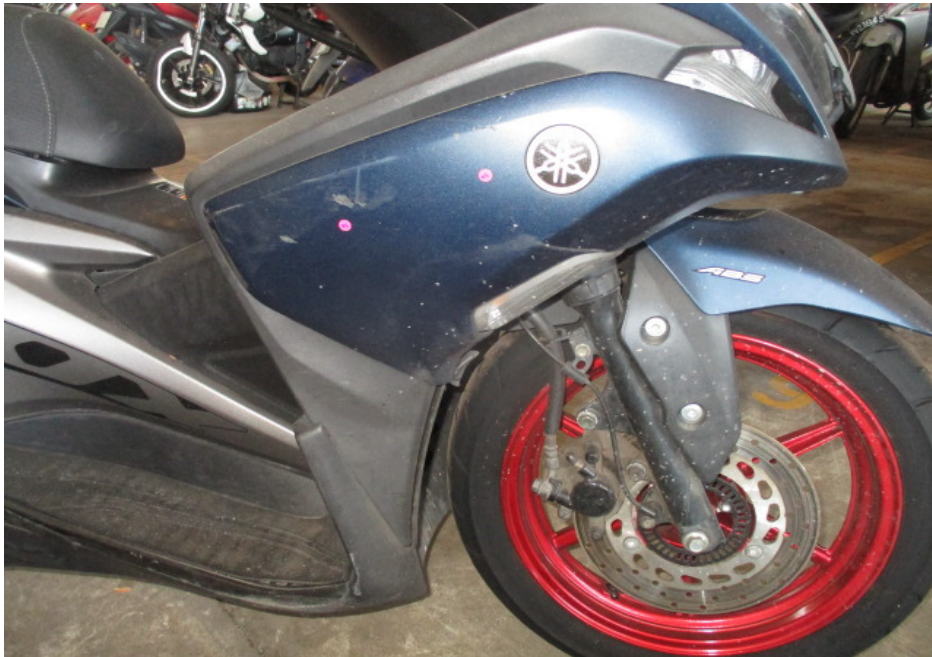
**Photo 7** shows a closer view of the right cowling which was amongst the body parts at the front body of the Motorcycle that had sustained damage as a result of the accident.

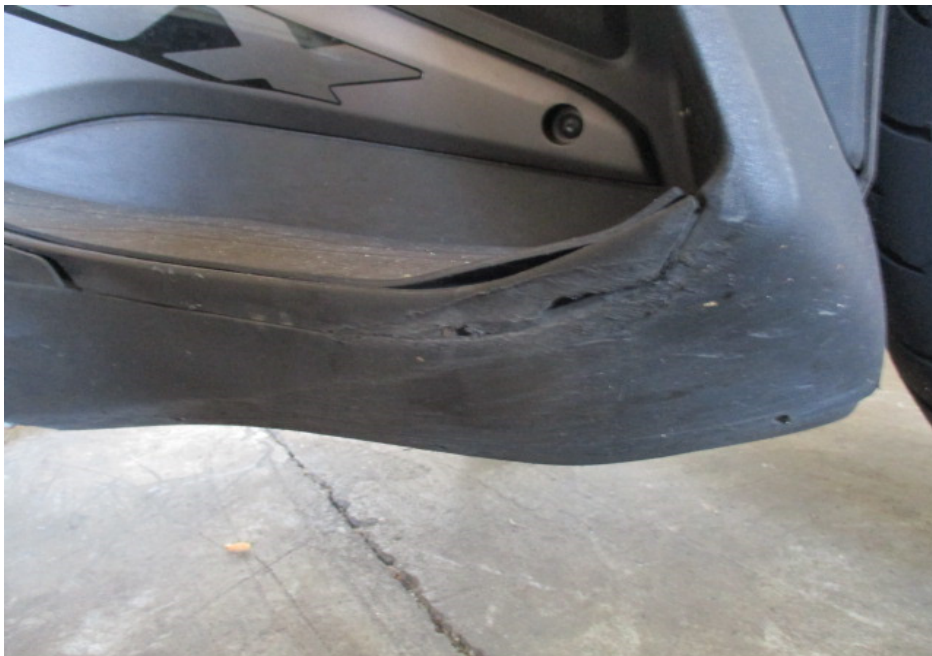
**Photo 8** shows a closer view of the right bottom cowling of the Motorcycle which was observed to be damaged due to the accident.

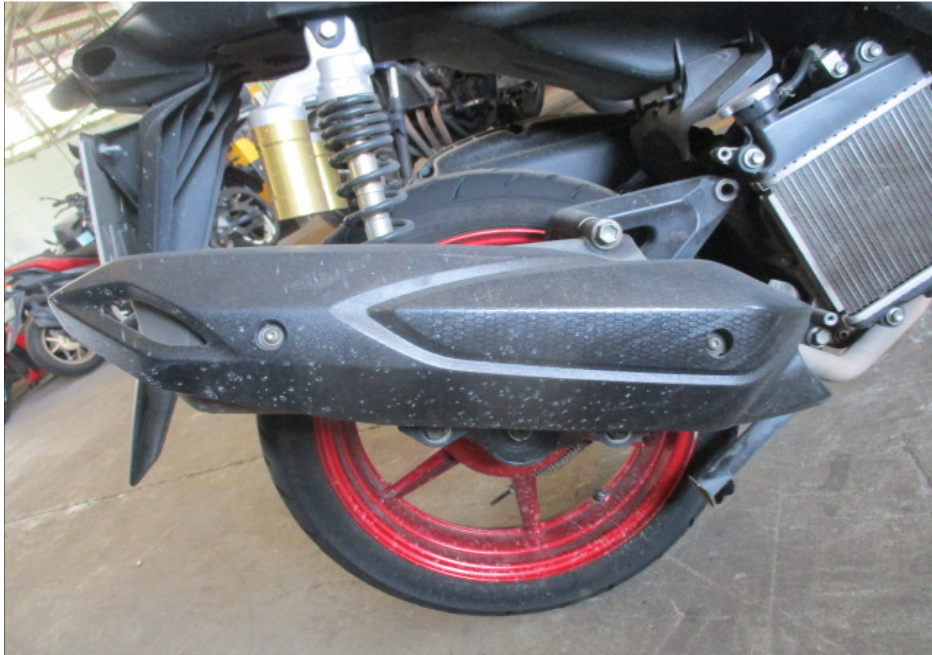
**Photo 9** shows a closer view of the exhaust muffler heat shield of the Motorcycle which had sustained damage due to the accident.

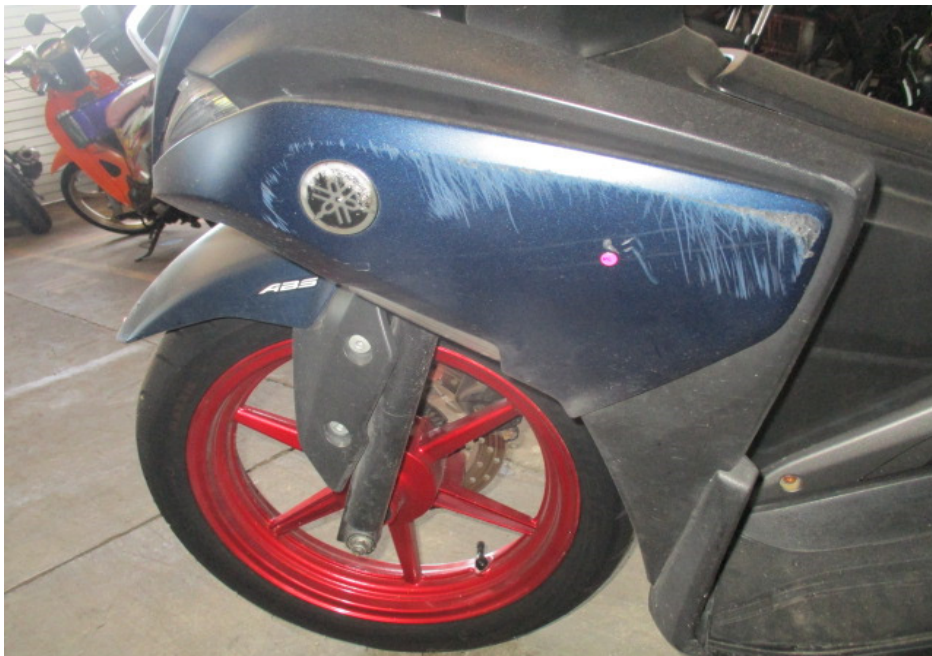
**Photo 10** shows a closer view of the left cowling which was amongst the body parts at the front body of the Motorcycle that had sustained damage as a result of the accident.

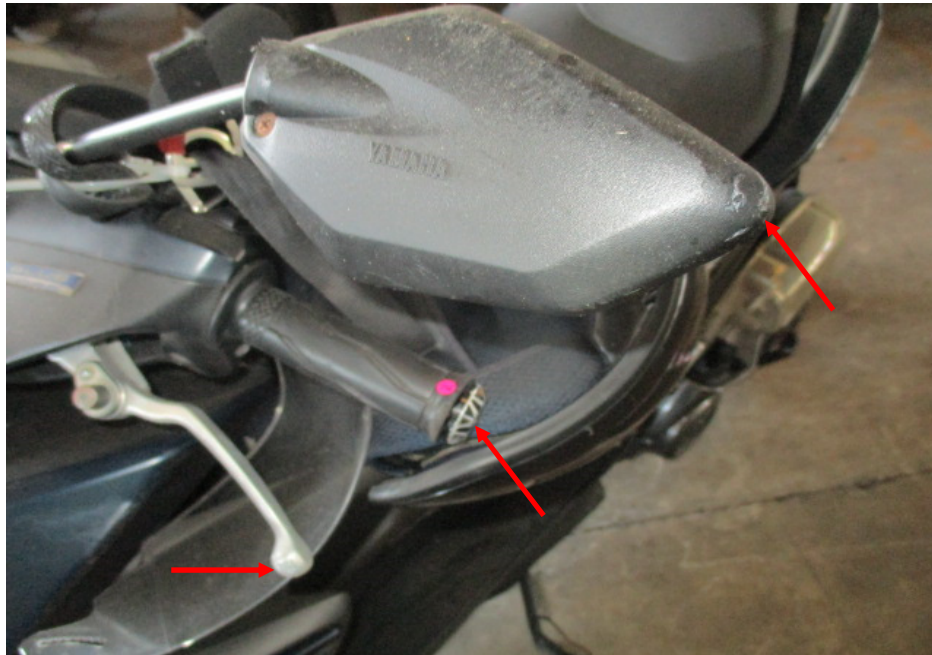
**Photo 11** shows a closer view of the rear brake lever, left side mirror and left handlebar end of the Motorcycle which were observed to be damaged due to the accident (arrowed).

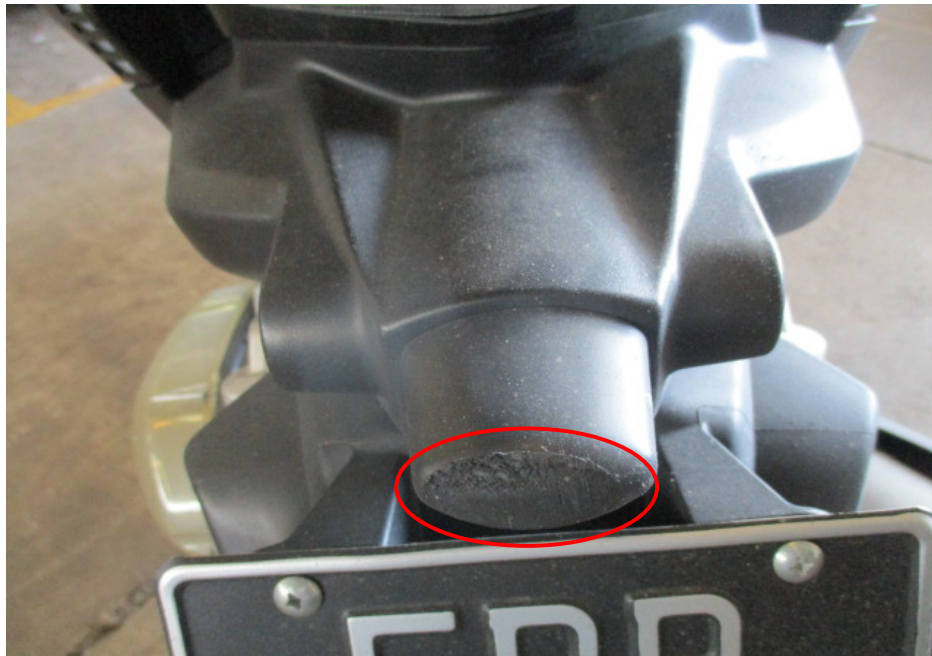
**Photo 12** shows grazed rear mudguard of the Motorcycle as a result of the accident (circled).

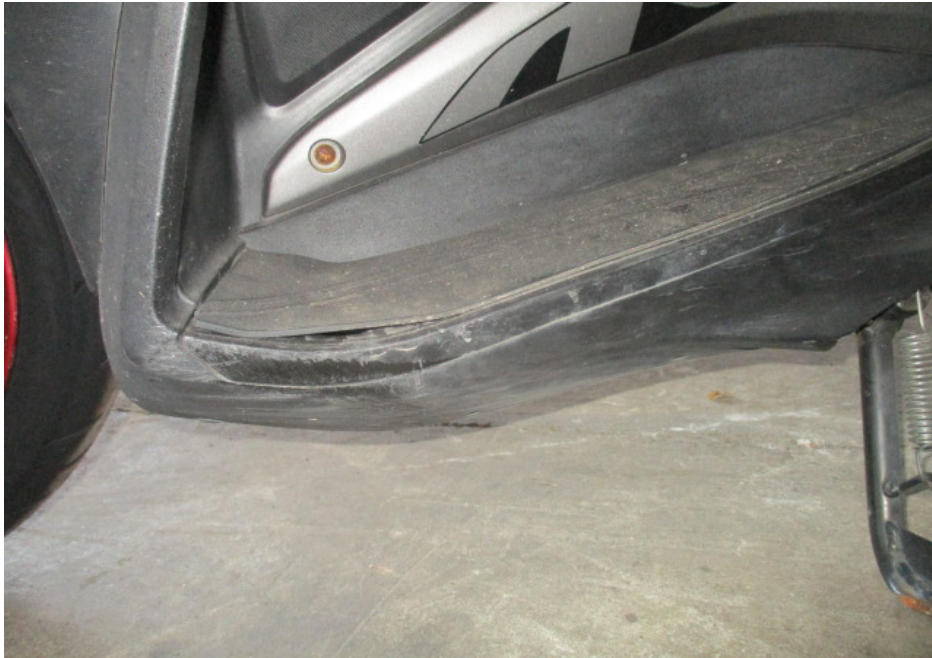
**Photo 13** show a closer view of the left bottom cowling of the Motorcycle which was observed to be damaged due to the accident.

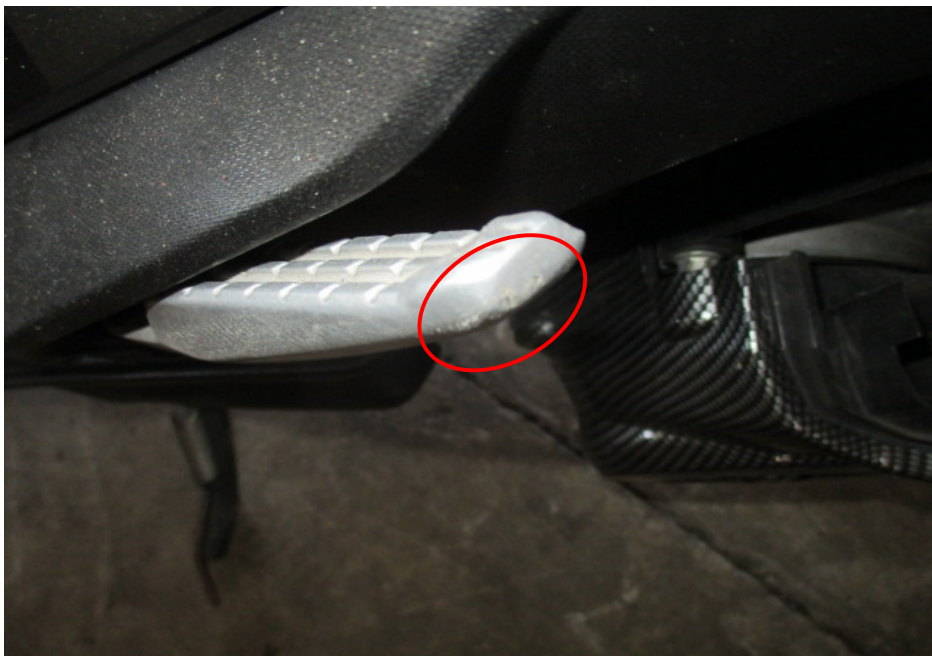
**Photo 14** shows a closer view of the grazed left pillion foot peg (circled) of the Motorcycle at the time of our inspection.

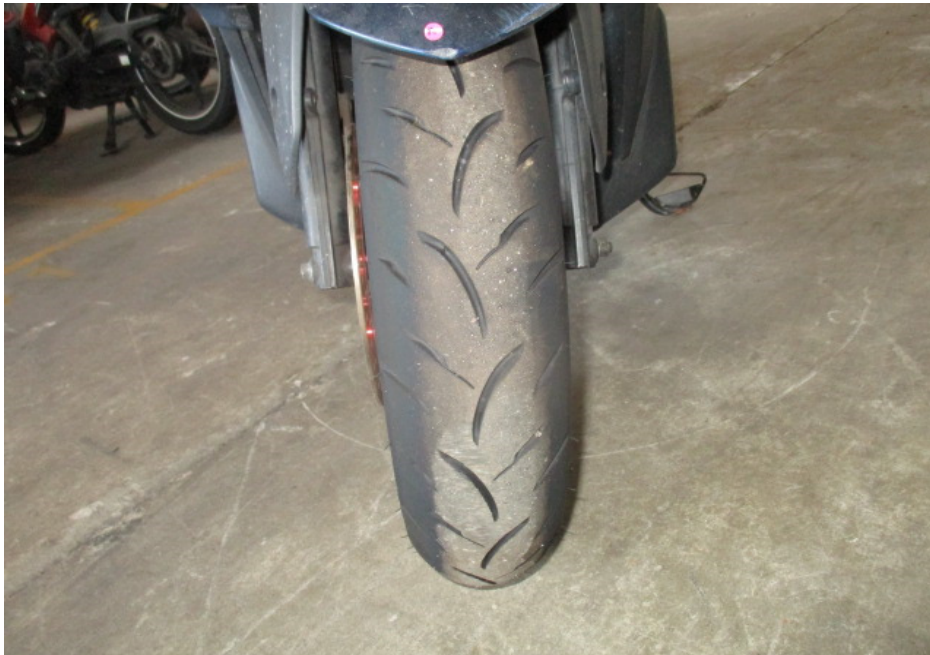
**Photo 15** shows the condition of the Motorcycle's front tyre. The front tyre was observed to be in serviceable condition with remaining tread depth of approximately 4mm. There was no tear, burst mark(s) and/or punctured hole(s) on the sidewalls as well as across the tread of the front tyre.

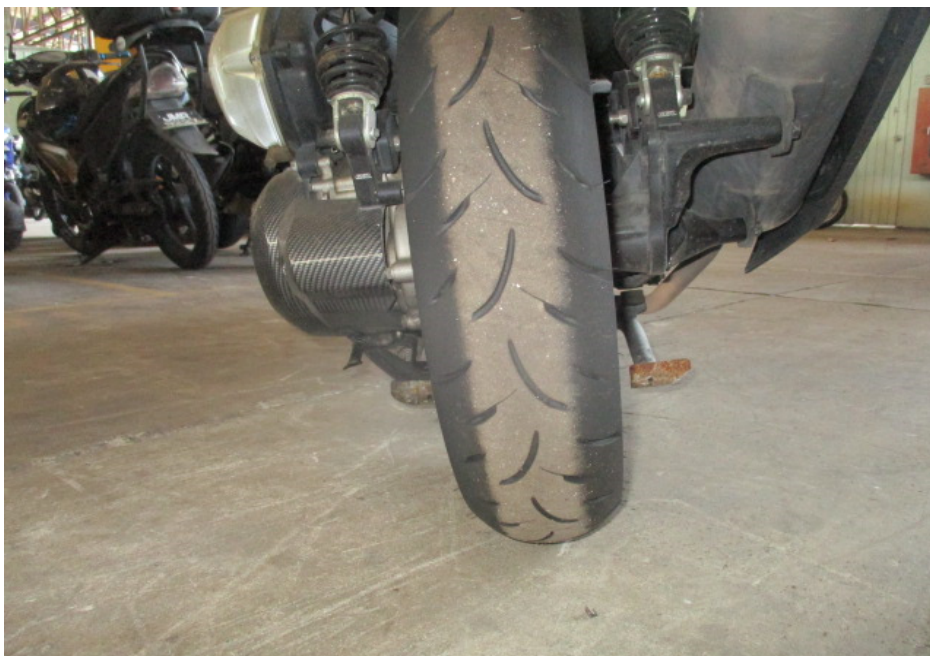
**Photo 16** shows the condition of the Motorcycle's rear tyre. The rear tyre was observed to be in serviceable condition with remaining tread depth of approximately 4mm. The tyre was also observed to be sufficiently inflated for vehicular operation. We did not observe any tear, burst mark(s) and/or punctured hole(s) on the sidewalls as well as across the tread of the rear tyre.

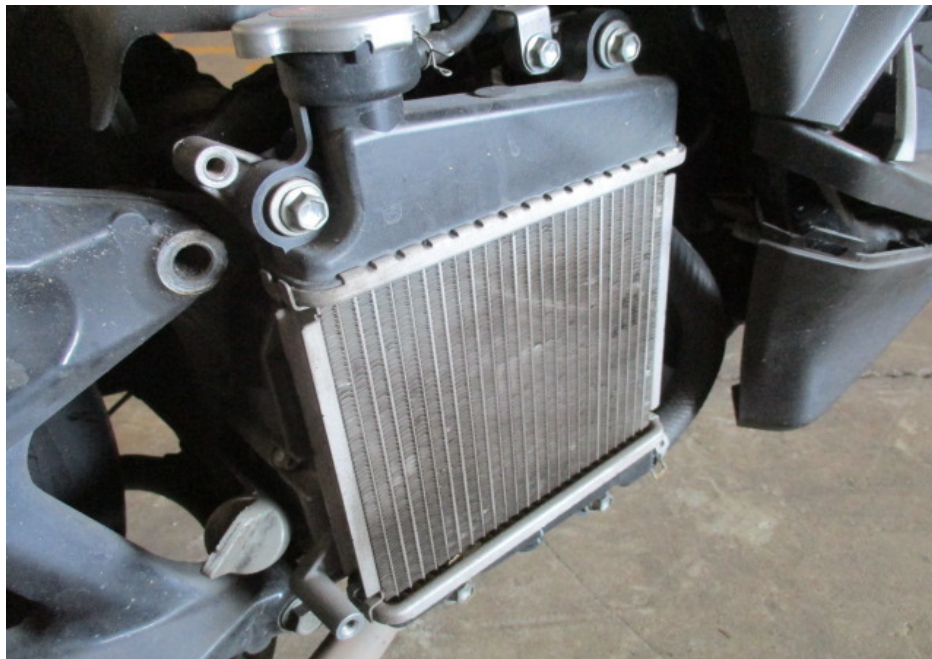
**Photo 17** shows the radiator of the Motorcycle at the time of our inspection. The radiator was found to be intact with no visible damage. There was also no sign(s) or indication(s) of fluid leak observed around the radiator of the Motorcycle.

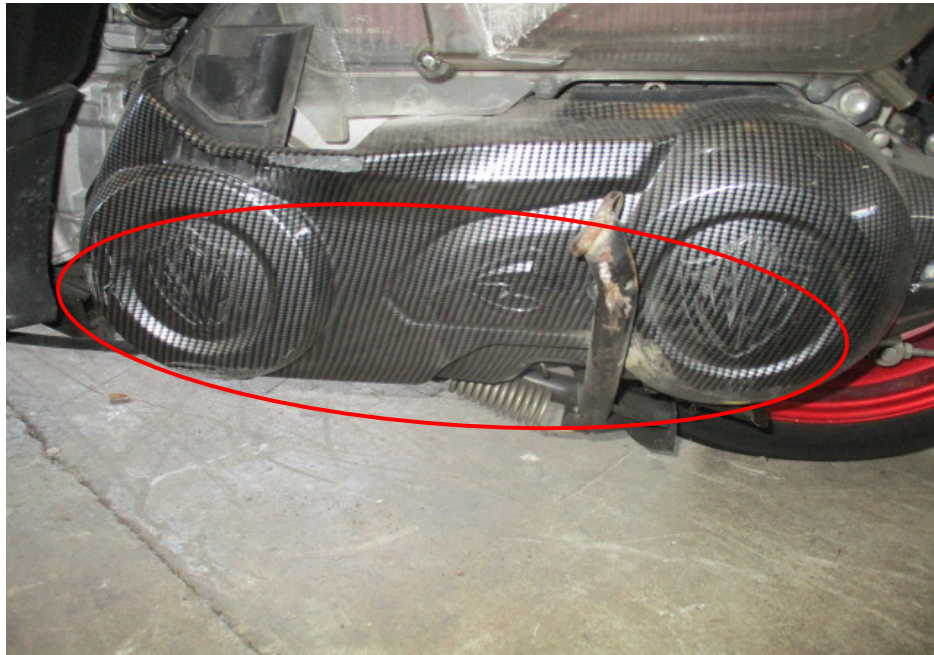
**Photo 18** shows the drive train cover of the Motorcycle which had sustained damages of grazing nature as a result of the accident (circled) however the engine components were still intact.

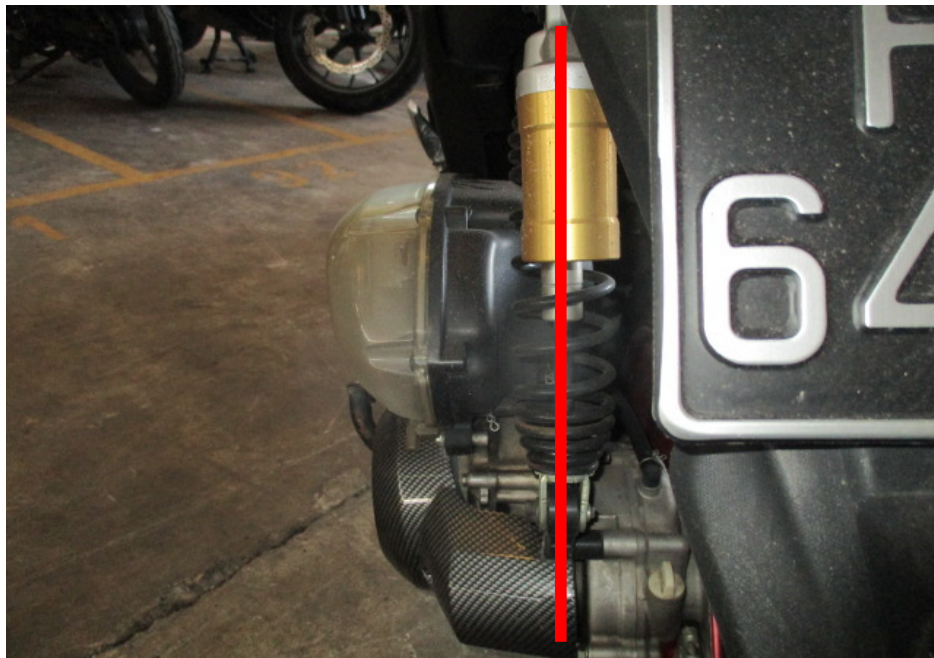
**Photo 19** shows the left shock absorber of the Motorcycle which was found to be intact without any misalignment.

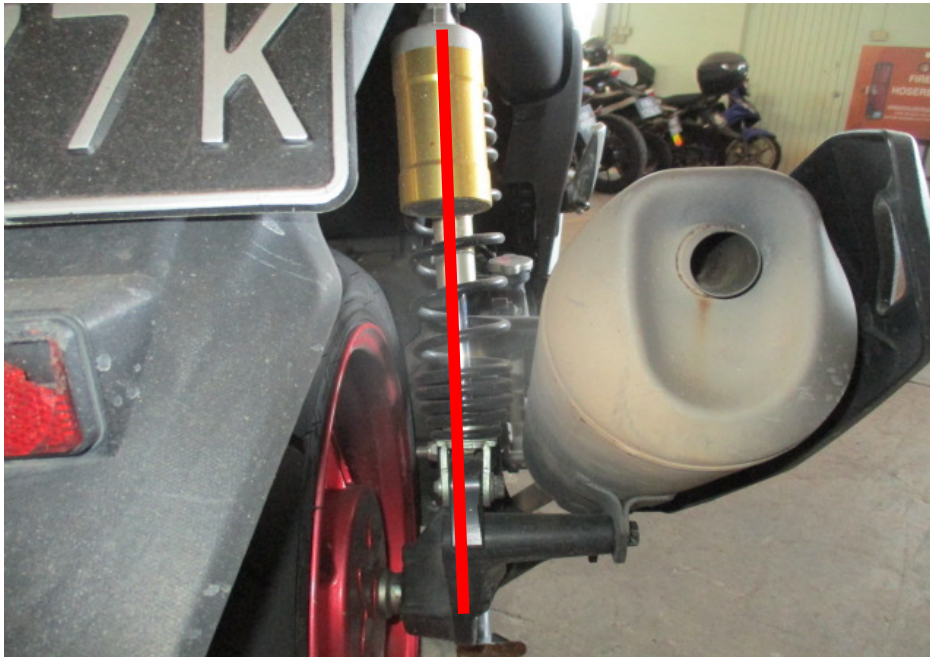
**Photo 20** shows the right shock absorber of the Motorcycle which was found to be intact without any misalignment.

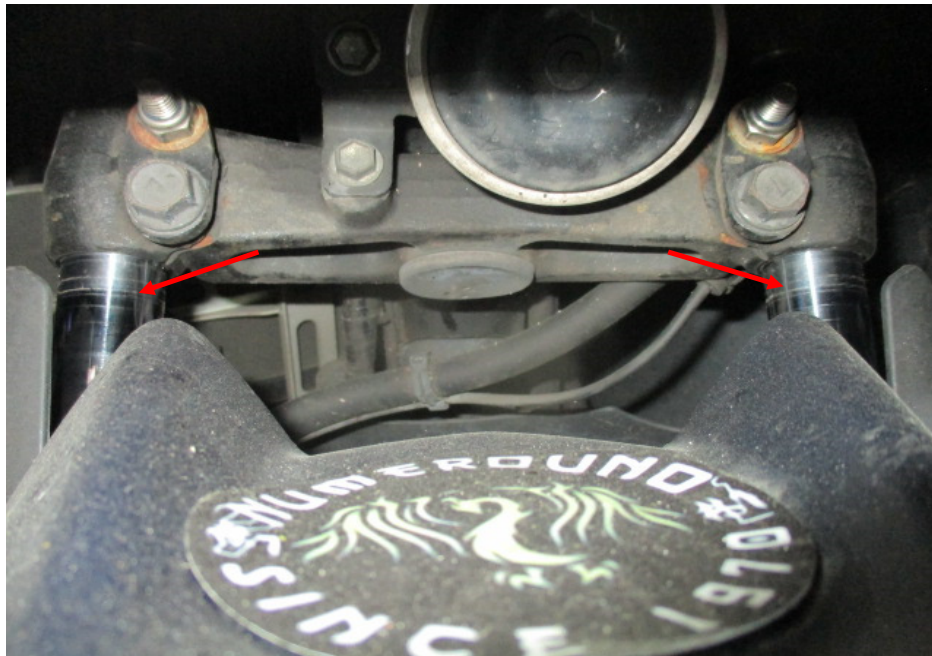
**Photo 21** shows the front forks (arrowed) of the Motorcycle. The front forks and fork brackets of the Motorcycle were both found to be intact and undamaged. Turning the Motorcycle's handle bar towards the left and right did not produce any abnormal free play and/or resistance. The steering system of the Motorcycle was in serviceable condition at the time of our inspection.

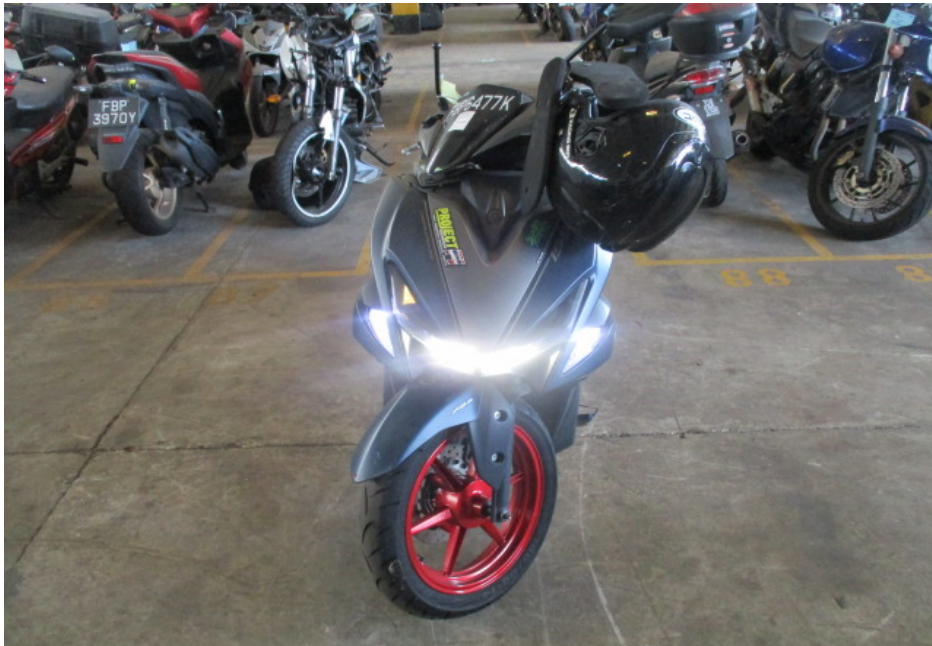
**Photo 22** shows the front wheel of the Motorcycle turned towards its full right. Turning the Motorcycle's handle bar towards the left and right did not produce any abnormal free play and/or resistance. This would indicate that the steering system of the Motorcycle was in serviceable condition at the time of our inspection.

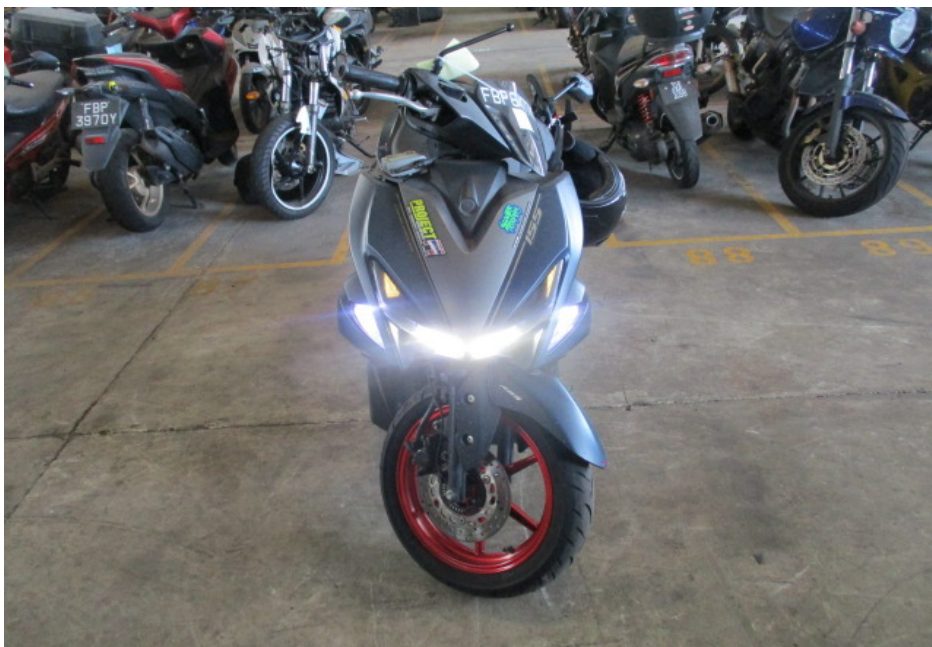
**Photo 23** shows the front wheel of the Motorcycle turned towards its full left. Turning the Motorcycle's handle bar towards the left and right did not produce any abnormal free play and/or resistance. This would indicate that the steering system of the Motorcycle was in serviceable condition at the time of our inspection.

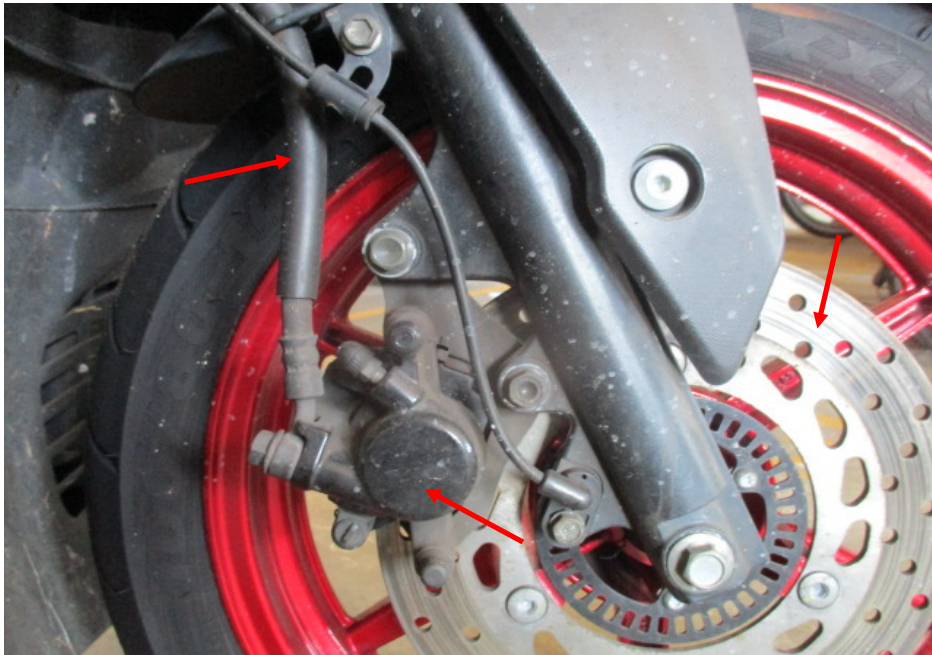
**Photo 24** shows a close up view of the front brake caliper, front brake disc and front brake hose (arrowed) of the Motorcycle, which are all part of the components in the hydraulic front brake system of the Motorcycle. Our visual checks of these various components had revealed all to be intact with no visible damage. No leakage of brake fluid was also observed.

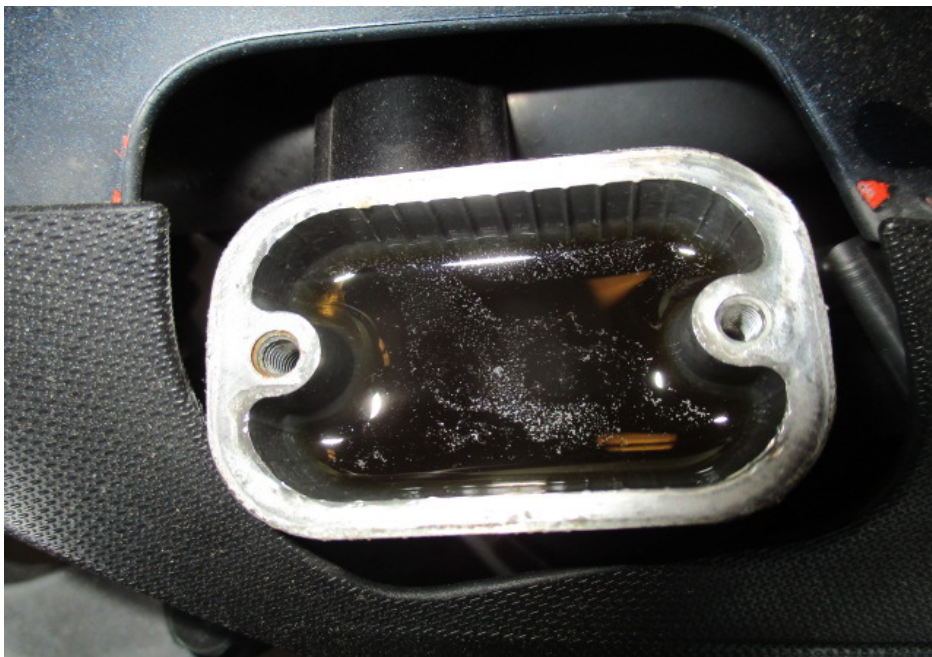
**Photo 25** shows a close up view of the brake fluid reservoir for the front brake of the Motorcycle. The brake fluid was observed to be of sufficient level and without contamination for operational purposes.

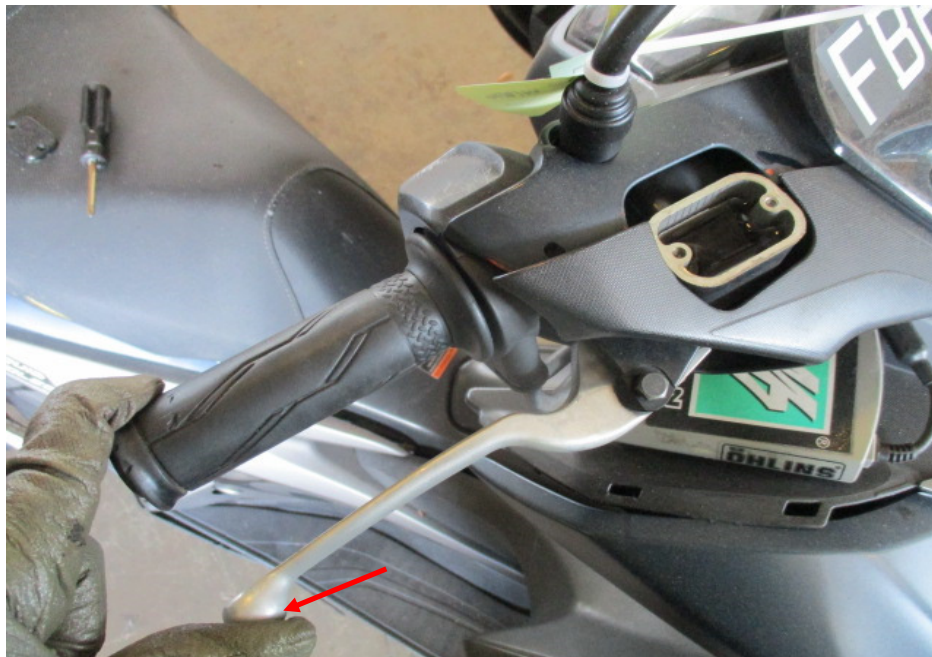
**Photo 26** shows the front brake lever being depressed. There was some resistance felt (spongy like feel) upon pressing the front brake lever (arrowed). This would indicate that there is no leakage of pressure/vacuum in the brake system.

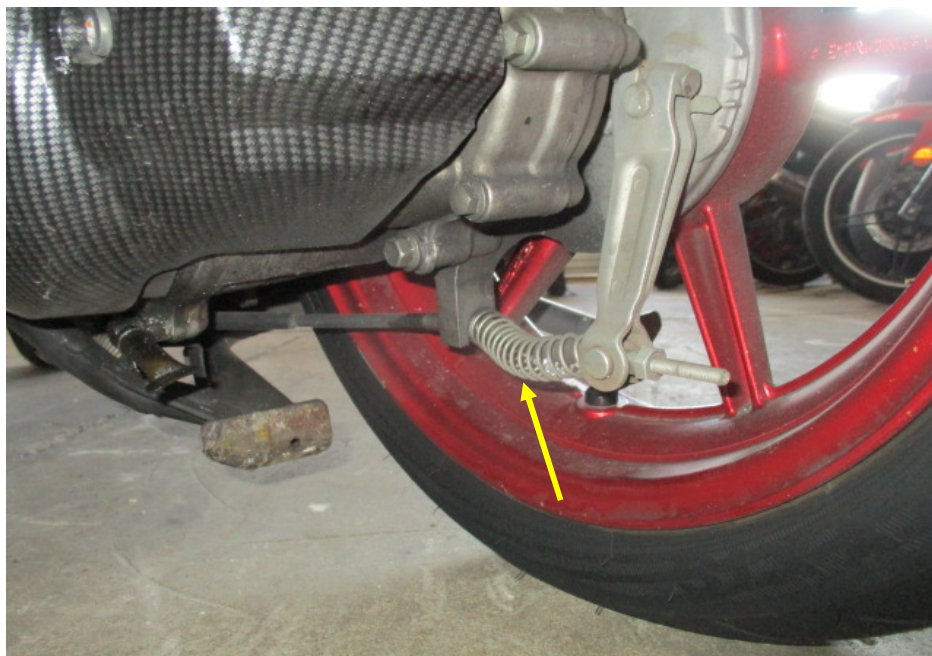
**Photo 27** shows the rear wheel of the Motorcycle. The type of brake system for the rear wheel was of a mechanical type, controlled by the brake foot pedal of the Motorcycle. Our checks of the cable (arrowed), spring and drum which are all part of the components in the rear brake system of the Motorcycle reveal all to be intact and without damage.
