Your Ref: TP/IP/47771/2020
Our Ref : CI/TPD20012513/N

22 December 2020

INSPECTION REPORT OF MOTORCYCLE FZ 8298Y

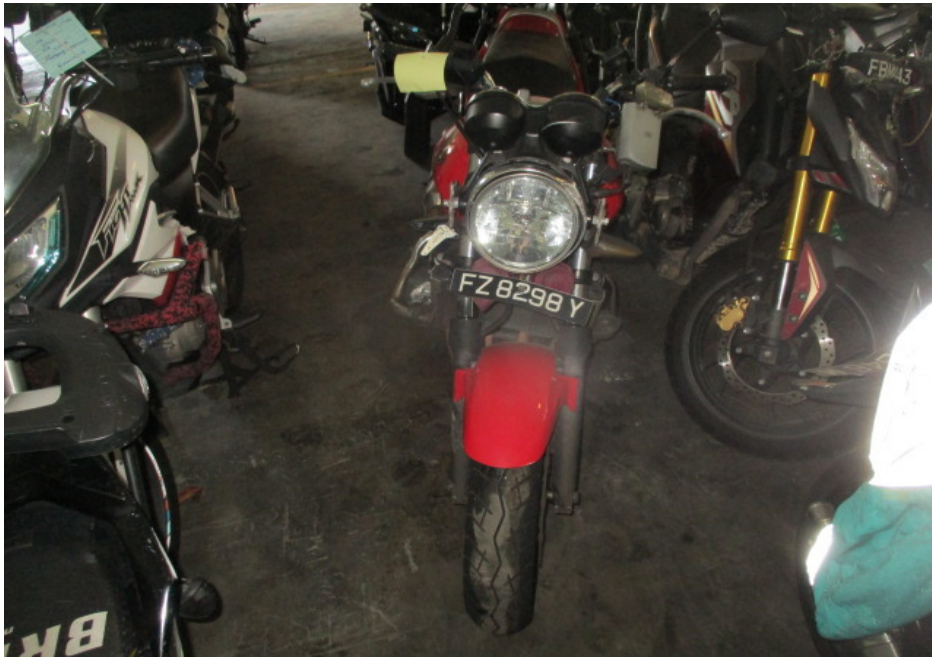
Photo 1 shows a general view of the frontal portion of the Motorcycle at the time of our inspection. The Motorcycle was observed to have sustained damages all around.

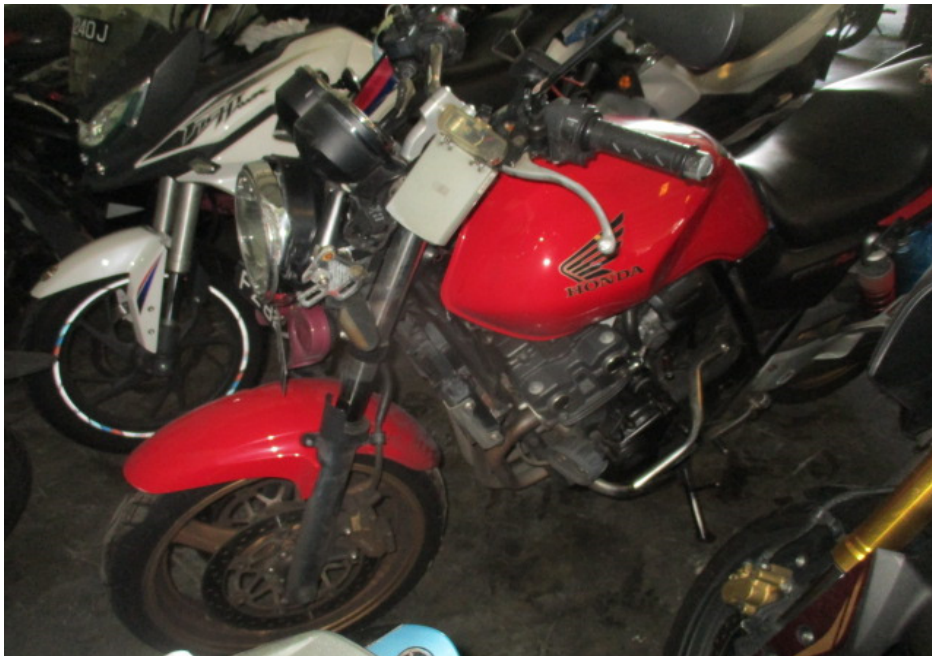
Photo 2 shows a general view of the left front body of the Motorcycle at the time of our inspection. The Motorcycle was observed to have sustained damages all around.

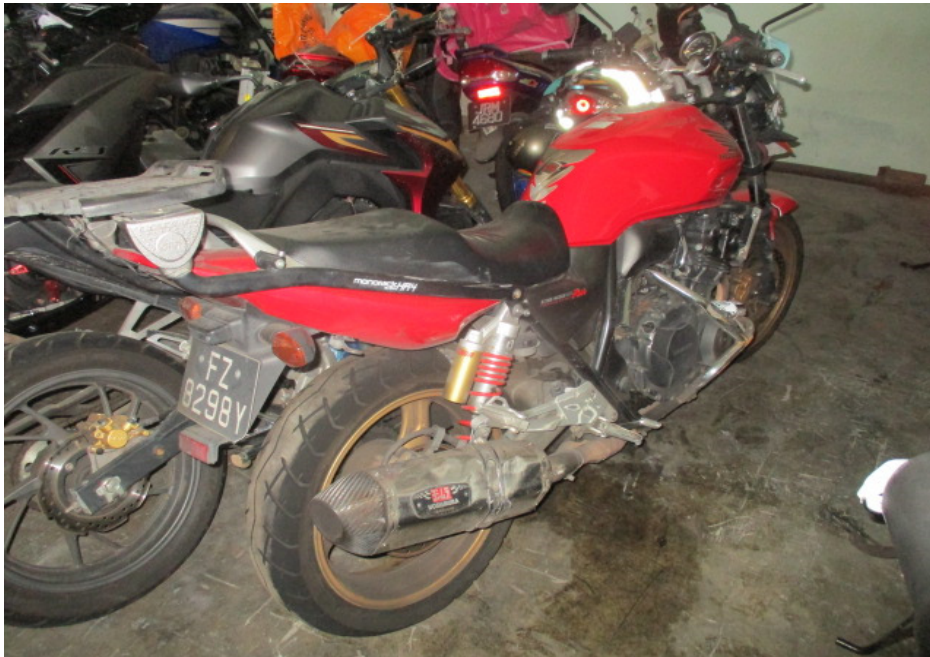
Photo 3 shows a general view of the right rear body of the Motorcycle at the time of our inspection. The Motorcycle was observed to have sustained damages all around. The body parts that were found to have been damaged include its headlight cover, headlight, front forks, front mudguard, radiator, right handlebar end, right side mirror, front brake lever, petrol tank, right rear side cover, right front footrest, rear brake pedal, left front footrest, exhaust muffler and top box rack, amongst others.

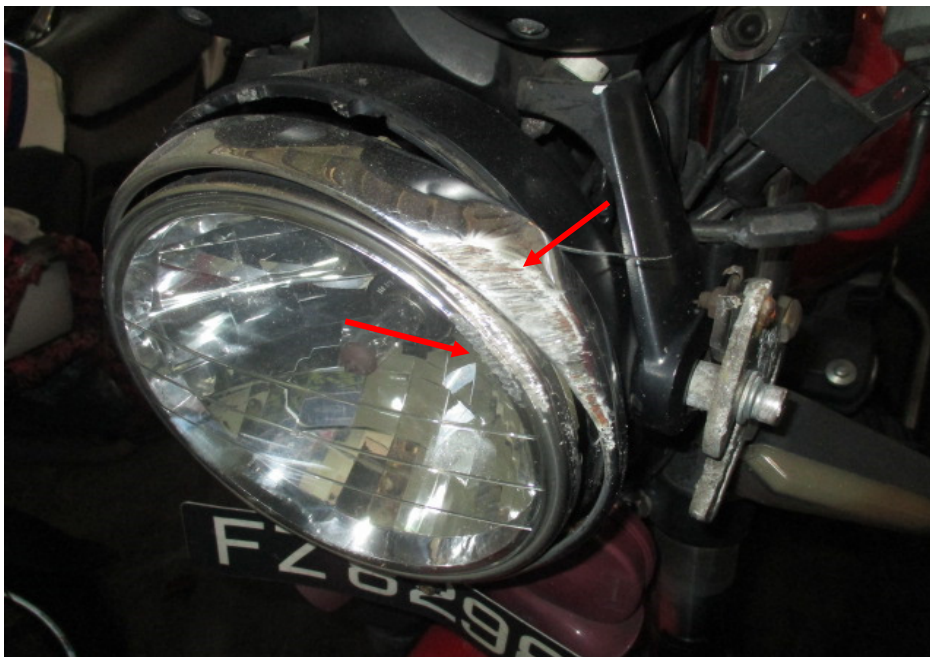
Photo 4 shows a closer view of the bent headlight cover and scratched headlight (arrowed) of the Motorcycle as a result of the accident.

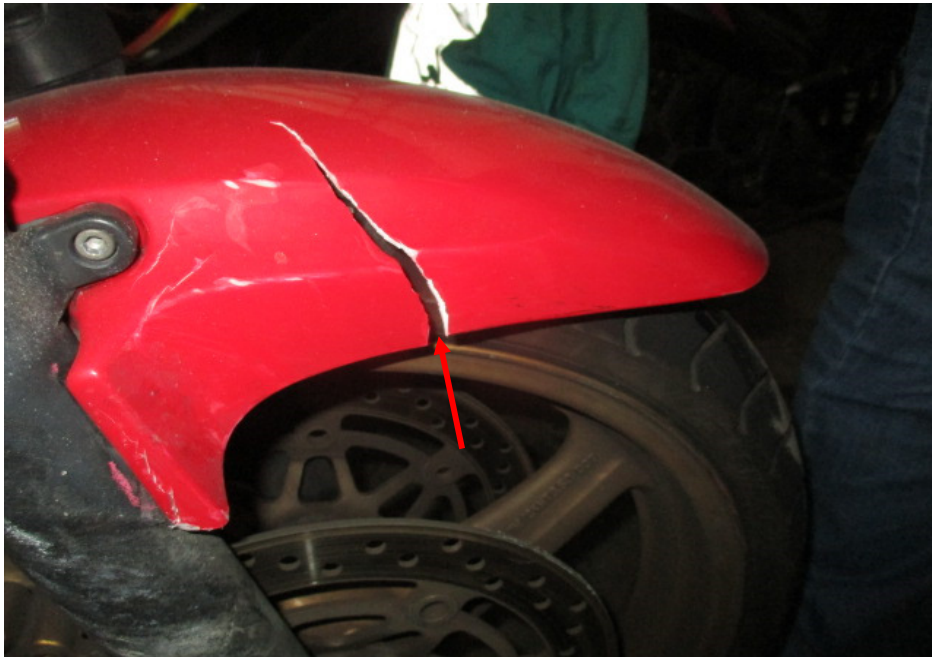
Photo 5 shows a closer view of the front mudguard which were amongst the body parts at the front body of the Motorcycle that had sustained damage as a result of the accident (arrowed).

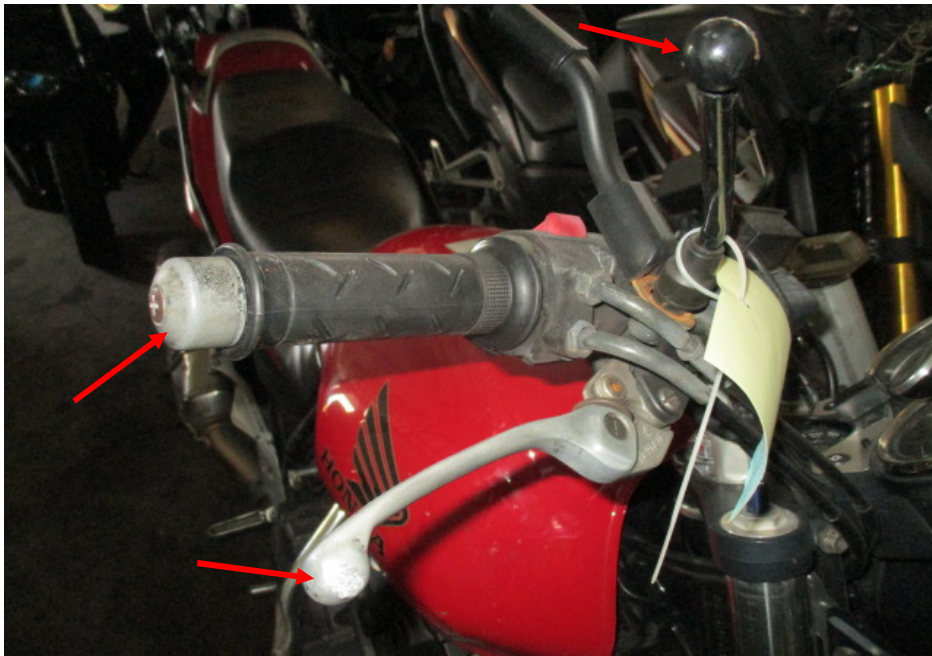
Photo 6 shows a closer view of the front brake lever, right side mirror and right handlebar end (arrowed) which were amongst the body parts at the front body of the Motorcycle that had sustained damage as a result of the accident.

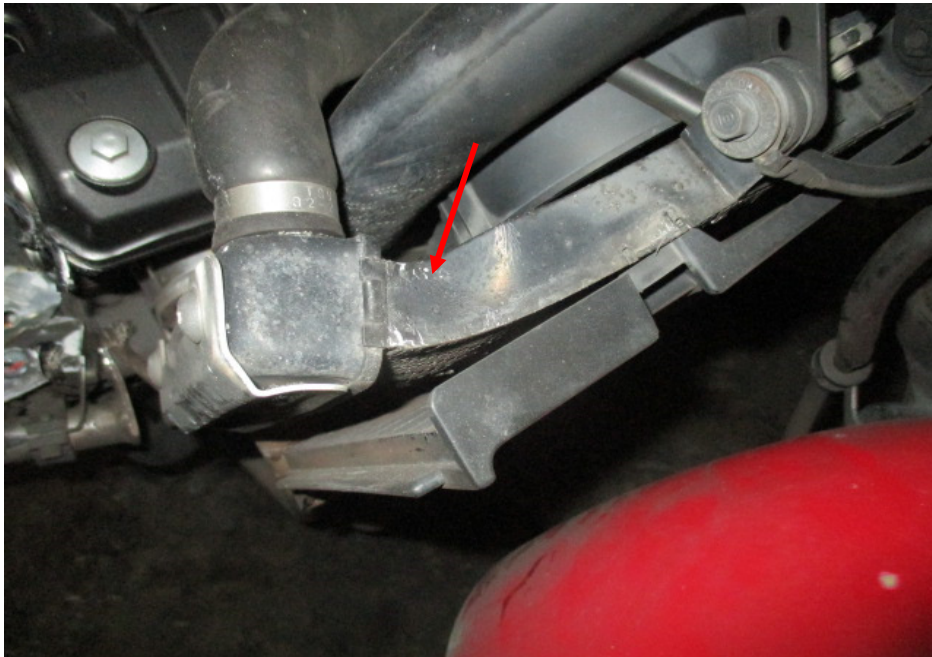
Photo 7 shows the deformed radiator of the Motorcycle as a result of the accident (arrowed).

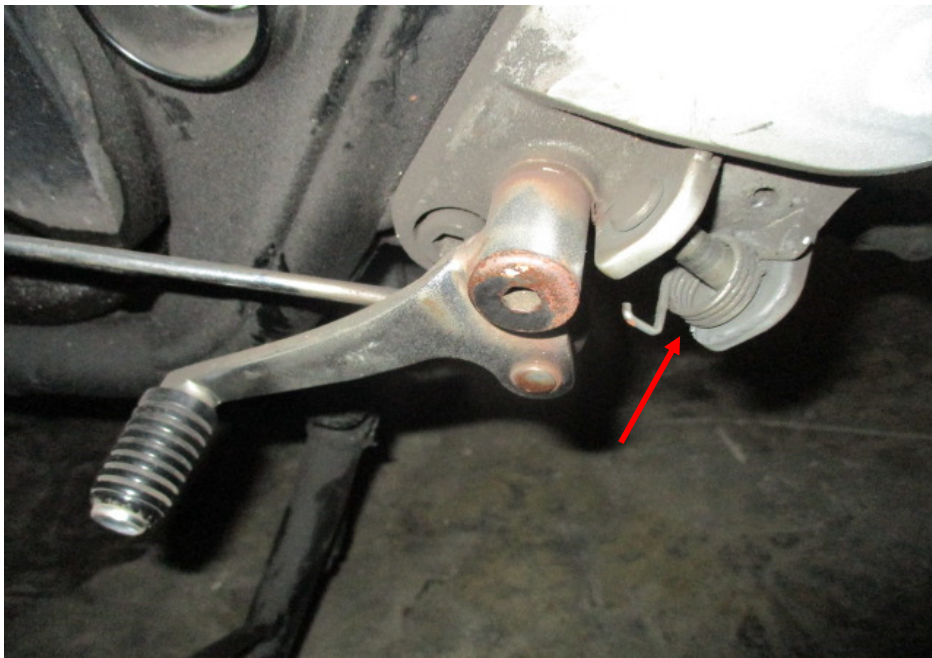
Photo 8 shows the broken left front footrest of the Motorcycle as a result of the accident (arrowed).

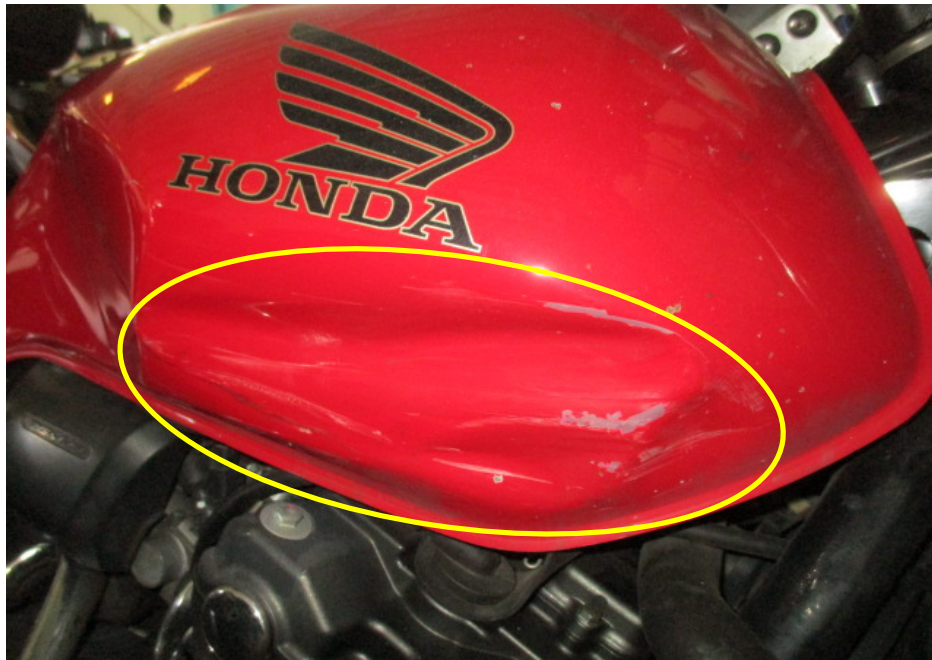
Photo 9 shows a closer view of the dented petrol tank of the Motorcycle as a result of the accident (circled).

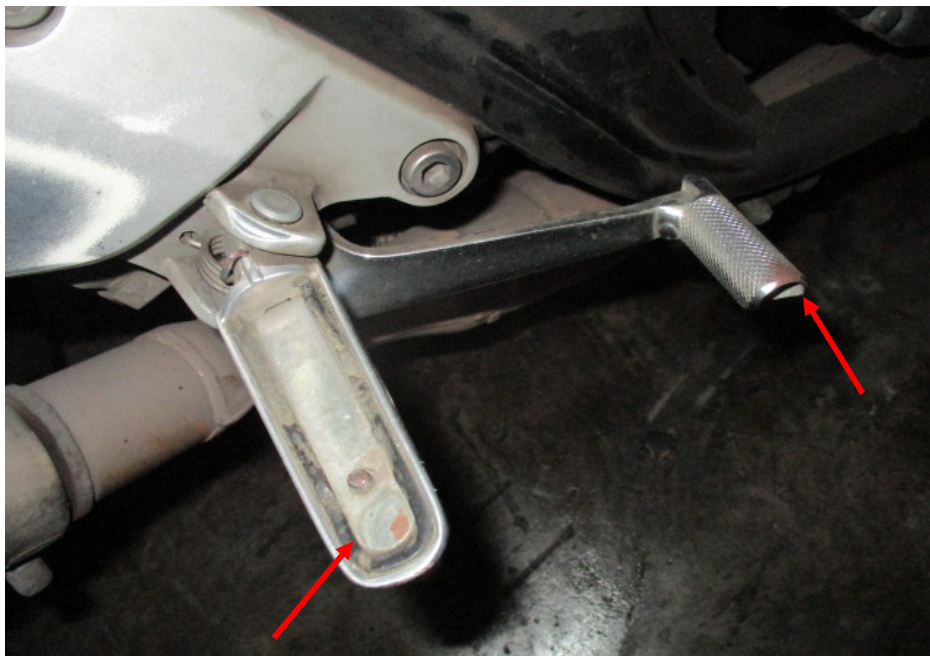
Photo 10 shows a closer view of the right front footrest and rear brake pedal (arrowed) which was amongst the body parts of the Motorcycle that had sustained damage as a result of the accident.

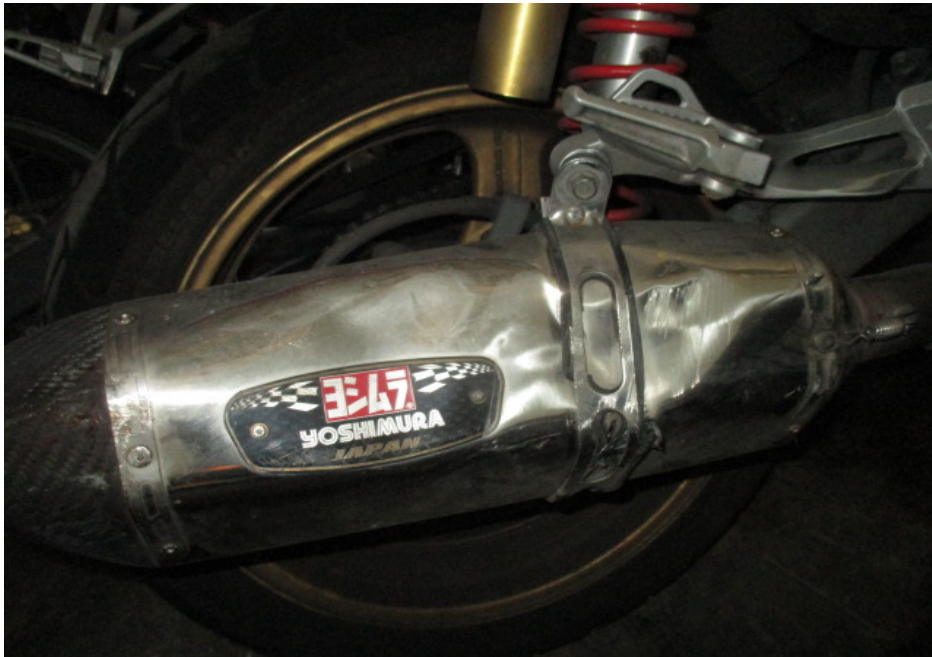
Photo 11 shows the dented exhaust muffler of the Motorcycle as a result of the accident.

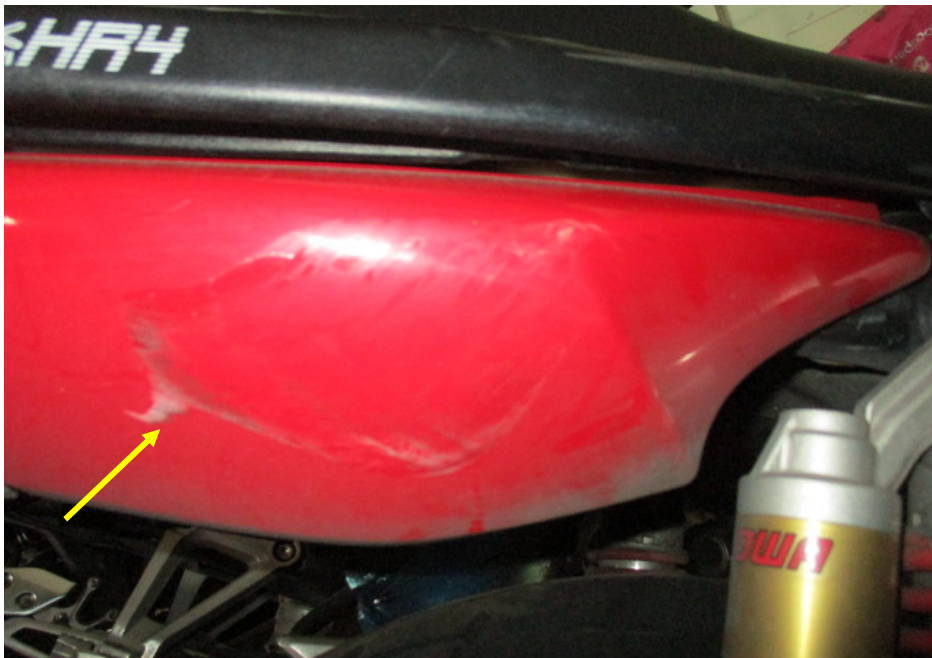
Photo 12 shows a closer view of the grazed right rear side cover (arrowed) of the Motorcycle as a result of the accident.

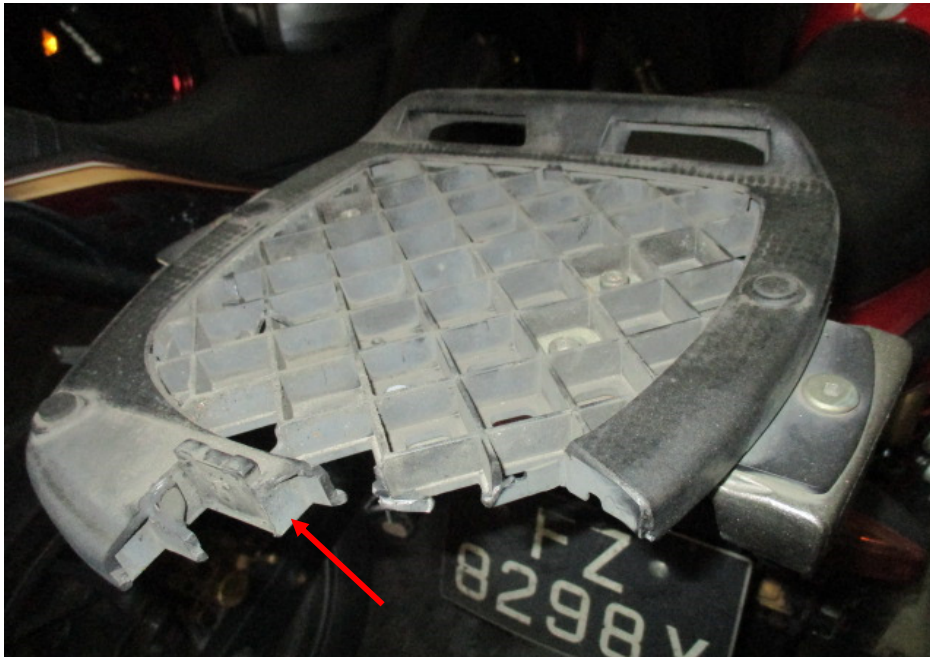
Photo 13 shows the cracked top box rack (arrowed) of the Motorcycle as a result of the accident.

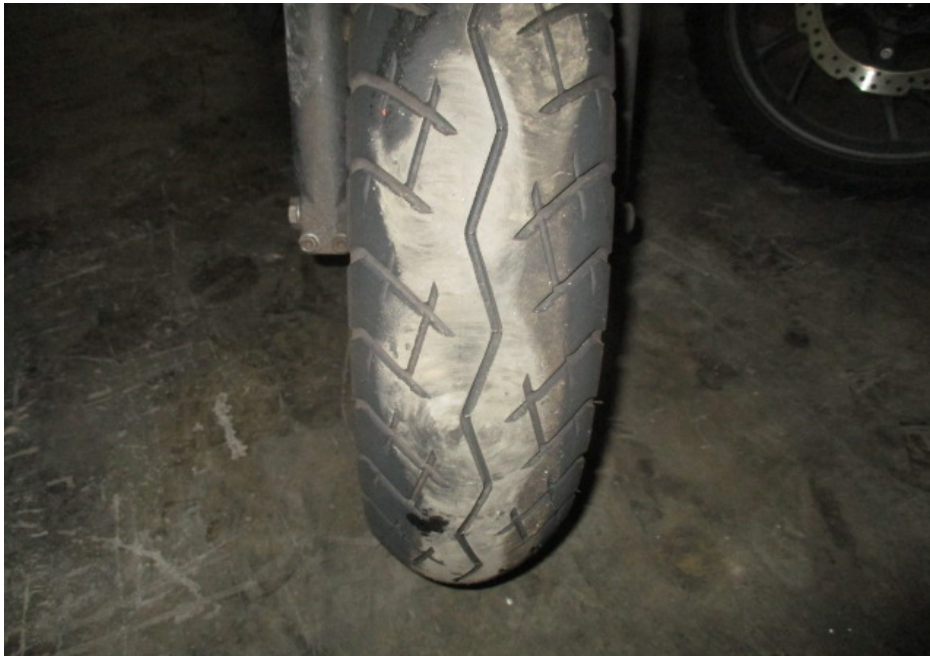
Photo 14 shows the front tyre of the Motorcycle at the time of our inspection. The front tyre was observed to be in serviceable condition with remaining tread depth of approximately 3mm. The pattern of the tread was also clearly visible. There was no tear, burst mark(s) and/or punctured hole(s) on the sidewalls as well as across the tread of the front tyre.

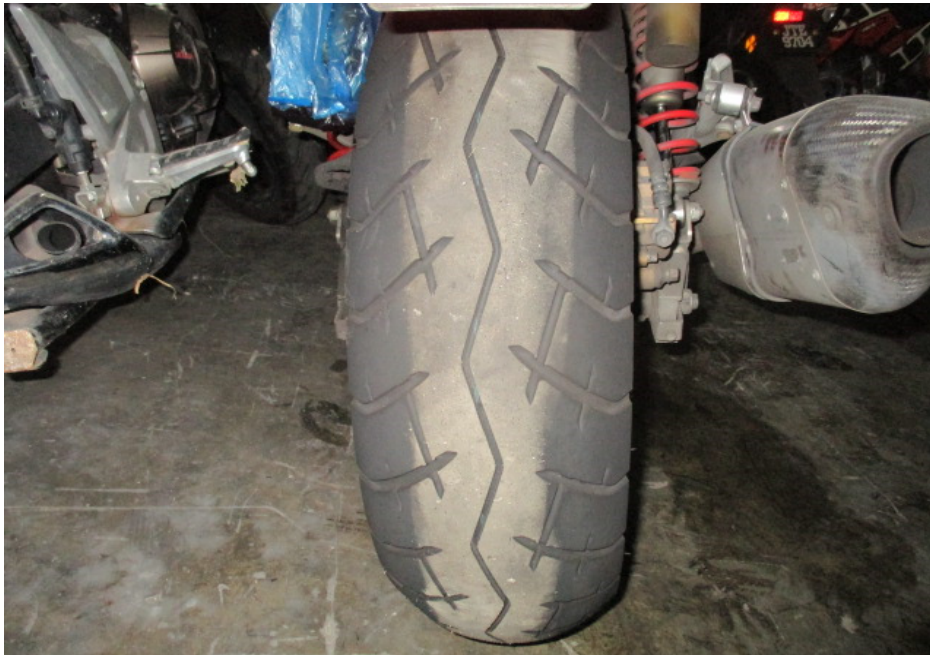
Photo 15 shows the condition of the Motorcycle's rear tyre. The rear tyre was observed to be in serviceable condition with remaining tread depth of approximately 3mm. The tyre was also observed to be sufficiently inflated for vehicular operation. We did not observe any tear, burst mark(s) and/or punctured hole(s) on the sidewalls as well as across the tread of the rear tyre.

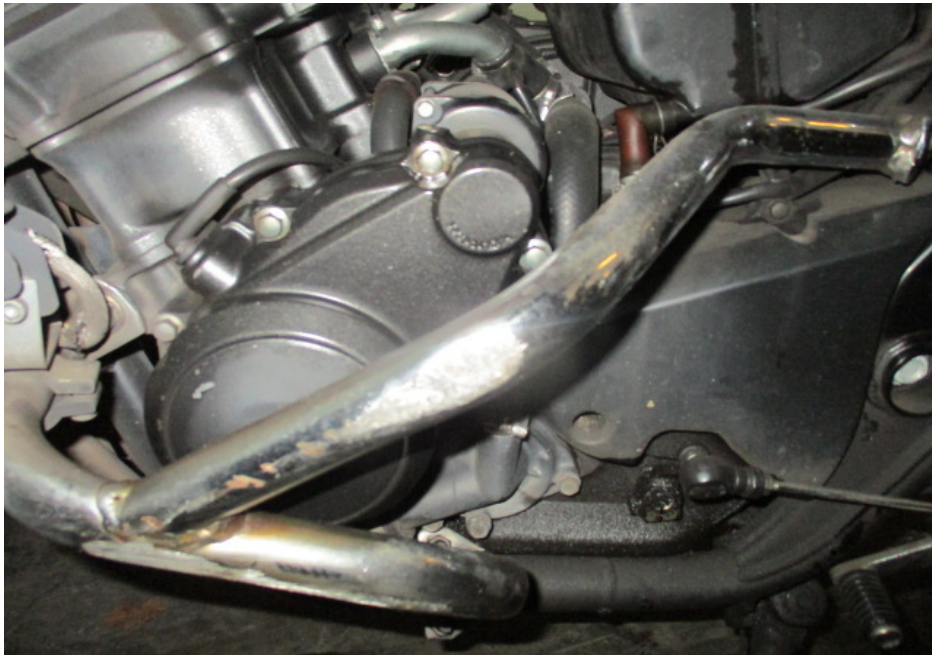
Photo 16 shows the left side of the engine of the Motorcycle at the time of our inspection. The various engine related parts and components were found to be intact with no visible damage. There was also no sign(s) or indication(s) of fluid leak observed around the left engine area of the Motorcycle.

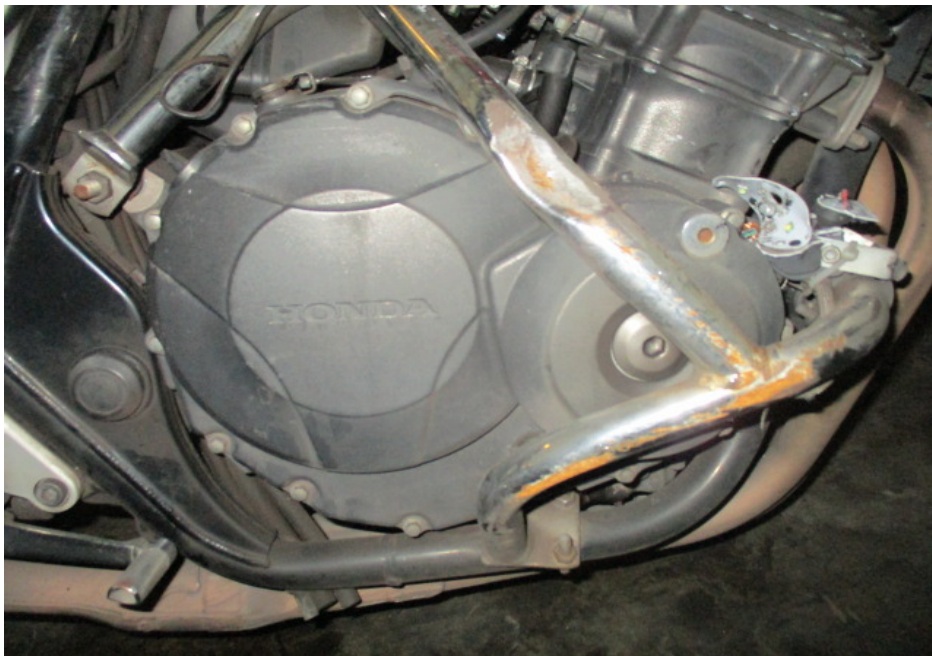
Photo 17 shows the right side of the engine of the Motorcycle at the time of our inspection. The various engine related parts and components were found to be intact with no visible damage. There was also no sign(s) or indication(s) of fluid leak observed around the right engine area of the Motorcycle.

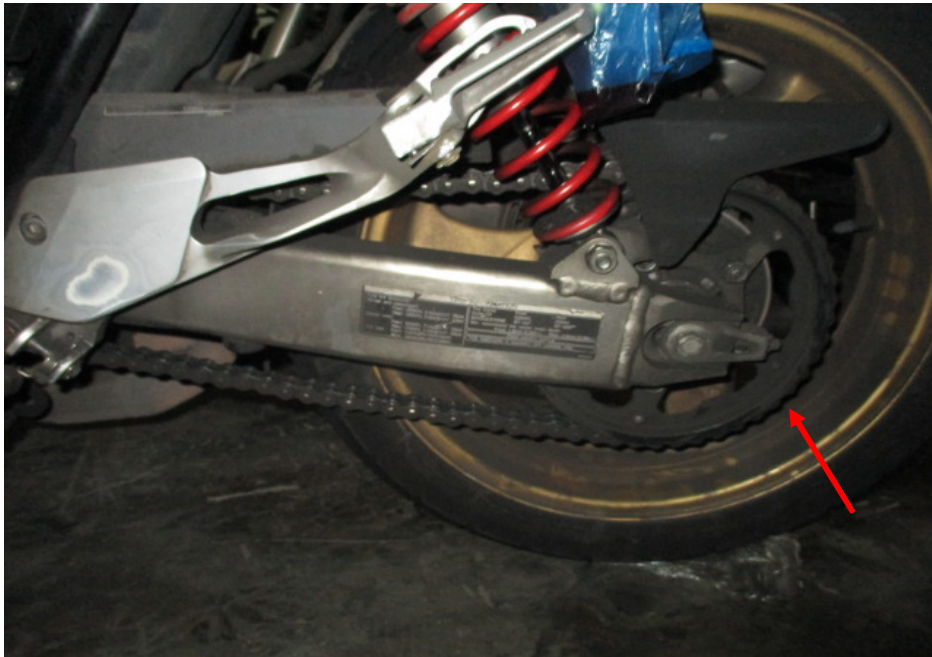
Photo 18 shows the general view of the gear train (arrowed) of the Motorcycle, which was observed to be intact with no misalignment. It was also adequately lubricated for operating purposes.

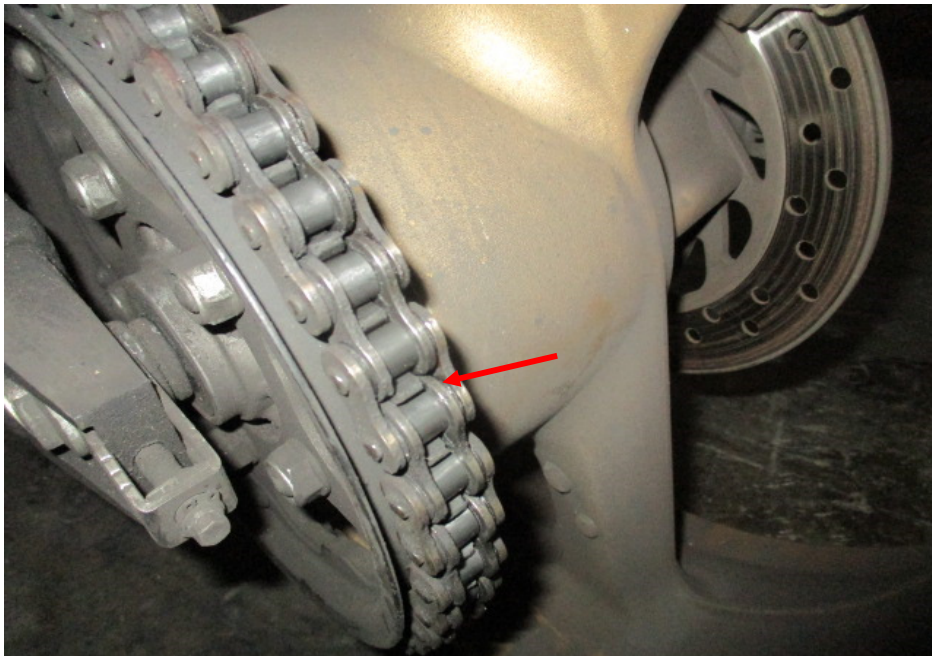
Photo 19 shows a closer view of the gear train (arrowed) of the Motorcycle, which was observed to be intact with no misalignment. It was also adequately lubricated for operating purposes.

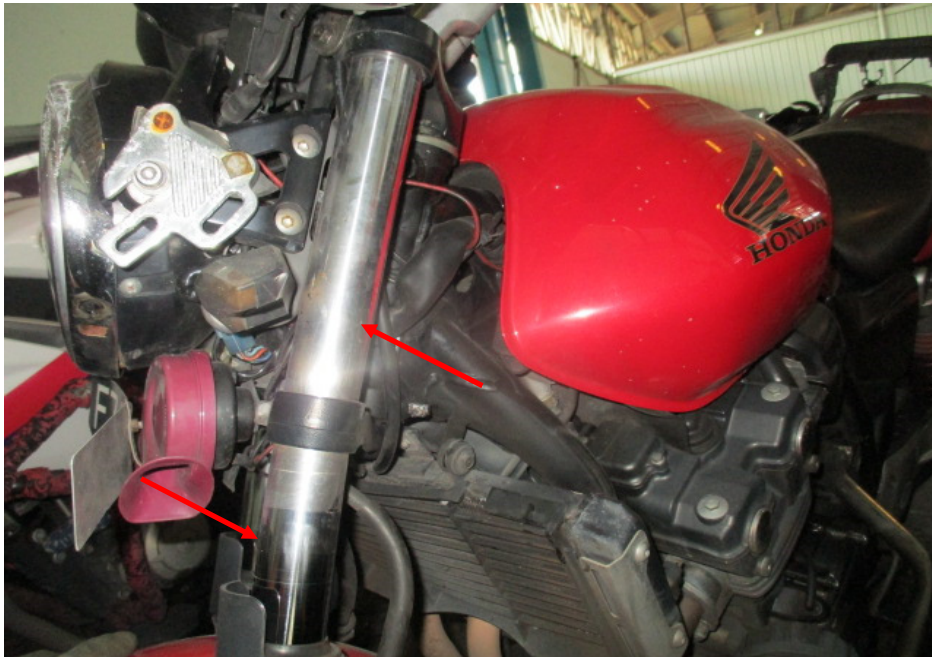
11. For this case, we were not able to conduct any test(s) on the steering system of the Motorcycle due to the damage of its front forks. The front forks were found to be bent inwards as a result of the accident which had rendered the Motorcycle immobile.

Photo 20 shows the left front fork of the Motorcycle. The left front fork (arrowed) was observed to be bent inwards as a result of the accident. We were hence not able to conduct any tests on the steering system of the Motorcycle.

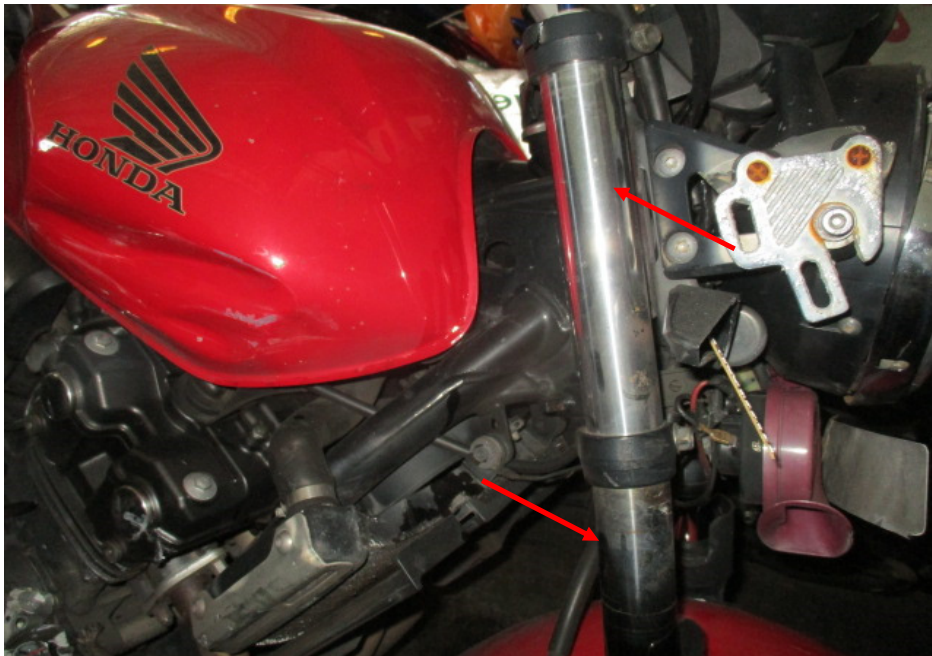
Photo 21 shows the right front fork of the Motorcycle. The right front fork (arrowed) was observed to be bent inwards as a result of the accident. We were hence not able to conduct any tests on the steering system of the Motorcycle.

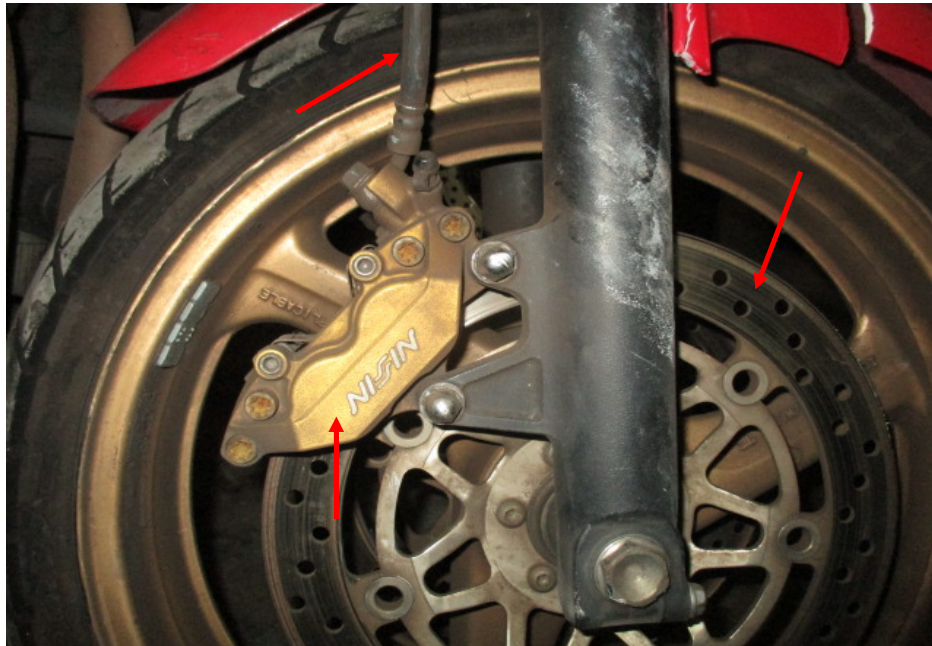
Photo 22 shows a close up view of the front brake caliper, front brake disc and front brake hose (arrowed) at the right side of the Motorcycle's front wheel, which are all part of the components in the hydraulic front brake system of the Motorcycle. Our visual checks of these various components had revealed all to be intact with no visible damage. No leakage of brake fluid was also observed.

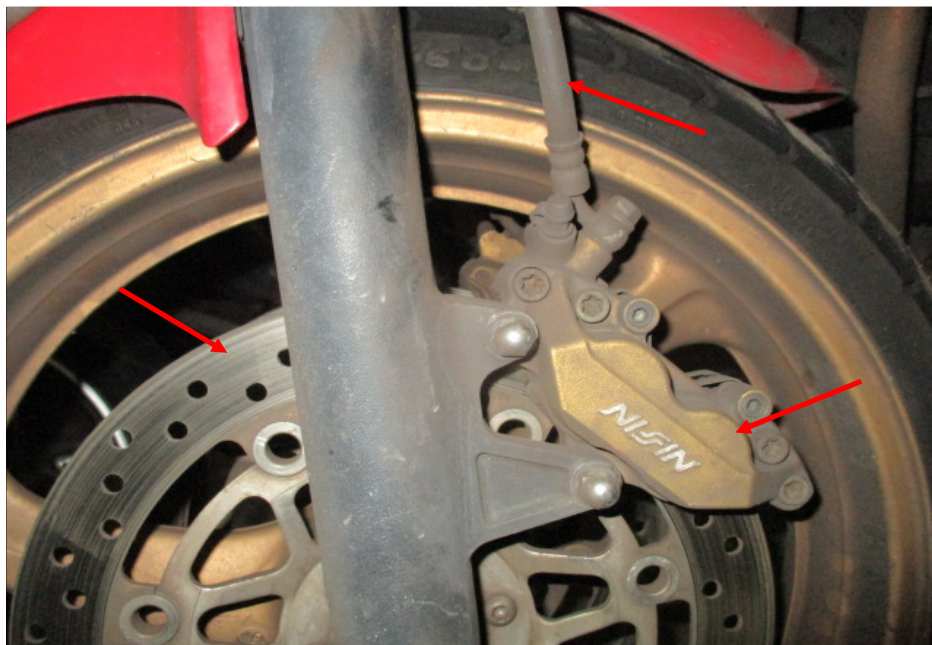
Photo 23 shows a close up view of the front brake caliper, front brake disc and front brake hose (arrowed) at the left side of the Motorcycle's front wheel, which are all part of the components in the hydraulic front brake system of the Motorcycle. Our visual checks of these various components had revealed all to be intact with no visible damage. No leakage of brake fluid was also observed.

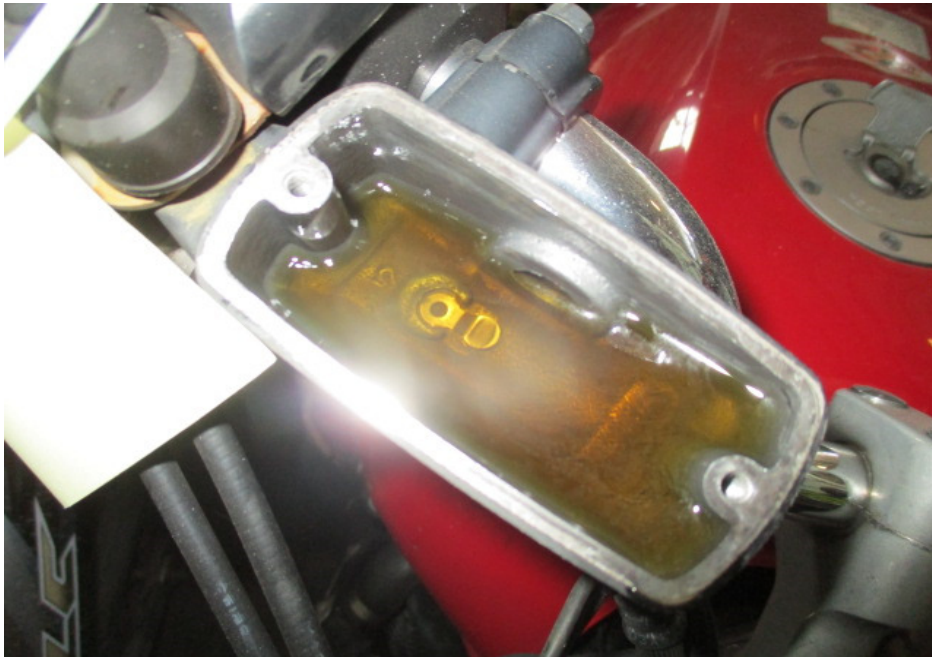
Photo 24 shows the brake fluid reservoir for the front brake of the Motorcycle. The brake fluid was observed to be of sufficient level and without contamination for operational purposes.

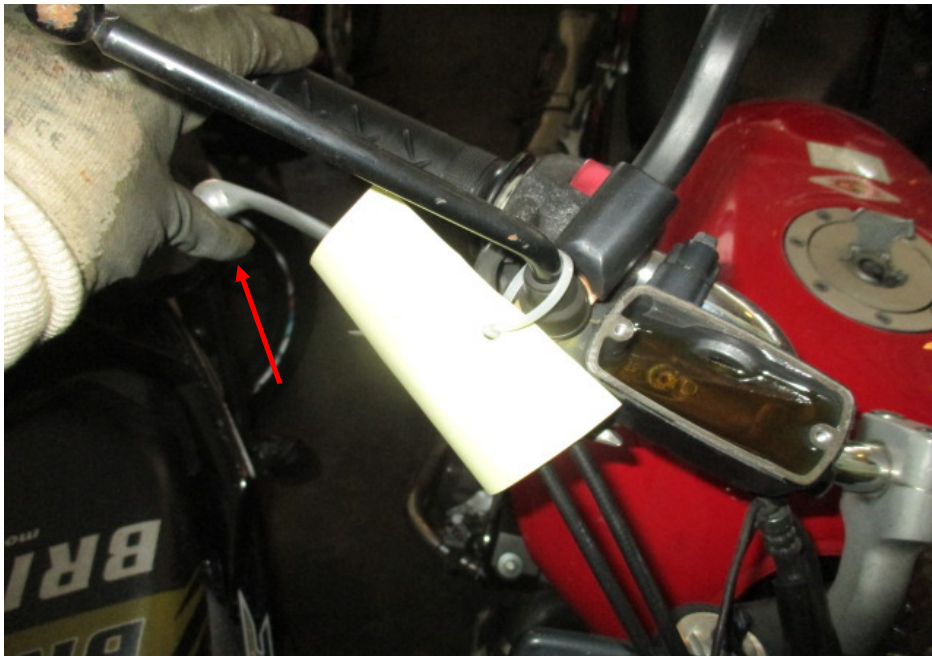
Photo 25 shows the front brake lever being depressed. There was some resistance felt (spongy like feel) upon pressing the front brake lever (arrowed). This would indicate that there is no leakage of pressure/vacuum in the brake system.

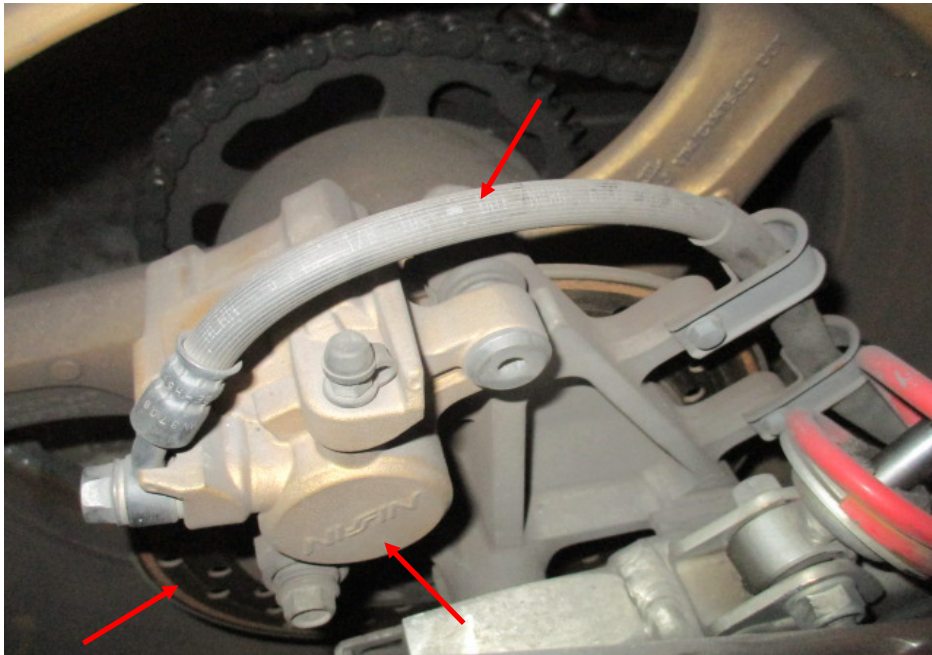
Photo 26 shows a close up view of the rear brake caliper, rear brake disc and rear brake hose (arrowed) of the Motorcycle, which are all part of the components in the hydraulic rear brake system of the Motorcycle. Our visual checks of these various components had revealed all to be intact with no visible damage. No leakage of brake fluid was also observed.

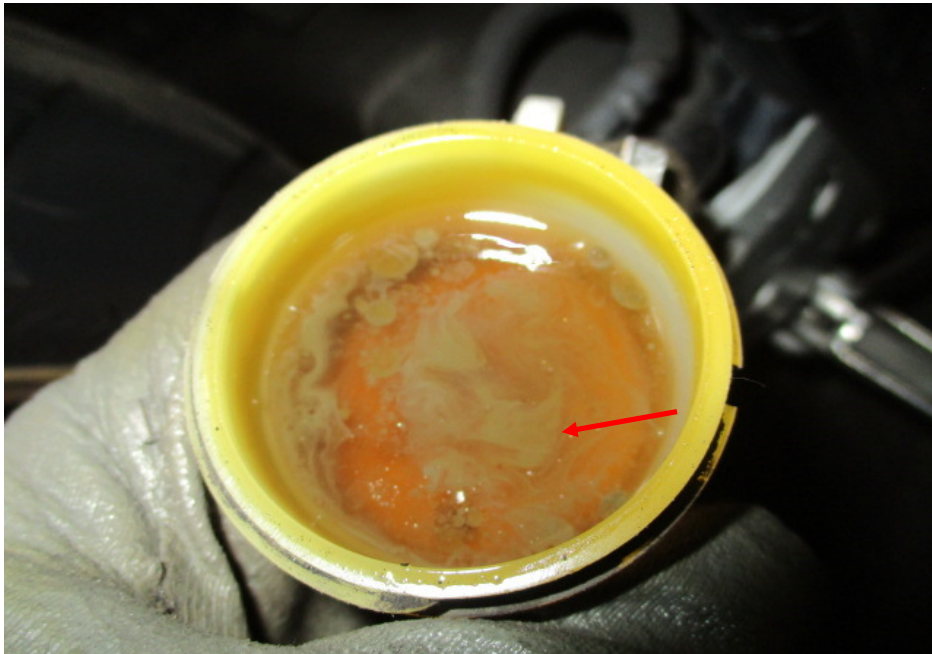
Photo 27 shows the brake fluid reservoir for the rear brake of the Motorcycle. The brake fluid was observed to be of sufficient level for operational purposes. However it was found to be slightly contaminated (arrowed).
