Your Ref: TP/IP/26025/2020
Our Ref : CI/TPD20012514/N

Fatal Accident Investigation Team

INSPECTION REPORT OF MOTORCYCLE JTL 4346

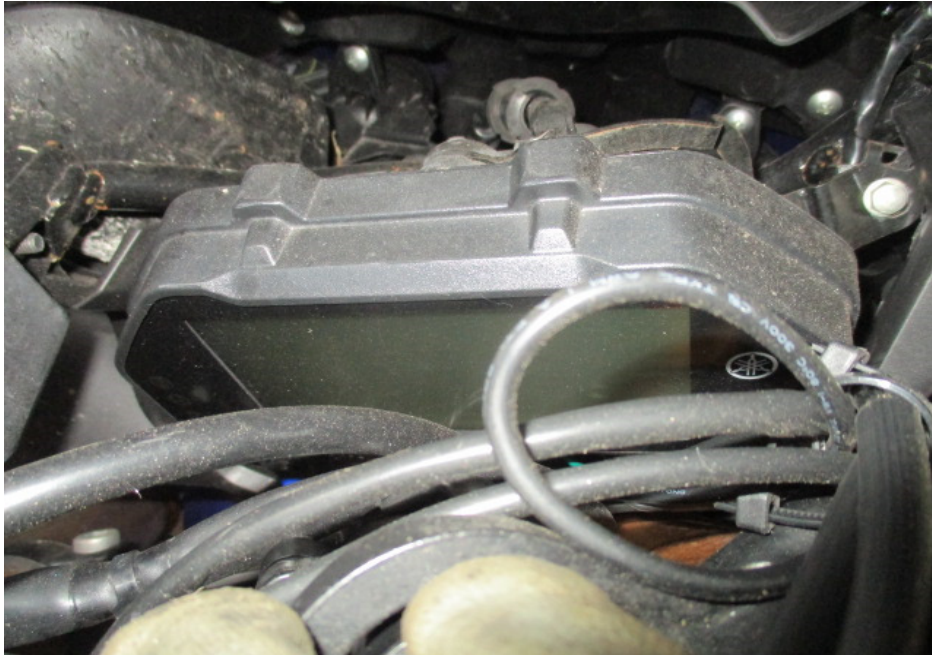
4. The mileage of the Motorcycle could not be recorded at the time of our inspection due to damages sustained to the speedometer gauge.
5. The Motorcycle was observed to have sustained damages all around. The body parts that were found to have been damaged include its speedometer gauge, front cowling, side cowlings, handlebars, handlebar ends, right fog light, right front signal lamp, front brake lever, gear shift pedal, rear brake pedal, right front footrest, right front footrest bracket, right rear side cover, exhaust muffler and top box rack, amongst others.

Photo 1 shows the speedometer gauge of the Motorcycle. The mileage of the Motorcycle could not be recorded at the time of our inspection due to damages sustained to the speedometer gauge.

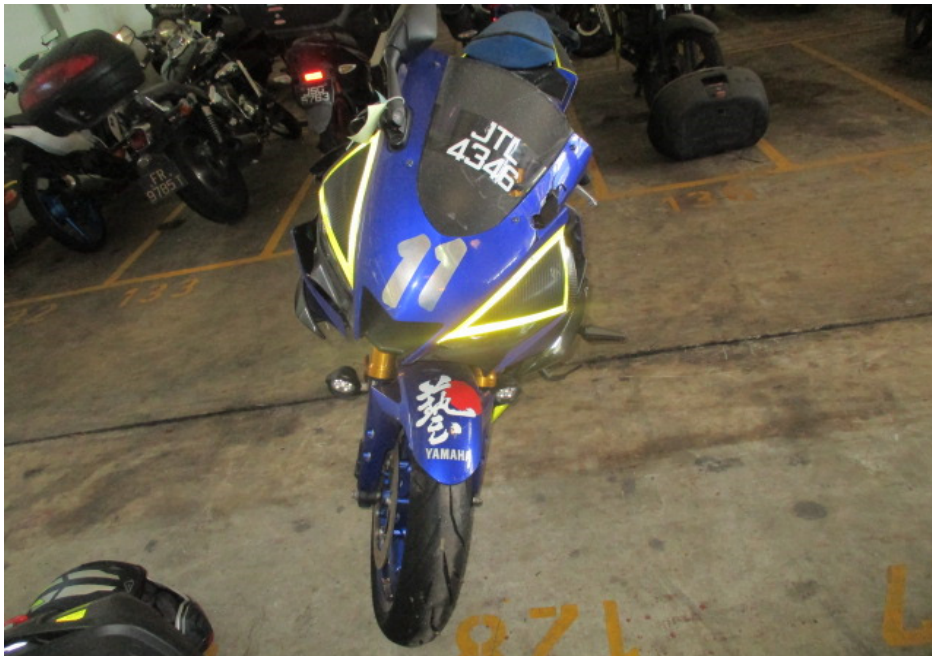
Photo 2 shows a general view of the frontal portion of the Motorcycle at the time of our inspection. The Motorcycle was observed to have sustained damages all around.

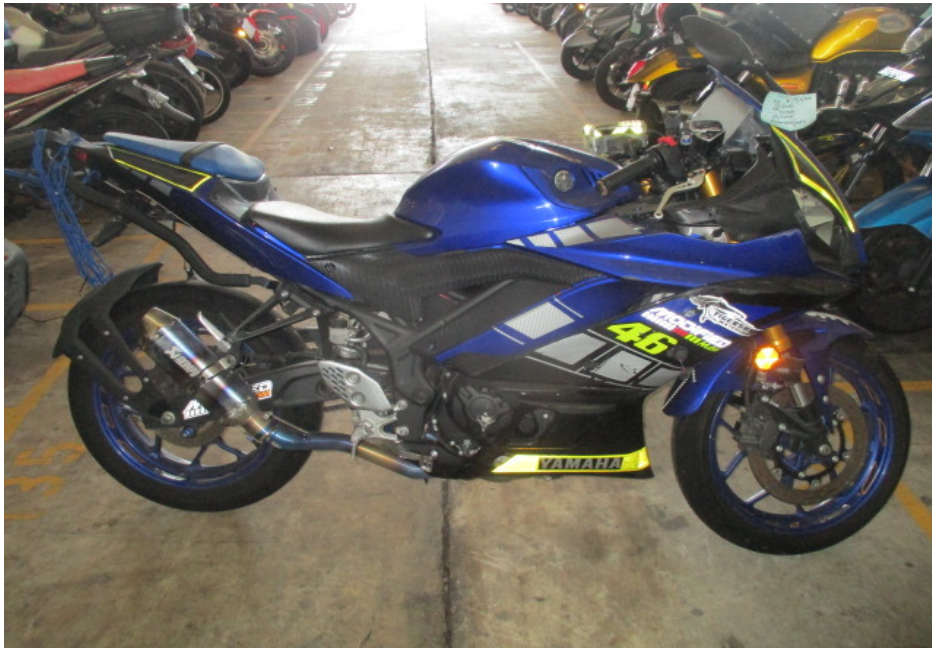
Photo 3 shows a general view of the right body of the Motorcycle at the time of our inspection. The Motorcycle was observed to have sustained damages all around.

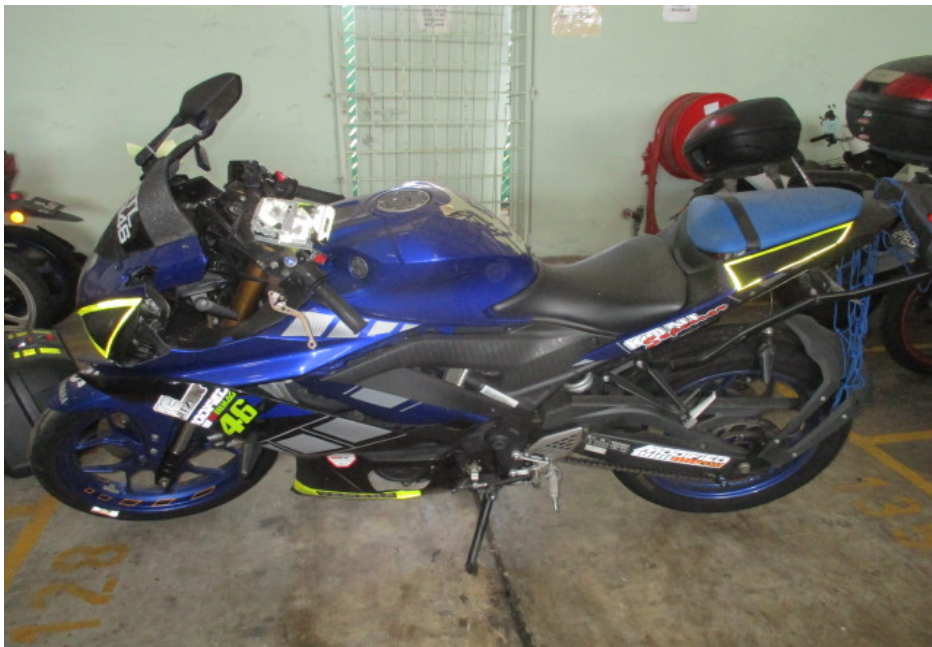
Photo 4 shows a general view of the left body of the Motorcycle at the time of our inspection. The Motorcycle was observed to have sustained damages all around. Amongst the body parts that were found to have been damaged include its speedometer gauge, front cowling, side cowlings, handlebars, handlebar ends, right fog light, right front signal lamp, front brake lever, gear shift pedal, rear brake pedal, right front footrest, right front footrest bracket, right rear side cover, exhaust muffler and top box rack, amongst others.

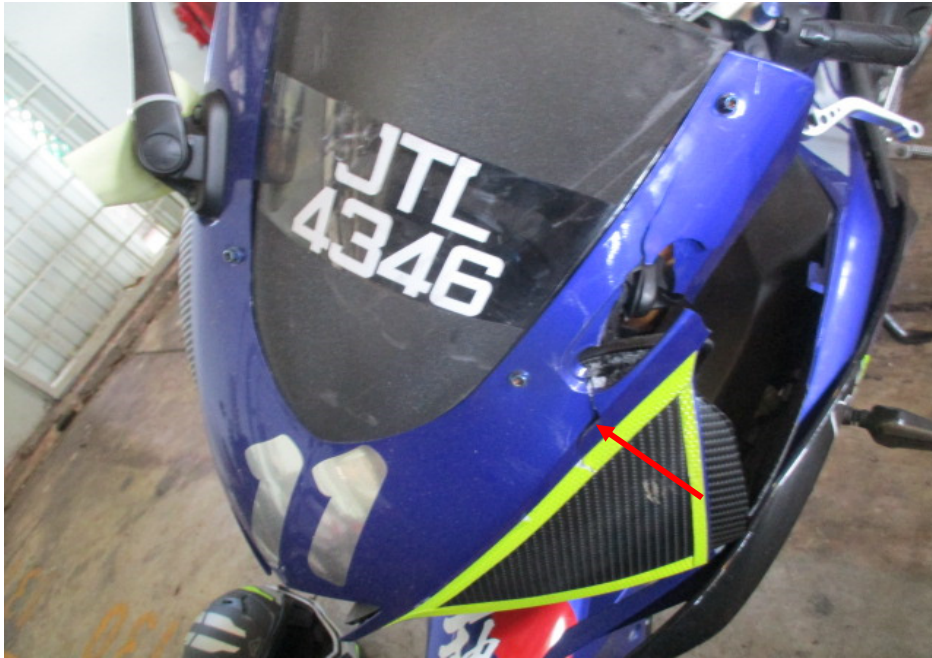
Photo 5 shows a closer view of the cracked front cowling (arrowed) of the Motorcycle as a result of the accident.

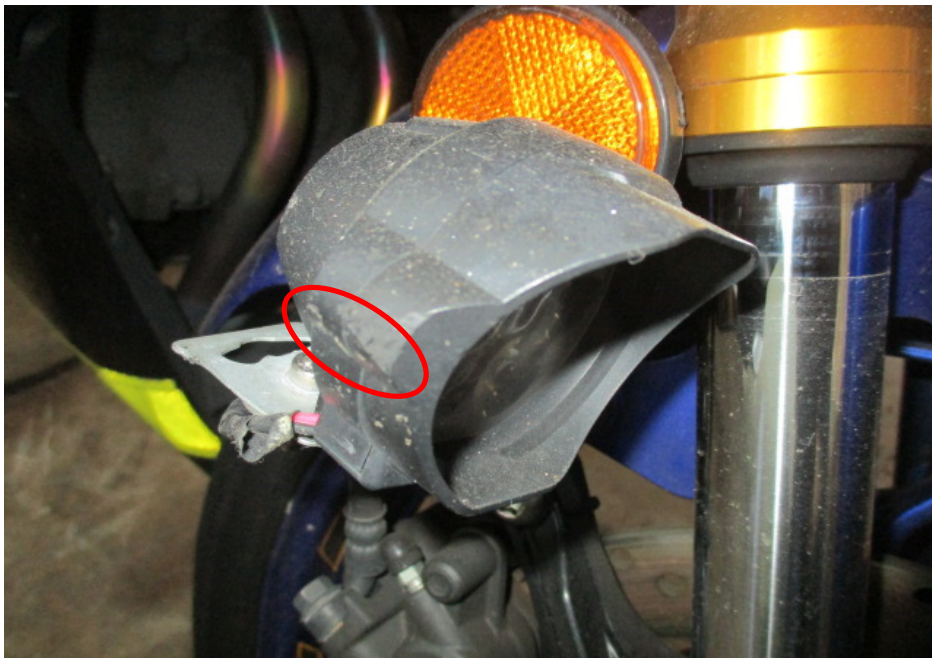
Photo 6 shows a close up view of the damaged right fog light of the Motorcycle as a result of the accident (circled).

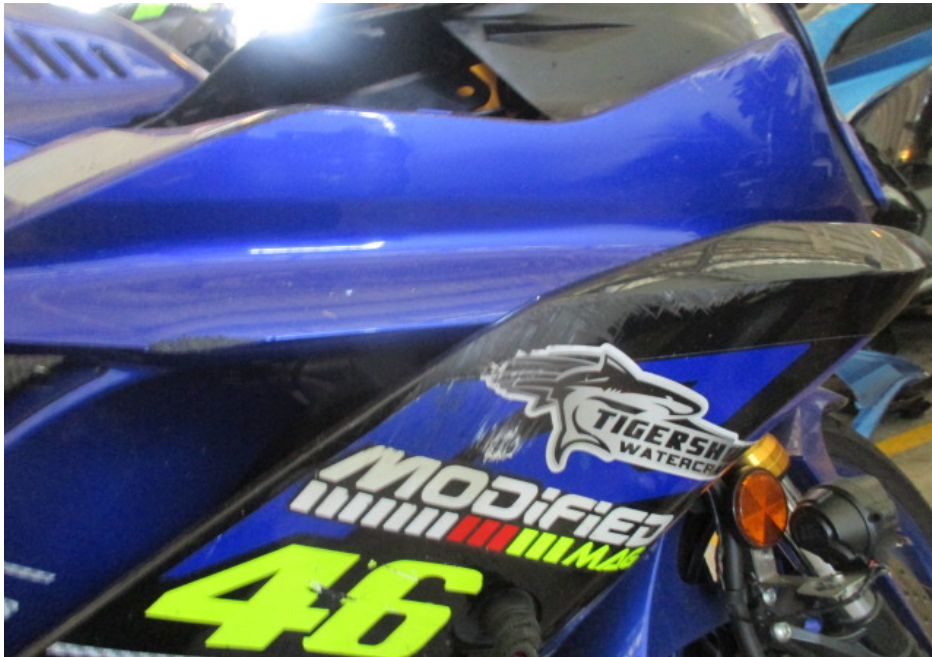
Photo 7 shows a closer view of the damaged right cowling of the Motorcycle as a result of the accident.

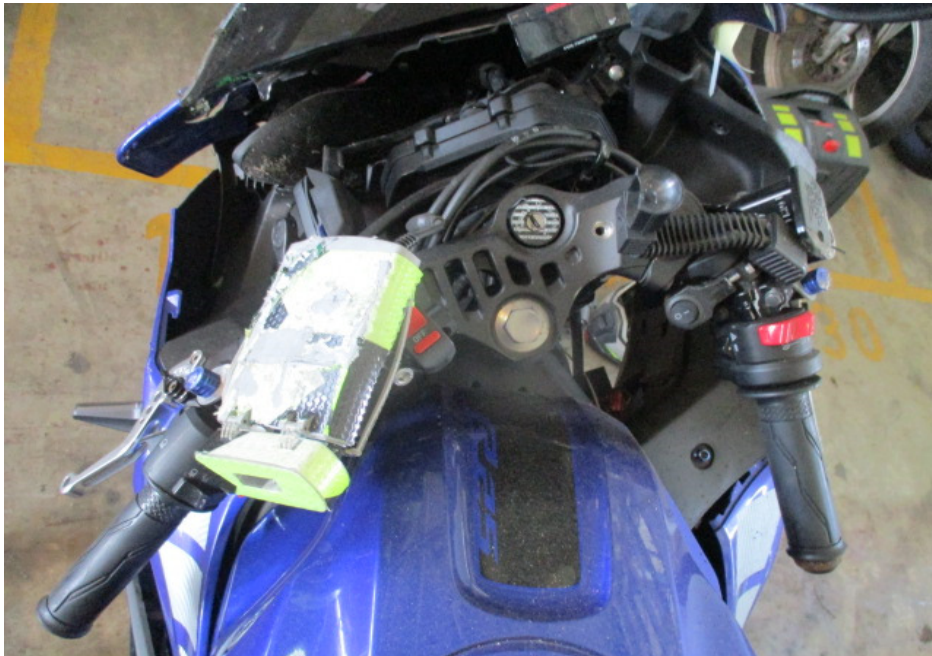
Photo 8 shows a closer view of the deformed handlebars which were amongst the body parts of the Motorcycle that had sustained damage as a result of the accident.

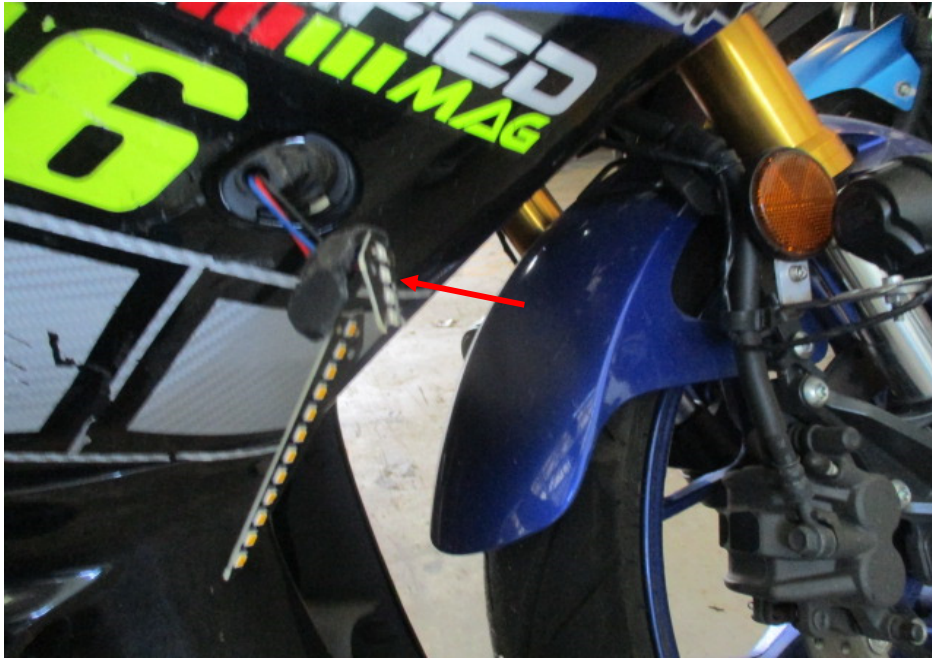
Photo 9 shows a closer view of the broken right front signal lamp of the Motorcycle as a result of the accident (arrowed).

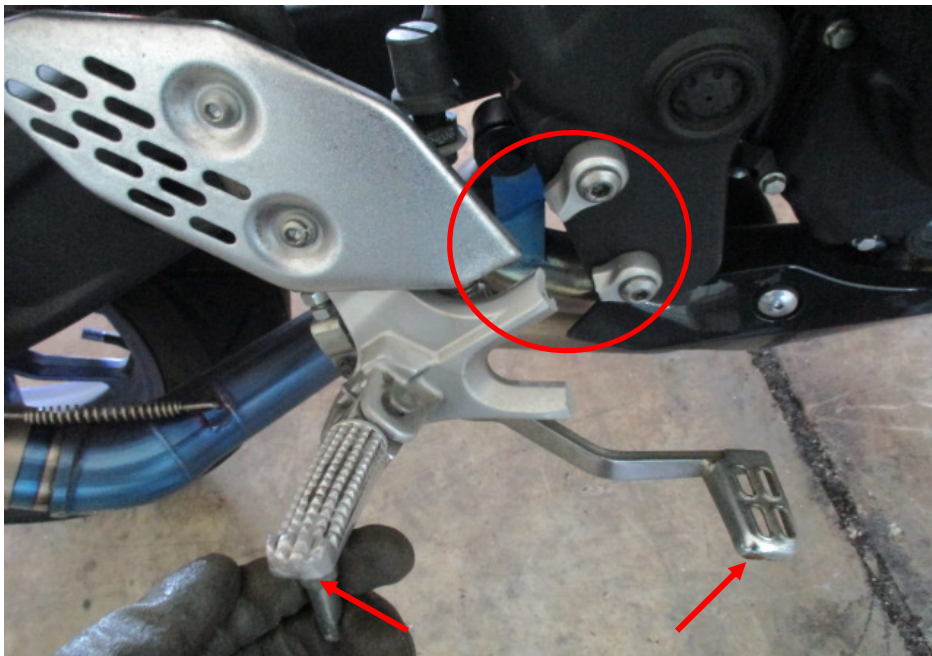
Photo 10 shows a closer view of the rear brake pedal, right front footrest (arrowed) and broken right front footrest bracket (circled) which were amongst the body parts of the Motorcycle that had sustained damage as a result of the accident.

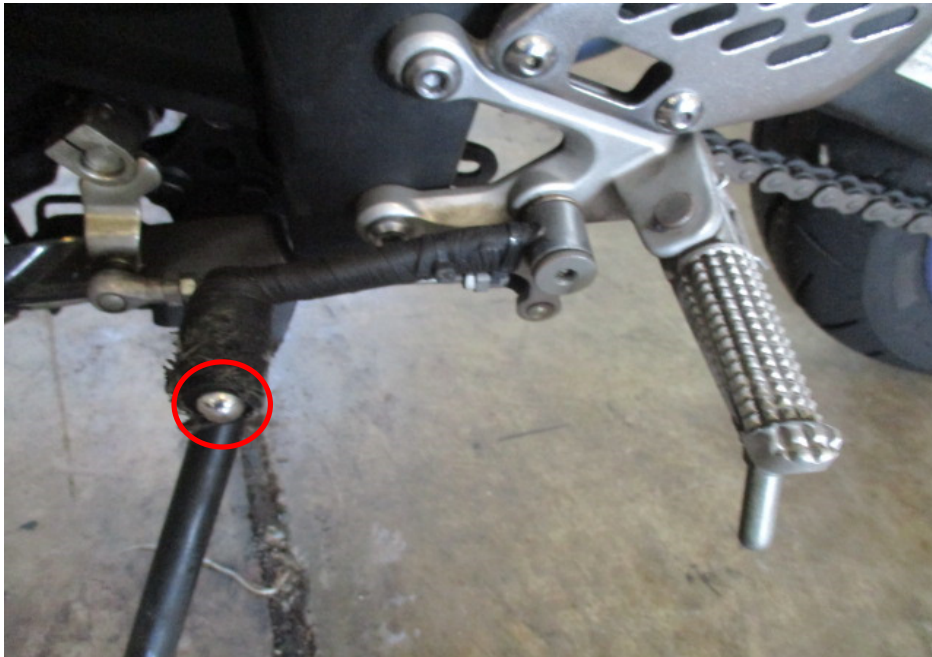
Photo 11 shows a closer view of the gear shift pedal (circled) which was amongst the body parts of the Motorcycle that had sustained damage as a result of the accident.

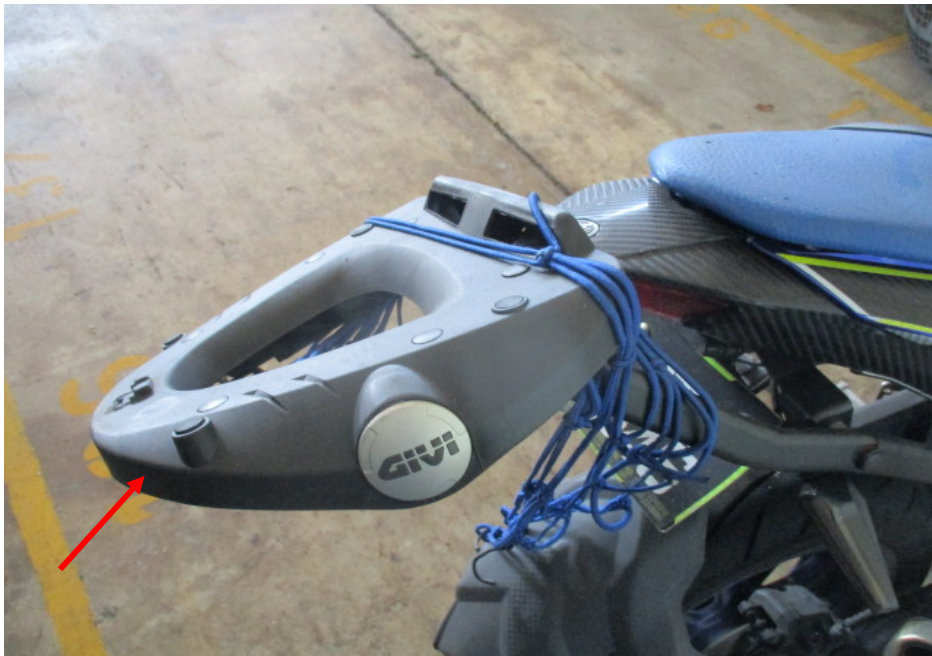
Photo 12 shows the damaged top box rack of the Motorcycle as a result of the accident (arrowed).

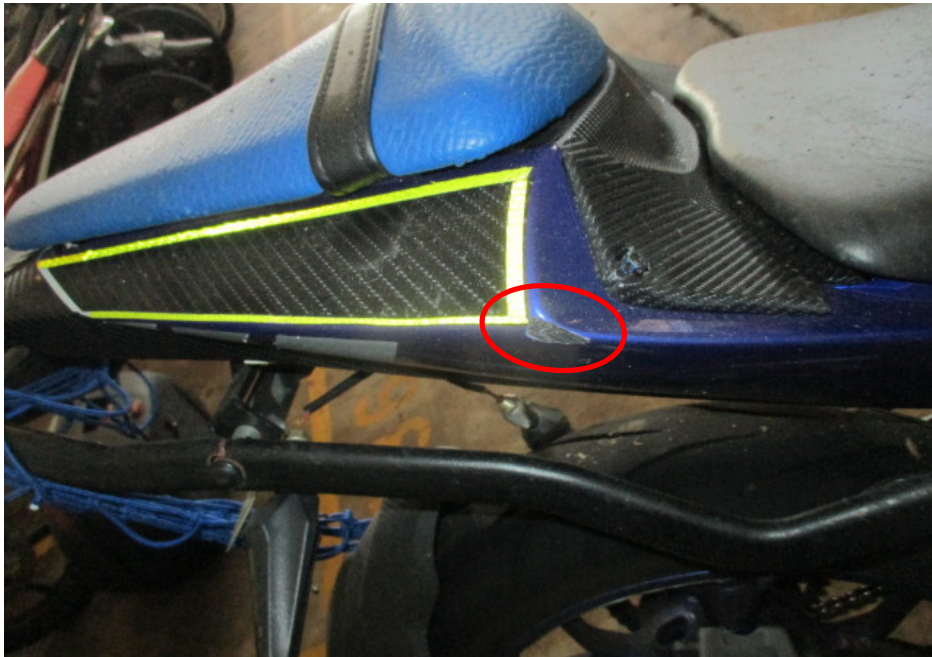
Photo 13 shows a closer view of the right rear side cover of the Motorcycle that had sustained damages of grazing nature as a result of the accident (circled).

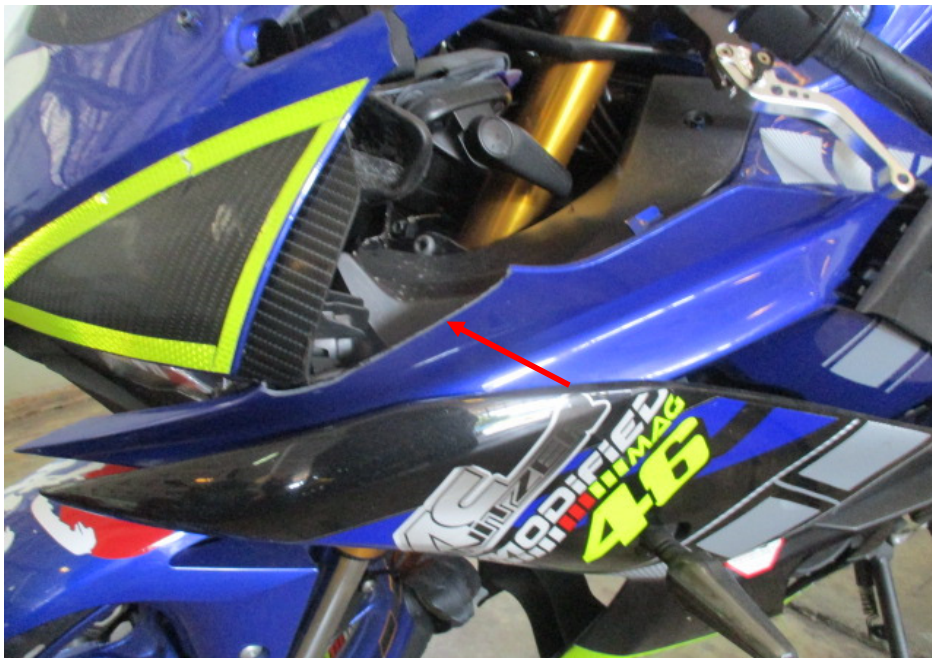
Photo 14 shows a closer view of the cracked left cowling of the Motorcycle as a result of the accident (arrowed).

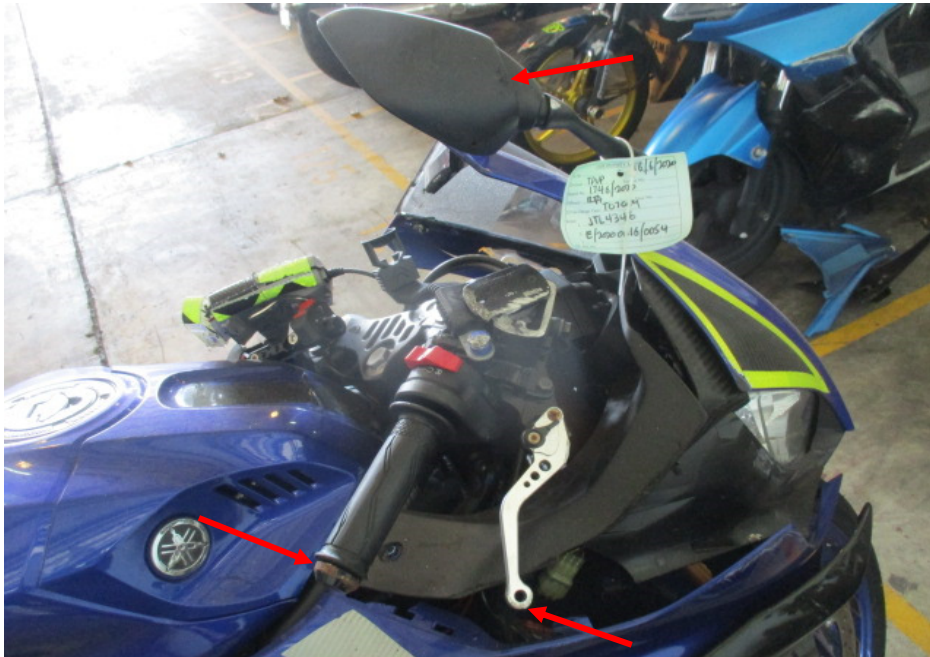
Photo 15 shows a closer view of the right handlebar end, right side mirror and front brake lever which were amongst the body parts of the Motorcycle that had sustained damage as a result of the accident (arrowed).

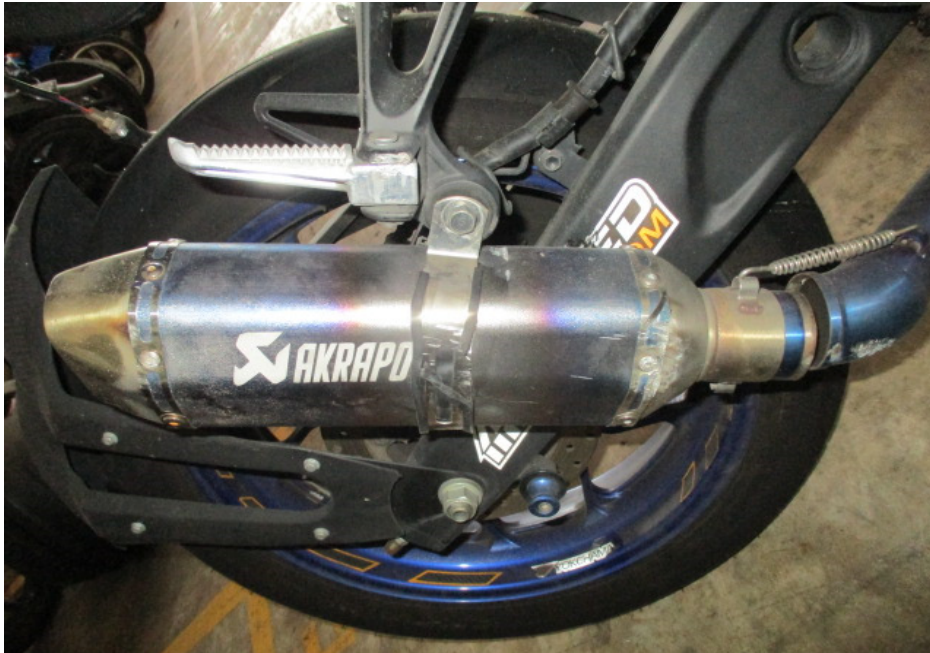
Photo 16 shows a closer view of the exhaust muffler which was amongst the body parts of the Motorcycle that had sustained damage as a result of the accident.

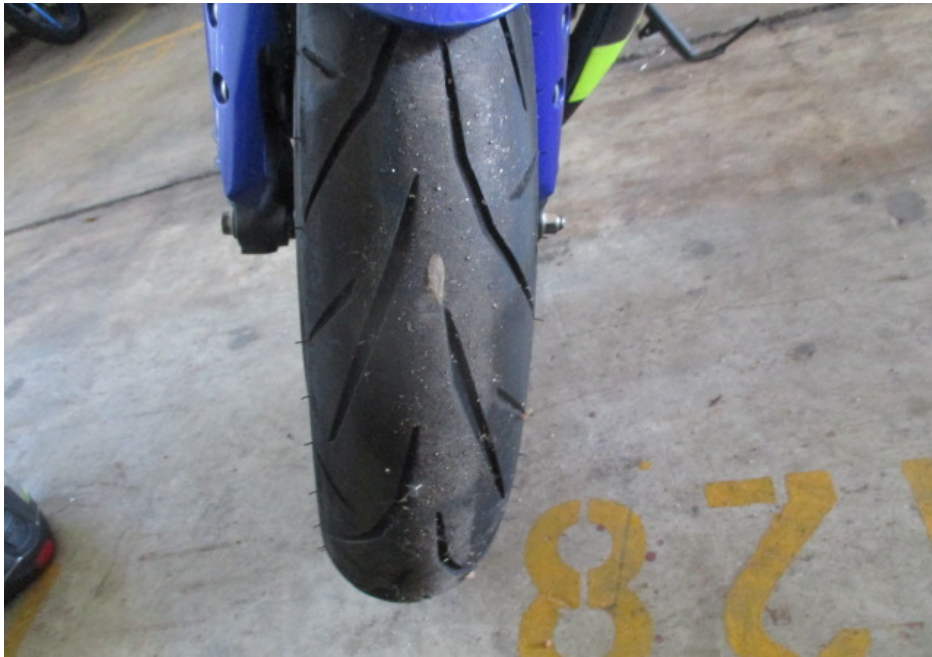
Photo 17 shows the condition of the Motorcycle's front tyre. The front tyre was observed to be in serviceable condition with remaining tread depth of approximately 4mm. There was no tear, burst mark(s) and/or punctured hole(s) on the sidewalls as well as across the tread of the front tyre.

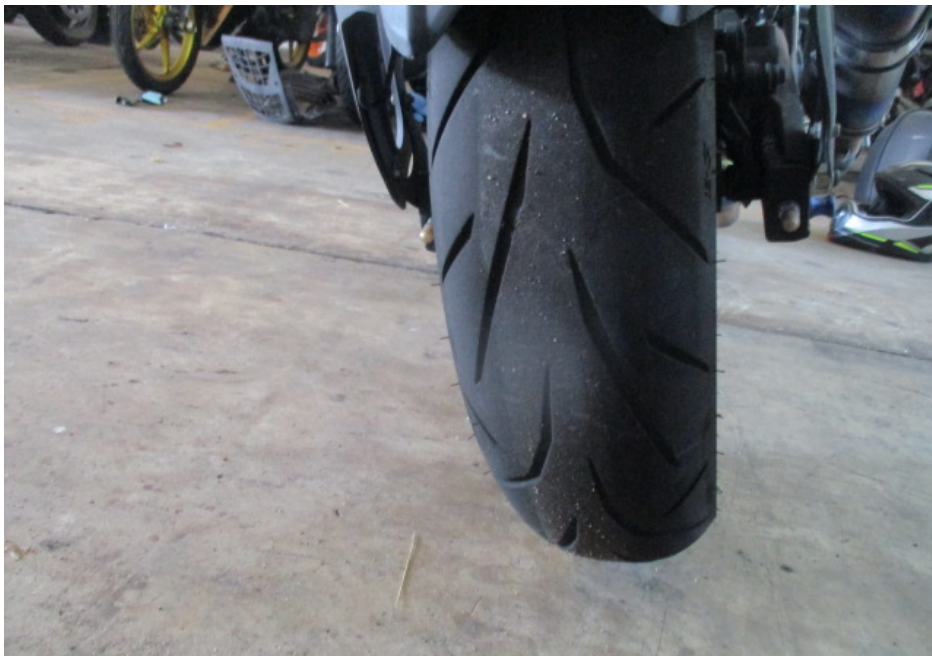
Photo 18 shows the condition of the Motorcycle's rear tyre. The rear tyre was observed to be in serviceable condition with remaining tread depth of approximately 4mm. The tyre was also observed to be sufficiently inflated for vehicular operation. We did not observe any tear, burst mark(s) and/or punctured hole(s) on the sidewalls as well as across the tread of the rear tyre.

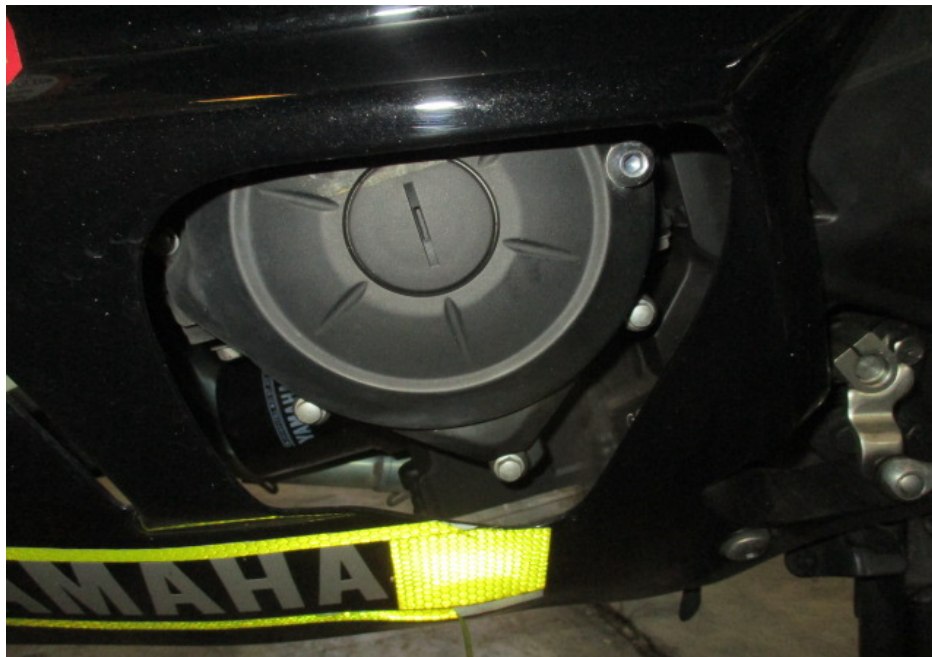
Photo 19 shows the left side of the engine of the Motorcycle at the time of our inspection. The various engine related parts and components were found to be intact with no visible damage. There was also no sign(s) or indication(s) of fluid leak observed around the left engine area of the Motorcycle.

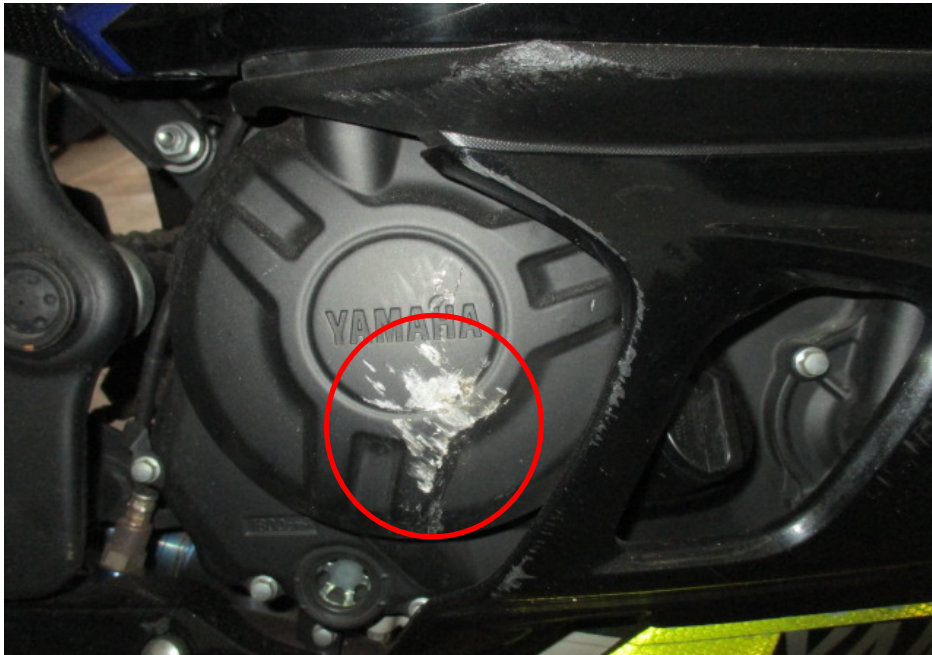
Photo 20 shows the right side of the engine of the Motorcycle at the time of our inspection. The various right engine components had sustained damage of grazing nature as a result of the accident (circled) however the engine components were still intact. There was also no fluid leak and/or fluid stain found around the right engine area of the Motorcycle.

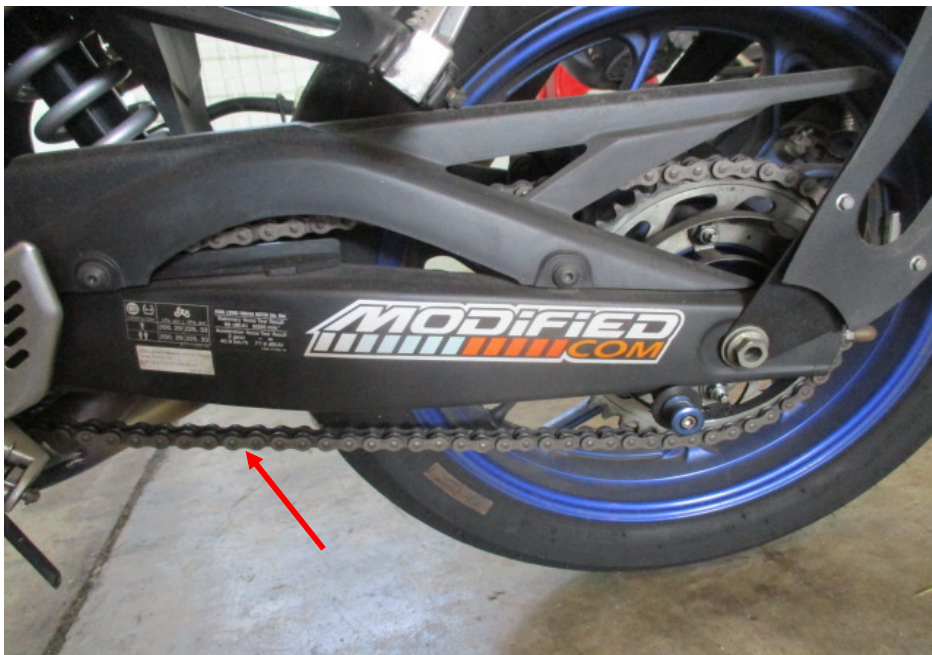
Photo 21 shows the general view of the gear train (arrowed) of the Motorcycle, which was observed to be intact with no misalignment. It was also adequately lubricated for operating purposes.

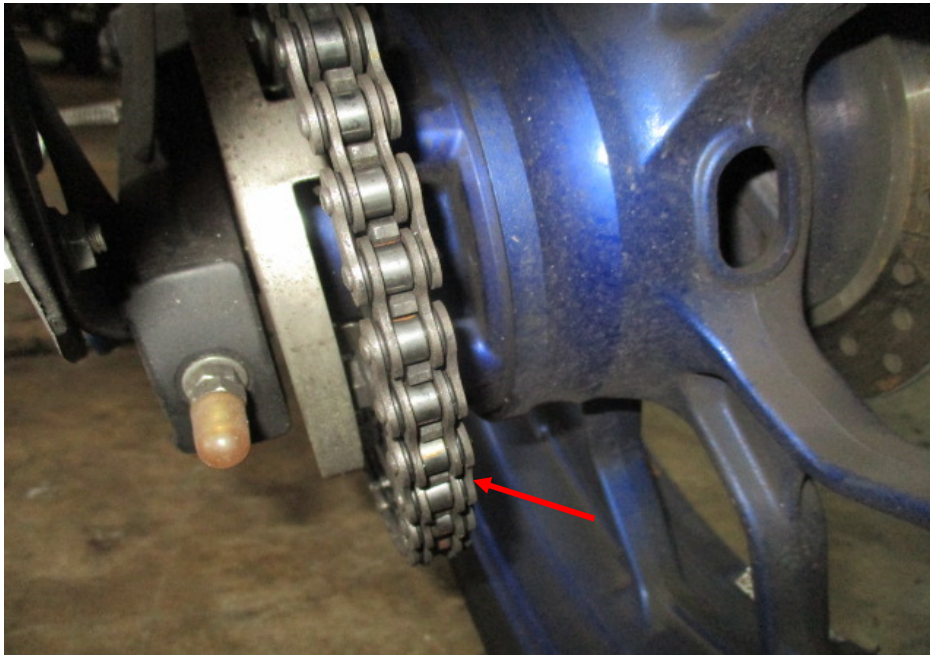
Photo 22 shows a closer view of the gear train (arrowed) of the Motorcycle, which was observed to be intact with no misalignment. It was also adequately lubricated for operating purposes.

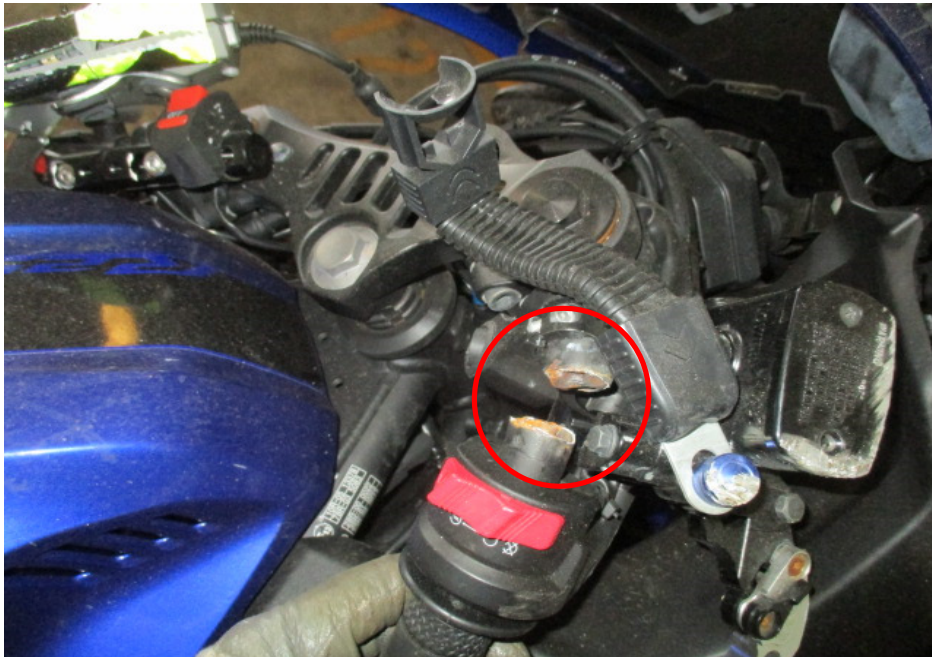
11. For this case, we were not able to conduct any test(s) on the steering system of the Motorcycle due to the damage to its handlebars. The right handlebar was observed to be broken as a result of the accident.

Photo 23 shows the right handlebar of the Motorcycle which was observed to be broken as a result of the accident (circled). We were hence not able to conduct any tests on the steering system of the Motorcycle.

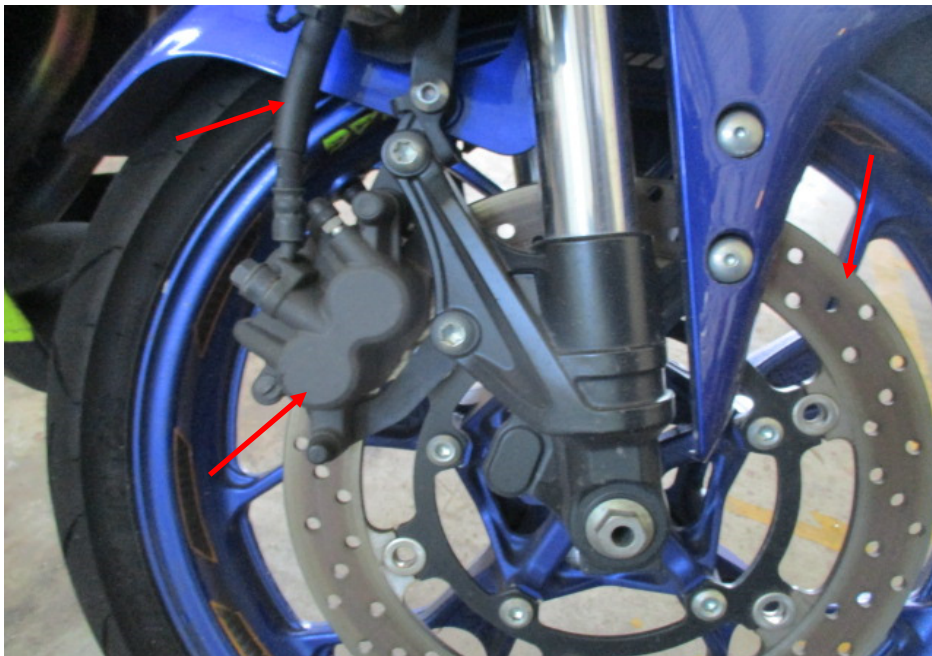
Photo 24 shows a close up view of the front brake caliper, front brake disc and front brake hose (arrowed) of the Motorcycle, which are all part of the components in the hydraulic front brake system of the Motorcycle. Our visual checks of these various components had revealed all to be intact with no visible damage. No leakage of brake fluid was also observed.

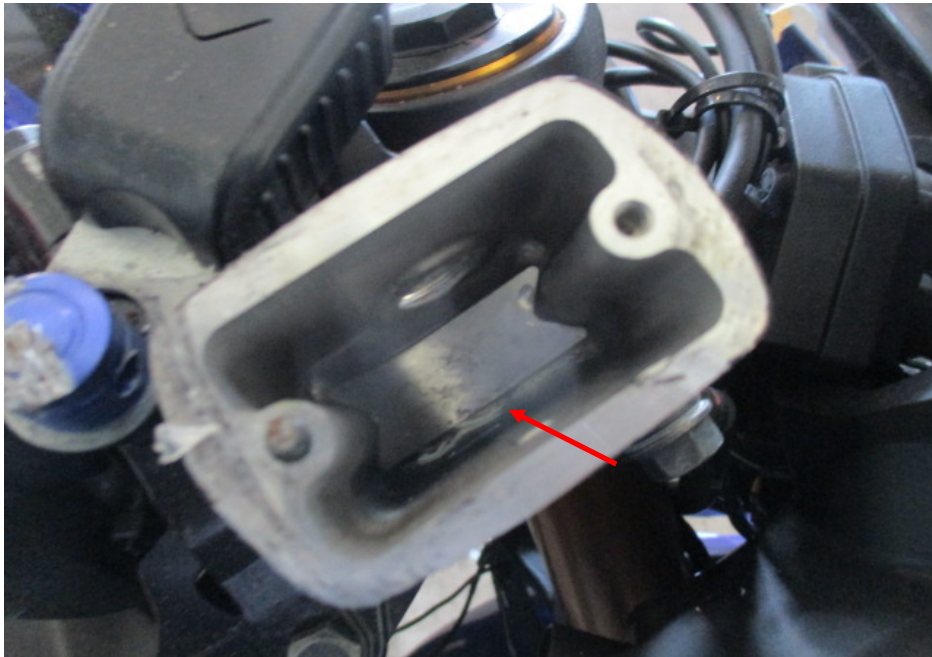
14. The brake fluid for the rear brake was also found to be of sufficient level for operating purposes and without any contamination. However the front brake reservoir was found to empty. Upon closer examination, we observed a crack in the front brake reservoir as a result of the accident.

Photo 25 shows the brake fluid reservoir for the front brake of the Motorcycle. The brake fluid reservoir was observed to be empty (arrowed).

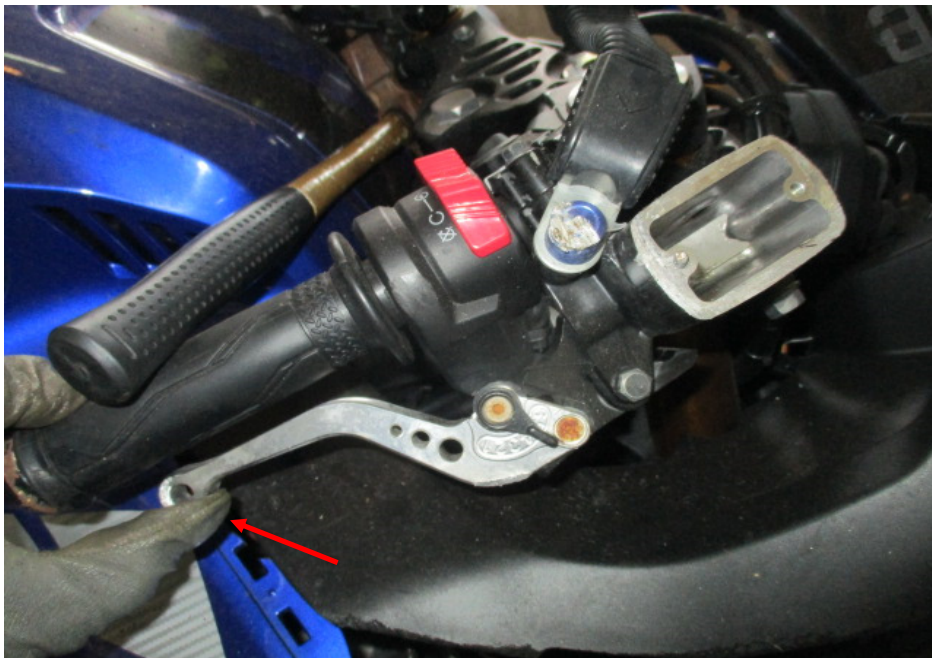
15. Static brake tests conducted on the Motorcycle had appear to indicate that the front braking system of the Motorcycle was not in serviceable condition. There was no resistance felt (spongy like feel) upon pressing the brake lever. This would indicate that there may be a leakage of pressure/vacuum in the front brake system.

Photo 26 shows the front brake lever being depressed. There was no resistance felt (spongy like feel) upon pressing the front brake lever (arrowed). This would indicate that there may be a leakage of pressure/vacuum in the front brake system.

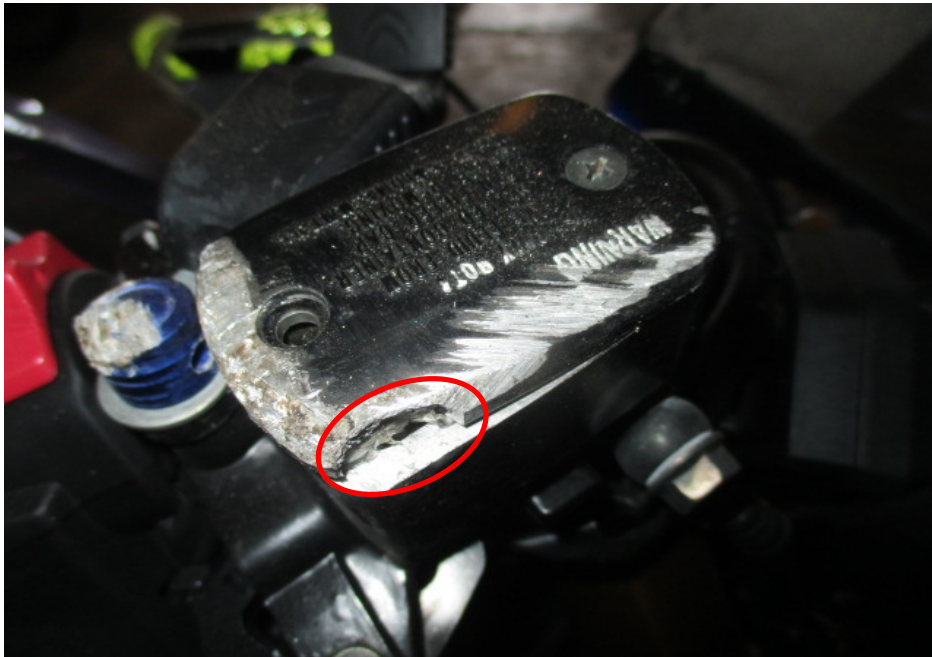
Photo 27 shows upon closer examination of the front brake reservoir, we observed a crack in the front brake reservoir as a result of the accident (circled).

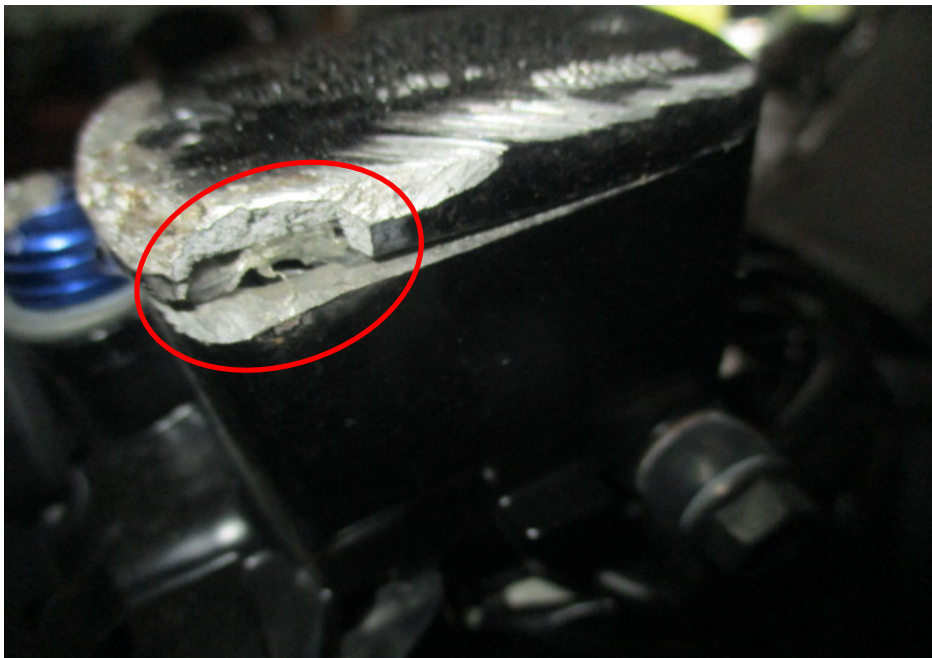
Photo 28 shows a close up view of the crack in the front brake reservoir as a result of the accident (circled).

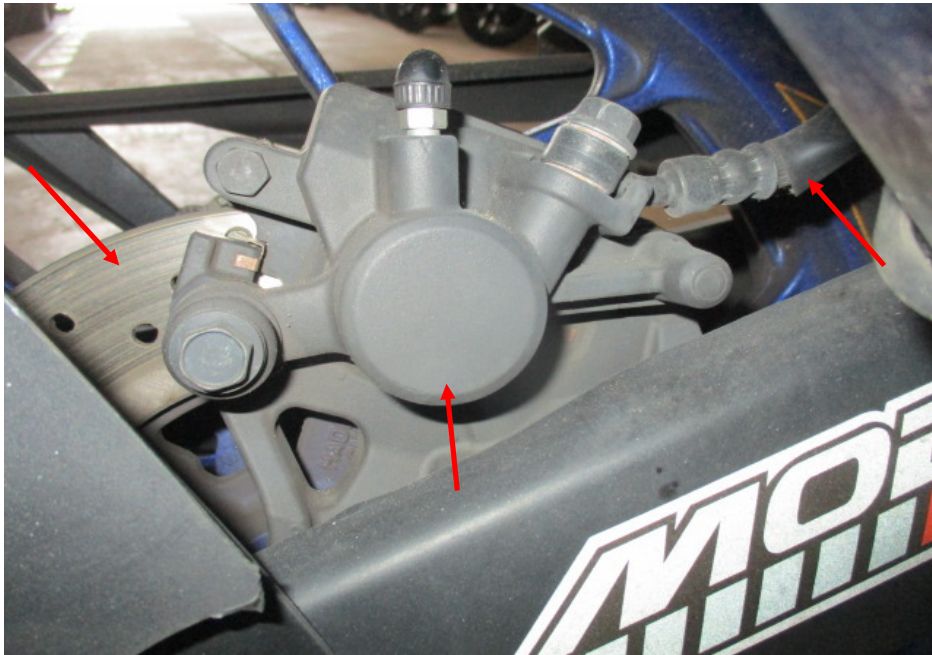
Photo 29 shows a close up view of the rear brake caliper, rear brake disc and rear brake hose (arrowed) of the Motorcycle, which are all part of the components in the hydraulic rear brake system of the Motorcycle. Our visual checks of these various components had revealed all to be intact with no visible damage. No leakage of brake fluid was also observed.

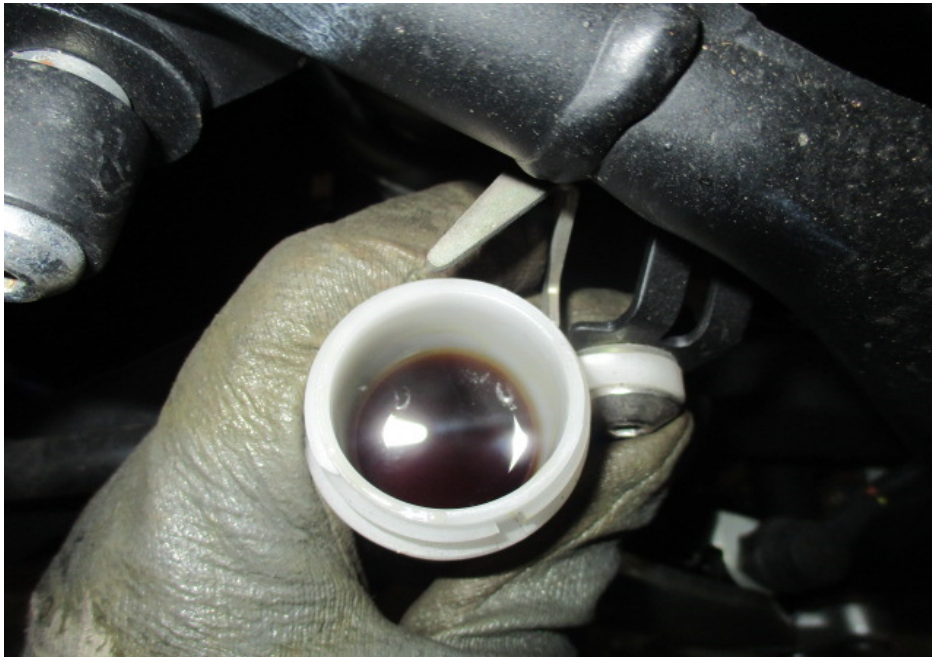
Photo 30 shows the brake fluid reservoir for the rear brake of the Motorcycle. The brake fluid was observed to be of sufficient level and without contamination for operational purposes.
