Your Ref: TP/IP/35857/2020  
Our Ref : CI/TPD20012516/N

**Fatal Accident Investigation Team**

**MECHANICAL INSPECTION REPORT OF MOTORCYCLE SAC 7099D**

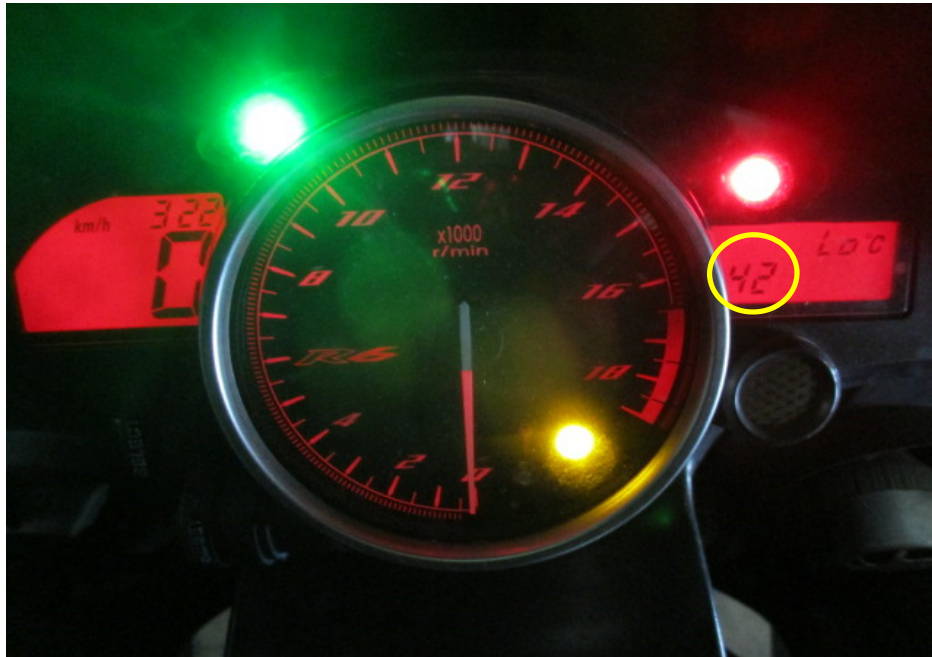
4. The mileage of the Motorcycle could not be recorded at the time of our inspection due to an error code displayed on the speedometer gauge as a result of the accident.
5. The Motorcycle had sustained damages significantly at its frontal portion and left body. Body parts that were found to have been damaged include its windshield, head cowling, front mudguard, handlebars, clutch lever, left handlebar end, petrol tank, left cowling, left front footrest, left pillion foot peg, left swingarm spool, left rear axle slider, rear seat and tail light assembly, amongst others.

**Photo 1** shows a closer view of the speedometer gauge of the Motorcycle. The mileage of the Motorcycle could not be recorded at the time of our inspection due to an error code displayed on the speedometer gauge as a result of the accident (circled).

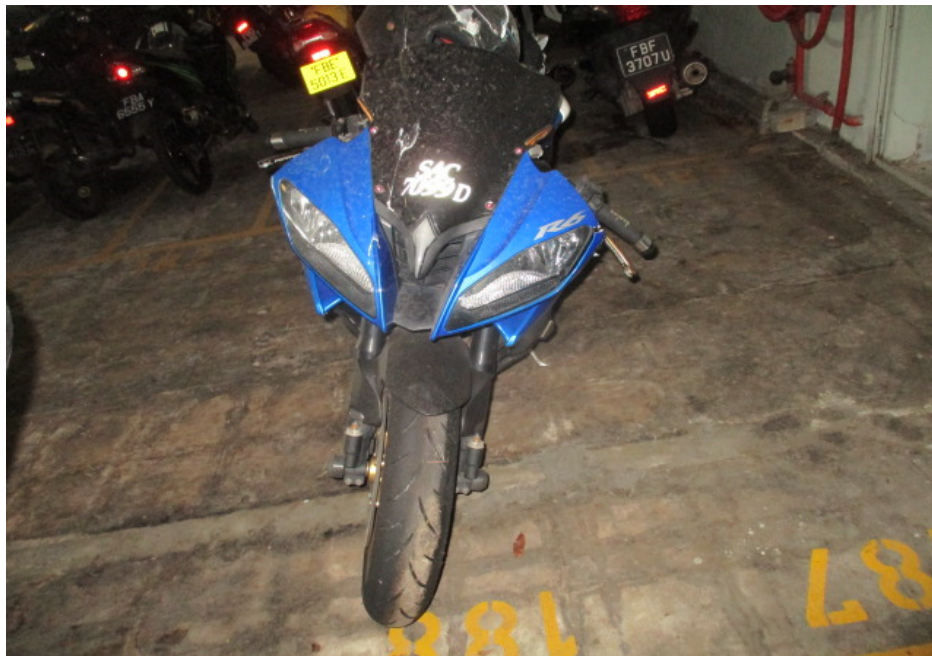
**Photo 2** shows a general view of the frontal portion of the Motorcycle at the time of our inspection. The Motorcycle was observed to have sustained damages at its frontal portion and left body.

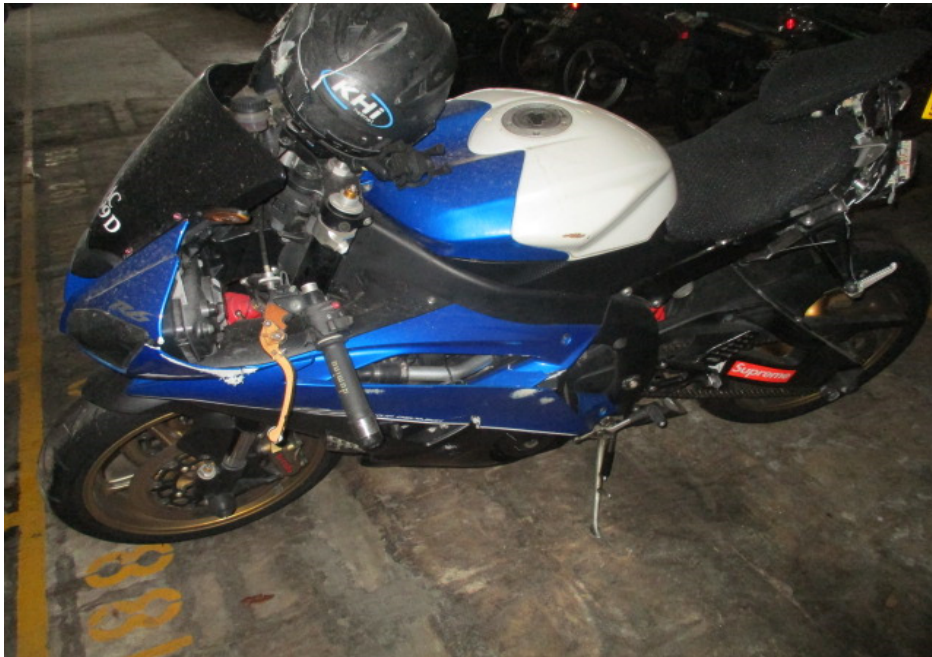
**Photo 3** shows a general view of the left body of the Motorcycle at the time of our inspection. The Motorcycle was observed to have sustained damages at its frontal portion and left body. The body parts that were found to have been damaged include its windshield, head cowling, front mudguard, handlebars, clutch lever, left handlebar end, petrol tank, left cowling, left front footrest, left pillion foot peg, left swingarm spool, left rear axle slider, rear seat and tail light assembly, amongst others.

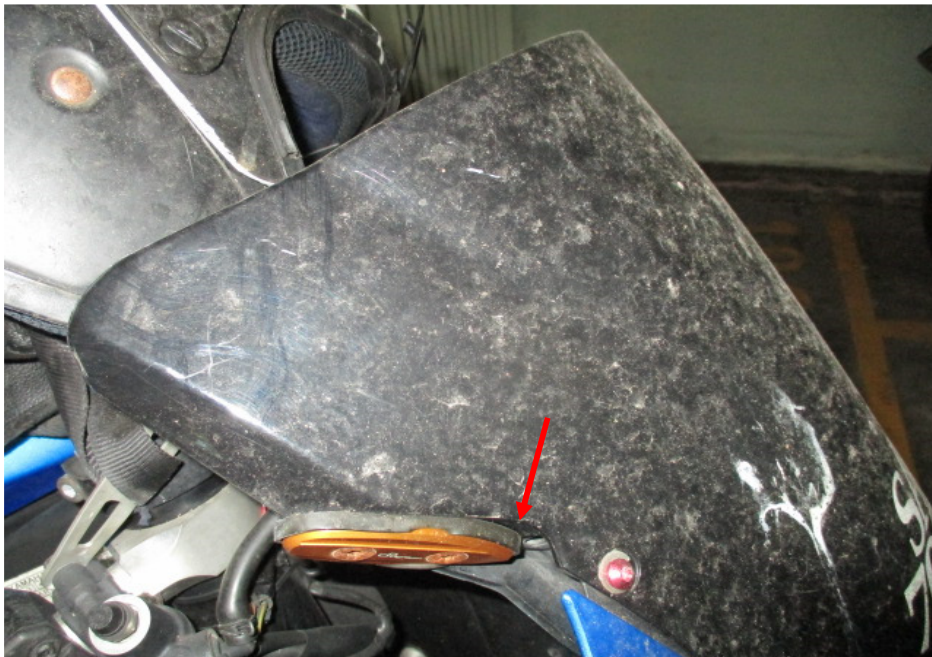
**Photo 4** shows a closer view of the cracked windshield (arrowed) of the Motorcycle as a result of the accident.

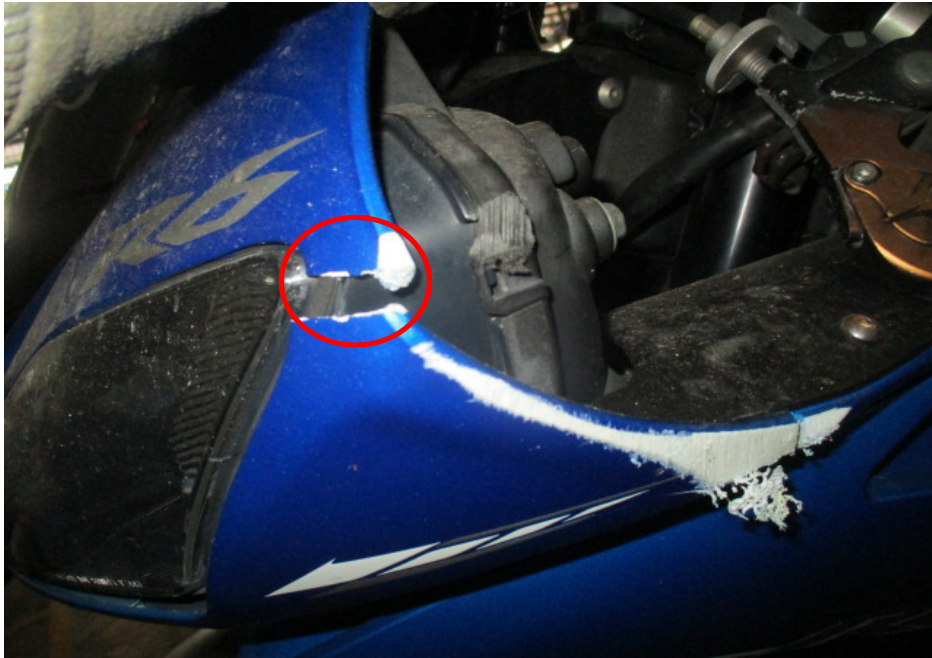
**Photo 5** shows a closer view of the cracked head cowl of the Motorcycle as a result of the accident (circled).

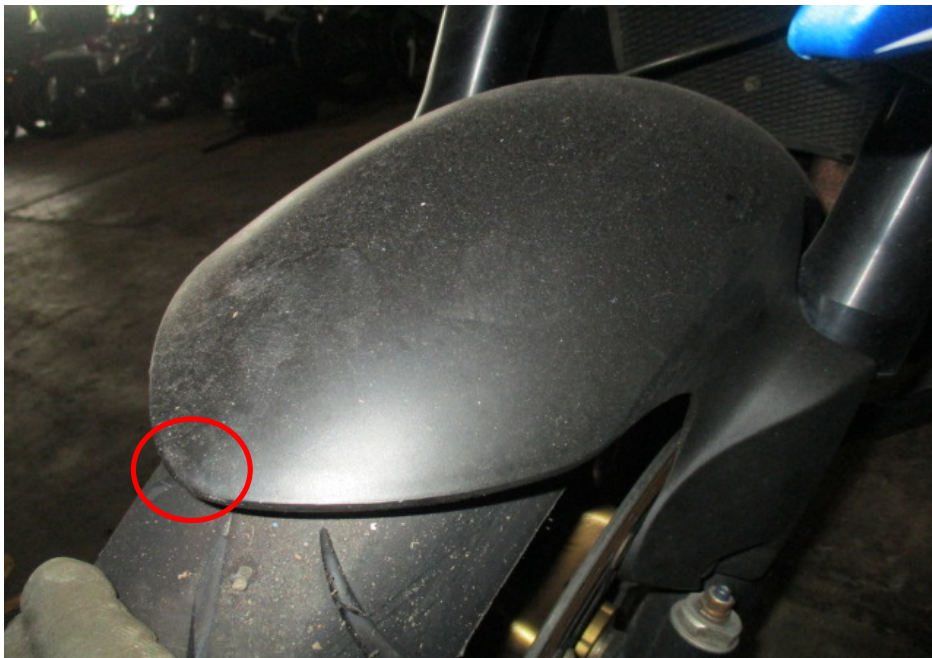
**Photo 6** shows a closer view of the front mudguard, which was amongst the body parts of the Motorcycle that had sustained damage as a result of the accident (circled).

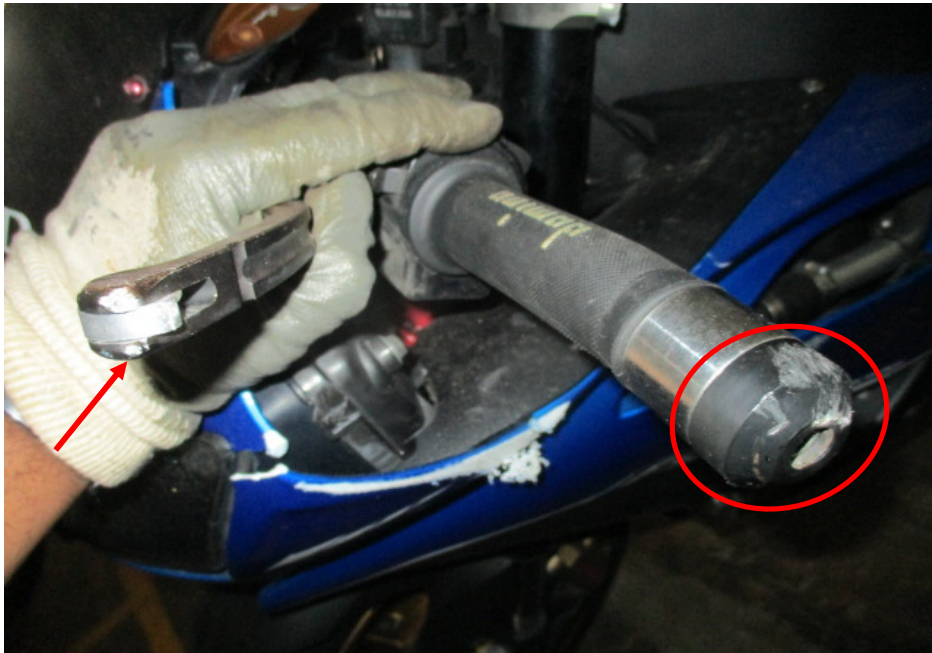
**Photo 7** shows a closer view of the clutch lever (arrowed) and left handlebar end (circled) which were amongst the body parts at the front body of the Motorcycle that had sustained damage as a result of the accident.

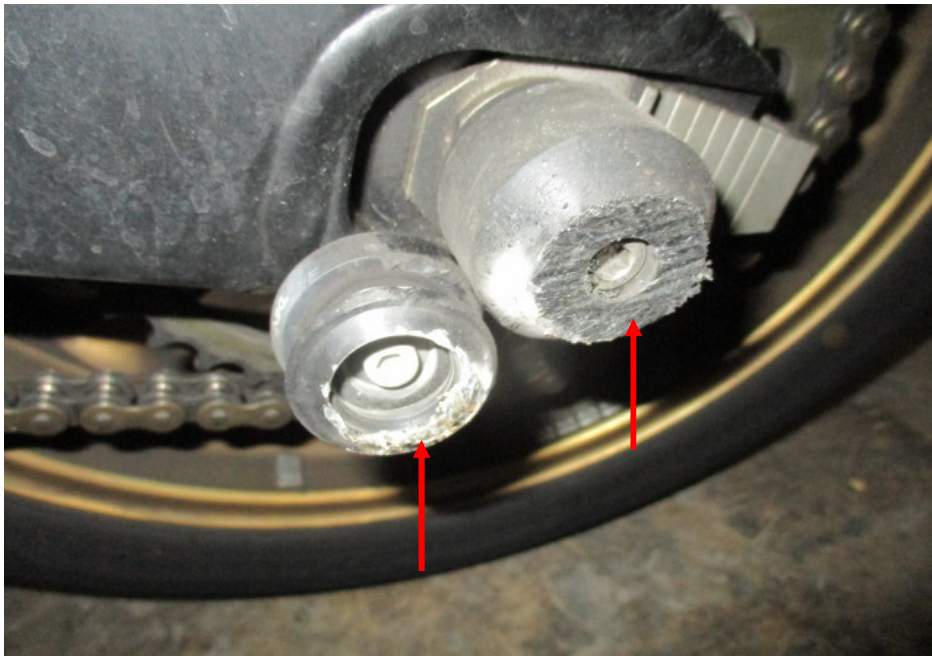
**Photo 8** shows the left swingarm spool and left rear axle slider which were amongst the body parts at the rear of the Motorcycle that had sustained damages of grazing nature as a result of the accident (arrowed).

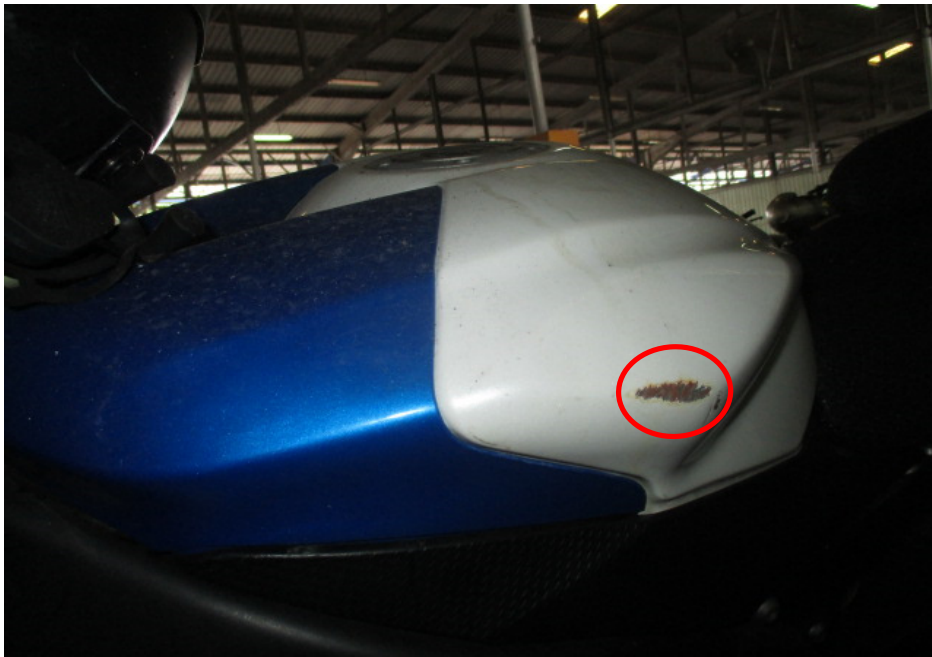
**Photo 9** shows a closer view of the petrol tank, which was amongst the body parts of the Motorcycle that had sustained damage as a result of the accident (circled).

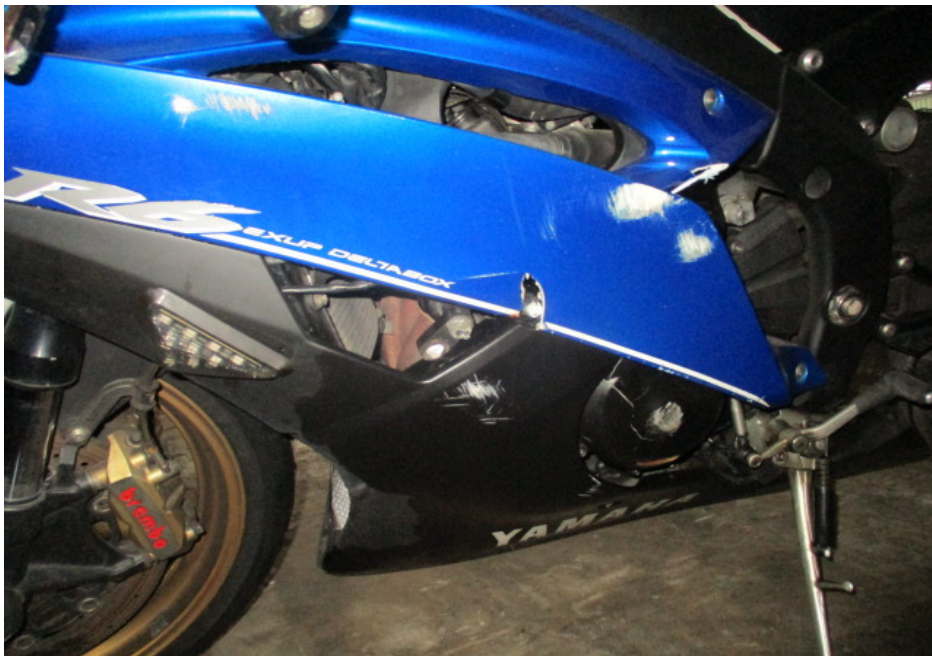
**Photo 10** shows a closer view of the left cowling which was amongst the body parts of the Motorcycle that had sustained damage as a result of the accident.

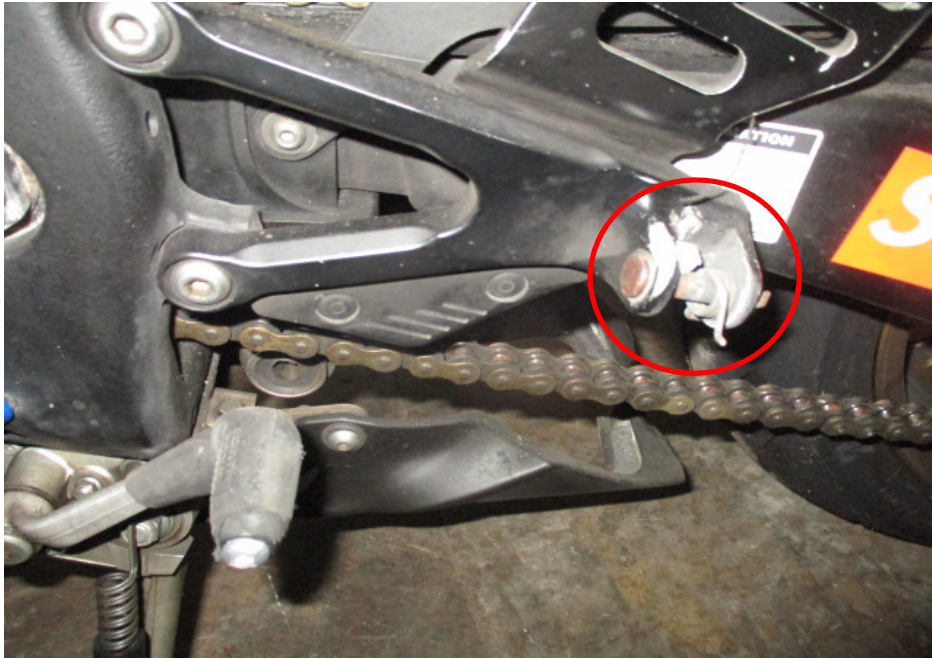
**Photo 11** shows a closer view of the broken left front footrest (circled) which was amongst the body parts of the Motorcycle that had sustained damage as a result of the accident.

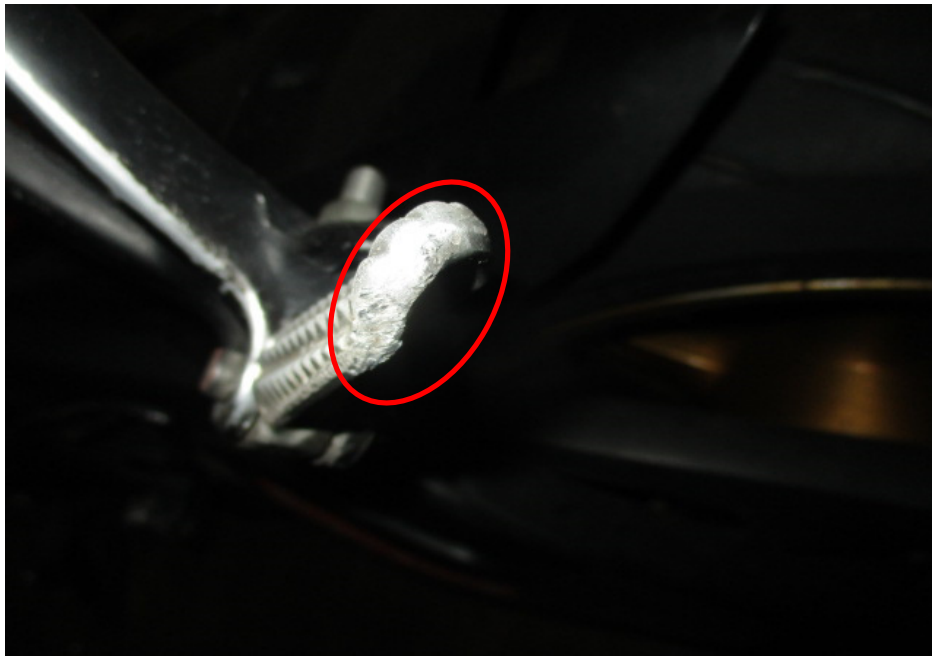
**Photo 12** shows a closer view of the left pillion foot peg (circled) which was amongst the body parts of the Motorcycle that had sustained damages of grazing nature as a result of the accident.

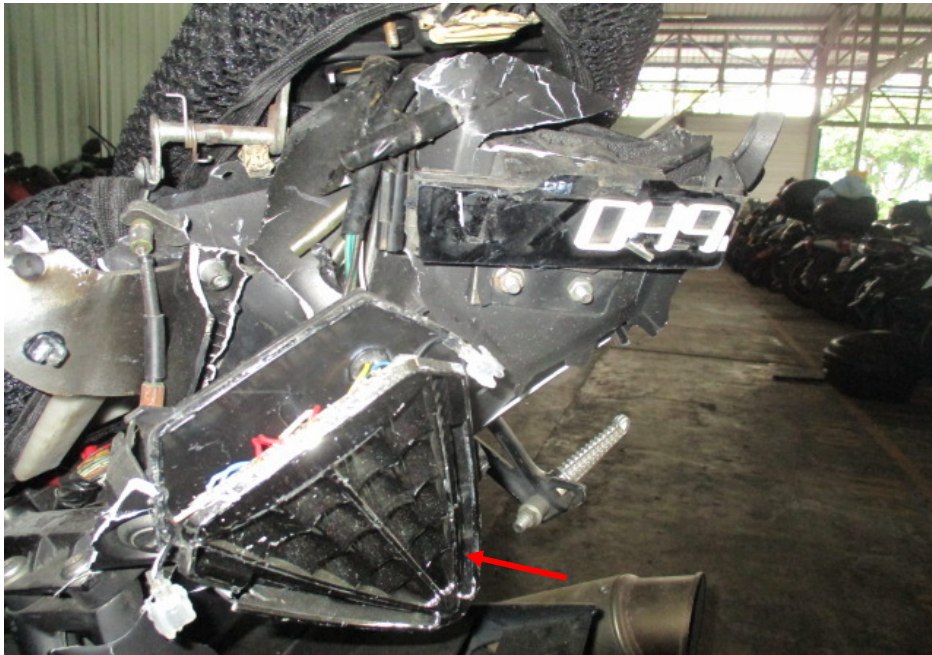
**Photo 13** shows the broken tail light assembly of the Motorcycle as a result of the accident (arrowed).

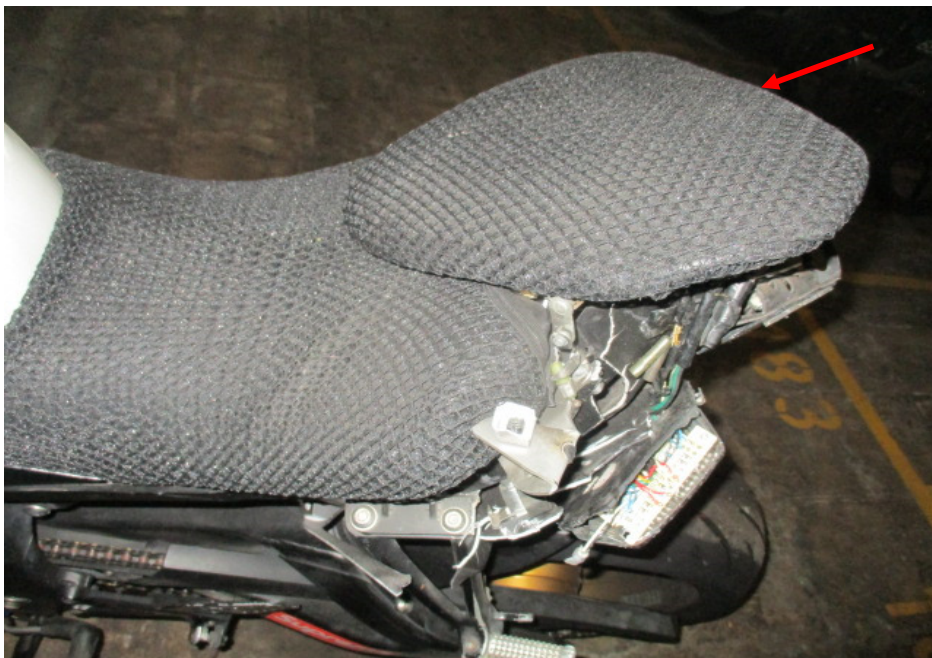
**Photo 14** shows the dislodged rear seat of the Motorcycle of the Motorcycle as a result of the accident (arrowed).

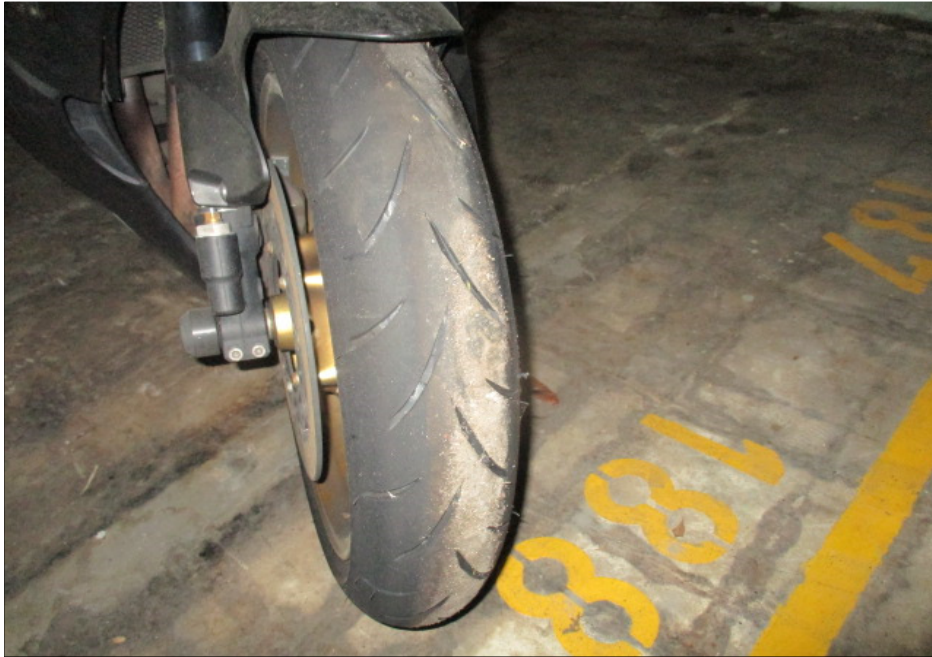
**Photo 15** shows the condition of the Motorcycle's front tyre. The front tyre was observed to be in serviceable condition with remaining tread depth of approximately 3mm. The tyre was also observed to be sufficiently inflated for vehicular operation. We did not observe any tear, burst mark(s) and/or punctured hole(s) on the sidewalls as well as across the tread of the front tyre.

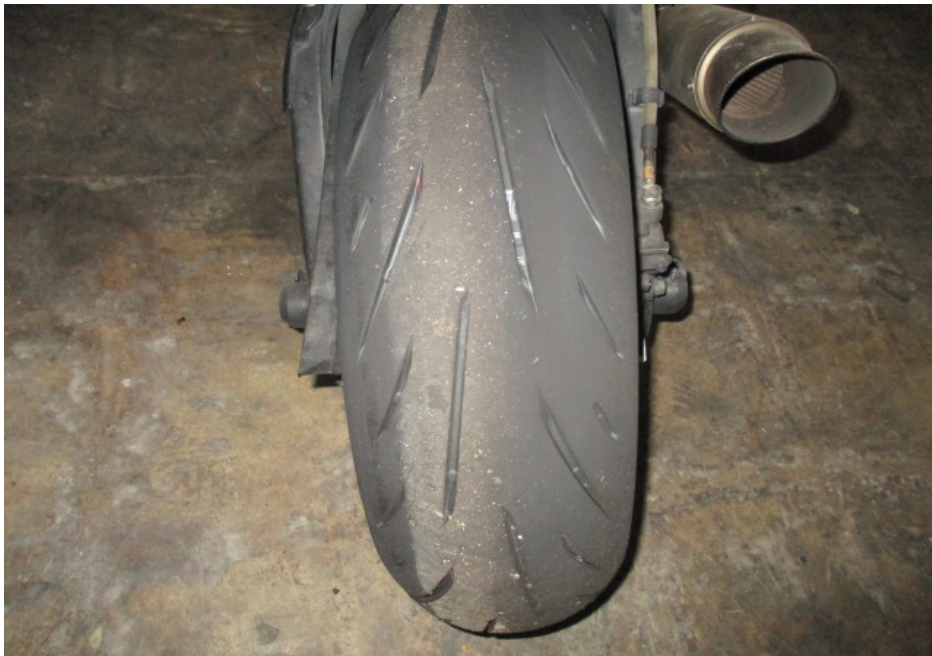
**Photo 16** shows the condition of the Motorcycle's rear tyre. The rear tyre was observed to be in serviceable condition with remaining tread depth of approximately 3mm. The tyre was also observed to be sufficiently inflated for vehicular operation. We did not observe any tear, burst mark(s) and/or punctured hole(s) on the sidewalls as well as across the tread of the rear tyre.

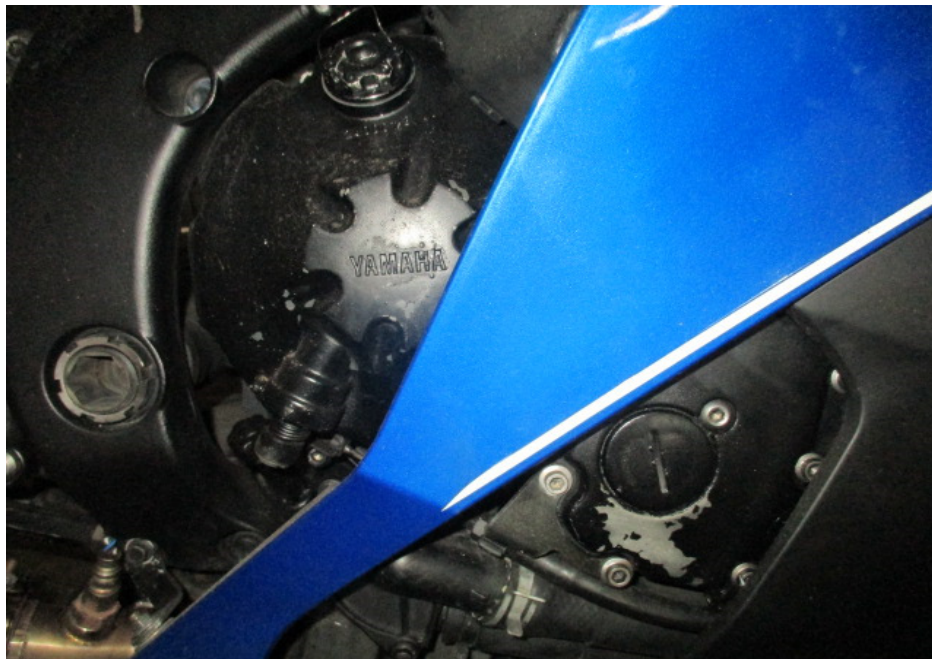
**Photo 17** shows the right side of the engine of the Motorcycle at the time of our inspection. The various engine related parts and components were found to be intact with no visible damage. There was also no sign(s) or indication(s) of fluid leak observed around the right engine area of the Motorcycle.

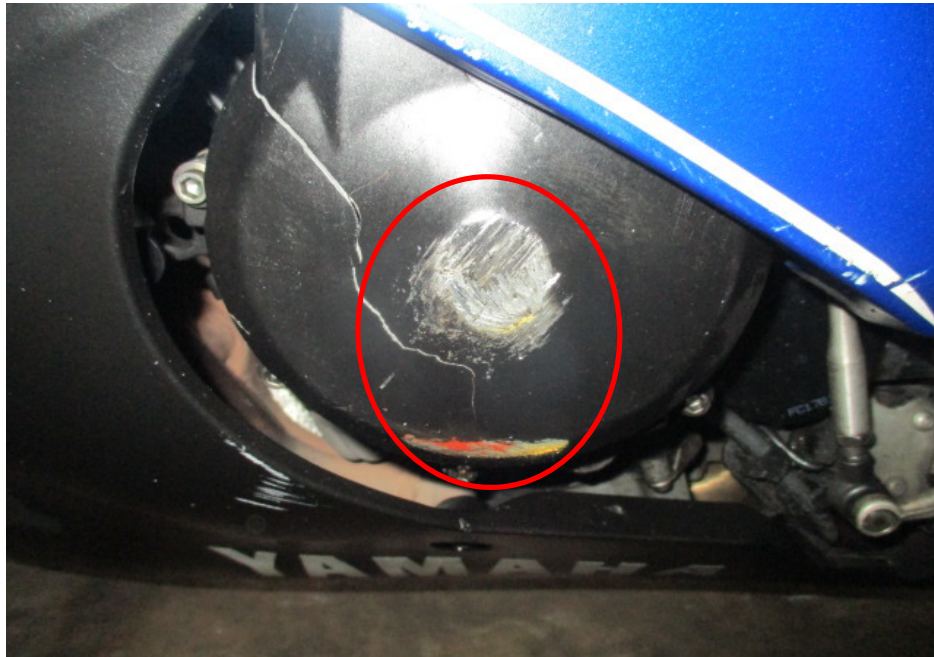
**Photo 18** shows the left side of the engine of the Motorcycle at the time of our inspection. The various left engine components had sustained damage of grazing nature as a result of the accident (circled) however the engine components were still intact. There was also no fluid leak and/or fluid stain found around the left engine area of the Motorcycle.

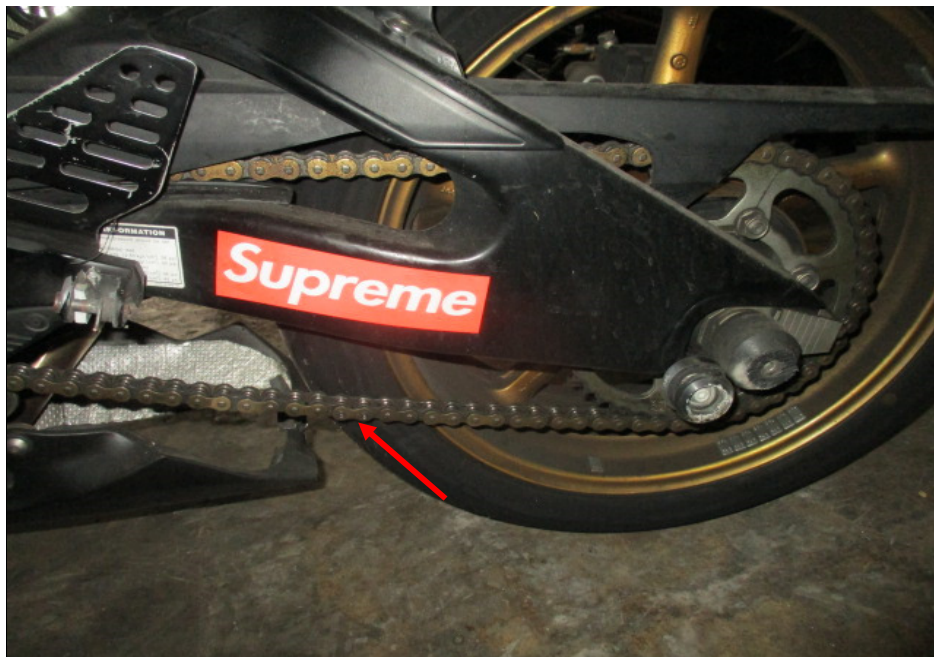
**Photo 19** shows the gear chain (arrowed) of the Motorcycle, which was observed to be intact with no misalignment. It was also adequately lubricated for operating purposes. The gear chain rotates the rear wheel of the Motorcycle.

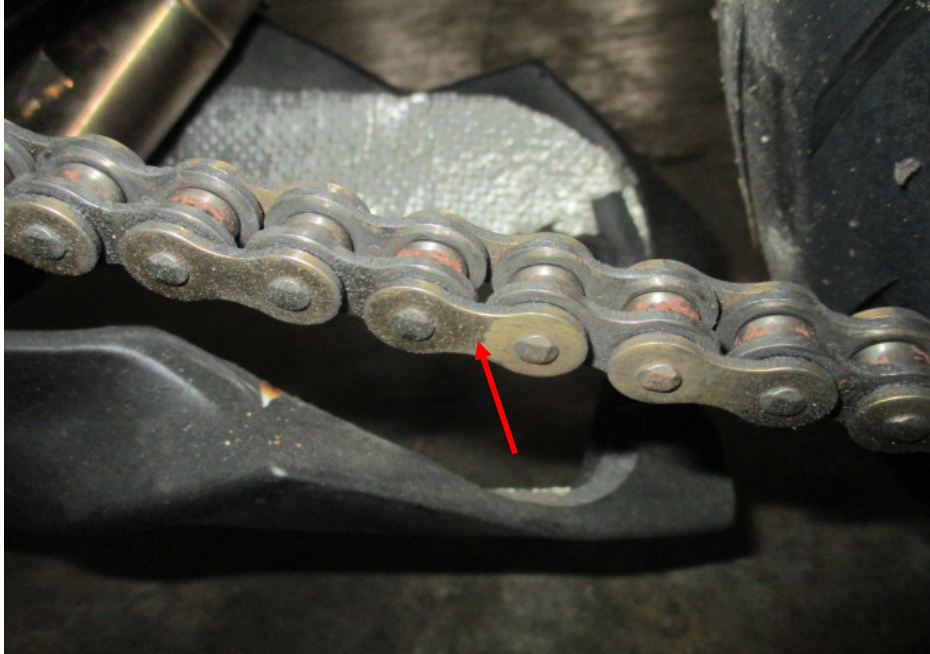
**Photo 20** shows the closer view of the gear chain (arrowed) of the Motorcycle, which was observed to be intact with no misalignment. It was also adequately lubricated for operating purposes.

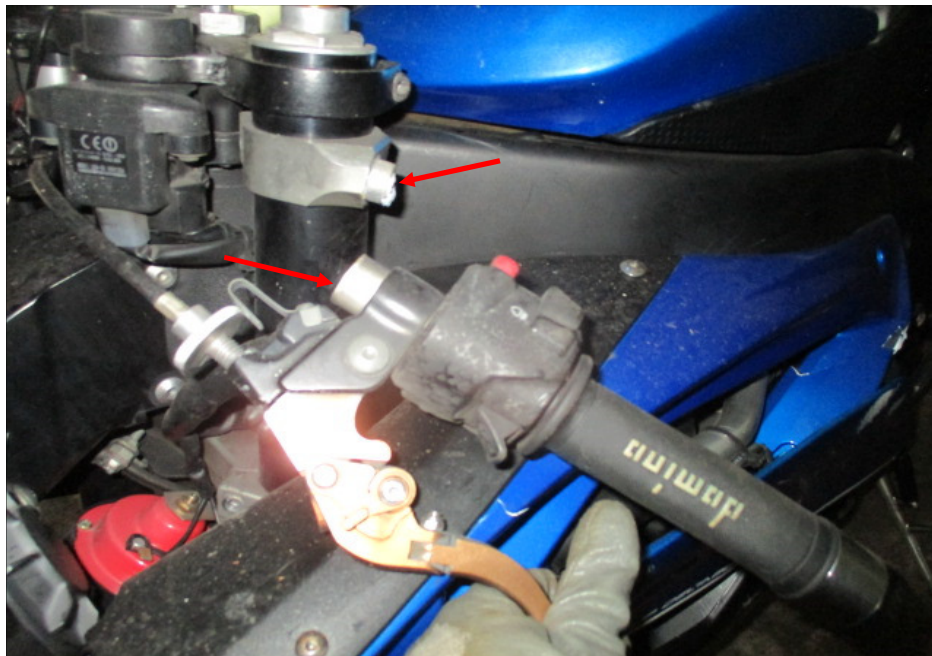
11. For this case, we were not able to conduct any test(s) on the steering system of the Motorcycle due to the damage to its handlebar. The left handlebar was found to be broken as a result of the accident.

**Photo 21** shows the left handlebar of the Motorcycle. The left handlebar (arrowed) was observed to be broken as a result of the accident (arrowed). We were hence not able to conduct any tests on the steering system of the Motorcycle.

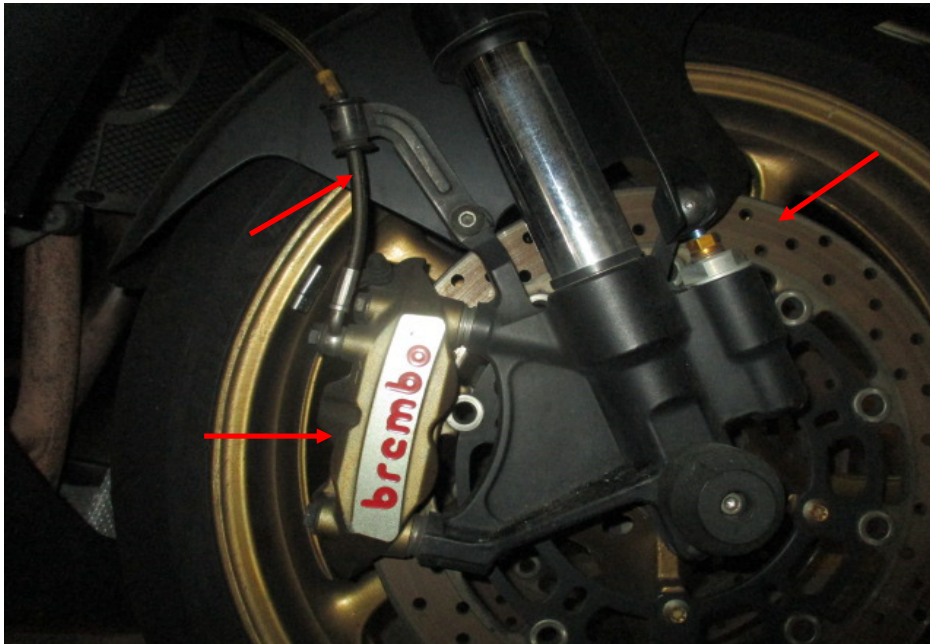
**Photo 22** shows a close up view of the front brake caliper, front brake disc and front brake hose (arrowed) at the right side of the Motorcycle's front wheel, which are all part of the components in the hydraulic front brake system of the Motorcycle. Our visual checks of these various components had revealed all to be intact with no visible damage. No leakage of brake fluid was also observed.

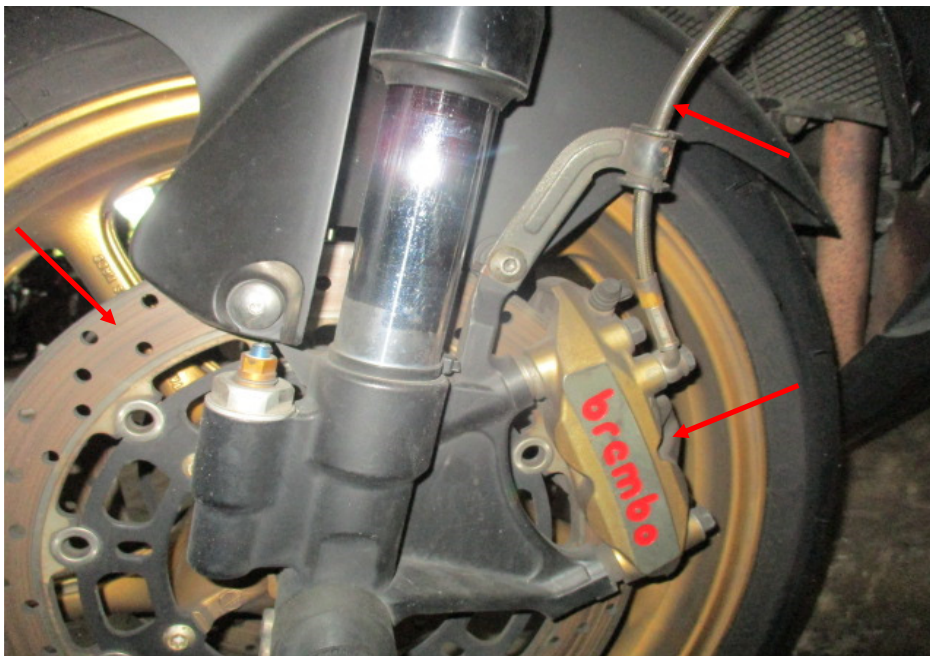
**Photo 23** shows a close up view of the front brake caliper, front brake disc and front brake hose (arrowed) at the left side of the Motorcycle's front wheel, which are all part of the components in the hydraulic front brake system of the Motorcycle. Our visual checks of these various components had revealed all to be intact with no visible damage. No leakage of brake fluid was also observed.

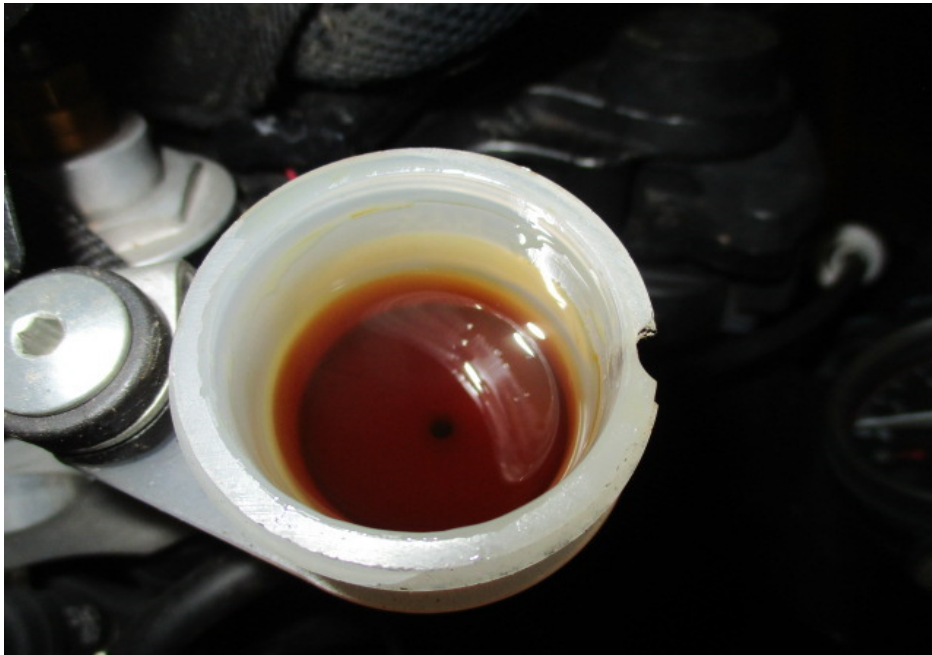
**Photo 24** shows the brake fluid reservoir for the front brake of the Motorcycle. The brake fluid was observed to be of sufficient level and without contamination for operational purposes.

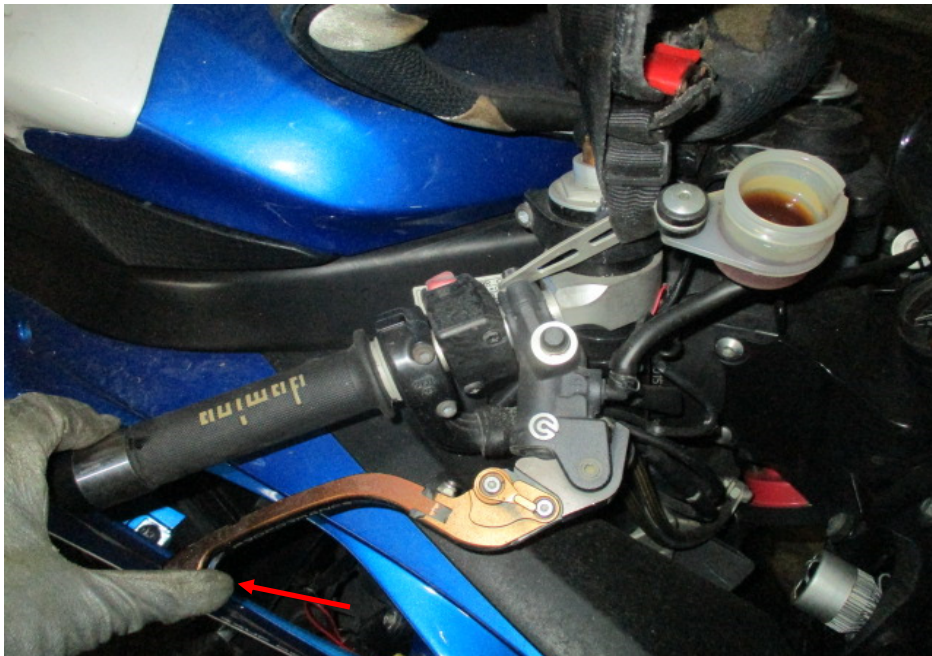
14. Static brake tests conducted on the Motorcycle had appear to indicate that the braking system of the Motorcycle was in serviceable condition. There was some resistance felt (spongy like feel) upon pressing the brake lever and upon stepping on the rear brake pedal. This would indicate that there was no leakage of pressure/vacuum in the brake system.

**Photo 25** shows the front brake lever being depressed. There was some resistance felt (spongy like feel) upon pressing the front brake lever (arrowed). This would indicate that there is no leakage of pressure/vacuum in the brake system.

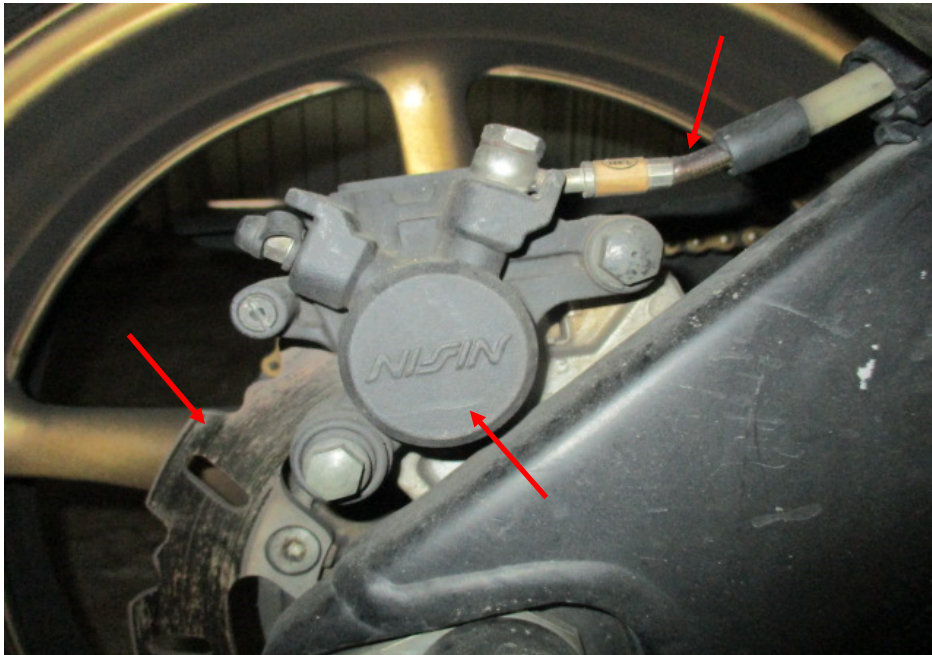
**Photo 26** shows a close up view of the rear brake caliper, rear brake disc and rear brake hose (arrowed) of the Motorcycle, which are all part of the components in the hydraulic rear brake system of the Motorcycle. Our visual checks of these various components had revealed all to be intact with no visible damage. No leakage of brake fluid was also observed.

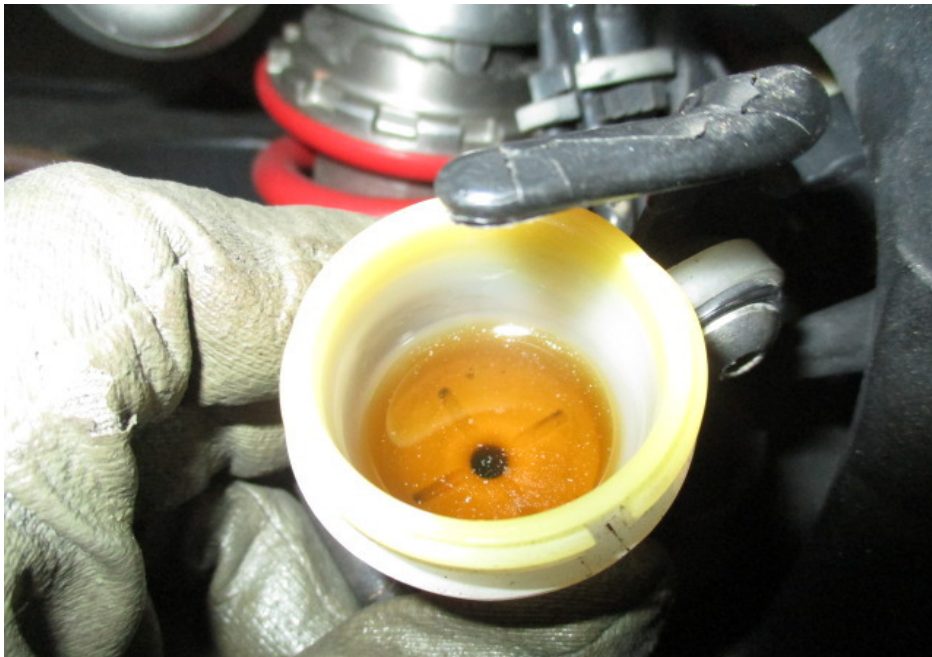
**Photo 27** shows the brake fluid reservoir for the rear brake of the Motorcycle. The brake fluid was observed to be of sufficient level and without contamination for operational purposes.
