Your Ref: TP/IP/44943/2020  
Our Ref : CI/TPD20012518/N

**Fatal Accident Investigation Team**

**INSPECTION REPORT OF MOTORCYCLE FBG 9671T**

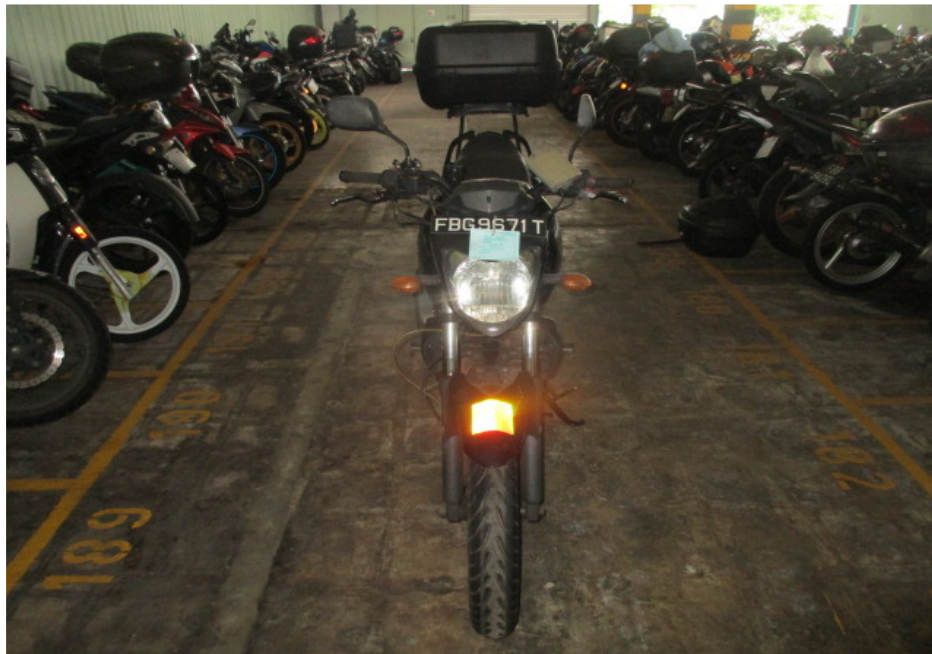
**Photo 2** shows a general view of the frontal portion of the Motorcycle at the time of our inspection. The Motorcycle was observed to have sustained damages at its frontal portion and left body.

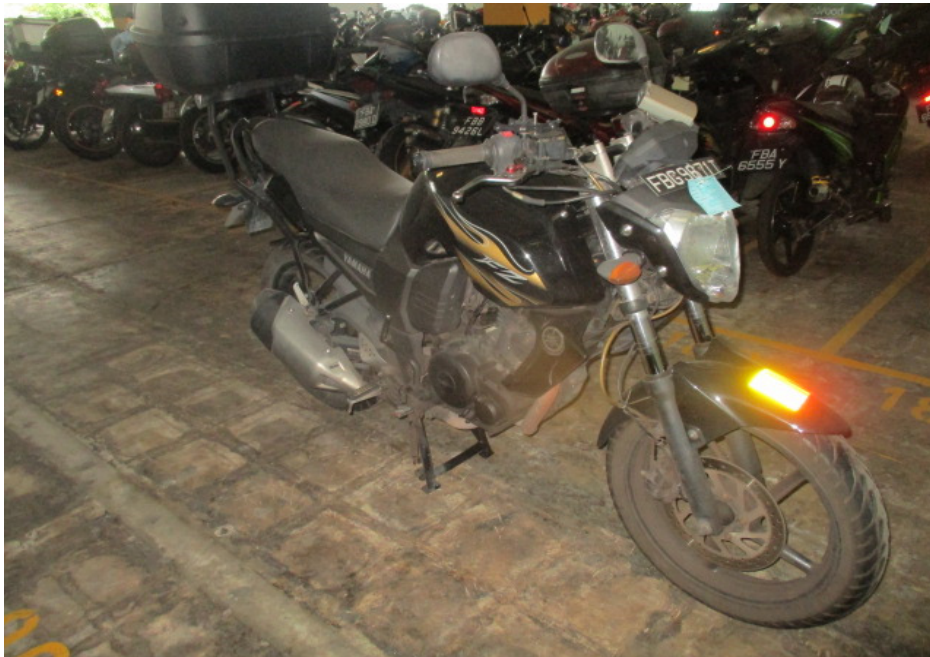
**Photo 2** shows a general view of the right body of the Motorcycle at the time of our inspection. The Motorcycle was observed to have sustained damages at its frontal portion and left body.

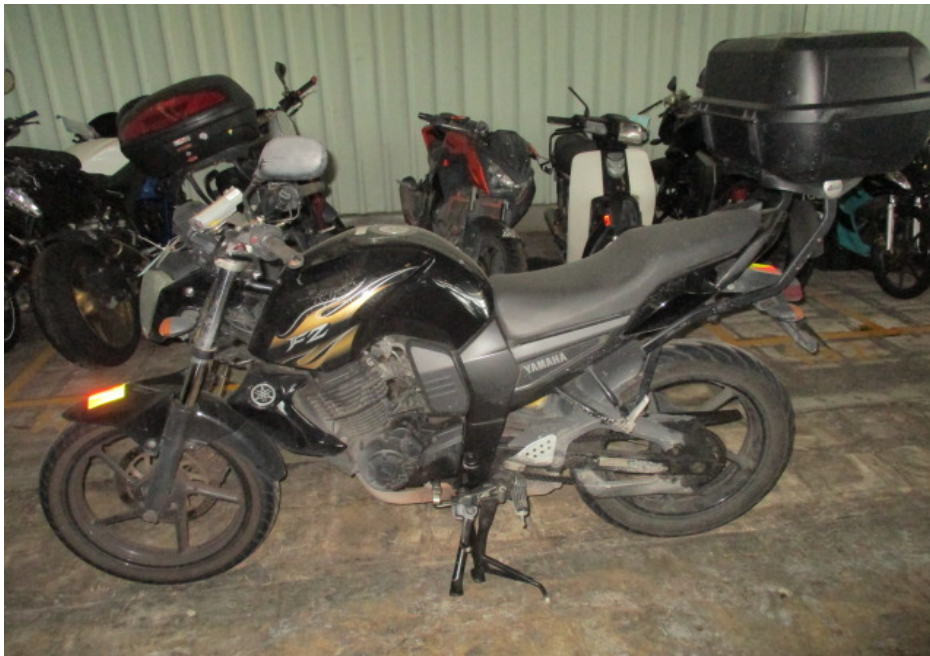
**Photo 3** shows a general view of the left body of the Motorcycle at the time of our inspection. The Motorcycle was observed to have sustained damages at its frontal portion and left body. The body parts that were found to have been damaged include its IU unit, front mudguard, left front signal lamp, left side mirror, left handlebar end, clutch lever, gear shift pedal, left pillion foot peg, left radiator cover, side stand, left rear side cover and top box, amongst others.

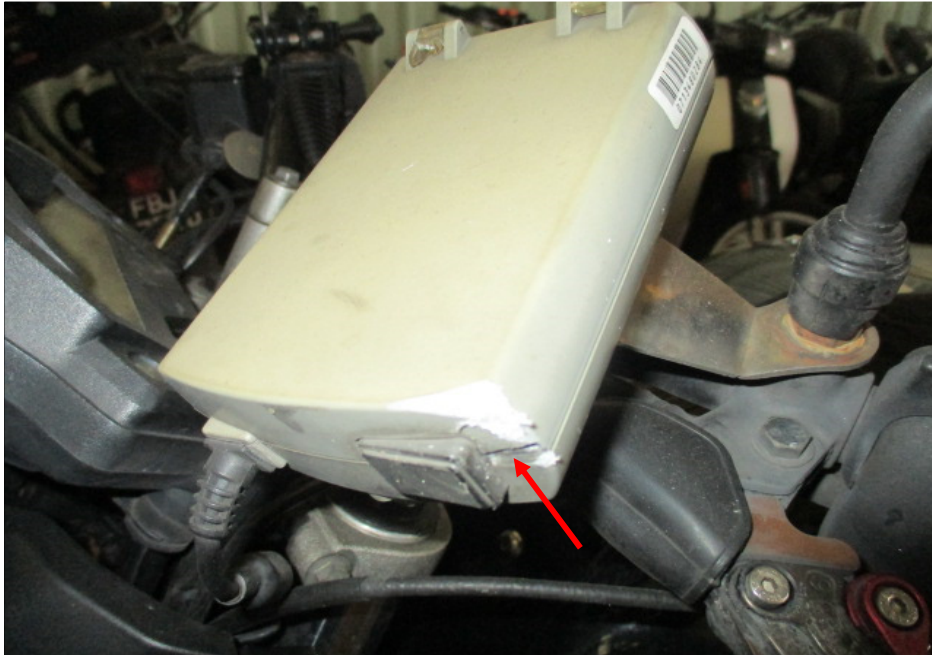
**Photo 4** shows a close up view of the cracked IU unit (arrowed) of the Motorcycle as a result of the accident.

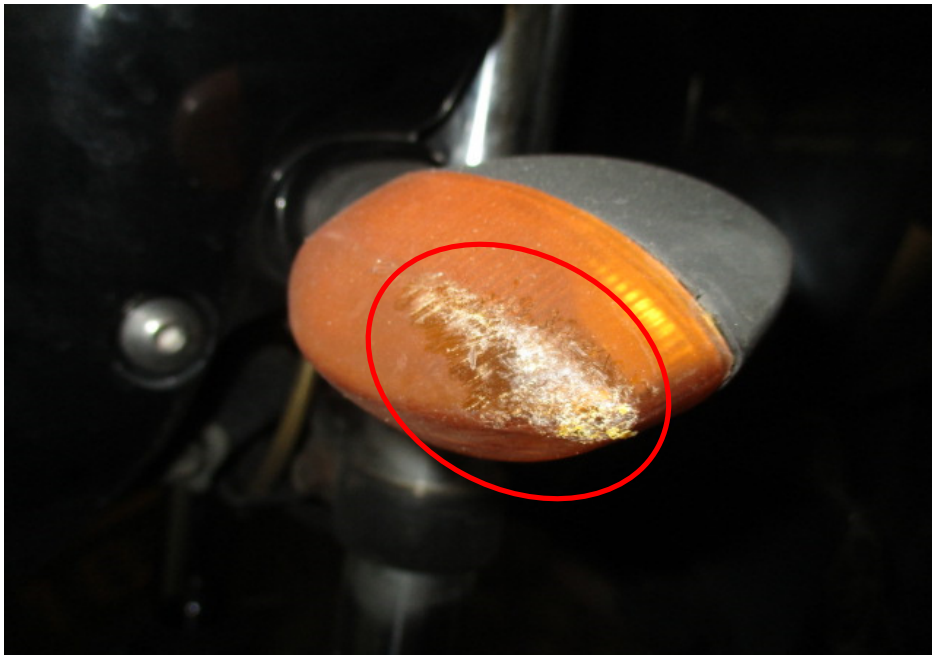
**Photo 5** shows a closer view of the left front signal lamp (circled) which was amongst the body parts of the Motorcycle that had sustained damage as a result of the accident.

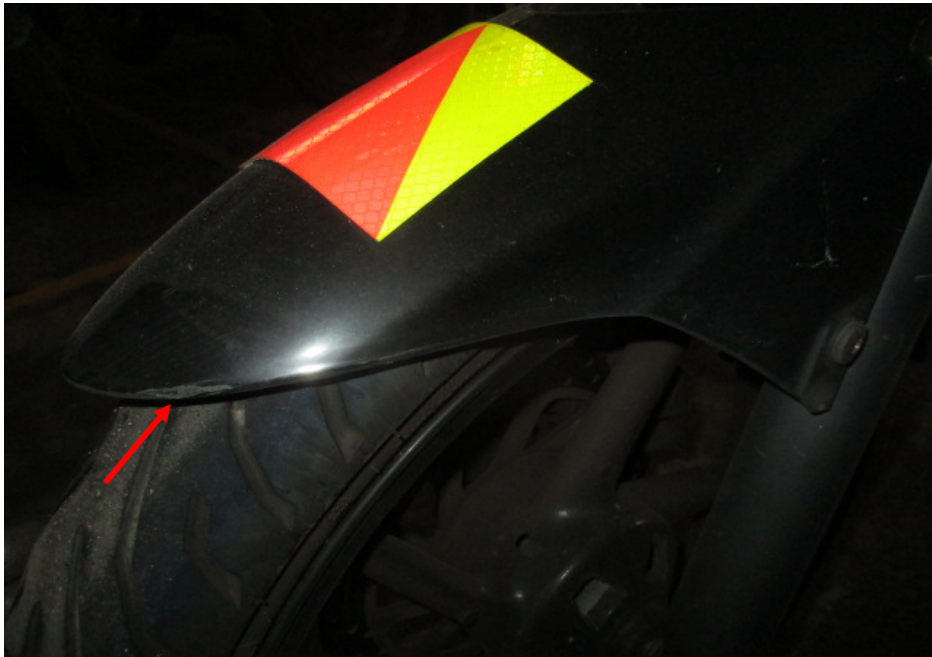
**Photo 6** shows a closer view of the front mudguard (arrowed) which was amongst the body parts of the Motorcycle that had sustained damage as a result of the accident.

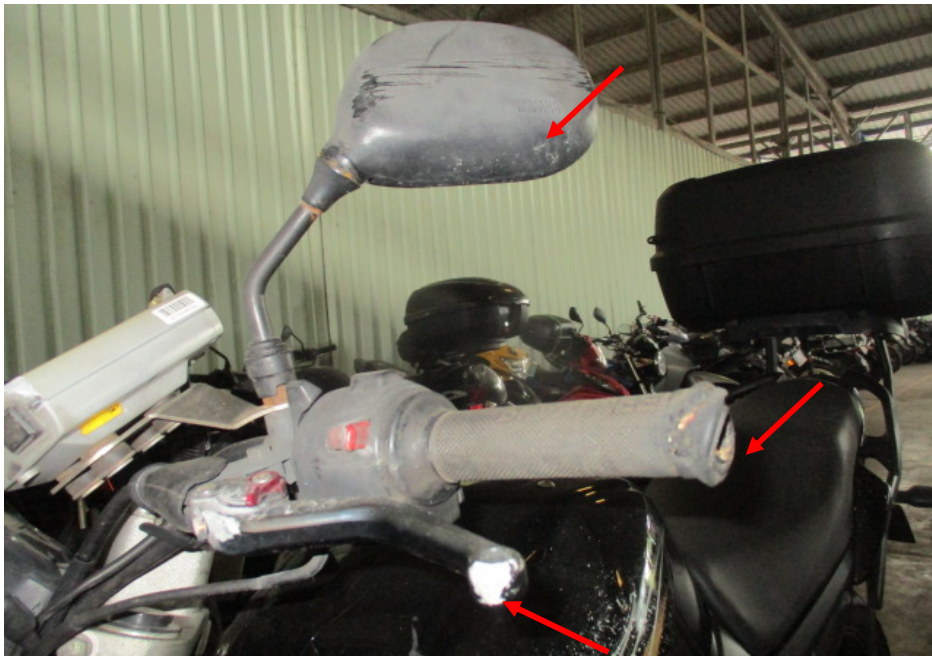
**Photo 7** shows the left handlebar end, left side mirror and clutch lever (arrowed), which were amongst the body parts of the Motorcycle that had sustained damage as a result of the accident.

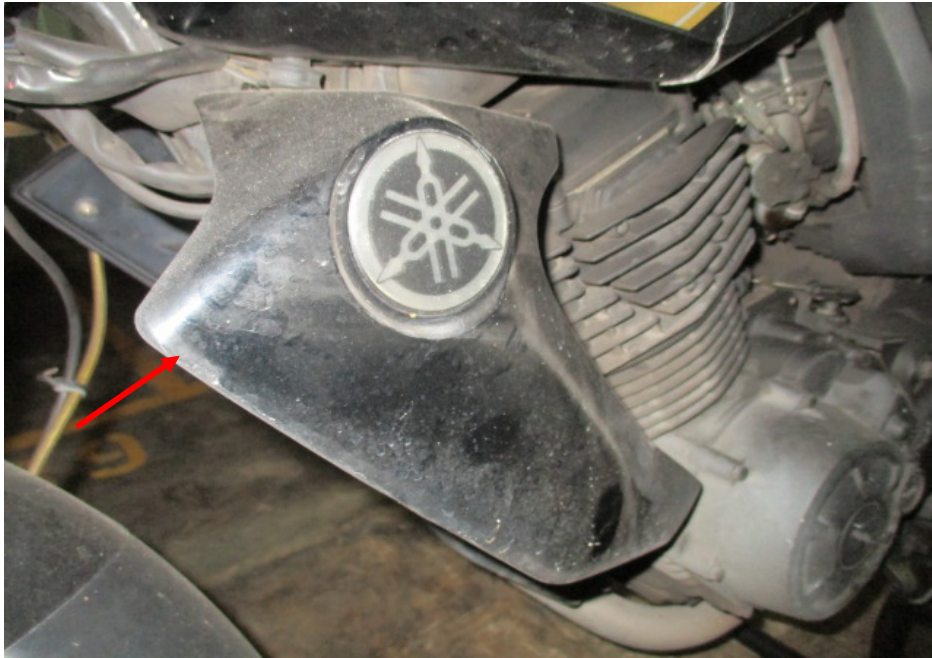
**Photo 8** shows the left radiator cover (arrowed), which were amongst the body parts of the Motorcycle that had sustained damage as a result of the accident.

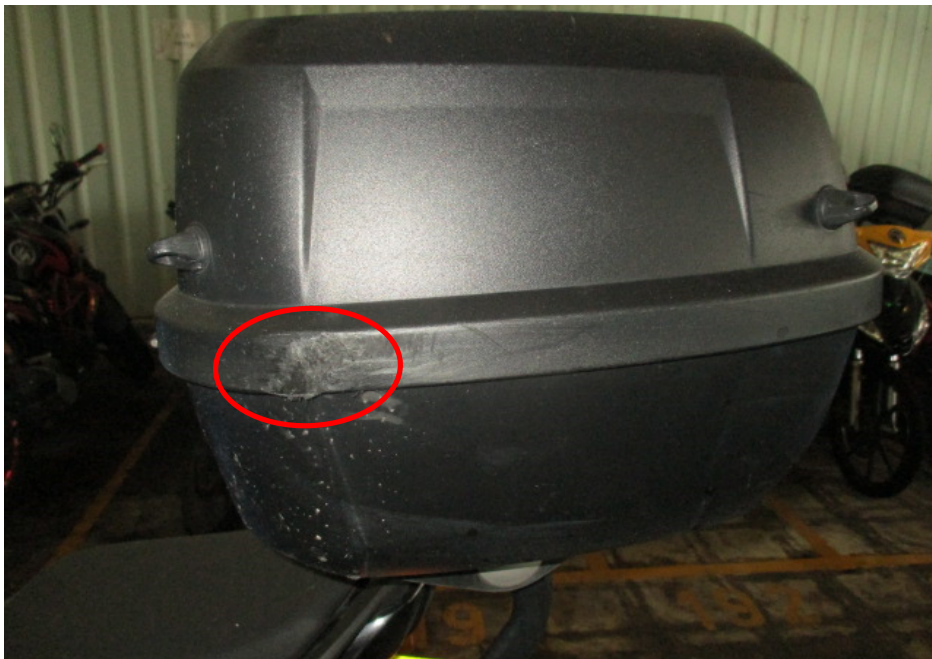
**Photo 9** shows the top box which was amongst the body parts of the Motorcycle that had sustained damage as a result of the accident (circled).

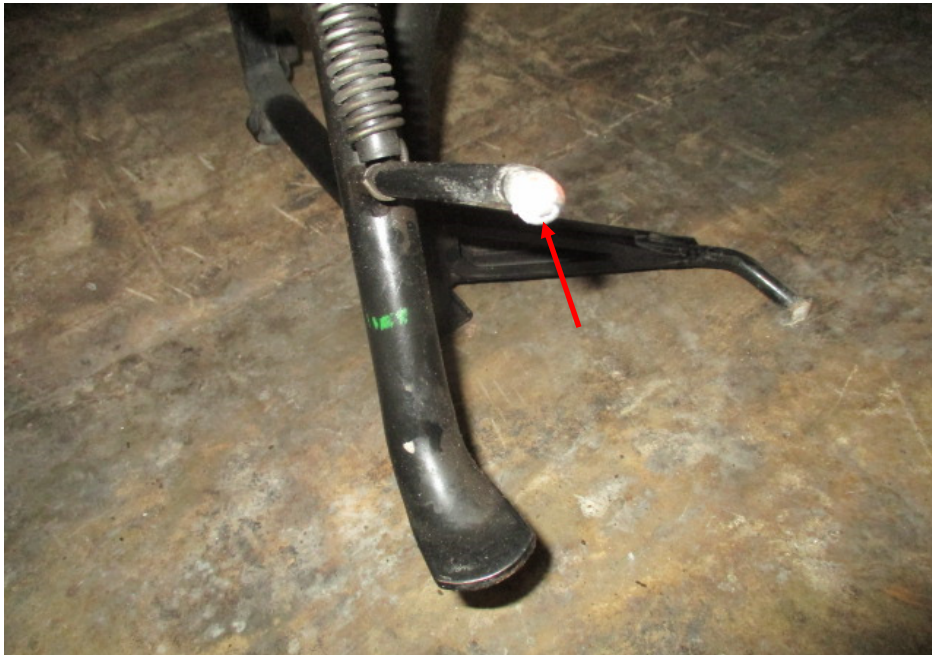
**Photo 10** shows a closer view of the side stand which was amongst the body parts of the Motorcycle that had sustained damages as a result of the accident (arrowed).

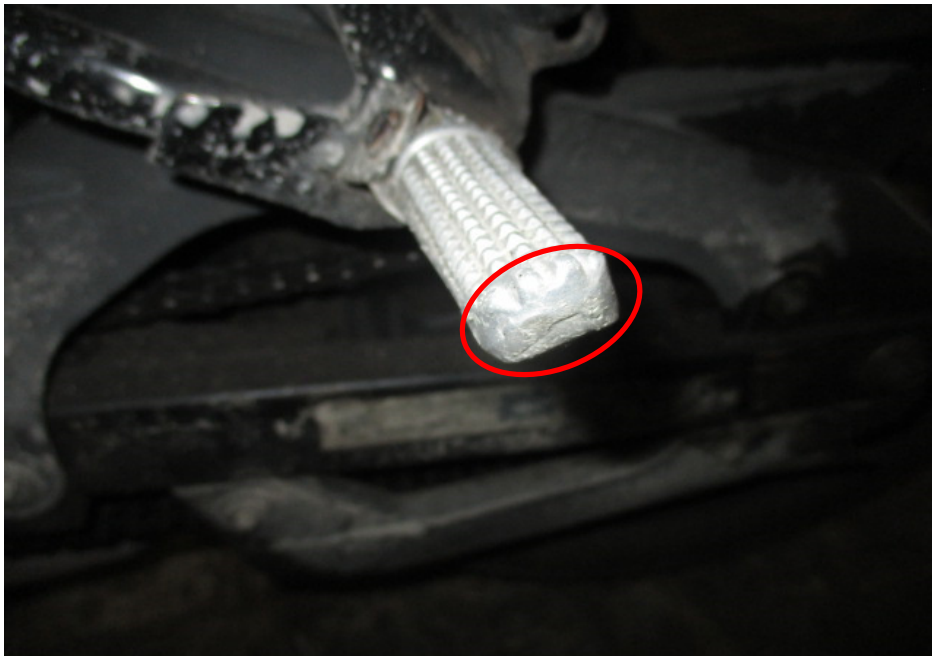
**Photo 11** shows a closer view of the left pillion foot peg which was amongst the body parts of the Motorcycle that had sustained damages of grazing nature as a result of the accident (circled).

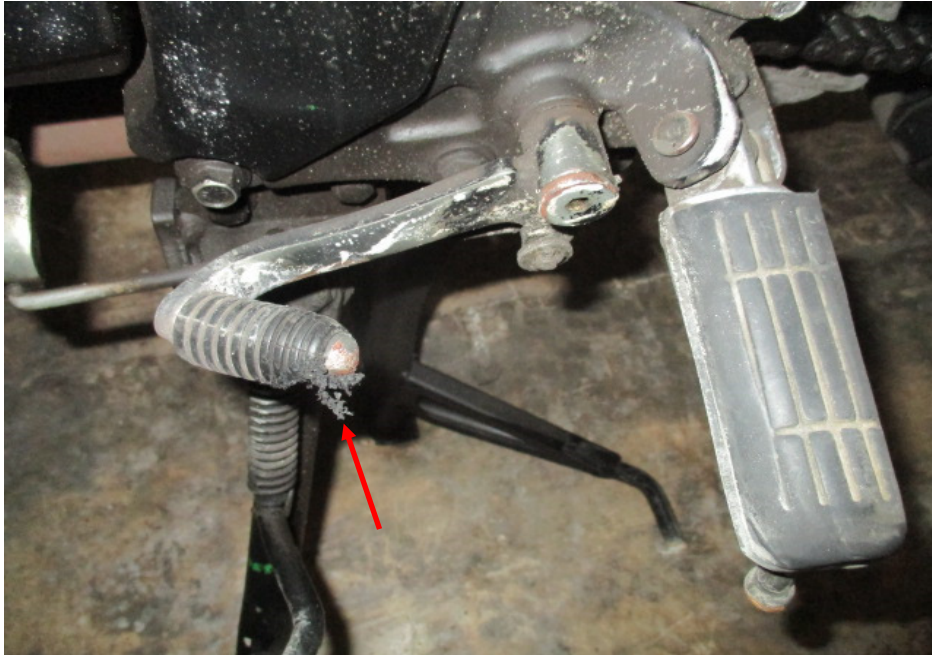
**Photo 12** shows the bent gear shift pedal of the Motorcycle as a result of the accident (arrowed).

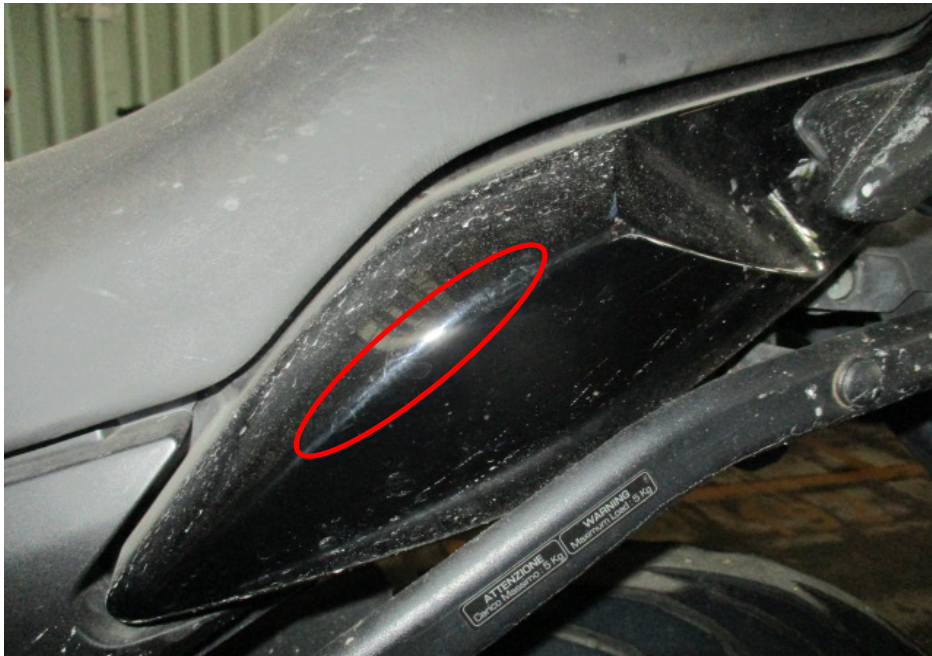
**Photo 13** shows the left rear side cover of the Motorcycle that had sustained damage as a result of the accident (circled).

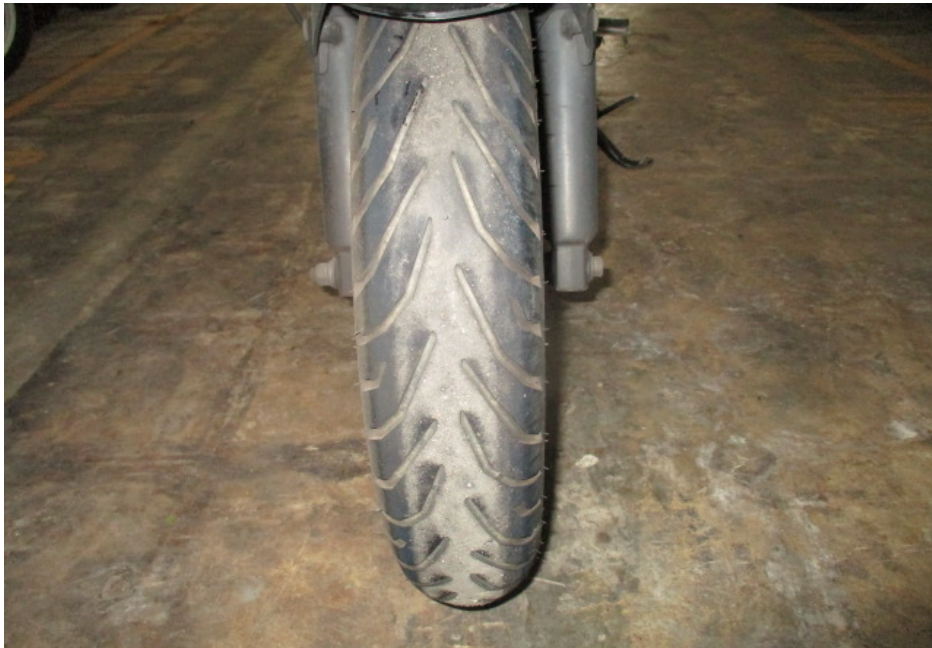
**Photo 14** shows the front tyre of the Motorcycle at the time of our inspection. The front tyre was observed to be in serviceable condition with remaining tread depth of approximately 3mm. The pattern of the tread was also clearly visible. There was no tear, burst mark(s) and/or punctured hole(s) on the sidewalls as well as across the tread of the front tyre.

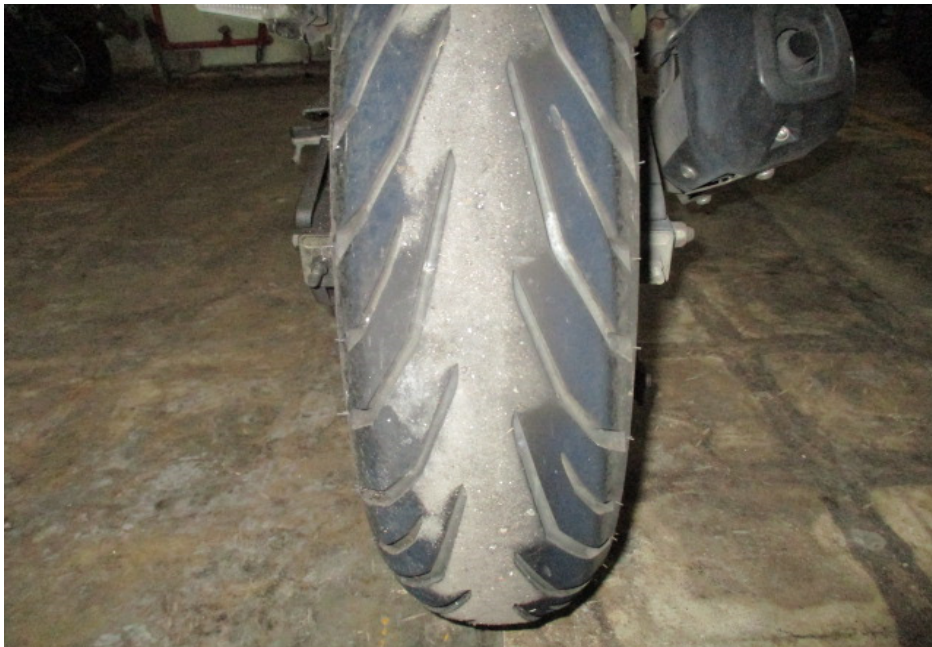
**Photo 15** shows the condition of the Motorcycle's rear tyre. The rear tyre was observed to be in serviceable condition with remaining tread depth of approximately 3mm. The tyre was also observed to be sufficiently inflated for vehicular operation. We did not observe any tear, burst mark(s) and/or punctured hole(s) on the sidewalls as well as across the tread of the rear tyre.

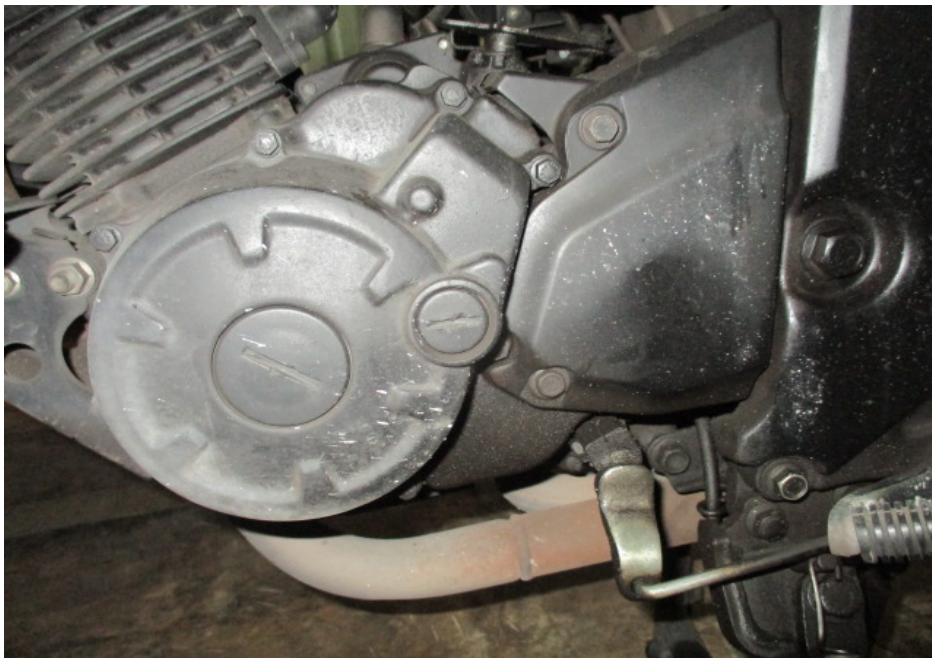
**Photo 16** shows the left side of the engine of the Motorcycle at the time of our inspection. The various engine related parts and components were found to be intact with no visible damage. There was also no sign(s) or indication(s) of fluid leak observed around the left engine area of the Motorcycle.

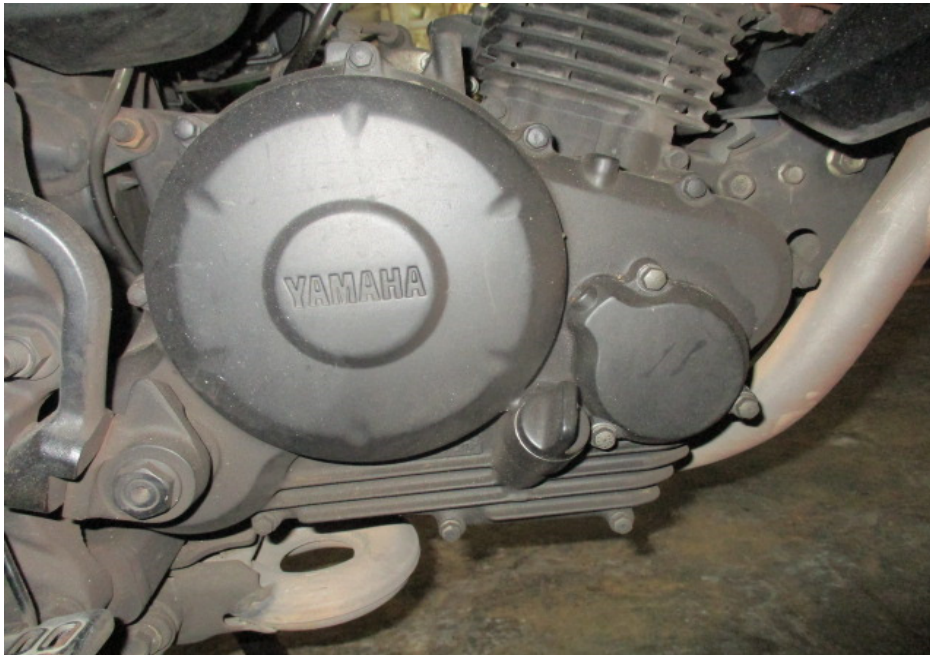
**Photo 17** shows the right side of the engine of the Motorcycle at the time of our inspection. The various engine related parts and components were found to be intact with no visible damage. There was also no sign(s) or indication(s) of fluid leak observed around the right engine area of the Motorcycle.

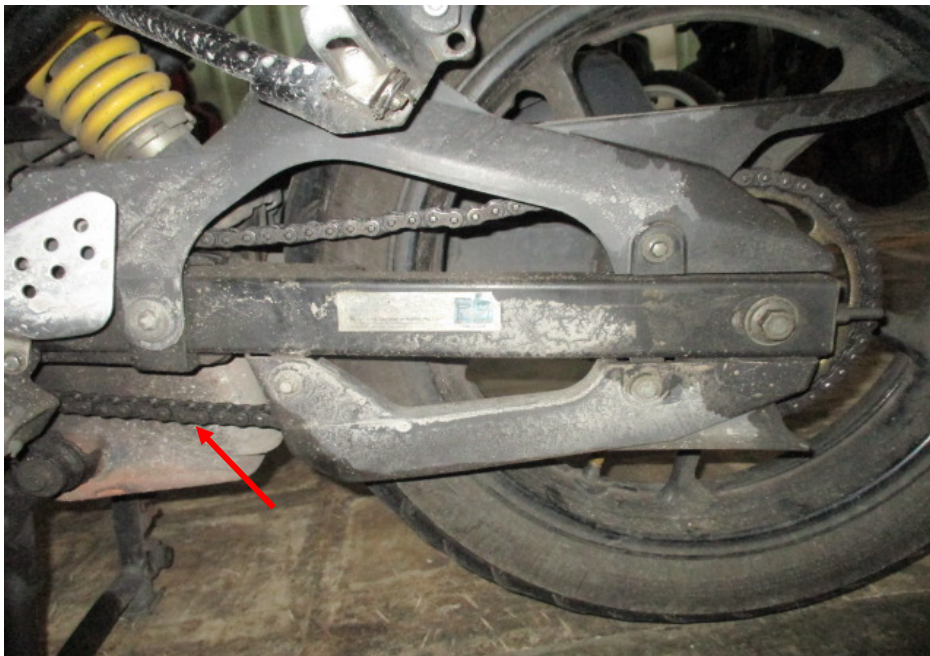
**Photo 18** shows the general view of the gear train (arrowed) of the Motorcycle, which was observed to be intact with no misalignment. It was also adequately lubricated for operating purposes.

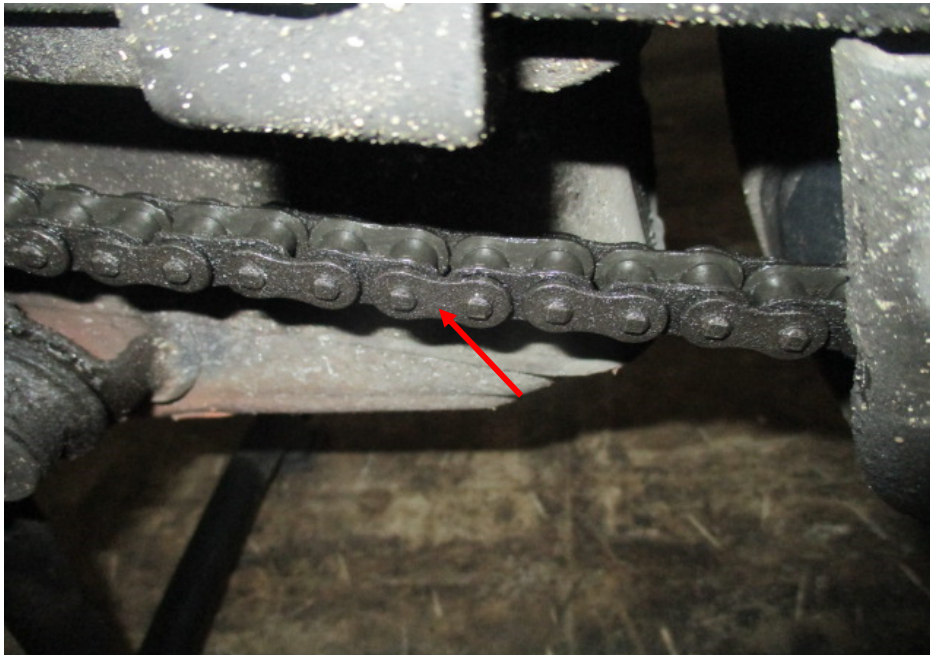
**Photo 19** shows a closer view of the gear train (arrowed) of the Motorcycle, which was observed to be intact with no misalignment. It was also adequately lubricated for operating purposes.

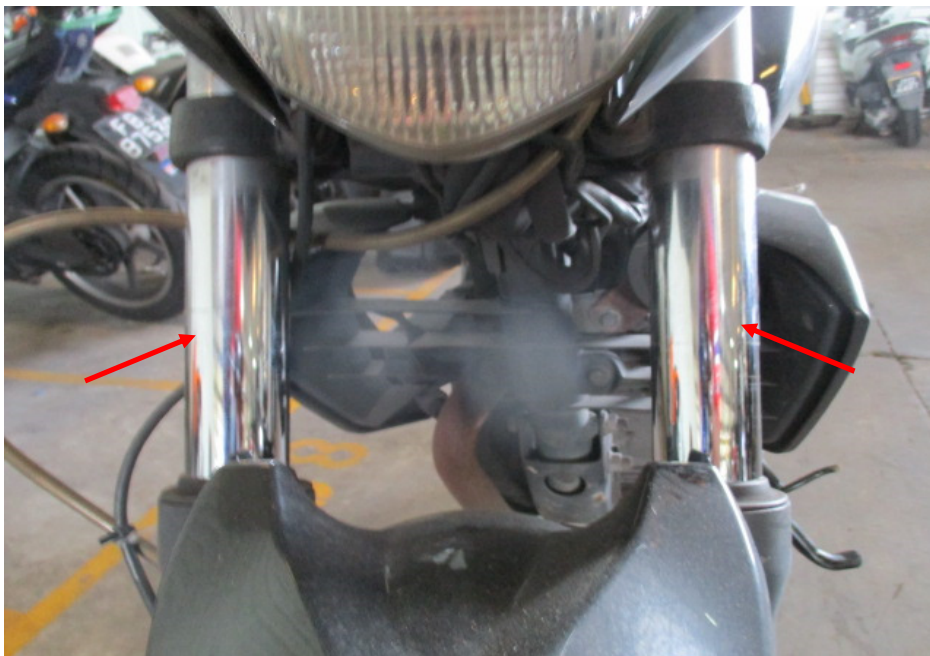
**Photo 20** shows the front fork (arrowed) of the Motorcycle. The front fork and fork bracket of the Motorcycle were both found to be intact and undamaged. Turning the Motorcycle's handle bar towards the left and right did not produce any abnormal free play. The steering system of the Motorcycle was in serviceable condition at the time of our inspection.

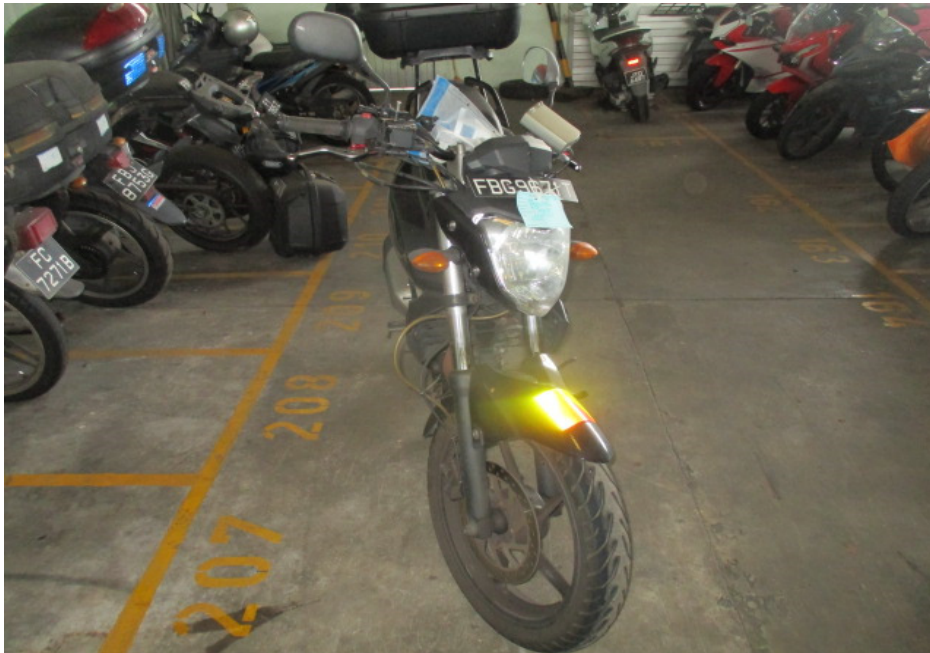
**Photo 21** shows the front wheel of the Motorcycle turned towards its full left. Turning the Motorcycle's handle bar towards the left did not produce any abnormal free play and/or resistance. This would indicate that the steering system of the Motorcycle was in serviceable condition at the time of our inspection.

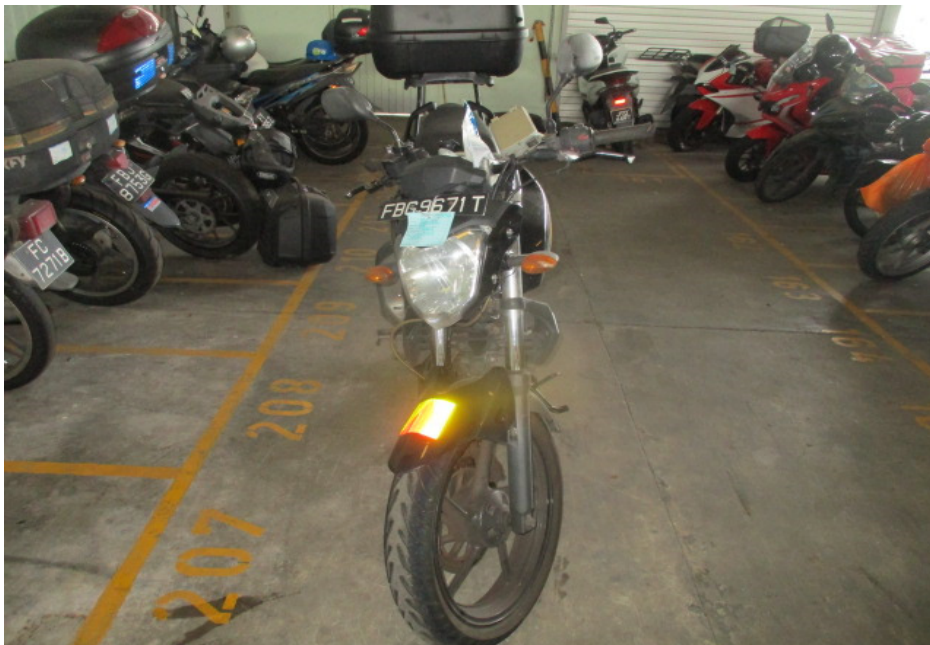
**Photo 22** shows the front wheel of the Motorcycle turned towards its full right. Turning the Motorcycle's handle bar towards the right did not produce any abnormal free play and/or resistance. This would indicate that the steering system of the Motorcycle was in serviceable condition at the time of our inspection.

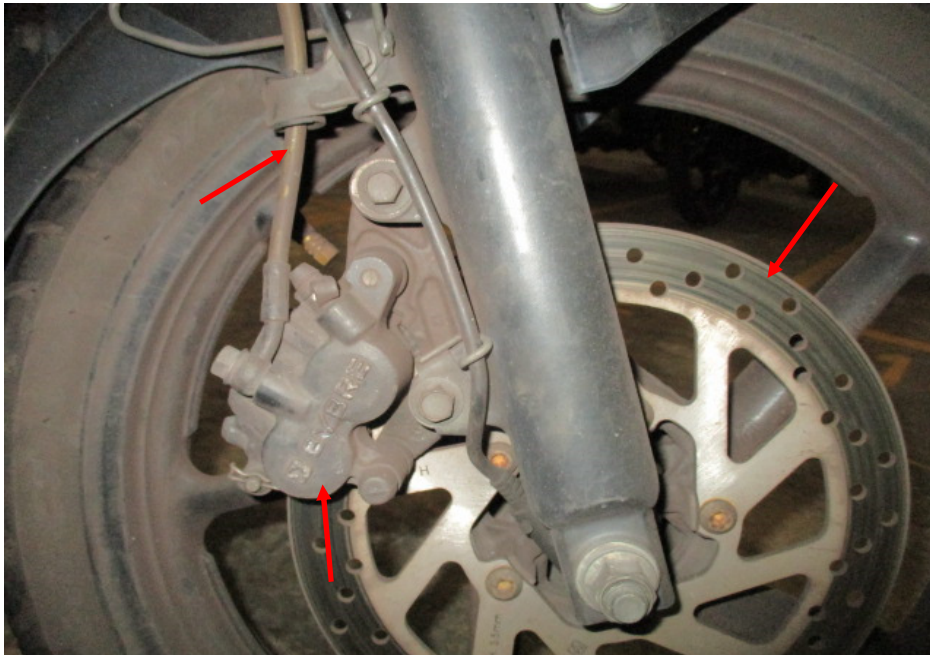
**Photo 23** shows a close up view of the front brake caliper, front brake disc and front brake hose (arrowed) of the Motorcycle, which are all part of the components in the hydraulic front brake system of the Motorcycle. Our visual checks of these various components had revealed all to be intact with no visible damage. No leakage of brake fluid was also observed.

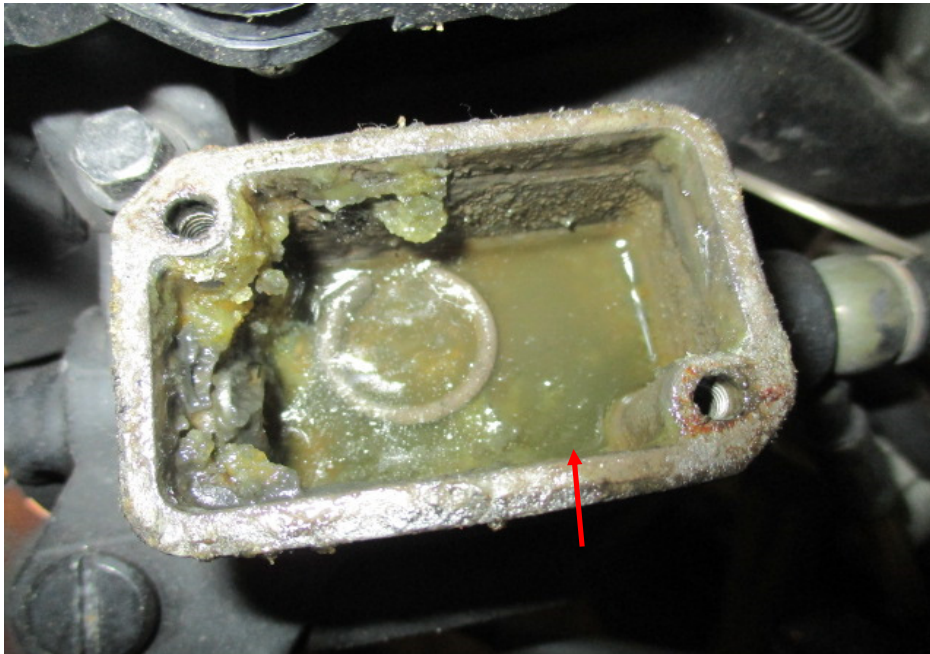
**Photo 24** shows the brake fluid reservoir for the front brake of the Motorcycle. The brake fluid reservoir was found to be contaminated and of insufficient level for operating purposes (arrowed).

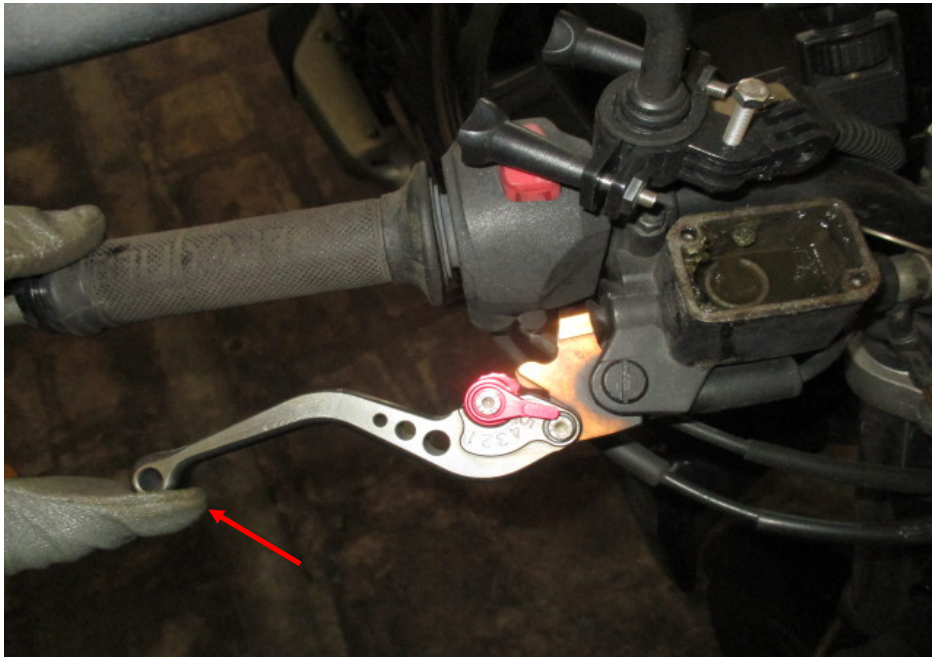
13. Static brake tests conducted on the Motorcycle had appeared to indicate that the front brake system of the Motorcycle was in serviceable condition. There was some resistance felt (spongy like feel) upon pressing the front brake lever. This would indicate that there is no leakage of pressure/vacuum in the front brake system.

**Photo 25** shows the front brake lever being depressed. There was some resistance felt (spongy like feel) upon pressing the front brake lever (arrowed). This would indicate that there is no leakage of pressure/vacuum in the brake system.

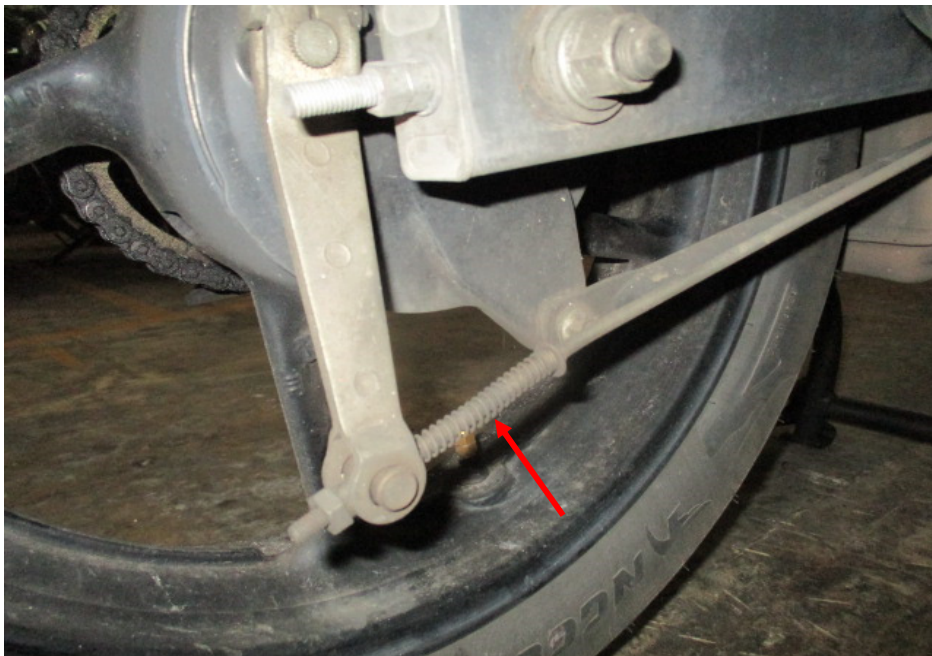
**Photo 26** shows the rear wheel of the Motorcycle. The type of brake system for the rear wheel was of a mechanical type, controlled by the brake foot pedal of the Motorcycle. Our checks of the cable (arrowed), spring and drum which are all part of the components in the rear brake system of the Motorcycle reveal all to be intact and without damage.
