Your Ref: TP/IP/37543/2020  
Our Ref : CI/TPD20012521/N

**Fatal Accident Investigation Team**

**INSPECTION REPORT OF MOTORCYCLE FR 9785T**

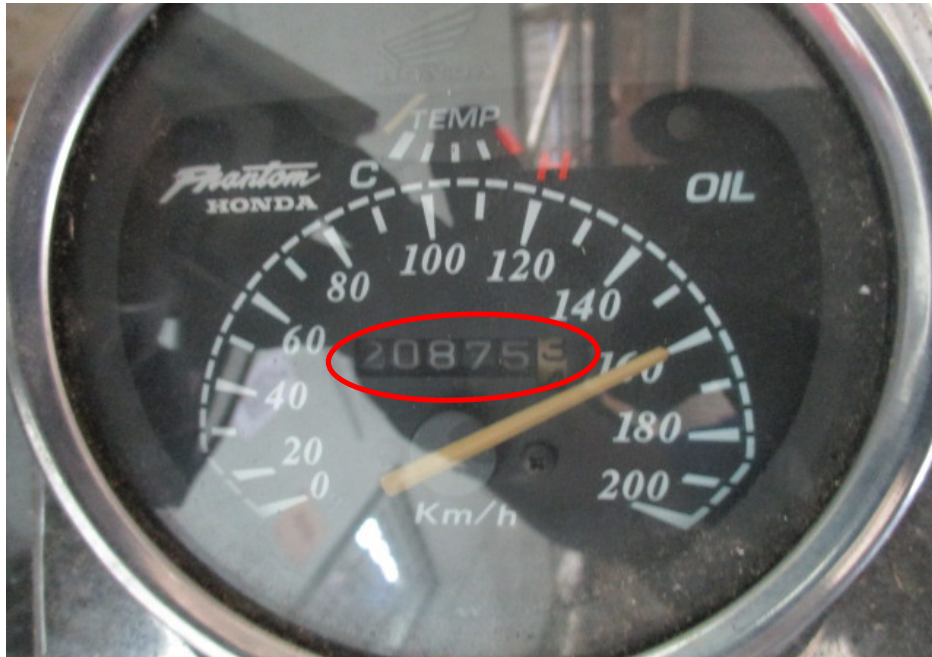
**Photo 1** shows the speedometer gauge of the Motorcycle where the mileage recorded at the time of our inspection was 20, 875km (circled).

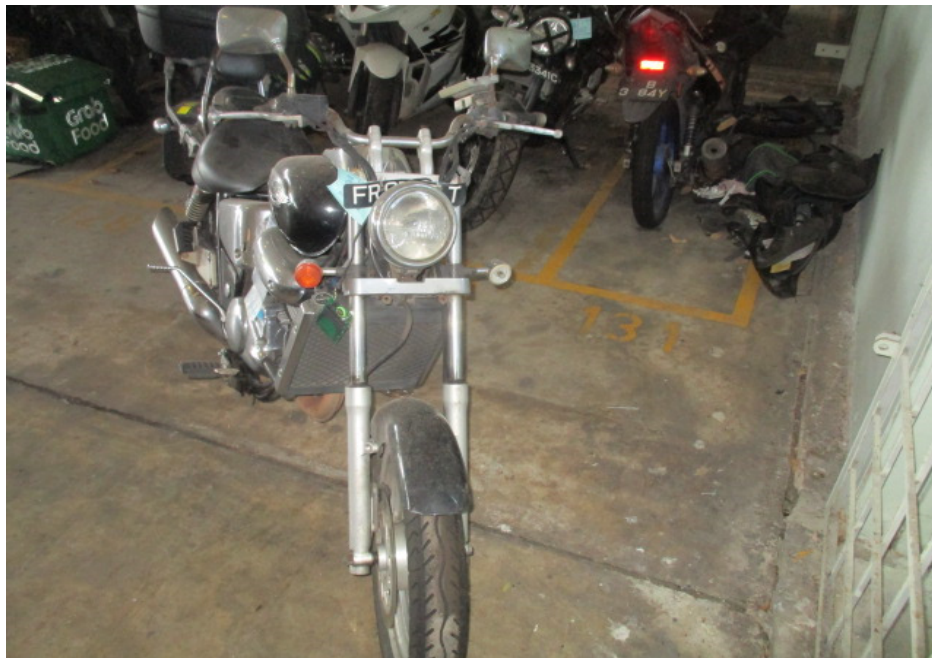
**Photo 2** shows a general view of the frontal portion of the Motorcycle at the time of our inspection. The Motorcycle was observed to have sustained damages at the frontal portion and left body.

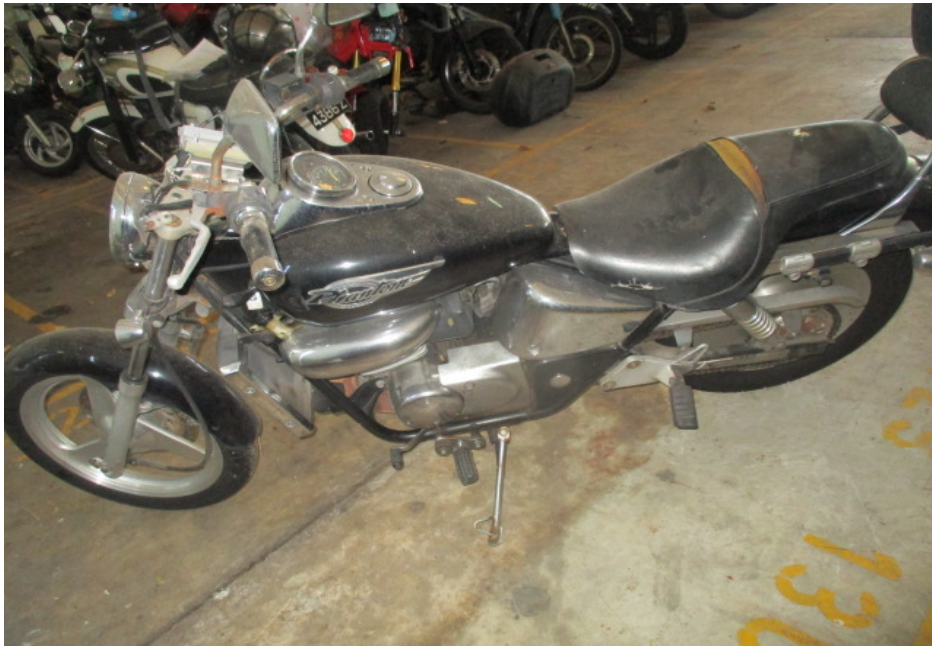
**Photo 3** shows a general view of the left body of the Motorcycle at the time of our inspection. The Motorcycle was observed to have sustained damages at the frontal portion and left body.

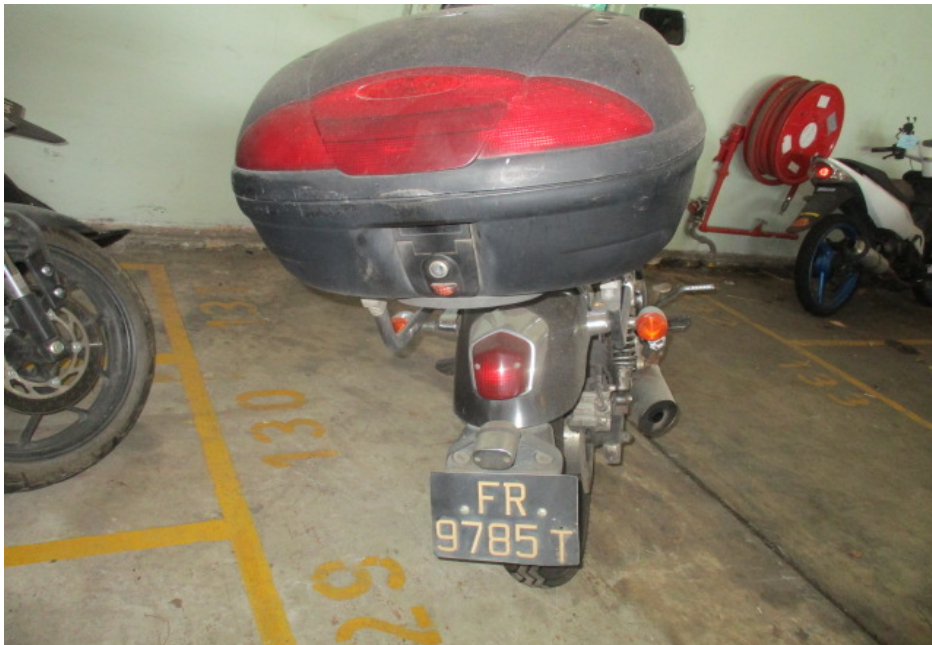
**Photo 4** shows a general view of the rear portion of the Motorcycle at the time of our inspection. The Motorcycle was observed to have sustained damages at the frontal portion and left body. The body parts that were found to have been damaged include its headlight assembly, ERP unit, front mudguard, fuel tank, left front signal lamp, left handlebar end, left side mirror, clutch lever, gear shift pedal, left front footrest, left pillion foot peg, seat and top box, amongst others.

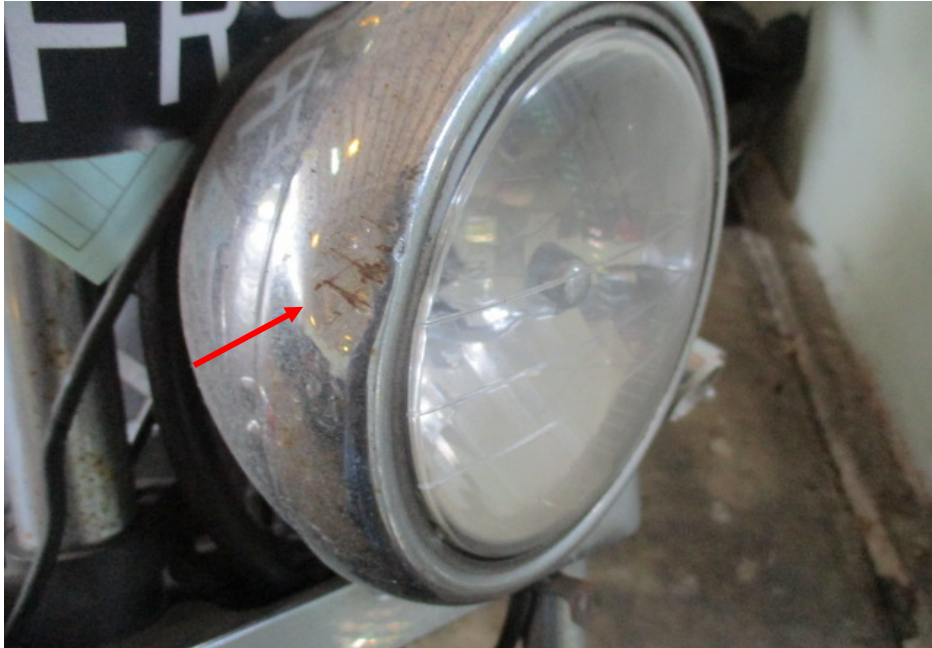
**Photo 5** shows a closer view of the headlight assembly which was amongst the body parts of the Motorcycle that had sustained damages as a result of the accident (arrowed).

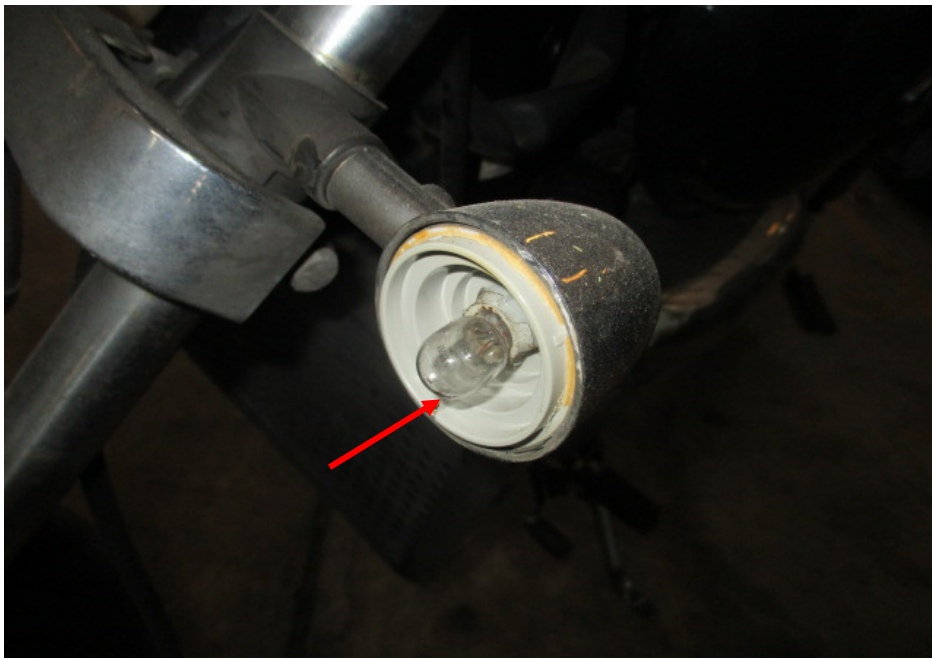
**Photo 6** shows a closer view of the broken left front signal lamp of the Motorcycle as a result of the accident (arrowed).

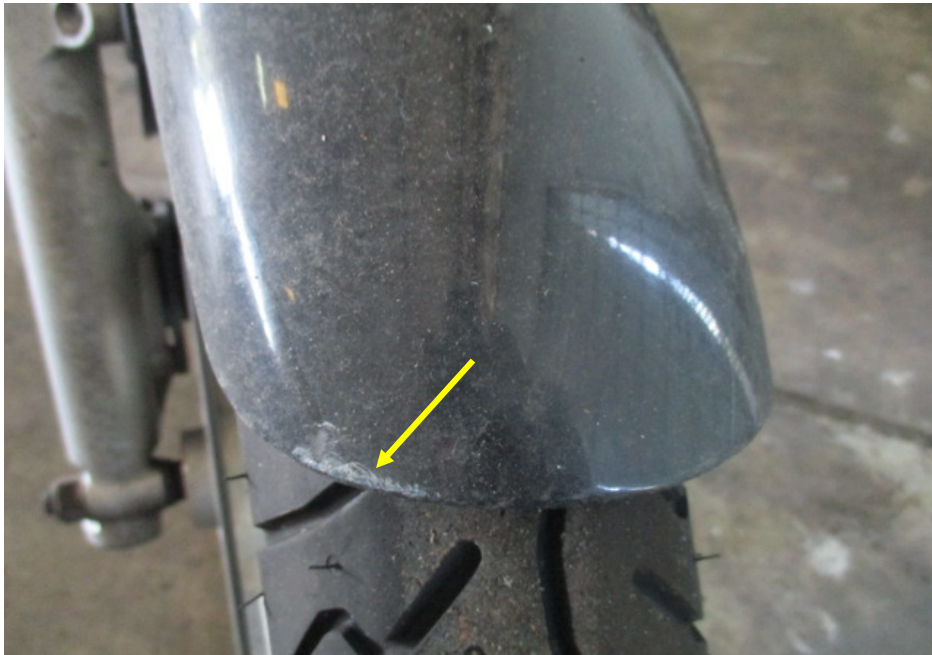
**Photo 7** shows a closer view of the front mudguard which was amongst the body parts at the front body of the Motorcycle that had sustained damage as a result of the accident (arrowed).

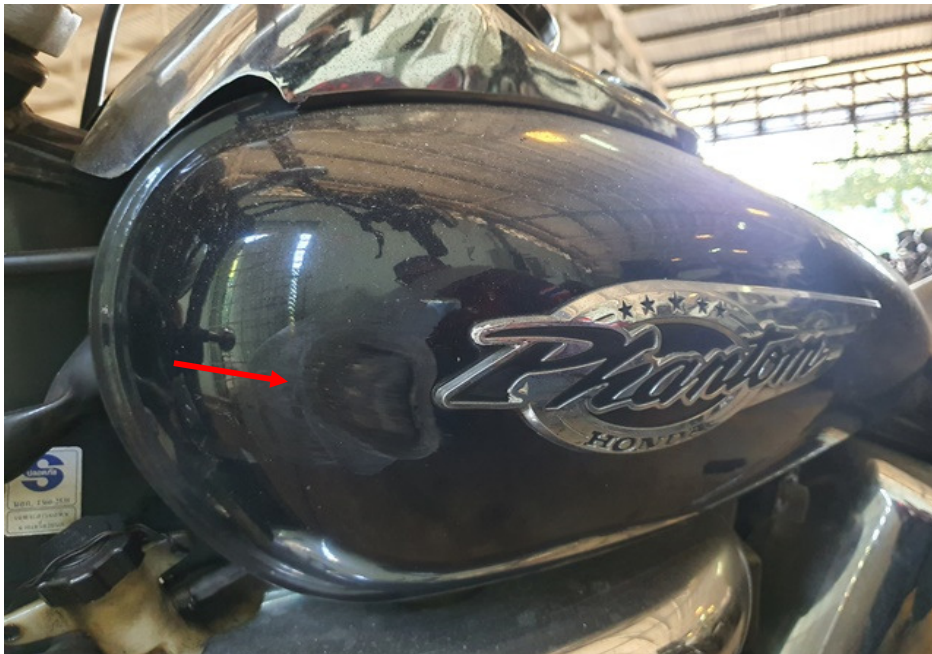
**Photo 8** shows a closer view of the fuel tank of the Motorcycle that had sustained damages as a result of the accident (arrowed).

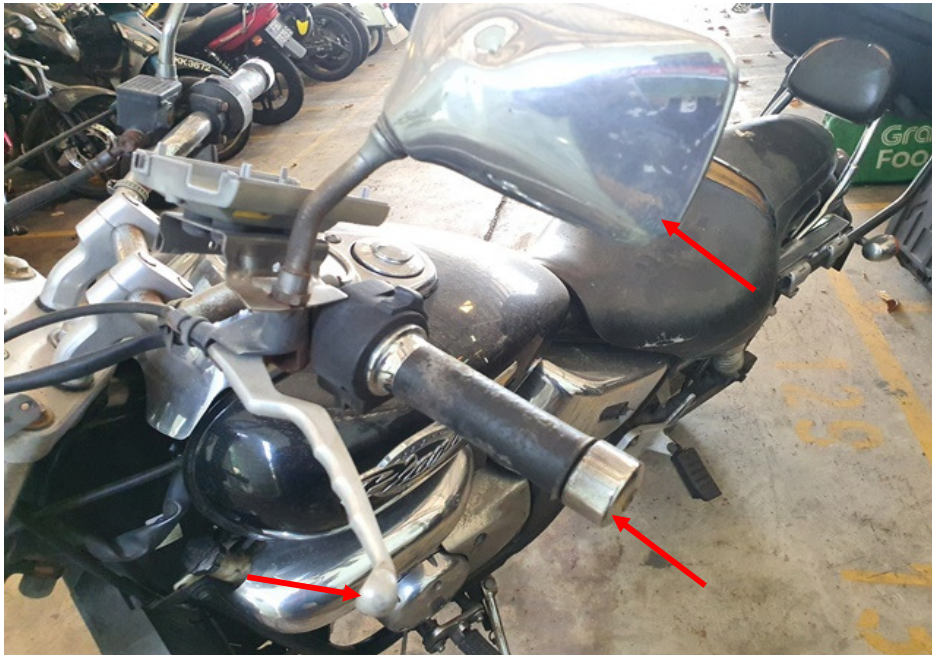
**Photo 9** shows a closer view of the left handlebar end, clutch lever and left side mirror (arrowed) which were amongst the body parts of the Motorcycle that had sustained damage as a result of the accident.

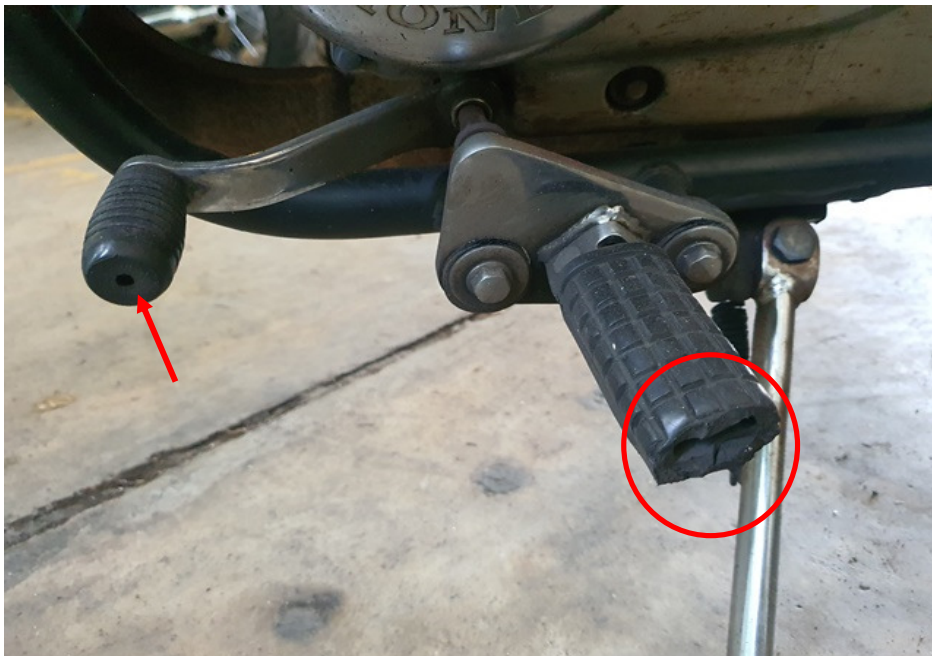
**Photo 10** shows a closer view of the gear shift pedal (arrowed) and left front footrest (circled) which were amongst the body parts of the Motorcycle that had sustained damage as a result of the accident.

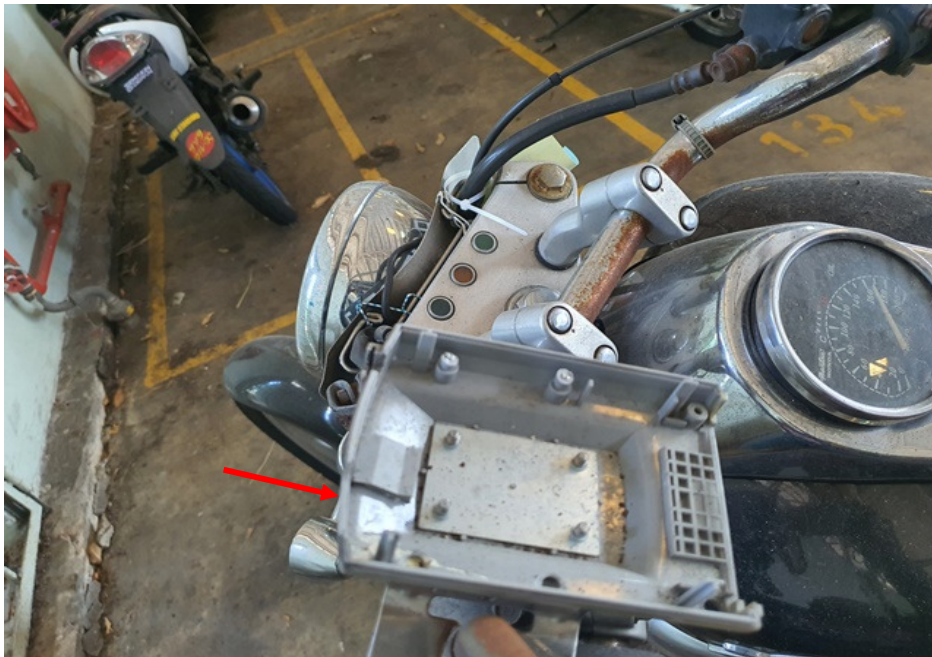
**Photo 11** shows a closer view of the broken ERP unit (arrowed) of the Motorcycle as a result of the accident.

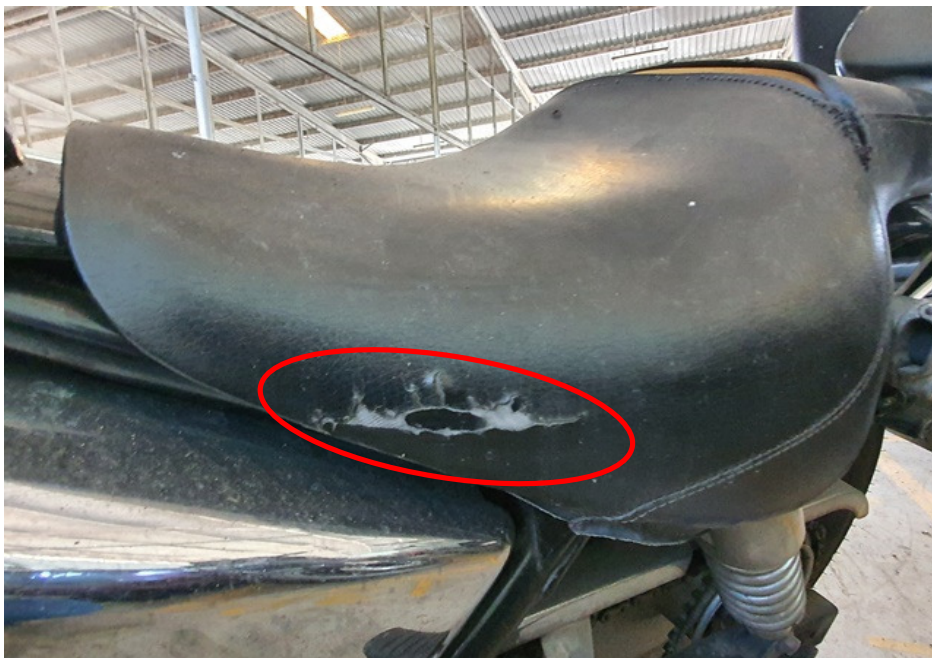
**Photo 12** shows the torn seat of the Motorcycle as result of the accident (circled).

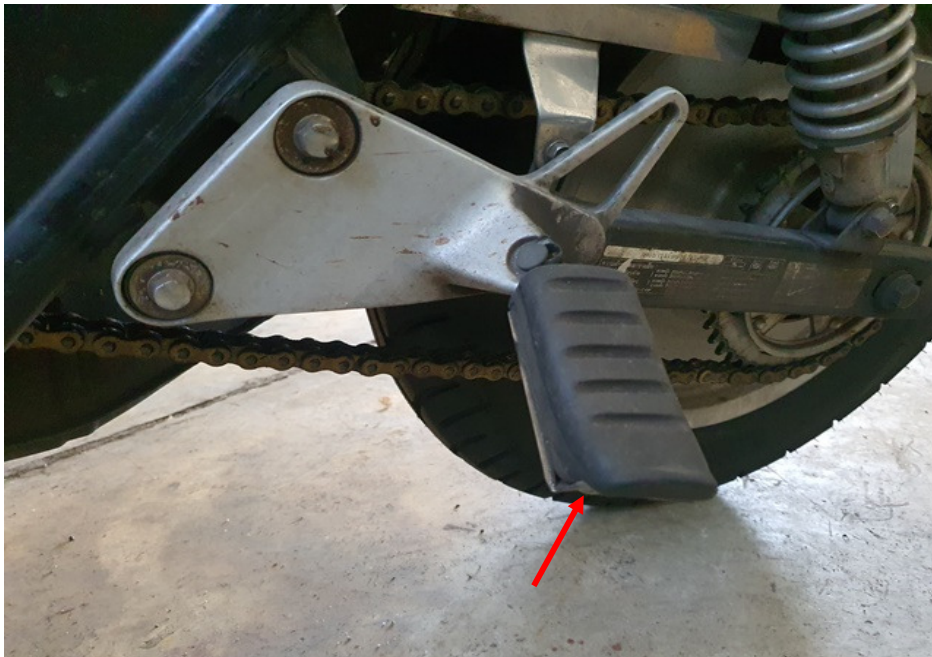
**Photo 13** shows a closer view of the left pillion foot peg (arrowed) which was amongst the body parts of the Motorcycle that had sustained damage as a result of the accident.

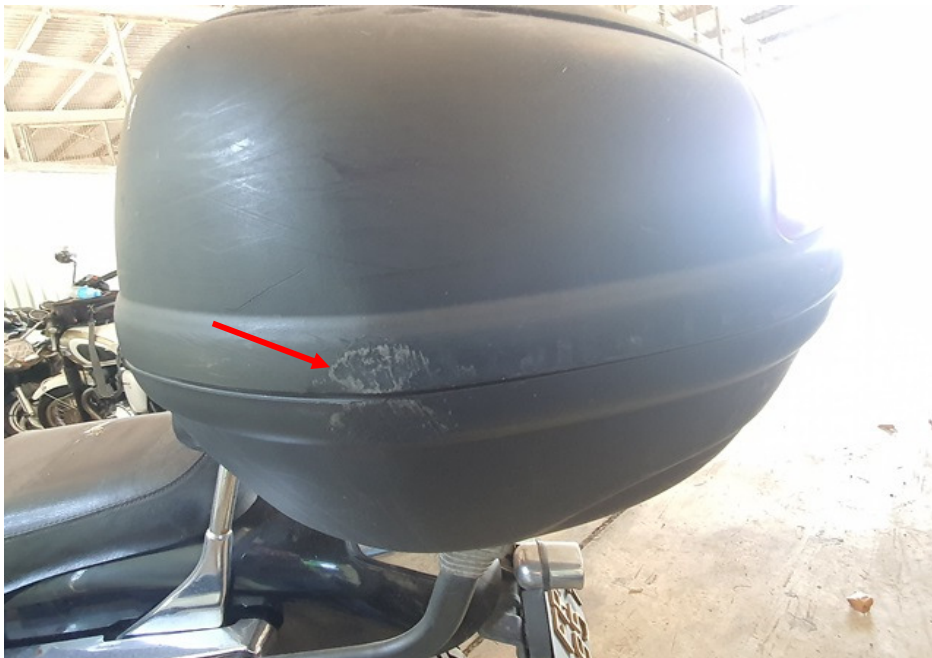
**Photo 14** shows a closer view of the top box (arrowed) which was amongst the body parts of the Motorcycle that had sustained damage as a result of the accident.

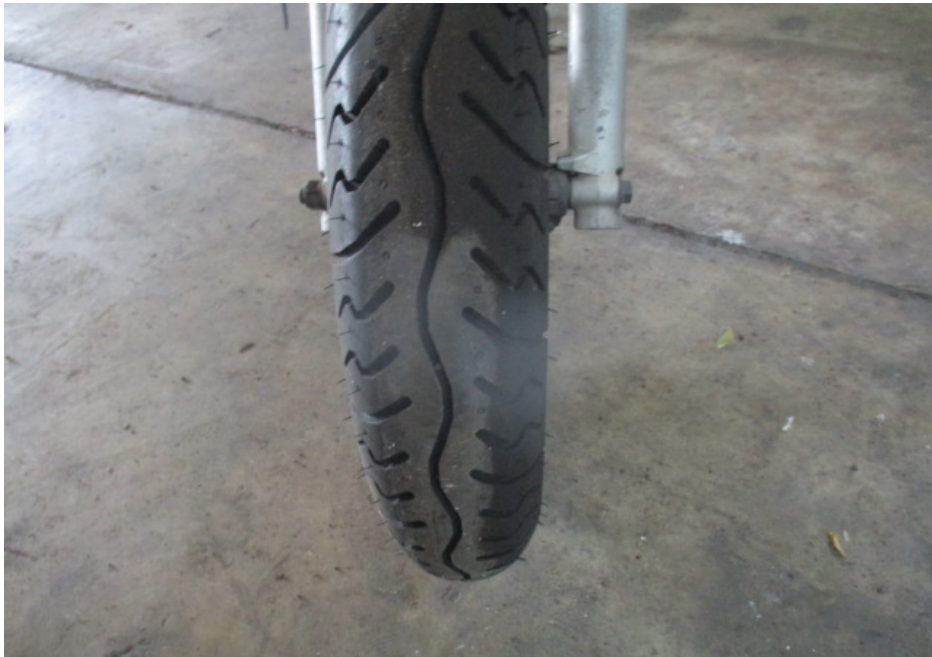
**Photo 15** shows the condition of the Motorcycle's front tyre. The front tyre was observed to be in serviceable condition with remaining tread depth of approximately 3mm. There was no tear, burst mark(s) and/or punctured hole(s) on the sidewalls as well as across the tread of the front tyre.

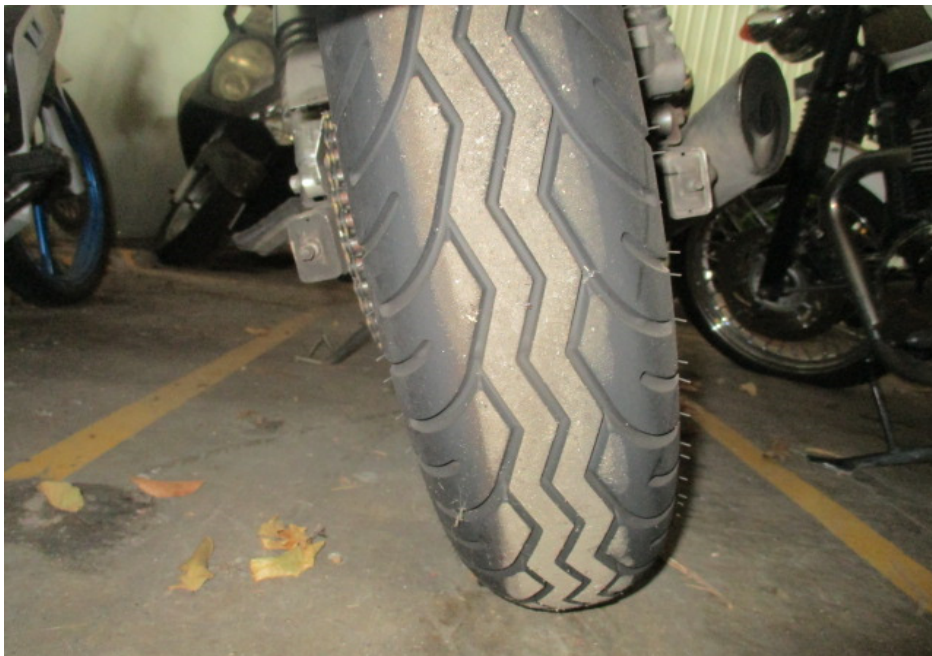
**Photo 16** shows the condition of the Motorcycle's rear tyre. The rear tyre was observed to be in serviceable condition with remaining tread depth of approximately 3mm. The tyre was also observed to be sufficiently inflated for vehicular operation. We did not observe any tear, burst mark(s) and/or punctured hole(s) on the sidewalls as well as across the tread of the rear tyre.

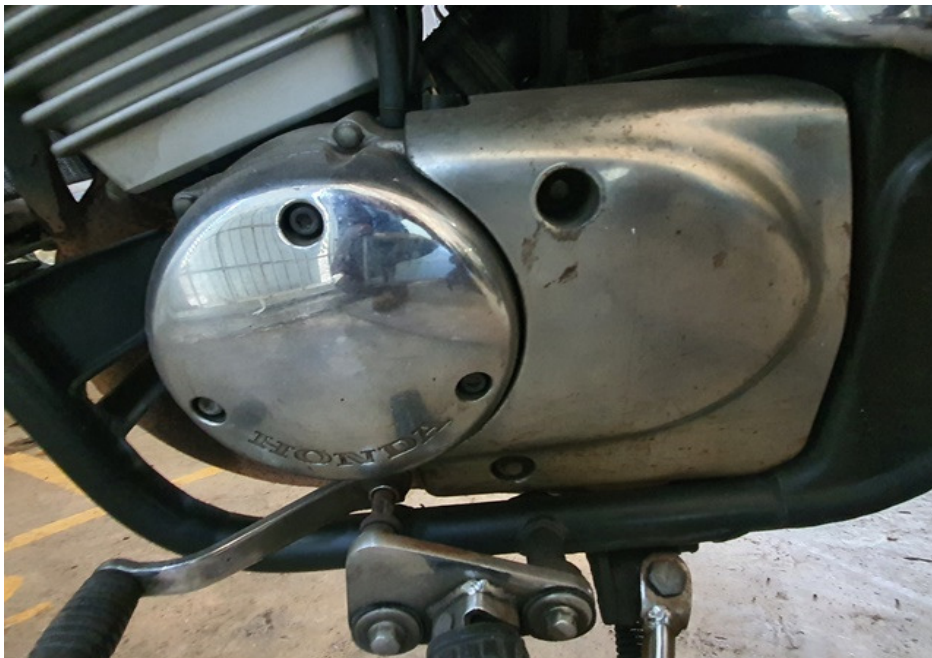
**Photo 17** shows the left side of the engine of the Motorcycle at the time of our inspection. The various engine related parts and components were found to be intact with no visible damage. There was also no sign(s) or indication(s) of fluid leak observed around the left engine area of the Motorcycle.

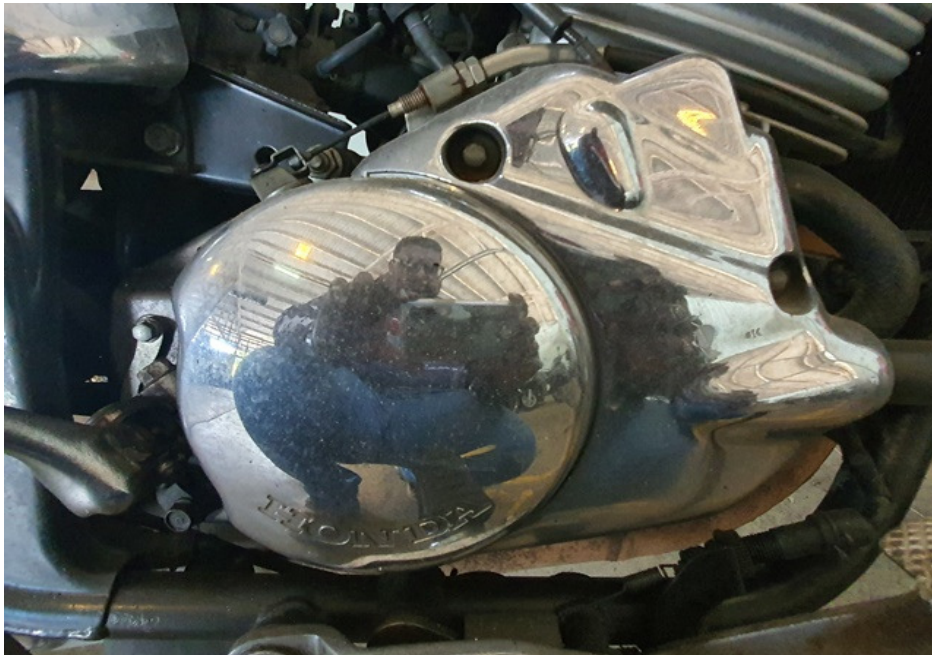
**Photo 18** shows the right side of the engine of the Motorcycle at the time of our inspection. The various engine related parts and components were found to be intact with no visible damage. There was also no sign(s) or indication(s) of fluid leak observed around the right engine area of the Motorcycle.

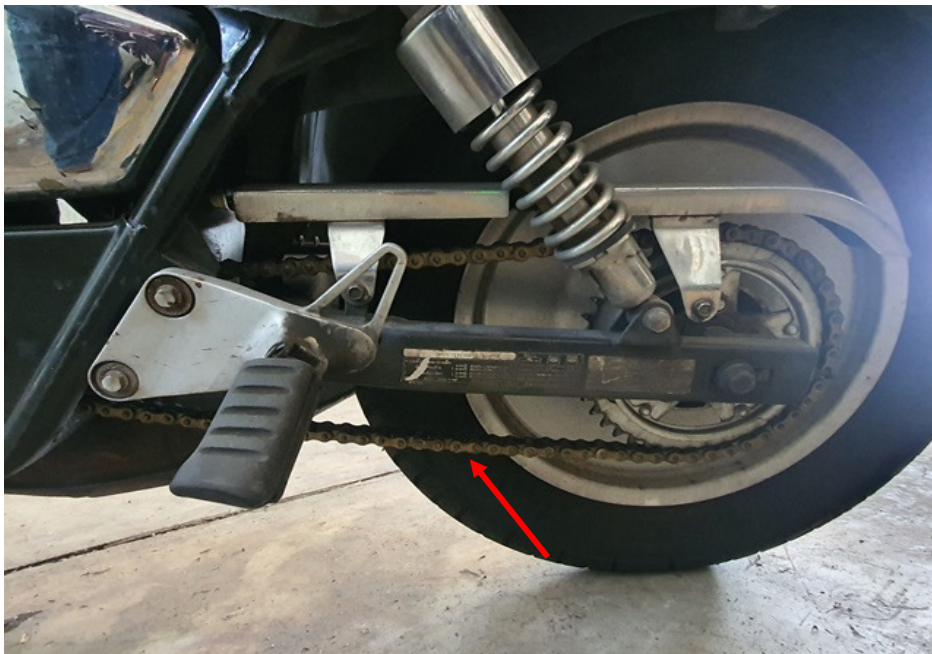
**Photo 19** shows the general view of the gear train (arrowed) of the Motorcycle, which was observed to be intact with no misalignment. It was also adequately lubricated for operating purposes.

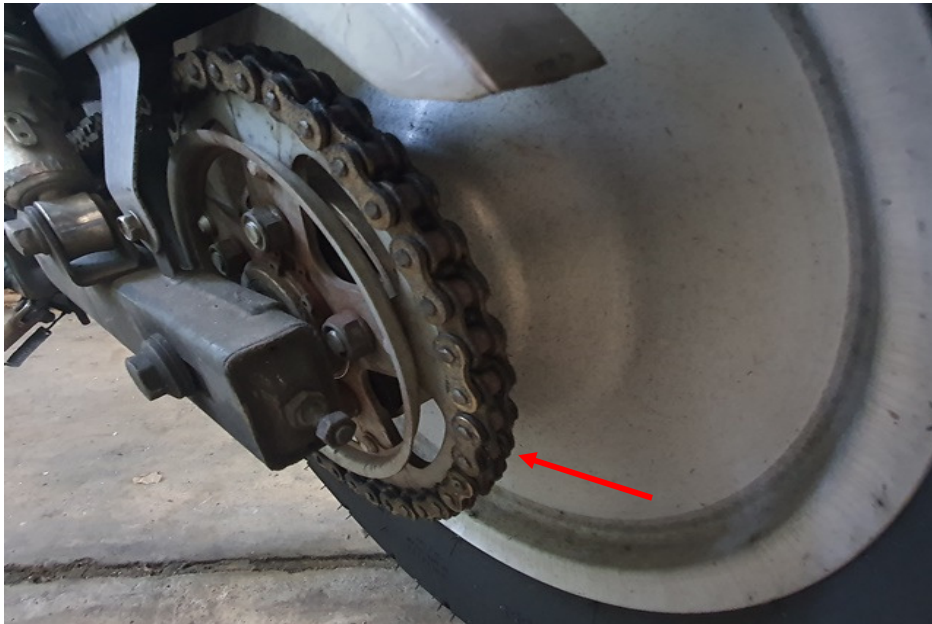
**Photo 20** shows a closer view of the gear train (arrowed) of the Motorcycle, which was observed to be intact with no misalignment. It was also adequately lubricated for operating purposes.

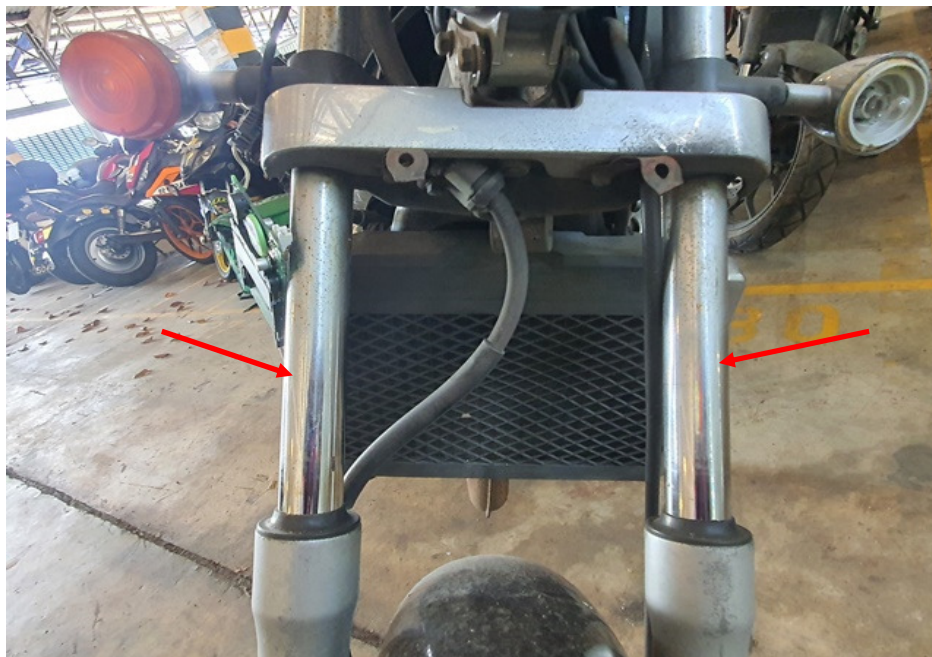
**Photo 21** shows the front fork (arrowed) of the Motorcycle. The front fork and fork bracket of the Motorcycle were both found to be intact and undamaged. Turning the Motorcycle's handle bar towards the left and right did not produce any abnormal free play and/or resistance. The steering system of the Motorcycle was in serviceable condition at the time of our inspection.

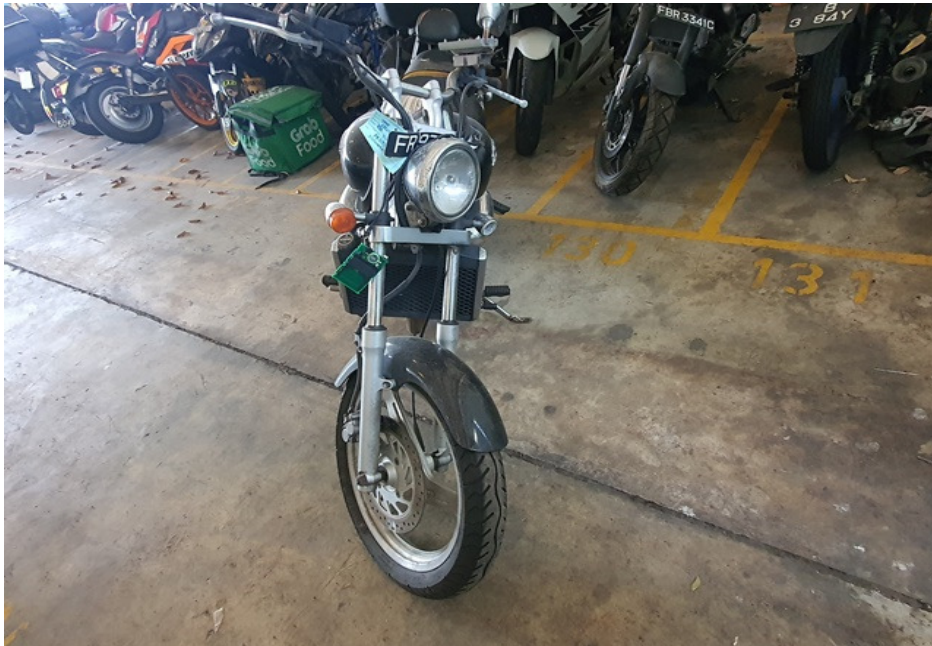
**Photo 22** shows the front wheel of the Motorcycle turned towards its full left. Turning the Motorcycle's handle bar towards the left and right did not produce any abnormal free play and/or resistance. This would indicate that the steering system of the Motorcycle was in serviceable condition at the time of our inspection.

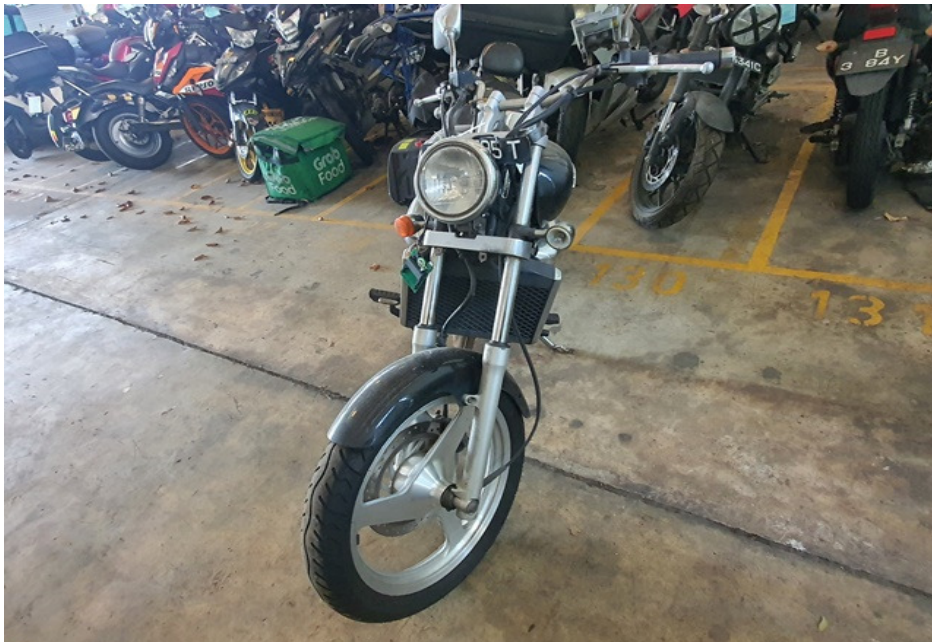
**Photo 23** shows the front wheel of the Motorcycle turned towards its full right. Turning the Motorcycle's handle bar towards the left and right did not produce any abnormal free play and/or resistance. This would indicate that the steering system of the Motorcycle was in serviceable condition at the time of our inspection.

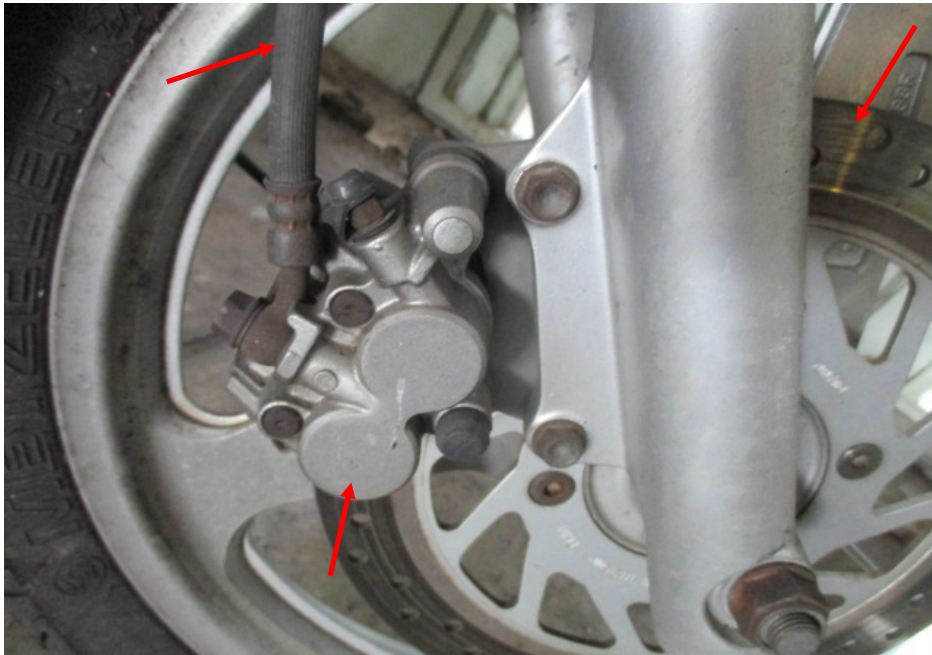
**Photo 24** shows a close up view of the front brake caliper, front brake disc and front brake hose (arrowed) of the Motorcycle, which are all part of the components in the hydraulic front brake system of the Motorcycle. Our visual checks of these various components had revealed all to be intact with no visible damage. No leakage of brake fluid was also observed.

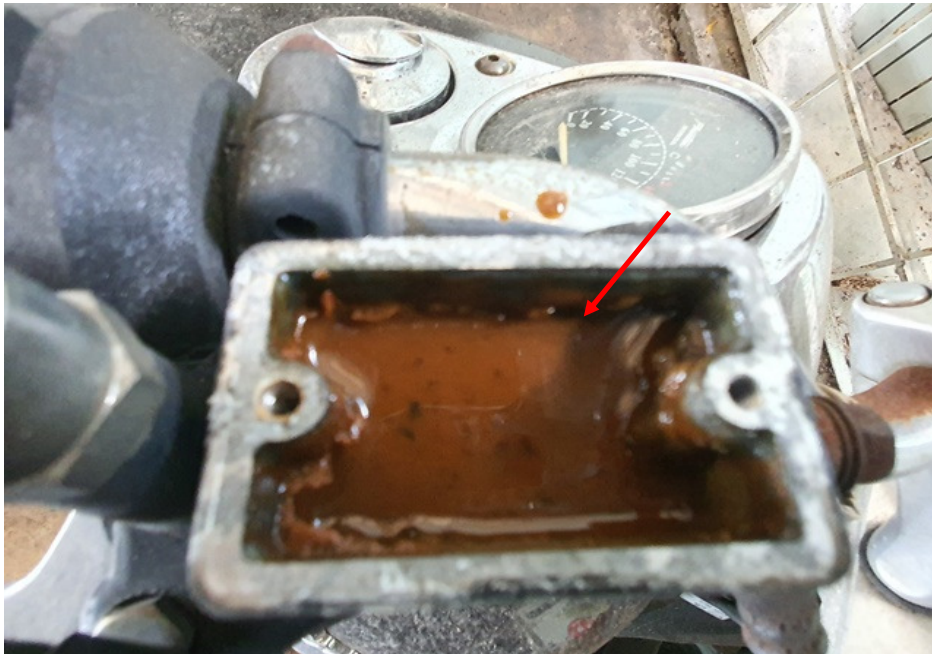
13. Our visual examination of the various components in the Motorcycle's braking system like the brake discs, brake calipers, brake lever, brake foot pedal and brake hoses revealed all to be intact and without damage. There was also no leakage of brake fluid observed along the brake hoses. This was from the respective brake fluid reservoirs to the front brake caliper and rear brake caliper of the Motorcycle. The brake fluid for the front brake and rear brake was also found to be of sufficiently level for operational purposes. However the brake fluid for the front brake was observed to be contaminated.

**Photo 25** shows the brake fluid reservoir for the front brake of the Motorcycle. The brake fluid was observed to be of sufficient level for operational purposes. However it was observed to be contaminated (arrowed).

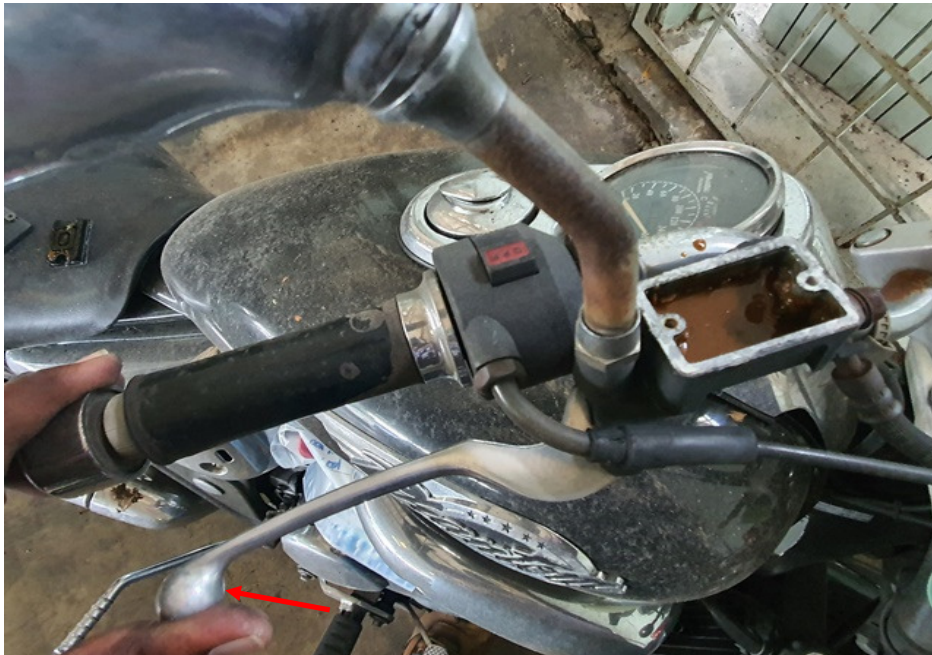
14. Static brake tests conducted on the Motorcycle had appear to indicate that the braking system of the Motorcycle was in serviceable condition. There was some resistance felt (spongy like feel) upon pressing the brake lever and upon stepping on the brake pedal. This would indicate that there was no leakage of pressure/vacuum in the braking system.

**Photo 26** shows the front brake lever being depressed. There was some resistance felt (spongy like feel) upon pressing the front brake lever (arrowed). This would indicate that there is no leakage of pressure/vacuum in the brake system.

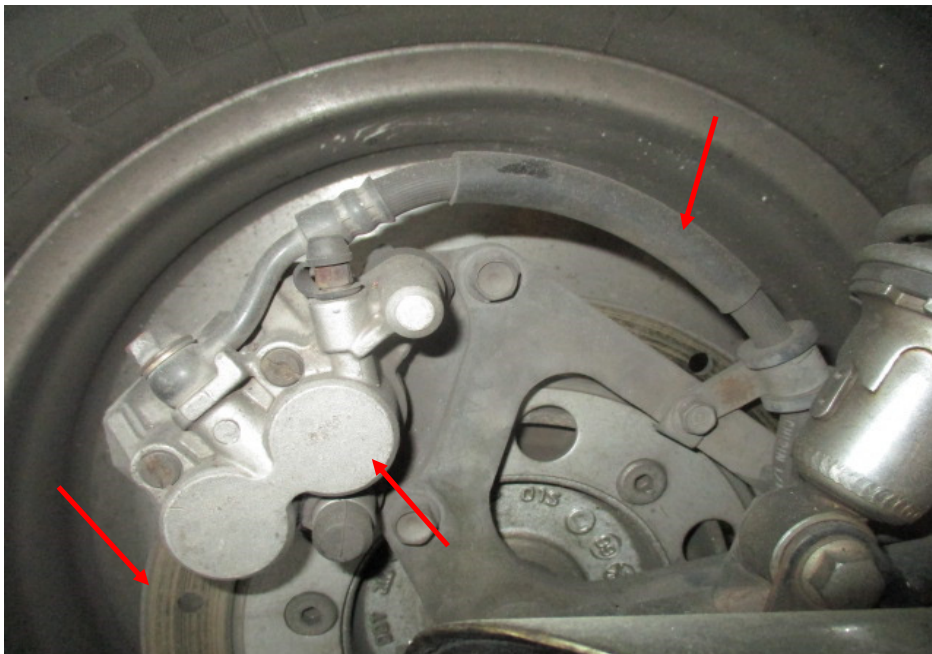
**Photo 27** shows a close up view of the rear brake caliper, rear brake disc and rear brake hose (arrowed) of the Motorcycle, which are all part of the components in the hydraulic rear brake system of the Motorcycle. Our visual checks of these various components had revealed all to be intact with no visible damage. No leakage of brake fluid was also observed.
